The Eastgate, Chester 1972

by P. H. Alebon, P. J. Davey, D. J. Robinson.

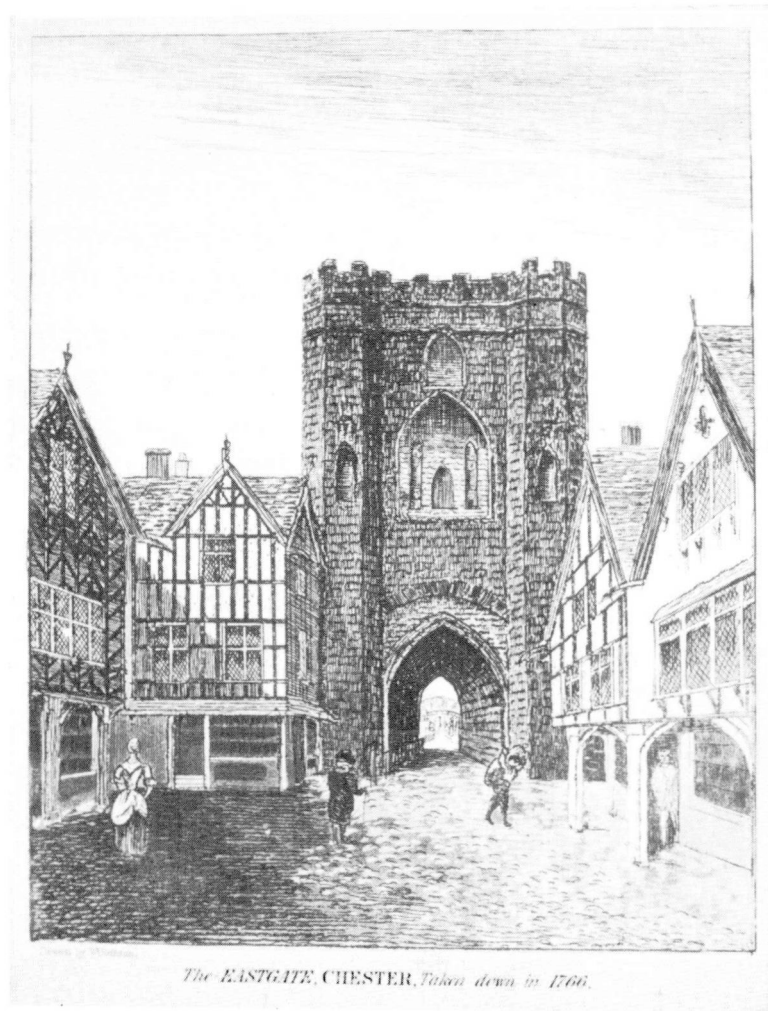
Fig. 24 'Etching by Wilkinson'.

3. An etching by Wilkinson (fig. 24) showing the gate from the east with the cluster of houses still round it—there are a number of versions of this in print form (e.g., Hughes 1856, 17). It is not clear if there is any relationship between this Wilkinson and the artist of the *Earwaker MSS*. Chronology would certainly allow them to be the same person.

Another difficulty is provided by Wilkinson's drawing. He shows an open stone gallery crossing the gate passage, while behind it lies a wall bearing the four shields and central statue which are a feature of all the drawings. This wall is thus recessed some distance behind the front face of the gate. At the top it is sealed by an arch, which appears on all the drawings, sometimes Roman sometimes Gothic in style. It is difficult to reconcile the two versions or to explain such an important discrepancy when a minor detail such as the shields appears on them all. Obviously a passage would be included in the structure to make the parapet-walk of the City Walls continuous, but it is not now possible to decide whether it was totally internal or partly open.

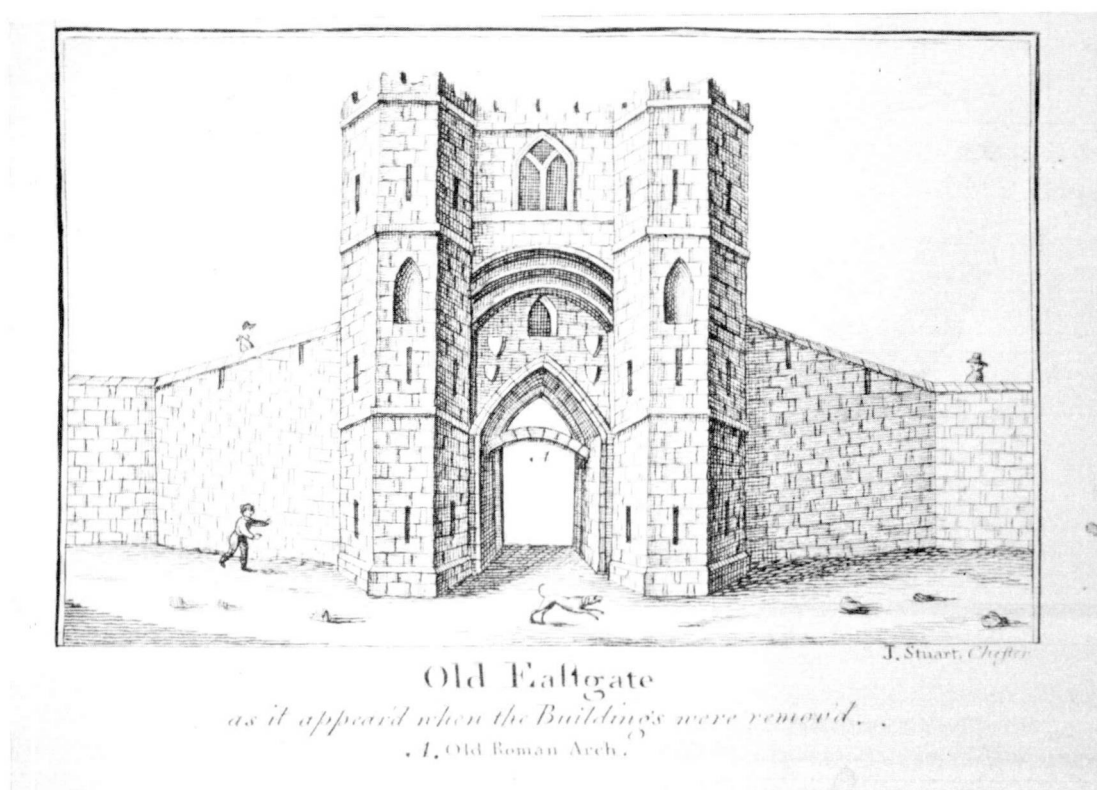
Fig. 25 'Etching by J. Stuart'.

4. An etching by Stuart (fig. 25) of the gate and adjacent walls viewed from the east 'when the buildings were removed' (see e.g., Simpson, 1910, 12-14).
