### EXCAVATIONS AT CHESTER HILL FORT, HUNDLESHOPE, IN MANOR PARISH, 1939. By Miss P. A. M. KEEF, F.S.A.Scot.

Chester Hill is one of a striking cluster of forts overlooking a dry valley of the Tweed in Manor Parish, two miles south of Peebles. It crowns a spur 1000 feet above sea-level of the great mass of Hundleshope Heights, which rise over 2000 feet high at the junction of the Manor Water and the Hundleshope-Haystoun valley.

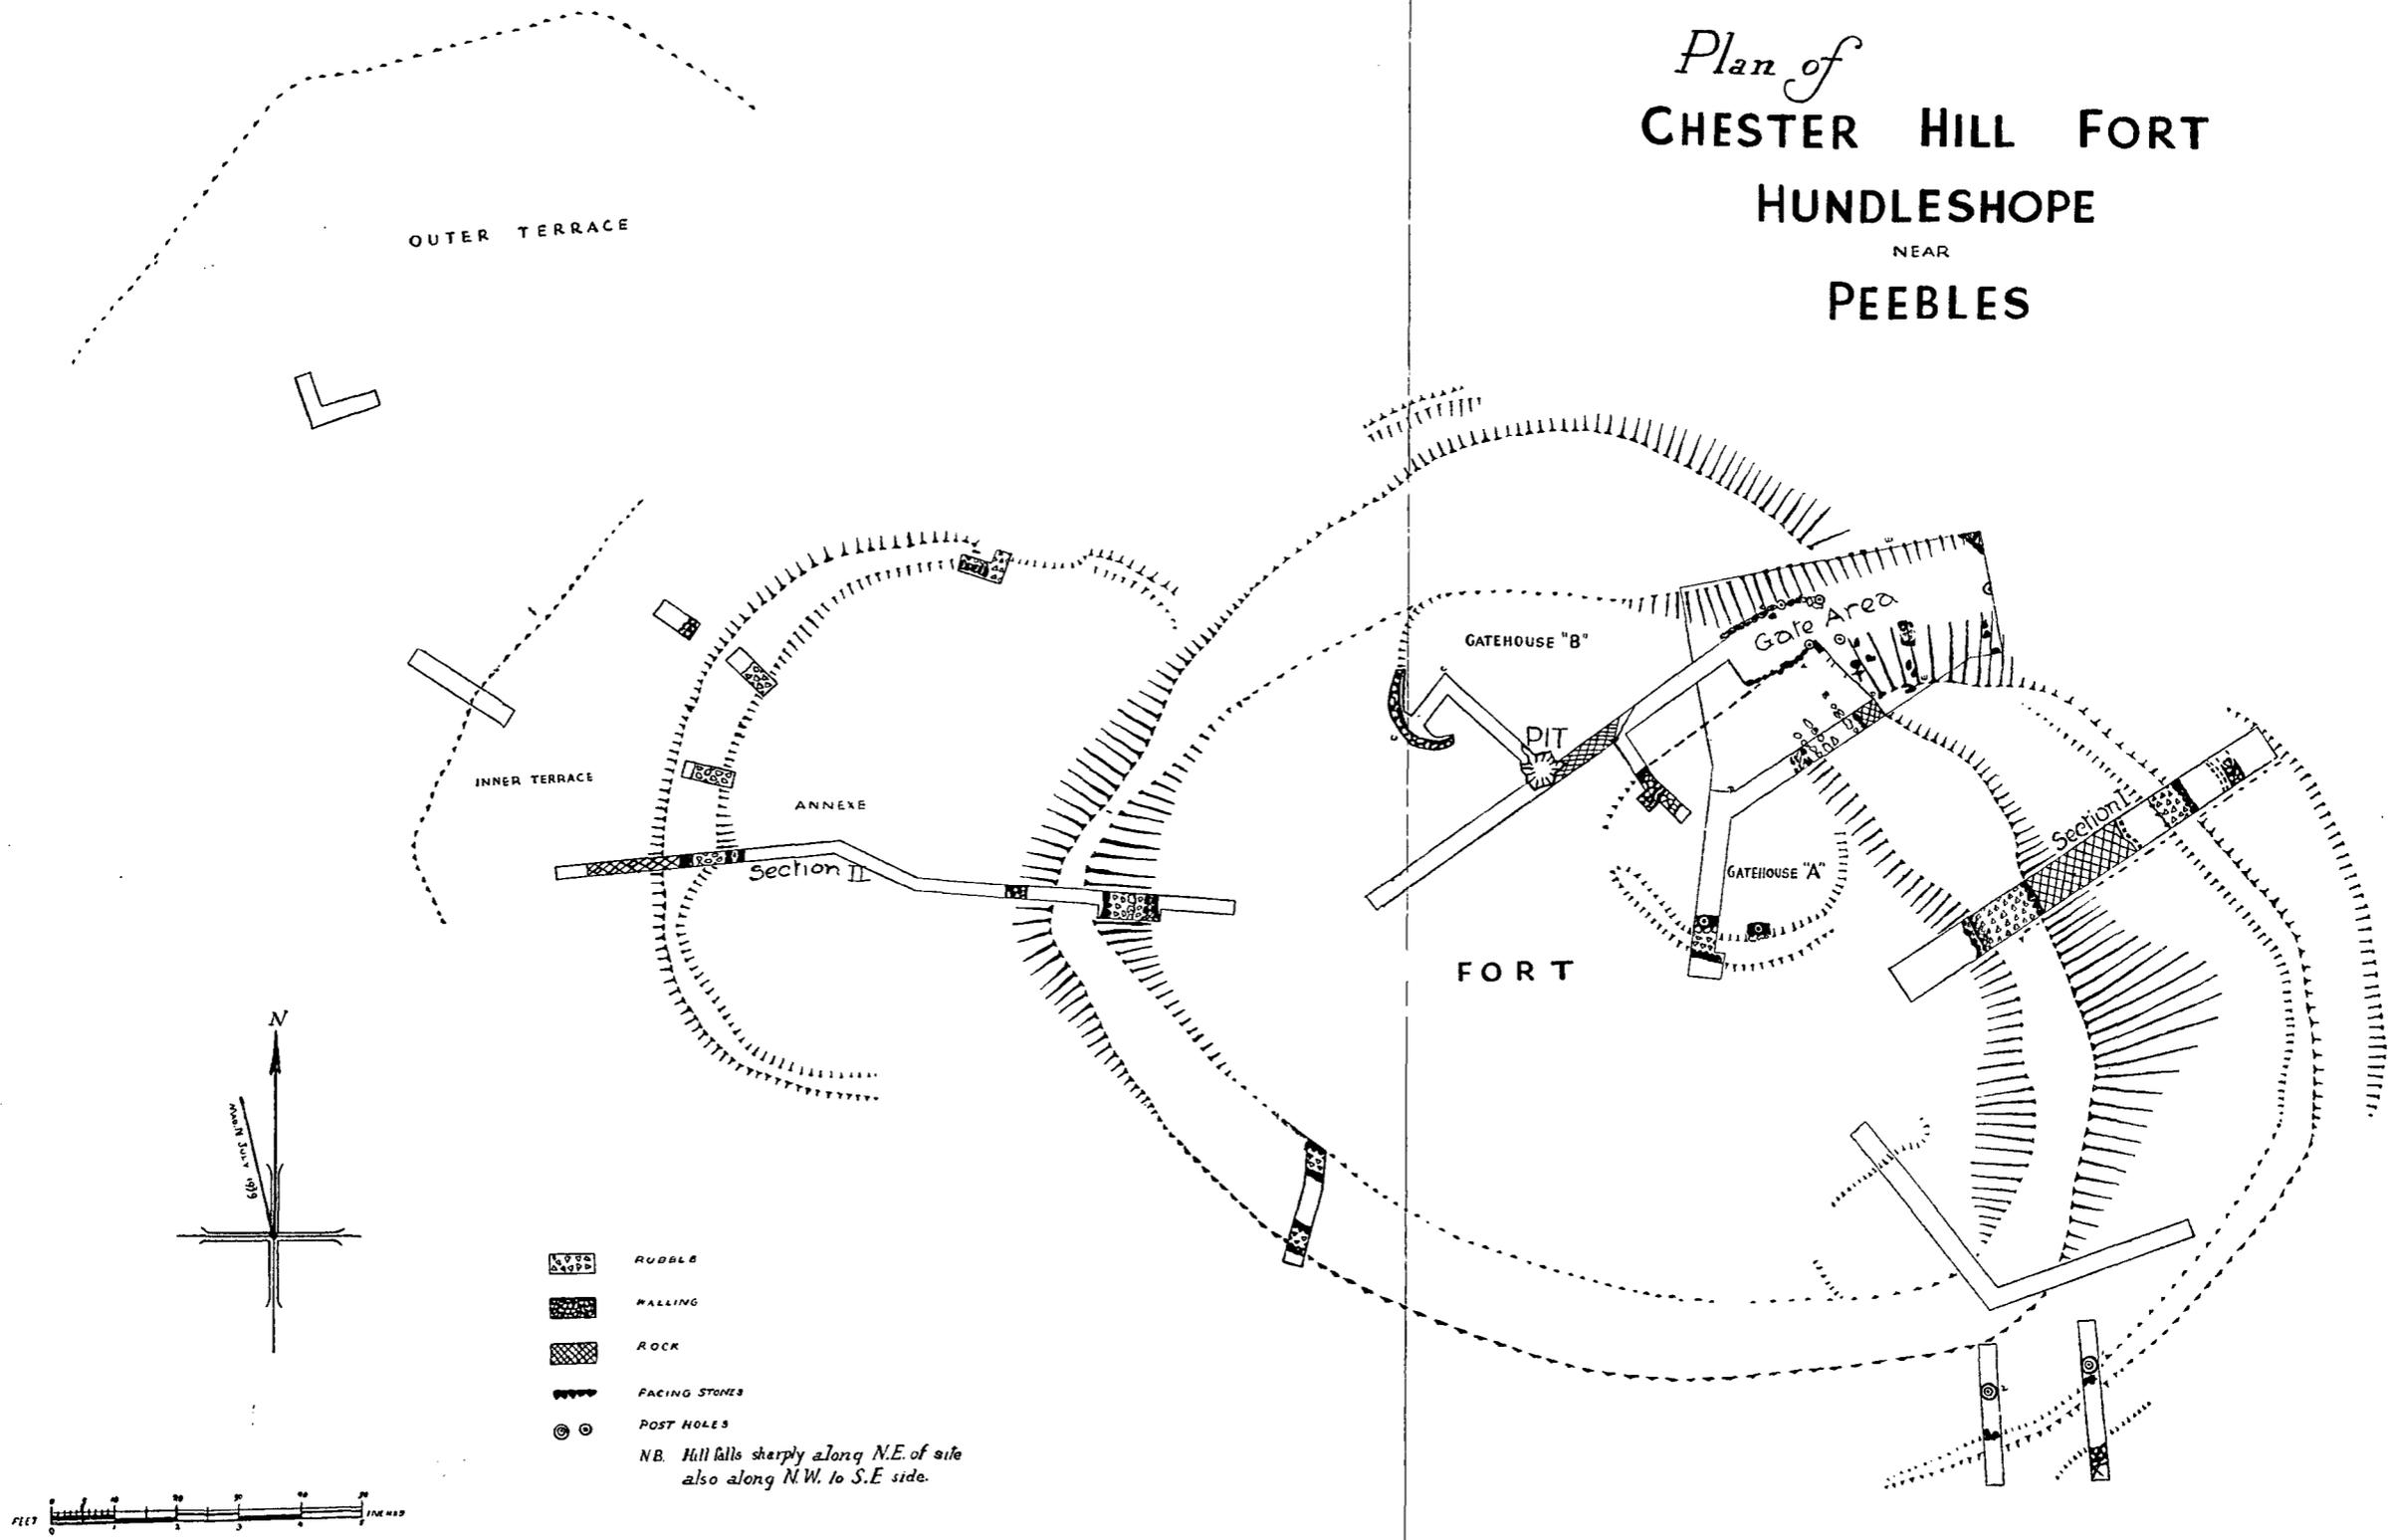
Fig. 1. Plan of Chester Hill Fort.

excavated area, as shown in the plan (fig. 1), are due to the position of trees, and many problems had to be left unsolved as trees were growing in critical places.

The road approaches the gateway obliquely, mounting steadily till at the gate it turns sharply to the left and levels out, rising again as it enters the camp. It was difficult to follow the road inwards beyond this point, as trees were growing close together over all the suspected line, but its continuation may be defined by a wall running side by side with the wall of gatehouse A (see plan), and seeming to carry on the line of the south revetment of the gateway.

The inner rampart, reduced to footing-stones, consists of a rubble core with built faces. The inner face follows a rock ridge that has been quarried away to enhance the height of the face. The latter seems to be double. The outer face is set back 4 feet from the edge of the outer ditch. The inner ditch has been almost entirely cut in the solid rock by splitting the stone along natural cleavage planes, leaving jagged edges (fig. 3). The outer rampart has been built on an earth surface. Its inner face, if any, had been entirely robbed, but, on the outside, a wall of large stones supported a rubble core. Between this revetment and the inner lip of the outer ditch is a berm 4 feet wide on which lay stones that had presumably slipped from the rampart. In the bottom of the outer ditch were found lying big stones from the face of the outer rampart and the outside wall. These lay on a small deposit of rapid silt that had accumulated while the defences were in use. Beyond the ditch were traces of a counter-scarp wall, represented only by footings consisting of large, carefully chosen stones, most of which had been pushed back into the ditch about the same time as the facing-stones from the outer rampart. Doubts as to the existence of the wall were, in fact, only removed after it had been found again, better preserved, in the section in the south corner (see fig. 1).

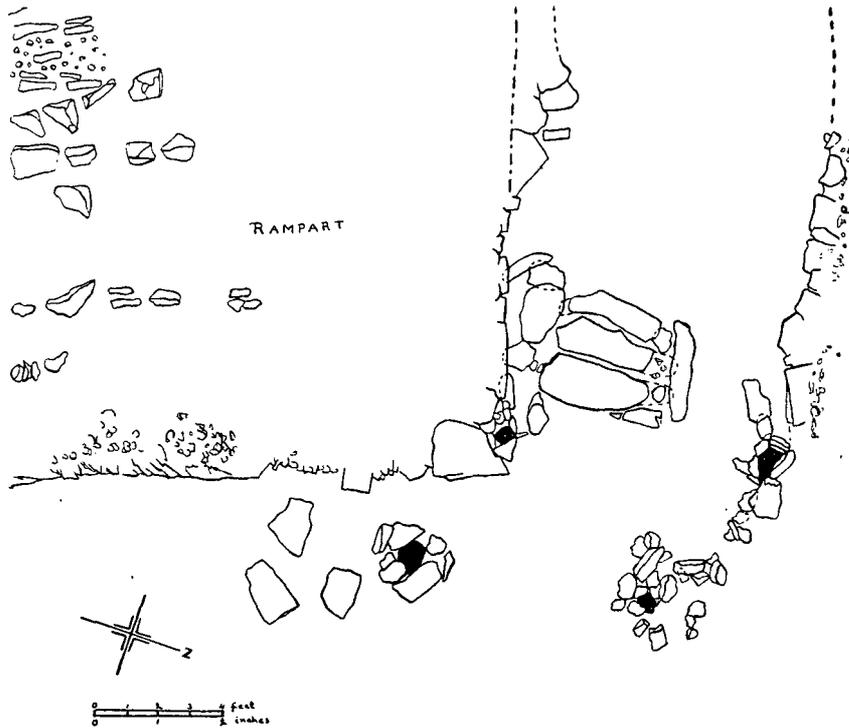
Fig. 2. Chester Hill Fort: enlarged plan of gate area.

*Entrance.*—The entrance (fig. 2) was clearly marked by a gap in the rampart on the east. At the gateway the rampart was robbed down to the foundations. It was apparently formed of a rubble core revetted inside and out with large stones, which were found at places appropriate for such facings. The entrance passage through the rampart is faced on the south

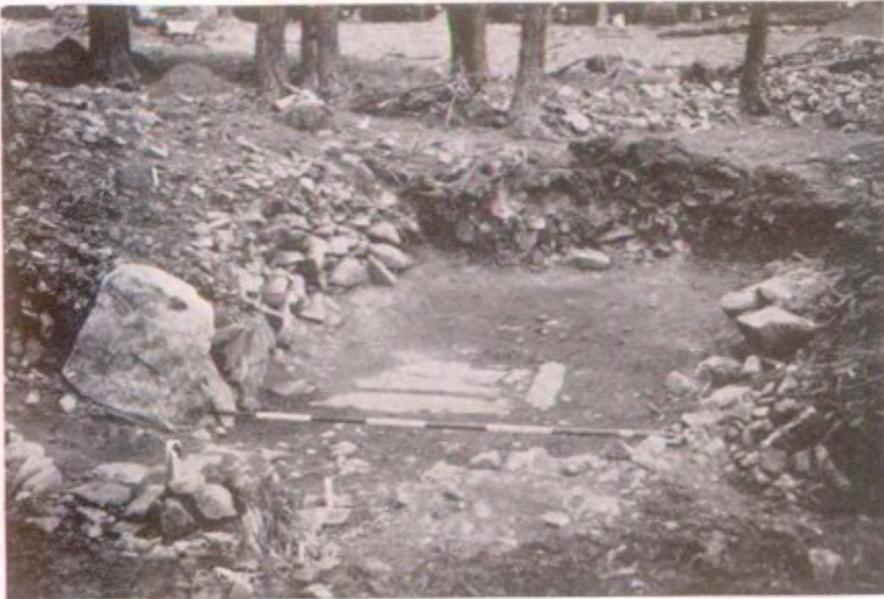
1. View through gate (represented by pole) into camp interior.

side with large irregular stones arranged with the flat side outwards (Pl. XIV, 1, 2), while the core itself is tied with large bond stones in the manner of a modern dry-stone dyke. This revetment stood 4 feet high, the best piece of walling exposed. The revetment terminates on the east in a massive corner-stone, a boulder of igneous rock, foreign to the site, so arranged that a groove on its face (perhaps artificially deepened) provides additional support for the gate-post. The socket for this gate-post (Pl. XIV, 4) lies immediately to the north of the corner-stone.<sup>1</sup> It is framed with interlocking stones, one of which extends under the rampart revetment so that its weight holds down all the stones. The interspaces between them are occupied with wedge-stones, driven in after the others were in place, to secure them in accordance with a system still current in the district under the local name of "pegging." The corresponding post-hole on the north side of the gate is made in the same way, but is deeper (Pl. XIV, 5). Two slabs found superimposed immediately behind the post-hole seem to represent the counterpart of the monolithic corner-stone.

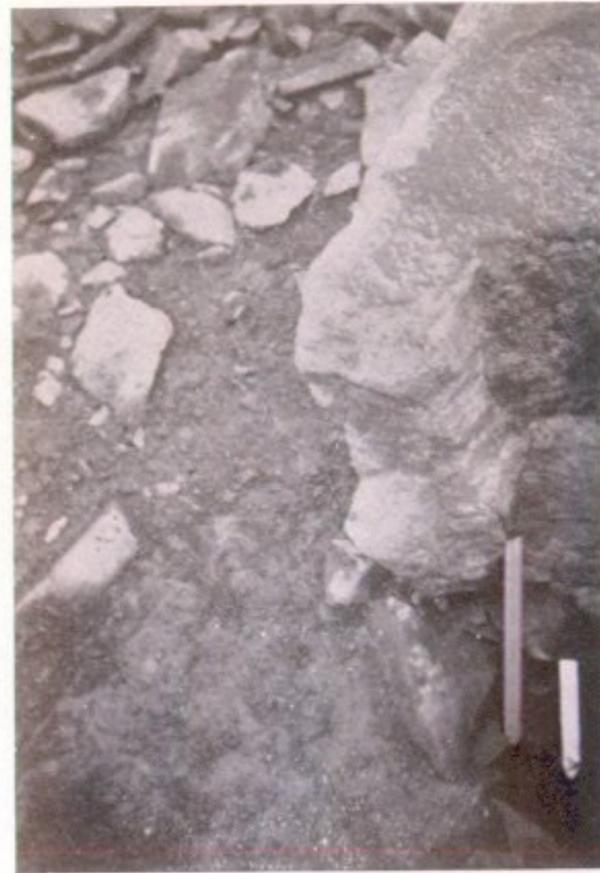
4. Enlarged view of south inner gate post-hole.

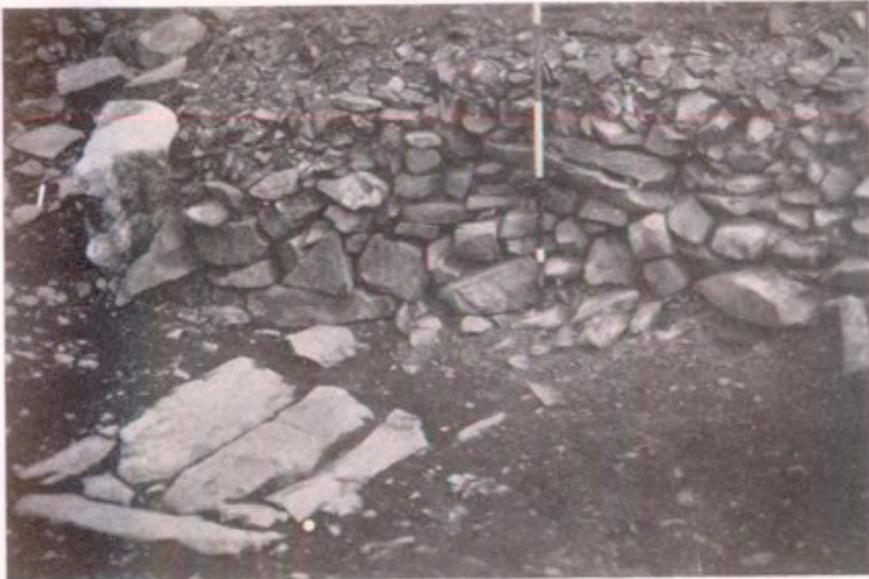
2. Gate area, showing original walling, threshold slabs, and south inner gate post.

The fairway between the gate-posts is 9 feet wide, and is not cobbled, but made of trodden earth<sup>2</sup> with a few flat stones in it. Across the threshold were found inset in their original position three flat slabs 5 feet long (Pl. XIV, 2) of local stone.<sup>3</sup> They had been placed side by side, with their length across the gate, and, when lifted, turned out to be 1 foot thick. Nothing was found under them. At their north end they were all tied down by a billet-shaped stone across their whole width.<sup>4</sup> To the south the paving was continued by a series of small stones, laid touching one another, and a final slab that partly underlies the south wall. The three threshold slabs are interlocked like the stones framing the post-holes. Thus the wall's weight keeps the slabs in place.

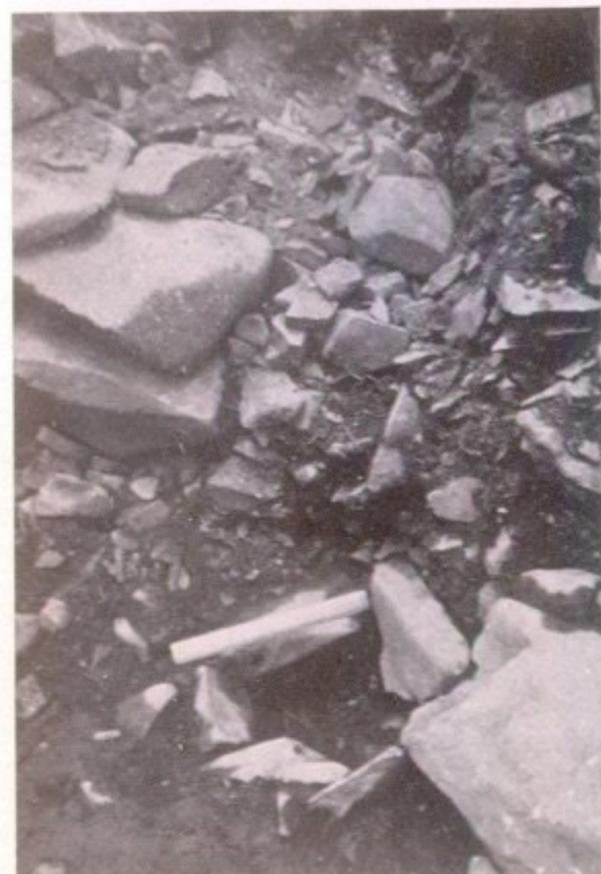
5. Inner gate post-hole, north side.

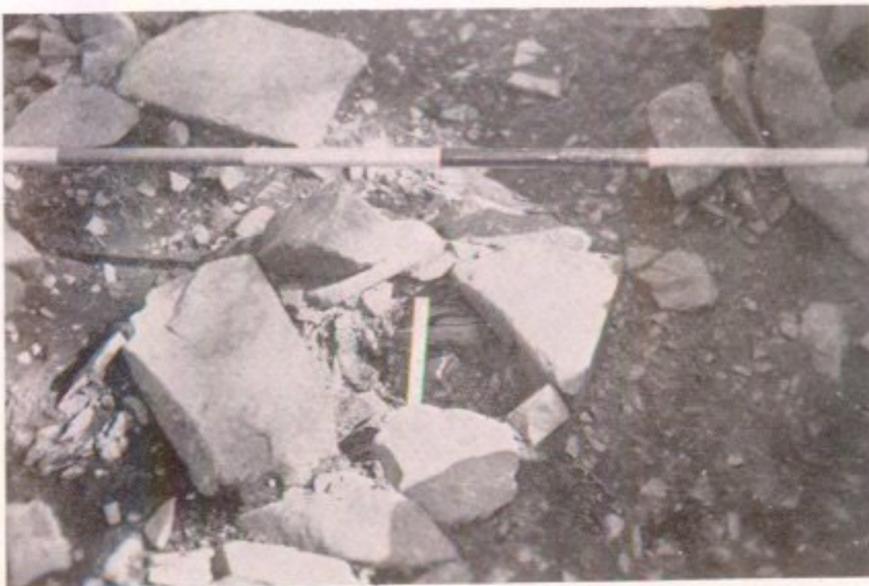
3. South outer gate post-hole.

Another pair of post-holes was discovered east of the foregoing and not continuing the line of the fairway through the ramparts, *i.e.* turning sharply to the right instead (Pl. XIV, 3). These post-holes are shallower than the inner ones, and the stones framing them are not interlocked, though one is pegged. As shown in the plan, a hornwork built out from the rampart on the north side of the gate connects the outer post-holes with the inner.

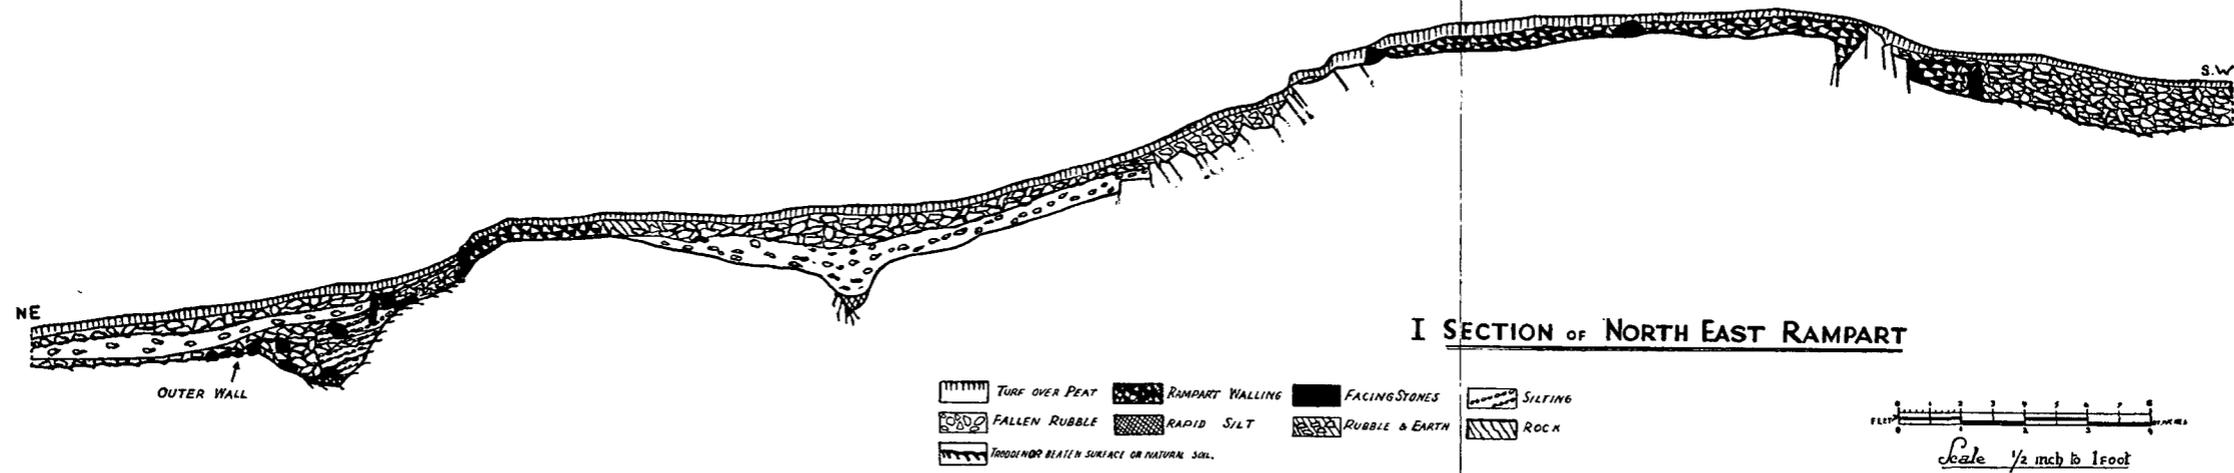
Fig. 3. Chester Hill Fort: Main and Outer Ramparts.

*Defences.*—South of the gate the defences were found to consist of an inner rampart 20 feet wide, a rock-cut ditch, an outer rampart, and an outer ditch dug in the subsoil with a free-standing wall beyond it.

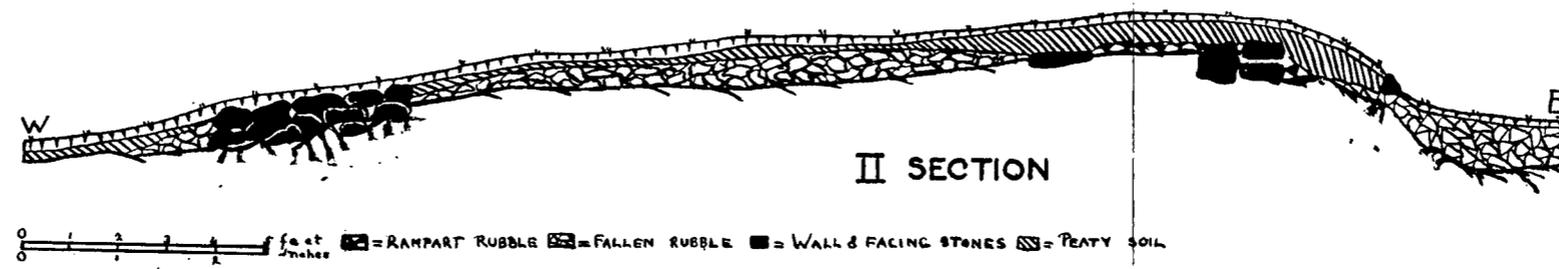
Fig. 4. Chester Hill Fort: Main South-west Rampart.

On the south-west, the main or inner rampart was tested in two places (figs. 4, 1). Prolonging the central trench southward we exposed an area of rock, studded at intervals with large stones, the southward of which should represent the south-west rampart, but this was here too far ruined for the construction to be discernible. To clear up the question the adjoining trench was extended southward, and here the rampart was quite clear, standing three courses high and 5 feet wide. Eight feet further south we exposed the footings of a second wall, also 5 feet wide. The earth in the space between the walls has been trodden hard. It was covered with a thin layer of rubble. We found no ditch outside this rampart, but the hill slopes steeply down beyond it. A second strip of

rampart was exposed outside the first, but only the foundations of the rubble core survived.

Further west the same rampart was exposed in a trench dug to determine the nature of the Fort's floor. Here the floor consisted of trodden subsoil and sloped up towards the rampart as in the east. As there, the rampart rested on the rock and was about 10 feet wide. It consisted of a rubble core faced on both sides with large stones. Outside this face compacted subsoil sloped steeply down to the annex floor, the slope being covered with a layer of rubble. At the point where the slope reached the annex floor another wall was found running parallel to the rampart at the top. It was built of large irregularly shaped stones, set about 9 inches deep in the earth. In two places handfuls of subsoil had been put between the stones, like mortar. Outside this rampart no trace of a ditch could be found, though two trial trenches were sunk in the annex to look for one.
