The Yorkshire Television vitrified wall experiment at East Tullos, City of Aberdeen District

Ian Ralston*

ABSTRACT

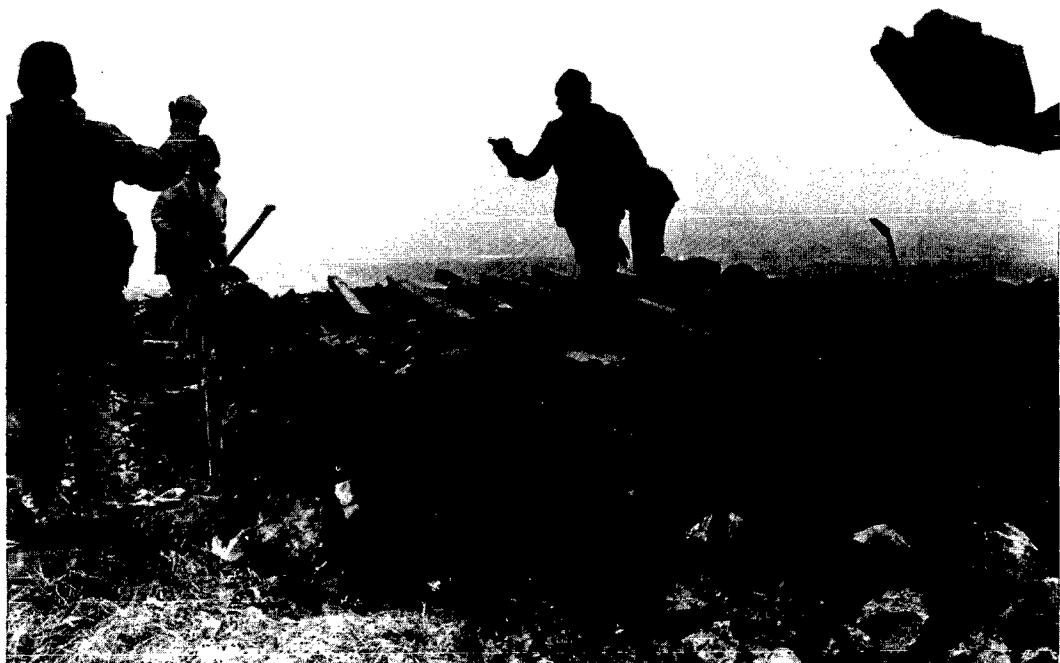
ILLUS 1 An early stage of the construction, looking north. The second row of longitudinals is visible on the surface

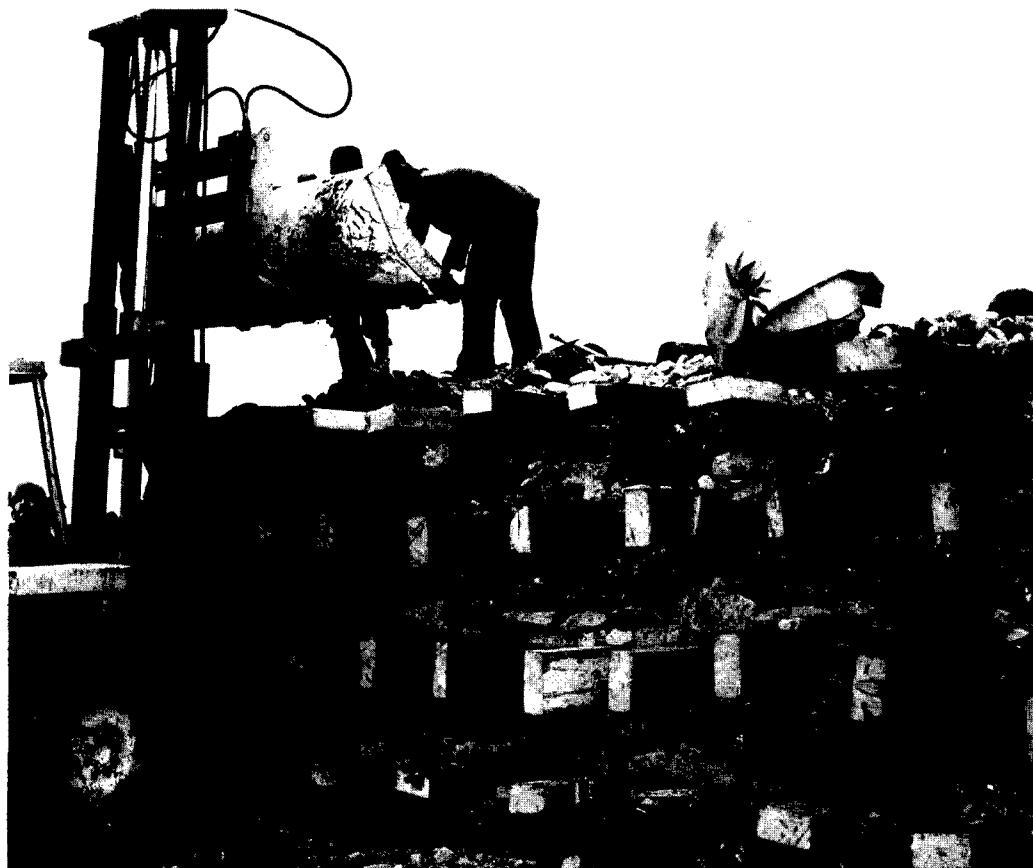
ILLUS 2 Small gabbro chips being added to the hearting of the upper part of the wall

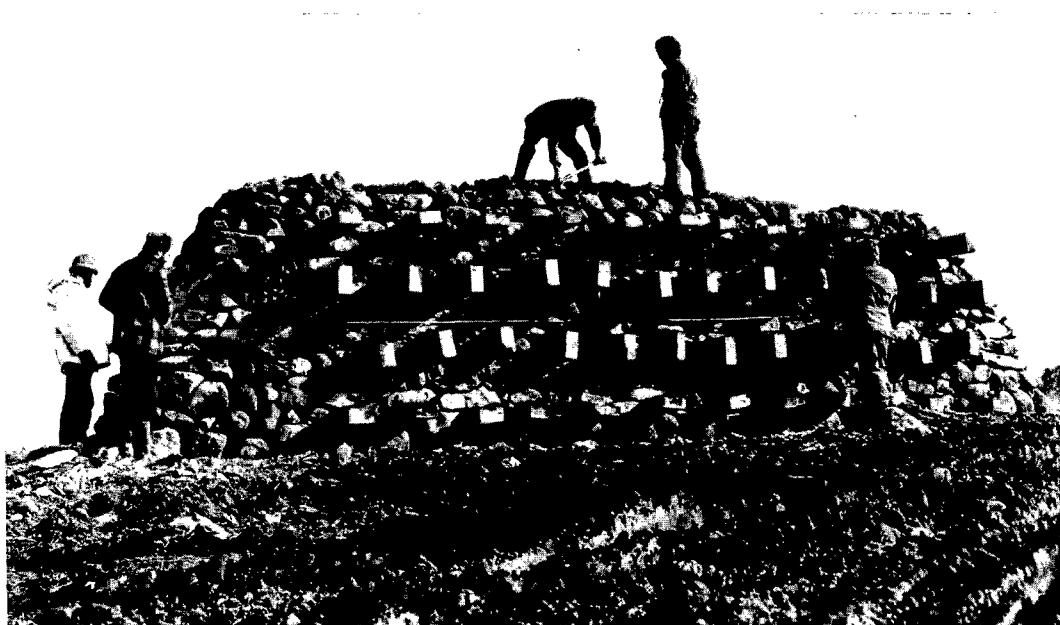
ILLUS 3 The wall nearing completion; measurement in progress as the final capping is spread on the wall-head

The first layer of timbers was inserted almost at ground level: eight of the slender timbers were evenly spaced out and arranged parallel to the principal wall faces; each subsequent horizon of longitudinal timbers used the same number of elements. The hearting at this level consisted essentially of the more substantial gabbros. The initial layer of transversals was incorporated at approximately 0·5 m above the ground surface, though this varied because of the sloping nature of the site. Each subsequent horizon of transversal timbers was off-set slightly, so that the centre-to-centre distance between the end transversals in the second horizon was 6·2 m. Moreover, the transversal beams in the second and third layers were set end-on, since it was felt that this might subsequently be of use in coaxing the beam-ends to ignite. In all, four rows of transversals were employed: 12 beams were placed in each of the three bottom rows, and 11 in the uppermost. The vertical separation of these beams, centre-to-centre, was (from bottom to top) 0·50 m, 0·50 m and 0·55 m. Exact distances were of course determined by the nature of the wall coursing. Midway between each row of transversals, a horizon of eight longitudinals was inserted, and a fifth row of longitudinals overlay the top horizon of transversals, this uppermost set of timbers being sealed by a final layer of stone chips, before the rampart was finally capped with a thin (0·10 m thick) layer of turf and soil (illus 3). It may

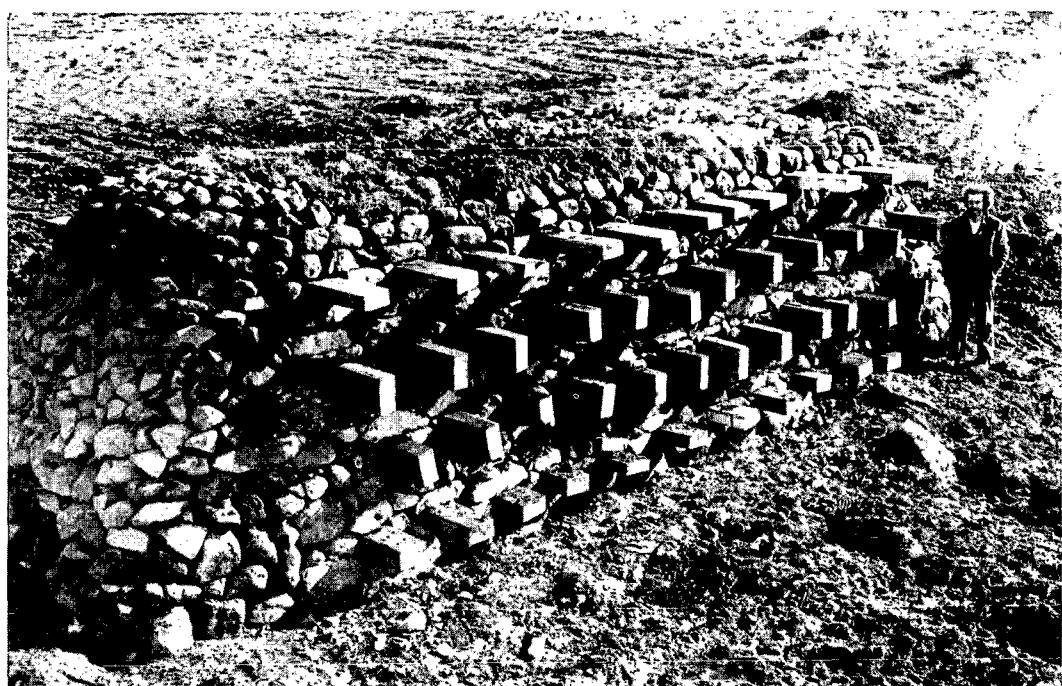
ILLUS 4 Oblique view of the completed wall, showing the south-west face and the drystone construction of the north-west end

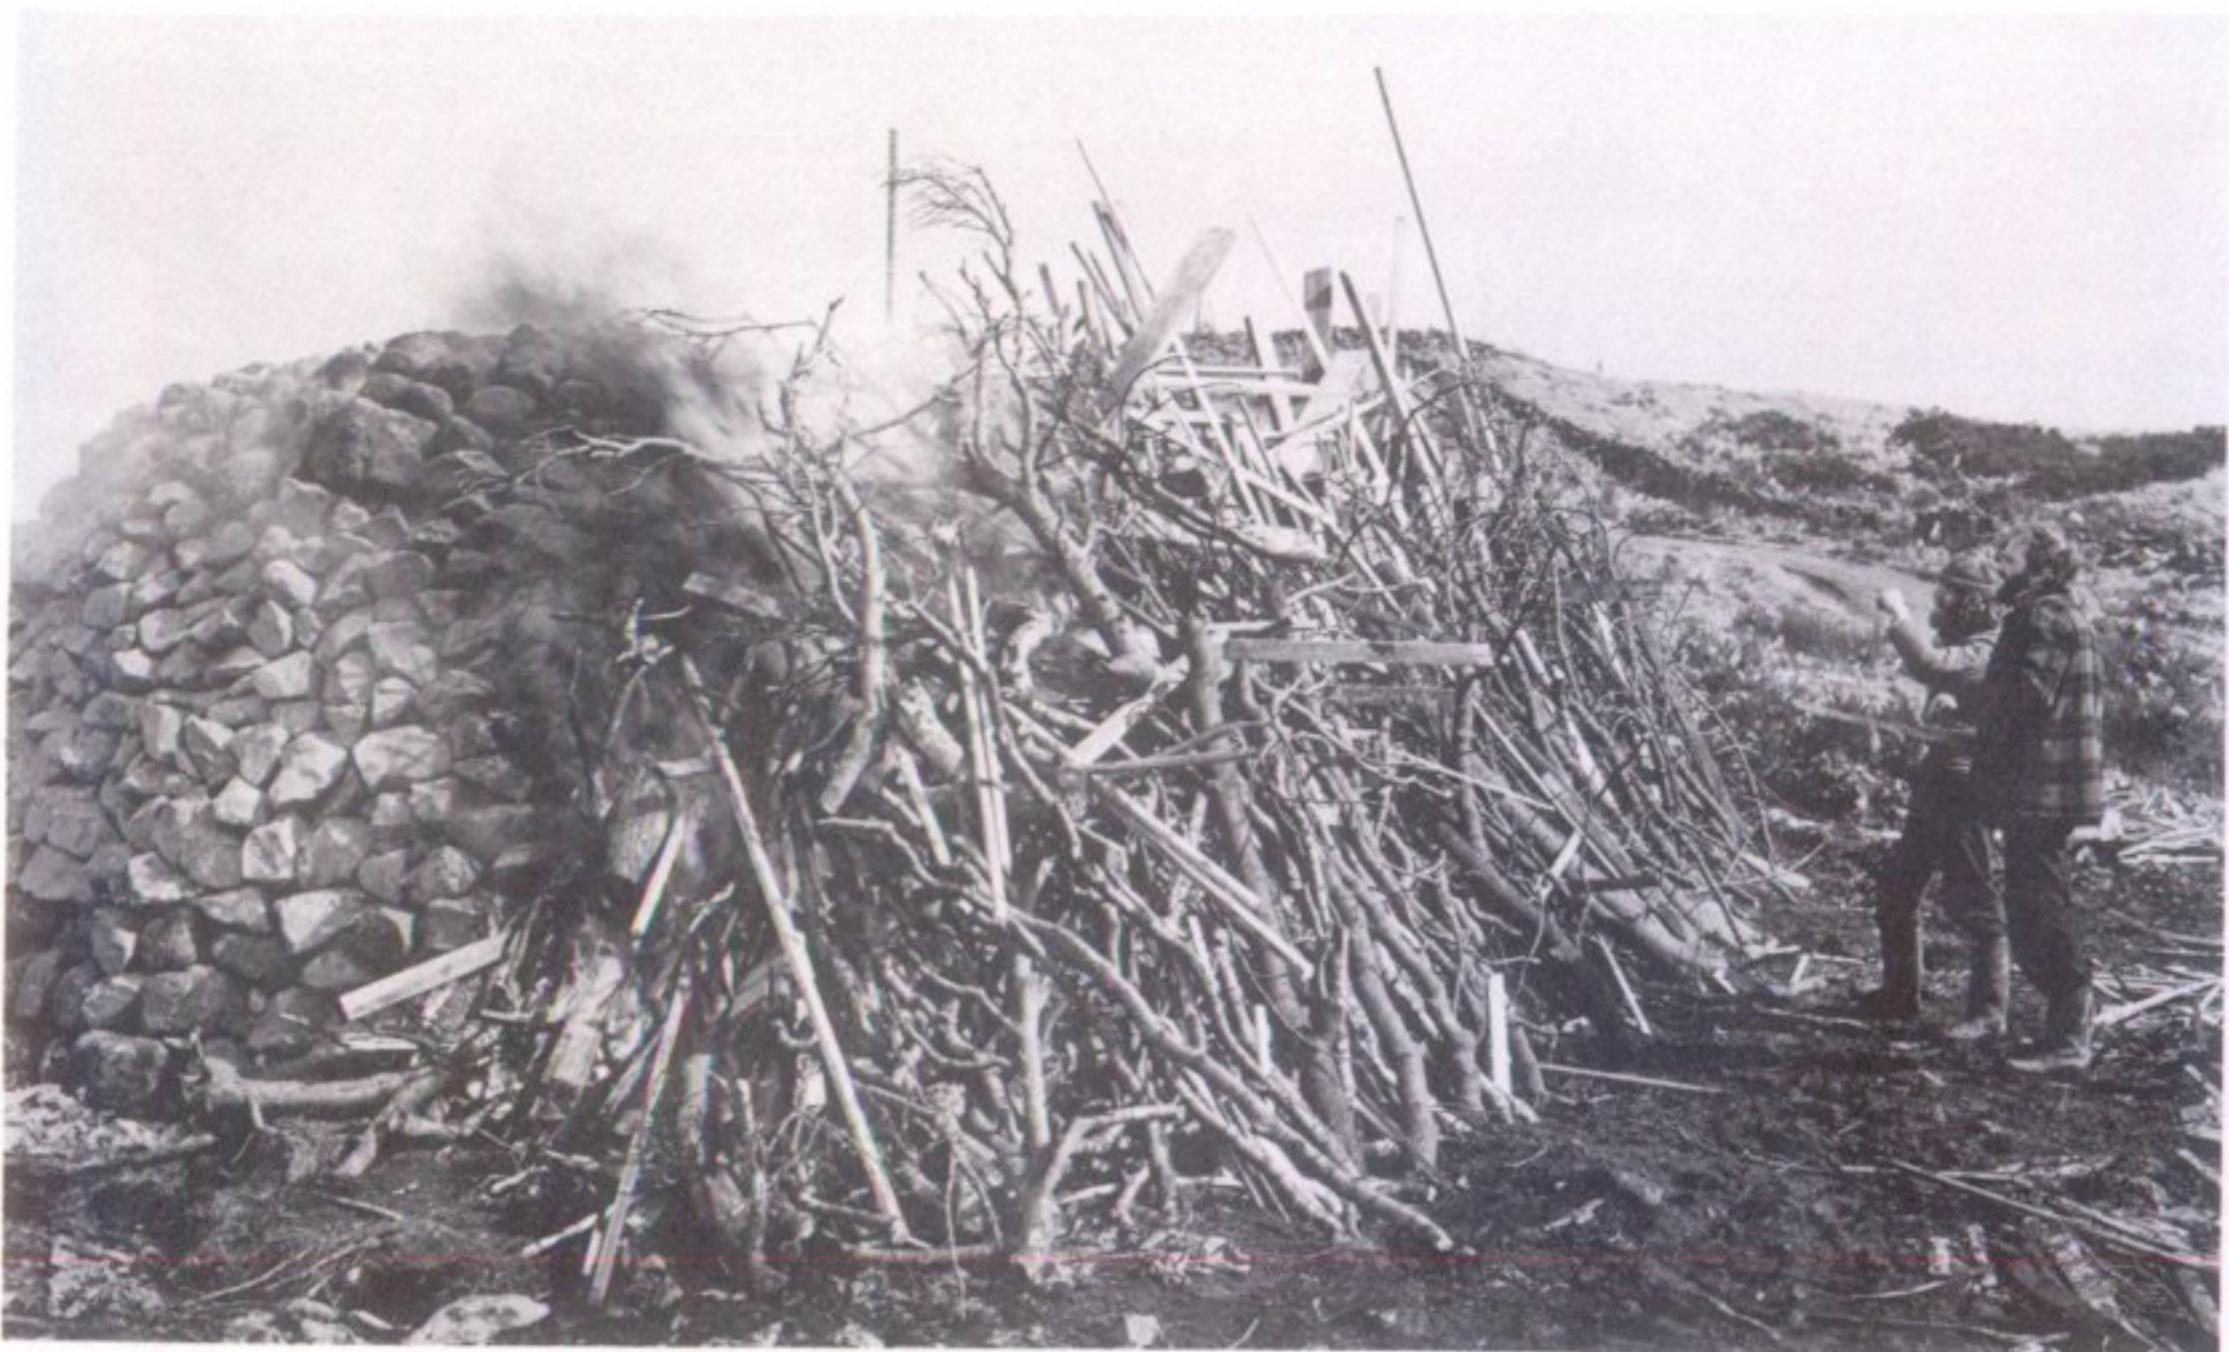
ILLUS 5 Lighting the external fire of brushwood and timber off-cuts against the south-west side just after noon

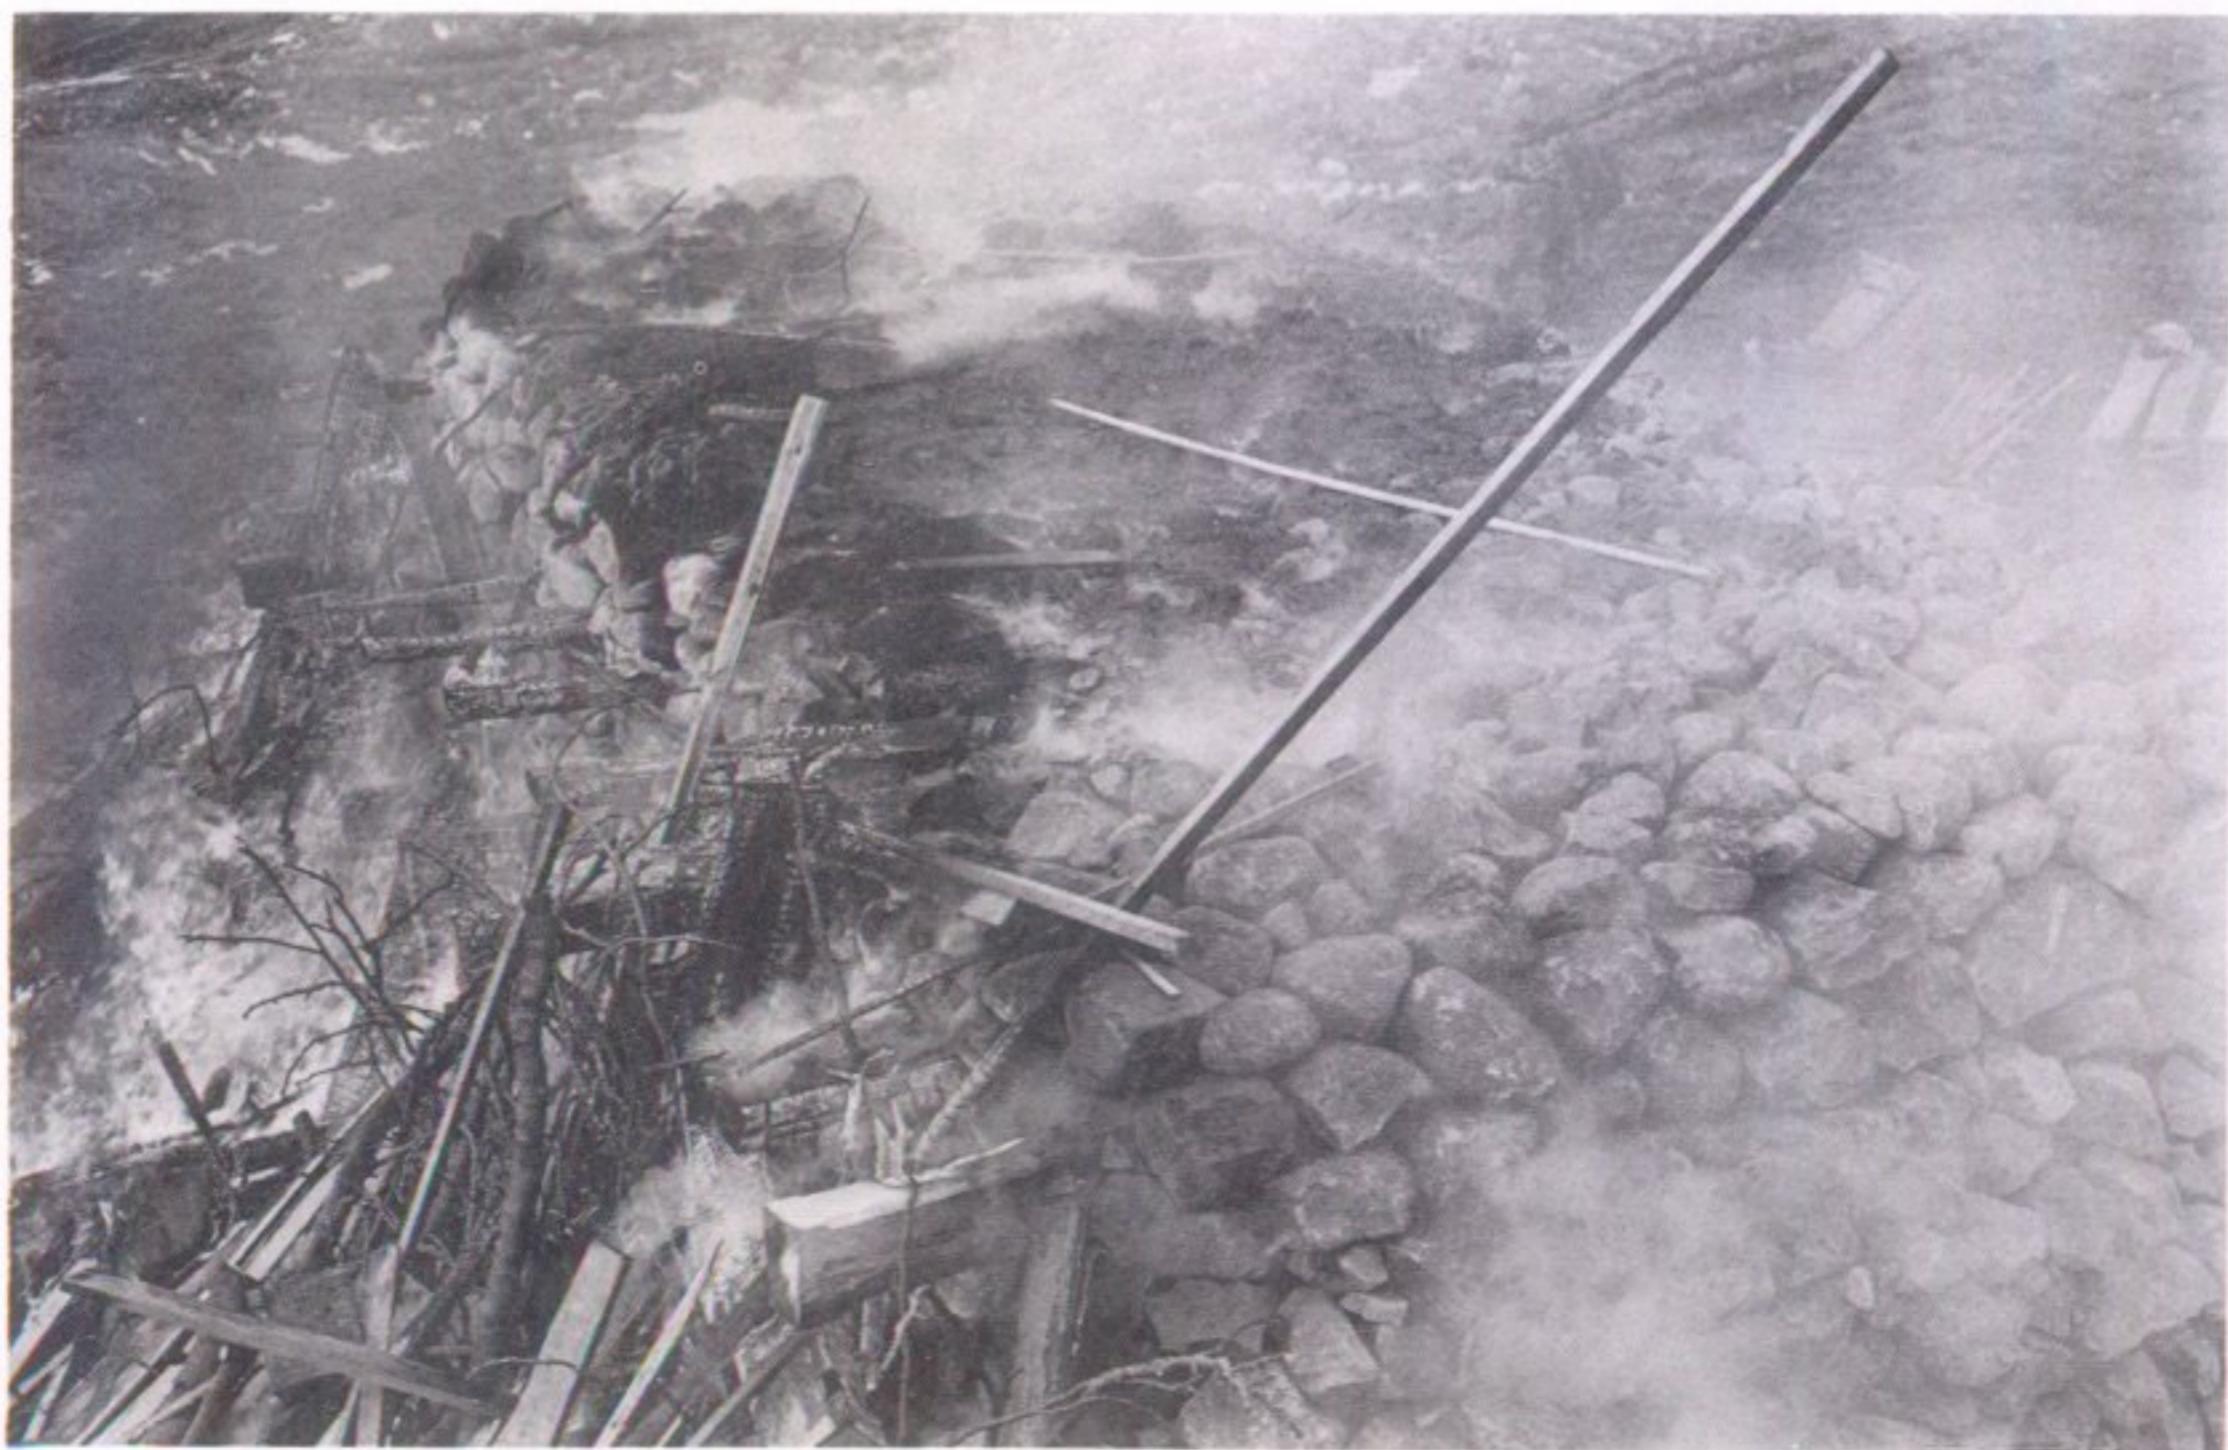
ILLUS 6 Smoke and steam emerging from the wall-head, seen from above the south angle of the wall

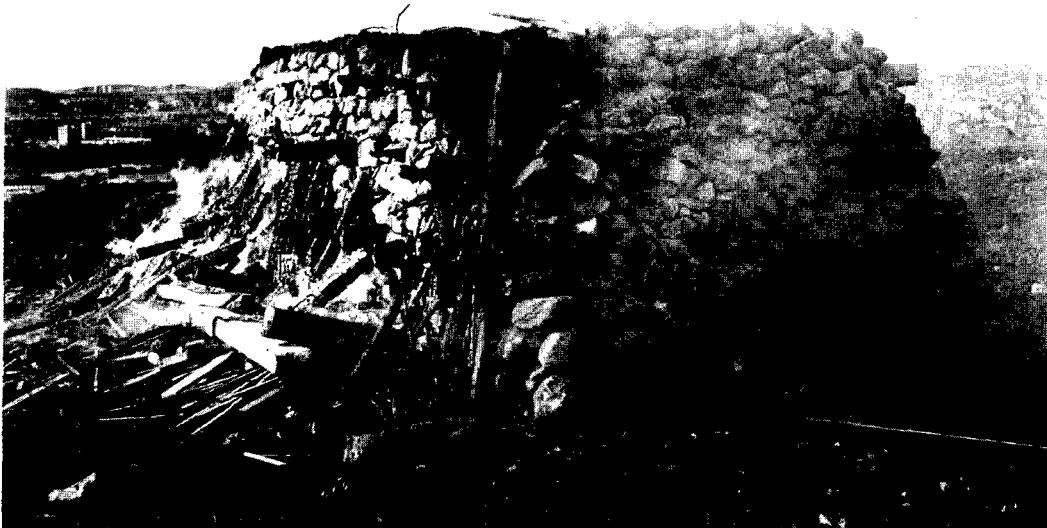
ILLUS 7 Smoke and steam issuing from the south-east end wall as the initial external fire burns down.
Time: approximately 14.00 hrs

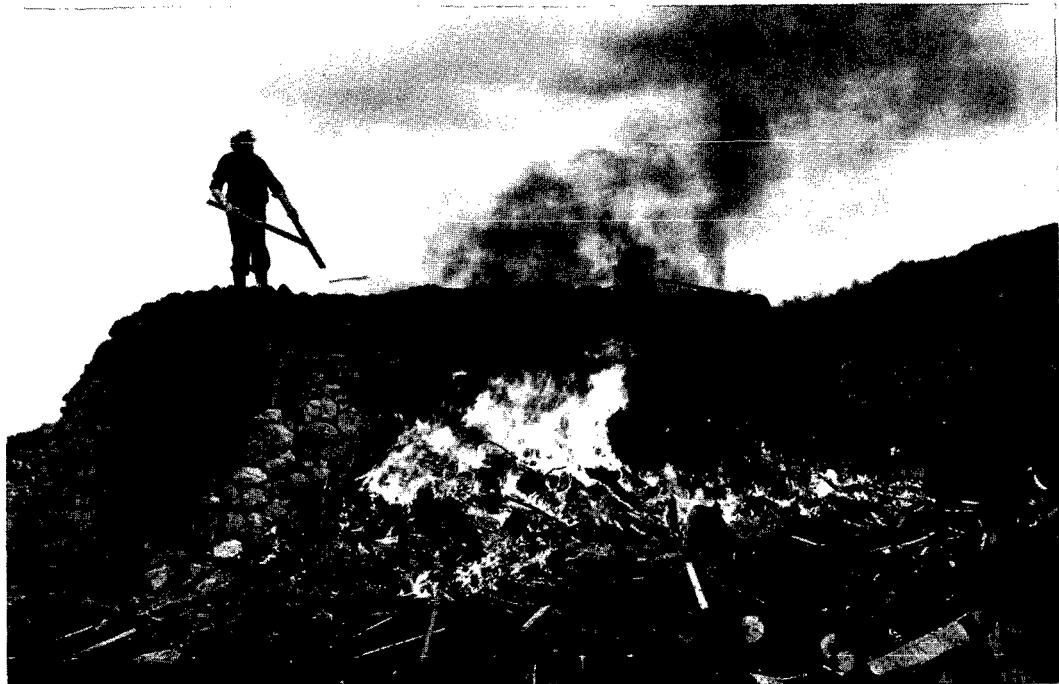
ILLUS 8 Removing partially-burnt debris of off-cuts from the wall-head; the tarpaulin has been removed from the north-west end, and lies folded at its base. Note that some of the facing stones display cracking

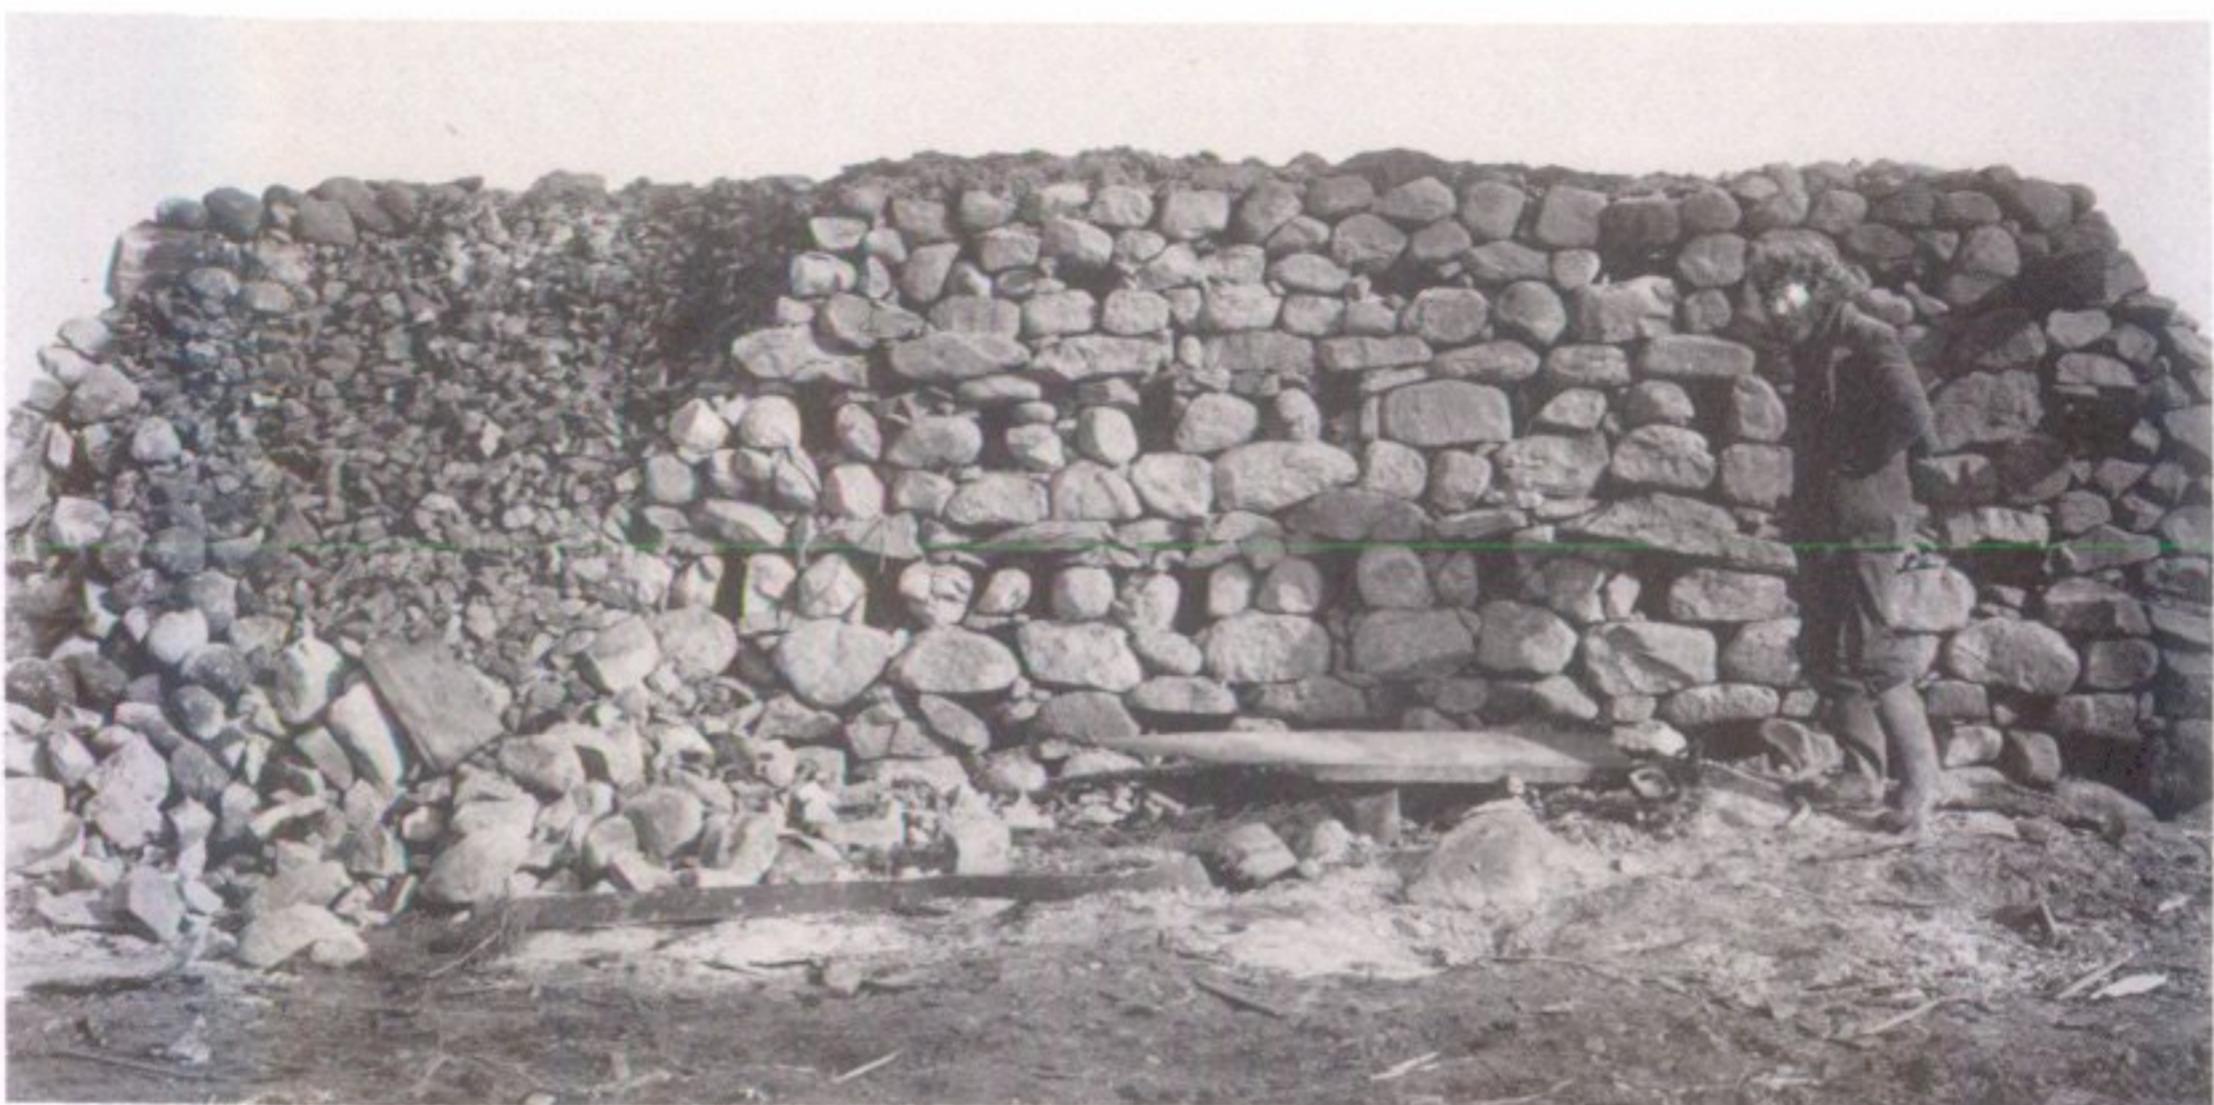
ILLUS 10 The south-west face at 08.30 hrs on 2 April

The next morning was still dry; there had been no rain overnight. The wind had reverted to the north-west, but was no stronger than previously. No further collapse had taken place, and no more general settling of the wall material had ensued from the previous evening's fall (illus 10). The fire on the north-east side of the wall had been extinguished; this side displayed localized cracking of the facing stones and charred beam ends. Contrastingly, the beams on the south-west side, immediately to the south-east of the area that had collapsed, were still alight a considerable distance – approximately 1 m – back into the core of the wall (illus 11). The beams directly behind the tumbled sector of

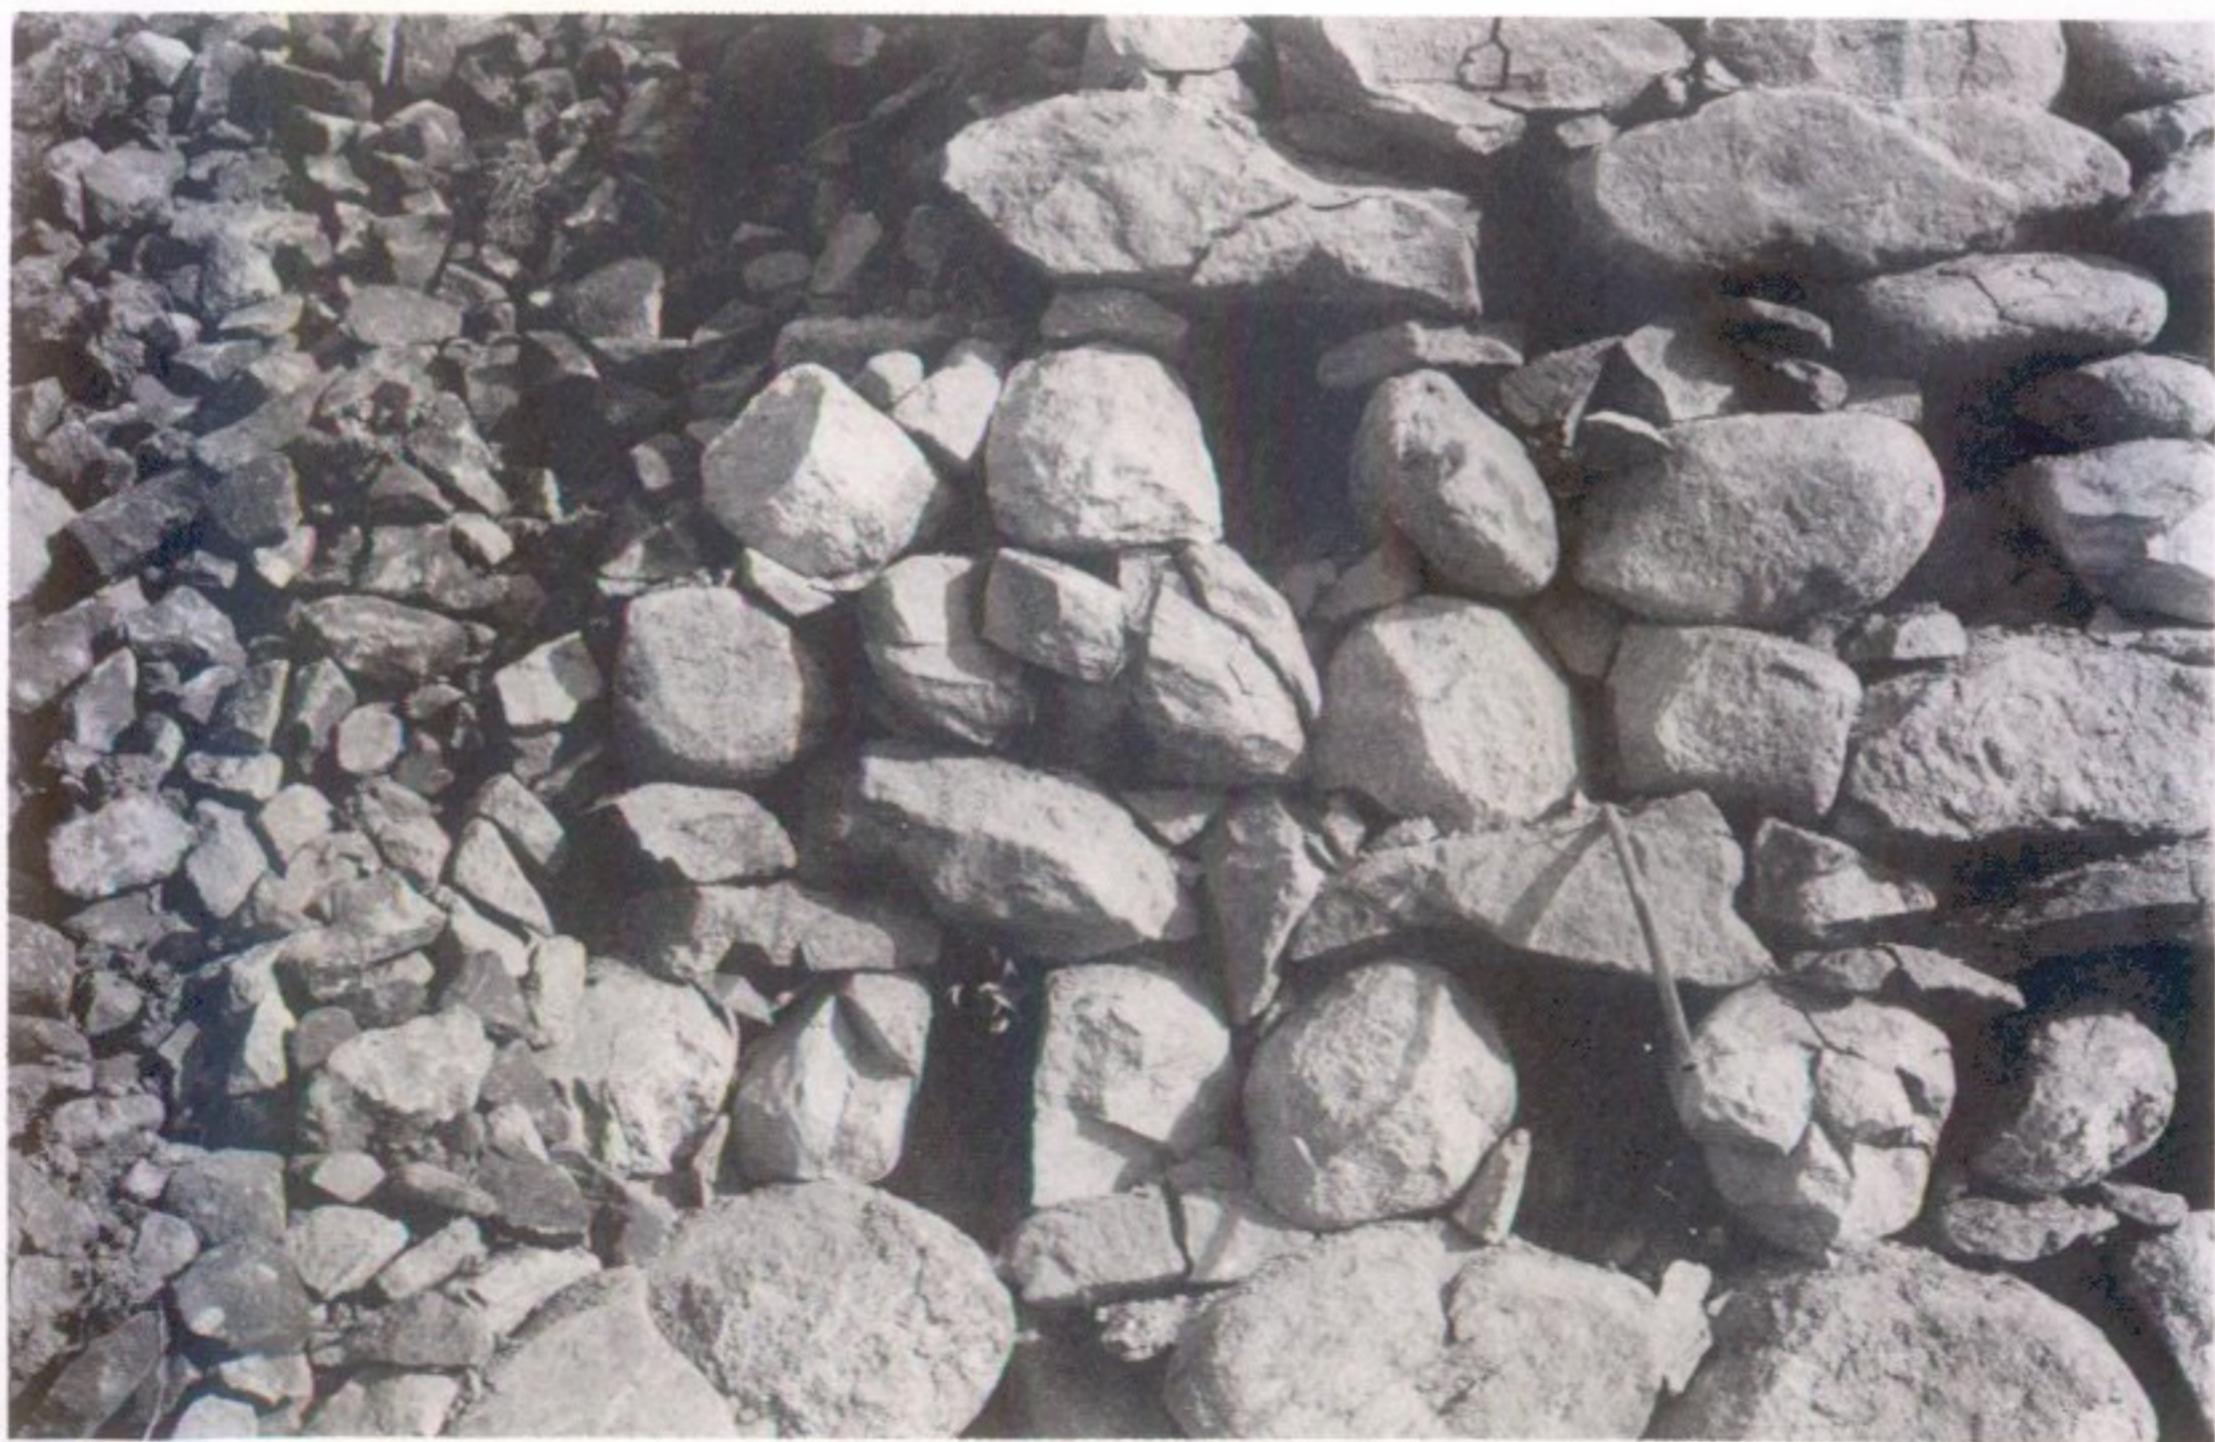
ILLUS 11 Detail of the wall-face adjacent to the collapsed section of the south-west face. Note the condition of the stonework, the beam still alight in the aperture, and the bent steel pipe – once used to insert the thermocouple

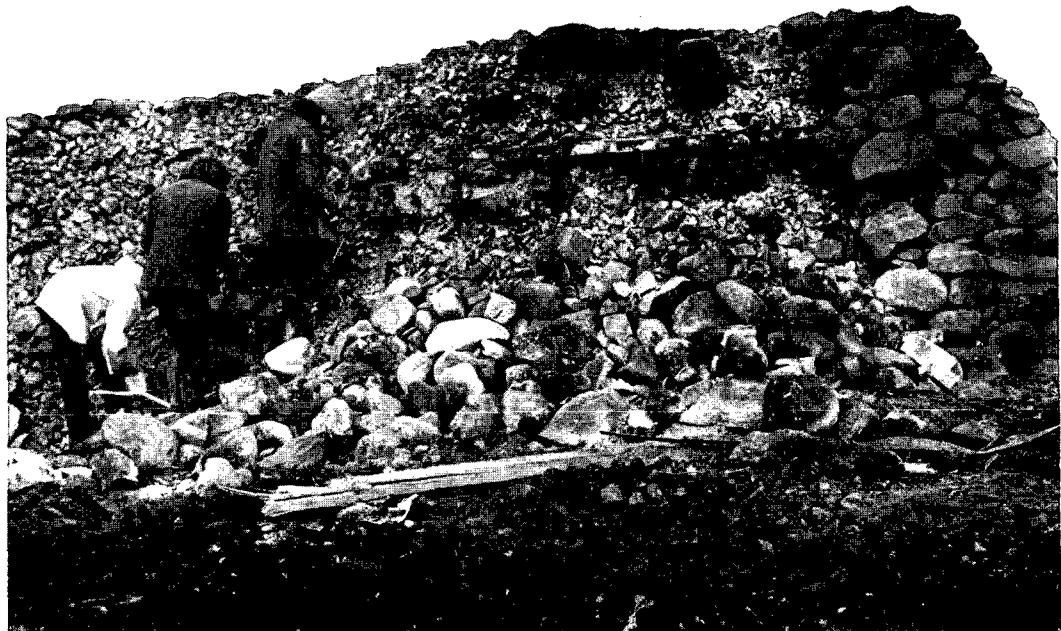
ILLUS 12 The south-east end of the south-west face after the collapse of the revetment, showing the substantially-intact timber lacing

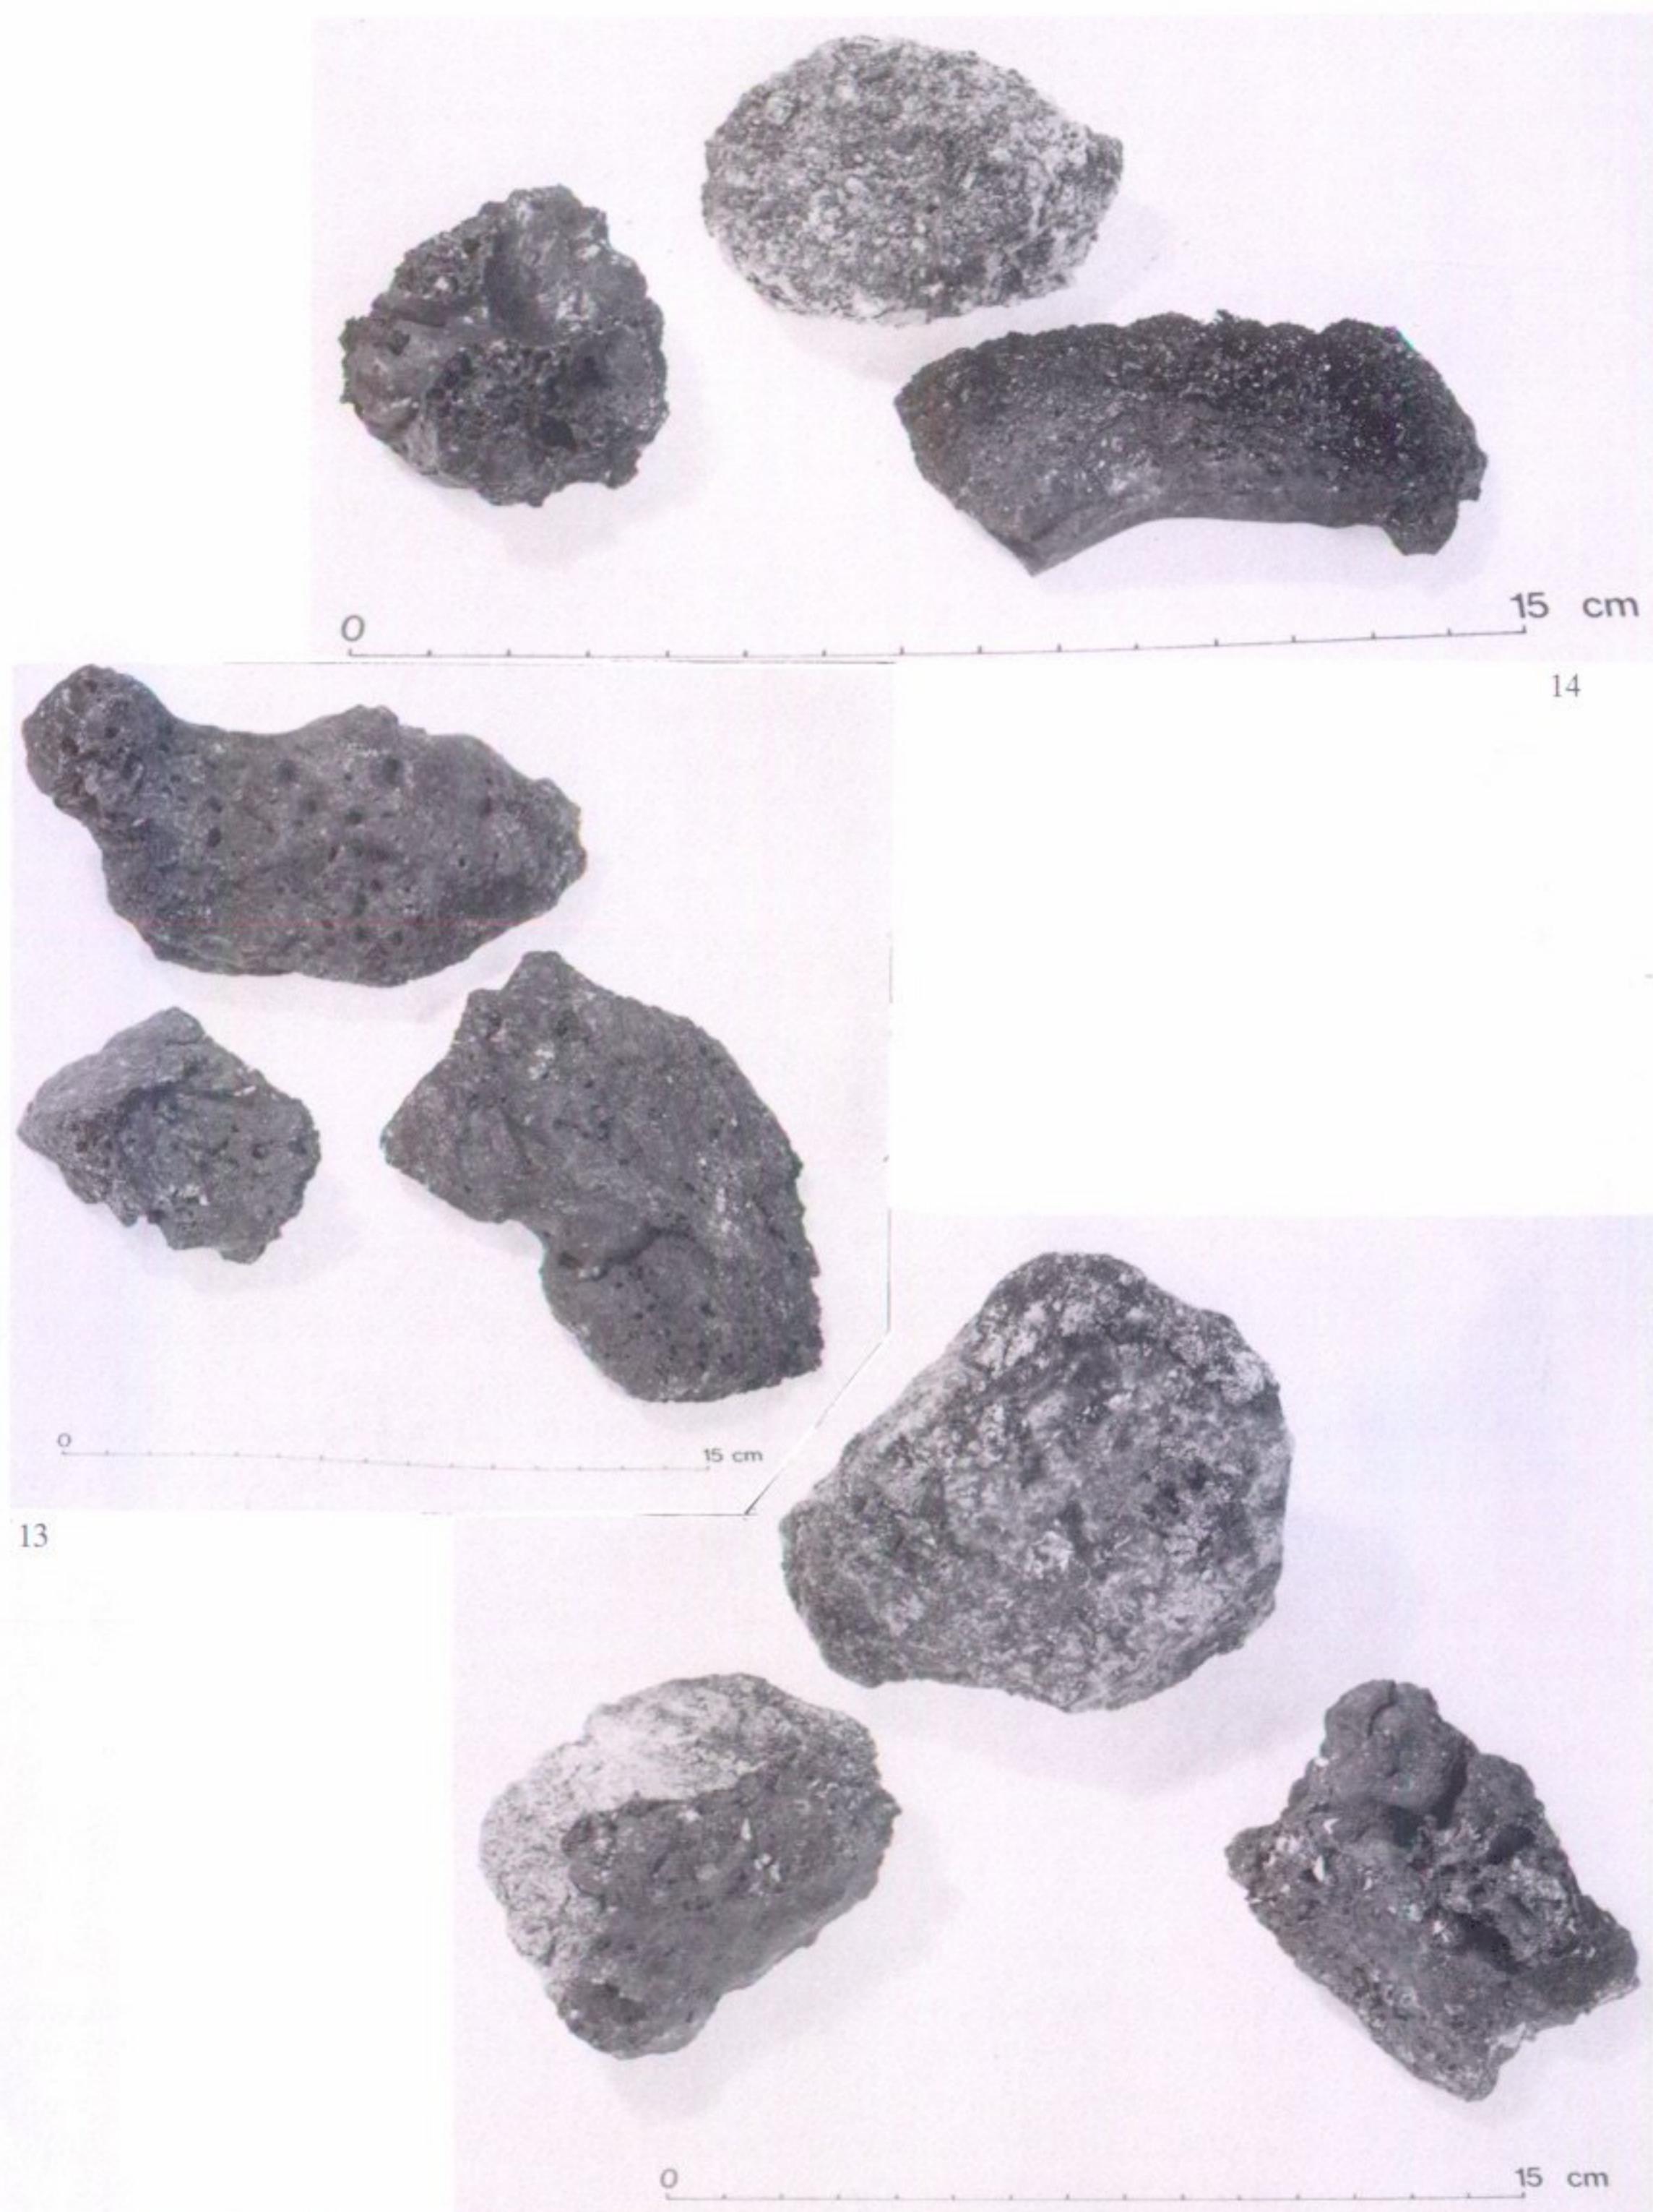
ILLUS 13-15 Examples of vitrified stonework recovered from the wall at East Tullos

ILLUS 16 Nail partially enveloped in
vitrified material

Small wood casts were noted on one of the pieces of vitrified stone, again duplicating a phenomenon noted in field observations. One of the nails incidentally incorporated in the wall was partially enveloped in vitrified material (illus 16), an observation which may offer support for the hypothesis that some vitrified forts may yet be shown to have contained nailed timber frameworks.
