### The survey and analysis of brochs

Cavers, G, Barber, J and Ritchie, M 2015 'The survey and analysis of brochs',  
*Proceedings of the Society of Antiquaries of Scotland* 145: 153-176.

# The survey and analysis of brochs

Graeme Cavers,<sup>\*</sup> John Barber<sup>†</sup> and Matthew Ritchie<sup>‡</sup>

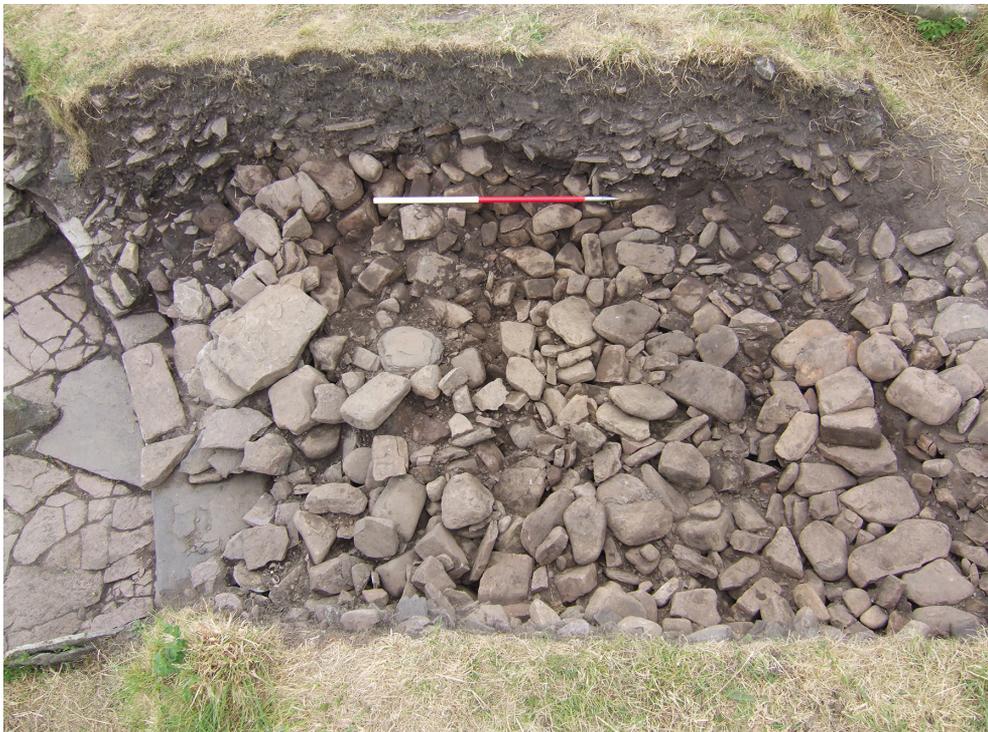
ILLUS 1 The wall of Whitegate broch, Caithness, comprised rounded beach cobbles retained by facing blocks and could not have been intended to carry the weight of a tower-like superstructure

a high wall, or, more correctly, the absence of horizontal placement of the building elements between retaining walls is a counterindication for tower construction. Thus, Whitegate broch in Caithness, for example (illus 1), was not intended to be and could never have been a tower.

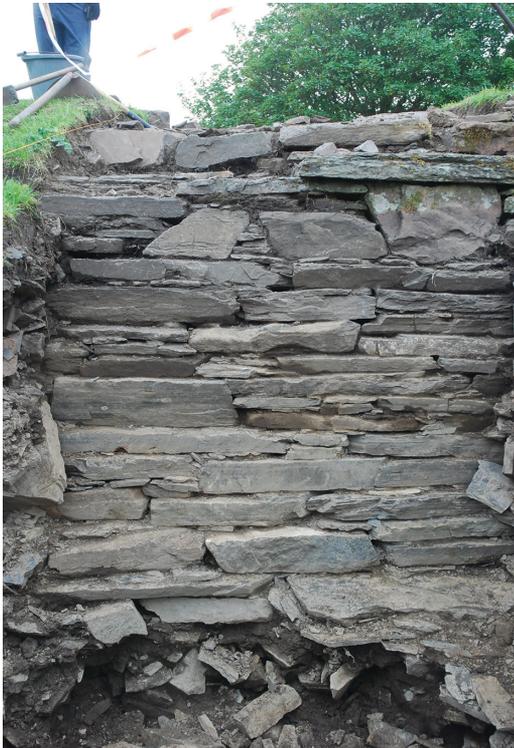
ILLUS 2 The infilled gully beneath Thrumster broch: a rare example of prepared foundations for a broch wall

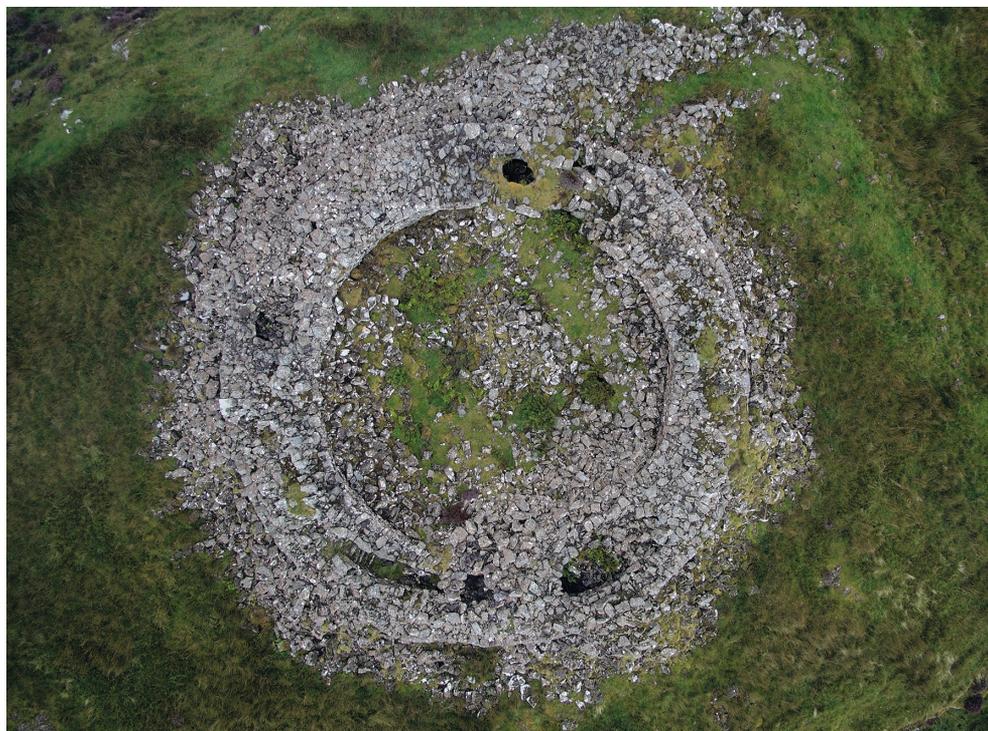
ILLUS 4 Low altitude vertical and oblique aerial photography uses a remote controlled microcopter equipped with a digital camera. This rectified vertical image captures the structural plan of Dun Suladale on Skye (NG 374 525)

photography, flown using a remote controlled microcopter equipped with a digital camera. The technique has proved remarkably adept at capturing images for illustration, site condition monitoring and for conservation management purposes, particularly in regard to upstanding masonry structures and large scale earthworks. The technique can be used to provide both detailed images and landscape setting (captured with 360° flexibility); and rectified vertical images can be used to support archaeological measured survey (illus 4).

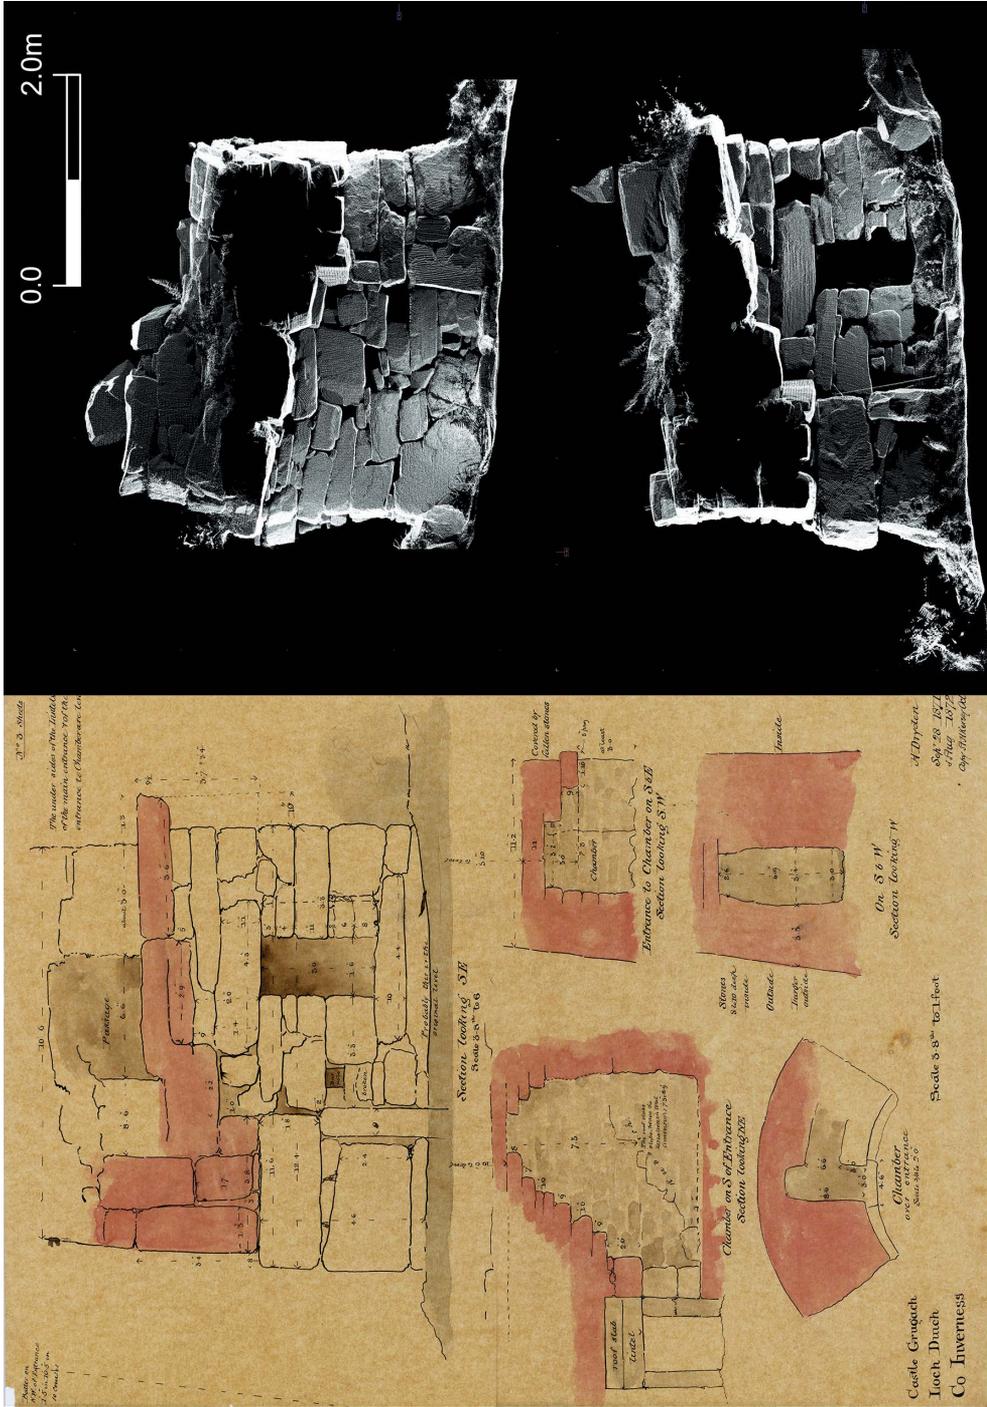
ILLUS 5 The broch of Caisteal Grugaig was the subject of several very attractive unpublished measured drawings made in 1871 and 1872 by Henry Dryden. He recorded the broch on plan and produced a series of annotated elevations and sections. This elevation of the south-east side of the entrance passage depicts the door check, barhole and guard chamber (presented alongside the corresponding point cloud elevations derived from the laser scan). (© Courtesy of RCAHMS (Society of Antiquaries of Scotland Collection). Licensor [www.rcahms.gov.uk](http://www.rcahms.gov.uk))

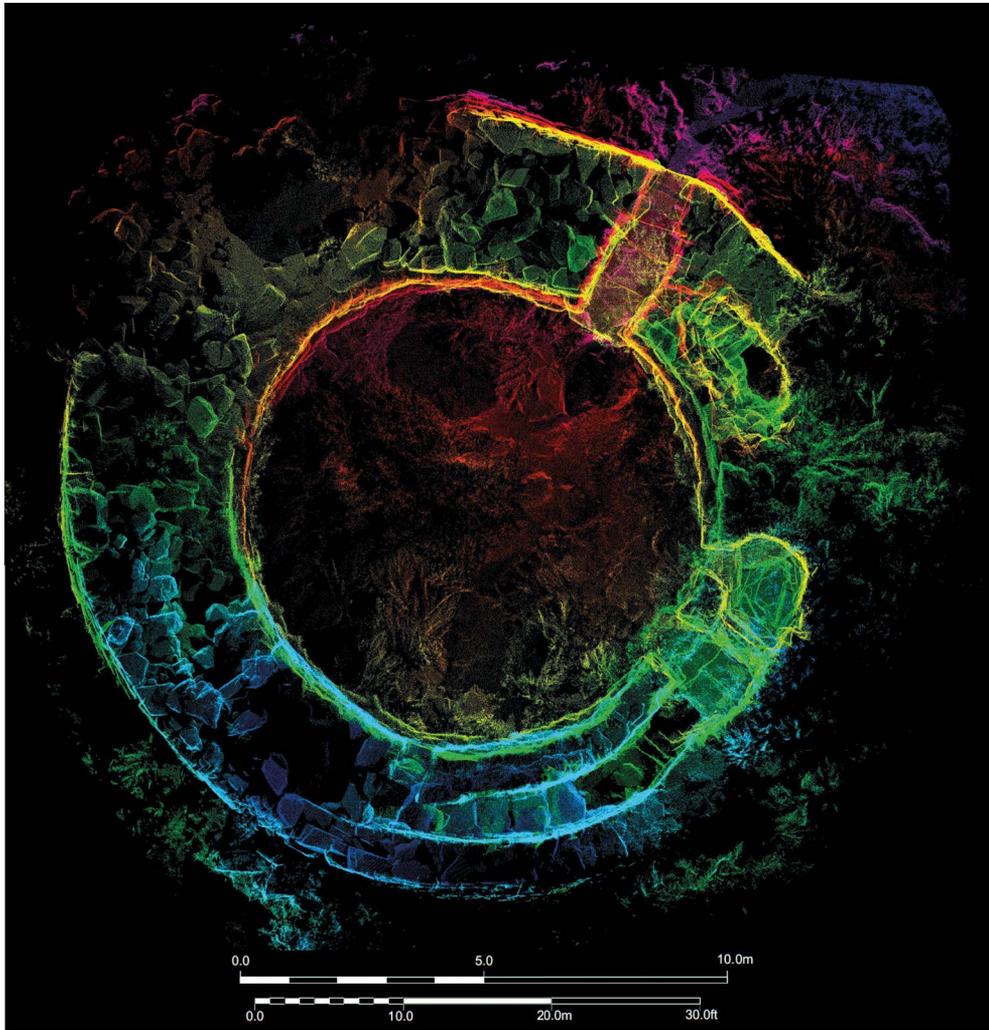
ILLUS 6 The orthographic plan of Caisteal Grugaig, derived from a laser scan, allows the depiction of the variable levels throughout the structure, and the position and heights of the intramural cells (purple/reds indicate low areas, light blue indicates high areas)

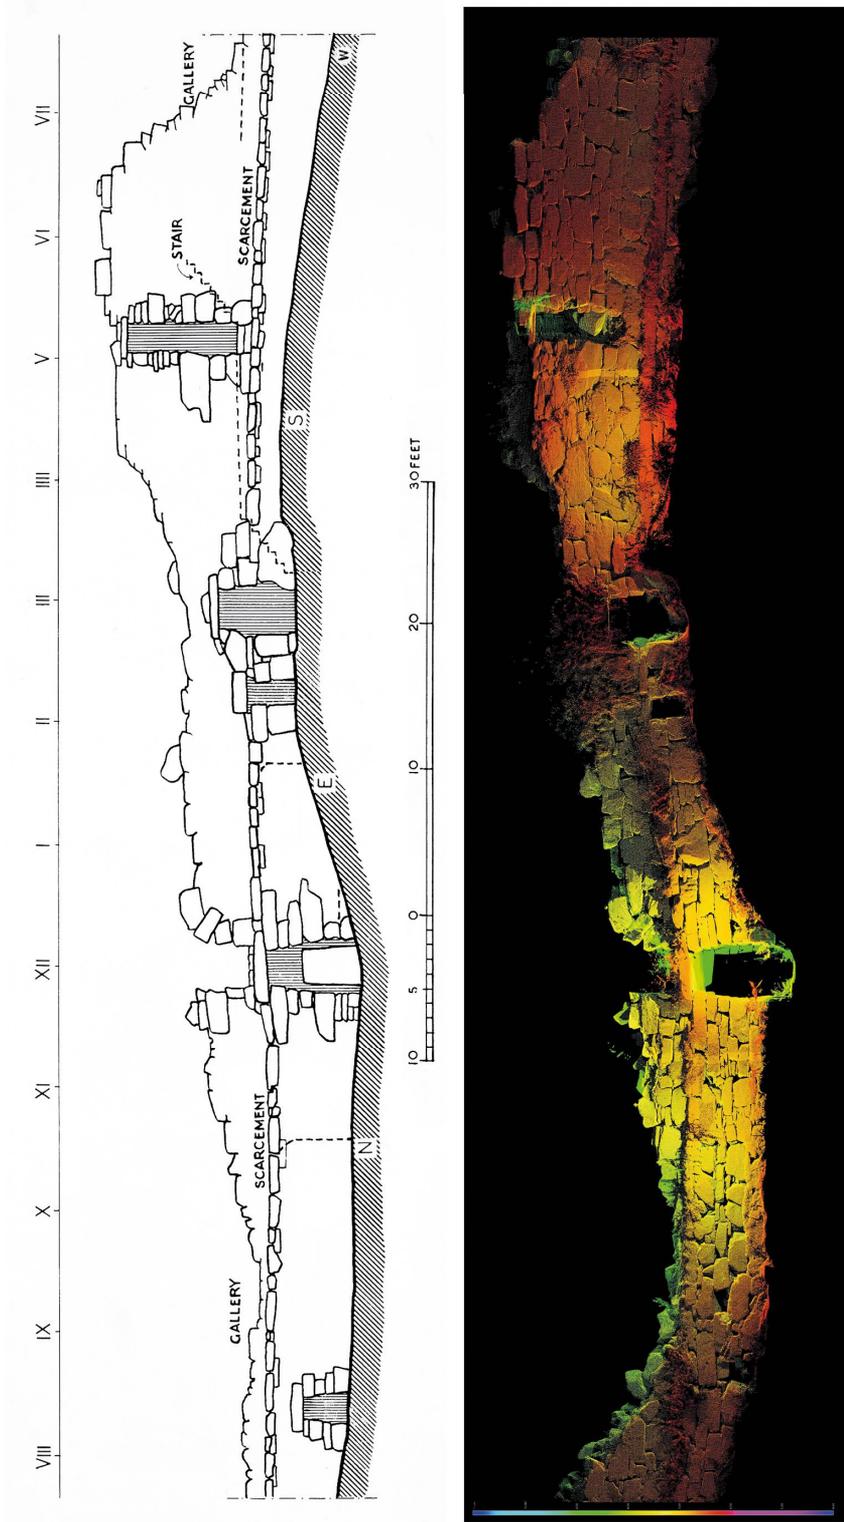
ILLUS 8 Caisteal Grugraig. Above: The innovative 'elevation of the interior developed on the flat' produced by Graham (1949) remains a very useful illustrative style, highlighting architectural features such as the scarcement. Below: the equivalent image produced by 'unrolling' the 3D point cloud and projecting onto a flat plane (© Crown Copyright: RCAHMS. Licensor: www.rcahms.gov.uk)

Caisteal Grugaig during the summer of 1949, the written description augmented by a measured survey and photographic record (Graham 1949: 12–24). The innovative ‘elevation of the interior developed on the flat’ used by Graham, a keen proponent of raising standards in archaeological recording and publication, at Caisteal Grugaig (1949: 15) and at Dun Telve (1947: 83) remains a very useful illustrative style, highlighting the entrance passage and scarcement (Dunbar 1992: 37).

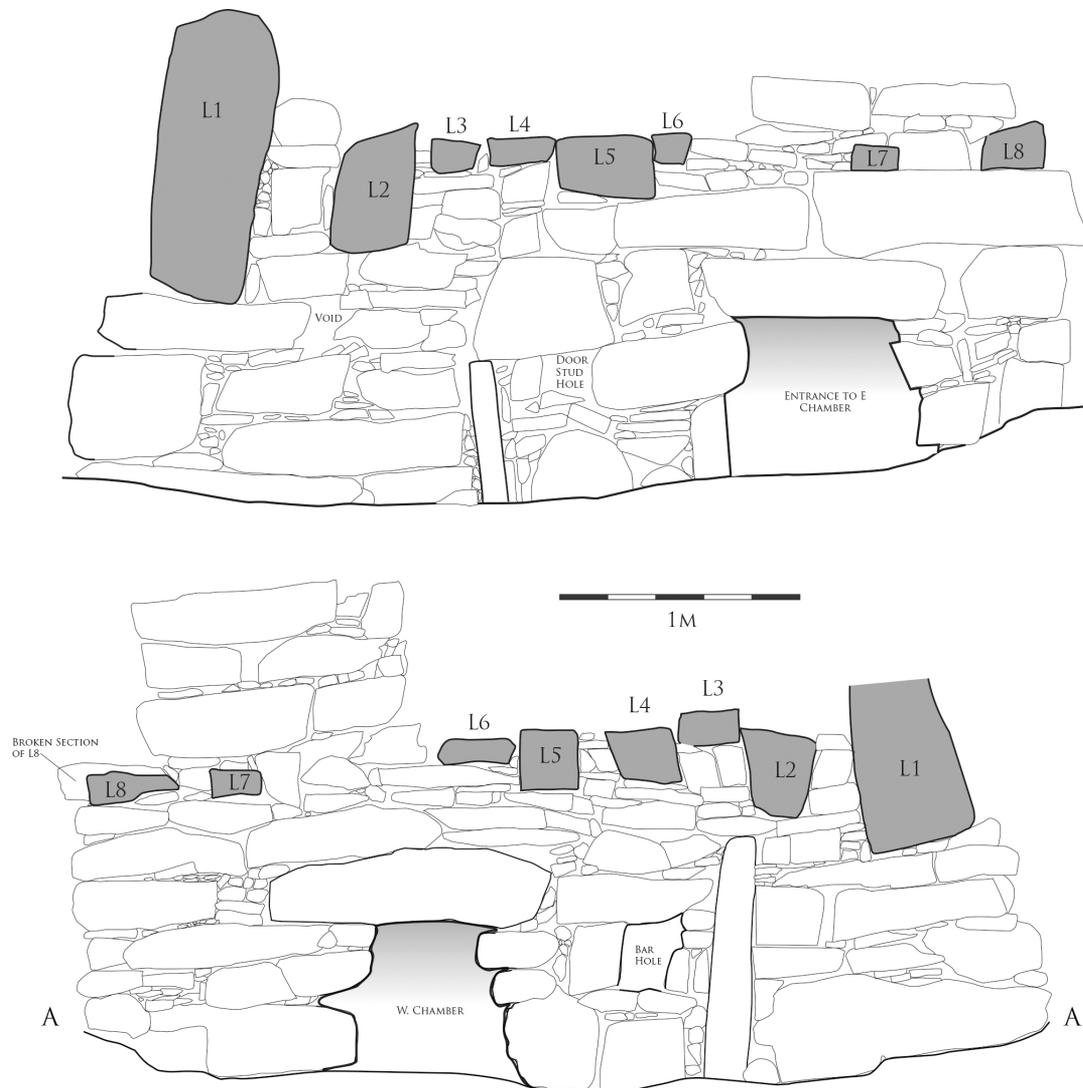
ILLUS 10 Elevations of the entrance to Clachtoll broch

There were probably 11 lintels over the entrance passage of which eight survive. The two outer lintels taken together form a compound beam structure designed to cope with loadings

associated with the mass of the thick outer wall. The outermost, a triangular lintel (L1), forces the wall mass to corbel either side of it. Between this and L2, the next lintel, a gap some 300mm wide occurs into which a corbelled arc has been built across the passage. L2, a massive stone, is set with its longest cross-sectional dimension in the vertical plane; it is edge-set. Lintels L3, L4 and L5 are also relatively massive. Re-excavation to the tops of the lintels for conservation purposes (Barber 2011) revealed an arrangement interpreted as provision for an upper set of lintels. Whatever the details of the original arrangement, it was clearly intended that the outer five lintels should carry the mass of the outer wall. The inner lintels were flattened slabs of limited carrying capacity (illus 10).

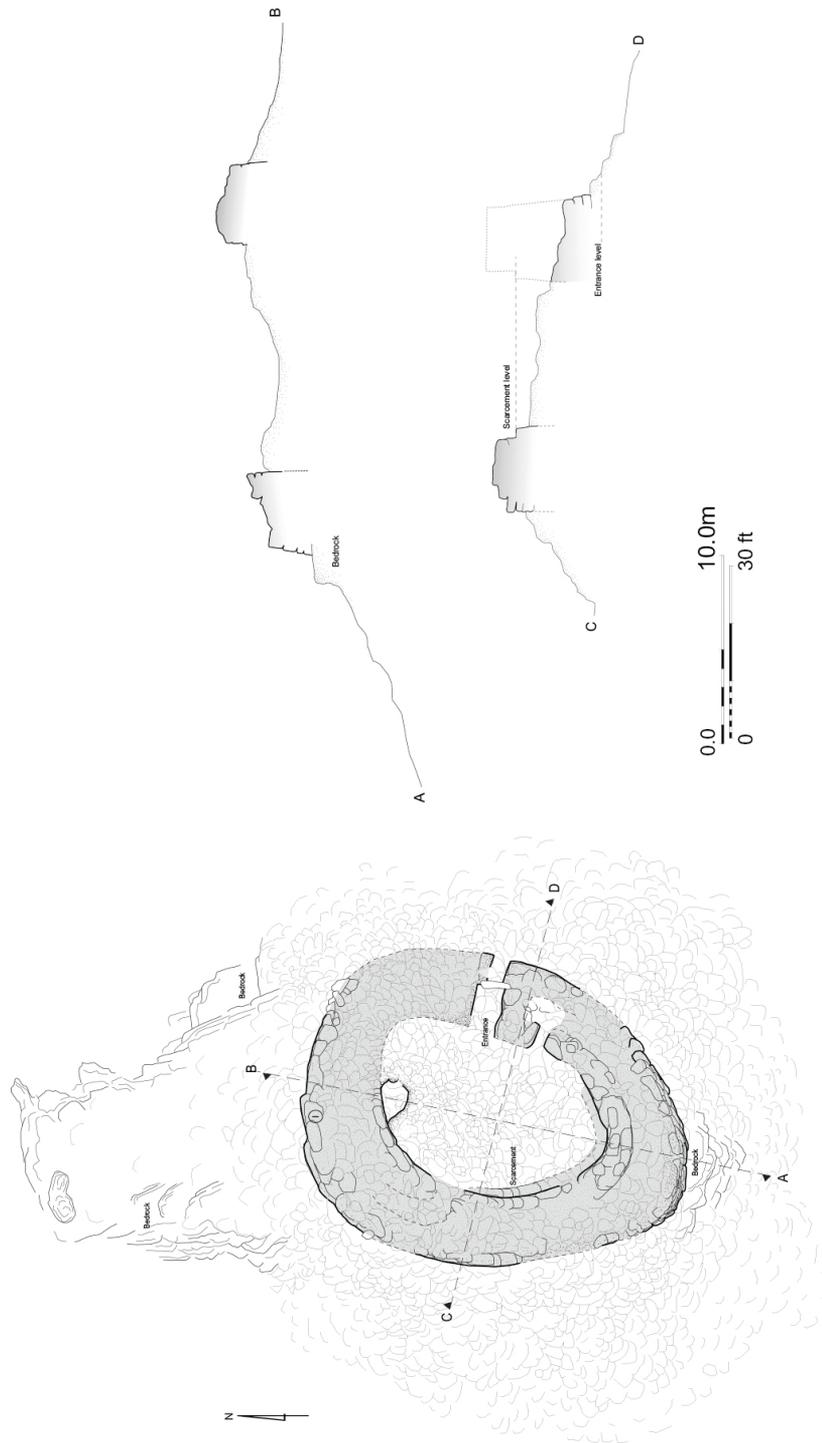
ILLUS 11 Plan and sections of Dun Boredate, Raasay

circular, rather forming an irregular oval plan, so that the site has tended to be considered a 'dun' rather than a true 'broch' (illus 11 and 12). Dun Boredale is not, therefore, a broch tower as defined by MacKie (above).

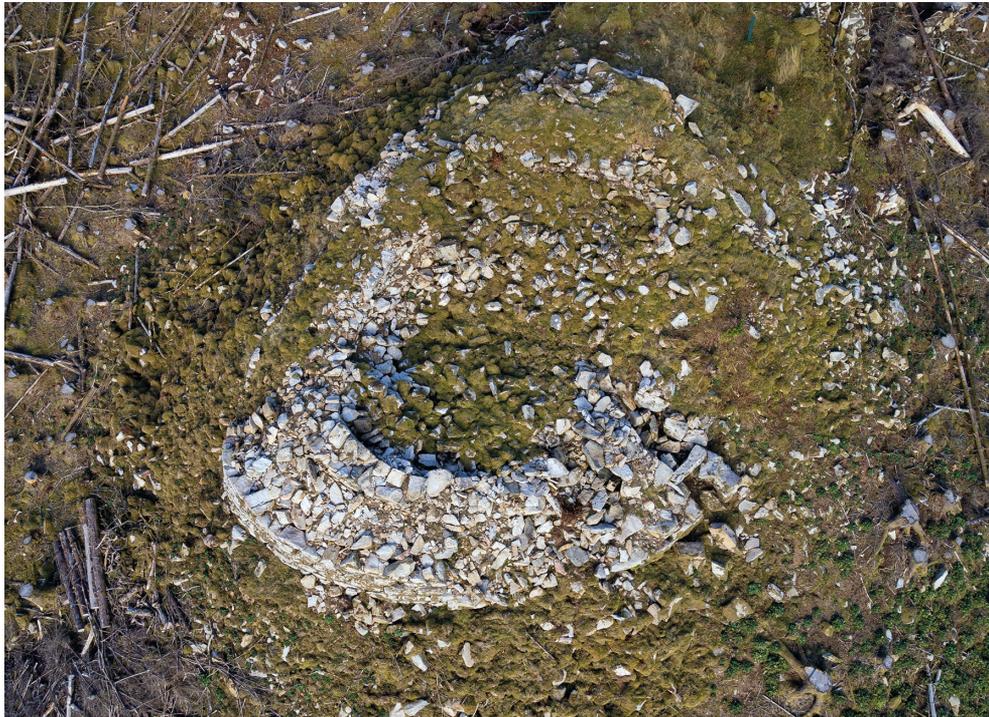
ILLUS 12 Dun Boredale, unrectified vertical low altitude aerial photograph

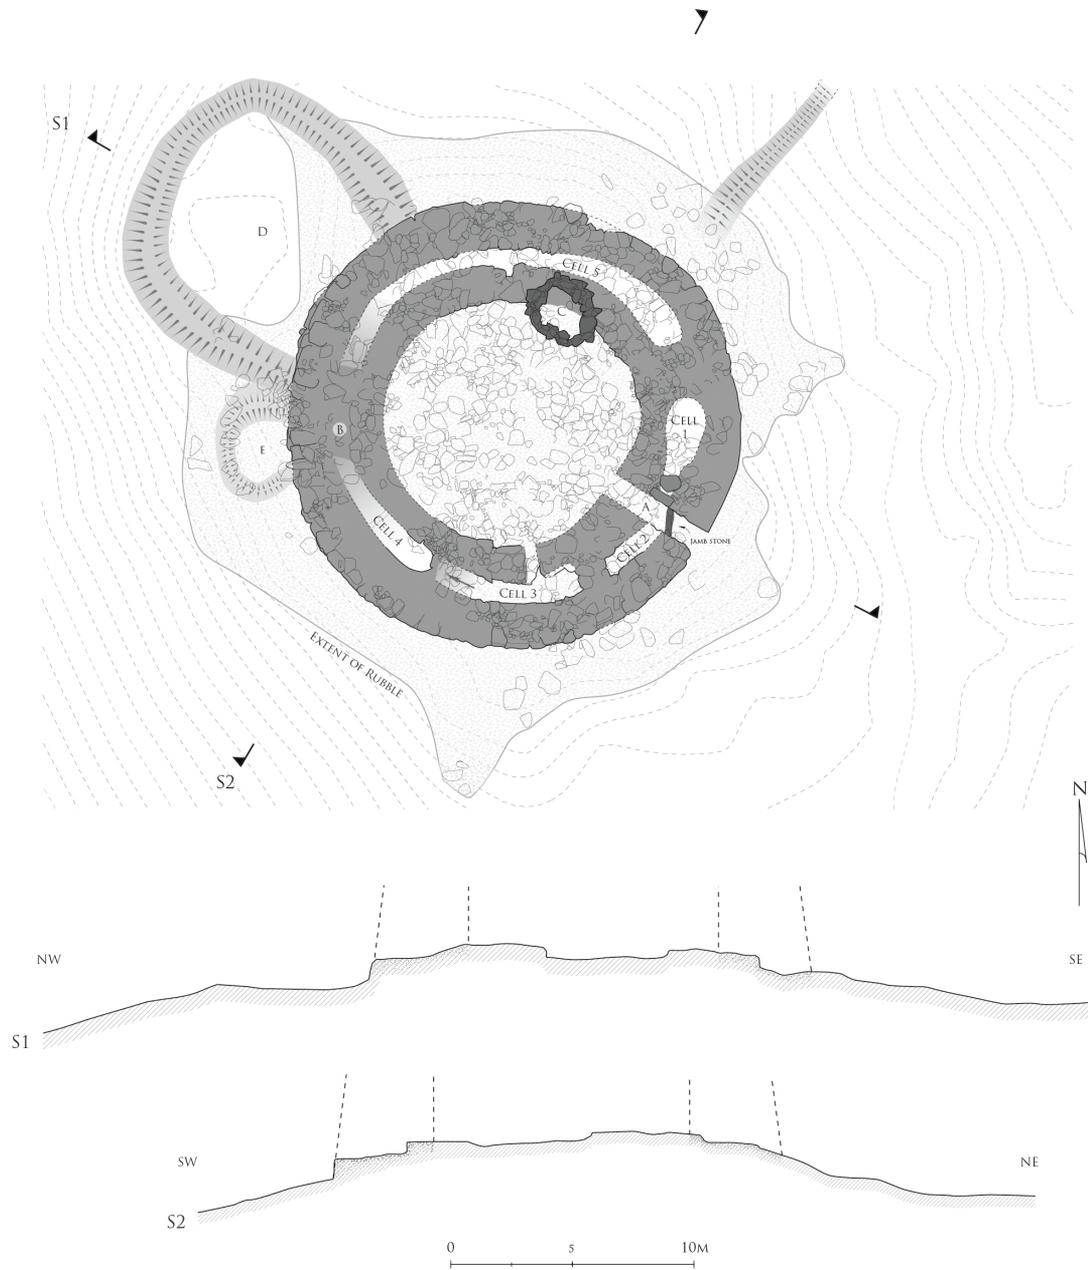
ILLUS 13 Plan and sections of Altbreck

now on the cusp of becoming meaningless to surface appraisal, but they have been surveyed when in a rather better condition by the Royal Commission for the 1911 Inventory. The writers examined and undertook a laser scan survey of the monument and its immediate setting in 2013 (illus 13). The Forestry Commission had supplied a copy of the plan and associated text of a recent survey which had been undertaken by operatives apparently innocent of the RCAHMS survey, and of its interpretation by Romankiewicz (2011, Vol II: 207). Original or authentic features which are at the point of final dissolution were interpreted in the survey from FCS, as modern rearrangements of the fallen masonry, an approach no doubt influenced by the existence of one clearly recent shooting butt which straddles the inner wall of the broch at the 3 o'clock position.
