Geophysical Survey of Hexham Abbey

Scheduled Ancient Monument Area

Sophie Hueglin, Alex Turner & David Astbury

9/05/2018

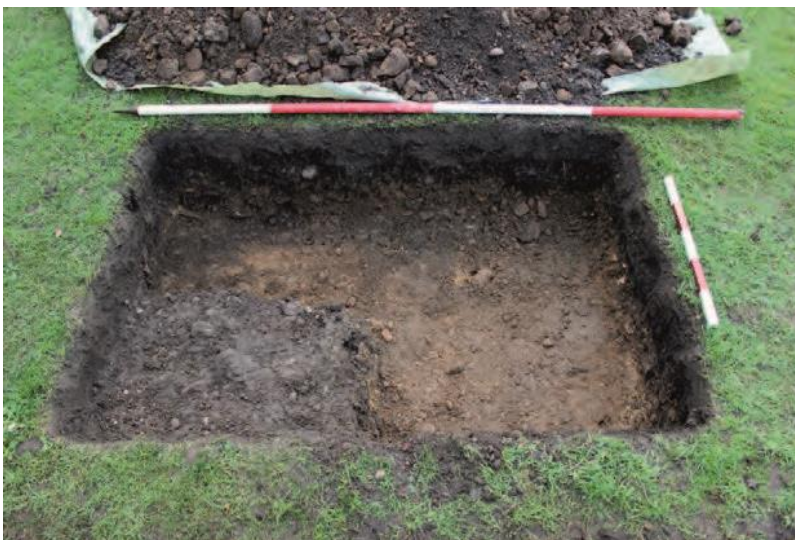
Figure 4: Photographs illustrating excavation results of test pit 3 (from: *Prior's Court, The Archaeological Practice 2016*, p. 13, Ill. 18)

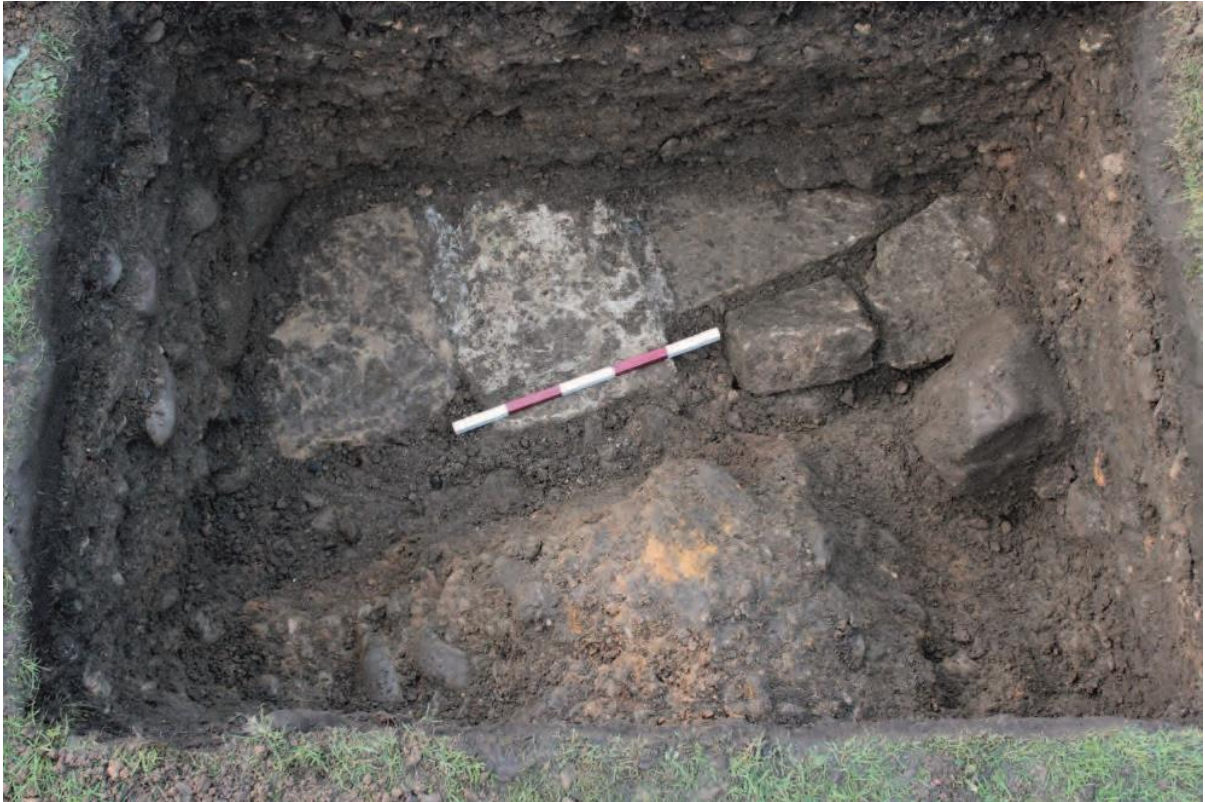
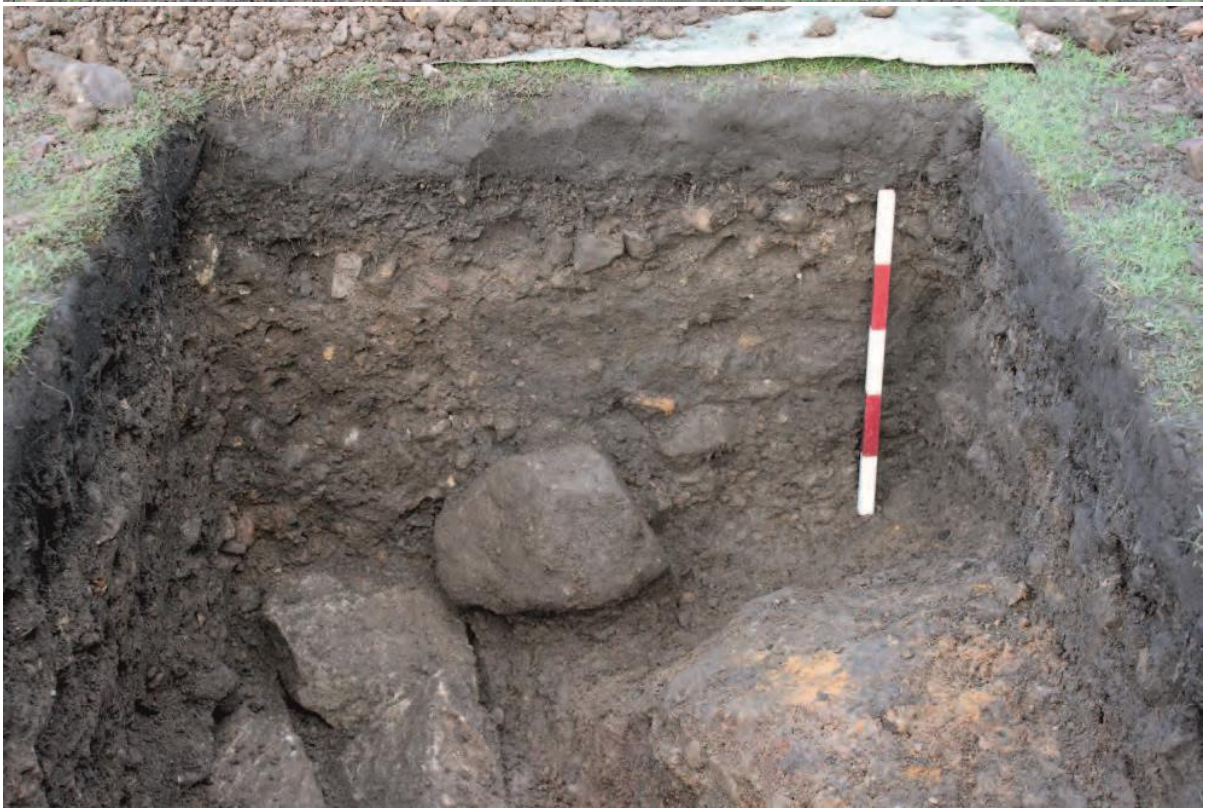
Figure 5+6: Photographs illustrating excavation results of test pit 4 (from: Prior's Court, The Archaeological Practice 2016, p. 16, ill. 26-27)

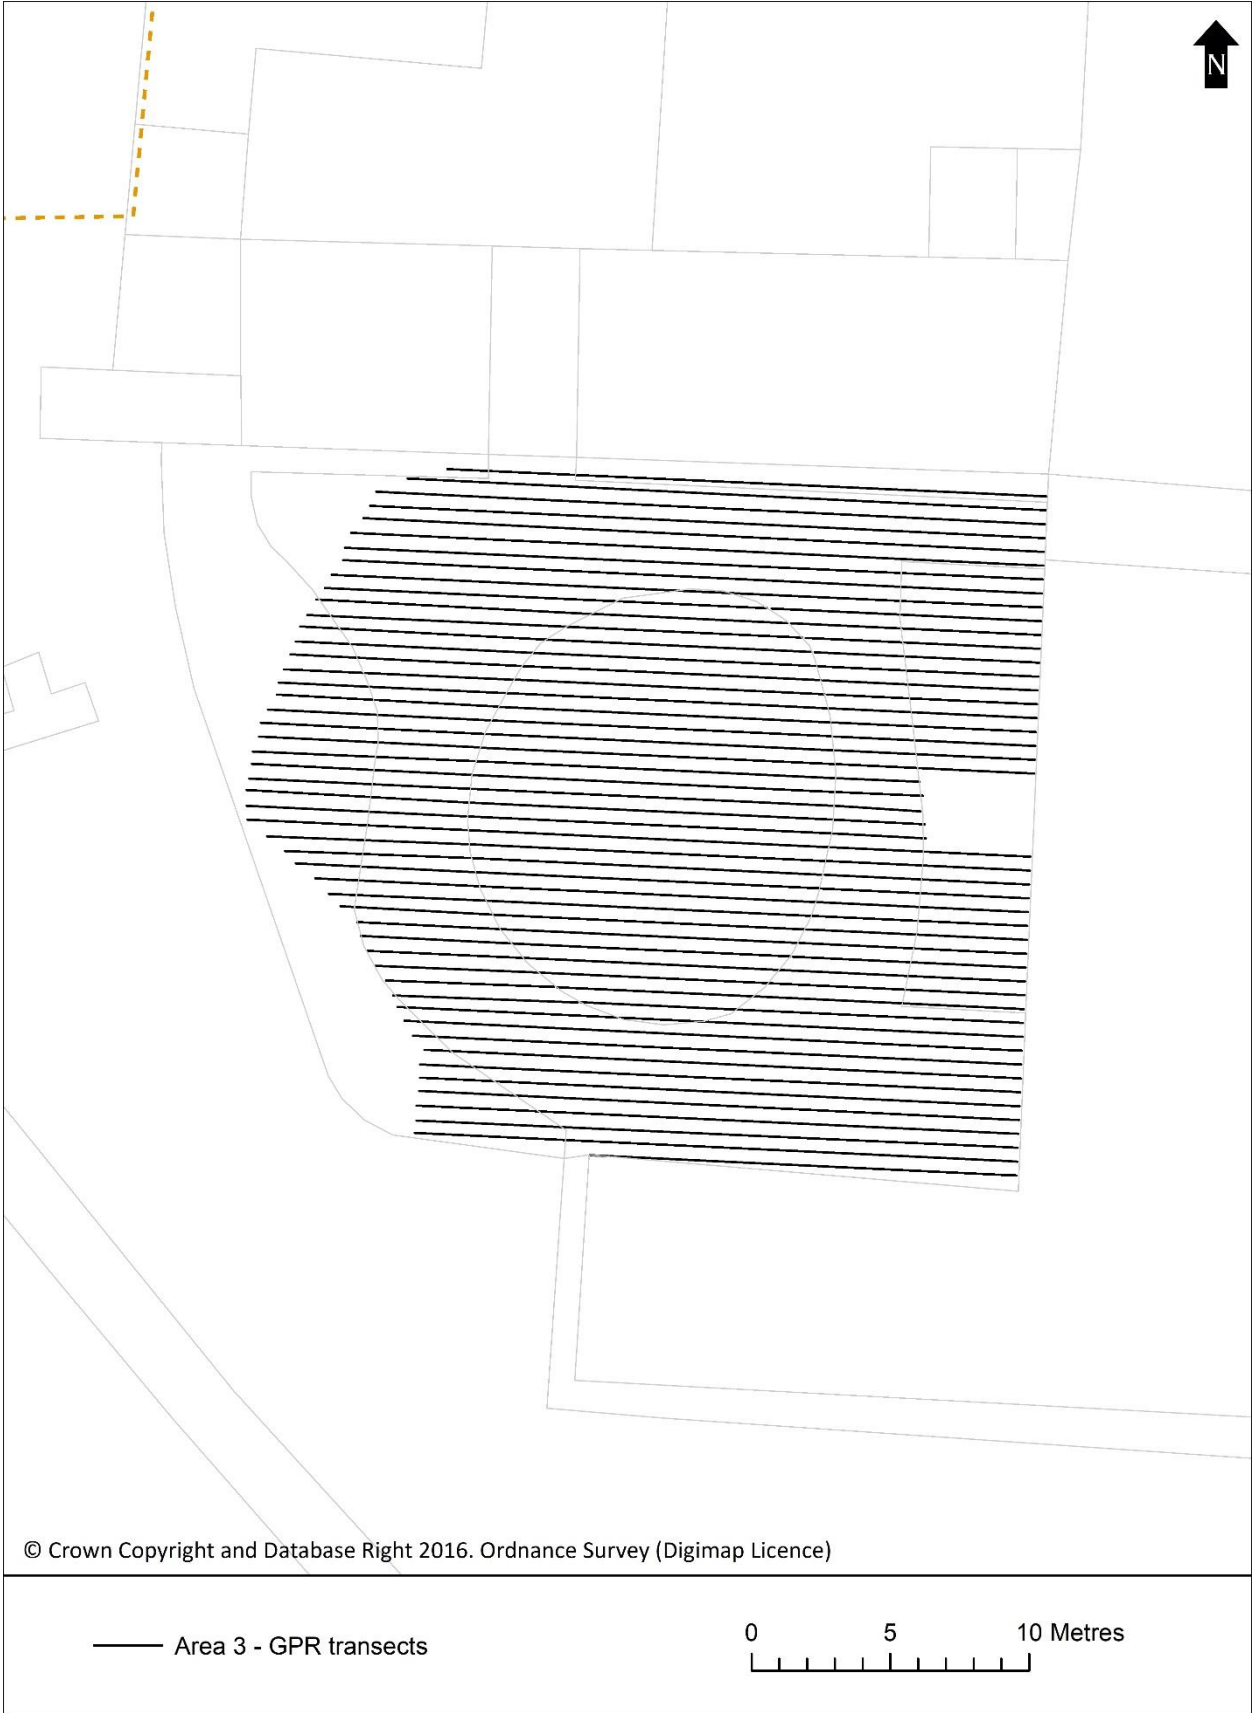
Figure 14: Ground Penetrating Radar, survey transects in area 3 (Prior's Court) (Graphics: A. Turner).

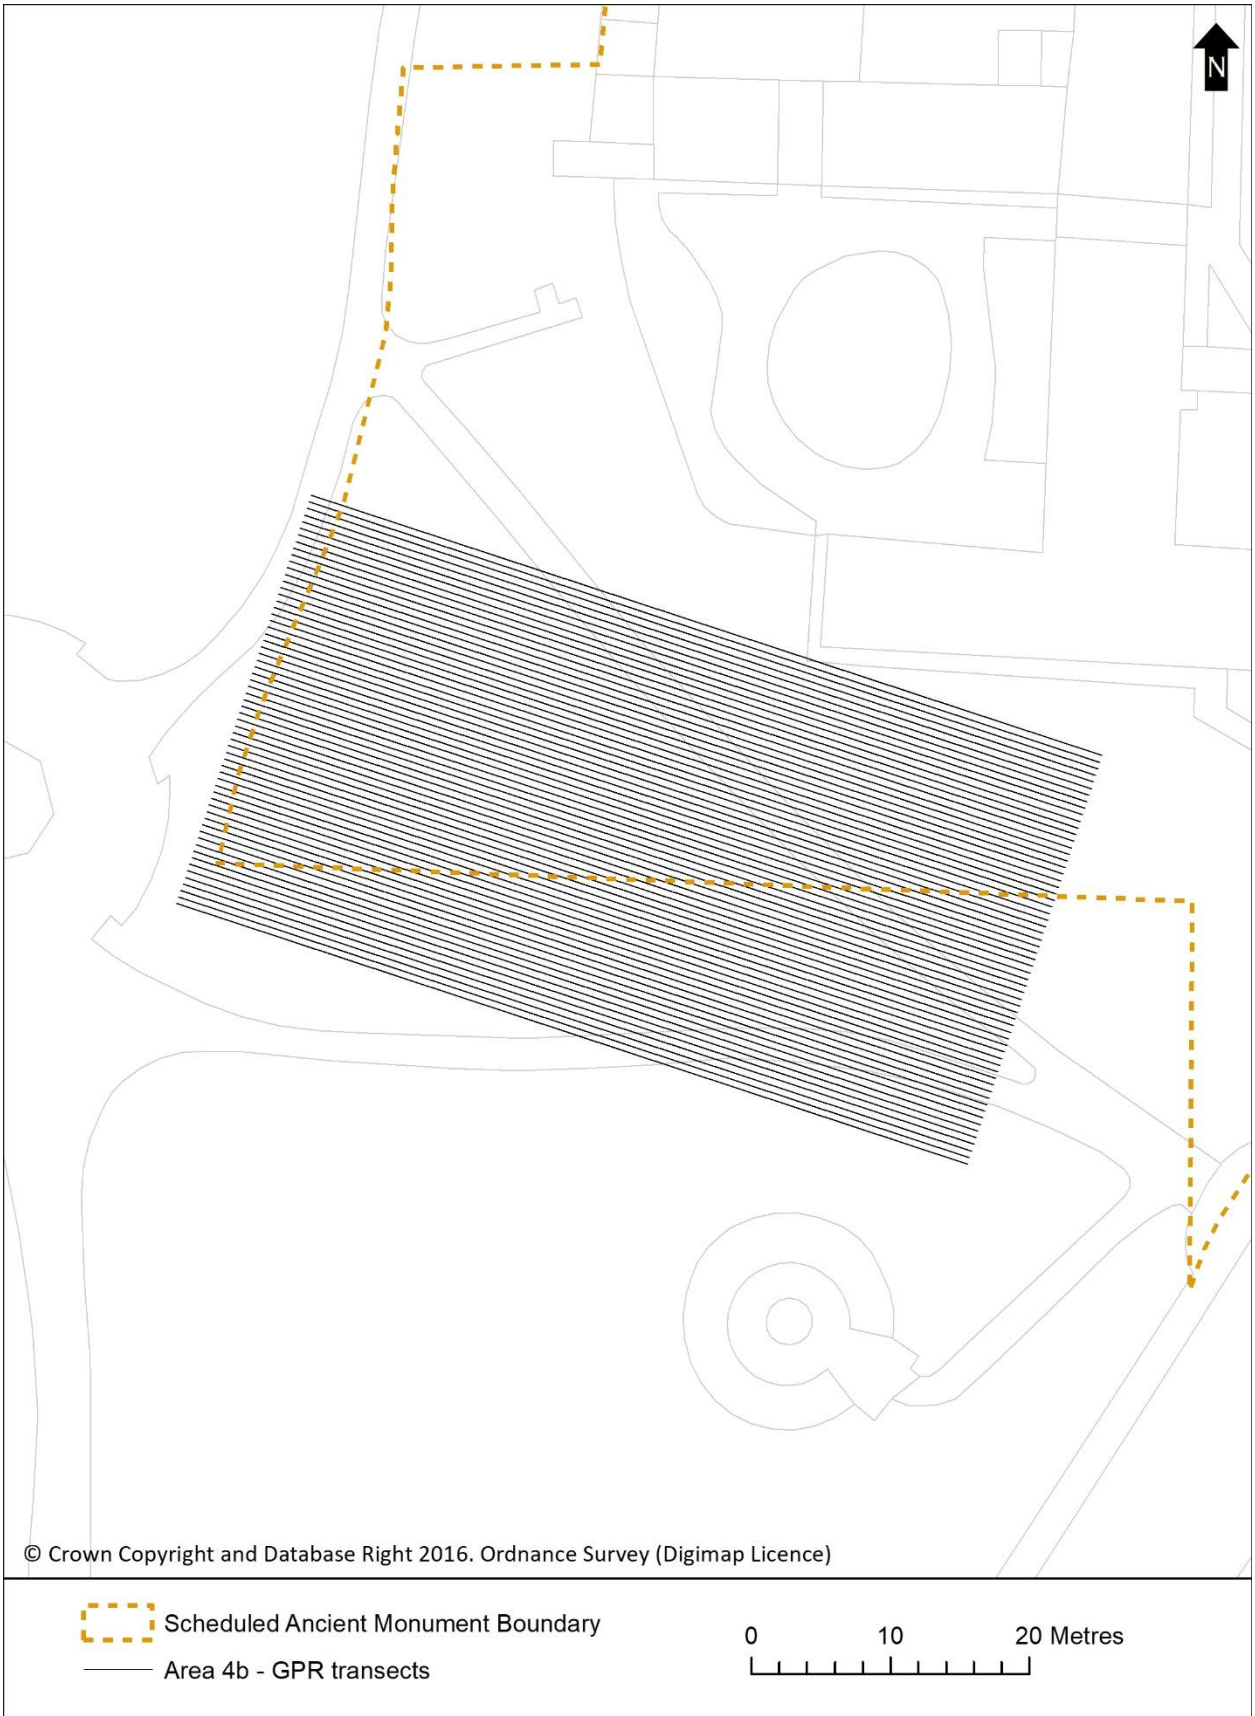
Figure 15: Ground Penetrating Radar, survey transects in area 4b (Park) (Graphics: A. Turner).

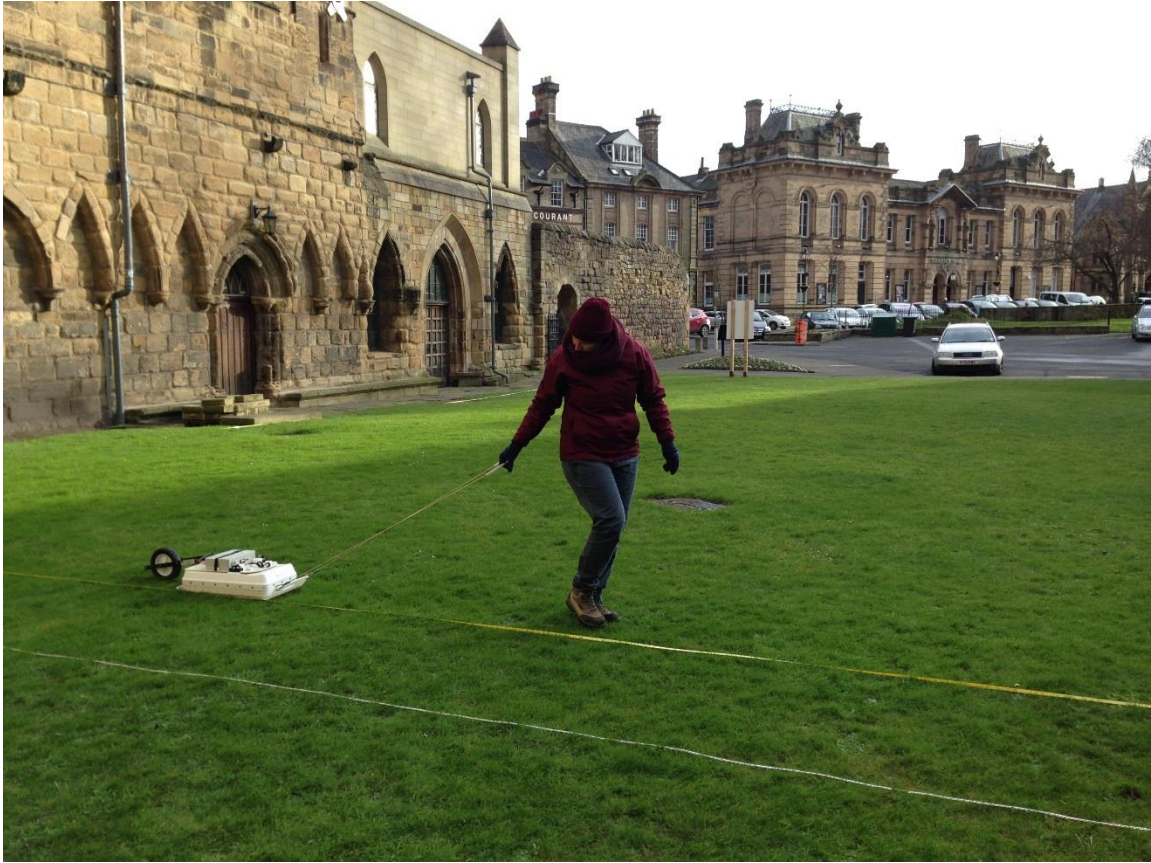
Figure 16: S. Hueglin pulling the GPR sled across area 1a (Cloister) 9/02/2016 (Photo: D. Astbury)

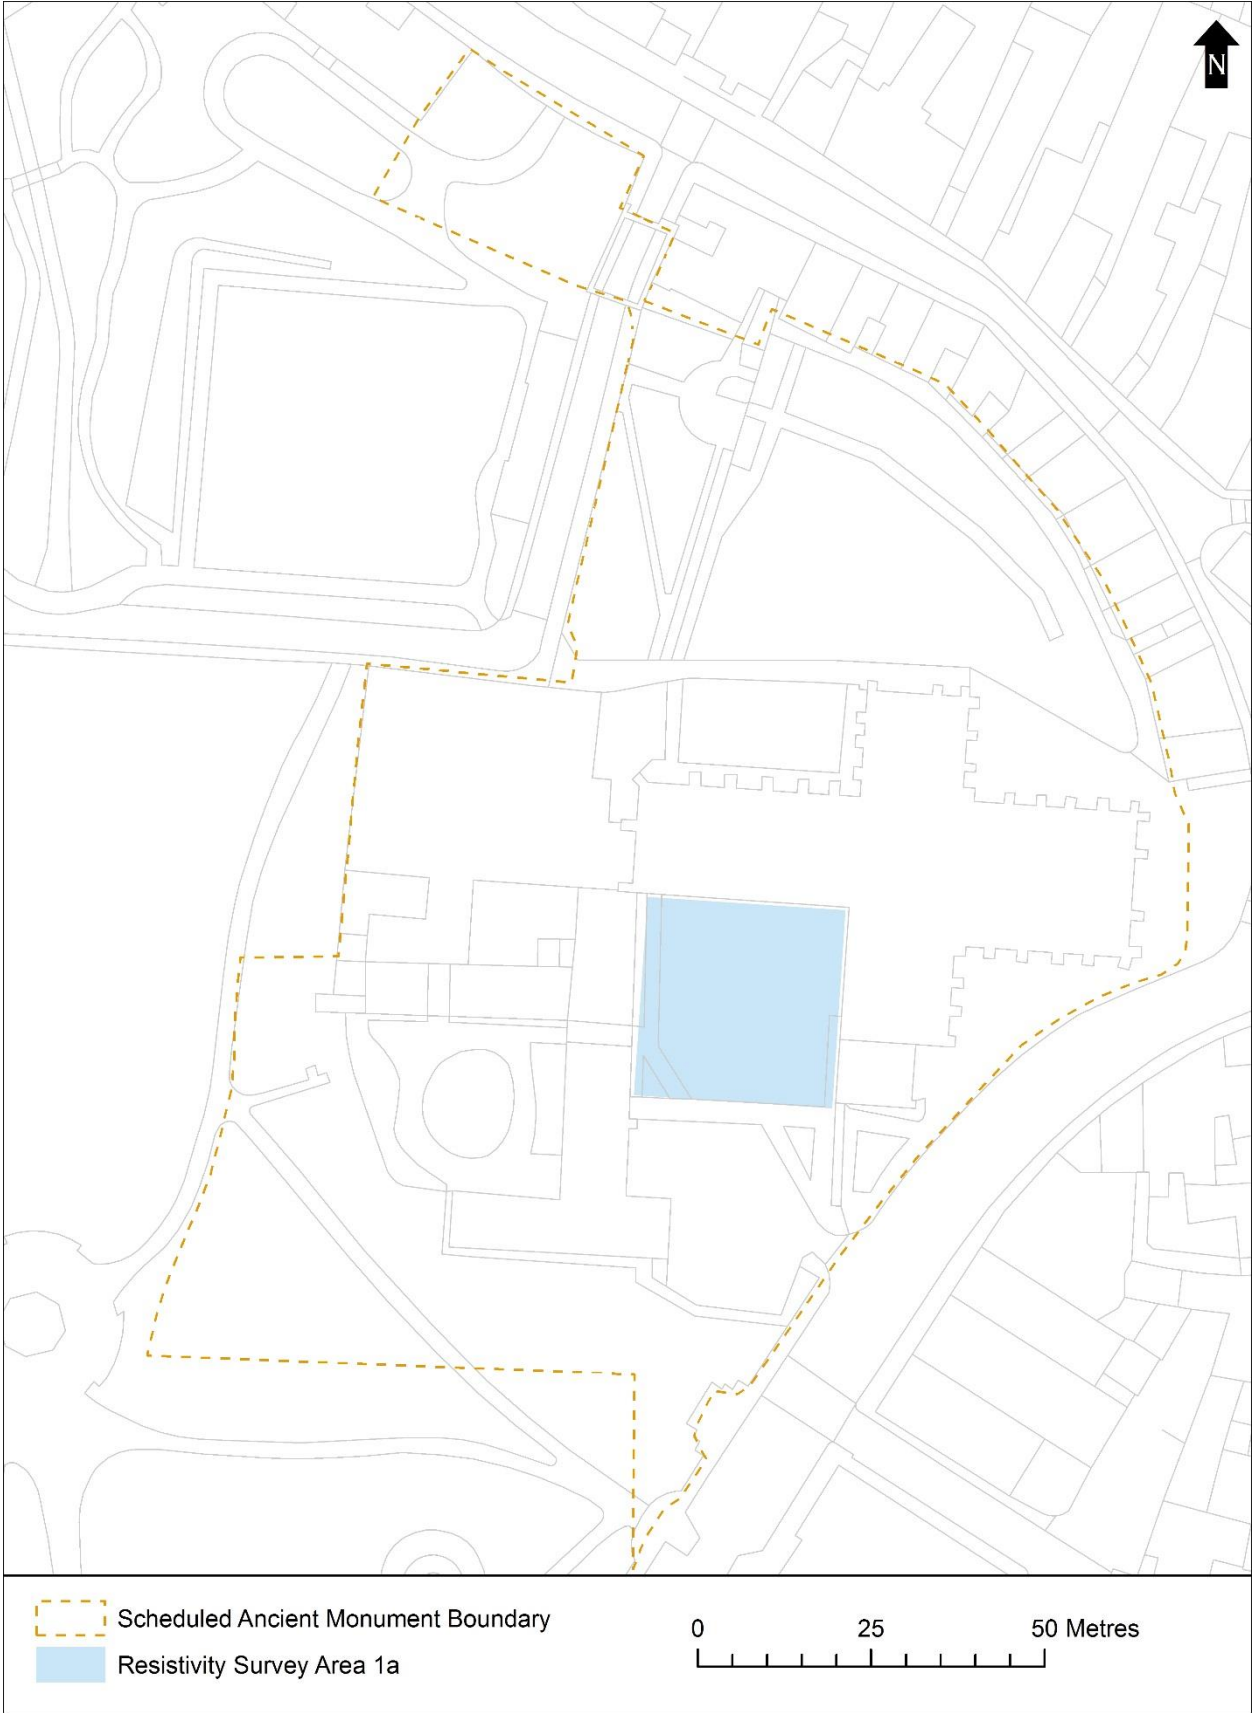
Figure 22: Location of the resistivity survey in area 1a (Cloister) (Graphics: A. Turner)

Resistance survey was carried out using a Geoscan RM15 Advanced equipped with a MPX15 multiplexer. The data were collected on a standard 30m x 30m grid using 0.5 metre traverses and 0.5 metre between samples. Due to the slowness of this technique it wasn't used as widely as the other two methods.

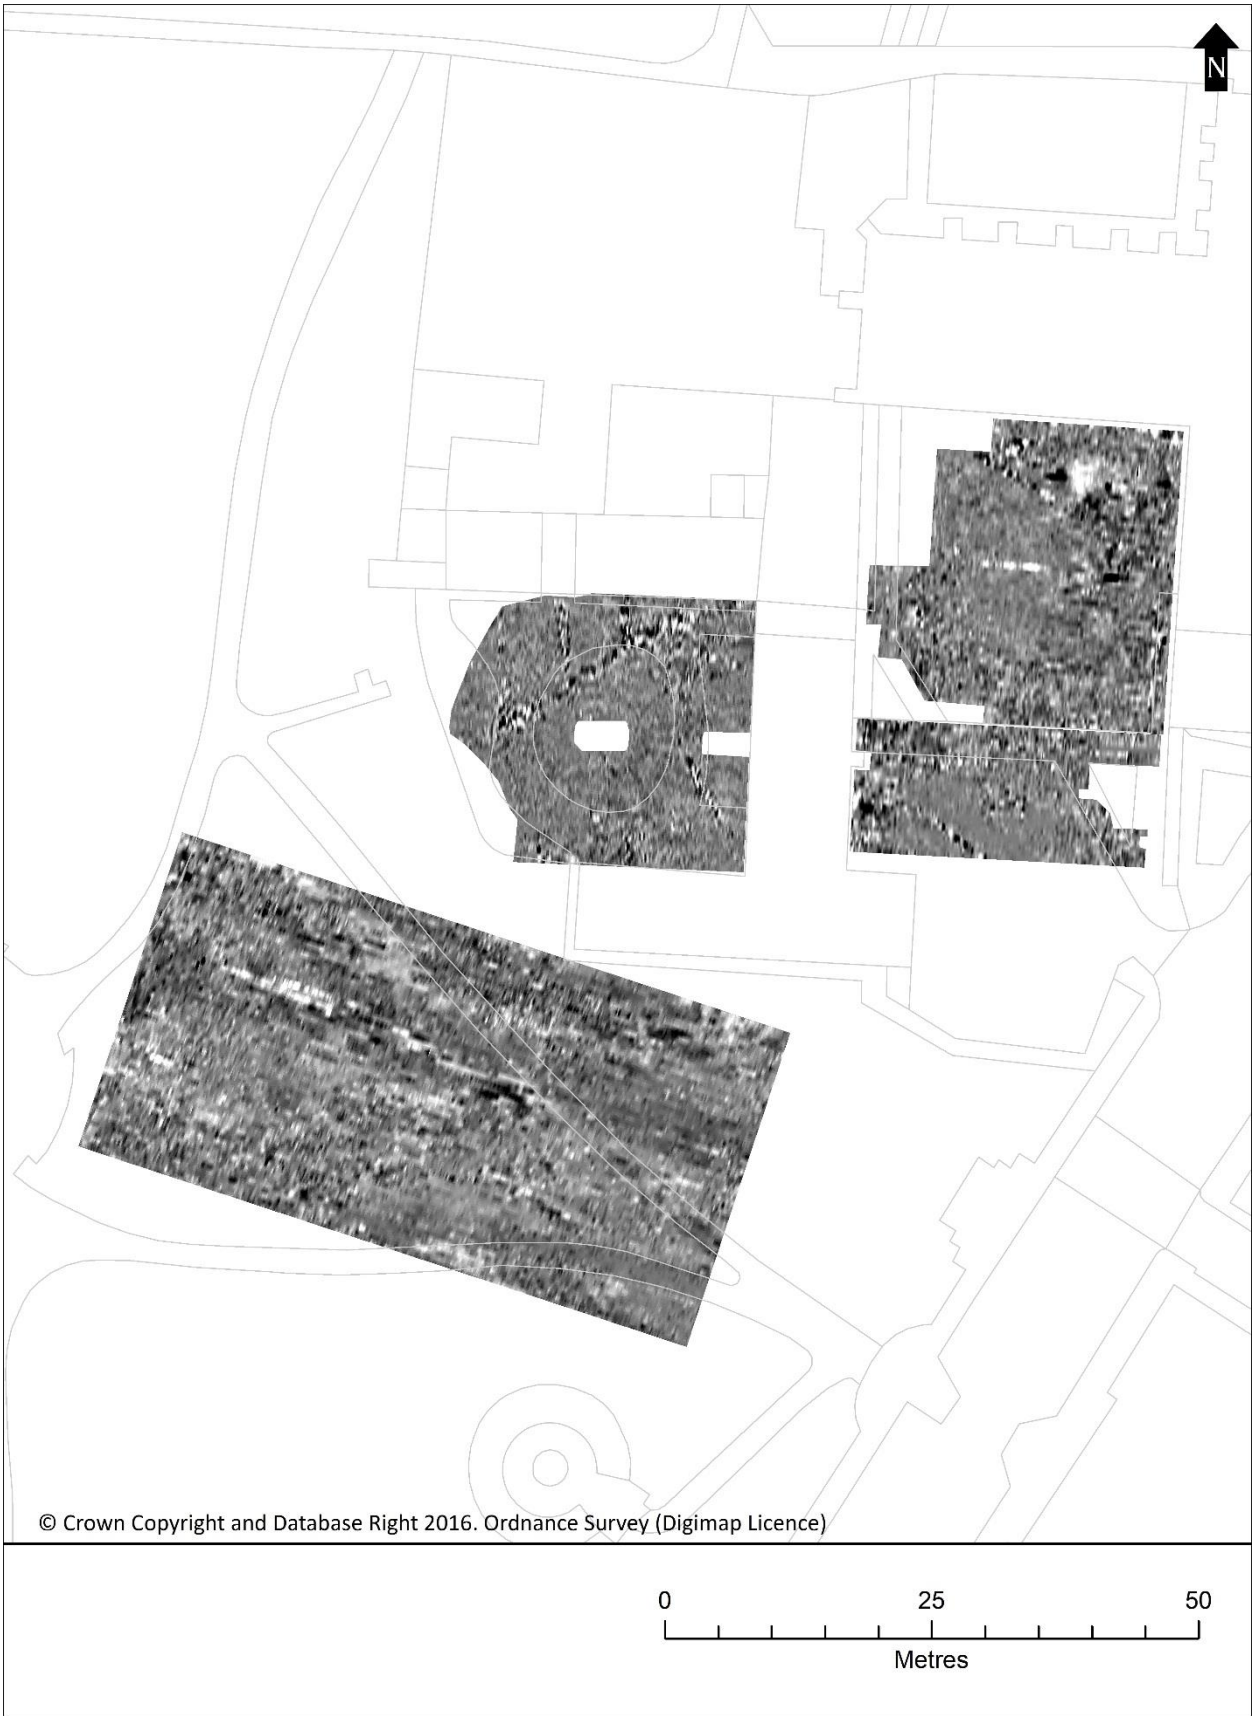
Figure 29: GPR results -0.6 m in areas 1a, 1b, 3 and 4b (Graphics: A. Turner)

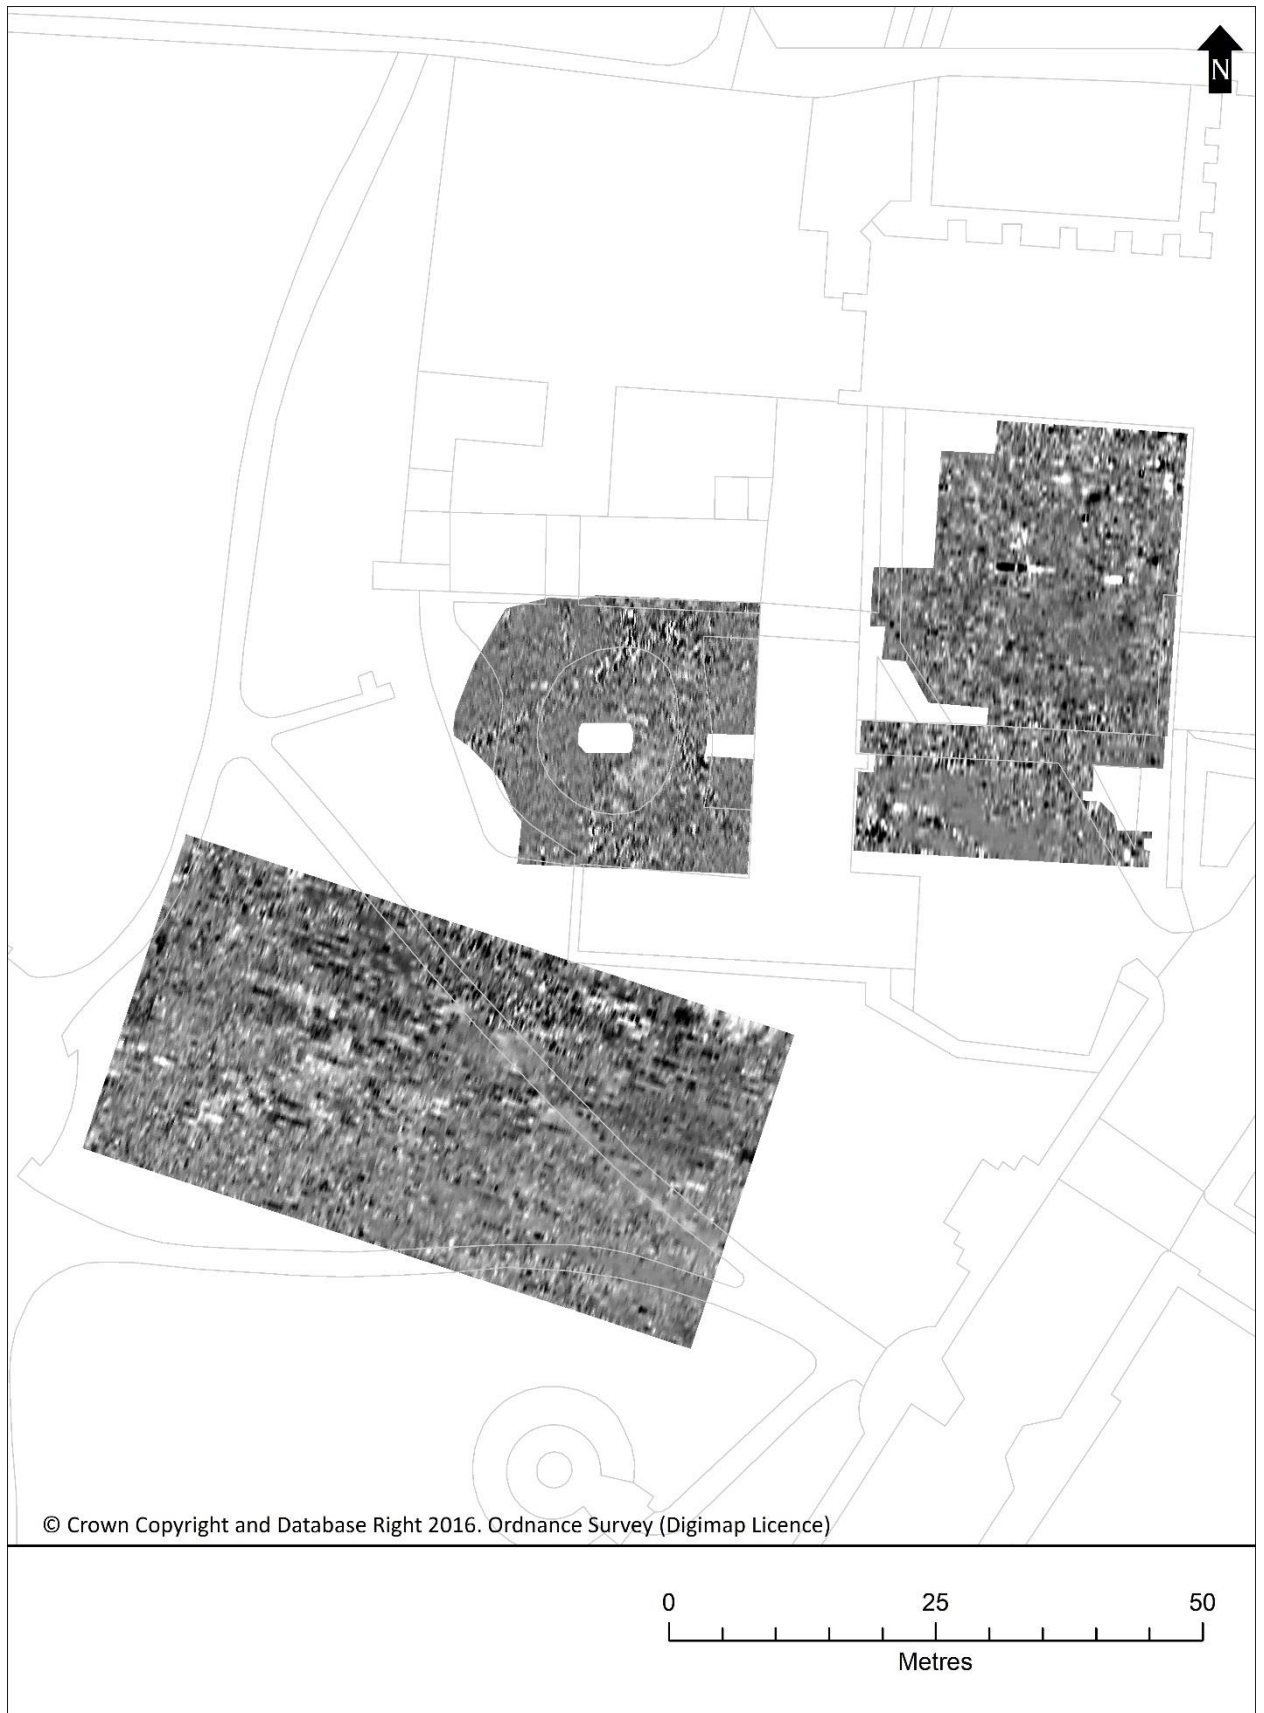
Figure 31: GPR results -0.8 m in areas 1a, 1b, 3 and 4b (Graphics: A. Turner)

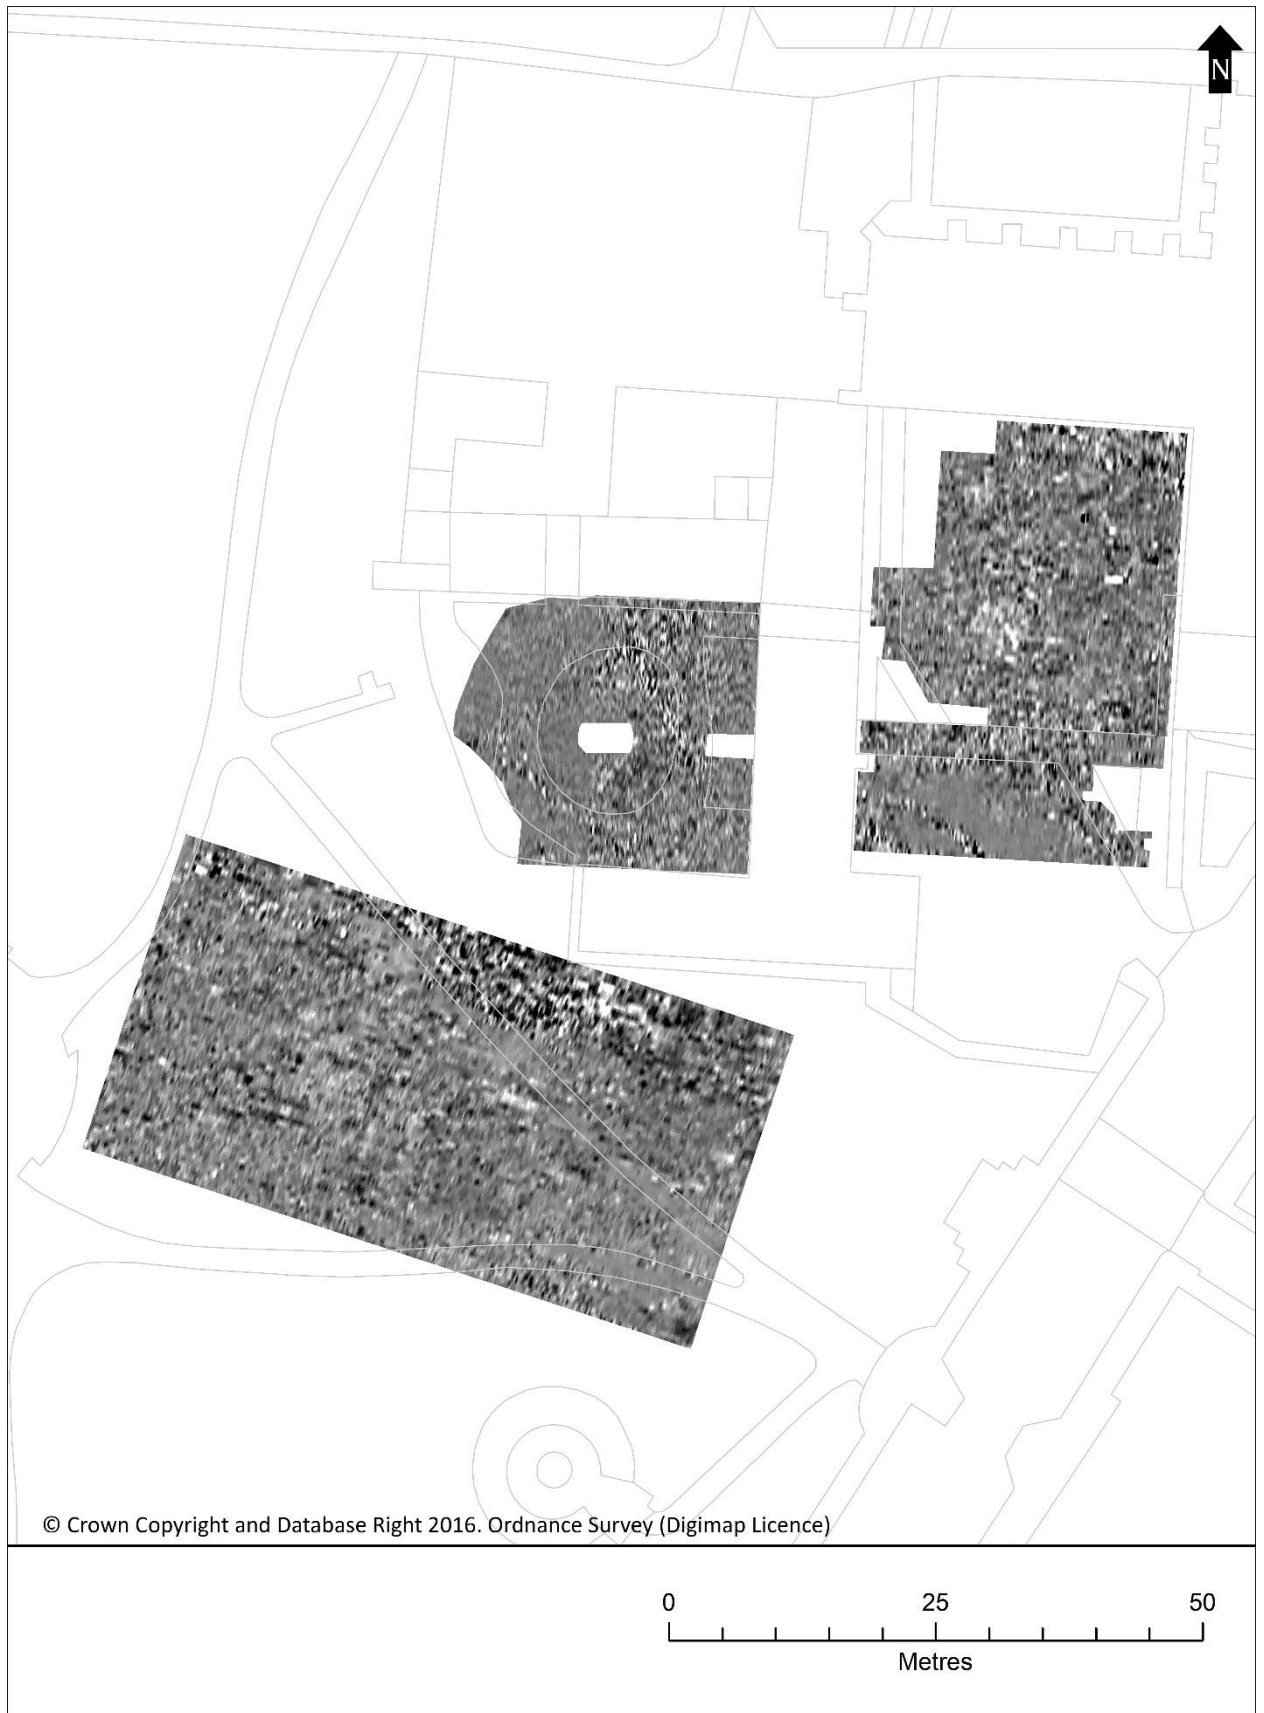
Figure 33: GPR results -1 m in areas 1a, 1b, 3 and 4b (Graphics: A. Turner)

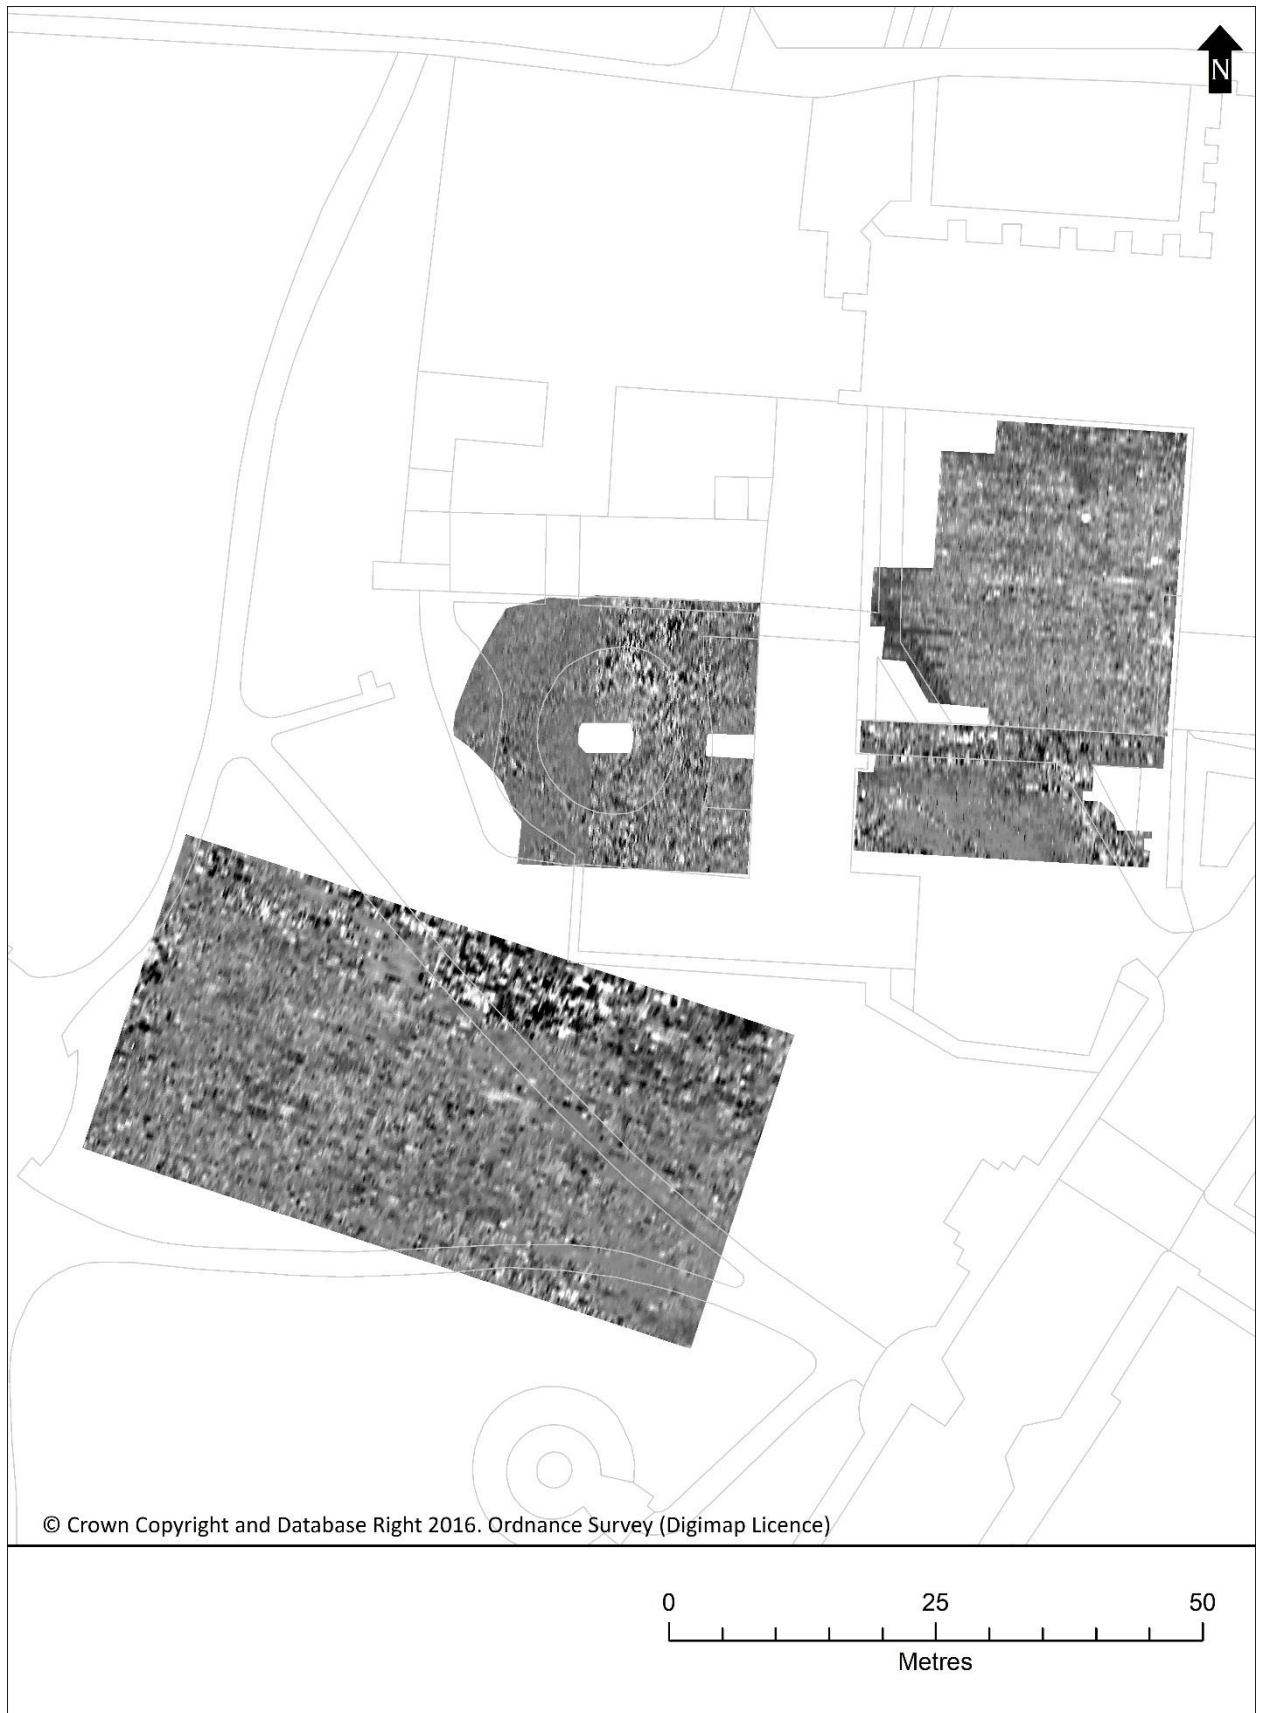
Figure 35: GPR results -1.20 m in areas 1a, 1b, 3 and 4b (Graphics: A. Turner)

Estimated depth c. 1.20-1.60 metres in areas 1a, 1b, 3 and 4b (Figures 35-38)

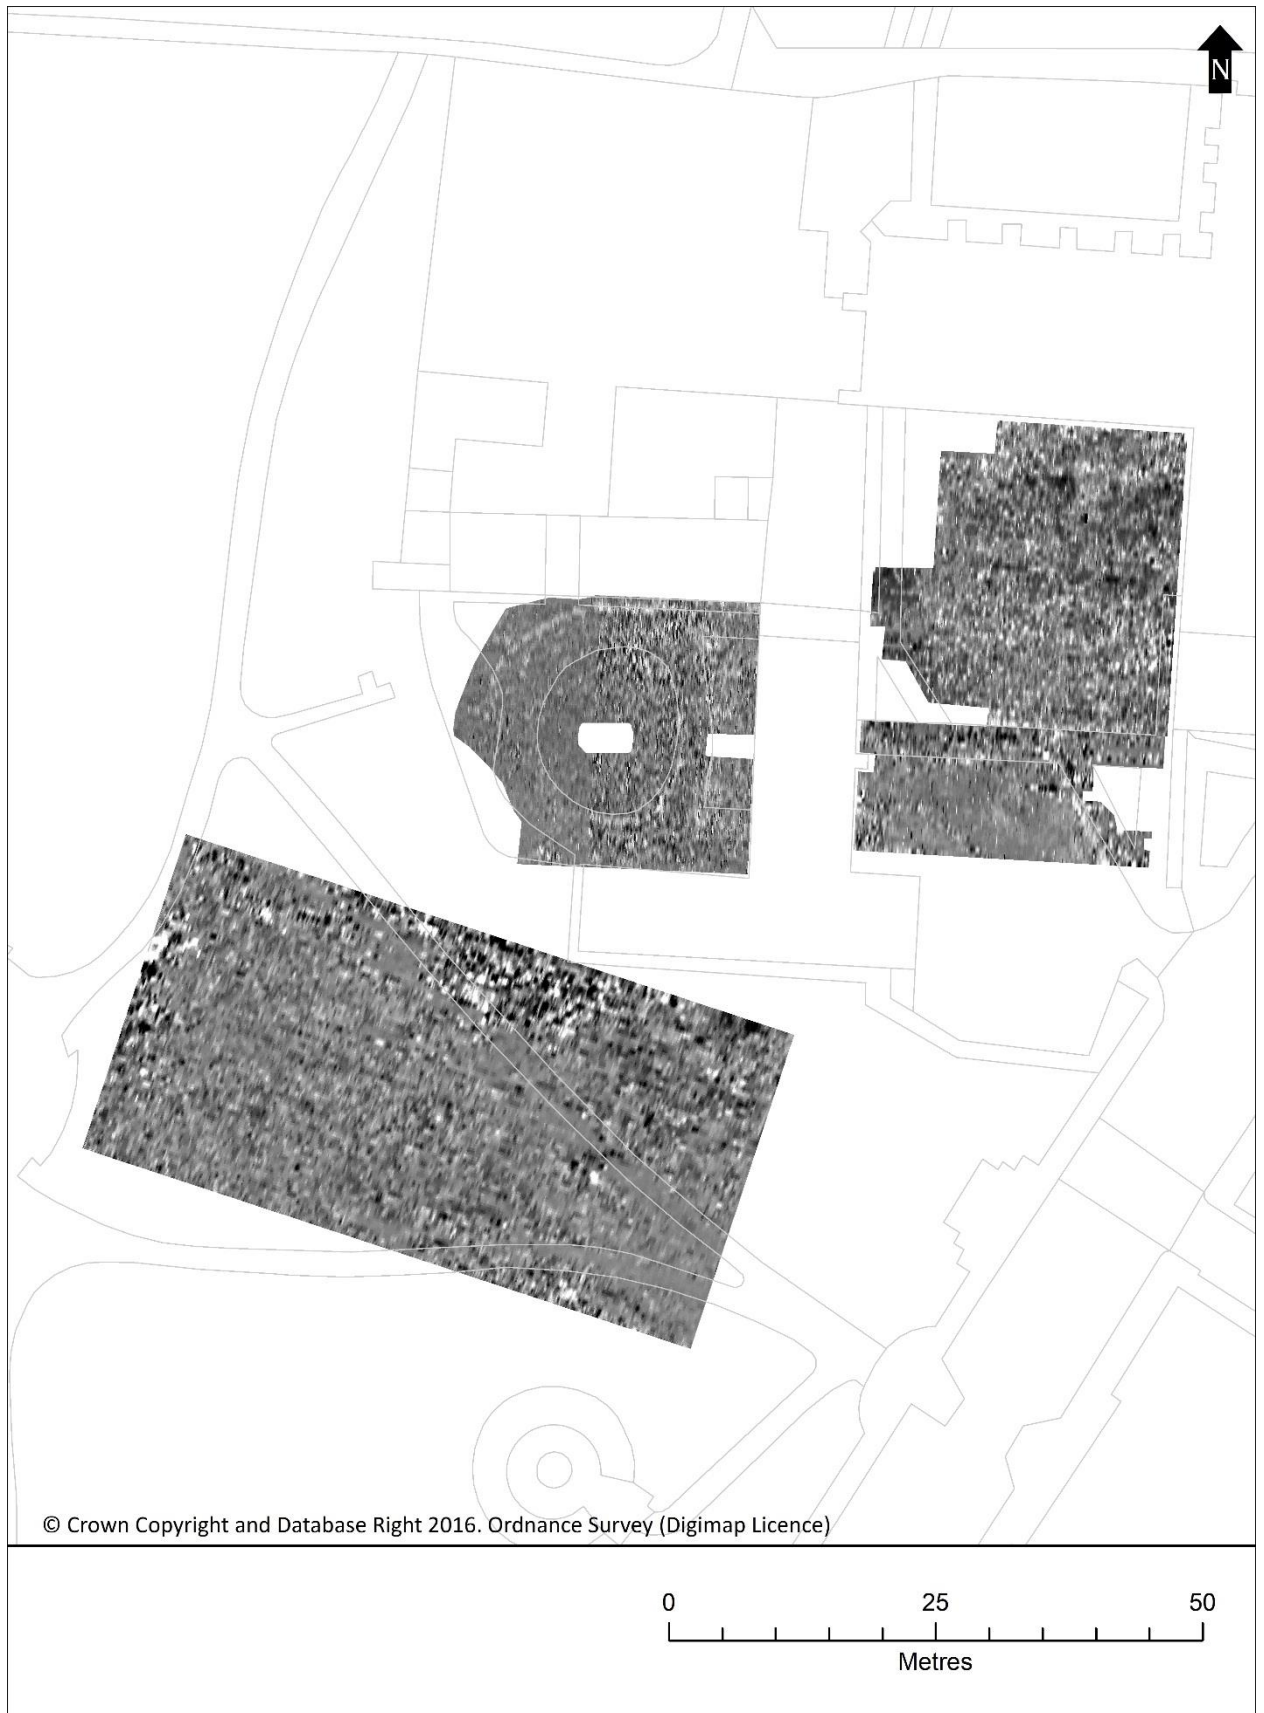
Figure 36: GPR results -1.40 m in areas 1a, 1b, 3 and 4b (Graphics: A. Turner)
