Geophysical Survey of Hexham Abbey

Scheduled Ancient Monument Area

Sophie Hueglin, Alex Turner & David Astbury

9/05/2018

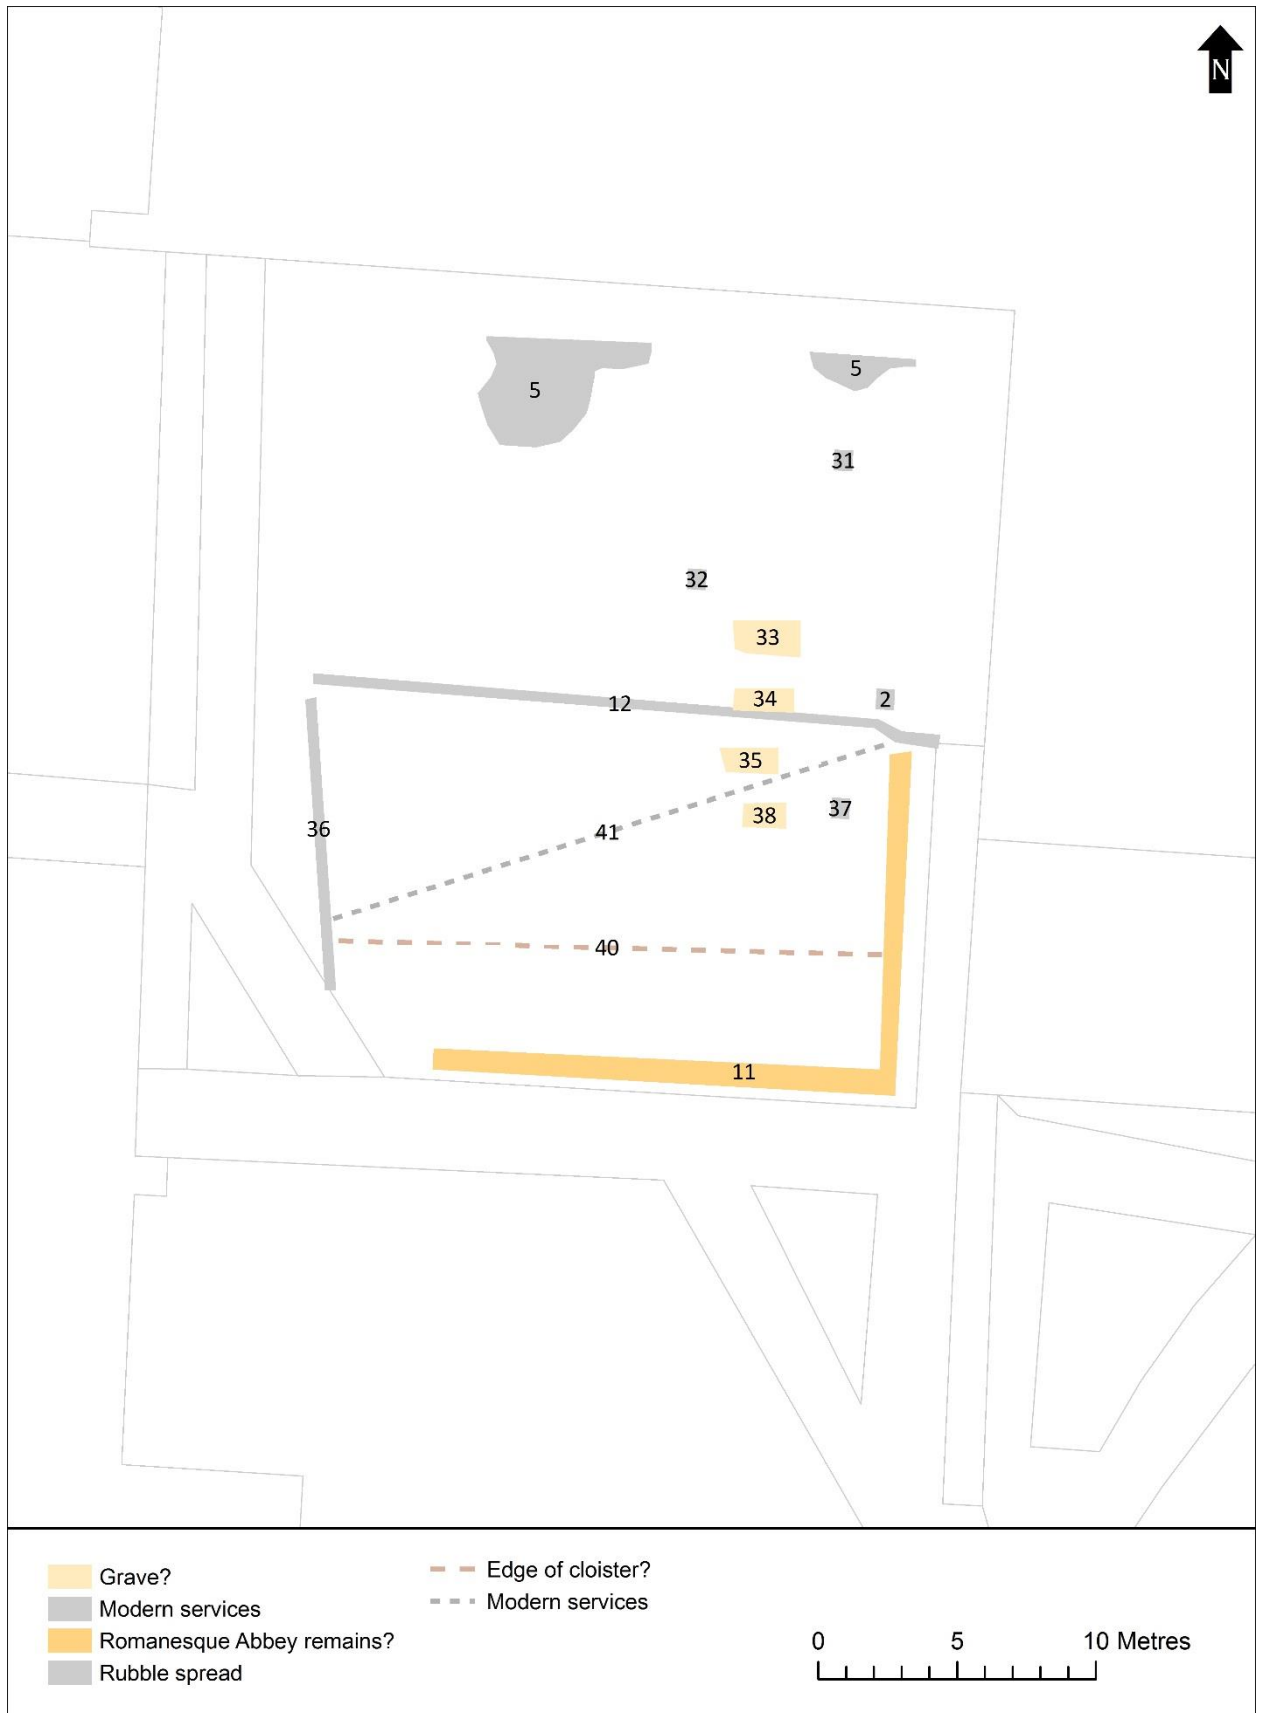
Feature 2 is a modern service cover and corresponds to feature 2 in the GPR survey. Feature 5 coincides with the rubble spread found during GPR survey and probably represents disturbance from the excavations of 1909. Feature 11 is a linear feature that runs parallel to the pathway south of the cloister and returns at right angles parallel to the west front of the building to the west of the Abbey. Its alignment coincides with the conjectured line of the Romanesque church and monastic remains shown in Cambridge and Williams figure 18 (Cambridge and Williams 1995). This feature was also detected by the GPR survey. Feature 39 may represent the edge of the covered walkway at the southern edge of the cloister.

Feature 12 is a modern pipe that crosses between the Abbey and its ancillary buildings to the east. This was also detected by the gradiometer and resistivity surveys. Features 31 and 32 are modern service covers. Features 33, 34, 35 and 38 are possible grave at the eastern edge of the cloister. Features 36 and 40 are a modern service pipes.

Figure 42: Resistivity result interpretation in Area 1a (Graphics: A. Turner)

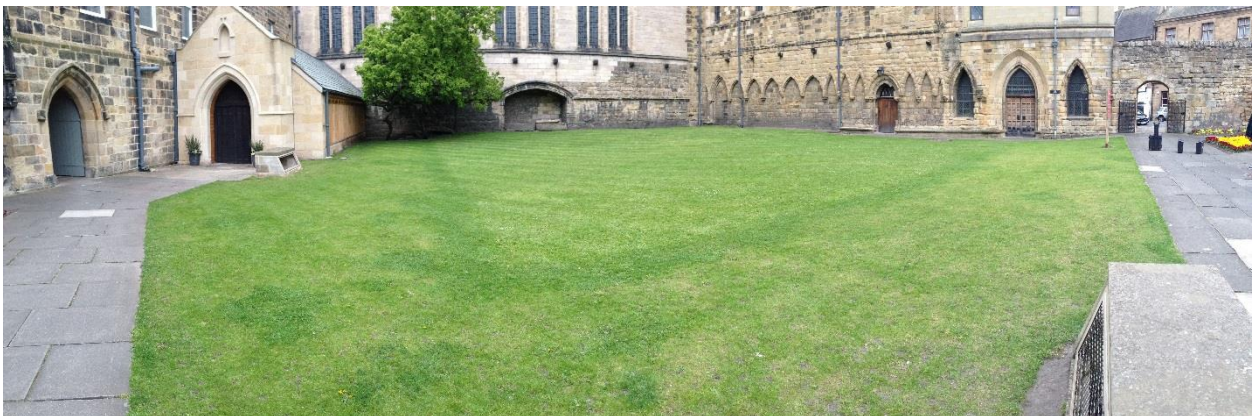
Figure 43: Parch marks in the Cloister area (1a) looking northeast on 26/04/2017 after an exceptional dry period (Photo: S. Hueglin)

Within the Scheduled Ancient Monument area, specifically in area 1a, the former cloister, the observed parch marks would be worth documenting with a photograph from higher up and with a total station. The shapes are very distinctive and relate clearly to walls in connection with the Romanesque Cloister garth.

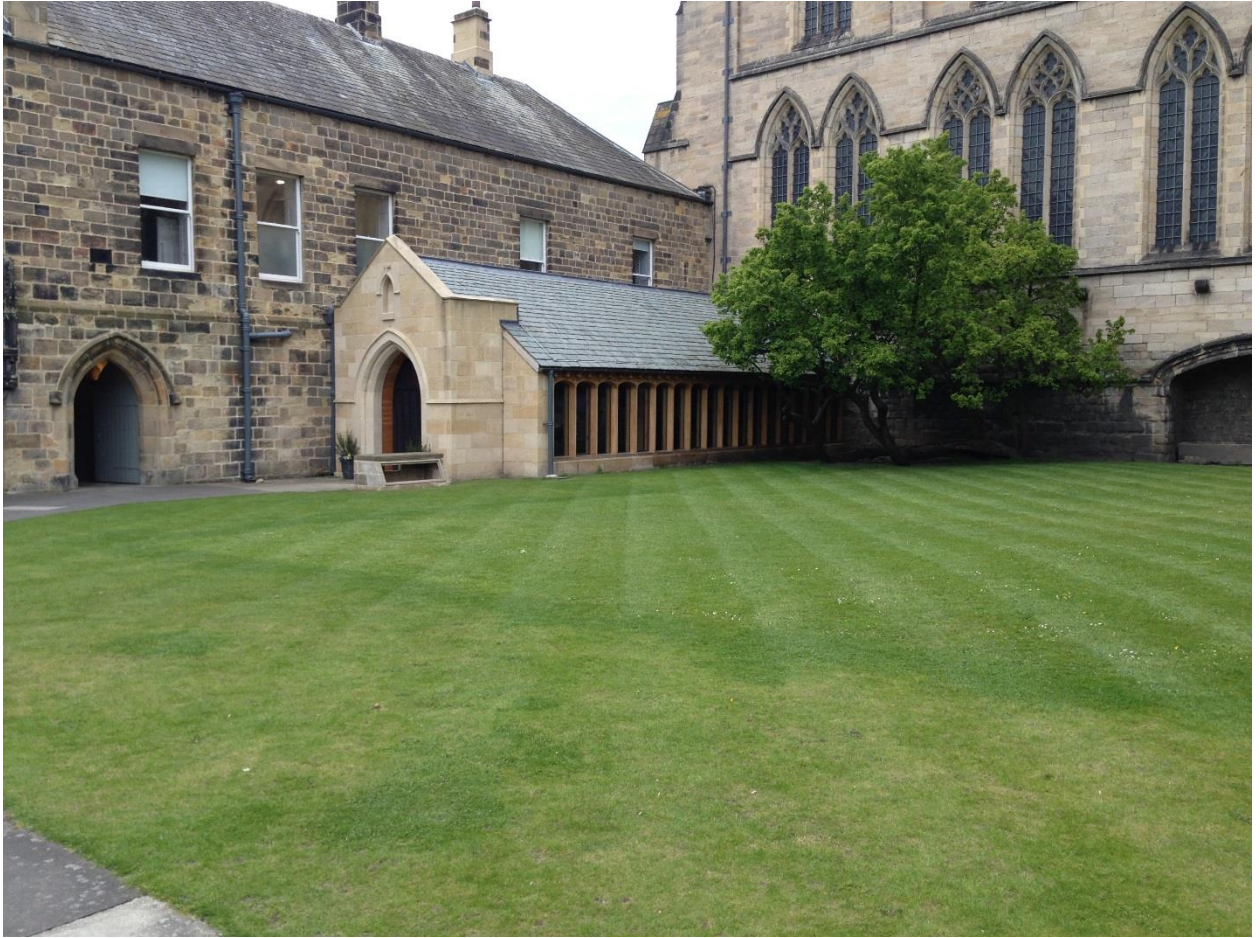
Figure 44: Parch marks in the Cloister area (1a) looking northwest on 26/04/2017 after an exceptional dry period (Photo: S. Hueglin)
