# Ebenezer Chapel, Salter Road, Rotherhithe, London Borough of Southwark: Historic Building Record

Planning Application: 11-AP-22421107

AOC Project No: 32077

Date: July 2012

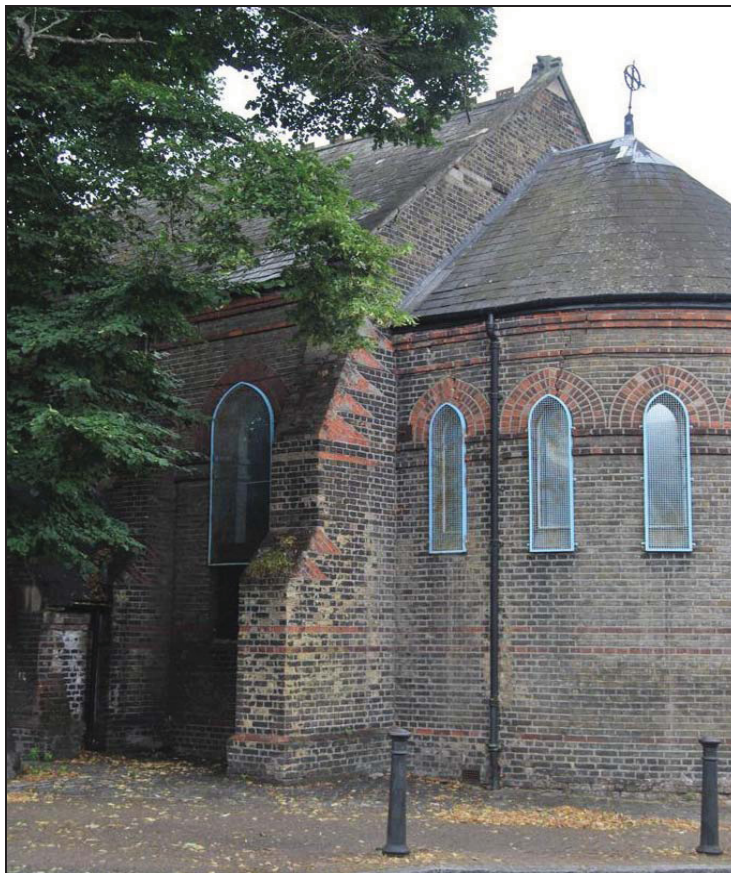
Plate 3: External View of Church

6.2.1 The principal room in the building, and the main function, is the church (**Room 1**). The nave has been partitioned and a floor inserted, but the original aspect is largely present. Externally, modern extensions providing toilet facilities and changing rooms have detracted slightly from its setting. Internally, the church is a rectangular building with a floor space measuring 13.5m by 7.25m. It is oriented northeast-southwest. The northwest side of the nave has four wide openings to the range of

rooms beyond. The walls of the nave are constructed of yellow brick, measuring 230mm by 100mm by 60mm, laid in English Bond, are 0.48m wide. The lower courses of the walls step out on the exterior, using red sill bricks to soften the angles.

- 6.2.2 The nave is lit by four lancet arched windows in the southeast wall. Each window has a stone sill, cut at 70°. All windows bar one are plate glass between lead glazing bars. Only one has part of its original glazing apparent: the third window has a lead-glazed window with textured opaque diamond panels. There is an outer row of amber glass panes. The window arches are formed of three rows of headers. Additional light was provided by three smaller windows in the southwest gable, but these are now boarded up and the upper end partitioned off. One of the windows has a crack on the lancet arch, which is held together by a metal tie.

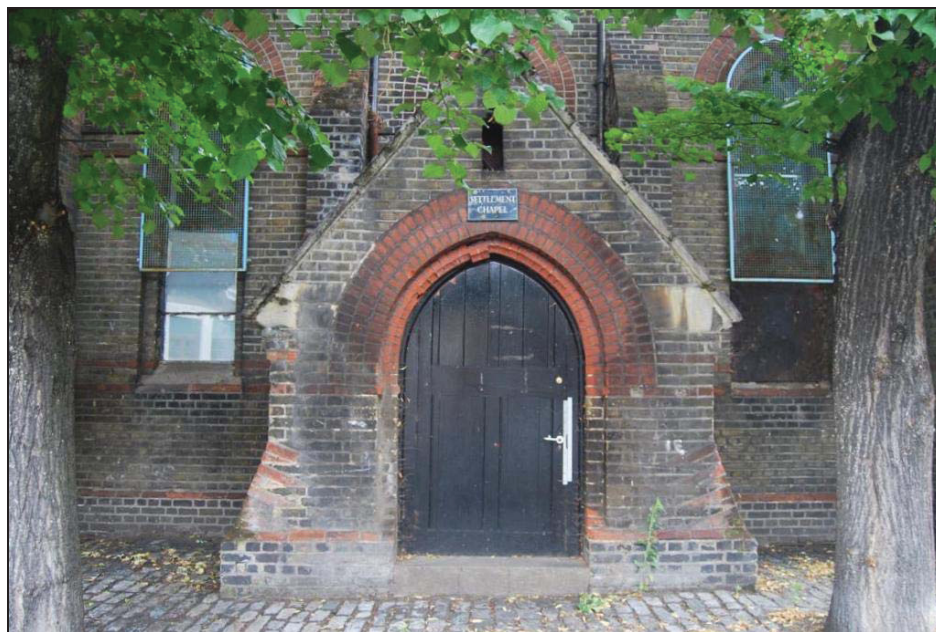
Plate 4: Porch on Southeast side of Nave

- 6.2.3 The southeast wall is supported by six stepped brick buttresses, with angled red brick dressing. These are 0.95m long and 0.50m wide. A porch on this side is located to the front end is also brick, with a pitched slate roof, and has a lancet-arched red brick opening. The inner course of the arch has concave-moulded bricks. Above the entrance is an eroded painted sign reading 'Settlement Chapel' (Plate 4).

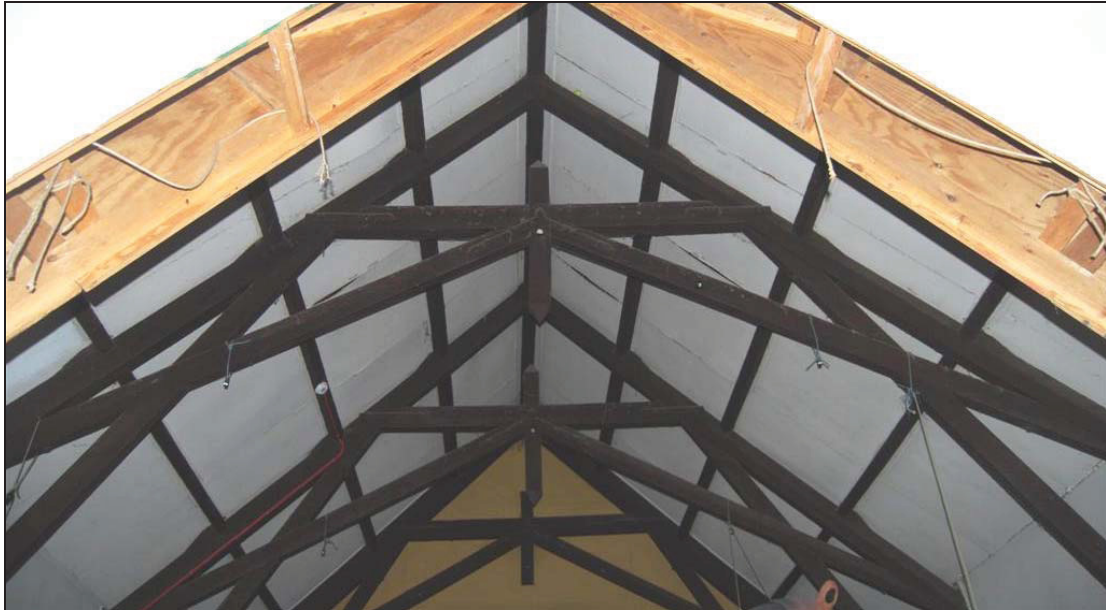
Plate 5: Roof Trusses of Nave

- 6.2.5 The roof of the nave is pitched slate, with the ridge surmounted by ornamental ridge tiles. Each alternate tile has a flange pierced by three circular holes. The gable-ends of the pitch are surmounted by stone coping, and there is a capstone at the northeastern end that may once have held a stone cross. The southwest gable end is lit by three smaller arched windows. The roof is supported on four trusses. Each truss is of the same form; a collar beam supported by pairs of scissor braces. The trusses rest on projecting stone corbels with concave undersides. Each scissor brace is lap jointed, and meets a central vertical beam across the collar, like an unsupported kingpost. Apart from lap joints, the principal technology shown is simple: the individual elements of the trusses are bolted together with square-headed bolts (Plate 5).

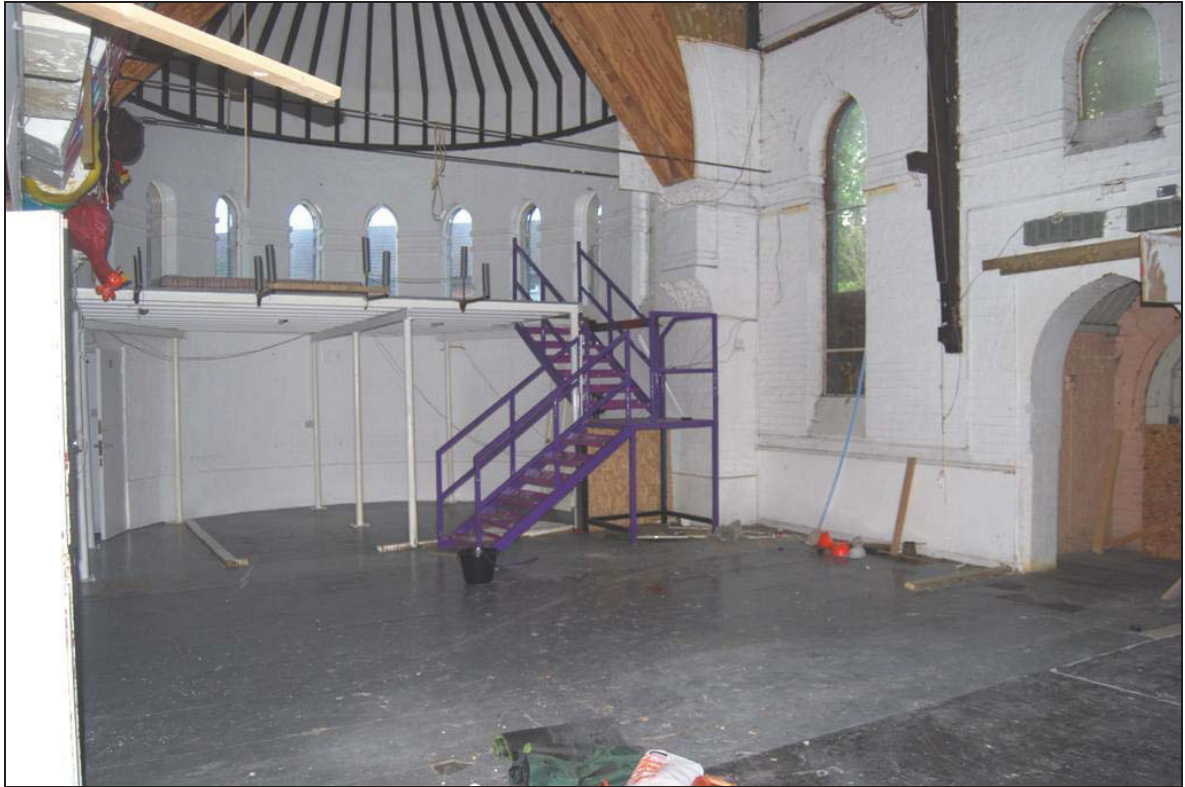
Plate 6: Nave and Chancel

- 6.2.7 The chancel has an apsidal end with a radius of 3.24m, set back by 1.7m (Plate 6). The opening from the nave to the arch is formed by a high, almost Romanesque arch. The arch springs from a pier on each side with two decorative stone corbels. The lower stones are larger, and both are decorated with floral designs (Plate 7). The chancel is lit by eleven high level lancet-arched windows, each 0.48m wide, at regular intervals. Two on the northwestern side are blocked up.

- 6.2.8 The roof of the apse is formed of rafters radiating from a central ridge. They are supported on a curving wall plate around the edge of the apse. A wooden former has been inserted within the arch. This is adding support, since a significant crack in the brickwork near the apex is indicating structural failure.

- 7.4 Structurally, the buildings are showing signs of deterioration. The church itself has a large crack in the main arch between the nave and the chancel. There is additional cracking on two external window arches, and another crack on the southwest end, where the window had been patched with an iron tie. The pastor's house, later warden's house, has severe subsidence in the southwest room, with a crack up much of the end wall, shown by movement around the chimneystack and along the wall line. The reason for the structural weakness is unproven, but may relate to altering ground conditions after many of the local docks were infilled.

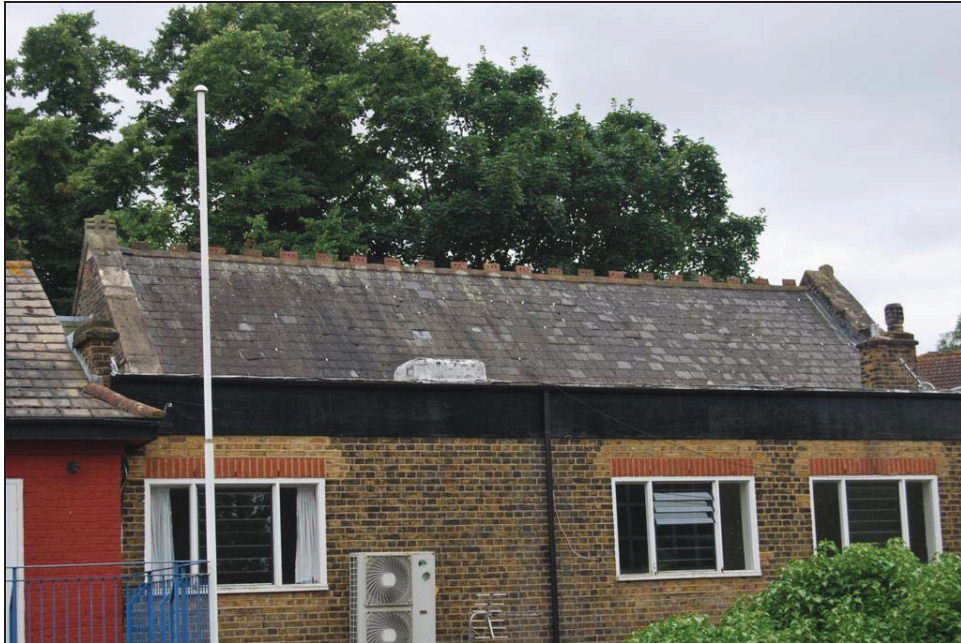
Plate 8: Northwest Upper Floor, Elevation of Ancillary Block: Church Roof Beyond.

- 6.3.1 The northwestern side of the nave has a two-storey range built next to it. This block measures 16m by 6m, parallel to the nave. The block is yellow brick, consistent with a 19<sup>th</sup> century date. However, the windows facing northwest have all been modified: the sills are wooden, and the lintels are red brick or concrete with steel beams behind. There is also some rebuild of the associated brickwork above the lintels (Plate 8). The windows themselves have plastic frames. There is one blocked opening in the northwest wall on the ground floor: this was formerly a door. Another door is still in use, and accesses the rear plot of land.

- 7.2 The attendant hall has been clearly modified, especially the northwest face, with new windows and lintels inserted into the 19<sup>th</sup> century wall. The flat roof of the block may also be part of a repair. As such, its value is much reduced. The only fixtures remaining of interest are a pair of chimneystacks on each floor in the northwest wall, and a small corner-set chimney at the south corner of the first floor, now hidden by a cupboard. The newer blocks that house changing rooms and toilet facilities are of no historical value. The use of red stringcourses in the walls makes them slightly more attractive externally than a plain wall would have.

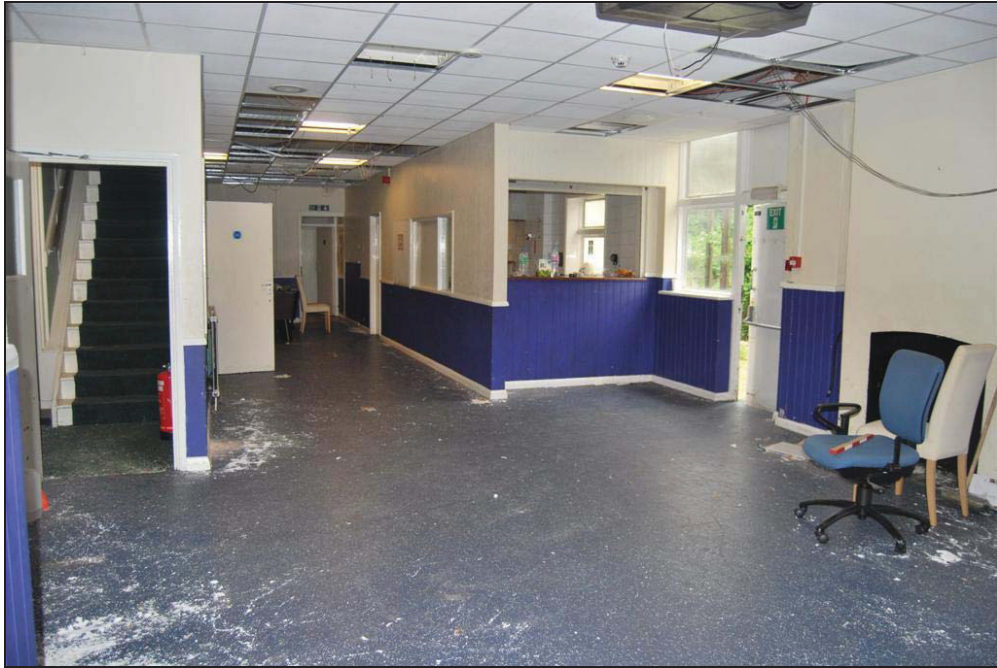
Plate 9: General View of Room 3 Looking Northeast

- 6.3.2 The ground floor has one large room (**Room 3**) (Plate 9), with a kitchen partitioned from it (**Room 4**). The walls of the main room are plastered and painted. One historic feature is a fireplace in the northwestern wall, northeast of the kitchen. This has no chimneystack above roof height, and must have been taken down. The fireplace has a segmental arch spanning the opening (Plate 10). The kitchen contains an oven, hob and sinks, all modern fittings. It has glazed white tiles on the internal walls, obscuring potential historic fabric. There are two doorways in the southwestern end of the room, both with bullnose brick reveals and segmental arched lintels. One is blocked, the other leads to and from the modern main entrance past the administration office.

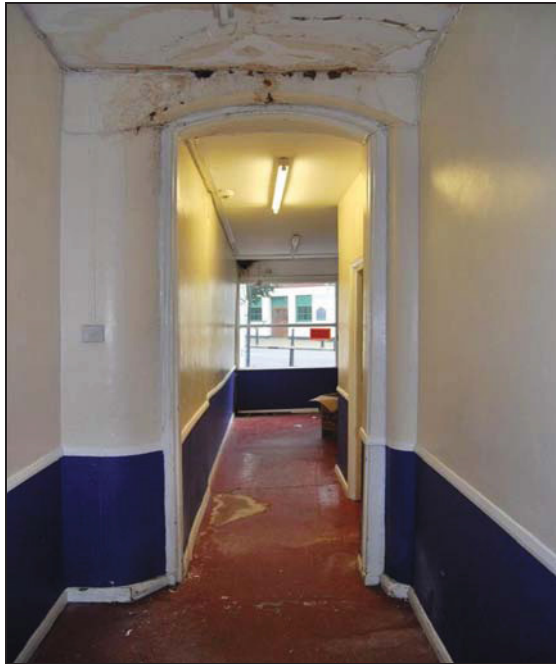
Plate 11: Archway Through to Room 38, Looking Southeast

- 6.3.5 On the ground floor, the first room southwest of the large one in the ancillary block is little more than an antechamber (**Room 7**) on the way through the building. To the southwest of it is small room with a toilet in it (**Room 8**), with a storeroom (**Room 29**) beyond. Both of these rooms have blocked windows in their southeast walls showing that these were once external walls. An arch spanning the end of Room 7 is quite high, and again has bullnose bricks (Plate 11).

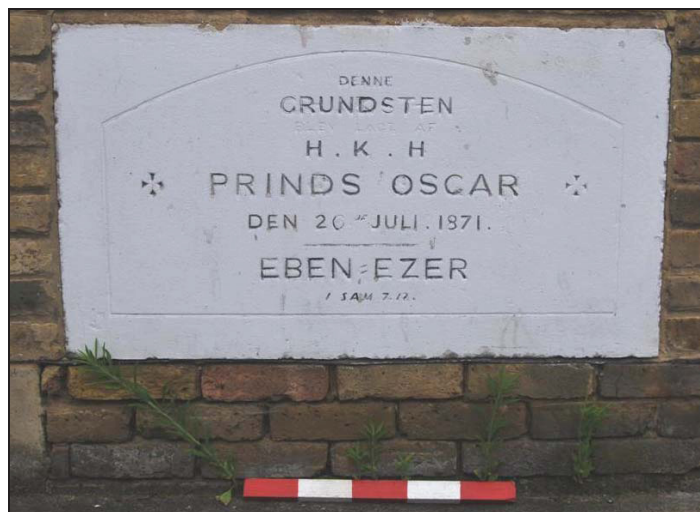
Plate 12: Foundation Stone

6.1.2 The church building has a foundation stone (Plate 12) citing a verse from the Old Testament (1 Sam 7.12). This verse reads: *'Then Samuel took a stone, and set it between Mizpah and Shen, and called the name of it Eben-ezer, saying, Hitherto hath the LORD helped us'*. The name 'Eben-ezer' translates as 'the stone of help'. A commentary on this passage notes that the stone records a victory, a memorial to the glory of God, and to encourage Israel. *"Through successive generations, the church of God has had cause to set up Eben-ezers for renewed deliverances; neither persecution nor corruptions have prevailed against the church, for the lord will help eternally'* (Henry 1706).

- 6.3.6 Southeast of these three rooms is a large room (**Room 38**) partitioned to form office space (**Room 9**). This has a plate window facing southeast and a large door. Both have their glazing reinforced with wire. The walls of this section are added to the original build. There is a foundation stone set within the new walls, and this is assumed to have been removed from the original outside wall and been incorporated when this was built (Plate 12).

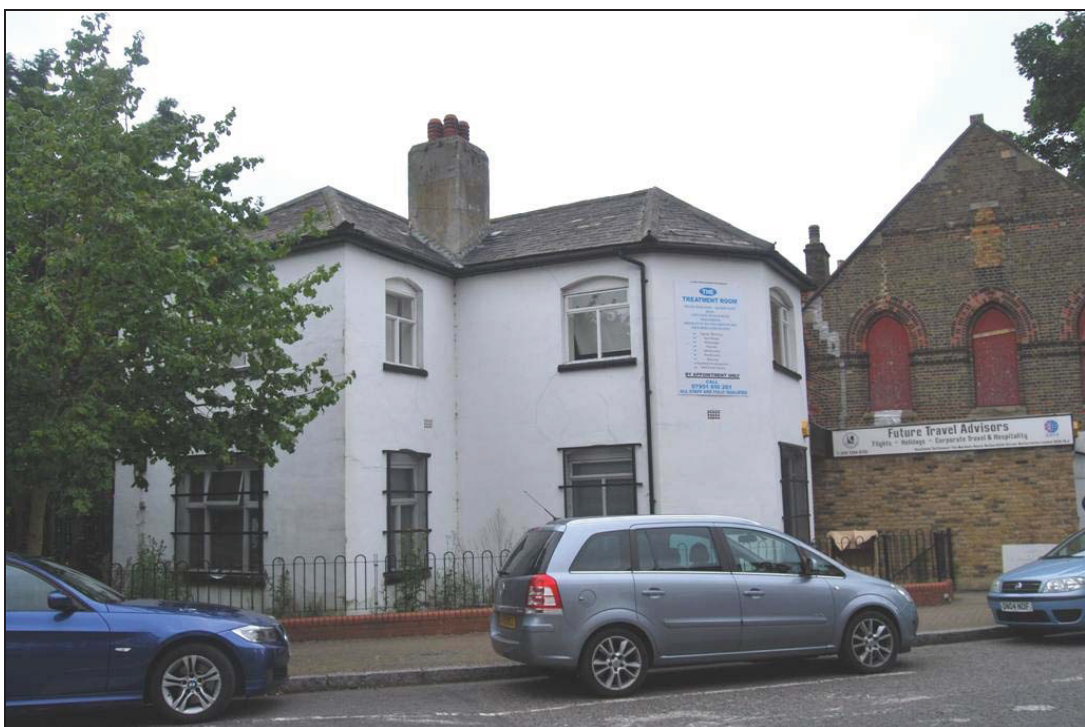
Plate 13: View of Pastor's House, Looking North

6.4.1 To the southwest of the church building is a two-storey house with a hipped slate roof. It abuts the church and is probably contemporary with it. The building is irregular in plan, but is basically a rectangular building measuring 14m by 4.5m, oriented northeast-southwest. A polygonal section of the building projects southeastwards, and a second square bay is shared with the church. The external walls are rendered and painted white over bricks (Plate 13). The bricks measure 220mm by 100mm by 70mm. Although this obscures much detail relating to the buildings form, its 1870s date is clear. Each external window has a brick lintel forming a segmental arch, and the sills are red glazed bullnose bricks, although these have been painted black, to contrast with the white render. All windows are casement windows. The hipped roof has two chimneystacks rising above it, both on the southeast side. This building was probably the residence of the Norwegian pastor, and more recently for the warden of the Docklands Settlements.

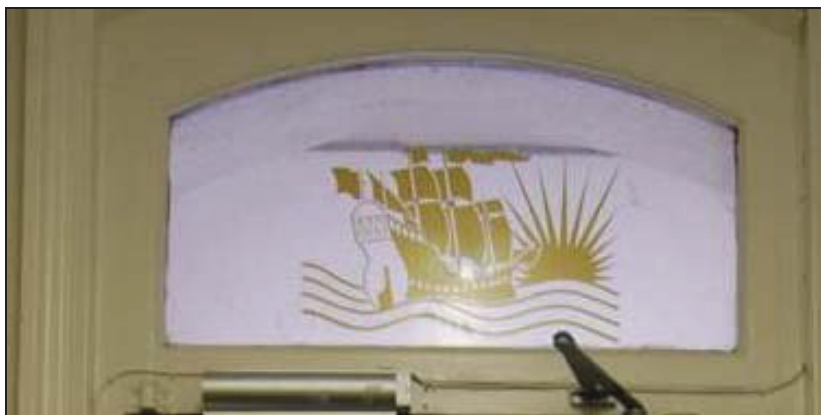
Plate 14: Fanlight from Interior

- 6.4.2 The dwelling's main entrance faces southeast, along a short covered passage immediately south of the offices and entrance, past the foundation stone. There is an additional external door at the rear of the building, opening northeastwards. The door opens into an entrance hall (**Room 18**), with a door to the left, and an opening at the end leading to stairs to the first floor, and doors to two other ground floor rooms. The doorway into the hall has an original frame, lined with two square bead mouldings and an ogee wave between. The doorway is surmounted by a fanlight with a curved top. The fanlight is decorated with an etched and painted marine design showing a ship sailing towards a sunburst: this is the logotype for the Docklands Settlement (Plate 14). The door is an original fitting, with a glazed pane now boarded. Two large bolts at the top and bottom are probably original. The skirting in the hall is plain.

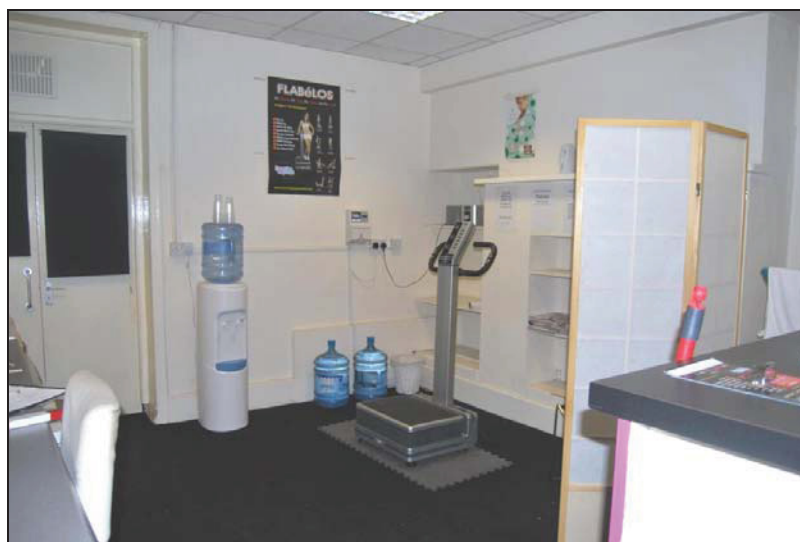
Plate 15: Kitchen, Room 17 Looking East

- 6.4.5 At the northeastern end of the ground floor is a large room (**Room 17**) which was the kitchen of the property (Plate 15). This has a 2.3m wide chimneybreast in the side wall, suitable for holding a large stove or range. The room has generally been refurbished, and few original details remain. The floor seems solid and may be tiled beneath modern finishes. The skirting is totally plain, simply a flat-topped board. The doorframes are also plain. This may express the functional needs of the kitchen rather than being modern décor. At the end of the room, a pair of double doors lead towards a small secondary, modern block, which opens into the grounds to the rear (**Room 39**). This extension is clearly a much later addition.

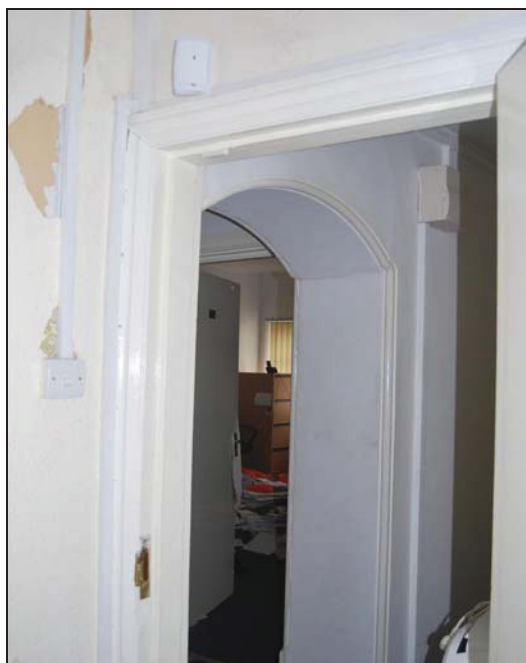
Plate 16: Room 21, Overview

- 6.4.6 The stairs to the first floor of the house are a dogleg stair with a landing. They rise up the centre of the long block. The newel posts are square in profile, with incised bands and a circular cap. The balusters are also square in profile, with two incised bands above the plinth and a single incised band at the capital. The skirting around the stairs and the landing (**Room 21**) has a stepped convex mould at the top. The landing leads to all rooms of the first floor (Plate 16).

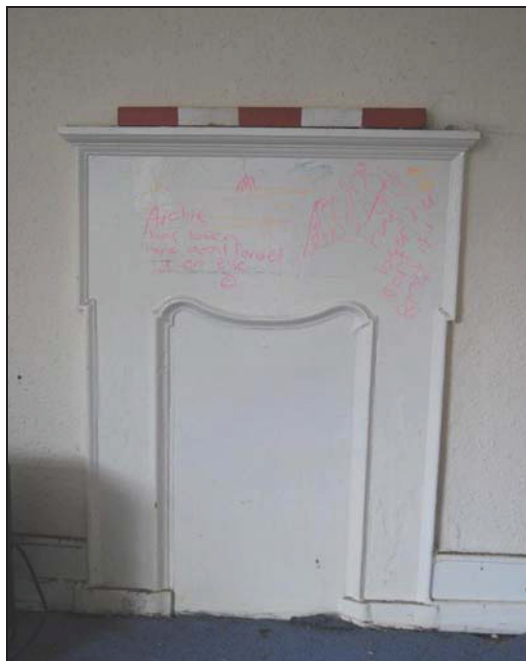
Plate 17: Fireplace, Room 24

- 6.4.9 At the top of the landing, an opening leads towards the other rooms. This is an arched opening flanked by a wide roll mould rising from a square plinth on each side. Beyond here, the polygonal bay to the southeast has a small room within (**Room 24**), with a corner-set chimneystack, its surround is still present. The outer surround has a geometric edge with an internal ogee mould, whilst the inner frame has a stepped edge and a convex upper edge (Plate 17). The mantelpiece has a stepped convex moulding below. The skirting around the room has a convex mould at the base. That across the chimneybreast is slightly wider.
