FORMER OBSERVER CORPS HEADQUARTERS, ABBOTTS ROAD, WINCHESTER, HAMPSHIRE

HISTORIC BUILDING RECORD

Planning Application: 06/03671/LIS

On Behalf of: Croudace Homes Ltd

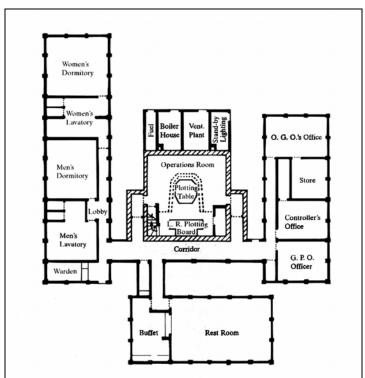
Illustration: the ROC Centre at Knavesmire (taken from Lowry 1996)

3.6 Two illustrations of the ROC building at Knavesmire show a building of virtually identical layout. The footprint of the building is almost identical: the internal divisions vary very slightly and there were additions made during the 1950s (*Tony Maasz, pers. comm*)

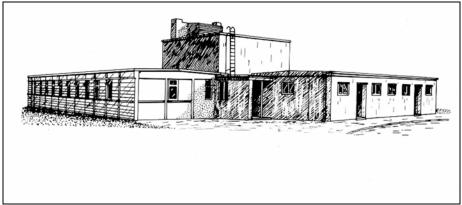
Illustration of the ROC centre at Knavesmire (taken from Lowry 1996))

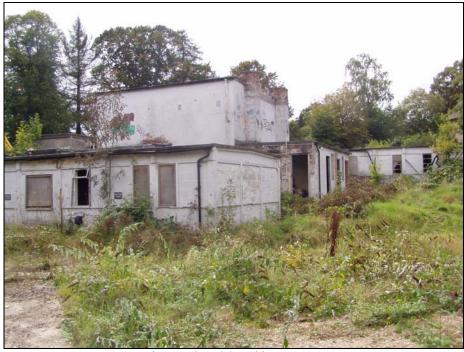
Plate 1: The ROC Building

- 4.1 The Royal Observer Corps Building is located at the top of a south and eastfacing slope, to the north of the city of Winchester. The building is terraced slightly into the hill. This does not so much provide protection as a mostly flat building platform.
- 4.2 The building has a main central brick operations room of two storeys. Plant for ventilation and heating was located on the northwest side of the complex: the plant is largely missing, although elements of the ventilation remain. The complex is oriented southeast-northwest.

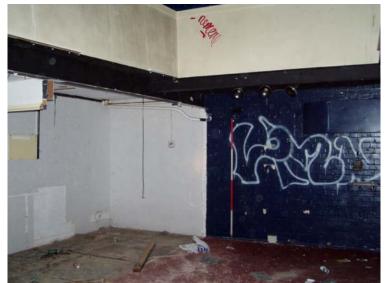
Plate 2: The Operations Block

- 4.3 The principal structure and reason for the building is the central operations block. This is a two-storey brick building which includes single storey rooms for plant to the rear, accessed from the outside. The roof is flat. The outside is painted white and currently disfigured by colourful graffiti. There are few external features: iron grills are present on all walls except the southeast wall, and are small rectangular grills, part of the ventilation system. Two brick flues rise on the northwest side of the block: these are thought to be also related to ventilation.
- 4.4 The foundations are set in a trench excavated to a depth of 1.11m, and the first foundation is a layer of concrete 0.20m deep, onto which were lain 13 courses of brick with an internal cavity filled with concrete. The concrete floor of the operations room was laid at ground level

- 4.6 The internal space is virtually square in plan, measuring 7.32m northeastsouthwest and 7.29m northwest-southeast. The walls are 0.39m thick, built of red bricks each 222mm by 108mm by 68mm and bonded with a hard cementitious mortar. The floor is concrete and the roof is flat, formed of rectangular concrete slabs each 1.87m by 0.61m. These concrete slabs are supported by two reinforced concrete beams which span the width of the building. Both are 0.24m wide and 0.29 m thick and have square profiles. This room originally held a large map-table with a map of Hampshire and parts of neighbouring counties. The location of this table is not known, but it is likely to have been constructed in situ, since reports describe it as too large to bring in as a single unit.

- 4.7 The ground floor is 2.17m high, and the first floor is only partial, being balcony on three sides rather than a full floor level. The walls are painted dark blue. In the east corner of the room is a partition which forms a small room with a shelf: this was the teleprinter room. Ventilation apparatus feeds into this room, suggesting hot working conditions. A two-part stairway rises up the south corner of the room, to the first floor balcony.

4.8 The first floor is 3.01m high, and the total internal height is 5.58m. The first floor balcony is supported by horizontal iron girders which sit atop upright iron beams. The beams are 0.17m in width and were manufactured by Dorman Long. The balcony is of lightweight timber construction of boards, now with linoleum on top. Thin upright posts just 0.05m wide hold a series of desk surfaces 0.31m wide at a height of 0.73m. Operatives would observe the tracks

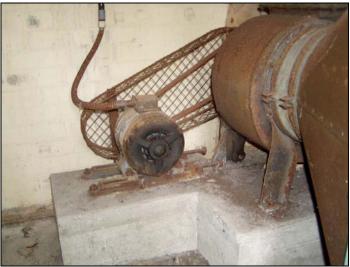
Plate 4: Ventilation plant

- 4.15 The room for ventilation plant still contained a large amount of the apparatus. A rotary electric motor, with attendant fuse box powered the system. The fuse box is manufactured by Simplex, and has, embossed on the cover, the information JS6 124/ 33, below which is 15A 1^{μ} SIMPLEX 600V. The motor powers a fan housed within a not accessible chamber, providing air extraction from the operations room. The outflow of air is fed into the western brick flue. The room is accessed through a door in the northwest wall: there is also a window with a tiled sill.

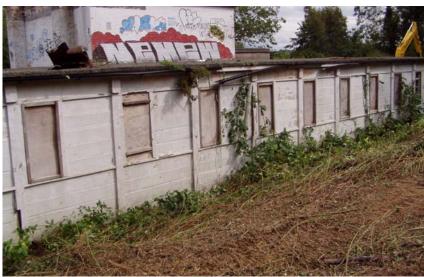
Plate 5: Exterior of accommodation block

- 4.24 The Accommodation Block is located to the southwest of the Operations Block, and is 22.22m long and 5.78m wide. This block is formed of thirteen principal structural frames and is the largest of the ancillary buildings. Entrance to the whole complex is through a door in a small brick addition on the southeast side. A guard was stationed at this door during the Second World War and the Cold War. The door itself had been broken from its hinges at the time of recording: it was formed of four panes within a frame with two parallel frieze rails and a lock rail. This door is thought to be an original fitting.

4.30 There are two doors in the northeastern wall of the building, leading to a pair of store rooms. These have been formed by roofing the space between the Accommodation Block and the Operations Block. There are no fittings in these two rooms that illustrate their function, nor the function of the building as a whole. It is known that the complex became little more than an attendant structure when the new building was built in the Cold War period, so these rooms were most likely used for storing materials, for instance uniforms or stationery.

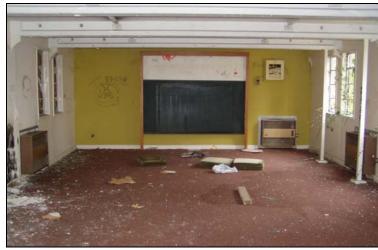
Plate 6: Canteen

- 4.32 Block C is formed of eight structural frames, and is 12.51m long and 5.78m wide. Internally, there are just two rooms, a canteen and a kitchen. The canteen contains no obvious original fittings, although the carpet may be early. Five windows light the southeast side of the room, and only one the northwest side: four other windows were blocked in the 1950s. The room is entered from the southwest. Also at the southwest end is the kitchen area.

4.35 The space between the canteen and the Operations Block has been roofed over to form an office. This is not an original feature of the Second World War layout, but was added in the 1950s. It was used as the Group Commandant's office, Tony Maasz, who was GC 14 Group when the ROC stood down in 1991, and who visited the site during this programme of recording. The office was formed by adding a ceiling above the level of the roof of the canteen, supported by wooden posts, and the upper portion glazed. The walls were covered with plasterboard and the whole interior painted white. The windows of the canteen on their northwestern side were thus blocked.

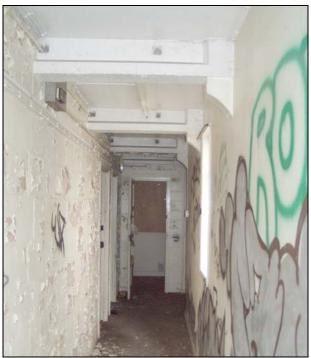
Plate 7: Corridor, Office Block

- 4.37 The corridor that accesses the rooms of the Block runs almost the whole length of the southwest wall. At its southeastern end is a small cupboard containing over 100 hooks for keys. One wall had keys for all the rooms at the Headquarters. A second wall contains keys to other military posts in the vicinity. The third wall has unlabelled hooks. There are 28 labels for military posts, and these are numbered 10-52, in groups of 3 or 4. These represent the 28 Cold War Monitoring Posts and their clusters: reported by Tony Maasz, Group Commandant and member of the ROC from 1948 to 1991. The locations are as follows:

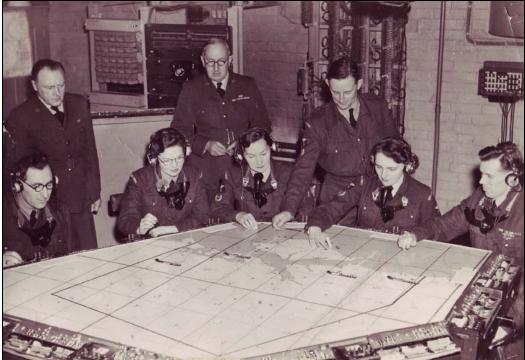
Plate 12: P2073, 1953? Main Table Aircraft Plotting. Plotters L to R: Dave Alford, Tommy Kemp, Ruby Walker, ?, Dave Abbott. Standing L to R: Claud Walker, Arthur Vear, Ted Waygood

- 3.3 In 1955, as an Observer, I was a "Plotter" of aircraft tracks on the Main Plotting Table – this being in the World war II Operations Room - this Table was a map covering No.14 Group area of Hampshire, the Isle of Wight, parts of Dorset, Wiltshire and Berkshire and also parts of our adjoining Groups of Bristol, Oxford and Horsham for hand-over of information. As plotters, we sat around the table wearing very cumbersome "head and breast" sets and we were plugged in to a telephone landline link with a "Cluster" of posts. The "Posts" were dotted around the countryside roughly10-15 miles apart and the Cluster would consist of 3 or 4 Posts; each manned by 2 or 3 Post Observers who would report information on bearing, direction, height and type of aircraft. They would also report whether they could see the aircraft of a "heard" plot if it was not visible. We plotted the information on "metal plaques" and then had counters in various colours – which corresponded to the colours on the large clock. This was an indication of when the plots were to be removed from the table.

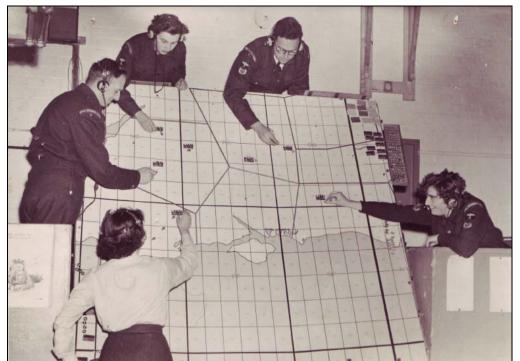
Plate 13: P31. 1953, Aircraft plotting on Long Range Board

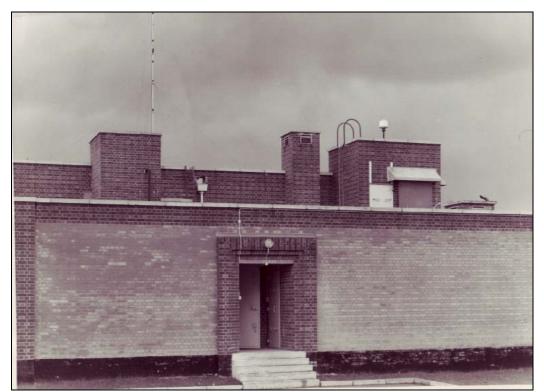
Plate 15: P1034. 1963. Exterior of protected control. Includes doorway and radio mast

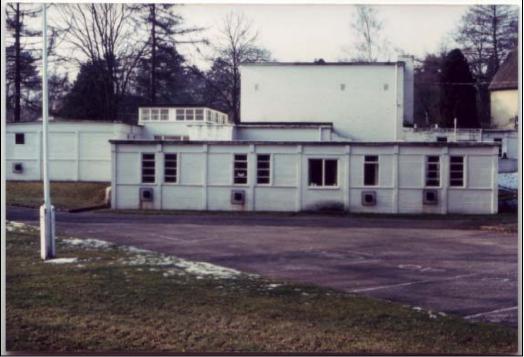
Plate 18: P316, 1978, Operations Centre in anti-nuclear flash colours
