Archaeological Attendance conducted during groundworks at Manor Farm, Main Street, Little Stretton, Leicestershire.

NGR: SK 66907 00133

**Planning application no. 16/00237/LBC**

**ULAS Report Number 2016-133**

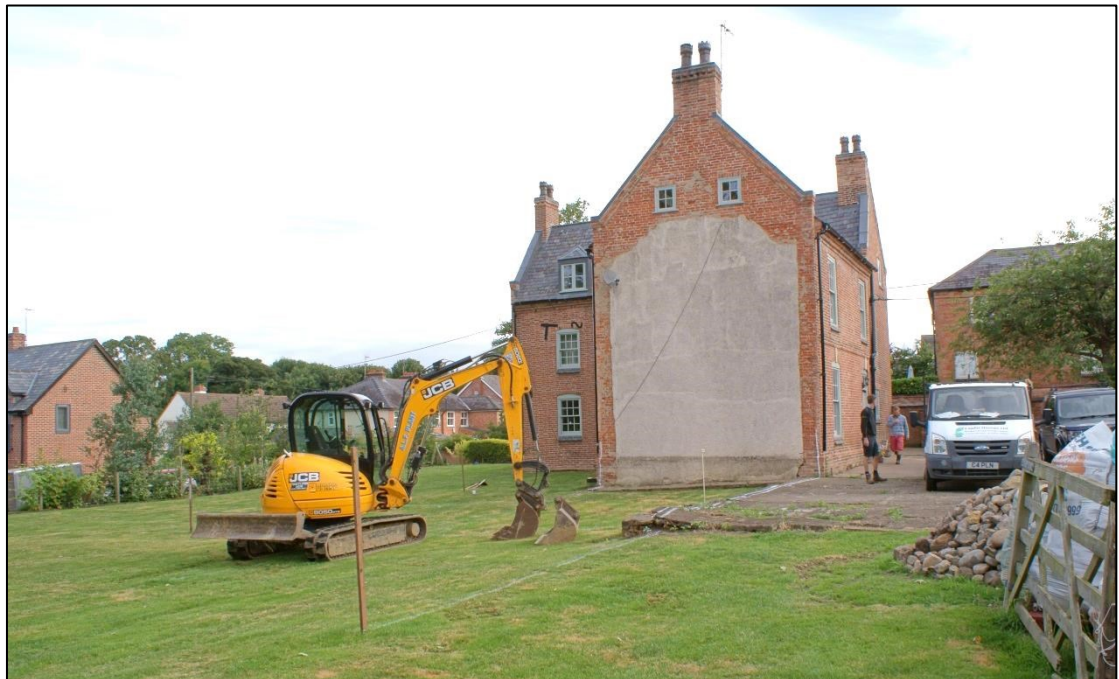
**Figure 3. The rear of Manor Farm looking north and showing the relatively level plot compared with the fall of land to the west.**

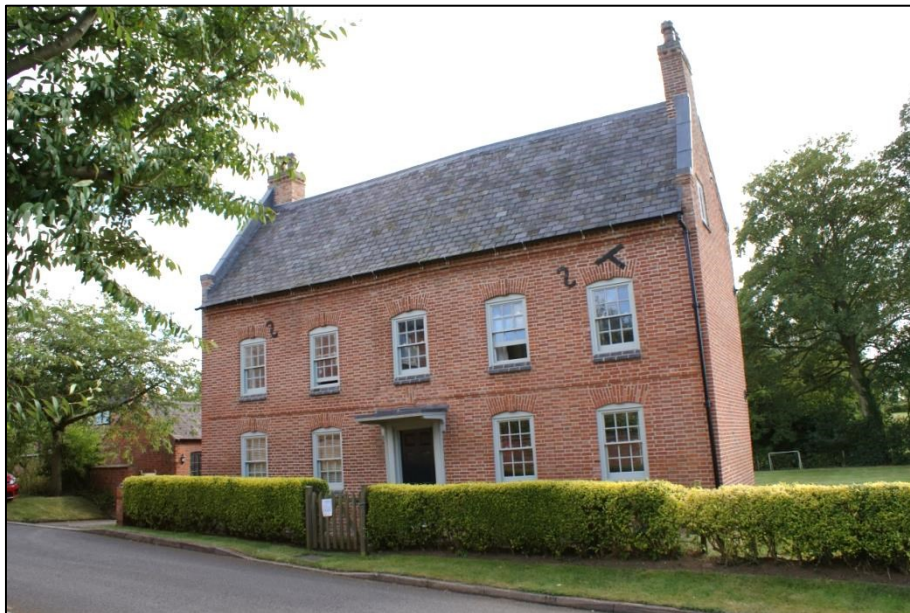
**Figure 4. The main wing of Manor Farm, showing the symmetrical frontage and brick key blocks to the windows, features of this 18th century building.**

Many of the houses and farms in the village date from the 18th century of which Manor Farm provides a good example (Figure 4). A full listing description can be found in Appendix A. In summary, however, the house is L-shaped in plan, built of red brick and Welsh slate and rises to two and a half storeys. There is a difference in style between the two wings and a corner projection contains the original staircase. These features suggest progressive changes to the existing building and an earlier building on the site is possible.

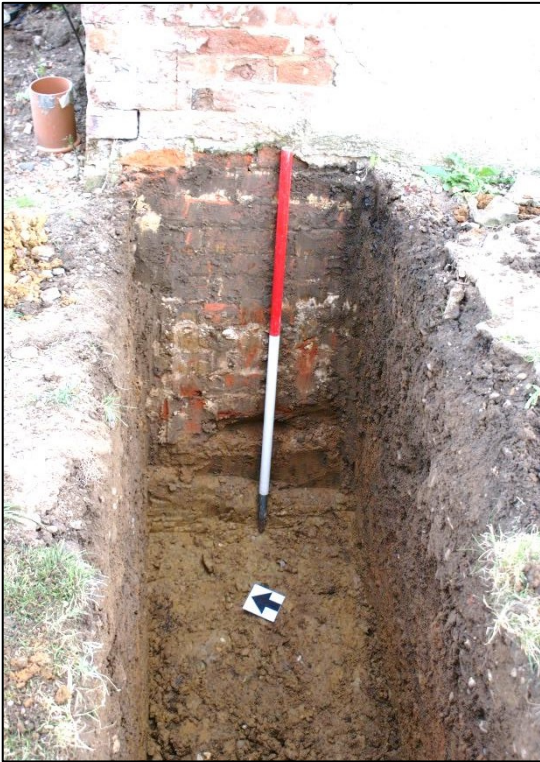
**Figure 9 (left).** View of the wall foundation of the southern wing of the present building, looking north-east

As a result of the complexity of manoeuvring the machinery within the plot, the trenches to the west were excavated before the remainder was stripped. Trenches were excavated to a depth of 1.00m and to the width of the ditching bucket at 0.60m. Excavation close to the house foundations revealed brick footings to a depth of approximately 0.80m cutting into natural greenish brown clay with occasional pebbles and flint fragments. There was no evidence of an earlier foundation and the subsoil appeared to butt up against the wall foundation rather than being cut by it (Figure 9).

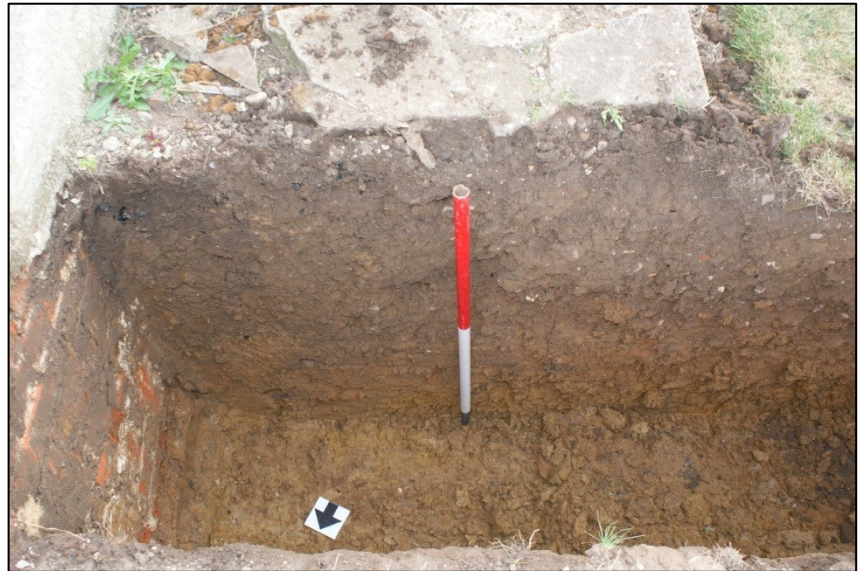
**Figure 10 (right).** View of the wall foundation of the southern wing of the present building, looking south-east.

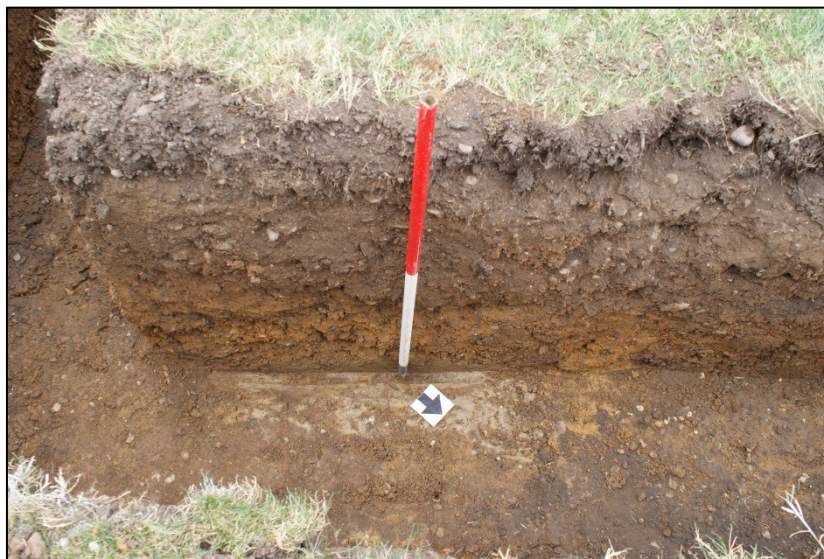
Further trenching to the west revealed a modern drain cutting through a fairly consistent stratigraphy. This comprised a mid greyish brown mixed topsoil to an average depth of 0.20m. Below this was a mid reddish brown subsoil with frequent small pebbles, flint fragments and occasional charcoal to an average depth of 0.50m. This layer had the appearance of a garden soil. Below these two layers were a mid to light orange brown natural sandy clay and finally a mid greenish brown natural clay.

**Figure 11.** View of the stratigraphy evident to the west of the plot.

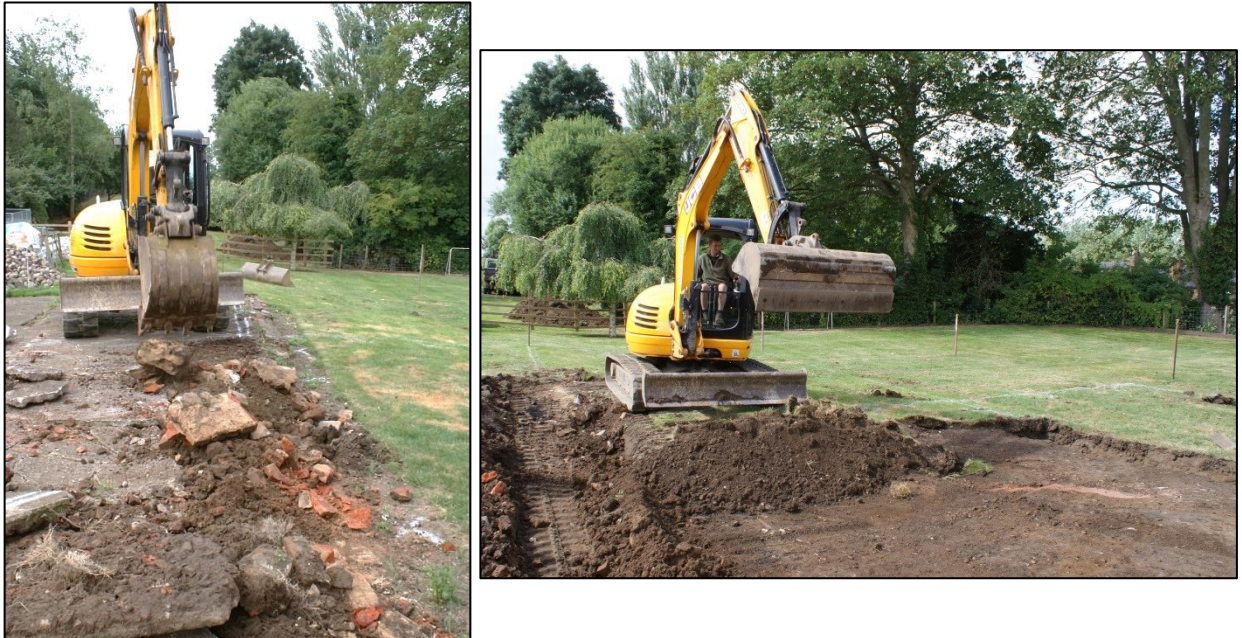
A concrete plinth, which was part of the driveway and a brick wall remnant running north-east to south-west were removed to the south-east of the site before the central area was stripped. The brick wall bordered the driveway and may be the boundary seen on the early maps (Figures 5-7). Stripping revealed a substantial drain running north-south across the site and a further small drain running parallel to the brick wall (Figures 11 and 12).

Figure 12-13. Views looking north-east showing brick wall remnant and drains running across the plot (See Fig 14).

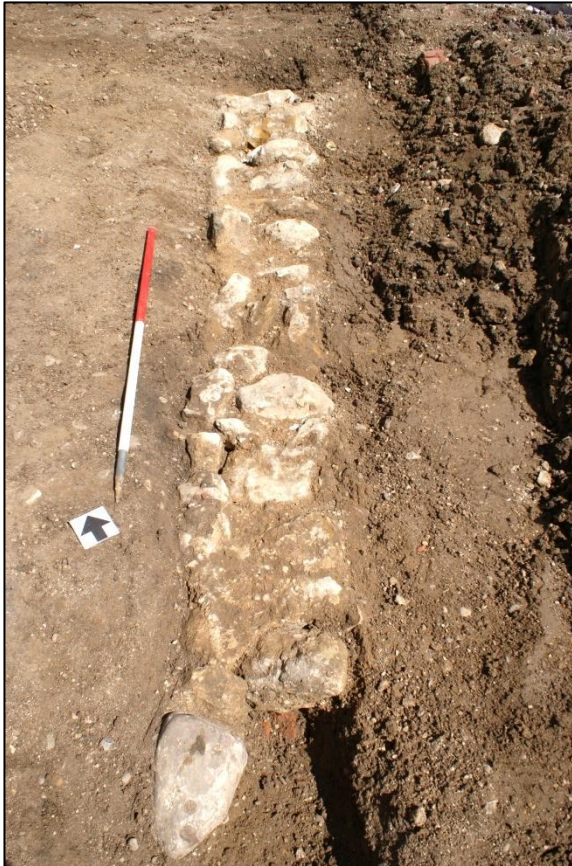
Also exposed, parallel to the brick wall, was a limestone and ironstone wall foundation (4) (Figure 15-16). This too appeared to be a remnant of a probably insubstantial wall. At this point, it was largely only two stones deep, the largest of the stones being 0.45m wide by 0.38m long by 0.35m deep. At one end the stones were overlying handmade brick of a similar size and fabric to those of the southern wing of the house (Figure 12). The wall was cutting the garden soil (2) visible elsewhere on the site and finds from this layer include fragments of clay pipe and pottery of Midland Purple ware (Cooper Appendix B).

**Figure 15 (left).** Wall foundation revealed parallel to the brick boundary and in line with the east wall of the present house looking north-east.

The wall had been truncated to the north, by an outbuilding and to the south by the drain identified earlier. As the foundations were just below the topsoil, it was possible to trace their outline as an earthwork further south-west and this appeared to turn south-east after approximately 15m. Stones beyond the excavations were also recorded, as landscaping around the building could potentially disturb these.

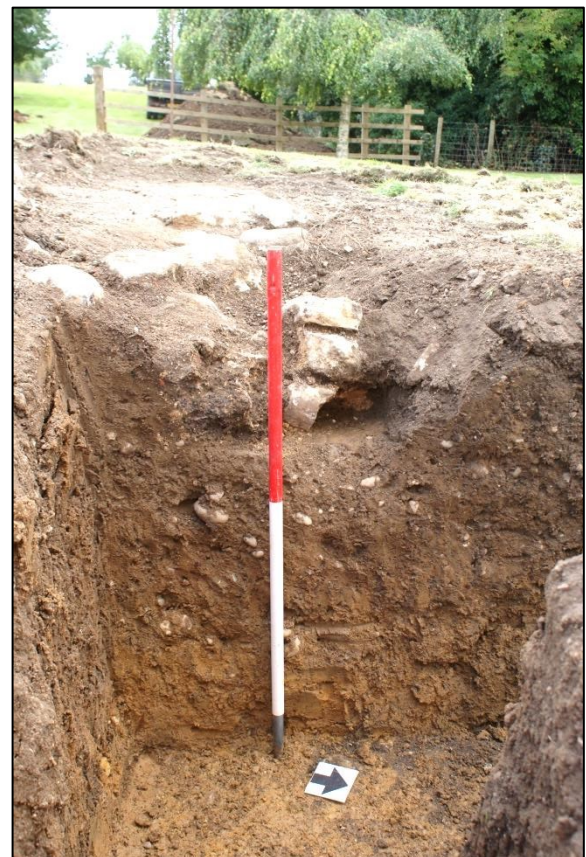
**Figure 16 (right).** Section across the wall foundation looking east.
