**ARCHAEOLOGICAL EVALUATION
BY TRIAL TRENCH**

**AUXILLIARY UNIT HIDEOUT
BEELEIGH MILL
ABBAY TURNING
MALDON**

Essex County Council
Field Archaeology Unit

MARCH 2007

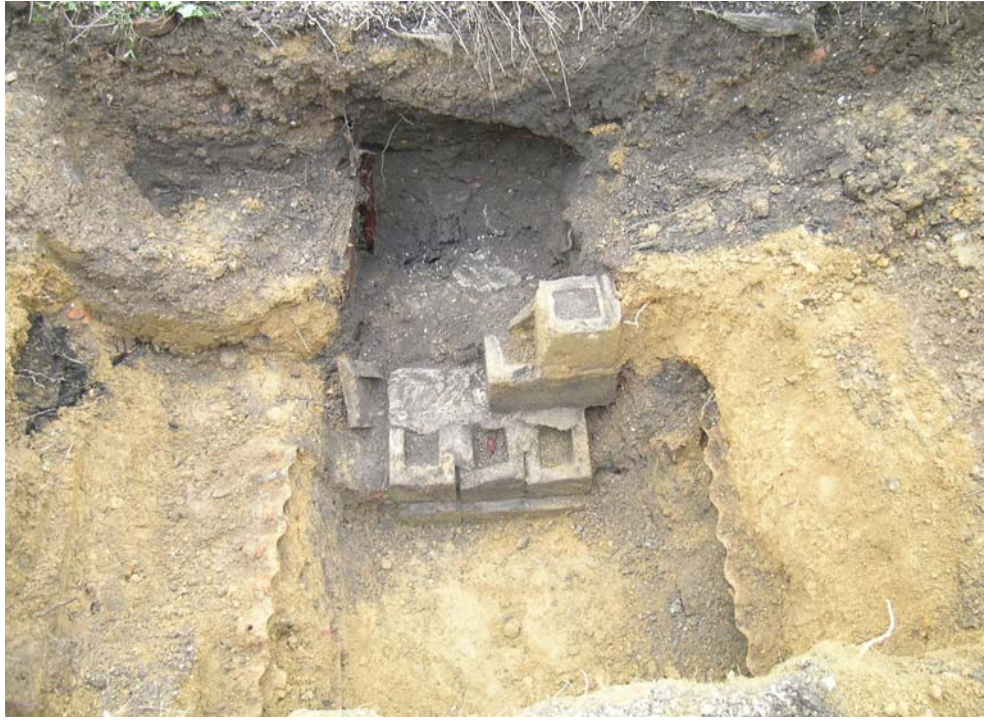
The yellow clay clearly indicated the position of the hideout and had been deliberately used to infill (at least) the top of it, either after the end of the Second World War or in the 1980s. The main chamber of the hideout was arranged at 90° to the steam mill wall and was constructed within a sub-rectangular cut approximately 6m long by 3m+ wide and in excess of 1.5m deep. Reddish grey ashy silt (not illustrated) observed around the top of the eastern edge of the hideout may be remnants of construction-cut backfill.

The sides of the main hideout chamber were constructed from curved lengths of corrugated Anderson Shelter sheets. The top of the arched roof was missing; these sheets presumably having been removed during the dismantling process. The surviving sheets were c.0.7m wide and each sheet overlapped with its neighbour. Small decayed fixing holes in the upper sheet matched with better preserved holes in the lower sheet. The presence of one *in-situ* nut and bolt suggested that some, if not all, of the sheets had originally been bolted together. Corrugated side-wall sheets, observed in a void to the north-west of the excavated section, appeared to be silver in colour and in apparent good condition.

The south end of the hideout was formed by a stack of large concrete bricks; each 0.48m long by 0.24m wide with two square holes. Two courses were clearly visible with the top of a probable third course protruding below. The top course comprised of one brick laid east-west. The position of a second brick to the east may have been marked by a vague rectangular outline in the underlying mortar. The second course was made up of three bricks aligned north-south. Fill was present on either side of the stack and there was no indication, at the excavation level, of any other end structure such as a brick wall or corrugated sheet. Traces of rusty corrugated iron to the west of the stack may have been the end of a sheet forming the western side of an escape tunnel located beyond the stack to the south.

It was not possible to fully excavate the hideout during this limited evaluation. It is anticipated that the base of the hideout may be about 2.5m below current ground level.

Plate 1 Hideout looking south

Although partially dismantled, the hideout appears to have survived reasonably well and the Anderson Shelter sheets forming the sides seem intact. However, the escape tunnel is in poor condition; one side has collapsed and the thinner corrugated iron sides used in its construction are very badly corroded. It was not clear whether the escape tunnel had been deliberately destroyed or had infilled more naturally as a result of decay and collapse. In either case, the infilling occurred prior to the backfilling of the hideout with yellow clay.

At the end of the evaluation the hideout and escape tunnel were carefully back-filled. Any plans for future excavation of the entire hideout will have to carefully address what is to be done if and when the structure is fully exposed. Clearly, issues such as the conservation and possible long-term preservation of the structure will need to be addressed along with basic health and safety considerations and the importance of retaining the structural integrity of the existing standing building.

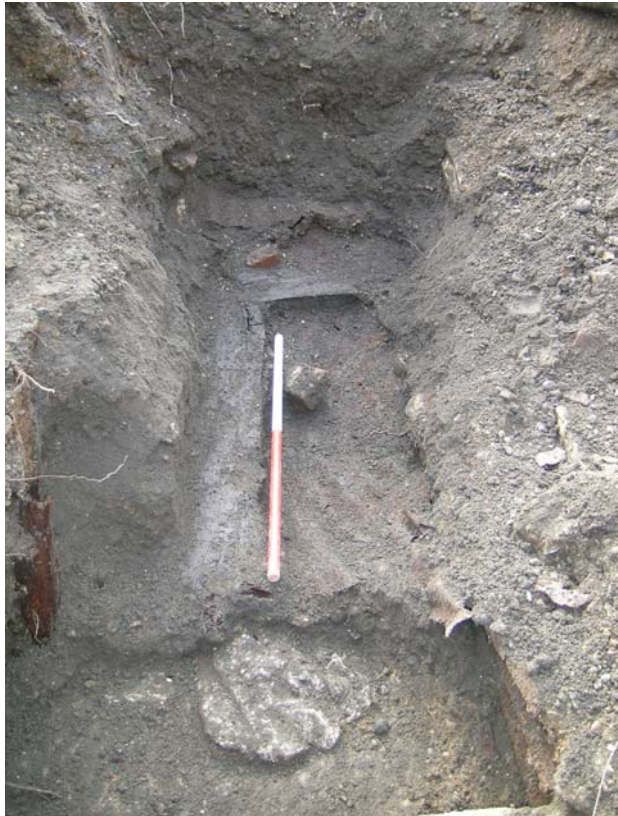
The position of an escape tunnel was clearly evident to the south of the hideout. Its position was indicated by a dark grey silt fill that probably accumulated separately from the deliberate infilling of the main hideout. The full extent of the tunnel was not exposed but it was in excess of 2.1m long, approximately 0.8m wide and extended to a depth of more than 1.25m below the ground surface. Removal of the dark silt revealed a firm deposit of light brown mixed clay and a thin lump of concrete immediately south of the concrete brick stack. Beyond these, a

horizontal, north-south aligned, timber beam was exposed along with an accompanying area of flattened and badly corroded corrugated iron. A second horizontal timber, aligned east-west, and which may have been a collapsed upright, was recorded at the south end of the tunnel. The timber and corrugated iron appeared to represent the bent-over and collapsed western side of the escape tunnel. The eastern side of the tunnel appeared to be still *in-situ* and comprised at least two vertically standing and overlapping sheets held in place by two timber uprights.

Plate 2 Escape tunnel (after further excavation) looking south
