ARCHAEOLOGICAL  
SERVICES  
DURHAM UNIVERSITY

Hope Inn  
Sedgfield  
County Durham

archaeological monitoring

report 4572  
September 2017

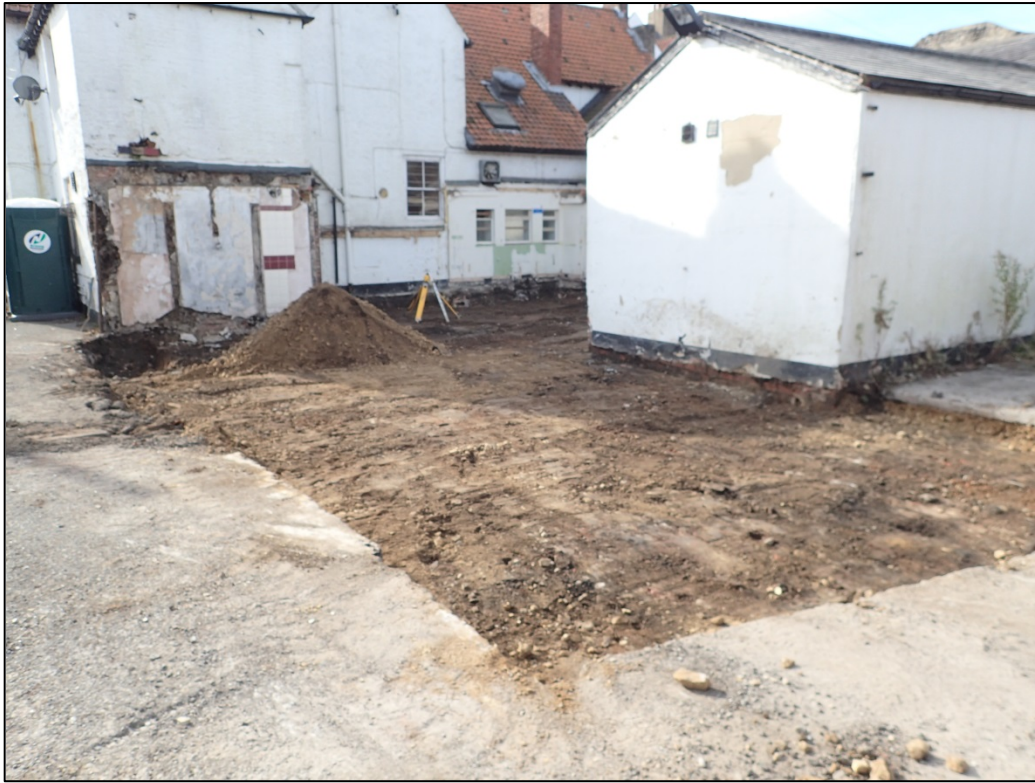
Photograph 1: Area of new extension following ground reduction, looking south

- 5.2 In the area of the new extension behind the inn, first the ground level was reduced across the site by around 0.3m. This involved removal of a tarmac surface [6] and partial removal of the sub-base below, exposing building rubble in brown silt over much of the development area and crushed dolomite [7] over its northern end (Photo 1).
- 5.3 Strip foundations were then excavated around the eastern, northern and western (where the new building extended beyond the limits of the standing building) sides of the new extension. All the way along the (longer) eastern foundation trench, natural yellow sand [3] was exposed almost directly below the limits of ground reduction. A test pit was excavated within this sand and it continued without change to a depth of at least 3.2m (Photo 2).

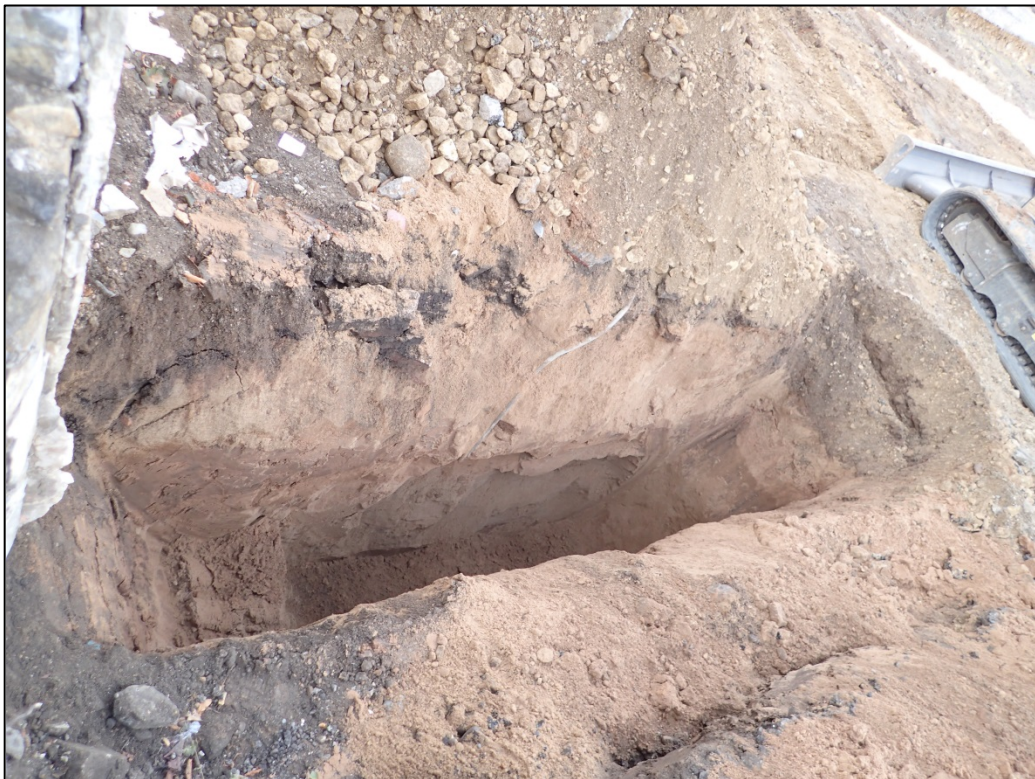
Photograph 2: Sondage into natural sand, looking northwest

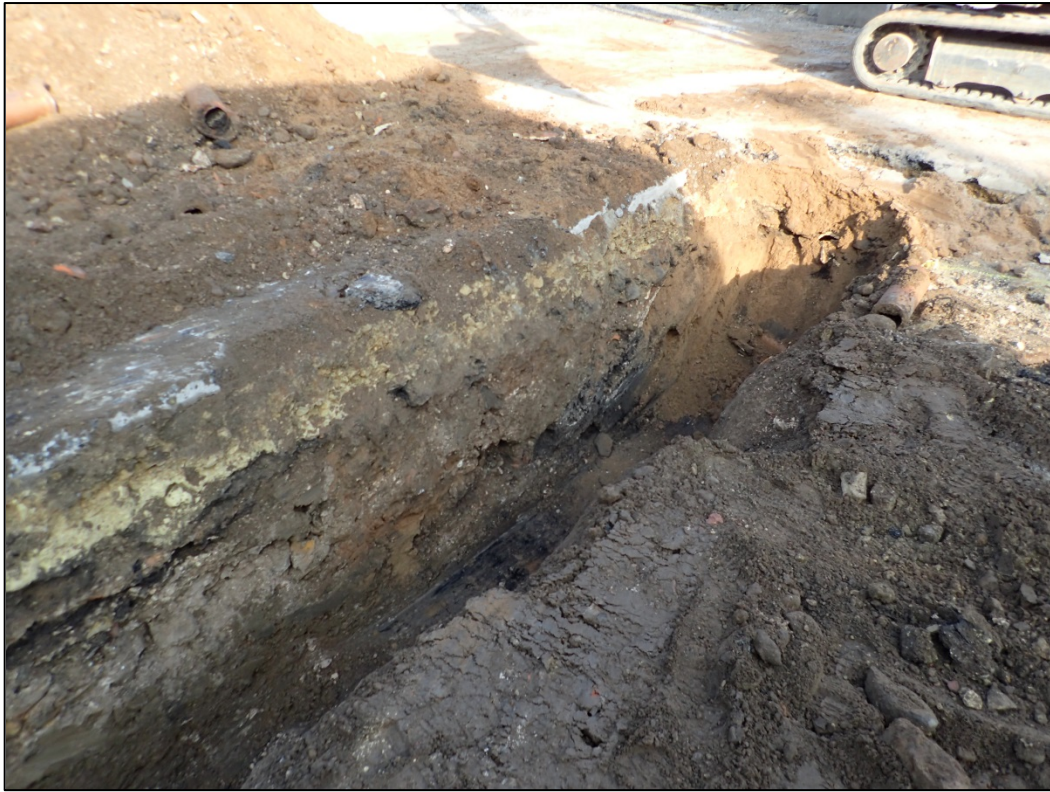
- 5.4 In the northern foundation trench, this natural sand was present for around 1.2m at the eastern end of the trench, but was then cut away by a near-vertical cut [F10 <4m wide by <1m deep]. The remainder of the trench was excavated through the fills of this cut. These consisted of a deposit of black silt containing building rubble and mortar flecks [11] angled against the sides of the cut and overlain by a brown sand containing mortar flecks [12] that extended beyond the base of the foundation trench across most of its length. Above this was a thin but persistent layer of brown clay [13: 0.1m thick], then a layer of building rubble [14: 0.15m thick] and then a layer of dark grey-brown silt containing building rubble [15: 0.15m thick]. This was overlain by the dolomite sub-base and tarmac of the current car park surface (Photo 3).

- 5.6 The steep-sided nature of the cut, and the presence of modern building rubble at its base, suggest that it was a pit used to dispose of building waste, perhaps during demolition of outbuildings behind the inn, recorded as having taken place sometime between 1964 and 1975 on historic Ordnance Survey editions.

Photograph 3: Modern cut F10, looking northeast

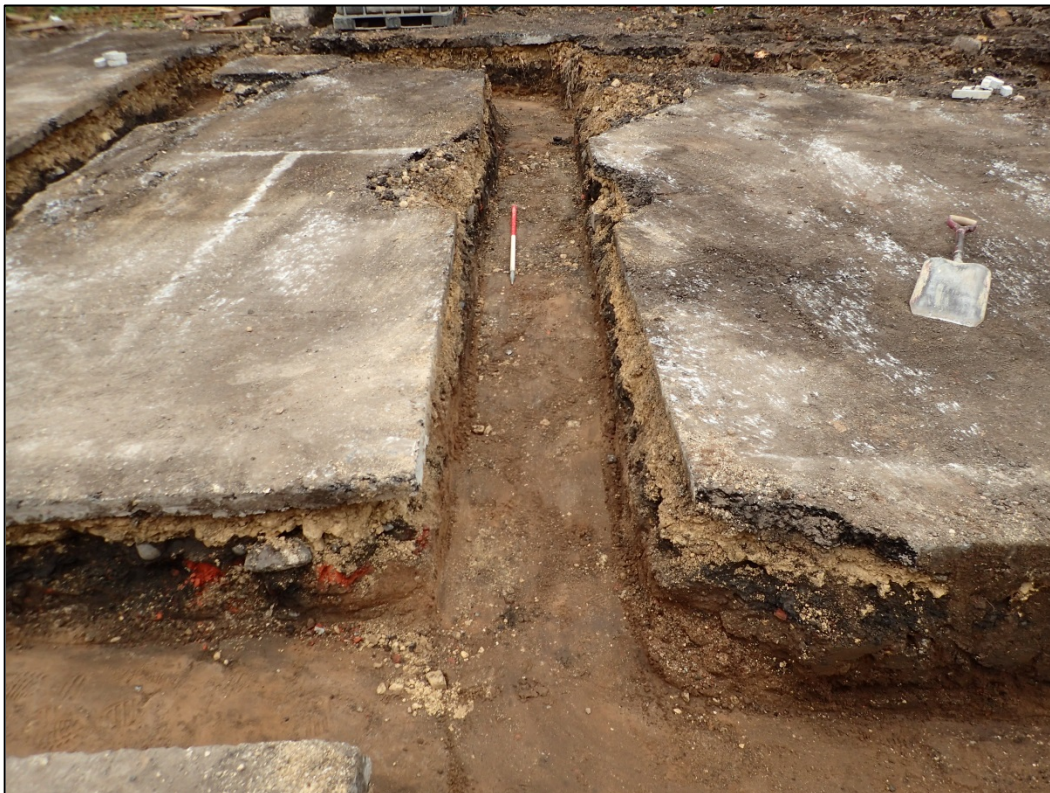
- 5.7 The new block of lettable rooms was built to the rear of the inn, partly on what had previously been part of the car park and partly on an area of lawn behind this. Throughout most of this area, natural yellow sand [3] was exposed; in the car park directly below a lower sub-base of black grit [8], followed by dolomite [7] and then tarmac [6] (Photo 4); and in the lawn directly below the topsoil, a dark grey-brown silty sand [1: 0.3m deep], except along the northern edge of the foundations, where an intervening deposit of dark brown sand [2: 0.45m deep] was present.

Photograph 4: Foundation trenches for lettable rooms, looking west

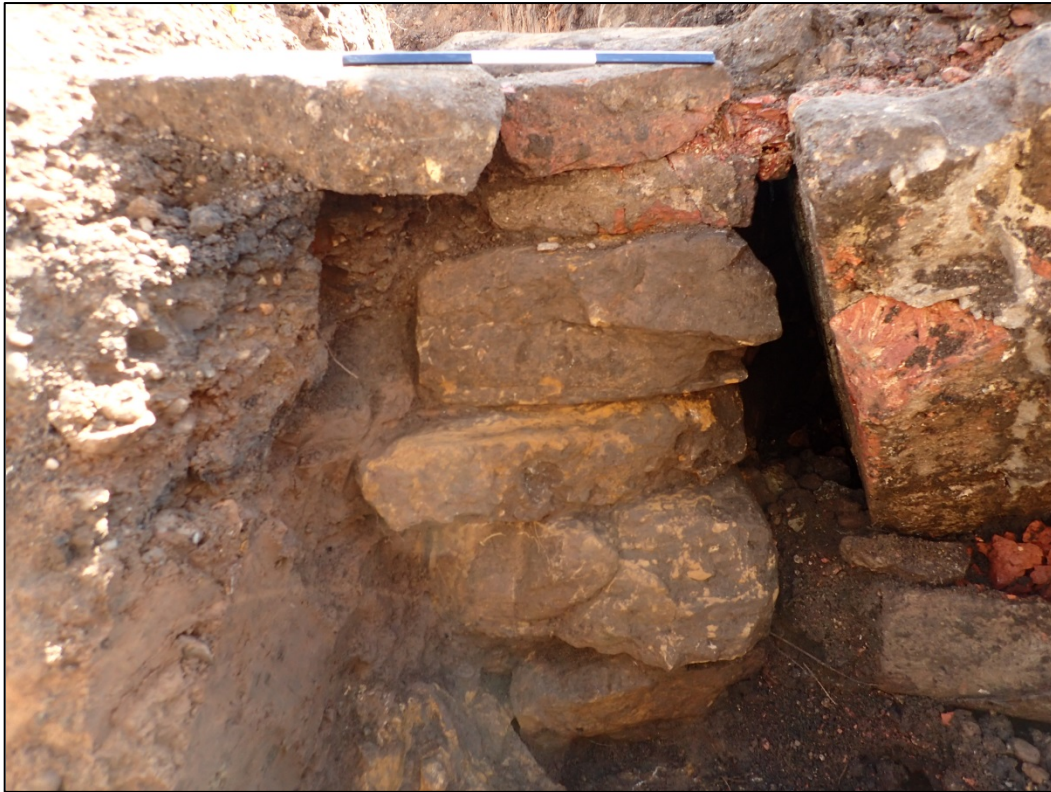
- 5.8 A large pit [F4: <6m by <5m wide] filled with modern building rubble covered much of the east wing of the new foundations, and was overlain by topsoil. Two wall fragments were exposed by the works. Towards the north-west corner of the foundations were fragmentary remains of a north-south wall [F5: 0.6m long by 0.4m wide and 0.8m high], comprised of mortared stone with a few bricks built into it (Photo 5). Towards the south-east corner was a second wall fragment [F9: 1.4m wide by 0.4m high] made of smaller, more rounded stones partly mortared together more irregularly (Photo 6). Both of these wall fragments were only visible in single foundation trenches and could not be traced further across the site.

Photograph 5: Wall fragment F5, looking east

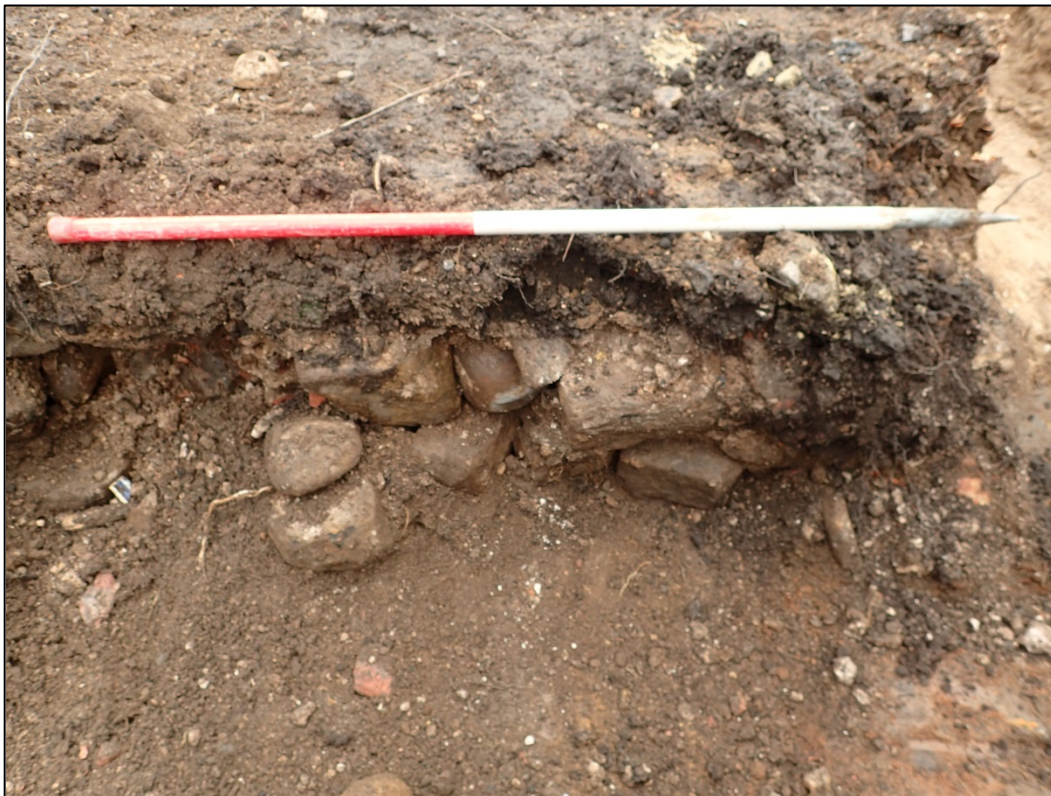
Photograph 6: Wall fragment F9, looking north
