# Deptford's Royal Dockyard: archaeological investigations at Convoy's Wharf, Deptford, 2000–2012

Duncan Hawkins with Caroline Butler, Antony Francis, Christopher Phillpotts and Andrew Skelton

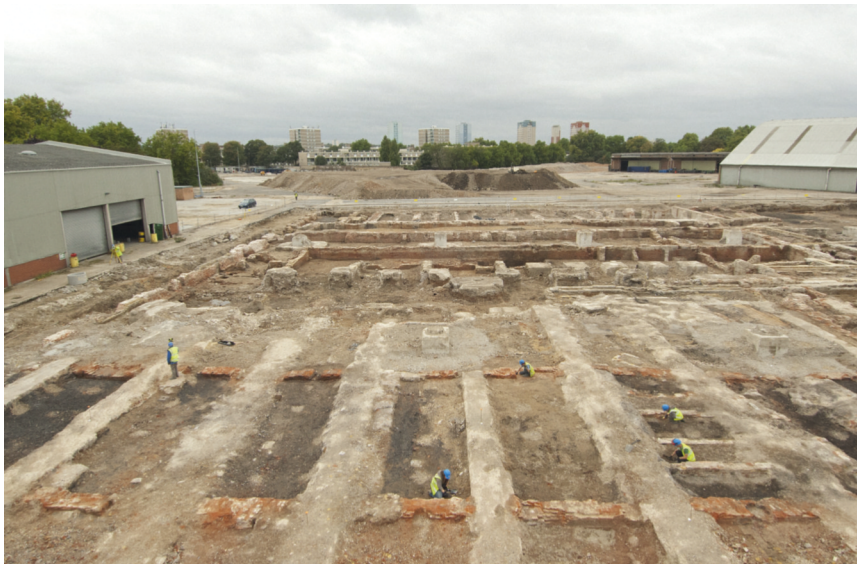
Fig. 2: the Tudor Storehouse as excavated (© MOLA)

The earliest Dockyard structure known to have existed on the site and recorded in the investigations was a Tudor storehouse. This building, which was oriented east-west flanking the Thames, survived at foundation level, with up to 0.74m (2.4ft) in height of brickwork present. The original north, south and west walls were traced giving a building footprint 52.30m (172ft) long east-west by 9.50m (31ft) wide north-south (Fig. 2). The east wall was a Georgian rebuild. No floor levels within the building survived, and it had been completely truncated in several areas by modern foundations. This building originally consisted of two storeys and an attic, and stood to a roof plate height of 10.67m (35ft) until it was demolished by order of the Admiralty in March 1952.<sup>2</sup> A foundation stone and flame-headed arch were salvaged and preserved at University College London

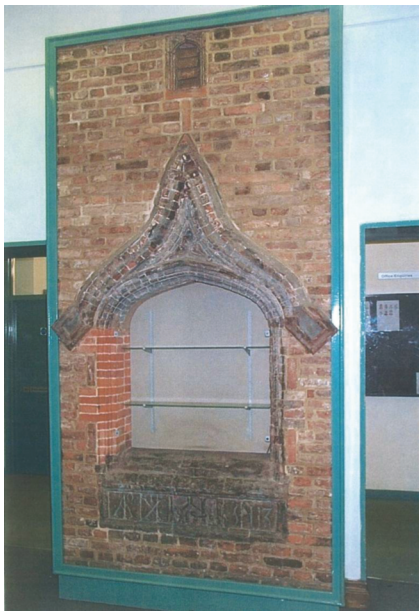
Fig. 3: flame-headed arch, UCL

(Fig. 3). Photographs taken at the time of demolition (Fig. 4), together with Edward Dummer's 1698 survey (Fig. 5),<sup>3</sup> and the dimensions recorded in 2011–2012, allow a comprehensive understanding of the form of the building.

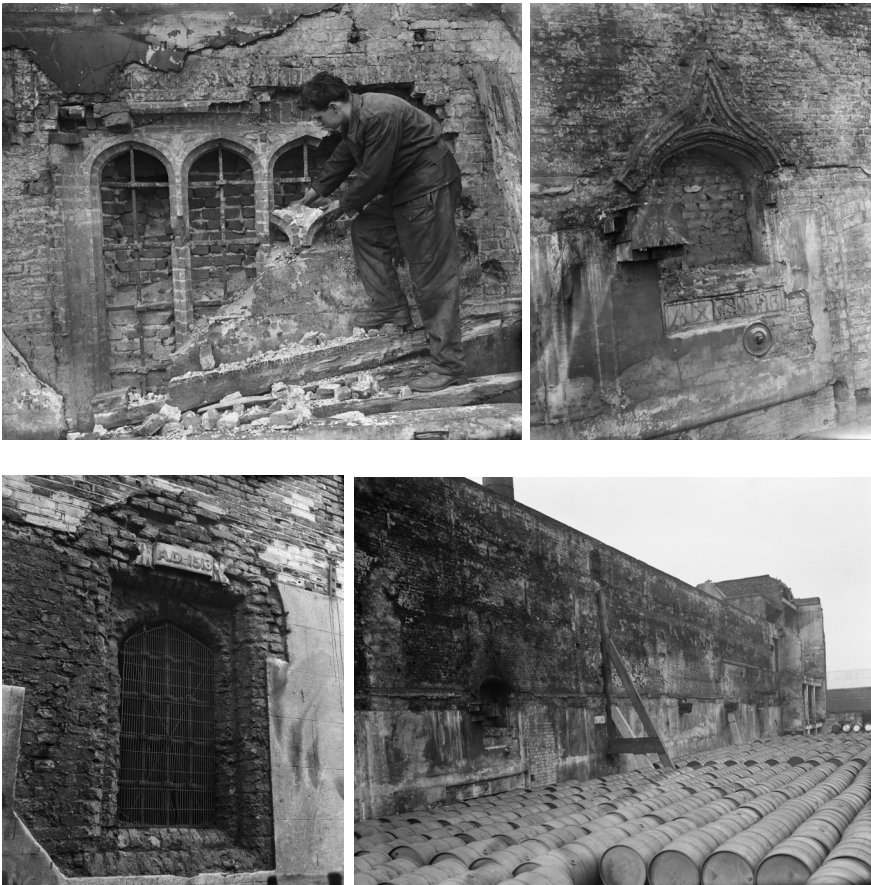
Fig. 4: Tudor Storehouse, March 1952 (©2012 Getty Images 156993167, 156993168, 156993169)

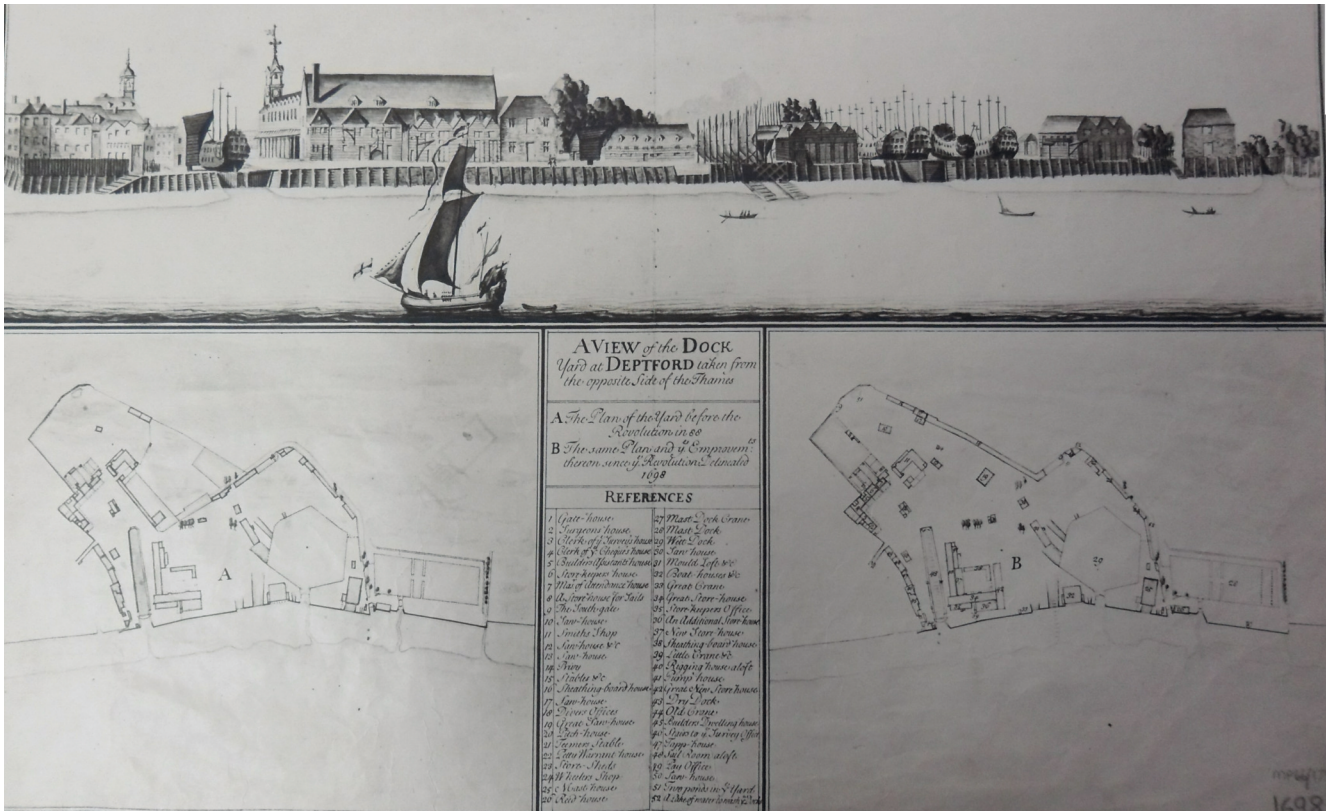
Fig. 5: Edmund Dummer's 1688/1698 survey (© British Library Board Kings MS 43 Vol 65v & 66)

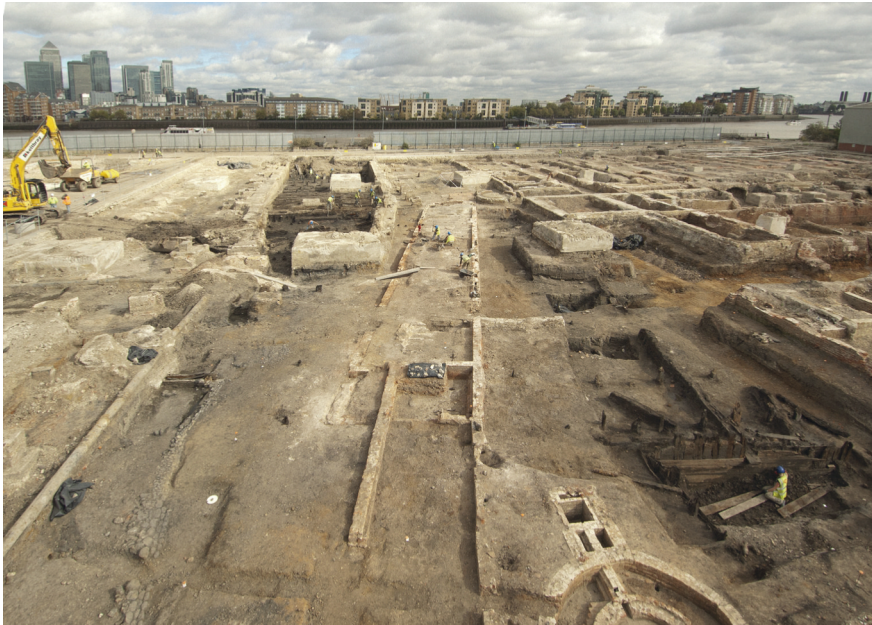
Fig. 6: excavation of the Navy Treasurer's House (© MOLA)

Navy's House, probably in existence by the 1540s and with surviving 16th- and 17th-century fabric (Fig. 6). It measured 50.50m (166ft) north-south by 5.70m (19ft) east-west and contained floor levels, including tiled floors, *in situ*. The Treasurer's House is shown in John Evelyn's sketch plan of 1623 (Fig. 7), but was demolished before 1688.

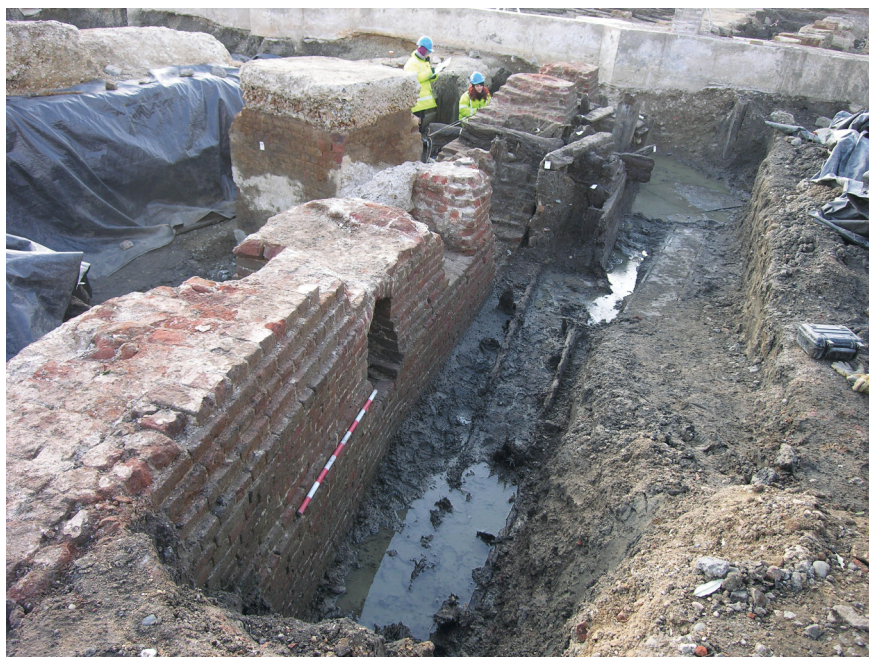
**Fig. 8: demolished 17th-century boundary wall of Dockyard (© MOLA)**

To the west of the basin, but between it and the 'small' mast pond, (built 1676–1688), a long section of mid-17th-century Dockyard perimeter wall was identified. Arched openings built through the 1.3m (4.3ft) wide wall accommodated timber tiebacks

(retaining beams) that braced a substantial timber revetment along the southwest side of the Dockyard – possibly channelling the ancient ‘Orfleteditch’ stream away from the basin and the core of the Dockyard (Fig. 8).

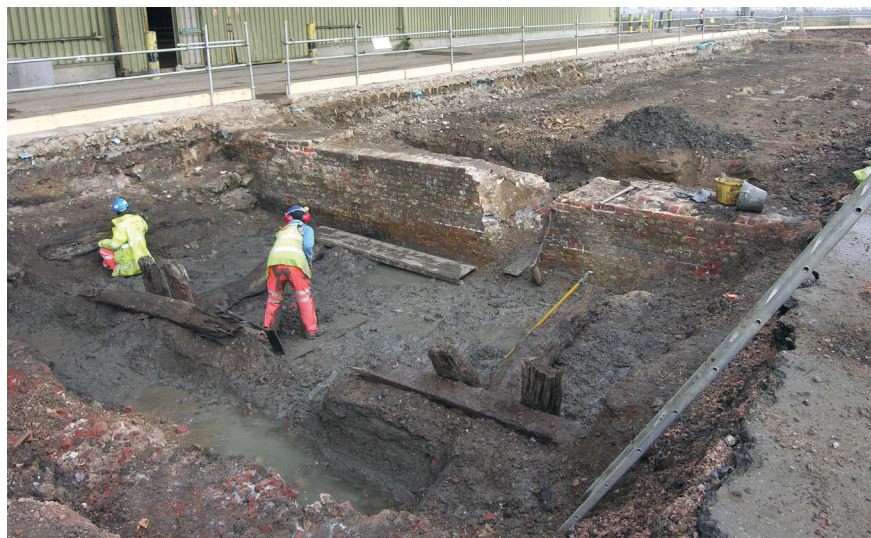
Fig. 9: redundant tiebacks of 17th-century mastpond and Georgian mastpond walls (© MOLA)

Evidence for the 1676–1688 small mast pond, or possibly an early 18th-century replacement, was identified on the north-west of the site in the form of sawn off timber tiebacks (Fig. 9). They had been cut back and the wooden lining of the small mast pond removed to insert a new brick lining between 1774 and 1808, which had in turn undergone several phases of rebuilding, possibly as late as the 1840s.

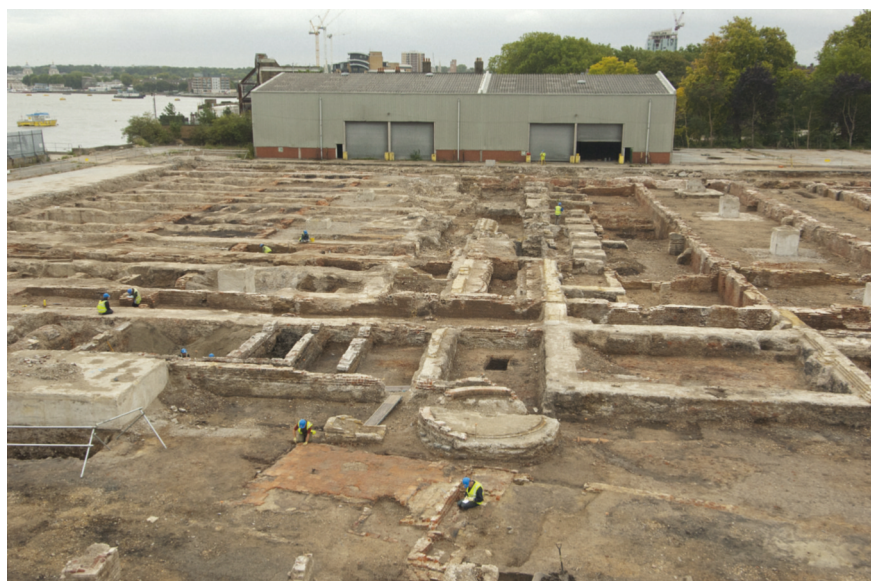
Fig. 11: the Georgian Storehouse and Rigging House under excavation 2012 (© MOLA)

The foundations of this Georgian rebuilding form the principal surviving element of the Storehouse. No contemporary floor surfaces survived (Fig. 11). A contemporary multi-phase timber river wall was recorded north of the storehouse behind the existing river wall, containing timbers spanning the late 17th to early 19th century.

After 1774 but before c. 1808 a substantial rigging house of three storeys plus attic, 75.0m (246ft) east-west by 17.3m (57ft) north-south, were added to the south of the Storehouse complex. A surviving photograph of c. 1880 shows this as an elegant late Georgian building range (Fig. 12). It was demolished before 1916. The 2011 to 2012 investigations revealed the whole footprint of the building with

robust foundation arches to carry the heavy superstructure (Fig. 11).

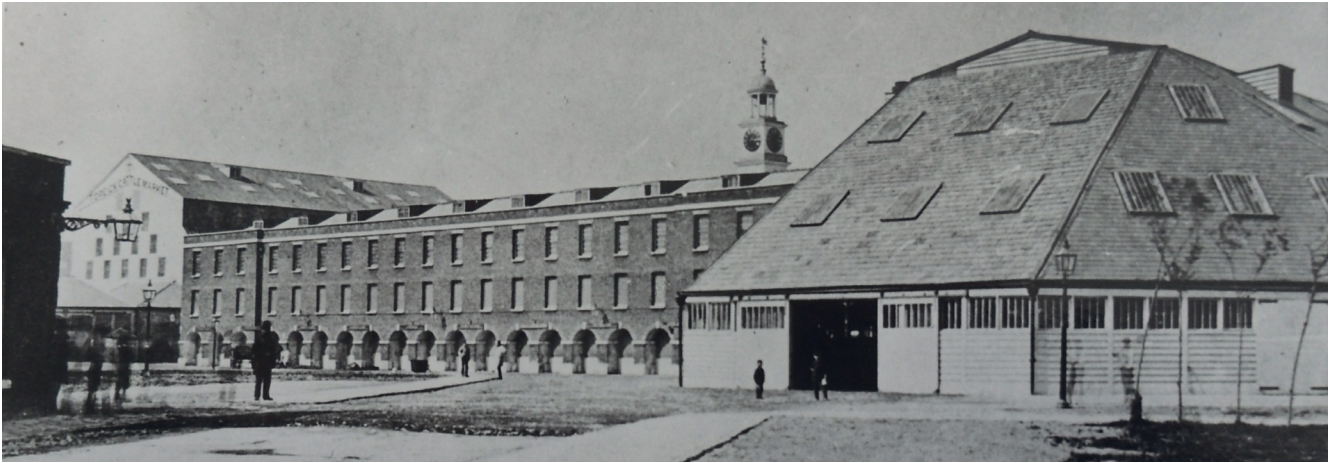
**Fig. 12: from left to right: Slip Cover Roof No 5 pre-1842; Rigging House of 1774-c. 1808; Great Dock Cover Roof pre-1842, photograph of c. 1880**  
(© Courtesy of Lewisham Local History & Archive Centre. Thankfull Sturdee Collection PH87-I339I SS63)

in a brick and lime concrete backing. Map and photographic evidence (Fig. 12) show that the Great Dock was covered by a substantial timber ‘roof’, a single stone foundation pad for which was identified *in situ*, on the east side of the ‘Head Dock’. This roof dates to no later than 1842, when a switch to all iron construction was made. There are very strong parallels between this dock cover roof at Deptford and No. 3 slip cover roof of 1838 at Chatham Dockyard.<sup>19</sup>

Map and photographic evidence (Figs 12 and 23) shows that slipways Nos 4 and 5 had been previously provided with wooden 'roofs'. The construction of these was discontinued in 1842 as a fire risk, with wood being superseded by iron. Slipways No. 4 and No. 5 were however evidently reconstructed under these wooden slip cover buildings, which were retained until the closure of the Dockyard in 1869, though then progressively demolished between 1869 and 1916.

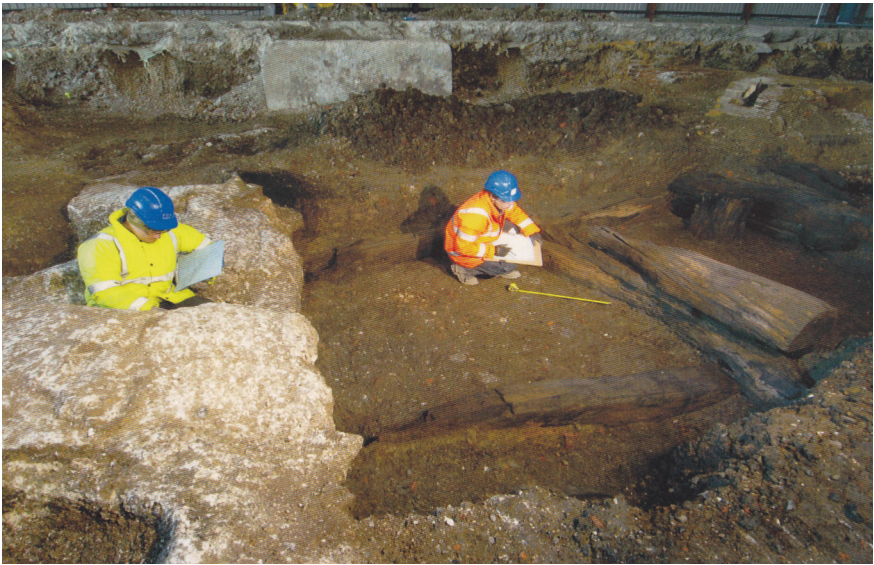
**Fig. 13: Georgian Slipway c. 1800 (© MOLA)**

Only a single late Georgian slip was identified on the site, sandwiched and truncated by the early Victorian slipways No 4 and No 5. It comprised a heavily truncated bed of timber on a chalk ballast base with revetted tieback timber sides (Fig. 13). The base at 3.61m OD was significantly shallower than that of the adjacent Victorian slipways by c. 1.65m (5.4ft). Prior to the introduction of slip cover roofs in 1814, slipways were very much regarded as ‘formwork’ for individual ship construction projects and were readily dismantled following launches.<sup>5</sup> The numbering of slipways after 1842 reflected their ‘permanent’ status.

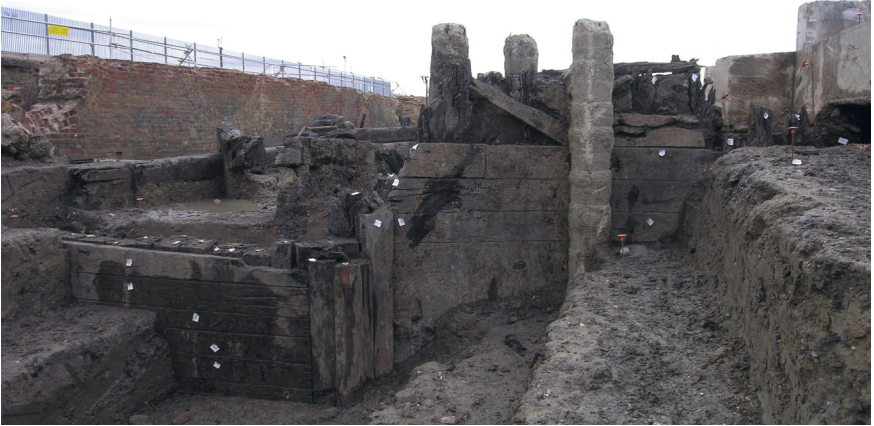
**Fig. 14: Timber Basin entrance of c. 1750 with depth gauge (© MOLA)**

deepened. This is indicated most vividly by comparing a depth gauge of c. 1750 formed of copper plate numerals (Fig. 14) with a stone depth gauge forming part of the remodelling of the basin entrance of c. 1813–14 (Fig. 15).<sup>6</sup>

The base of the latter depth gauge was 1.73m below that of the former, suggesting the basin entrance – and by implication the basin itself – was considerably deeper by the early 19th century. The final Georgian re-working of the basin included a Dock and two slips on the south side and a boat slip on the north side. These were all demolished and filled in during 1844–46, from which time only two slips, Nos 2 and 3, suitable for relatively small warships, ran into the basin.

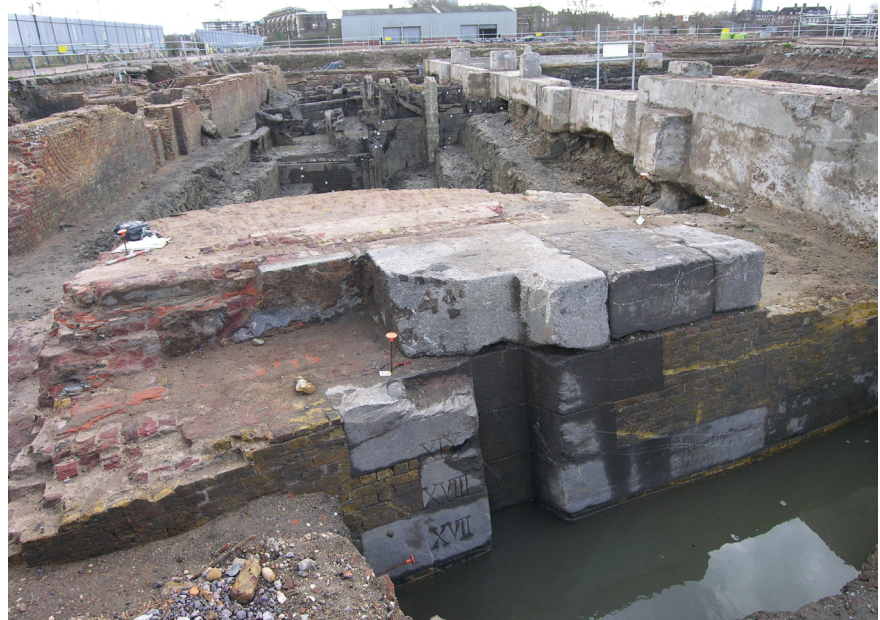
Fig. 15: Stone Basin entrance of c. 1814 with depth gauge (© MOLA)

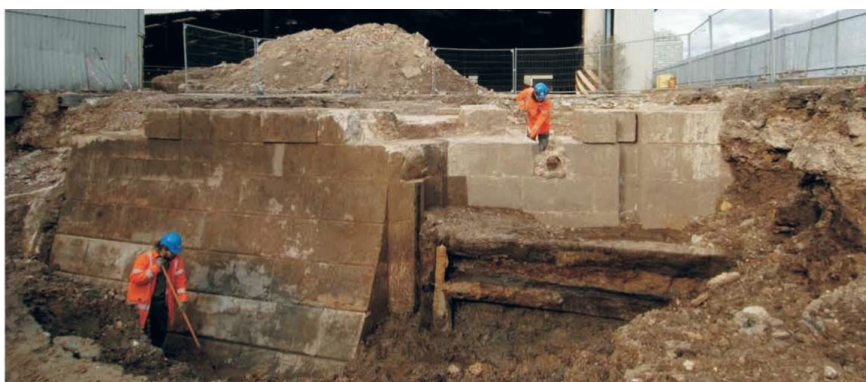
Fig. 16: Great Dock entrance, 2010 (© MOLA)

The reconstructed stone dock entrance of 1839–41 was identified in the 2010 evaluation. Although partly truncated by later development the entrance still survived to an internal height of 5.2m (17ft) (Fig. 16). Construction of a Portland stone facing, was held in place by a timber frame of tiebacks (now largely perished) bedded

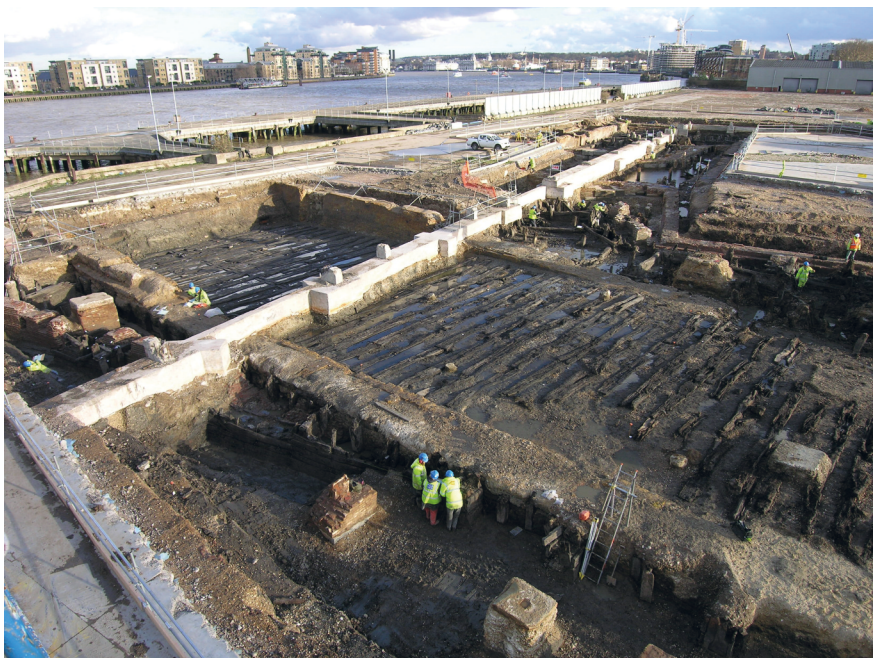
Fig. 17: No 1 Slipway by George Baker and Sons, 1845–46, 2012 (© MOLA)

Between 1844 and 1846 new slipways (No. 1 running into the Thames and Nos 2 and 3 running into the basin) were constructed by Messrs George Baker and Sons of Lambeth.<sup>22</sup> The slipways were provided with wooden decks using scrap or rejected timber from the Dockyard for the

horizontals, which were supported on vertical Baltic Deal piles shod with iron, driven into the underlying alluvium. The slip walls were of yellow stock brick backed with lime concrete (Figs 17 and 18). Baker also modified the basin walls on the south side at this date.

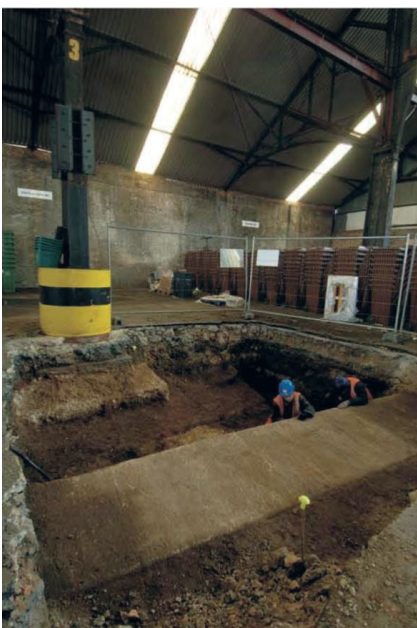
Fig. 18: No 2 Slipway by George Baker and Sons, 1845–46, part of Baker’s original iron roof in background, 2010 (© MOLA)

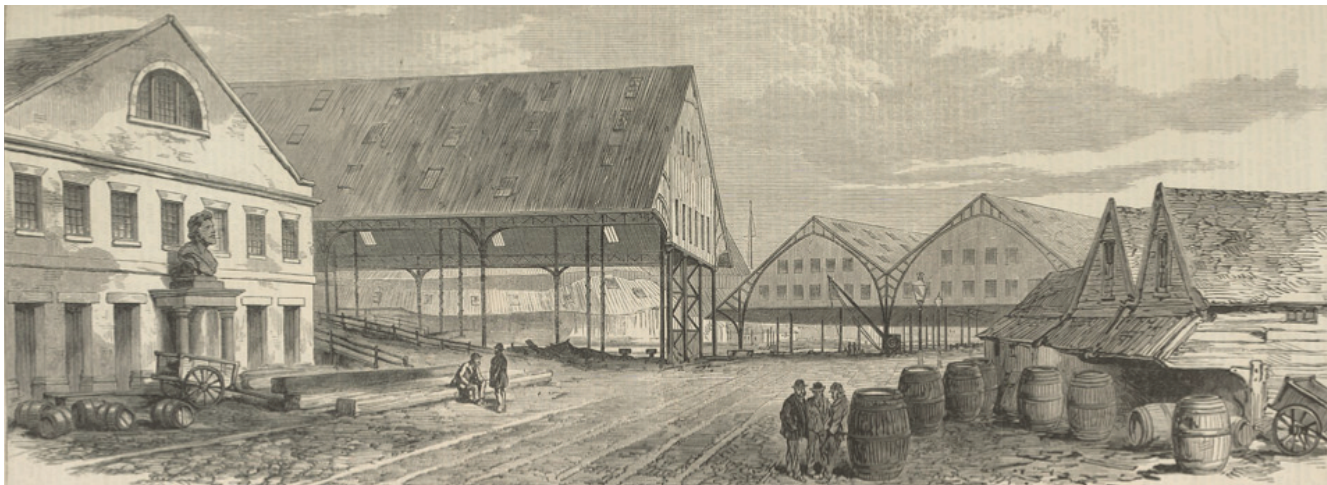
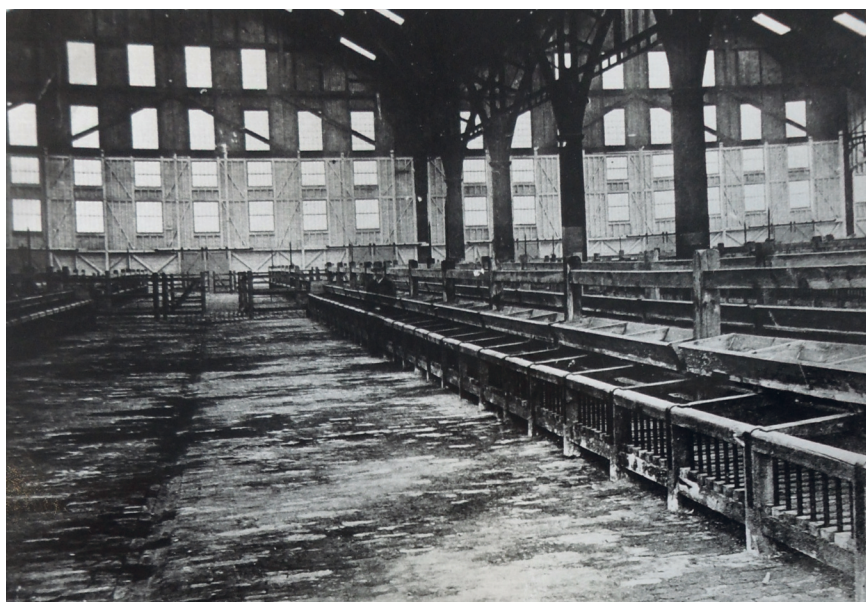
Fig. 19: Baker’s iron roofs over Slipways Nos 1, 2 and 3 engraving of 1869 (© British Library Board ADD MS 32360)

**Fig. 20: Baker's iron roofs over Slipways Nos 2 and 3 interior photograph, c. 1880**  
(© Courtesy of Lewisham Local History & Archives Centre, PH 71-4157 LS33)

Slips 1, 2 and 3 were all roofed in iron by Baker, with cast and wrought iron frames clad in galvanised corrugated iron pierced by numerous windows (Figs 19 and 20). Baker produced eleven such roofs in total at Chatham, Deptford, Pembroke and Portsmouth of virtually identical form.<sup>23</sup> The three Chatham roofs still survive

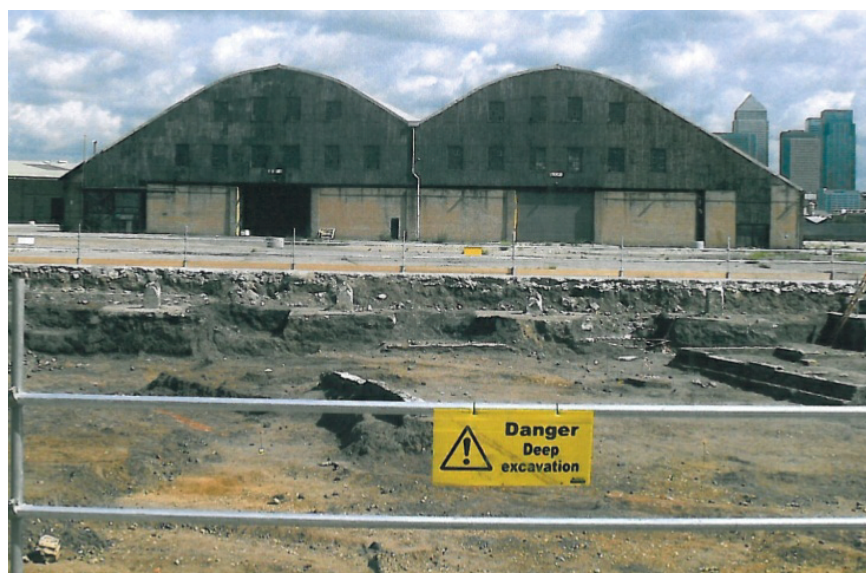
**Fig. 21: Olympia Building, 2011**  
(© Duncan Hawkins)

The iron slip cover roof over No. 1 slipway appears to have been destroyed during the Second World War, and only the foundation piers for the building and fragments of the cast iron standards set in them now survive, flanking either side of the slipway. The iron slip cover roofs for slipways Nos 2 and 3 survive in a much mutilated form as the Olympia Building, the original roof having been largely replaced between 1880 and 1913 (Fig. 21).

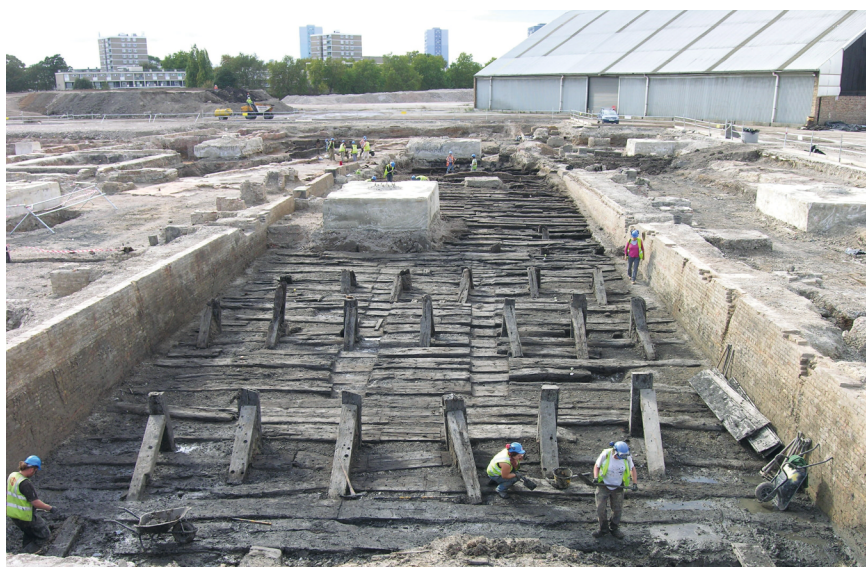
**Fig. 22: Slipway No 5 as rebuilt c. 1844-46 (© MOLA)**

The archaeological evidence suggests that slipways Nos 4 and 5 were also rebuilt in the mid-1840s, the form of construction and material as identified in the 2011-2012 excavations being identical to that in

slipways Nos 1, 2, and 3 (Fig. 22). A drawing of 1844 records both these slips as 'old' suggesting replacement was after that year and probably after 1845.<sup>24</sup>

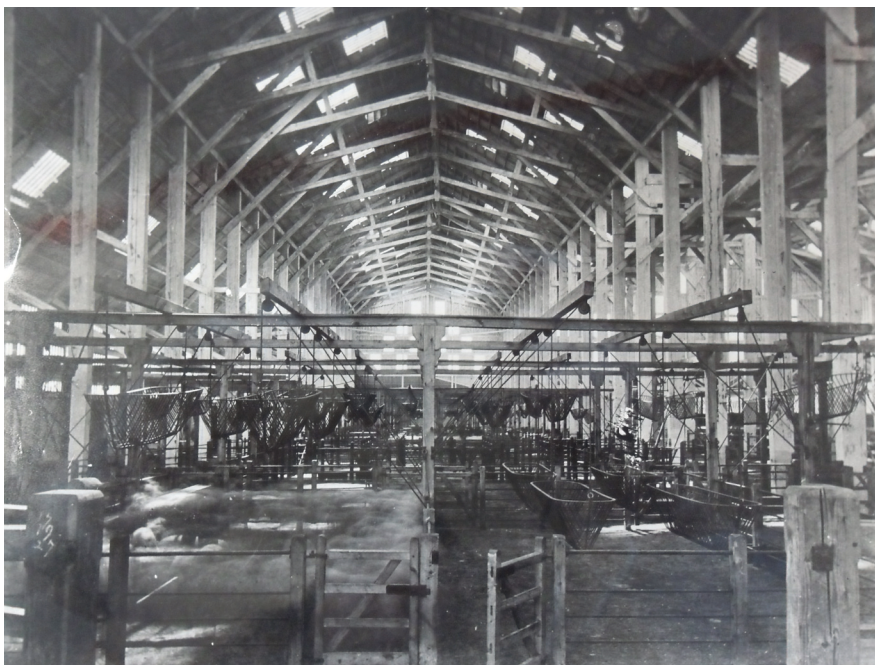
**Fig. 23: interior of wooden cover building over slipway No 5, c. 1880**  
(© Courtesy of Lewisham Local History and Archives Centre Thankfull Sturdee Collection PH 71-4158 LS34)

The brick foundation piers of these cover buildings were identified, with cut off timber standards still in place. However, analysis of the surviving internal photograph of the wooden ‘roof’ over Slipway No. 5 (Fig. 23) shows that the complexity of the wooden structure could never have been reconstructed from the surviving archaeological evidence alone.

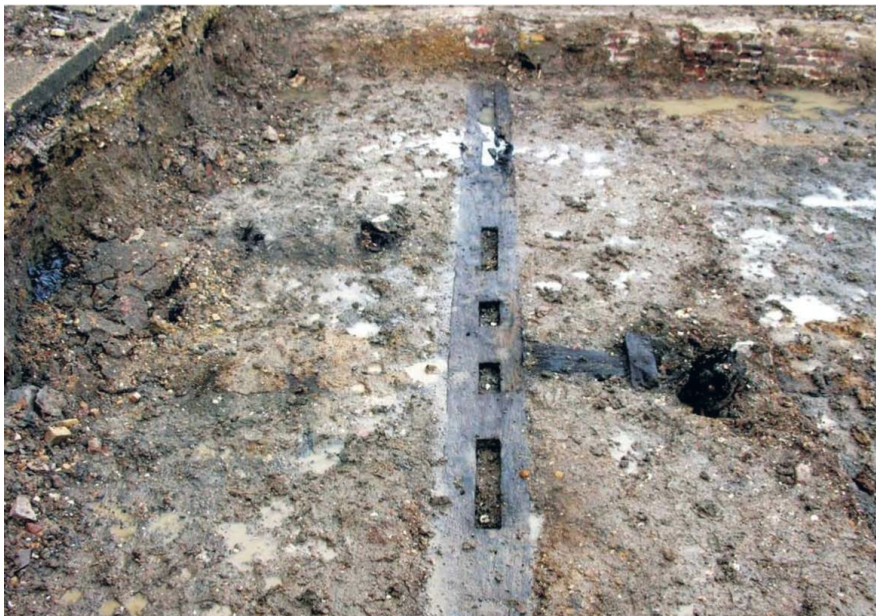
**Fig. 25: timber baseplate to Tank Shed**  
(© MOLA)

Investigation of part of the range of officers’ houses, the plank store and sail loft, Naval Store House, saw pits and plank sheds, revealed truncated foundations comprising a few courses of brickwork or timber base plates (Fig. 25) all superstructure and floor levels to the buildings having been entirely removed.

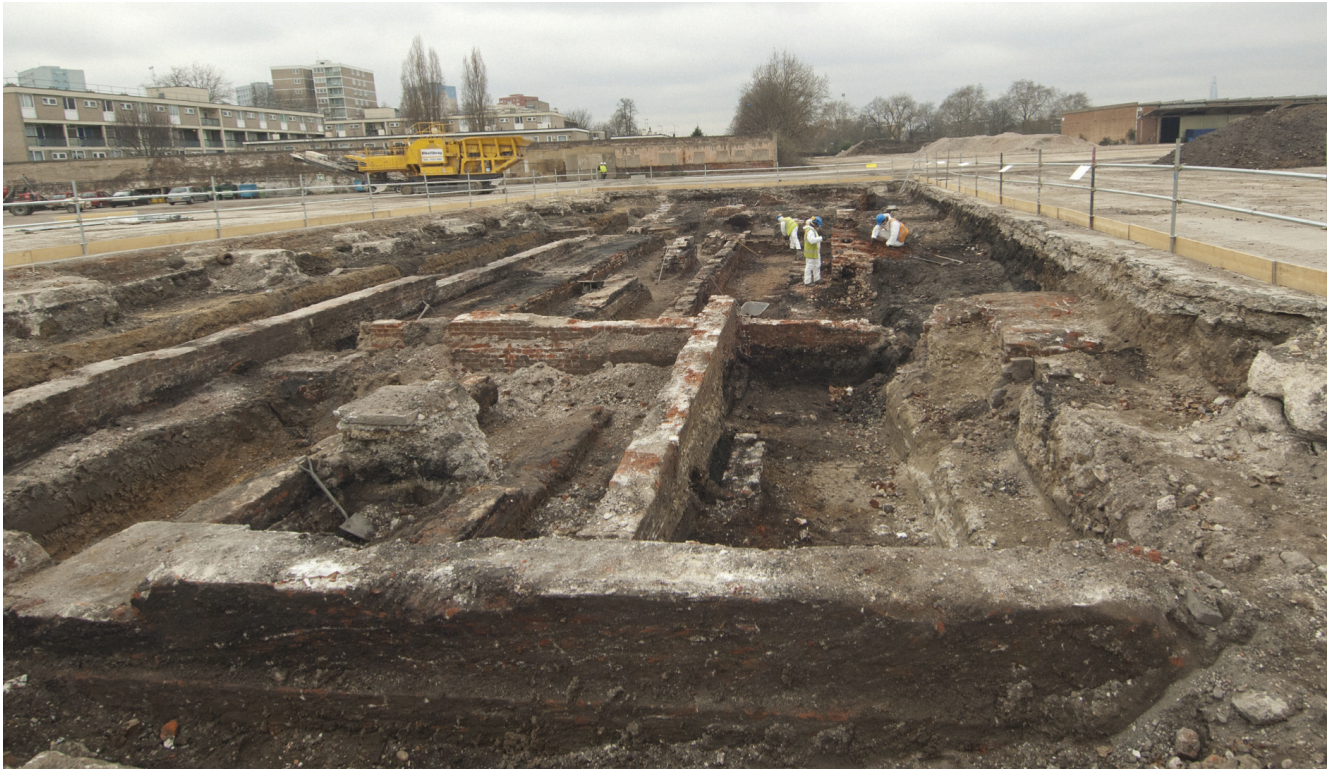
Fig. 26: excavation of the Dockyard Smithy, 2012 (© MOLA)

Parts of the Dockyard smithy were examined in an area excavation in 2011–2012. Evidence for the bases of hearths and flue work was identified, together with the base for an early Victorian steam hammer. The majority of survival was at foundation level, making recovery of the process flow within the building impossible (Fig. 26).
