Calke Abbey, Calke, Derbyshire:

an archaeological watching brief,
2005

Project No.1342

For
the National Trust

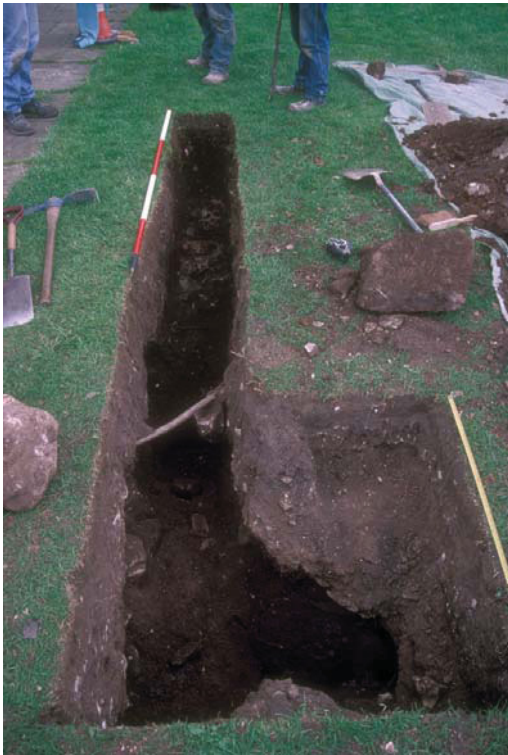
Plate 1

Plate 1: Trench 2, looking north

This pit was 1.12m x 1.14m, but was subsequently extended 4.0m to the north, at a width of 0.40m, and it terminated in a 1.0m x 1.0m trial pit (Plates 1, 2 & 4). A small brick-lined culvert (2004), was discovered on a east- west alignment at the most southerly end of the trench and this was capped by large sandstone blocks. A second larger culvert (2006) was uncovered at the northern end of the trench and was of similar construction to culvert 1004, in Trench 1. Culvert 2006 was 1.40m wide and 0.70m deep and was orientated northeast-southwest.

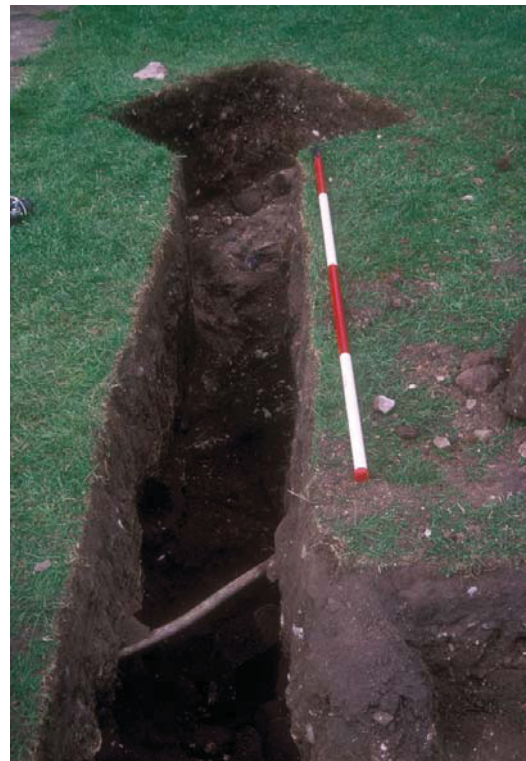
Plate 2

Plate 2: Trench 2, looking south

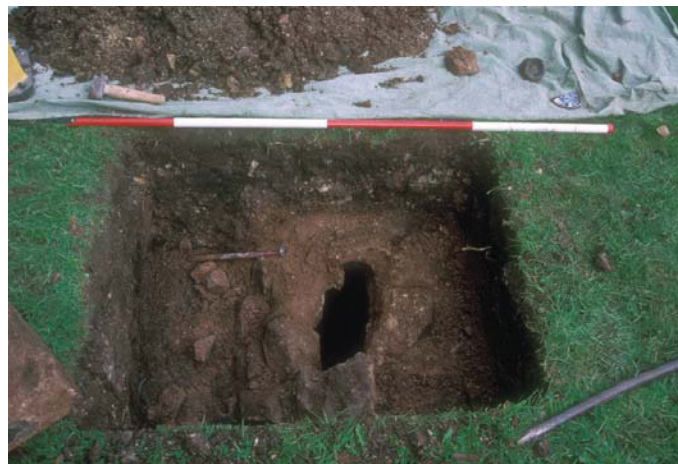
Plate 3

Plate 3: Trench 1, looking north

A trial pit measuring 1.20m x 1.03m was excavated to the east of the house in order to find an existing eighteenth century culvert (Plate 3). A culvert (1004) was located 0.39m below the present ground surface, running on a north-south alignment, and was of a rough mortar and sandstone rubble construction. The internal walls were also rubble built with brick and tile in places. The culvert was 0.80m wide and 0.50m deep. A fragment of wine bottle glass was

recovered from within the culvert 1004. The culvert was overlain by a 0.25m thick layer of mixed silty clay backfill (1002), which contained coal and degraded sandstone fragments. This was in turn sealed by a layer of topsoil (1001), 0.14m thick.

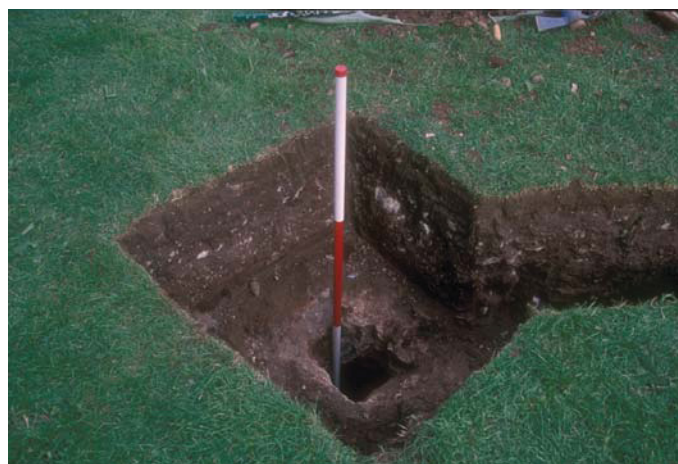
Plate 4

Plate 4: Trench 2, looking south-west

The culverts 2004 and 2006 were sealed by a layer of rubble (2003), 0.48m thick, which consisted of large and medium sized sandstone fragments that appeared unworked. One piece of worked stone was recovered from layer 2003. Layer 2003 was overlain by a mixed silty clay layer, (2002), being 0.48m thick. A piece of slate roof slate, a sherd of medieval pottery and a sherd of post-medieval pottery were recovered from context 2002. This was in turn sealed by a layer of topsoil (2001), 0.15m thick.
