BARN AT PICKTHALL GROUND FARM, BROUGHTON MILLS, BROUGHTON-IN-FURNESS, CUMBRIA

Archaeological Building Recording

Client: Mr and Mrs Lainson

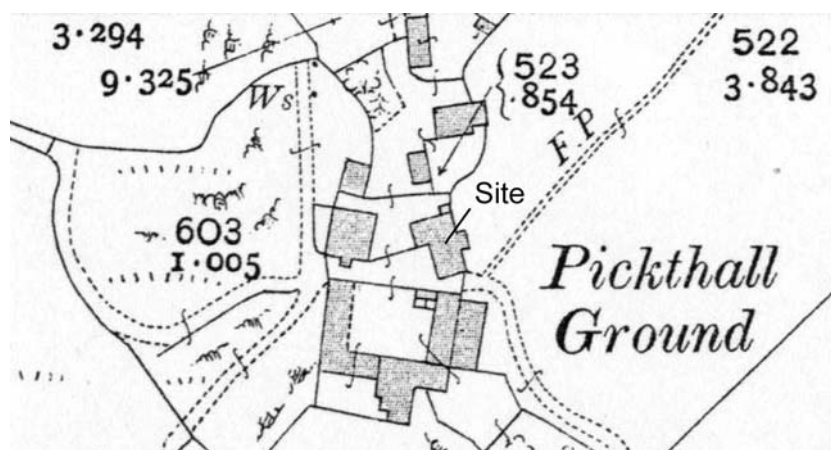
Plate 4: Extract from Ordnance Survey map of 1913

3.2.5 **Ordnance Survey 1913:** this shows that there has been little alteration to the site since the previous mapping, although some rearrangement of the buildings to the north of the barn has evidently taken place (Plate 4).

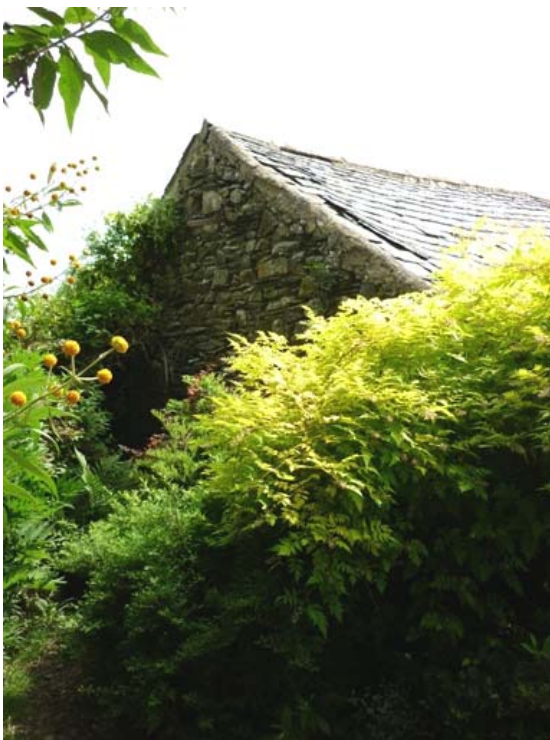
4.2.1 **North elevation:** this forms the gable end of the building, and is extended to the west by the monopitch roof of an outshut and is largely obscured by vegetation (Plate 5), although this is in part because it is built into the slope. It is relatively plain, the ground level obscuring much of the wall of the outshut but dropping down at the south end where there is a flight of slate steps (Plate 6). There is an owl hole beneath the apex, with electrical cables passing through it, and an iron bar projecting from the wall below and slightly to the west. A thin line of concrete has been added along the roofline patching the area below the slates.

Plate 5 (left): North external elevation

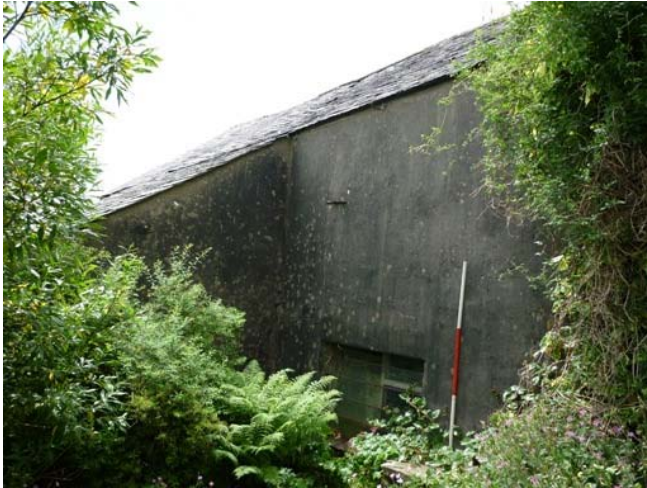
4.2.2 **East elevation:** the north end is finished with concrete render with a smooth finish, and has a piece of projecting slate high on the south side, perhaps part of a string course or a lintel (Plate 7). At the base of the window there is a long low window with a three-light fixed casement and roofing slates forming the sill. The wall immediately below this is not rendered. The wall returns to the east following the line of the extension on this side. This too is finished with plain concrete render. The return to the south is the same; although there is a large crack in the render here and it has a machine cut timber

Plate 7 (left): North end of the east external elevation

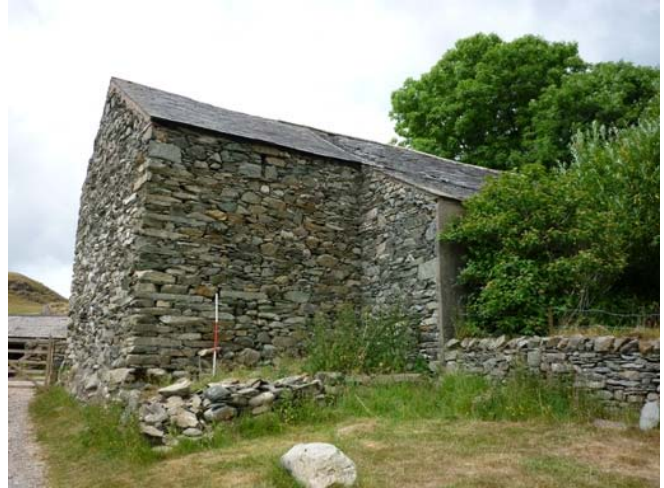
wallplate or lintel along the top. The return to the west is not rendered, there are some large quoins at the top of the corner, and the lower part of the extension clearly butts the main wall to the east. There is a wall connecting the south-east corner of the extension to the south-east corner of the main building, which forms a revetted area filled with rubble against the building. The south end of the elevation is also unrendered (Plate 8). It has a narrow ventilation slot at high level, and a wider one at ground floor level, which has been blocked with stone. There are long rough quoins at the south-east corner, although the upper few are larger, more dressed, blocks, and seem to indicate that the building has been raised in height by c1m.

Plate 8 (right): South end of the east external elevation

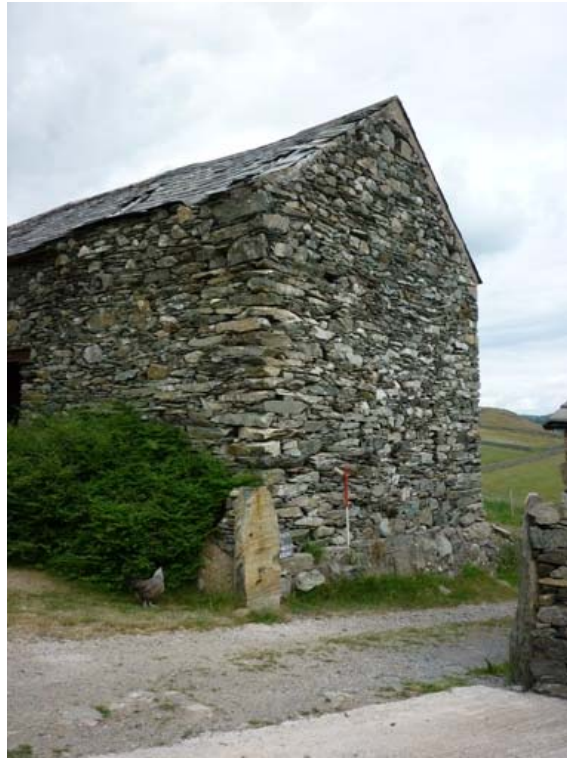
4.2.3 **South elevation:** this forms the opposing gable (Plate 9). It has a large plinth at the base pointed with cement and there are rough quoins at either end of the wall, again the top few are more dressed and larger and seem to indicate that the wall has been raised in height. There are two narrow ventilation slots at ground level, both roughly blocked with stone, and two higher level square vents plus a square owl hole beneath the apex. There are other possible square vents lower down, but these are less certain. There is a short boundary wall butting the elevation on the west side incorporating a large boulder and a gate post with a modern gate.

Plate 9: South external elevation

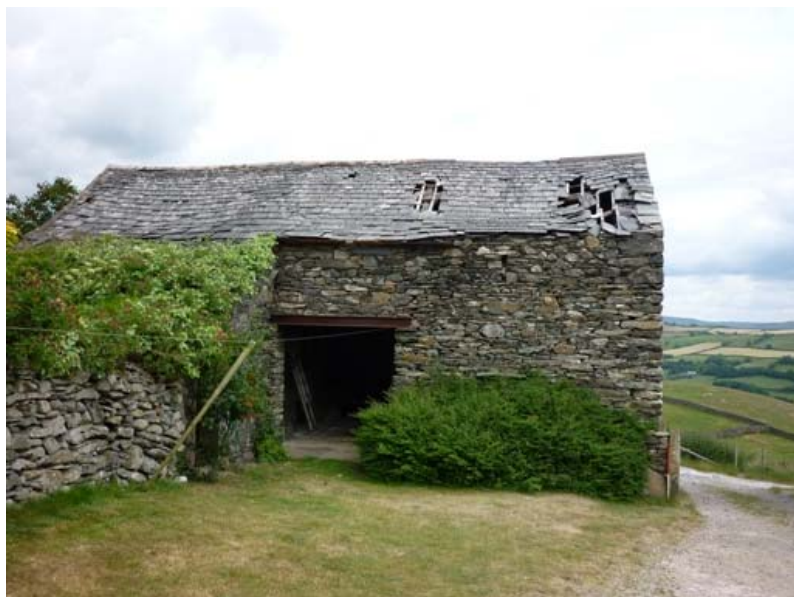
4.2.4 **West elevation:** there is doorway blocked with stone on the south side, with a projecting slate lintel and a ventilation slot above, also blocked (Plate 10). To the north there is a large wagon doorway with an iron I-beam lintel externally and three timber lintels internally with a central block fitting for the door attached (Plate 11). The two central timber lintels are machine cut as is the central block, which also has a section cut out of the centre and chamfered edges. The inner lintel is hand-finished and supported on inserted concrete blocks on the south side and a short section of hand-finished timber on the north side, probably the sawn off end of part of a former canopy. There is an iron gutter above the wagon doorway. The wall returns to the west to the north of the wagon doorway, forming the wall of the outshut, which clearly butts the main wall. There is a slot in the wall lining up with the timber beneath the inner lintel, which evidently formed part of a canopy support, and there is a slate drip course in the outshut wall that evidently follows the line of a monopitch canopy roof. There is a doorway on the west side of the outshut wall, which seems to have been inserted or rebuilt (Plate 12). It has a projecting stone lintel, but concrete has been added over the jambs. There are numerous fragments of re-used dressed red sandstone around this doorway. The garden wall butts against the south-west corner of the outshut, and the raised level of the garden to the west means that the north end of the west elevation is almost entirely obscured.

Plate 10 (left): General view of west external elevation

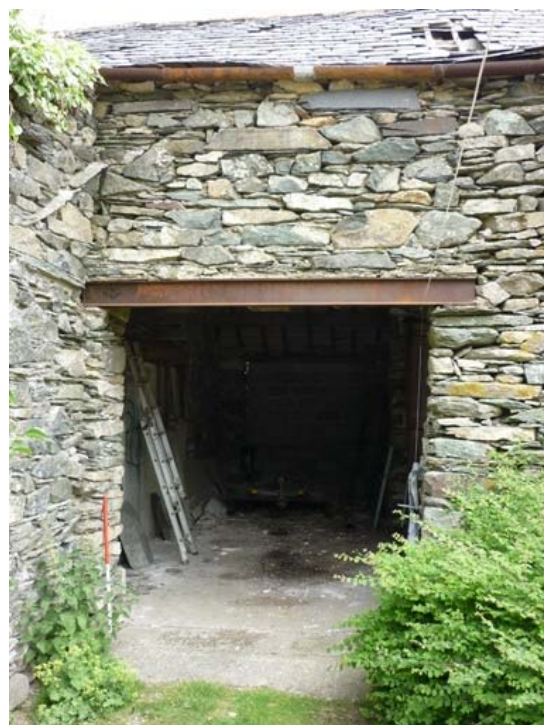
Plate 11 (right): Wagon doorway within the west elevation

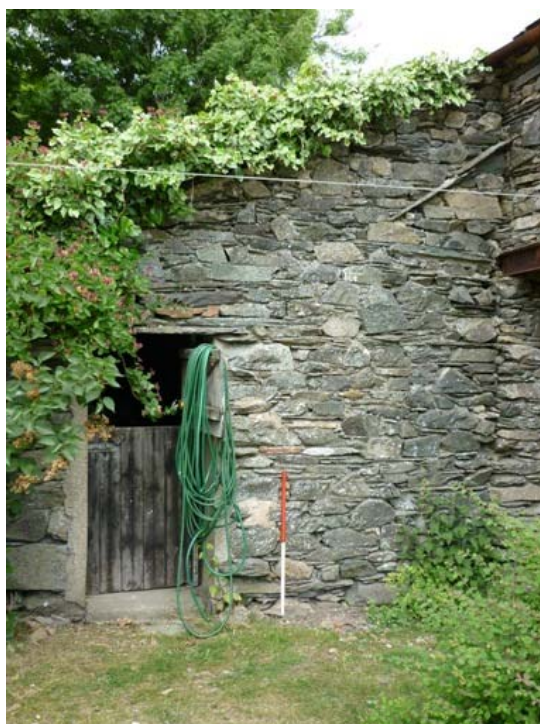
Plate 12: Doorway in the south side of the extension to the west elevation

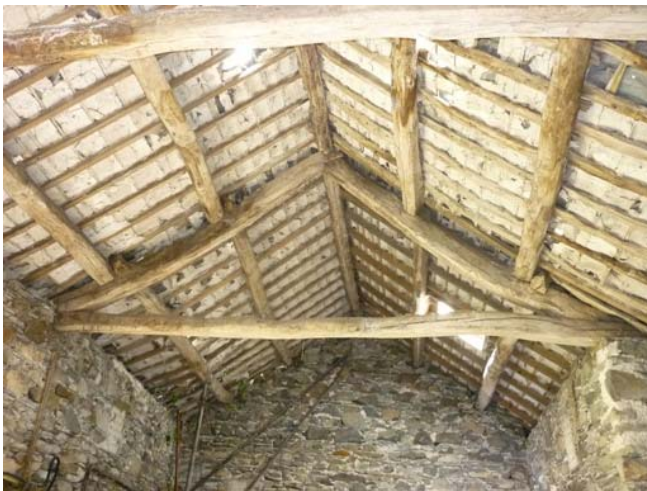
4.3.1 **Room 1:** this forms the main part of the internal space, and includes the upper level above Room 2. The area of the former threshing floor, in the centre of the building, is concrete. To the south it is finished with floorboards orientated east/west laid on machine-cut joists. The roof has two purlins per pitch plus a diagonally-set ridge purlin supported by two trusses, which overlap at the trusses, the ridge

purlin being formed by several scarf-jointed pieces, the joints again meeting at the trusses. Each of these comprises a tie beam and principal rafters, overlapping west on top of east with a notched joint, but there are slots in the principal rafters for a former collar, which is no longer present (Plate 13). The majority of the timber, especially the purlins and trusses, is hand-finished and jointed with pegs, but later timber has been used in places and some modern timber is present at the south-east end. Most of the rafters are machine cut and two further machine cut purlins have also been added within the extension to the east. The backs of the slates are finished with lime plaster. The only part of the north elevation contained within this room is that situated above the inserted floor forming the ceiling of Room 2. It forms one gable end, and incorporates a projecting block supporting the ridge purlin, a blocked owl hole, and two blocked square vents, one on either side. There is modern cabling attached to timber battens extending along the west side and the floor is formed by tongue and groove boards orientated east/west forming the ceiling of Room 2. At a lower level the north elevation is effectively formed by the inserted concrete block wall, which has a doorway with a tongue and groove plank door in the centre and timber boards edging the top (Plate 14).

Plate 13 (left): General view of southern roof truss

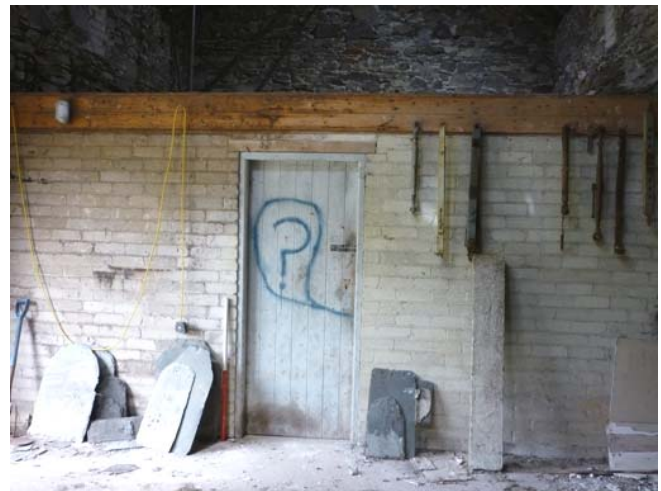
Plate 14 (right): Concrete block partition wall

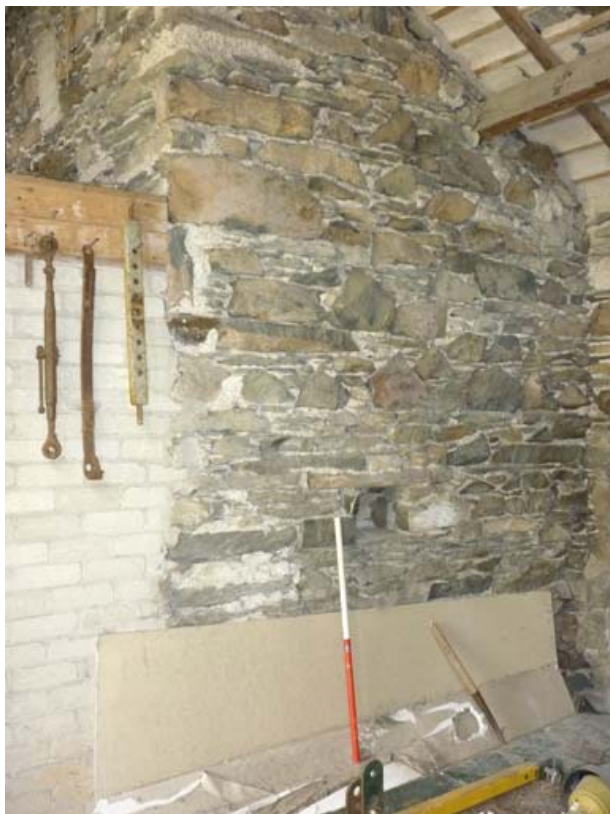
4.3.2 The north end of the east elevation is also above Room 2, and has a blocked ventilation slot at this level. It returns to the east near the centre to form a porch for a wagon doorway (now blocked). The lower part of the north side of this porch evidently butts the main wall of the building, but is continuous with the upper part, suggesting that the porch was added when the wall was raised (Plate 15). A piece of hand-finished timber has been incorporated into the return, and there is a small alcove in the porch wall with a timber lintel into which the initials 'IW' have been scratched. The return to the south evidently originally formed the wagon doorway, which has been blocked with concrete blocks. The return to the west forms the other side of the porched entrance, the lower part of which also butts the main wall while the upper is continuous, and there is also an alcove incorporated into the wall with a timber lintel (Plate 16). The wall returns again to the south, where there is blocked narrow vent at high level and a wider one below with an over-large timber lintel. The southern part of the elevation is finished with a patchy rough plaster, which extends to the base of the upper vent and probably also indicates the height to which the building originally extended. The south elevation also has a patchy rough plaster over the lower part, though less regular in form (Plate 17). It has two tall narrow vents with timber lintels at ground level, both blocked, and two square ones above plus a square owl hole, all of which are also blocked. There are projecting stone slabs connecting to the side walls at either end. The west elevation has a very low level doorway on the south side with a timber lintel with stop chamfer decoration and a second over-long lintel above (Plate 18). There is a narrow ventilation slot above this, which has been blocked with concrete blocks. To the north is the wagon doorway, which has perhaps been widened on its south side. There is a projecting timber stub above its south side, below the truss, and a blocked narrow slot vent above it, which is not evident externally. At the far north end, above Room 2, there is another blocked slot vent.

Plate 15 (left): North flanking wall of porch on east side of Room 1

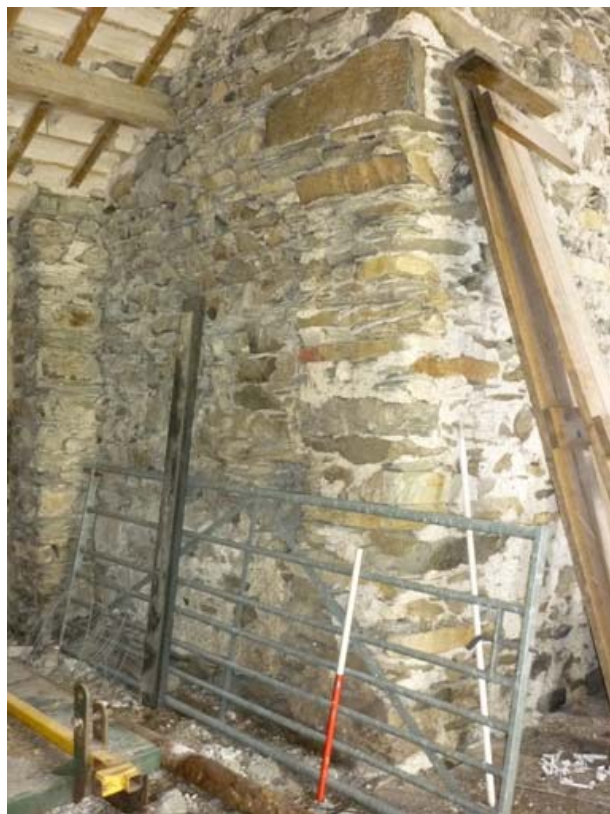
Plate 16 (right): South flanking wall of porch on east side of Room 1

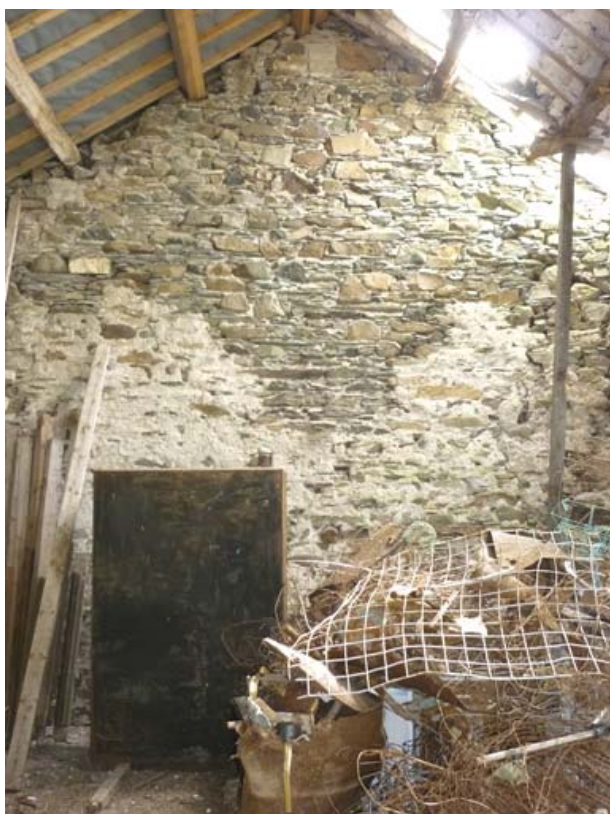
Plate 17 (left): South internal elevation, Room 1

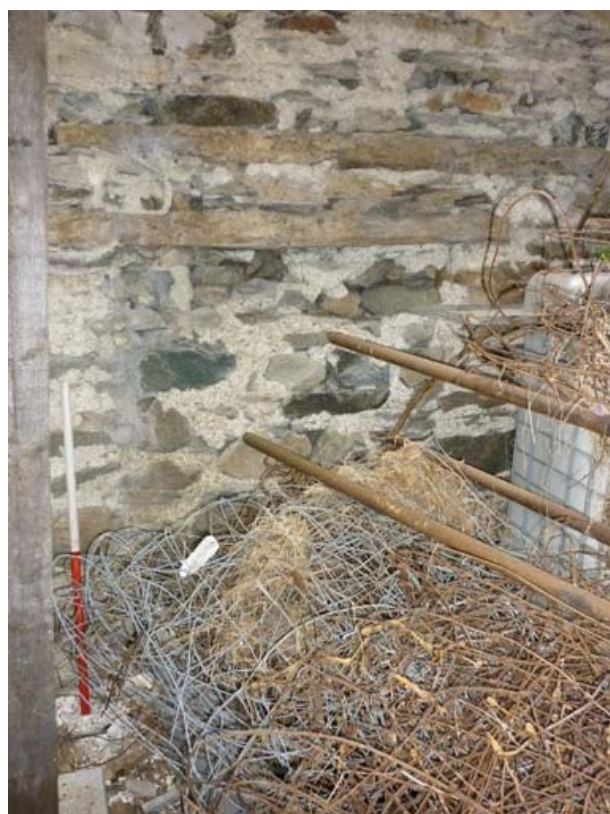
Plate 18 (right): Blocked doorway in south end of west internal elevation, Room 1

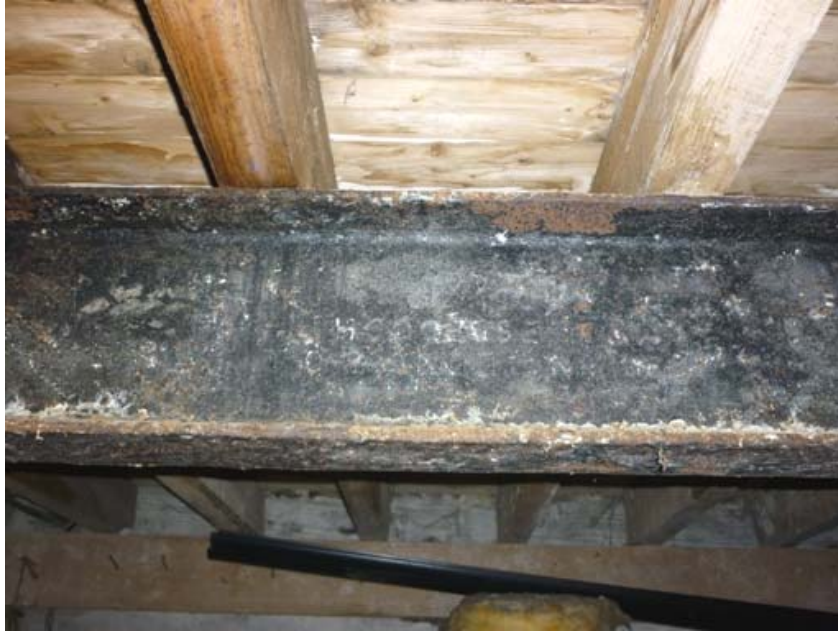
4.3.3 **Room 2:** this forms a small room at the north end of the building, formed by the insertion of the modern concrete block dividing wall and associated ceiling and only occupies part of the ground floor. It has a concrete floor and the ceiling comprises machine cut timber joists orientated north/south supported by a single iron I-beam orientated east/west, which is marked '[...] LONG & C^o [...]SBOROUGH' (most likely Dorman Long and Co of Middlesborough; Plate 19). All of the walls are plain and finished with concrete render, apart from the south, which is of modern concrete block construction with a central plank and batten door. There is a long low window in the east elevation with a fixed three-light casement and iron I-beam lintel and fuse box and electrical fittings attached to the west elevation.

Plate 19: Iron girder supporting ceiling of Room 2
