# FORMER METHODIST CHAPEL, STOREY SQUARE, BARROW-IN-FURNESS, CUMBRIA

Archaeological Building Recording

Client: Ian Turnbull

Planning ref.: B13/2009/0040

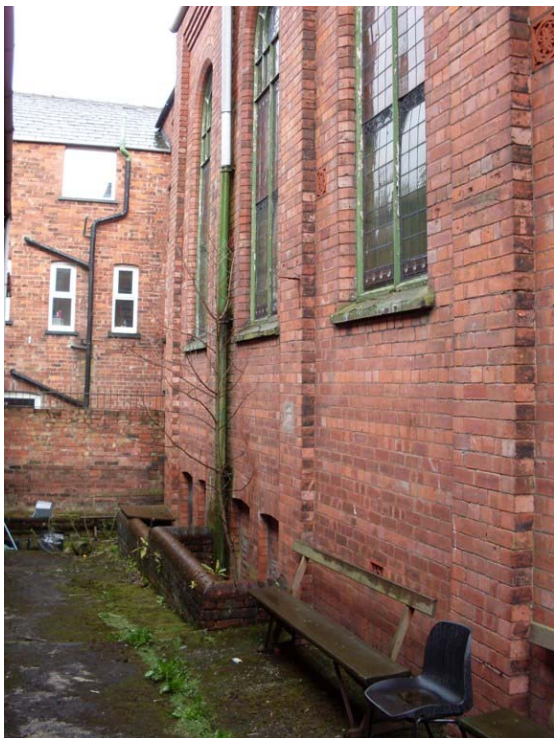
Plate 19 (left): General view of the north-west external elevation (photograph provided by John Dryden)

4.3.1 **North-west elevation:** this elevation was not fully accessible at the time of the survey but was essentially similar to the south-east elevation (Plate 19). There were five tall windows, still retaining their original stained glass across the elevation, plus a smaller one at the north-east end, and a door at the south-west end, which had six panels with raised centres. A row of ceramic vents was present across the length of the elevation and there was an evident junction between the two types of brick at the south-west end. At the north-east end all of the windows and doorways to the basement were blocked with

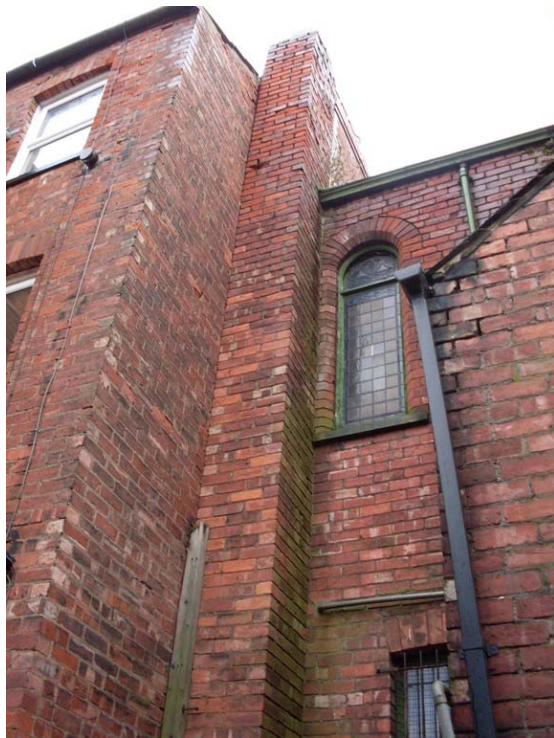
Plate 20 (right): The flue at the north-east end of the north-west external elevation (photograph provided by John Dryden)

concrete blocks, and there was a low projecting wall around the windows. A square projection at the very north-east end represents the position of a flue from the basement (Plate 21).

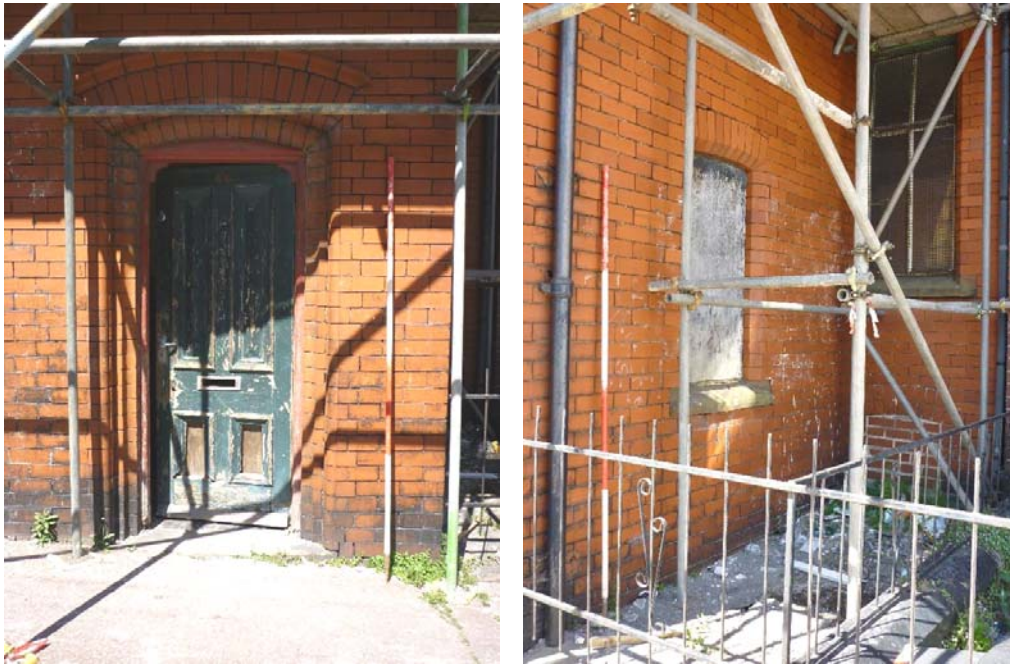
Plate 23 (left): Porch doorway in the south-east elevation

Plate 24 (right): Blocked and open windows to the north-east of the porch

4.3.3 **South-east elevation:** this elevation fronts onto Storey Square (Plate 26). There was a small access porch at the north-east end of the elevation which had a gabled top and a flattened arch over a four panel door (Plate 23). In the north-east wall of the porch there was a blocked window and there were two small windows in the return to the north-east and a blocked coal hole (Plate 24). The main elevation had five tall, round-headed windows with moulded brick jambs and at the west end there was a tower, which was square in plan and flat topped, with a moulded edge and two ceramic plaques in each face and small round and square windows. There were projecting pillars between each large window and at the corners of the tower. There was a door at the east and west ends of the elevation. The east door had four moulded panels while the west door had six. A bench mark was carved into the brickwork slightly below the sandstone foundation stone at the south-west corner of the building. There was railing across the elevation set on sandstone coping and there were four smaller cellar lights at the north-east end.

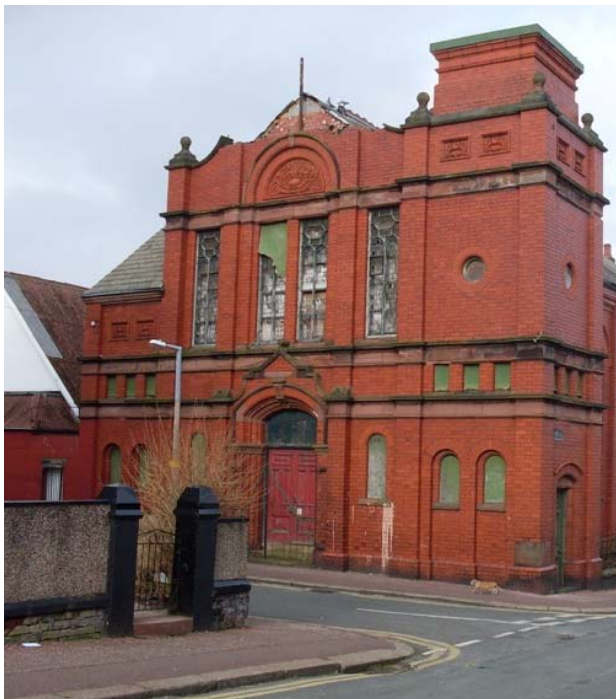
Plate 25 (left): South-west external elevation (photograph provided by John Dryden)

4.3.4 **South-west elevation:** this elevation fronts onto Allison Street and formed the main façade of the building (Plate 25). There were two sets of three small round-headed windows on both sides of a large central double-doorway on the ground floor. The red sandstone foundation stone at the south corner of the building reads: 'THIS STONE WAS LAID JULY 31<sup>ST</sup> 1894 BY C.W. CAYZER <sup>ESQ</sup> MP FOR BARROW-IN-FURNESS'. The doorway had moulded ceramic edging and two six-panel doors with a large arched top and blocked over light with a sandstone keystone and pediment on top and the date 1894 inscribed above. There were four tall windows above and the remains of the gable on top, with the façade missing, and ball finials. There was a small round window in the tower to the south and two ceramic plaques (Plate 27) to the north at this level. The whole elevation was finished with decorative stone string courses and moulded brick and the date '1894' was carved in a sandstone block above the door (Plate 28).

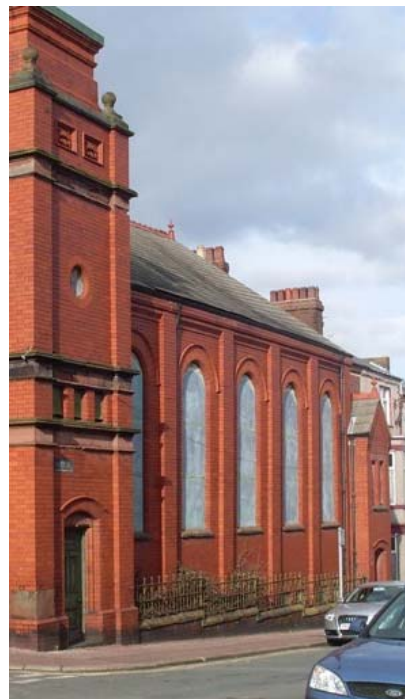
Plate 26 (right): South-east external elevation (photograph provided by John Dryden)

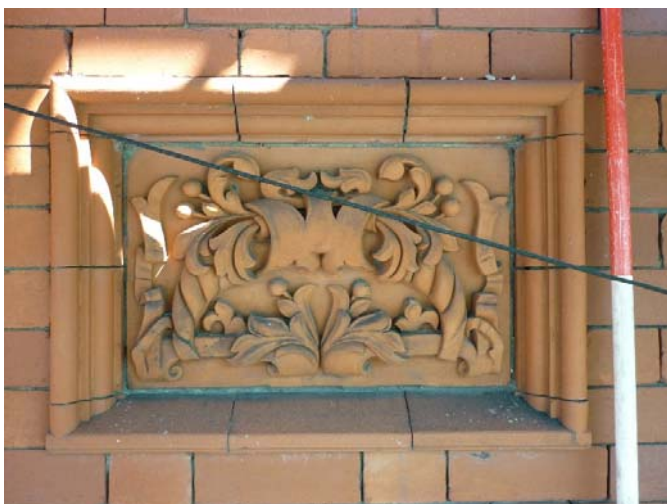
Plate 27 (left): Decorative plaque in the south-west elevation

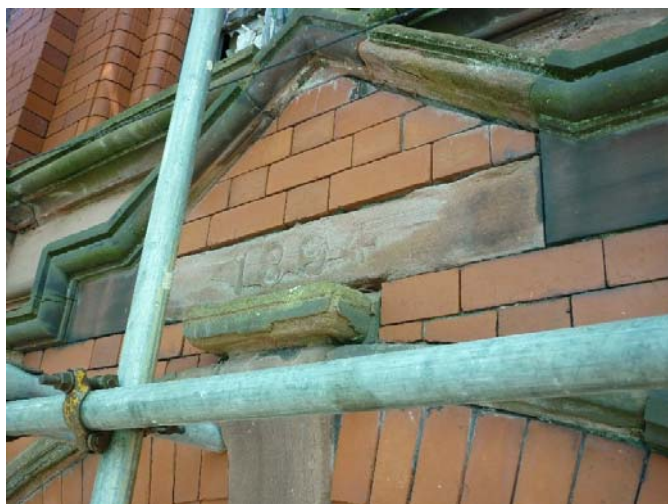
Plate 28 (right): Datestone in the south-west elevation

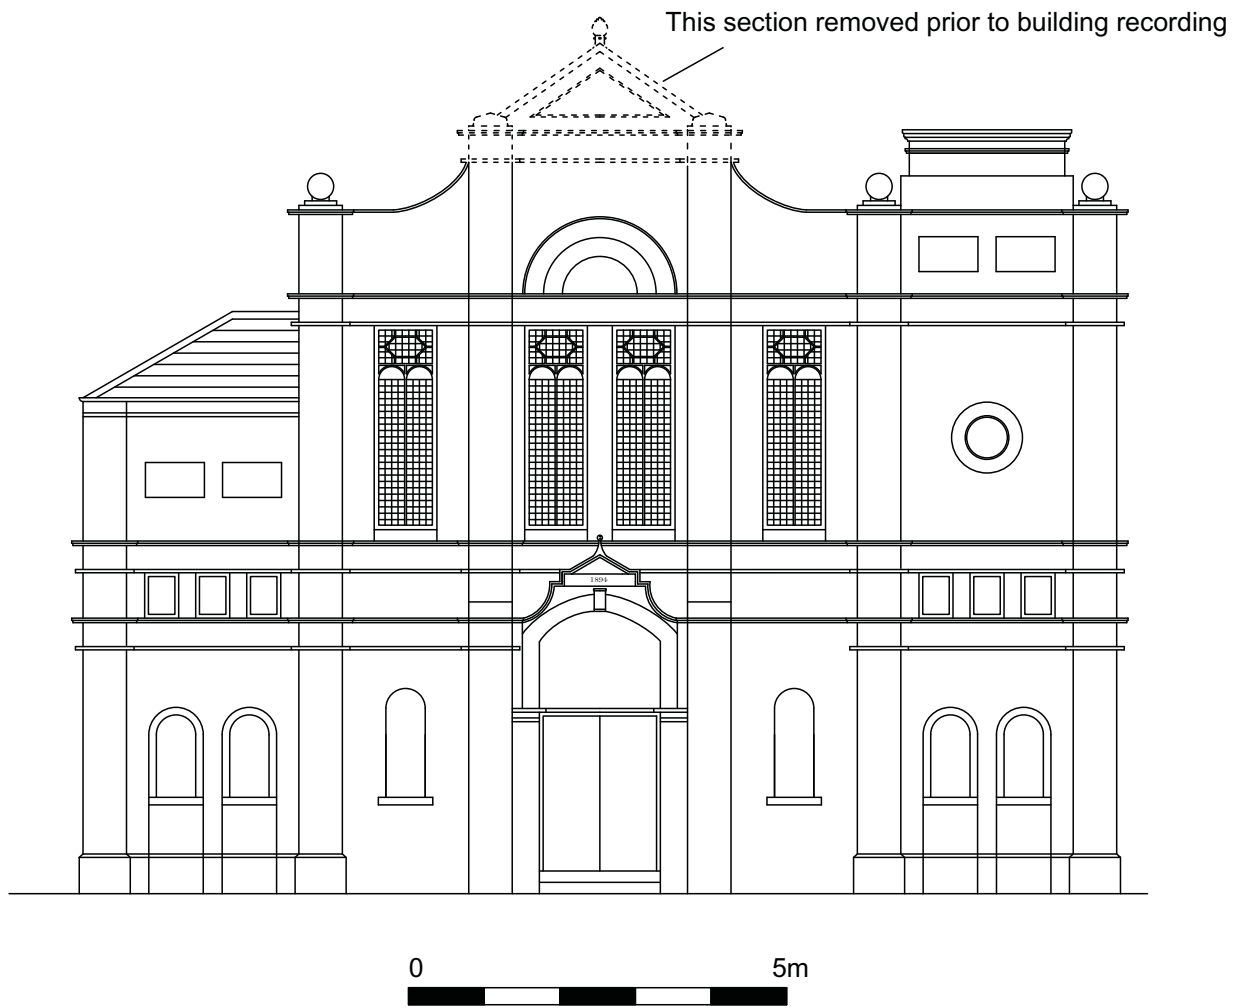
Figure 3: South-east external elevation

4.3.5 The adjoining building to the north-west extended this elevation of the building, and while it evidently butts against the chapel is has been keyed in. A sign on it reads 'BARROW CHRISTIAN FELLOWSHIP' and there are two stones marked 'LAID ON BEHALF OF THE CHURCH 1931'.

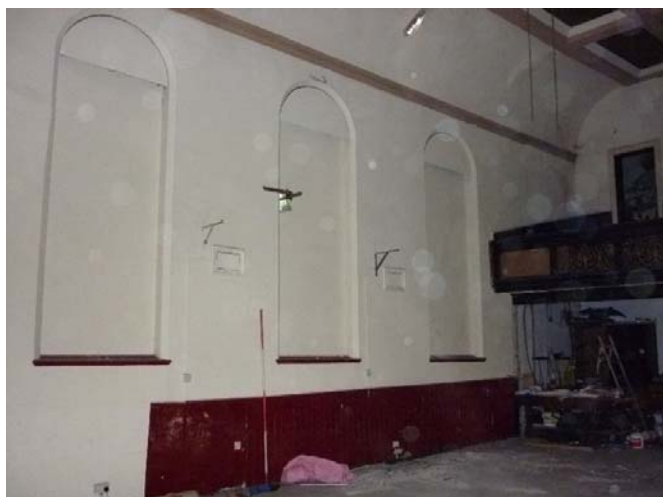
Plate 29 (left): Round-headed windows on the south elevation of the main hall

4.4.2 **Ground Floor 2:** this was the main hall and it had galleries at either end (see *Sections 4.4.3 and 4.4.4*). The timber floorboards were aligned north-east/south-west across the room. The ceiling was plastered with decorative square moulded panels (see *Plate 30 and Plate 31*). The north-west and south-east walls had four tall, round-headed windows with elaborate stained glass behind hardboard coverings and timber sills (*Plate 29*), with a further window partially covered by the south-west gallery, and a row of hinged vents along both elevations between the windows. The lower part of the walls was finished with tongue and groove boards (see *Plate 29*). The west end gallery was supported on two rounded iron pillars with a roll-moulded top and bottom (*Plate 30*) with inserted stud work behind forming walls and electrical housing. The area below the gallery had two doorways to the south-west leading to the access hall/vestibule. The door to the south had six raised and fielded panels, the one to the north had four moulded panels and both had moulded surrounds. There was a central large doorway with a plain surround. The front of the west gallery was finished with timber fret work of elaborate foliage forms with heavy moulded rails above and below (*Plate 31*). The projecting balcony at the north-east end was finished with timber panelling below a large four-point arch with a moulded plaster surround. It has two small brass plaques attached to it, one of which reads '*Officially opened for BARROW AMATEUR OPERATIC SOCIETY by Councillor Mrs JD Fleet Mayoress of Barrow September 1, 1977*', while the other reads '*Barrow Amateur Operatic and Dramatic Society STOREY SQUARE HALL Opening Ceremony performed by Councillor Mrs. J.D. Fleet Mayor of Barrow-in-Furness 21st December 1992*'.

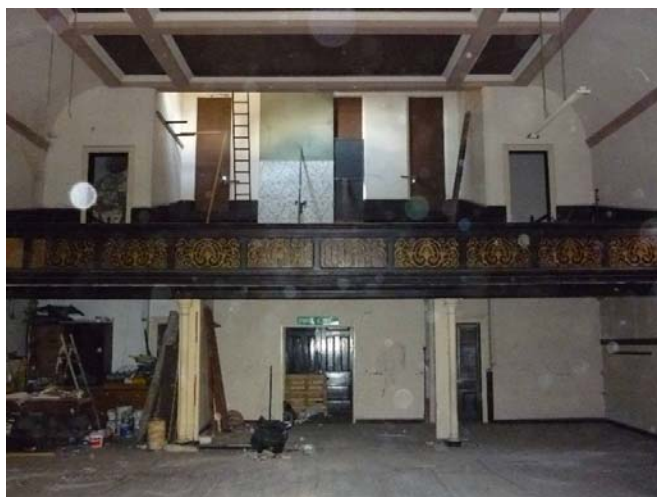
Plate 30 (right): View of the west gallery from the main hall

4.4.3 **Ground Floor 2 – south-west gallery:** this gallery was raised above the floor of the main hall. Its timber floor stepped down to the north-east to accommodate the original seating. The ceiling was plastered and had a moulded rail. There were two vent/access hatches into the former roof space, which also had moulded surrounds. The walls were plastered and had tongue and groove boards along the lower part, some of which covered the windows to the north-west and south-east. The doorways to the stairs in the south-west and north-west corners had moulded surrounds. The stairs were timber with the remains of the original banisters, and turned newels with finials. The stair towers had multiple windows; some small and square and others round in the south tower; some square and others tall and rectangular in the west tower; all with chamfered surrounds. The towers are otherwise plain. The south-west elevation had four large windows which were blocked with boards.

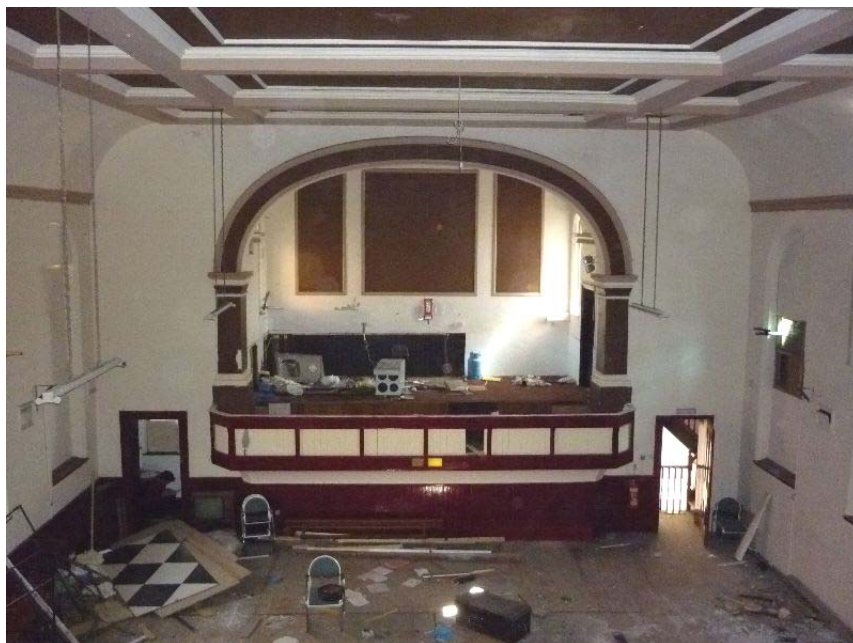
**Plate 31 (left): The east gallery viewed from the west gallery**

4.4.4 **Ground Floor 2 – north-east gallery:** this gallery was also raised relative to the main hall (Plate 31) and had a timber floor which stepped down to the south-west. Some of the tongue and groove boarding remained on most of the walls. The ceiling was finished with an elaborate plaster ceiling rose (Plate 32) and moulded rails. The door to the south-west had a moulded surround. There were small round-headed windows to the north and south, with stained glass. There were three panels on the north-east wall with relatively plain moulded surrounds.

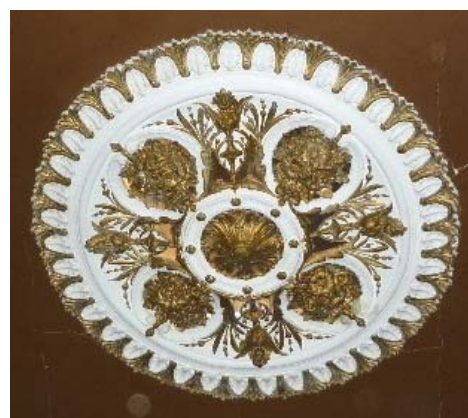
**Plate 32 (right): Detail of the ceiling rose above the east gallery**

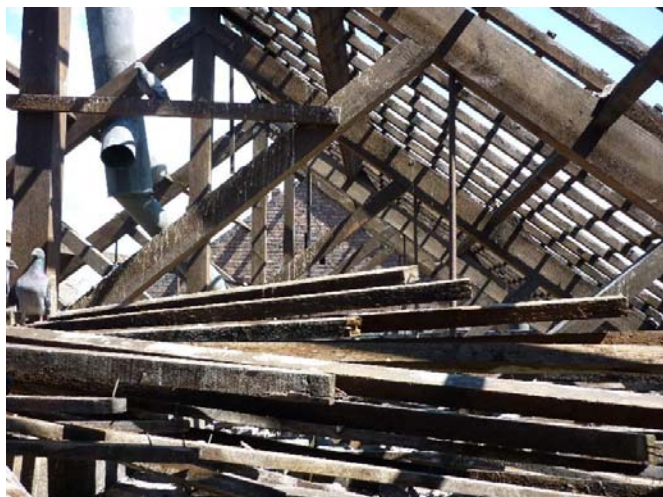
**Plate 33 (left): The roof space viewed from a hatch in the west gallery**

4.4.6 **Roof space:** the roof structure was supported by four king post trusses with angled braces and three purlins per pitch and a ridge board and iron tie rods between the principal rafters and the beams (Plate 33 and Plate 34). The trusses had hammered carpenter's marks at the junctions of the braces and principals to the king post principals, labelled 'III', 'II', 'I', 'IIII' from north-east to south-west (their asynchronous ordering might suggest that the roof had been rebuilt at some stage). The king posts had squared heads slightly angled at the top and held with iron straps. There were wedges behind some of the purlins.

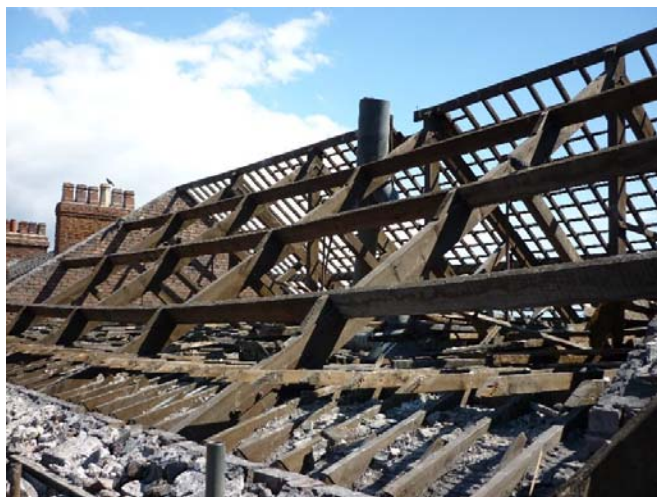
**Plate 34 (right): The exposed truss work of the roof**

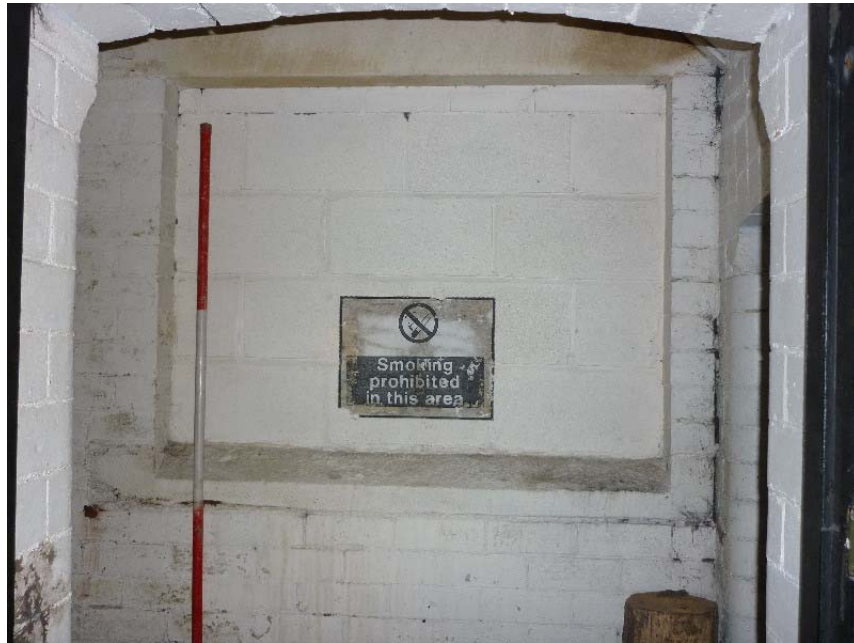
**Plate 36: Blocked window in the east elevation of Basement 8, showing the curvature of the arched doorway from Basement 6**

4.4.14 **Basement 8:** the doorway to this room from Basement 6 had a brick arch made from two rows of bricks laid end on above the doorway and bull-nosed jambs. There was a plain frame within the archway but the door was not present. There was a similar arched doorway housing a plain doorframe through to Basement 9. The brick jambs were also bull-nosed on the north-east side of the entrance to Basement 9 and the south-west elevation was painted brick. There were two steps at the north-west end that lead up to a doorway in the north-west elevation, which had been blocked with concrete blocks with a single course of frogged bricks on top below a sandstone lintel. The concrete floor and steps were painted red and the walls were painted white. The north-east elevation housed a large blocked window, which had been blocked with concrete blocks (Plate 36). This window had a sandstone lintel and sloping sandstone sill. The south-west end of the lintel was obscured slightly by the ceiling, which sloped towards Basement 9. The ceiling was finished with plastered and plain.

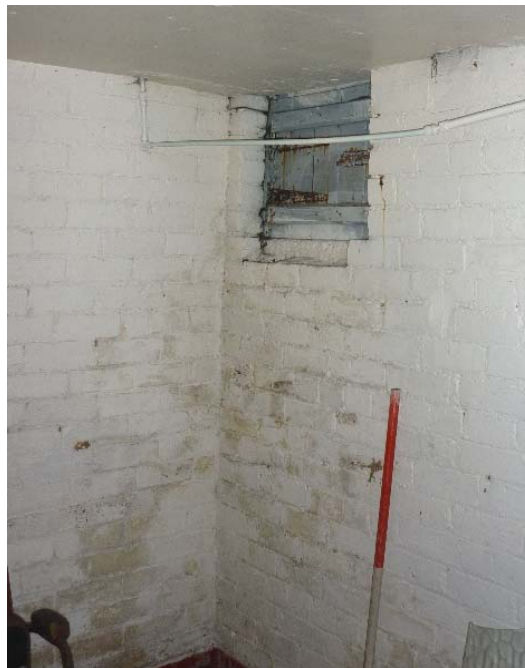
**Plate 37: Hatch in the south-east corner of Basement 9**

4.4.15 **Basement 9:** this had evidently originally formed a boiler room and coal/wood store. The elevations were all clearly brick, which had been painted white. No beams were visible in the ceiling. There were two steps into the room from Basement 8 in the north-west corner, which were painted red and the floor was concrete. There were two small vents in the north-west elevation with metal grills, within what was evidently originally an opening that had been blocked with brick, below which there was some evidence for metal piping. A short north-east/south-west aligned brick partition wall, a single course thick, divided the room; the north-west side of the room probably having been the boiler room and the south-east the coal/wood store. There was a hinged timber board hatch in the east corner of the room (Plate 37), which probably originally covered a coal hole accessed from Storey Square, but this had been blocked. There was no skirting board in this room.
