CASTLE DAIRY, WILDMAN STREET, KENDAL, CUMBRIA

Archaeological Building Recording

Client: NPS Group

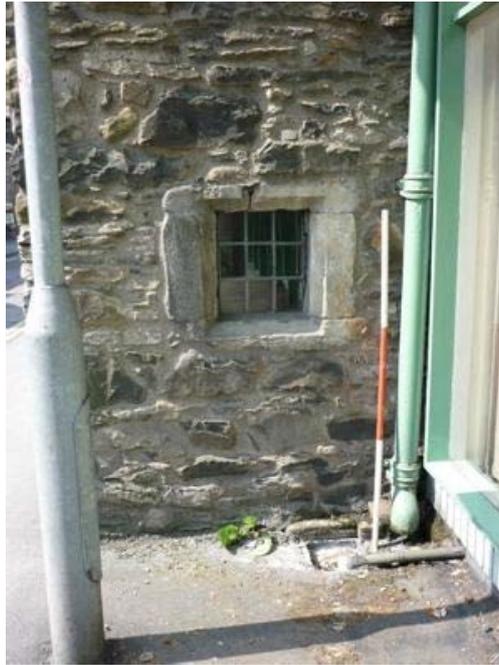
Plate 30: Ground floor window in the north-east elevation

4.2.1 **North-east elevation:** only a small part of this was visible as the majority is obscured by the adjoining modern building. It is fairly plain, apart from a single small window on each floor, both of which are square and with a chamfered stone surround (Plate 30). The ground floor window, which is the larger of the two, also has holes for a pair of iron bars, since removed, in the sill and lintel.

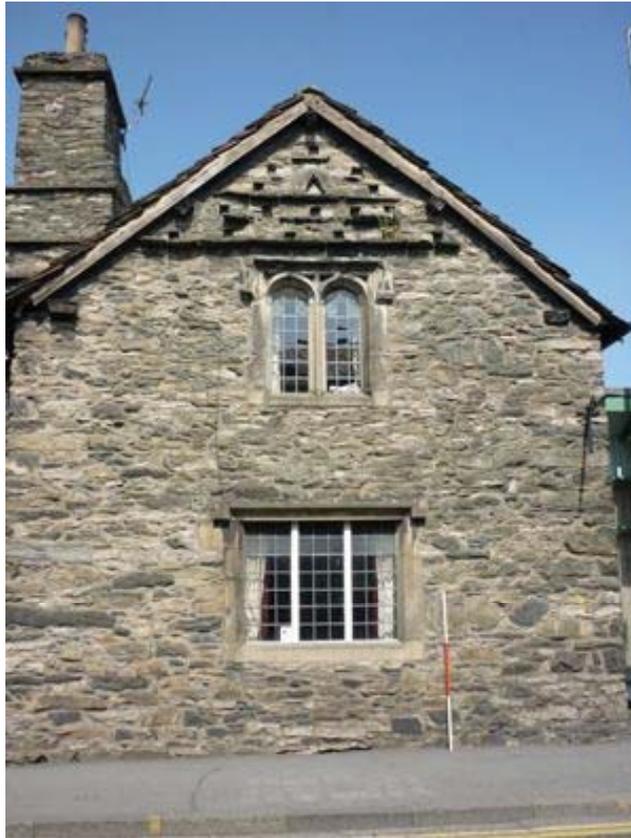
Plate 31: South-east facing gable of the north-east wing

4.2.2 **South-east elevation:** this forms the front façade of the building, and is stepped at either end to accommodate the projecting wings. The north-east end forms the gabled end of the north-east wing (Plate 31). There are rough quoins at the east corner and a large three-light ground floor window with chamfered surrounds and a label mould much of which is evidently a recent replacement. The jambs appear to have originally extended slightly further, suggesting that the window was originally slightly taller. On the first floor there is a two-light mullion window with trefoil heads and label mould, and above this, in the apex, there are four rows of projecting slate courses and associated holes in the wall forming a dove cote. Incorporated within this is a moulded piece of stone (limestone?), perhaps a re-used piece of window arch or piscine, with the initials 'AG' carved into it (Plate 32). The ends of two purlins project on each side plus the ridge purlin and wall plate. The wall returns to the north-west on the south-west side and is stepped although the step is filled at ground level with roughly dressed limestone blocks with a sloping top. There is a very small window above this with a chamfered stone surround, and a projecting chimney stack fills the remainder of the elevation against the return to the south-west, where there is a possible butt joint with the main elevation. The chimney is tiered and the steps finished with red sandstone flags and there are two ceramic pots on top (Plate 33).

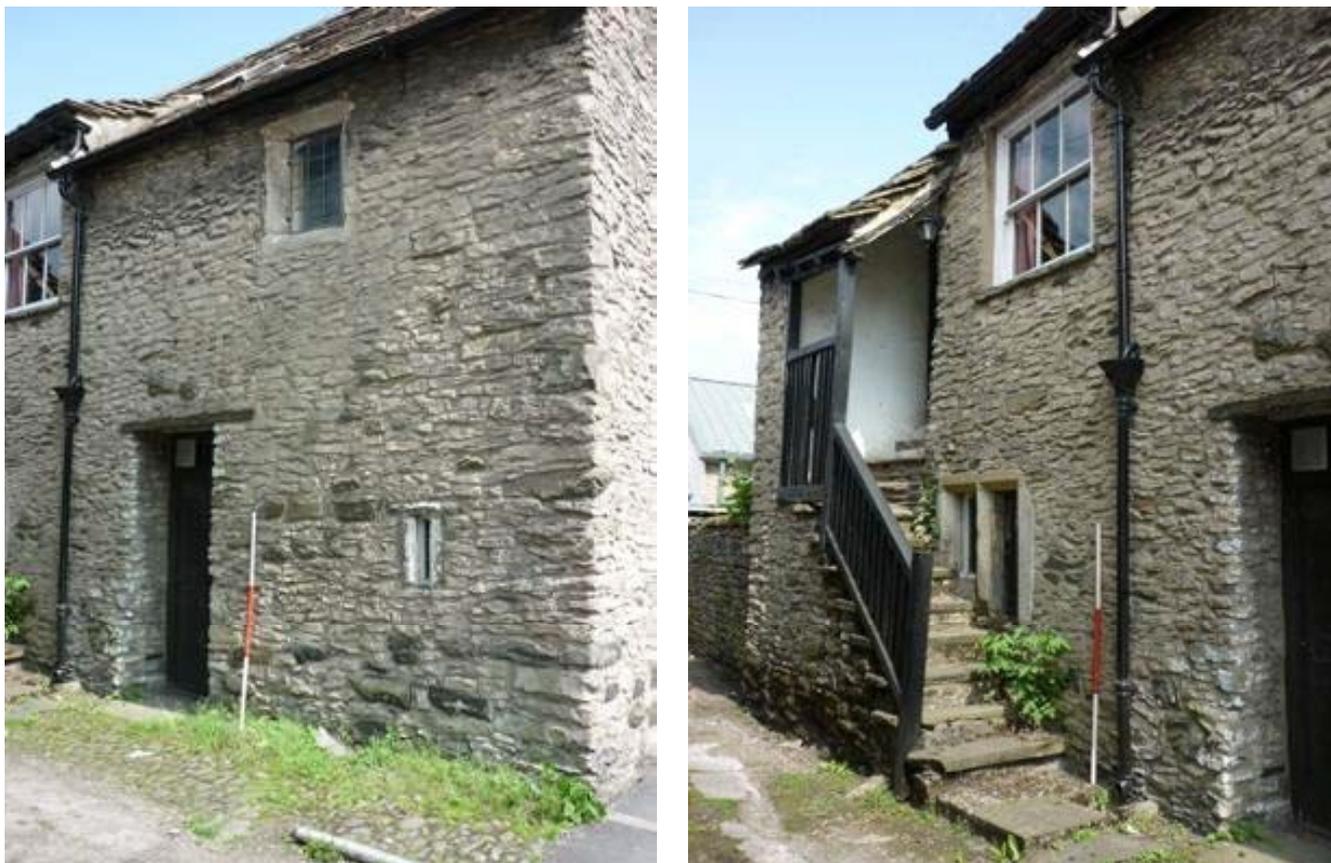
Plate 39 (left): South-east side of the south-west elevation

4.2.5 *South-west elevation:* this forms the side of the south-west wing and is of a similar build to the main wall but with slightly more slate (Plate 39). There is an external staircase attached on the north-west side (Plate 40) with stone and concrete steps, which turns to the north-east at a small landing near the top and has a very plain timber banister (all parts being square in section) along the side, some of which is evidently a modern replacement. The staircase is covered by a monopitch canopy roof, extending the line of the roof proper. The ground floor has a narrow slot window on the south-east side with rough limestone jambs, more like a ventilation slot than a window but now glazed. There is a doorway in the centre of the ground floor, which appears to be inserted and has a timber lintel and plank door. To the north-west there is a two-light mullion window with chamfered surrounds and mullion, each light housing an iron bar. Parts of the jambs have been repaired with concrete, and the window is partially covered by the staircase and so part of it has been blocked. The first floor has a window on the south-east side with chamfered surrounds and a larger window to the north-west with a six-light sliding sash casement and extends above the roof line to form a sort of simple low dormer. It has a timber lintel and slate sill but is otherwise plain. The doorway at the top of the stairs is also plain, with a heavy timber lintel and thick plank doorway with large strap hinges.

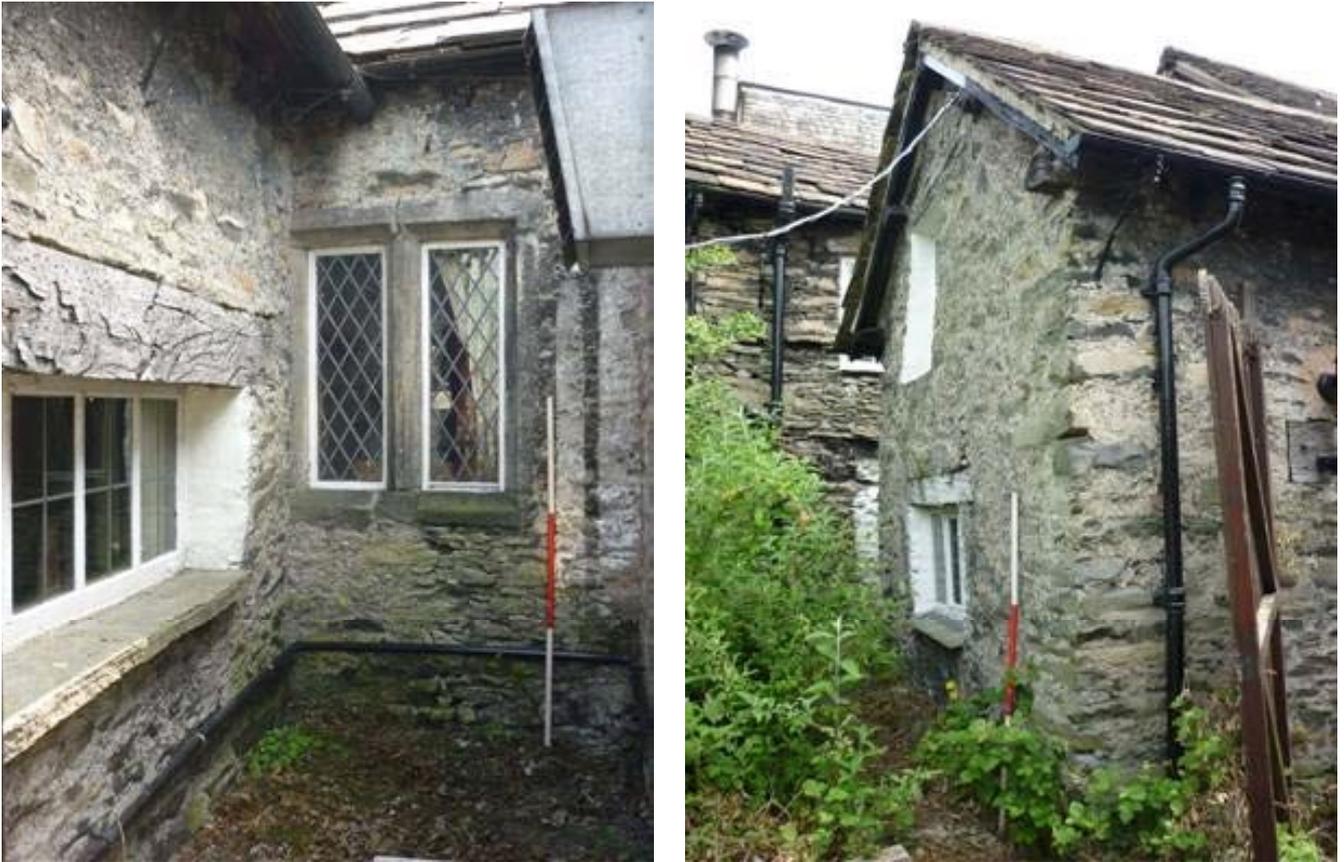
Plate 43 (left): Mullion window between the modern outshut and the extension to the north-east of it

4.2.7 The south-west side of this extension has a long ground floor window with a heavy timber lintel, four-light fixed casement, and stone sill (Plate 43). The north-west elevation forms a gable, with the ends of purlins projecting through it and a four-light window with a hinged casement and heavy timber lintel on the first floor, and a three-light window in the same style, with a slate lintel on the ground floor (Plate 44). The north-east elevation of the extension is plain. The ground floor part of the return to the north-east is covered by a small monopitch outshut apparently extending between the extension to the south-west and that to the north-east (Plate 45). It has a flag roof, apparently in the same style as the rest but of rougher construction (perhaps earlier?), and a small two-light window with a stone sill and machine cut timber lintel and machine cut timber wall plate over. The main wall is visible above this at first floor level, extending to form the rear gable of the north-east wing. Beneath the apex there are three projecting slate courses for a dove cote, but the associated wall has evidently been recently rebuilt. Below this is a two-light ogee headed lancet mullioned window (Plate 46). These have been inserted as a rebuild line is evident on the south-west side, and there is moulding, perhaps for a third window, orphaned on the north-east side. At the north-east end the elevation returns to the north-west with another, much taller two-storey, extension. This has a doorway on the ground floor with a plank door and chamfered lintel with a rougher lintel above extending to the north-west where it is evident that the doorway was originally wider but subsequently partially blocked. There is a small slot, perhaps some form of drain at the base of the wall, and projecting timber lying beneath and perpendicular to the large lintel, and there is a projecting slate drip course over the doorway. On the first floor there is a blocked window against the main wall on the south-east side and a six-light sliding sash window near the centre, which has a timber lintel and slate sill, and the south-east jamb has been covered with cement. There is a possible butt joint or slot to the north-west. The whole extension is continued at ground floor level to the south-west with a separate building not forming part of the site, but at first floor level it returns to the north-east forming effectively half a gable, again with four projecting slate courses, presumably for a dove cote, but it has evidently been recently rebuilt and/or modified.

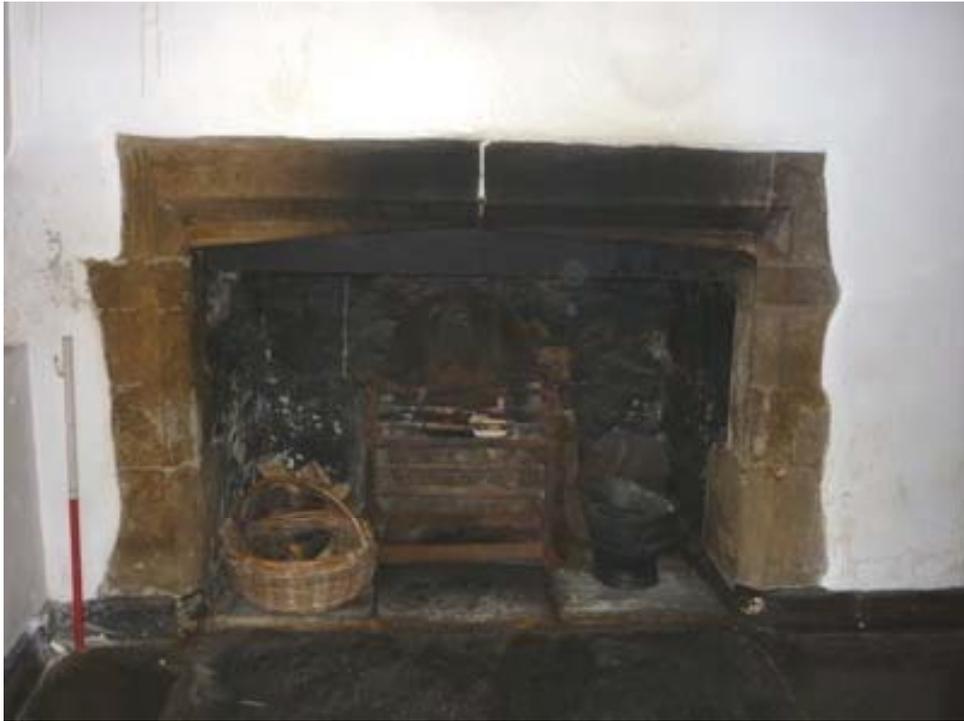
Plate 51: Fireplace in the south-west elevation

4.3.3 The south-west elevation is dominated by a large fireplace on the south-east side (Plate 51) with a dressed stone surround with chamfered jambs and arch (which is supported by iron bar hooks on the north-west side). The jambs too have mason's marks carved into some of the individual stones (Plate 52; see Figure 2). The fireplace has a slightly curved back and the base is finished with stone flags. To the north-west there is a doorway into G2 with a six-panel ovolo-moulded door, a beaded surround, and a timber lintel with stop chamfered ends; the opening for the doorway stepping slightly on the south-east side. At the far north-west end there is another doorway with a heavy piece of re-used timber built vertically into the south-east jamb, sat on an even larger block of timber laid horizontally. The door is constructed from two large planks with battens and strap hinges. The north-west elevation has a small window on the south-west side with splayed jambs, which is blocked and has been converted to form a small cupboard with a glazed front. There is an area of projecting stonework at floor level of unknown purpose, perhaps part of a staircase? Beyond this is a large doorway, with splayed jambs, and two steps up, presumably originally a window. The door is finished with modern panelling and has a beaded surround.

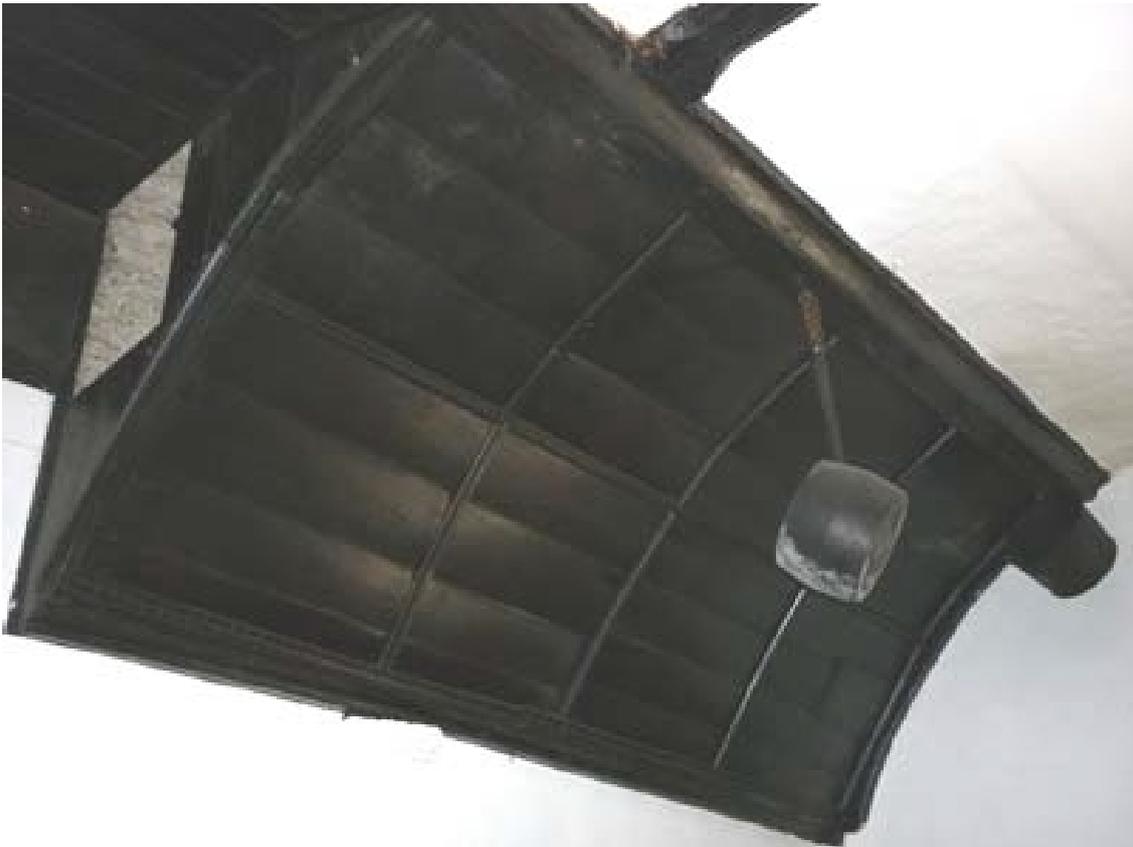
Plate 53: Barrel vaulted panelling against the north-east elevation

cupboard, inside which the stairs can be seen and are supported by two large re-used pieces of timber with a plank and batten door with strap hinges. The upper part of the south-west end of the room is dominated by a projecting canopy, which evidently originally formed the front of a firehood. It is constructed from moulded vertical rails with a horizontal rail along the top, sat on a heavy moulded bressumer beam, which in turn sits on a moulded heck post at the north-west end and is inserted into the wall at the south-east (Plate 58). The top of the heck post has the date '1560' scratched into it. The rails resting on the beam have evidently been truncated and moved slightly as the relict peg holes are visible and the bases have had rough plinths added, cladding the point at which they have been cut. What are presumably full-length rails, extending to the doorhead and without the 'plinths' continue to the north-west. The bressumer beam has clearly also been modified, it having been cut at the north-west end and moved upwards to sit on top of the remaining stub on the heck post, the sawn end having been crudely chamfered to disguise the alteration. The continuation line of the original moulding is evident and there are additional iron straps between the post and the beam. There is a small slot cut in the rear of the bressumer beam and iron meat hooks in the ceiling.

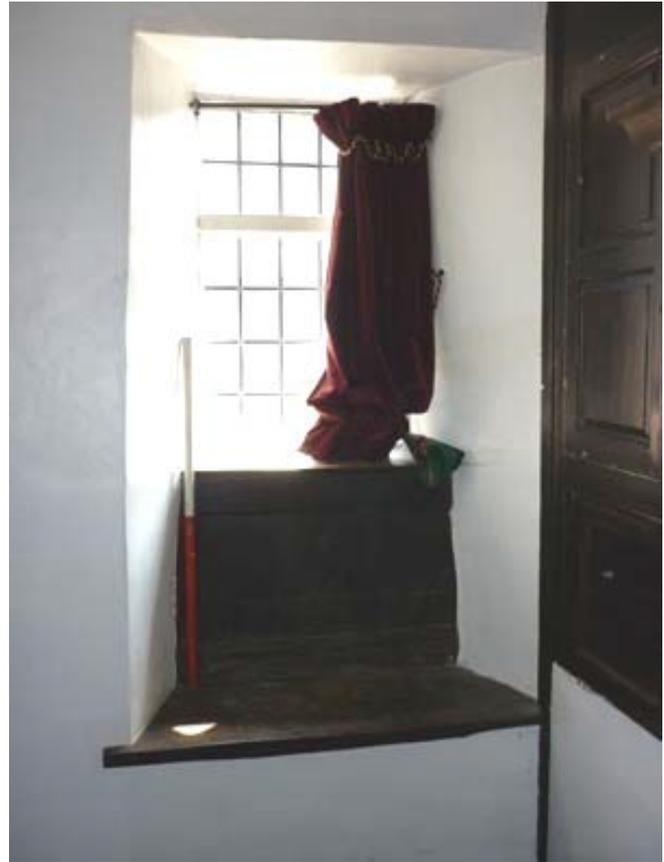
Plate 57 (right): Window at the south-west end of the south-east elevation

4.3.5 The north-east elevation is fairly plain, with the exception of the stairs and barrel vaulting attached to it. There is a doorway on the south-east side with a six-panel bevel raised and fielded door with a beaded surround below a chamfered lintel. There is a second doorway on the north-west side, below the stairs, of beaded plank construction and plain surrounds. The south-east elevation has a doorway on the north-east side with a splayed north-east jamb, the door having four panels and a moulded over-light (Plate 55). To the south-west there is a low projecting stub wall clearly built of stone, but capped with thick pieces of timber. There are two windows to the south-west; the first has three lights and a timber panelled window seat with beaded decoration to most of the rails, but which appears re-used (Plate 56). There are small iron hooks, presumably for shutters or earlier hinged casements either side, and a plain timber lintel. The leaded glass within the window incorporates two pieces of stained glass one incorporating a *fleur de Lys* and crown motif, the other with mottos and the initials 'AG' and date of 1567. The second window, to the south-west, is plainer and has similar panelling with the date of '1560' carved into it (Plate 57).

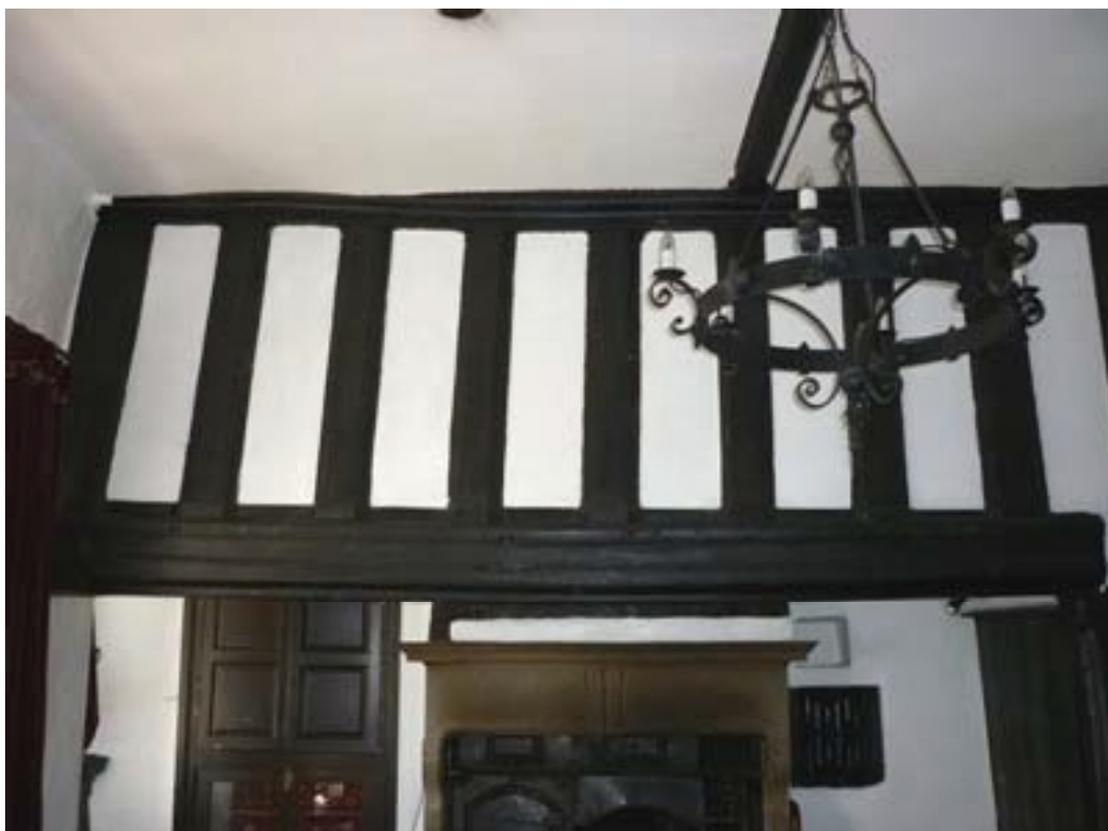
Plate 58: Screen above the bressumer beam at the south-west end of the room

4.3.6 The south-west elevation has a built-in cupboard on the south-east side with two bevel raised and fielded panelled doors in the top half and a two-light glazed section below, hung horizontally (Plate 59). The surround extends to the ground and it seems likely that originally this housed a further pair of tall doors, and that the glazed door has perhaps been re-used but on its side. There is a moulded rail above the cupboard and it now houses fuse boxes and associated wiring. Dominating the centre of the elevation is a large fireplace (Plate 60). Against the walls this comprises a projecting chimneybreast with a stone surround with a moulded over mantle with keystone on projecting corbels forming part of the jambs. Above this a large timber beam is exposed. Within the opening below a cast iron range has been inserted, which comprises various ovens and water tanks, and some of its structure comprises machine made frogged bricks. There is a small spice cupboard in the wall to the north-west of this with a, presumably original, timber door with linen-fold decoration (Plate 61), a wrought brass handle with a heart and leaf form, two key holes (one upside down), early hinges (one pair replacing another), and two shelves inside, above which is a smaller plain alcove. A modern moulded rail has been attached below these alcoves. To the north-west there is a plank screen wall on a thick rail orientated north-east/south-west forming a corridor to G3 to the south-west (Plate 62). The opposing side of this wall has a modern moulded rail attached supporting coat hooks, a small section cut out of it covering what is presumably a draw bar slot, before returning to the north-west where there is a doorway (see *Section 4.3.7*). The access to this passage is through a doorway at the north-east end, which has a flat round arch finished with chamfer decoration (Plate 63). Its south-east jamb is attached to the heck post and the door itself is constructed from two large planks with an early brass latch and escutcheon plate (Plate 64), and a moulded rail along its base. The north-west elevation has a built-in cupboard on the south-west side with three shelves and a plain surround, which presumably originally held a door or doors. There is a window to the north-east with a raised timber sill and single square mullion forming two lights (Plate 65), panelling as per the windows on the south-east side, and a pointed arch. At the far north-east end there is a doorway, which is plain apart from a pointed arch and a slight chamfer to the jambs (Plate 66). The door is of beaded plank and batten construction with one early strap hinge remaining.

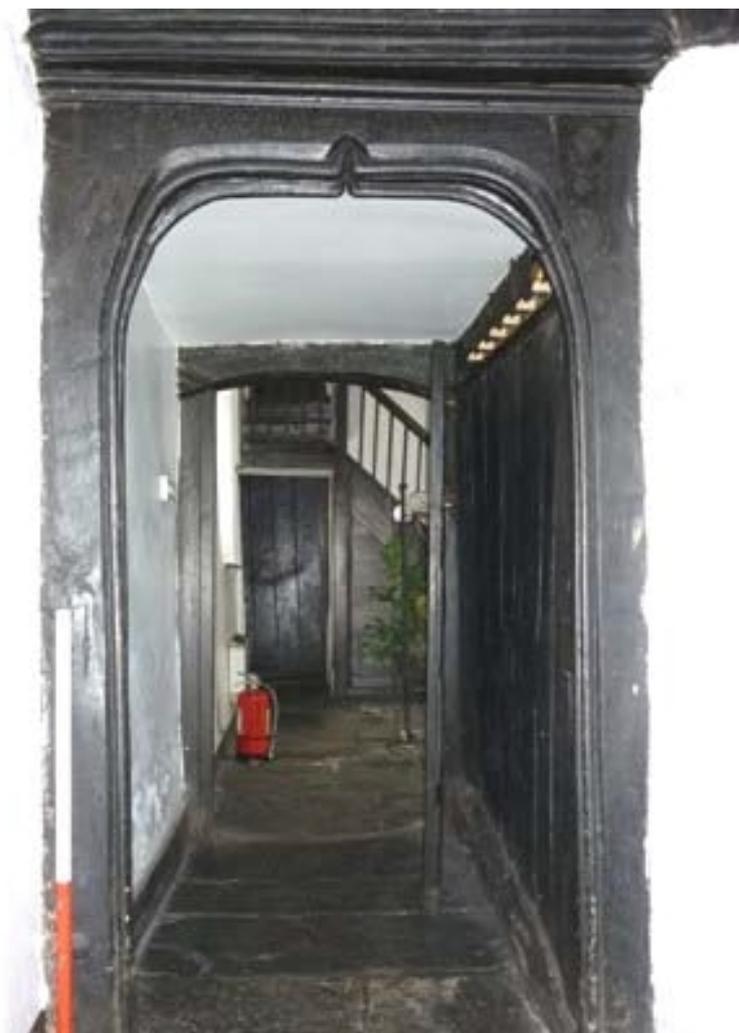
Plate 67: Moulded doorway in the north-east elevation

4.3.7 Ground Floor Room 3 (G3): this forms the original north-west/south-east cross passage (Plate 67). The floor is mainly finished with small cobbles, presumably original as they are very worn (Plate 68), although the north-west end is stone flags (see Plate 69). The ceiling is finished with plaster supported on north-east/south-west beams at the south-east end, which are in turn supported by a beam parallel to each wall. At least one of these timbers is evidently re-used. The walls are typically finished with plaster and paint, apart from the south-west, which is exposed pointed stone. The north-east elevation is largely plain, with a skirting board, and there is a slight step in the wall line at either end. There is a draw bar hole (with draw bar) at the south-east end and a doorway at the north-west end leading to the passage in G2 (Plate 69). This has an elaborate moulded arch dated 1558 with a Latin motto carved into it. The north-west elevation has a step up formed by a large stone slab to a doorway with a square surround and pointed arched top. The door is constructed from very heavy planks and has strap hinges but is relatively plain from this side. The south-west elevation is dominated by a row of three arched and cavetto chamfered doorways (Plate 70), each with its own pair of repeating mason's marks, one type on each stone in the south-east jamb another in the north-west (Plate 71). The north-west doorway also has a separate mason's mark at the apex of the arch. They are all quite crudely cut. The south-east end of the elevation has been finished with plaster and has a modern coat rack attached, and there is a perhaps truncated drawbar slot at the far end. The south-east elevation essentially just comprises a doorway, with a heavy stone lintel and early plank door with long strap hinges and a draw bar across it. The gaps around the sides have been filled with foam sealant and one of the planks is a later replacement as it has Baltic timber marks on it.

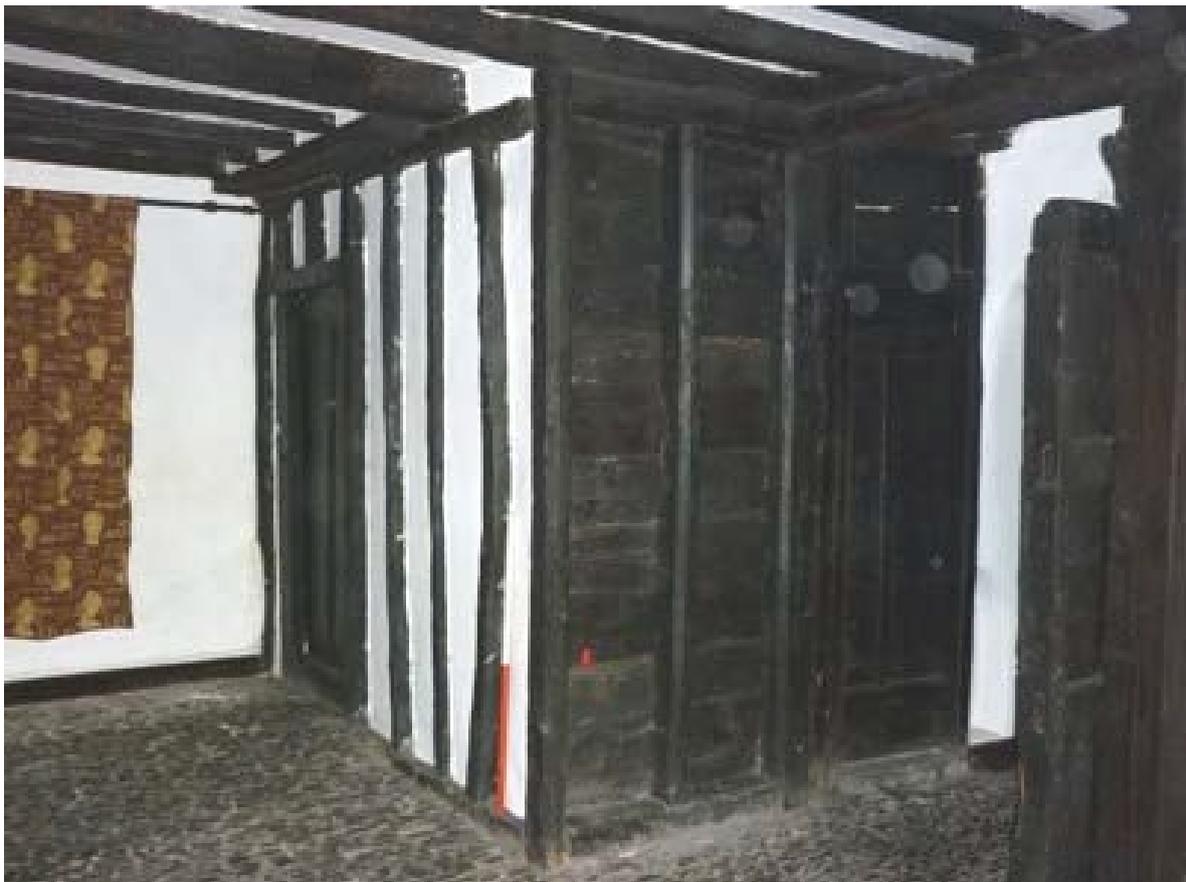
Plate 72: Internal stud walls

4.3.8 Ground Floor Room 4 (G4): the floor is constructed from similar cobbles to those in G3, although more angular and less worn, very uneven and incorporating concrete in places (possibly in association with later alterations, see below), and clearly not laid at the same time as those in G3 or to the same standard. The ceiling is supported by a series of joists orientated north-west/south-east several of which are clearly re-used. In the north corner there are inserted timber stud walls (Plate 72) forming a smaller room within the room (4a) and there is a section of re-used timber panelling alongside the doorway to the north-east forming a flanking wall (Plate 73). The north-west side of the north-east elevation is therefore covered by this stud walling, which is constructed from a mix of timbers, all hand-finished and some re-used forming upright studs set in a rail at the base (where it is noticeable that the cobbled flooring butts against it) and top, below the joists. There is a doorway on the north-west side with moulded rails and battens and panels, perhaps a piece of re-used wall panelling, with an early latch. In the return to the north-east there is another doorway with a door in a similar style. This also has the initials 'T T' carved into it in a Gothic script with the date '1564' (Plate 74). Beneath this two geometric 'daisy wheel' motifs have been scratched into the panelling and there is another early latch (Plate 75). In the return to the main wall there is a doorway, the rear of one of the arched doorways in G3, which has plain square surrounds, with large iron hooks for the original door. It is flanked by a piece of re-used timber panelling on the south-east side, which is pegged and jointed together with chamfer decoration on the south-east side. It is attached to a large machine-cut post in the south-east side, which is set into the cobble floor and supports an additional beam orientated north-west/south-east that extends into G4a. There are hooked timber brackets either side of the passageway created by this flanking panelling, which presumably originally held a curtain rail. To the south-east there is a fireplace with a modern jointed timber frame construction with slate infill and a rounded stone arch (Plate 76). It currently houses a wood burning stove, which is sat on a raised brick base, and the cobbles have evidently been re-laid around this.

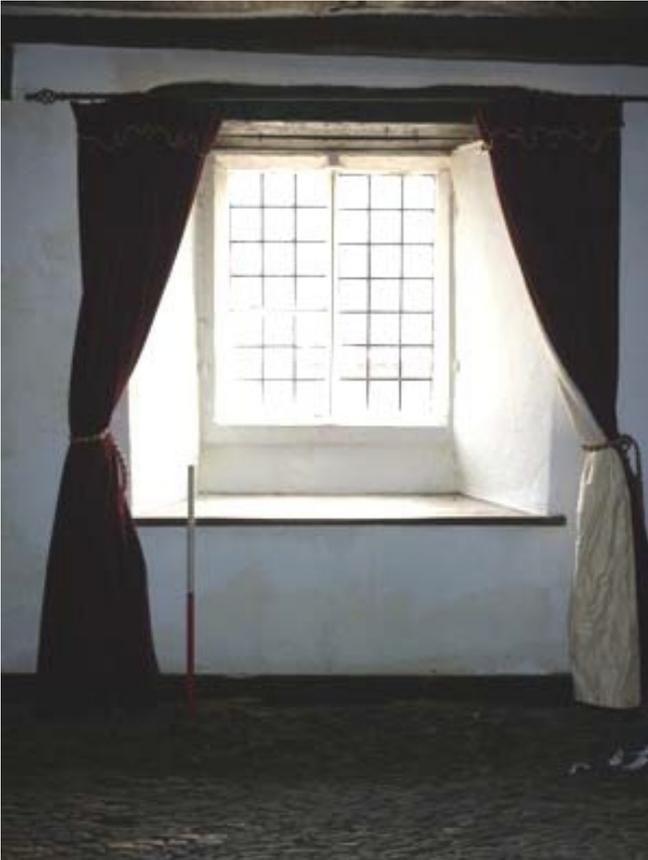
Plate 77 (left): Window in the south-east elevation

4.3.9 The south-east elevation is plain, apart from a large central window, which has splayed jambs, with iron hooks for shutters or earlier hinged casements, and a timber sill (Plate 77). There is a central timber mullion although the line of the original stone one is visible, and a timber lintel, which has been scored for plastering. The south-west elevation has a very narrow window on the south-east side, little more than a slot, with splayed jambs and a stone sill and lintel. There is a doorway to the north-west with an over long timber lintel, splayed jambs, and a slight stone step up (Plate 78). The door is early and constructed from rough planks with three strap hinges and a five-light over light (incorporating a modern vent that fills what would have been two more lights), and has plain surrounds. The north-west end has a window with splayed jambs, timber sill and lintel and single central stone mullion (Plate 79). It is partially blocked on the north-west side. The north-west elevation is plain, apart from the timber panelling on the north-east side already described.

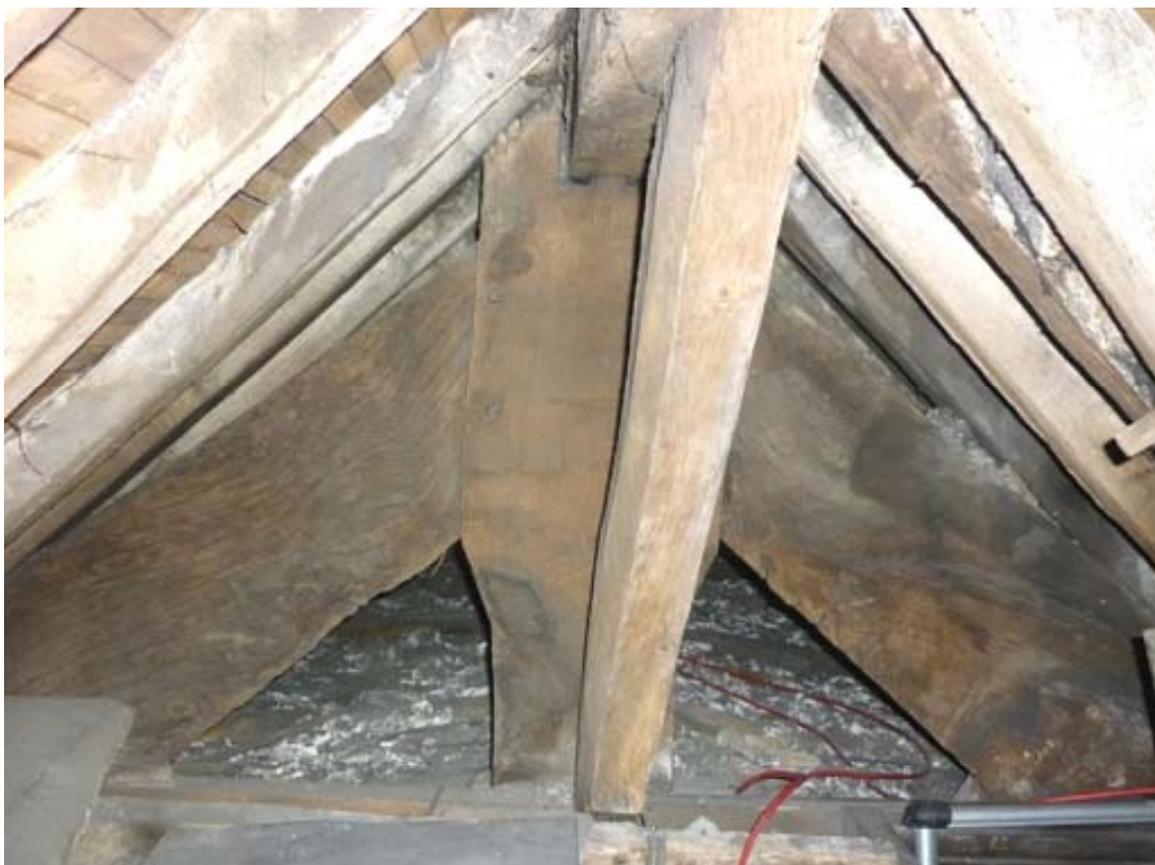
Plate 104: Top of the truss in the roof space above F2

4.3.24 **Roof space above F1 and F2:** this contains the top part of three trusses each comprising a king post and heavy principal rafters with a slight curve cut out of the underside of one side and additional angled braces between the tie beam and the ridge purlin on both sides (north-west and south-east; see Plate 104), apart from the south-eastern truss. There are carpenter's marks at the junction between these braces and ridge purlin in the form of hammered crescents, numbered one to four from south-east to north-west. There are some later and modern replacement purlins, including one that has Baltic timber marks, but many are original and hand-finished. The underside of the roof is finished with modern timber sarking. The joists too appear largely original but some are later replacements and many are obscured. The south-east end (above F1) is different; the truss has been modified by having its king post shortened and a new collar added below, and the angled brace extending to the north-west removed (the slot with its carpenter's mark number one is still present) (Plate 105). There are no joists in this part but the rounded ribs of the barrel vaulted ceiling below are exposed, some incorporating additional blocks presumably to support the bosses in the room below. There are no north-east and south-west elevations as such. The north-west elevation has been extensively rebuilt in modern bricks. The south-east has a small 'window' with splayed jambs finished with plaster, behind the inserted moulded stone marked 'AG' visible externally (see Section 4.2.2).
