# OUTBUILDINGS AT WOODGATE HALL, LOWICK GREEN, ULVERSTON, CUMBRIA

## Archaeological Building Recording

Client: Mr B Entwistle

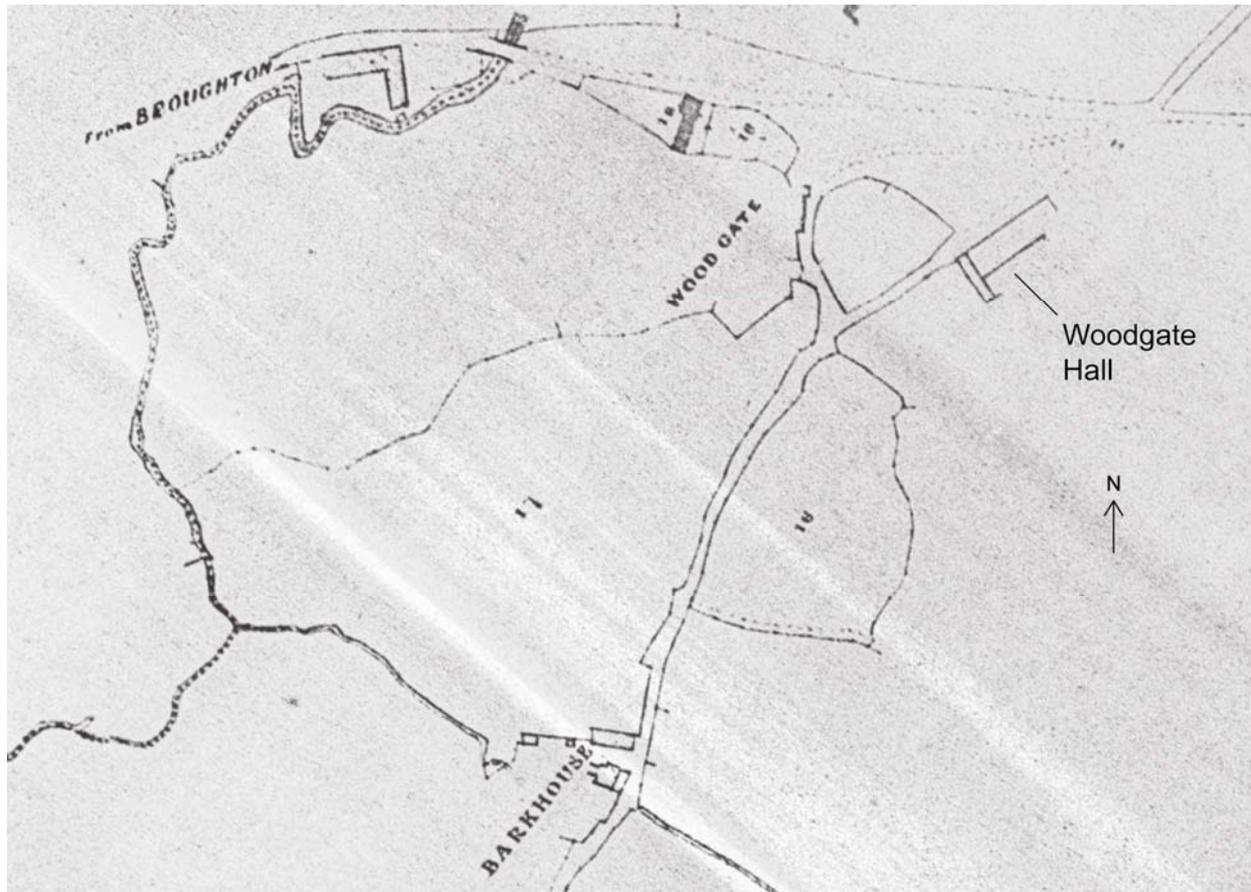
Plate 1: Extract from the Tithe Map of 1849 (CRO(B) IR/30/18/204 1849)

3.2.2 **Tithe Map 1849:** this shows the areas of land for which tithes were payable and so it seems that much of the area covered by Woodgate Hall did not have to pay tithes as it is only just shown on the map and not listed in the schedule (Plate 1). A group of plots of land adjoining Woodgate Hall (labelled 18 on the plan) are described as being owned by Elizabeth Towers, occupied by James Tyson, John Turner, and Richard Houson, and described as a 'homestead and garden etc' (CRO(B) IR/29/18/204 1849). Part of the south-west end of the range of buildings making up Woodgate Hall is visible, however, on the bottom edge of the map, and it is shown as being L-shaped although the outbuildings at its north-east end are not shown.

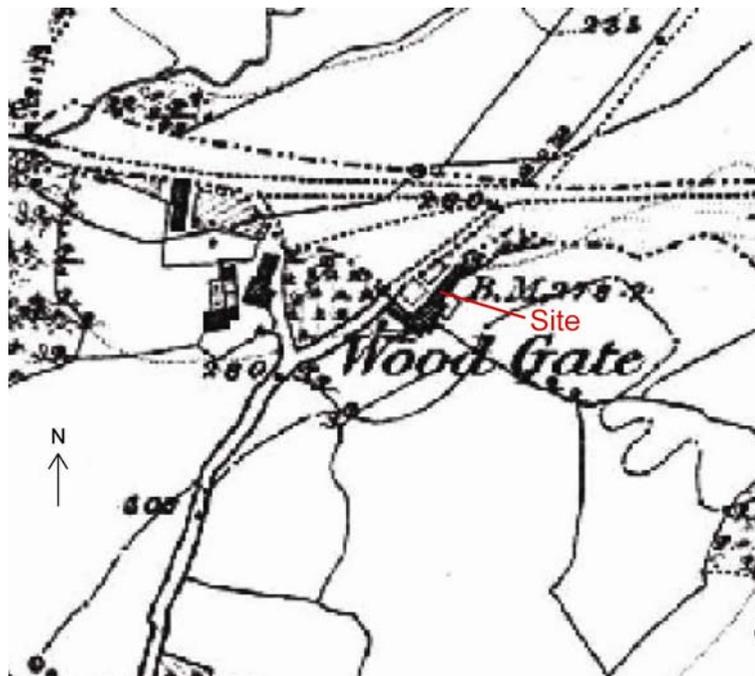
Plate 2: Extract from the Ordnance Survey map of 1850

3.2.3 **Ordnance Survey 1850:** this is the first useful map of the area, and it shows that by this date the site was well developed and consisted of a large L-shaped block, the north-east end and north-west arm being noticeably thinner than the central section (Plate 2). Possible gardens or small enclosures are shown to the north and an enclosure is shown attached to the south-east side.

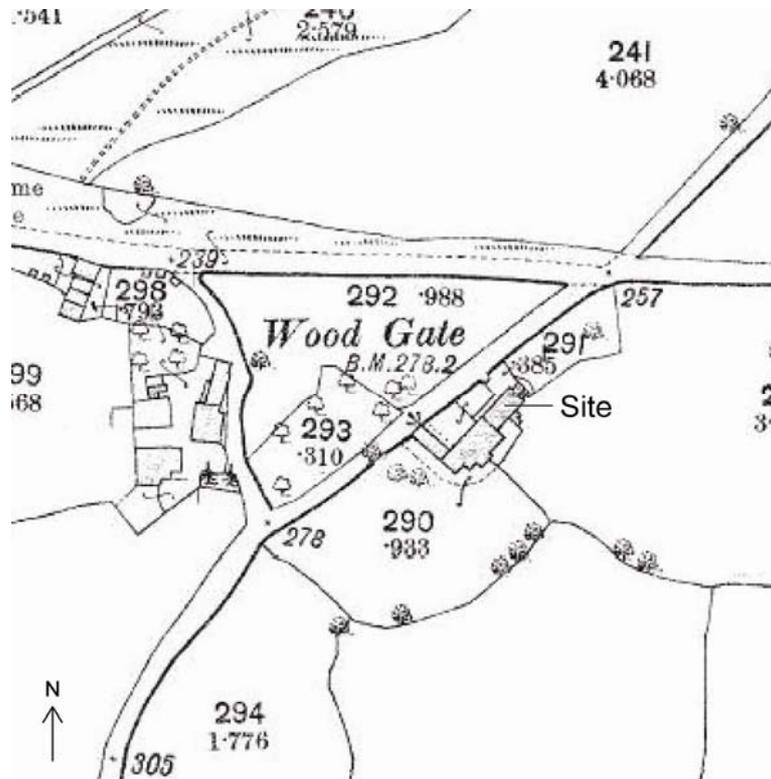
Plate 3: Extract from the Ordnance Survey map of 1890

3.2.4 **Ordnance Survey 1890:** this is a much more detailed plan of the site but it essentially contains the same information as the earlier map (Plate 3). The major divisions within the building can be seen and it is apparent that it comprises a central section at the south angle with smaller extensions to the north-east and north-west. The north-west extension is apparently open-fronted, while the north-east seems to have a staircase leading to an upper floor.

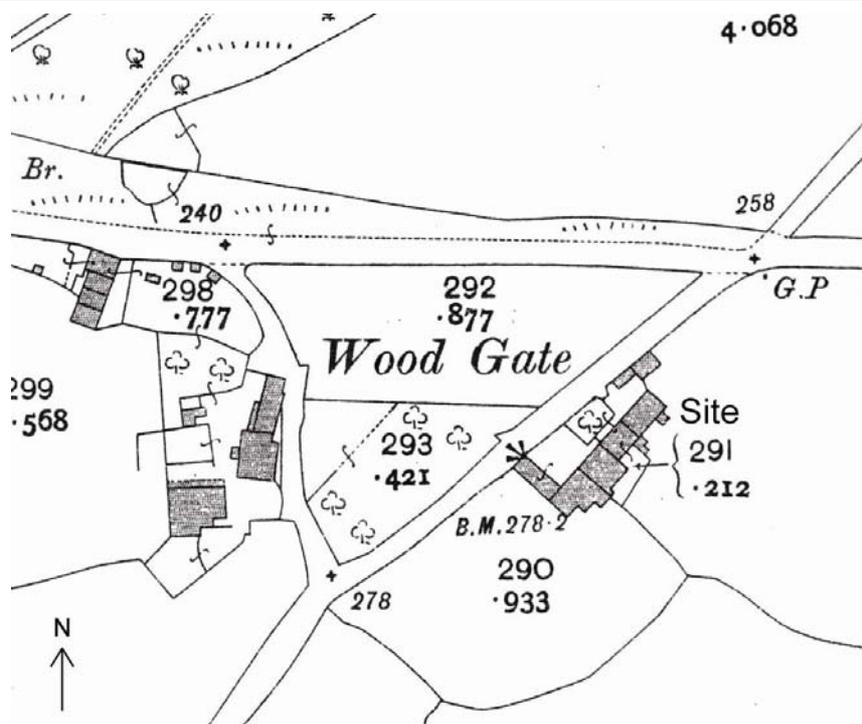
Plate 4: Extract from the Ordnance Survey map of 1913

3.2.5 **Ordnance Survey 1913:** this shows a similar arrangement to the previous plan, but it is apparent that the north-east extension has been modified, perhaps extended again, and the stairs removed (Plate 4). Further small outshuts are evident to the south-east of this extension and small outbuildings have been built to the north of it. The north-west extension does not seem to have been altered in size but it is no longer shown as being open-sided.

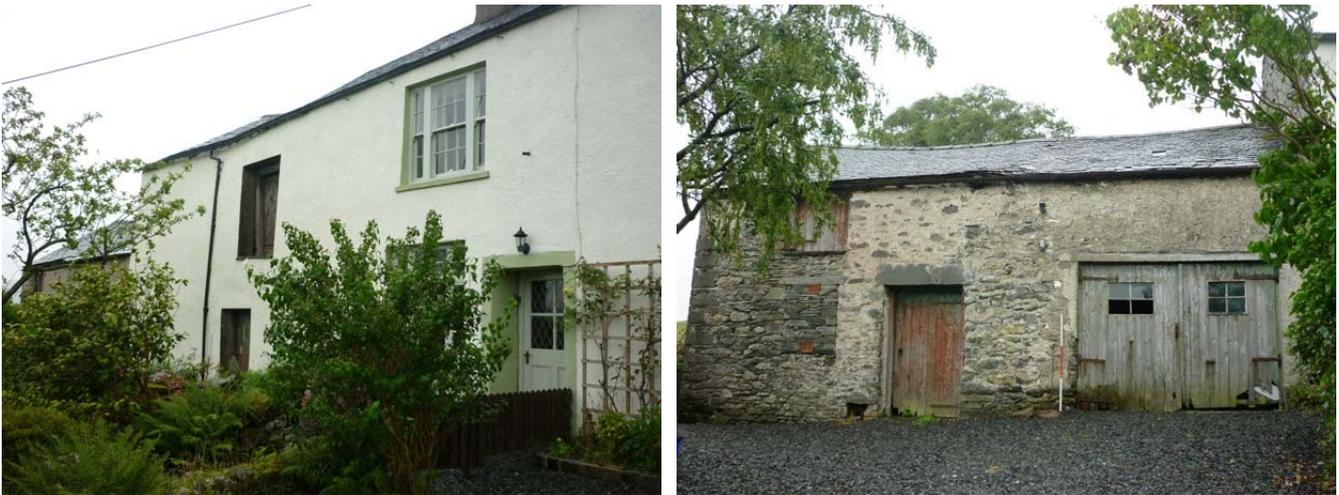
4.2.1 **North-west elevation:** the south-west end is two storeys, and evidently originally formed a single block with a section that is now incorporated into the house and known as 'the cottage' (Plate 5). This block is slightly lower than the house proper which it evidently butts against to the south-west. The entire section is finished with render and painted. There is a pitching doorway on the first floor, with a plank door with a beaded surround. Below this is a doorway with a plank door of somewhat random construction incorporating a single light window, which also has a beaded surround. To the north-east of this the central section of the elevation is slightly lower again but still two storeys (Plate 6). It is un-rendered and has a large garage doorway on the ground floor with a double door of plank construction, which has either been inserted or rebuilt as it has concrete over the lintel and evident rebuild in the jambs. There is a plinth at ground level to the north-east of this doorway and rough quoins at what would have been the original end of this section. The north-east end, which is the same height as the central section, has a doorway on the ground floor with a stone lintel and plank door. To the north-west of it is a window, also with stone sill and lintel, that has been blocked with stone incorporating two ceramic vents. Above this is a pitching doorway with a stone sill and plank door with a plain surround. The end of the elevation is finished with roughly dressed quoins.

**Plate 5 (left): North-west external elevation, south-east side**

**Plate 6 (right): North-west external elevation, centre and north-east end**

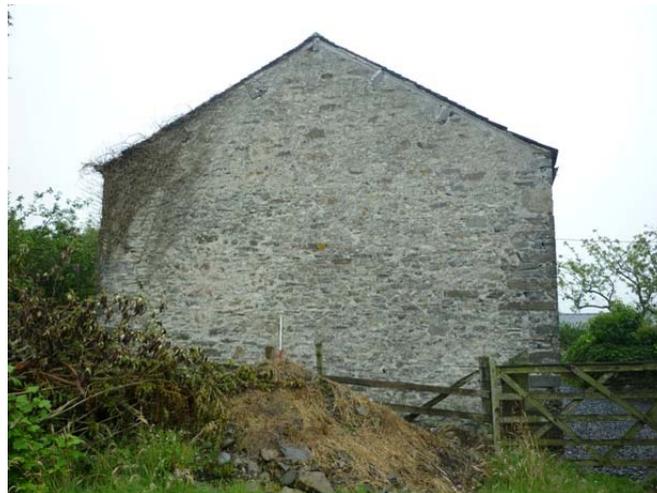
**4.2.2 North-east elevation:** this forms the gable end of the building, but because the north-east end and centre are slightly lower, the upper part of the gable of the south-west section and the house beyond that are visible. The main part is relatively plain, with rough quoins at both ends and the ends of the purlins covered with a single roofing slate nailed on. The upper part, above the central section, has a rough render finish, and the ends of the purlins projecting through it. There is a row of through stones across the centre. Beyond this is a single square chimney stack with a single ceramic pot and beyond this is the gable of the house, which is rendered and painted.

**Plate 7: North-east external elevation**

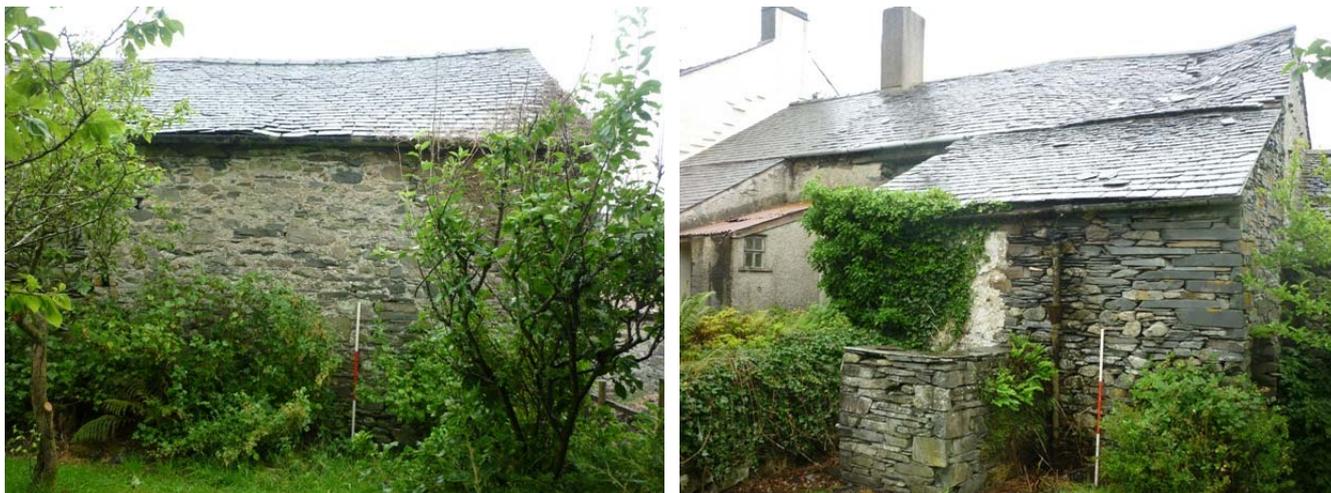
**4.2.3 South-east elevation:** the north-east end is relatively plain, although there are rough quoins at the corner and the junction with the central section is evident, at which point a small square vent built out of bricks has been incorporated into the wall (Plate 8). This section also has quoins at the junction, and incorporates a small window to the south-west with a four-light casement, timber lintel and slate sill over a patch of concrete. Beyond this the wall returns to the south-east where there is a small monopitch extension, although this was originally two storeys high, and there is a small blocked window at first floor level on the north-west side (Plate 9). There is a doorway on the south-east side, with a stone sill and split door constructed from a mixture of planks and re-used pieces, one marked with lettering and perhaps originally part of a sign. This returns to the south-west beyond the doorway, where there is a low wall projecting from the outshut forming an L-shape and enclosing a small area by running towards a boundary wall, which butts against the outshut, where it forms a doorway. The wall has a flat top finished with slate slab coping and there is no evidence that it originally had a roof or was any taller, except for a patch of plaster on the external wall of the outshut, which extends to below its roofline.

**Plate 8 (left): South-east external elevation, north-east end**

**Plate 9 (right): South-east external elevation, central outshut**

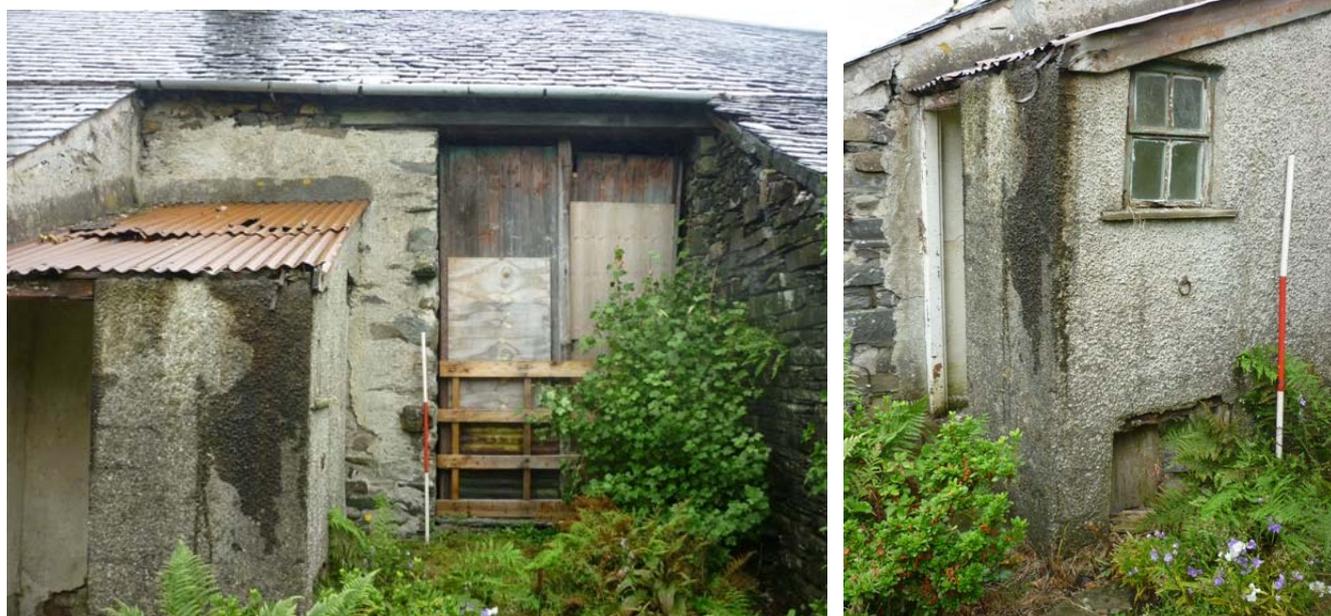
4.2.4 Beyond the boundary wall, the wall of the outshut returns to meet the main wall again. There is a doorway at what is ground floor level here, although this is considerably elevated compared to the internal ground level (see *Section 4.3.5*), which has been blocked with stone and has a stone lintel. The main wall of the building has a tall wagon doorway with a machine cut over long timber lintel and double plank door, augmented by modern chipboard sheets (Plate 10). To the south-west of this there is a small monopitch outshut, which is brick built but largely finished with concrete render. Its north-east elevation has a doorway on the north-west side with a plank door (largely covered by an attached sheet of chipboard), and a small window to the south-east with a four-light hinged casement and stone sill, below which is a small aperture at ground level, with the remains of a timber surround, with iron pins in the top suggesting it had a hinged cover (Plate 11). The south-east side of this outshut was relatively plain; with a doorway on the south-west side with no door and little surround remaining, but a machine cut timber lintel.

**Plate 10 (left): South-east external elevation, wagon doorway and south-west outshut**

**Plate 11 (right): South-west outshut**

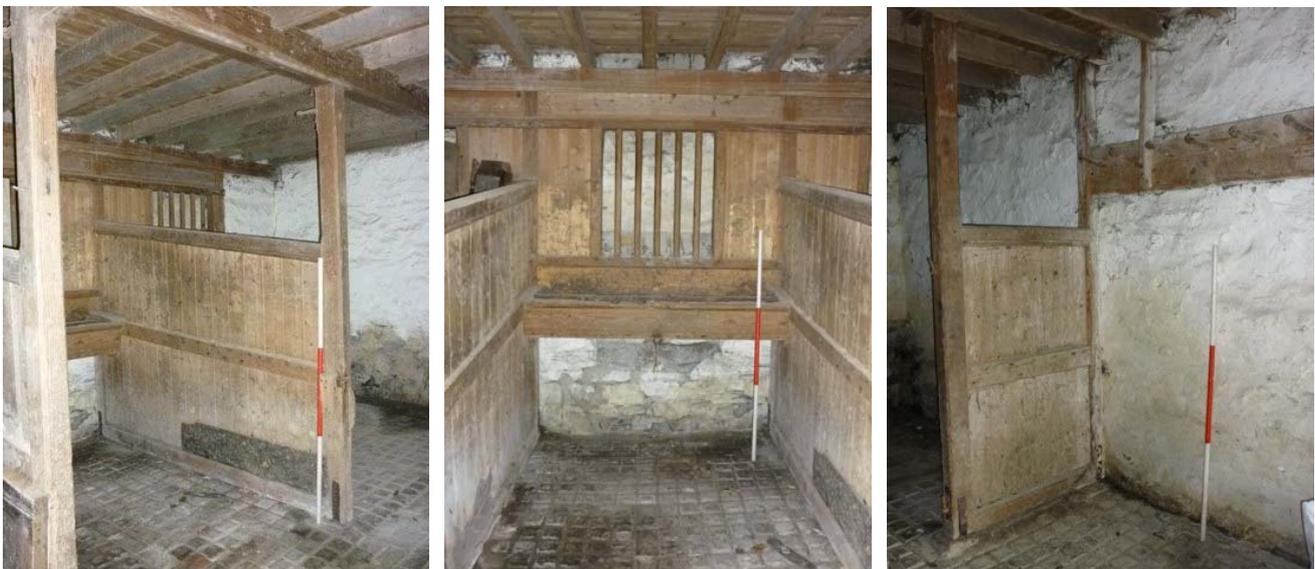
4.3.1 **Ground Floor Room 1:** this has a ceramic block floor with a gridded surface, with a central drainage channel running the length of the room (orientated north-west/south-east) including offshoots to the north-east. There are timber stalls against the north-east and south-west walls, two against the north-east and one to the south-west. The stalls are constructed from tongue and groove planks with rails and stop-chamfered posts at the ends, which support a beam also with stop-chamfered decoration corresponding to the position of the stalls (Plate 12). The north-east elevation is mostly covered by tongue and groove panelling forming part of the stalls, with gridded sections over chutes built into the walls opening onto troughs; there are three stalls with this arrangement in total (Plate 13). The south-east elevation is plain, the south-west elevation has a slight plinth on the south-east side, and there is one stall attached plus a timber batten with a row of large pegs (Plate 14). The north-west elevation has a doorway on the south-west side, with a large plank and batten door, with a machine cut timber lintel. There is a window to the north-east of this, which has been blocked to leave an alcove. There is a further alcove to the north-east extending to the ceiling incorporating a timber ladder, which is fixed to the wall and accesses the floor above via a hatch.

Plate 12 (left): South-eastern stall against the north-east elevation, G1

Plate 13 (centre): Example of stall trough, G1

Plate 14 (right): Stall and batten with pegs against south-west elevation, G1

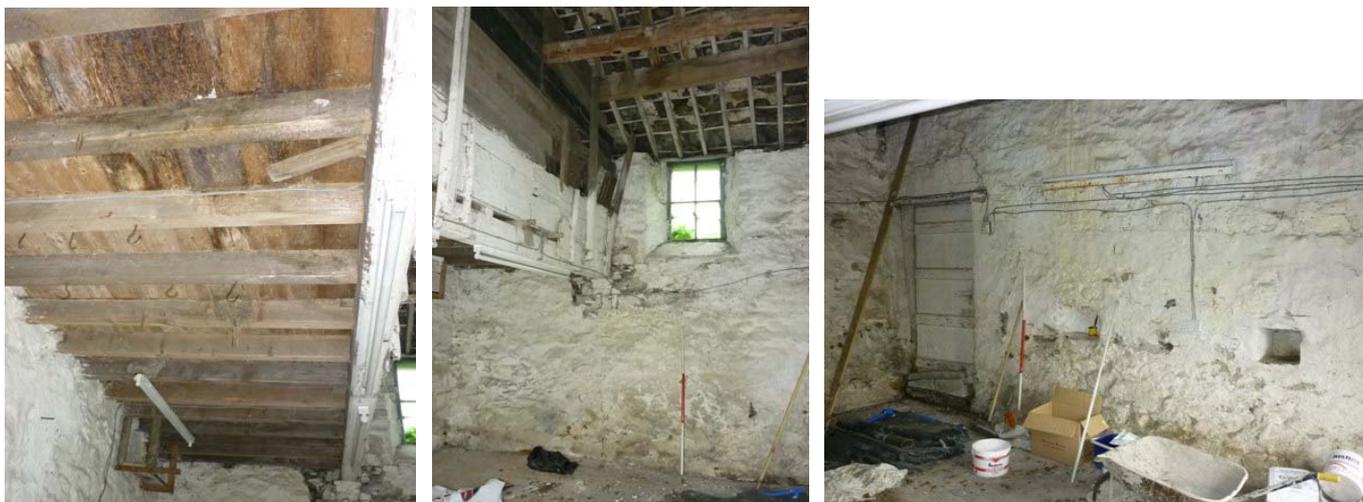
4.3.2 **Ground Floor Room 2:** this has a concrete floor, sloping slightly down to the north-west, with a drain cover on the same side. It is open to the roof on the south-west side, where there are two purlins per pitch plus a ridge purlin, and an inserted rough timber beam with a chain attached, which was presumably used as a hoist. The north-east side has a ceiling with an upper floor above, the end of which, which is effectively exposed in the open space to the south-west, was finished with a rough timber partition wall (Plate 16). The ceiling is formed by hand-sawn joists supporting tongue and groove boards with iron meat hooks inserted into the joists and a large stop-chamfered beam along the south-west edge (Plate 15). The walls are all finished with whitewash. The north-east elevation, below the ceiling, is plain, but with scars for partitions or perhaps stalls evident and some electrical fittings. The south-east elevation is plain, except for a window at the upper level with splayed jambs, sloping sill, and four-light casement. The south-west elevation has a doorway on the south-east side, with a stone step up and a tongue and groove plank and batten door and timber lintel (Plate 17). To the north-west of this there are two small alcoves at ground level, the south-east one being shallower and with splayed jambs, the north-west one being deeper and with straight sides and a slate sill. There is some scarring in the wall above, perhaps where floor joists for a previous upper floor were situated. The north-west elevation has a large doorway on the south-west side with a double tongue and groove plank and batten door and iron I-beam lintel clad with tongue and groove boards. Each half also has a four-light casement window.

**Plate 15 (left): Ceiling on the north-east side side, G2**

**Plate 16 (centre): Stud wall above the ceiling and south-east elevation, G2**

**Plate 17 (right): South-west elevation, G2**

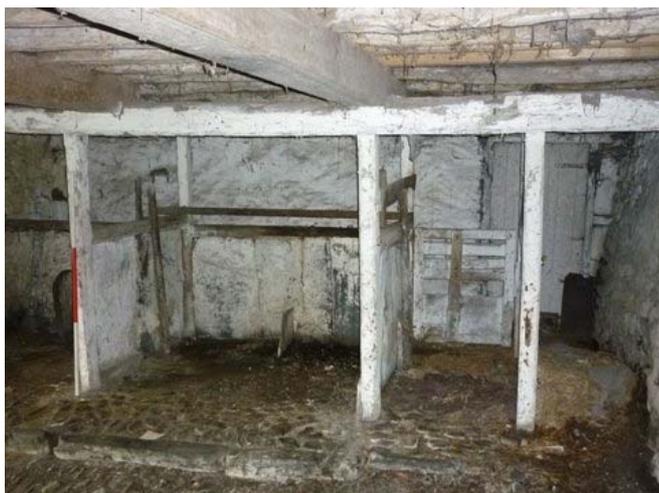
4.3.3 **Ground Floor Room 3:** this has a cobbled floor, with raised sections on the north-east and south-west sides with stone edging and a drainage channel parallel to each one constructed from a single line of bricks laid flat. There are stall partitions against the north-east and south-west walls. Those to the north-east form three stalls, with a passage on the south-east side between two of them and a feed channel along the north-east wall (Plate 18). Each stall is constructed from timber rails and posts, the posts finished with stop chamfer decoration. The sides are largely formed by slate slabs, but some planking has also been used. Within each stall there is a trough at the north-east end formed by stone edging with a stone slab dividing it into two parts (Plate 19). The passage at the south-east end connects to the passage along the north-east wall and leads to a doorway at the south-east side of the north-east elevation. There are three stalls against the south-west elevation although these are much more irregular; the central one extending further into the room than that to the south-east and the north-west one orientated north-west/south-east (Plate 20). The ceiling comprises two chamfered beams orientated north-east/south-west, with the posts of the stall beneath, and joists north-west/south-east. A further north-west/south-east orientated beam of rough timber is located against the posts at the south-west end of the north-east stalls.

**Plate 18 (left): Stalls against the north-east elevation, G3**

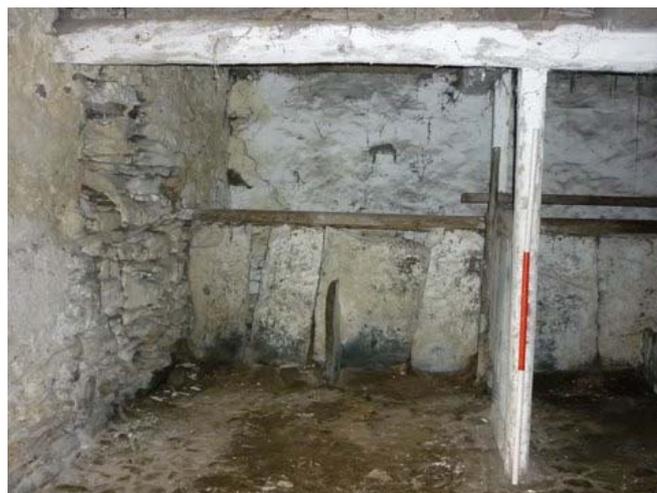
**Plate 19 (right): Detail of stalls against the north-east elevation, G3**

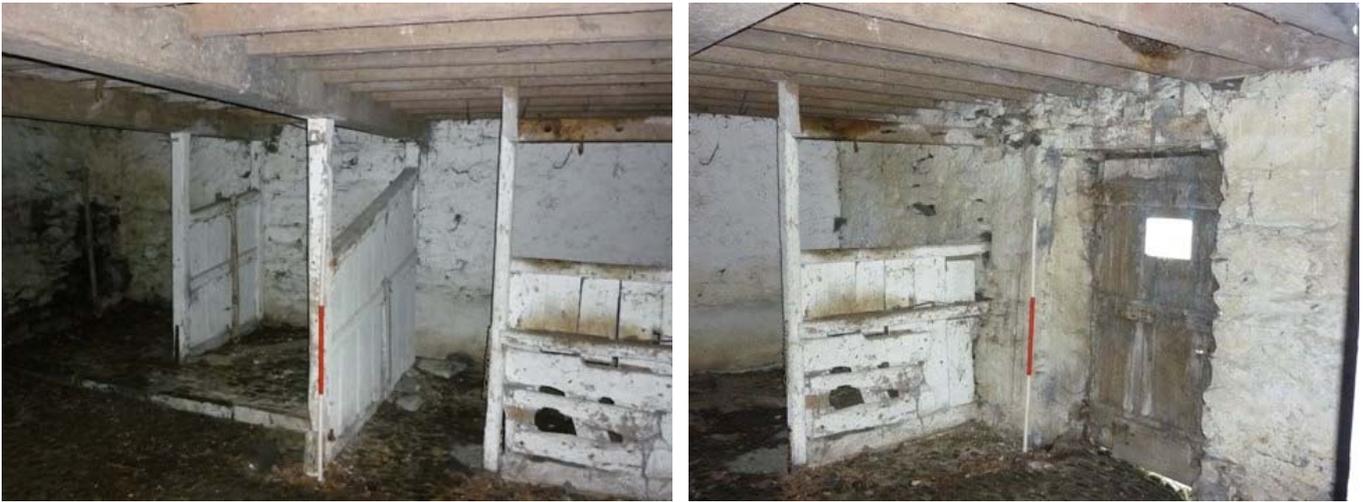
**Plate 20 (left): Stalls against the south-west elevation, G3**

**Plate 21 (right): Stall and doorway in the south corner of G3**

4.3.4 All of the walls are whitewashed. The north-east elevation is plain, and apparently butts against the north-west wall. There is a doorway at the south-east end with a rough timber lintel and plank and batten door (Plate 21). The south-east elevation has a ventilation slot on the north-east end, which had been partially blocked leaving a slight alcove. The south-west elevation is plain, with stall posts set against it. The north-west elevation has a central doorway with a rough timber lintel and a beaded plank and batten door with a single light window. To the north-east is another partially blocked vent.

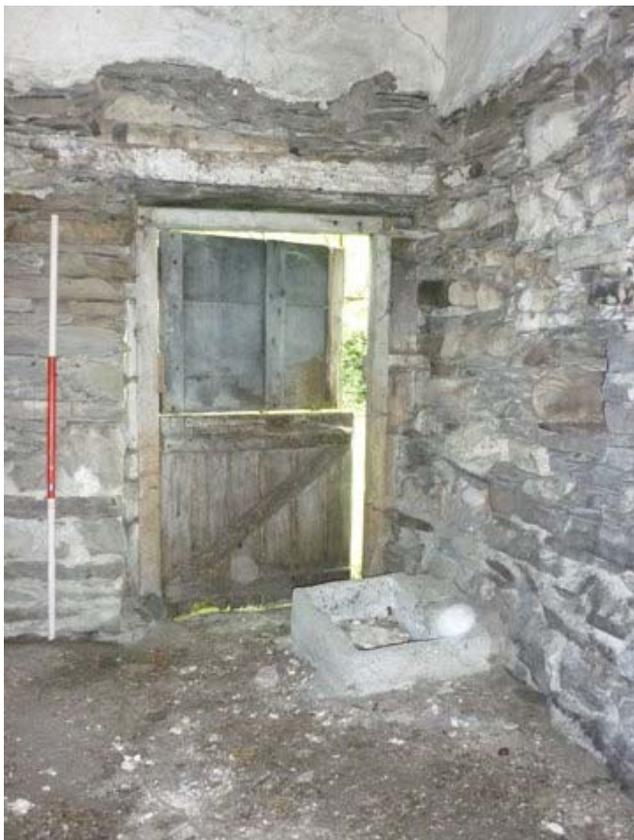
4.3.5 **Ground Floor Room 4:** this is the interior of the larger of the two outshuts on the south-east side of the building. It has an earth floor with a concrete trough in the east corner (Plate 22). The room originally had two floors, but is now entirely open to the roof, which comprises a single beam orientated north-east/south-west and rafters, all of which are hand-sawn. The lower parts of the walls are exposed, while the upper parts are finished with plaster and whitewash. The north-east elevation has a blocked window on the north-west side of the upper floor with a stone lintel but no sill, although the scar of the former floor level is evident as an area of some rebuilding and blocked joist slots. On the ground floor there is a doorway on the south-east side with a rough re-used lintel and a split plank and batten door with a beaded surround. The south-east elevation is plain, apart from a small alcove on the ground floor. The south-west elevation has less plaster. There is a shallow long alcove on the south-east side of the upper level, and a blocked doorway on the north-west side with a slate lintel but no sill (Plate 23). The lower part of the wall is plain, but of a noticeably different build, comprising larger and more rounded stones, and there is a slight bulge. The north-west elevation is largely plain, with concrete re-pointing at the lower level and a probable blocked ventilation slot.

Plate 22 (left): Concrete trough and doorway in the east corner of G4

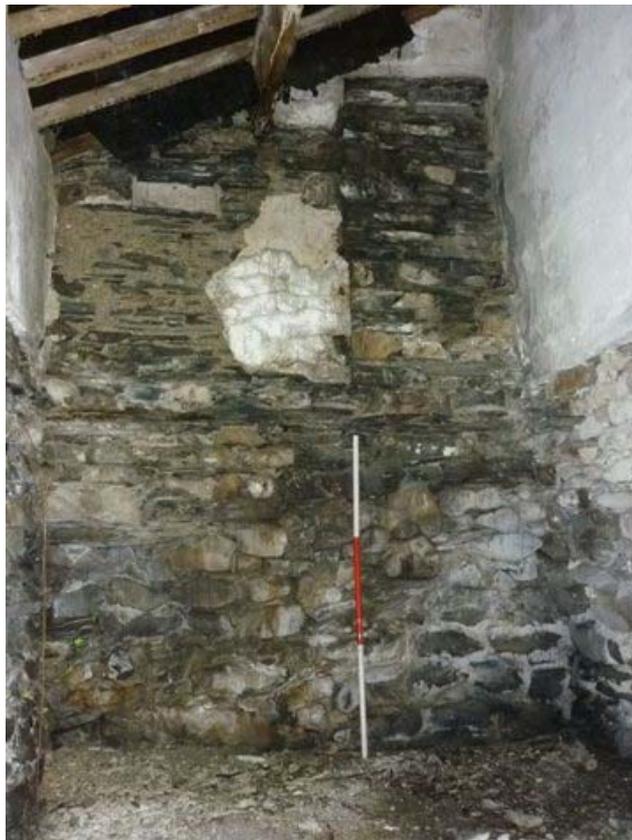
Plate 23 (right): South-west elevation, G4

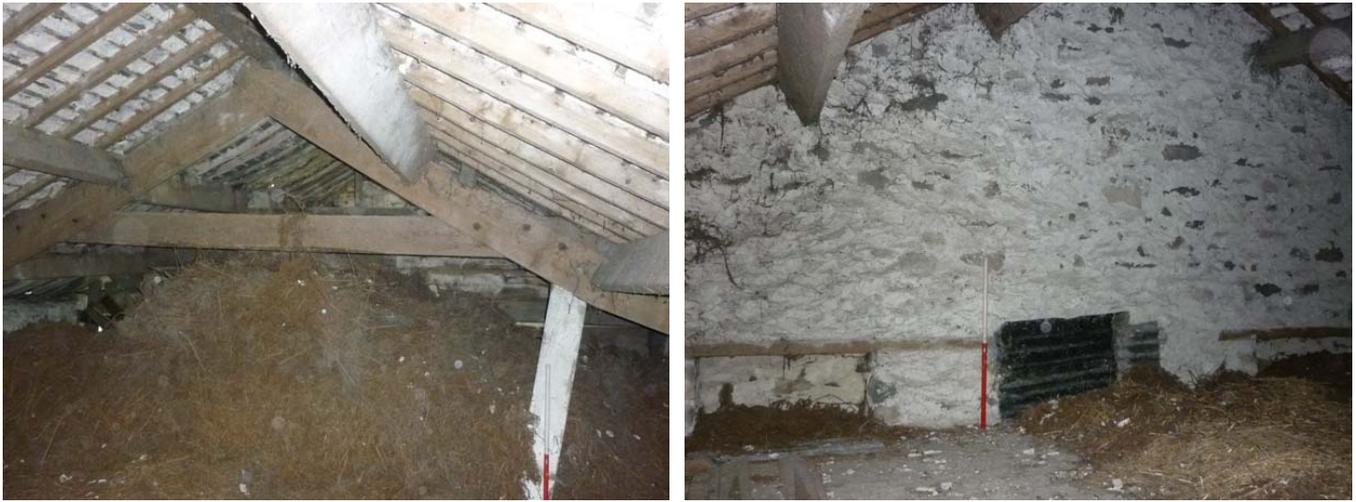
4.3.6 **First Floor Room 1:** this has a timber floor; the boards orientated north-west/south-east, although this is largely covered by a pile of bracken. It is open to the roof, which comprises two purlins per pitch and a ridge purlin, all hand-sawn, plus a single truss on the south-west side comprising only principal rafters, supported on blocks in either wall, with a collar bolted between them (Plate 24). The principal rafters are joined together with a simple lap joint, and an angled brace has been added on the north-west side below the principal rafter on that side. All of the walls are whitewashed, apart from the south-west, which is a timber partition. The north-east elevation has timber blocks below the ridge purlin, and the tops of the three chutes visible in G1 below are exposed, although the central one is covered by corrugated metal sheeting (Plate 25). The south-east elevation is plain, and the south-west is similarly plain and built out of re-used planks. The north-west elevation is plain, apart from a pitching doorway on the north-east side, with a tongue and groove plank and batten door. To the north-east there is a small alcove housing the top of an alcove for the access ladder, which has a slate lintel and the chute is topped with an iron grill.

Plate 24 (left): Truss in F1

Plate 25 (right): North-east elevation in F1 showing chutes

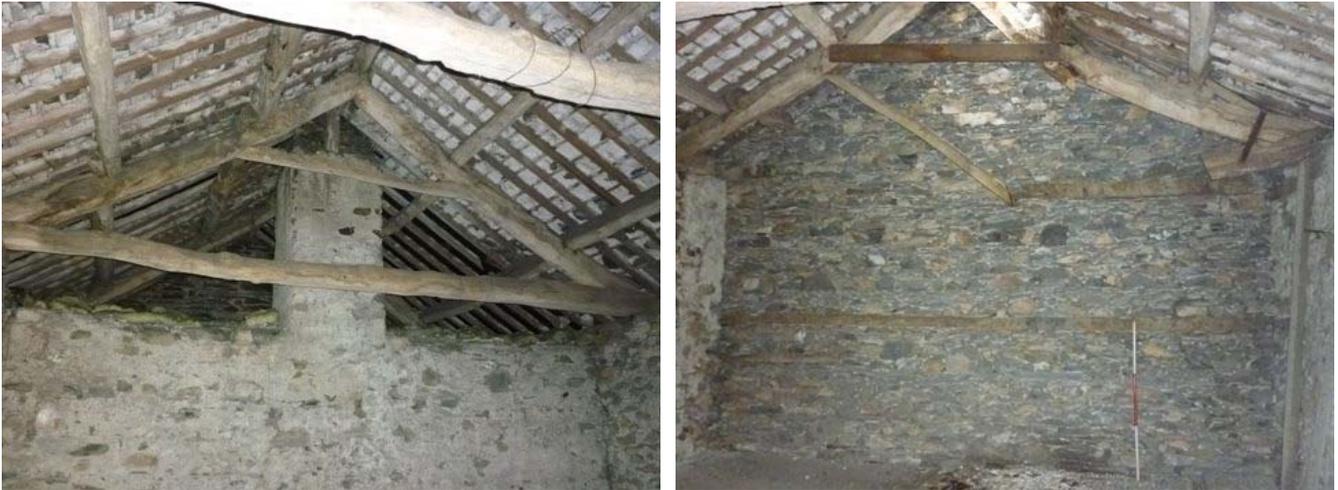
4.3.7 **First Floor Room 2:** this has a timber floor, the boards orientated north-east/south-west, many in poor condition and evidently much repaired. It is open to the roof, which extends across the south-west elevation and comprises three trusses in this room, plus another to the south-west. Each truss comprises a simple tie-beam type, originally with a collar, although the only one surviving intact is on the south-west example (Plate 26). The central one has no collar while the north-east one, which is in a poor condition, has had a new collar bolted to it, while the original one hangs loose (Plate 27). The principals are all joined by a simple lap joint and there are two purlins per pitch, overlapping at the trusses, and with a diagonally set ridge purlin. All the truss timbers are hand finished and fixed with timber pegs. The rafters are largely later, but with plaster backing the slates. The north-west, south-west, and south-east elevations are all relatively plain with some rough render, while the north-east appears rebuilt; the purlins at this end are very short and the truss remarkably close to the wall, perhaps suggesting the building was originally longer. The north-east elevation incorporates at least three large pieces of timber, set horizontally into the stonework, which are evidently re-used as they have numerous empty peg holes (Plate 28). There are two rows of square ventilation slots above these. The south-east elevation is plain, with a wagon doorway on the south-west side with a plank and batten double door in pivots and with a machine cut lintel. The south-west elevation doesn't extend to the roof leaving the space to the south-west exposed, although there is a chimney projecting above it on top in the centre. The north-west elevation has a pitching doorway on the south-west side, with a rough timber lintel and plank and batten door with the angled stones of the voussoir arch of the door below forming a sill of sorts. There is a ventilation slot to the north-east with a timber lintel, which is blocked with stone. There is a large crack at the north-east end, below the damaged truss.

Plate 26 (left): Surviving truss on south-west side of F2

Plate 27 (right): North-west elevation and damaged truss, F2

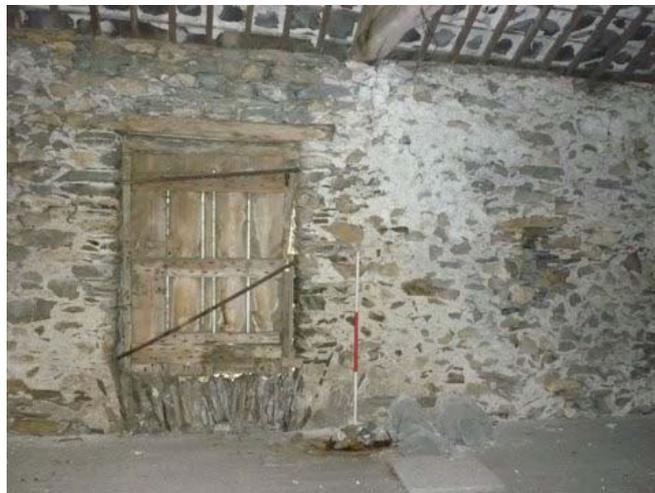
Plate 28: Doorway and ventilation slot in north-west elevation, F2
