SALTHOUSE FARM, SALTHOUSE ROAD, MILLOM, CUMBRIA

Archaeological Desk-Based Assessment and Building Recording

Client: Neil Price Ltd

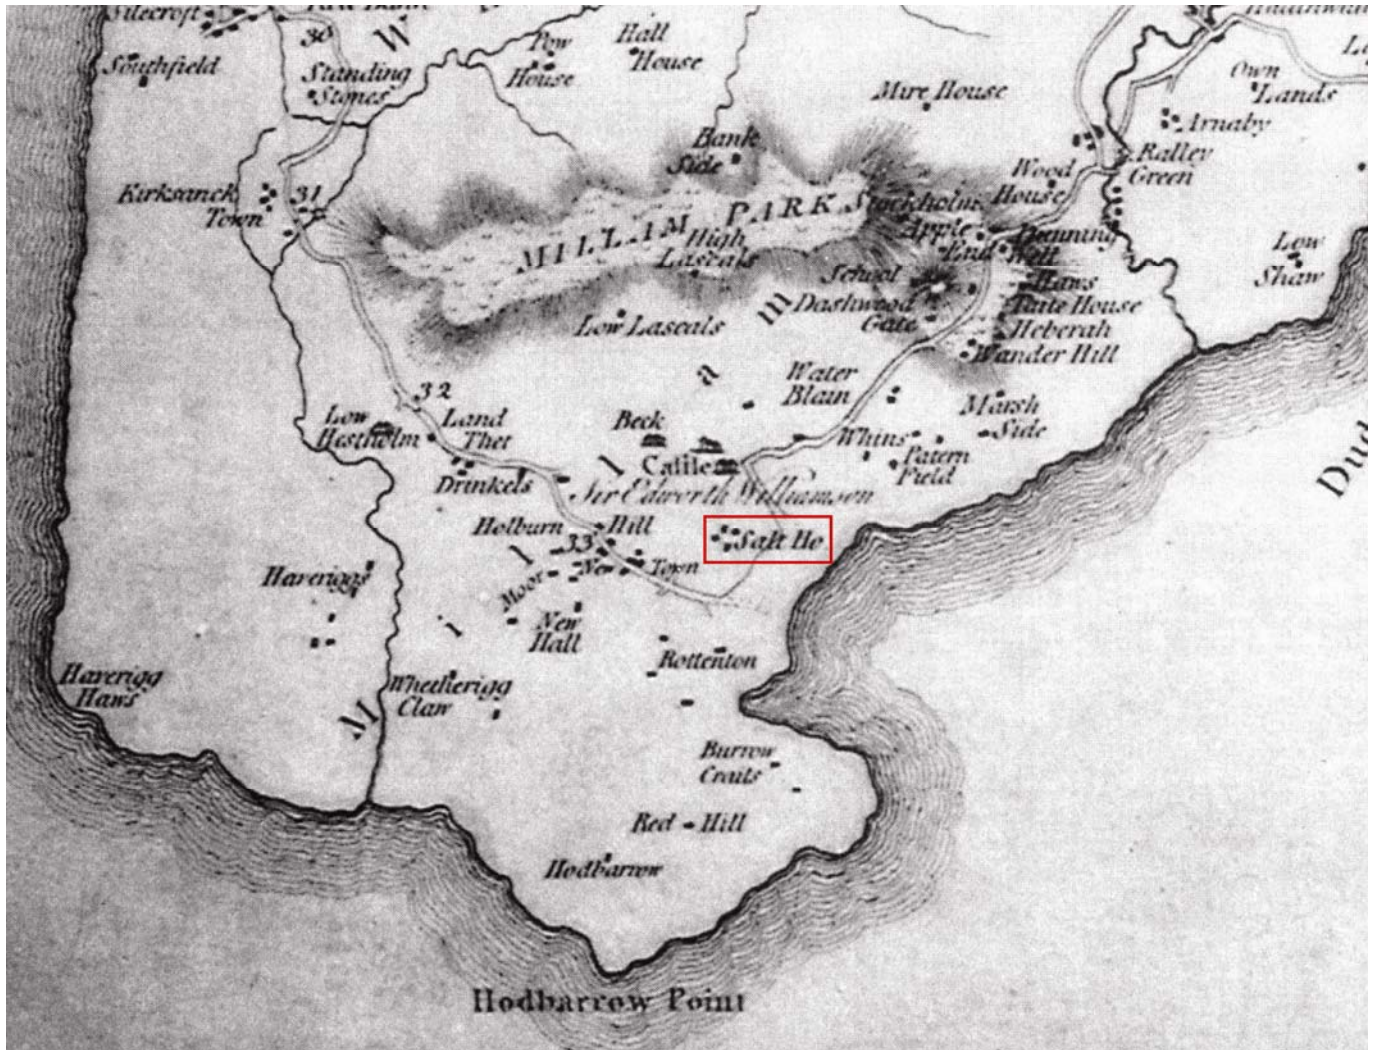
Plate 2: Extract from Donald's map of Cumberland, 1774

3.2.2 **Donald's map, 1774:** this plan (Plate 2) shows various buildings at 'Salt Ho' but it cannot be determined which, if any, represents Salthouse Farm.

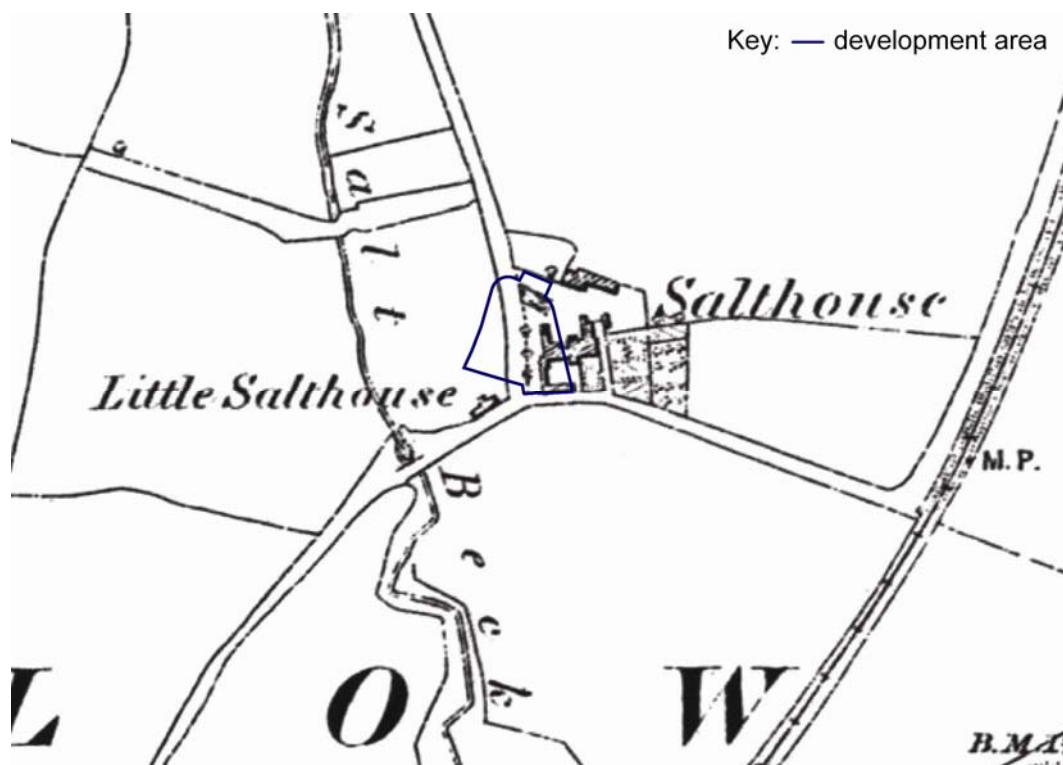
Plate 4: Extract from the Ordnance Survey map of 1867

3.2.4 **Ordnance Survey, 1867:** many of the farm buildings are shown on this edition of the Ordnance Survey map (Plate 4), including the L-shaped building to the south-west of the site (Building 1), the main east/west section of the barn (Buildings 2 and 3), and the long north/south aligned barn at the west end of this east/west section (Building 4). However, the detail is limited and the alignment of the buildings has been slightly simplified inasmuch as the various buildings appear to be almost equidistant and perpendicular to the main road, to the west of the site, and are more squarely drawn than they really were. None of the internal divisions are shown but it appears that three outshuts are shown to the north and south side of the main east/west section of the barn. These would appear to relate to Buildings 3b, 3c, and 3d; Buildings 3a, 4a, and 4b, and the extension to the north end of Building 4, have yet to be built. The arrangement of the roads at this time is much clearer, with the road connecting Salthouse to the castle and church running approximately north/south immediately adjoining the west side of the site. The original road linking to the castle and church to the east is possibly still present running along the site of the railway.

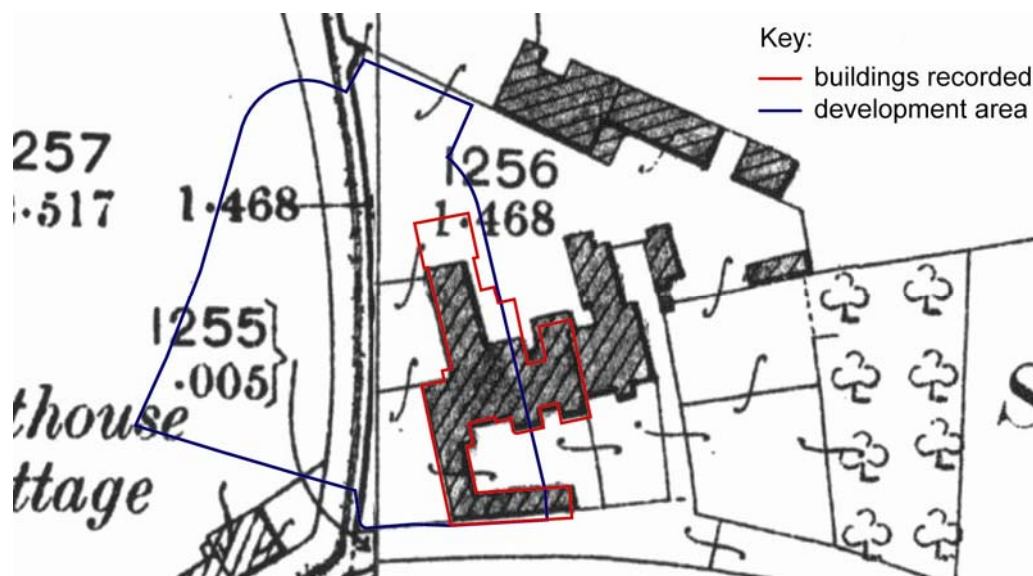
Plate 5: Extract from the Ordnance Survey map of 1900

3.2.5 **Ordnance Survey, 1900:** this map (Plate 5) shows the site in more detail than the earlier edition of the Ordnance Survey (*cf.* Plate 4) and shows a similar arrangement of the main barn buildings (Buildings 1 to 4). The outshut (Building 3c) to the north side of the east/west section of the barn is shown to butt against the corner of the farmhouse, which has a dividing line along its westernmost extent, and another outshut (Building 3a) has been added to the south side of Building 3.

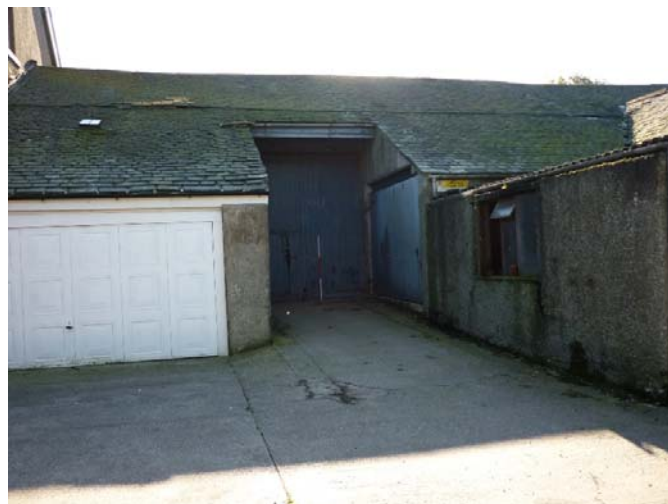
Plate 10 (right): Outshuts to the north of Building 3

The elevation then returns slightly to the east along the east external walls of Buildings 4a and 3d. Building 4a effectively had a flat roof with a slight mono-pitch, and a single modern five-light window, and butts against Building 3d to the south (Plate 10). Building 3d had a large doorway on this side, which had a steel I-beam lintel and a modern double door and concrete step and possibly butted against Building 3 to the south, although this relationship was unclear.

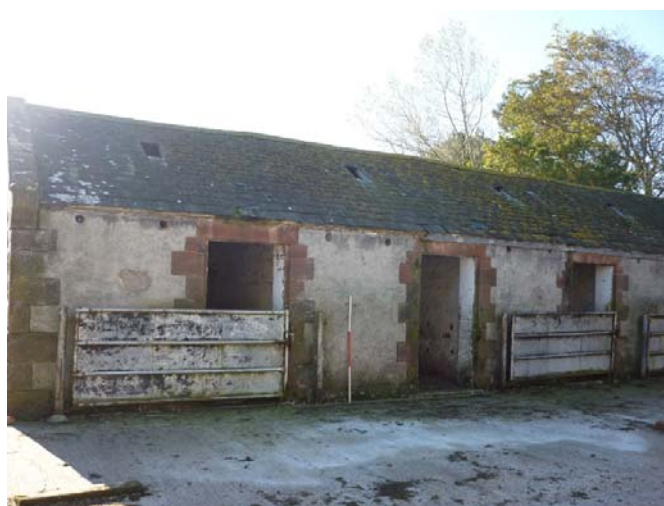
Plate 11: The north elevation of Building 1

4.2.2 The north elevation of Building 1 formed the south side of the courtyard and was roughcast rendered and had a row of ceramic pipe vents below a timber barge board. There were four doorways in this elevation, all of which had ashlar dressed sandstone quoins and lintels, with a slight rebate for the doors which were missing although the pintels remained (Plate 11).

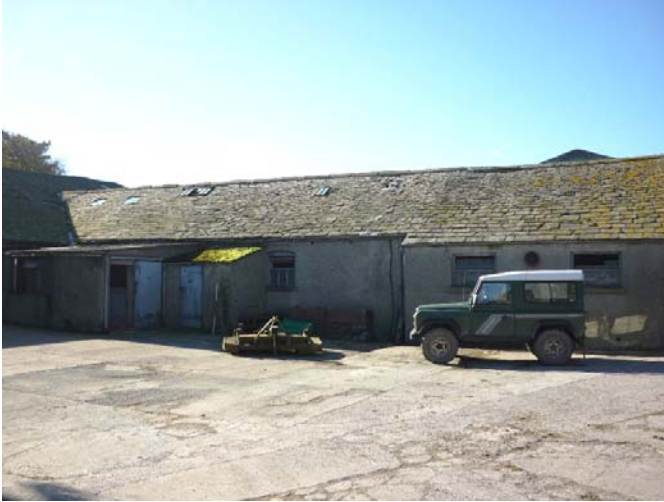
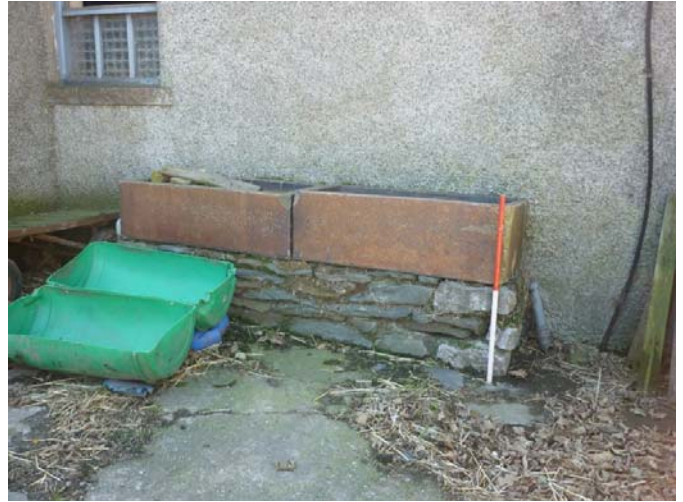
4.2.3 **East elevations:** the east elevation of the site incorporated elements of Buildings 1, 2, and 3a to the south side of Building 3, and Buildings 3d, 4, 4a, and 4b to the north. The east elevation of Buildings 3, 3b, and 3c were part of the farmhouse, which was adjacent to the eastern side of these three buildings. The east elevation of the buildings to the north of Building 3 are described in *Section 4.2.4* (below); the east elevation of those buildings to the south of Building 3 is described in *Section 4.2.4* (below), apart from the east elevation of Building 3a, which is described as a whole in *Section 4.2.7*. The north side of the east elevation of Building 4 and along the wall from the return to the south were roughcast rendered (Plate 12). The projecting section of Building 4 had two windows (Plate 9); the north window had had originally been an eight-light tilting casement, the same as the one to the south, but only the lower four remained. The return to the south was rendered and there was a stone plinth against it with two ceramic troughs on top, which were marked 'WILSON / BROUGHTON MOOR' (Plate 13). There was seven-light tilting-casement window with an arched top to the south of these. The elevation then returns to the east where there were three rendered outshuts (Plate 12). The northernmost outshut, Building 4b, had a plank door and a timber frame on the south side on the east elevation and a corrugated concrete roof.

Plate 12 (left): The east external elevation of Buildings 4, 4a, 4b, and 3d

Plate 13 (right): Ceramic troughs to the east side of Building 4

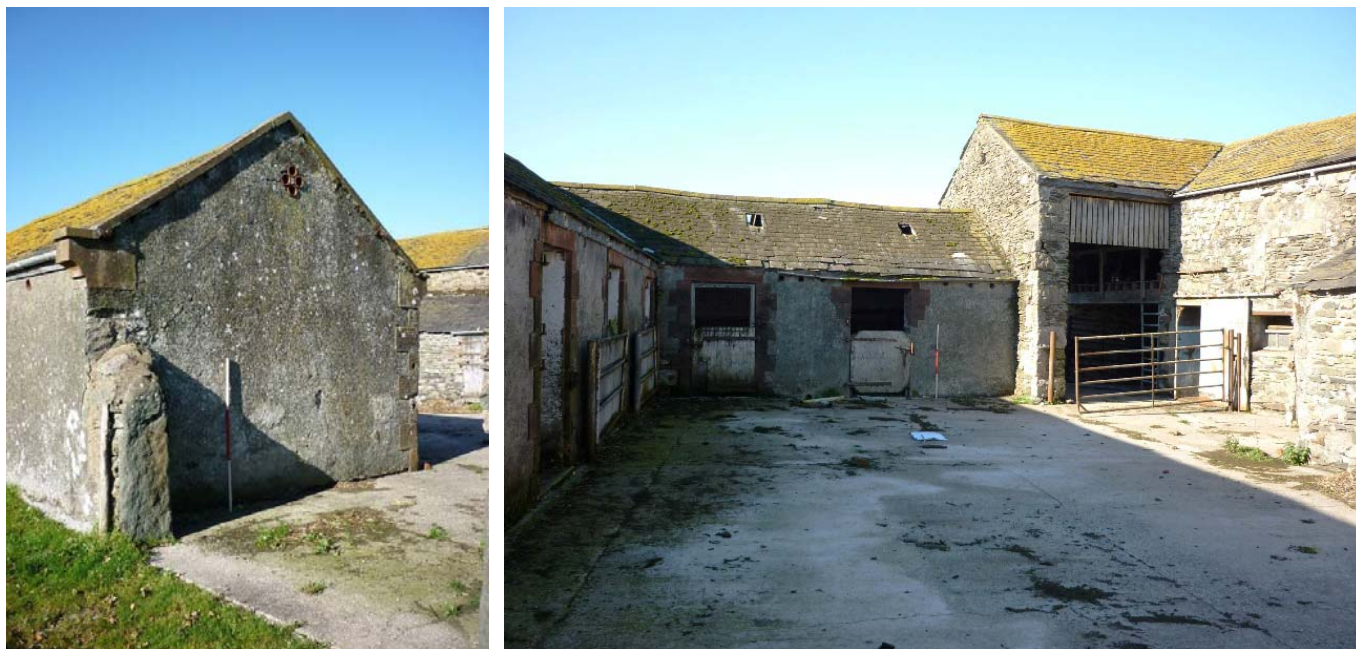
4.2.4 The south end of the east elevation of Building 1 formed the gable, which was rendered and had sandstone coping with dressed sandstone quoins on the north side, with two holes for a former gate and kneelers on both sides, and a group of four ceramic pipe vents below the apex (Plate 14). The south side had rougher quoins, which either did not extend to the floor or were hidden behind the boundary wall, possibly suggesting that this barn had been built onto an existing boundary wall. The north end of the east elevation of Building 1 formed the south side of the west elevation of the courtyard. It had a plastic gutter and two doorways which were similar to those on its north elevation (which are described in *Section 4.2.2*); the one to the north was probably originally a window as the lintel was very thin and the bottom quoins were cut through (Plate 15). Also, there was no rebate for the frame of a door and there was the scar of some paint, which would further suggest that it had originally been a window. The north side of this elevation was the east external elevation of Building 2. It had quoins on the south side and a wide doorway formed against the end of Building 3. This doorway was probably inserted and rebuilt in smaller stones (like the facing doorway on the west elevation of the same building, see *Section 4.2.5*). It had a rough re-used timber lintel and a timber panel infill at the top, and a modern metal door.

Plate 14 (left): South end of the east elevation of Building 1

Plate 15 (right): The north end of the east external elevation of Buildings 1 and the east external elevation of Building 2

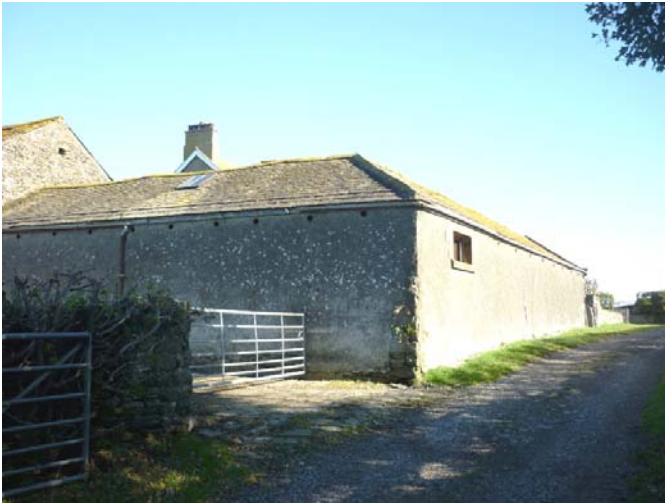
Plate 16 (left): The south and west external elevations of Building 1

4.2.6 South elevations: the south elevation of the site principally comprised the south side of Building 1. It was roughcast rendered and had a row of ceramic pipe vents below the eaves and a timber barge board and a plastic gutter (Plate 16). It had a dressed sandstone kneeler at the east end. There was a small two-light timber casement window at the west side with dressed ashlar sandstone quoins, lintel and sill. The building had a hipped gable at the west side but not at the east. The boundary wall was located to the east end of the elevation and there was a gate with large stone gateposts against the east end of Building 1 (see Plate 14). The gable end of Building 2 stood taller than Building 1 at the west end and was fairly plain and built from stone, with a square owl hole (see Plate 16).

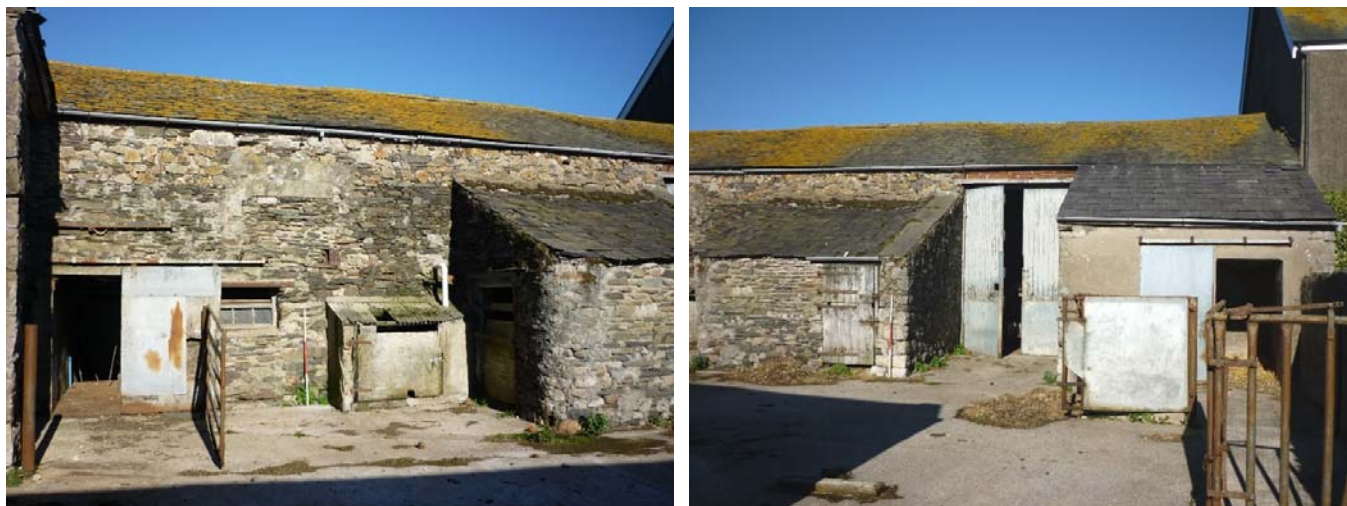
4.2.7 The south elevation of Building 3 was a much rougher build than the other buildings surrounding the courtyard and the upper section had been rebuilt using more angular stone (Plate 20). The upper level of Building 3 had the remnants of a blocked window with a concrete lintel and what appeared to be the ends of an iron beam were sticking out from the wall beneath it. The lower level had an inserted doorway on the west side and a concrete lintel above and concrete in the jambs. It had a sliding door; the brackets were labelled 'KING 717-1'. There was a small, hinged, six-light window to the east of this, which had an L-shaped iron beam for a lintel and a concrete sill. To the east of this window there was a small outshut made from concrete and brick that had a mono-pitch concrete roof and a central door. A plastic pipe protruded from Building 3 and entered the top of this outshut. The east side of this small

outshut was angled back to the north to meet a larger outshut to the east, Building 3a. This formed one of the mono-pitch outshuts which were located either side of the wagon doorway in the south elevation of Building 3, the one to the east side of the wagon door was Building 3b (Plate 21). The outshut to the west of the wagon door appeared to be built onto an existing canopy wall, which originally jugged to the south from Building 3 and was not butting against it. The west elevation of Building 3a had had a doorway inserted and had brick in the jambs and a machine-cut timber lintel. The doorway had a slate drip course and rebated timber surround with pintels but no door. The building had a rounded corner to the south-west and a boulder under the corner for foundation and there was another doorway to the east on the south elevation, which had a machine cut timber lintel and surround and a split plank door. The east wall of this outshut was plain and returned to the north and met the side of the wagon doorway, which had a heavy machine cut timber lintel with a brick build over and a double plank tongue and groove door. The wall returned to the east side of the doorway and was built in brick in a stretcher bond to form the west elevation of the east outshut, Building 3b. There was red machine made brick against stone to the south side of this outshut, which incorporated a window with a flattened arch, which was blocked with brick and a doorway with a stone flag drip course and the lintel of which appeared to be formed by a piece of rail. The doorway was part blocked to leave a plain window with a concrete skim over the jambs. The south side of this outshut was stone but rendered with concrete and had a modern sliding door. The boundary wall attached to the east side of the outshut before returning to the house to the north.

Plate 20 (left): West end of the south elevation of Building 3 and Building 3a

Plate 21 (right): East end of the south elevation of Building 3 and Buildings 3a and 3b

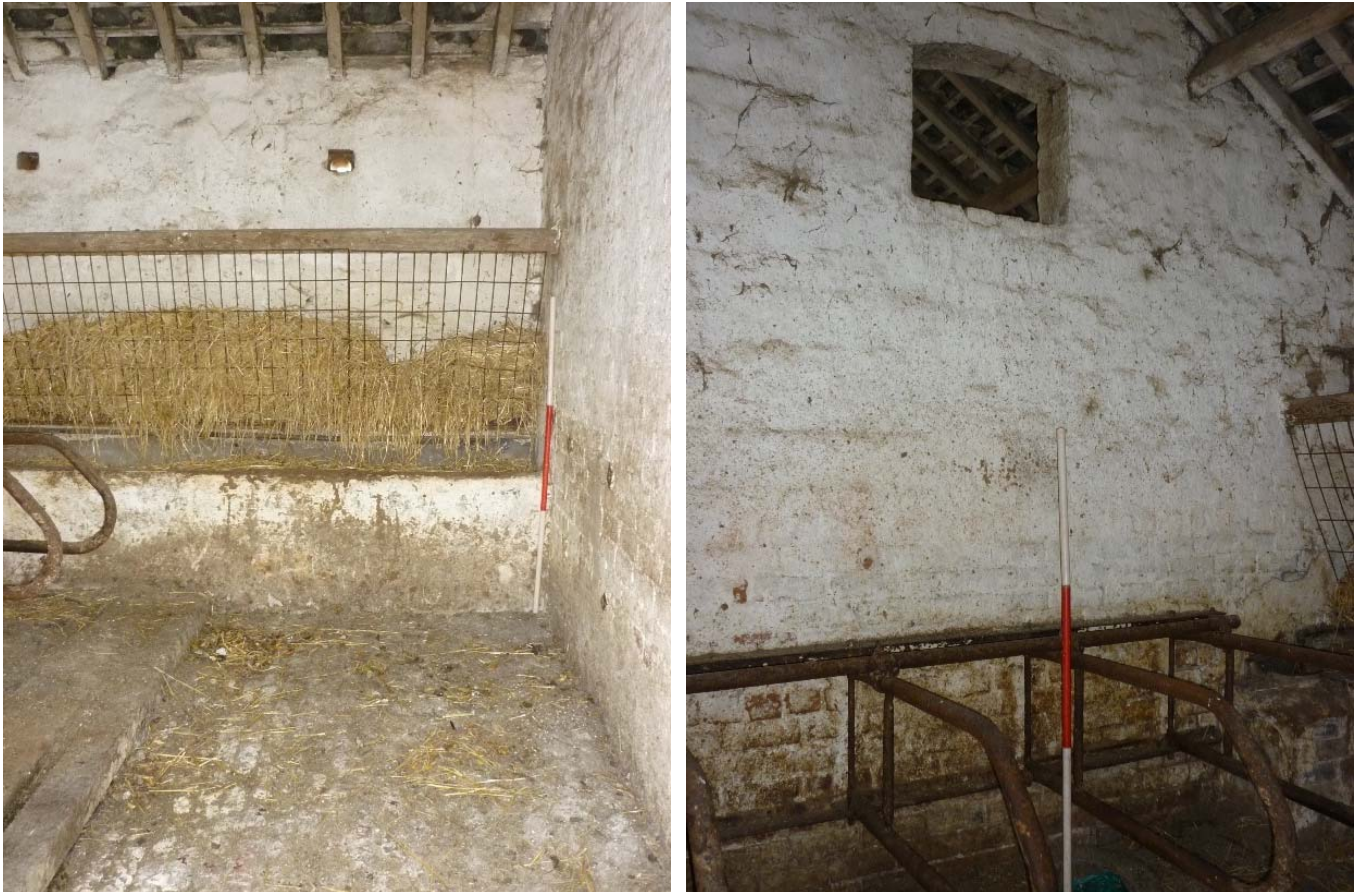
4.3.1 **Building 1:** this was L-shaped in plan, with the east/west arm comprising four rooms, and the north/south comprising one room. The four rooms in the east/west arm were essentially all the same, with a floor constructed from edge-set red bricks covered by the remains of a concrete skim in places, and a raised section on the east side formed by a timber sleeper and layer of car tyres (Plate 22). There was a raised brick-built trough against the south elevation, covered by a skim of concrete, and incorporating a stand for a metal water basin which was set on either the east or west side. The roof was supported by two machine cut timber purlins and there was a skylight on the north side. All of the walls were finished with whitewash. In each of the east/west range of rooms the north elevation was stone built and had a single doorway with dressed ashlar sandstone jambs with rounded corners, and there were two square vents to the east of the doorway, corresponding to the ceramic pipes visible externally. The dividing walls between the rooms were built from brick, in English garden wall bond (at a ratio of three rows of stretchers to one row of headers), with a metal manger attached to the east wall (Plate 23) and heads for bolts projecting through the west, which held the corresponding manger in the adjacent room. There was a small window between each of the rooms, with a flattened brick arch (Plate 23).

Plate 22 (left): South elevation in one of the rooms in the east/west arm of Building 1

Plate 23 (right): East elevation in one of the rooms in the east/west arm of Building 1

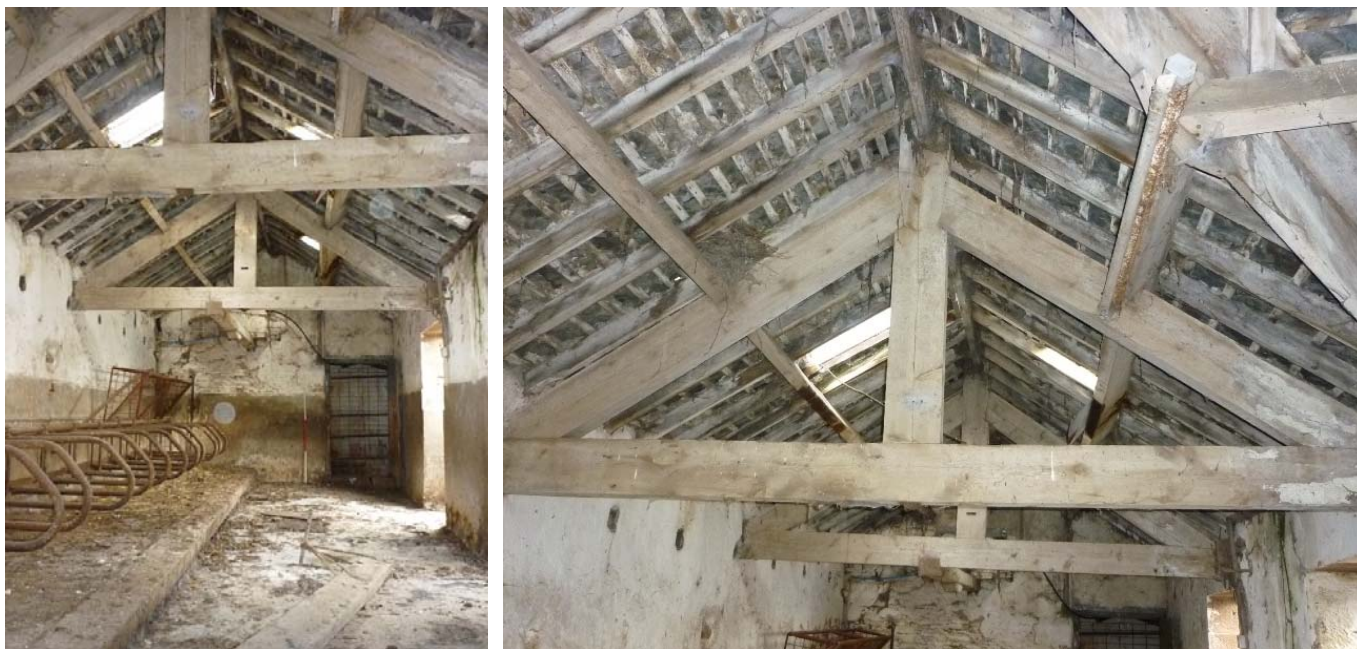
4.3.2 The fifth room making up Building 1 filled the whole of the north/south end of the building and was therefore much larger than the rest. It had a concrete floor, raised on the west side with timber edging and also with a concrete floor (Plate 24). The upper part of the walls was again whitewashed but there was a concrete skim over the lower part. The roof was hipped at the corner forming the junction with the east/west wing and there were two trusses supporting the main part. These were both of a simple king post type with the king post bolted to the tie beam and a single purlin per pitch plus a ridge board (Plate 25; see Figure 4). There were two single-light skylights in the east elevation and a single two-light skylight in the west. In addition a beam ran between the underside of the tie beam of the northernmost truss and the north wall. This had a shaped block with a socket hole in the underside, which presumably originally housed a stall post or similar, and there was a modern water tank sitting on it against the north wall. The north elevation had an inserted doorway on the east side, with bull-nosed red bricks in its west jamb and bricks in its east jamb and a beaded plank and batten door. There were two doorways in the east elevation, the northern one was evidently originally a window as the rebates for the frame, paint lines and evidence for where the sill was broken out was evident. The lower part of the newly created jambs had concrete added around them. The south elevation had a central window with a slightly recessed area above it that was wider than the window. The west elevation had metal stall partitions attached all along it and a wire manager, and at the south end in the corner there was a metal basin marked 'BAMFORD'S UTTOXETER'.

Plate 24 (left): View looking north in the north/south arm of Building 1

Plate 25 (right): Detail of the truss in the north/south arm of Building 1, viewed from the south

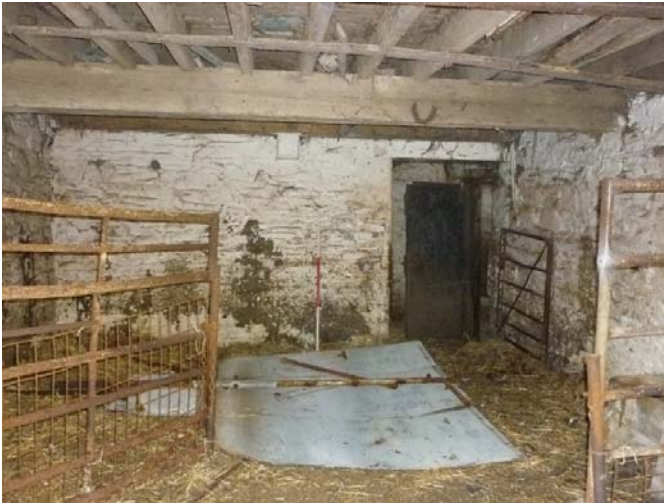
4.3.3 **Building 2:** the lower level had a concrete floor with two stone slabs forming what was presumably an earlier threshold for a slightly smaller doorway on the east side. The room was open to the roof at the south end (see *Section 4.3.4* below) but the ceiling over the rest was formed by two heavy timber beams orientated east/west, the southern of which had Baltic timber marks, and smaller joists north/south, supporting tongue and groove floorboards. The walls were all finished with a rough whitewash (Plate 26). The north elevation had a central rounded stone corbel with chamfered edges, supporting a beam and a doorway on the east side, with a sawn timber lintel, and bull-nosed bricks in the west jamb. The east elevation had a ceramic trough and water tank housed within a brick structure that was finished with a concrete skim in the centre. There was a large wagon doorway at the south end which was formed by the corner of Building 3 on the north side, and the south jamb had evidently been extensively rebuilt resulting in it extending the full height of the wall. The south elevation had a doorway on the east side, which was evidently inserted and had bull-nosed bricks in both jambs (Plate 27). There was a corbel matching that to the south in the centre and scars for a row of joist holes, which corresponded to the level of the upper floor and had been partially filled with a patchy rebuild in concrete and brick. The west elevation had a corresponding wagon doorway on the south side, with the area of rebuild around the north jamb extending to the north on the ground level only, below an iron I-beam set into the wall. A ceramic pipe had been inserted into the wall to the north of this to act as a vent.

Plate 26 (left): The ground floor level of Building 2, viewed from the south

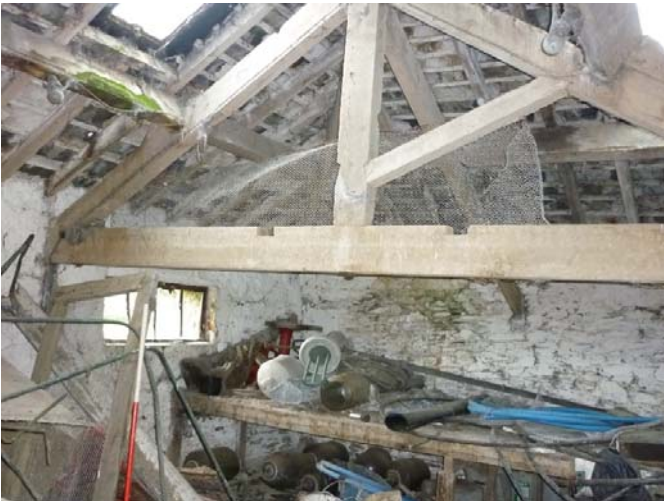
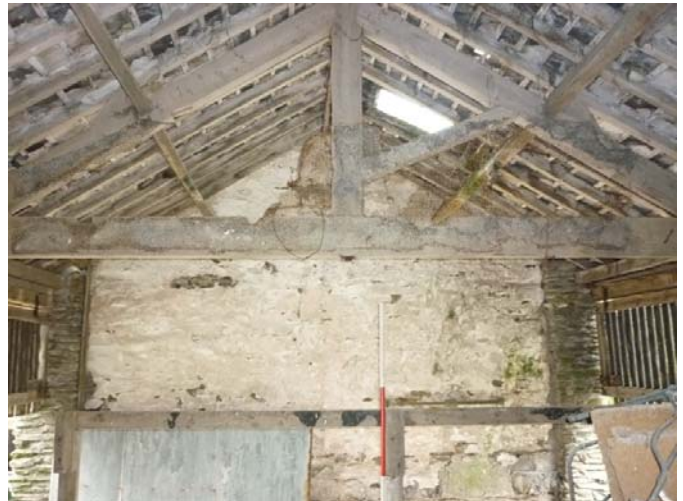
4.3.4 The upper level had a timber board floor with a bench or perhaps low additional floor against the north wall (Plate 28). The roof was supported by two trusses, each of king post type, originally with a pair of angled braces but only one now remained on each truss; the east one on the north truss and the west one on the south truss (Plate 29). Both trusses had slots, perhaps for former joists, cut into the upper side of the tie beam (see Plate 28 and Plate 29) and the roof was hipped at the north end of the building. There was a single purlin per pitch, supported by wedges attached to the principal rafters at the trusses, plus a ridge plank, and additional timbers where it met Building 3. There were three single-light skylights in the west pitch. The north elevation was plain, apart from the bench attached to it. The south elevation had an owl hole below the eaves. The west elevation had two long windows, both inserted, with a four-light casement remaining in the southern one. At a high level at the north end of the east elevation there was a blocked aperture with a stone lintel, perhaps a large owl hole in what was the gable end of Building 3, and there was a further blocked aperture with a rough timber lintel to the south, with a shallow alcove remaining (Plate 30).

Plate 28 (left): The north elevation of the upper level of Building 2

Plate 29 (right): The south truss in Building 2, viewed from the north

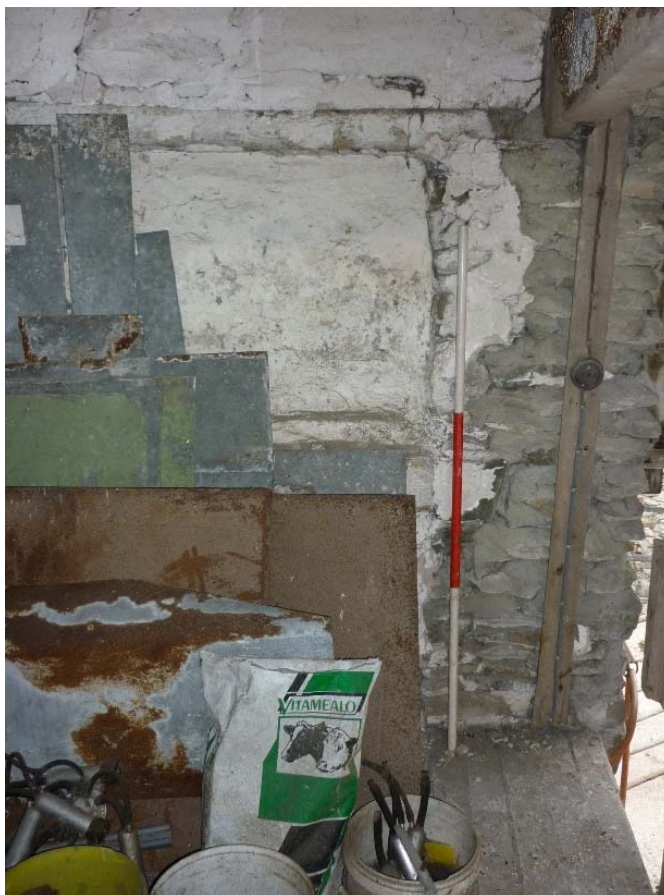
Plate 30: Blocked aperture to the south side of the east elevation on the upper floor of Building 2

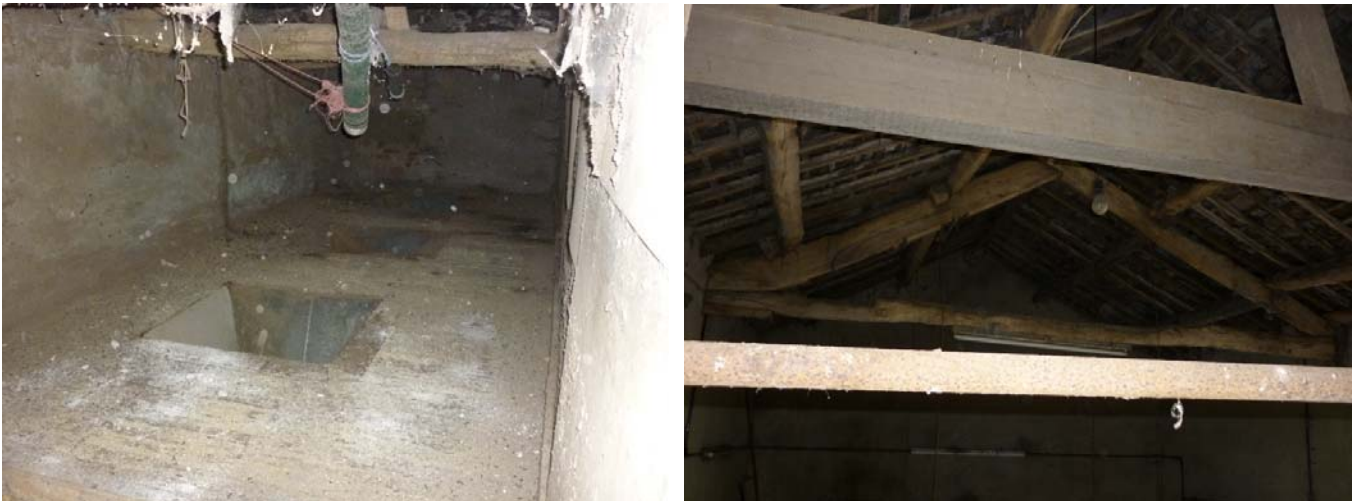
4.3.6 The upper floor of Building 3 only truly existed on the west side, where there was an actual floor (Plate 37); the east end was simply open to the floor below (see Plate 35). The roof was supported by five trusses, typically comprising a quite basic tie beam form (Plate 38), with much re-used timber evident, but the central three had later sawn timber and a pair of angled braces (see Figure 4). The re-used timber was hand finished and some pieces were likely to have been sections of crucks, while one of the sawn sections had Baltic timber marks. There were two purlins per pitch and a ridge purlin. The elevations were largely inaccessible and there was a modern timber-built sub-division along the south side, enclosing feed chutes connected to the milking room below (Plate 37).

Plate 37 (left): Feeding chutes in the floor above the west end of Building 3

Plate 38 (right): Truss in Building 3

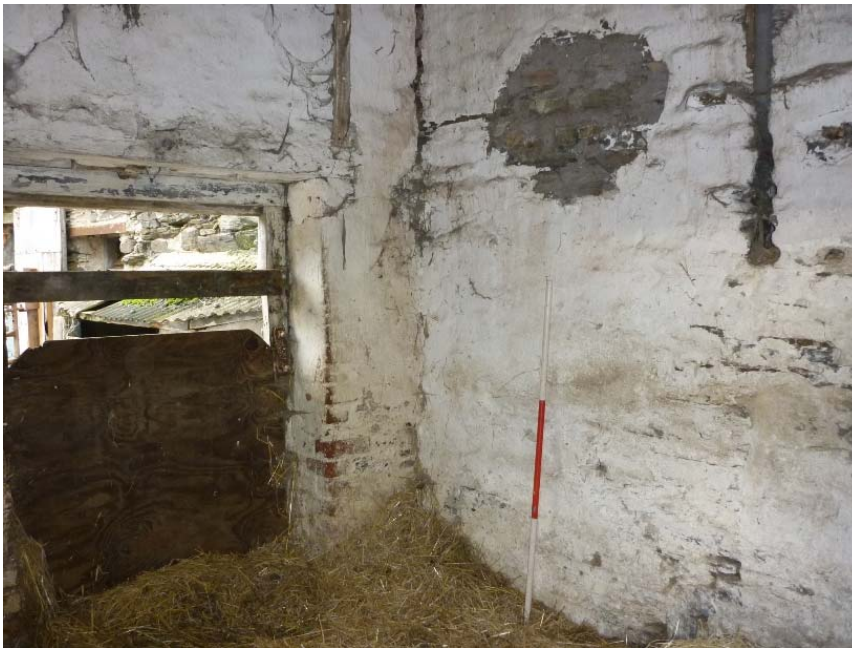
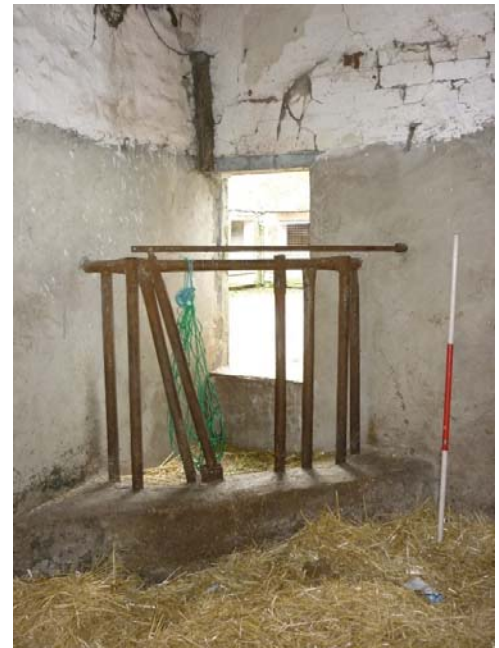
4.3.8 Building 3b, on the south-east side of Building 3, had a concrete floor and the roof was supported by two purlins and a single beam, which was located strangely almost against the west elevation at which the purlins stop, although the southern one was continued by a new timber. All of the timbers were hand sawn and the walls were finished with a concrete skim over the lower part and whitewashed over the rest. The north elevation was plain apart from a possible through stone near the top and a hole roughly mid-way down it that was presumably a partially blocked ventilation slot. The east elevation was plain, and butted against the north wall. The south elevation had a doorway on the east side, with sawn timber and concrete lintels. The west elevation had a window on the south-side with concrete skim over the jambs (Plate 40) and an arch for a further, larger window to the north, which had been blocked.

Plate 39 (left): North-west corner of Building 3a

Plate 40 (right): South-west corner of Building 3b

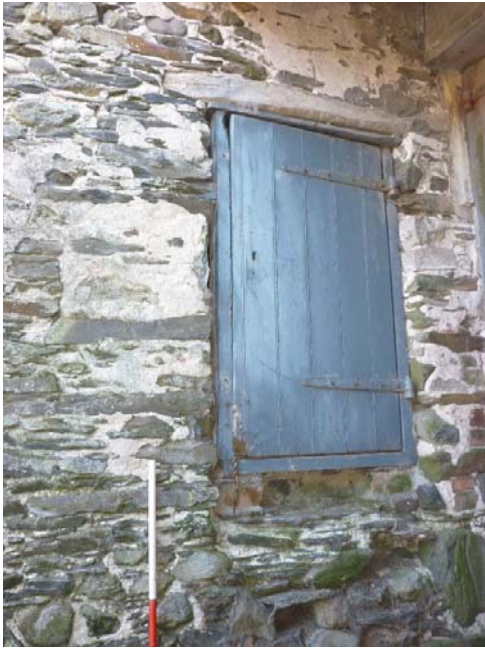
Plate 41 (left): Doorway in the west external elevation of Building 3c

4.3.9 Building 3c, on the east side of the north elevation of Building 3, comprised two levels; the upper floor was only accessible from a high-level doorway in the west elevation where there was a large step (Plate 41). It had a modern timber floor and a mono-pitch roof with two purlins and a skylight. The walls were finished with plaster and whitewashed and plain (Plate 42), apart from the south elevation, which incorporated the only doorway into this floor, which had a rough and re-used timber lintel and a plank and batten door. The lower level had a concrete floor (this was formerly lower than at present and was filled in when the building was converted into a garage; Stephen Whitaker pers comm.), and the ceiling was finished with modern timber and had two machine cut joists. The walls were all finished with a concrete skim and relatively plain. There was a tilting modern garage door to the north, and in the west side of the south elevation there was a small cupboard built into the wall thickness, with a plank and batten door on strap hinges (Plate 43). The south-east corner of the room was angled and housed a doorway, which had been filled with concrete blocks (Plate 44). There were three angled sandstone corbels along the wall, which presumably originally supported a joist for a former floor.

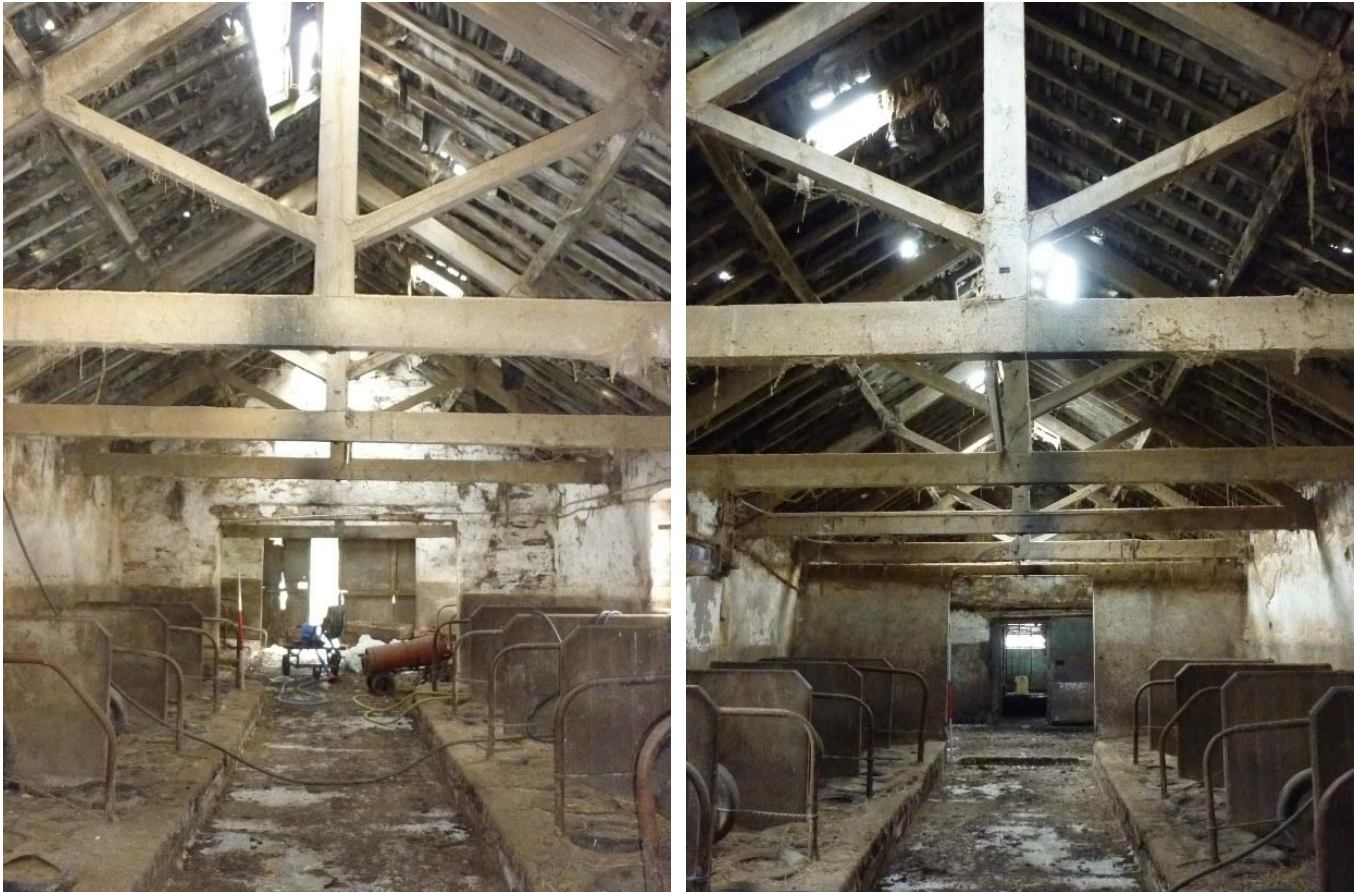
Plate 45 (left): General view of Building 4 from the south

Plate 46 (right): General view of Building 4 from the north

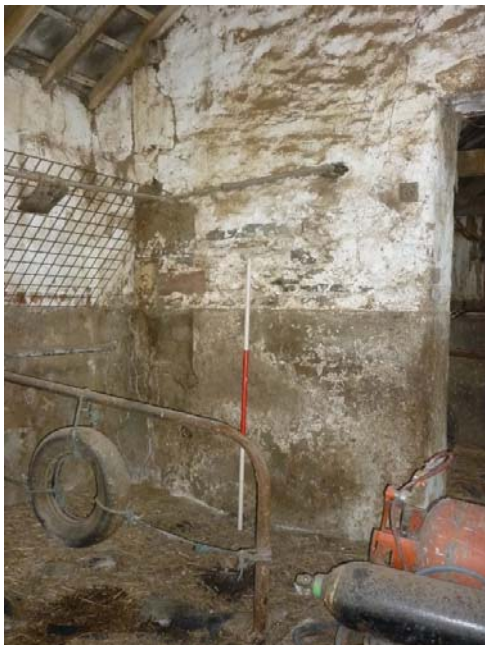
Plate 47 (left): Detail showing quoins from the original limit of the northernmost wall of Building 4

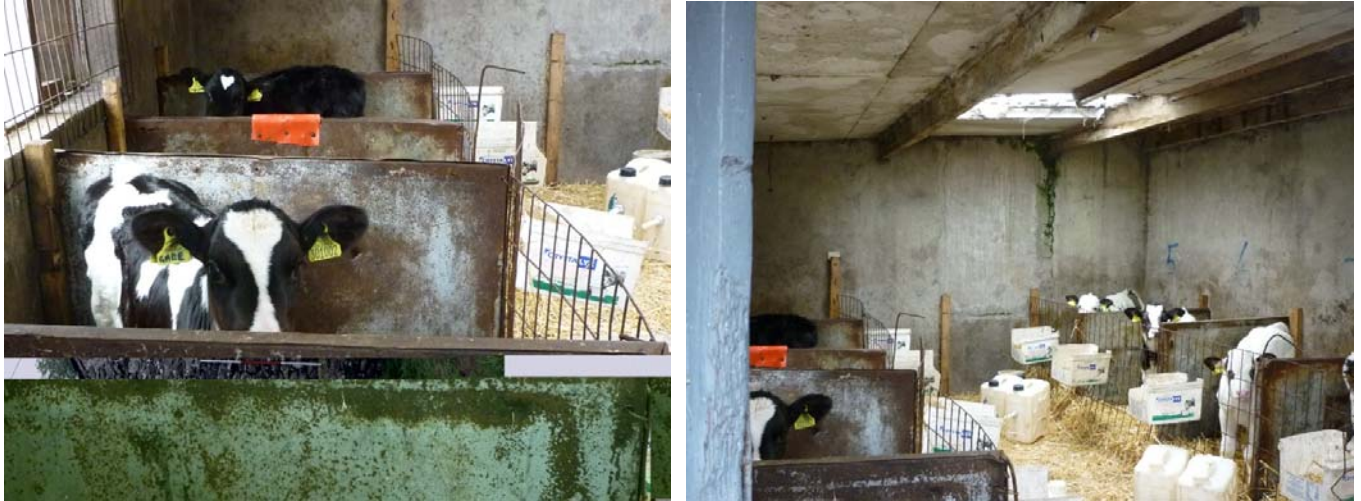
4.3.12 Building 4a had a concrete floor, with modern metal stalls attached to the east and west elevations (Plate 49). It had a slightly mono-pitch roof that sloped to the east, which was supported by

two machine cut purlins, and two skylights formed by translucent corrugated sheets (Plate 50). There was a concrete skim over all of the walls and they were all relatively plain. The east elevation had a window and the north elevation had a wide doorway on the east side and a ceramic trough and basin to the west. Building 4b was a much smaller outshut, adjoining the centre of the east side of Building 4. It had a monopitch roof constructed from corrugated concrete sheeting sloping down to the east, with two chamfered purlins orientated north/south. It had a concrete floor, raised relative to the yard surface to the east. The walls were all whitewashed and plain, with a water pipe against the west, modern shelf brackets attached to the south, and a plank and batten door to the west.

Plate 49 (left): Metal stalls in Building 4a

Plate 50 (right): General view of Building 4a from the north

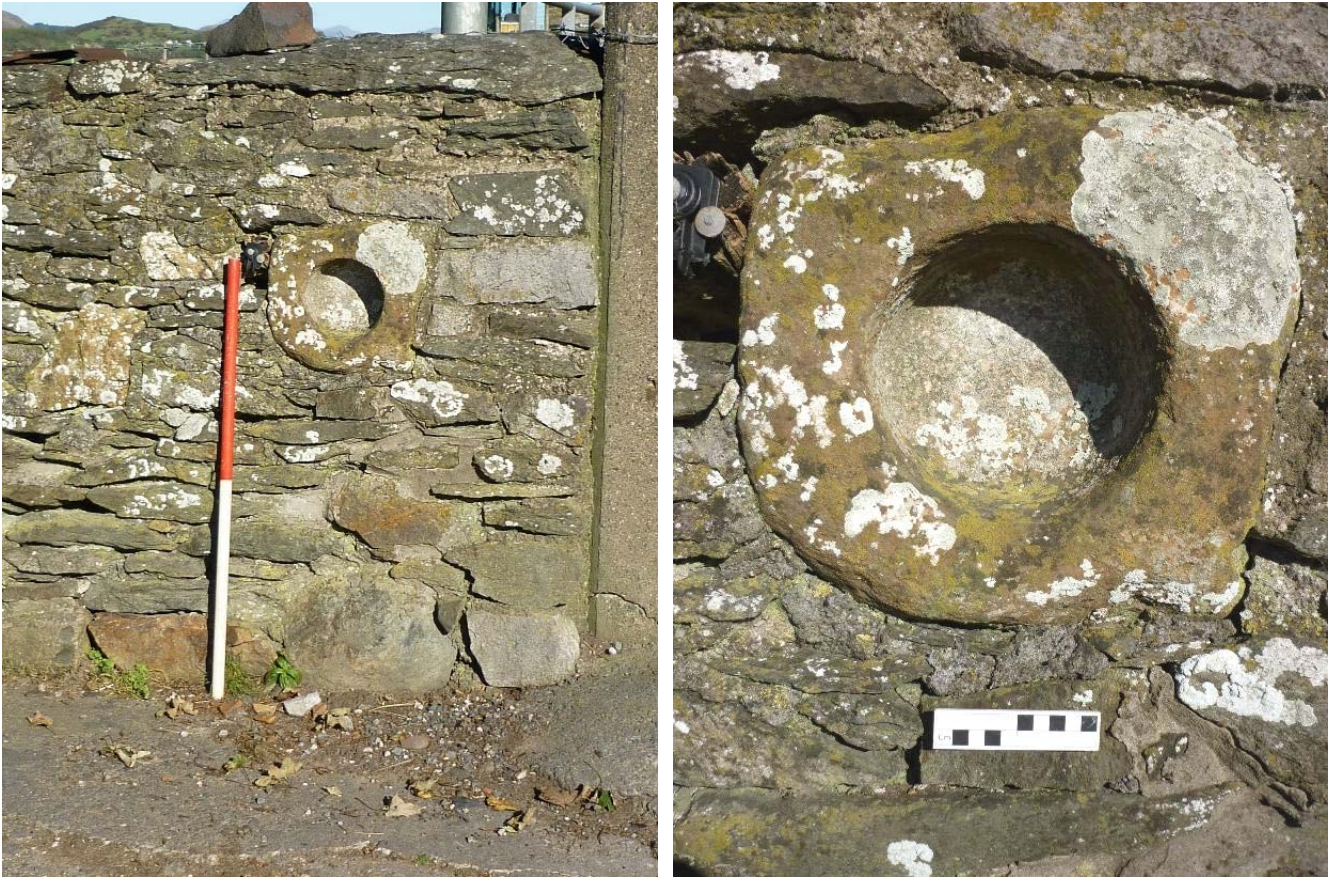
4.4.1 Built into the boundary wall to the north of the north end of Building 4 (Figure 1) was a roughly cuboid block of red sandstone, perhaps 0.3m³. The south face of this was dressed to a smooth finish, with a neatly formed 'bowl' cut into it approximately 0.2m in diameter and about as deep. Although presumably of some antiquity its purpose is uncertain; anecdotally it is thought to have been for cleaning coins given as payment by lepers (Stephen Whitaker pers comm.) but it could have formed any number of functions.

Plate 51 (left): Stone 'bowl' and associated boundary wall
Plate 52 (right): Detail of stone 'bowl'

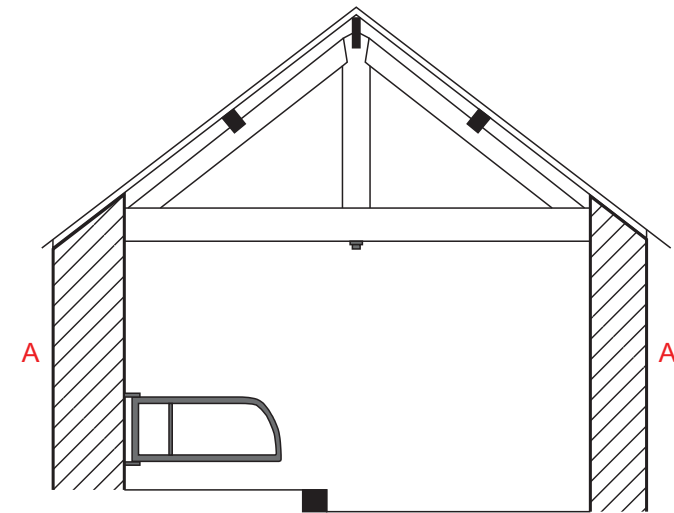
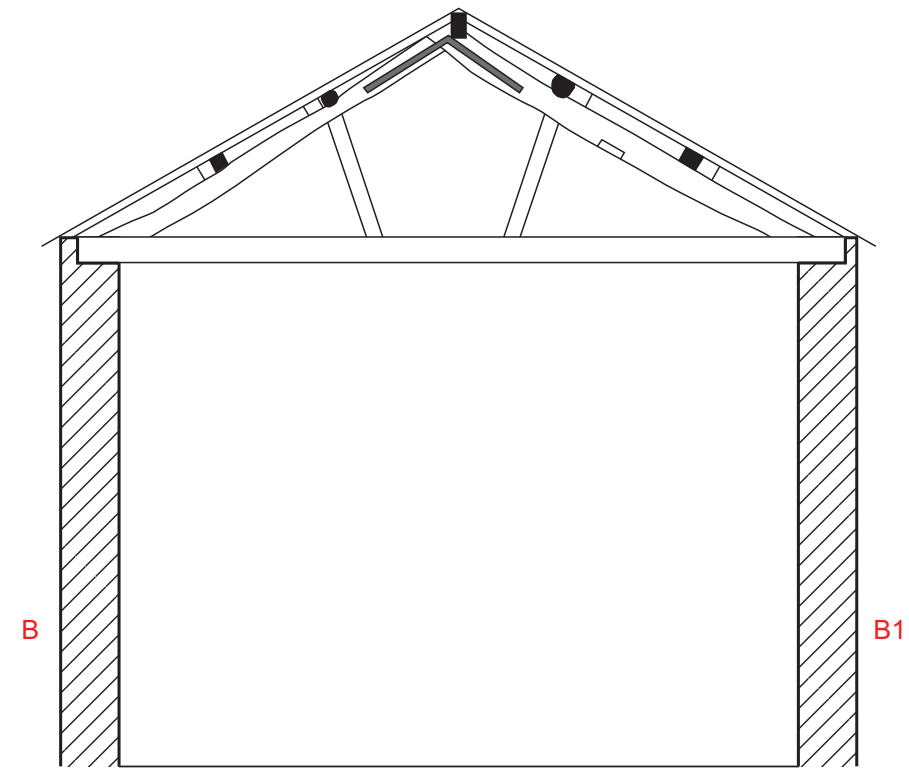
Figure 4: First floor plan and cross-sections through Building 1 and Building 3

NORTH-FACING CROSS-SECTION A-A1 THROUGH BUILDING 1

WEST-FACING CROSS-SECTION B-B1 THROUGH BUILDING 3
