BRUNSWICK ROAD, PENRITH, CUMBRIA

Archaeological Building Recording

Client: Booths (Penrith) Ltd

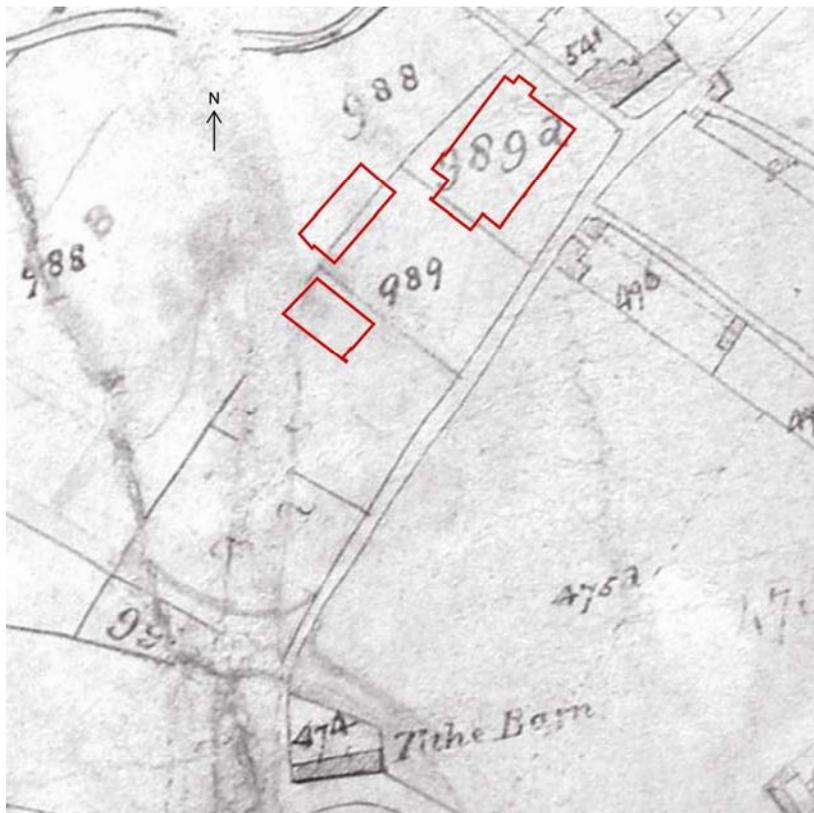
Plate 2: Tithe Map, 1845

3.3.2 **Tithe Map, 1845:** the tithe map shows the division of the area into plots (Plate 2). The fields in this area were named 'Clowers' in the apportionment and described as arable and meadow; the tithe barn shown to the south was owned by the Lancaster and Carlisle Railway Company (CRO(C) DRC/8/150 1845, cited in ASDU 2009, 5-6). The route of the railway is marked faintly on the map, although it is shown slightly further to the east than it is in reality.

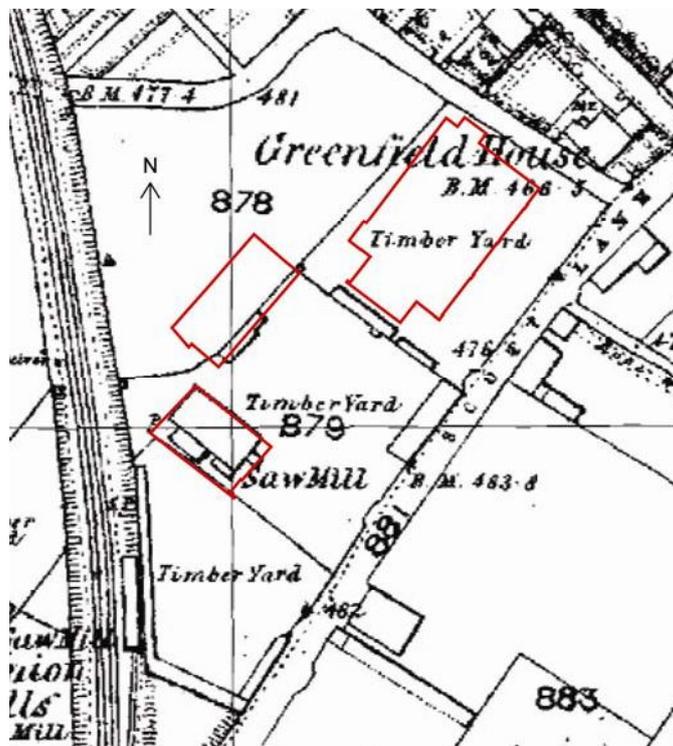
Plate 4: Ordnance Survey, 1891

3.3.5 **Ordnance Survey, 1891:** this shows essentially the same information at the previous maps, with the timber yards and a saw mill along Scott Lane clearly depicted (Plate 4). The saw mill is again shown as comprising four parts: a long north-west/south-east aligned section with two parts attached to the south-west and another to the south-east, although the chimney shown in 1861 is not apparent. The area around the saw mill was open ground at this point, apart from what appeared to be long sheds along the edges of the timber yards.

3.3.6 **Ordnance Survey, 1900:** Scott Lane had been renamed Brunswick Road and the area both in and around the site had seen substantial development since 1867 (Plate 5; cf. Plate 4). The saw mill had been extended to the south-west and to the south-east and occupied its fullest extent. Several other buildings were also constructed within the timber yard next to the saw mill and the northern timber yard was then occupied by 'Northern Carriage Works'.

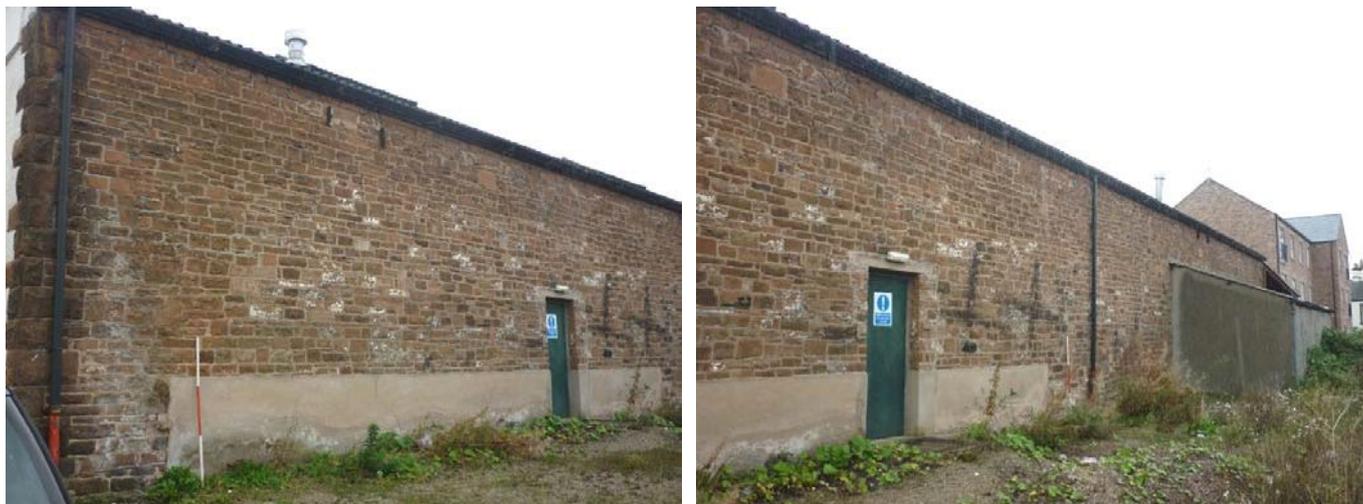
4.2.1 **Bowman's – north-east elevation**: the north-east elevation was constructed from irregular courses of exposed and rough cut sandstone blocks with an orange to buff coloured cement and red brick was used for blocking and for some areas of rebuild. There was a concrete skim over the lower section of the wall, to a height of 1.06m, which covered several small blocked vents which were visible only on the inside of the building. There were neatly dressed sandstone quoins at the south-east corner and plastic rainwater goods (Plate 10). There was clear rebuild around a fire door, below a concrete lintel, which had been inserted, and which was accessed by a low concrete step (Plate 11). There was a doorway to the north-west of this, which was blocked with sandstone but which had a machine-made red brick surround. There was a roughcast rendered outshut attached to the north-west end of the elevation, which had three purlins visible in the south-east side, with a corrugated sheet roof with skylights and plastic rainwater goods. There were quoins to the north-west end of the elevation, which were the same as the ones at the south-east corner of the building. There was a modern lean-to with a canopy cover to the north-west of the main building constructed from round metal beams supports and I-beam trusses, which currently housed various vehicles including a forklift truck. This had a corrugated sheet roof, the same as the main building.

Plate 10 (left): South-east end of the north-east elevation

Plate 11 (right): North-west end of the north-east elevation

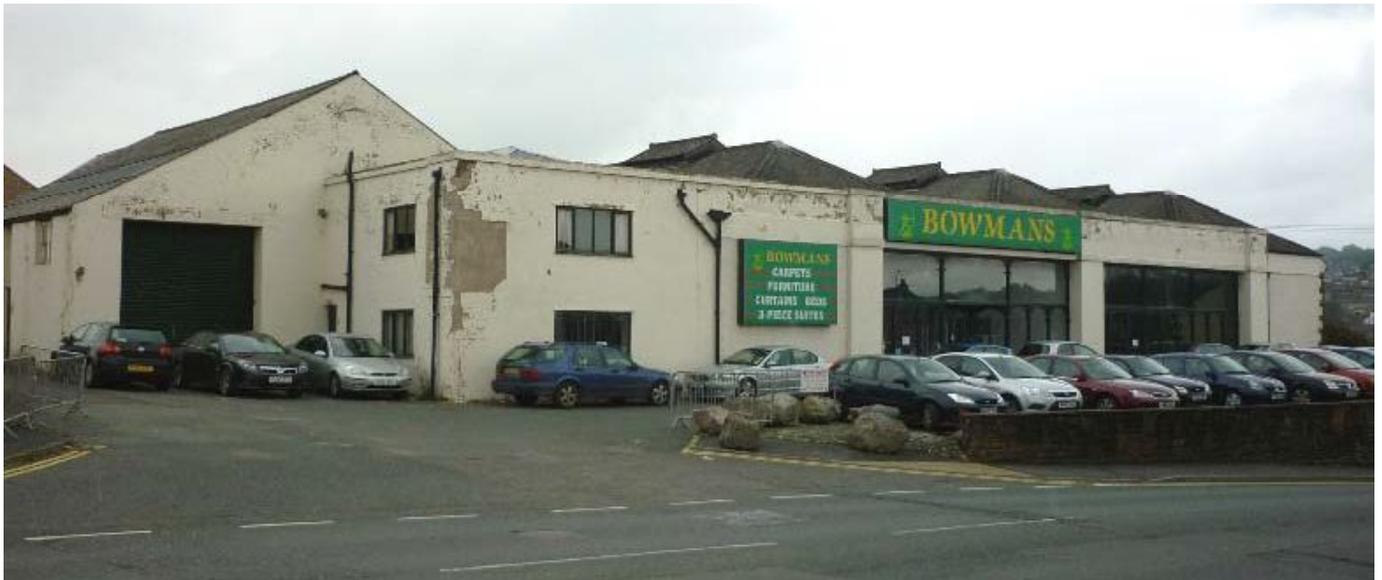
4.2.2 **Bowman's – south-east elevation:** the south-east elevation was the main entrance to the building and fronted onto a car park to the north-west of Brunswick Road (Plate 12). The elevation was largely smooth-rendered and painted white, with corrugated sheet roofing and plastic rainwater goods. This side of the building was dominated by two large expanses of windows between slightly jutting out 'columns', which were smooth-rendered and painted white. The north-east corner had neatly dressed sandstone quoins (the same as the north-east elevation) and the wall was roughcast rendered to the first column at the north-east end of the elevation. The large set of windows to the north-east housed nine curve-headed windows along the base of the elevation, with decorated timber surrounds and panelling below, above which were three larger windows. The timber surrounds were painted a dark bluish-green and were not opening. The set of windows to the south-west were similar in style and arrangement except that the central three panes had been replaced with similar curve-headed lights to form splayed jambs, one either side of a central double door. The doors also had a curved head, with a single light above and a timber panel below, and were accessed via a small tiled step. There was a large 'BOWMANS' sign above the top set of three lights, centred above the door. The large columns either side of the large windows were smooth rendered with concrete and each had a slight decorative plinth near the top. There was another large 'BOWMANS' sign on the wall to the south-west side of these windows. There was an area of roughcast render where the sign was located, below the level of the plinth near the top of the columns, which continued some distance to the south-west. The remaining part of the elevation to the south-west was smooth-rendered and painted white, although some sections of the paint were peeling off to reveal the concrete render underneath. Towards the south-west end of the elevation there was a four-light window with a timber frame and a painted over lintel. The end two panes were hinge-opening to the outside edge. A similar set of windows was located directly above this one on the first floor. The elevation was stepped back behind the column at the south-west end and appeared to butt against a building which had recently been used as a garage. There was a large rolling metal door to the south-west side of the gable end, below a heavy concrete lintel. The gable end of the garage formed a continuation of the main elevation and was also smooth-rendered and painted white.

Plate 12: South-east elevation of Bowman's

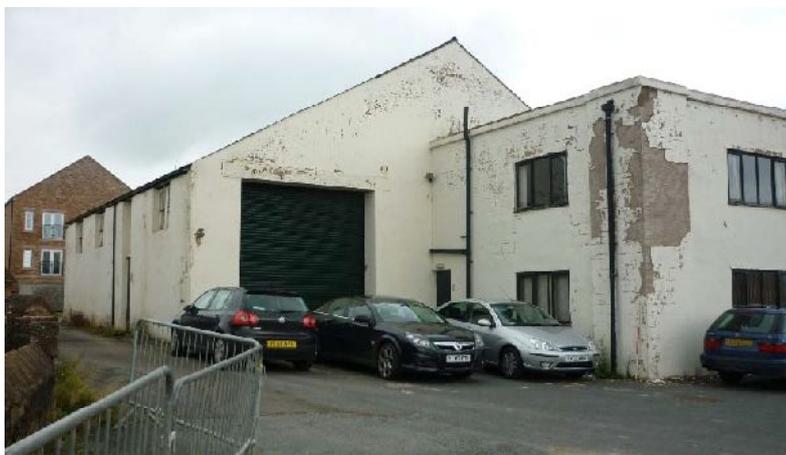
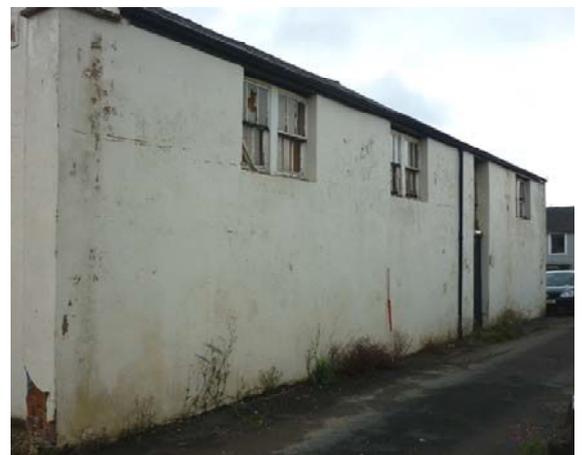
4.2.3 **Bowman's – south-west elevation:** the central section of the elevation is stepped out to the south-west by a structure which had recently been used as a garage, which was smooth-rendered and painted white and had a slate roof (Plate 13). The south-east end of the elevation was a continuation of the smooth-rendered and white-painted façade of the south-east elevation, culminating in one of the columns at the south-east corner, and had plastic rainwater goods. There was one three-light window on both the first and second floor in this section, which were similar to those on the south-east elevation (see Section 4.2.2) with the outside two lights hinge-opening. To the north-west of these windows on the ground floor there was a plain door with timber surrounds below an electric light and with a letterbox. Towards the south-east end of the jutting garage wall there was a set of two six-light sliding sash windows with timber surrounds and a timber frame (Plate 14). To the north-west of this there was a plain timber door with a wood frame at ground floor level, above which was a 12-light metal casement window with four rows of three-lights (the upper six lights possibly once slid down to open). There were two more sets of two six-light timber framed sliding sash windows to the north-west on the first floor level. There was a lean-to against the north-west side of the return wall of the garage (Plate 15). The lean-to was smooth-rendered and painted white with a plain fire door and slight return in the wall. The lean-to had a slate roof and plastic rainwater goods and partially obscured the sandstone block and red brick 'quoins' of the structure to the north-east. The far north-west end of the elevation comprised a canopied area, which was supported by several I-beam trusses atop round metal columns (Plate 16). The side of the canopied area was enclosed by large timber boards (Plate 15).

Plate 13 (left): Garage against the south-west side of Bowman's

Plate 14 (right): South-west side of the garage

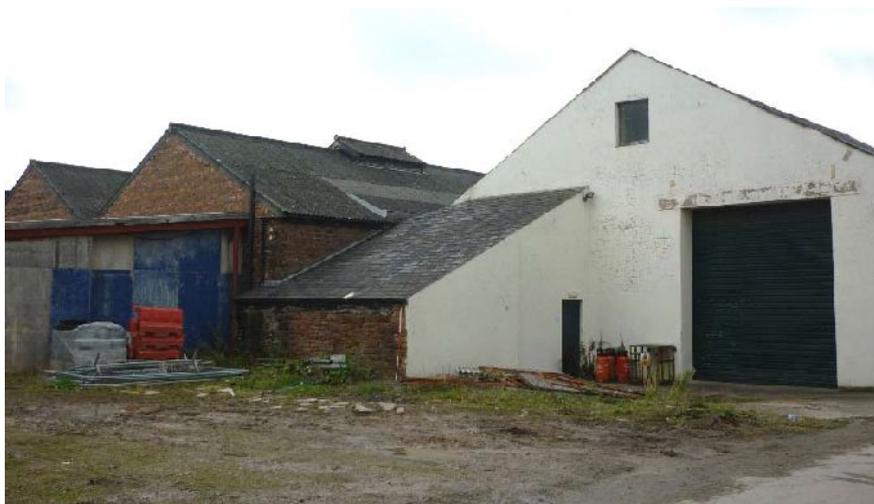
4.2.4 Bowman's – north-west elevation: the south-west end of this elevation formed the back end of the garage which had a sliding door opposite a similar one on the south-east elevation (Plate 15; see Section 4.2.2). This side of the garage was also smooth-rendered and painted white and had a blocked window with a timber frame below the apex of the gable. There was one purlin visible in the elevation. The lower part of the gable of the garage was obscured by a lean-to against the garage to the north-east. The orange sandstone construction of the lean-to was exposed on this side, below a large machine-cut timber beam. The three gable ends of the Bowman's, Room 2 and 3 were visible at the back of the canopied area and above the sloping roof of the canopy (Plate 16). The gable ends were of a red brick construction, with an English garden wall bond (at four to one). The canopy was corrugated sheet metal above iron I-beams and round metal column supports. It was mainly open but there was a closed timber-boarded area to the south-west with a plain single and plain double door with strap hinges. The lower section of the gable end was concrete (possibly rendered?). The north-east corner was quoined to the north-east with neat sandstone blocks and butted by the boundary wall.

Plate 15 (above): South-east end of the north-west elevation

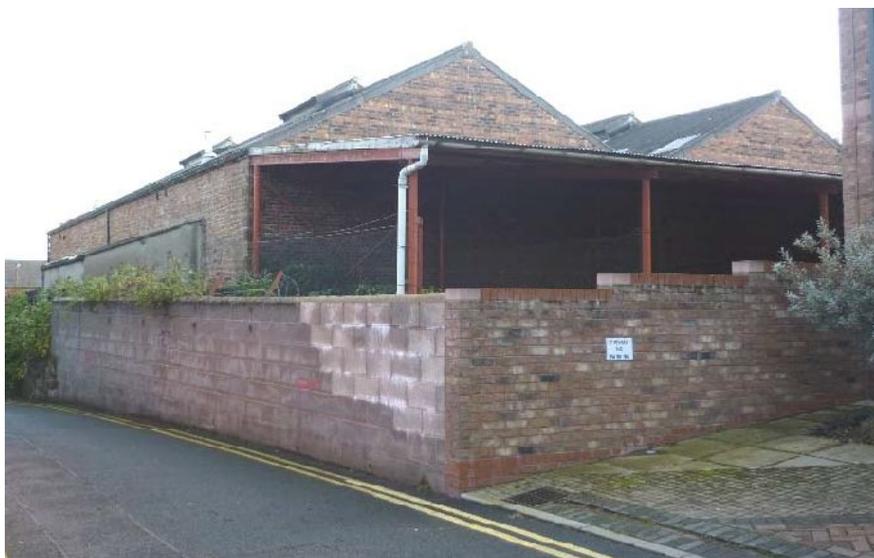
Plate 16 (above): North-east end of the north-west elevation

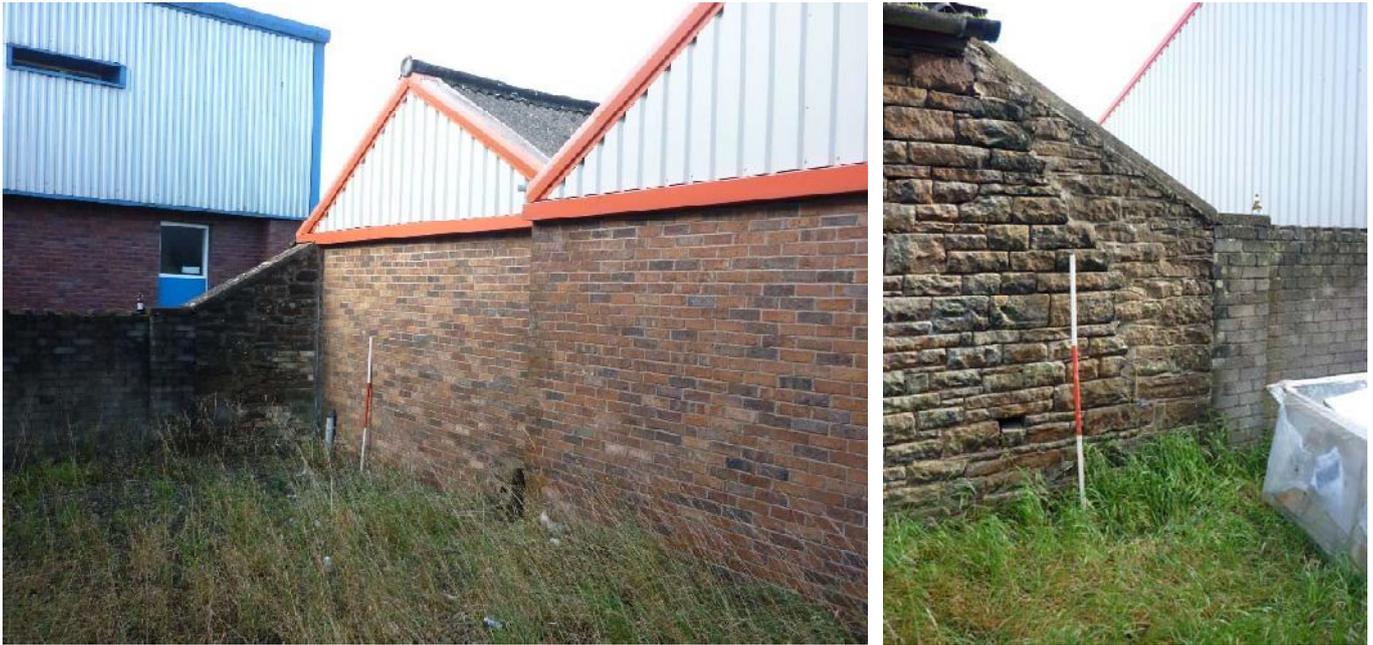
4.2.5 Rickerby's – south-east elevation: a stub of the south-west wall extended to the south-east along the boundary wall at the end of this elevation and indicates that the external wall of what was the saw mill originally extended further in this direction. This wall stub was mostly sandstone blocks but incorporated some yellow firebrick and the sloping top to the south-east was finished with concrete (Plate 17). The stub wall was extended by a lower level concrete wall to the south-east (Plate 18). The

gable at the south-west end of the elevation was modern brick and there was a large seven-light window to the north-east end of the elevation.

Plate 17 (left): South-west end of the south-east elevation

Plate 18 (right): Stub of the south-west wall of the saw mill and boundary wall showing rebuilt section

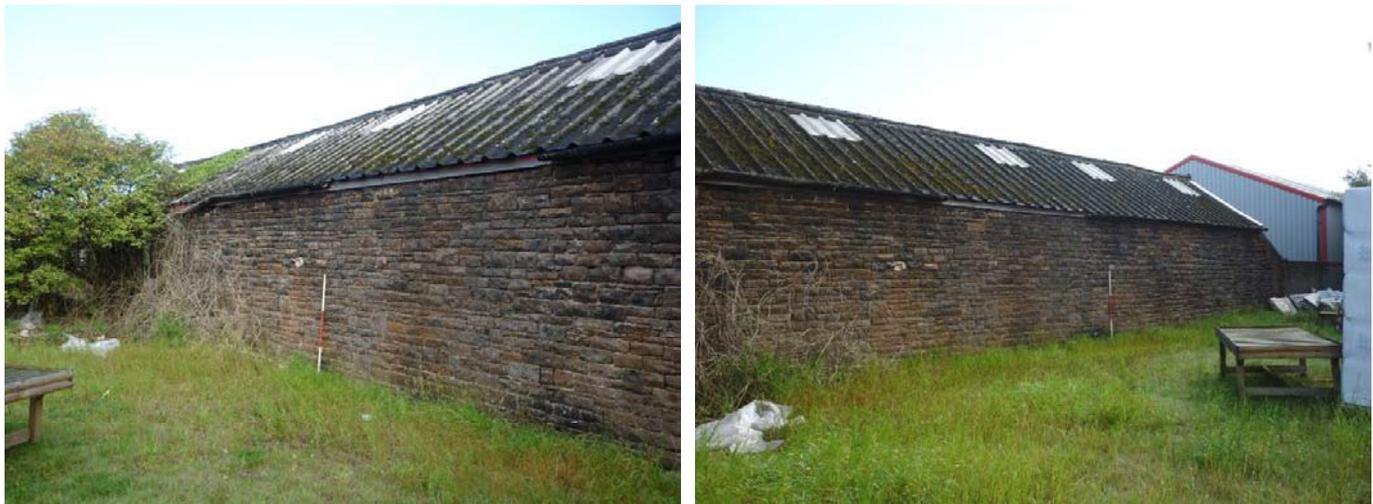
4.2.6 *Rickerby's – south-west elevation*: there was an iron down pipe attached and the remains of a concrete skim from a former outshut at the north-west end of the south-west elevation (Plate 19). There was a barge board attached at the top of this elevation with plastic rainwater goods attached. The elevation was constructed from neatly dressed sandstone blocks and was plain (Plate 20), although the stub at the south-east end had been rebuilt (see Plate 18).

Plate 19 (left): North-west end of the south-west elevation of the saw mill

Plate 20 (right): South-east end of the south-west elevation of the saw mill

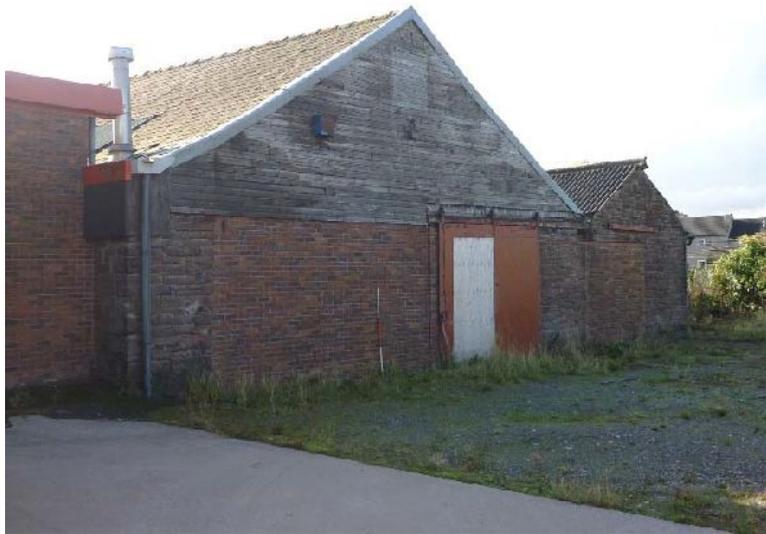
4.2.7 *Rickerby's – north-west elevation*: the north-west elevation formed two gable ends, the north-east one being slightly taller and having a slate roof whereas corrugated sheets were used on the roof of the south-west section (Plate 21). There was a slight return at the north-east end of the elevation where there was a window blocked with modern bricks. The wall of a modern building butted against this part of the building to the north-east. The window had a sandstone sill and had dressed quoins and the lintel was covered by modern plywood that extended round the corner. The top part of the north-east gable

was covered by timber tongue and groove planks, below which was a large original door, with quoined jambs. The lintel was obscured and part blocked with modern red brick and incorporated a sliding doorway. The north-east jamb was slightly projecting. The south-west gable was all stone built and had a large doorway with an iron I-beam lintel and large quoins on the north-east side (which formed the original end of the building) and smaller quoins to the south-west. This end was a later extension. There was a piece of timber bolted to the wall here, but its function was uncertain, and there was evidence of a blocked window above that. Only the south-west side was visible and the lintel, but the north-east side was not apparent. There was some rebuild and re-pointing along the roof line. There were quoins at the south-west corner of the building and concrete scars from a formerly attached outshut, the footings of which were still visible.

Plate 21: North-west elevation of the saw mill

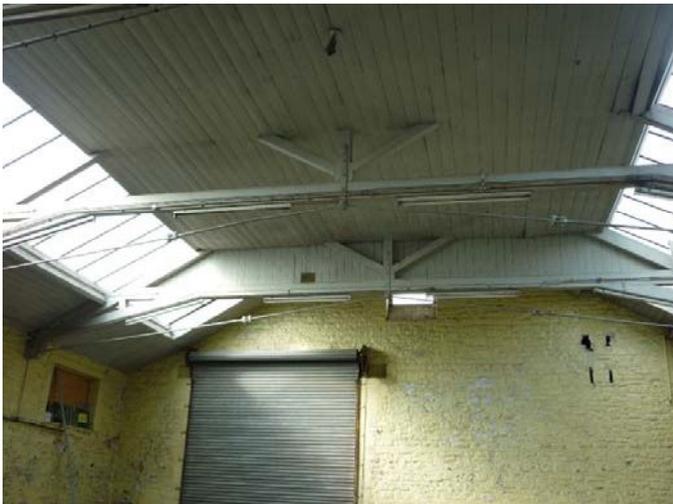
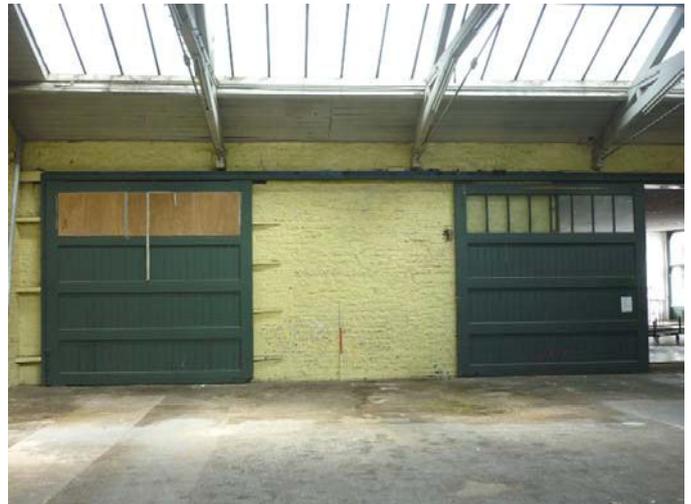
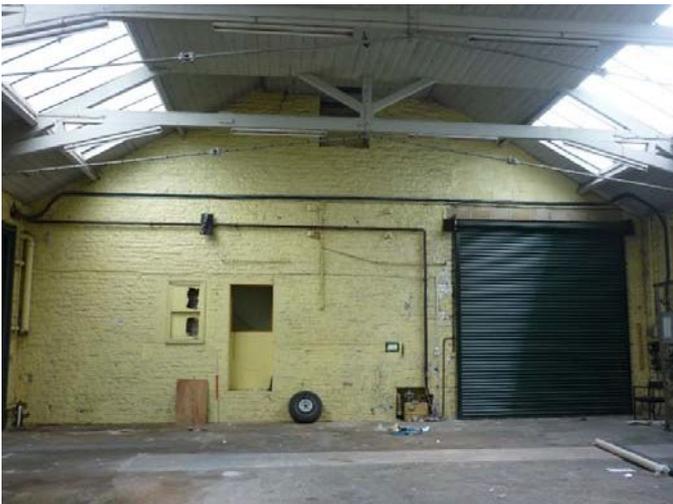
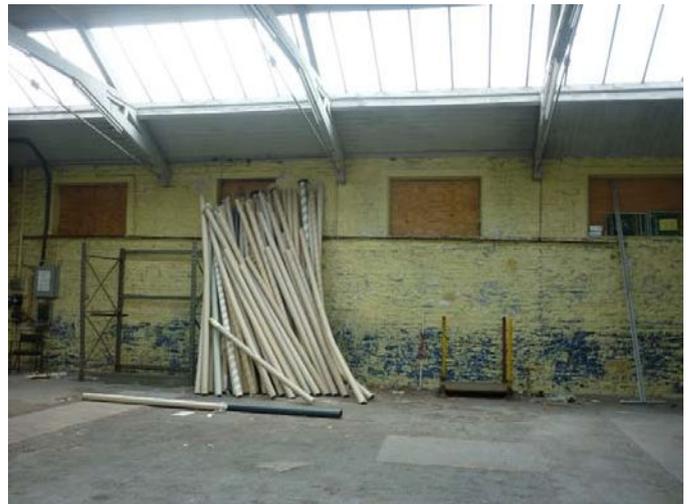
4.3.1 **Bowman's, Room 1:** this room had clearly recently been used as a garage but was now derelict. The room was open to the roof and had three elaborate trusses, each comprising a tie-beam and principals with a king post truss and a pair of angled braces (Plate 22). There were additional braces below the tie-beam which were attached to the principals. The principals extended beyond the end of the tie-beams and sat atop scrolled corbels in the north-east and south-west walls. These also had tie rods, which were fixed between the base of the king post and the corbel ends. The ceiling above the trusses was formed by tongue and groove boards. There were large skylights extending the full length of the room on both sides. All the walls were exposed painted stone. There were two filled in inspection pits in the concrete floor which were aligned north-east/south-west and corresponded to the two large doors which dominated the north-east elevation (Plate 23). The two large doorways were probably inserted or at least enlarged as the south-east one was cut through a doorway on either side and the south-west doorway had brick re-build in the jambs. The doorways had sliding doors of a large plank and batten construction with eight lights over the south-east door but the space above the north-west door was boarded up, the top rail marked with an 'H' insignia. The former doorway which was cut through to the south-east had a bull-nosed brick jamb and what was probably a timber lintel and the one to the north-west had rougher jambs and a sawn timber lintel. There was a further line of bull-nosed brick jambs to the south-east of the north-west door. The south-east elevation was stone built with some timber levelling courses in the centre and was perhaps re-built on the north-east side and had an inserted ground floor doorway and window to the north-east of its centre (Plate 24). Brick was used in the jambs and sawn timber was used for lintels. The window still had a four-light sash and moulded surround, but was bricked up on the other side. The door was raised from floor level and had a concrete step and had been partially blocked to leave a single-light window. There was a hole cut in the wall to the south-west for a gas valve. The south-west end of the elevation had been substantially re-built to accommodate a large roller door, and concrete block had been used around this insertion. There was a blocked window

below the eaves which was mirrored on the north-west elevation. The south-west elevation was built from stone courses with timber levelling and had a row of three first floor level windows (which had possibly been inserted) with bull-nosed brick jambs (Plate 25). The doorway (hidden behind the rolls in Plate 25) had a small concrete step and had a window above it which extended to the top of the wall. Brick was used in the jambs, but not bull-nosed brick. All of the windows had timber lintels. The north-west elevation had a large inserted roller shutter door to the south-west of centre (Plate 22). Concrete blocks were used in the jambs. The build was the same as described above for the south-east elevation with timber levelling, except for the north-east end, which was evidently re-built. There was a high-level single-light window below the apex with a sloping sill, which might have been inserted. The window had brick jambs and there were scars from fixings to the north-east for a water tank or something similar.

Plate 22 (top left): View of the truss, looking north-west in Bowman's, Room 1 – the derelict garage

Plate 23 (top right): North-east elevation of Bowman's, Room 1 – the derelict garage

Plate 24 (bottom left): South-east elevation of Bowman's, Room 1 – the derelict garage

Plate 25 (bottom right): South-west elevation of Bowman's, Room 1 – the derelict garage

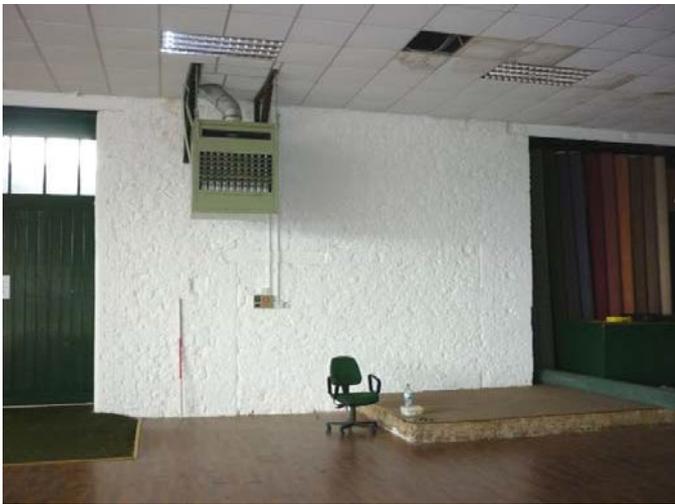
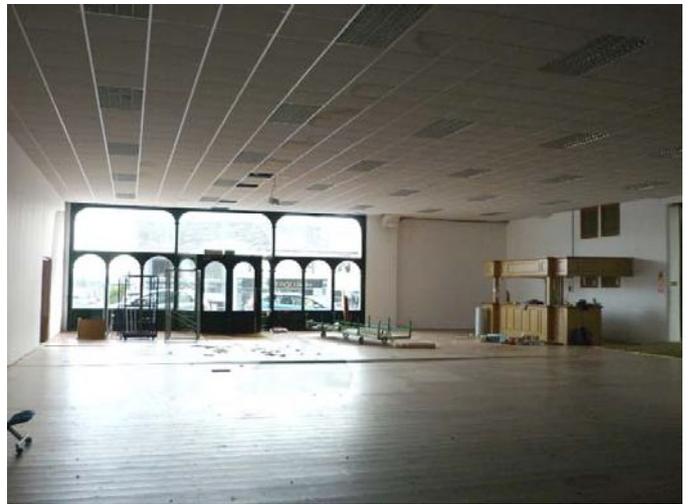
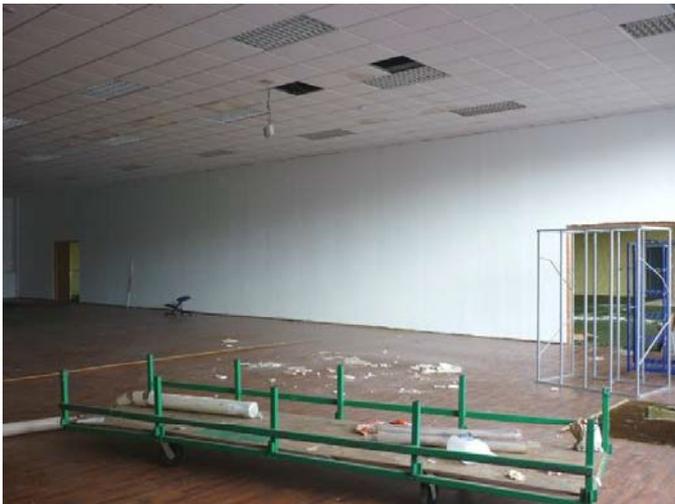
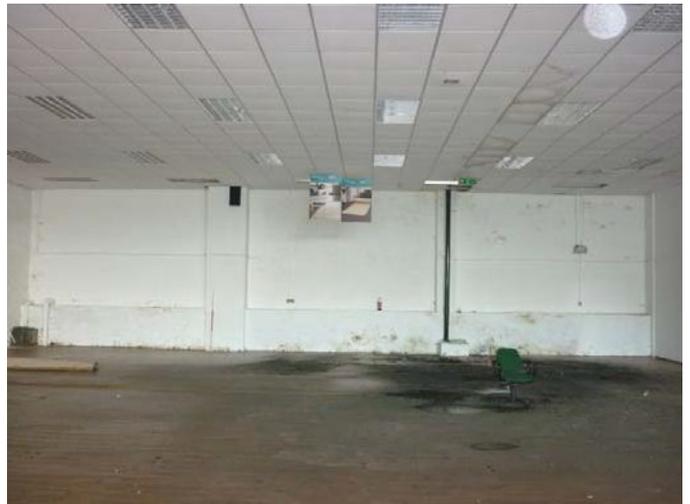
4.3.2 Bowman's, Room 2: this room had presumably been used as a showroom when it had been occupied by Bowman's after it had been used as a bus depot in the 1970s (see *Section 3.3.9*). It had a laminate floor with a slight ramp to the large doorway to the south-east side on the south-east elevation and a raised area constructed from concrete blocks in front of the other doorway on this side of the room (Plate 26). There was a desk in the south corner of the room and the whole room had a suspended polystyrene ceiling with iron trusses above, which were visible through gaps in the tiles (Plate 27). The north-east elevation was a modern stud wall with double doors on the north-west and south-east side (Plate 28). The south-east elevation was filled mostly by a large glazed frontage, which comprised eight-

lights, including two which were canted to form an entrance with a double door. There were three larger lights over all of this, and there was a slight step in the wall to the south-east. The south-east side of the south-west elevation had a modern finish and a single door to the rooms beyond (which were not recorded). The rest of the elevation was painted rough stone. There were two large sliding doors to the north-west of this door; the south-west doorway had bull-nosed brick jambs, the one to the north-west had square brick jambs, but both looked original. Between the two sliding doors there was a blocked doorway with a stone lintel, with bull-nosed brick used in the jamb on the south-east side. There was a further bull-nosed jamb to the north-west but this did not correspond to the other side of the doorway as it was in effect the wrong way round. This appeared to correspond to a similar jamb to the north-west. Both of the large doors had iron I-beam lintels and the door handles were labelled 'THE HENDERSON' and '[illegible] BARKING LONDON'. There was a further pedestrian doorway at the north-west end of the elevation, which had a concrete lintel and a c. 1930s door with a moulded rail above and an automatic closing hinge labelled 'THE BRITON PATENT No. 621457747'. The door led through into a block of toilets and stores (see Section 4.3.3 below). The north-west elevation had a stone plinth with two brick pillars, the south-west one extending beyond the plinth (Plate 29). There were downpipes coming into internal drains against this wall. The upper part of the top of the plinth was brick in English garden bond (at 4:1).

Plate 26 (top left): South-west elevation of Bowman's, Room 2 – derelict showroom to the south-west
Plate 27 (top right): South-east elevation of Bowman's, Room 2 – derelict showroom to the south-west
Plate 28 (bottom left): North-east elevation of Bowman's, Room 2 – derelict showroom to the south-west
Plate 29 (bottom right): North-west elevation of Bowman's, Room 2 – derelict showroom to the south-west

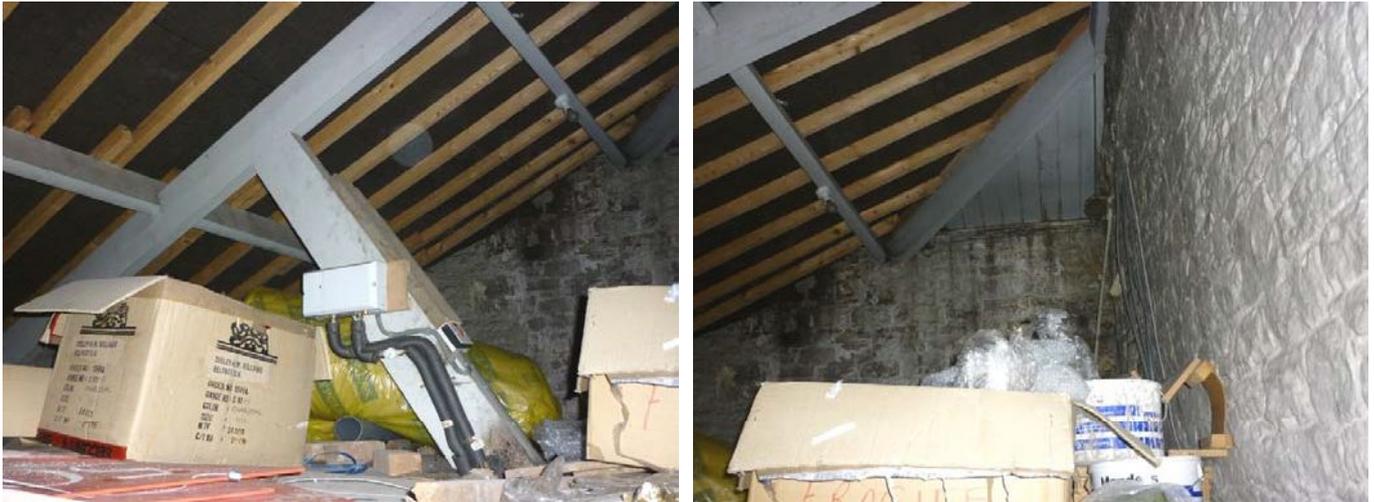
4.3.3 **Bowman's, Room 2a:** this area was accessed from through a doorway in the west corner of Bowman's, Room 2 and was subdivided into two toilet blocks and a storage room, which were accessed via a small corridor. The rooms were on the north-west side from a corridor which ran along the south-east. There was a tiled floor throughout and a plaster ceiling, and there was a north-west/south-east beam across the centre. Where the structure was visible it was brick built in a stretcher bond. The door at the south-west end of the corridor led outside. The rooms had a generally modern finish and were unremarkable; the area was of interest because of the roof-space. The south-east wall was stone (visible to the right hand side in Plate 31), and probably original, and the others were brick. The door to the south-west extended much higher and a single half-truss, with an angled brace, supported the roof (Plate 30). There were four purlins. The east corner of the roof was angled and finished with tongue and groove boards (Plate 31).

Plate 30 (left): Angled brace supporting the half-truss above Bowman's, Room 2a – the toilet block

Plate 31 (right): Corner of the roof space above Bowman's, Room 2a – the toilet block

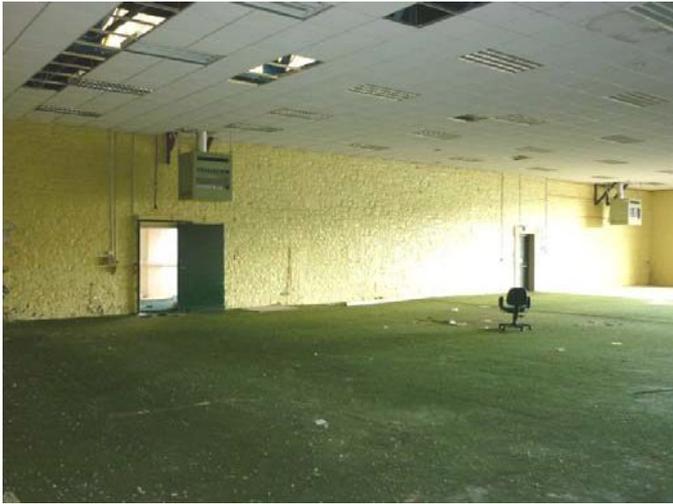
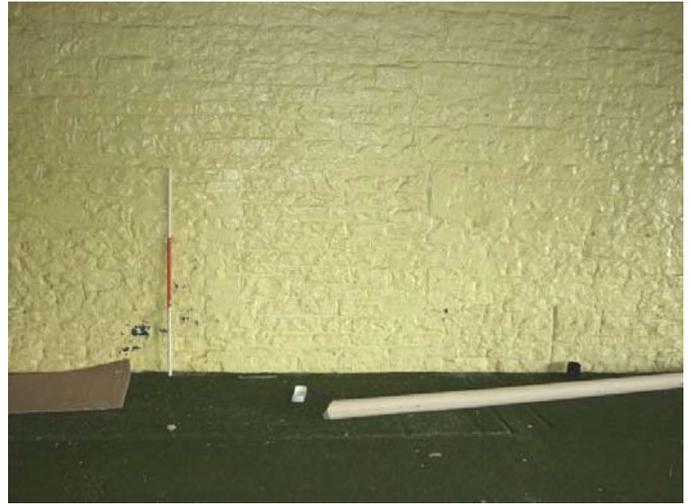
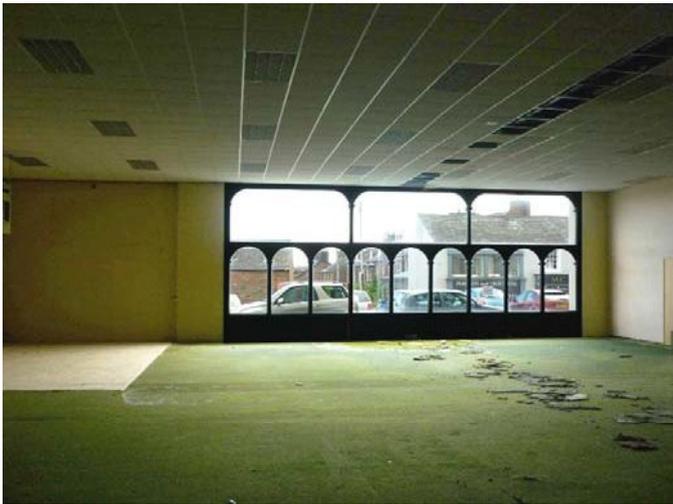
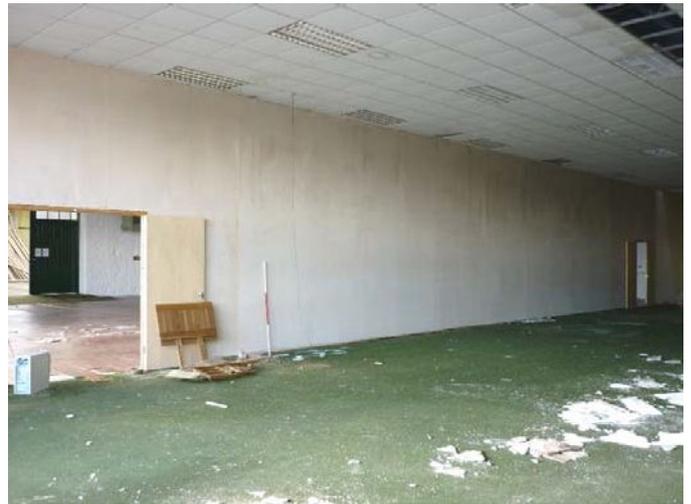
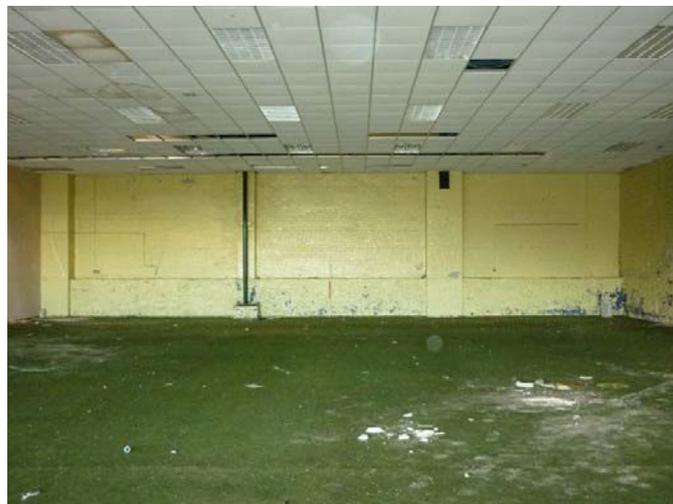
4.3.4 **Bowman's, Room 3:** carpet covered what was probably a concrete floor and there were two lines, possibly of earlier walls, running north-east/south-west across the room. There was a suspended polystyrene tile ceiling below the iron trusses, which were visible through gaps in the tiles. The north-east elevation was exposed painted stonework and some dressed blocks appeared to have been re-used (Plate 32). The doorway to the north-west was possibly original and had a concrete lintel and a sliding door. The runner was marked 'COBURN N^o 1'. There was a blocked doorway to the south-east which had brick in the jambs but no lintel remained (Plate 33). The doorway to the south-east of that was inserted and had projecting concrete surrounds. The south-east elevation had a brick build to the north-east end in English garden bond (in a ratio of 4:1), with an off-centre projecting pillar and a large window to the south-west (Plate 34). There were nine lights in the window and three lights above. The south-west elevation was a modern partition and formed the north-west elevation to Bowman's, Room 2 (Plate 35; see Section 4.3.2). The north-west elevation was also like that for Bowman's, Room 2 and had a stone plinth and a brick top between two columns and a drain.

Plate 32 (top left): North-east elevation of Bowman's, Room 3 – derelict showroom to the north-east

Plate 33 (top right): Blocked doorway in the north-east elevation of Bowman's, Room 3 – derelict showroom to the north-east

Plate 34 (middle left): South-east elevation of Bowman's, Room 3 – derelict showroom to the north-east

Plate 35 (middle right): South-west elevation of Bowman's, Room 3 – derelict showroom to the north-east

Plate 36 (bottom): North-west elevation of Bowman's, Room 3 – derelict showroom to the north-east

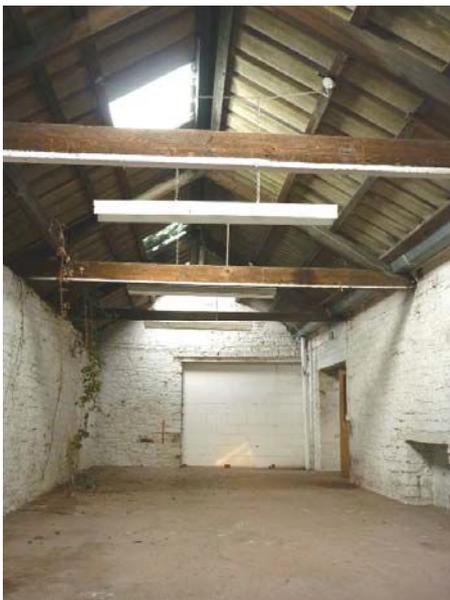
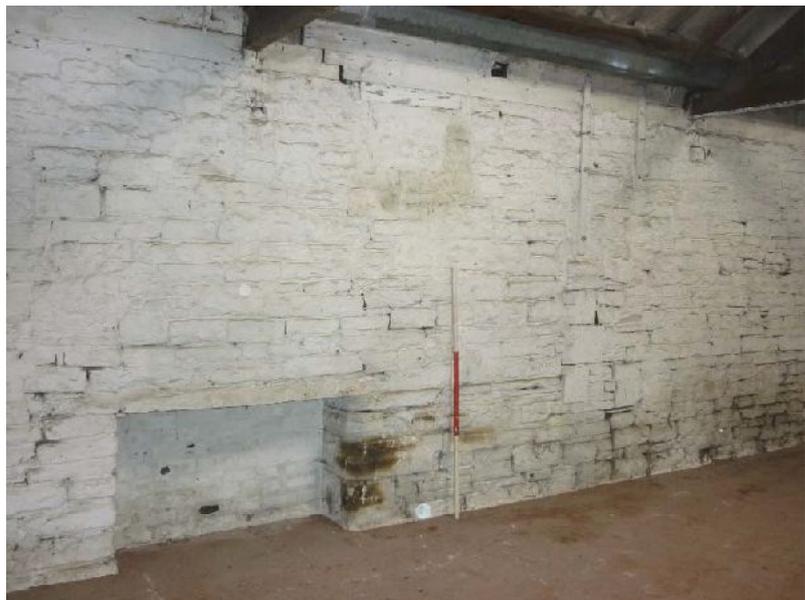
4.3.7 **Rickerby's, Room 1:** this room had a concrete floor and was open to the roof (Plate 37). The roof structure comprised four machine-cut timber trusses, each a very simple tie-beam type, with the principals overlapping, south-west on north-east, with an additional beam between the two central ones on the south-west side, strapped in place with iron rods in the same position on either side (but not at the north-west end). There were three purlins on the north-east side and two much closer together on the south-west side, and a double ridge purlin. There were four skylights in the south-west side, made from clear corrugated sheets. There was a galvanised steel or aluminium gutter on the north-east side, at a junction with the section to the north-east. The north-east elevation had exposed stone in rough courses, which had been whitewashed. The south-east end of the elevation was plain. There was possibly the line of an aperture near the centre and part of a quoined edge (visible to the right on Plate 38). There was nothing corresponding to it to the north-west, but there was a slight plinth beyond it. At ground level there was an opening to the north-west, which was possibly a hearth, with roughly quoined jambs and a timber lintel and a brick-built back in a stretcher bond (Plate 38). There was some evidence for it having been inserted or possibly rebuilt to the north-west of this and there was a smaller blocked aperture above it with a timber lintel below the wall plate, which was the full length of the wall top. The wall plate was jointed in the middle and at the south-east end with small timber brackets for the gutter all the way along. There were two iron straps attached across the wall plate and bolted off centre to the wall. There was a doorway with a heavy machine-cut timber lintel at the north-west end which possibly had the original quoin jambs, but the quoins were smaller and less regular to the north-west side of the aperture (Plate 39). The doorway housed a modern double door, with infill evident at the edges of the aperture, and there was a single light in each door. The north-west elevation was plain except for the doorway on the north-east side which was blocked with concrete blocks to leave an alcove (Plate 37). The doorway had an iron I-beam lintel and there was evidence for another blocked window over this as per the exterior (see Section 4.2.7). A tie rod or water pipe ran above the lintel. The south-west elevation was plain (Plate 40). There was a crack at the north-west end and a row of low-level small holes for vents, which were blocked. The wall top was lowered and the trusses were on blocks. There were some scars for walls or possibly fittings at the south-east end (towards the left-hand side of Plate 40). The south-east elevation was a modern stud partition wall with a double door, with a single light in each (see Plate 45).

Plate 37 (left): General view of Rickerby's, Room 1, looking north-west

Plate 38 (right): Doorway in the north-east elevation

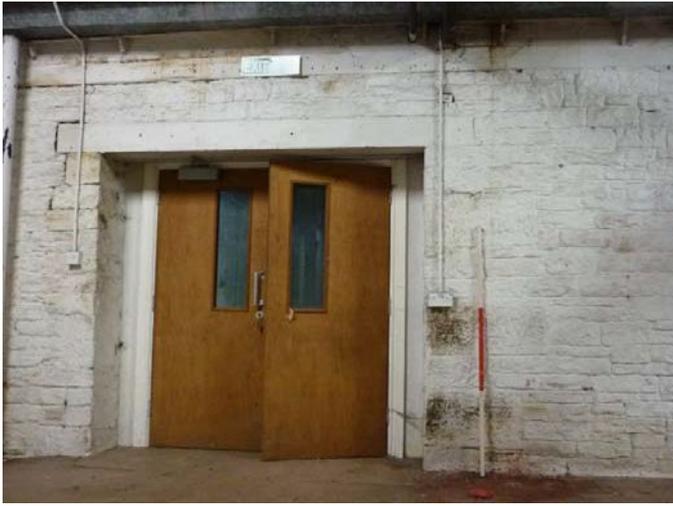
Plate 39 (left): Possible hearth in the north-east elevation

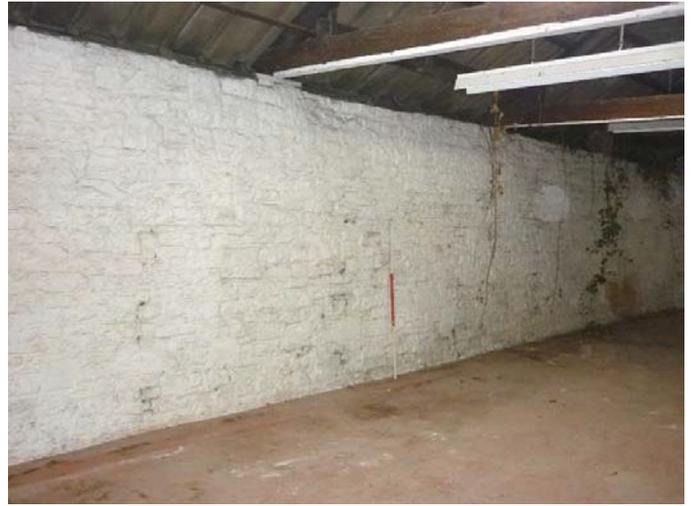
Plate 40 (right): South-west elevation

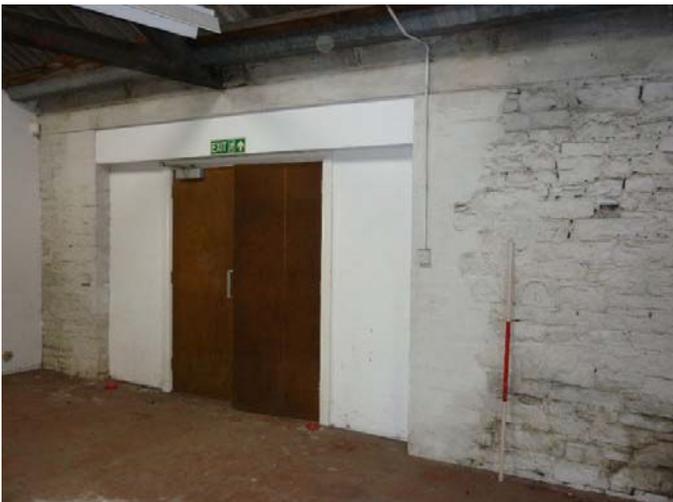
4.3.8 **Rickerby's, Room 2:** this room was open to the roof, with two trusses which were the same as those in Rickerby's, Room 1, of which this room was effectively a continuation. It had a concrete floor at the same level as Rickerby's, Room 1, which was c. 0.05m lower than Rickerby's, Room 4. There was a pipe along the south-west side of the room, connecting to a gas valve in the south corner. There was a doorway on the north-west side of the north-east elevation which housed modern double doors and had quoins evident in the lower part of the north-west jamb; the top section was rebuilt (Plate 41). The south-east jamb was rebuilt in brick and the timber lintel was formed from the continuous beam / wall plate with boxing below and some infill. The wall plate supported the trusses in this room and the ends of the trusses from Rickerby's, Room 4. There was more timber above with small timber brackets supporting what appeared to be the original lintel. There was a modern aluminium gutter beyond. The rest of the wall was largely plain apart from a blocked window at the south-east end where the quoins were evident but there was no lintel or sill (Plate 42). To the north-west there was a circular section cut in stone with two nails inserted (visible immediately to the right of the scale bar in Plate 41). The south-east elevation was a modern concrete block construction and had metal brackets attached (Plate 43). The south-west elevation was plain apart from a row of low level apertures, all but one of which were blocked (Plate 44). The north-west elevation was a modern partition with a modern double door (Plate 45).

Plate 41 (left): Doorway in the north-east elevation of Rickerby's, Room 2

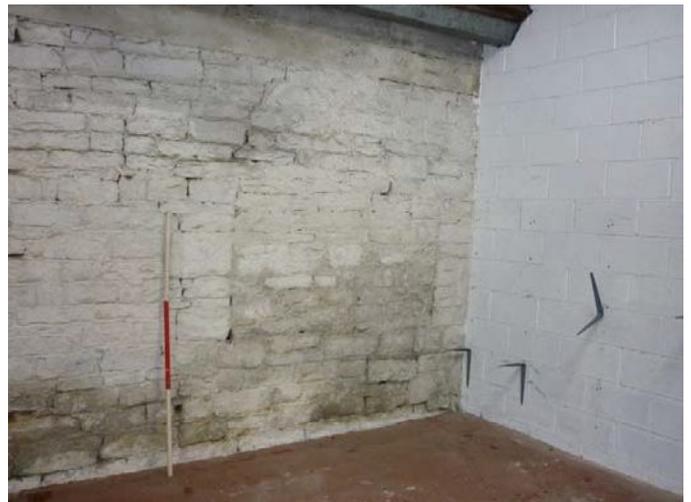
Plate 42 (right): Blocked window at the south-east end of the north-east elevation

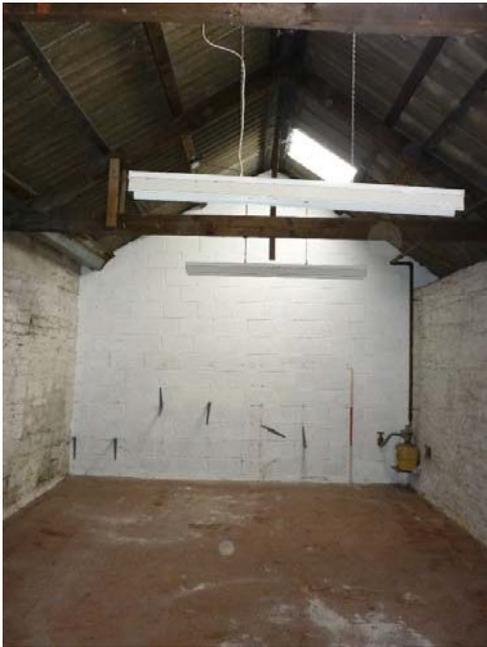
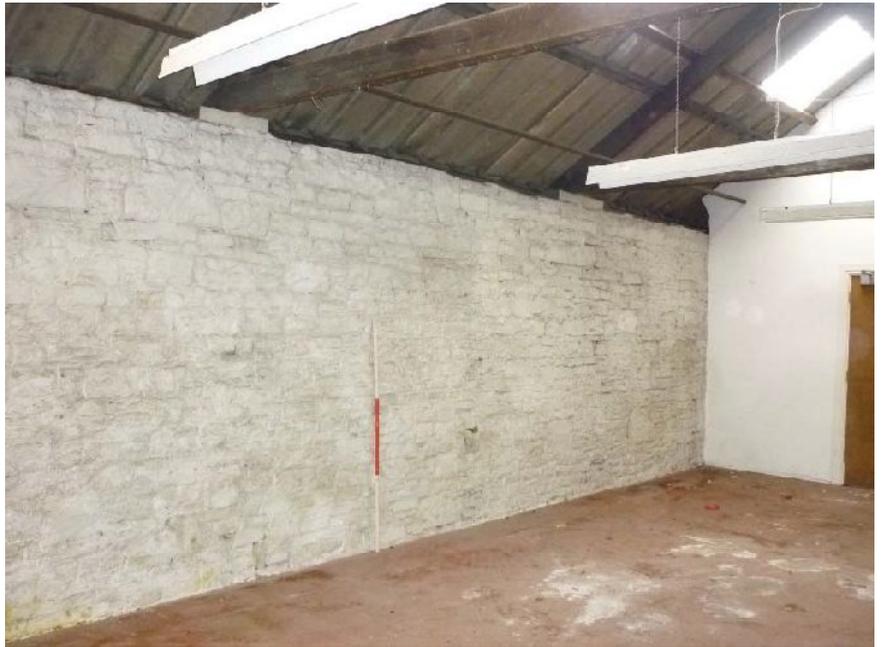
Plate 43 (left): South-east elevation of Rickerby's, Room 2

Plate 44 (right): South-west elevation of Rickerby's, Room 2

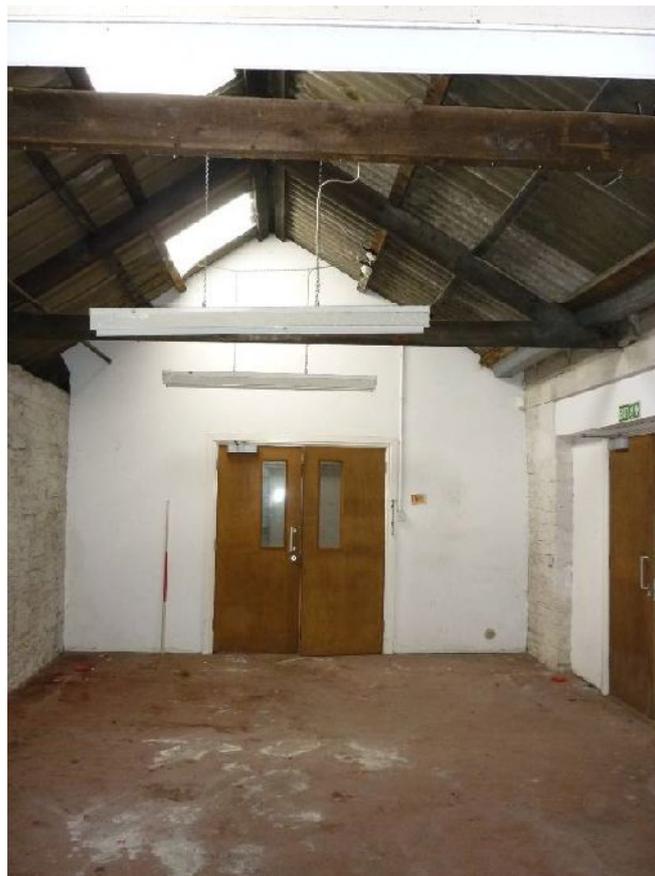
Plate 45: North-west elevation of Rickerby's, Room 2
