BRUNSWICK ROAD, PENRITH, CUMBRIA

Archaeological Building Recording

Client: Booths (Penrith) Ltd

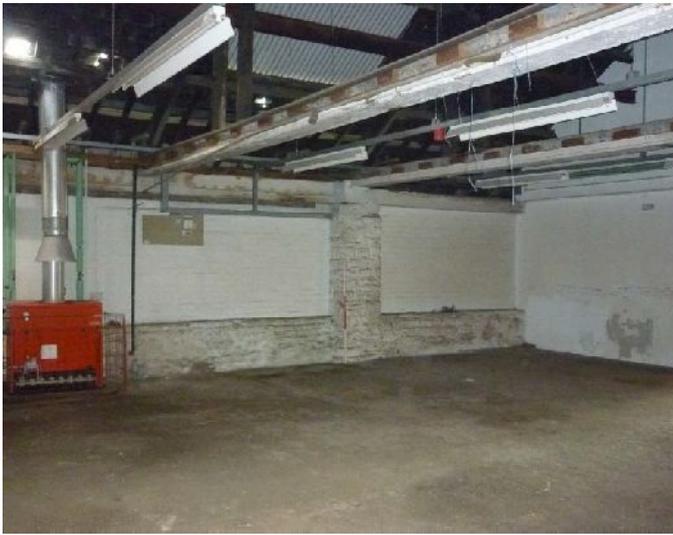
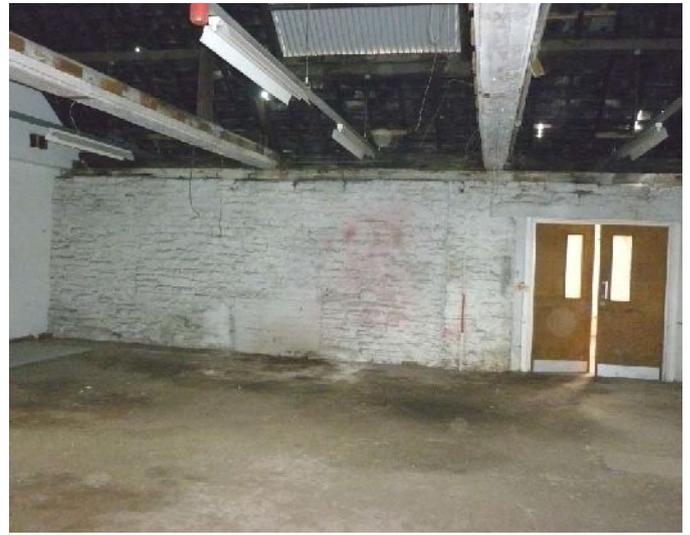
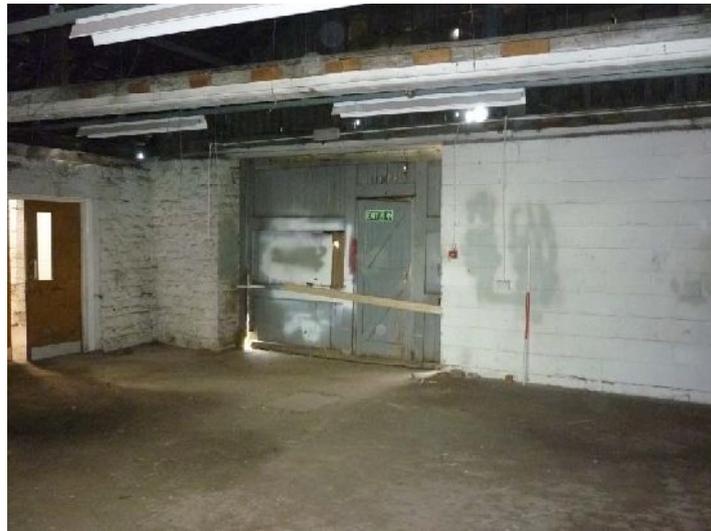
4.3.9 **Rickerby's, Room 3:** there was a manhole cover in the north-west corner of the concrete floor and a boiler in the north corner of the room. There were two tie-beam trusses in the roof, with a collar and queen braces bolted on and additional parallel braces on the north-east side with iron brackets for principals, which just overlapped at the junction, and an additional north-west/south-east beam. There

were three purlins per pitch and a plank ridge purlin. There was a timber beam / wall plate in both the north-east and south-west elevations. The north-east elevation was relatively plain but had two large openings, with stone sills and a lintel formed by the wall plate, essentially taking up the entire wall apart from the column in between (Plate 46). The north-west end lintel projected over the south-east lintel and was slightly chamfered and cut away on the south-east end. The south-east elevation was a modern partition with a central double door. The south-west elevation had some evidence for a butt joint on the south-east side, with bolts for straps above it in extending into Room 1. There was a blocked low-level aperture to the north-west side (Plate 47), with a timber lintel, which had been filled with brick corresponding to the 'hearth' in Room 1 (see *Section 4.3.7*). There was a slight return at the north-west end before the doorway, which had a machine-cut lintel and a modern door. The wall did not extend to the roof and the tie-beams sat atop the wall plate. The north-west elevation was stone on the south-west side, with quoined jambs for the door (Plate 48). The doorway housed a large sliding plank and batten door that incorporated a smaller pedestrian door as well. There was a block work wall beyond the door to the quoined return of the original wall. A timber construction formed the upper part of the wall, which was effectively another truss with modern timber coverings attached and incorporating a pair of 24-light windows with iron frames.

Plate 46 (top left): North-east elevation of Rickerby's, Room 3

Plate 47 (top right): South-west elevation of Rickerby's, Room 3

Plate 48 (bottom): North-west elevation of Rickerby's, Room 3

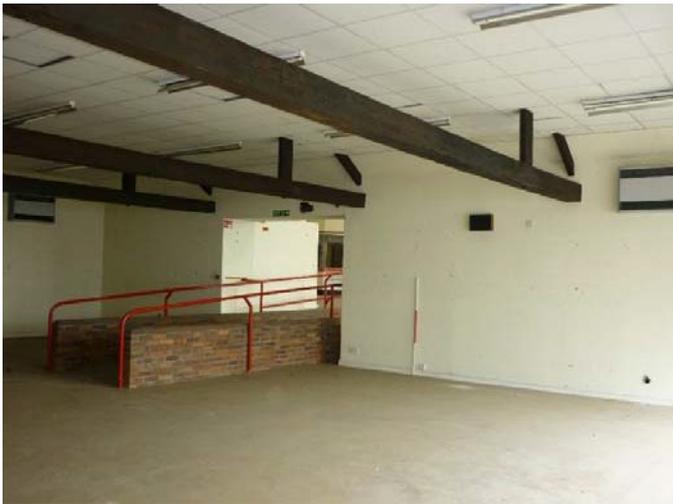
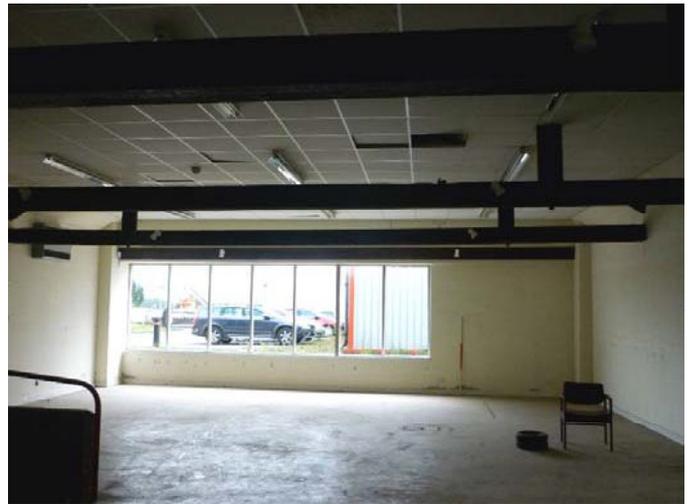
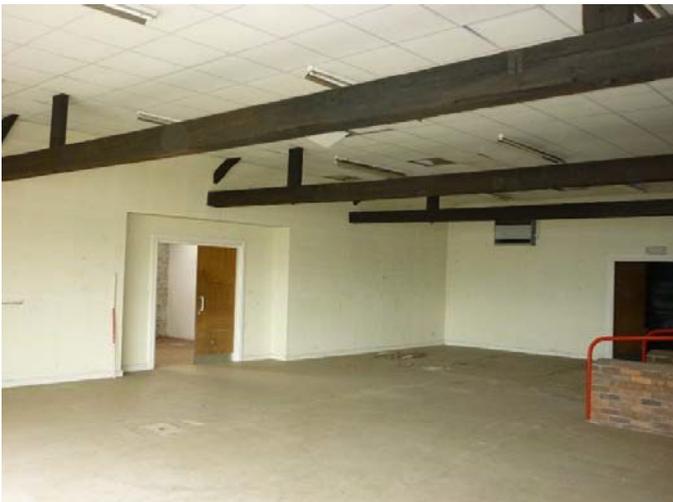
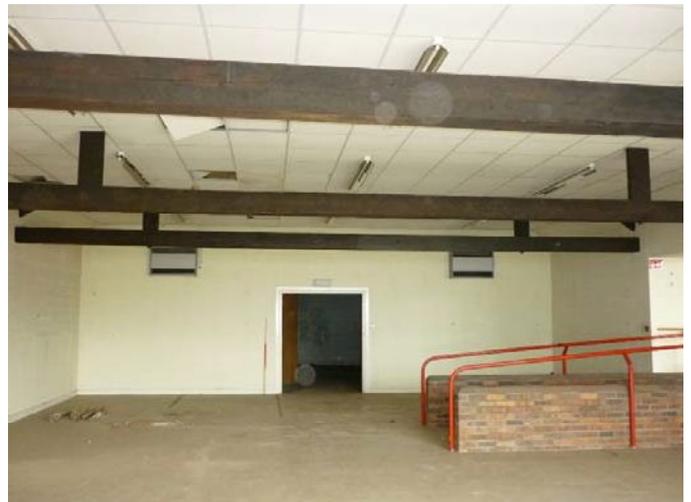
4.3.10 Rickerby's, Room 4: the concrete floor of this room had been painted and the room had a suspended polystyrene tile ceiling. Some of the original trusses projected through this suspended tile

roof but the roof structure was inaccessible; it was presumably the same as those in Rickerby's, Room 3, although without the additional queen braces on the north-east side. All the tie-beams had extensive Baltic timber marks, mostly on the north-west face. The walls were all modern and had a plaster and paint finish. The north-east elevation was plain and had some modern electrical fittings (Plate 49). The central doorway had an access ramp with flanking walls and metal hand rails. The original timber lintel was covered by boxing. The south-east elevation had a large seven-light modern window with a timber lintel (Plate 50). The lintel was in two pieces which had been strapped together with iron plates and perhaps were re-used pieces of a truss. The wall was slightly angled below this on the south-west side. The south-west elevation was plain apart from the doorway in the centre, which had a recessed modern panel infill and a modern double door (Plate 51). The north-west elevation had some electrical fittings and a central double door (Plate 52).

Plate 49 (top left): North-east elevation of Rickerby's, Room 4

Plate 50 (top right): South-east elevation of Rickerby's, Room 4

Plate 51 (bottom left): South-west elevation of Rickerby's, Room 4

Plate 52 (bottom right): North-west elevation of Rickerby's, Room 4

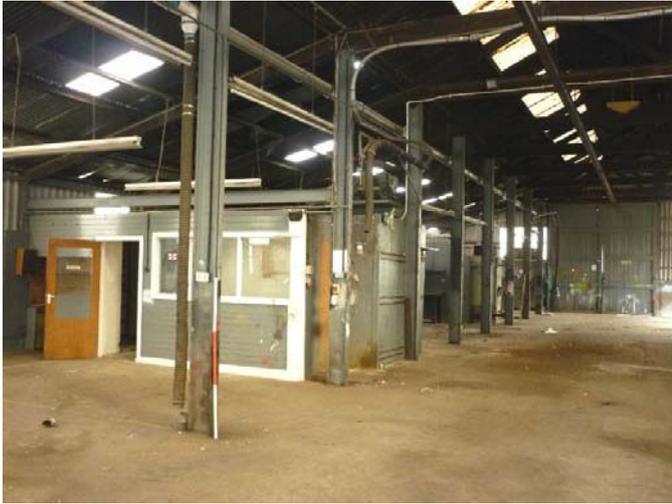
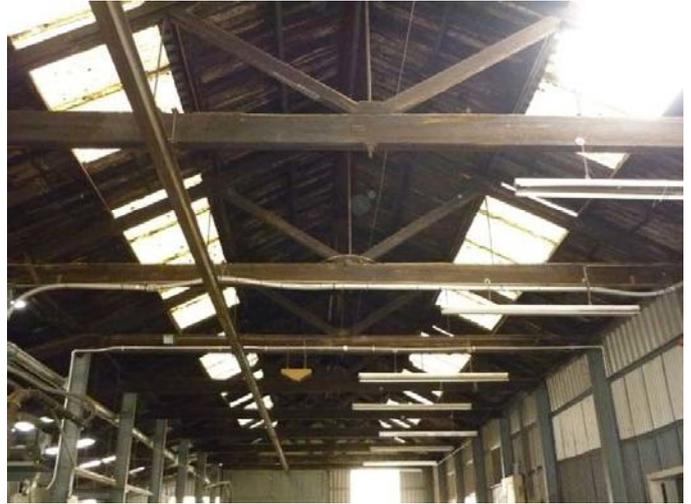
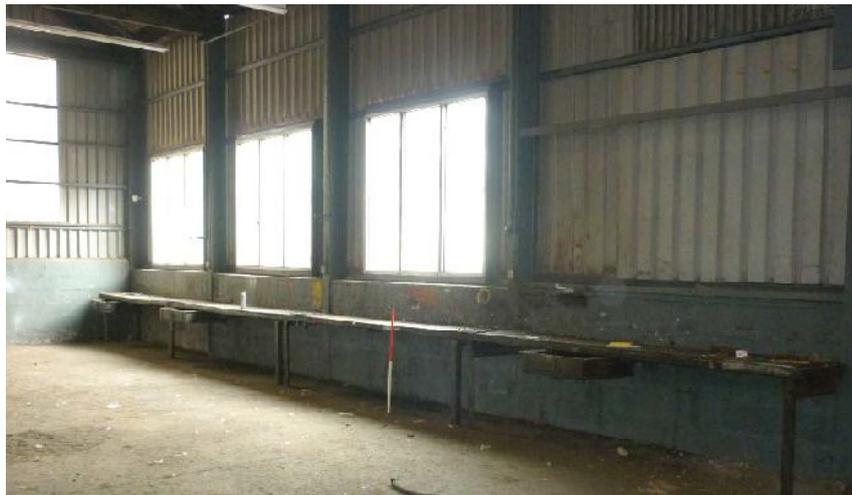
additional tie rods were used below the braces. The girders were marked 'DORMAN LONG & Co MIDDLESBOROUGH ENGLAND'. Additional timbers extended the space to the north-west on smaller girders. All of the walls were formed by a low wall of concrete blocks built between upright girders and the upper part was finished with corrugated sheets. There were large roller doors in the south-west elevation and a sliding timber plank and batten in the north-east side. There were small 'rooms' formed by stud partitions to the north-west and timber stud extensions to this side through two doorways. There were windows in the north-east end of the south-east elevation and three pedestrian doorways to the south-west. There was a large wooden bench with three heavy drawers in the east corner of the room against the south-east elevation, with an iron superstructure which was fixed to the girder in the wall (Plate 55).

Plate 53 (top left): General view of Rickerby's, Room 5

Plate 54 (top right): Truss in Rickerby's, Room 5

Plate 55 (bottom): Large bench against the south-east elevation of Rickerby's, Room 5

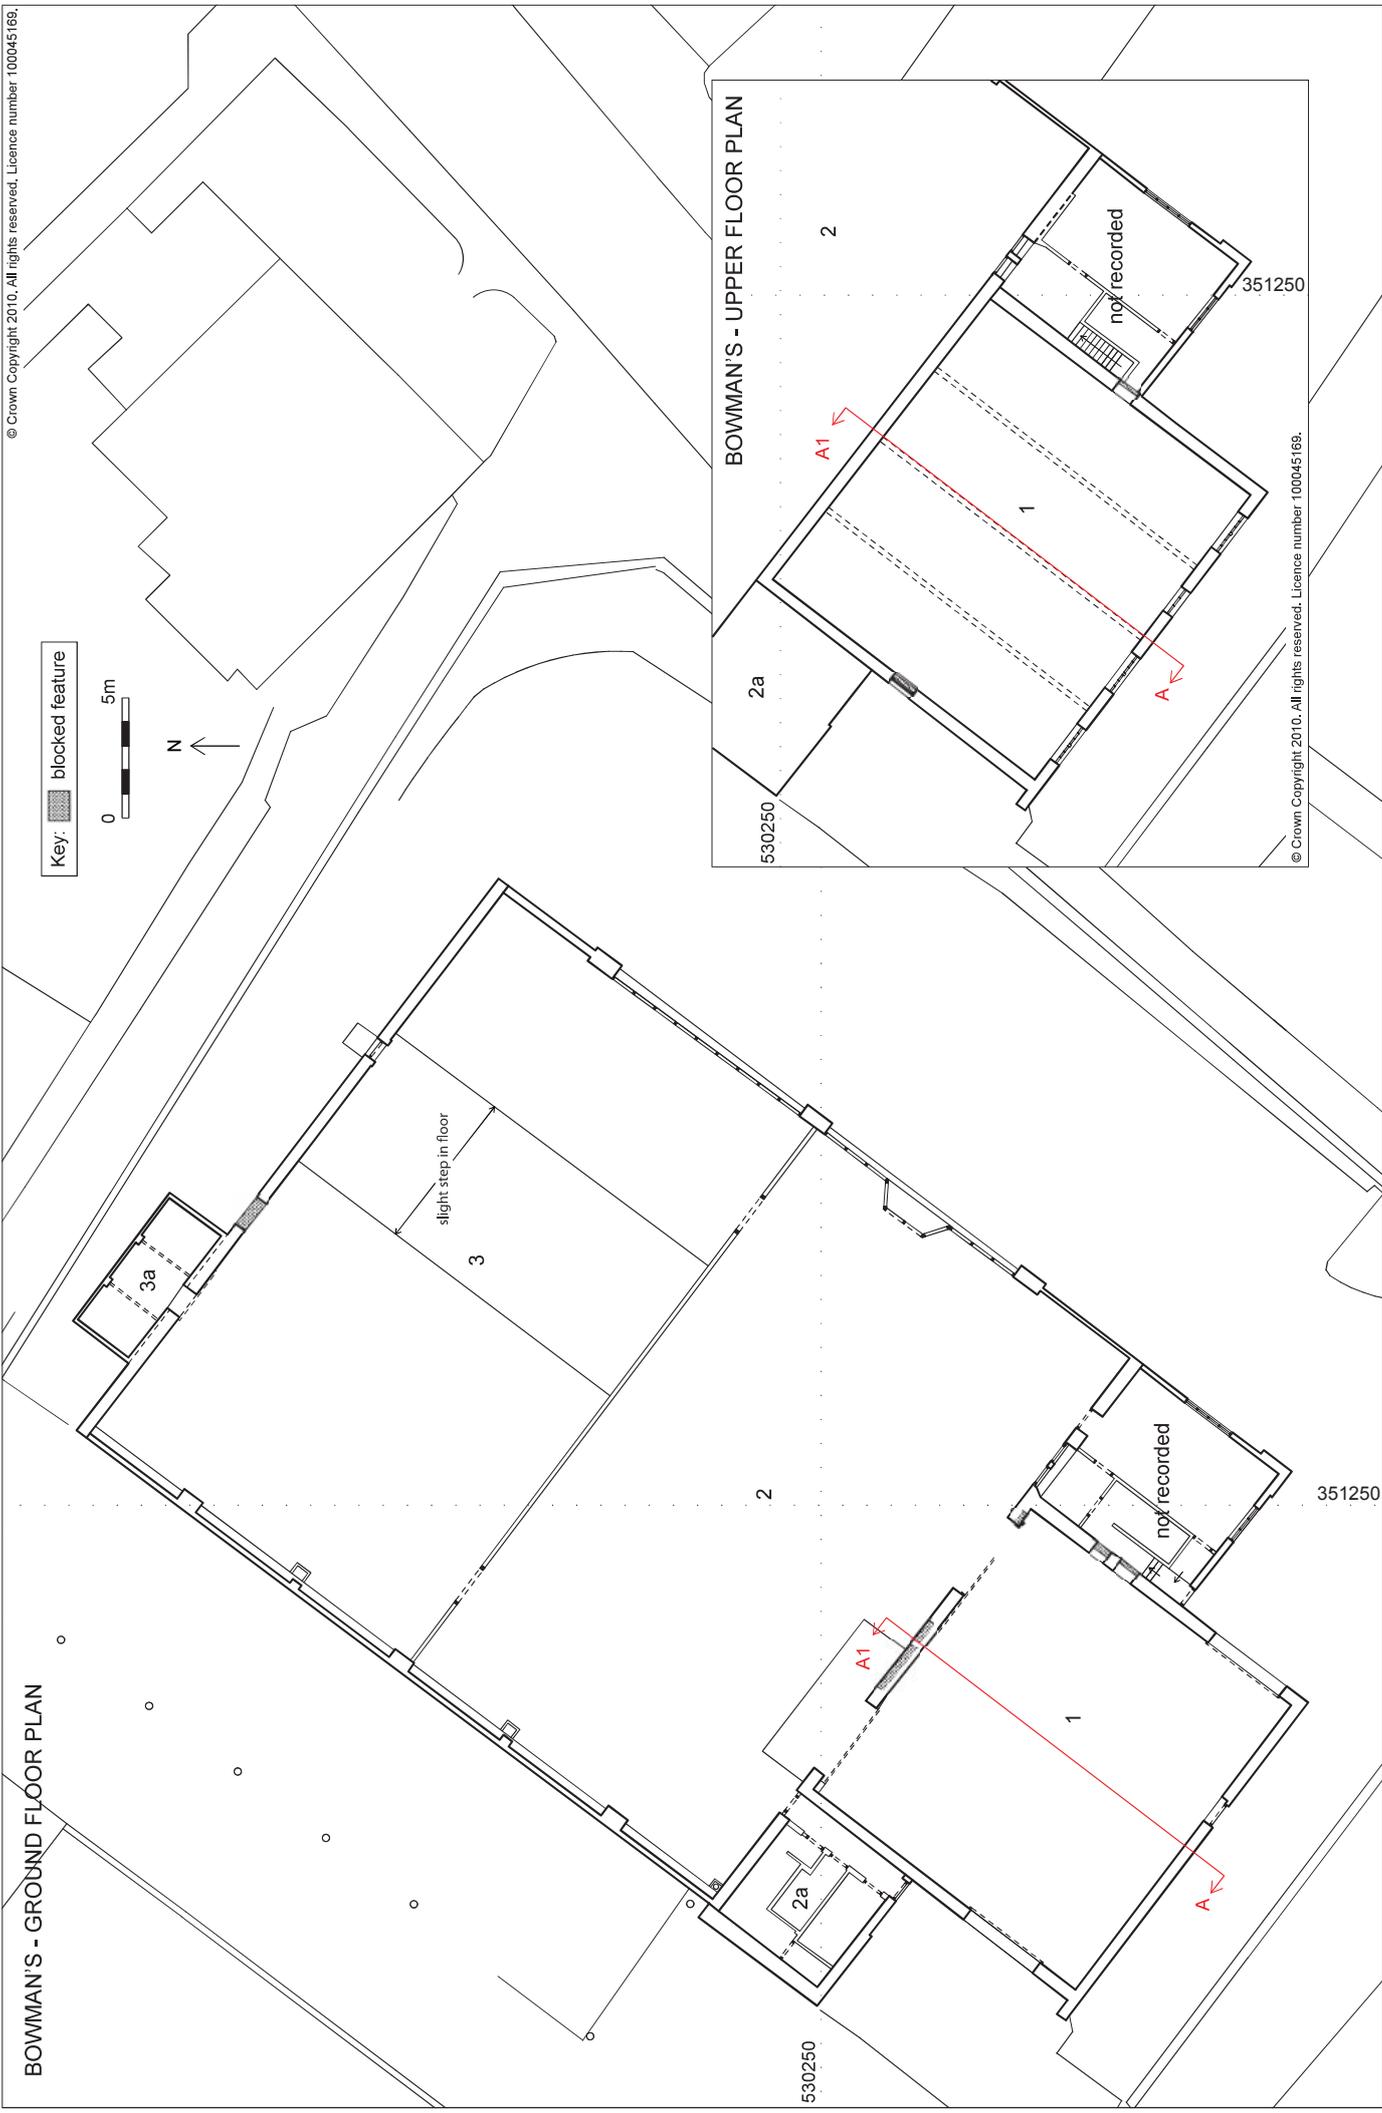
Figure 2: Ground floor and upper floor plan of Bowman's

RICKERBY'S - GROUND FLOOR PLAN
