FORMER MADRESSA AND JOINERY WORKSHOP, PEEL HALL STREET, PRESTON, LANCASHIRE

Archaeological Building Recording

Client:
Preston Muslim Society

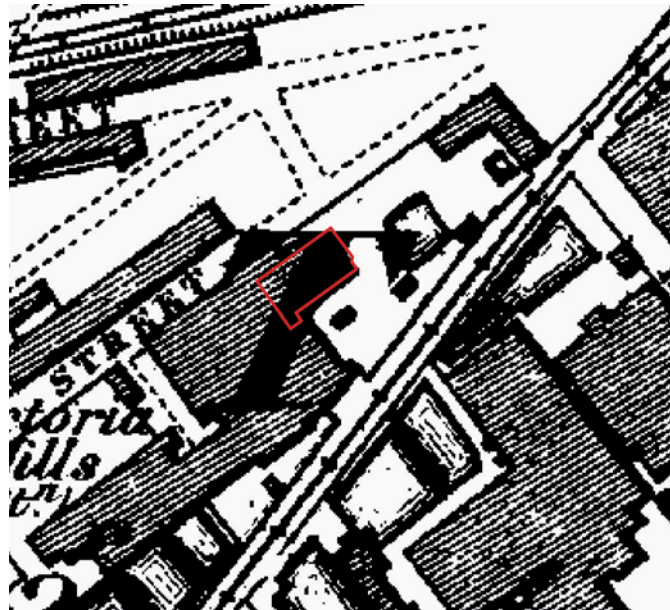
Plate 1: Ordnance Survey, 1849

3.3.3 **Ordnance Survey, 1849:** this map shows the development area as occupying the north-east part of what was the site of 'Victoria Mills (Cottⁿ)', which fronted onto Peel Hall Street to the north-west side of the site, and the railway passes the site immediately to the south-east (Plate 1). There are buildings shown across the site at this time, some of which possibly related to the functioning of the cotton mills, including some that are within the footprint of the building being recorded. It is unfortunate, however, that much of it is obscured by a large letter 'T' in the word 'PRESTON', and that the scale at which this map was produced is inadequate to discern further details of the buildings that were on the site at this point.

3.4.2 There appear to be buildings shown within the area of the current building recording on the Ordnance Survey map of 1849, but unfortunately much of the area of the site is obscured on this edition by a giant letter 'T' (Plate 1). The site appears at this time to occupy the north-east end of Victoria Mills, which was a cotton mill. More of the detail of the site is shown on the 1893 edition of the Ordnance Survey, which indicates that it formed part of a foundry (Plate 2). It seems likely that much of the fabric of the early structure was incorporated into the later phases of use, since the footprint of the building is identical to that shown on the later maps. The large rectangular building which occupied the footprint of the site was extended to the south-east along most of this side by the time the 1929 edition of the Ordnance Survey map had been produced (Plate 3).

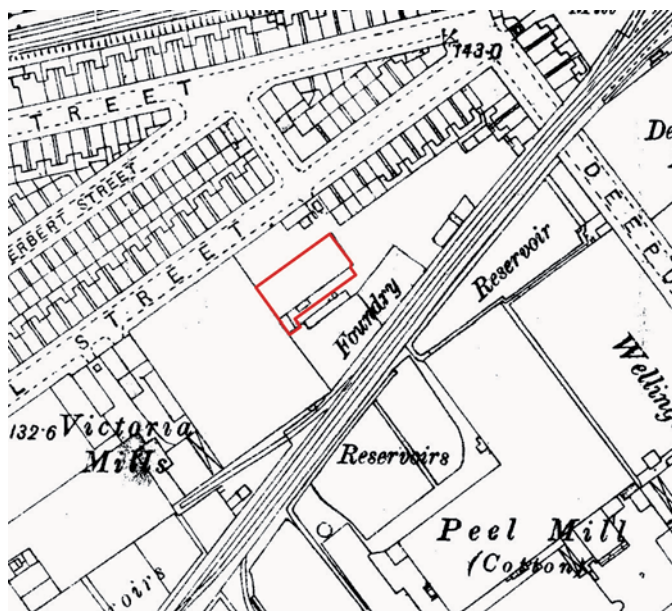
Plate 2 (left): Ordnance Survey, 1893

3.3.4 **Ordnance Survey, 1893:** this edition of the Ordnance Survey was published in 1893 but surveyed in 1891. Some of the internal divisions of the buildings are shown on this map and 'Victoria Mills' is labelled to the south-west of the site (Plate 2). To the north-east of the site there has been further development with rows of terraced housing built along Peel Hall Street and Deepdale Mill Street since the 1849 edition of the Ordnance Survey (*cf.* Plate 1). Although they were obscured in the Ordnance Survey map of 1849, the buildings within the footprint of the current building recording are shown in some detail; there are two small buildings butting against the south-east side of a large rectangular structure, which is orientated north-east/south-west. In addition, there are apparently buildings immediately to the south of the site labelled 'Foundry', which seem likely to relate to the building being recorded.

the south of the site, labelled 'Foundry', which are shown on the 1891 Ordnance Survey, have been removed (Plate 3; cf. Plate 2). The large rectangular building within the footprint of the current building recording has been extended to the south-east along most of its length from the north-east end and the small building that was shown at the south-east corner of the building in 1891 has been removed.

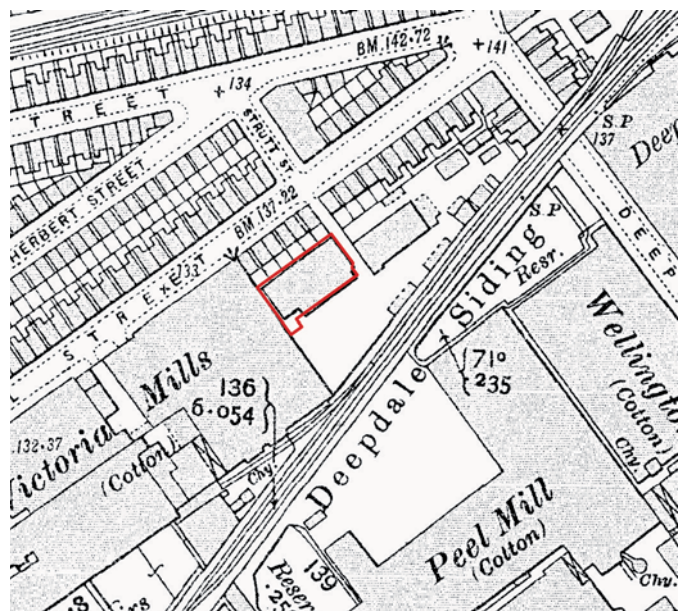
Plate 3 (right): Ordnance Survey, 1929

3.3.5 **Ordnance Survey, 1929:** by this date the area to the north-west of the site had been filled with terraced housing and 'Victoria Mills (Cotton)' is still present to the south-west (Plate 3). The structures to

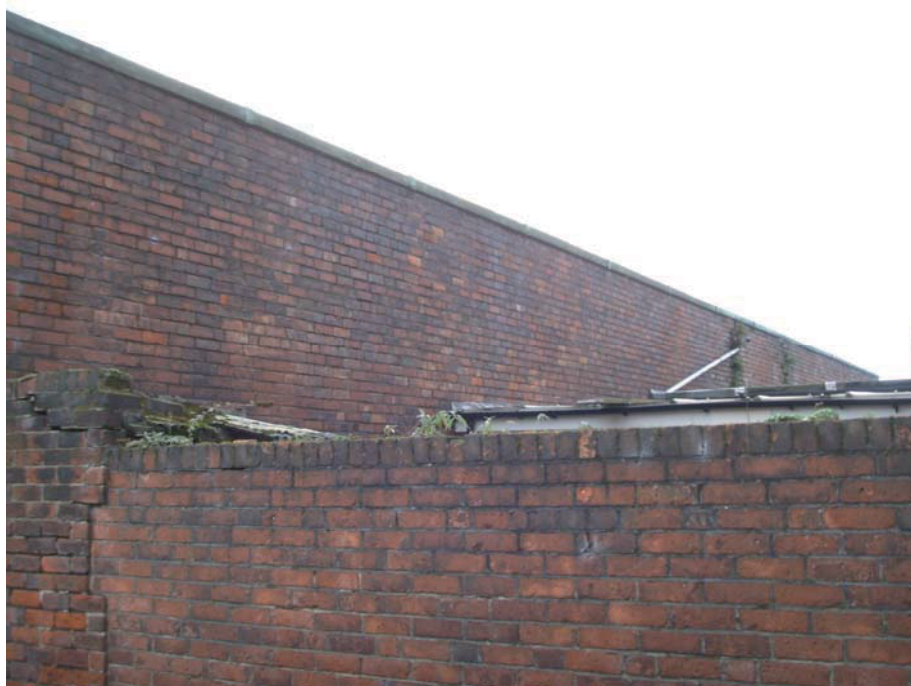
Plate 4: North external elevation from the north-east

4.2.1 **North elevation:** this was inaccessible on account of the proximity of adjacent buildings, including some directly adjoining outbuildings, and difficult even to view adequately (Plate 4). It is an essentially plain, brick construction, with no apparent apertures; the junction comprising the replacement skin of brighter red brick extending to the east and south is evident on the east side. There are two large 14-light skylights in the roof, and an iron box gutter along the wall top.

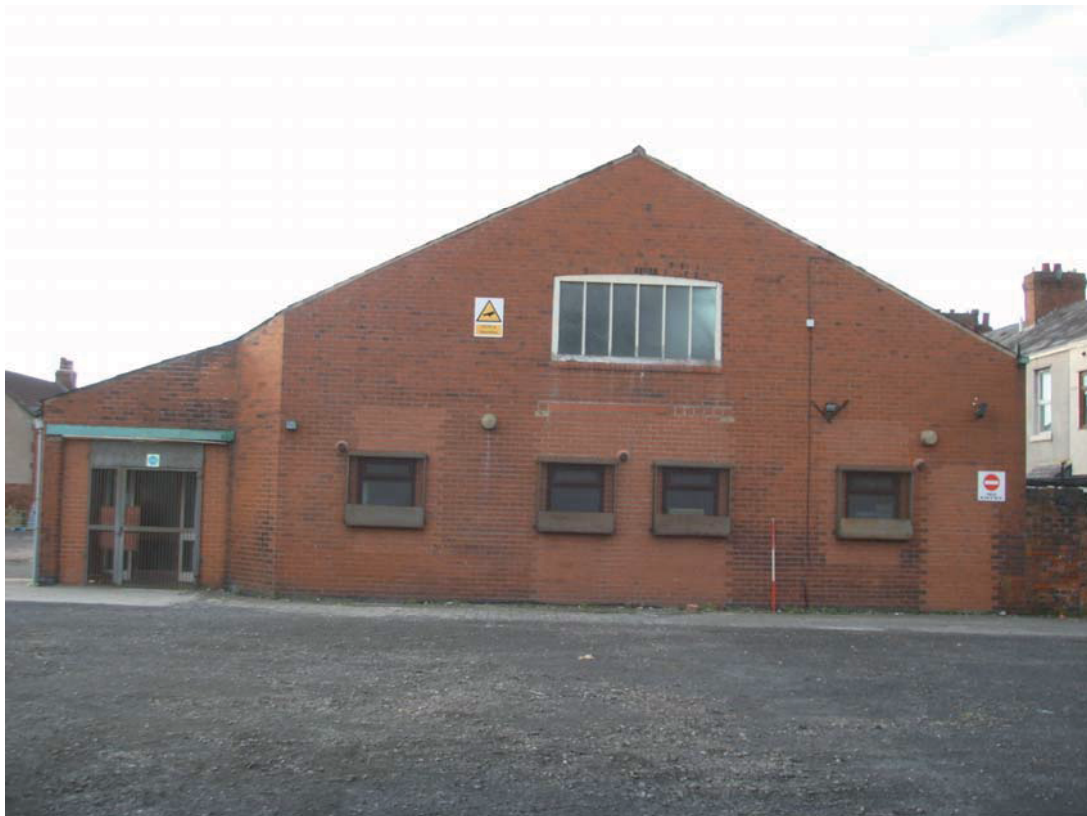
Plate 5: General view of the east external elevation

4.2.2 **East elevation:** this forms the gable end of the building, extended on the south side with a monopitch roof (Plate 5). The north end is butted by a lower boundary wall, and there is an evident former doorway blocked with later red brick to the south of this (Plate 6). Immediately to the south of this there was a window with a two-light UPVC casement, which is evidently within an earlier aperture that has been remodelled. Beyond this, in the centre of the ground floor of the elevation, there was evidently a large doorway, which has been blocked with brick and used to house two further windows in a similar style (Plate 7). The line of the original lintel of this large doorway is visible as a row of red ceramic tiles and at either end there is a piece of dressed yellow sandstone forming the pads for the lintel. Above the central blocked doorway there is a large window with a flattened brick arch and six light fixed casement. The south end of the main part of the elevation has another window housed within an earlier aperture partially blocked with brick. To the south of this the wall has a slightly angled turn before returning to the same line. Within the far southern end, which comprises a monopitch extension, there is a wide doorway with a timber board attached across the line of its lintel, which again sits on a dressed yellow sandstone pad at either end, and the columns forming the jambs have bull-nosed bricks in the corners. The original opening has been slightly narrowed with the insertion of modern brick sections, which house an outer gate and form a small porch. The internal door proper is modern with two lights and is flanked by glazed sections of stud walling each also with two lights.

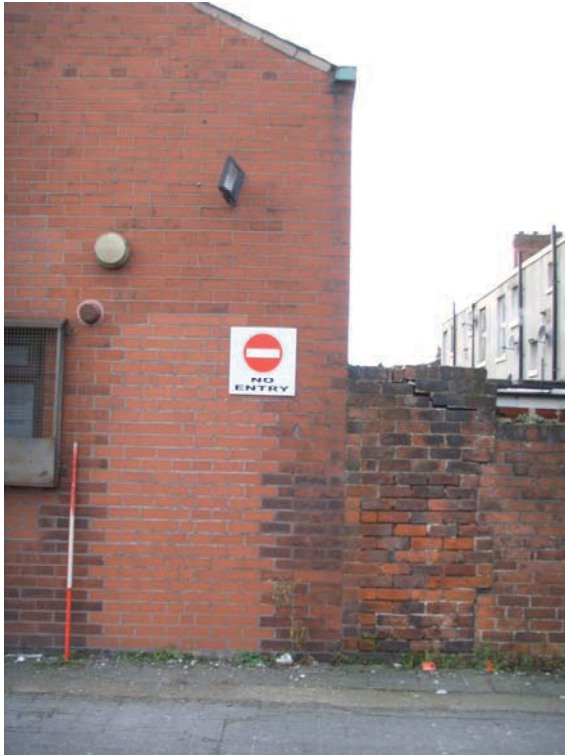
Plate 6 (left): North end of the east external elevation, showing the blocked doorway and adjoining boundary wall

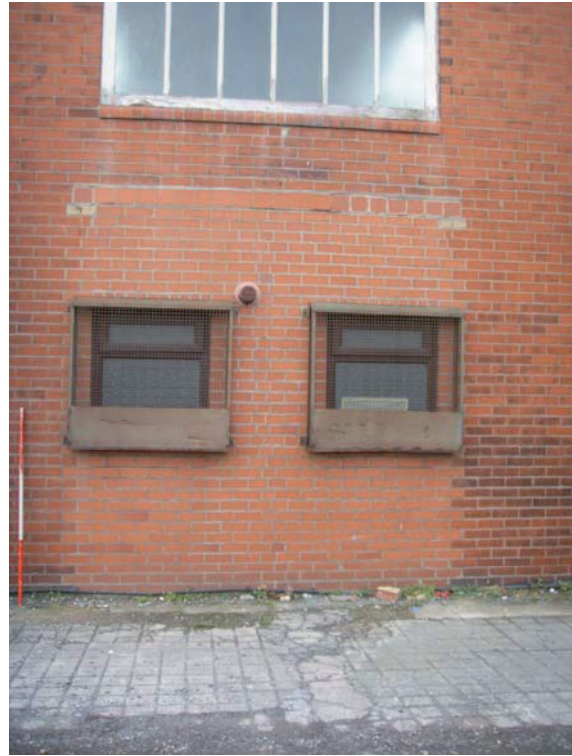
Plate 7 (right): Large central doorway blocked and incorporating two windows

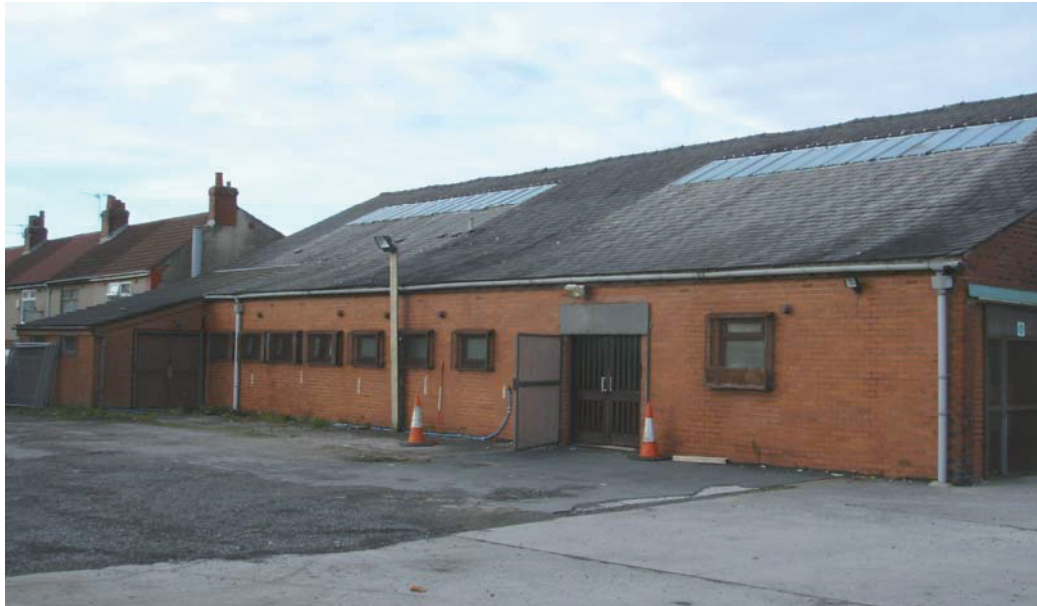
Plate 8: General view of the south external elevation

4.2.3 **South elevation:** this comprises the long side of the monopitch extension to the main building and the later monopitch outshut at the south-west corner, although the roof of the main part of the building is evident above and incorporates two large 14-light skylights (Plate 8). The east side has a relatively large window with a two-light UPVC casement with a double doorway to the west, the doors of which have multiple glazed sections and a two-light over light covered externally by a piece of the framing for the metal bars. To the west there is a row of three single-light windows and to the west of these is a row of four two-light windows, each with blank central sections where further lights might have been. The wall returns at the west end where it is extended by the modern outshut. There is a double doorway in this return with a very plain timber plank door. In the return to the west there are two further very narrow single-light windows with timber casements and plastic rain water goods are attached to a timber barge board, both of which run along the entire elevation.

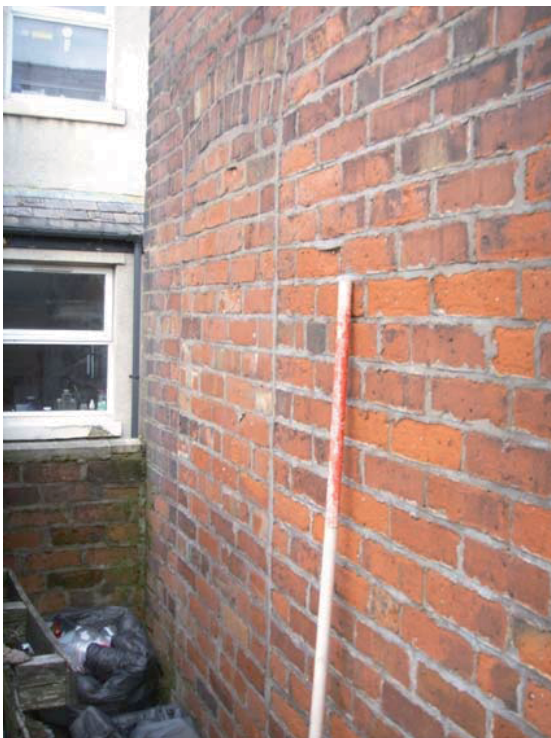
Plate 9 (left): Blocked doorway at the north end of the west external elevation

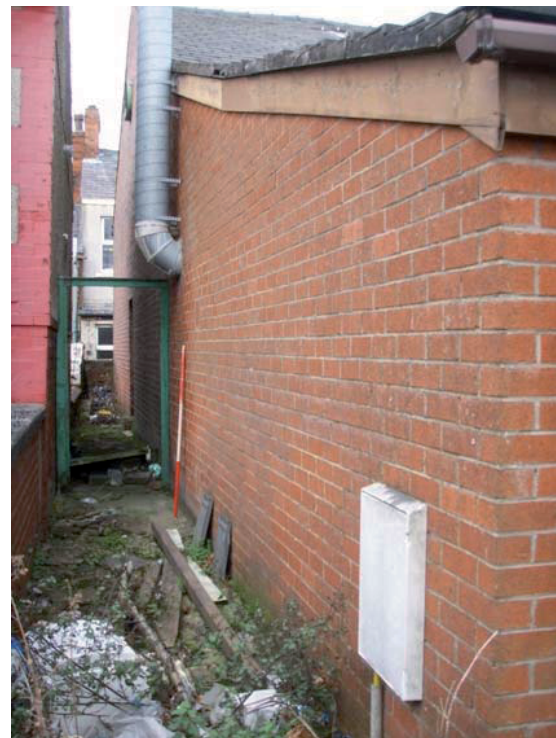
Plate 10 (right): Modern outshut extending the west external elevation

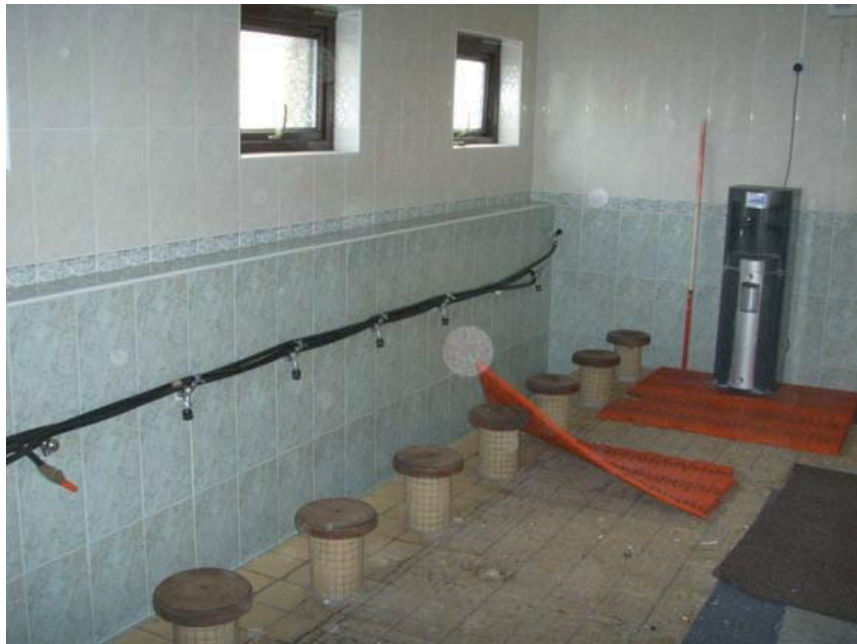
Plate 11 (left): South side of Room 1c

4.3.2 Room 1c has a tiled floor, with a drainage channel along the south side with eight low timber topped stools with tiled bases alongside it (Plate 11). The walls are also finished with tiles. The north elevation has a window, which is now internal, covered by furniture and a notice board but intact, and has a fixed four-light timber casement (Plate 12). There is a double doorway to the west with glazed panels within the doors, a two-light over light and two-light flanking panels. The east elevation has a double doorway with plain modern doors, while the south has three single-light windows and water piping attached. The west elevation has a doorway on the west side, the door having glazed panels and plain surrounds. Room 1d comprises a toilet and is sub-divided to form cubicles along the south and west sides. It too has a tiled floor and walls and a plaster ceiling. The north elevation has an alcove on the east side, which was probably originally another window like that in Room 1c, housing a timber bookshelf. The east elevation has a doorway on the north side, the door with glazed panels. The south elevation has a row of two-light windows each divided by the stall partitions providing a single light per cubicle. The west elevation is plain.

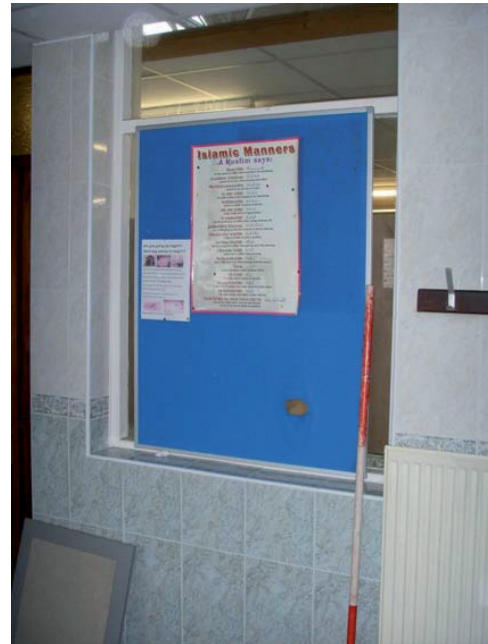
Plate 12 (right): Disused window in the north elevation of Room 1c

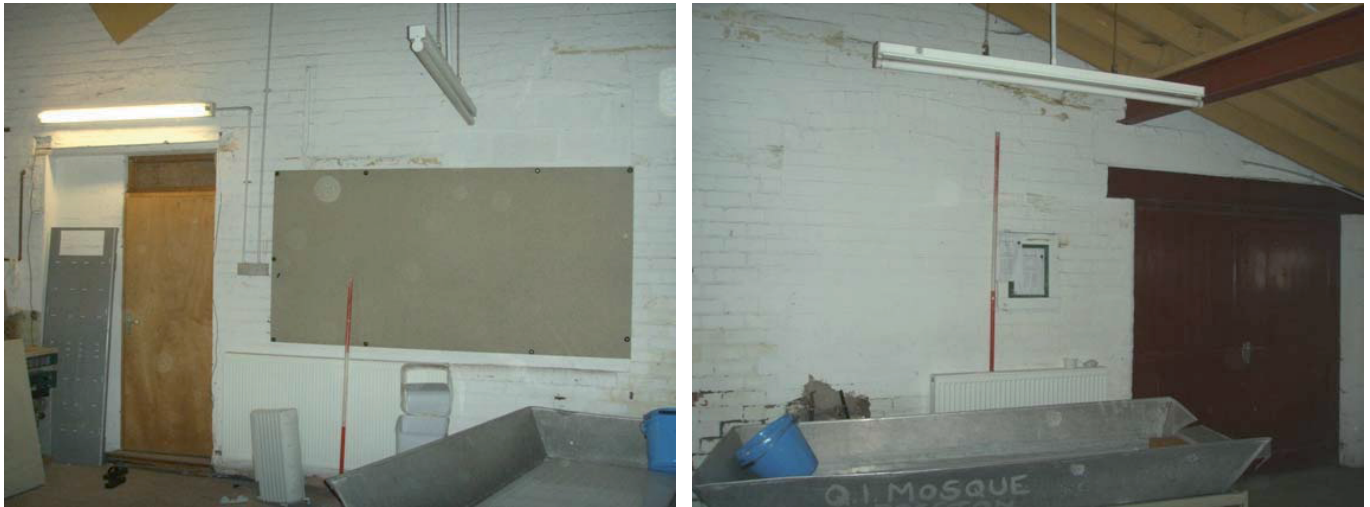
the south and west are concrete blocks. The north elevation has a doorway on the west side, which has clearly been inserted through an earlier window, which had a flattened brick arch (Plate 13). A timber lintel has been inserted into this at a lower level, the original sill and walling below presumably removed, and the west side partially filled with concrete blocks to form a narrower opening, which houses a modern timber door. The open area of wall to the east shows the form of the brickwork, which is laid in five rows of headers to one row of alternating headers and stretchers. There is a further window to the east, also with a flattened brick arch but also with bull-nosed bricks forming the sill, which is blocked with concrete blocks (Plate 13). The east elevation is apparently constructed in the same style, although the south end is extended in concrete blocks and incorporates a double doorway with a modern plank door and a perforated iron box lintel. The brick section contains another window with a flattened brick arch, which is blocked with bricks (Plate 14). The south elevation is plain apart from two narrow windows with timber sills, while the west elevation was also apparently plain but was largely obscured and had a boiler sat against it at the north side. The west elevation clearly butted the north.

Plate 13 (left): North elevation of Room 2, showing remodelled and blocked window

Plate 14 (right): East elevation of Room 2, showing blocked window and extension

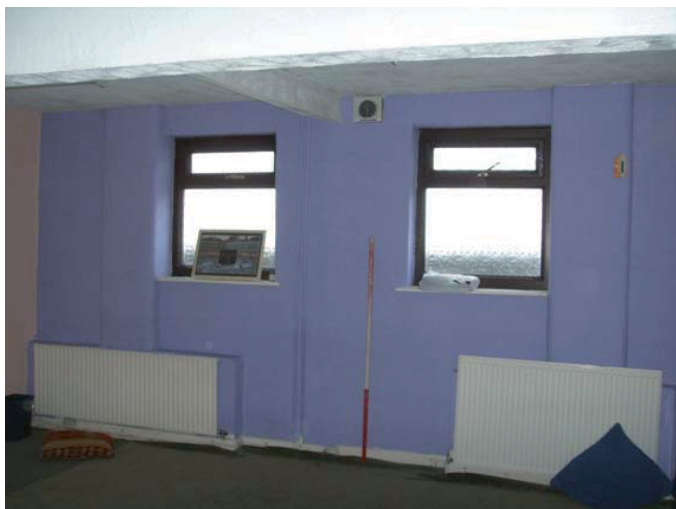
Plate 15 (left): east elevation of Room 3b showing window between buttresses

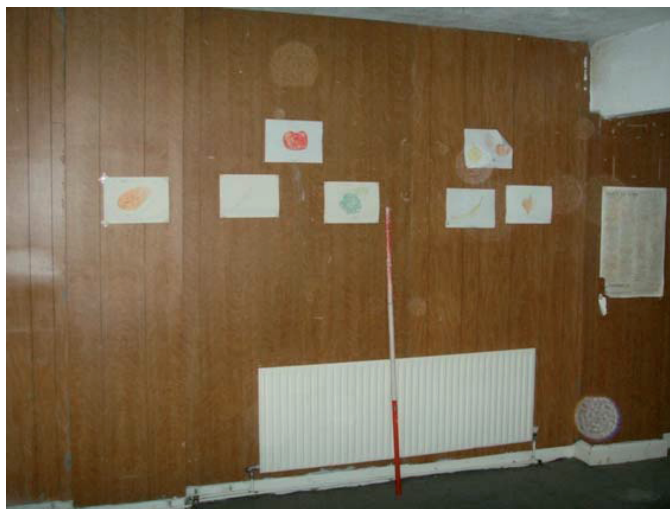
Plate 16 (right): north elevation of Room 3d showing buttress

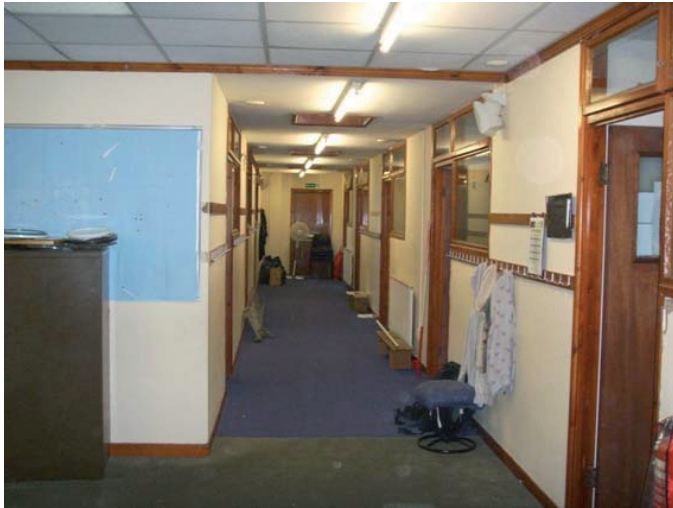
4.3.6 Room 3e forms a large hall connecting to the other rooms in the main part of the building, and includes a corridor at the west end for this end (Plate 17). The floor is finished with a carpet and has a suspended ceiling constructed from insulated tiles supported by an aluminium frame with the occasional glazed panels effectively forming skylights. There are six doorways to the north, each with a modern door, single slight over light and a single-light window on the east side. The east elevation has a doorway on the north side with a plain surround and door, and there is a long, narrow single-light window just below ceiling level. The south elevation has the brickwork exposed, although it is painted, and there are two buttresses visible plus a smaller one to the west (Plate 18). Between the two larger buttresses there is a window with a four-light fixed casement, and to the west of this is a double doorway the doors of which have glazed panels with glazed sections of walling flanking them and a two-light over light. The west end returns to the north before returning west to form the side the corridor, where there are three doors each with an associated window on the east side, as per those to the north. The west elevation, at the end of the corridor, has a slight step on the south side, and a doorway in the centre with a modern door.

Plate 17 (left): Corridor at west end of Room 3e

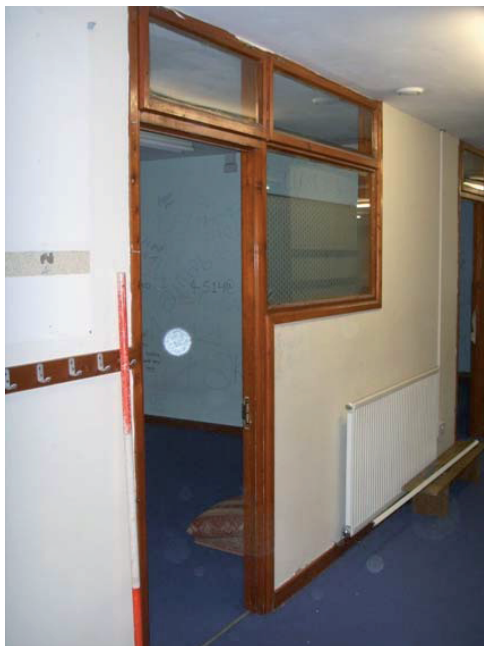
4.3.7 Rooms 3f to 3k are essentially all identical. The floors are all finished with carpet and the ceilings with plaster ceiling with a single light into the roof space. The walls are all painted and there is a plain skirting board throughout, and a doorway on the south side with a single window on the east side. Room 3f has a long narrow window in the east elevation just below the ceiling level. Rooms 3l to 3n are essentially a mirror image of the rooms to the north. Room 3l has a doorway into Room 2 in the south elevation, which is plain apart from an over light, although this is covered with a piece of chipboard.

Plate 19 (left): typical type of doorway into Rooms 3f to 3n

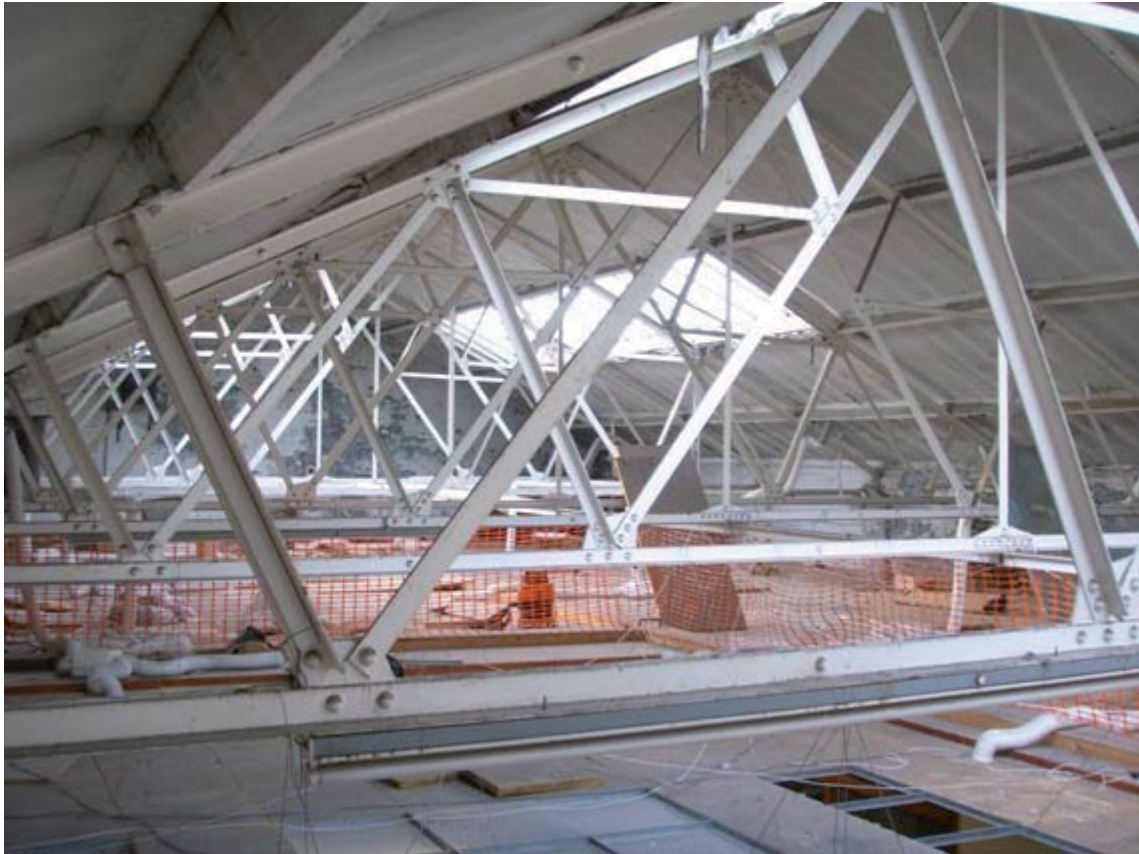
Plate 21: General view of roof trusses in the main roof space

are two blocked apertures in the north elevation both with flattened brick arches. The roof in the main part of the roof space is supported by bolted iron trusses the ends of which typically sit on top of the buttresses in the north and south elevations, although these are not continuous. Each truss is formed from bolted L-shaped pieces, with three timber purlins per pitch, the skylights formed between two of these. The floor is constructed from chipboard, but the central southern area is formed by a suspending ceiling, and there are inserted flimsy walls in the north-east corner forming a small room. The north elevation is painted brick with buttresses arranged along it; the east has a central window between two central buttresses. The south elevation is similar to the north, although there is a return to the east of the centre meaning there are no buttresses in this central section. The west elevation has a circular aperture formed by brick in the centre, below the eaves, which is filled with concrete blocks.
