MATSON GROUND, WINDERMERE, CUMBRIA

Archaeological Building Recording

Client: The Matson Ground
Estate Co Ltd and Peter Scott
1958 Children's Settlement

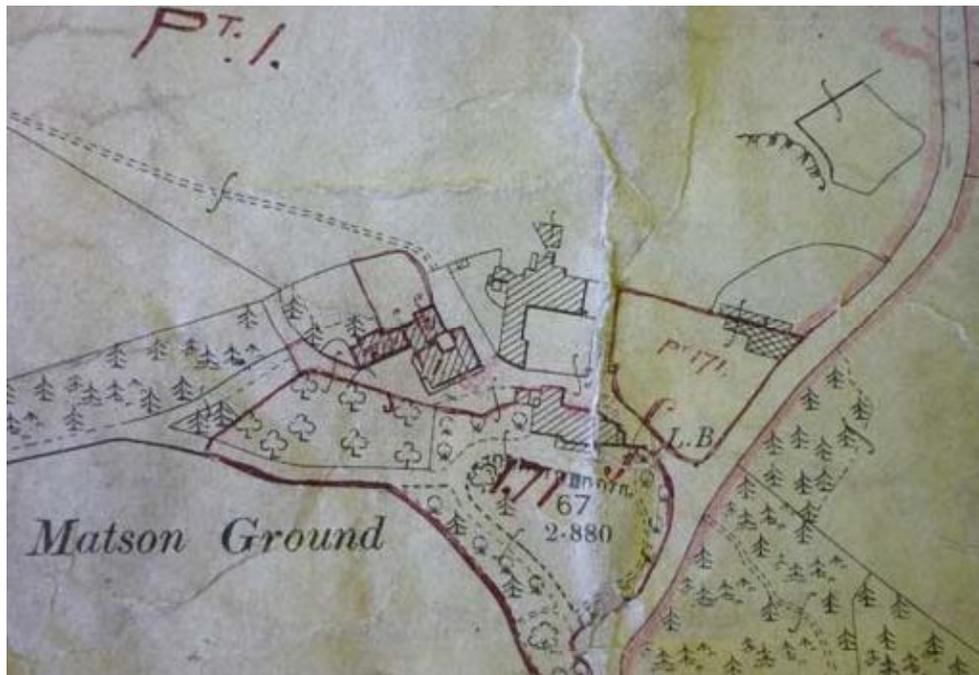
3.2.6 Ordnance Survey 1898: this shows that there has been relatively little alteration to the site since the previous map, although additions have been made to the block of buildings on the north side of the site and the gardens reorganised, with the addition of a large area of glass houses to the north-west (Plate 5). This map has also been used to show the plot numbers used for the 1910 valuation survey; plots numbered 1, which seem to include The Cottage attached to the barn (but not the barn) and the block of buildings to the north, are described as land at Matsons belonging to the executors of 'D Cloudsdale per Bolton & Bolton Lots Kendal [sic]' and occupied by James Robinson. Plots numbered 171, which include the barn, the main house and associated garden, and the garden to the north, are described as 'house garden and stable', with the same owner, but occupied by an A Coulthard (CRO(K) WT/DV/2/26 1910).

Plate 5: Extract from Ordnance Survey map of 1898, showing the plot numbers corresponding to the 1910 valuation

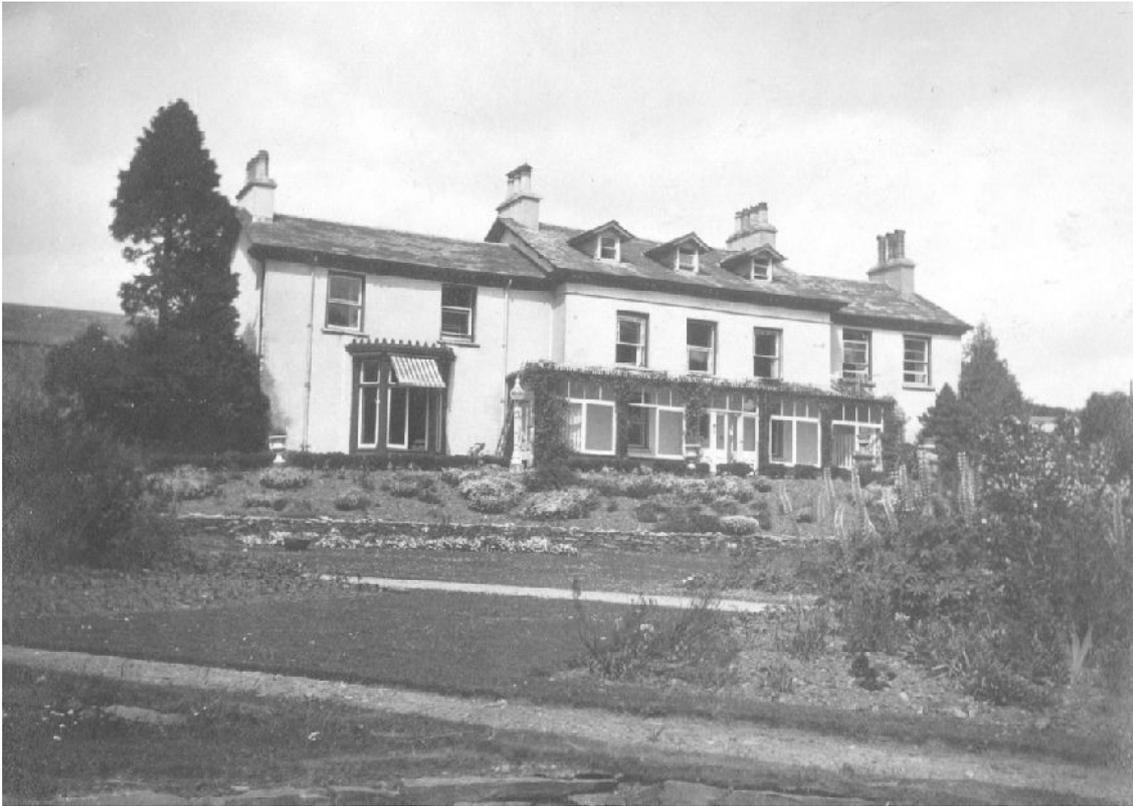
3.2.9 **Photos, 1923-1925:** two photographs of the south elevation of the house dated to between 1923 and 1925 were provided by the client (Plate 8 and Plate 9). These are significant because they show the house prior to a series of substantial alterations and additions (see *Section 3.2.10* below). Of particular interest is the large veranda, which is shown covering a large part of the centre of the elevation; it was clearly considerably longer east/west than the current structure (and much larger than the structure shown in the original drawings (see *Section 3.2.7* above)), in a different location to the present structure (slightly to the east), and had glazed sections with timber casements between the iron framing. The window to the west of the veranda at this date, which is now covered by it, was evidently a bay window at this time and it is apparent that the adjoining garden has been substantially altered since these photographs were taken.

Plate 8: Photograph of the south elevation of the house dated 1923-1925

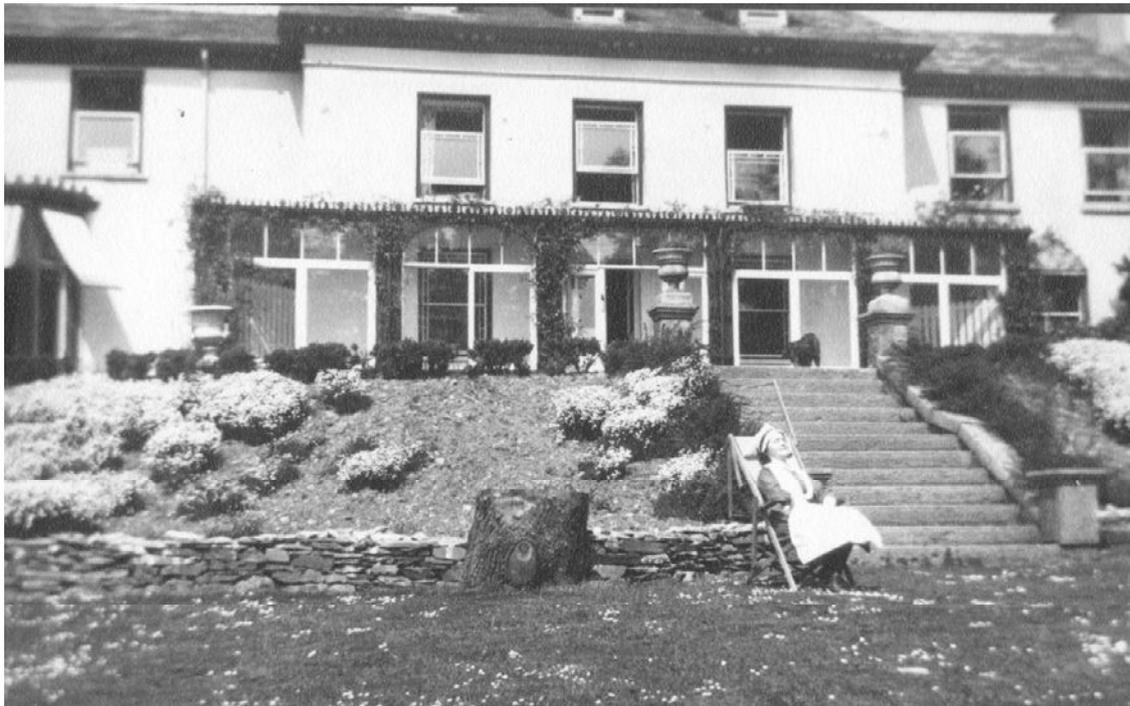
Plate 9: Photograph of the south elevation of the house dated 1923-1925, showing the veranda in more detail

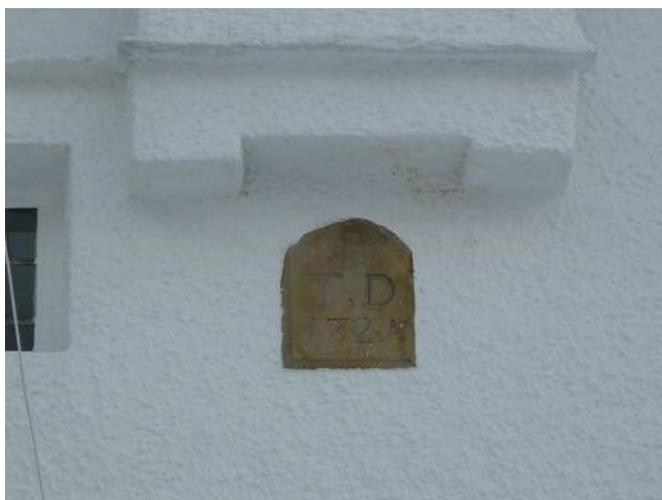
Plate 13 (right): Detail of the datestone of 1721 on The Cottage

6.1.2 **Barn – Phase 1 (18th – early 19th century):** it is evident from the datestone on the associated cottage and the cartographic sources that the barn was constructed between 1721 and 1842. This is certainly fitting with the style of the trusses (Brunskill 2002, 153), although the original arrangement of the building is difficult to ascertain because of the numerous subsequent alterations that were made. It is also possible that the barn replaced an earlier building as it contained numerous pieces of re-used timber in the roof much of which was probably taken from a cruck-framed building, although this could have been brought from another site entirely or re-used several times before, the re-use of materials being widespread from at least the 17th century (Tyson 2000). The barn was clearly constructed as a bank barn, with lower level accommodation for cattle certainly present at the south-west end (corresponding with lower level Room 3; the ground level in the adjoining Room 2 having been apparently been subsequently lowered) and a threshing barn with a threshing floor situated between the central wagon doorways (the north-western of which was later blocked but probably originally had some form of flanking wall on the north-east side), which is also indicated by the presence of ventilation slots for winnowing. Curiously, the building appears to have been originally built with a projecting section on the north-west side. The purpose of this is uncertain, although it is not unknown on similar buildings. The upper floor, accessed by the raised level doorway in the south-east elevation, was probably a granary and as it at least partially corresponds with the area of the projecting area the two may have been connected. The apparent wide aperture covered by a drip mould evident in the south-east elevation and inside lower floor Room 3 perhaps formed the original access to this area, although it appeared to be a window rather than a doorway. The construction of the barn also seems to have led to the blocking of an upper level aperture and possible owl hole in the end of the adjoining part of The Cottage, which possibly became defunct at this point.

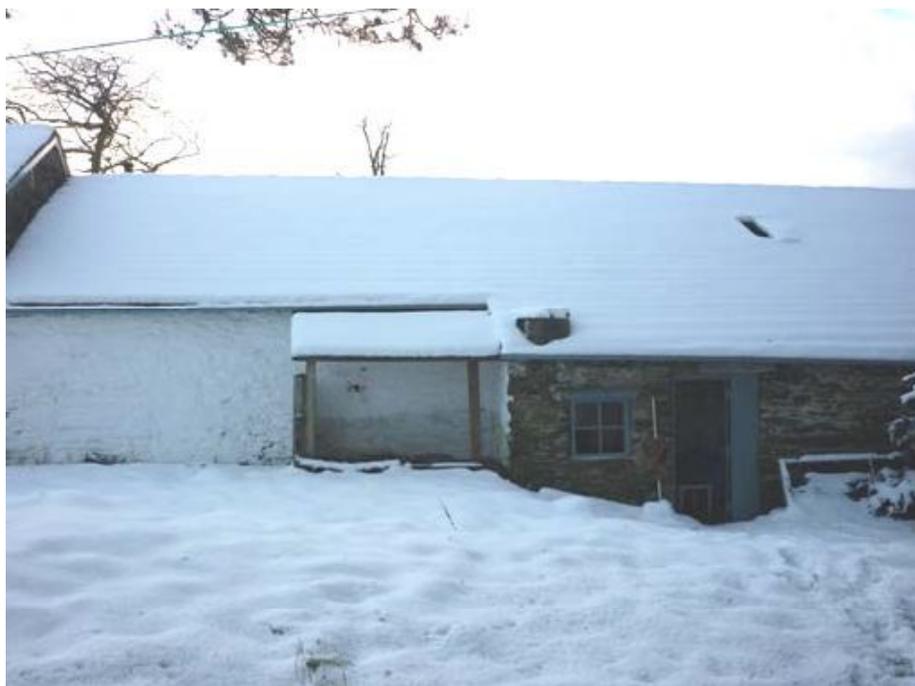
Plate 14: The north-east side of the north-west elevation

4.2.1 **North-west elevation - barn:** the south-west end has a pair of cross-shaped tie rod plates and a blocked ventilation slot. It returns to the north-west forming a projecting section with a monopitch roof continuing the line of the main roof. This contains another blocked opening, perhaps a further ventilation slot or small window, with a rough hand-finished timber lintel. Attached to the north-east side of the projecting section is a further short section of wall forming a further projecting area, with a plank and batten door on the south-west side, constructed from tongue and groove planks and with a similarly constructed panelled section filling the gap to the south-west (Plate 14). To the north-east of the doorway there is a small window with a fixed four-light casement with a machine cut timber lintel with a slate drip course above it, a concreted sill, and some red brick in the south-west jamb. A squat square chimney projects from the wall top at the return to the south-east, although there is a further modern timber extension to the north-east. The remainder of the wall proper is relatively plain, although there is what appears to be another ventilation slot, which has been blocked but used to house a ceramic drain that has subsequently been broken off.

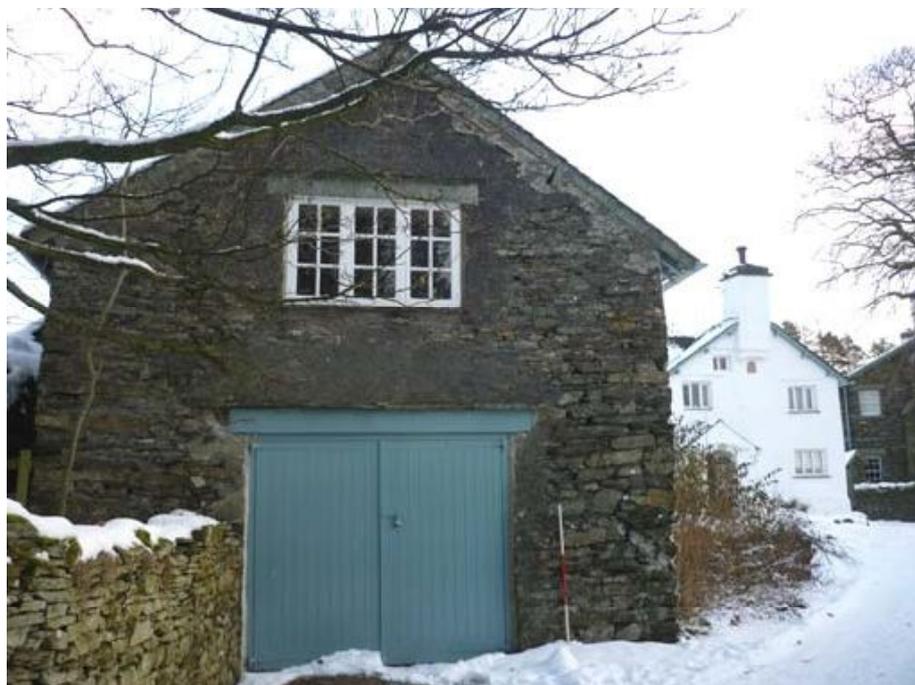
Plate 15: South-west external elevation, with The Cottage in the background

4.2.2 **South-west elevation - barn:** this forms the gable end of the building (Plate 15). The roofline has been re-pointed with cement and is slate hung and there are slates hung over the projecting ends of the purlins. The upper floor has a wide window with a relatively modern casement of three sections with six-lights, a slate drip course above, slates hung over the lintel, and a stone sill. The lower level has a large wagon doorway with a double plank and batten door built of tongue and groove planks with a timber lintel and slate drip course. There is rough render or concrete patching around both the doorway and window, perhaps suggesting that they have both been inserted or widened.

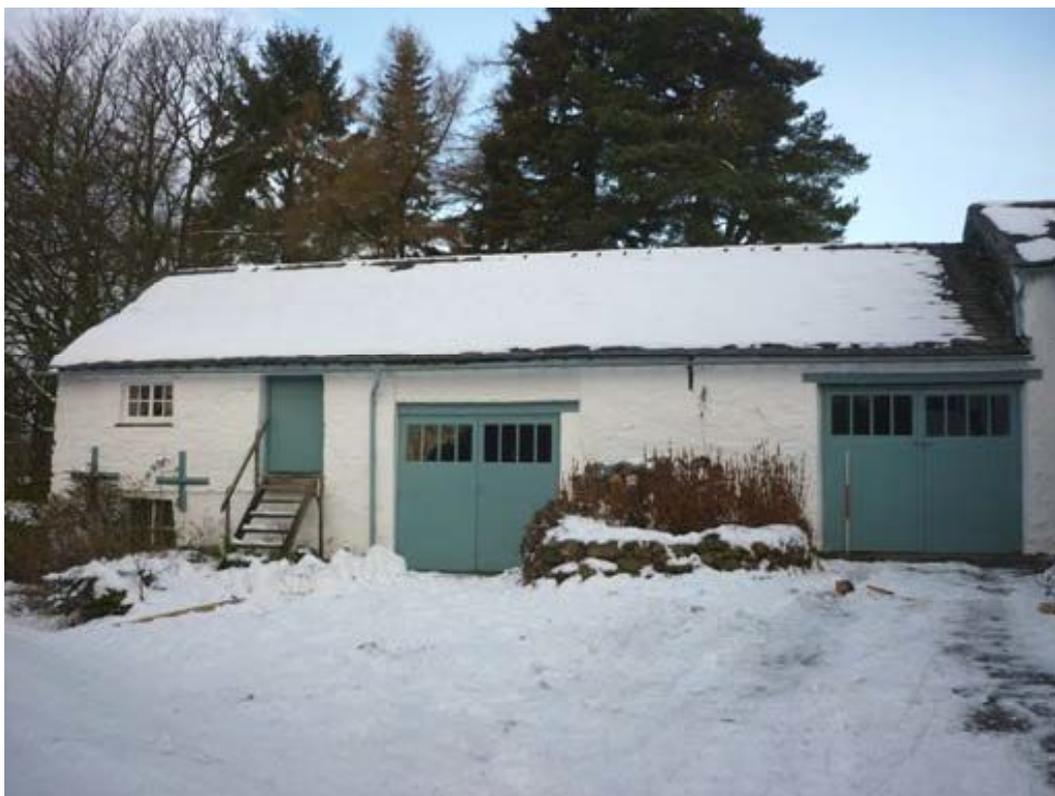
Plate 16: General view of the south-east elevation

4.2.3 **South-east elevation - barn:** this is entirely finished with paint, evidently with render beneath in most parts, which obscures much of the detail. It extends over two levels, with the floor level dropping from the north-east to the south-west, and its north-east end butts the adjoining cottage. The north-east

end has a large wagon doorway with a relatively modern plank and batten double door, each part housing a four-light window, and a machine cut timber lintel. Immediately to the south-west there is a ventilation slot just below the eaves, and further south-west there is a second wagon doorway in a similar style but with a slate drip course above it and set into a recessed area that extends to the eaves, indicating that it was originally taller than at present. South-west of this there is an upper level doorway accessed by a flight of timber steps and with a plank and batten door with a chamfered surround and stone step. South-west of this there is a window on each floor, the lower one has a four-light casement, stone sill, and rough timber lintel, above which is a slate drip course that extends to the north-east almost beneath the steps to the upper level doorway, and suggests that this window was originally much larger. The upper level window has an eight-light casement and a stone sill and lintel, and between the two windows there are a pair of cross-shaped tie-rod plates.

2 was probably knocked through at this time and any upper floor structure that might have existed was removed, if this had not already been done in phase 2. The tie rods with their cross-shaped plates were added in 2009 (Madeleine Scott pers comm.), perhaps having been made necessary by evident instability in the south-east wall caused by the various earlier alterations.

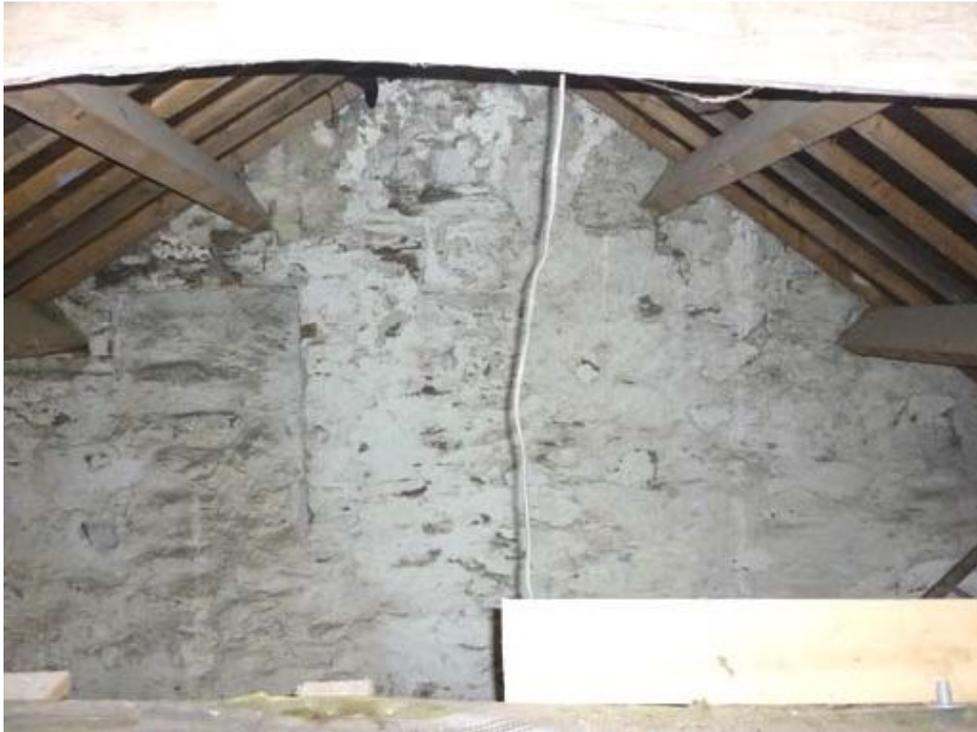
Plate 17: Upper part of the north-east elevation showing the blocked apertures

4.3.1 **Lower floor – Room 1:** this is the north-easternmost of the main rooms making up this floor. It has a concrete floor and is open to the roof (see *Section 4.3.5* below). The walls are all finished with whitewash. The north-west elevation has a horizontal timber built in on the north-east side; perhaps a lintel for a blocked window as there is a line in the masonry perhaps corresponding to the sill. The north-east elevation originally formed the external gable of the earlier building forming part of The Cottage to which the barn has been added. It has a small blocked aperture below the eaves, perhaps a former owl hole, and a blocked window or pitching doorway to the north-west of this on the upper level with a rough timber lintel (Plate 17). There is a further rough piece of horizontal timber built into the wall to the south-east. The south-east elevation has a large double doorway on the north-east side with a timber lintel. The south-west elevation comprises two angled stubs of wall; these are perhaps the remains of an original internal dividing wall, although the one to the south-west appears to butt the wall so they may in fact have functioned as buttresses. They support a large roughly finished tree trunk, which acts as a beam supporting the floor above, with an additional post below this on the south-east side. The gap above the floor (on the upper floor level) is filled with a rough fence built of timber planks. A modern flight of timber steps with a ladder fixed to the south-east side to form a hand rail provides access to the upper level on the north-west side.

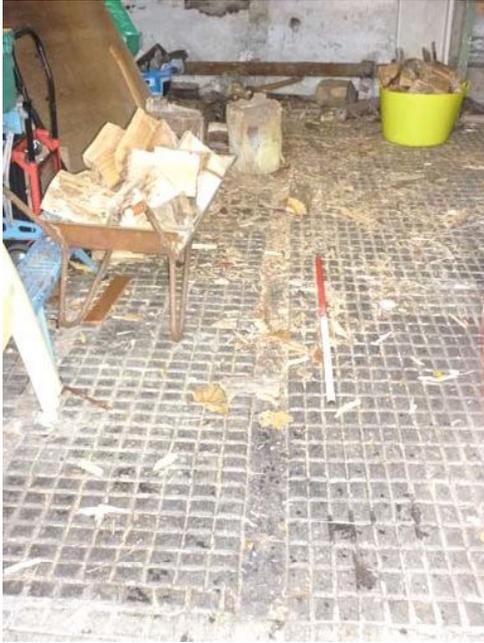
Plate 18 (left): Gridded floor of lower floor Room 2

4.3.2 Lower floor – Room 2: this is the central room on the lower floor. It has a gridded ceramic block floor, which is notably lower than the floor in Room 1 to the north-east, with a north-west/south-east channel running across the centre (Plate 18) and through a doorway to the south-east before turning to the south-west and running to into a ground drain. The ceiling is supported by two beams orientated north-east/south-west, both with empty slots for posts and supporting north-east/south-west orientated joists, and all the timber is hand-sawn (Plate 19). The walls are all finished with plaster and whitewash and most are relatively plain. The north-west elevation has a window on the south-west side with a stone sill, which has been covered with a sheet of hardboard (Plate 20). There is a long timber 'lintel' running above the window, below the ceiling, which corresponds to the line of the blocked doorway visible in lower floor Room 4 (see *Section 4.3.4* below). The north-east elevation comprises only two short stub walls supporting the ceiling, as per Room 1, with the gap between filled with large rugs. The south-east elevation has a large double doorway, the north-east jamb of which is slightly projecting and evidently built of brick. The south-west elevation is plain.

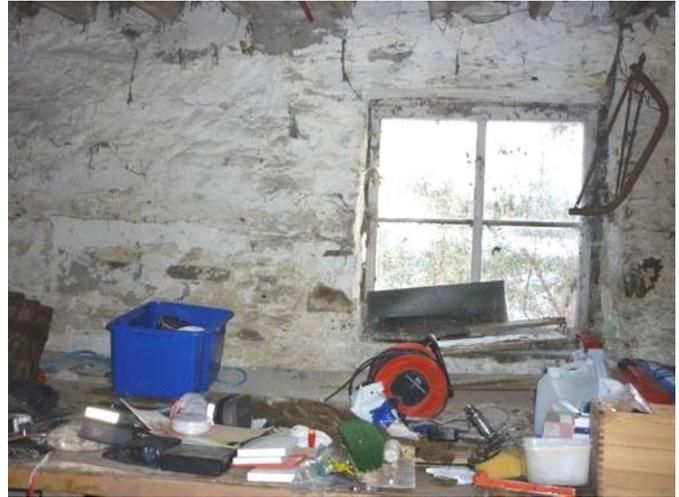
Plate 22 (right): Window in south-east elevation of lower floor Room 3, with blocked aperture to left

although there is a narrow ventilation slot at the north-east end, which is roughly blocked externally and has a square iron grill over it on the inside. The north-east elevation is essentially plain, with the two posts, one beneath each of the beams, against it. The south-east elevation has a window at the far south-west end to the north-east of which is a rough timber built into the wall, presumably a lintel for a blocked window, the north-east side of which is discernable (Plate 22). The extant window to the south-west also has a rough timber lintel and there is a timber work bench against the entire elevation. The south-west elevation is relatively plain, being mainly taken up by the large wagon doorway, which seems likely to be inserted as it has a lintel constructed from two iron I-beams, which support one of the two ceiling beams and there is some evidence for rebuilding around the jambs.

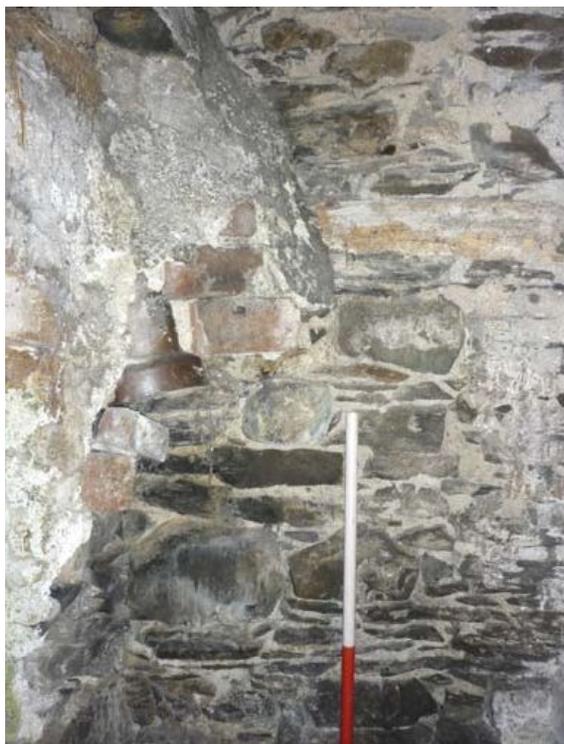
Plate 23 (left): Flue in the north corner of lower floor, Room 4

4.3.4 Lower floor – Room 4: this comprises a small room on the north-west side of the building, formed by the addition of walls against the projecting section on the south-west side. It has a concrete floor and a monopitch roof supported by sawn rafters. The walls are all exposed stone. The north-west elevation has a doorway on the south-west side with a plank and batten door and plank infill to the south-west. The window to the north-east of this has a concrete sill and timber lintel. The north-east elevation has projecting brickwork forming a flue in the north corner, with a piece of re-used ceramic drain forming the flue itself (Plate 23). The elevation proper has a horizontal timber built into it on the south-east side, perhaps a lintel for a small aperture or alcove (there was some evidence for a jamb), and below it there was apparently a butt-joint in the wall. The south-east wall appears to butt both the south-west and north-east elevations and has a large timber lintel running across its full length, suggesting it was originally a wagon doorway that has been blocked. In the centre of it there is a window with a single-light ovolo-moulded casement, a concrete sill, and a machine cut timber lintel (Plate 24). It appears to be inserted and there are evidently red bricks in the jambs. The south-west elevation is plain.

6.1.3 **Barn – Phase 2 (early 20th century?):** the barn was extensively altered, perhaps in the early 20th century or later 19th century. New windows were inserted into upper level Room 3, a large doorway into the south-west elevation (accessing lower floor Room 3), the earlier opening in the south-east elevation of lower level Room 3 was blocked and the smaller window probably inserted. The original opposing wagon doorways accessing lower floor Room 2 were modified, the north-western one being blocked, with a window subsequently added, and the south-east one slightly lowered in height. It seems likely that at this time the floor level in lower floor Room 2 was lowered, the upper floor added above it (perhaps extending across lower floor Room 1 to the north-east), the roof extensively repaired with a new truss added against the existing one at the south-east end and new purlins and rafters added, and the second wagon doorway, at the north-east end of the south-west elevation was probably also added. The small addition to the north-west side, around the former wagon doorway (lower floor Room 4), was also most likely added at this date, although this cannot readily be confirmed through reference to the early maps. The purpose of the building seems likely to have changed at this time, the south-west end becoming a garage with perhaps an office or store above, the north-east end perhaps also becoming a garage, while the centre continued to be used for housing animals. The small outset to the north-west evidently incorporated a small flue and so was heated but its function is uncertain.

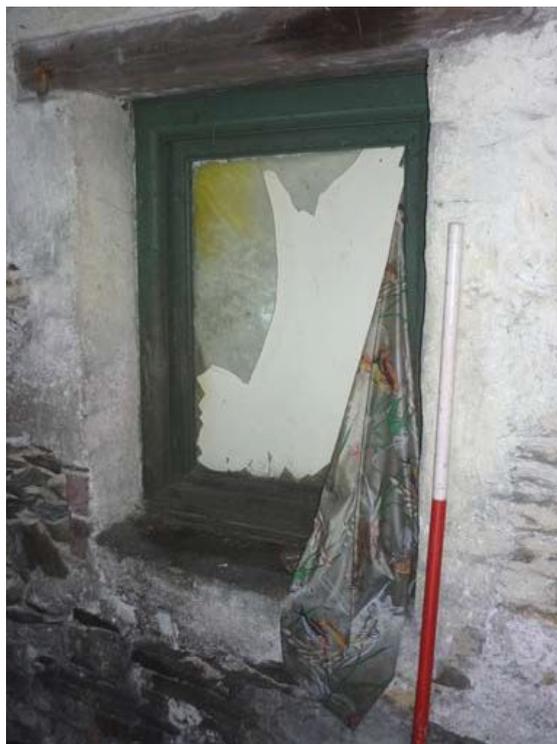
Plate 24 (right): Window in the south-east elevation, lower floor Room 4

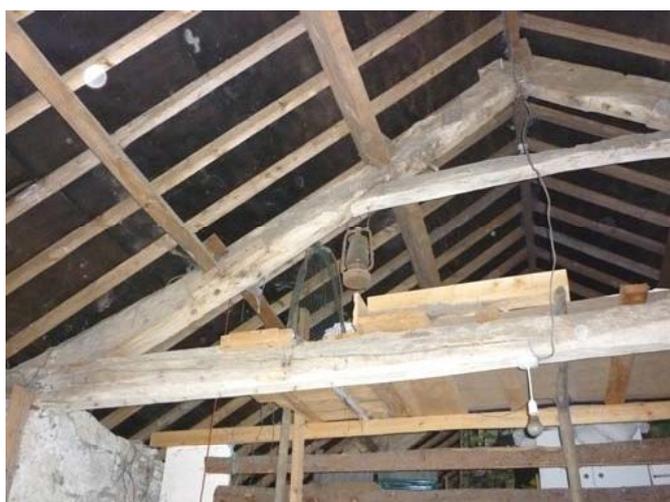
Plate 25 (left): Typical truss, north-east end of upper floor Room 1

4.3.5 Upper floor – Room 1: this is essentially just a half-loft, the north-east end extending over lower floor Room 1 and described in *Section 4.3.1*, and was not easily accessible. The floor, where visible, are timber boards finished with carpet. It is open to the roof, and there are three trusses, one at either end and one in the centre, each of a similar style comprising a simple tie beam with a collar, with all of the joints pegged and some evidence of re-used timbers being present most probably piece of cruck blade. The purlins and rafters, in contrast, are evidently a much more recent replacement and all comprise machine cut timber (Plate 25). The south-east end of the central truss has a carpenter's mark on the principal rafter at its junction with the tie beam in the form of a chiselled 'VI' (Plate 26). Only the tops of the north-west and south-east walls are visible and there is a ventilation slot in the latter. The north-east elevation is described in *Section 4.3.1*.

century, and the proposed changes are, by comparison relatively minor. The greatest loss might be the early trusses, which are, in some cases at least, in poor condition, and likely to need repairing or replacing.

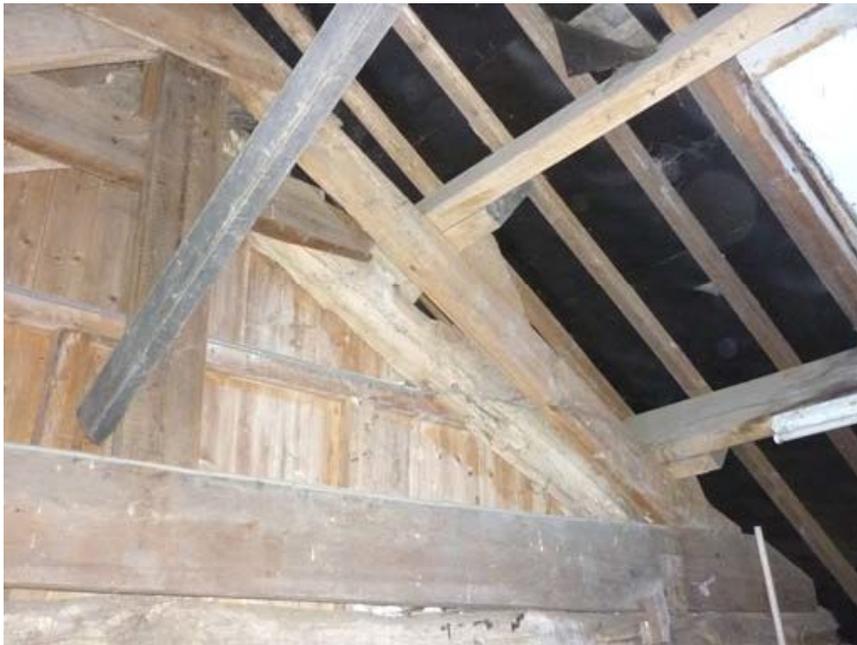
Plate 27 (left): Truss on the south-west side of upper floor Room 2

4.3.6 **Upper floor – Room 2:** this has a timber board floor, with a mixture of machine sawn and earlier wider boards, and is open to the roof, which has one of the same type of tie beam trusses evident in Room 1 on the north-east side on top of the wall. The south-west side has a similar truss again on top of the wall on this side, but a later machine-cut king post truss has been fixed against its north-east side (Plate 27). All of the walls are exposed stone, apart from the south-west, which comprises a stud wall finished with tongue and groove planks. The north-west elevation is plain, and entirely within the projecting section on this side of the building. The north-east elevation is plain and does not extend to the full height of the building, with the truss effectively sitting on top of it. The south-east elevation is essentially plain, but with a doorway in the centre with a plank and batten door and machine cut timber lintel (Plate 28). The south-west elevation is a timber stud partition finished with tongue and groove planks, which extend behind the line of the doubled truss, and with a central doorway with a plank and batten door (Plate 29). The far north-west end is stone, formed by the return for the projecting section to the north-west, and the base of the original truss sits on top of this, with an additional projecting timber below it bolted on to give additional support (Plate 30).

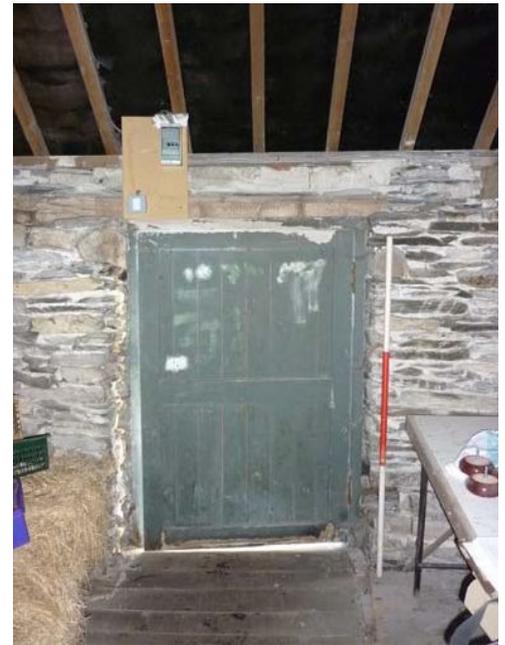
Plate 28 (right): Doorway to south-east, upper floor Room 2

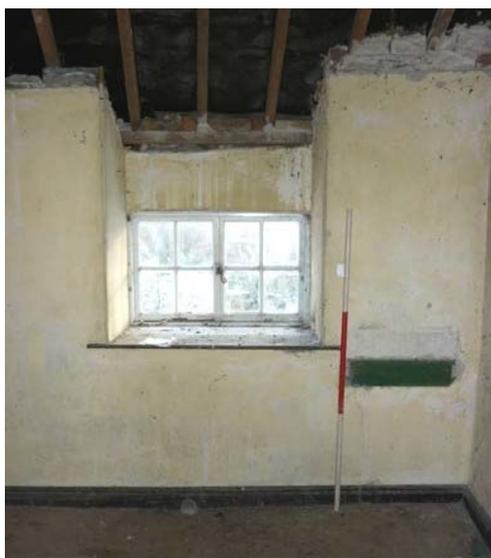
Plate 31 (left): Window to south-east, upper floor Room 3

4.3.7 Upper floor – Room 3: this also has a timber board floor, although all of the boards are a regular size and tongue and groove. It is open to the roof, which has a truss corresponding to the position of the north-east wall and modern timber purlins extending from the north-east. The walls are all finished with plaster and paint, apart from the north-west. The north-west elevation is plain, with modern shelves attached. The north-west elevation is a timber stud construction with a central doorway, the planks covering the trusses from this side. The south-east elevation has a single window with an eight-light hinged casement, timber plank sill, timber lintel and recessed area extending to the roof (Plate 31). There is a timber batten attached to the wall to the south-west. The south-west elevation has a single large window with three six-light casements and a timber sill, with timber beading around the jambs and lintel (Plate 32).

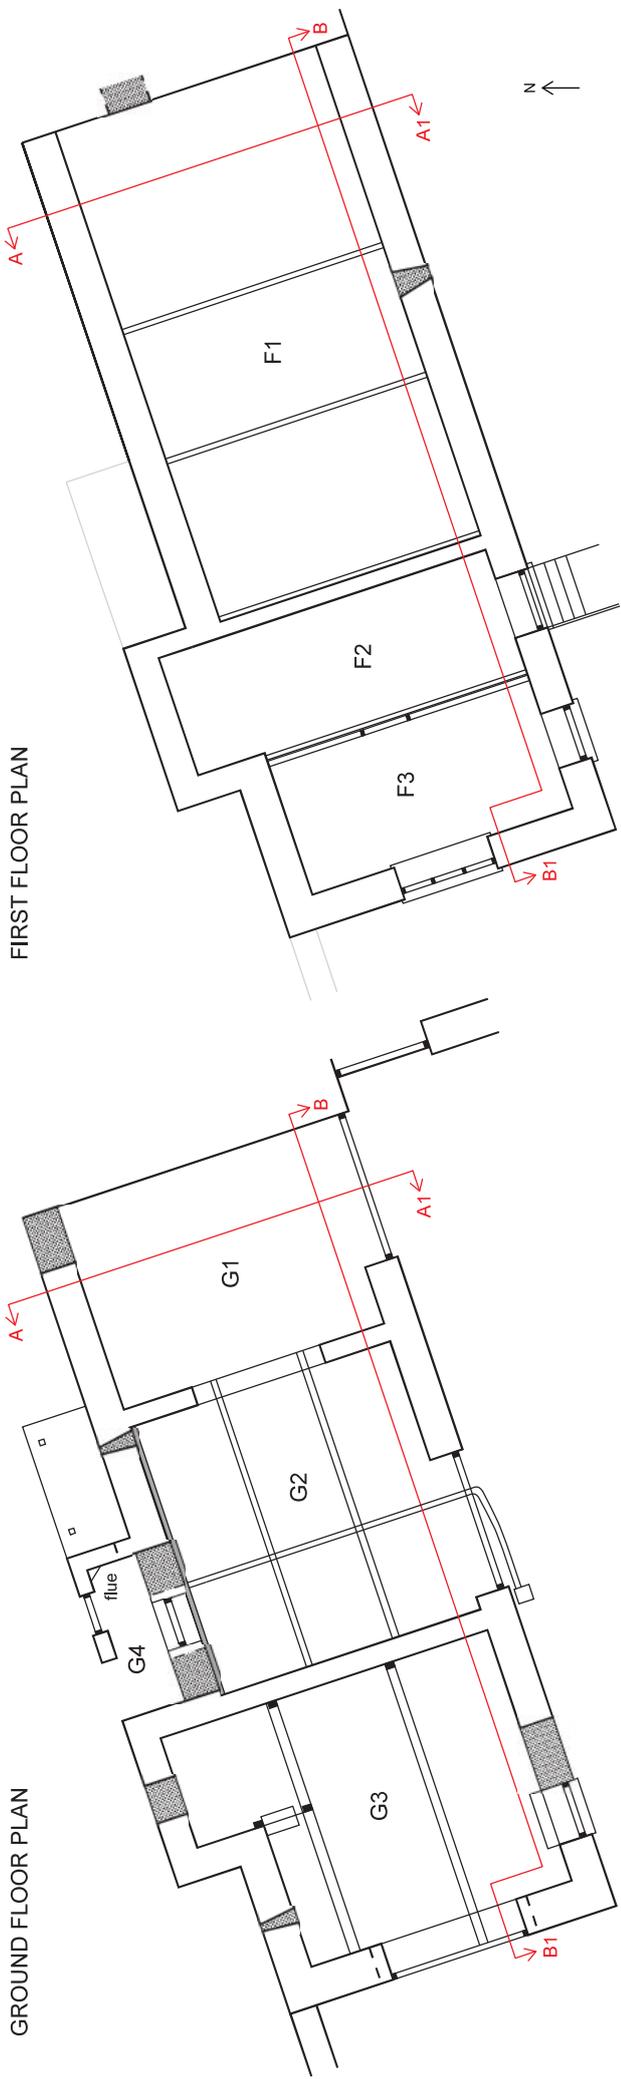
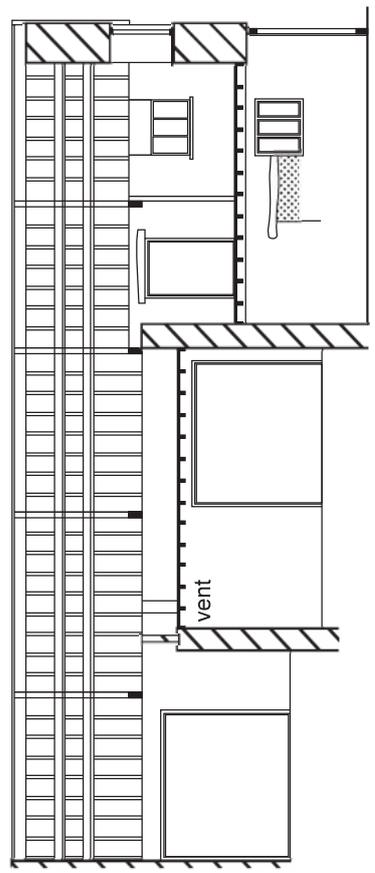
Figure 3: Floor plans and south-east facing cross-section of the barn

4.1.1 The barn is orientated approximately north-east/south-west (see Figure 1 and Figure 3), the north-east end butting part of the adjoining cottage (so there is no north-east elevation; Plate 12 and Plate 13) and the north-west side built into the slope (see Figure 2), and is evidently a former threshing barn that has been extensively modified. The entire building is constructed from local slate, laid in rough courses with rough long quoins, although the whole of the south-east and most of the north-west elevations are finished with a thick coat of off-white paint and some render and there is patchy rough-cast render over the south-west end. Some concrete has been used in patching areas and for later alterations. The roof is finished with local slate topped with ceramic bonnet ridge tiles, and considerably overhanging eaves. Internally the floors are typically concrete, although one is formed from gridded ceramic tiles. The timber is a mixture of early hand-finished and re-used material, largely found in the trusses, and machine cut, largely in the doors and windows and for the rafters and later alterations.

SOUTH-EAST FACING SECTION B-B1

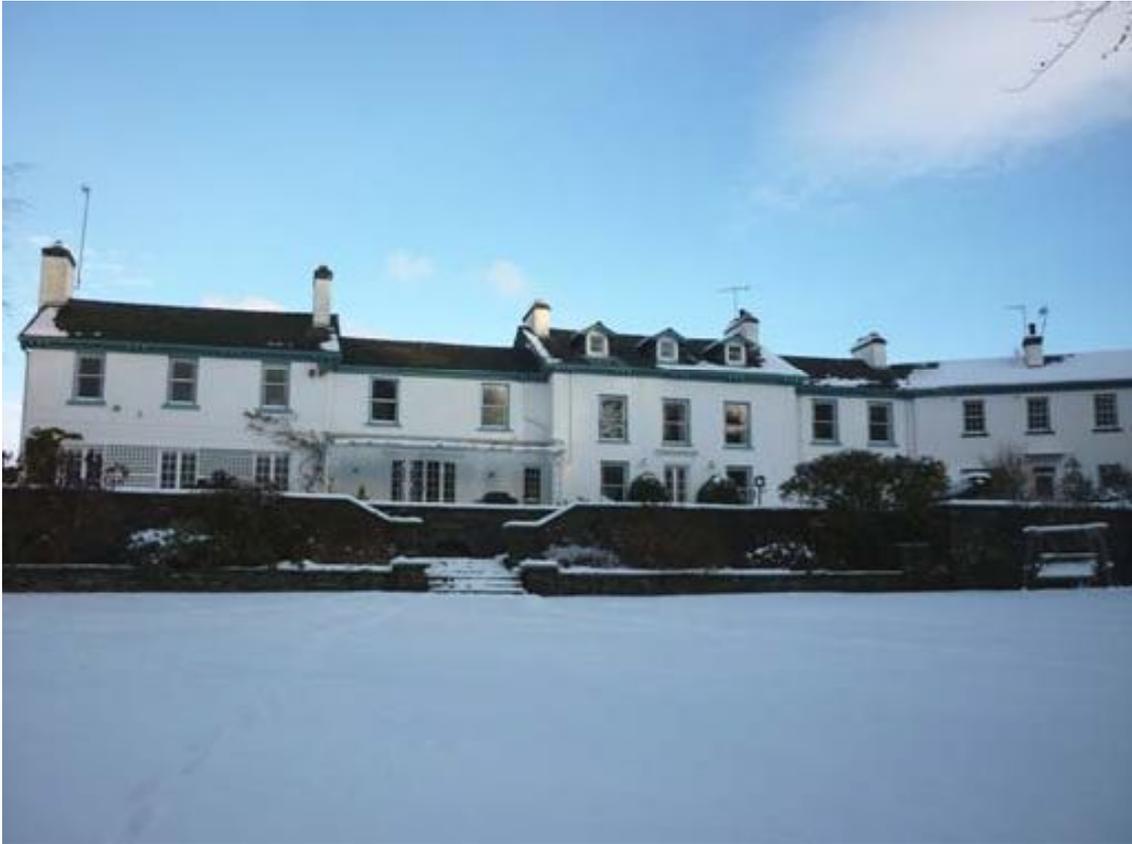
5.1.1 The veranda is attached to the south elevation of the main house, slightly west of centre with the house forming a long range orientated east/west, with the east end turning south-east (Plate 33). It is constructed from a series of wrought iron decorative sections, topped by timber beams and supporting a relatively modern glass panel roof, fixed by aluminium strips. Within its footprint the floor comprises stone flags, but there is an edging strip of concrete along the south side housing an iron rail (Figure 4).

Plate 33: General view of the south external elevation of the house, with the veranda left of centre

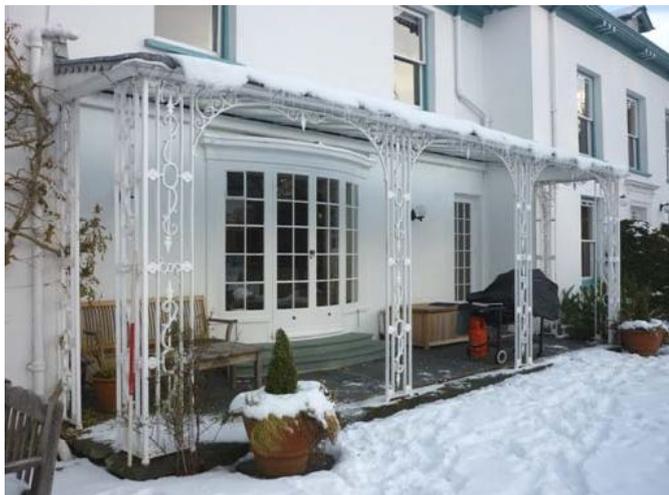
Plate 34 (left): General view of the veranda

5.2.1 **Veranda:** as described in *Section 5.1.1* above, the veranda has a largely stone flag floor, but with a concrete strip along the south edge, which incorporates an iron rail divided into two parts. Along the north side of this there are a series of shallow holes in the concrete, typically single examples but with two pairs, which presumably supported an earlier substructure although not one apparently matching the current arrangement. Indeed, the iron rail seems likely to have supported some form of outer structure, perhaps a sliding partition of some form. The roof is comprised of 13 relatively modern glazed panels held together with aluminium strips and with a scalloped-edged lead flashing against the wall of the house. Below the roof line on the south side is a cast iron gutter held with metal brackets affixed to a timber beam supported by the iron trellis-work comprising the main part of the structure. Each section of gutter is marked with the initials 'H9 68 [?]' and what is perhaps a patent mark or British standard kite mark in the form of a rhombus. The main east/west orientated section of the timber beam comprises two pieces fixed together with a stop-splayed scarf joint. The north/south orientated beams supporting the sides are shorter single pieces. The main structure of the veranda comprises eight wrought iron sections, although the corners comprise two sections combined together to form a 90° angle. They are essentially all identical, with a typical foliate pattern twisting around a pair of 'spears' within a geometric border with rose roundels and on ball feet, with additional central 'daggers' and further twists between the main

pieces (Plate 34 and Plate 35). The east end is slightly different in that the northern section is slightly taller than the rest, and actually cuts through the line of the beam while the others rest against it and are presumably fixed to it (Plate 36). There is also a smaller detail between the two main sections on the east side, but not on the west.
