THE CASTLE HOTEL, MAIN STREET, HORNBY, LANCASHIRE

Supplementary Archaeological Building Recording

Client: Applethwaite Ltd

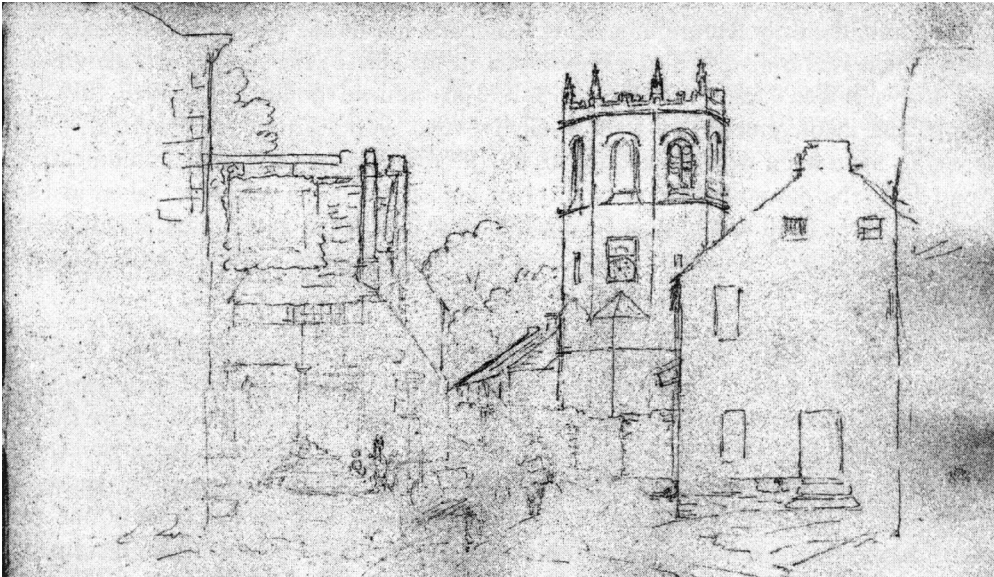
Plate 2: Sketch of Hornby town hall and St Margaret's church by Emily Sharp, 1836 (after White 2009, 43)

3.5.3 **Sketch of Hornby by Emily Sharp, 1836:** this sketch, which mainly shows the town hall and church, depicts in relatively good detail the east side of the southern end of the Castle Hotel (visible to the left-hand side in Plate 2). The quoins of the wall and even the kneeler are clearly depicted, as is a sign projecting from the front. Although of limited use in interpreting the site, it demonstrates that the south-east section projecting out into the road had certainly been constructed and that there was no building stood against the south-east corner by this date.

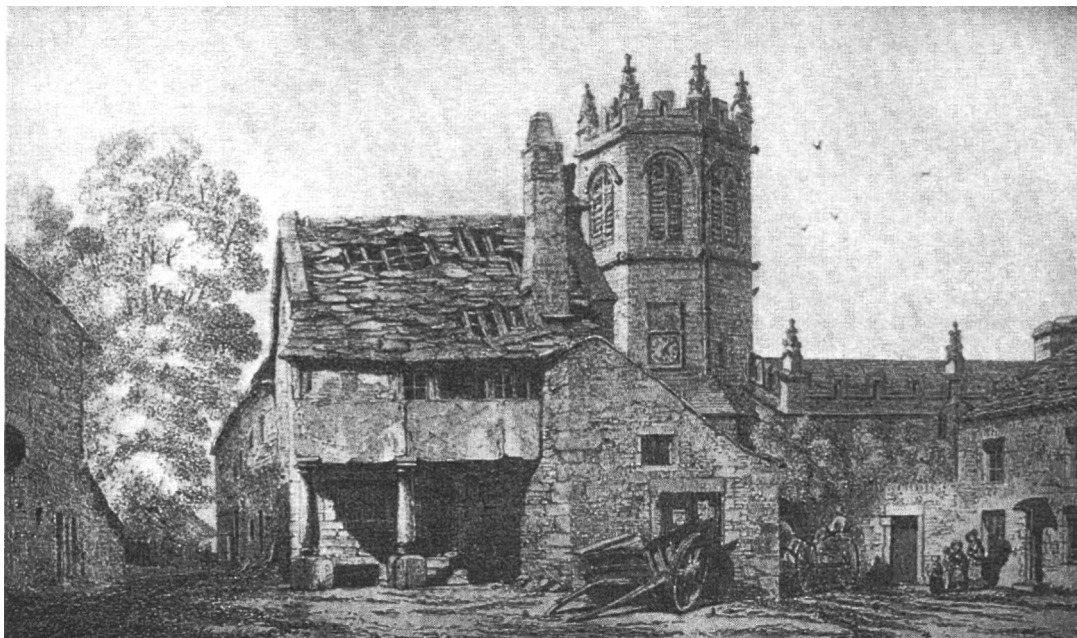
Plate 3: An illustration of the old market hall by Reverend Rooke, drawn some time prior to its demolition in 1853 (after Farrer and Brownbill 1914, opposite page 188)

3.5.4 Illustration by the Reverend Rooke: this undated view, of the market hall in Hornby, reproduced in 1914 (Farrer and Brownbill 1914, opposite 188; Plate 3), must have been produced some time prior to 1853 when this building was partially demolished (*op cit*, 188-189; the remains of it were not completely demolished until 1953 (White 2009, 44)). This view was originally thought to show a building at the north end of the site (Greenlane Archaeology 2007, 12), however, on the basis of information which has been published since the original report was produced, it is likely that the gable end with a circular or round arched opening (to the left-hand side of the picture) is the south elevation of the large building that was shown to the north of the current site in the plan of Hornby from 1803 (recently reproduced in White 2009, 44; see Plate 1). This drawing, therefore, might be considerably earlier than originally thought and at least predates the surveying of the first Ordnance Survey map in 1844-1845, by which time the building to the north of the current site had been removed.

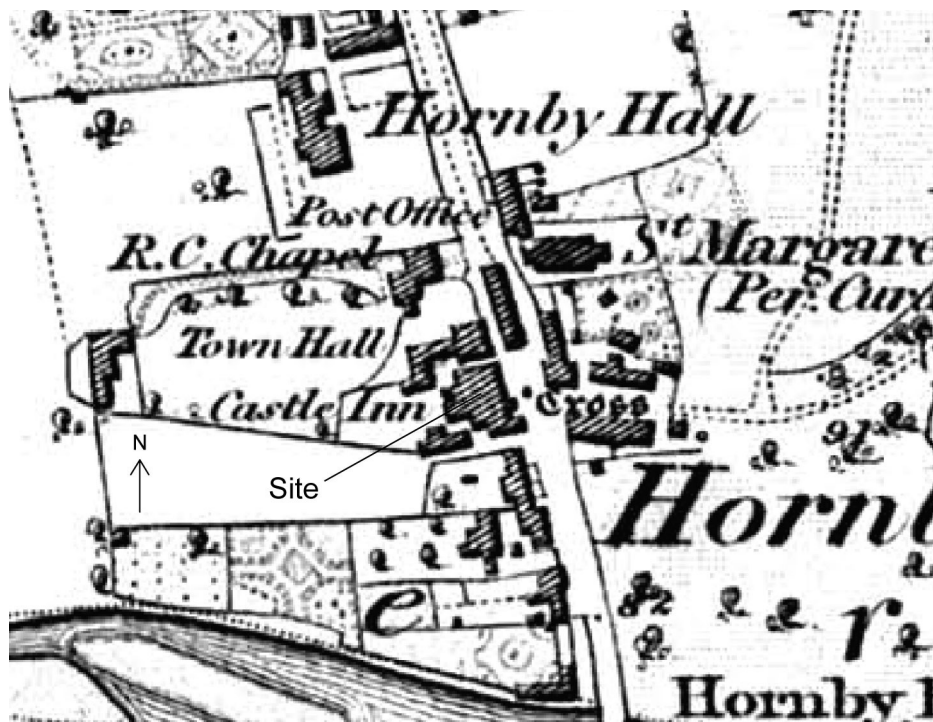
Plate 4: Extract from the Ordnance Survey map of 1847

3.5.5 Ordnance Survey 1847: the first edition Ordnance Survey map, which was surveyed in 1844-1845, is at a scale of 1:10560 and as such is lacking in some detail (Plate 4). The Castle Hotel is named 'Castle Inn' and shown as a large irregular block orientated approximately north/south along the road.

Interestingly, the building at the north end appears to be shown as a separate block to the rest of the complex, or it may be showing the covered access that still exists and is present on later maps (e.g., Plate 6). There is also a block of buildings in the south-west part of the site that are evidently separate from the main part of the complex.

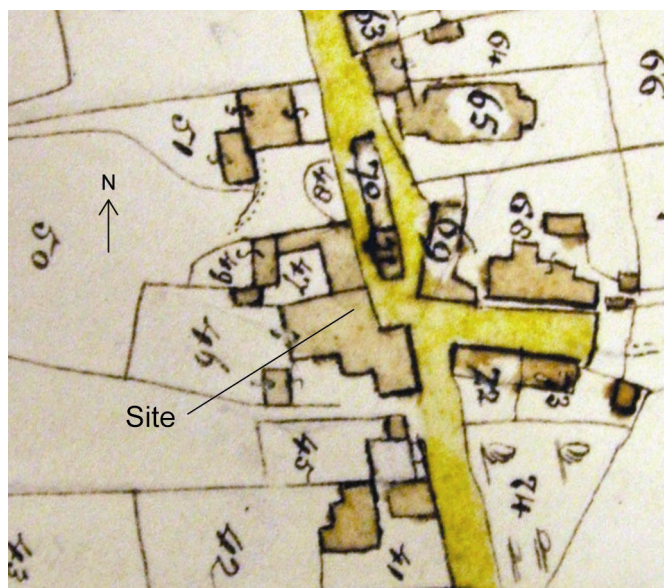
Plate 5: Extract from the Tithe Map of 1850

3.5.6 *Tithe Map 1850*: this map (LRO DRB 1/110 1850a; Plate 5), although only slightly later, is considerably more detailed than the earlier Ordnance Survey map (*cf.* Plate 4). The basic plan of the complex is essentially the same as it has already been shown, although the south-eastern block is clearly shown as projecting a considerable distance to the east compared to the rest of the line of the buildings and apparently extends further to the north. The detached building to the north is no longer shown as detached, while the block of buildings to the south-west has been simplified to a single rectangular structure.

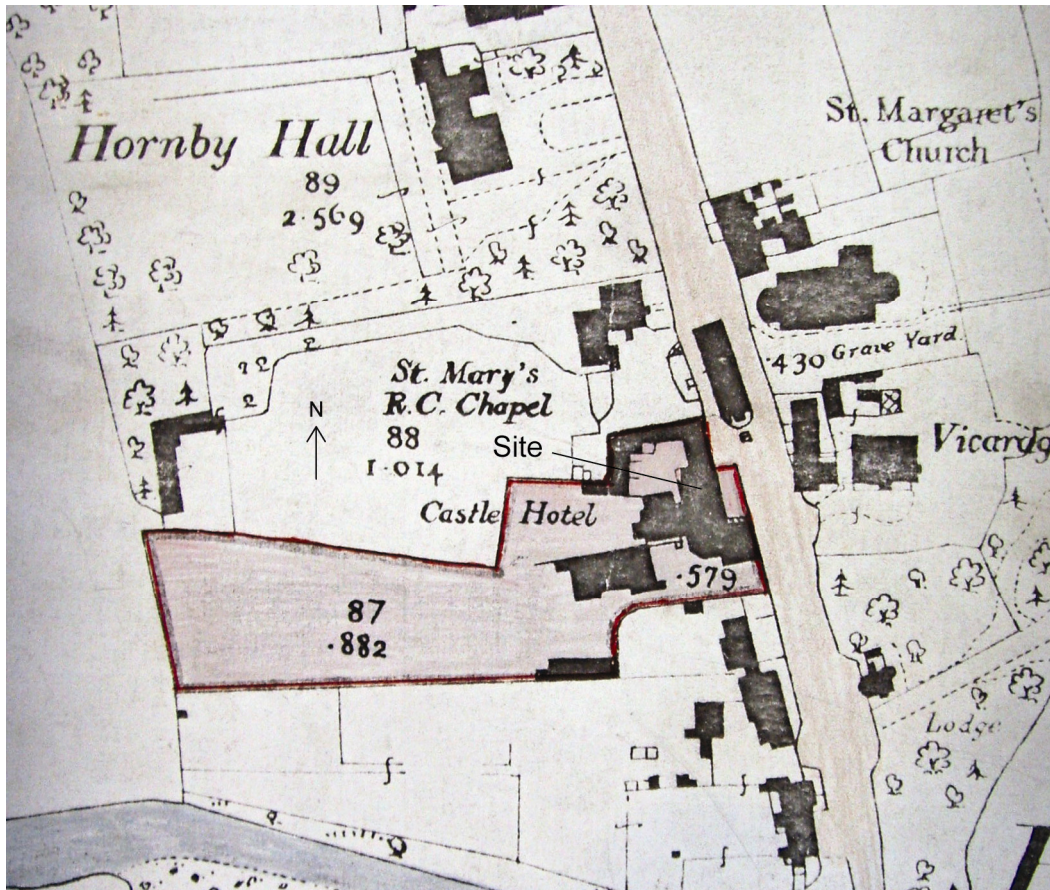
Plate 8: Extract from a plan of c1964 included with the deeds

3.5.9 **Plan c1964:** this plan (Plate 8), which is included with the deeds, shows much the same arrangement as the previous one (*cf.* Plate 7). It is noticeable, however, that the small outshuts added to the west end of the south-western block have been reduced in size, and the outshut attached to the west end of the central section has taken something approaching its present form. Significantly, the plan shows the extent of the estate associated with the hotel at this date, which shows it at its largest extent.

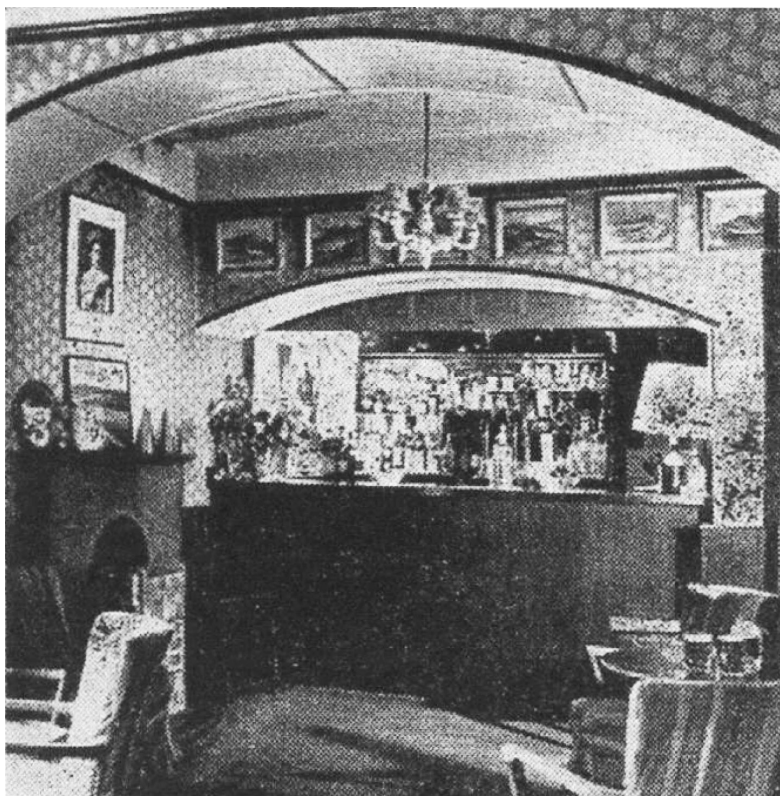
Plate 9: Illustration of the bar of the Castle Hotel, post-1955 (from Jackson Advertising Service n.d., 63)

3.5.11 **Illustration post-1955:** this is an undated photograph of the hotel bar (which, according to text elsewhere in the same publication must post-date 1955, and is probably from the 1960s or early 1970s; Plate 9). It provides only a limited amount of information about the building, as it shows a small part of the whole property, but it demonstrates that the bar at this time was in the south-west corner of Building 4.

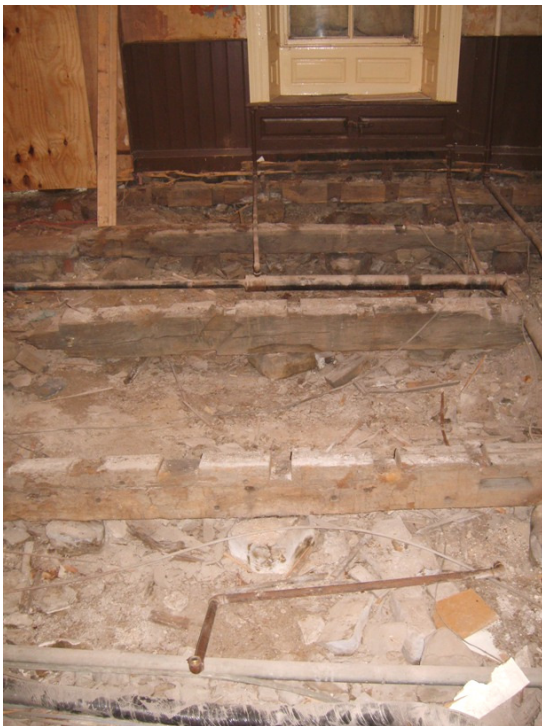
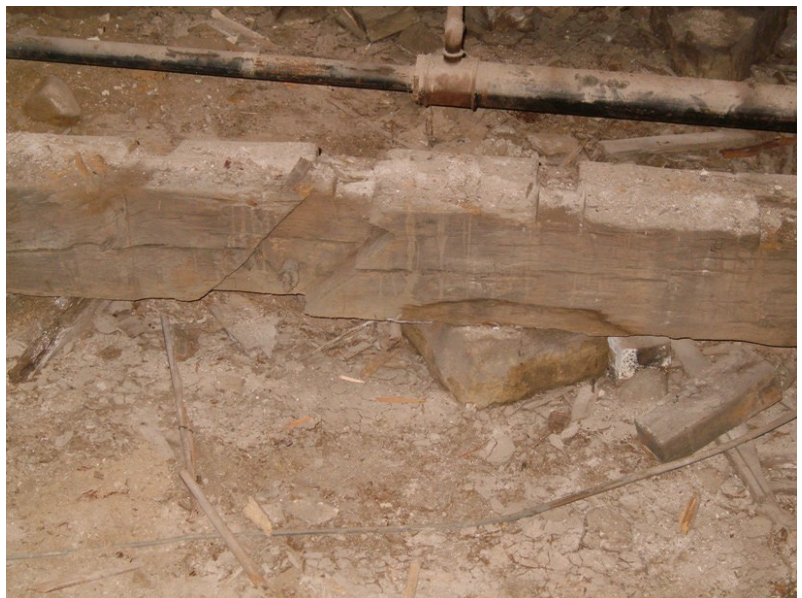
4.2.2 **Room G6:** an area of north/south orientated beams in the south-west corner had been exposed and comprised three small iron I-beams. In addition, the removal of the floorboards within the room revealed at least some evidently re-used timbers forming the joists, most likely former cruck blades (Plate 11 and Plate 12).

Plate 11 (left): exposed joists beneath the floor of Room G6 (photograph by Stephen Gardner)

Plate 12 (right): detail of empty joist slot in joists below floorboards in Room G6 (photograph by Stephen Gardner)

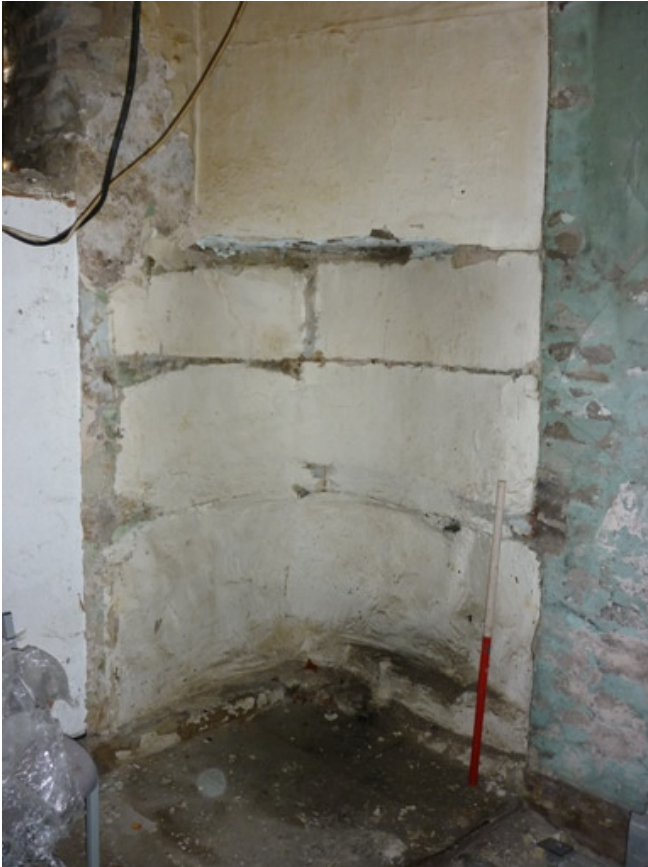
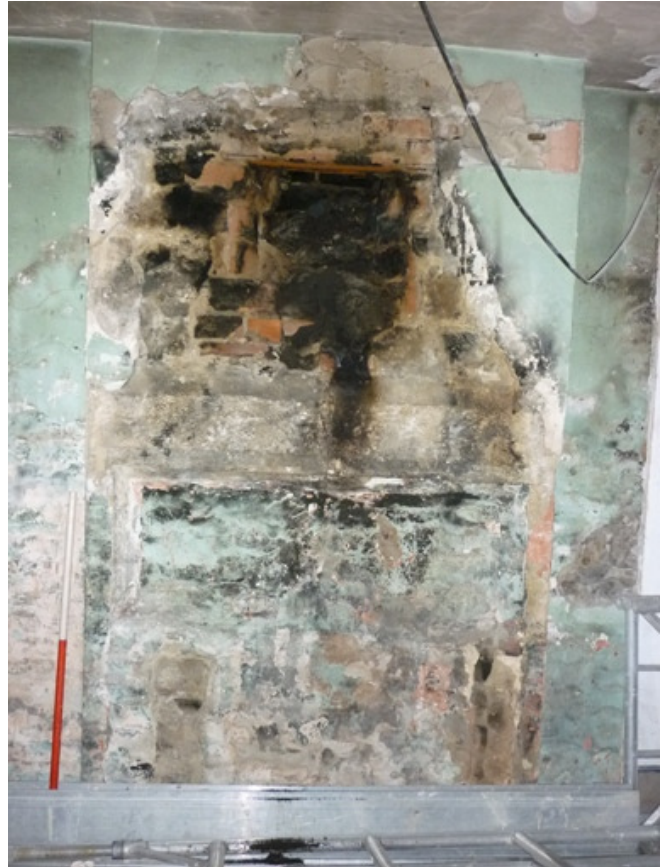
4.2.3 **Room G7:** the north wall had evidently been clad with modern timber and its removal revealed a centrally located projecting chimneybreast with fireplace and that the north-west corner was curved into the thickness of the wall (Plate 13). This curved area had evidently held shelves or had something fixed to the wall, above which was a small opening into a flue formed by stone lintels and incorporating an iron hanging bar. The flue turned sharply to the east to connect to the flue in the fireplace. The fireplace was blocked, with a rough finishing, but part of the surround was revealed on the west side and was stone with a plain double ogee moulding (Plate 14). Above the fireplace there was a hole inserted into the flue, presumably for ventilation, which had an iron strap for a lintel.

Plate 13 (left): Recessed area in the north-west corner of Room G7

Plate 14 (right): Fireplace in the north elevation of Room G7

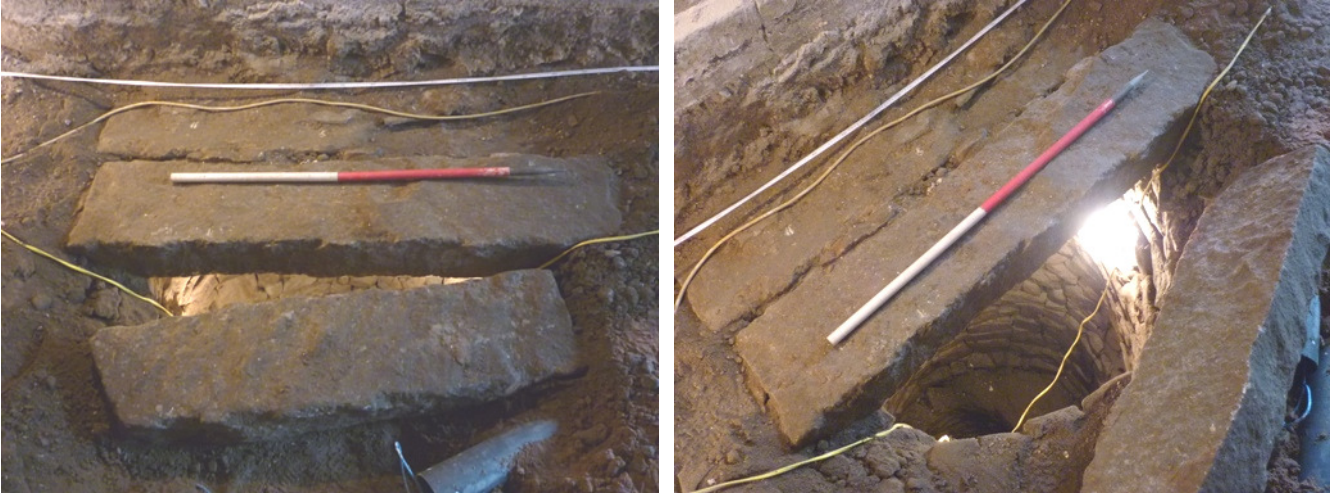
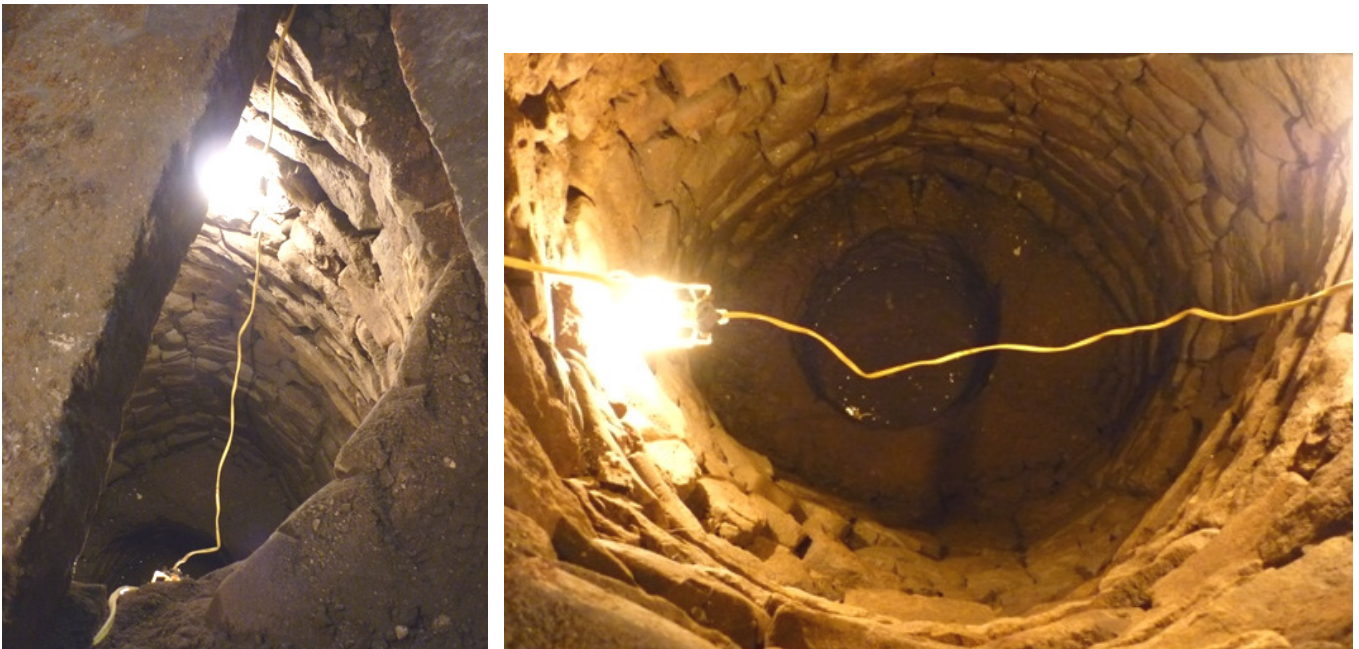
4.2.4 **Room G8:** the ceiling had evidently been extensively remodelled as steel I-beams were exposed where the coverings had been removed. In addition, a well was exposed beneath the concrete floor against the west elevation (see Figure 3 and Figure 6). This had been capped with large, roughly-worked stone slabs on a similar alignment to the west wall (Plate 15 and Plate 16). The dry stone walls of the well were in loose courses approximately 0.1 to 0.15m high and each stone measured approximately 0.2 to 0.3m on a side (Plate 17). The outer ring of the well had an internal diameter of approximately 1.2m and extended below the west wall. The outer wall continued to a depth of at least 2.8m from the top of the capping material. At the lower level there was an 'inner' dry stone wall feature (Plate 18), with a diameter of approximately 0.77m, which continued to a depth of at least another 0.7m. The outer ring of the well was said to have formed a hollow beneath the capping material when it was first exposed and no finds were recovered from it. The lower level feature may have been enlarged to form the outer ring of the well before it was capped. A fragment of pottery and three clay tobacco pipe stem fragment were recovered from the floor surface of Room G8, below the concrete floor, at the level of the capping material of the well (see *Appendix 2*). This material dates from the late 17th to early 20th century (although an 18th to 19th century date is perhaps most likely given the suggested date of the stem fragments of the clay tobacco pipe, which were present) and must postdate when the well was sealed.

Plate 15 (left): The well in Room G8, viewed from the east

Plate 16 (right): Tilted view of the inside of the well in Room G8 with the capping material partially removed

Plate 17 (left): Detail of the wall construction of the well in Room G8

Plate 18 (right): View of the lower level feature of the well in Room G8, viewed from above

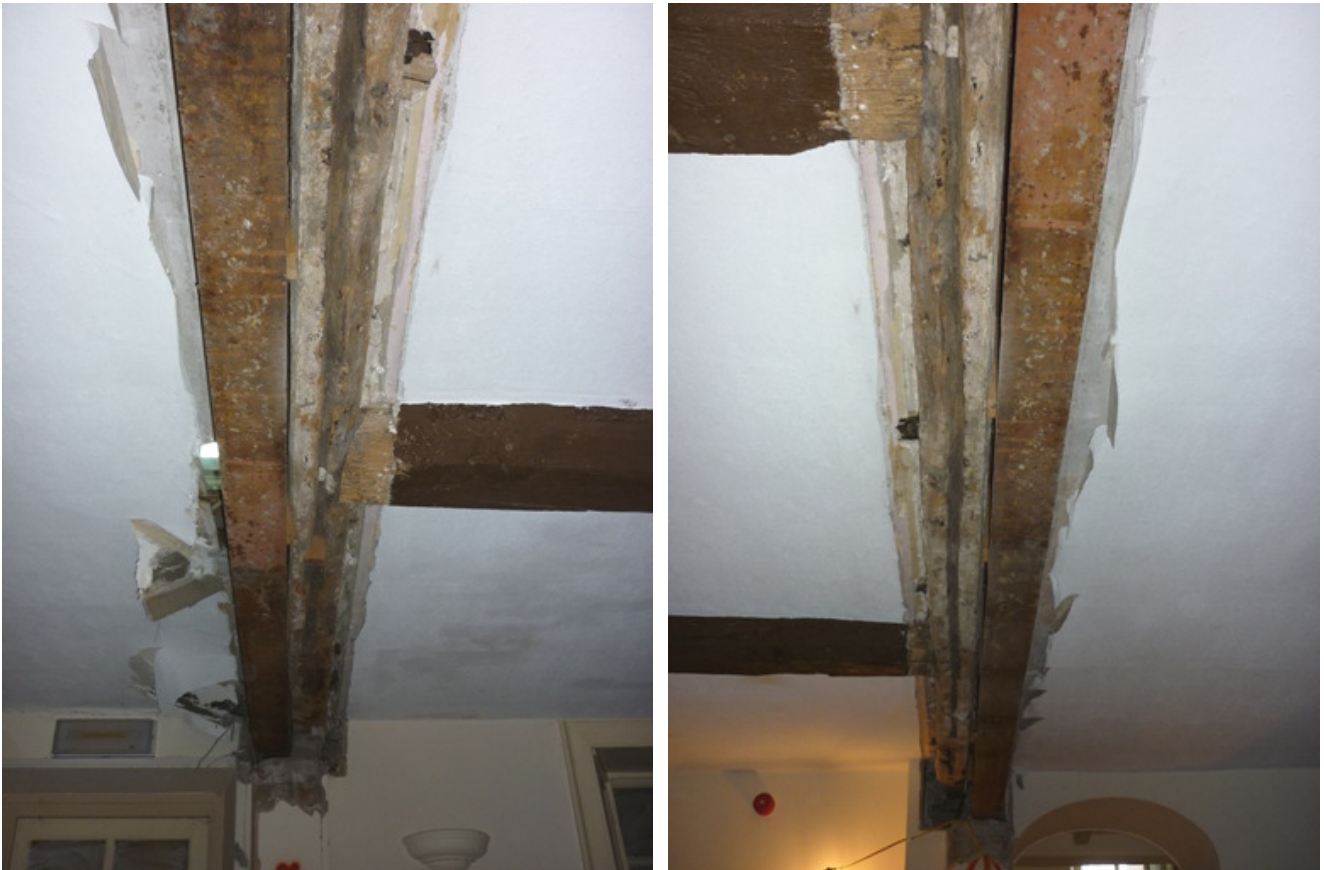
4.2.5 **Room G10:** the boxing around the east/west beam immediately south of the doorways in the east and west elevations had been removed to reveal a modern steel I-beam on the north side of a timber beam, which was clearly a re-used part of a timber stud partition as it had a continuous rail slot and numerous empty joist holes (Plate 19 and Plate 20).

Plate 19 (left): East end of the iron and timber beams in Room G10

Plate 20 (right): West end of the iron and timber beams in Room G10

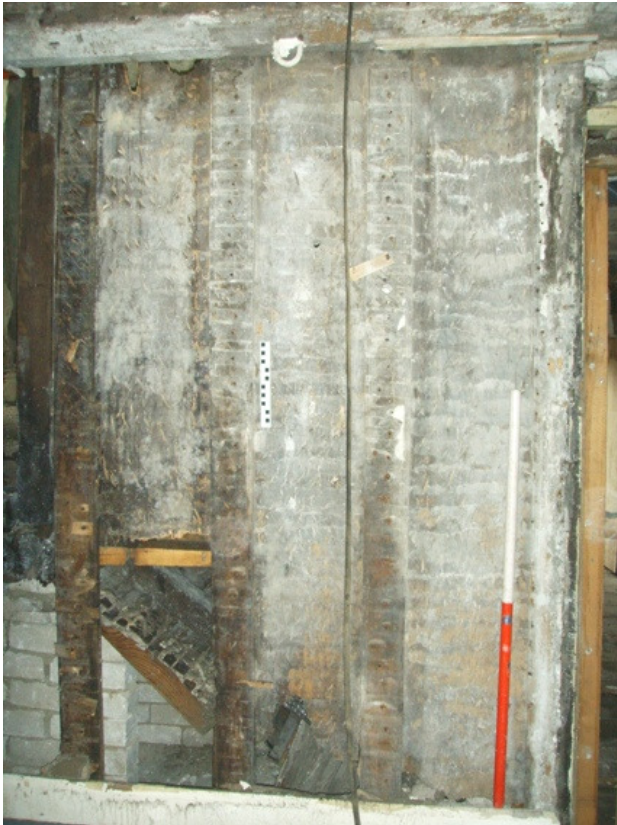
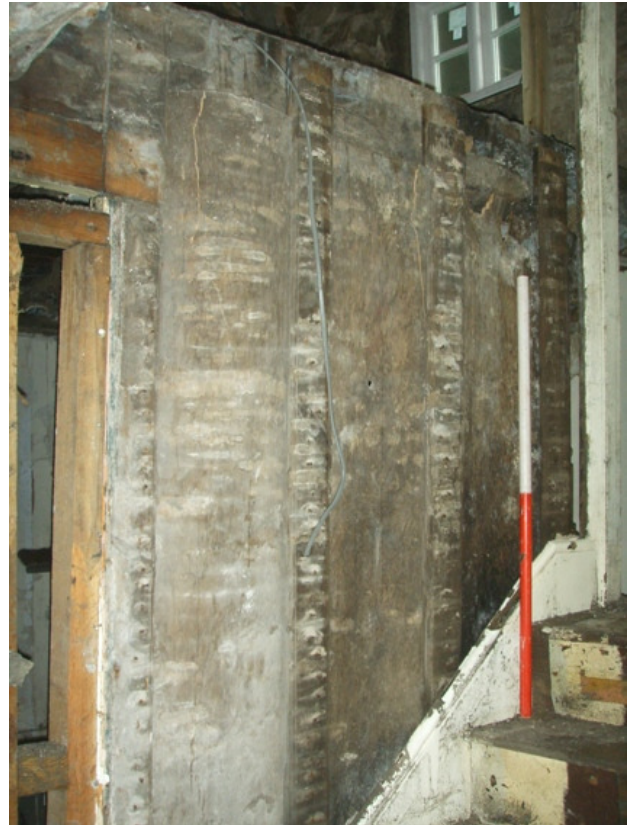
Plate 21 (left): South face of panelling between G10a and G10b
Plate 22 (right): North face of panelling between G10a and G10b

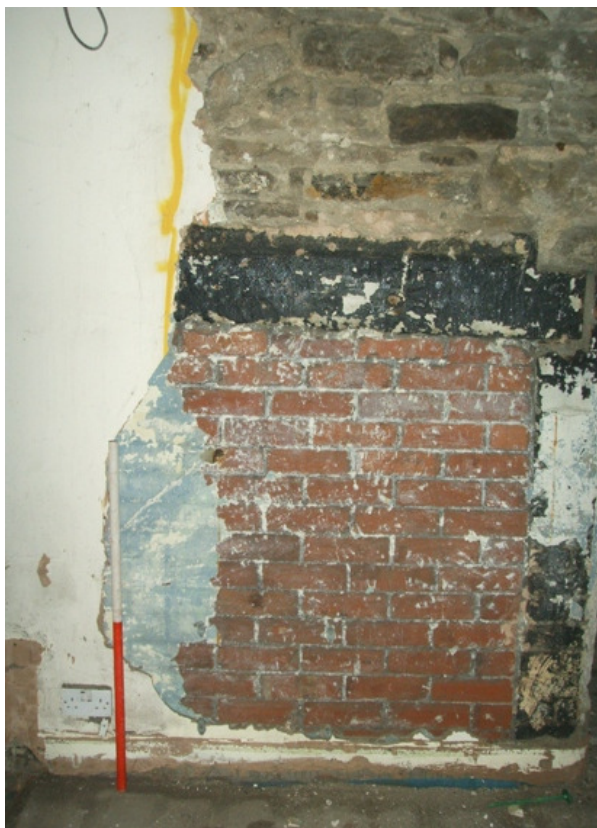
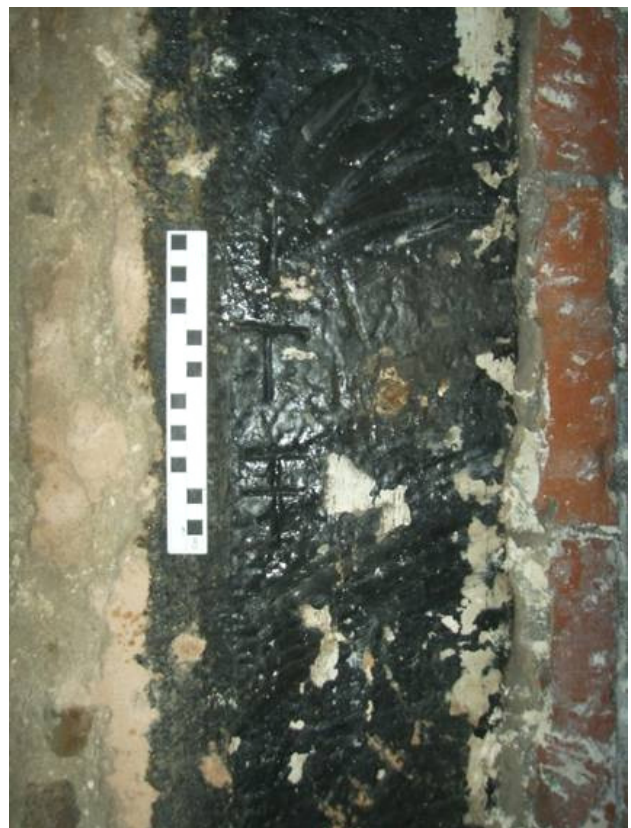
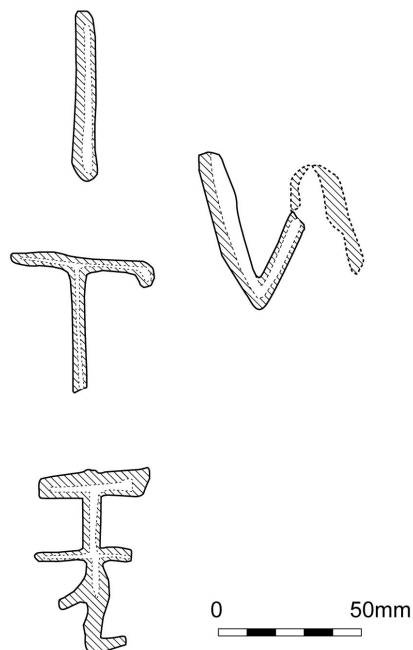
4.2.7 **Room G10c:** the plaster had been removed from the west wall, revealing that this essentially comprise a large chimneybreast, with a wide fireplace, blocked with machine made red brick (Plate 23). The lintel of the fireplace comprised a large slab of dressed local gritstone, into which were carved what appeared to be the number '1', with the initials 'T' and 'V' or more likely 'W' below and below that a less certain symbol, perhaps a cross or stylised 'I' or '1' (Plate 24 and Plate 25). This appears to be part of a datestone, presumably re-used and turned on its side, although if this is the case the original stone would have been extremely large. In addition, the east wall, opposing the fireplace, had had its plaster partially removed demonstrating that it too was constructed from red machine-made bricks and evidently therefore blocking an earlier opening, which had three rough lengths of timber forming its lintel, all of which were probably re-used and one of which had a number of curious curved slots cut into it.

Plate 23 (left): Blocked fireplace in G10c
Plate 24 (right): Detailed view of the carved letters, numeral, and symbol in the lintel (turned 90° to the left)

Plate 25: Overlay of the carved letters, numeral, and symbol in the lintel (turned 90° to the left)

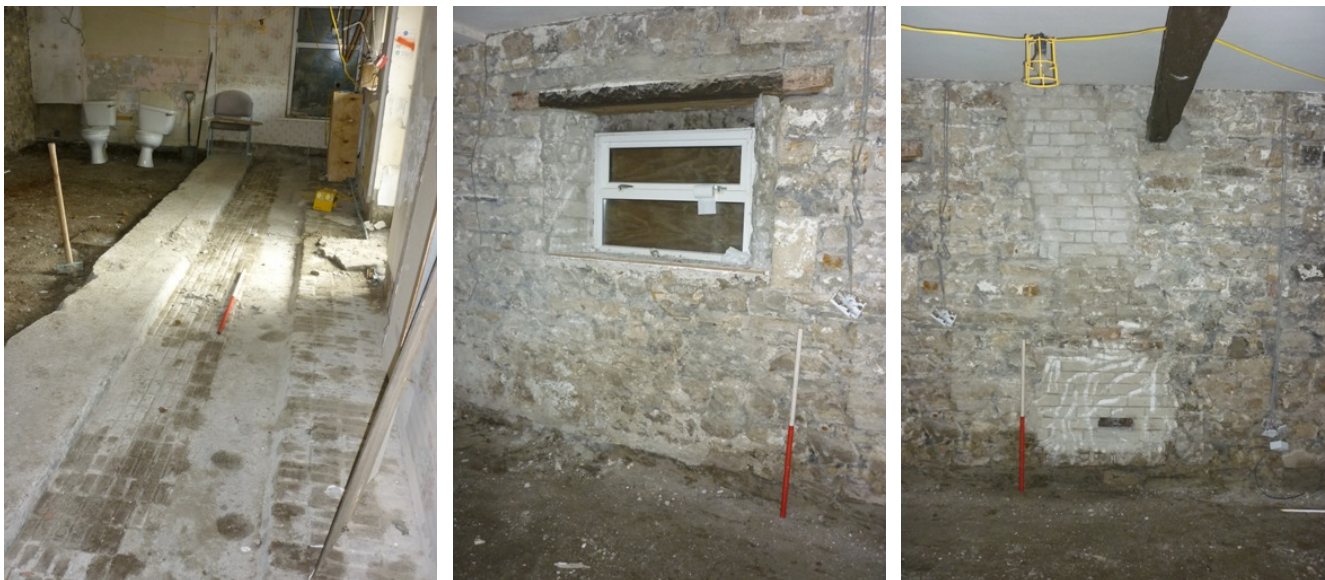
4.2.8 **Room G12:** the removal of the floor had exposed bare earth on the east side of the room but also the remains of a concrete channel with a gridded finish running north/south along the west side, with an apparent drain leading to the door to the west (Plate 26). This arrangement evidently originally extended over a wider area and presumably represents the remains of a former cow house or stable floor complete with dung channel. The stonework of the east elevation had also been exposed by the removal of the plaster, which revealed that the jambs of the north window had originally been square but had been built up with concrete blocks to make them splayed, and the area above the lintel had been rebuilt (Plate 27). The line of a flue was evident built into the wall in the centre of the east elevation as an approximately linear patch of concrete blocks, below which was an evident opening for a fireplace, stove, or boiler, which had again been filled with concrete blocks (Plate 28).

Plate 26 (left): Concrete floor revealed in Room G12

Plate 27 (centre): Remodelled window in the east elevation of Room G12

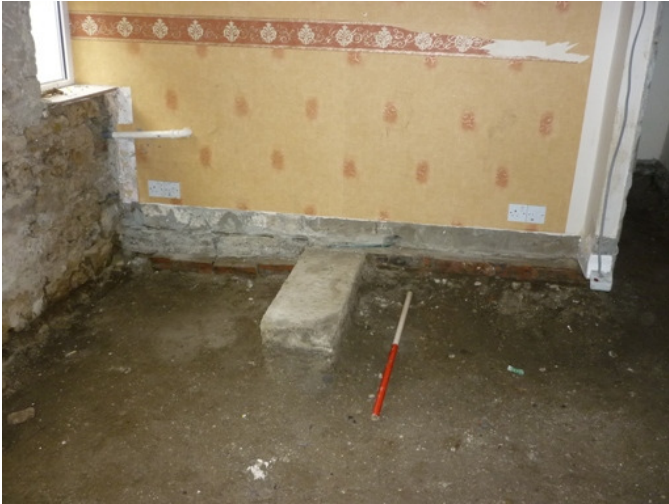
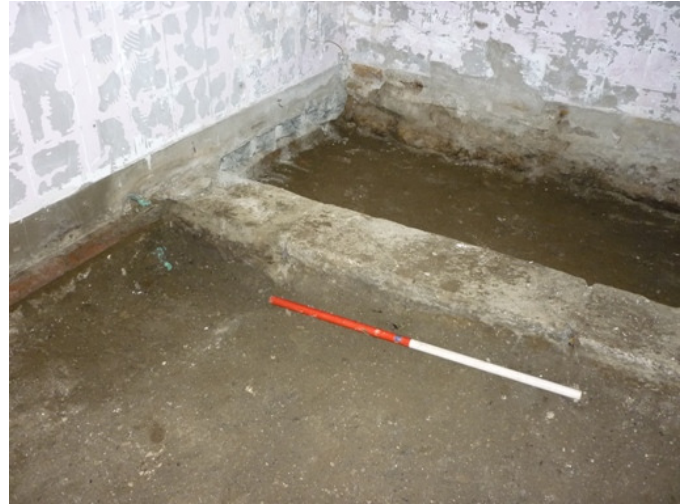
4.2.9 **Room G13:** the floor was exposed to bare earth and had the base of a wall or a plinth constructed from dressed stone blocks running east/west approximately along the centre of the room and up to the west elevation, below the dividing wall on the west side (Plate 29 and Plate 30). Below this wall, which was constructed from concrete blocks, was a row of ceramic floor blocks that had either been utilised in the wall's construction or the wall sat above. These tiles were evidently part of a larger gridded floor that presumably covered the entire room and indicates that the room was originally a cow house or stable. The north and south walls had had the plaster removed exposing the stonework; the north had one or possibly two pieces of re-used stone with a small rectangular notch cut into it, which was probably a former threshold (the notch being the housing for the door frame). The windows in the south elevation had clearly either been inserted or enlarged as the jambs and area above the lintel had been rebuilt in concrete blocks.

Plate 29 (left): Stone 'plinth' running beneath a partition wall in Room G13

Plate 30 (right): Stone 'plinth' at the west end of Room G13

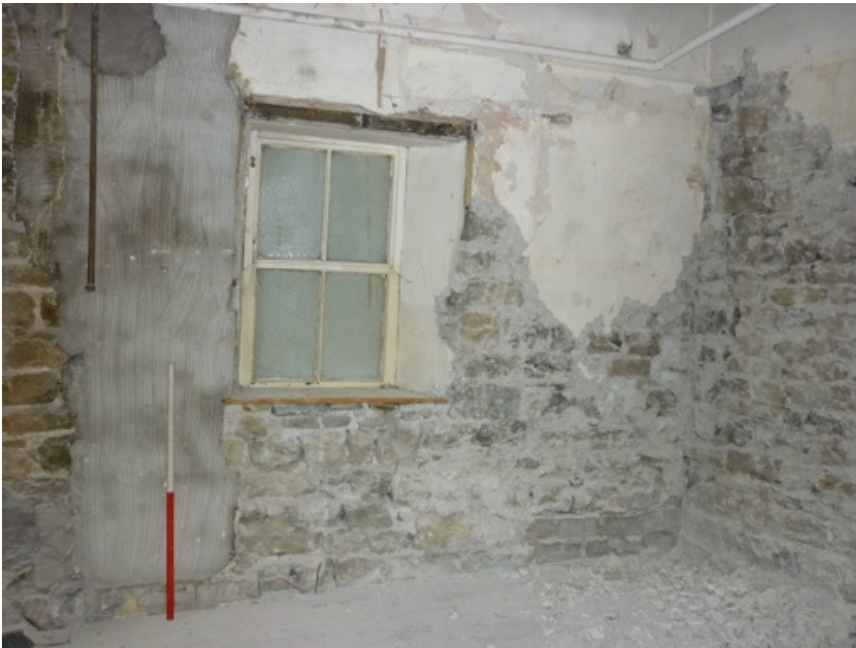
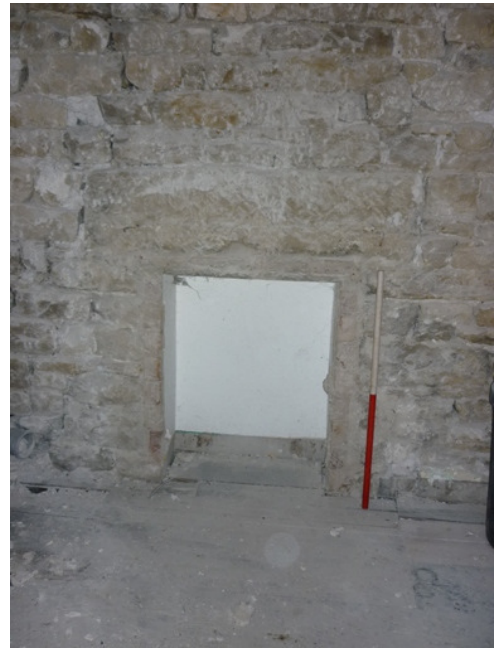
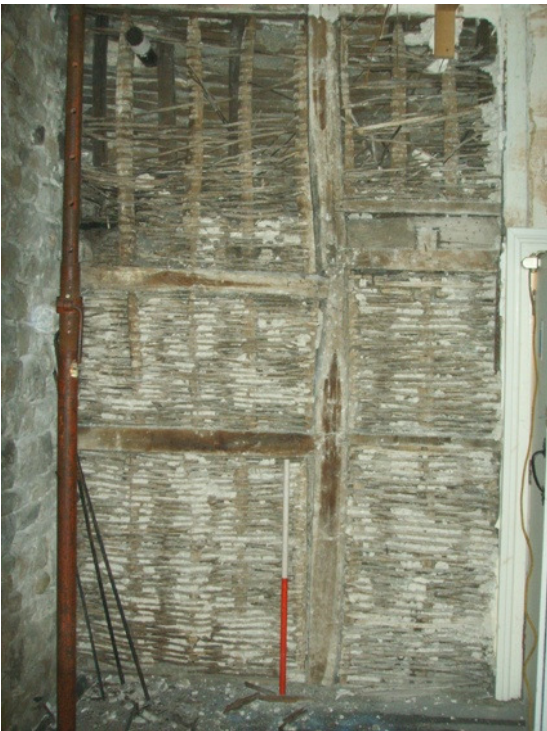
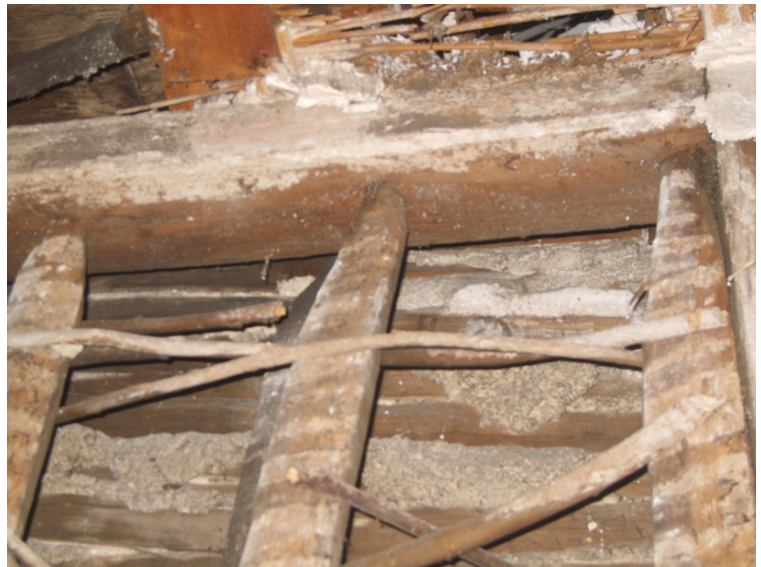
4.2.11 **Room F3:** the south and west walls had been exposed by the removal of wall coverings and plaster and the former stud walls. The west elevation had a well-preserved window on the north side, with a four-light hinged casement with a latch, a timber sill, and splayed jambs (Plate 31). To the south there was a fireplace, with a heavy, dressed stone lintel, and the jambs of which had been reduced slightly in size with bricks (Plate 32). It had a plaster finish, which was the same as the back, and had subsequently been covered with flock wallpaper. To the north of the window at ground level there was an area of rebuilding, perhaps the remnants of a blocked aperture, filled with concrete blocks. The walls in general contained some evidently re-used pieces of dressed stone and the east wall was evidently a relatively early stud partition. The removal of the plaster from this revealed that it was constructed from timber studs inserted into horizontal rails filled with woven withies, presumably of hazel (Plate 33 and Plate 34).

Plate 31 (left): Window revealed in the west elevation of Room F3

Plate 32 (right): Fireplace revealed in west elevation of Room F3

Plate 33 (left): Exposed timber stud wall in Room F3

Plate 34 (right): Detail of junction between studs and rails in Room F3 (photograph by Stephen Gardner)

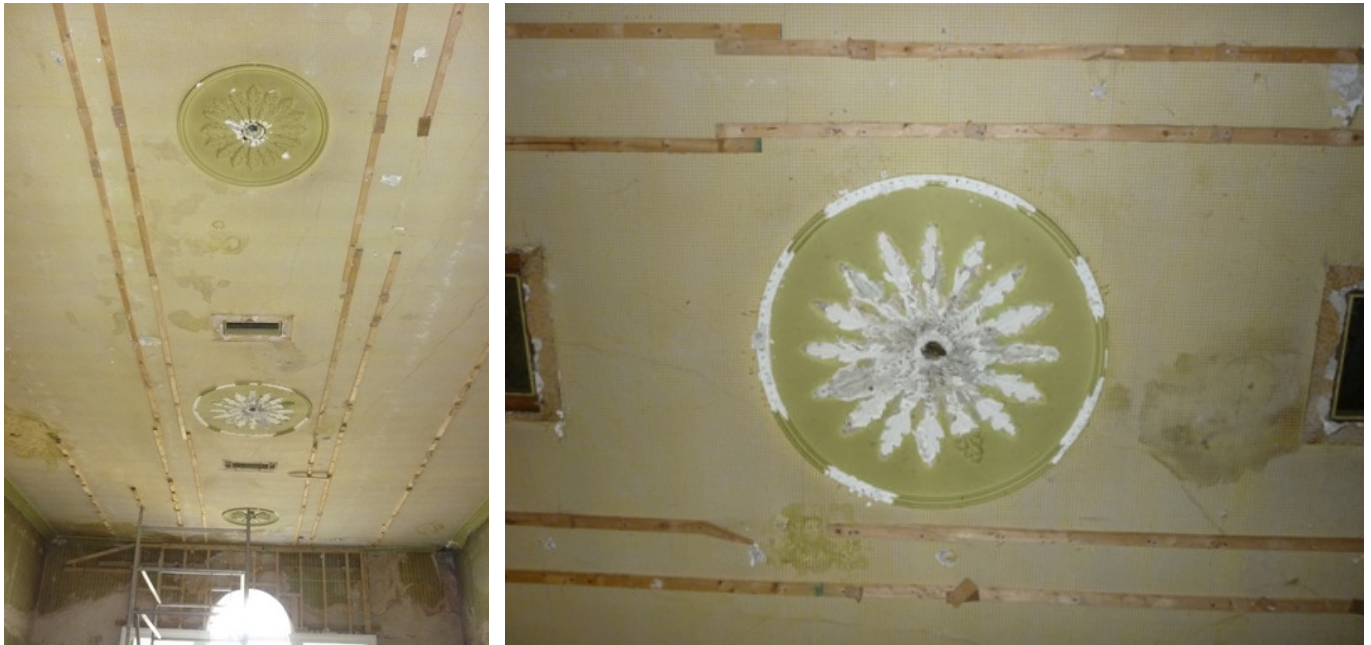
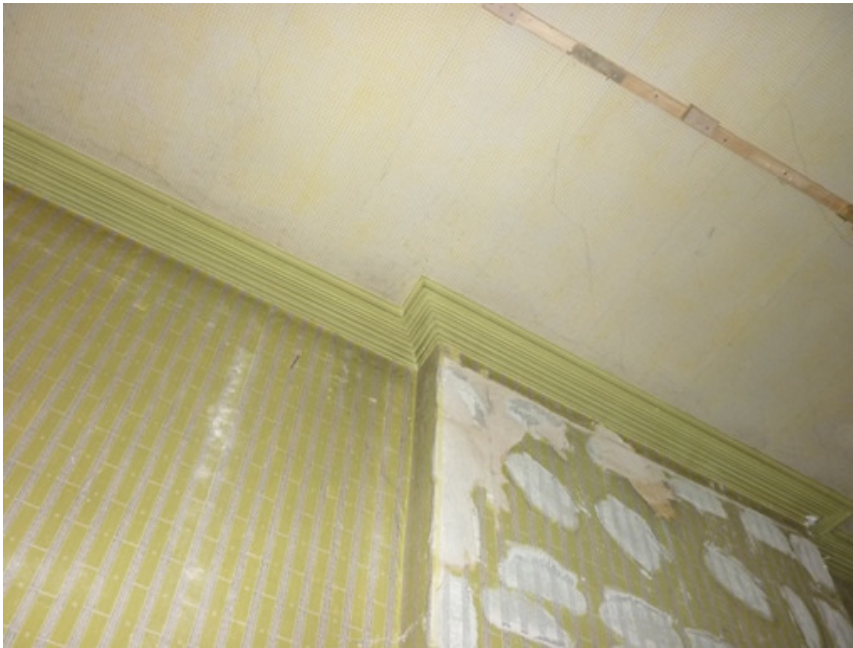
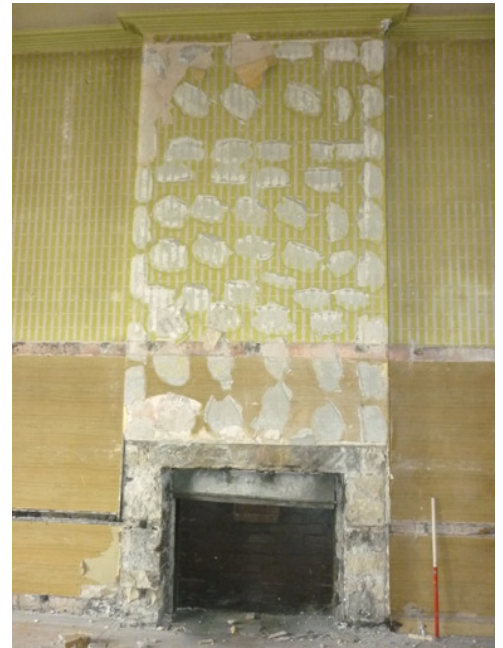
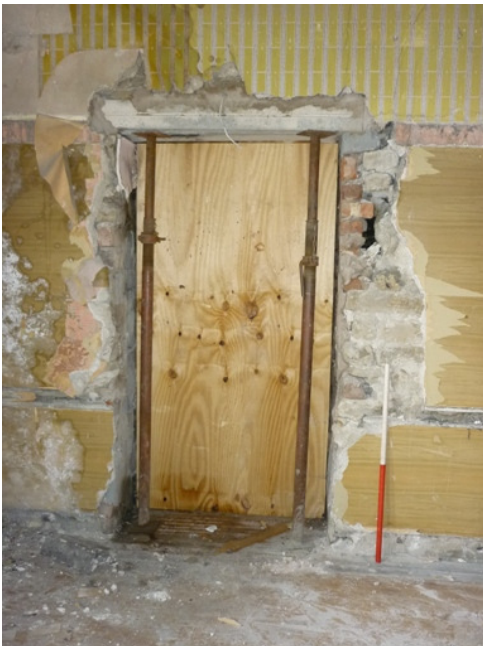
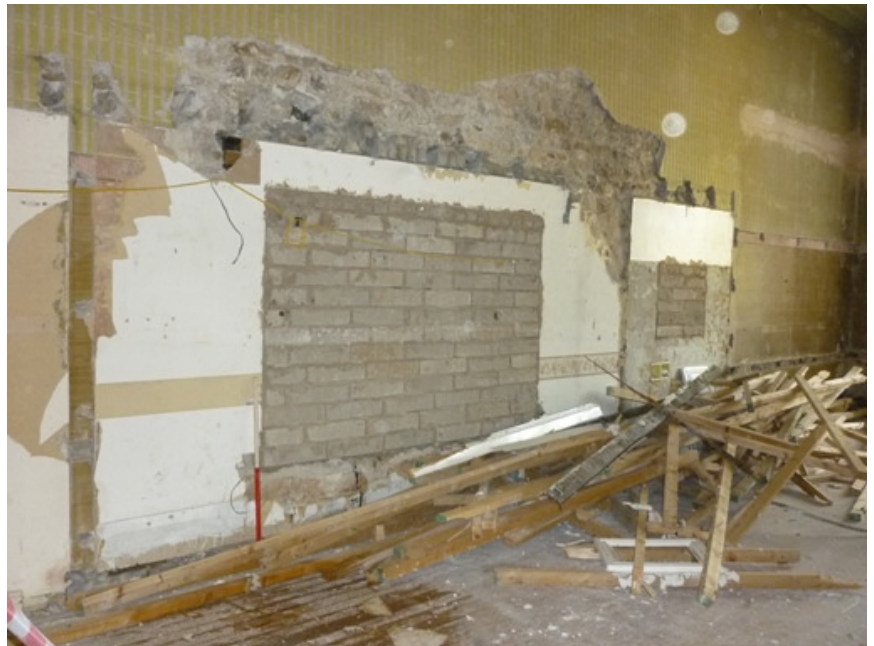
4.2.14 **Room F6:** the ceiling was evidently clad with boards attached to battens over the original ceiling, and the removal of these revealed a number of features. Along the centre line of the ceiling there were three elaborate circular ceiling roses, each decorated with acanthus leaves and an outer raised border (Plate 35). The central one was slightly larger than the other two, but had been partially hacked off, presumably to provide enough space for the attached sheeting (Plate 36). In addition, the removal of the sheeting revealed the original cornice around the room, which had a reeded decoration (Plate 37). The walls too had evidently been covered by later timber cladding and the removal of this revealed several more features of interest. In the north elevation there was a central projecting chimneybreast and fireplace with a heavy dressed stone lintel, brick back, and inserted metal hood (Plate 38). The doorway to the west was evidently inserted and had a concrete lintel and rebuilt jambs (which were not properly supporting the lintel and cracks were visible in the wall above (Plate 39)). The large window casement in the west elevation was evidently an entirely modern construction, although the original stone mullions were visible in the formerly boxed in area below the sill and extended to the floor. The south elevation had the scar for a relatively modern former partition on the west side, which had evidently at least partially formed a toilet as a recessed toilet roll holder with toilet roll was still present in the wall (Plate 40). Towards the centre of the elevation there was what appeared to be a large aperture, which was blocked with concrete blocks, east of which was an even larger aperture which was also blocked. Above all of this was a row of what appeared to be joist slots, although these were rebuilt with concrete blocks and were evidently quite modern and presumably related to the former partition wall.

Plate 35 (left): Ceiling roses exposed in Room F6

Plate 36 (right): Detail of damaged central ceiling rose exposed in Room F6

Plate 37 (left): Detail of cornice in Room F6

Plate 38 (right): Fireplace on the north side of Room F6

Plate 39 (left): Inserted doorway in the north elevation of Room F6

Plate 40 (right): Blocked apertures and wall scars in the south elevation of Room F6

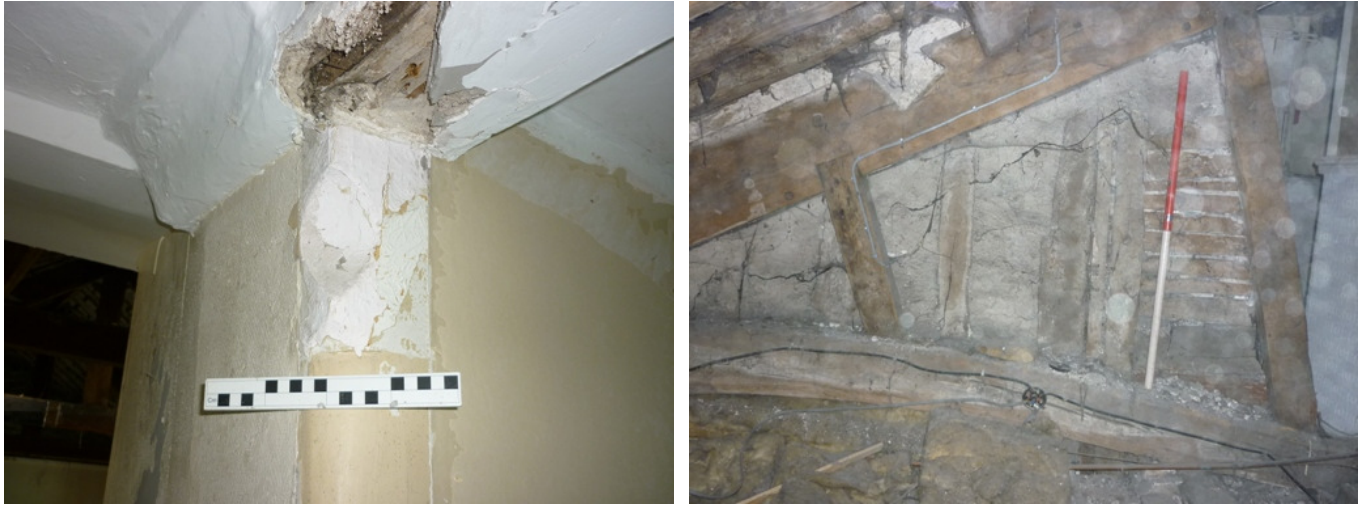
4.2.16 **Room F9**: an original or early stud wall at the north end had been removed; joint marks where it had been attached to the beam were evident. In addition, where the later stud wall forming a passageway along the west side of the room had been removed, a moulded section on the corner of the chimneybreast was revealed which mirrored that in the east side of the south chimneybreast (Plate 41).

Plate 41 (left): Moulding on the west edge of the chimneybreast on the north side of Room F9

Plate 42 (right): Truss utilised as a dividing wall between Room S6 and the roof space over Room F12

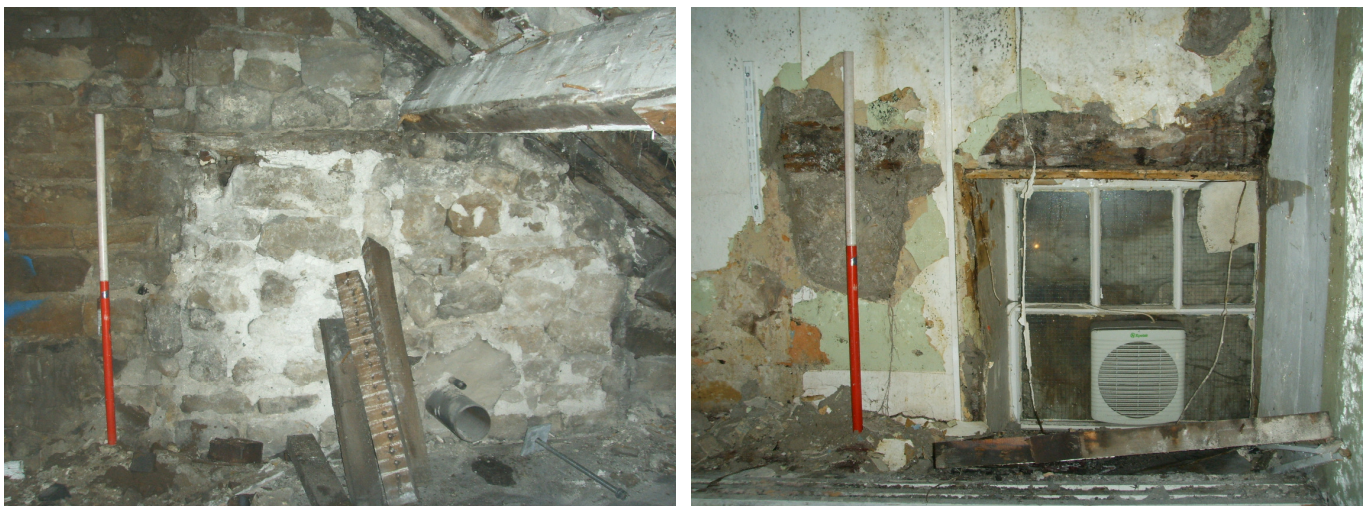
4.2.18 **Room S1**: all the added stud walling and the wall plaster had been removed, which exposed the single truss in centre, and a small window on north side of the west elevation, with a rough timber lintel (Plate 43). This was only evident externally on account of a vent in the wall. In addition, at the top of the stairs, a modern pane of reinforced glass had been removed revealing the top of the original tall stair window behind, which extended into Room F4 below (Plate 44).

Plate 43 (left): Blocked window at west end of S1

Plate 44 (right): Top of stair window on east side of north wall, S1
