THE CASTLE HOTEL, MAIN STREET, HORNBY, LANCASHIRE

Supplementary Archaeological Building Recording

Client: Applethwaite Ltd

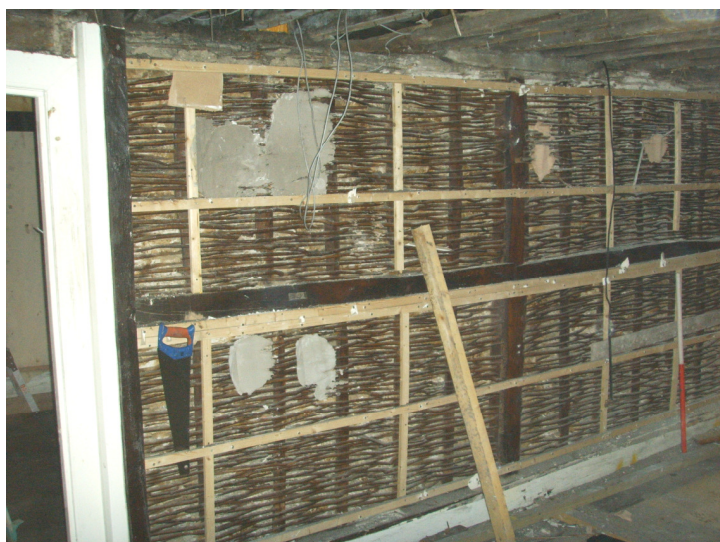
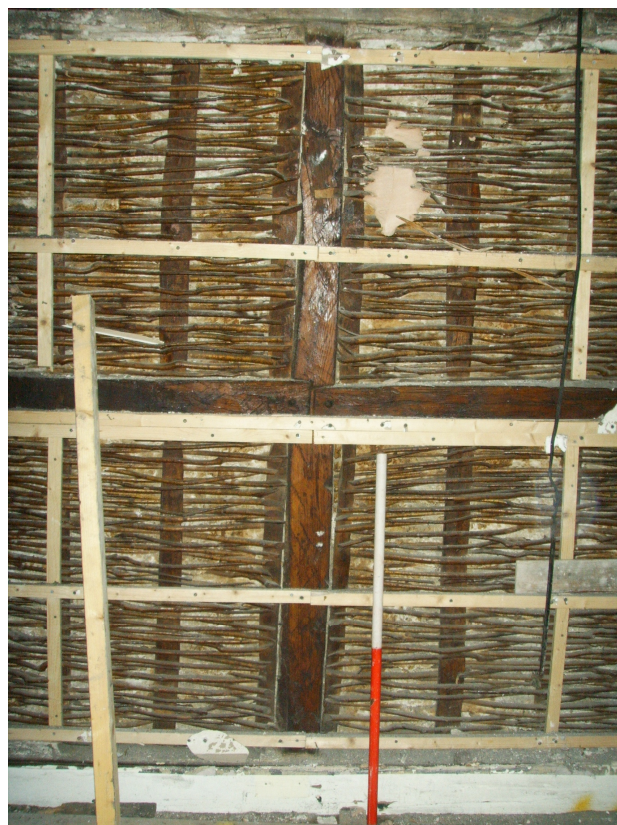
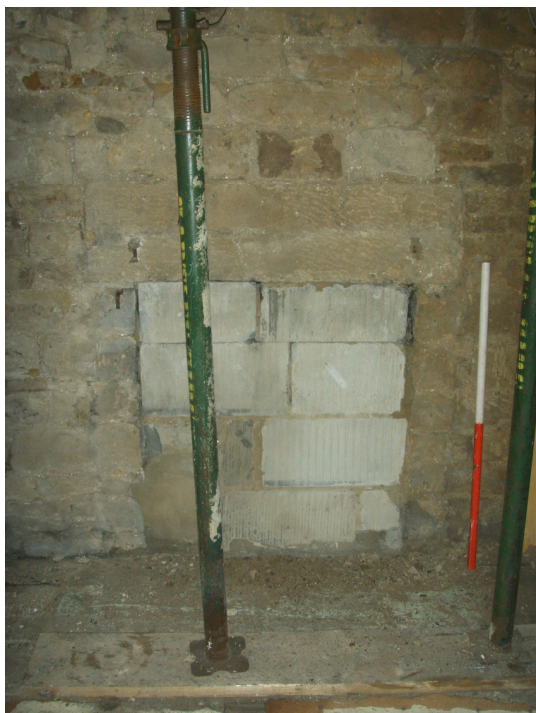
4.2.19 **Room S2:** the plasterboard covering the south face of the dividing stud wall within this room had been removed, revealing that it was constructed from horizontal rails jointed to upright posts, with smaller horizontal staves between the rails and hazel withies woven between these. It is apparent that at some point, probably quite recently, the plaster had been removed from the south face of the wall to leave the structure beneath deliberately exposed and that the timber work had even been stained brown to enhance this, before it had been covered with plasterboard fixed to small battens. It was also notable that the top rail comprised three parts, the central part being thicker and with chamfered ends. In addition, the ceiling in this room also originally comprised reed plaster, and where the plaster had been removed from the south elevation a fireplace had been exposed, which had a heavy dressed gritstone lintel and had been filled with concrete blocks. The plaster had also been removed from the east elevation revealing that the lintels for the windows comprised rough and largely re-used pieces of timber.

Plate 45 (left): Stud wall with woven withies in S2

Plate 46 (right): Detail of construction, showing brown staining

Plate 47: Blocked fireplace in south elevation of S2

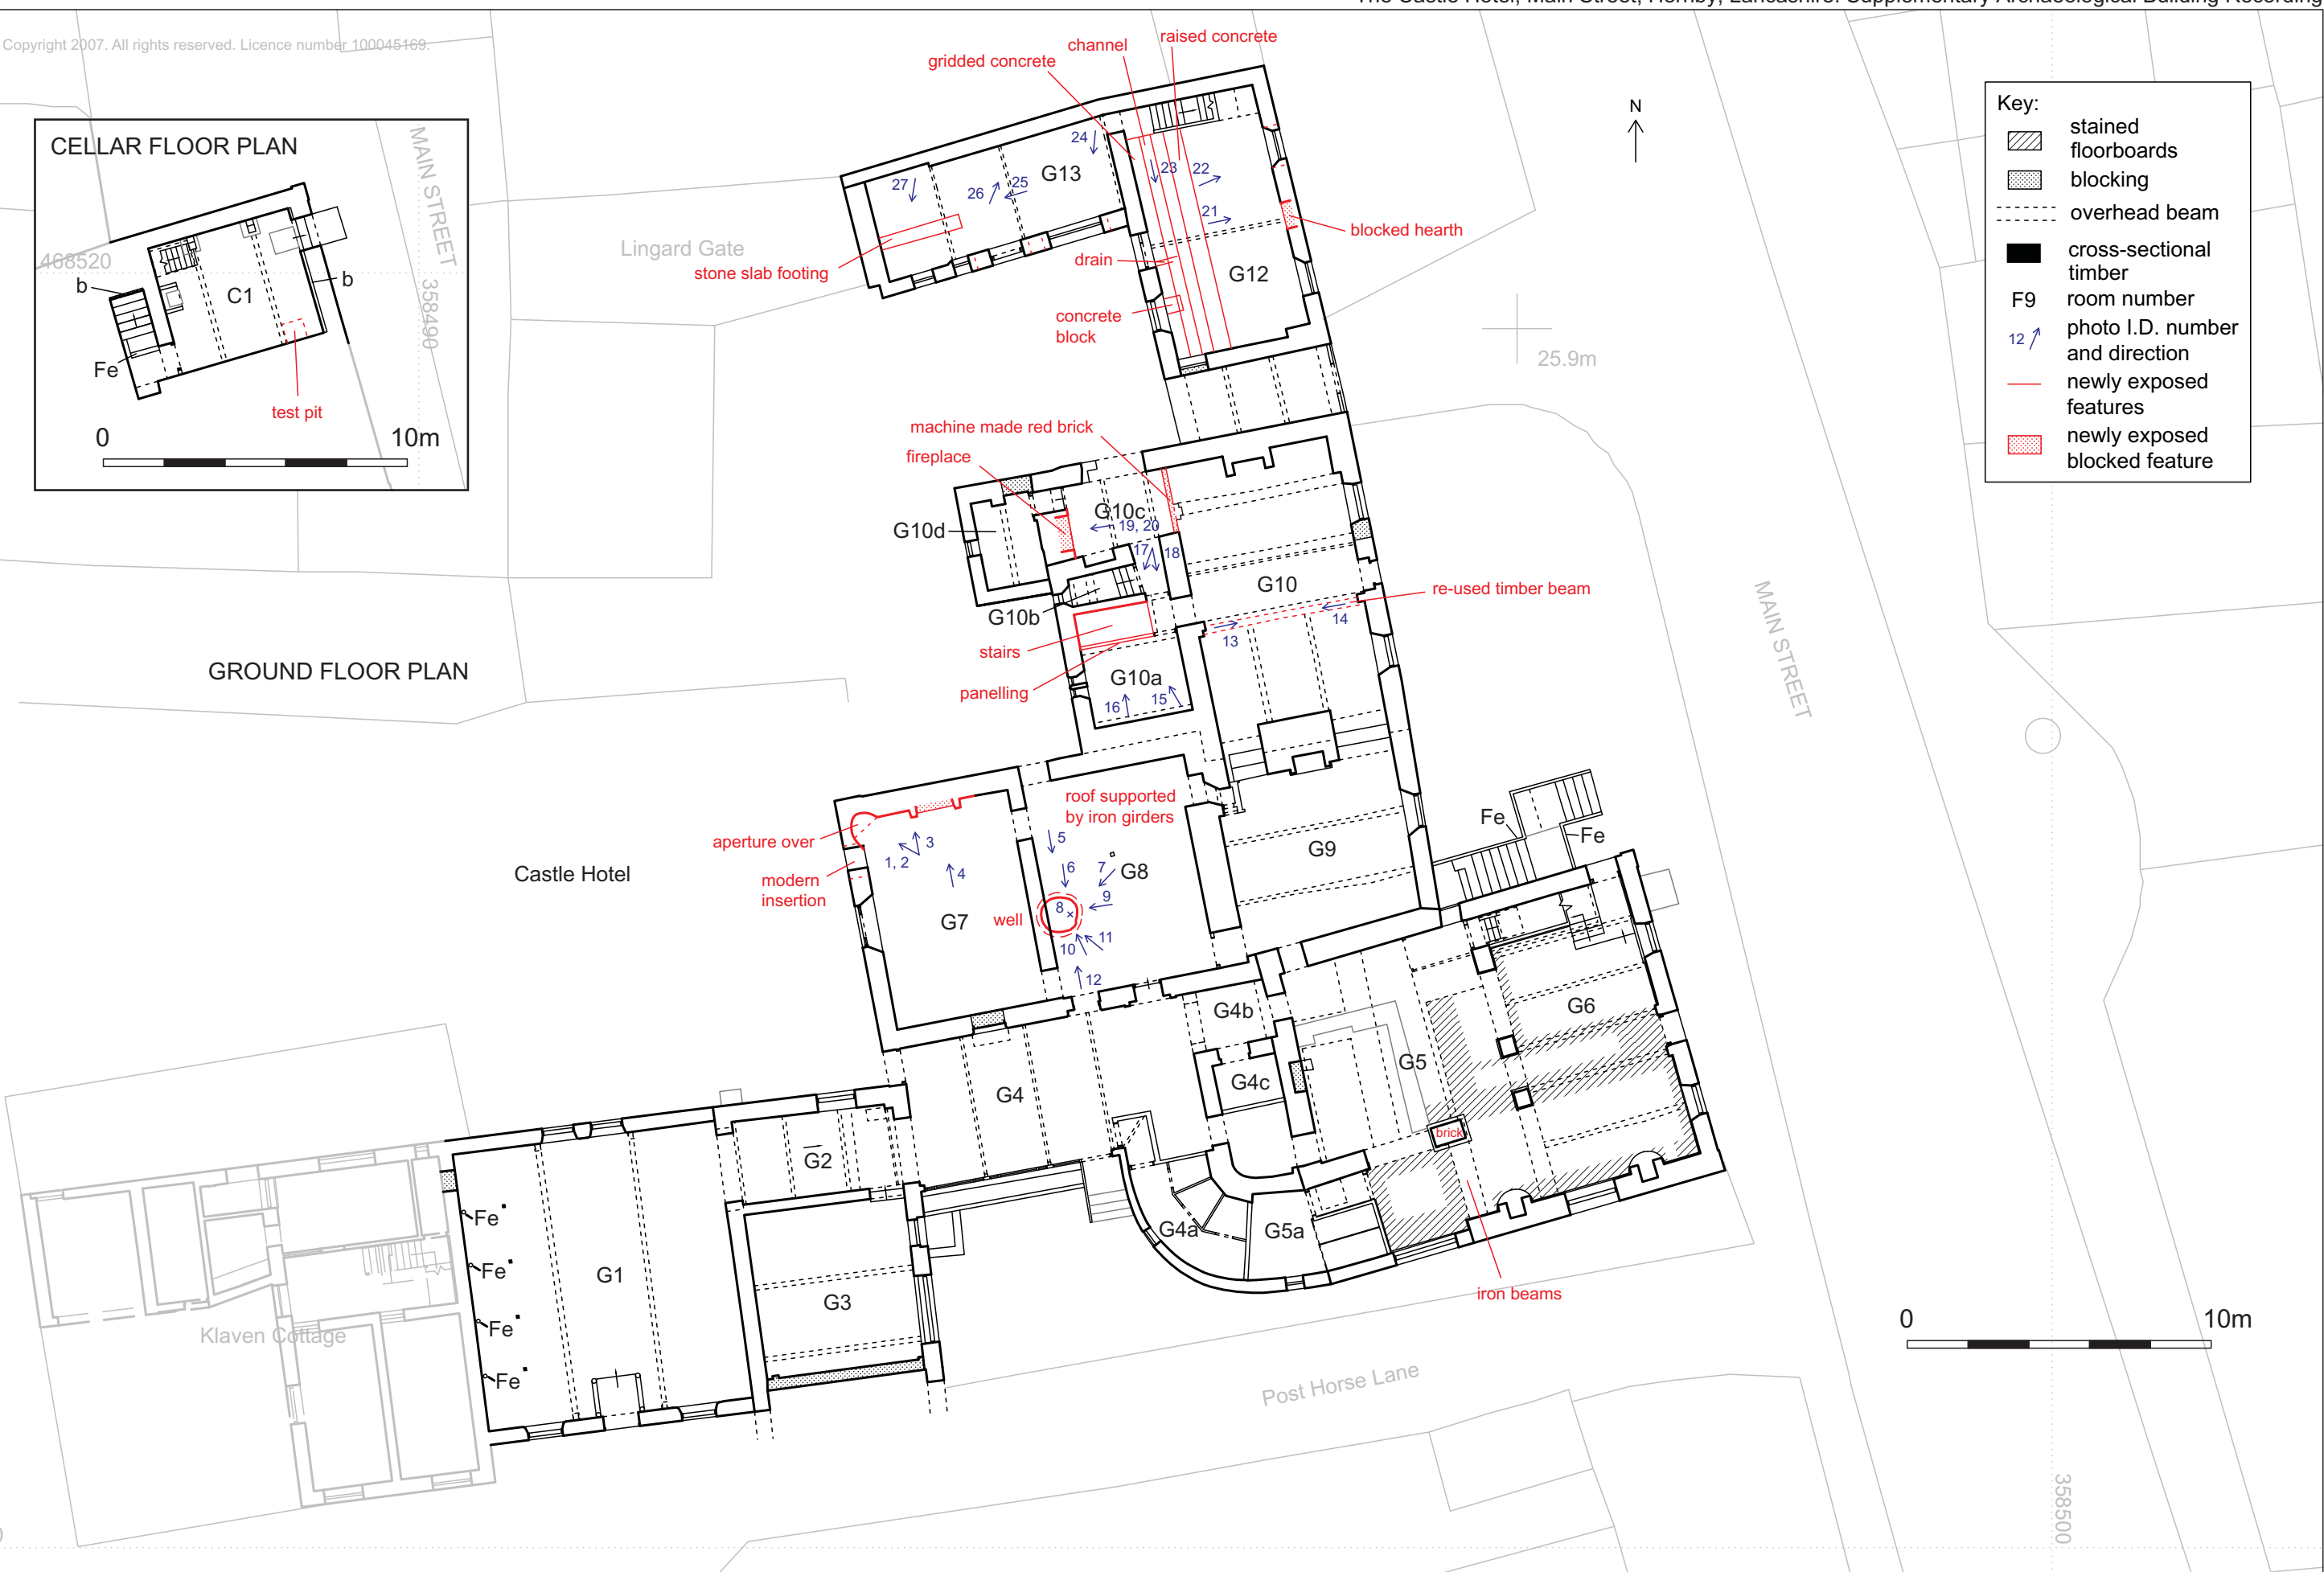
Figure 3: Ground floor and cellar floor plans

4.2.4 **Room G8:** the ceiling had evidently been extensively remodelled as steel I-beams were exposed where the coverings had been removed. In addition, a well was exposed beneath the concrete floor against the west elevation (see Figure 3 and Figure 6). This had been capped with large, roughly-worked stone slabs on a similar alignment to the west wall (Plate 15 and Plate 16). The dry stone walls of the well were in loose courses approximately 0.1 to 0.15m high and each stone measured approximately 0.2 to 0.3m on a side (Plate 17). The outer ring of the well had an internal diameter of approximately 1.2m and extended below the west wall. The outer wall continued to a depth of at least 2.8m from the top of the capping material. At the lower level there was an 'inner' dry stone wall feature (Plate 18), with a diameter of approximately 0.77m, which continued to a depth of at least another 0.7m. The outer ring of the well was said to have formed a hollow beneath the capping material when it was first exposed and no finds were recovered from it. The lower level feature may have been enlarged to form the outer ring of the well before it was capped. A fragment of pottery and three clay tobacco pipe stem fragment were recovered from the floor surface of Room G8, below the concrete floor, at the level of the capping material of the well (see *Appendix 2*). This material dates from the late 17th to early 20th century (although an 18th to 19th century date is perhaps most likely given the suggested date of the stem fragments of the clay tobacco pipe, which were present) and must postdate when the well was sealed.

4.3.1 A test pit had been excavated through the concrete floor in Room C1 (Figure 3) to a depth of c0.5m, which revealed an apparently homogenous deposit of dark brown sandy clay containing 30% rounded pebbles. While the lack of variety and apparently sterile nature of this deposit suggested it was the underlying natural geology, a single find was recovered from the spoil in the form of a possible whetstone (see *Appendix 2*). This find is unfortunately not particularly diagnostic, and could be of almost any date, but its position, below the floor of the present building, suggests that it cannot have been deposited any later than the 18th century.

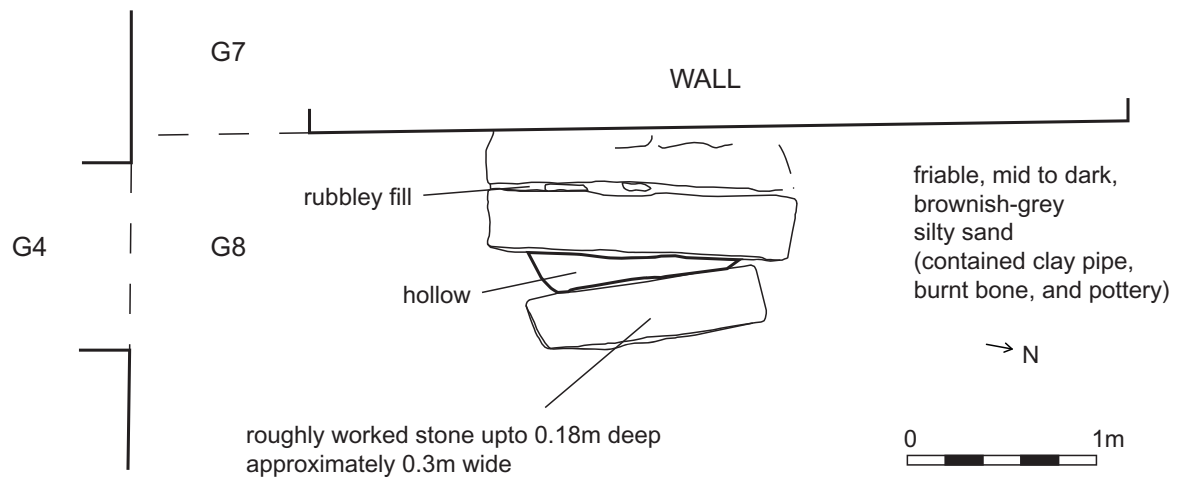
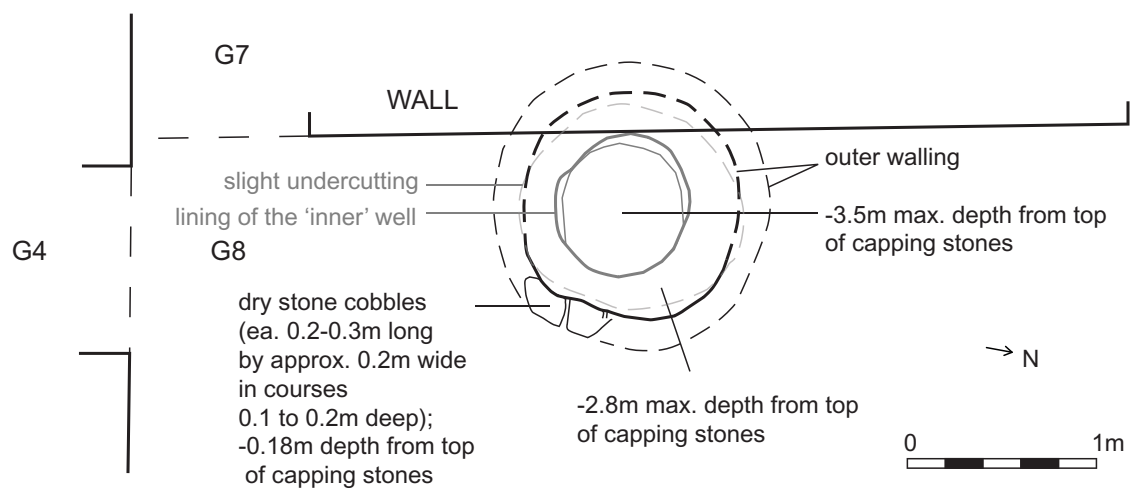
Plan of the well in Room G8, showing the alignment of the capping stones

Measured sketch plan of the lower level features of the well in Room G8
