BRUNSWICK ROAD, PENRITH, CUMBRIA

Archaeological Watching Brief

Client: Booths (Penrith) Ltd

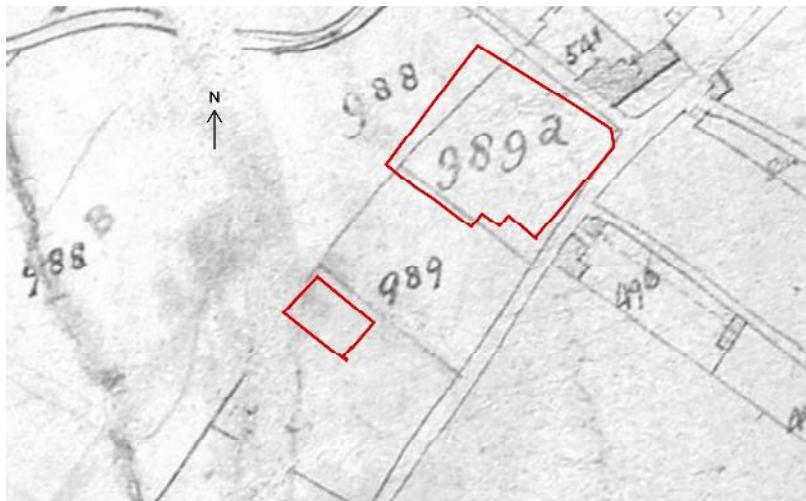
Plate 2: Tithe Map, 1845

3.3.2 **Tithe Map, 1845:** the tithe map shows the division of the area into plots (Plate 2). The fields in this area were named 'Clowers' in the apportionment and described as arable and meadow; the tithe barn shown to the south was owned by the Lancaster and Carlisle Railway Company (CRO(C) DRC/8/150 1845, cited in ASDU 2009, 5-6). The route of the railway is marked faintly on the map, although it is shown slightly further to the east than it is in reality.

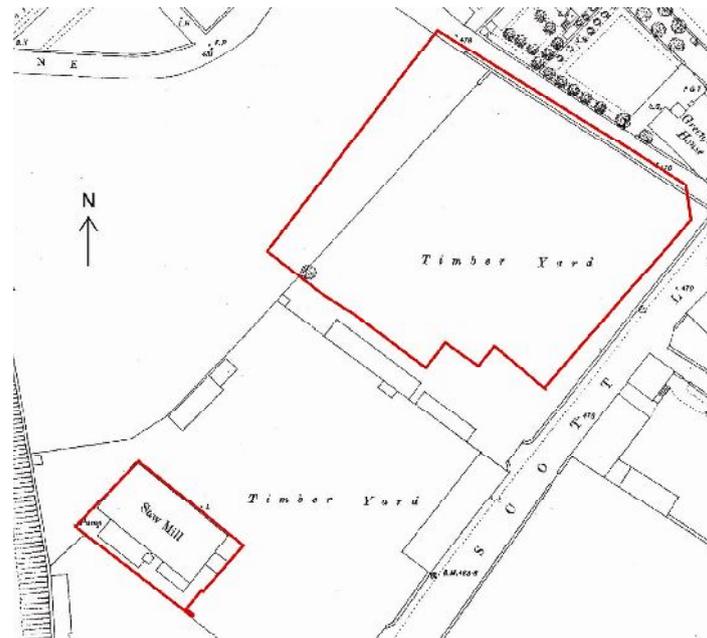
Plate 3: Extract from the Ordnance Survey map of 1861

3.3.3 **Ordnance Survey, 1861:** remarkably there is a detailed, 1:500, Ordnance Survey map of Penrith from 1861, predating the subsequent standard 1:2,500 and 1:10,560 scale maps. This clearly shows the saw mill and associated timber yards with a number of associated smaller buildings.

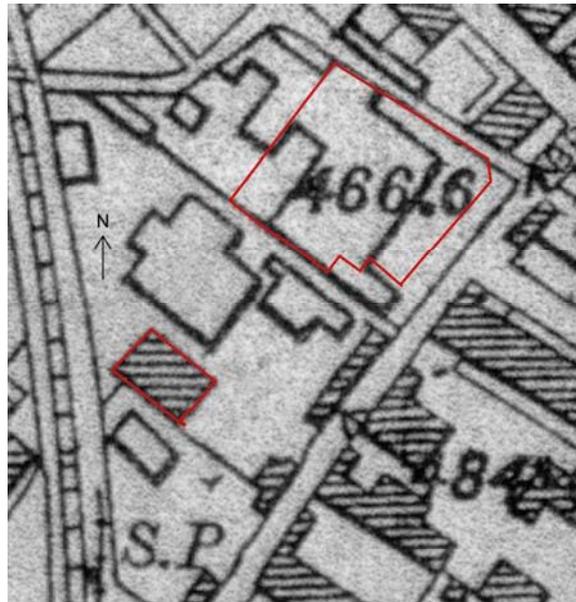
Plate 7: Extract from the Ordnance Survey map of 1938

3.3.8 **Ordnance Survey, 1938:** this map is limited in detail due to its scale; however, it is clear that some alterations have taken place on the site since 1925. Two blocks of buildings have been constructed in the gap between the saw mill and the carriage works, although no detail of their use is given. The buildings which comprised the carriage works have also evidently been enlarged to the south-east and at the north-west end of the north-west elevation; however, the buildings to the south-east end of the north-west elevation appear to have been removed by this point. All of these alterations are shown as open blocks, although the reason for this is not certain.

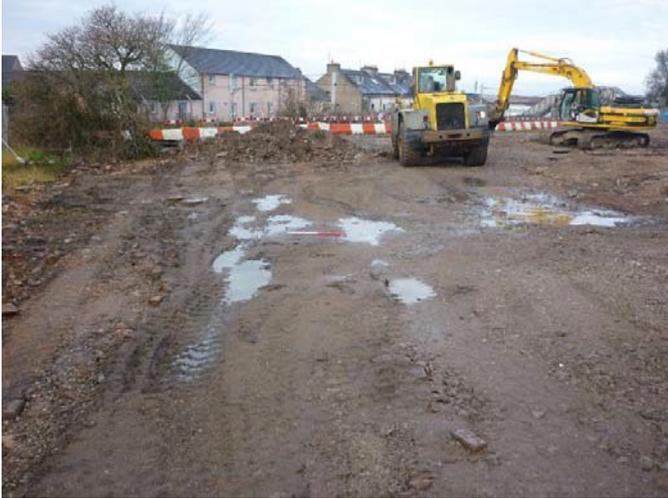
Plate 10 (left): Pre-excitation view of the Rickerby's site, looking north-west

4.1.1 The ground surface within the watching brief area comprised areas of tarmac, concrete, and gravel, and rubble associated with the buildings that had been demolished on site ahead of this phase of the archaeological work (see Plate 10, Plate 11, and Plate 12).

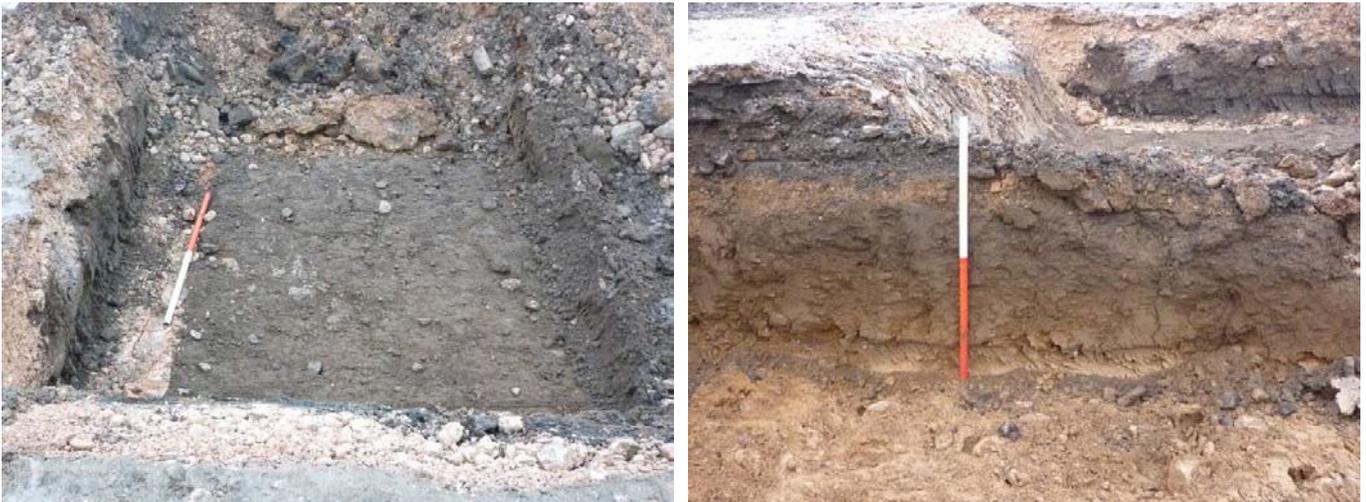
was also removed from this area. The underlying natural (**105**) was exposed at a depth of approximately 1.0m to 1.1m where the test pit was stepped down to the south-west (Plate 14).

Plate 13 (left): Possible boundary wall (104)

Plate 14 (right): Layers exposed within the test pit to the north of the Rickerby's site

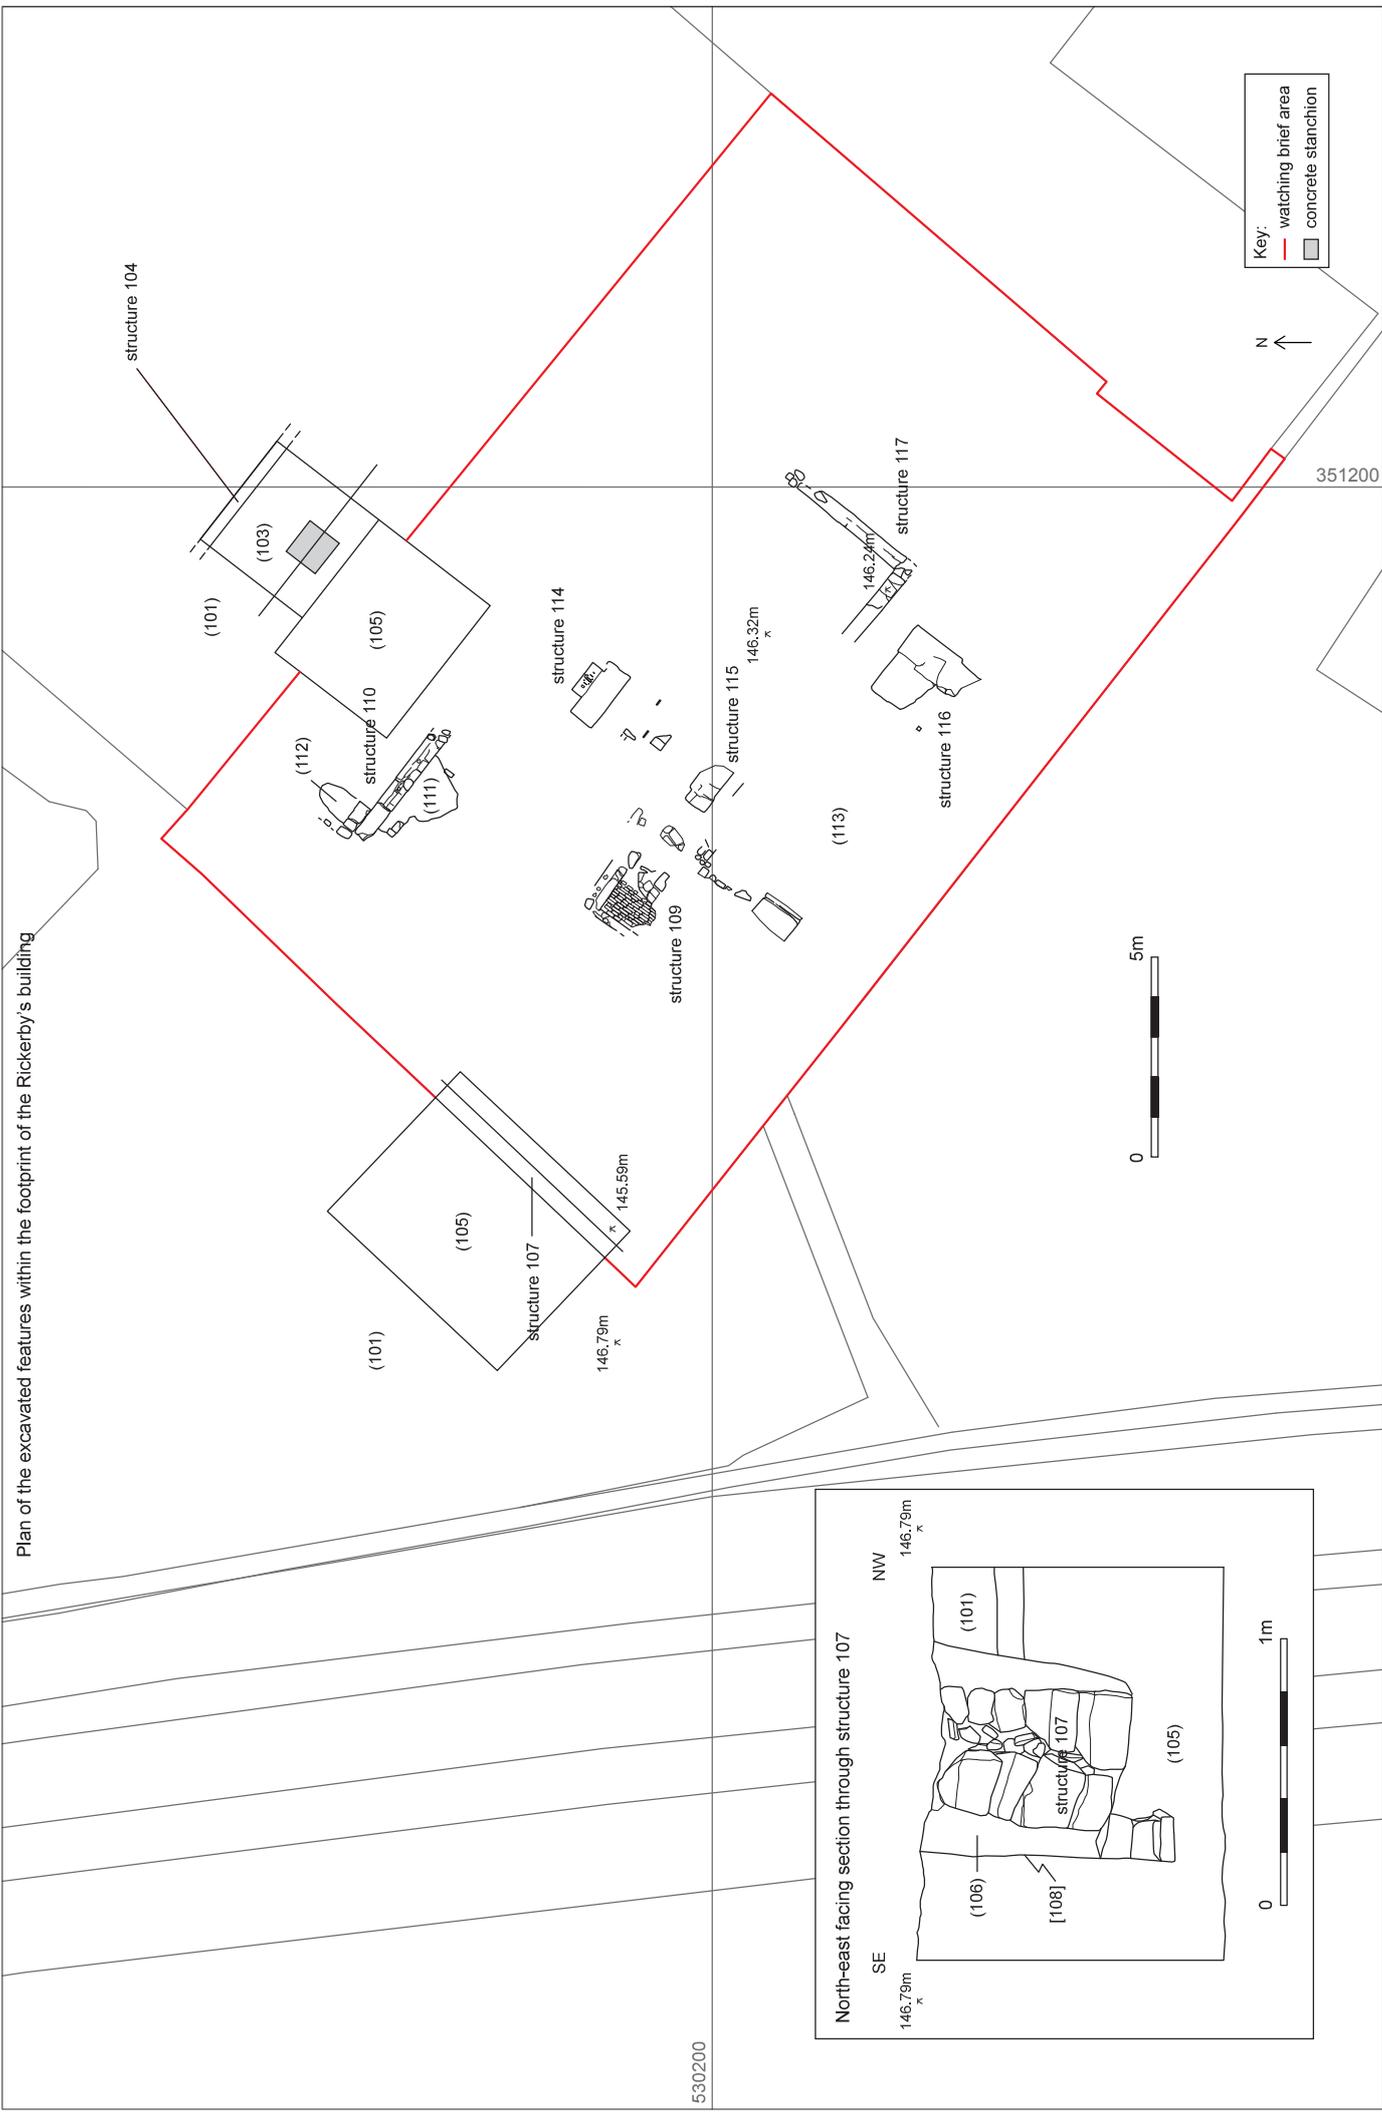
Figure 2: Plan of the Rickerby's area and north-east facing section through structure 107

4.2.2 An area approximately 4.8m by 5.8m was excavated to the north-west end of the Rickerby's site to a depth of 1.2m without the supervision of a trained archaeologist (Plate 15). The north-west elevation of the saw mill (**107**) and the associated foundation cut (**108**) and fill deposit (**106**) were revealed in section (Plate 16). The section was drawn (Figure 2) and photographed subsequently, but it could not be cleaned because space was prohibitive and the ground was frozen.

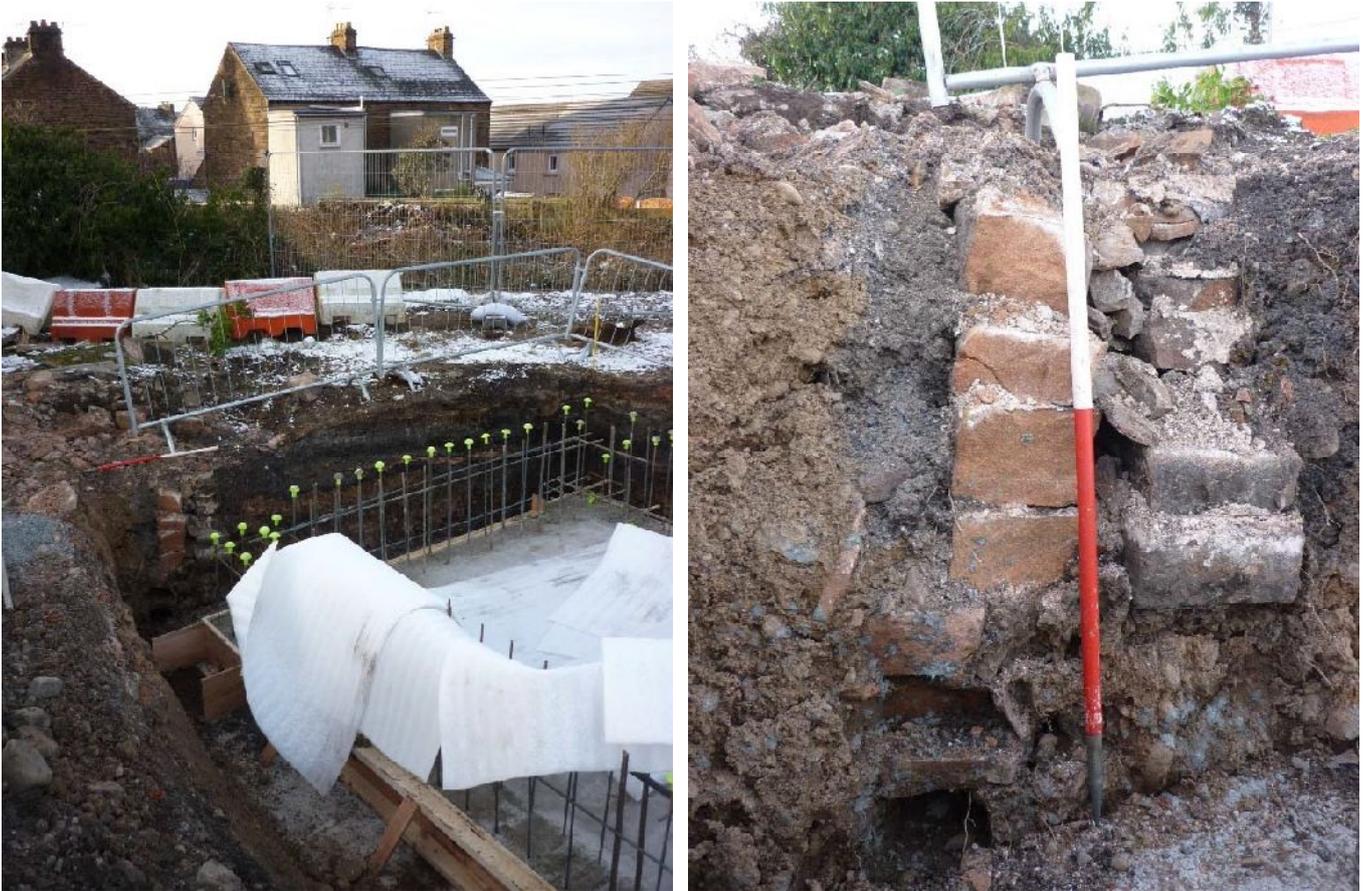
Plate 15 (left): Excavated area at the north-west end of the Rickerby's site

Plate 16 (right): Section through the north-west elevation of the saw mill

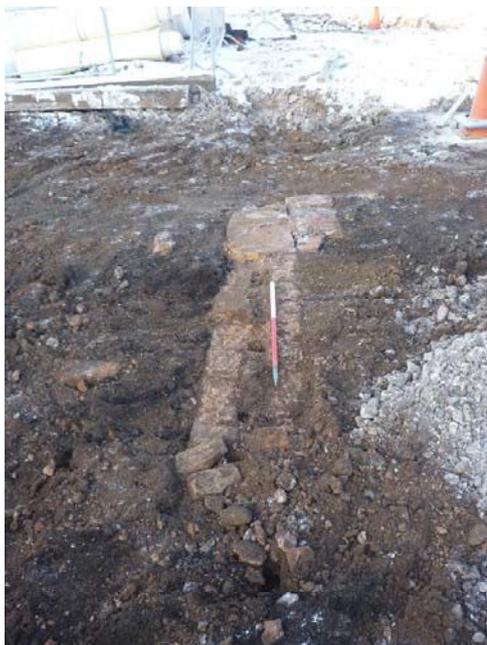
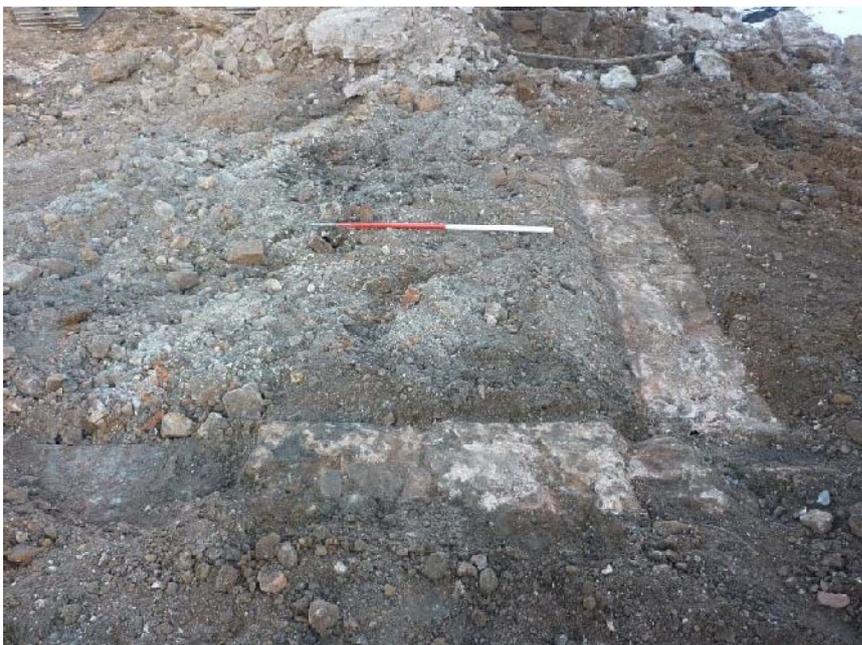
4.2.3 Excavation within the footprint of the Rickerby's building itself revealed various other structural elements (**109**, **110**, and **117**) at a depth of approximately 0.5m below the current ground surface that were probably internal walls of the saw mill that was located here during the 19th century. These features were underlying a layer of rubble within a blackish, silty matrix, between 0.3 and 0.5m thick (**113**), and appeared to be set into the underlying natural (**105**). They were usually of a very similar construction, built using fairly neatly cut reddish-orange sandstone blocks, often with a light pinkish orange mortar and occasionally with a rubble core (see Plate 17 and Plate 18). The only exception was the corner of a room to the north-west (**109**), which had a yellowish brick floor (see Plate 19 and Plate 20). This brick floor was noted to coincide with the location of an alcove, possibly relating to a hearth, which was recorded in the dividing wall of the Rickerby's building ahead of its demolition (Greenlane Archaeology 2010, 25). Some larger sandstone blocks were also partially exposed, notably to the south-west side (part of **109**) and across the centre of the site (notably structures **114** and **115**, which were on a parallel alignment), which might have functioned as engine beds and possibly mark the location of cutting machines within the mill (see Plate 21 to Plate 25; one of these blocks (forming part of **114**) was noted to have metal attachments (Plate 23).

Plate 17 (left): Wall 110

Plate 18 (right): Corner of building 117 exposed by hand

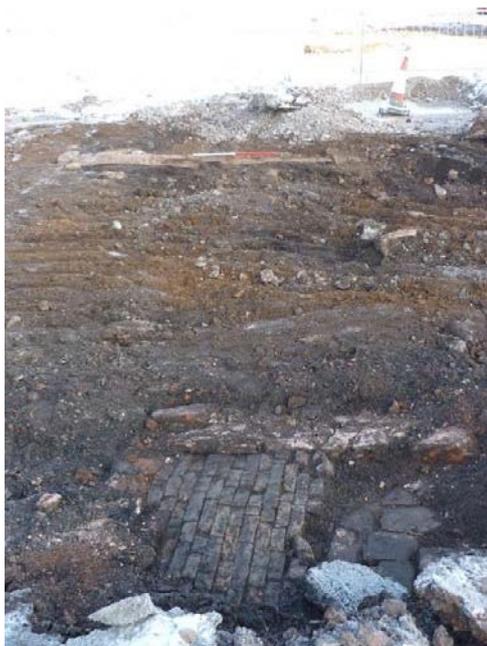
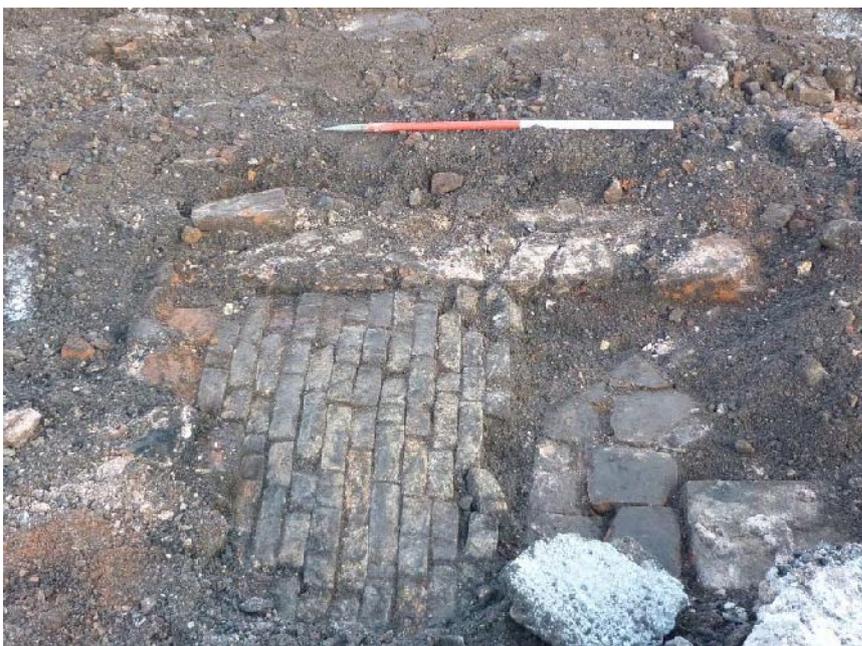
Plate 19 (left): General view of the north-west end of the site

Plate 20 (right): Detail of the brick floor 109

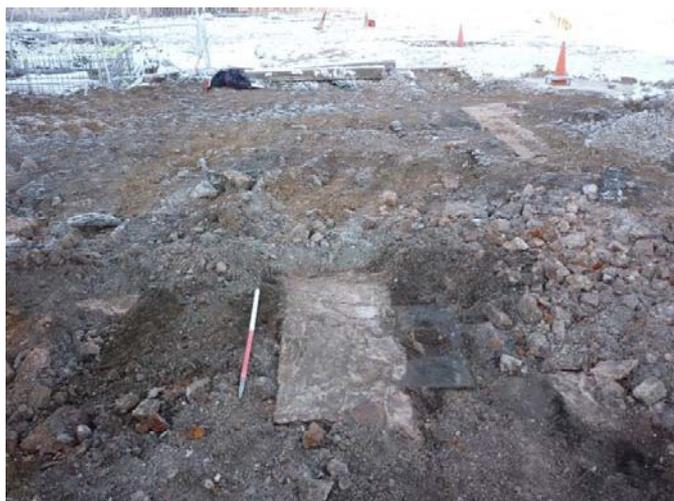
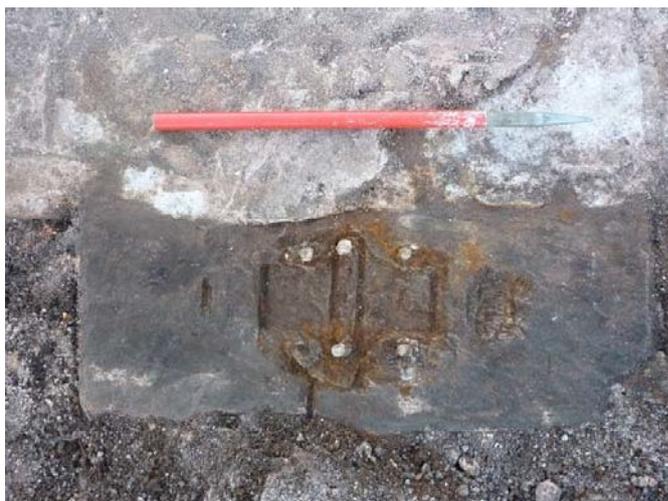
Plate 22 (left): Possible machine base (114) situated towards the centre of the Rickerby's site

Plate 23 (right): Detail of the metal attachments set within one of the possible engine beds

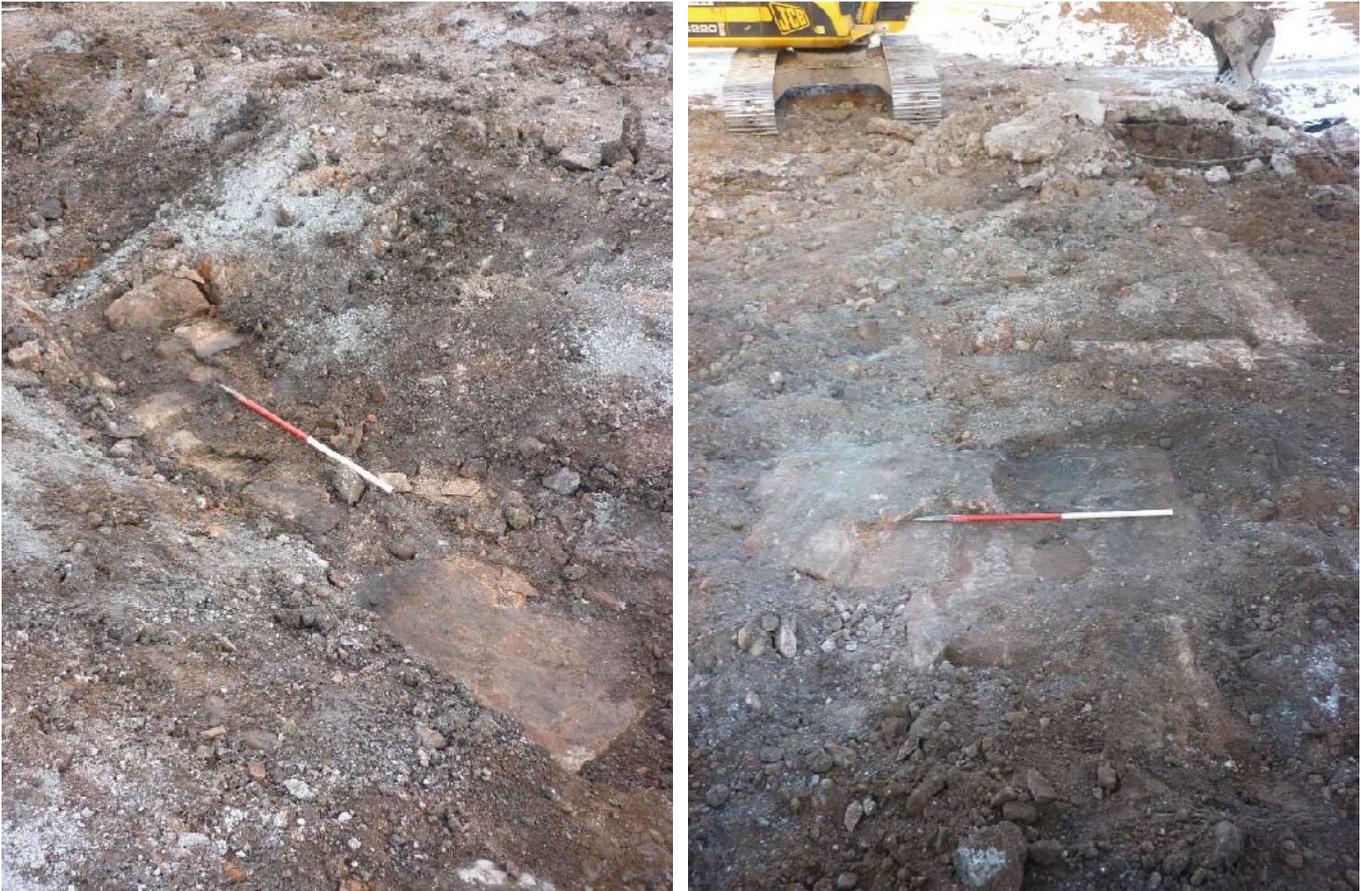
Plate 24 (left): Partially exposed sandstone block (part of structure 109) on the south-west side of site

Plate 25 (right): Partially exposed sandstone surface 116

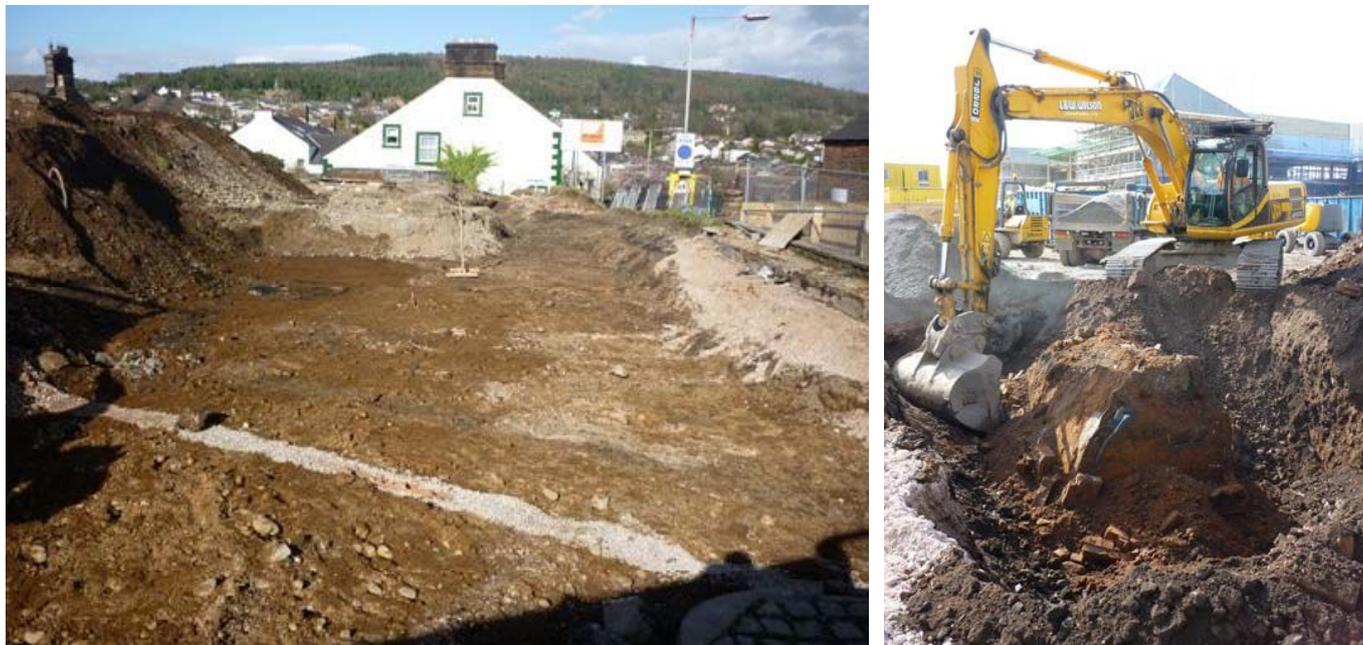
4.2.7 Various drainage features and associated manholes were exposed beneath the car parking area at the south-east side of the site (Plate 26), a large area of which was excavated more deeply to remove a sub-surface fuel storage tank and the contaminated soil that was associated with it (Plate 27). The tank, which had been filled with concrete, appeared to be located within a small bricked area, which was made from frogged bricks marked 'WHITEHAVEN' (each measuring 230 x 130 x 90mm) and might have had a concrete floor. It presumably related to the 20th century bus depot.

Plate 26 (left): The south-east side of the Bowman's area

Plate 27 (right): Removal of a concrete-filled sub-surface fuel storage tank

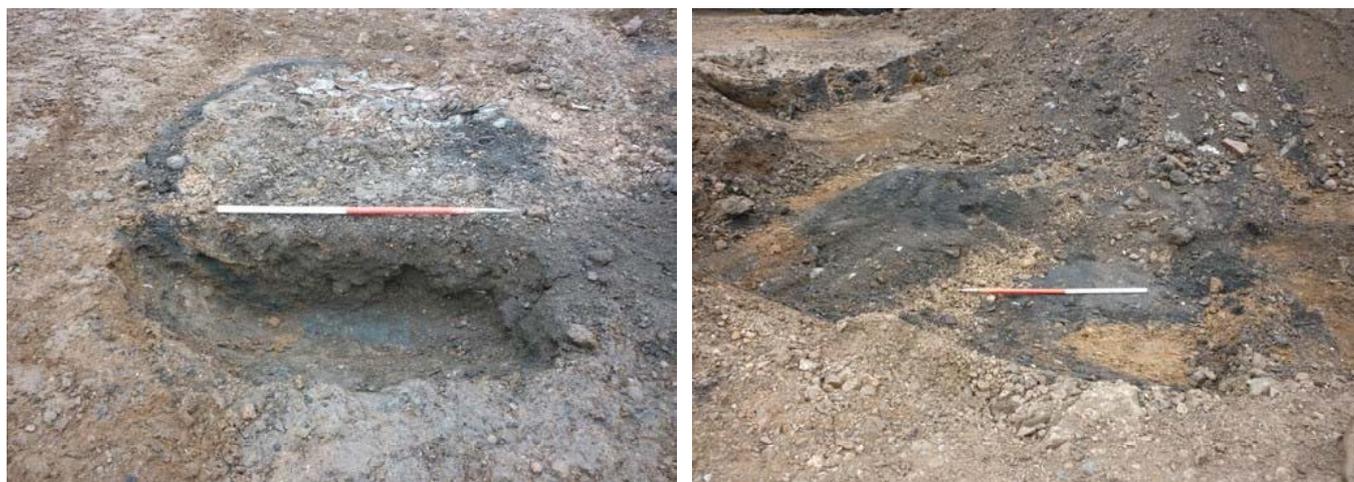
4.2.9 Another pit (**136**) was observed to the north west of pit **128**. The loose gritty black ash fill (**135**) of this pit was widely spread on the surface; however, the underlying cut was approximately rectangular in shape and had straight and steep sides and a firm, stone-lined base. The fill contained a large quantity of dumped domestic refuse, including a broken plant pot, and was not fully excavated.

Plate 28 (left): Pit 128

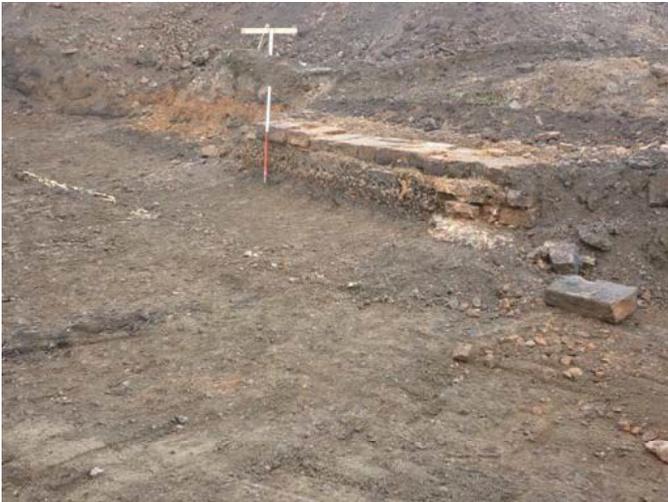
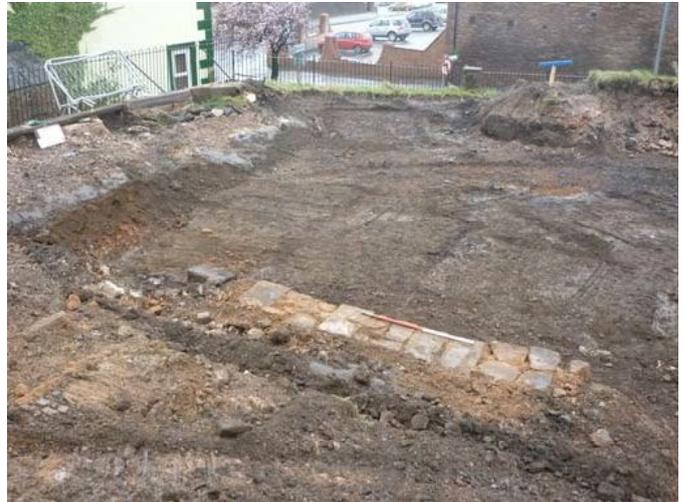
4.2.11 Part of a neatly cut red sandstone block wall (structure **129**) was exposed at the location of the north-west end of the south-east elevation of Bowman’s (Plate 31 and Plate 32). The wall returned to the north-west at its north-east end (Plate 33) but was severely truncated to the south-west (Plate 31). This red sandstone structure had a pale yellow concrete base (**130**) (see Plate 34 and Plate 35; Figure 4), which was not characteristic of the other structures in this area, such as structure **139** and structure **140**, which are likely to be older (see Sections 4.2.15 and 4.2.13 respectively). A small concrete plinth (**131**) or section of a concrete foundation was present at its north-easternmost extent (Plate 35).

Plate 31 (left): South-east elevation of structure 129

Plate 32 (right): Raised view of structure 129

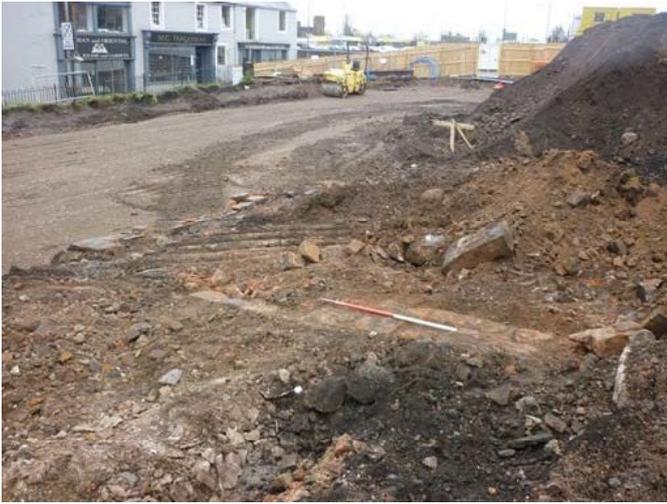
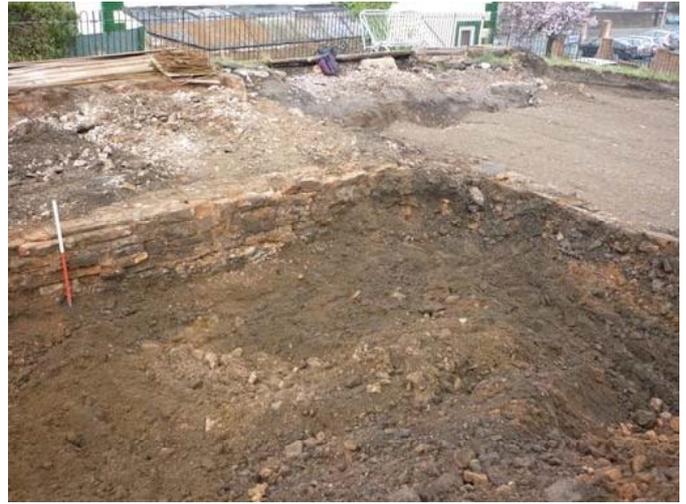
Plate 33 (left): Return wall of structure 129 (marked by the ranging rod)

Plate 34 (right): View of the interior space of structure 129

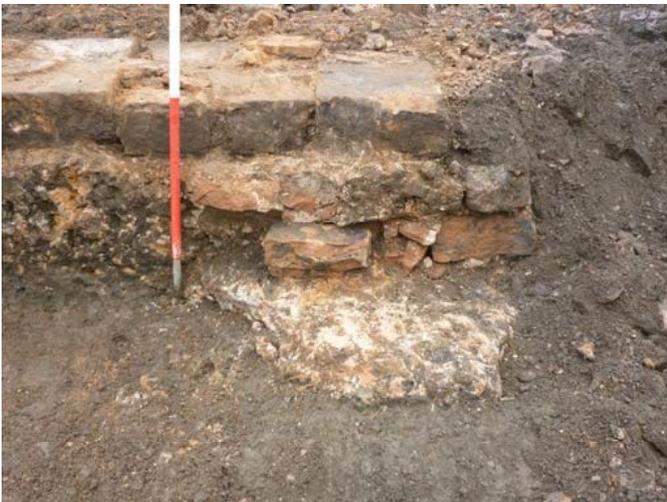
Plate 35 (left): Detail of the construction of structure 129

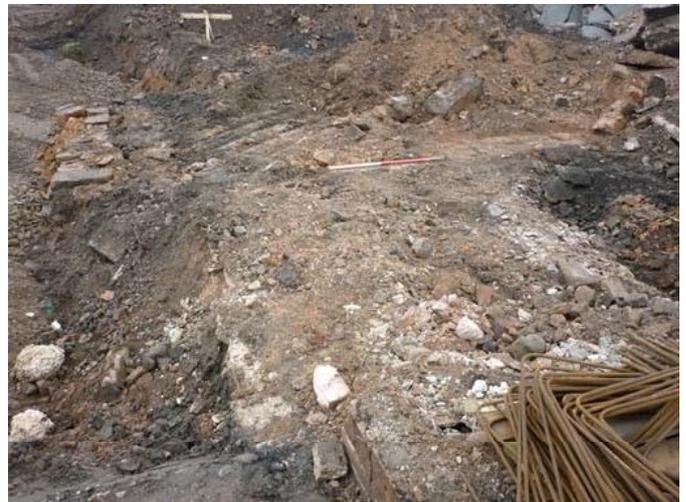
Plate 36 (right): View of structure 129 from the east corner of structure 132

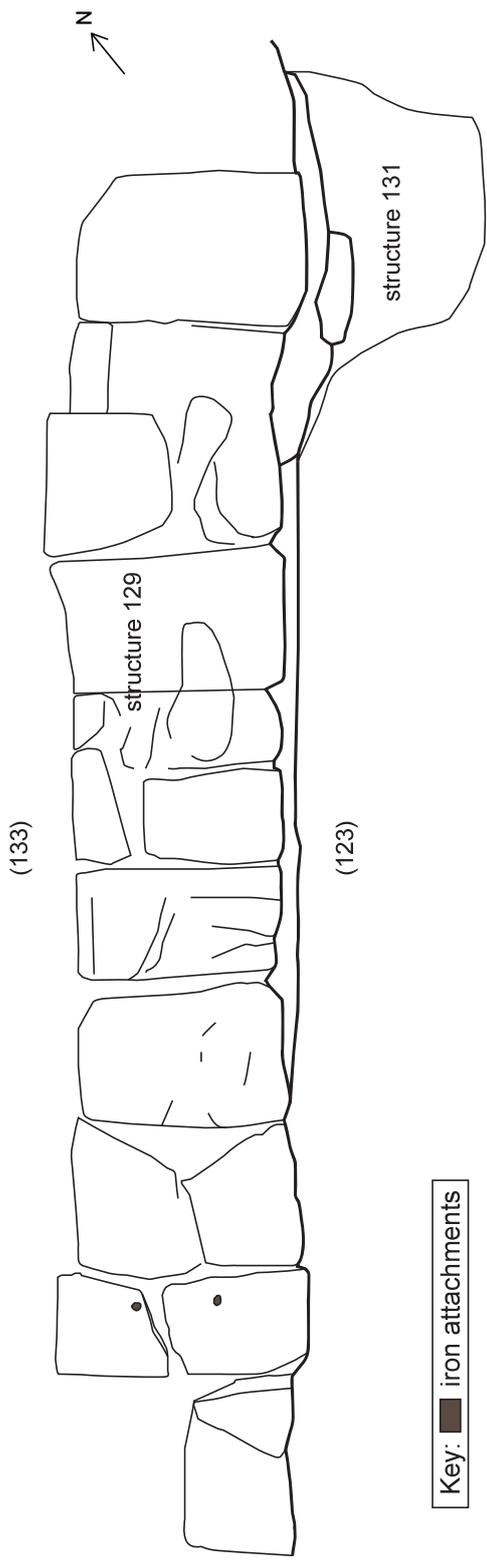
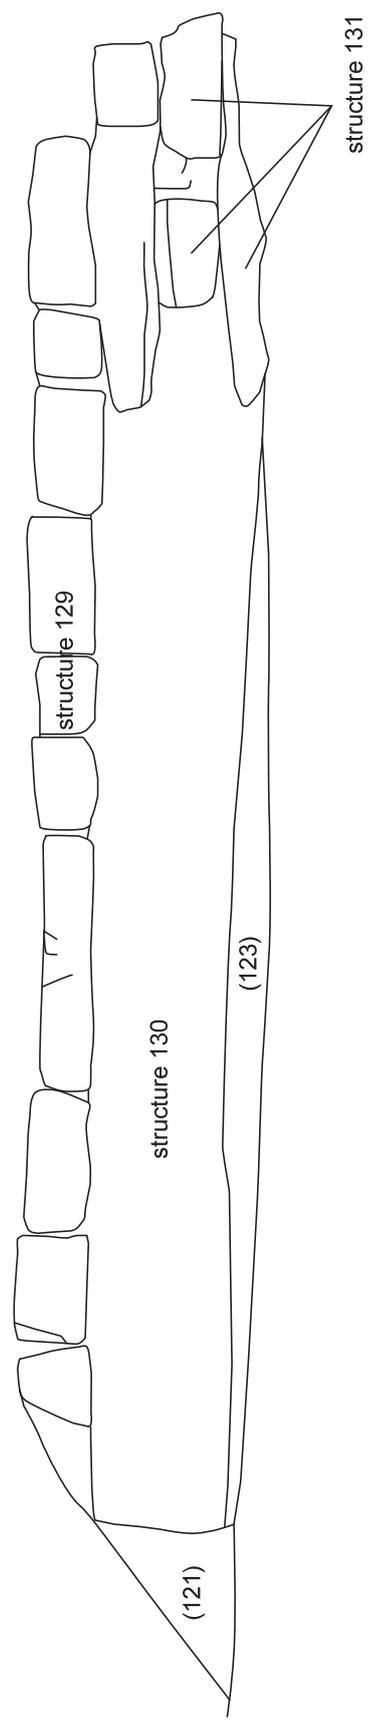
Figure 4: Structure 129

DETAILED PLAN OF STRUCTURE 129

SOUTH-EAST ELEVATION OF STRUCTURE 129

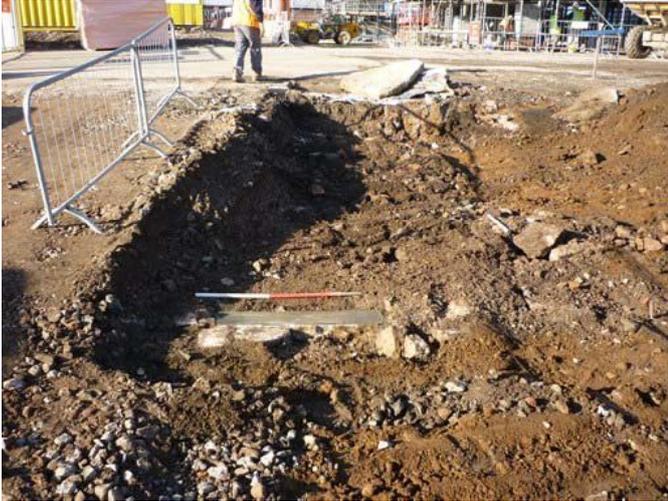
4.2.13 A red sandstone wall (structure **140**) was exposed which was aligned along the north-east elevation of the small offices that stood at the south-west end of the Bowman's building and had a stone threshold at the north-west end (see Plate 37 and Plate 38). This would originally have led from inside the carriage works to the courtyard before the buildings were extended in this direction between 1925 and 1938 at which point the doorway may have become redundant. This wall returned to the south-west at its north-west end (Plate 37; the return wall is visible in section below the slabs of concrete on the edge of the area of excavation) and was of a similar construction to structure **139** (see Section 4.2.15). The south-east and south-west walls of the offices were modern red brick.

Plate 37 (left): Structure 140

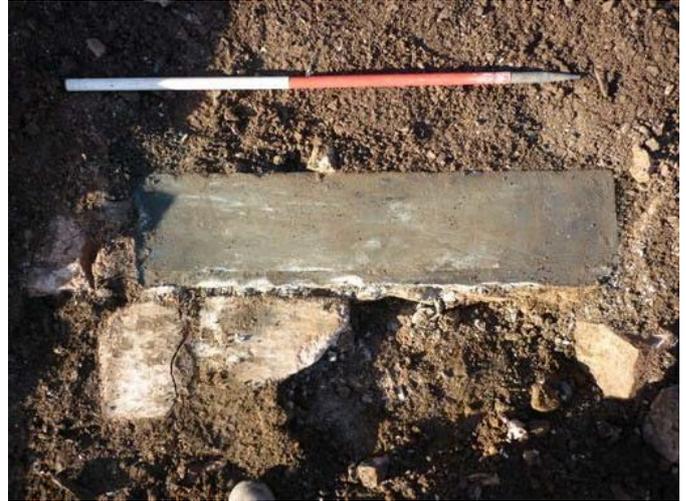
Plate 38 (right): Stone threshold to structure 140

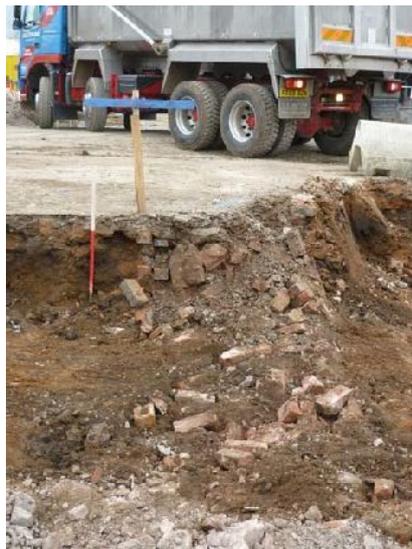
4.2.14 It was observed at the time of the building recording that the room to the north-west of these small offices had recently been used as a garage (Greenlane Archaeology 2010, 20). Two vehicle inspection pits were exposed within the footprint of this garage, which were in-filled with brick rubble, the bricks marked 'WHITEHAVEN'. These pits had been concreted over and had been visible on the garage floor at the time of the building recording (*ibid*). At that time they lined up with the sliding doors which led to the showrooms, but they were most likely inserted originally when the carriage works was extended and when the site became a bus depot. The rubble fill contained modern rubbish, which was not retained.

Plate 39: Vehicle inspection pit at the south-west end of the site

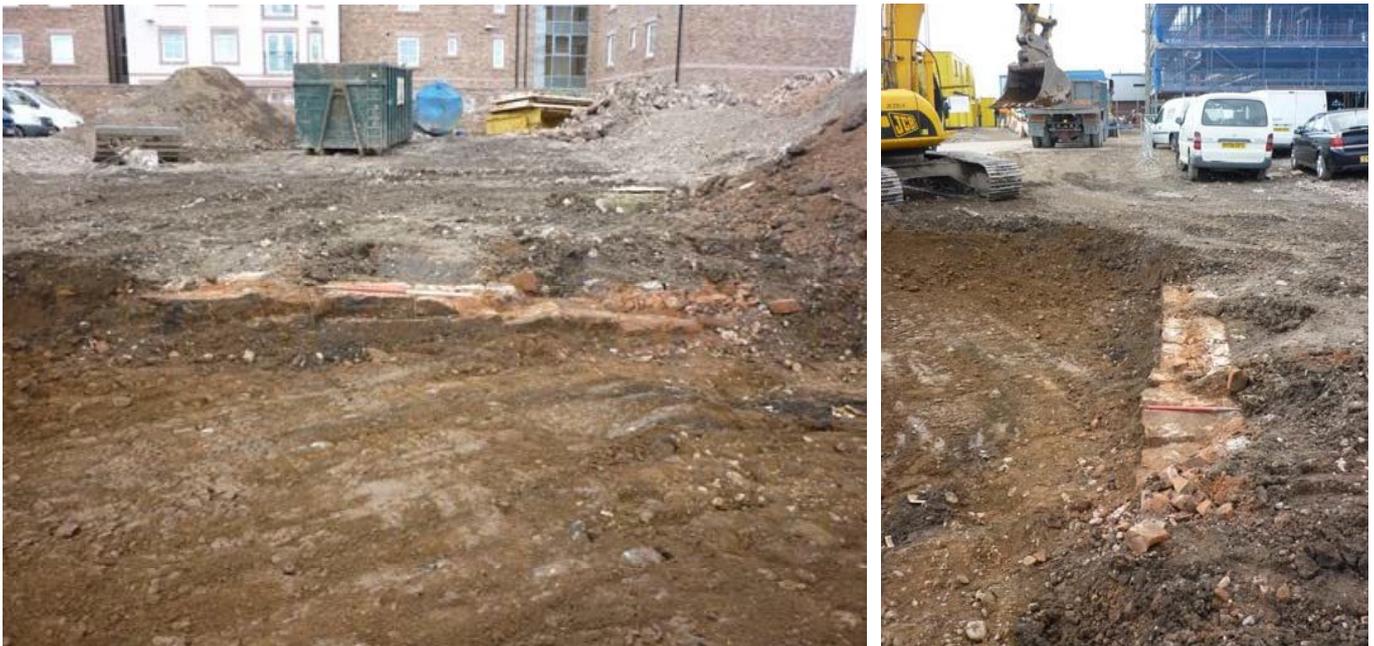
4.2.15 The foundations of the north-east elevation of the garage were partially intact and this reddy-orange sandstone block wall returned and continued north-west/south-east across the centre of the area (see Plate 40, Plate 41, Plate 42, and Plate 43). This wall (forming part of structure **139**) had a gritty pinkish cement mortar and at least two courses of it remained intact (see Plate 40 and Plate 41). It is likely that this was the foundation of the south-east elevation of the original structure of the carriage works and probably dates to its earliest phase of construction (between 1891 and 1900). It contained some evidently re-used worked stone but otherwise had a very similar construction to parts of the structures associated with the saw mill (see *Section 4.2.3*) and did not have a concrete foundation, unlike structure **129** which was probably later in date (see *Section 4.2.11* for comparison). This north-west/south-east wall may have become redundant and was likely removed to the level of its foundations when the carriage works was extended to the south-east between 1925 and 1938; indeed, the later editions of the Ordnance Survey maps do not show an internal 'dividing' wall where this wall would have stood. The south-east elevation of structure **139** was continuous along the length of the Bowman's building before returning along the alignment of what would have been the north-east (Plate 44 and Plate 45) and north-west elevations of the original carriage works (Plate 46), however, the south-west corner of the structure was heavily truncated and the foundations to the south-east side were observed to have been truncated by later drains (drain **142**). The north-east elevation incorporated a brick hearth with a slate base (structure **187**; see Figure 5) against which there was a mixed, dark grey silty-clay residue (deposit **186**). Somewhat incongruously this feature appears to line up with a blocked doorway that was recorded in the north-east elevation of Bowman's during the building survey (Greenlane Archaeology 2010, 31). There were various features located inside the area of structure **139**, including structures **180**, **185**, and **147**, and pits **183**, **191**, and **196**.

Plate 40 (left): Illustrated section of structure **139**

Plate 41 (right): Detail of structure **139**

Context	Type	Description	Interpretation
139	Structure	A detailed section of a north-west/south-east aligned reddy-orange sandstone block wall, with a gritty pinkish cement mortar was recorded in some detail when it was exposed; each course was 0.14 to 0.16m high and at least two courses were exposed. A clay tobacco pipe stem was recovered from within the cement/mortar. This structure was observed to continue across the length of the site and had return walls corresponding to the location of the north-east and north-west elevations of the original carriage works. Some evidently re-used worked stone was incorporated into the construction of the wall, including a curved fragment of roughly worked stone.	The section of wall which was recorded in some detail was probably part of the original south-east elevation of the carriage works and likely dates to its earliest phase of construction (between 1891 and 1900). It was later observed to continue across the centre of the area and was observed to have a very similar construction to the saw mill. This north-west/south-east wall may have become redundant and was likely removed to the level of its foundations when the carriage works was extended to the south-east between 1925 and 1938; indeed, the later editions of the Ordnance Survey maps do not show a 'dividing' wall where this wall would have stood. The structure marks the north-eastern extent of the original carriage works.

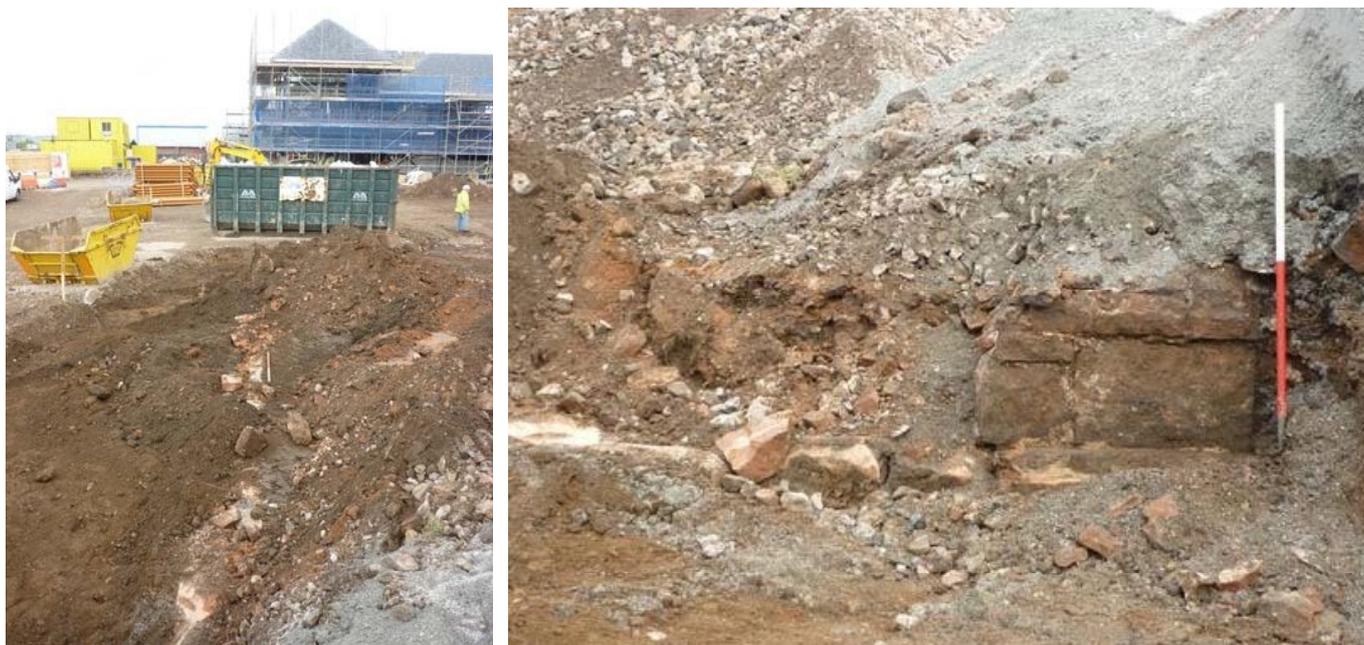
Plate 42 (left): Continuation of the north-east/south-west section of structure 139

Plate 43 (right): North-east corner of structure 139

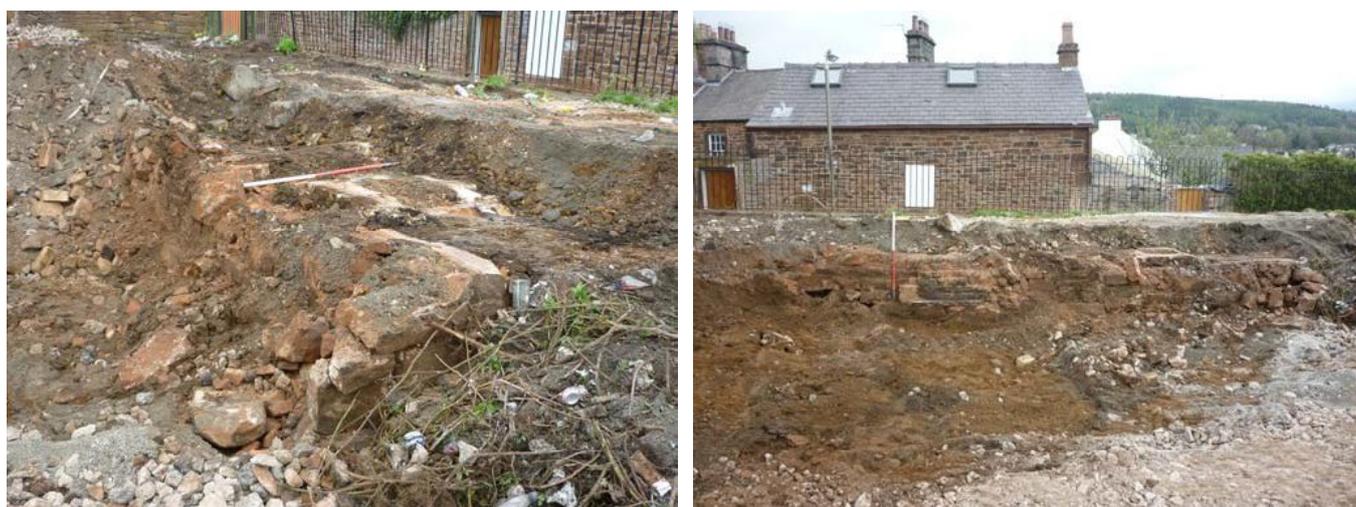
Plate 44 (left): Return wall at the north-east end of the south-east elevation of structure 139

Plate 45 (right): North-east elevation of structure 139, showing the location of structure 187

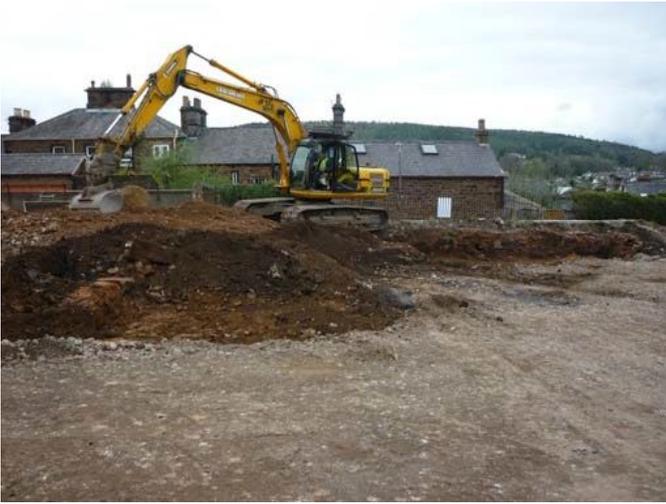
Plate 46 (left): The north-east end of the original carriage works (structure 139)

5.1.2 **Bowman's**: much of the original structure of the carriage works was preserved below ground in the Bowman's area. The original fabric, dating to the earliest phase of construction of the carriage works, was represented by the neatly cut sandstone block walls, which dated to between 1891 and 1900. Structure **139** comprised much of the surviving fabric of the original structure and included the north-east elevation, which incorporated a brick hearth (structure **187**), as well as much of the north-west elevation of the carriage works. These walls formed part of the standing remains of the carriage works, which were incorporated into later buildings on the site, and as such were also recorded as part of the archaeological building survey of the site ahead of their demolition (Greenlane Archaeology 2010). The remains of the south-east elevation of the original structure was also exposed, although it is likely that this wall was removed to the level of its foundations when the carriage works was extended to the south-east between 1925 and 1938.
