BRUNSWICK ROAD, PENRITH, CUMBRIA

Archaeological Watching Brief

Client: Booths (Penrith) Ltd

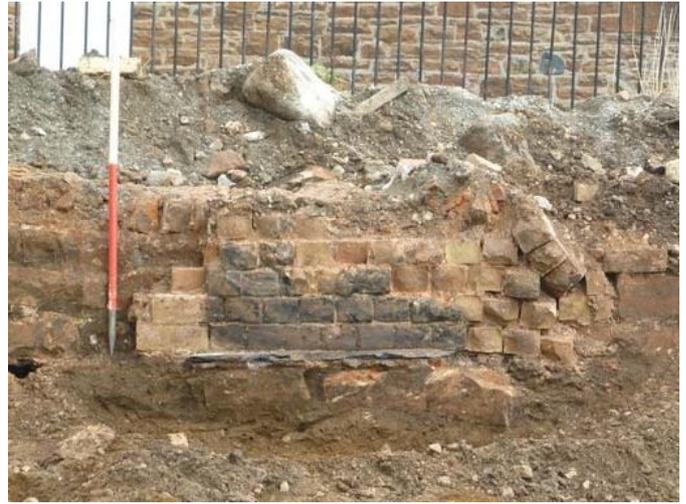
Plate 47 (right): Detail of hearth structure 187

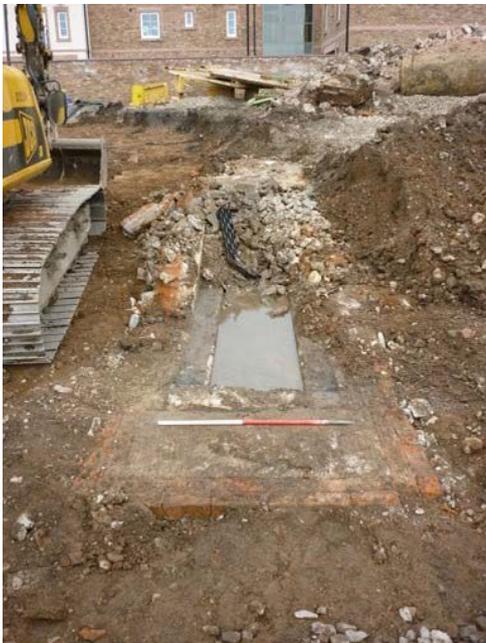
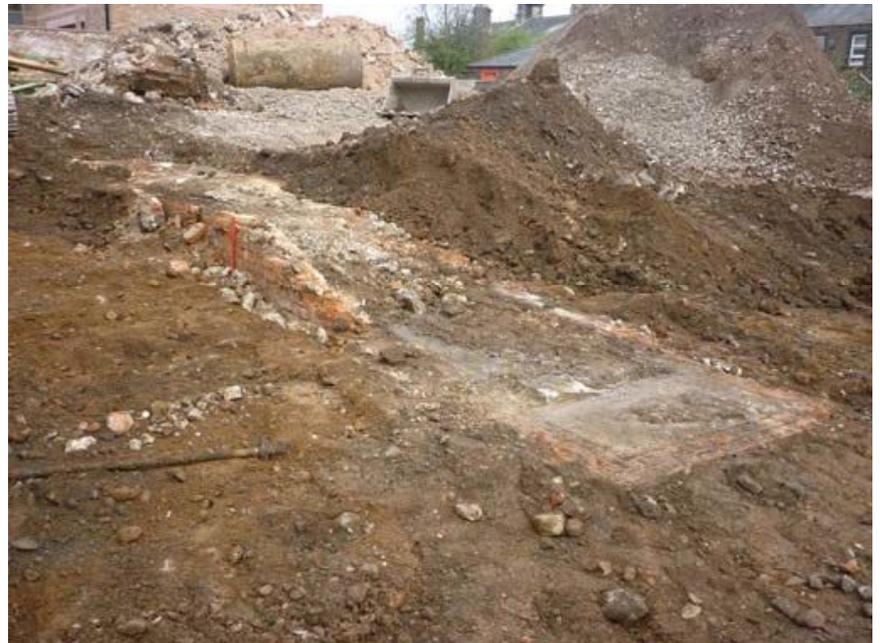
4.2.16 Structure **180** was aligned north-west/south-east and located close to the centre of the area enclosed by structure **139**. The date of its construction is uncertain; it was initially thought to be relevant to the carriage works because of its central location within the footprint of the original structure (as demarcated by structure **139**); it may of course be later. If it does relate to the carriage works, it seems that it later saw use as a vehicle inspection pit when the building was used as a bus depot. The structure was a mix of brick, concrete, and stone (Plate 48 and Plate 49; Figure 6); the 'outer' lining of red bricks was frogged and marked 'CLAUGHTON MANOR / BRICK C^o CATON', and it had been purposefully back-filled. A steel grill and a broken sign for a bus stop were amongst the rubble, which was heavily contaminated with diesel. The grill may relate to a 20th century industrial installation or perhaps more likely was simply used to cover over a vehicle inspection pit. The sign was labelled 'Cumberland', so pre-dates 1974 and the creation of the current county of Cumbria.

Plate 48 (left): Structure 180

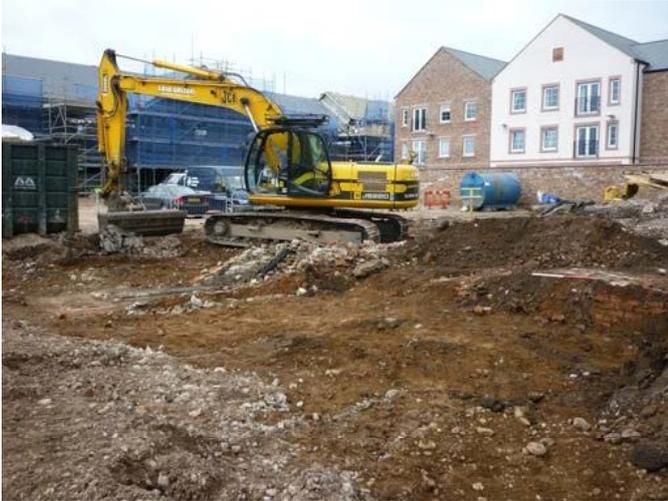
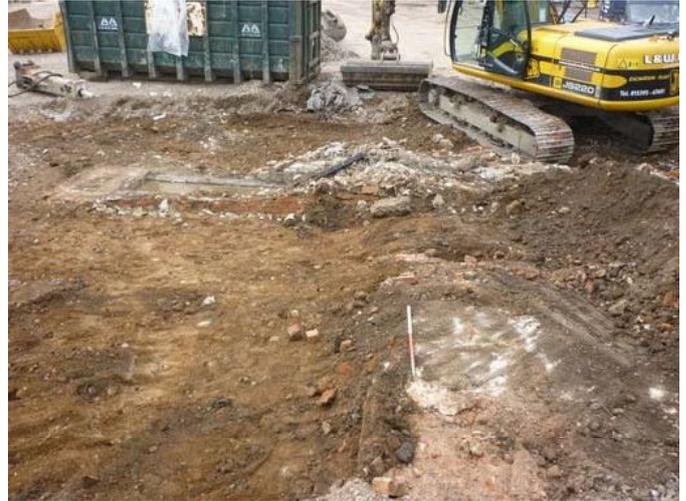
some way. However, structure **185** was made from unfrogged and more roughly made orange brick, which might suggest that it was an earlier construction than structure **180**, which was made from machine-made frogged brick. The base of structure **185** was stone and had iron attachments (Figure 6).

Plate 50 (left): Oblique view of structures 180 and 185 (to the right)

Plate 51 (right): View of structure 180 from on top of structure 185

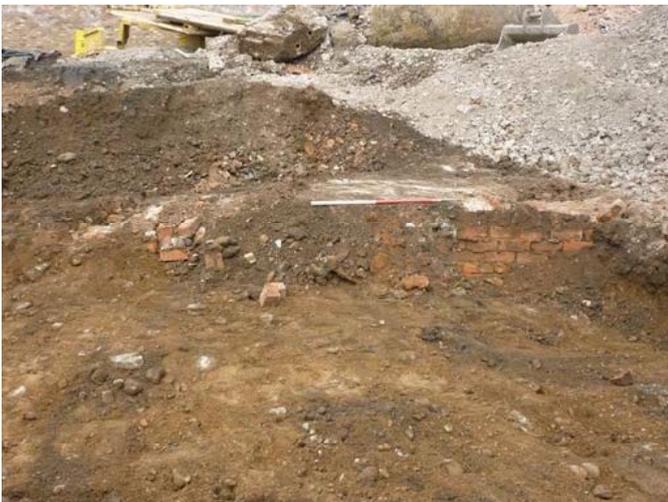
Plate 52 (left): South-east side of structure 185

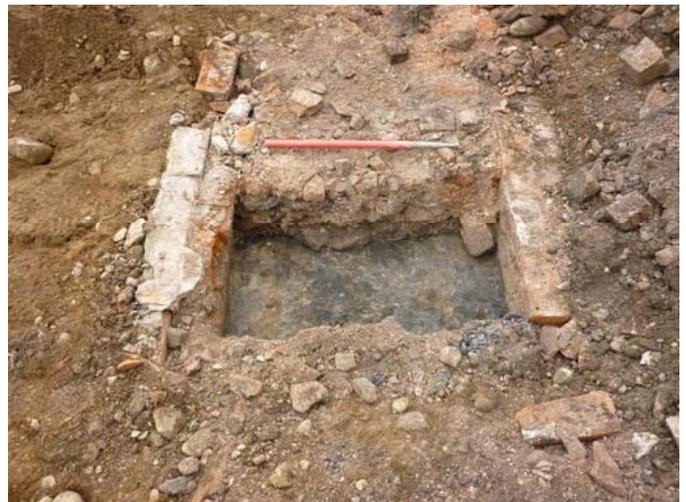
Plate 53 (right): Section through the rubble fill of structure 185

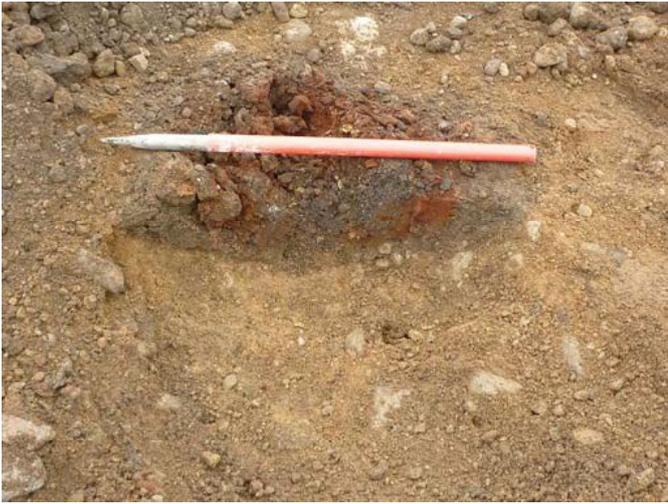
4.2.18 There were three discrete pits near to structures **180** and **185**: pits **183**, **191** and **196**. Pit **183** and **191** were similarly sized but of unknown purpose. Pit **183** contained two fills (**181** and **182**; see Figure 6), the upper one of which mostly comprised a large rusted bolt; pit **191** contained a single fill (**190**; see Figure 5). Pit **196** was lined with sawn pieces of timber (**195**) and contained three fill deposits (**192** to **194**; see Figure 5) which contained a large amount of slag-like material and various metal objects. It also contained the rubber tyre tread, which suggests a 20th century date for the feature. It is assumed that this pit had some sort of industrial function but it is uncertain as to what that might have been.

Plate 54 (left): Pit 183

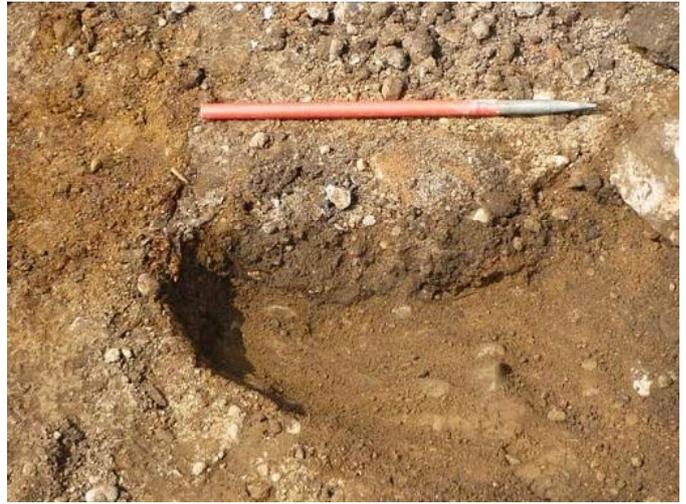
Plate 55 (right): Pit 191

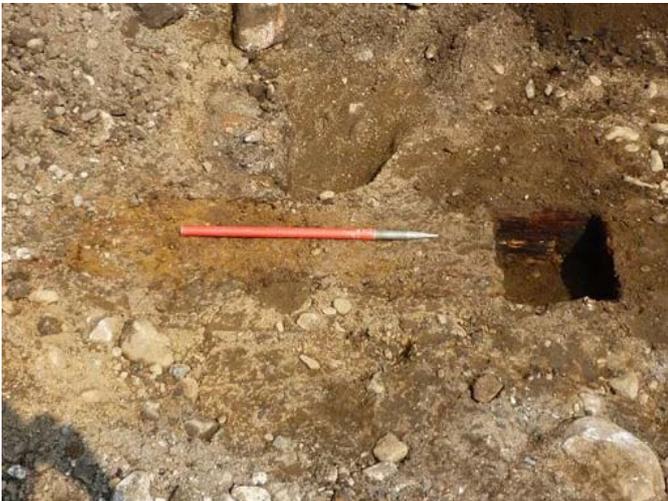
Plate 56 (left): Pit 196 viewed from the south-west (pit 191 is visible to the top of the photograph)

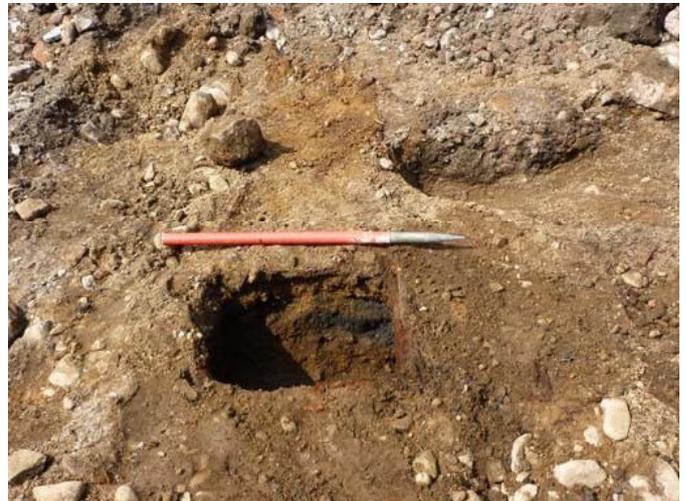
Plate 57 (right): Section across pit 196 and 191 (to the right)

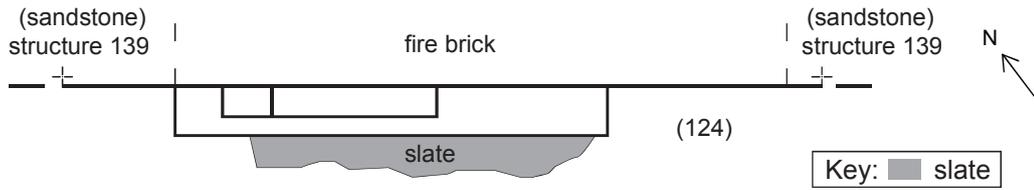
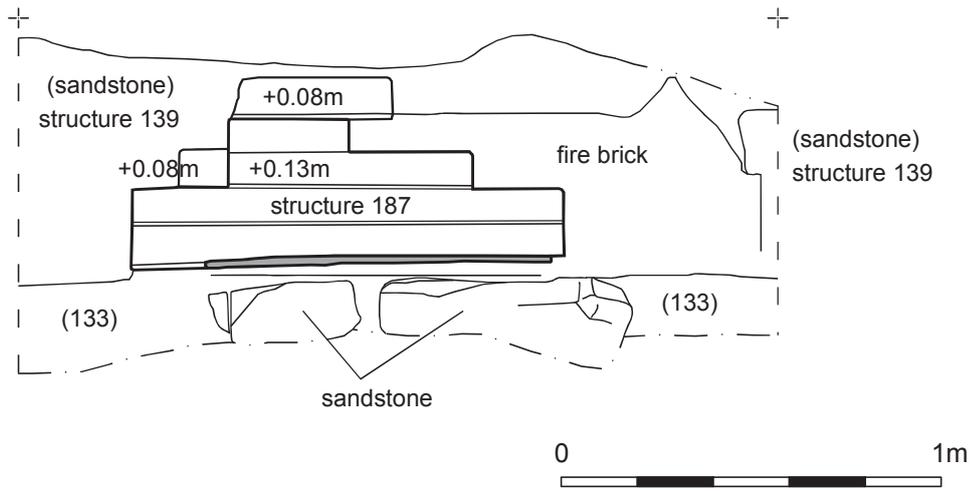
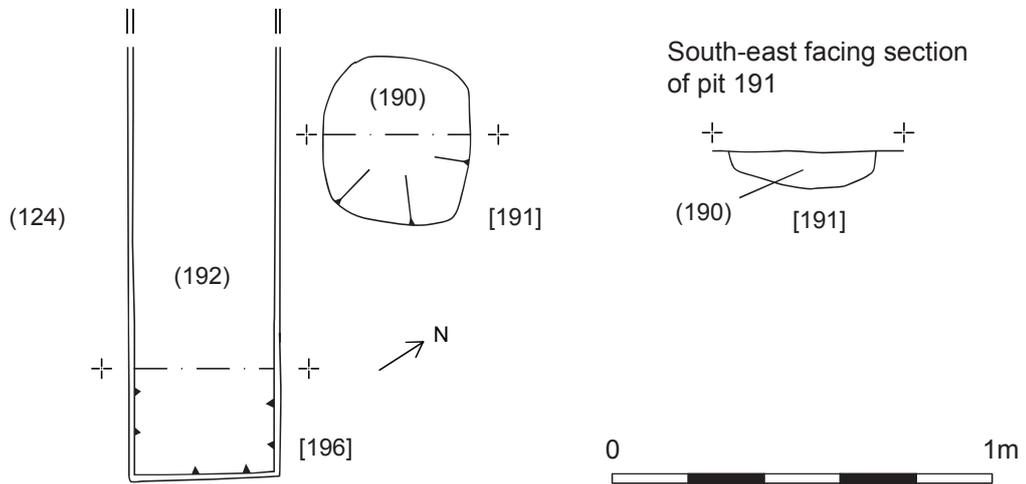
Figure 5: Structure 187 and pits 191 and 196

Detailed plan of structure 187

South-west elevation of structure 187

Detailed plan of pits 191 and 196

South-east facing section of pit 196

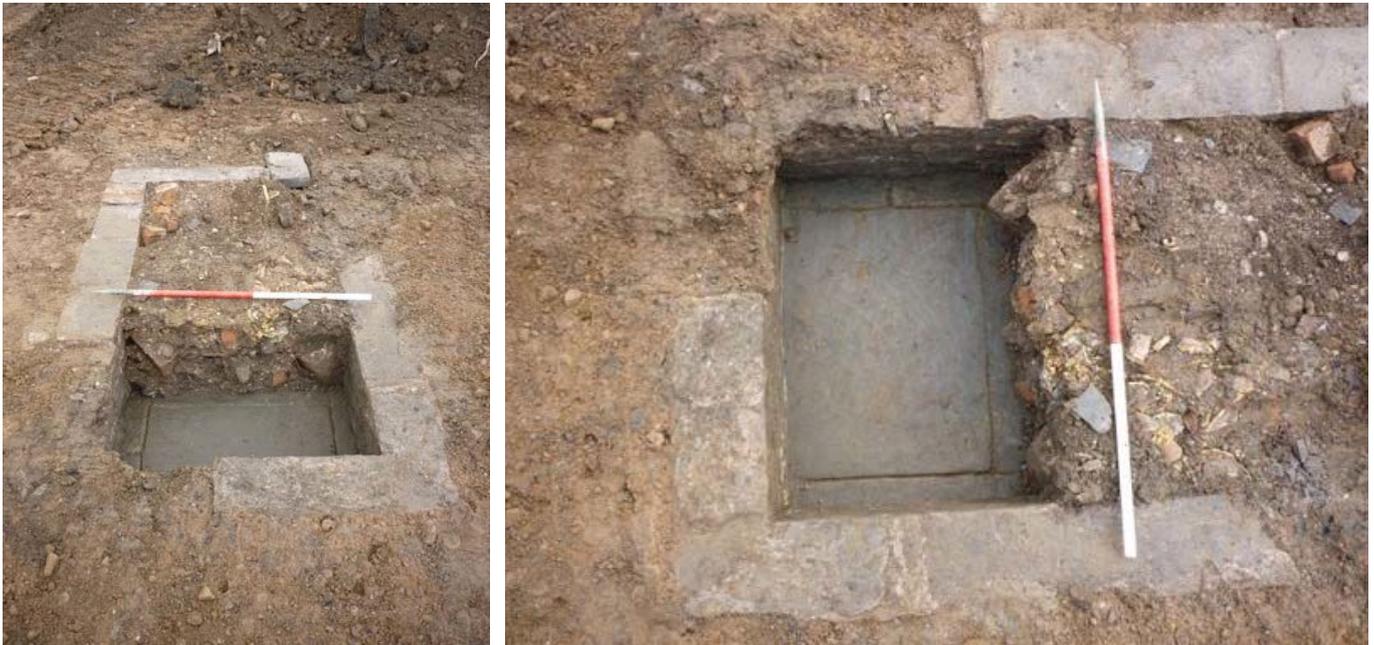
4.2.19 Structure **147** was also inside the area that was demarcated by structure **139** and was aligned north-east/south-west. It was built from neatly cut rectangular sandstone blocks and had a flagged floor with iron attachments (Plate 58 and Plate 59; see Figure 7). It is assumed that this pit originally had some sort of industrial function. It had then been deliberately filled in with rubble (**145**), including fragments of brick marked 'WHITEHAVEN', and there was some industrial residue (**146**), containing glass and slag, concentrated towards the base of the pit. Other finds from this context included various iron finds with a possible date range from the 19th to 20th century. This residue was also slightly dispersed within the rubble fill, probably as a result of disturbance caused by a later drain (**144**) which cut diagonally across the feature.

Plate 58 (left): Section across structure **147**

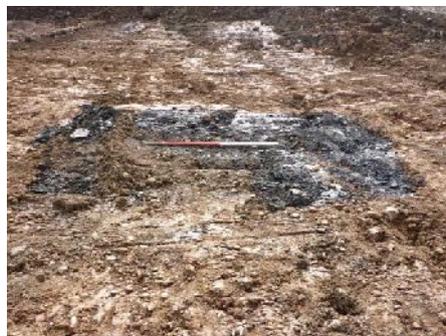
Plate 67 (centre): Pit 172

4.2.21 Of the pits located at the west end of the site pit **172** was of particular interest. The cut was approximately rectangular in plan (see Plate 67 and Plate 71) and had near vertical sides, but the base was not fully exposed since the feature began to fill with water at a depth of around 0.2m. It contained a loosely compacted, very dark grey, silty deposit (**171**), and large quantities of slag. Finds from this context suggest a 19th to 20th century date for the feature. It also contained the base of a barrel, which appeared to have been neatly sawn (Plate 72).

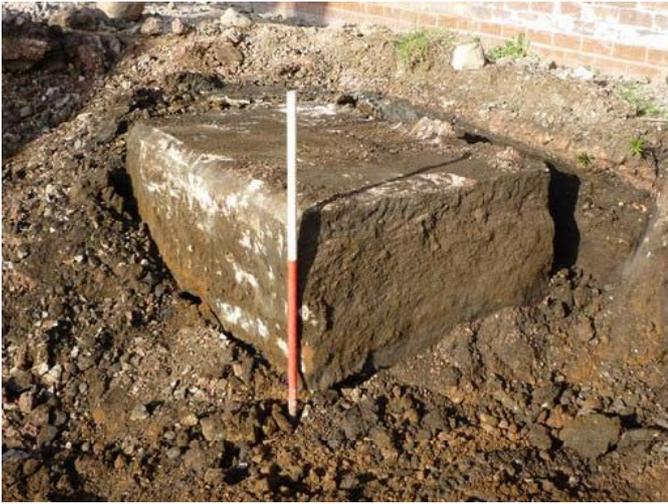
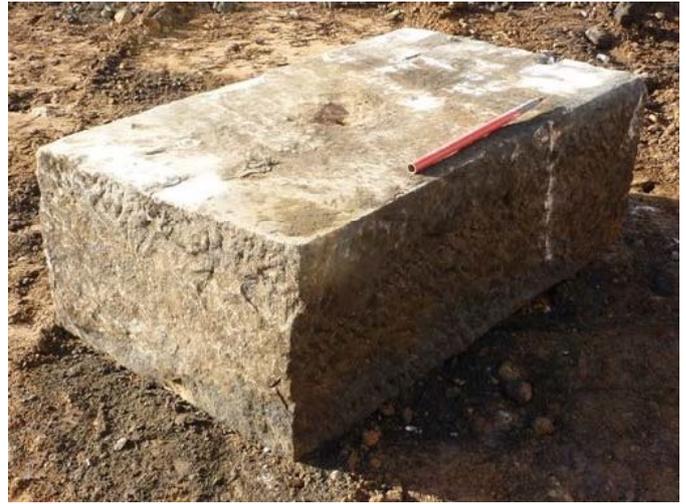
Plate 69 (left): Possible engine bed (structure 148) located against the north-west boundary wall

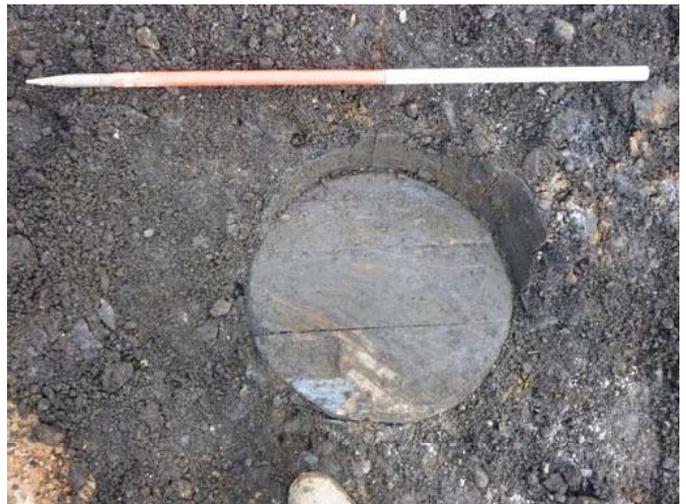
Plate 72 (right): The base of a barrel in the fill of pit 172

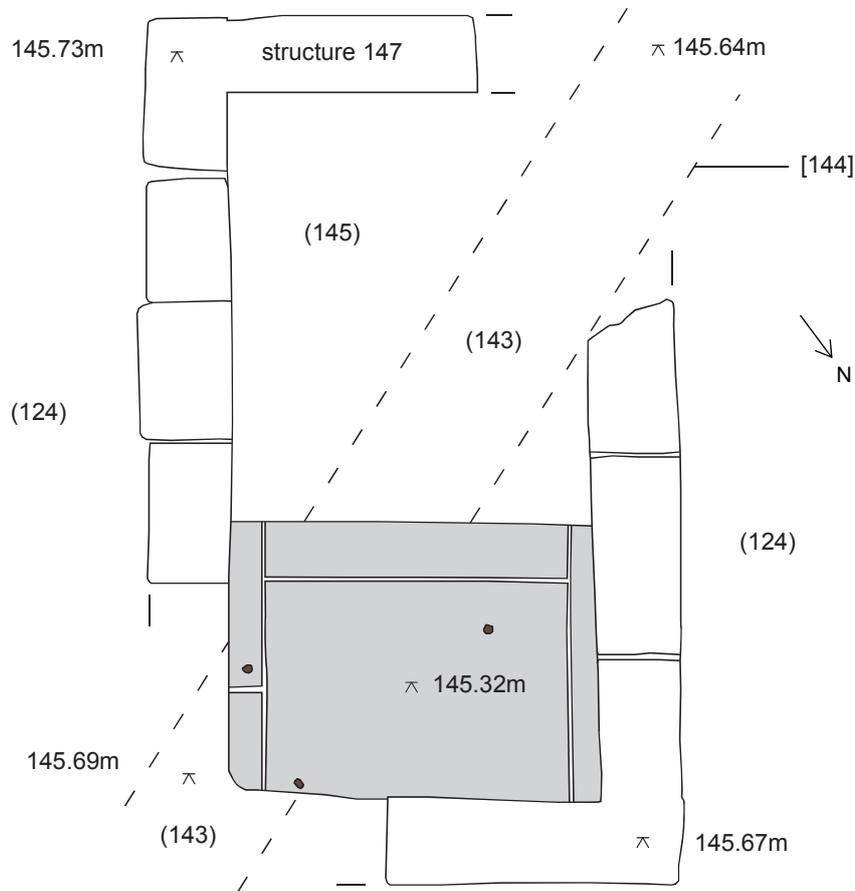
Figure 7: Structure 147

DETAILED PLAN OF STRUCTURE 147

North-east facing section

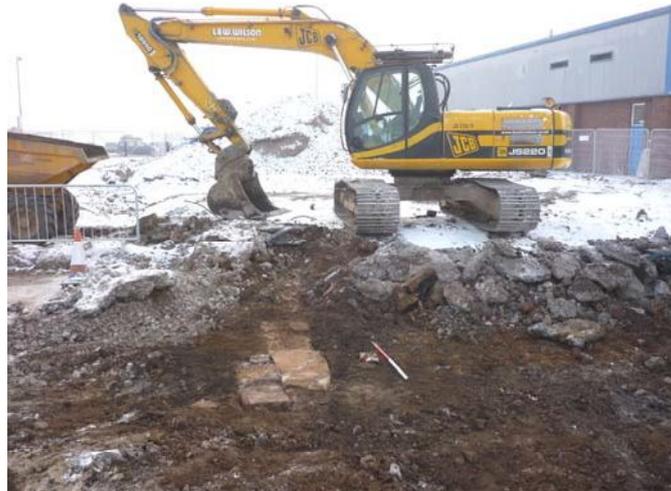
5.1.1 **Rickerby's**: excavation of the Rickerby's area partially exposed structural elements which probably related to internal features of the 19th century saw mill. The level to which the area was being reduced caused minimal damage to these underlying features because the depth of intervention was sufficiently shallow to effect their preservation *in situ* (Plate 73). Unfortunately, the relationship between these features, which were effectively viewed in isolation, could not be determined during the course of the watching brief. The apparently structural features encountered, such as blocks **114**, **115** and **116** and walls **110** and **117**, are suggestive of elements relating to a large steam-powered saw, and the area of brick flooring (**109**), which corresponded closely to the position of a large aperture in the wall present during the building recording, is probably connected to a steam engine; perhaps the charging floor for loading the boilers with coal.

Plate 73: Exposure of underlying features which will effectively be preserved *in situ*
