# LOWWOOD GUNPOWDER WORKS, HAVERTHWAITE, CUMBRIA

## Archaeological Excavation and Watching Brief

August 2011

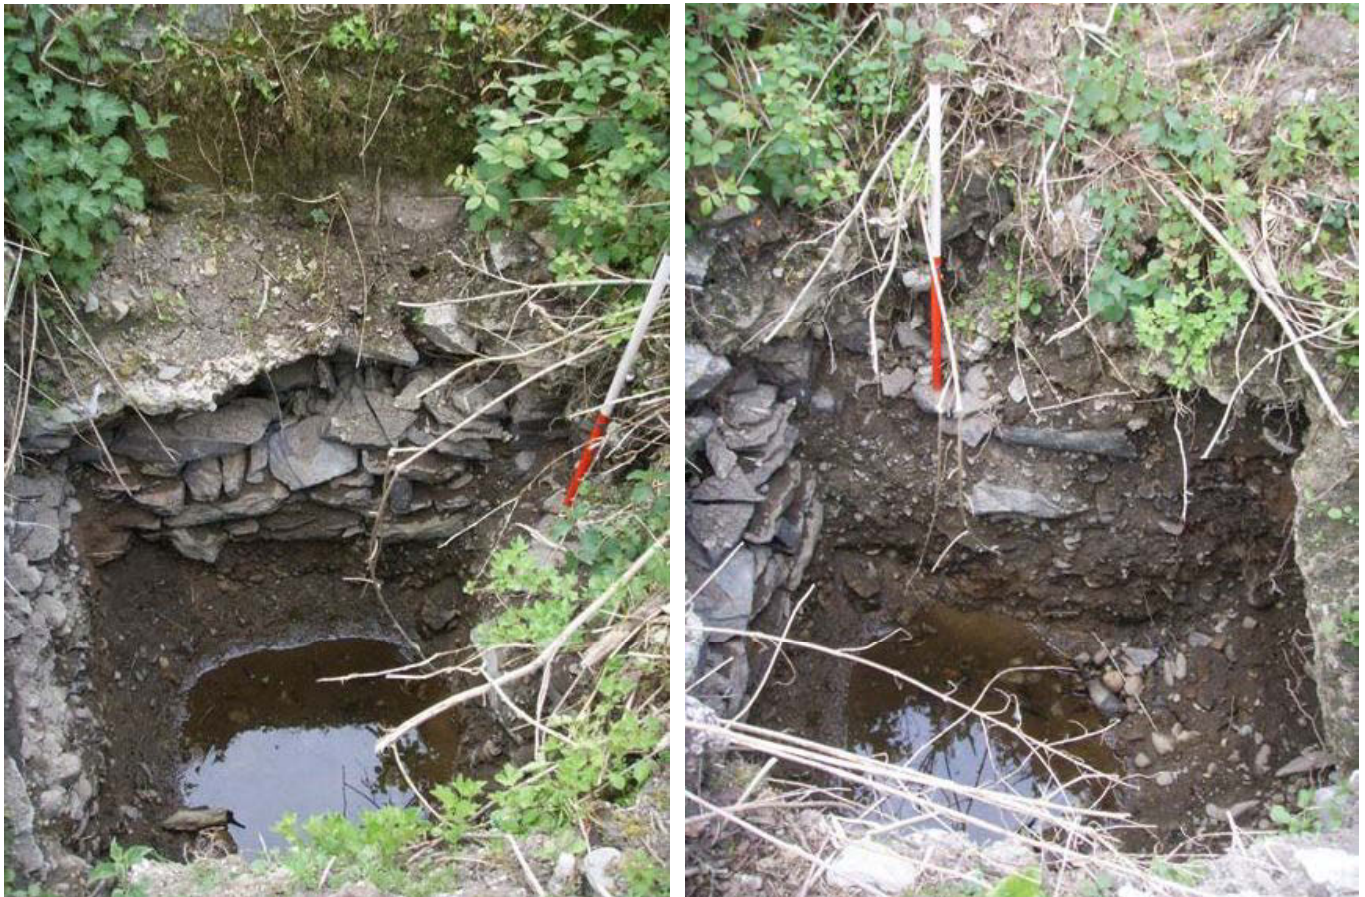
4.2.1 Prior to the excavation commencing an engineering test pit had been excavated (without being monitored) to the north-east of the excavation area (see Figure 2). Some observations were made from this however: it was apparent that the original stone leat wall was still *in situ*, albeit buried beneath a considerable amount of overburden, and that the present concrete and brick leat wall had been built against its south-east side, effectively forming a second skin or cladding layer, although approximately 1m taller than the original (Plate 1). Clay deposits were also evident behind (to the north-west) of the original stone leat wall, presumably forming a water tight boundary (Plate 2).

**Plate 1 (left): Leat wall exposed in the test pit**

**Plate 2 (right): Deposits against the leat wall in the north-facing section of the test pit**

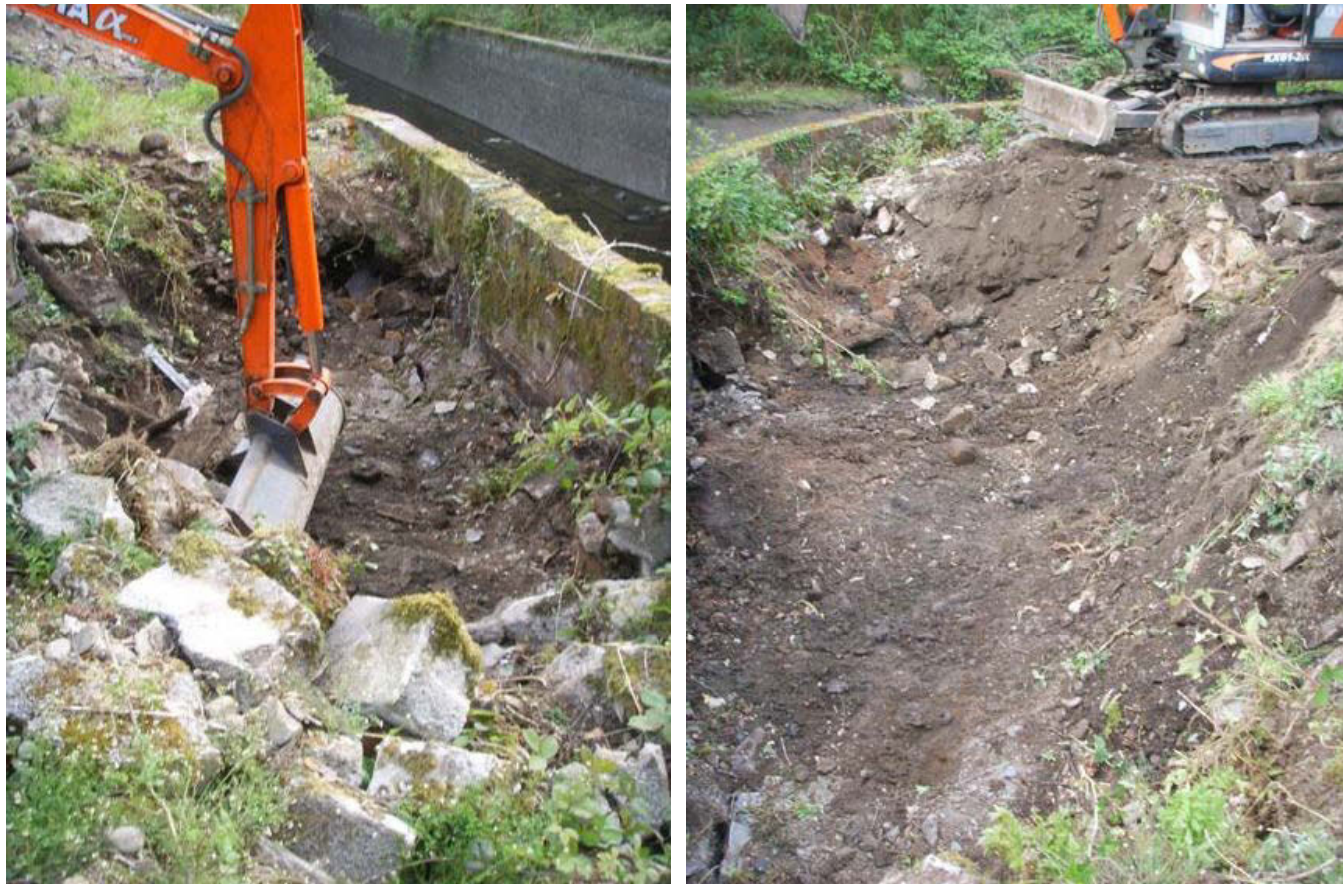
**Plate 3 (left):** Overburden being removed by machine from the north-east end of the excavation area

**Plate 4 (right):** Overburden being removed by machine from the north-west end of the excavation area

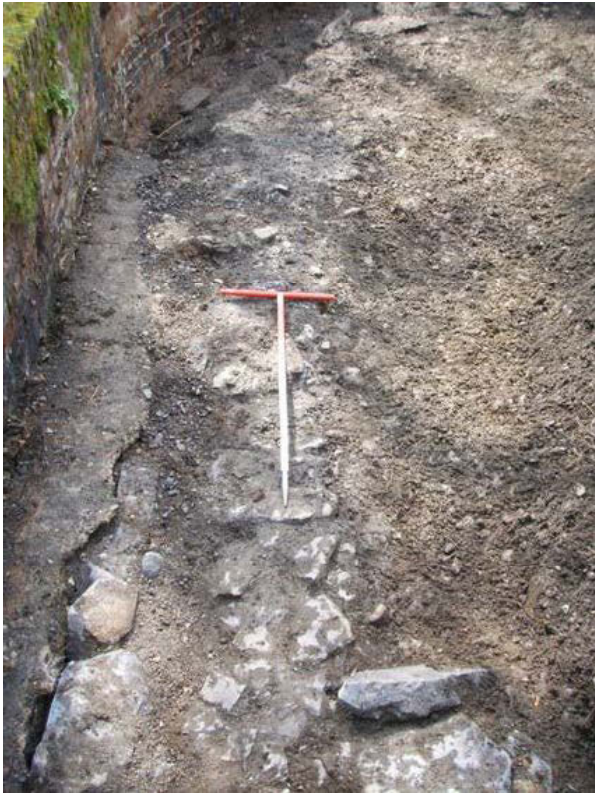
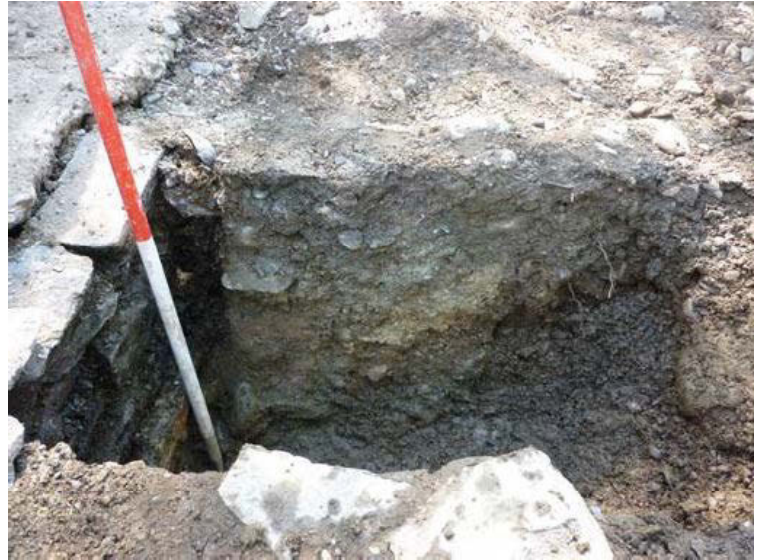
4.2.3 In the north-east end, a thin layer of mid orange sand with a small amount of rounded gravel content (**1003**) was present across some of the area, and covered the north end of a linear spread of angular stones in a matrix of mid grey brown sandy/silty clay (**1004**; Plate 5). This was approximately 0.5m wide, orientated north-east/south-west, parallel to the extant concrete and brick leaf wall (**1015**), and extended for at least 5m to the south from the north edge of the trench, although its south-western end was less distinct and seemingly composed only of grey clay. Immediately to the south-east of **1004** the top of a stone wall, constructed from four or five courses of angular slate blocks without mortar and 0.5m tall by at least 0.2m wide, was exposed (**1019**), running parallel to the extant leaf wall (**1015**) and partially capped with a layer of concrete, 0.05m thick (**1021**). This stone wall evidently represents the original leaf wall, with the later one built inside it to the south-east, as revealed in the existing test pit (see Section 4.2.1 above). A small sondage was excavated across deposit **1004** against **1019**, which revealed that **1004** was up to 0.4m thick. Beneath it was a mixed deposit of essentially mid yellow sandy clay, although with lenses of grey clay, up to 0.15m thick and 0.4m wide, and a smaller area of firm pink clay up to 0.2m wide and 0.2m deep (**1018**; Plate 6). Between this and the original leaf wall was a layer of loose dark reddish brown rounded gravel 0.1m wide and 0.45m thick (**1022**), which appeared to have been created by water penetrating through the stone leaf wall and washing out the fine content of the deposits behind it. The various layers of clay essentially comprised the fill of a u-shaped cut (**1024**) against the leaf wall, which was sat on a layer of greenish grey clay with 50% rounded cobble inclusions less than 0.1m thick. **1024** was cut into a fairly loose mid orange/brown sandy gravel (**1017**), which probably represents a variation on natural **1025** disturbed during the excavation of **1024**.

**Plate 5 (left): Linear feature 1004**

**Plate 6 (right): Sondage through 1004 showing underlying clay deposits and leat wall**

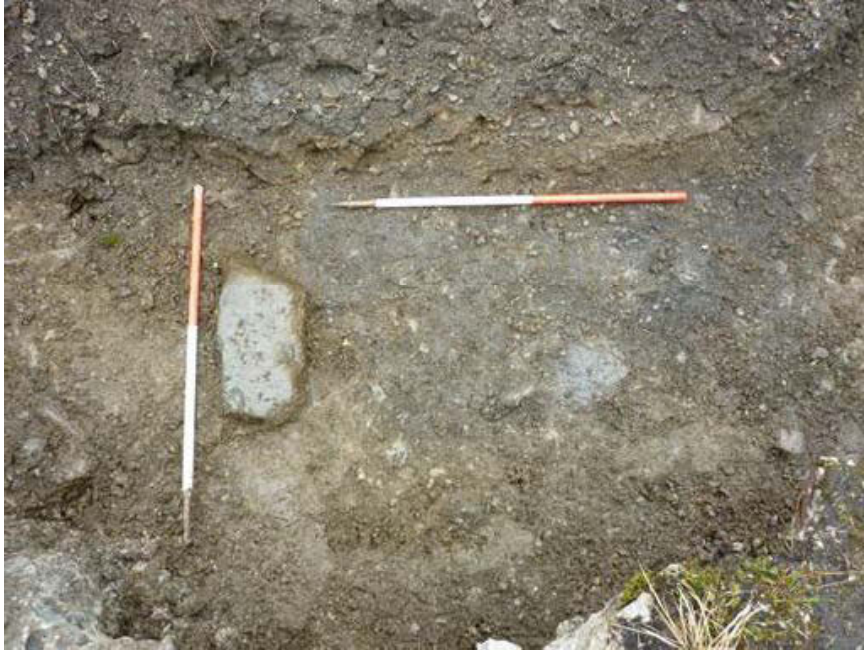
4.2.4 At the north-west end of the trench the removal of the overburden revealed a layer of apparently re-deposited natural orange sandy clay (**1005**), and what initially appeared to be a pair of pits, one over 1.5m wide north-west/south-east (which was covered by **1005**), the other approximately circular and 0.6m diameter (**1012**; Plate 7). Further excavation revealed that the larger of these was in fact a tipped spread of dark grey sandy silt and containing a relatively large amount of slag, 0.2m thick (**1006**), dipping down slightly to the south. This in turn covered two further deposits, a soft mid grey silty-sandy clay 0.1m thick (**1009**) and a very loose deposit of orangey-brown rounded gravel up to 0.4m thick (**1010**), which were filling a linear feature over 1m wide and 0.5m deep orientated north-east/south-west (**1024**; Plate 8). This in turn was cut into a firm mid yellowish-orange sand (**1013**), which appeared to be natural. To the west of this pit **1012** was filled with a loose mid orange-brown rounded gravel (**1007**) to a depth of approximately 0.5m. In the base of this pit there was a large piece of degraded timber, apparently a tree stump, with a root extending to the south-east (Plate 9). It was apparent that pit **1012** cut through the sequence of deposits filling **1024** but was itself situated within it, this cut evidently extending beyond the north-west end of the trench judging by the presence of the re-deposited natural (**1005**), which seemed to be specifically covering it.

**Plate 7: Deposit 1006 and feature 1012 as initially revealed**

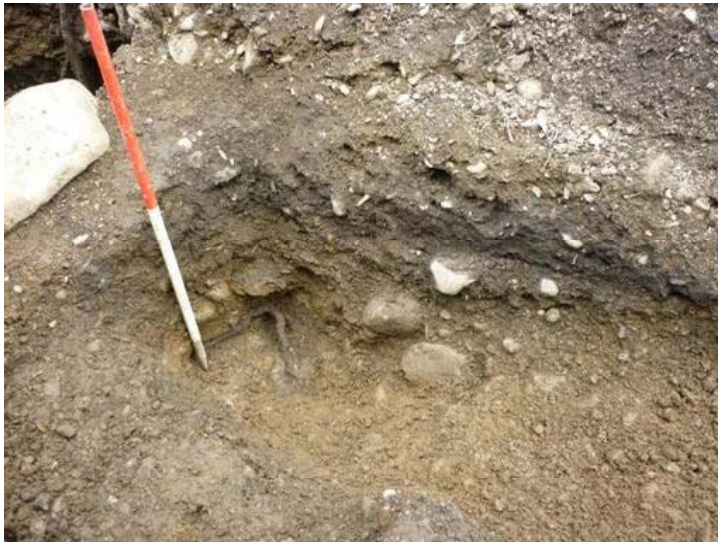
**Plate 8 (left): Section through feature 1023 showing filling deposits**

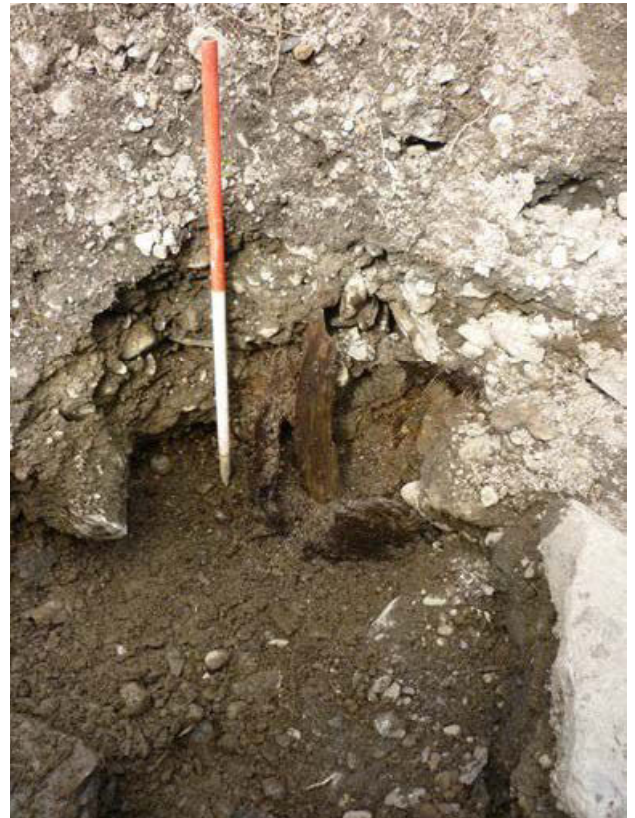
**Plate 9 (right): Tree stump exposed in 1007**

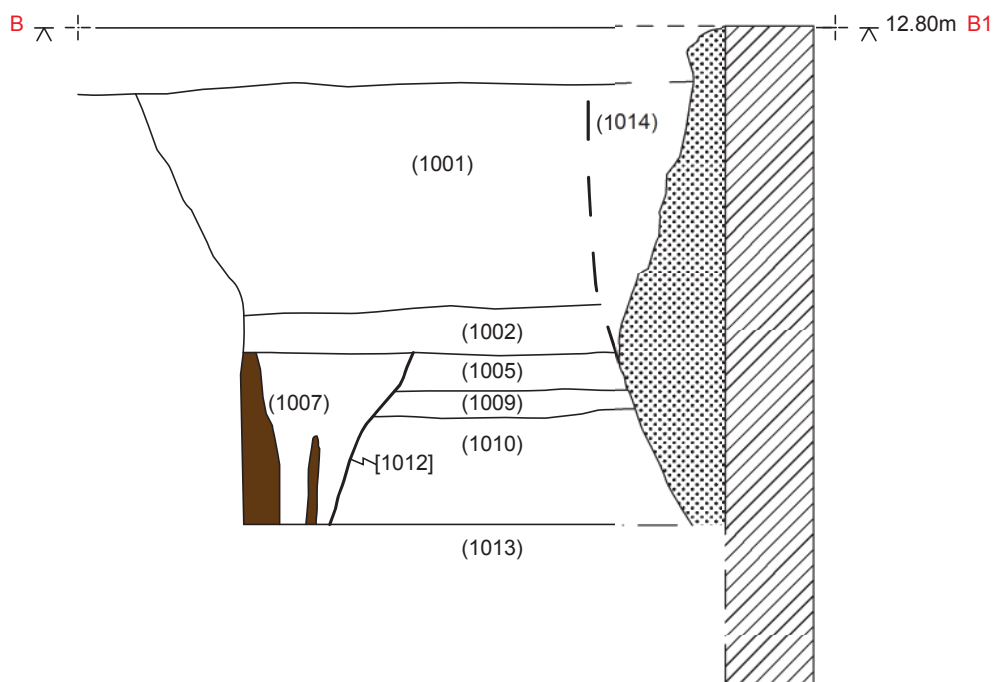
Figure 4: Sections A-A1 and B-B1

South-west facing section A-A1

North-west facing section B-B1

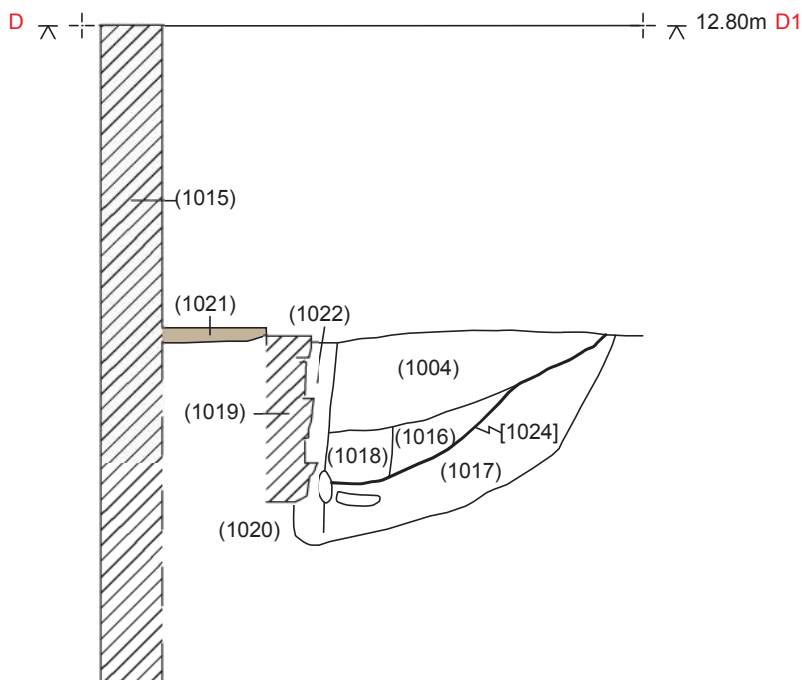
Figure 5: Sections C-C1 and D-D1

### South-east facing section C-C1

### North-east facing section D-D1

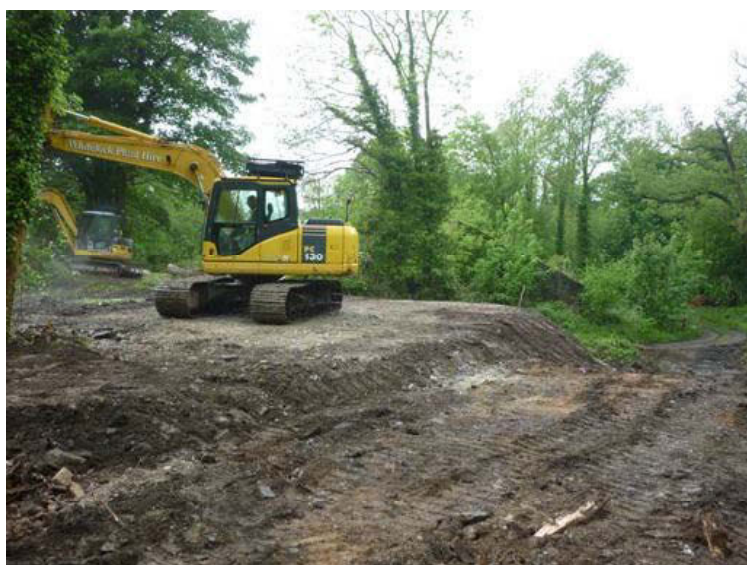
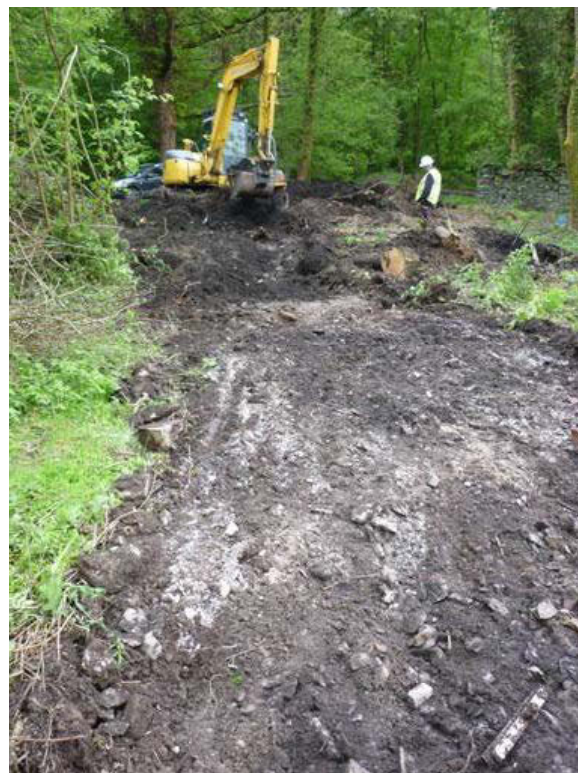
4.3.2 **Access track and site compound:** vegetation and overburden was initially stripped from the area forming the site compound, essentially around Area 4 as defined during the evaluation (Greenlane Archaeology 2010), and a deeper cut was formed along the north-east side to create the track connecting the road to the south-east with the track leading to the site of the powerhouse and end of the leat (Plate 10). This comprised a large amount of brick and concrete rubble, with some metal and plastic but also concreted slag (**01**). Beneath this was a raised area of concreted slag, with lenses of compacted iron-rich material and firm orange sand (all part of **02**). Topsoil, comprising a dark brown loose sandy-silty clay with large amounts of humic material (**06**) was subsequently stripped from a small triangular area adjoining the road to the south-east. Beneath this a dark orangey-brown sandy clay subsoil (**07**) was revealed during hand excavation carried out to locate a service pipe. In general, however, only the topsoil and vegetation was removed, although in the area against the road this did include a lens of mortar-rich rubble comprising yellow fire bricks, slate, and some glass.

Plate 10 (left): Topsoil stripping around Area 4 and creation of the access track

Plate 11 (right): Topsoil stripping around Area 2, revealing deposits 10, 11, and 12

area of concreted slag (**10**) dumped on top of the topsoil (**08**). This continued almost to the leat wall to the south-west, but there was another deposit of stone rubble in a loose brown sandy clay matrix with pieces of timber, apparently fragments of window frame, between it and the wall to the north-east (**11**). On top of the slag (**10**), at the junction with the topsoil (**08**), there was a further thin layer of dumped mortar-rich building rubble (**12**) with slate flags and pieces of iron guttering, which was on top of topsoil **08** (Plate 11).

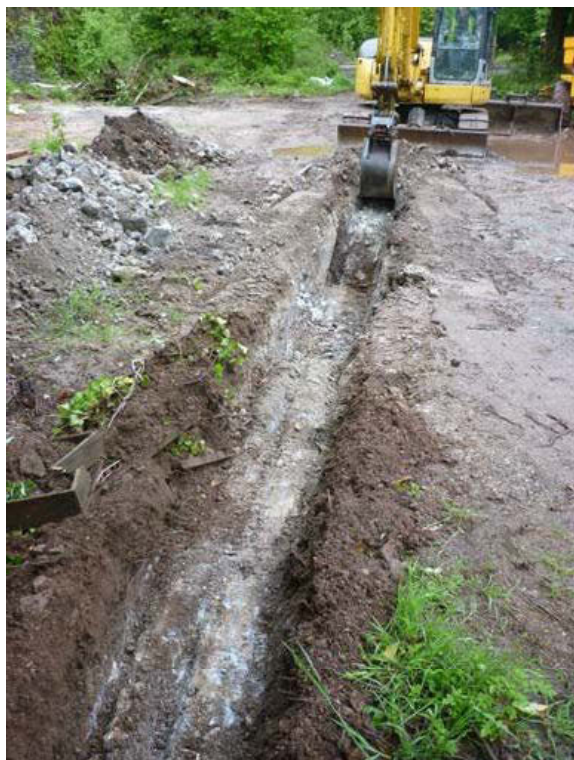
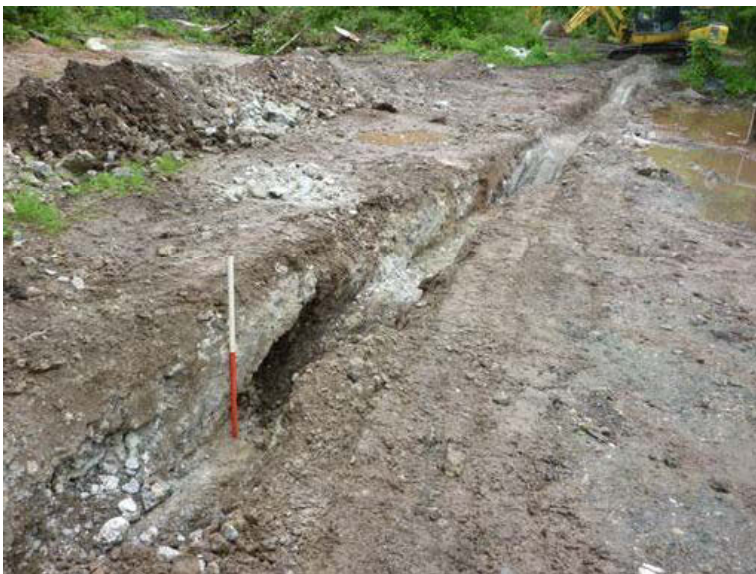
4.3.4 **Service trench:** this was excavated from an existing telegraph pole and the temporary electrical junction point within the former builder's yard area, towards the area stripped for the site compound to the south-east. There was no overburden as such, the entire area comprising part of a large mound of concreted limey blast furnace slag and the excavation of the trench confirmed this (**03**; Plate 12). However, within this deposit variations were evident with large lenses of dark brown sandy/gritty material, loose ashy material, and mid orange firm sandy deposits, representing obvious layers tipped from the east (Plate 13). The slag deposits continued until the track to the east, at which point a mid orange-brown (although more grey towards the top) sandy clay with 30% rounded cobbles up to 0.5m thick (**04**) was encountered, which apparently ran underneath the slag (**03**). Further east still a loose dark grey deposit containing large amounts of angular stone and glassy slag (**05**) was present, and also on top of **04** (Plate 14). This appears to be a continuation of the dumped deposits of slag further to the east (**02**) and it is likely that **04** represents the original ground surface or a layer deposited to form the current track.

Plate 12 (left): Excavating through slag to create the service trench

Plate 13 (right): Dumped deposits visible in the section of the service trench

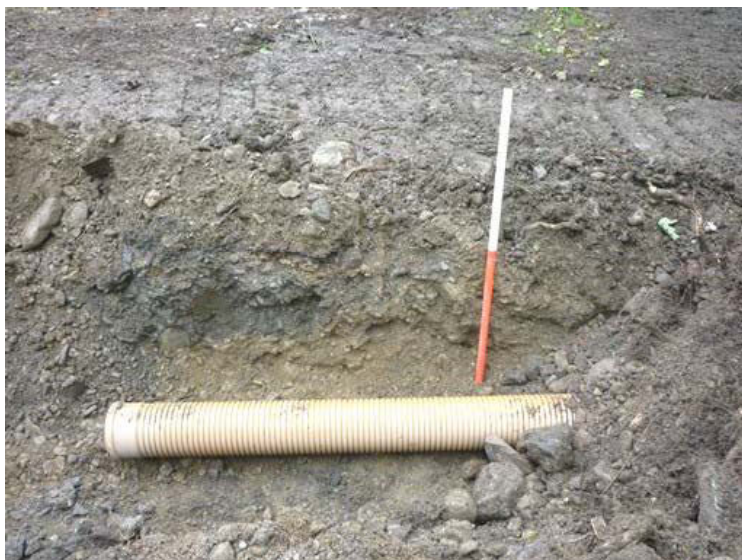
**Plate 14: Possible original ground surface (04) and slag deposit (05) at the west end of the service trench**

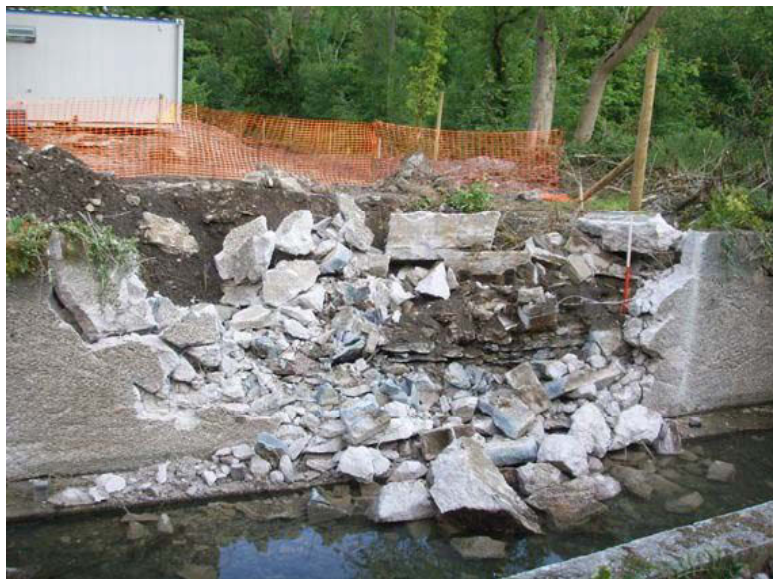
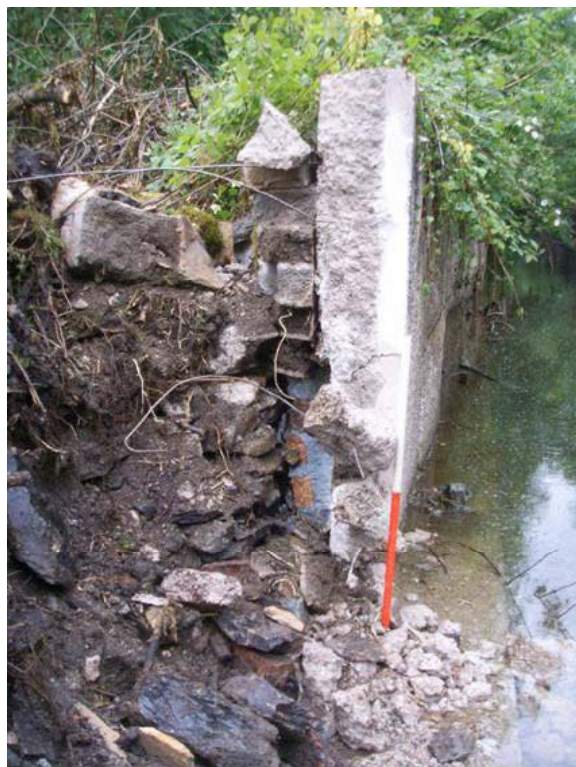
4.3.5 **Bridge abutments:** the concrete block and brick walls of the extant leat and some of the material immediately behind them had been removed with a breaker prior to monitoring taking place, and it was apparent where the wall had been broken through that it was constructed from reinforced shuttered concrete (Plate 15). On the north-west side of the leat the original stone leat wall was evident, as per the earlier excavation, and was c0.7m tall and constructed from four or five courses of drystone slate slabs. It was also apparent that the extant concrete block wall had a further concrete block wall built on a foundation of fire bricks and concrete between it and the original stone wall on the north-east side (Plate 16). Otherwise the range of deposits exposed in the north-west abutment is similar to that seen in the excavation – layers of overburden essentially on top of natural clay, although a thin layer of dark grey material and the interface was observed. Of more significance was an apparent wall of drystone build, revealed in section at the south-west end of the cutting, and a better preserved wall exposed in the south-west section. These appeared to form the two sides of a culvert, the open area between filled with loose gravelly clay and firm clay lenses, extending from the original leat wall and apparently contemporary with it (Plate 17). The better preserved side had five or six courses remaining, with the wall having a distinctly angled plan and an apparent ‘slot’ formed between upright slabs and the leat wall (Plate 18).

**Plate 15 (left):** The north-west abutment following the demolition of the leat wall

**Plate 16 (right):** The section through the leat wall on the north-east side of the north-west abutment cut

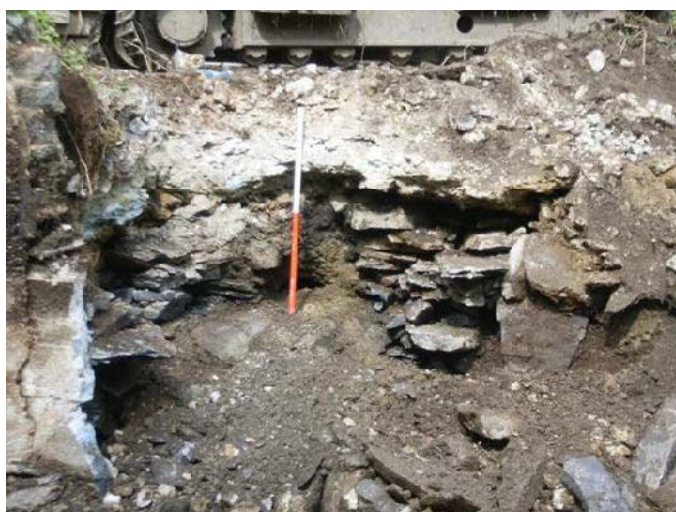
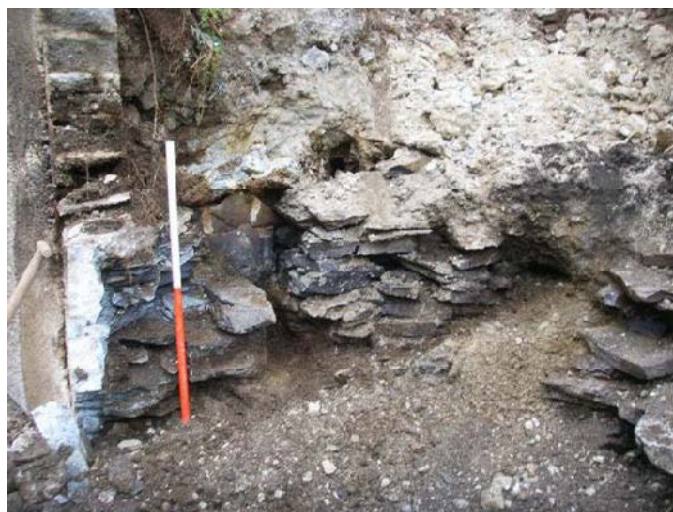
**Plate 17 (left):** Culvert encountered in the north-west abutment cut

**Plate 18 (right):** Detail of culvert construction and 'slot' on south-east side

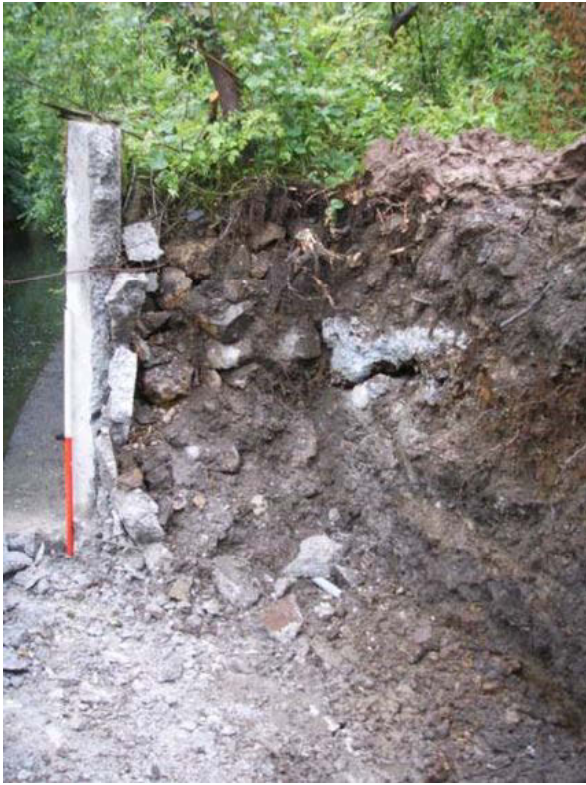
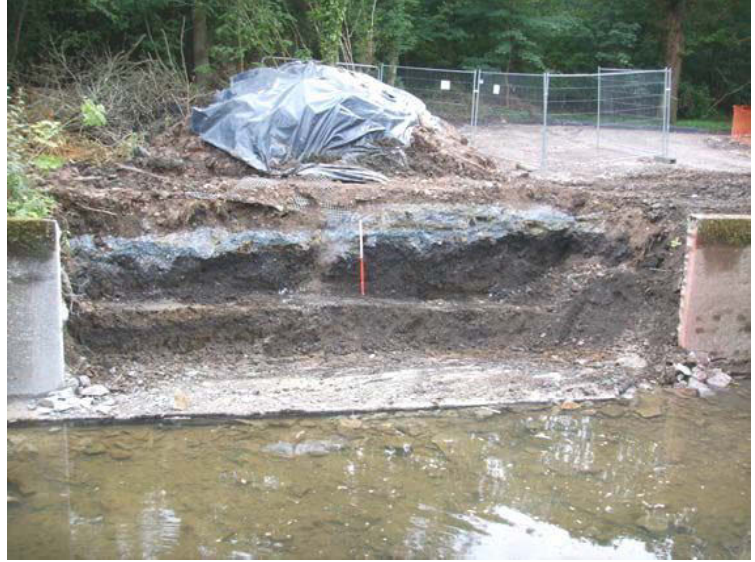
4.3.6 The cut for the abutment on the south-eastern side of the leat revealed in more detail the deposits encountered during the initial watching brief in this area. Specifically, it was apparent that deposit **11** comprised material dumped to backfill the cut made for the concrete block leat wall, which had an approximately 1m wide roughly v-shaped profile (Plate 19). The slag deposit (**10**) was apparently cut by this and up to 0.7m thick, and below it was a similar sequence of deposits to that revealed further to the south-east: a layer of topsoil up to 0.7m thick (as per **08**), and a layer of mid brownish orange subsoil 0.2-0.3m thick (as per **09**) on top of a mid-orange clay, which was presumably the underlying natural (Plate 20). In addition, there was a thin lens of re-deposited mid orange clay between the topsoil and subsoil containing a small amount of blast furnace slag.

**Plate 19 (left): North-east section of the south-eastern abutment cut**

**Plate 20 (right): General view of the south-eastern abutment cut**

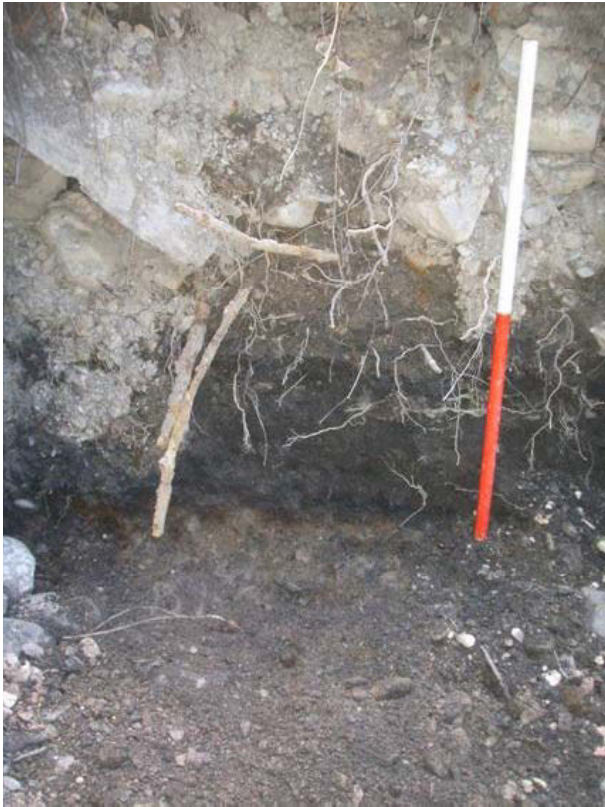
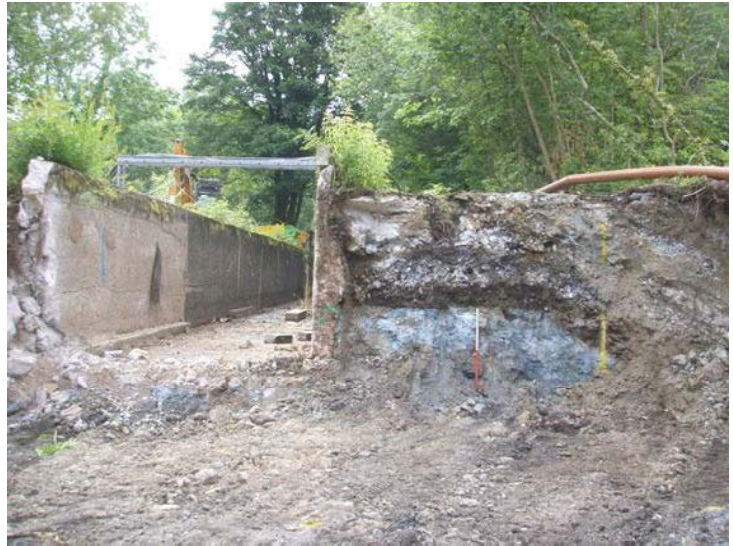
**4.3.7 Former powerhouse area and leat end:** a small area had been excavated to the west of the former powerhouse in order to provide access to the river at this point without being fully monitored (Figure 6). This comprised a cut ranging from 4-5m wide east/west and 5m long north/south, sloping down from the north to form a ramp into the river. A sequence of deposits was revealed in section (Plate 21) comprising an upper layer of loose orangey-brown clay and rubble up to 0.7m thick with large amounts of rounded boulders and at least one slate flagstone (**14**). Beneath this was a firm mid orange-brown clay subsoil 0.15m thick (**15**) containing 10% rounded cobbles, a small amount of glassy blast furnace slag, and with three large iron rods projecting from it (Plate 21). This was in turn on top of a dark greyish-black silt up to 0.4m thick (**16**) containing large amounts of slag and thick pieces of ceramic material, and beneath this was a pale buff-orange firm clay at least 0.1m thick (**17**), which contained blue glassy slag.

**Plate 21 (left):** Detail of deposits in the west-facing section of the excavated area west of the powerhouse

**Plate 22 (right):** Section through the dumped slag deposits at the north-west end of the leat

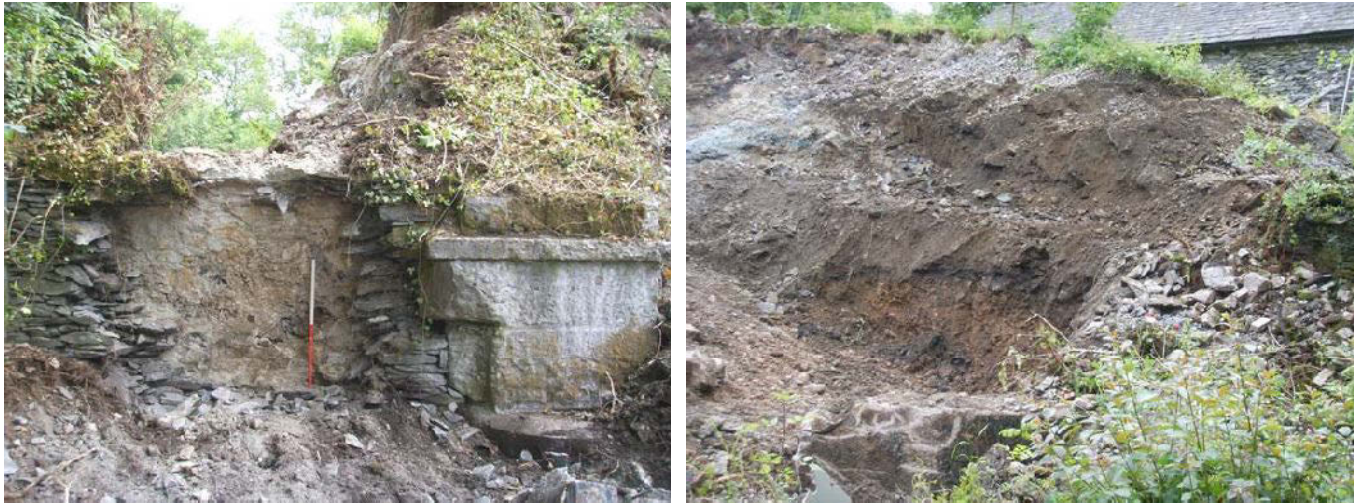
4.3.8 The original end of the leat serving the previous hydroelectric generation plant was also extensively modified largely through the demolition of the existing structures associated with it. However, some excavation associated with this was also monitored. This confirmed that the existing leat structure was situated entirely within a large mound of concreted limy slag, which was at least 2.5m deep and within which several tip lines could be seen (Plate 22). In addition, where the excavation broke through part of a wall on the south-west side, a number of features were exposed: it was apparent that this wall had been standing when the slag was deposited on the site, as it was built up against its north-east side. The wall incorporated what appeared to be the jamb of a massive gate or perhaps a bridge footing, built of large limestone blocks with a rusticated finish, including a projecting ridge on top and sat on top of a re-used edge-runner stone from an incorporating mill (Plate 23). On the west side of the excavations around the original end of the leat the natural ground level, evident as a mid orange-brown clay, was apparently encountered, on top of which was a thin layer of dark greyish-black material, presumably representing the original ground surface (Plate 24). The remains of a wall of drystone slate construction, buried by the slag and built on top of the original ground surface, continued the line of an extant wall to the north-west.

**Plate 23 (left): Remains of wall with slag built against it and incorporating limestone built 'gate pier' on re-used edge-runner stone**

**Plate 24 (right): Deposits and wall remains exposed along the west side of the leat cut**

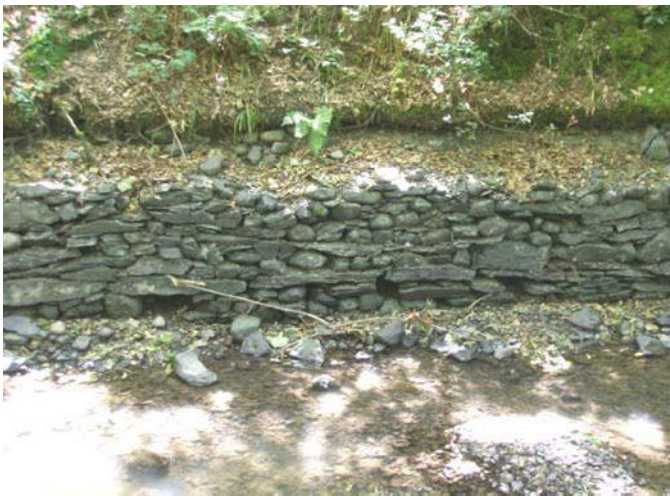
5.1.1 **Excavation:** the excavation revealed two main features of interest; the line of the original leat wall on the east side (**1019** and associated deposits), and the presence of a backfilled channel (**1023**), perhaps running parallel to it on the west side of the site. The leat wall was of a similar construction throughout, where it survived, with a later capping of concrete (**1021**), and it had been augmented with a later leat wall of concrete block and brick construction (**1015**). The latter must correspond with the alterations created for the original hydro electric scheme in 1952. The dating of the layer of concrete is more difficult but as it was sealed below deposit **1002** is likely to be 20<sup>th</sup> century although it must have been at surface level when initially laid. The sections of leat wall that were exposed cannot have formed part of the original 18<sup>th</sup> century structure as the deposits of clay and other material forming a waterproof layer to the west were laid on top of a deposit of disturbed natural (**1017**) that contained pottery of at least 19<sup>th</sup> century date, suggesting that the leat wall belonged to a later phase of rebuild or that the original leat was not actually in this position, although the map evidence would seem to contradict this. That such rebuilding must have taken place is likely for two reasons; firstly, the creation of the paired incorporating mills in the early 19<sup>th</sup> century (perhaps the period between 1828 and 1848; Jecock *et al* 2005, 210-213) must have required some reorganisation of the leat wall to provide access for the culverts needed to power them (further evidence for this was revealed during the watching brief, see *Section 5.1.3* below). Secondly, since the leat was almost drained while during the watching brief it was possible to examine its structure in more detail at different points. It was apparent that there were two main types of build style evident; Style 1 comprising long slabs and rounded boulders (Plate 25), and Style 2 consisting almost entirely of well-dressed slabs (Plate 26). Rebuilding clearly must have taken place, even if only as part of general maintenance.

**Plate 25 (left): Example of leat wall showing build Style 1**

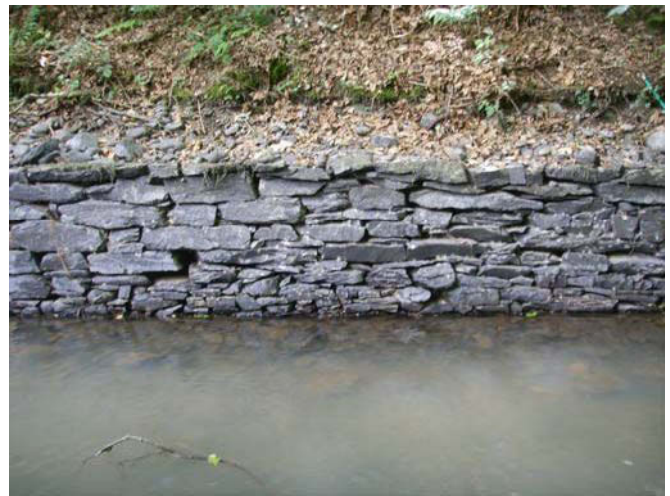
**Plate 26 (right): Example of leat wall showing build Style 2**
