# LAND ADJACENT TO THE MILLOM CRICKET CLUB, ST GEORGE'S ROAD, MILLOM, CUMBRIA

## Archaeological Building Recording

Client: Mr Nigel Woodhouse

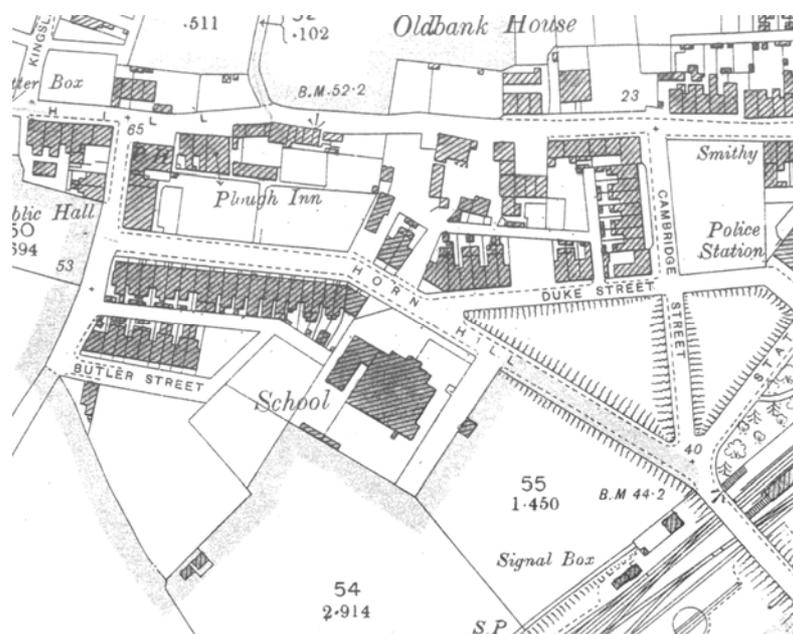
Plate 1: Extract from the Ordnance Survey map of 1899

3.2.2 **Ordnance Survey, 1899:** this is the first Ordnance Survey map to be produced after the building was constructed. It clearly marks the school, which is a considerably larger building than what now remains, and comprises a large approximately square block on the south-west side with a distinct L-shaped arm on the north-west side.

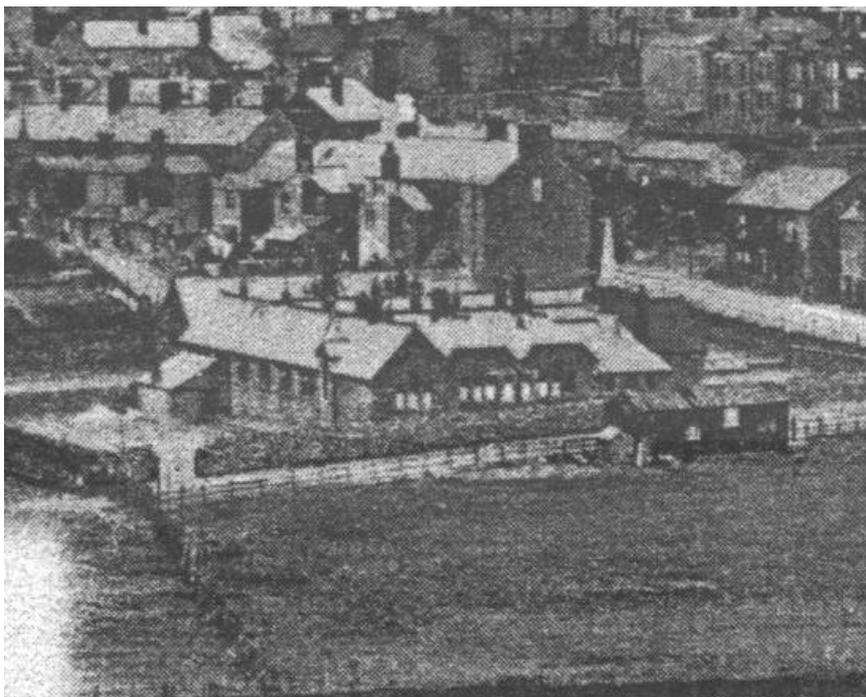
**Plate 2: Extract from a photograph of c1895 published in 1904 (from Myers 1991, 24)**

3.2.5 **Photograph, c1895:** this shows the building at its peak, although as it is taken from the south-east it shows very little of what now remains. Some elements of the detail of the structure can be seen, however, such as hipped gables on the south-east side (mirroring those still remaining).

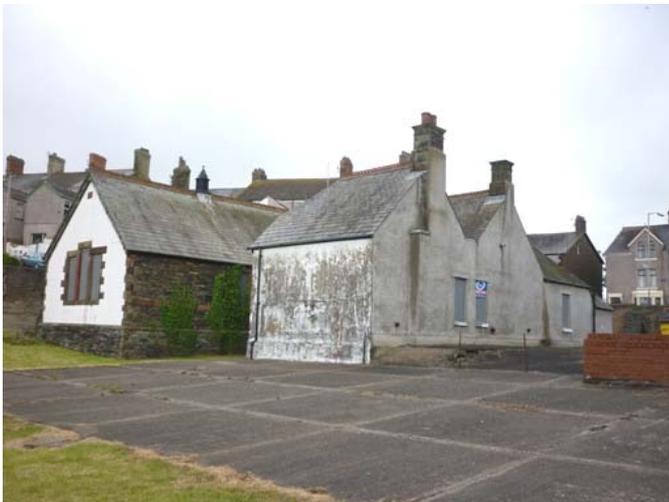
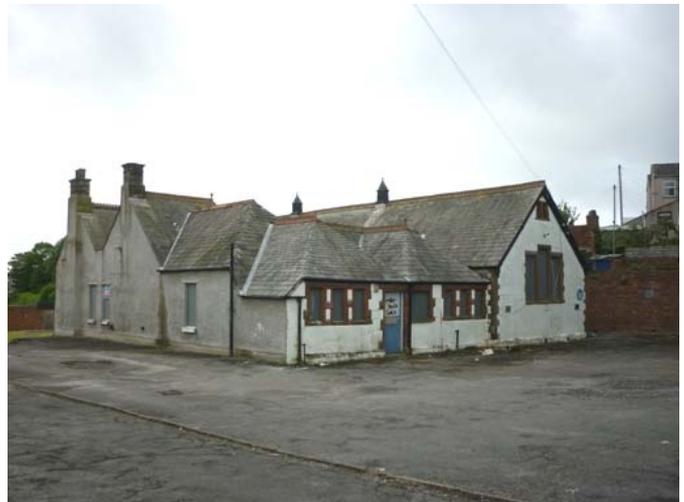
4.1.1 The building forms an almost C-shaped range orientated approximately north-east/south-west, with the open end of the 'C' to the south-west (Plate 3) and the opposing continuous elevation facing towards the A5093 (Plate 4; see Figure 1 and Figure 2). The south-west external elevation therefore includes the 'internal' faces of this section. The external ground level is significantly lower to the south-west, giving the appearance of a cellar at that end of the building, although there is no evidence for this internally. Where it is exposed, it is apparent that the entire structure is constructed from the local grey slate, which has been roughly dressed and laid in fairly random courses, although large areas have been finished with concrete render, which hides this. Details such as window and door lintels and sills, the plinth, a decorative band, and the quoins are picked out in dressed red sandstone with rusticated panels inside a rilled border. The roof is finished with local grey slate topped with terracotta ridge tiles, some perforated, finished with finials. The chimneys, present on the north-west and south-east sides, are constructed with dressed ashlar sandstone blocks with a moulded cornice or band. There are numerous iron and ceramic vents in the walls, and two cylindrical metal vents with cone-shaped tops projecting through the roof on the north-west side.

**Plate 3 (left): View of the south-west and south-east external elevations**

**Plate 4 (right): View of the south-east and north-east external elevations**

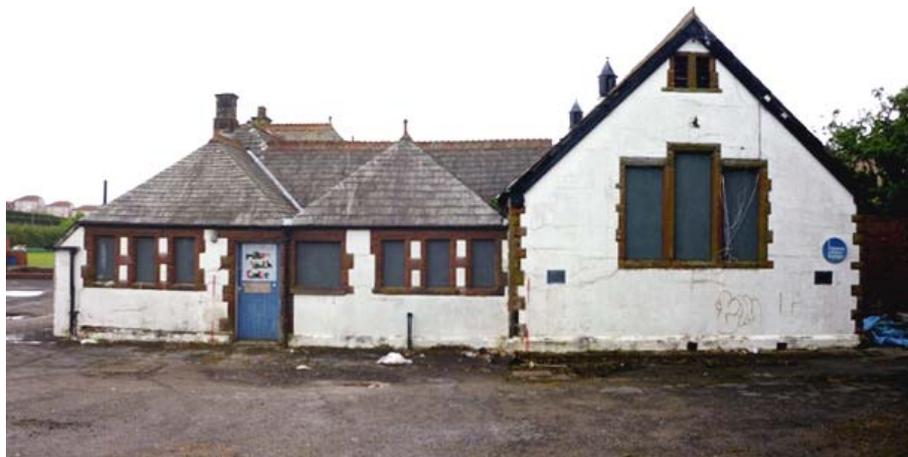
Plate 5: Composite photo of the north-east external elevation

4.2.1 **North-east elevation:** this is entirely finished with concrete render (see Plate 5), the majority of which has a smooth finish, although a small section remains on the south-east side which has been scored to give the appearance of ashlar blocks. This suggests that the rest has been more recently re-rendered. Only the dressed sandstone quoins, lintels, and other details have been left exposed. The south-east half is formed by a pair of hipped gable ends, finished with terracotta ridge tiles and finials. There are two pairs of three-part windows in this section, plus one off-centre doorway and a further window to the north-west of this with a concrete lintel, which was perhaps also originally a doorway. The doorway has a modern timber plank door with a sign reading 'Millom Youth Centre' attached and all of the windows are boarded up. There is a slight return to the north-east near the centre of the elevation, before a large gable that forms the north-west half, again with a decorative finial. In the centre there is a large three-part window with sandstone mullions; the central section is slightly taller than those flanking it. There are iron ventilation grills in the wall on either side at the level of the window sill, with a maker's mark 'H... H...' on the top and 'MANCHESTER' on the bottom, and at the far north-west end there is a round plastic sign reading 'citizens advice bureau'. There are a further two holes, presumably for smaller vents, in the plinth at the base of the wall and a small two-light aperture filled by slatted timbers below the apex. The top of the gable is finished with moulded barge boards with a beaded central rail and additional beaded stops and corresponding stop chamfer decoration and roundel stops.

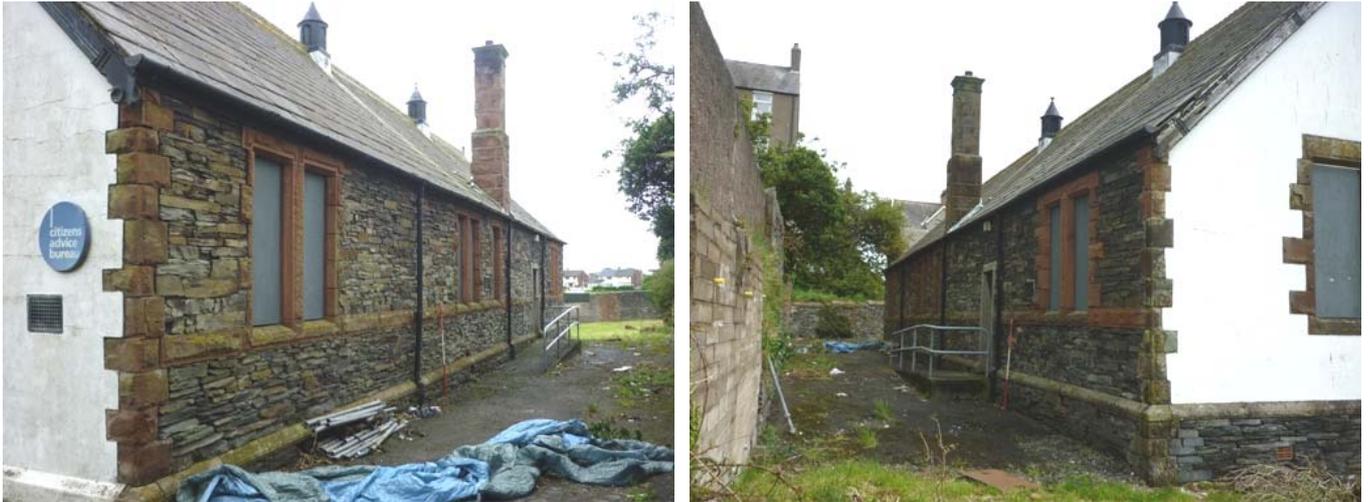
4.2.2 **North-west elevation:** this forms the side elevation, and it mostly comprises exposed local slate laid in rough courses (see Plate 6 and Plate 7). There are three paired windows, plus one single window, all of which are boarded up and have dressed sandstone lintels and quoins and a continuous band forms the sills. A dressed sandstone plinth extends along the bottom of the wall, through which there are occasional perforations forming vents, all of which have sandstone sills and one of which also has a lintel. There are two larger ventilation grills above the sill band and several other small plastic and ceramic vents. There is a single tall stone chimney with a cavetto-moulded step mid way and cyma-moulded entablature on top. Towards the south-west end there is an inserted doorway, with concreted jambs, scored to give the appearance of ashlar blocks, accessed via a concrete ramp with a metal hand rail. To the north-east of this there is an evident line of re-build in the wall – the sill band is noticeably different beyond it, the stonework largely has sawn faces and it incorporates an iron tie rod with square plate towards the south-west end.

**Plate 6 (left): North-east end of the north-west external elevation**

**Plate 7 (right): South-west end of the north-west external elevation**

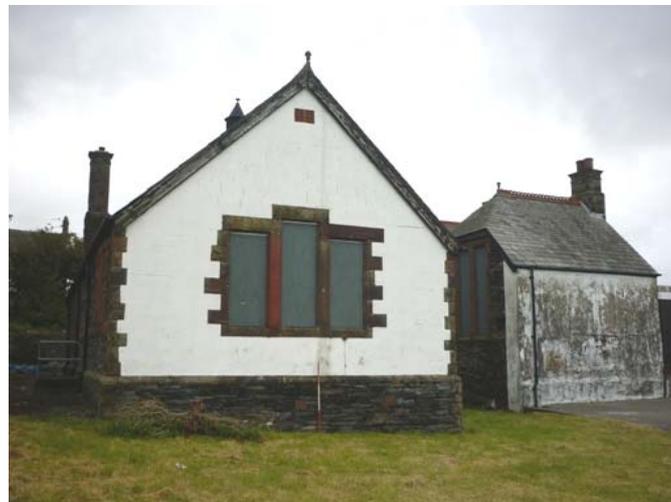
**Plate 8: North-west end of the south-west external elevation**

4.2.3 **South-west elevation:** this comprises two small sections at either end (north-west and south-east) plus a large central section that returns to the north-east. The north-west side comprises a large gable, corresponding to that in the north-east elevation, although as the ground level is lower on this side the plinth is relatively taller (see Plate 8). The stonework is exposed within the plinth, where there are three modern ceramic vents and some sawn stone like that in the south-west end of the north-west elevation. The rest is finished with concrete render, with a central three-part window in the centre as per the north-east elevation, although the north-western mullion is a painted concrete replacement. It has the same decorative barge boards and terracotta finial as the north-east elevation. The elevation returns to the north-east beyond this gable, forming a central recessed area.

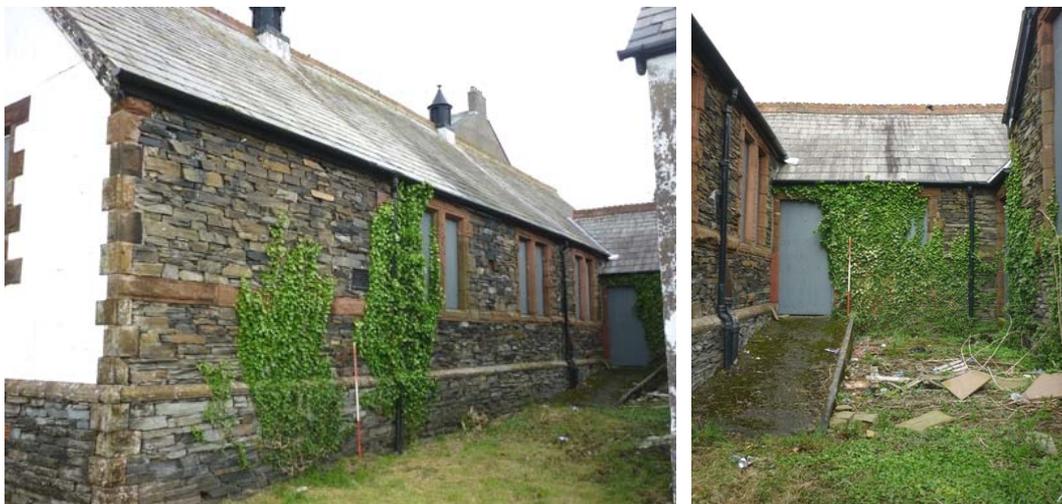
4.2.4 The south-east facing part of this recessed area has three paired windows, as per the north-west elevation, plus two large vents with iron grills (Plate 9). A rebuild line is apparent also as per the north-west elevation. A concrete ramp runs along the base of the north-east end leading to a doorway in the south-west facing central section (Plate 10). This door was perhaps a modified window, as concrete has been added to the north-west jamb and moulded and painted to give the appearance of sandstone quoins. There is a small window to the south-east. The north-west facing part of this area (Plate 11) has a doorway on the north-east side, with one concrete and one sandstone step. To the south-west there are two hipped gables both with large three part windows with stone mullions and decorative barge boards as per those elsewhere. Again the difference in ground level means that the base of the wall is

much lower than elsewhere, but there is no plinth on this side. There is a row of small holes near ground level with stone lintels and sills and ceramic vents plus one large vent with an iron grill to the north-east and one between the two large windows. Concrete render has been added to the south-west corner, which continues over the return to the south-east (Plate 11). This is essentially plain, with the render obscuring all the detail. It has a square plinth and a single ceramic vent below. A short flight of concrete steps is situated against the south-east end and runs along the south-west end of the south-east elevation.

Plate 9 (left): South-east facing part of the recessed area

Plate 10 (right): South-west facing part of the recessed area

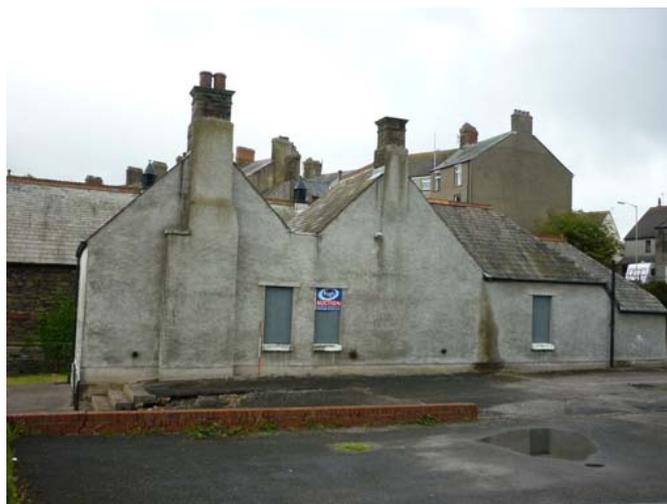
Plate 12 (right): South-east external elevation

4.2.5 **South-east elevation:** this is entirely covered by roughcast concrete render, which appears to have been added quite recently (Plate 12). It mainly comprises two gables, with a short side wall at the north-east end. There are two chimneys, both constructed from ashlar sandstone with moulded details as per that to the north-west, but larger. The south-west chimney has two ceramic pots and a projecting chimney breast, with a step on the south-west side, while the north-east chimney has a slightly projecting section near the top. There are three plain windows each with a concrete sill, and two modern vents for boilers. There are beaded barge boards and mainly plastic rain water goods at the north-east end.

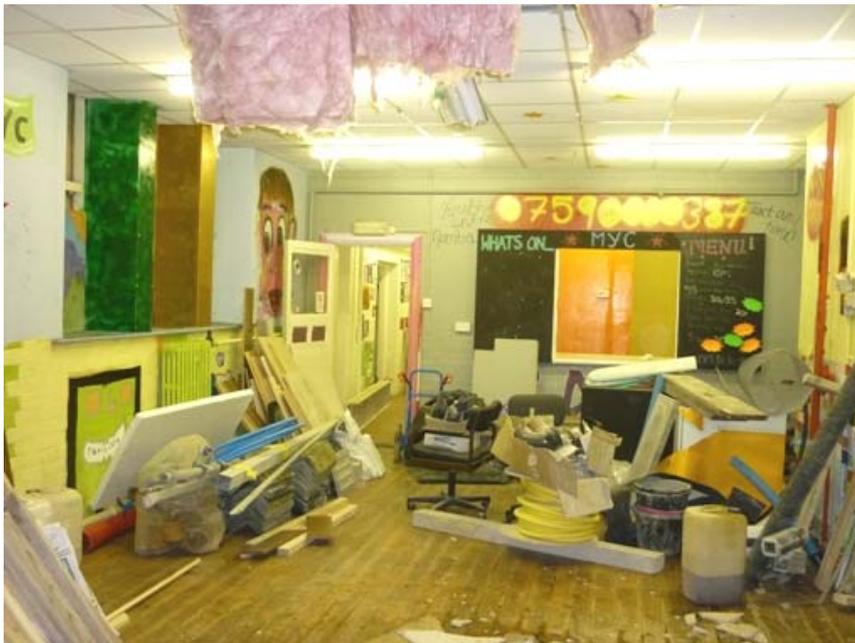
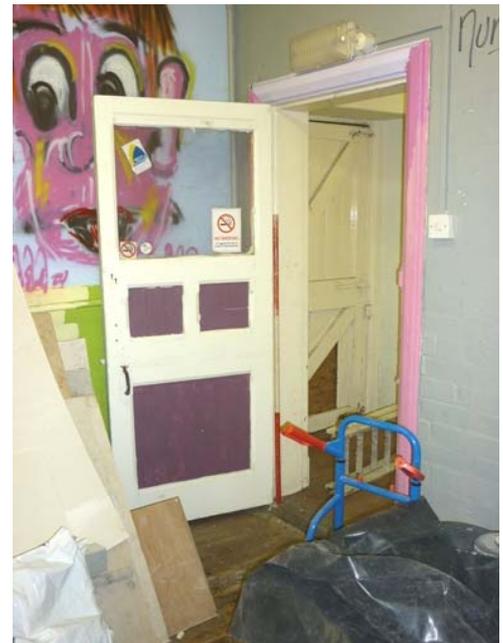
4.3.1 **Room 1:** this room forms a large hall, which occupies the main part of the south-east wing of the building. It has a tongue and groove timber board floor and a suspended fibre-board panel ceiling (Plate 13). The roof proper, above the suspended ceiling, comprises two north-west/south-east gables, with a beaded beam with moulded decoration and a cornice at the junction of the two. Each gable is supported by a pair of north-west/south-east orientated beams with stop-chamfer decoration supported at either end by an elaborate brace, also with stop-chamfer and perforated decoration in a gothic style (see Section 4.3.6 and Figure 3). The walls are all plastered and painted. The north-east elevation is brick, apparently in Flemish bond (alternating header and stretcher) and there is a central aperture, which was probably inserted, with a menu board surrounding it and with a modern counter top forming a sill. There is a doorway to the north-west of this window which has a moulded surround and houses an early, three-panel door with beaded plank infill and a glazed top panel with chamfered surrounds and an early latch plate (Plate 14). The north-west elevation has two three-part two-light windows with fixed casements and timber sills. The brick construction of the walls is exposed below the level of the sill and is also in Flemish bond. There are two boxes fixed to the wall which have side handles and dog-tooth decoration below a moulded top (Plate 15). The handle turns a flap inside to open and close a vent cover. The south-west elevation is plain (Plate 16). The lower part is exposed brick in a Flemish bond while the rest is covered by modern notice boards. The brick work of the south-east elevation is also exposed at the lower level and is again in a Flemish bond. There are two chimney breasts along this side of the room and although they are blocked there is some evidence for the extent of their original openings and the scar of a rounded top or surround is visible. There are two windows with beaded edges either side of the central pillar which supports the beam in the roof. The timber sills of these two windows are lower than those to the north-west elevation and both windows are boarded up.

Plate 13 (left): View of Room 1, looking north-east

Plate 14 (right): Doorway in the north-east elevation of Room 1

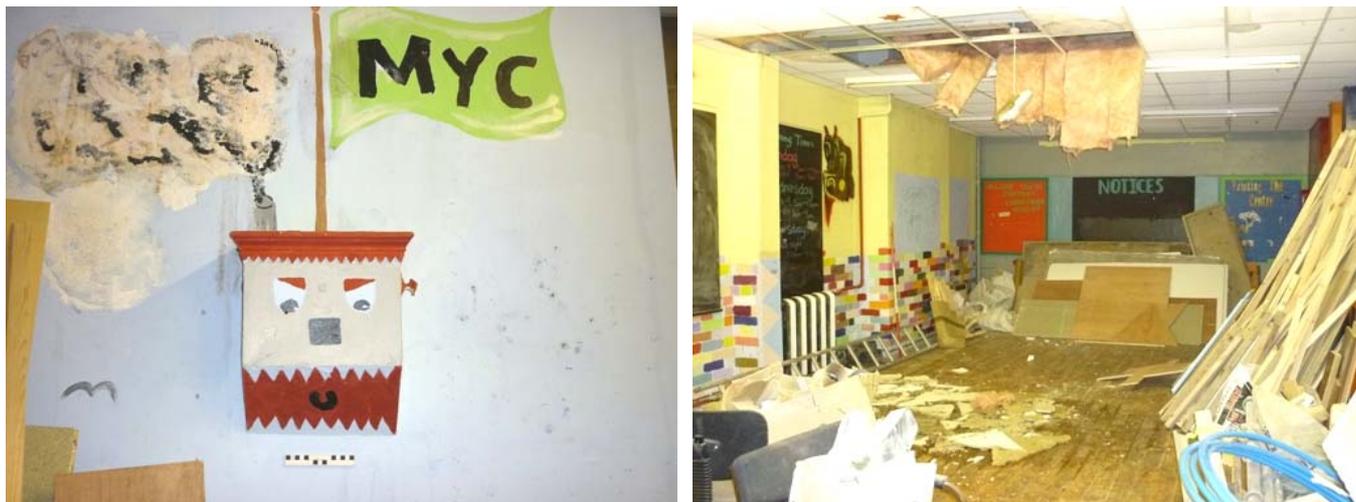
**Plate 15 (left): Decorated box covering a vent in the north-west wall, Room 1**

**Plate 16 (right): View of Room 1, looking south-west**

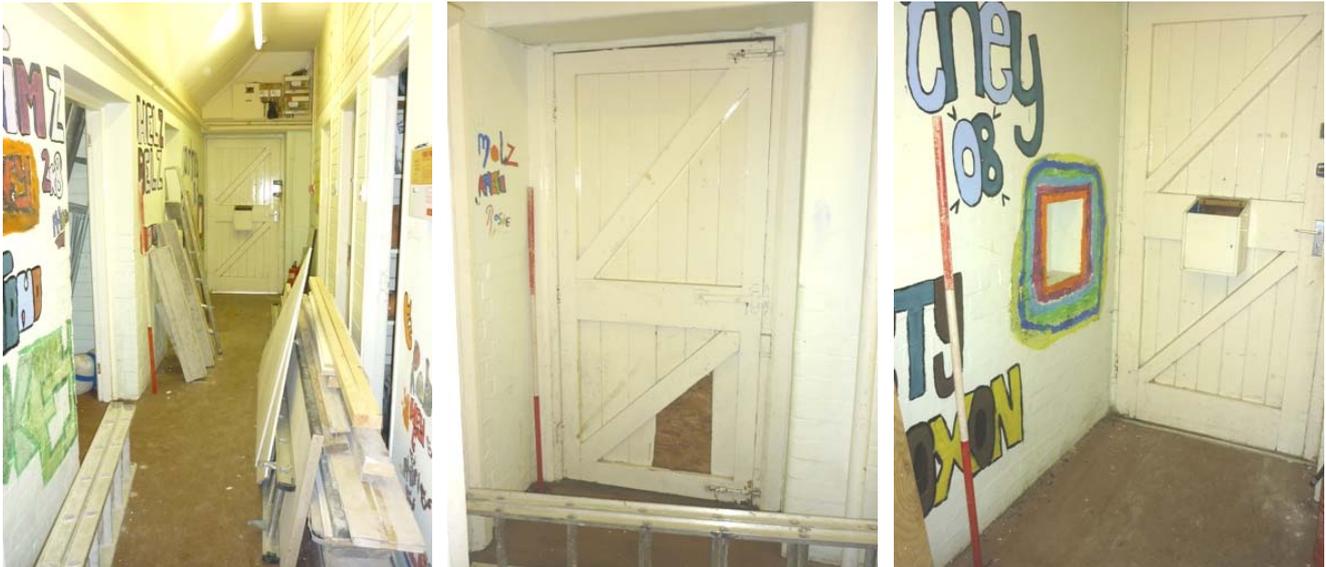
4.3.2 **Room 2:** this room forms the north-east corner of the block of buildings with an entry corridor along its north-west side (Plate 17) and a number of smaller rooms along its south-east side formed by modern partitions. The corridor has brick in a Flemish bond along the north-west wall with a plank and batten construction external door at the south-west end (Plate 18). The doorway has bull-nosed bricks in the north-east jamb, the top one of which has a slight chamfer. There are two further doors to the north-east, both of which have either been inserted or widened, with very plain surrounds and a modern door to the north-east. There is a small alcove in the wall at the north-east end which is 0.30m wide by 0.38m tall by 0.18m deep and accommodates the letter box (Plate 19). The rooms along the south-east side of the corridor are formed by partition walls covered with tongue and groove planks. The door at the north-east end of the corridor is plank and batten construction, but the doors are modern along the south-east side and have plain surrounds. There is a toilet block at the north-east end of the room, which has three small two-light hinged casement windows in the brick-built north-east elevation (two of which can be seen in Plate 20). The toilet block is further partitioned to form a small cubicle. The rooms immediately to the south-west of the toilet block are used as storage cupboards and the partitioned off room at the far south-west end is used as a kitchen (Plate 21). Some of the partitions appear to be brick. There is a two-light hinged casement in the south-east wall of the kitchen. The ceiling is flat and plastered throughout apart from where the slope of the roof intrudes along the north-west and south-east sides and at the north-east end of the room. The floor appears to be concrete with a vinyl (?) covering.

**Plate 17 (left):** View of corridor along the north-west side of Room 2, looking north-east

**Plate 18 (centre):** Plank and batten door at the south-west end of the north-west elevation of Room 2

**Plate 19 (right):** Small alcove in the wall at the north-east end of the north-west elevation of Room 2

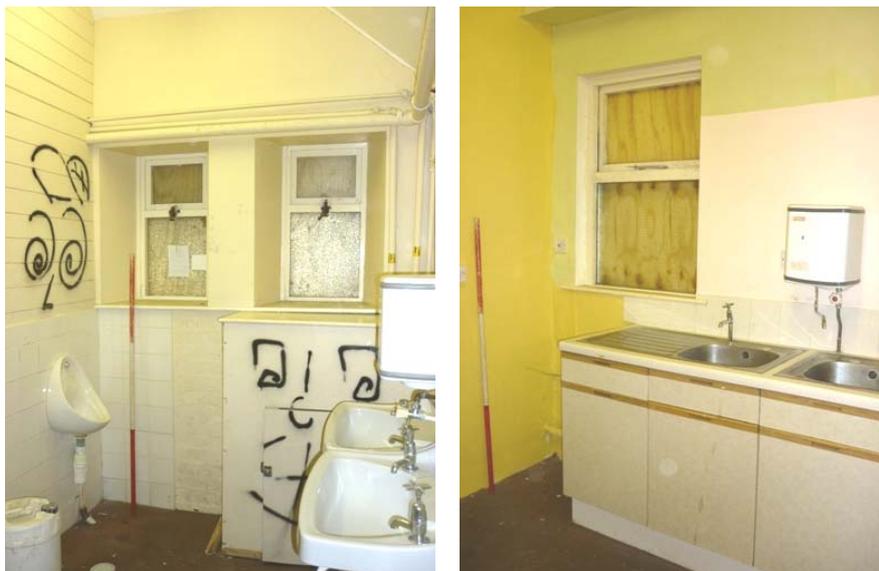
**Plate 20 (left):** Windows in the toilet block, forming part of the north-east elevation of Room 2

**Plate 21 (right):** Kitchen area at the south-west end of Room 2

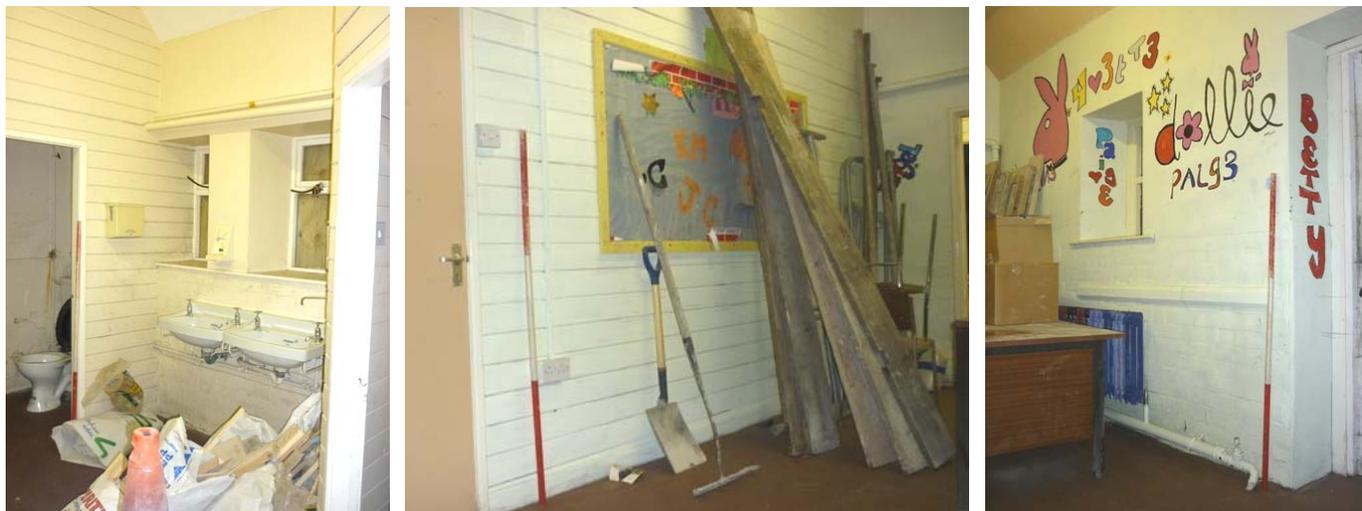
**4.3.3 Room 3:** this room effectively forms a small lobby between the north-west and south-east wings with a toilet block along the north-east side, which is partitioned into separate cubicles (Plate 22). There was no access to the small room at the north-west end of the lobby at the time of the survey. The ceiling is plastered and slopes at the south-west and north-east ends for the roof. The floor is probably concrete with a vinyl covering. The north-east elevation has three small windows and one large window, which formerly may have been a door, each of which has a two-light hinged casement. The brick work is exposed on this side of the room, but the bond is not clear. The rest of the walls are covered with horizontal boards. Modern doors are used for the cubicles and to the south-east. The south-west half of the room comprises a lobby area or hall. The north-east elevation is finished with tongue and groove boards horizontally and with a modern door on the north-west side, which was locked at the time of the survey (Plate 23). The rest of the walls are brick built in a Flemish bond and painted. There are modern doors to the south-east and north-east and a modern fire escape to the south-west end of the lobby. The

fire escape was probably inserted through a former window as the lower part has been rebuilt in the jambs. There is a small two-light window to the south-east of this, with a fixed casement and a timber sill (Plate 24). There is one modern six-panel door to the north-west and one original, four-panel door, with beaded plank infill and chamfered battens.

Plate 22 (left): Toilet block to the north-west side of Room 3

Plate 23 (centre): North-east elevation of the lobby area, forming part of Room 3

Plate 24 (right): South-west elevation of Room 3

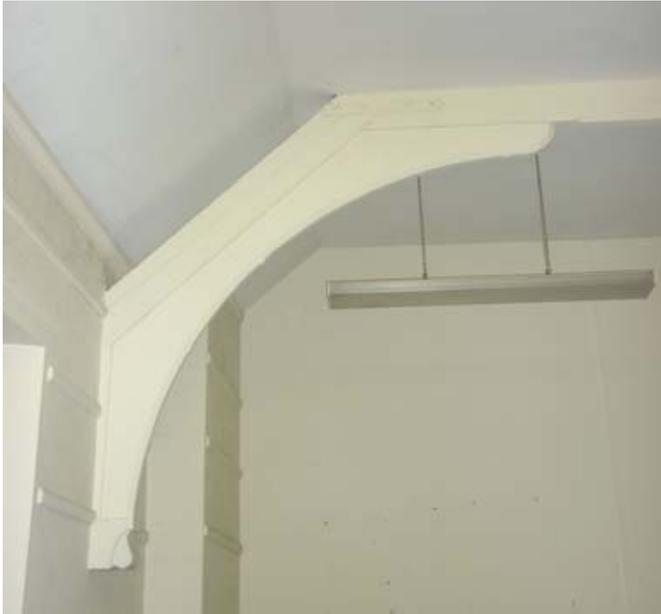
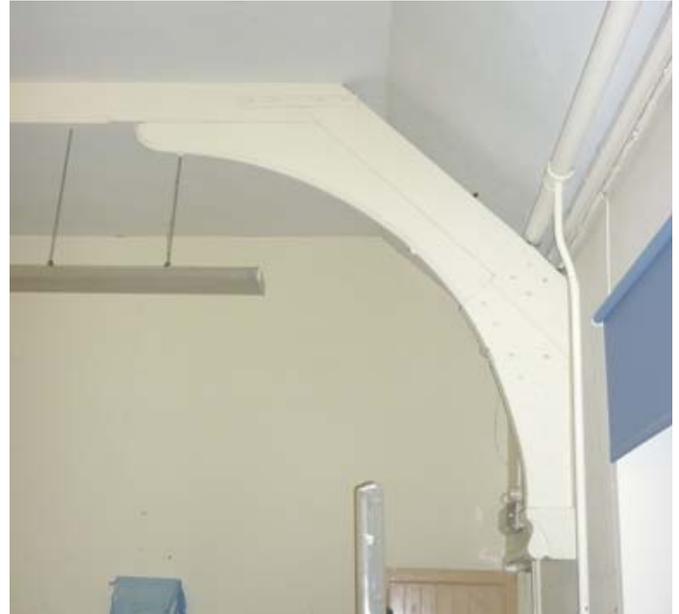
4.3.4 **Room 4:** this room forms a large hall at the north-east end of the north-west wing of the building and has various subdivisions. It has a timber floor covered with carpet and a plaster ceiling and the main section has a vent grill located towards its centre. The ceiling slopes on the north-west and south-east sides following the line of the roof. There are three north-west/south-east trusses across the room (Plate 25 and Plate 26), each of which is supported by a scrolled stone (?) corbel at either end (Plate 27), and comprises an angled brace bolted between the principal rafter and collar. The principal rafter is also fixed to the collar with an iron strap (see Figure 3). The top part of the truss is not visible from inside the room, but a bolt in the centre of the principle truss evidently attaches to the king post above (see Section 4.3.7). The lower part of the centre truss is encased by iron work on the south-east side (Plate 26). There are boxed vents either side of the room near the base of the south-west truss, as per those elsewhere in the building; the one on the south-east wall is marked '...LAND MANCHESTER' and the handle is cast in the shape of a small hand holding a stick (Plate 28). There is a partition wall between the north-east and central truss, which is plain on the south-west side and tongue and groove boards on the north-east side, and there is a north-east/south-west aligned wall sub-dividing the area to the north-east side of this. Both partitions have small apertures with hinged doors. The north-east elevation of Room 4 (within the partitioned area) has a radiator, the same as those elsewhere in the building, which is marked 'REC-CLASSIC' (?) and 'IDEAL' (?). The wall is brick built in a stretcher bond. There are boxed vent covers on the south-east and north-west sides of the partitioned area and there is a large three-light top hinged/vented window, which is split by the north-east/south-west partition (Plate 29). There is a modern door through this partition at its south-west end. The north-west elevation of the partitioned area is painted brick in a stretcher bond and has a similar radiator below paired two-light windows with hinged/vent opening tops and timber sills (Plate 30) and there is a row of chamfered battens across the wall and onto the north-east elevation. Within the partitioned room to the north-west, the north-east elevation returns at the south-west end for the fireplace (Plate 31) across which the battens continue. There is a scar for a rounded aperture from the original extent of the opening of the fireplace, which is now blocked. There are doorways through the partitions from within this room to the south-west and the south-east; the one to the south-west must be blocked on the other side. The fireplace continues to the south-west side of the partition (Plate 32) and there are three further two-light windows with timber sills to the south-west of the partition on the north-west elevation and two further

small rooms formed by another partition at the south-west end of Room 4. These partitions are all modern and butt against another chimney breast at the south-west end of the north-west elevation, which has had a later boiler fitted to it (Plate 33). The south-west elevation of Room 4 is brick in a Flemish bond. The doorway on the north-west side has a plain moulding and no door. The door between the partitions is a re-used original four-panel door, with chamfering and beaded tongue and groove infill like the others. The lower part of the south-east elevation is painted brick and the rest is plastered, mostly in a Flemish bond. There are two paired two-light top hinged casement windows to the south-west (see Plate 34 and Plate 35) and an early door to the north-west of these (as per Room 3; see *Section 4.3.3*). There are chamfered battens on the north-east end extending onto the north-east elevation.

**Plate 25 (left): North-west end of the centre truss in Room 4**

**Plate 26 (right): South-east end of the centre truss in Room 4**

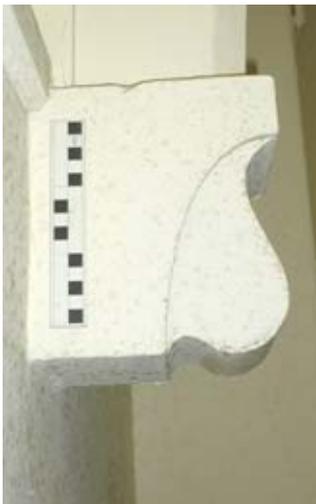
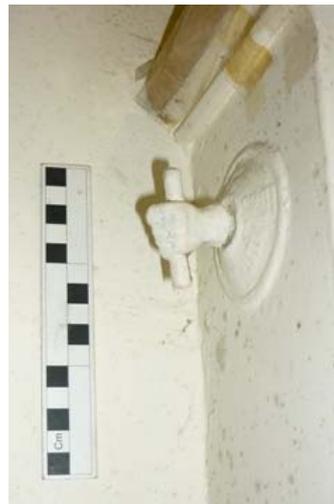
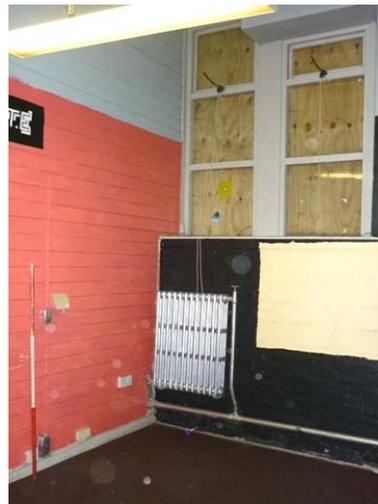
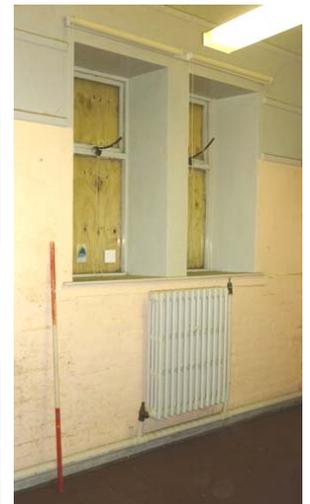
**Plate 27 (far left): Detail of the scrolled corbels in Room 4**

**Plate 28 (centre left): Detail of the handle on one of the boxed vents**

**Plate 29 (centre right): Window split by the partition wall at the north-east end of Room 4**

**Plate 30 (far right): North-east elevation of Room 4 within the partitioned area**

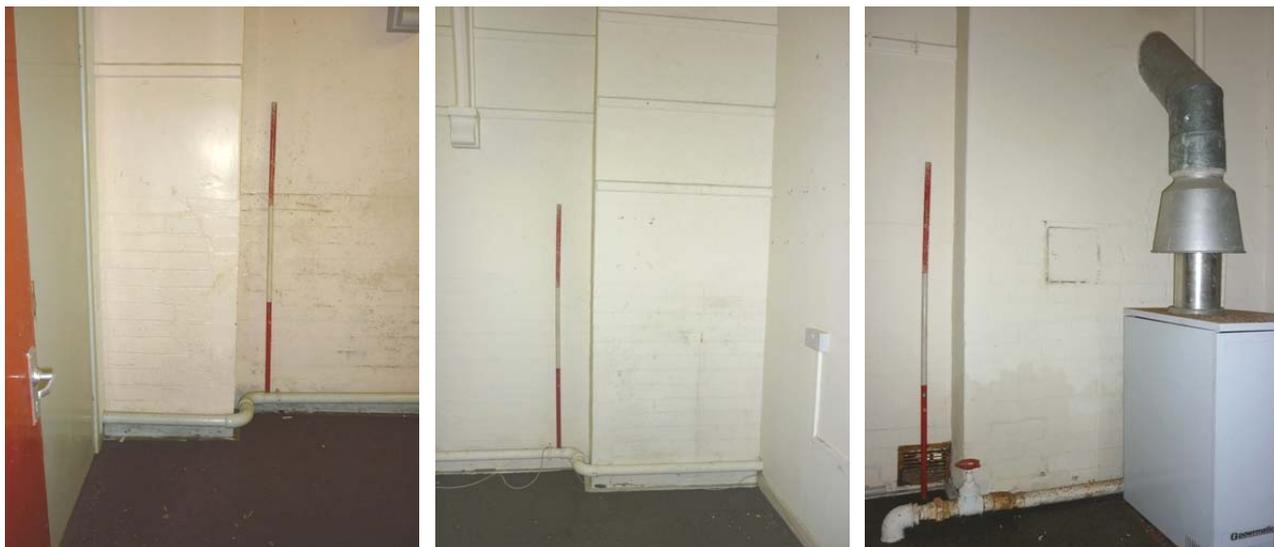
**Plate 31 (left):** Fireplace within the partitioned area at the north-east end of Room 4

**Plate 32 (centre):** Continuation of the fireplace into the central section of Room 4 at the north-east end

**Plate 33 (right):** Boiler in the partitioned area at the south-west end of Room 4

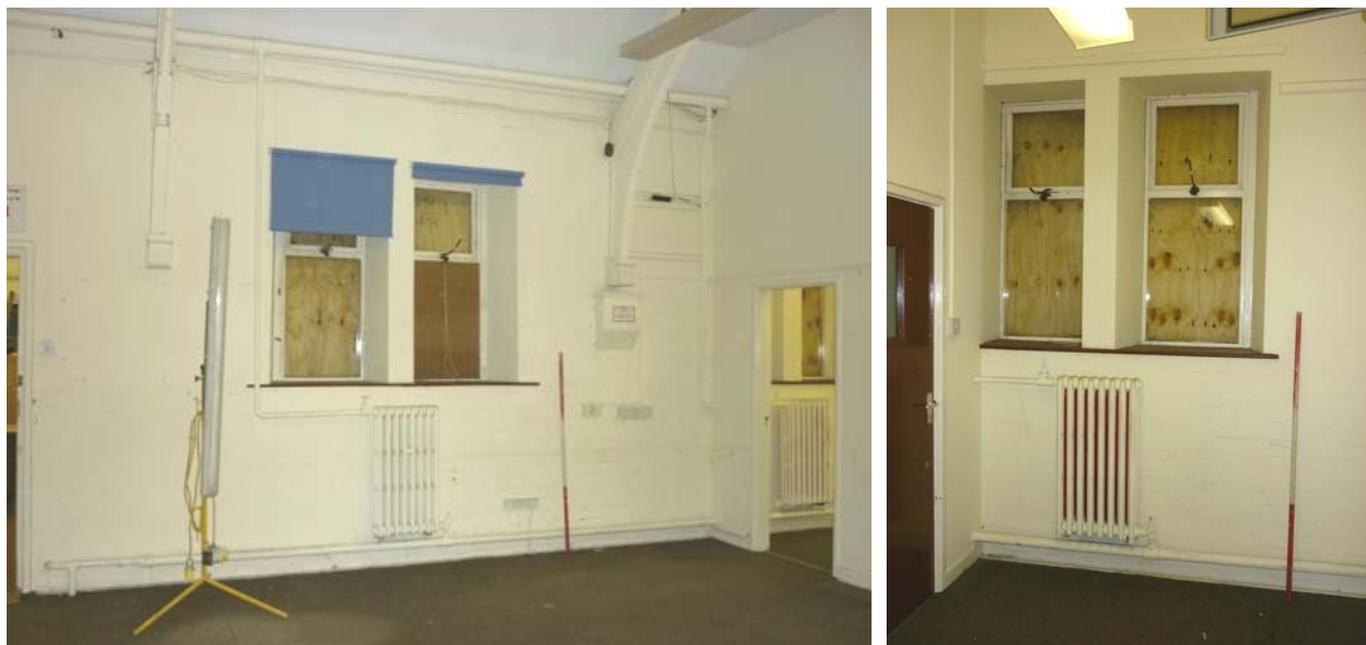
**Plate 34 (left):** Central section of the south-east elevation of Room 4

**Plate 35 (right):** South-west end of the south-east elevation of Room 4

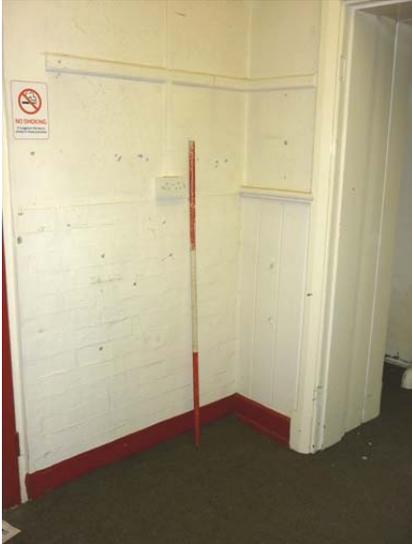
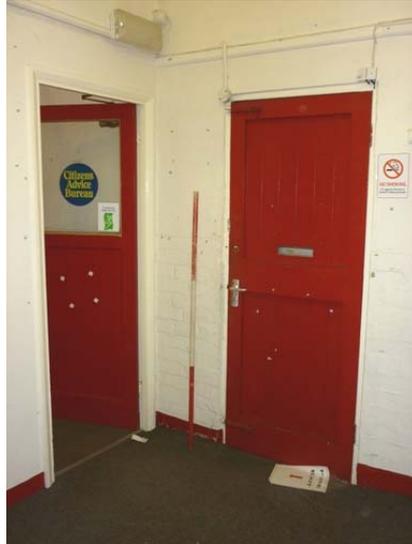
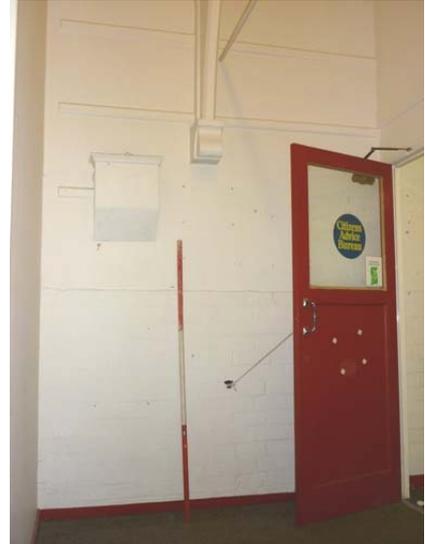
**4.3.5 Ground Floor Room 5:** this room forms the south-west end of the north-west wing and is divided into four smaller rooms by modern stud walls with modern doors. The floor is finished with carpet over floorboards (?) and the ceiling is plastered and slopes down to the north-west and south-east. There is a single truss across the centre of the room, which is partially covered by the stud walling of one of the partitions but is otherwise the same as those in Room 4 (see *Section 4.3.4* above). The north-east elevation of Room 5 is plain and plastered and there is a doorway with a very plain moulded surround on the north-west side with remnants of vertical tongue and groove panels and a moulded rail on the north-west side (Plate 36). This must have originally extended around the entire building, the exposed brickwork showing where it has been removed. The north-west elevation is brick in a Flemish bond and the plank and batten construction door at the north-east end, which was probably inserted (Plate 37).

There is a vent box in the centre of the elevation (Plate 38) and a pair of two-light vent casement windows with timber sills at the south-west end. There are three three-light windows, with vent lights in the outer two (Plate 39), in the centre of the south-west elevation, which is otherwise plain and has a plastered finish. The modern partition divides the north-westernmost window from the other two. The lower part of the south-east elevation is exposed brick in a slightly random bond and has a vent box near the centre and two two-light casement windows to the north-east with vent tops and timber sills (Plate 40). The chamfered battens extend to the north-east.

**Plate 36 (left): Remnants of vertical tongue and groove panels on the north-east elevation of Room 5**

**Plate 37 (centre): Inserted doorway in the north-west elevation of Room 5**

**Plate 38 (right): Vent box beneath the truss in the north-west elevation of Room 5**

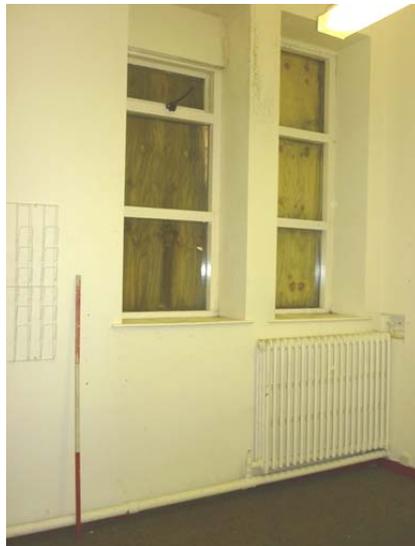
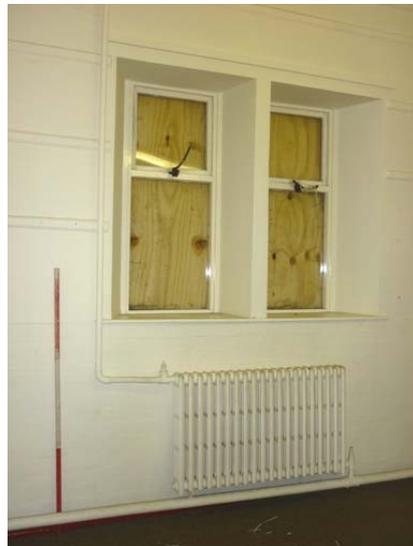
**Plate 39 (left): Windows in the south-west elevation of Room 5**

**Plate 40 (right): Windows in the south-east elevation of Room 5**

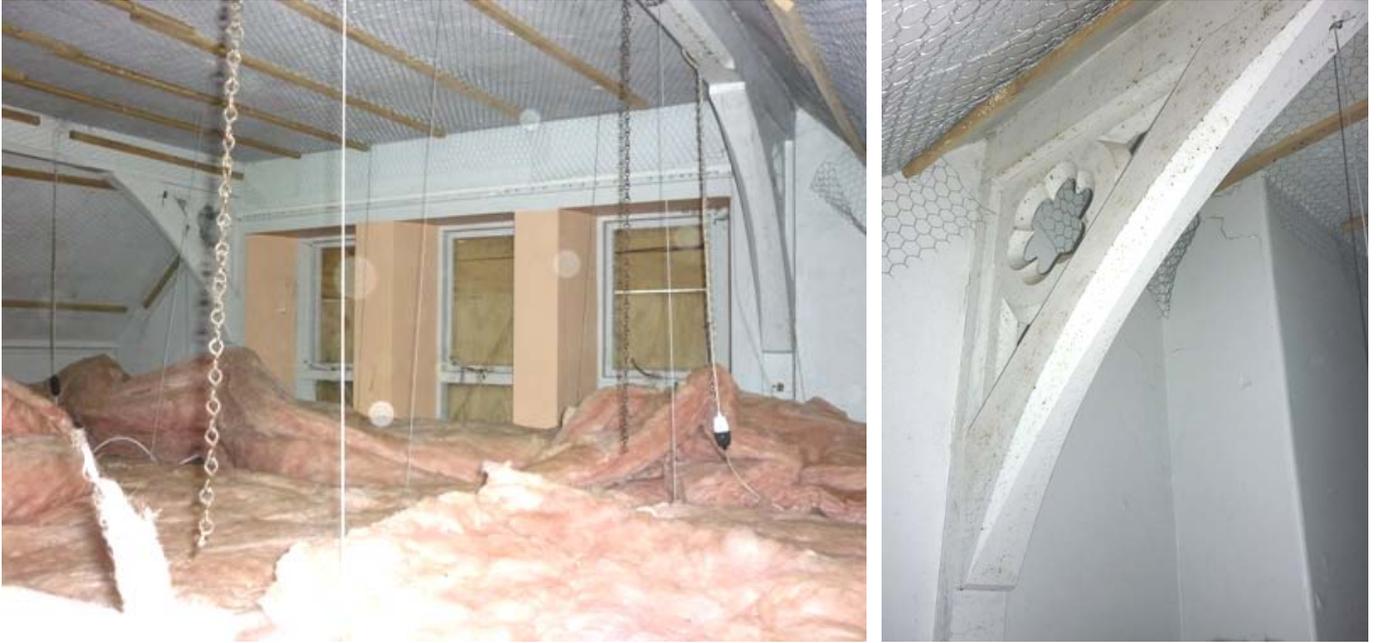
**4.3.6 Roof space above Room 1:** the tops of the windows extend above the level of the suspended ceiling into the roof above Room 1 (Plate 41), which slopes down on the south-west and north-east sides. There are four north-west/south-east beams supporting the roof, each of which has a decorative brace at either end (Plate 42), supporting the beam. All of the timber is decorated with stop-chamfer.

**Plate 41 (left): Roof space above Room 1**

**Plate 42 (right): Decorative brace in the roof space above Room 1**

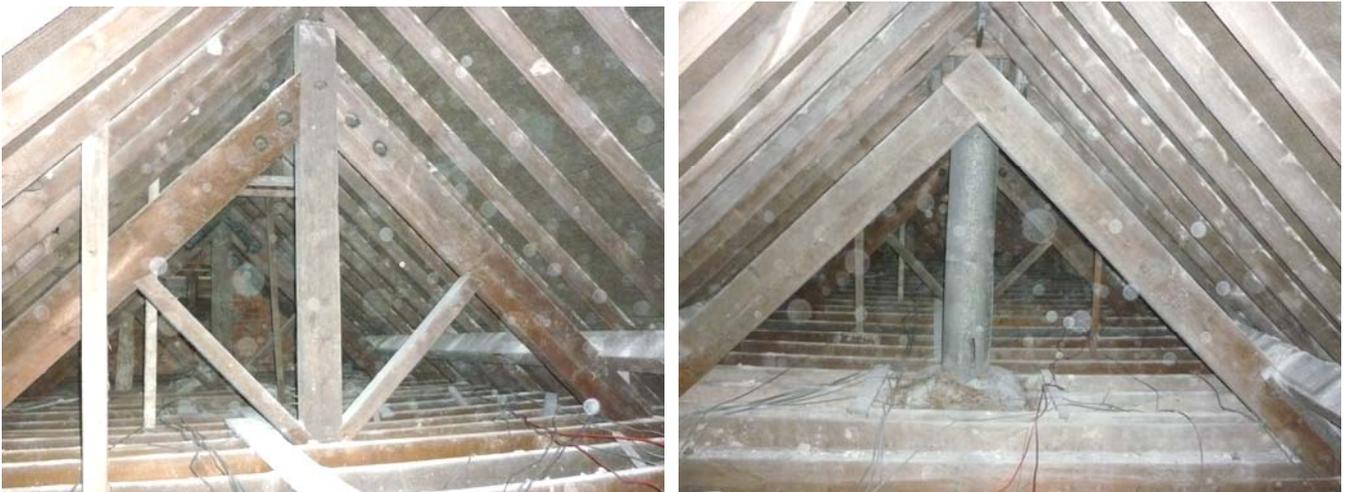
4.3.7 **Roof space above Rooms 4 and 5:** the upper part of the two trusses at the north-east end has a king post truss and a pair of angled braces (Plate 43). There is one purlin per pitch and a ridge board. The braces are cut into joints in the king posts and principles. The principles and king posts have v-shaped iron straps. The wall at the north-east end is brick as is the dividing wall between Rooms 4 and 5 which has a hole knocked through for access. The south-west wall is a concrete block construction and has metal (possibly zinc, tin, or aluminium) pipes for vents leading to vents in the roof. The south-west truss over Room 4 is just overlapping the principles but does not meet the ridge, perhaps indicating that it is a later replacement (Plate 44). The wall between Room 4 and 5 has a slate core clad with red bricks, which are frogged on one side, but no maker's marks were evident. The truss over Room 5 also has a king post and pair of angled braces.

**Plate 43 (left): Trusses in the roof space above Room 4, north-east end**

**Plate 44 (right): South-west truss over Room 4**
