# LAND ADJACENT TO THE MILLOM CRICKET CLUB, ST GEORGE'S ROAD, MILLOM, CUMBRIA

## Archaeological Building Recording

Client: Mr Nigel Woodhouse

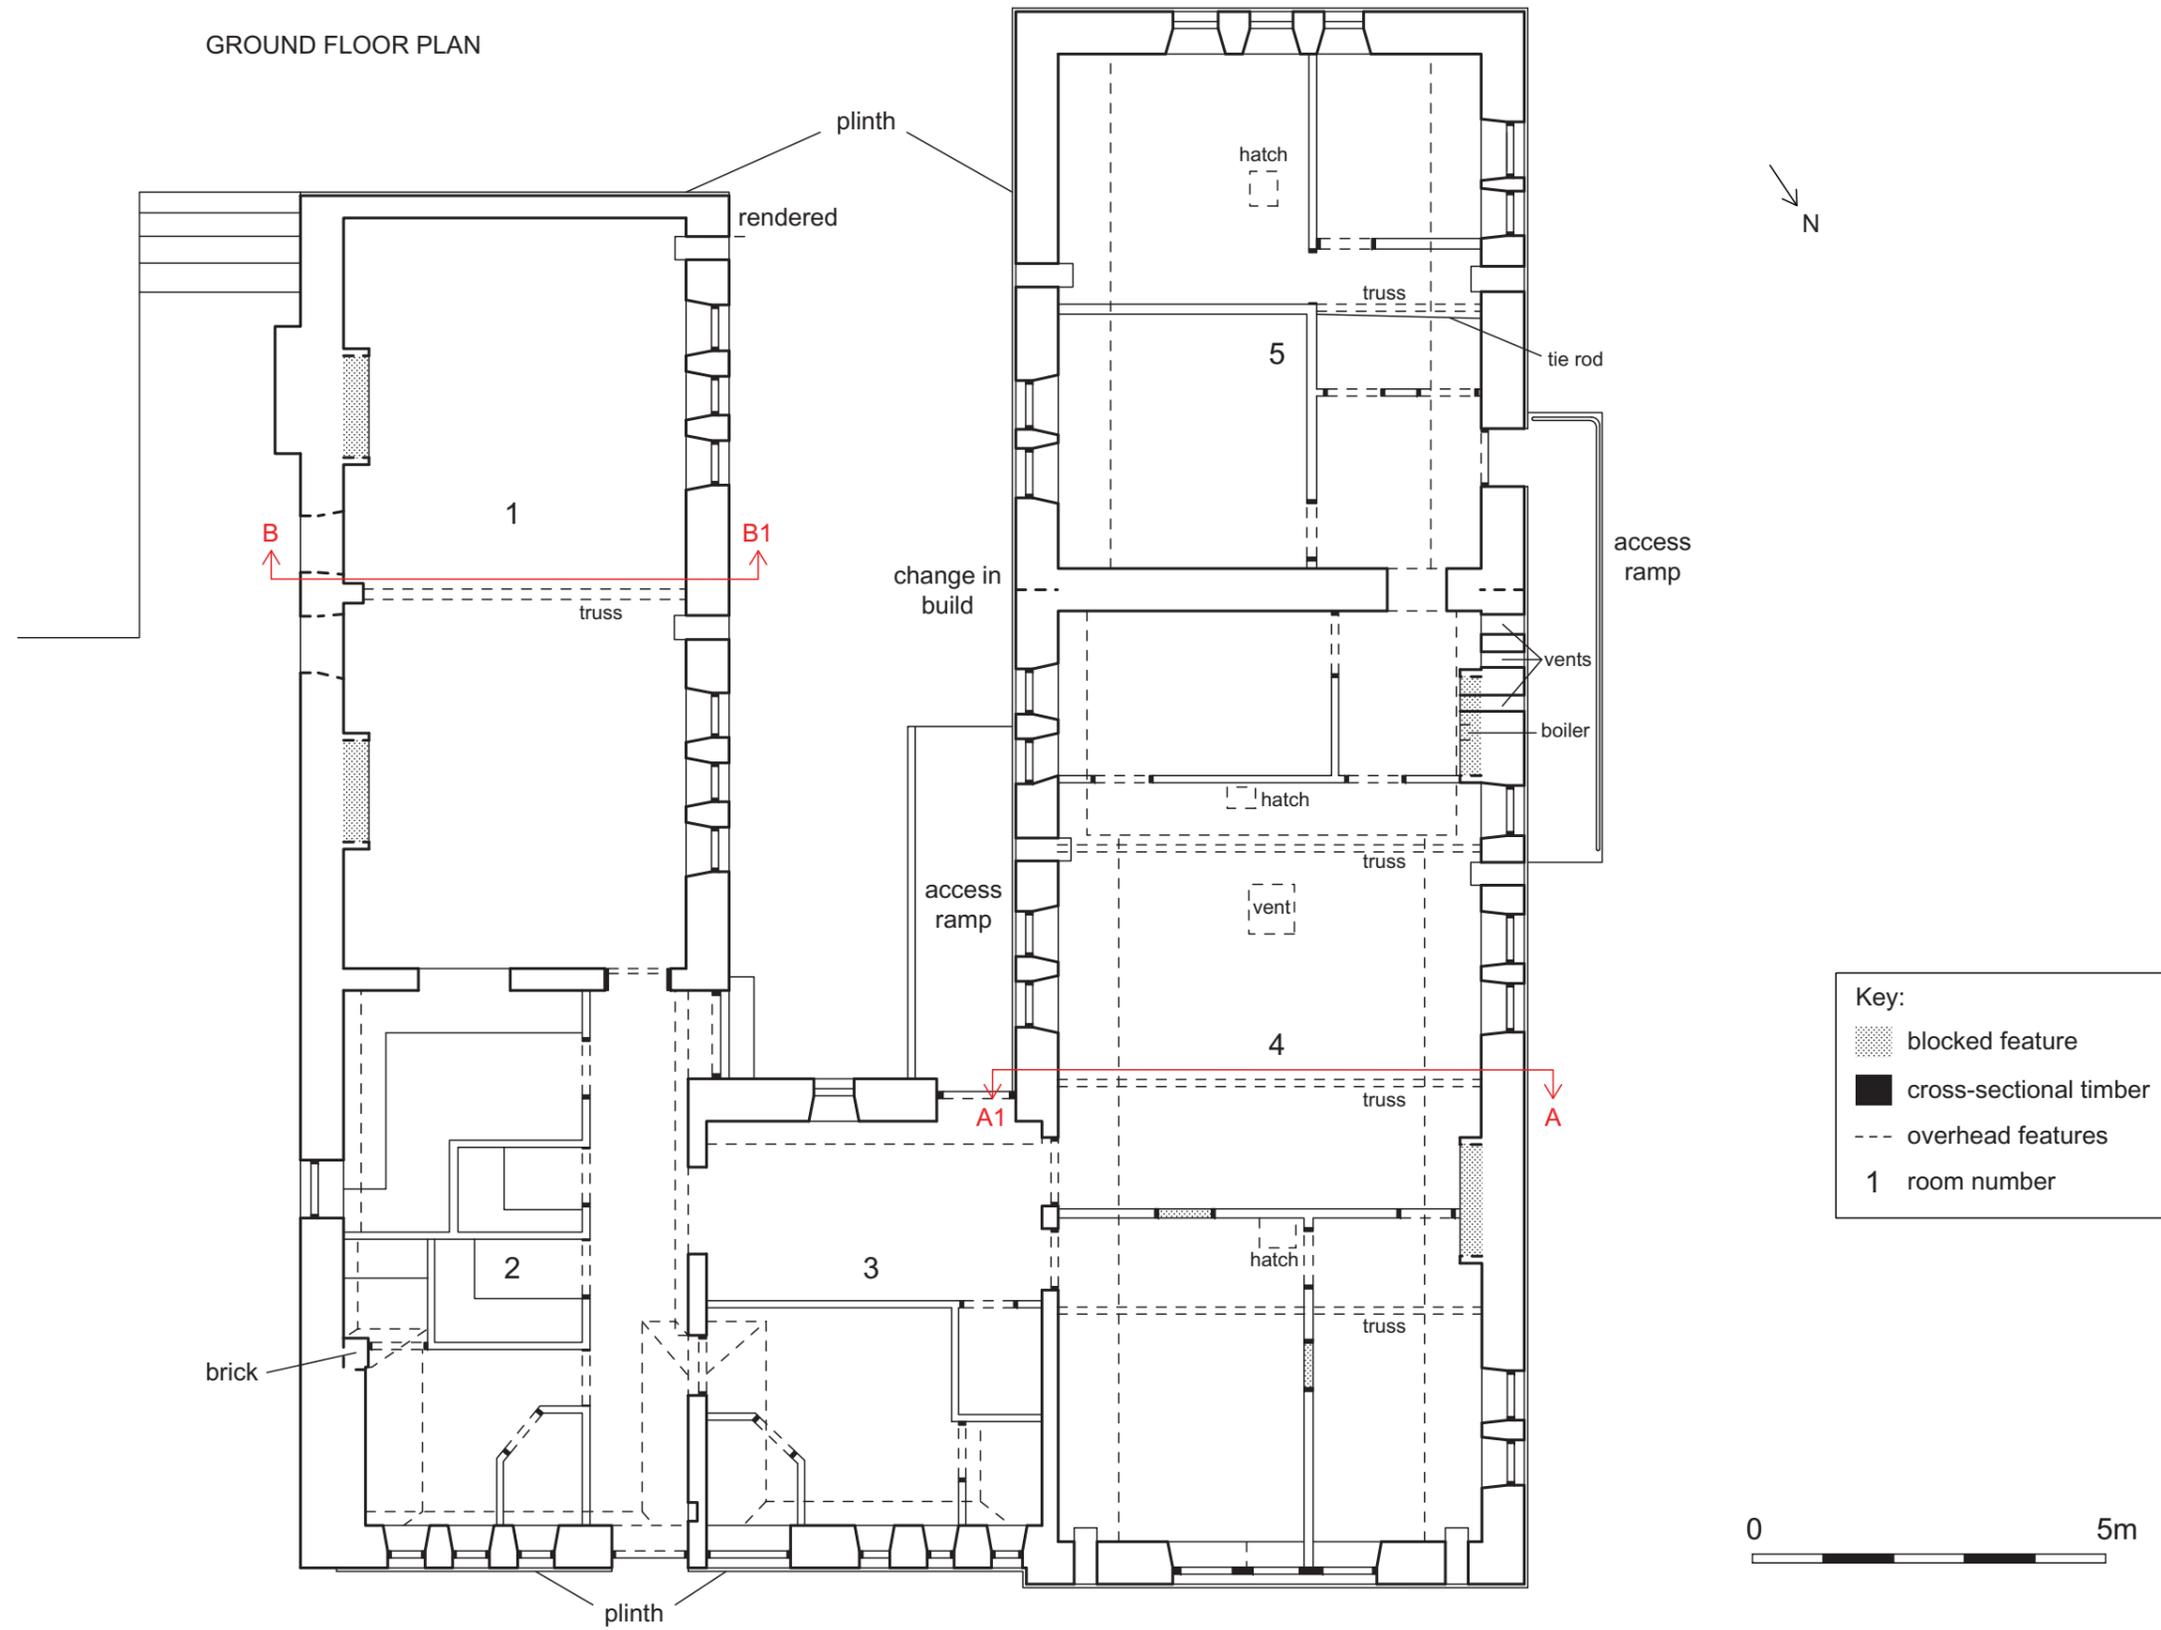
Figure 2: Floor plan

4.1.2 Internally, the building is broken into five main rooms (see Figure 2). The walls are evidently constructed from brick, typically finished with plaster and paint although in most areas the paint has been directly applied to exposed brickwork along the lower part; evidence from within the building indicates that the current paint scheme was added in 2008 by the users of the Millom Youth Centre, who were using the building at the time (see *Section 4.2.1* below). The internal walls are typically of timber stud construction; many are evidently quite modern and finished with horizontally placed tongue and groove planks. Other internal walls are brick. The floors are apparently mostly concrete, especially at the north-east end, but tongue and groove timber floorboards are present at the south-west end, corresponding with the relatively lower external ground level (see *Section 4.1.1* above). The ceilings are generally finished with plaster and paint, although a modern suspended ceiling is present in Room 1. A series of large and elaborate trusses are visible in the north-west part of the building and smaller trusses are visible to the south-east. The doors and associated surrounds and window casements are mostly quite late in date, although some original doors do remain. Several chimney breasts are present, with some scarring indicating the size and form of the original fireplace opening.

GROUND FLOOR PLAN

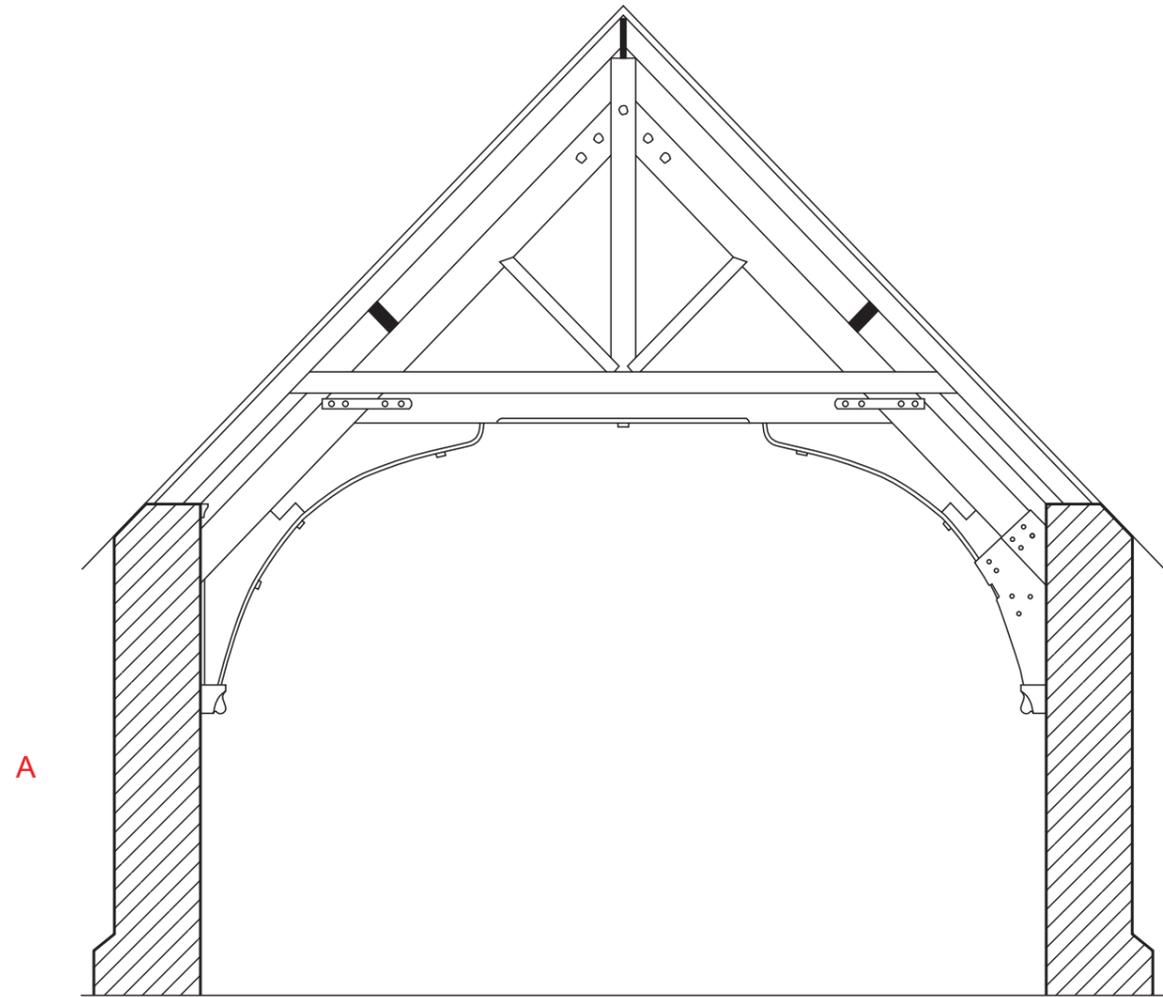
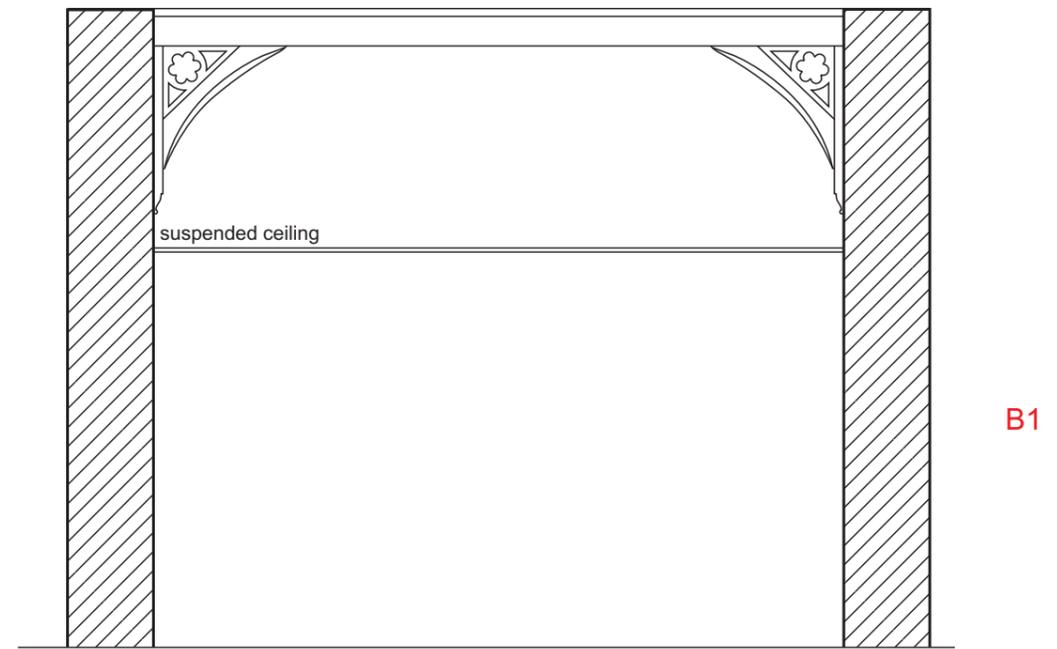
Figure 3: Cross-sections

CROSS-SECTION A-A1, FACING NORTH-EAST

CROSS-SECTION B-B1, FACING SOUTH-WEST
