HOLKER HALL ESTATES HIGHER LEVEL STEWARDSHIP SCHEME

Archaeological Building Recording

Client:
John Coward Architects

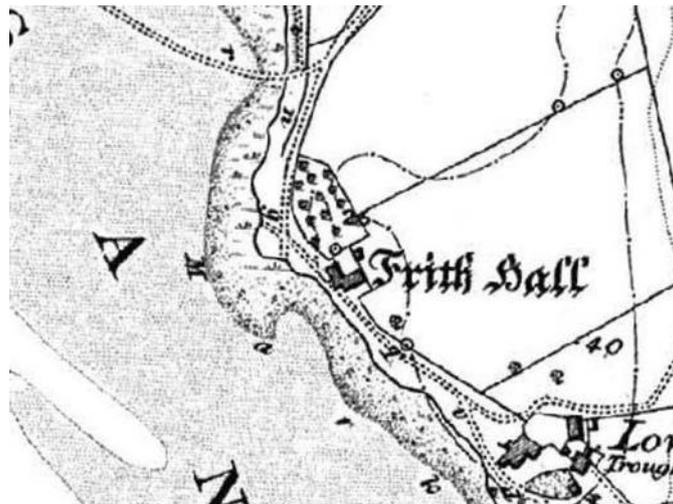
Plate 3: Frith Hall as it appears on the 1851 Ordnance Survey map

3.2.3 **Ordnance Survey, 1851:** this map shows a large approximately L-shaped range of buildings adjacent to the track along the shore and a further square building on the other side of a field boundary wall to the north-east (Plate 3); the small building to the north-east corresponds to the location of the standing remains of the Hall which form the focus of the current survey. It appears that the north-west/south-east wing of Frith Hall is butted by the boundary wall at its north-west end. Low Frith is clearly shown a short distance to the south-east of Frith Hall. The locations of the north and south limekilns are also shown but are marked simply by a circle (see Plate 4 and Plate 5), although the southern kiln has

associated walls and the north has a track nearby. Interestingly, the southern lime kiln is labelled 'Old Park Limekiln' but this is a reference to its location within Old Park, rather than its relative age.

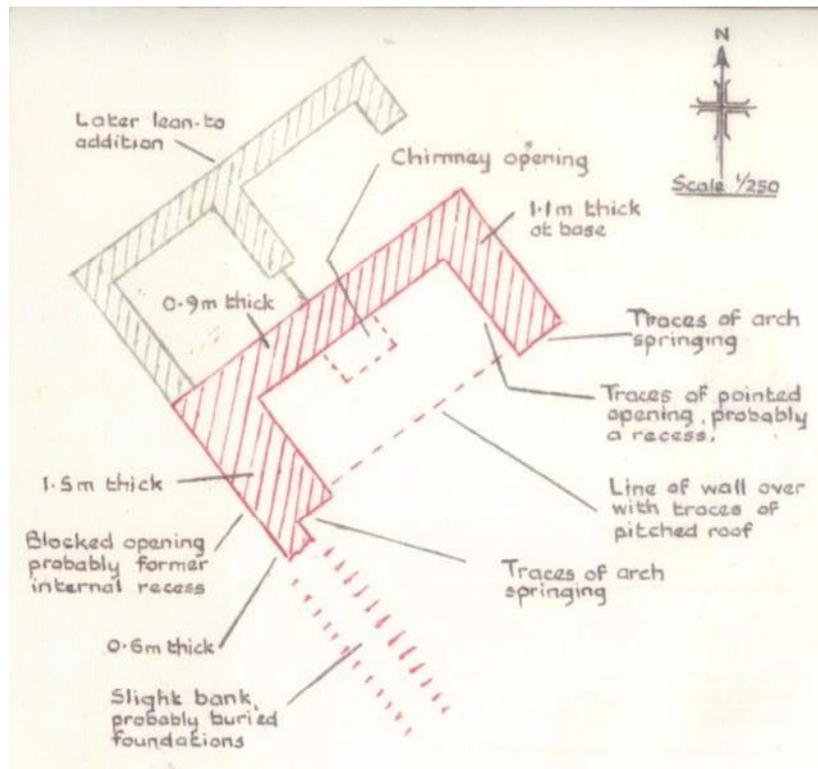
Plate 12: Sketch plan by E Geary dated 5th September 1957

'The remains of the hall consist mainly of a huge fireplace. It is constructed of rubble masonry with bonding courses of slate at intervals. The fireplace takes the form of a large pointed vault terminating in a square opening. Viewed from the exterior the upper part of the chimney stack is round and the lower part a square 'stepped' structure. The springing of the fireplace arch is visible in each of the side walls. Mutilated openings in each side of the fireplace were probably originally recesses. The only traces of the building adjoining the fireplace to the S.E. is [sic] a small fragment of wall projecting from the S.W. corner and traces of its continuation under the turf. On the upper part of the S.E. wall of the fireplace is a course of slates representing the lines of a pitched roof. N.W. of the fireplace but not bonded to it are the remains of a small lean-to hut and yard, presumably modern. The remains are in fair condition.' (ref. F1 EG 05-SEP-57).

3.3.3 It is apparent from these comments, and an accompanying measured plan (Plate 12) produced at the time, that while considerably more of the building then survived, it still only comprised the remains of a chimney breast and associated features. It is apparent, however, that the original structure was more readily discernable, with springers for the arches visible on both sides of the fireplace opening, apparent recesses or openings present in the west and east sides, the upper part of the chimney still over hanging, and the line of a wall running to the south-east recognisable in the ground. A later visit, in 1969 (ref. F2 BHP 14-JAN-69), described the condition as unchanged without giving any further information but a photograph was taken at the time, which shows how much more survived at this time (Plate 13).

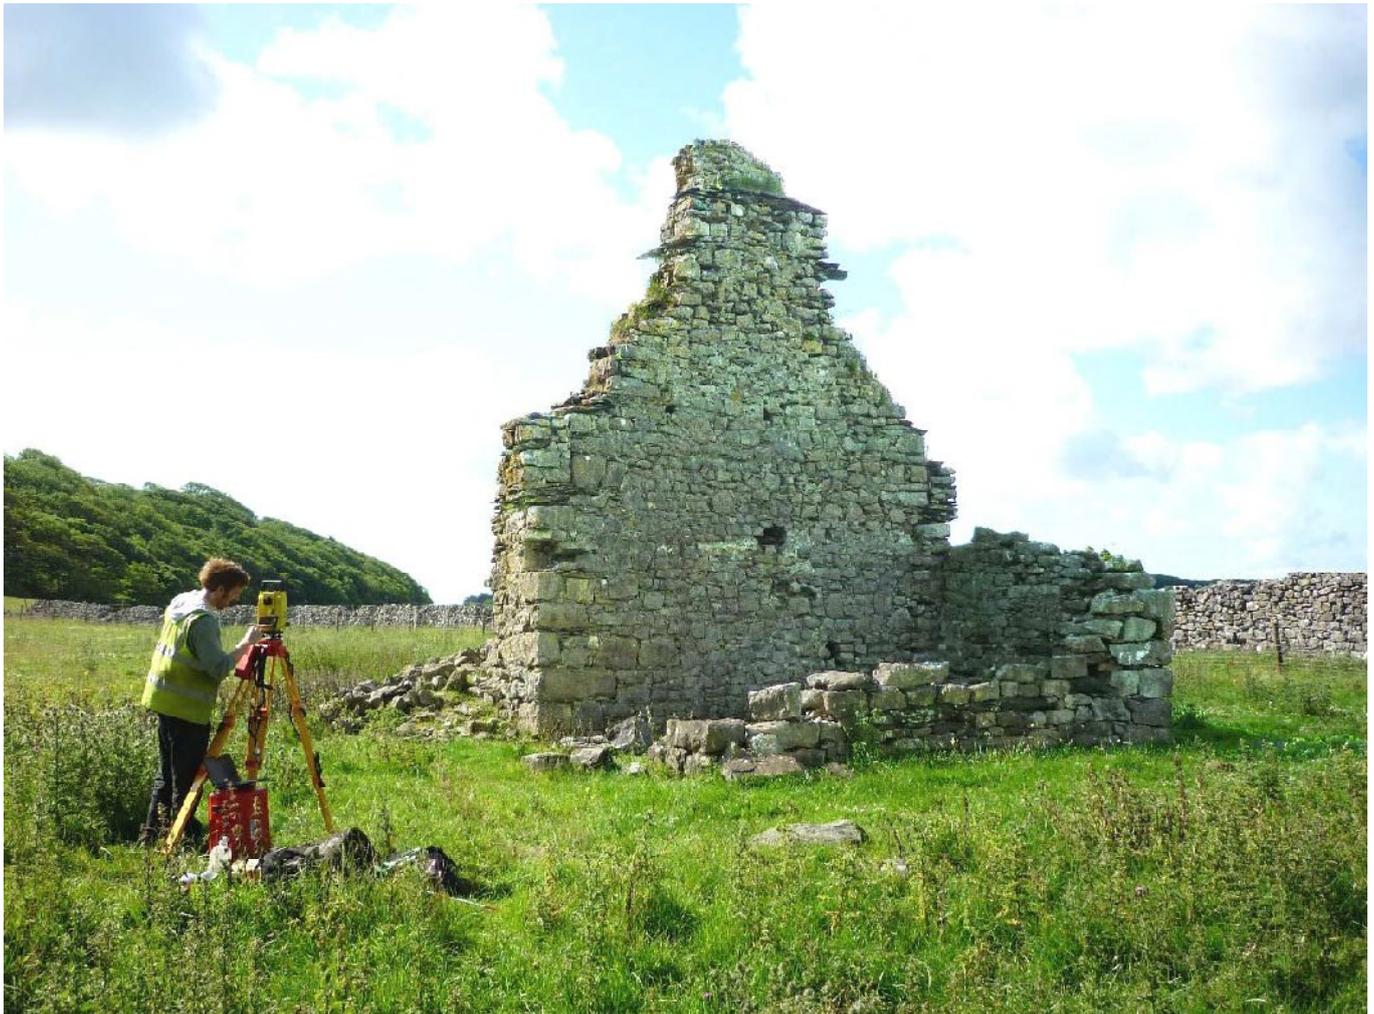
Plate 14: Survey being carried out at Frith Hall (light levels artificially enhanced to show detail)

4.1.1 **Frith Hall:** the remains of the Hall are mostly constructed from courses of limestone with slate used for string courses and for levelling. A gritty mortar is present on the lower levels of the Hall, which is butted by a dry stone outshut to the north-west (Plate 14; see Figure 2 and Figure 3). The outshut is enclosed on the north-west and south-west sides but very dilapidated and all that remains of the Hall is a north-east/south-west aligned wall with small jutting sections at each end which form a partially enclosed fireplace to the south side. The internal and external features of the Hall are described in separate sections despite the fact that much of the structure has collapsed, with the wall core often exposed, and there are large areas of rubble to the south side of what remains of the Hall, including substantial blocks of masonry (see Plate 20). Structural elements incorporated into the boundary wall to the south-west probably also relate to the Hall.

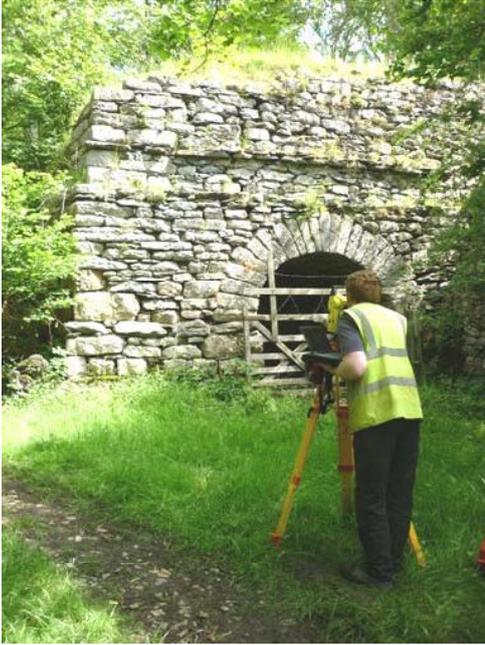
Plate 15 (left): Survey being carried out at the south kiln

4.1.2 **The south kiln:** the south limekiln is largely constructed from courses of limestone cobbles and boulders with dressed blocks used to form quoins and arch stones (Plate 15; Figure 4). Some other stone, mostly slate, is used for string courses and fire brick is used internally. The west elevation is mostly collapsed and built into the slope on the north and east sides. The arched entrance is closed by a timber gate. The boundary wall butts against the south elevation (Plate 16) and curls round to the west to a gate with a large stone gatepost. The flue hole in the top of the kiln is largely backfilled with rubble and overgrown with vegetation and although it remains partially open it is collapsed on the west side. A rounded depression in the ground to the north-west of the flue was considered to possibly represent the

remains of a collapsed second flue, but there is no other evidence that one existed (see *Section 3.2* above).

4.3.1 **South facing external elevation:** the south elevation is tiered, with three stepped levels finished with slate and forming a plinth at the base (see Plate 15). There are large quoins on the west side that disappear into the slope and it is butted by the boundary wall to the east (see Plate 16). There is a central arch of well-dressed stone, which continues into the hearth, and there is an iron ring embedded in the wall on the west side, probably for the gate (Plate 28). The top of the kiln has partially collapsed and forms a rough line (see Figure 4). The flue hole on the top was not obviously brick lined; there were possible traces of vitrified material that was possibly damaged brick, although it was not easily accessible (Plate 29). There is a modern bench adjacent to it.

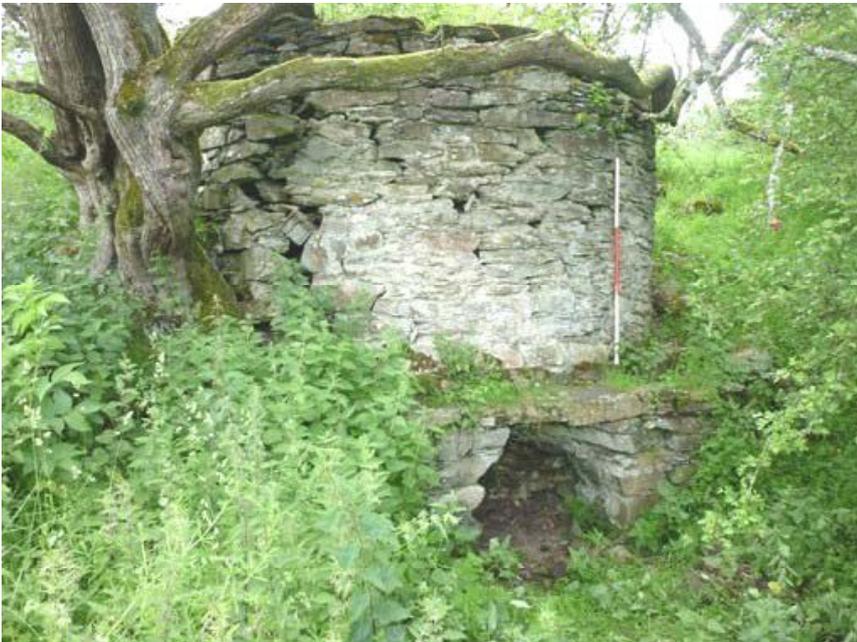
Plate 17 (left): The north elevation of the north kiln

4.1.3 **The north kiln:** the north kiln is built almost entirely from courses of local slate. The upper part is circular in plan whereas the lower part is rectangular (Figure 4). There is a round flue hole in the top and a corbelled opening in the north side (Plate 17). The kiln is built into the slope, which slopes down from the south and west, so there is no south elevation as such and the top of the flue edge is finished with larger coping stones (Plate 18).

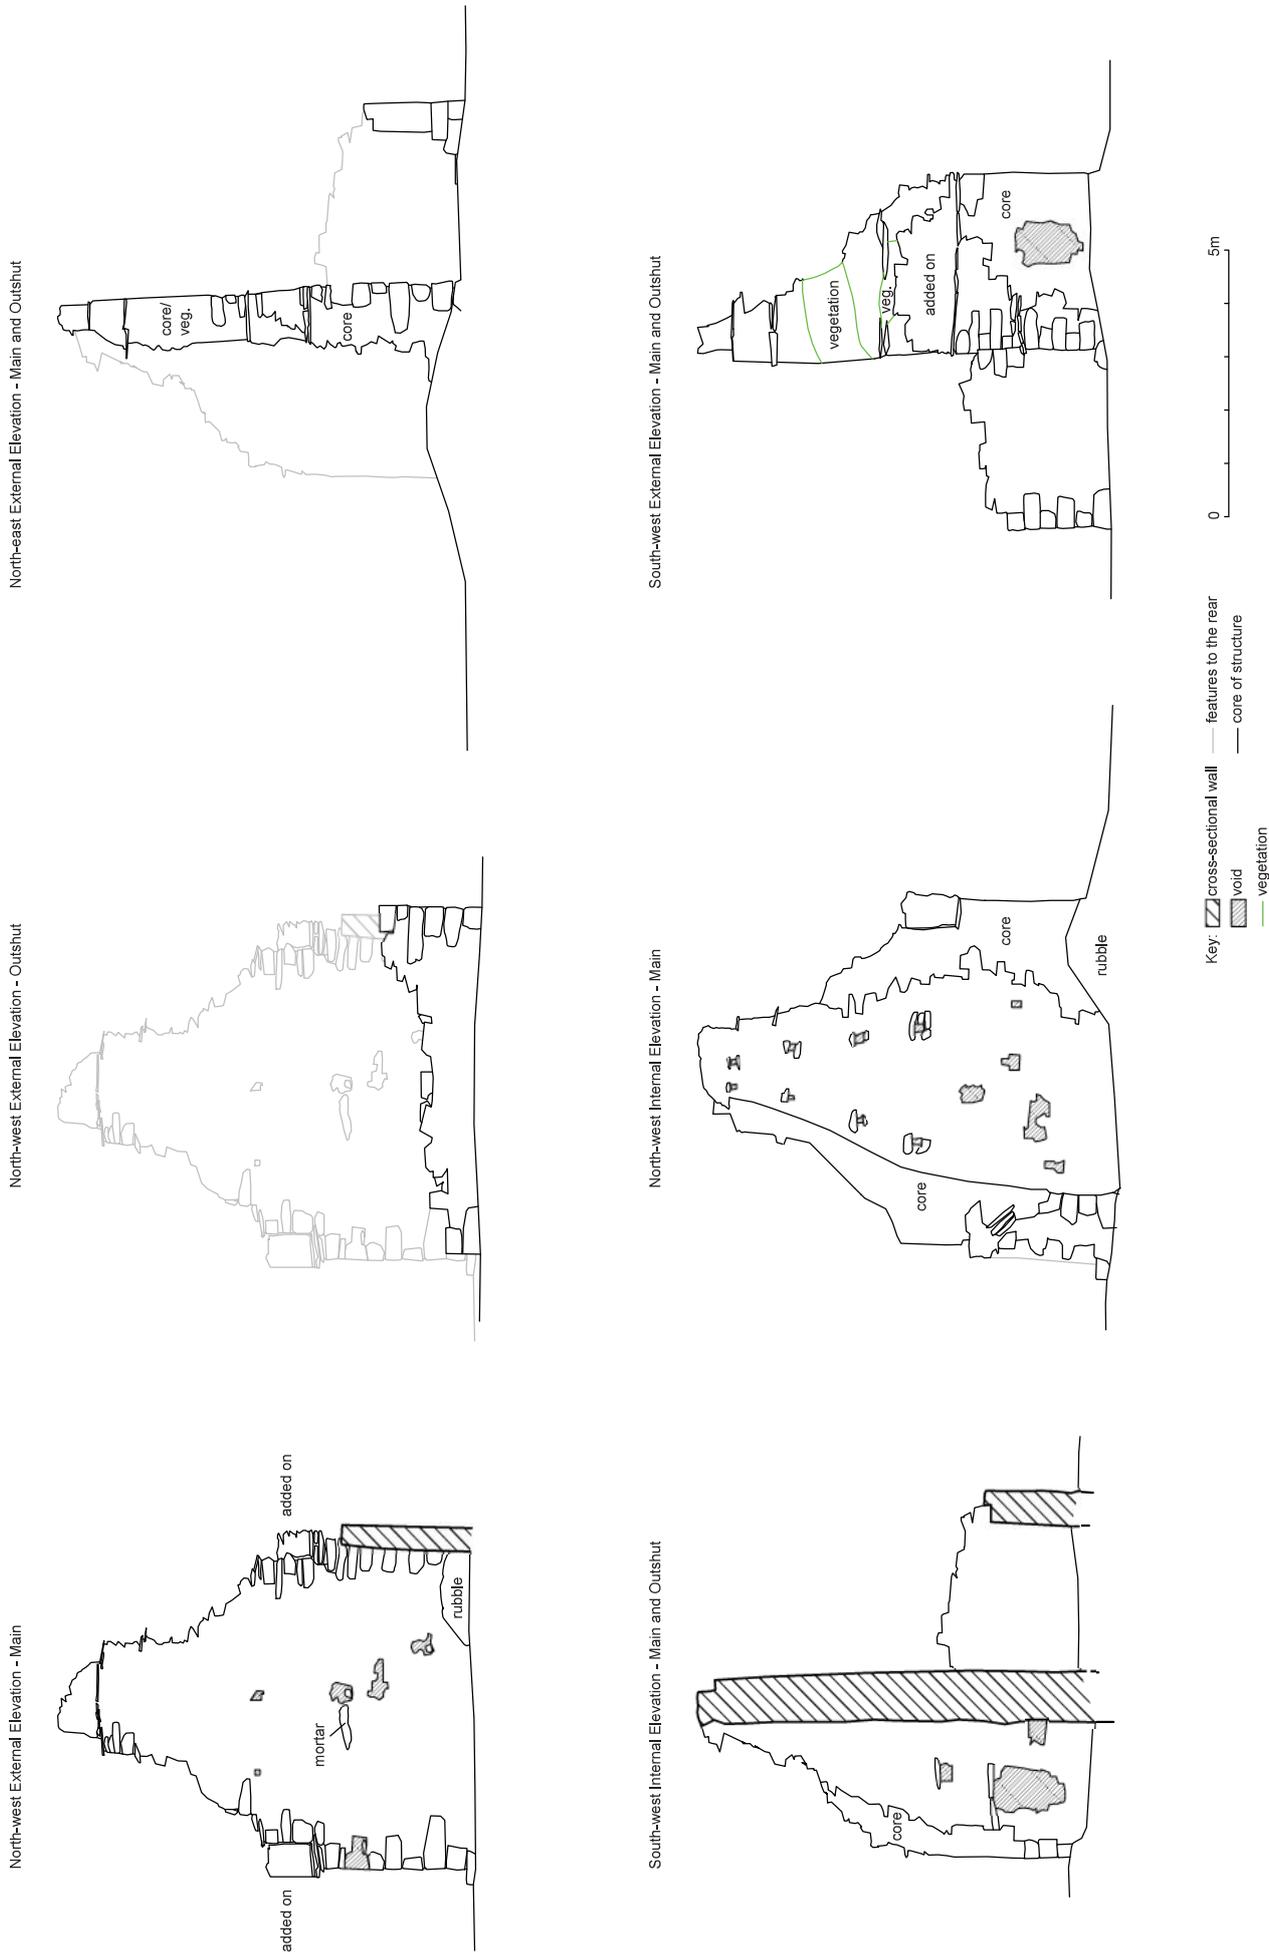
Figure 2: Elevations of Frith Hall

4.2.1 **North-west facing external elevation:** the lower part of the main north-west elevation of the Hall is partially obscured by the north-west elevation of the outshut which continues from the south-west side (Plate 19; Figure 2). The outbuilding is built from slate and limestone blocks with squared outer facing and is quoined at the north-east and south-west ends. Main elevation of the Hall is constructed mainly from smaller cobble-sized pieces of limestone, which are less smoothly cut and in more random courses when compared to the facing on the outshut. The Hall is quoined to the north-east and south-west and a gritty mortar has been used throughout. At ground floor level slightly to the south-west of the centre there is what appears to be a small hole or alcove of unknown function at about waist height and to the north-east of this there is a small hole drilled into the wall, probably for the latch of a gate. Slate has also been used in the wall construction of the Hall but not in full courses. There is an almost central through-hole with a sill at approximately the level of the ground-to-first floor. The wall originally stepped in at the ends at slightly above the level of this hole and the wall has been raised at this point and filled to the extent of the underlying / supporting wall and the quoins of the original wall are still visible. At the same height as the top of this added section of the wall there are two putlog holes in the main elevation before the wall slopes in towards the centre, following the angle of the roof, before rising vertically again with the central stack. There is a slate course in the stack near the top.

4.2.2 **North-east facing external elevation:** the outer part of the north-east elevation comprises the quoined return of the north-west wall of the outshut and remnants of the north-east wall of the Hall. Most of the rest of the wall of the outshut has collapsed. The quoins at the north-east end of the Hall are visible in the stub wall as are the slate courses of a slate in-filled section which raised the level of the wall (which can be seen to the right of the scale bar in Plate 20) and which presumably mirror those on the south-west facing elevation, although little remains on the north-east side. The north-east wall of the Hall has mostly collapsed beyond the extent of the lowest quoins at this corner. The north-west wall of the Hall leans in towards the main Hall to the south-east and there is a large crack in the wall at ground floor level.

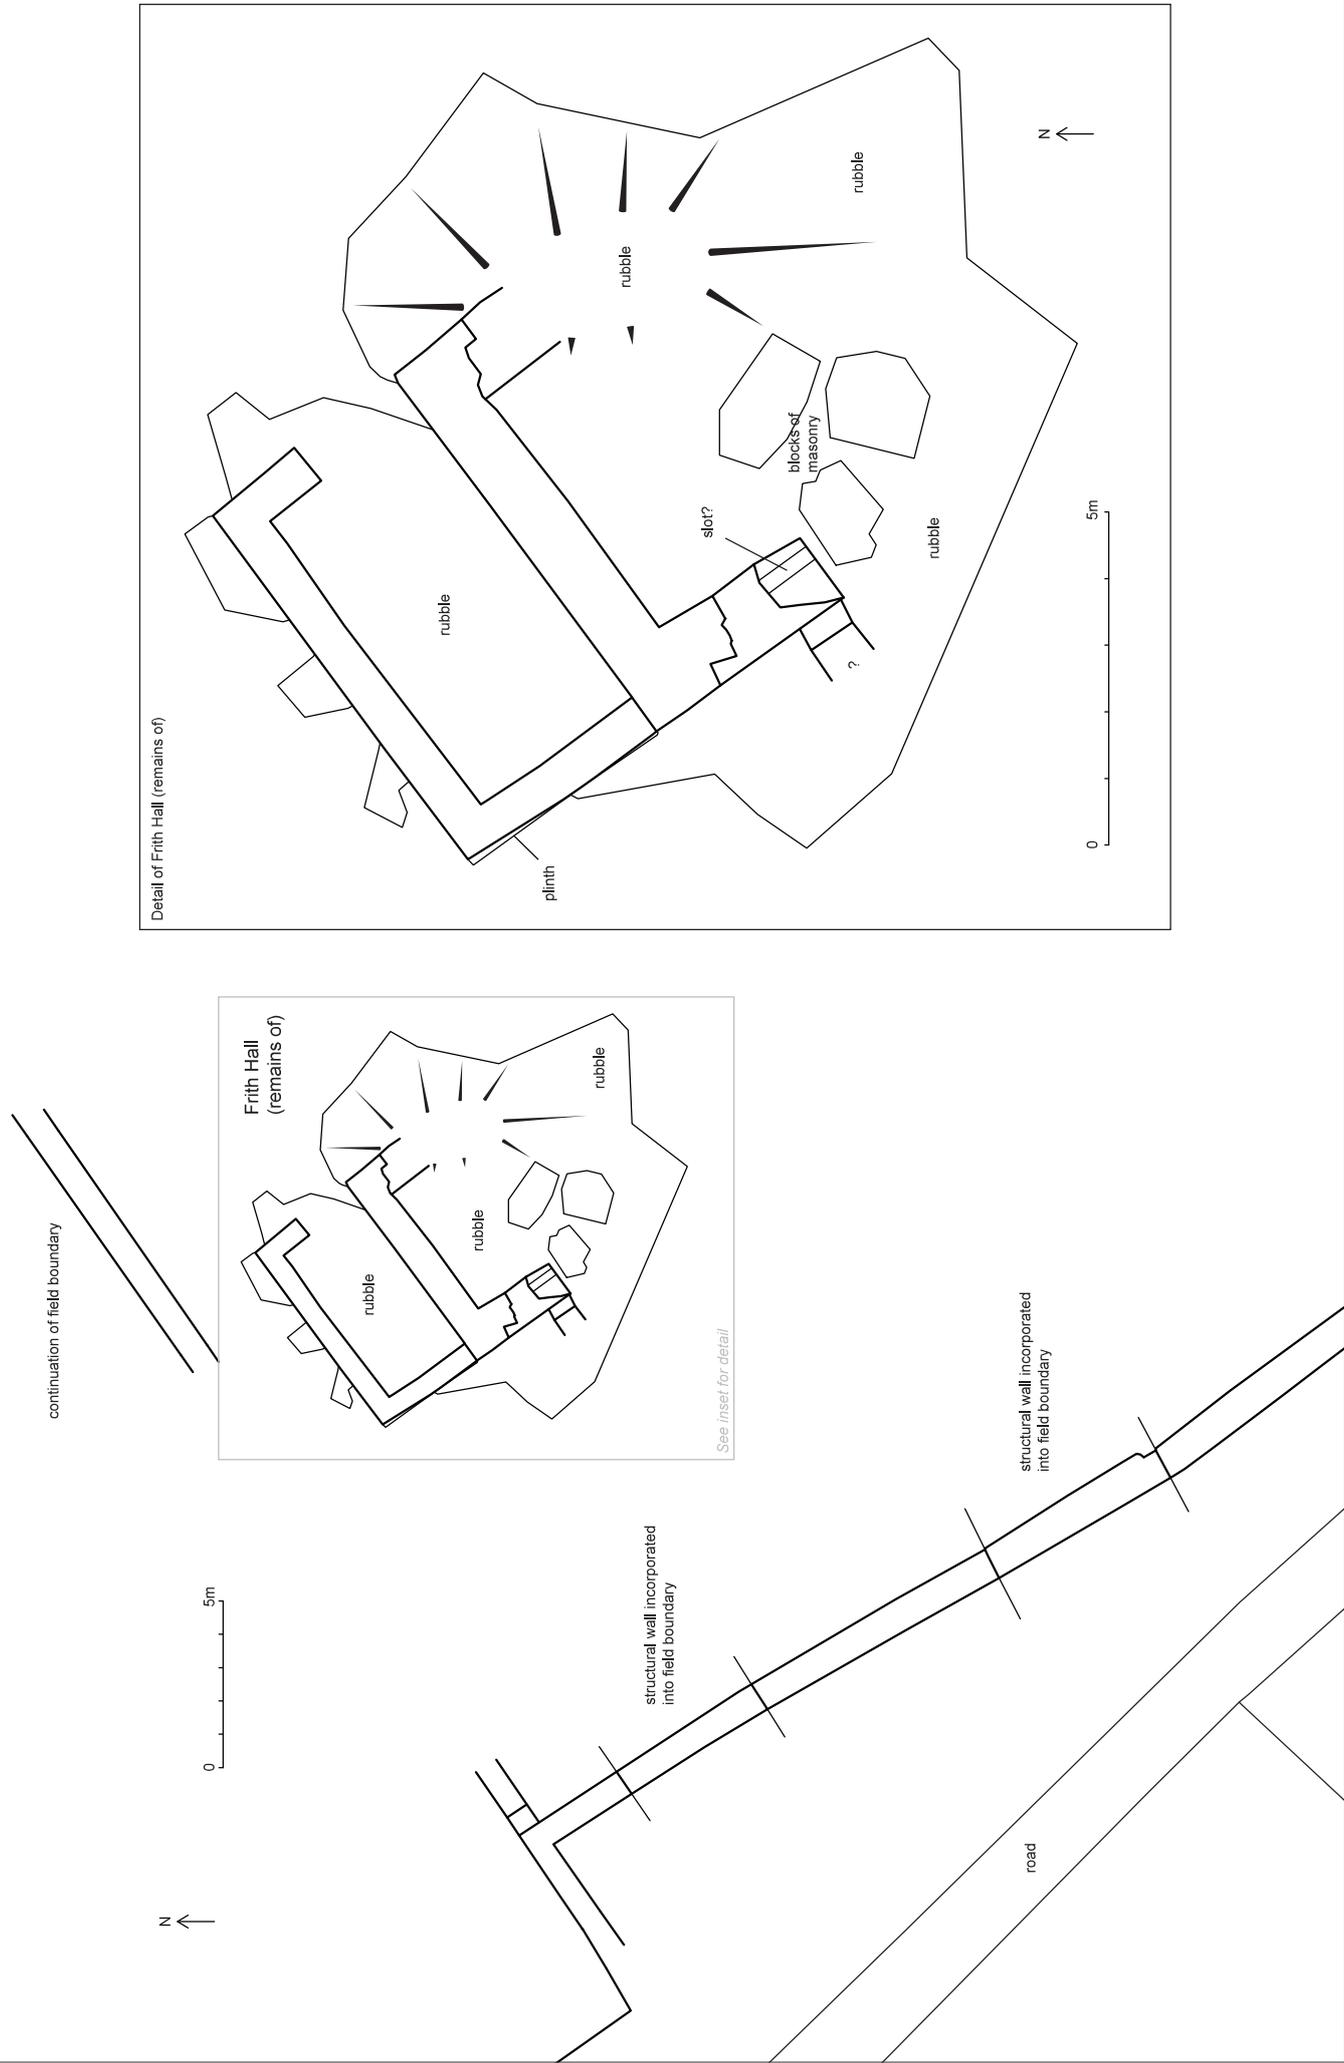
Figure 3: Plan of Frith Hall

4.2.7 Associated structural elements: there are two pieces of wall, which probably relate to Frith Hall incorporated into the field boundary to the south-west (Figure 3). The north-west section includes two quoined ends of a section of wall with mortared construction, although the central section has collapsed (Plate 26). The ends of the structure are butted by the boundary wall, and the upper part has been rebuilt in dry stone. It is not obvious which direction the building that this wall represents originally extended, but this is presumably the end of a building orientated north-east/south-west. The south-east structural wall is loosely coursed in rough limestone, mostly with large blocks at the base with a possible string course mid-way up (Plate 27). The south side is rebated and covered by thick lime mortar, and the field boundary butts against it at either end. Again there is no indication of the direction that this building extended but it too appears to be the end of the building that was orientated north-east/south-west.

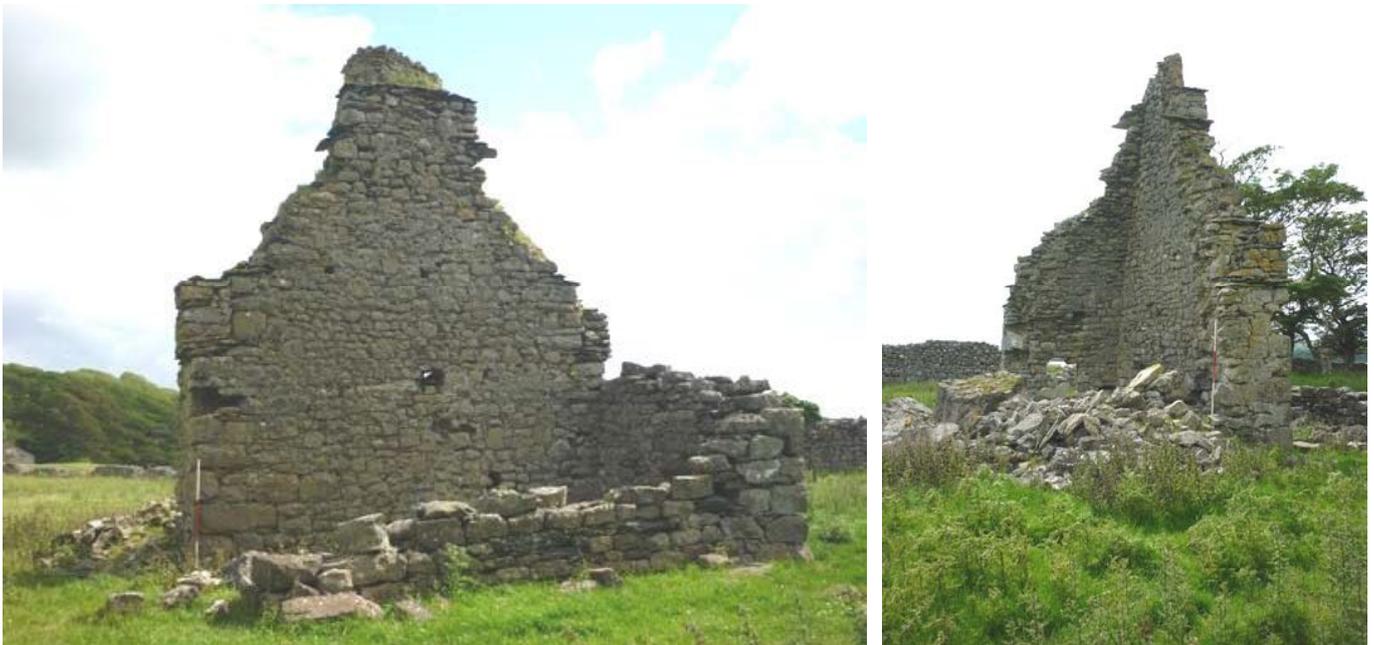
Plate 19 (left): North-west elevation of Frith Hall and the outshut

Plate 20 (right): The inner and outer walls of Frith Hall viewed from the east

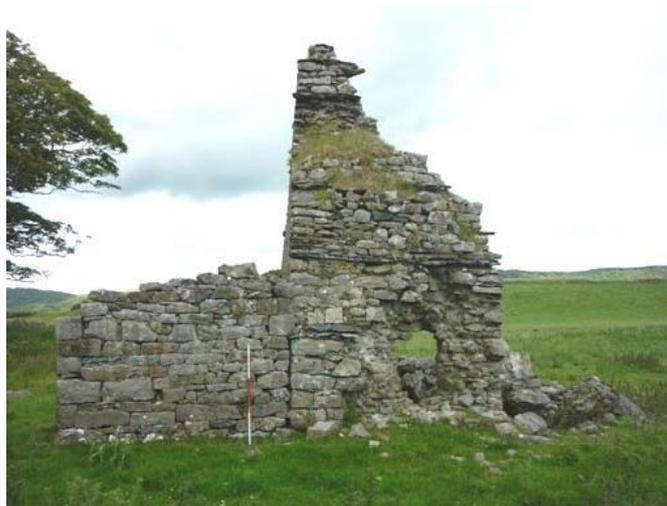
Plate 21: South-west external elevation of Frith Hall

4.2.4 South-west facing external elevation: the north-west end of this elevation forms part of an outshut, which appears to butt against and slightly overbuild the Hall to the south-east (see Figure 2; Plate 21). What remains is divided approximately in half, the north-west end comprising the outshut with the Hall to the south-east. The outshut has regular courses of angular limestone blocks and some inserted slate for levelling purposes (but not in distinct courses) and appears to be dry-stone built with no mortar used externally. There are heavy quoins at the north-west end (up to two courses high) and there are heavy quoins to the south-east where the wall sits above the main wall of the Hall to the south-east. The construction of the Hall is much less regular, with less even courses of limestone, and is only heavily quoined on a small jutting section up to a course of slate where it is butted by the outshut. The limestone facing above the first complete slate course is actually a later facing which is more apparent from the north-west side of the building (see *Section 4.2.1*). A gritty white (lime?) mortar has been applied to the lower level of the Hall (to approximately the first complete slate course), but has scarcely been used above that. It was presumably added to consolidate the wall and possibly as render to the north-west. The limestone block work is divided by courses of slate and is severely dilapidated to the south-east and further up the stack. The wall has fallen away around what may have been a window(?) on the ground floor but there is no obvious sill or lintel associated with it. To the south of this window the wall appears to return slightly to the west.

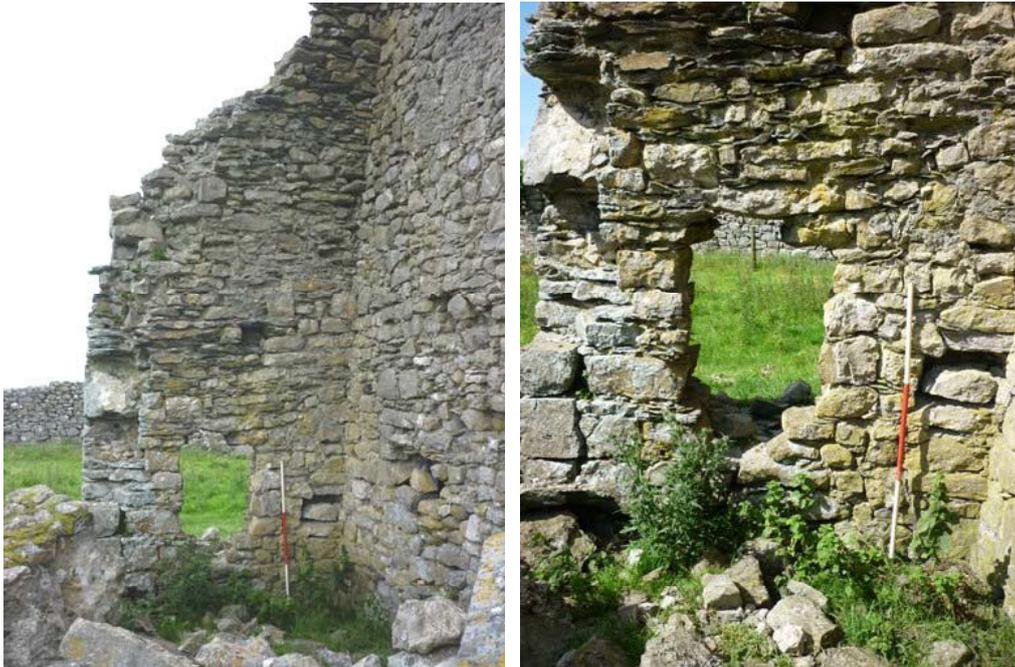
4.2.5 North-east facing internal elevation: at the south-west end Hall the quoins of the south-west wall are visible at the south-east end and to the north-west of these there is a possible window, although it is mostly collapsed (visible to the left of the scale bar in Plate 22). There is a small putlog or beam hole above and to the north-west of the window and this alcove has a slate sill and lintel. The wall then curves inwards and overhangs the space to the north-east, following the line of the north-west wall. On the north-west side of the hall proper, the internal face of the attached outshut is consolidated with a gritty mortar up to where it butts the main wall of the Hall.

Plate 22 (left): North-east facing internal elevation of the Hall

Plate 23 (right): Detail of the possible window in the north-east facing internal elevation of the Hall

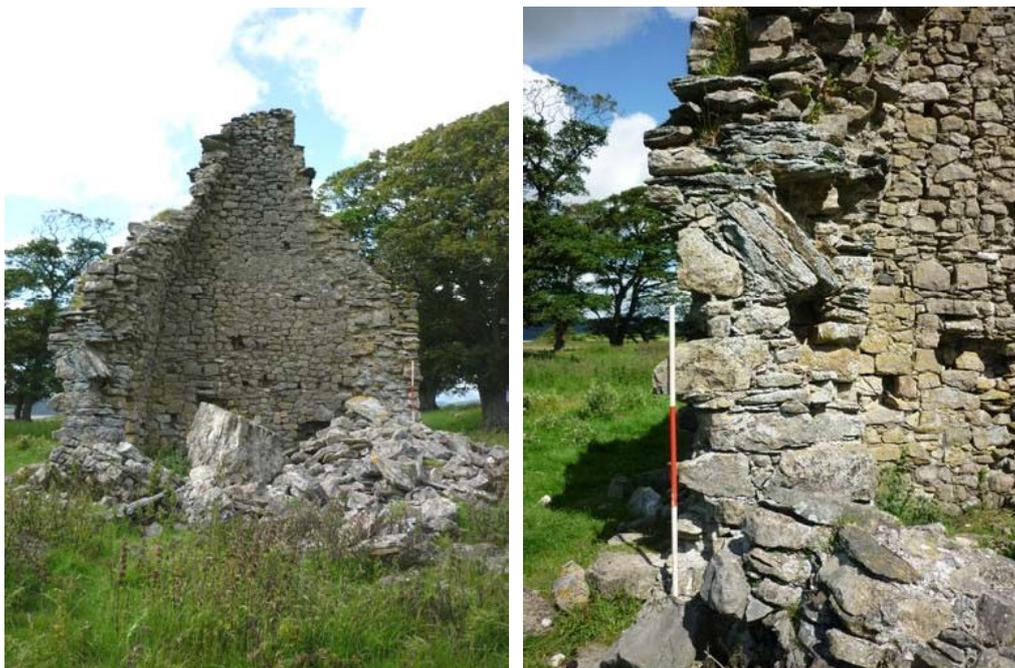
4.2.6 **South-east facing internal elevation:** the south-east facing internal elevation of what remains of the Hall is effectively the interior of the chimney. It is conical, with the south-west side surviving in better condition (Plate 24; Figure 2); the north-east side is ruinous but the scar of the original wall is still evident. The original wall forms a slate topped tier and has additional stonework on top. There are three rows of paired putlog holes and one further one lower down in the main part of the elevation as well as small areas of collapse in the wall face. The wall of the Hall returns to the south-west to the south-west side of the chimney stack and there are three *voussoirs* and a possible angled springer remaining of the arch from the north-east/south-west fireplace which would have extended across the front of the chimney (Plate 25). What remains of the arch is to the south-west side of the chimney stack, near the point where the wall of the Hall again returns to the south-west. Below the arch there is a c. 10 cm square hole visible in the core of the wall above the "window". This hole had squared mortared edges like a drain bar slot but it was truncated by collapse to the north-west and south-east.

Plate 24 (left): The south-east facing internal elevation of the Hall

Plate 25 (right): Detail of the arch springers

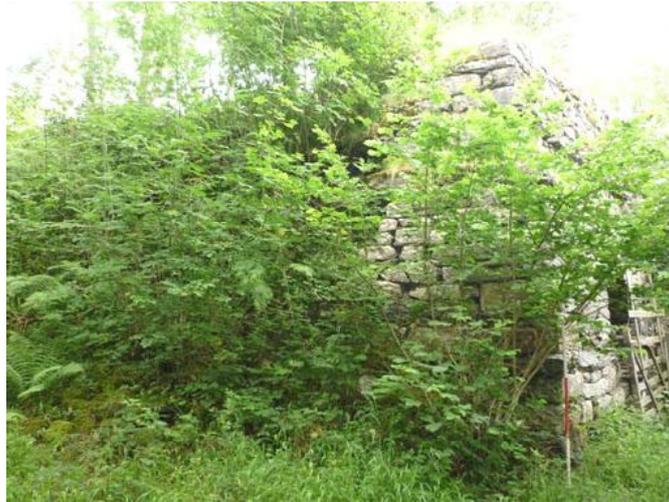
Plate 30: The west external elevation of the south kiln

4.3.2 **West facing external elevation:** the west elevation of the south kiln is mostly ruinous, with an area of collapse to the north where it runs into the slope and is overgrown. What survives is as per that to the south, which is described above in *Section 4.3.1*, with steps or tiers including a plinth, topped with slate and large quoins (see Plate 30; Figure 4). The rubble core of the wall is partially visible and perhaps did not extend fully to the north, the kiln instead perhaps having been built into an existing slope.

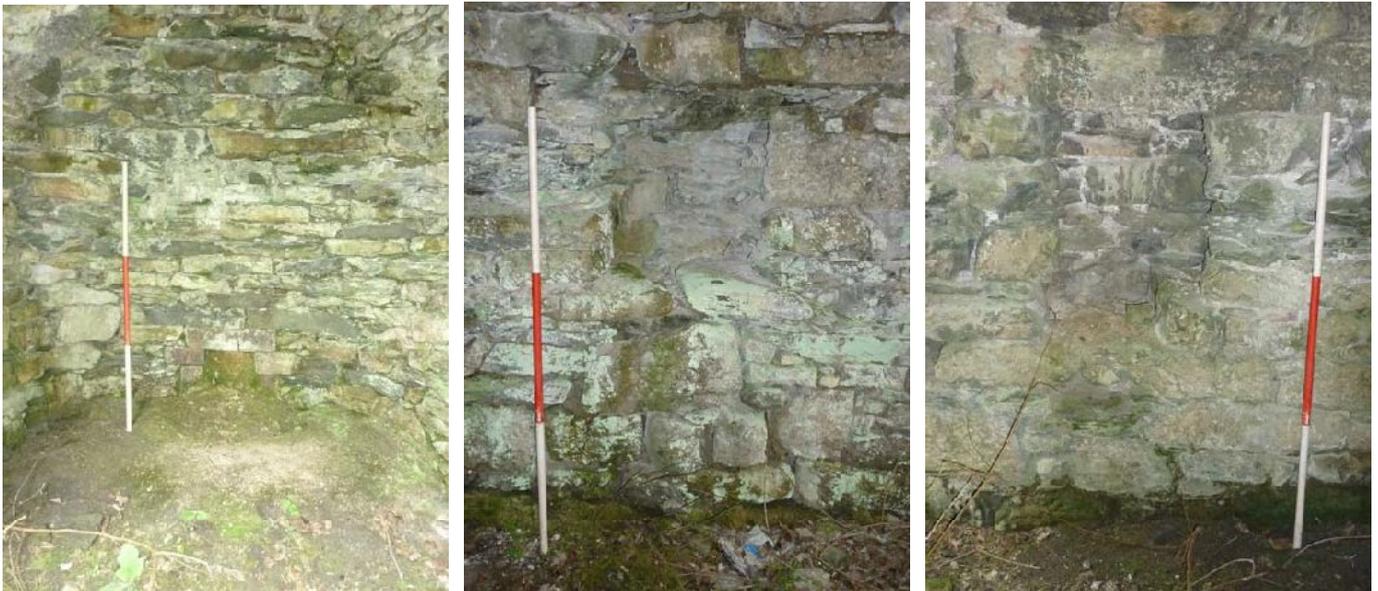
4.3.2 **Internal detail:** the well-dressed stone of the arched entrance continues into the hearth. Internally, the back of the kiln curves round and there is a blocked brick-lined flue near to the centre at the rear and an alcove on either side in the side walls.

Plate 31 (left): Brick-lined flue at the back of the south kiln

Plate 32 (centre): Alcove in the inside of the south kiln

Plate 33 (right): Alcove in the inside of the south kiln

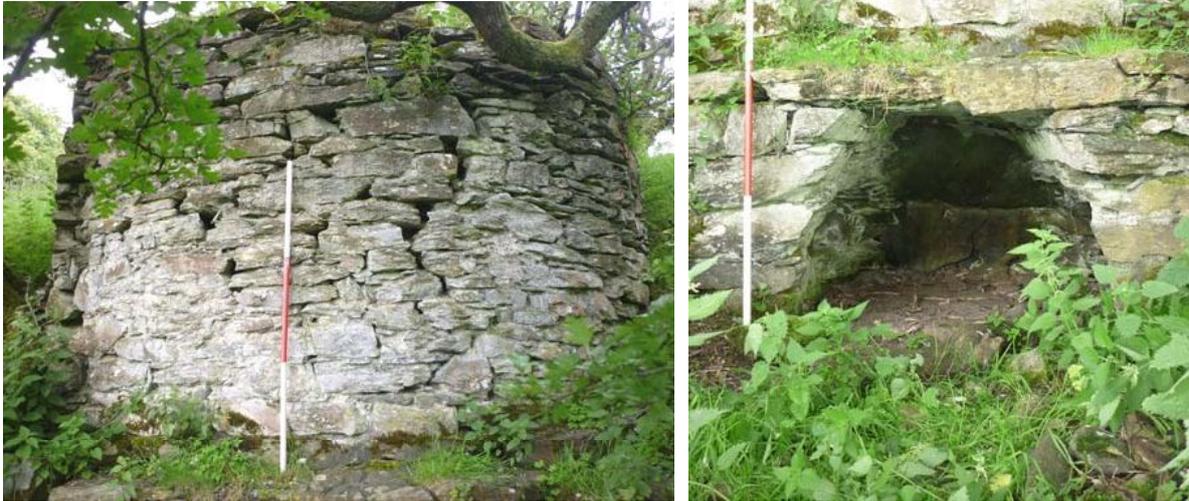
4.4.1 **North facing external elevation:** the north elevation of the kiln is essentially continuous round the top as the upper part is round in plan (Plate 34; Figure 5). The upper part is constructed from courses of slate and is plain apart from a large crack on the east side. The lower part has a square section facing north, which is parallel and flush with the slope, and has a corbelled opening with a heavy slate lintel and a slightly projecting upper part (Plate 35).

Plate 34 (left): Detail of the upper section of the north kiln

Plate 35 (right): Detail of the corbelled entrance to the north kiln

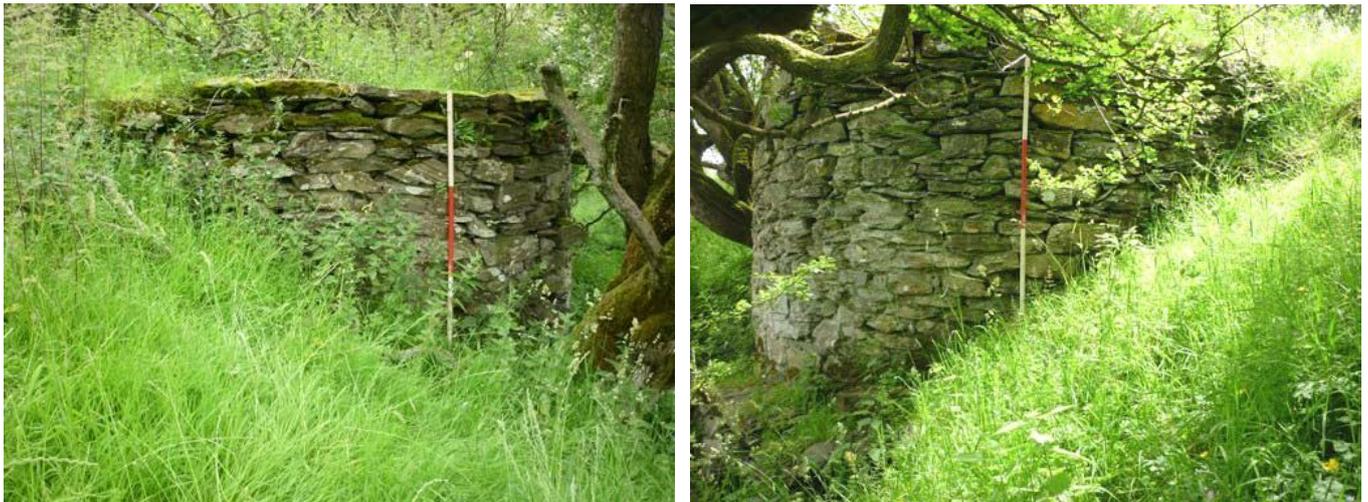
4.4.2 **East and west facing external elevations:** the east and west elevations are essentially plain and rounded against the slope (Plate 36 and Plate 37).

Plate 36 (left): East external elevation of the north kiln

Plate 37 (right): West external elevation of the north kiln

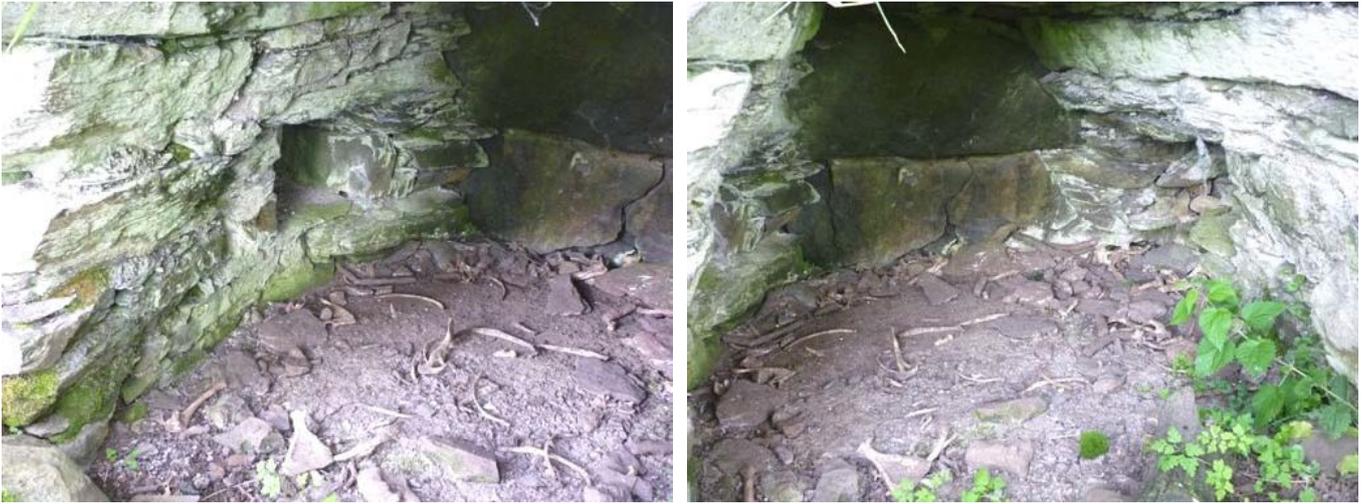
4.4.3 **Internal detail:** the north limekiln has a small internal area with small alcoves with stone lintels and sills or shelves in the east and west elevations. The back wall is finished or possibly in-filled with two large flat stone slabs and with no obvious flue opening. There are large slabs forming the ceiling and it has an earth floor, which was scattered with animal bones. The kiln must be backfilled as there is no useable space inside it and no flue.

Plate 38 (left): East internal elevation of the north kiln

Plate 39 (right): South and west internal elevation of the north kiln
