# LEVENS HALL, KENDAL, CUMBRIA

## Archaeological Watching Brief

Client: Mr CH Bagot

Planning Application Refs:  
SL/2011/0207

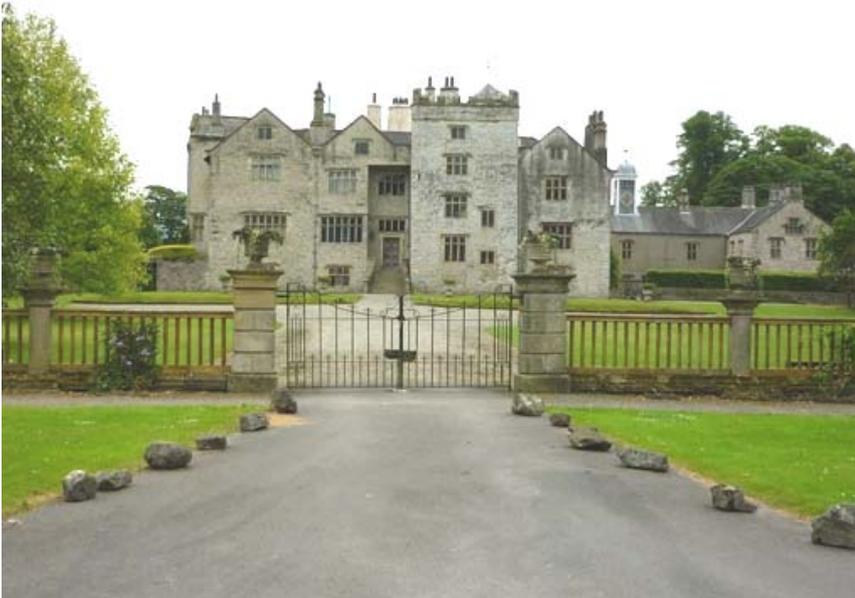
**Plate 1 (left): The north elevation of Levens Hall (the south wing and boiler house are visible to the right)**

1.2.1 Levens Hall (Plate 1) is located in the Lake District on the south bank of the River Kent approximately 10 kilometres south-south-west of Kendal (Ordnance Survey 2008; see Figure 1). The excavation took place within the courtyard and across a small path to the side of the potting sheds and the greenhouses to the west of the main house. The courtyard has a fairly level cobbled surface, which is criss-crossed by limestone guttering, and has large slate flags to the outer edges (Plate 2). The gravel track between the potting sheds and the greenhouse has a gentle slope from east to west.

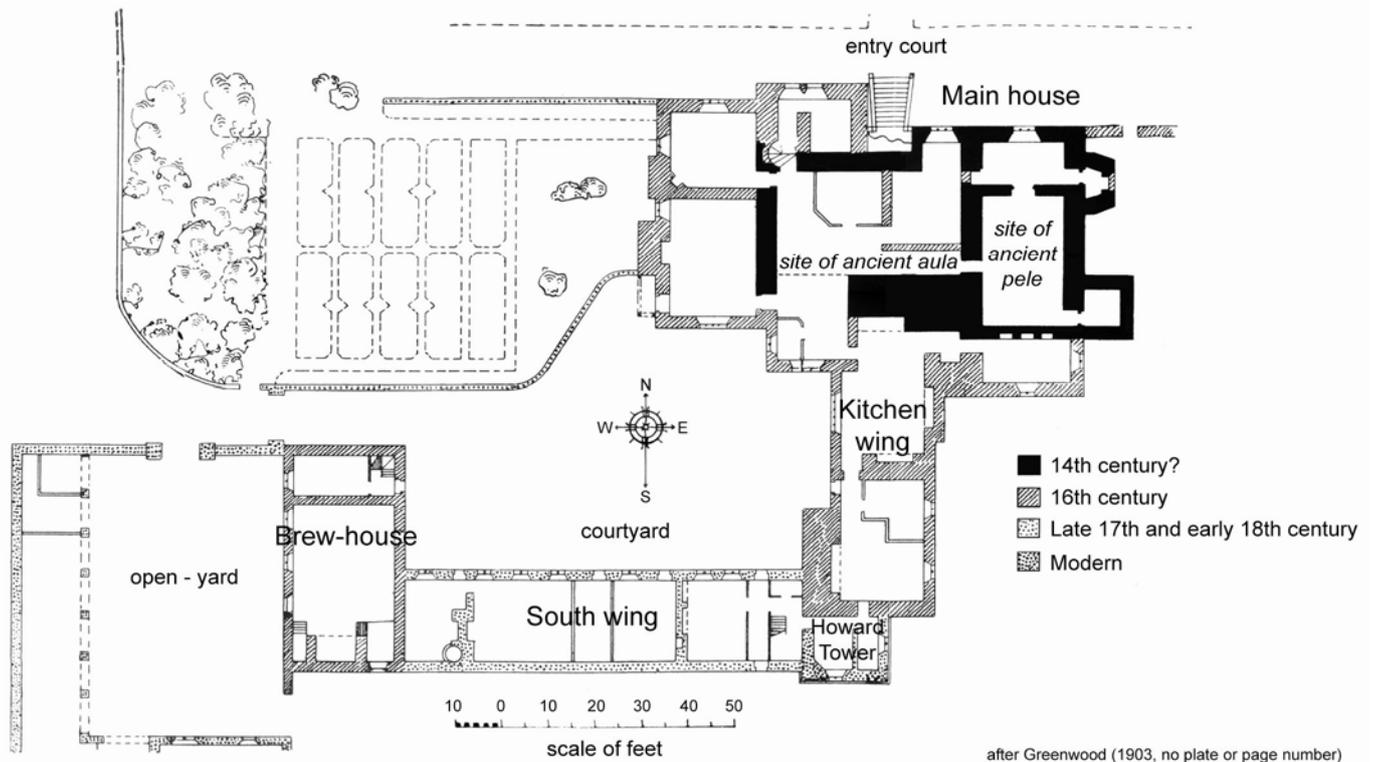
**Plate 5: Phase plan of Levens Hall**

3.2.2 **Phase plan of the Hall (after Greenwood 1903, no plate or page number):** a plan reproduced by Greenwood (1903) from an original drawing by Curwen shows the suggested phases of development

of the Hall to that point. At the time, the area to the west of the brew-house was marked as an open yard with a coal house to the west side. The phase plan has been simplified and re-oriented here, so that north is up the page (Plate 5). The suggested dates are based upon those given by Curwen in his *Historical Description of Levens Hall* (1898).

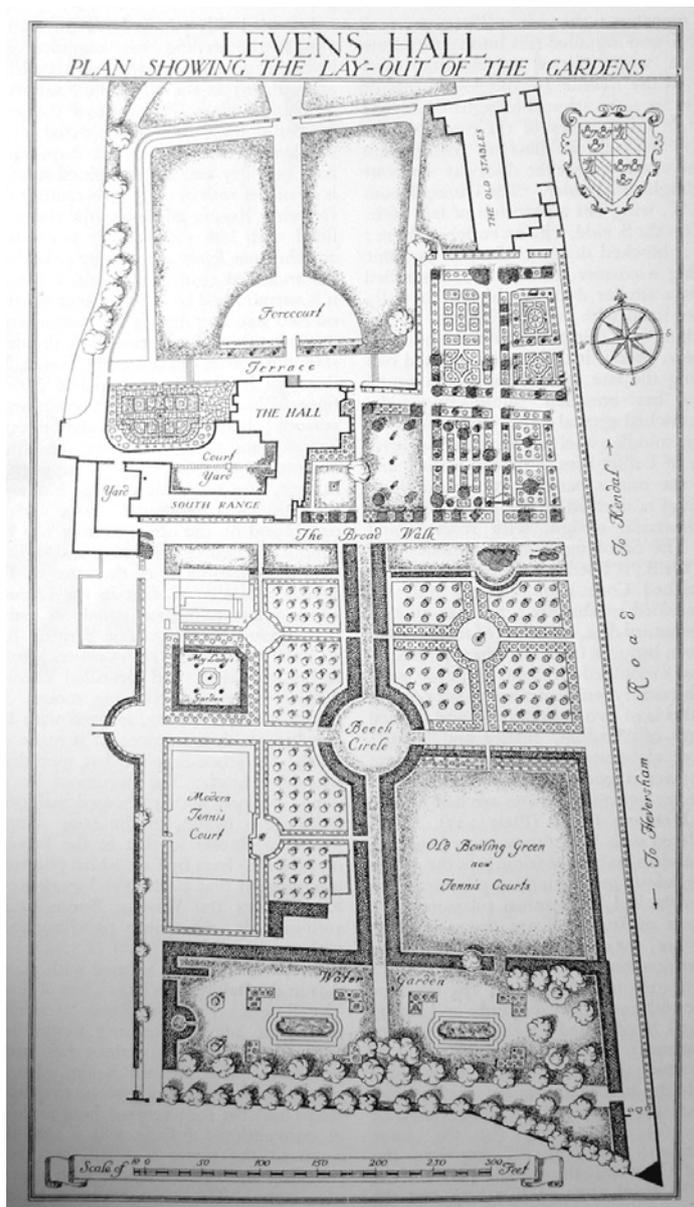
Plate 6: Plan of Levens Hall, showing the gardens c1936 (from RCHME 1936)

3.2.3 **Plan of 1936**: the plan reproduced in *An Inventory of the Historical Monuments in Westmorland* (RCHME 1936, 154) shows that the arrangement of the house is mostly unchanged to this day and that the courtyard and areas to the west of the main house were still open at the time (Plate 6). The guttering and cobbled surface of the courtyard is shown in more detail.

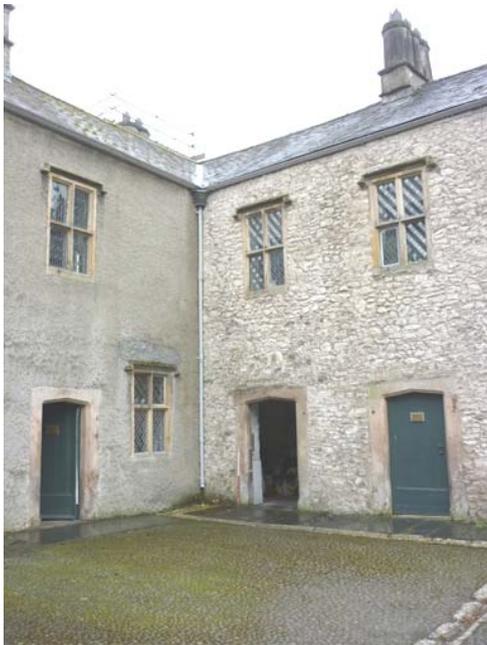
**Plate 7 (left): The south-west corner of the courtyard**

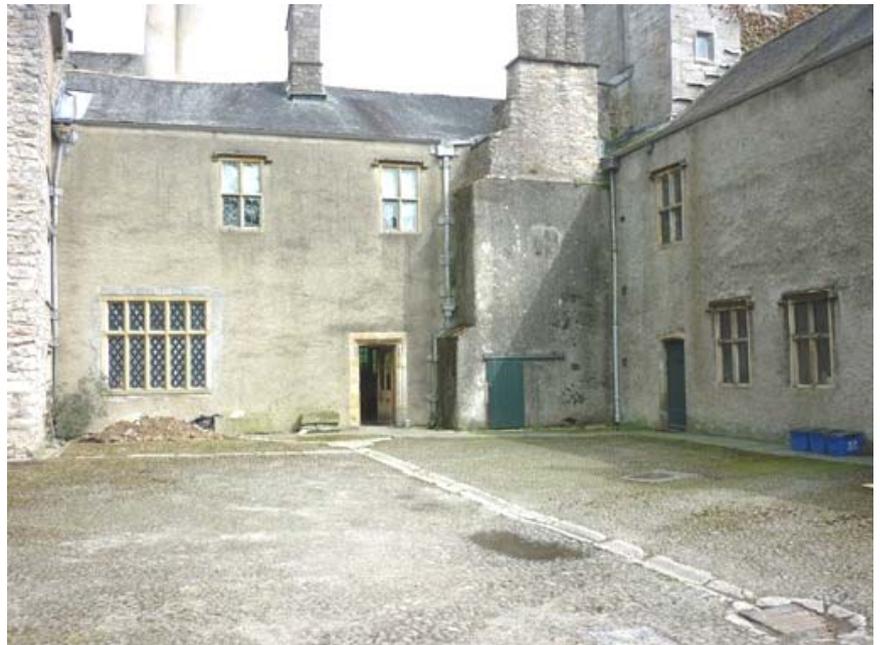
**Plate 8 (right): The east end of the courtyard**

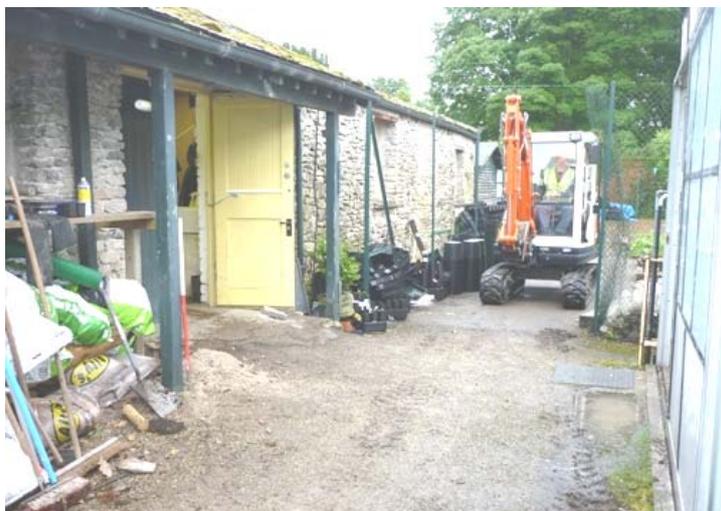
**Plate 9: The area between the potting sheds and the greenhouse, looking south**

4.1.1 The groundworks began in the area of the courtyard to the south-west of the main house, close to the north elevation of the south wing, and continued between the potting sheds and the greenhouse to the west of this area. The ground surface within the courtyard area, which is to be reinstated after the completion of the groundworks and comprised a fairly level cobbled surface, is cut across by limestone guttering and skirted by slate flags (see Plate 7 and Plate 8). The groundworks followed the edge of the slate flags along the west end of the south wing before turning approximately midway across the courtyard to take a more north-east/south-west route across the remainder of the area. The walls of the surrounding buildings were constructed from fairly regular courses of limestone and were sometimes finished in a concrete render. It was also necessary to lift a small area of the flagged floor within the boiler room for the installation of the pipes. The floor of the greenhouse was concrete and the area between the potting sheds and the greenhouse comprised a gravel track (Plate 9).

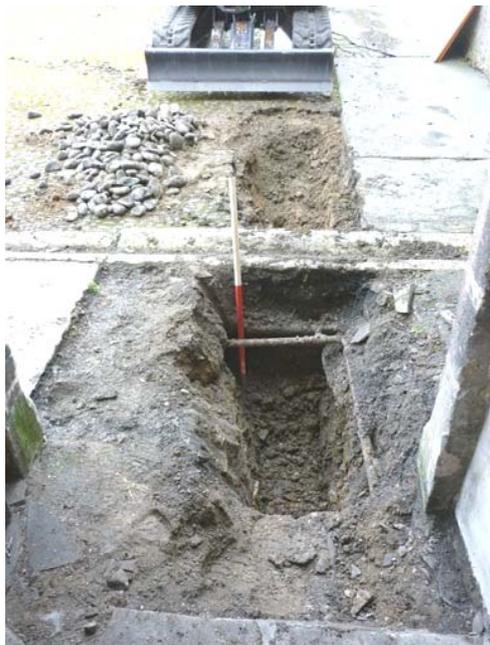
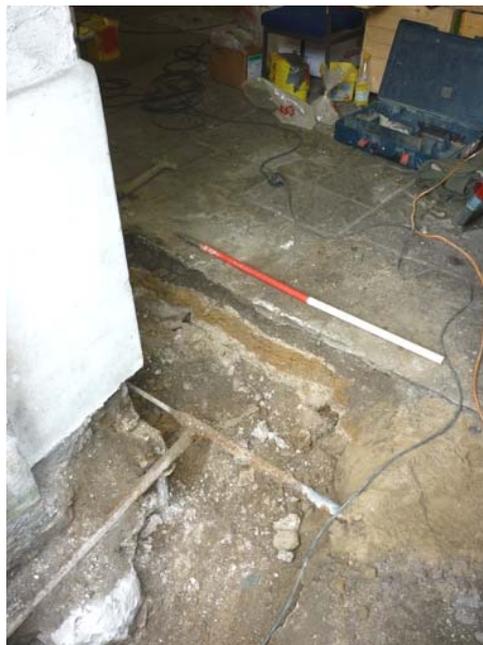
**Plate 10 (left): Removal of the flags at the west end of the courtyard**

**Plate 11 (right): Removal of the flags within the boiler house**

4.2.1 **Courtyard Area:** one of the flags at the west end of the courtyard area was lifted and found to sit on a loose bedding layer of fine dark grey gravel up to 0.07m thick (Plate 10). This in turn overlay a friable, mid greyish-brown sandy-silt deposit (**102**), which was above a soft mid to light slightly orangey-brown sandy-clay (**103**). In addition, a small section of the flagged floor of the boiler house had to be lifted for the installation of the pipes. Various metal pipes were observed to cut across the flagged area beneath the bedding material (within context **102**) and continue beneath the floor of the boiler house to the west (Plate 11). The flags were above a dark grey-brown sandy-silt layer, which had frequent small sub-angular stone pebble and gravel inclusions. This was above a gritty white mortar, which was in turn above light orange sand and another powdery white lime mortar with moderate angular stone inclusions. No finds were recovered from within the boiler room.

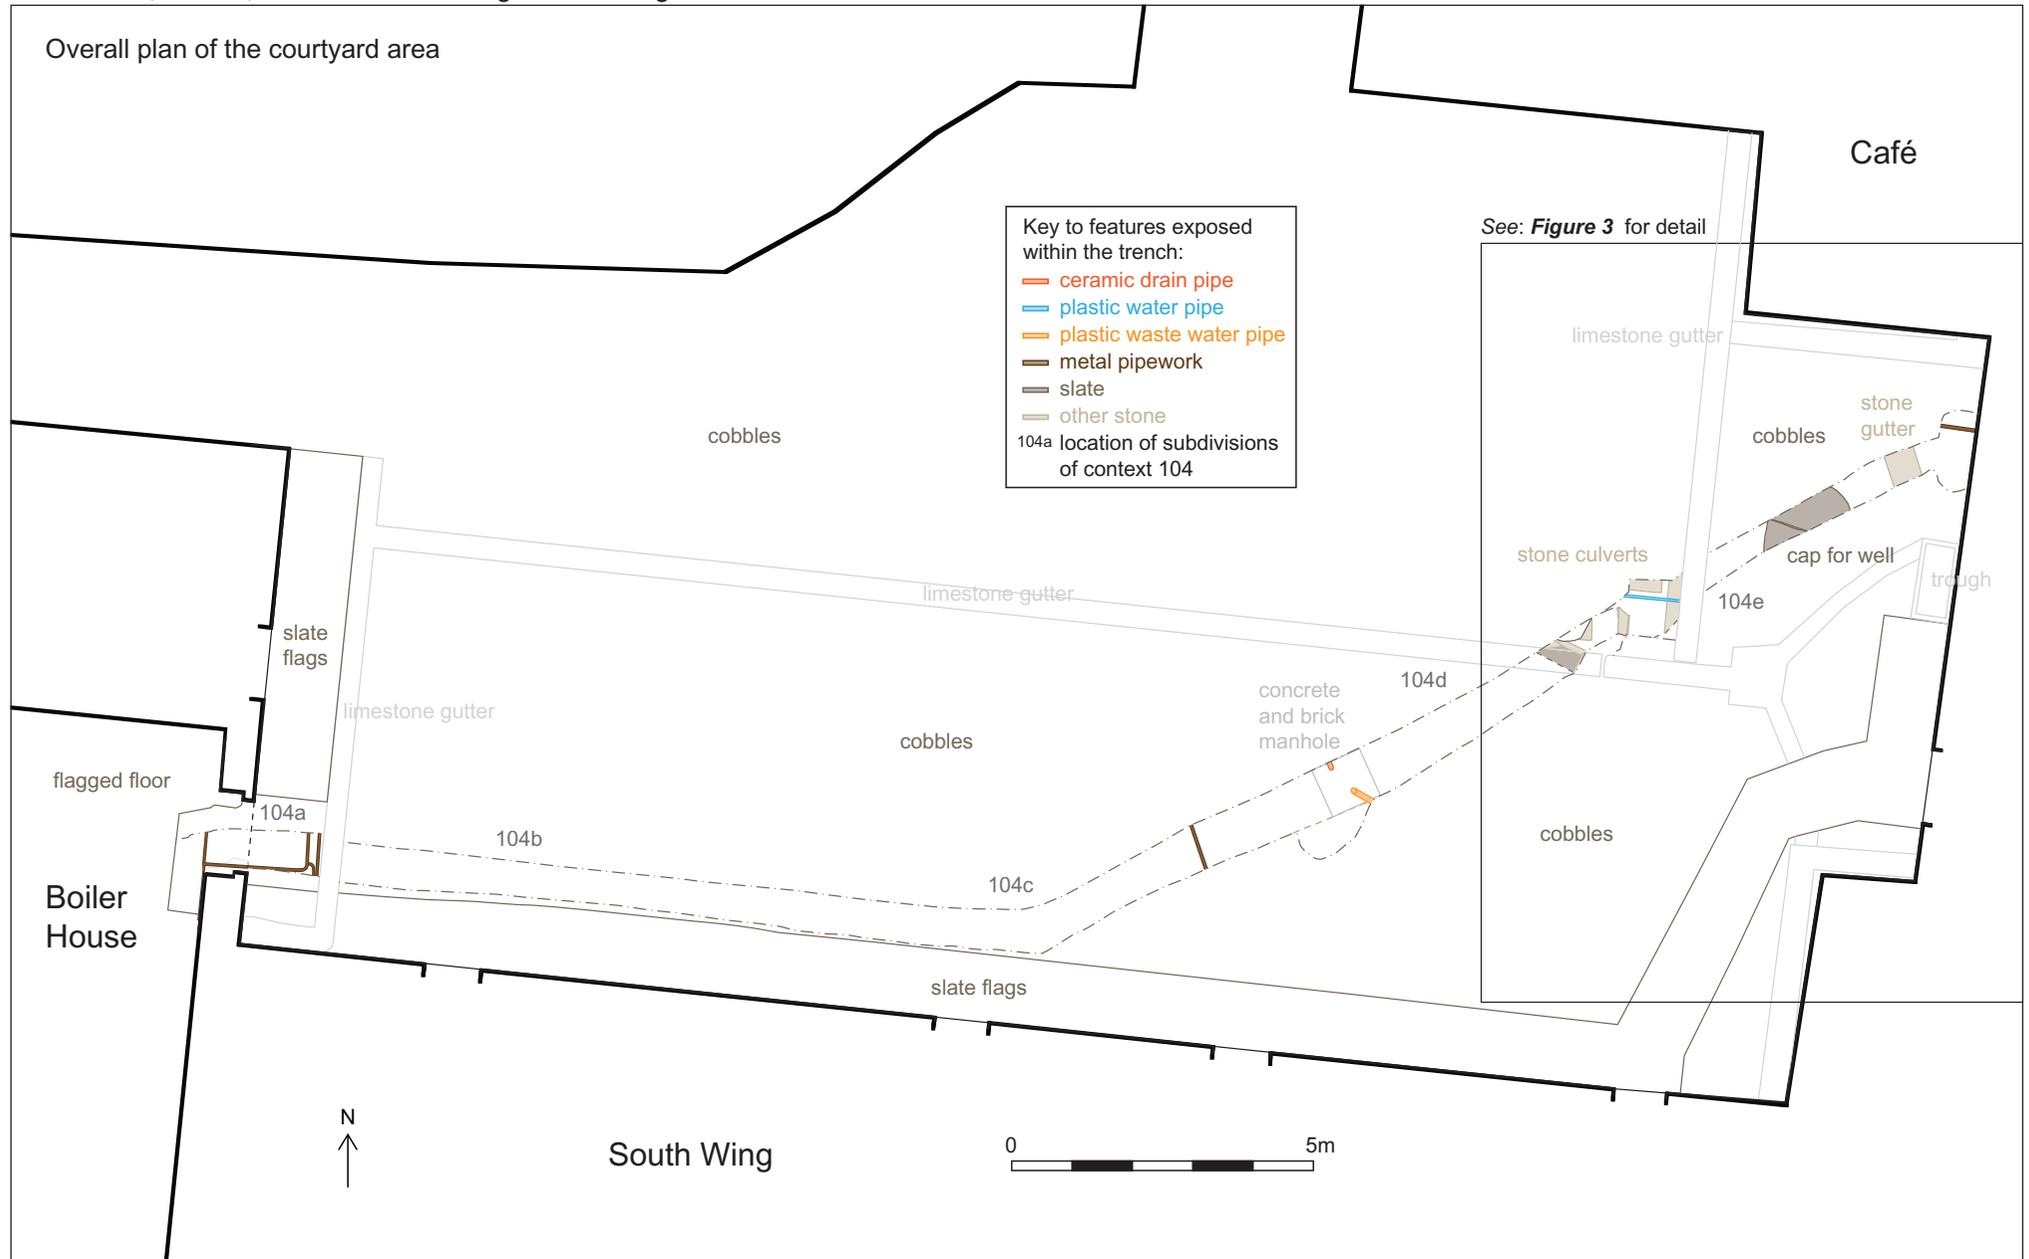
Figure 2: Overall plan of the courtyard area

4.2.2 The uppermost layer (context **102**) beneath the bedding material for the slate flags appeared to continue to the east of the limestone guttering, which was left in place (Plate 12). Certainly, the uppermost deposit to the east of the guttering was a very similar greyish-brown sandy-silt (**104**), although it was covered in a loose sand bedding material up to 0.18m thick below the cobbled surface to the east. The cobbled surface was approximately 0.08 to 0.10m thick and extended across the area of the courtyard except for the areas of guttering and slate flags, which were generally towards the outer edge. Below this deposit, context **104**, was a softer, mid to dark grey-brown silty-clay deposit, context **105**, which might have been a variation within the same deposit or possibly represented an interface between this deposit and the underlying soft, orangey-brown sandy-clay (**103**). This clay was encountered at a depth of approximately 0.75m below the current ground surface and may have been an underlying geological layer (the 'natural'). This sequence of deposits continued along the east/west section of the trench and most of the courtyard (Plate 13).

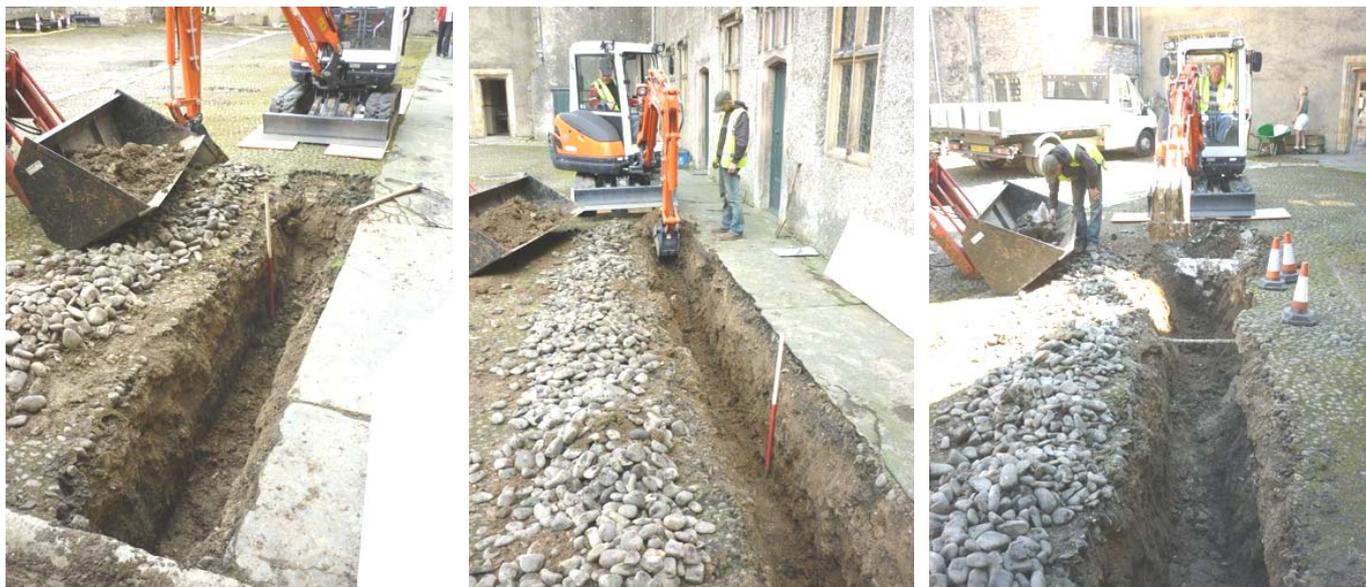
**Plate 12 (left): Trench section at the west end of the courtyard**

**Plate 13 (centre): Trench along the south wing**

**Plate 14 (right): Working shot, manhole exposed**

4.2.3 A further metal pipe was exposed beyond the realignment of the trench approximately midway across the courtyard and a modern brick-built and concrete coated manhole was removed to the north-east of this (Plate 14). Context **104** was noted to be slightly stonier and there was a small concentration of disarticulated animal bone in front of the doorway at the turning point of the trench (sub-context **104c** was issued for the assemblage of finds recovered from this area based on their location (see Figure 2)).

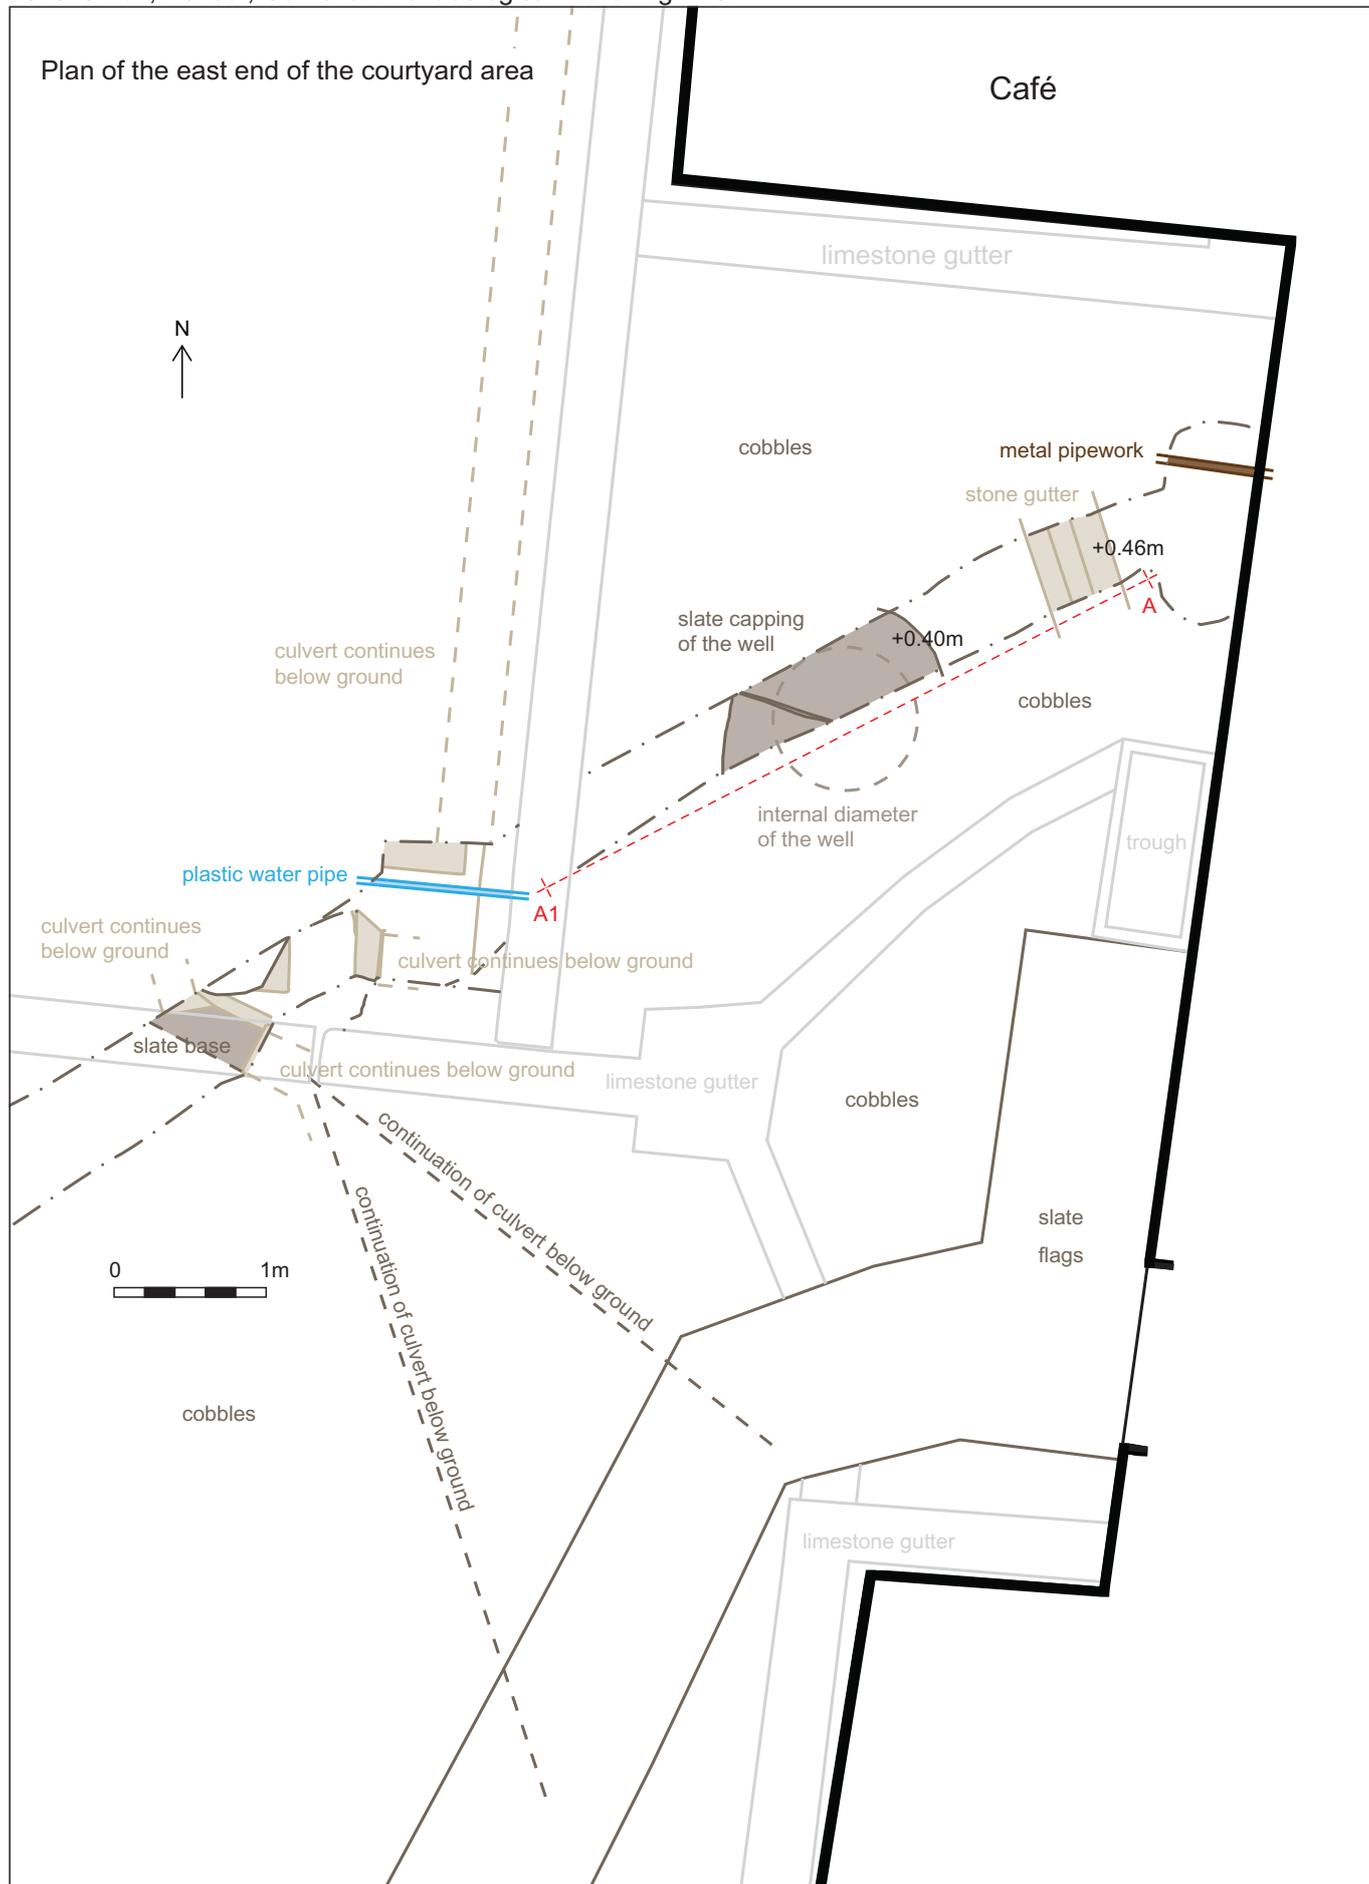
Figure 3: Plan of the east end of the courtyard area

4.2.4 Several stone-lined culverts were observed within this deposit to the north-east of the manhole; their position was close to the junction of the limestone guttering which cuts across the cobbled surface at this point (Plate 15 and Plate 16; see Figure 3). The sides of the culverts appeared to be built from courses of angular limestone blocks with gritty yellowish-white cement with small gravel inclusions. The cement was up to 0.03m thick between the courses each of which was approximately 0.1m high. The open channel was approximately 0.33m wide and between 0.21 and 0.26m high, although sometimes the opening was blocked with angular limestone rubble with fragments that were approximately 0.1m long on a side. Each section of the culvert appeared to have a slate-lined base (Plate 15) and often very large angular sandstone blocks had been used to cap it. The limestone gutters across the area were approximately 0.18m deep and there was up to a further 0.13m of the greyish-brown sandy-silt, context **104**, below the base of the guttering to the top of the angular sandstone capping of the culvert, which was up to 0.13m thick. Some of the capping stone for the culverts had evidently been reused in their construction; a piece of a scooped limestone drain had been upturned and reused to cap one section of the culvert. Another section appeared to possibly have had minor repairs made to it using machine-made frogged red brick, stamped "CLAUGHTON MANOR BRICK C<sup>o</sup> CATON", which was incorporated into the side. This possible repair was noted to be close to the position of a modern cross-cutting plastic water pipe (Plate 17). It was also noted that context **104** contained a slight concentration of red earthenware (c17<sup>th</sup> to 20<sup>th</sup> century) and domestic refuse, including cockle shells, between the area of the culverts and the brick-built and concrete manhole to the south-east (sub-context **104d**).

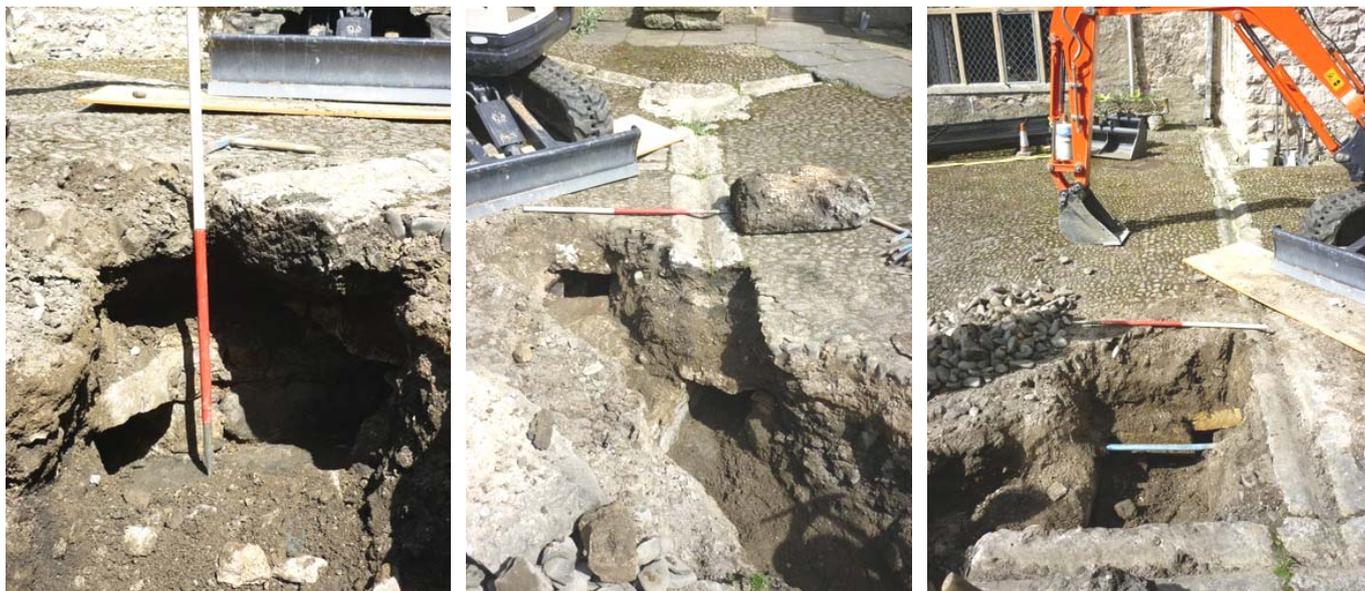
**Plate 15 (left): Stone culvert (the slate base of which is visible at the point of the scale bar)**

**Plate 16 (centre): Stone culverts below the limestone gutter**

**Plate 17 (right): Modern plastic water pipe cutting across the trench**

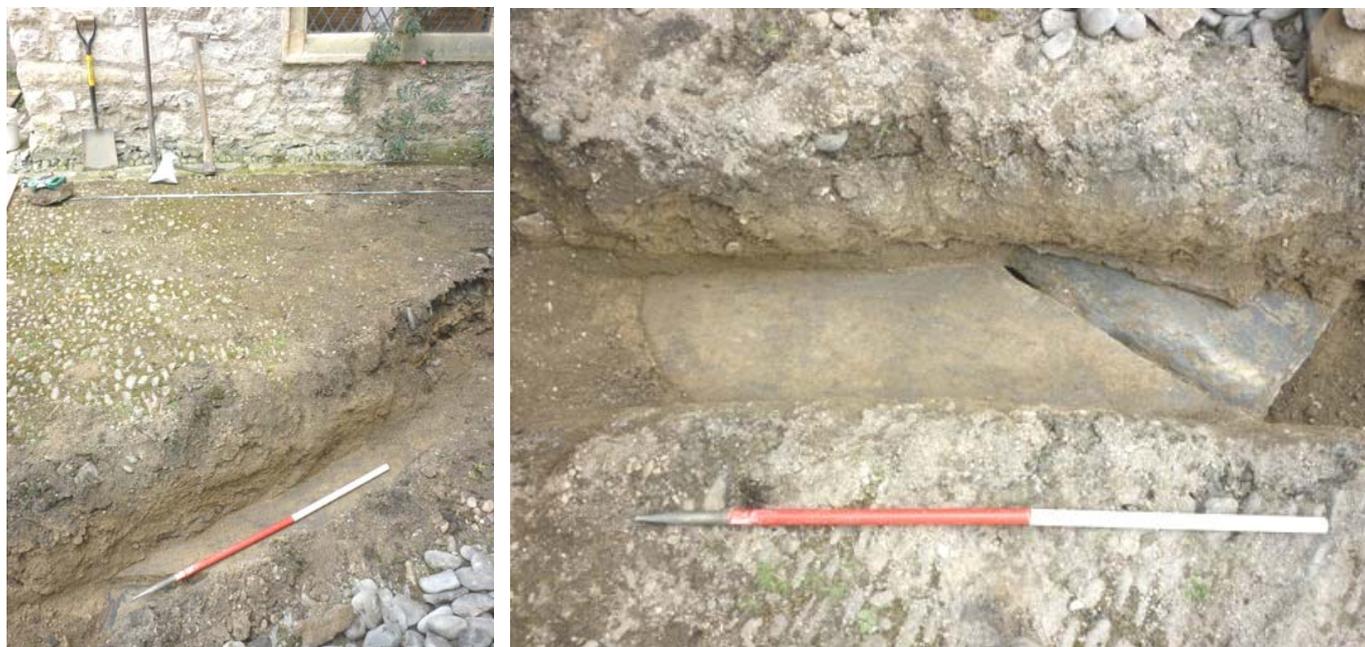
**Plate 18 (left): The well (located below the scale bar)**

**Plate 19 (right): Detail of the slate capping material of the well**

4.2.5 A neatly constructed well was exposed a short distance to the north-east of the culverts in front of the windows in the south elevation of the café (Plate 18; Figure 3). It was constructed from regular courses of angular limestone blocks (Plate 20) and had an internal diameter of 0.95m (Plate 21). Up to 0.03m thick of firm, gritty, brownish-yellow clay packing material had been used between the courses of stone and it was capped with slate (Plate 19). It was approximately 5m deep and the bottom 1.5m was filled with water.

5.1.2 The well (**107**) at the north-east corner of the courtyard is potentially medieval in date, but since no finds were directly associated with it, its actual construction date is uncertain. The inside was left open after it went out of use but it was capped with slate and then seems to have been covered with a yellowish sandy-clay (**106**), which appears to extend above dark silty deposits to the east and west. The well itself cut a deposit with a similar colour, composition, and consistency to context **106**, context **112**, but its extent was not readily discernible within the confines of the trench and it could not readily be distinguished from the deposit overlying the capping material.

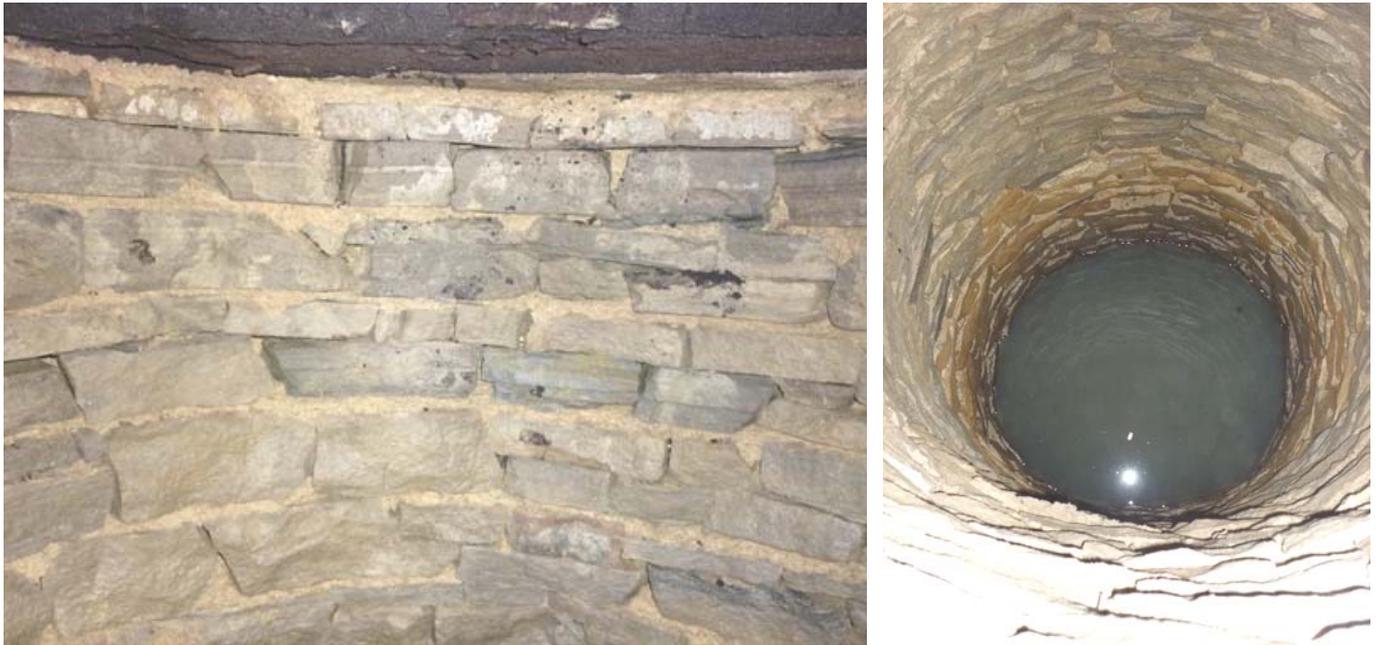
**Plate 20 (left): Internal construction detail of the well**

**Plate 21 (right): The base of the well**

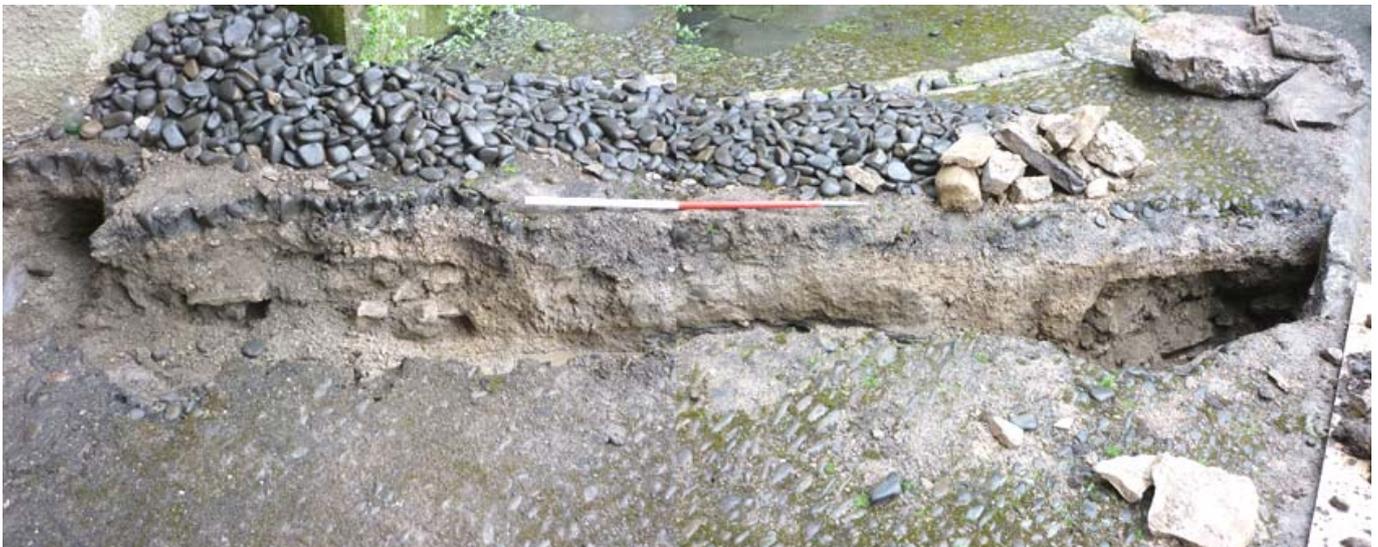
**Plate 22: Composite photograph of the north-west facing section above the well**

4.2.6 Above the well was a light brownish-yellow clayey-sand deposit, context **106**, which appeared to extend some distance beyond the edge of the well to the north-east and to the limestone gutter to the south-west (Plate 22; Figure 4). Context **104** continued only a short distance to the north-east of the junction of the limestone gutters before apparently being replaced or cut across by this light yellowish clayey-sand deposit (**106**). This yellowish deposit apparently overlay context **104** to the west and a similar deposit, context **100**, to the east. The well itself apparently cut a yellowish deposit of a similar composition and consistency to context **106** (context **112**). The sandy bedding material present below the cobbles to the south-west of the junction of the limestone guttering was much softer and looser and was not considered to represent a continuation of context **106**.

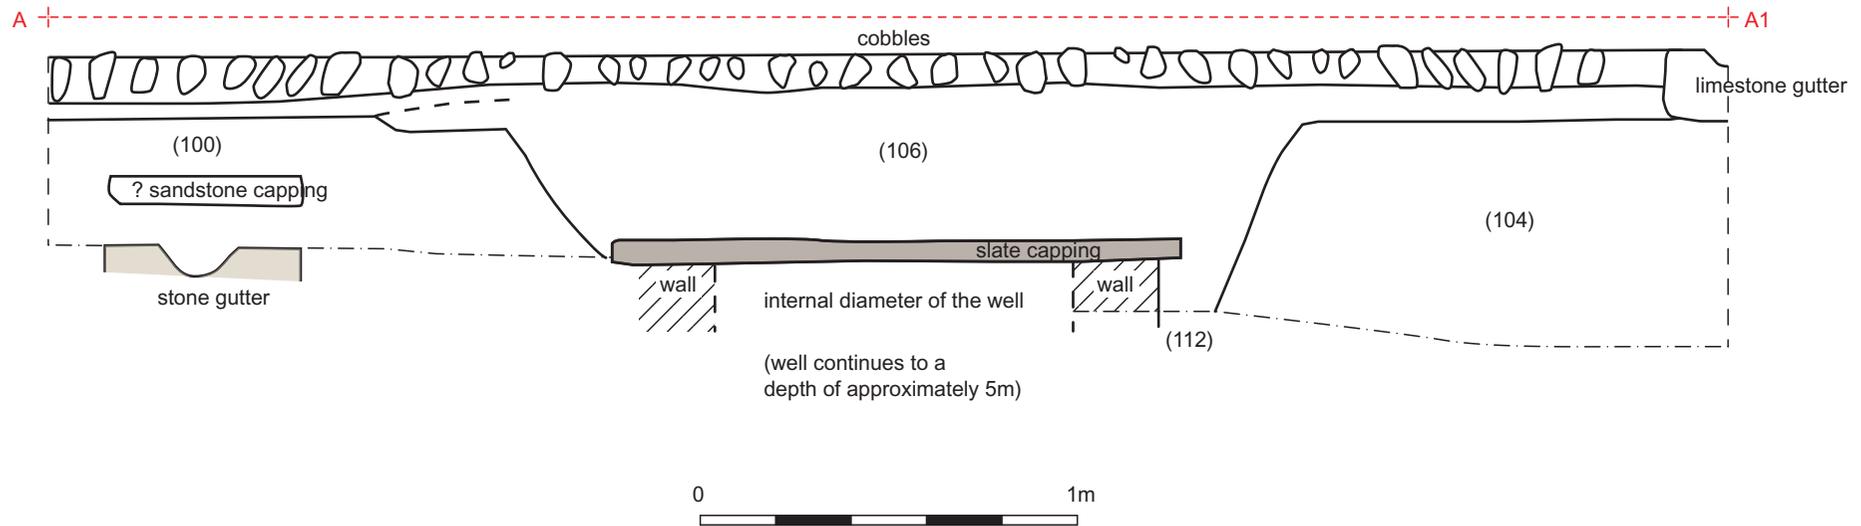
Figure 4: North-west facing section of the trench

North-west facing section A-A1 - above the well

4.2.7 A loose greyish-brown sandy-silt deposit, context **100**, was exposed below context **106** to the north-east of the well and continued to the wall of the kitchen-wing. Context **100** was below a compact sandy whitish-brown deposit to the east, which appears to have continued slightly above context **106** to the west. Context **100** was noted to be looser where it had been re-deposited above an oil pipe. The limestone boulders which formed the foundation of the kitchen-wing were exposed to a depth of approximately 0.4m below the current ground surface and a fine gravel deposit was exposed at a depth of 0.8m, which probably represented the underlying 'natural'.

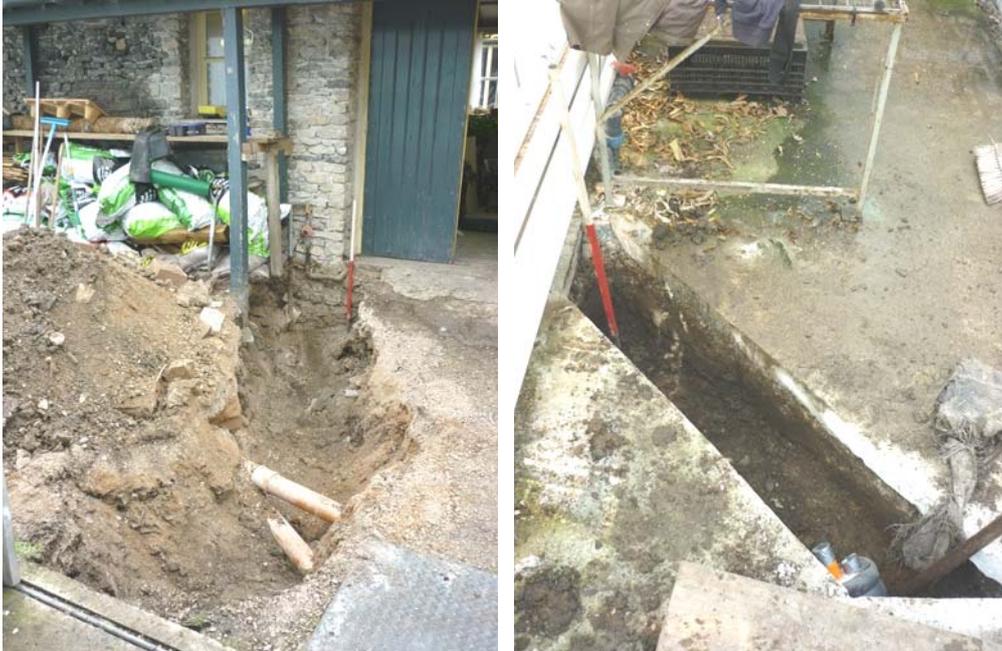
Plate 23 (left): Area of excavation between the potting sheds and the greenhouse

Plate 24 (right): Area of excavation below the floor of the greenhouse

4.2.9 **Between the potting sheds and the greenhouse:** this area was very disturbed. For the most part the uppermost layer comprised whitish gravel, which formed the current pathway around the potting sheds, and the lower part comprised orange sand, but both deposits were very disturbed (together forming context **108**). Various very modern finds were noted in this area, including marker pens and refillable gas lighters, but none were retained, and were probably associated with the 20<sup>th</sup> construction of the potting sheds. Context **108** was above a gravel deposit (**109**) to the east, which might have represented another layer or surface, but it was only partially exposed at the base of the trench (at a depth of 0.9m) and was not investigated further. The mixed sand and gravel deposits, context **108**, extended as far as a concrete manhole to the west and two plastic wastewater pipes cut across the trench at this point (Plate 23; Figure 5). Part of the concrete floor of the greenhouse was also removed. The concrete floor was set on a gritty brownish-white gravel bedding material, below which was a layer of dark grey-brown, slightly clayey silt, context **110**, which was probably the old topsoil (Plate 24). This appeared to extend and may have been overlain by the disturbed deposits associated with the construction of the potting sheds to the east. This possible topsoil layer was above a soft mid orangey-brown clay, with few inclusions, which may have been the underlying 'natural' (context **111**) at a depth of approximately 0.46m.
