# CAVENDISH ARMS, MARKET PLACE, DALTON-IN-FURNESS, CUMBRIA

## Archaeological Building Recording

Client: Frederic Robinson Ltd

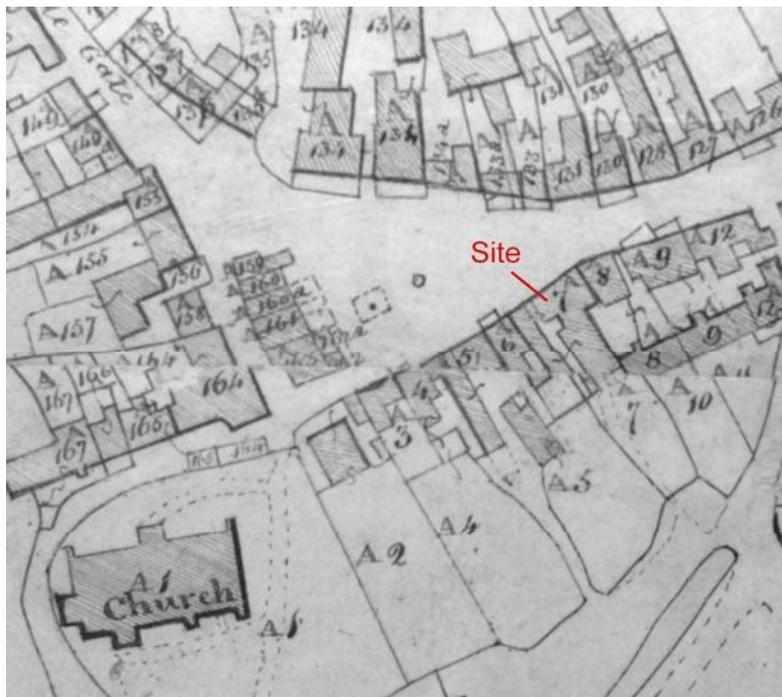
Plate 2: Extract from the Tithe Map of 1842

3.2.3 **Tithe Map, 1842:** this is the most detailed early map of the town, with clear distinctions between properties shown and what appears to be a generally accurate depiction of buildings and associated land (CRO(B) BPR 1 I3/1/2 1842; Plate 2). The Cavendish Arms has a clear passageway at the west side of the north end, connecting the yard along the west side to the Market Place, while the east end of the northern part of the building appears to extend much further to the east than at present, forming an open yard along the east side. The accompanying schedule states that the property (labelled A7), which is described as 'Cavendish Arms Gardens etc' is owned by the trustees of the late William Atkinson and occupied by Willian Danson (CRO(B) BPR 1 I3/1/1 1844).

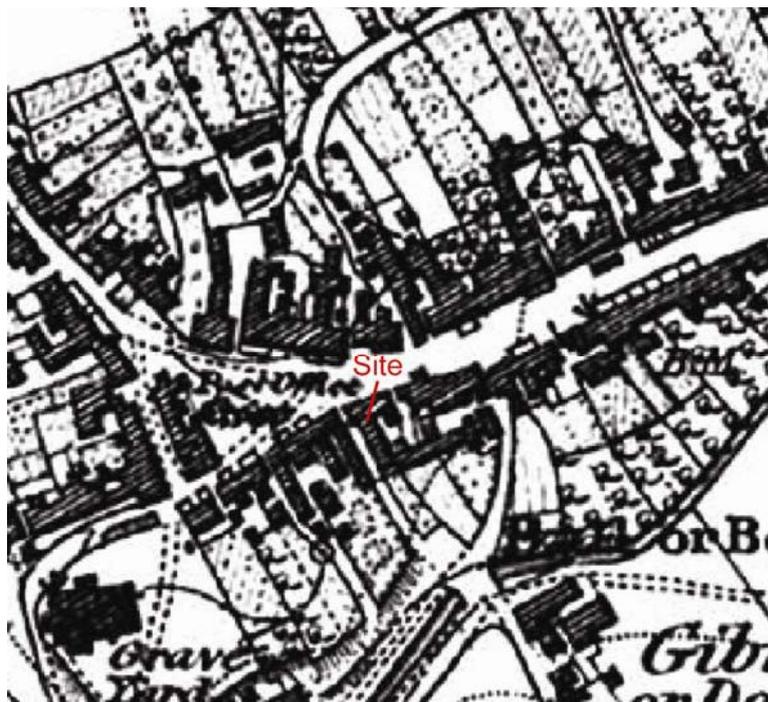
Plate 3: Extract from the Ordnance Survey map 1850

3.2.4 **Ordnance Survey, 1850:** in many ways this is not as detailed as the preceding map, although it shows the general arrangement, with the long block extending to the rear. In addition, it clearly shows an open side passage extending along the west side and connecting to the Market Place (Plate 3).

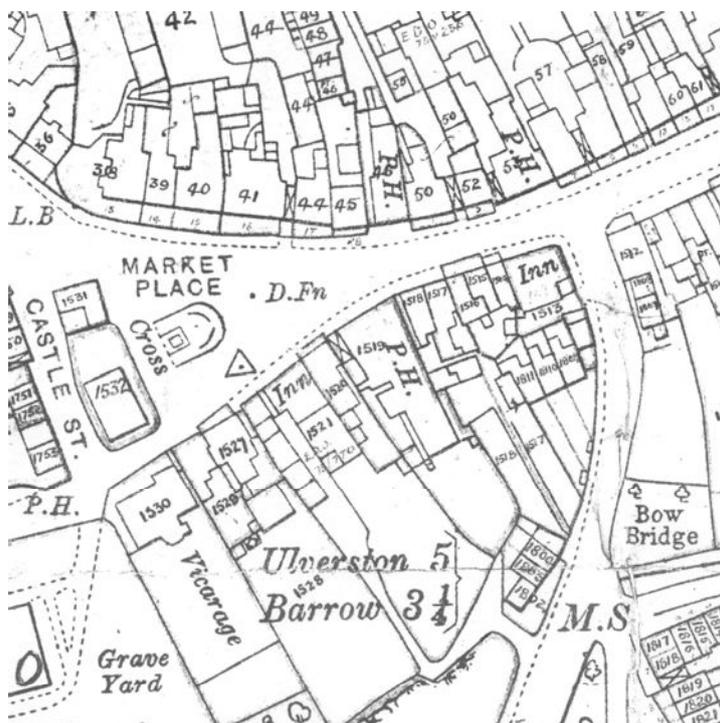
Plate 5: Extract from the Ordnance Survey map of 1912

3.2.6 **Ordnance Survey, 1912:** this shows much the same information as the preceding map, although without the detail in the garden and second covered passage. The 1910 rating valuation information, which makes use of this map, describes it (Plot 1518) as an inn called the Cavendish Hotel, owned by William JA Baldwin of Market Place, Dalton, and occupied by Isaac Dixon (CRO(B) BT/IR 1/16, 1910).

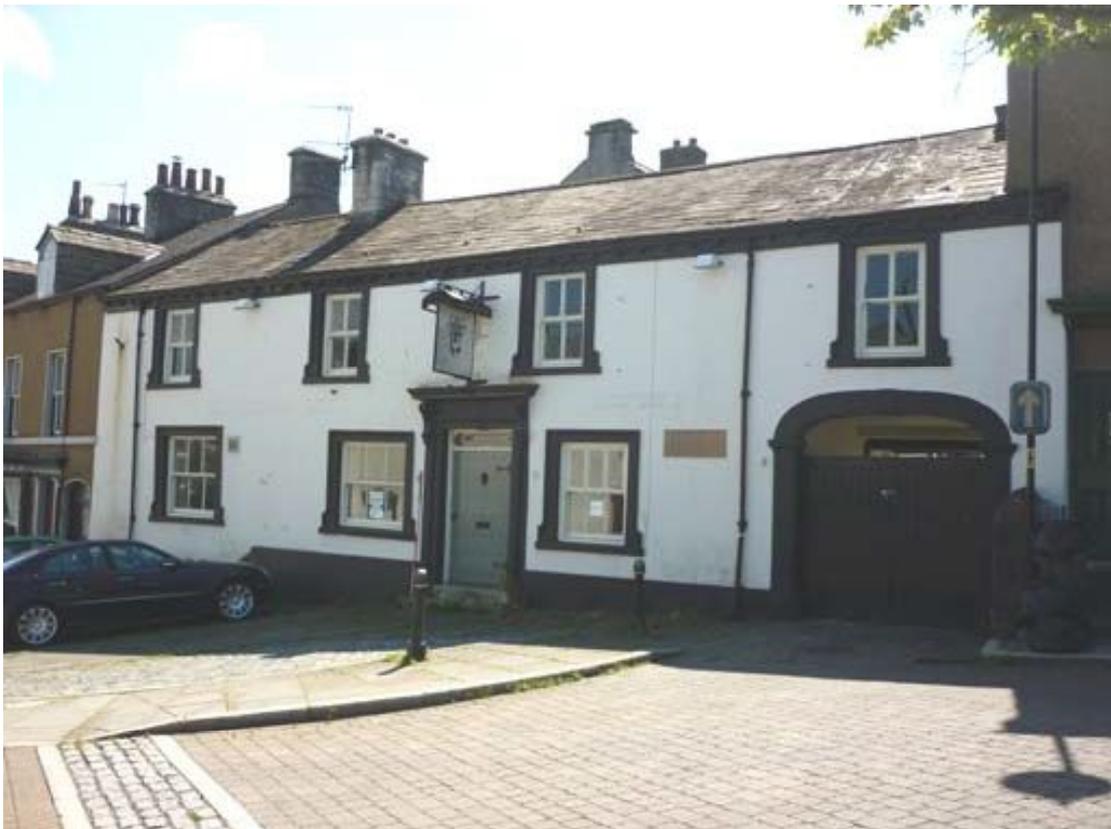
Plate 12: Front (north) external elevation

4.2.1 **North elevation:** this was entirely finished with concrete render, scored to give the appearance of ashlar blocks and painted black and white and with a projecting plinth, which stepped down on the east side where it appeared to incorporate a large boulder. The slate roof had what appeared to be grey concrete ridge tiles, with a chimney stack on the east side constructed from ashlar rock-faced limestone with a sloping coping slab and three ceramic pots. A smaller, perhaps truncated, brick chimney was situated at the west end, against the adjoining building. There was a moulded iron gutter along the eaves line resting on square corbels, presumably the ends of the rafters, and attached to a moulded barge board. The first floor had four windows, each with moulded lugged surrounds and four-light sliding sash casements with horns. The ground floor had three larger windows in a similar stile, with six-light sliding sash casements. There was an approximately central doorway with a similar surround, an entablature supported on scrolled brackets with a single-light window below, two stone steps, and a large studded door with elaborate hinges. At the west end was an arched opening to a passage formed by ashlar stone pillars and an arch constructed from ashlar blocks, with a projecting keystone with the date '1855' carved in relief. There was a modern sign hanging over the door and the scars for lettering (spelling out 'CAVENDISH ARMS' and 'ROBINSONS') as well as other modern fittings and a row of lights along the top.

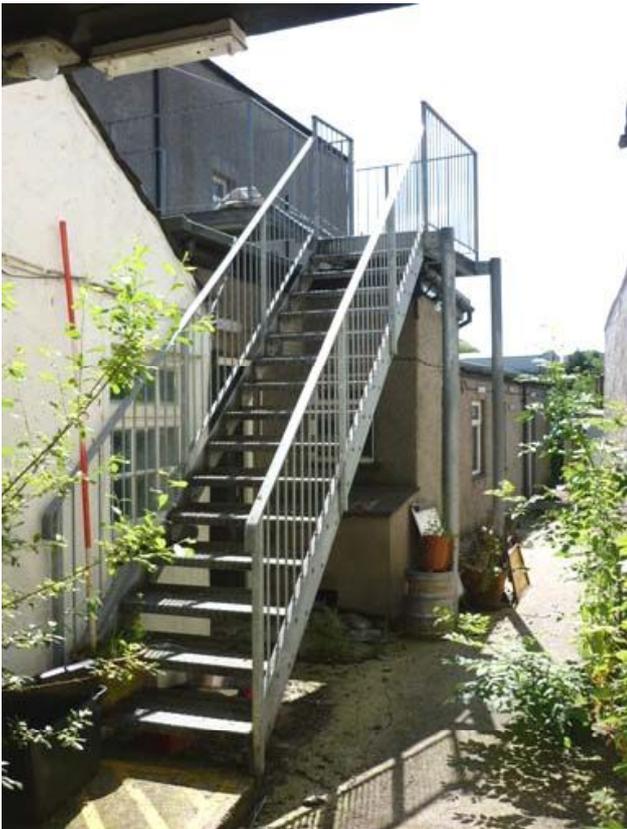
**Plate 15 (left): Fire escape against the west elevation**

sloping down to the south finished with rough modern plaster and with a small 12-light hinged casement window and modern doorway forming a fire escape. To the south the ground floor has been extended to the west with the addition of a relatively modern flat roofed-addition finished with a plain rough-cast render. This has a doorway at the north end with a plank door, before returning to the west – the return housing a small two-light window. After a blank section it returned to the east where there was the scar of what was evidently a blocked doorway, covered by rough-cast render, with two two-light windows with hinged casements to the south and a further doorway with a plain plank door. At first floor level, above the flat roof there was a two-light window with a hinged casement and at a slightly lower level than the rest at the north end, with a doorway connecting to a modern aluminium fire escape and another two-light window to the south of this. The far south end is slightly lower and has a modern doorway. The roof houses two chimneys at the north end, the northern of which is stone built but with a concrete coping with bricks on top, while the south is finished with render and has a single ceramic pot. There were iron and plastic rain water goods throughout and a tie rod with a large circular plate at the south end of the central section and three vents.

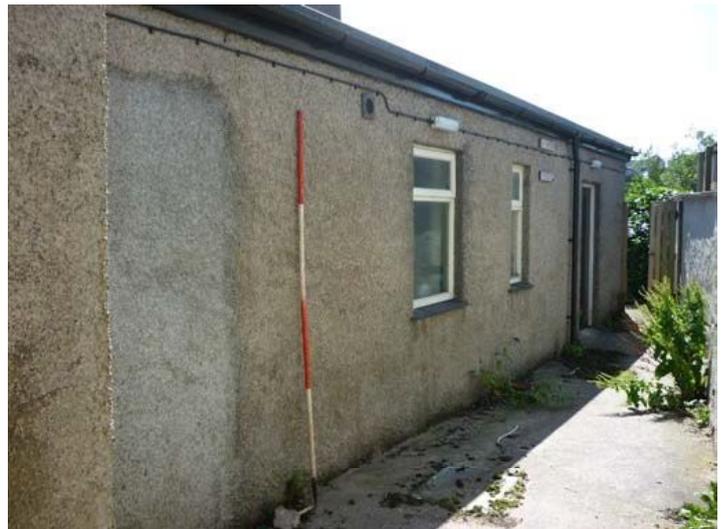
**Plate 16 (right): Single storey central section of the west elevation**

4.2.2 **West elevation:** the north end of this continued into the area forming a passageway from the front elevation (see Room G4; *Section 4.3.5* below). To the south of this it comprised a monopitch roof,

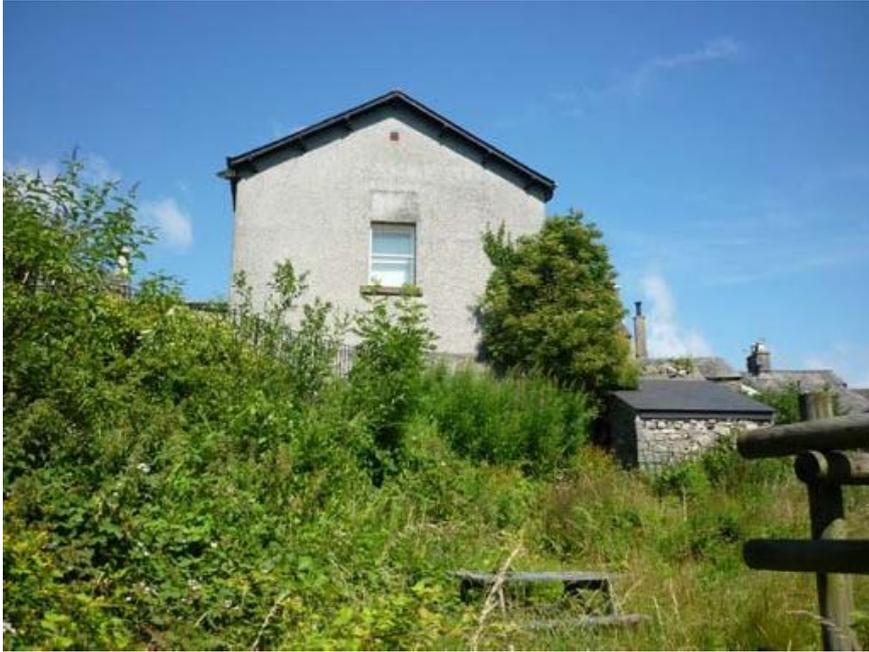
Plate 17: General view of the south external elevation and outshut

evident at approximately that level. To the east was a small monopitch outshut butting the boundary wall that extended from the south-east corner of the main building. This had an imported (non-slate) stone tile roof and un-rendered walls revealing a limestone build with roughly dressed quoins. There was a small doorway on the west side with a stone lintel and bricks in the jamb.

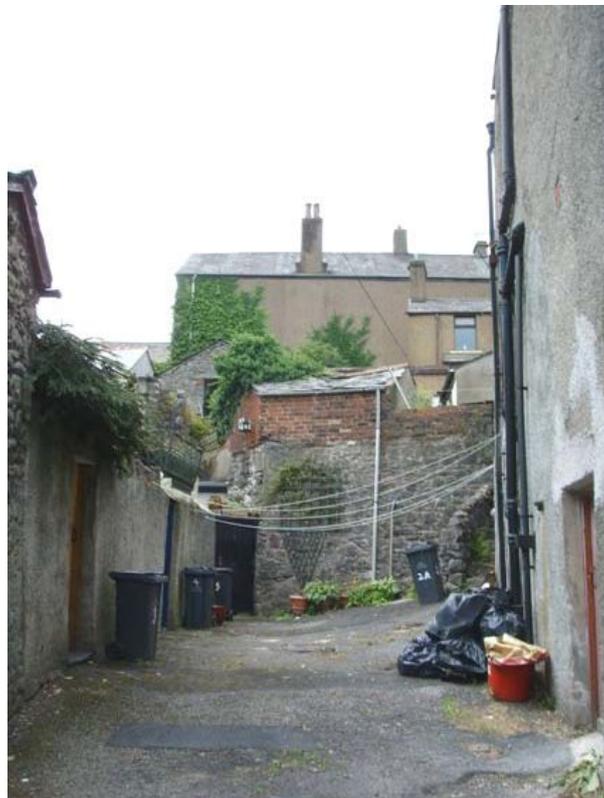
Plate 18: General view of the east external elevation

4.2.4 **East elevation:** although not actually accessible most of this elevation could be viewed from a distance. It was evidently finished with a pebble-dashed render and had a tall narrow central chimney stack with two ceramic pots. It was otherwise relatively plain.

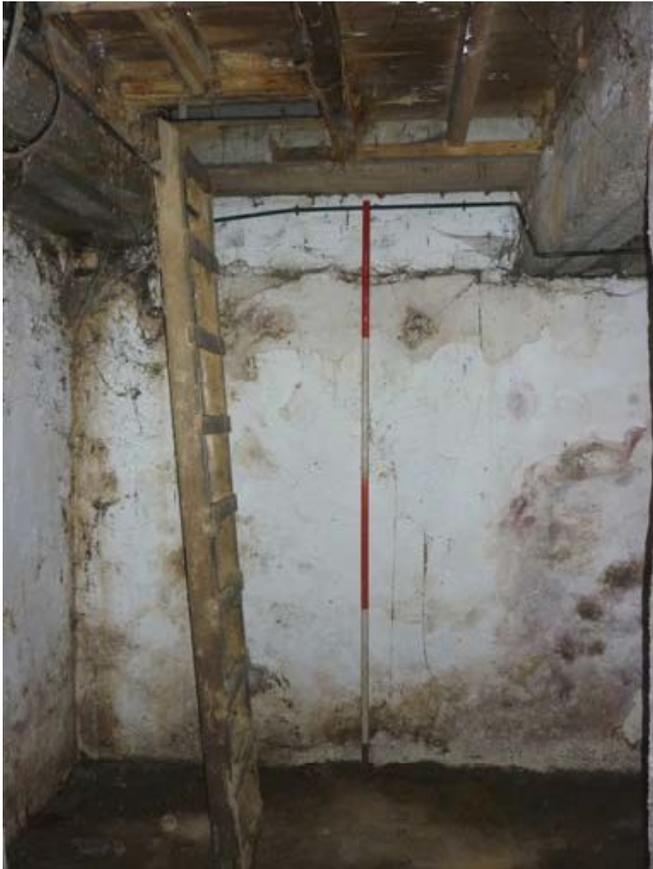
Plate 19 (left): Ladder between the cellar and Room G9a

4.3.1 **Cellar:** this is effectively divided into two parts, the southern of which forms the current point of access via a ladder to a hatch leading into Room G9a (Plate 19). The entire cellar had a concrete floor, the southern part of which was plain, while the northern part incorporated a small rectangular hole housing a gas meter and a drain cover. The ceiling was in general formed by timber joists supporting the boards of the floor above, all of which were machine cut, although the southern part also had rows of concrete beams orientated east/west either side of the access hatch. The walls were all finished with plaster, in poor condition, and whitewash and were all plain in the southern part although the access between the southern and northern parts was apparently inserted. The walls of the northern section were also relatively plain; the south-east corner was angled mirroring Room G5 above, and a now disused and blocked staircase was situated on the north side of the east elevation, the stairs comprising bricks with stone treads (Plate 20).

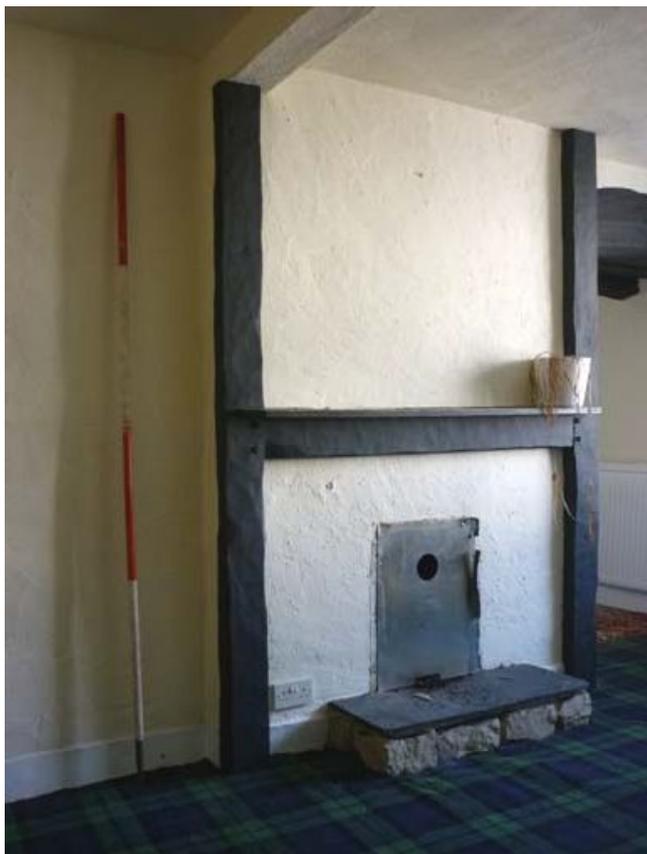
Plate 21 (left): Fireplace, west side of Room G1

4.3.2 **Ground Floor Room 1:** this formed the eastern most room of the northern section of the building, and had a carpeted floor over hardboard sheets (presumably lain on floorboards) with modern bench seating around the east and north walls. The ceiling was finished with wall paper and there was a single beam orientated east/west. All of the walls were finished with flock wallpaper and painted, except the west, which had a rough plaster finish. The north elevation had a modern aluminium vent on the west side and a central window with splayed jambs and a timber sill. The east elevation was plain, while the south had a narrow doorway on the west side with a rough piece of timber, with no apparent function, attached on the east side and a re-used beam and two other rough timbers forming a lintel. Between these was stuffed newspaper dated February 20<sup>th</sup> 1994. The west elevation had a doorway on the south side with two rough pieces of timber forming the lintel, and a central chimney breast with attached rough timbers and a mantle piece forming a surround of sorts (Plate 21). The hearth opening was covered by a metal sheet with a central hole, presumably to house a flue for a wood burning stove, and to the north

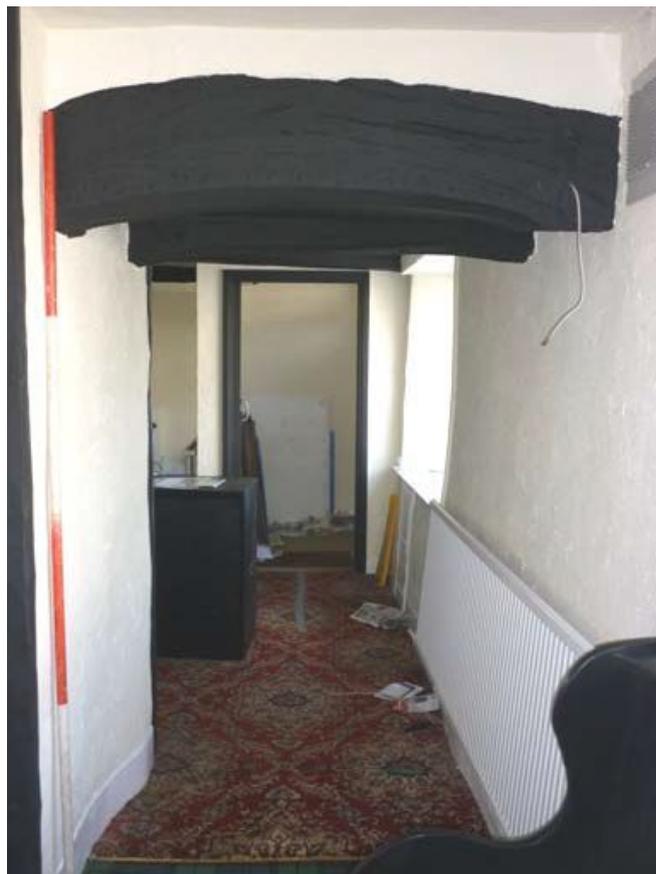
Plate 22 (right): 'Arched' doorway between Room G1 and G2

there was a second doorway with a large hand-finished timber lintel with a stop-chamfered arch carved into it (Plate 22).

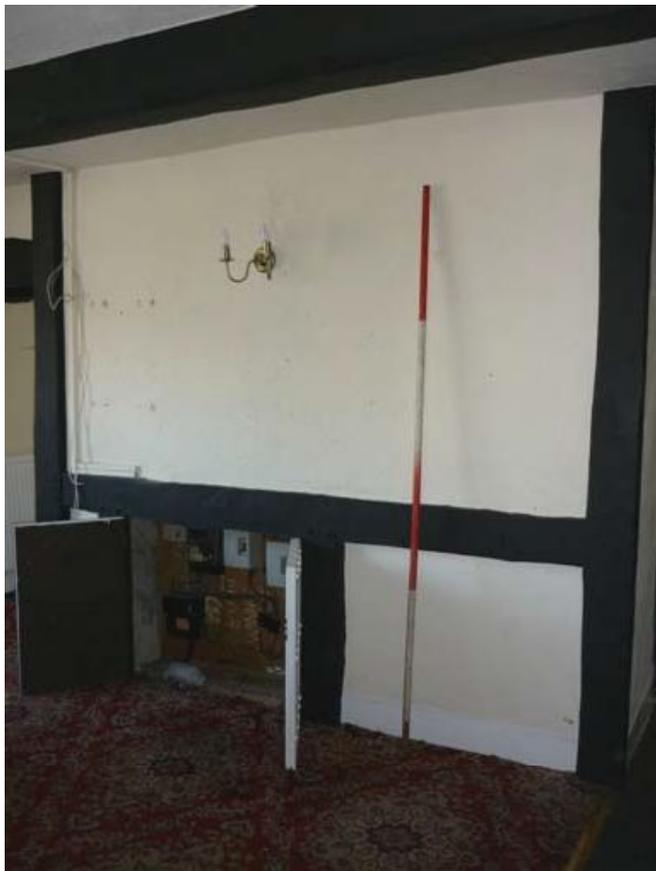
**Plate 25 (left): Fireplace re-used as a cupboard on the east side of Room G2**

**4.3.3 Ground Floor Room 2:** this forms the main ground floor room of the northern part of the building connecting the front entrance to the rest. The floor was finished with carpet and vinyl and the ceiling finished with wallpaper and supported by two centrally positioned north/south orientated beams. The western of these was probably original, and was hand-finished with stop-chamfer decoration (Plate 23). In addition it had a row of small notches on the north side (Plate 24) and other marks on the underside, perhaps carpenter's marks or levelling notches (Miles and Russell 1995). The eastern beam was perhaps modern as it was apparently covered by false rough-timber boxing. Two further hand-finished beams were also present at the west end forming lintels for the access to Room G3, and short sections of wall formed a porch around the doorway to the north, the southern and eastern of which were evidently not substantial and housed a 10-light window and modern doorway. The north elevation proper had the main door on its west side, the jambs of which were covered with beaded panelling and which had a plain door with a single-light overlight. To the east was a large window with splayed jambs, slightly in-turned at the top and a timber sill and below it a small alcove had been cut into the wall to house a meter box. This had brick in the 'jambs' and was covered by a plank door. The east elevation had a central chimney breast with doorways either side leading to Room G1, the northern of which had a chamfered 'arch' cut into the timber lintel while the other timbers making the lintel were re-used. The central section had attached timbers to provide a 'half-timber' affect and the fireplace had had a pair of plank doors attached to form a meter box within the opening (Plate 25), which had splayed jambs and the original form of the flue visible inside. The south elevation had essentially been removed to form the opening for the bar and access to rooms to the south-west. Re-used timbers have been used to create the structure of the bar and support the opening although a column of masonry had also been retained and modern beams clad with false distressed timber boxing supporting this opening. The bar itself was an essentially modern construction (Plate 26). The west elevation had also been largely opened up to

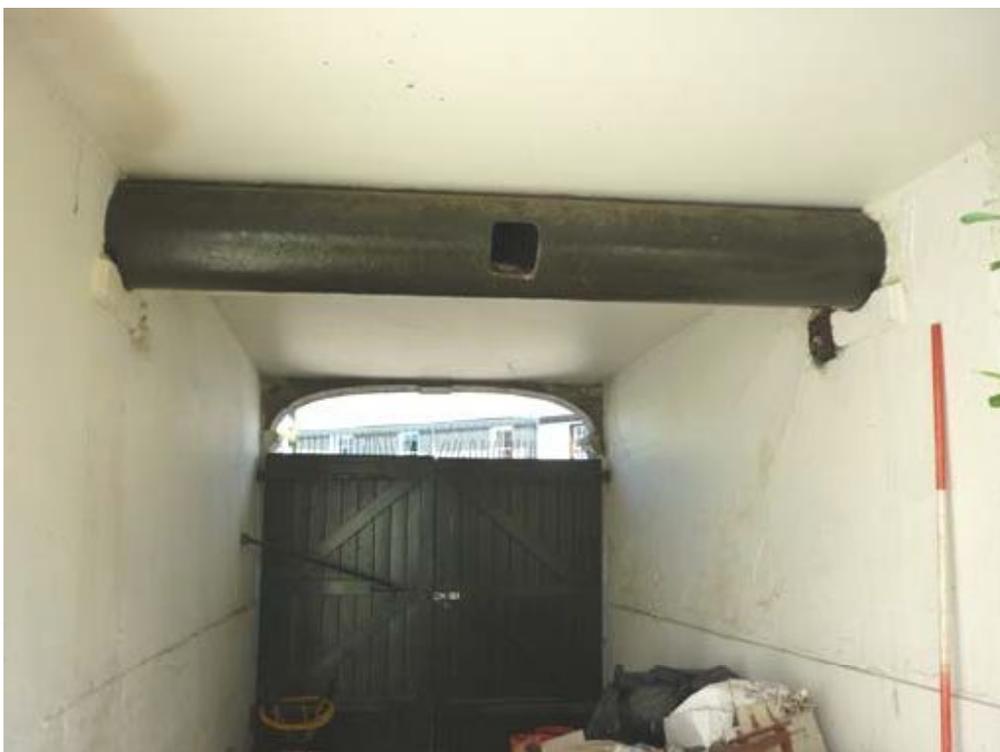
**4.3.5 Ground Floor Room 4:** this is essentially an exterior space, forming an access passage between the street to the north and the yard along the west side of the southern part of the building. The floor was finished with a mixture of flags and cobbles and the ceiling plastered, and supported by a large east/west orientated timber beam. There is also a large iron pipe on a similar alignment to the south, which is supported on dressed stone corbels in the east and west elevations (Plate 27), adjacent to each of which was a small iron-lined opening with a hinged iron door. The walls, which are only present to the east and west, were finished with plaster and paint. The north elevation comprised a wide opening to the street, filled by a double wagon-gate of plank and batten construction with large strap hinges. The east elevation was relatively plain, the upper part of the plaster scored to give the appearance of ashlar blocks and the lower part projecting slightly. On the south side was a 12-light window in a recessed area extending from ceiling to floor, above which was a plastic vent grill. The south elevation was open to the yard beyond, the opening supported by a large machine cut square-section lintel. The west elevation was plain, with a slight step in the plaster creating a plinth like that to the east.

**Plate 27: General view of Room G4, showing the gated entrance and pipe supported by corbels below the ceiling**

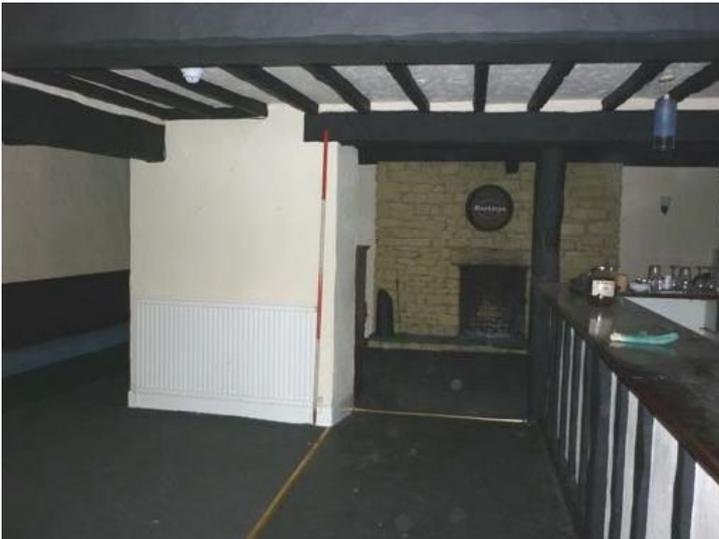
**Plate 28 (left): General view of south side of Room G6**

**4.3.7 Ground Floor Room 6:** this formed a room to the rear (south) of the east end of rooms along the north range. The floor was finished with carpet and vinyl and the ceiling was supported by a large east/west beam clad with rough timber boxing, with smaller north/south joists running from it (Plate 28), while to the east the joists were orientated east/west (Plate 29). The walls were generally finished with rough plaster. The north elevation was open on its west side to Room G2 although containing the bar, with rough timbers forming beams and posts supporting the bar structure. To the east the elevation was essentially plain apart from two doorways/openings to Rooms G1 and G2, with the section of wall between angled. The east elevation was essentially plain, with a continuous run of bench seating against it. The south elevation was largely open to Room G7 beyond, with the beams supporting the openings in turn supported by upright posts that form have been used as part of the bar structure. The west elevation was within the bar and largely obscured by later shelving and fittings. There was an angled recess in the south-west corner, which had evidently originally formed a window and housed a single-light casement that had been painted over. The north side of the elevation was essentially open into Room G5 over above bar.

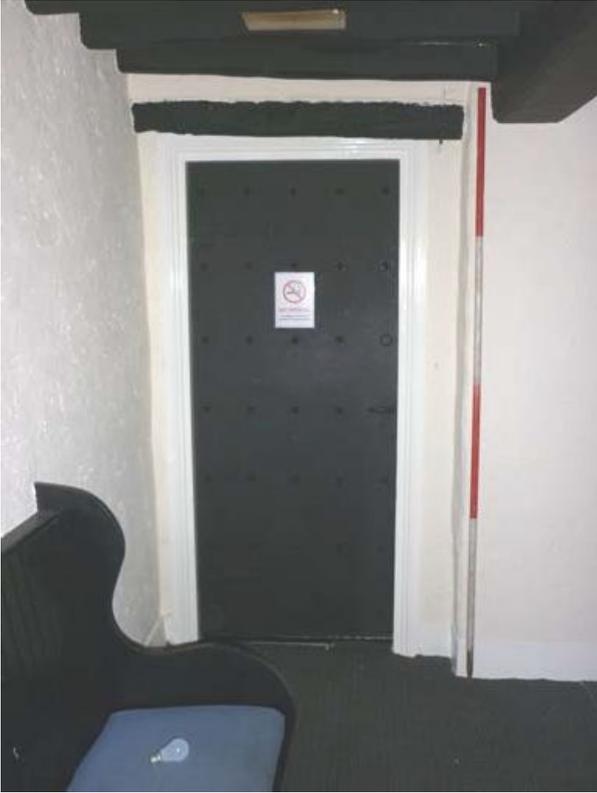
Plate 30 (left): Doorway between Room G7 and G8

**4.3.8 Ground Floor Room 7:** this formed a second back room to the rear (south of Room G6). The floor was finished with carpet and the ceiling supported by two beams orientated north/south with east/west joints between, although it was apparent that this was almost entirely a false suspended structure (see below) with a single access hatches on the east and west of the south side. The walls were typically finished with plaster and paint. The north elevation had two large openings into Room G6, the western of which contained part of the bar, with false half-timbering. The east elevation was relatively plain, with bench seating along it. The south elevation had a doorway on the east side with a moulded surround, rough timber lintel, and studded door with elaborate hinges (Plate 30). The central part of this elevation comprised a projecting chimney breast of stripped stone that had been painted (Plate 31). The fireplace opening had a heavy limestone lintel and a raised plinth topped with slate extended across the base of the entire chimney breast, in front of which there was a thick iron sheet acting as a hearth. The back of the fireplace was finished with brick. The west elevation also had bench seating along its entire

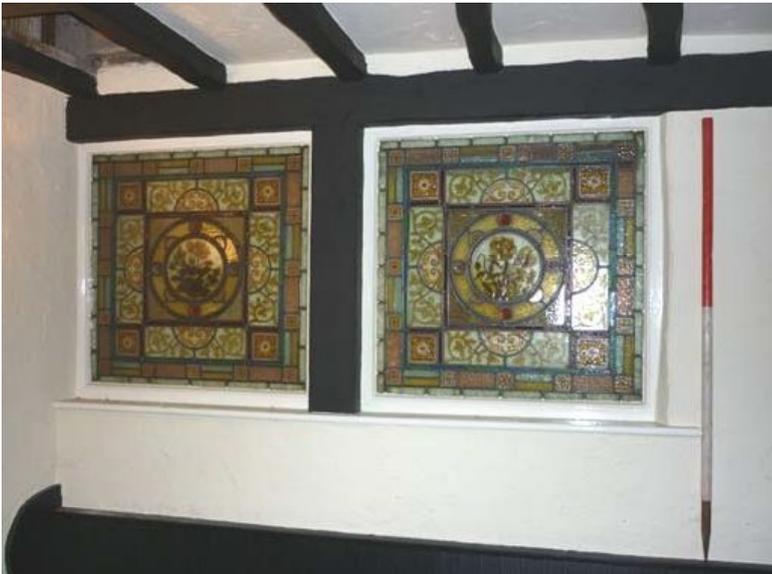
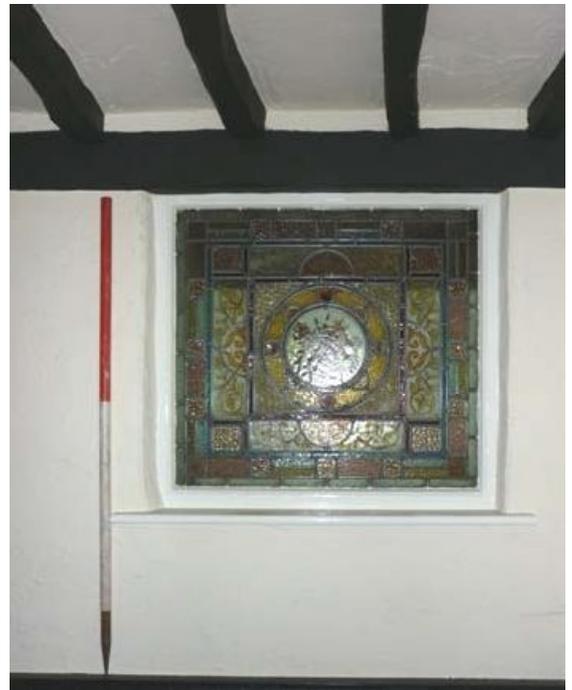
length and housed three windows each with stained glass panes with painted floral motifs (Plate 32 and Plate 33).

Plate 32 (left): Southern stained glass windows in the west elevation of Room G7

Plate 33 (right): Northernmost stained glass window in the west elevation of Room G7

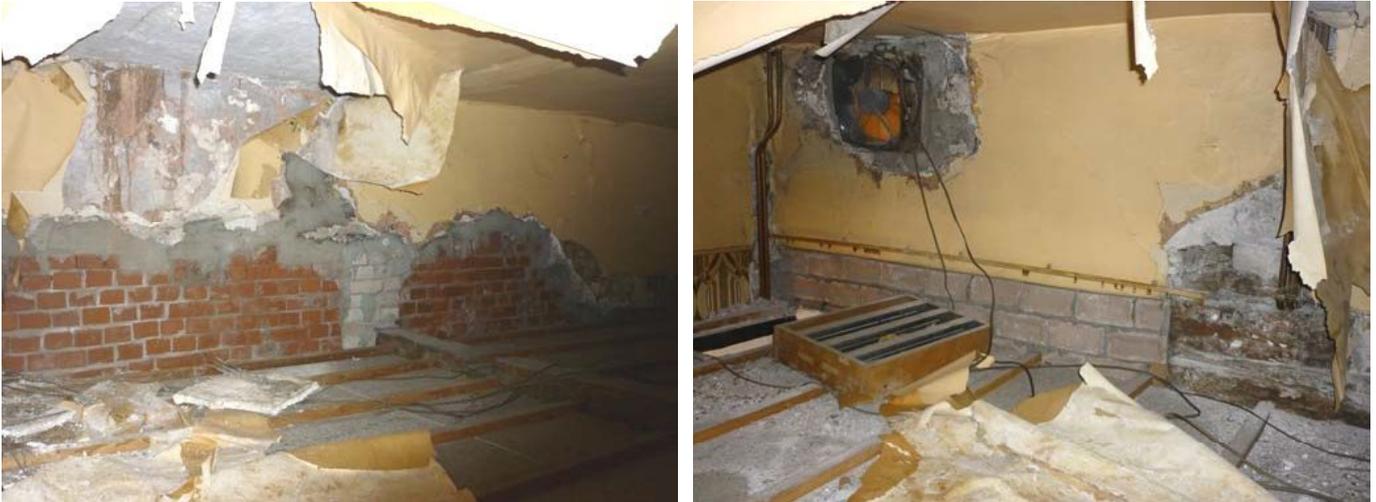
while the central beam was perhaps original, although it had clearly been reused. The proper ceiling was in poor condition in the north-west corner, which revealed that it was of reed plaster construction attached to what was probably Baltic pine. The north and east elevations had evidently been extensively modified, with new beams added above the suspended ceiling with resulting rebuild in brick (Plate 34). It was also apparent that there was originally a wall on the line of the eastern north/south beam, to the west of the current east elevation, suggesting that there was originally a covered passageway extending along the east side of this part of the building. In addition, the top of a large opening was evident in the west elevation, above the three stained glass windows, which had evidently been filled with concrete blocks; a curtain rail was still attached to the wall above it (Plate 35).

**Plate 34 (left): Rebuilt section of the north elevation above the suspended ceiling in Room G7**

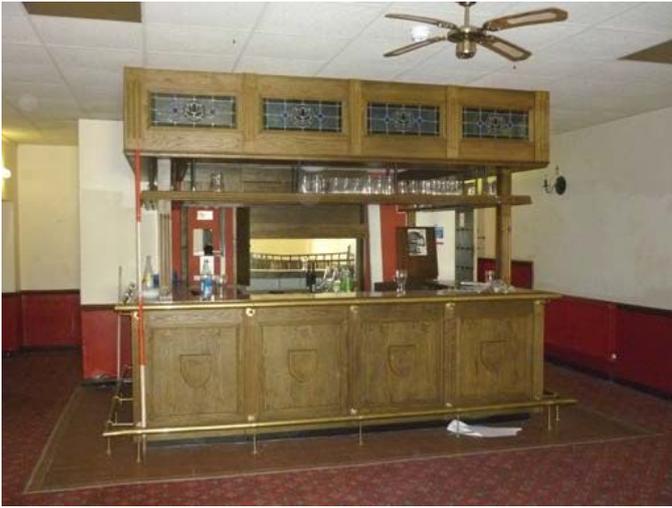
**Plate 36 (left): Bar at the north end of Room G8**

**4.3.10 Ground Floor Room 8:** this forms a large hall at the south end of the building, with an associated staircase (Room G8a) within stud walls at the north end of this. The main had a bar at the north end (Plate 36) and raised sections of flooring in the south-west corner and against the centre of the east elevation. The floor at the north end was finished with carpet, while the rest comprised tongue and groove boards orientated east/west. The actual ceiling was not visible, it being obstructed by a suspended ceiling constructed from foam tiles supported by an aluminium frame. The walls were all finished with plaster and paint with an attached dado rail and skirting board. The centre of north elevation was covered by a large bar with stud walls behind enclosing the stairs, and a doorway to the east accessed via two stairs. The east elevation was essentially plain, with projecting timber boxing (presumably around pipes) on the north side and a raised area and seating against it. The south elevation also had a raised area against it on the west side and seating (Plate 37). In the centre there was a large window with projecting jambs, while the west elevation was plain apart from three modern inserted and plain doorways and further boxing around pipes.

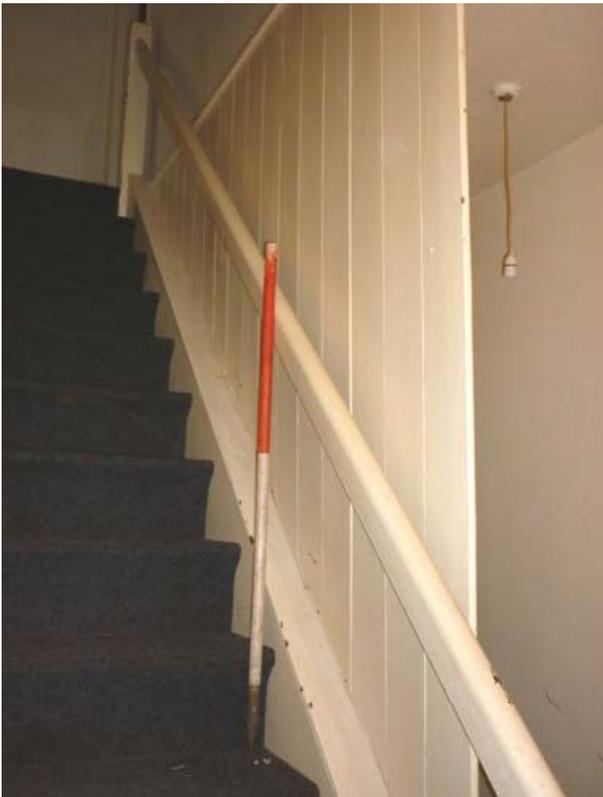
**Plate 38 (left): Panelling against stairs in Room G8a**

4.3.11 The stairs (Room G8a) comprised a small room formed by stud walls at the north end of Room G8. The steps themselves were finished with carpet and the walls and ceiling with flock wallpaper, although the walls also had a modern skirting board. There was a doorway to the east with a plain modern surround and tongue and groove plank door. The stairs were relatively plain although a square newel post and section of tongue and groove panel, beaded on the south side, against the square-section hand rail are perhaps original (Plate 38). In addition, a section of early moulded cornice was also present along the ceiling on the north side of the landing (Plate 39).

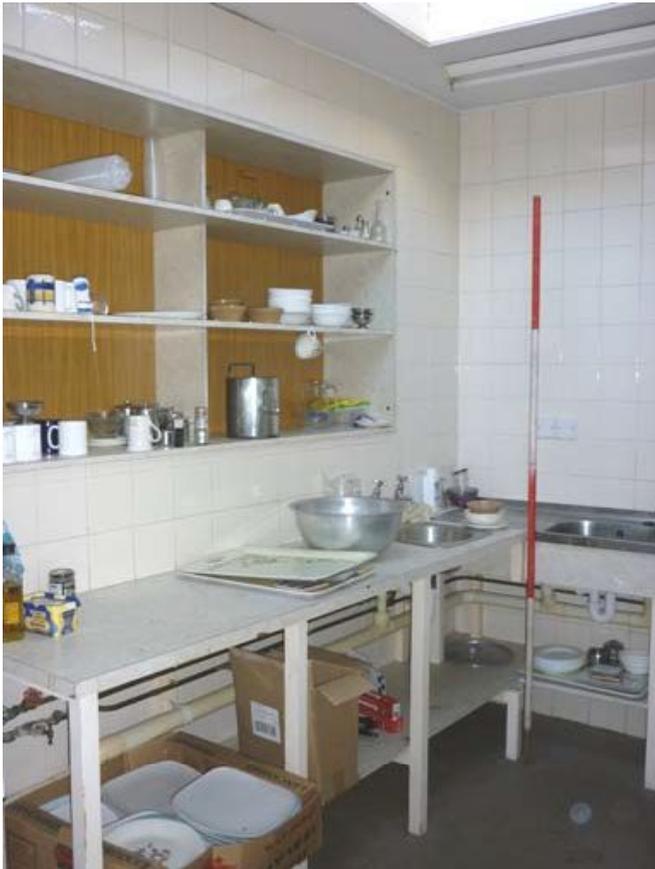
**Plate 40 (left): General view of Room G9a showing alcoves in east elevation**

kitchen, with a vinyl-covered floor (with a hatch to the cellar on the north side), work tops against the east and south elevations, and a flat plaster roof with a domed skylight. All of the walls were tiled. The north elevation had a large central alcove, perhaps originally a doorway that had had shelves added to it. The east elevation also had two alcoves, corresponding to the windows in Room G6, also with shelves (Plate 40). The south elevation was plain, while the east had a doorway at the north end with a plain panel door with a single light. Room G9b formed a short linking corridor. The floor was also finished with vinyl, and had two steps up to the north, and the ceiling was flat and finished with plaster. The walls were also finished with plaster and paint and had a modern skirting board. The walls were typically plain and each had a single doorway with a modern door, apart from the west, which had two. Room 9c formed a small storage room on the west side of 9b, with a bare concrete floor and flat plaster ceiling. The walls were all plain and finished with plaster and paint and there was a two light window in the north with a hinged casement and a doorway to the east.

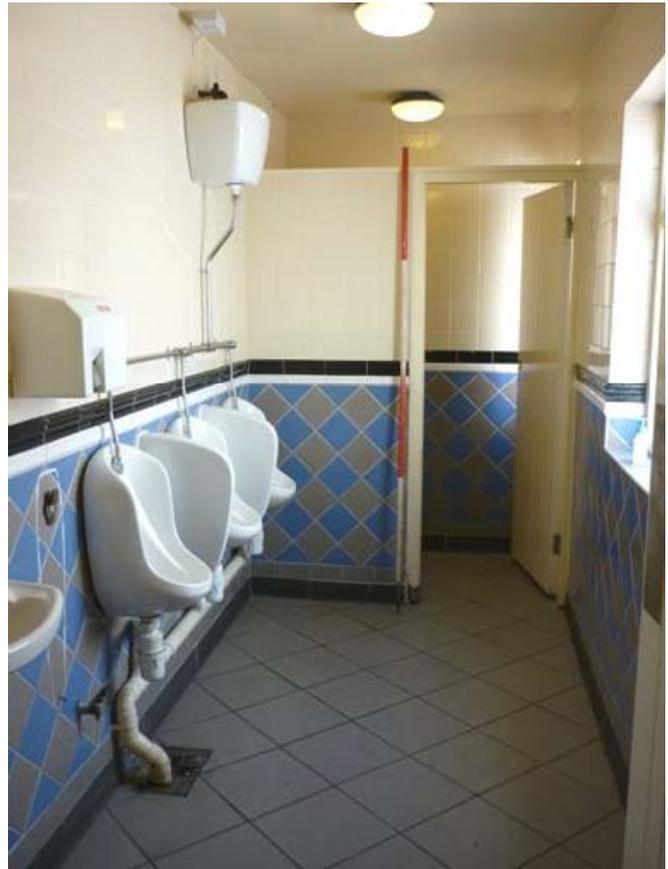
**Plate 41 (right): General view of gents toilets in Room G10**

4.3.13 **Ground Floor Room 10:** this forms the male and female toilets, linked by a corridor orientated east/west along the north side. The floor was tiled throughout and the ceiling plastered and painted; the walls were finished with plaster and paint within the corridor and tiled in the toilets. The corridor was plain, with modern doors at both ends and one to the north on the west side and one to the south on the east. The toilets had modern cubicles and toilet fittings throughout, with the ladies' toilets to the east and gent's to the west (Plate 41).

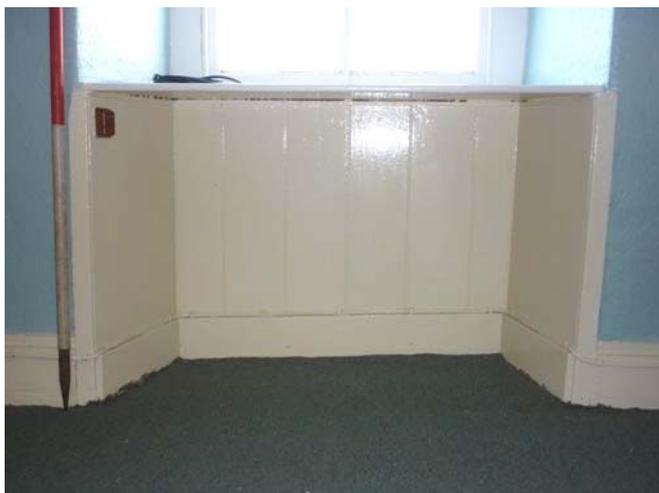
**Plate 42 (left):** Panelling in the lower part of the window reveal, north side of Room F1

4.3.16 **First Floor Room 1:** this formed the easternmost room within the northern part of the building. The floor was finished with carpet and the ceiling plastered and painted, with the south-east corner sloping down. The walls were finished with painted wallpaper and there was a roll-moulded skirting board throughout. The north elevation had a window east of the centre with splayed jambs extending to the floor with a thin sill below the casement resting on top of beaded panelling that covered the lower part of the jambs (Plate 42). The east elevation was relatively plain, apart from a moulded beam running north/south below the ceiling level. The lower edge of this was ovolo-moulded and there was bolt in the underside and a further ovolo-moulded fascia attached on top (Plate 43). The south elevation was plain, as was the west although it had a doorway on the south side with a moulded surround and four panel door, plain on the east side and moulded on the west.

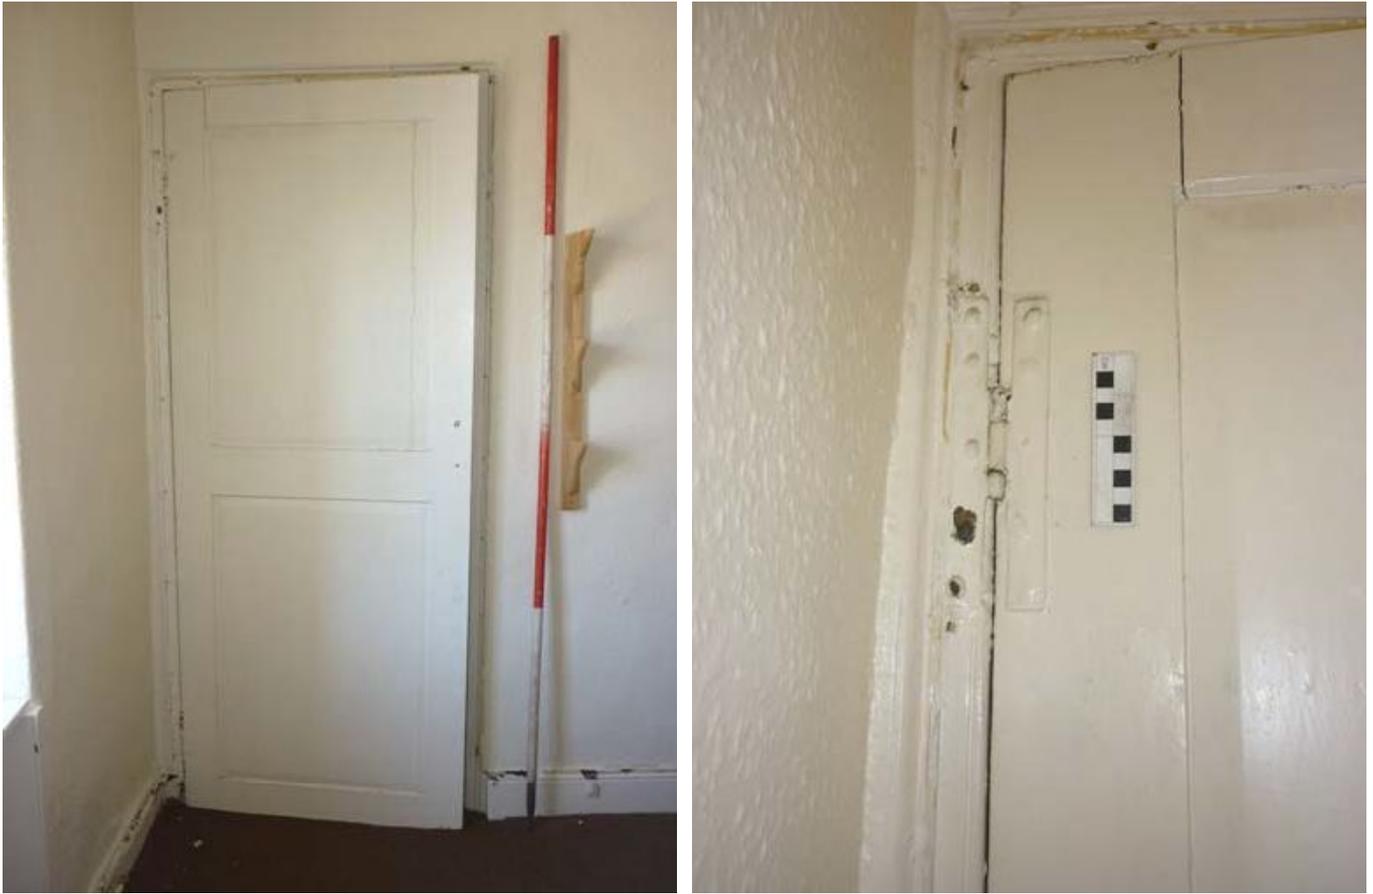
4.3.17 **First Floor Room 2:** this was the adjoining room to the west of F1. The floor was finished with carpet laid on over largely modern replacement floorboards, and the ceiling plaster finished with flock wallpaper. The walls were finished in a similar style, with a modern skirting board. The north elevation had a central window with splayed jambs and a thin timber shelf resting on beaded panelling, as per Room F1, although a square hole had been cut through the centre and filled with cement. The east elevation had a cupboard on the west side (Plate 44), with an early panelled door held by H-shaped hinges (Plate 45). Internally it had chamfered battens forming shelf brackets. The south elevation curved at its west end before meeting the doorway into the corridor, which had a plain surround but a moulded four panel door. The west elevation was plain.

**Plate 44 (left): Cupboard, east side of Room F2**

**Plate 45 (right): Detail of H-shaped hinge to cupboard door, east side of Room F2**

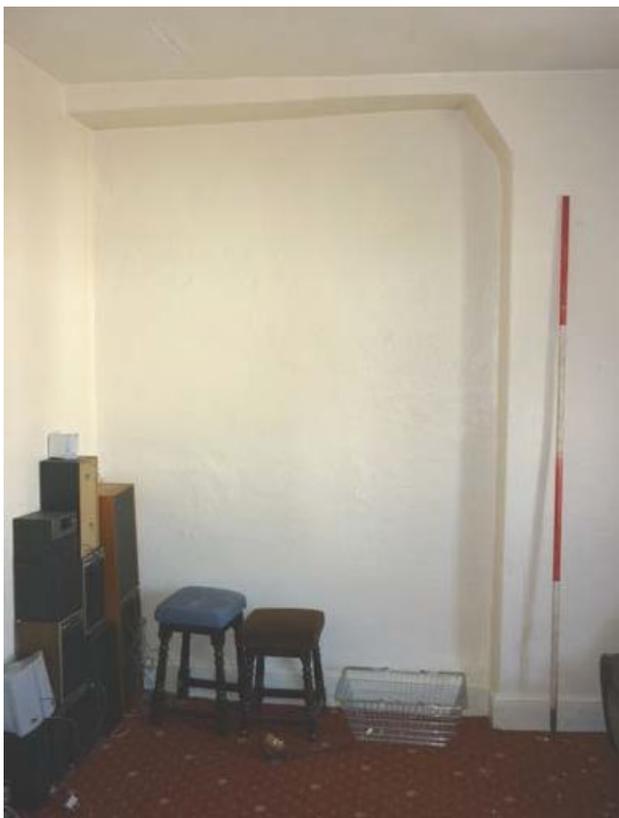
**Plate 46 (left): Alcove in the west elevation of Room F3**

4.3.18 **First Floor Room 3:** this was situated to the west of Room F2. Its floor was also finished with carpet and the ceiling plaster covered with flock wallpaper. The walls too were all finished with plaster and wallpaper and had a skirting board. The north elevation had a central window, as per those in Rooms F1 and F2 with the same sill and beaded panels. The east elevation was relatively plain, while the south had a doorway on the east side with a four moulded panels. The west elevation was also relatively plain, apart from an alcove on the south side (Plate 46), which was angled at the top; the thicker section of wall to the north evidently housing the base of the cruck blade visible in the roof space (see Section 4.3.29 below).

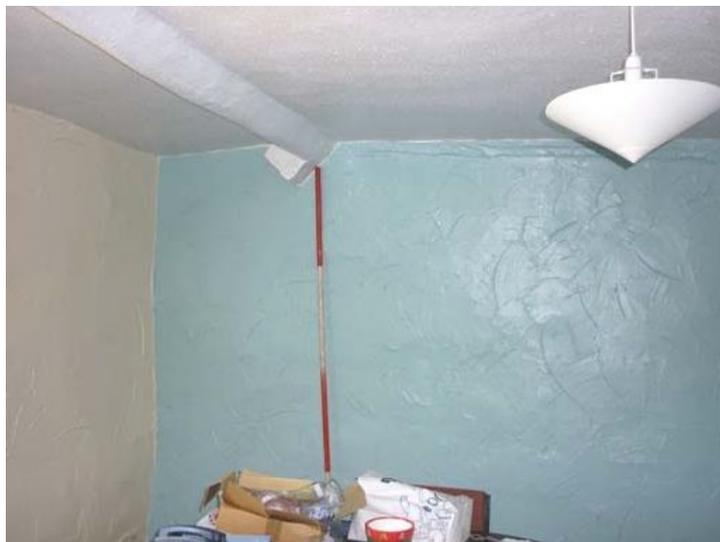
**Plate 47 (right): Exposed beams on the north side of Room F4**

4.3.19 **First Floor Room 4:** this formed the most westerly of the row of rooms along the north end of the building. The floor was finished with carpet and the ceiling plaster finished with flock wallpaper, with a beam or purlin exposed on the north side (Plate 47) and slope of the ceiling on the south side evidently incorporating another boxed beam (Plate 48). The walls were all finished with rough plaster, painted blue, and had a roll-moulded skirting board. The north elevation had a central window with splayed jambs, which didn't extend to the floor, and had a timber sill. The east elevation had a doorway on the south side with a moulded surround and moulded four panel door, and a step down into the room beyond (F5). The south and west elevations were both plain.

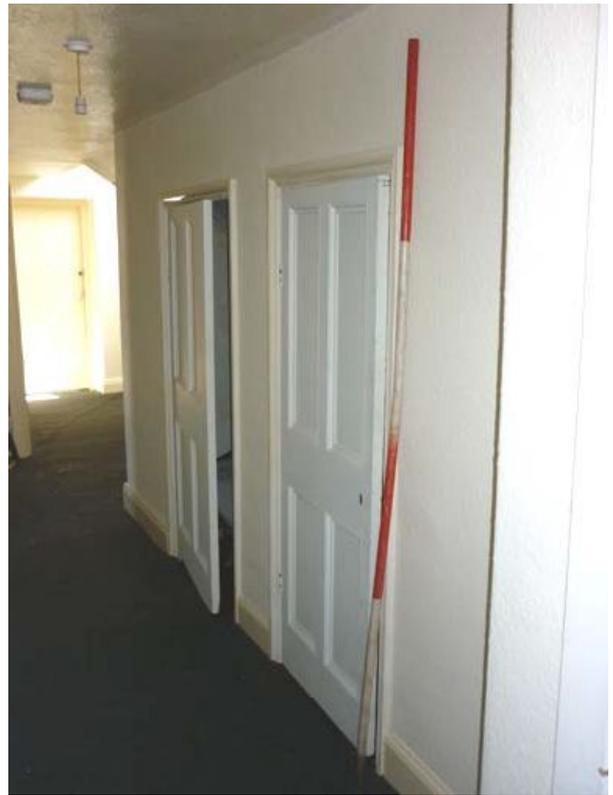
**Plate 49 (right): Cupboards against the south side of Room F5**

**4.3.20 First Floor Room 5:** this formed an essentially L-shaped corridor linking Rooms F1-F4 and F6 to the southern end of this floor and the stairs to the ground floor, with a small bathroom (Room F5a) off the south side of the centre. It also had a small hatch accessing the roof space on the centre of the north side. The floor was finished with carpet with a step at the east end down towards the stairs, while it rose slightly to the west prior to the step into F4. All of the walls had a modern flock wallpaper finish throughout and a modern skirting board on the south side and earlier type on the north. The ceiling generally sloped down to the south along the east/west section, following the line of the roof, although there was a raised section at the return to the south housing a skylight. There were stud walls along the south side at the west end forming a large cupboard with two doorways with moulded four-panel doors (Plate 49). Internally the stud work of the cupboard walls was exposed and apparently of relatively early construction and the sloping line of the ceiling continued within. At the east end of the corridor, at the turn to the south, there were further inserted stud walls forming another cupboard, with a small single-light window in the west side with the word 'LADIES' painted on (Plate 50), and a doorway in the south side with a moulded door but plain surround. Inside this cupboard was a single skylight in the ceiling/roof on the east side and the south elevation was constructed from timber panelling on the east side with two moulded rails. This panelled section formed the side of a large alcove with shelves in the east elevation, with a moulded surround that appears to have originally housed sliding doors (Plate 51). Room F5a had a tiled floor and walls, the north and east walls being stud partitions. There were modern fittings attached across the south elevation and the ceiling sloped down on the west side.
