# CAVENDISH ARMS, MARKET PLACE, DALTON-IN-FURNESS, CUMBRIA

## Archaeological Building Recording

Client: Frederic Robinson Ltd

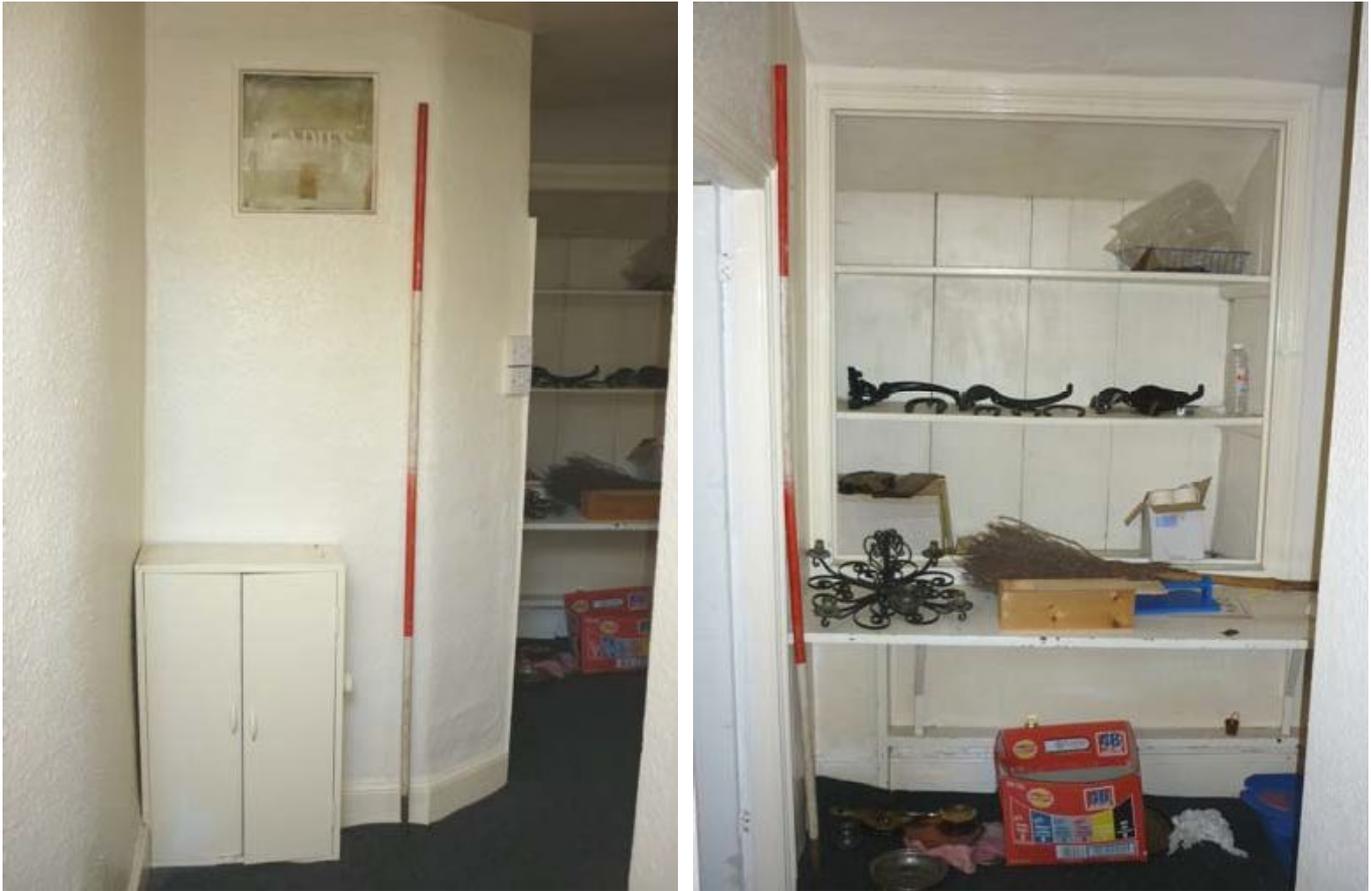
**4.3.20 First Floor Room 5:** this formed an essentially L-shaped corridor linking Rooms F1-F4 and F6 to the southern end of this floor and the stairs to the ground floor, with a small bathroom (Room F5a) off the south side of the centre. It also had a small hatch accessing the roof space on the centre of the north side. The floor was finished with carpet with a step at the east end down towards the stairs, while it rose slightly to the west prior to the step into F4. All of the walls had a modern flock wallpaper finish throughout and a modern skirting board on the south side and earlier type on the north. The ceiling generally sloped down to the south along the east/west section, following the line of the roof, although there was a raised section at the return to the south housing a skylight. There were stud walls along the south side at the west end forming a large cupboard with two doorways with moulded four-panel doors (Plate 49). Internally the stud work of the cupboard walls was exposed and apparently of relatively early construction and the sloping line of the ceiling continued within. At the east end of the corridor, at the turn to the south, there were further inserted stud walls forming another cupboard, with a small single-light window in the west side with the word 'LADIES' painted on (Plate 50), and a doorway in the south side with a moulded door but plain surround. Inside this cupboard was a single skylight in the ceiling/roof on the east side and the south elevation was constructed from timber panelling on the east side with two moulded rails. This panelled section formed the side of a large alcove with shelves in the east elevation, with a moulded surround that appears to have originally housed sliding doors (Plate 51). Room F5a had a tiled floor and walls, the north and east walls being stud partitions. There were modern fittings attached across the south elevation and the ceiling sloped down on the west side.

**Plate 50 (left): Cupboard on the east side of Room F5**

**Plate 51 (right): Cupboard built into an alcove in the east elevation of Room F5**

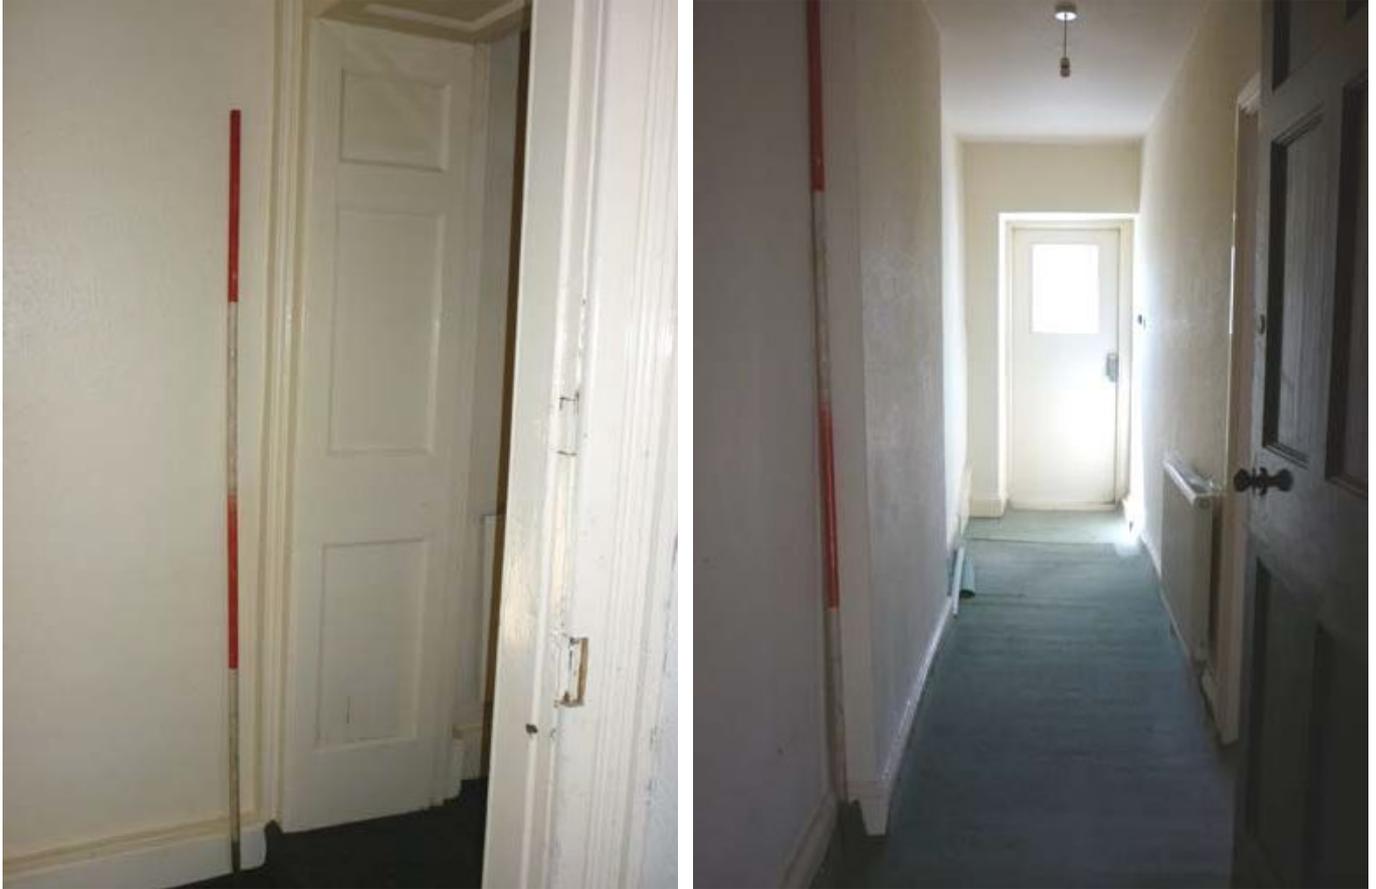
actual door. The east elevation was essentially plain, but with a circular window on the north side with iron bars across it and a single frosted pane. The south elevation was formed from modern stud walls, with doorways linking to the other rooms on this floor. Within the east/west section the south elevation was a solid wall, with a central projecting chimney breast (Plate 53). The west elevation also comprised stud walls on the south side with further doorways before meeting the access to the stairs to the ground floor before reaching the east/west section, which had a doorway with a modern forming a fire escape at the west end, and the panelled opening at the top of the linking stairs.

**Plate 52 (left): Panelled door jamb in Room F8**

**Plate 53 (right): East/west section of Room F8 showing chimney breast**

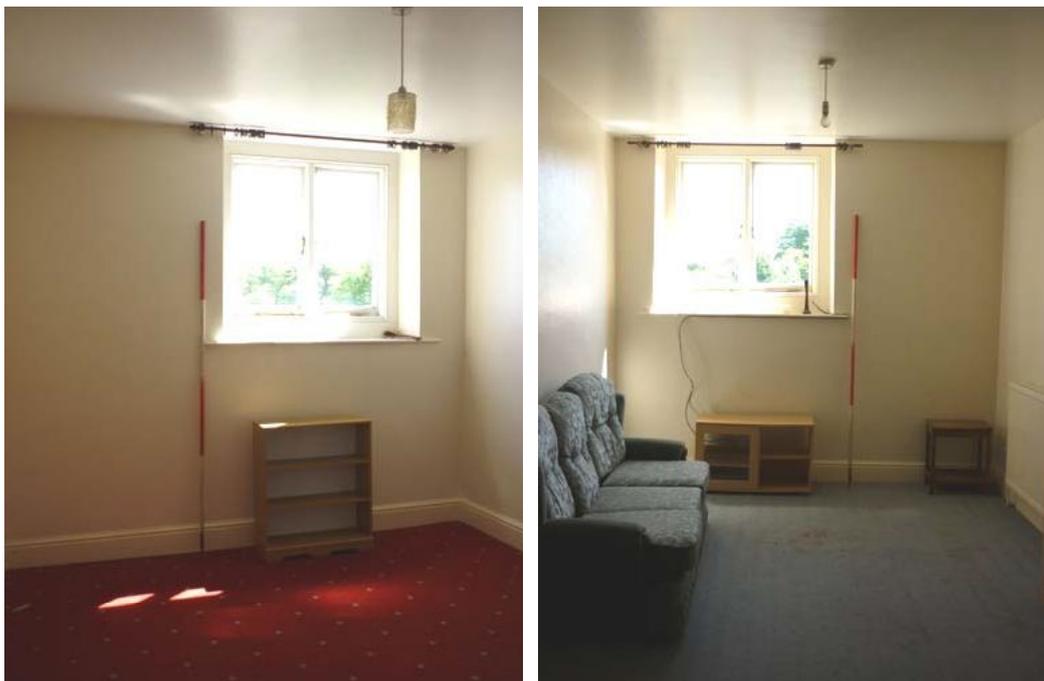
**Plate 54 (left): Window in south elevation of Room 11**

4.3.26 **First Floor Room 11:** this formed a bedroom. The floor was finished with carpet and the ceiling plaster and paint. The north and east walls were modern stud construction and all the walls were finished with plaster and paint with a moulded skirting board. There was a doorway to the north with a modern door and a window to the south with a two-light hinged casement, splayed jambs and timber sill (Plate 54).

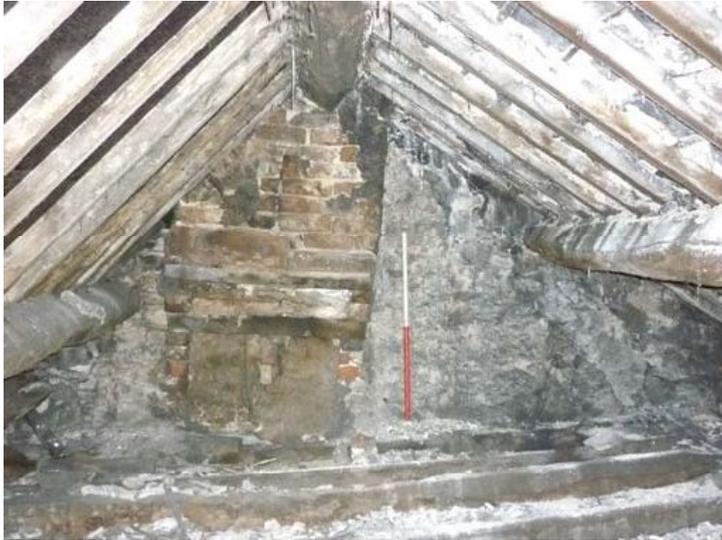
**Plate 56 (left): Chimney breast in the western bay of the north roof space**

**4.3.28 North Roof Space:** this comprised two sections: an east/west part running over Rooms F1-F4 and part of F5, and a north/south part running over the remaining part of Room F5 and F6. The east/west section was four bays long, the easternmost bay formed between the solid masonry wall at the end of the western three bays and the wall shared with the adjoining property to the east, while the north/south section was essentially a single roof space. The western bay of the east/west section (above Room F4) had rough hand-finished joists forming the floor, which was slightly lower than that to the east, and two hand-finished purlins per pitch, plus a diagonally-set hand-finished ridge purlin. All the purlins end at the truss forming the bay to the east; the ridge purlin joined by a simple scarf joint, the others overlapping. The north and south elevations were not visible while the west was a solid stone wall, with an attached brick chimney stack projecting from it (Plate 56 and Plate 57). The bricks were hand-made and mid reddish-orange in colour, the upper part finished with rough plaster, and the base of the stack was finished with two blocks of red sandstone, one of which was moulded and had iron fittings and was evidently re-used. These sat on a timber beam, which was in turn on a pair of projecting timbers forming a corbelled base, below which was brickwork seemingly forming the top of two flues. The east end of this bay comprised the face of a raised cruck truss (Plate 58). The cruck blades were relatively straight, and had additional packing pieces, particularly on the north side, which was perhaps caused by the apparent unevenness in the pitch of the roof, seemingly caused by modifications to the south side. There was a short collar just below the apex and a longer one close to the floor/ceiling level, with the cruck blades extending through the floor level to be encased in the stud walls of the rooms below. Additional spurs were also apparent within this area, and a levelling mark was visible on the west face of the northern packing piece. All of the joints between the timbers were pegged.

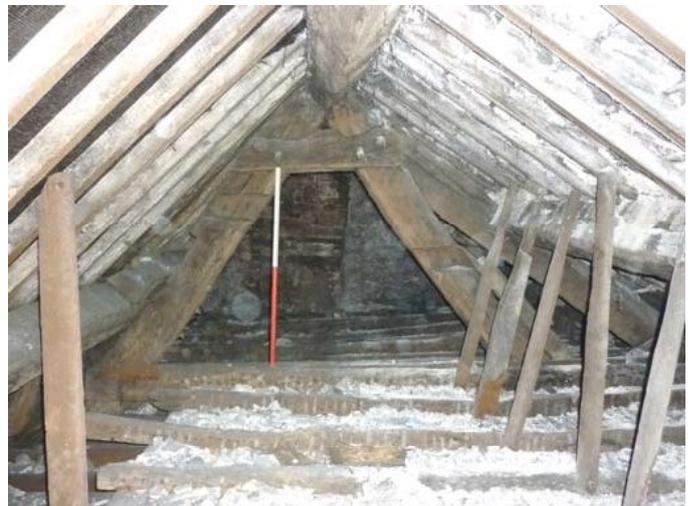
**Plate 58 (left): West face of the western cruck truss**

5.3.1 In order to better understand the development and origins of the site it would be necessary for a programme of dendrochronological dating to be carried out on the early trusses. However, unless these are due to be removed or badly damaged as part of the proposed development it is difficult to justify such work. However, it is likely that further information of interest would be revealed inside the building following soft stripping of internal fittings, if redevelopment was to go ahead. In addition, the proposed demolition of the 20<sup>th</sup> century additions along the west side, while being of great benefit to the setting of the historic fabric of the building, might also reveal remains of archaeological interest below ground.

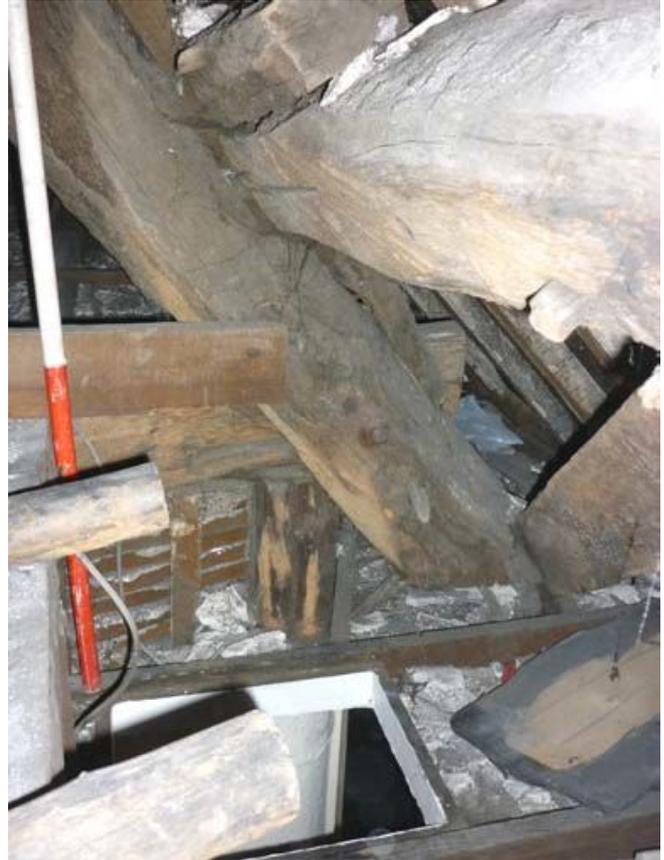
purlin, although a truncated wind brace was present on the south side extending from the purlin towards the truss, which it had evidently originally been attached to. The east end of the bay was formed by the west face of the eastern cruck truss, which was essentially the same as the west (Plate 60). However, the base of the southern cruck blade had been sawn off while the wind brace between it and the southern purlin was still complete and attached (Plate 61). There were less packing pieces supporting this truss, although the north side again had a more complex arrangement with a spur, and the northern cruck blade extended into the stud wall of the room below.

**Plate 60 (left): West face of the east cruck truss**

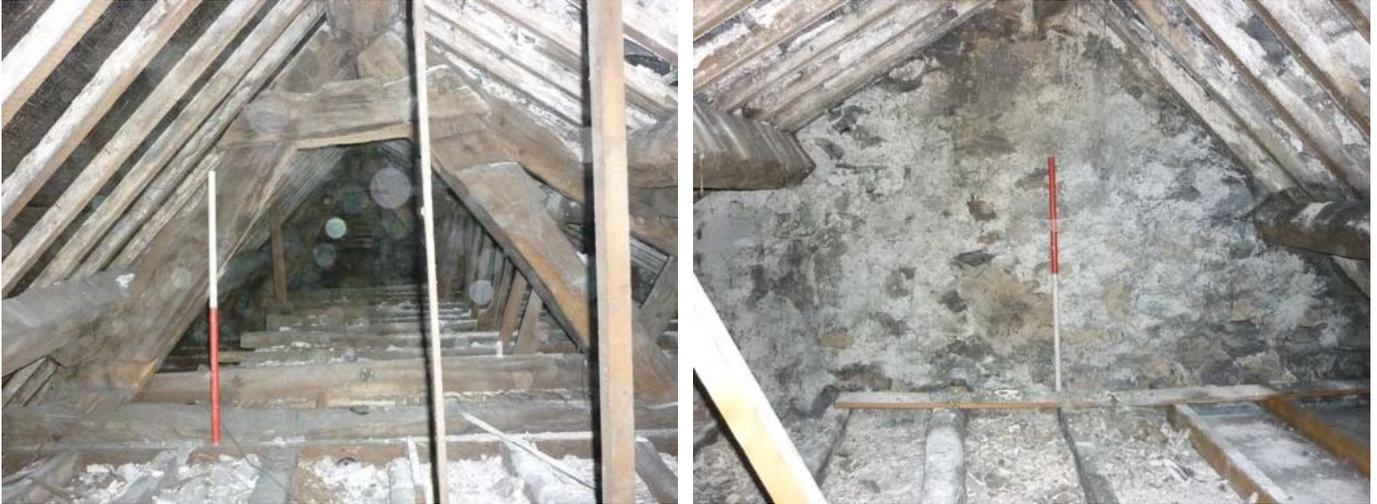
**Plate 62 (left): East face of the east cruck truss**

4.3.30 The east of centre bay was formed between the eastern truss and the solid wall at the east end. The floor was slightly lower than to the west but was again constructed from hand-finished timbers while the southern purlin had an empty joist slot and was evidently re-used and at least one of the rafters had Baltic timber marks. The east face of the truss to the west showed a similar arrangement to the western truss, with empty slots on the blades suggesting they were re-used and a slightly T-shaped upper collar (Plate 62). A carpenter's mark in the form of a chiselled 'I' was evident at the junction with the empty slot on the northern blade and a possible crescent-shaped carpenter's mark on the south plus possible levelling marks. The east elevation comprised a solid stone wall housing the flue for the chimney, and had evidently been truncated on the north side. The eastern bay was completely different in character to the rest. The floor was a mixture of rough hand-finished joists and machine cut timbers, supporting a chipboard ceiling, while the roof was supported by two purlins on the north pitch and one to the south plus a horizontal ridge purlin. The upper level purlins were hand-finished while the lower one on the north side and the ridge were sawn and probably Baltic timbers (Plate 63). The west elevation was partially truncated on the south side and the purlin was resting on a timber inserted into the masonry, rather than the end of the purlin in the bay to the west. Similarly, the lower purlin in the north pitch had clearly been inserted into the wall. There was some rough plaster on the upper part of the west elevation and all over the east elevation, and the west side of the south elevation was open into the roof space beyond. This had the top of the wall exposed in the floor, and a complex series of changes in roof line corresponding

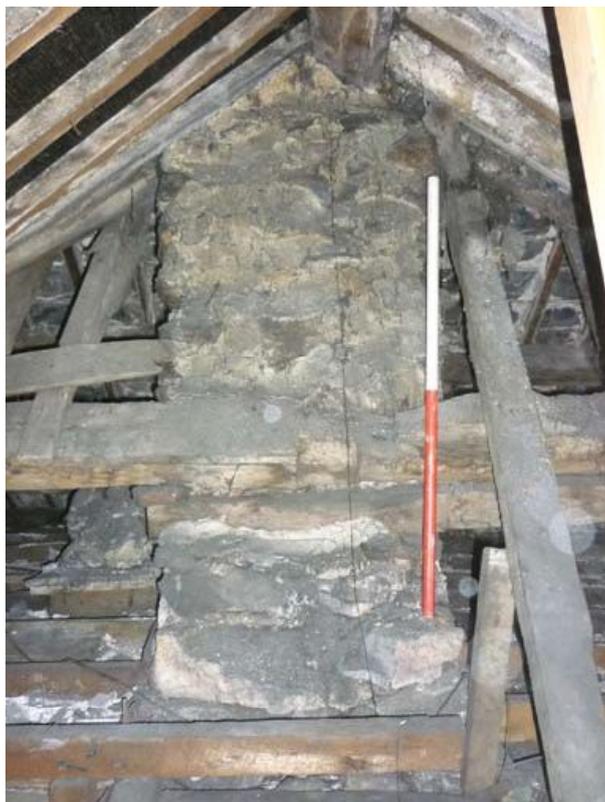
to areas of skylights above Room F5. There were a pair of sawn purlins on each side (east and west) with an evident scar approximately midway along the roof space denoting the former position of a truss, apparently removed to accommodate the sloping roof and skylight on the west side. On the west side the removal of this had been mitigated by the insertion of a brick-built wall that supported the purlins and was rendered on the north side (Plate 64). On the east side a single piece of timber resting on the top of the wall had been added to act as a prop. The south elevation was formed by a plain stone wall (Plate 65), while the arrangement of the timbers in the truncated wall between the end bays of the east/west section could clearly be seen from this end (Plate 66).

**Plate 66: Wall in north roof space showing inserted purlins**

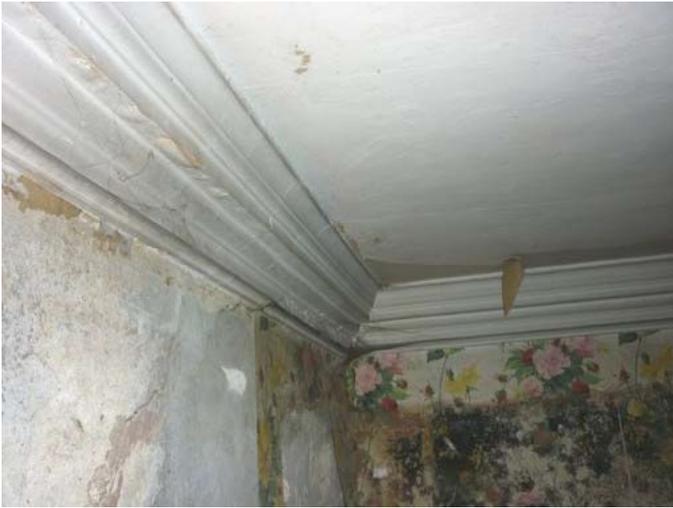
**Plate 67 (left): Cornice in the lower section of the south roof space**

4.3.31 **South Roof Space:** immediately above the suspended ceiling was a low crawls-space, the floor formed by modern joists supporting the suspended ceiling and associated insulation, while the ceiling above is the original ceiling comprising plaster with a moulded cornice extending all around and a second hatch into the main roof space above (Plate 67). The walls were all finished with plaster with the remains of wallpaper and were all plain apart from the south, which had two openings, one on either side, filled with plastic sheeting but with splayed jambs and evidently once part of the extant windows below. The upper roof space had tongue and groove sarking boards backing the slates and was supported by two king post trusses, with angled braces and two purlins per pitch and a ridge purlin (Plate 68). All of the joints were held with pegs, the purlins scarf-jointed, and sawn but adze finished and probably Baltic timber. The northernmost truss had a crescent-shaped carpenter's mark on the west brace, while the south truss had chiselled Roman numerals 'II' and 'I' at the junction between the king post and braces plus chalk(?) lines marking out the cuts for the purlin slots. The north elevation had a brick central section forming the chimney flue, which extended through the roof (Plate 69), either side of which were gaps providing some access to the space beyond, within which the roof was not supported by any trusses but only purlins and there was a stone wall on the north side. The south elevation of the main area of roof space was also of stone construction, but with a greater amount of red sandstone and brick, and a large rectangular aperture with a timber lintel within which a circular slotted frame has been inserted (Plate 70).
