# THE BIRCHES, CANTSFIELD ROAD, CANTSFIELD, LANCASHIRE

Archaeological Building Recording

Client: Mr Jeff Niland

© Greenlane Archaeology Ltd  
October 2011

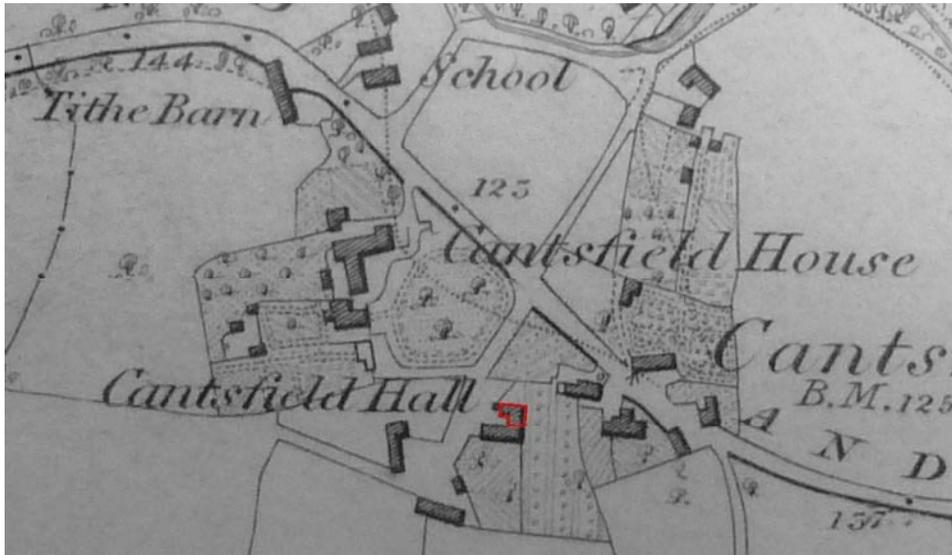
Plate 2: Extract from the Ordnance Survey map of 1847 showing Cantsfield Hall

3.3.3 **Ordnance Survey 1847:** this is the first Ordnance Survey map, although its scale means that the site is very small and no internal divisions are shown (Plate 2). The basic arrangement of the whole building can be discerned and is much as it now appears. In addition, what appears to be a short flight of stairs can be clearly seen leading up to the north-west corner.

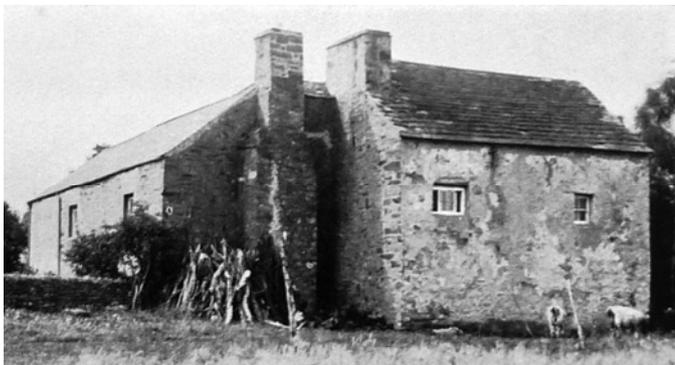
**Plate 5 (left): Photograph of 'Cantsfield Hall', c1940 (Chippindall 1940, fig 3)**

3.3.6 **Photograph, c1940:** Chippindall includes two photographs relating to Cantsfield Hall in his history of the Parish of Tunstall (Chippindall 1940). The first shows the south-east corner of what at the

time evidently was still known as Cantsfield Hall, rather than The Birches, as it is labelled as such (*ibid*, fig 3; Plate 5). The building is relatively unchanged compared to today (*cf.* Plate 16), although it appears to have been re-roofed since it was taken and the northernmost of the first floor windows is only half its current width. More noticeable is the change to the east gable of the building to the south (currently known as Cantsfield Hall), which had a massive external chimney stack and the north pitch of the roof seems to have been flat rather than sloping (perhaps incorporating a dormer window). In addition the numerous boundary walls that are now present had not been constructed by this time. The second image is of the datestone, which shows the Cantsfield coat of arms (Plate 6).

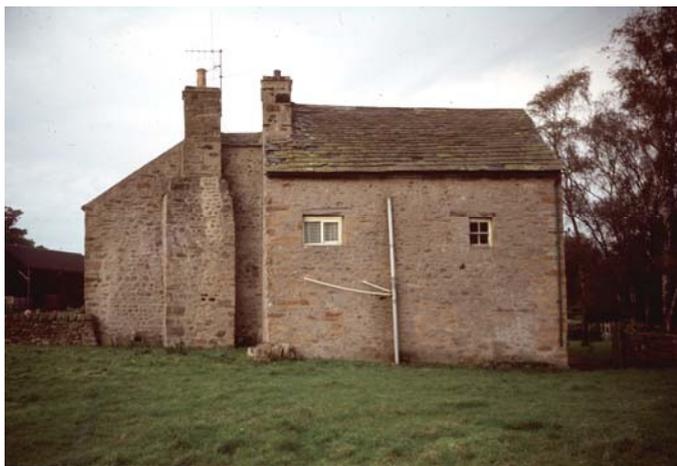
**Plate 7 (left): Photograph of the east external elevation in 1978 (provided by Jonathan Ratter)**

**3.3.7 Photographs, 1978/1979:** Cantsfield Hall and the Birches were visited in 1978/1979 as part of the Lune Valley Architectural Survey carried out by Lancaster University (the full archive for which is now held by the Centre for North-West Regional Studies - <http://www.lancs.ac.uk/depts/cnwr/archives.html>, 32 images can be found at <http://cat.lib.lancs.ac.uk>). These show that The Birches has changed very little since this date, although it is apparent that there was open access between attic of The Birches and Cantsfield Hall and the external flight of steps to the first floor was still extant. Two digital images based on slides taken as part of this survey were made available by Jonathan Ratter. One of these shows the east external elevation (Plate 7), which is relatively unchanged from the c1940 photograph with the addition of chimney pots, a television aerial, and water pipes relating to the plumbing of the bathroom on the first floor. The second image, of the datestone (Plate 8), shows that its condition was similar in 1978, although the timber frame that is still partially present had not been added by this date (compared to Plate 22).

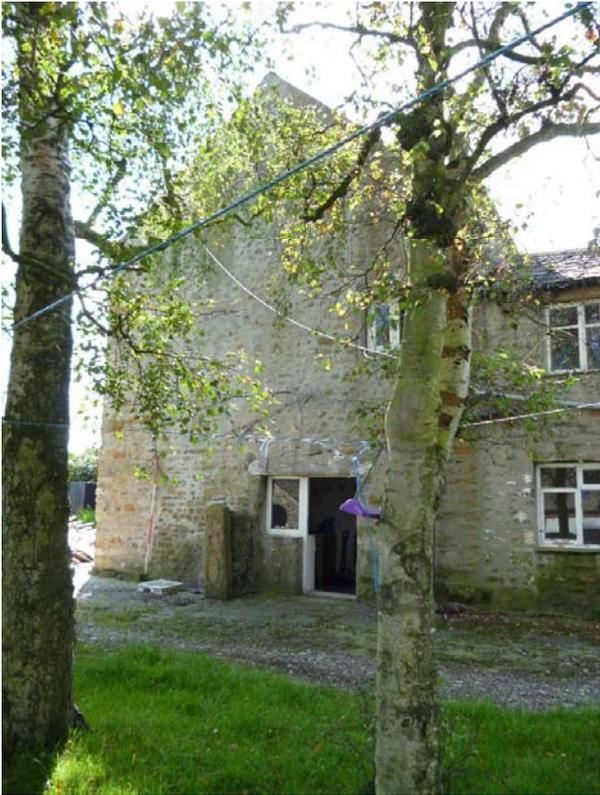
**Plate 9 (left): The east side of the north external elevation**

4.2.1 **North elevation:** the western part of this forms the gable end of the north/south arm and is three storeys tall, while the eastern part forms the side elevation of the east/west arm and is two storeys tall (Plate 9 and Plate 10). Within the west section there is a doorway at ground floor level with an adjacent window with a single-light casement, both of which are below a hand-finished timber lintel with stop-chamfer decoration. It is likely that this originally represented a single large window that was modified to incorporate a doorway on its west side. At first floor level there are two windows with rough timber lintels, the eastern of which has been blocked with stone and the western of which has a two light casement formed around a timber mullion. The second floor has two slightly smaller windows, again also with rough timber lintels, but with the western one blocked with stone and with the east housing a two-light timber casement. There are various metal and plastic water pipes attached across the elevation.

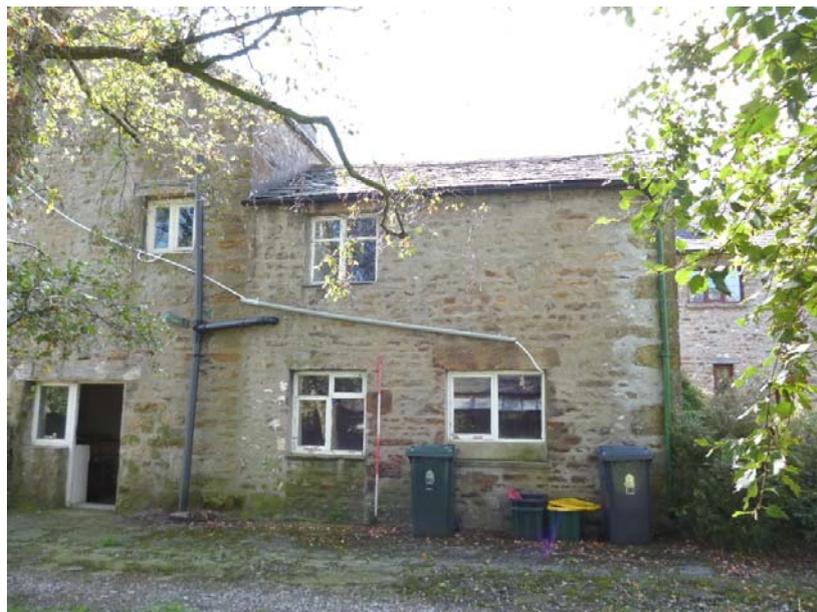
**Plate 11: The west side of the north external elevation**

4.2.2 The western end has two ground floor windows, the one to the east was formerly a doorway with the lower part filled to form a window, which has a narrow stone sill (Plate 11). The western window has a concrete sill and a small section above this filled with concrete below the casement. Both windows have stone lintels and modern timber casements; four lights in the east and two in the west. The first floor has a single window on the east side with a stone lintel and slate sill (probably reused roof slates) and a four-light timber casement.

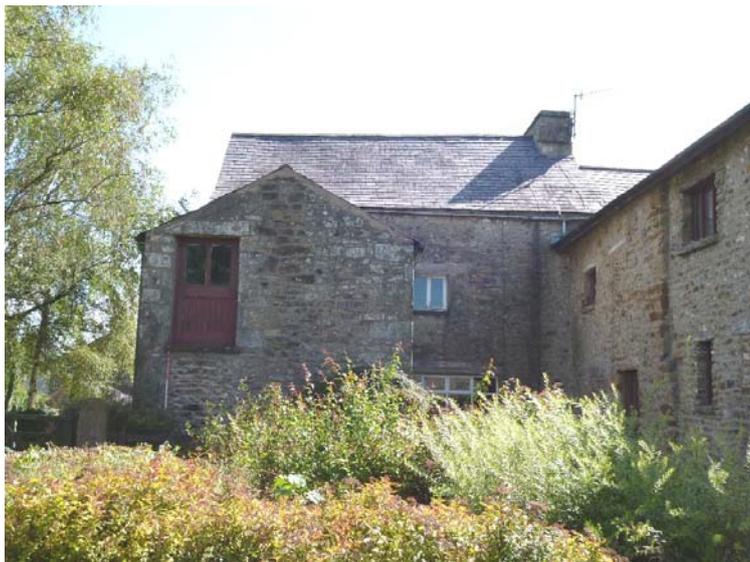
Plate 12 (left): North side of the west external elevation

4.2.2 **West elevation:** the north side comprises the gable end of the east/west section, while the south side is the side elevation of the north/south section. The north end is two storeys high; the ground floor has what appears to be a doorway blocked with stone on the north side, although it may just be rebuilt as it has no apparent lintel or quoins. Above this is a first floor doorway with quoined jambs, a stone lintel and step and modern tongue and groove plank door with two lights in its upper half (Plate 12). The southern section is three storeys tall, although the top floor is not evident and there are no windows into it. The ground floor has a very wide window spanning a considerable amount of the elevation (Plate 13). This has evidently been extended to the south and has a long stone lintel extending the full length of the original opening with an iron beam (clad with a concrete skim) below spanning the full length including the extended section. The sill comprises a single dressed piece of stone, again extending as far as the original opening, with an added piece filling the gap in the extension on the south side. The southern jamb is skimmed with concrete, the window houses a modern eight-light casement, and the entire wall section has a shallow plinth (c0.1m deep) along it. The first floor has a single window against the east/west arm, with sill constructed from two layers of slate held together with concrete, with some possible rebuild below, and what appears to be a timber lintel covered with a skim of concrete. It evidently originally extended c0.4m further to the south but has been partially blocked, and houses a modern two-light casement.

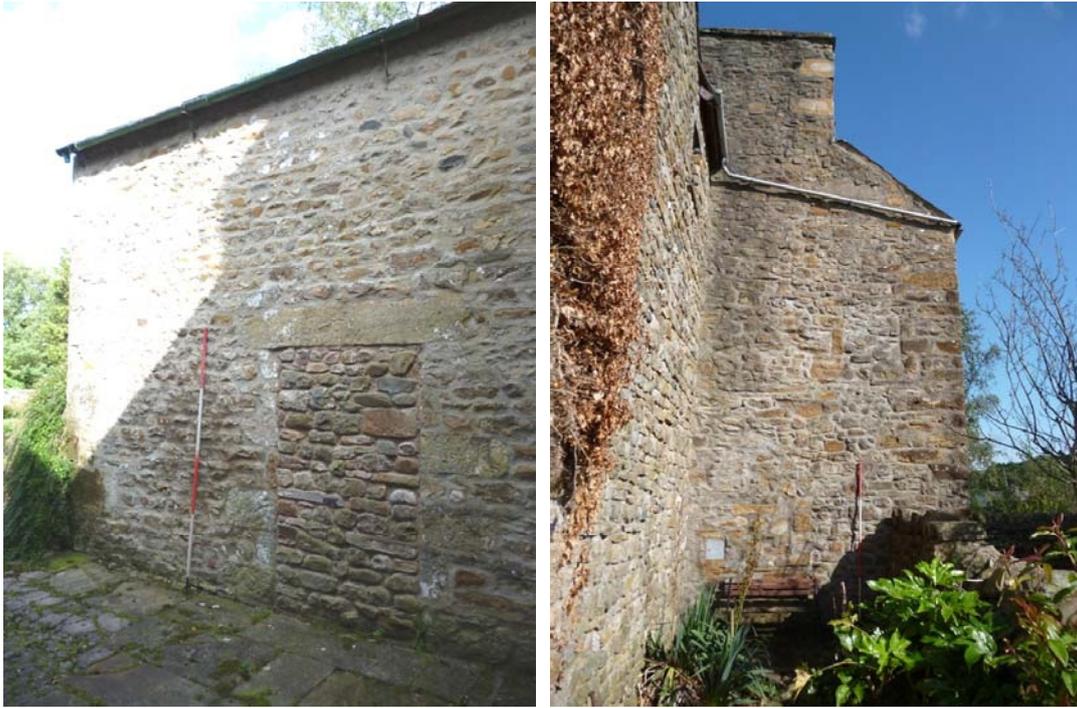
4.2.3 **South elevation:** this is divided by the adjoining Cantsfield Hall, and so only two sections are visible. The western section comprises the south side elevation of the east/west arm. It has a central doorway, which is blocked with stone and has a stone lintel and the end of the wall and jambs of the doorway are finished with dressed quoins (Plate 14). The eastern part represents the east side of the end gable of the north/south arm. It is topped by the chimney, which has some quoins on the east side (much squarer than elsewhere in this part of the building). Below it is a former window blocked with stone at first floor level with no evident sill or lintel but with some quoins (Plate 15). Below this, at ground floor level is a wide blocked aperture, presumably a doorway, again with no lintel, and some rough quoins, which is also blocked with stone.

**Plate 14 (left): Blocked doorway in the west side of the south elevation**

**Plate 15 (right): East side of the south elevation showing blocked openings**

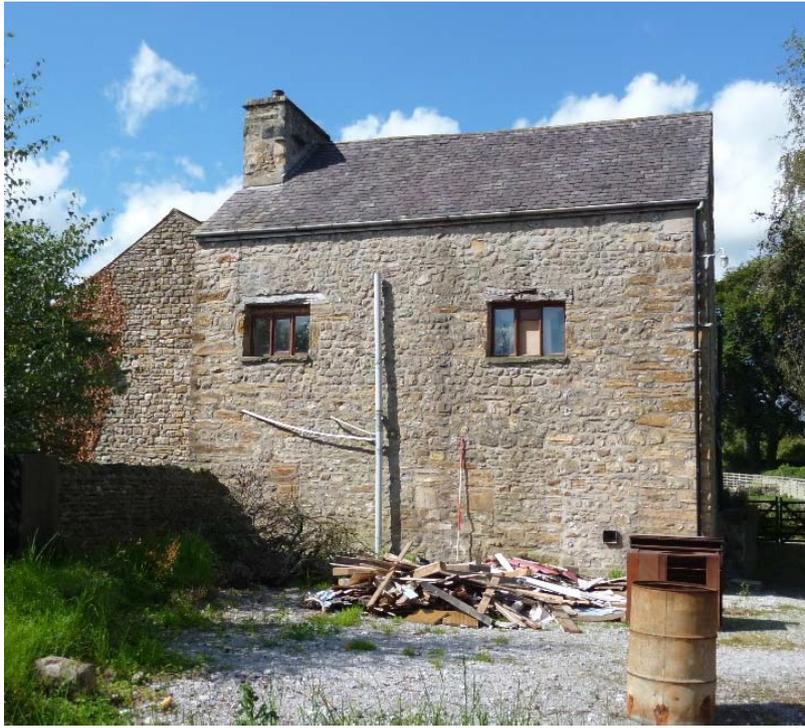
**Plate 16: East external elevation**

4.2.4 **East elevation:** this forms the side wall of the north/south arm only. It is three storeys, although the second floor is not visible from this side and there are no windows (Plate 16). The ground floor has a former doorway blocked with stone on the north side, with no evidence for a lintel (this has presumably been removed) and a modern vent has been inserted through the blocking. There are two further grill vents and ground floor level to the south. Above these are two former windows, both also blocked with stone. The northernmost is only small, and adjacent to the blocked doorway, while the southernmost is very long. Both have no evident remains of a lintel (these too have presumably been removed) but there are rough quoins denoting the position of the jambs. The first floor has two small windows, both with hand-finished timber lintels and stone sills, although these have possibly been raised slightly. Both have modern three-light casements, and the southernmost has a second rough timber set below the lintel, perhaps part of an earlier casement. There is a modern timber barge board below the roof and plastic rain water goods.

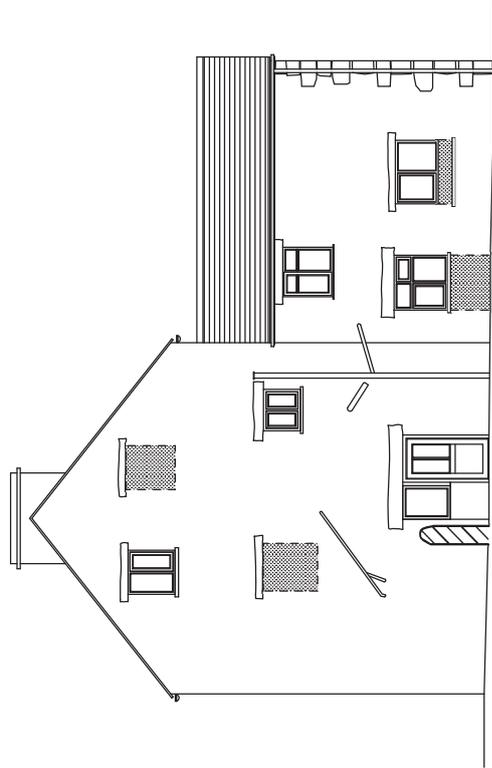
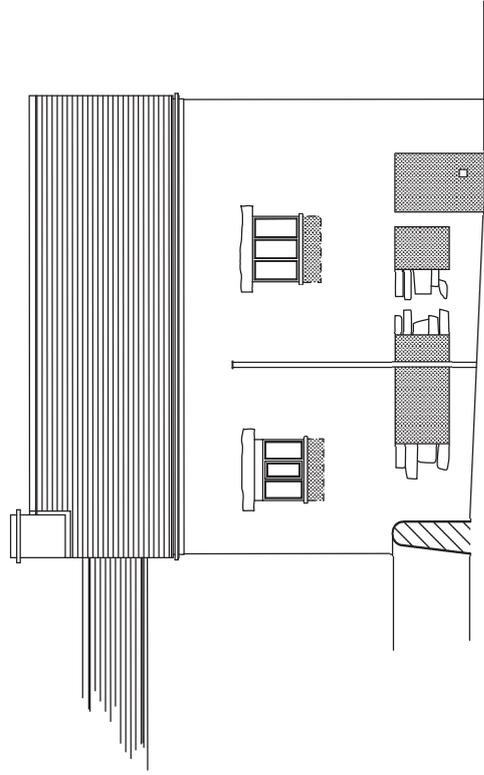
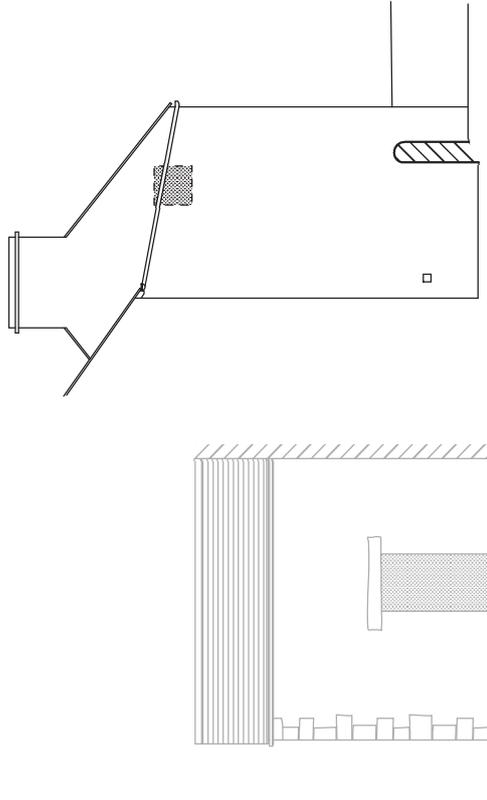
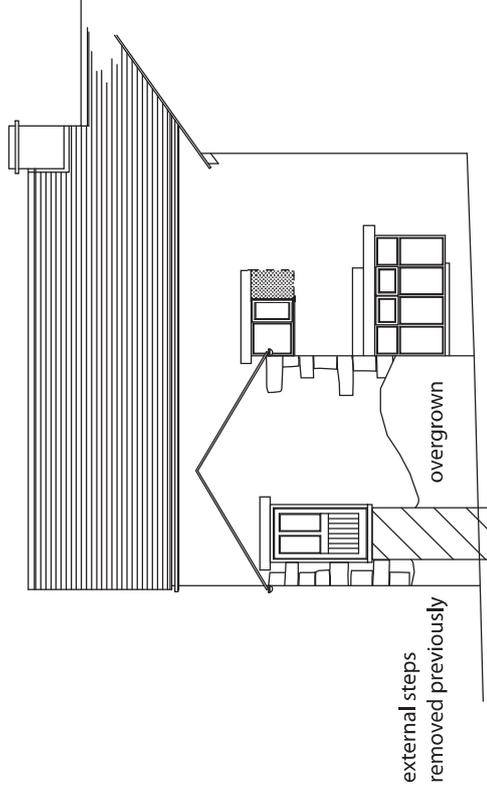
NORTH ELEVATION

EAST ELEVATION

SOUTH ELEVATION

WEST ELEVATION

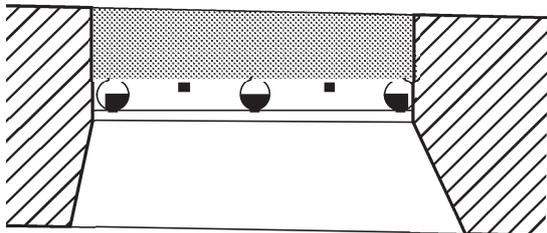
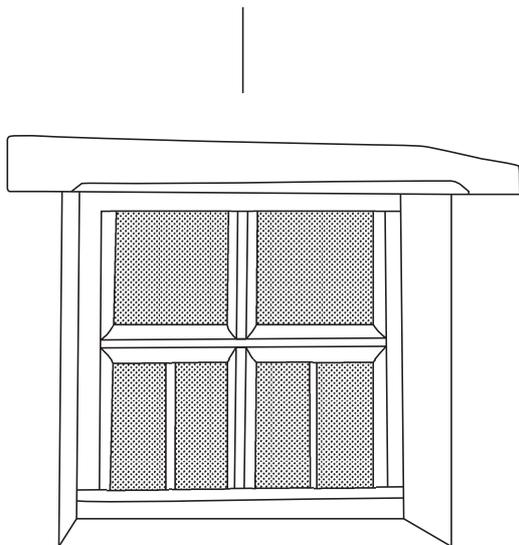
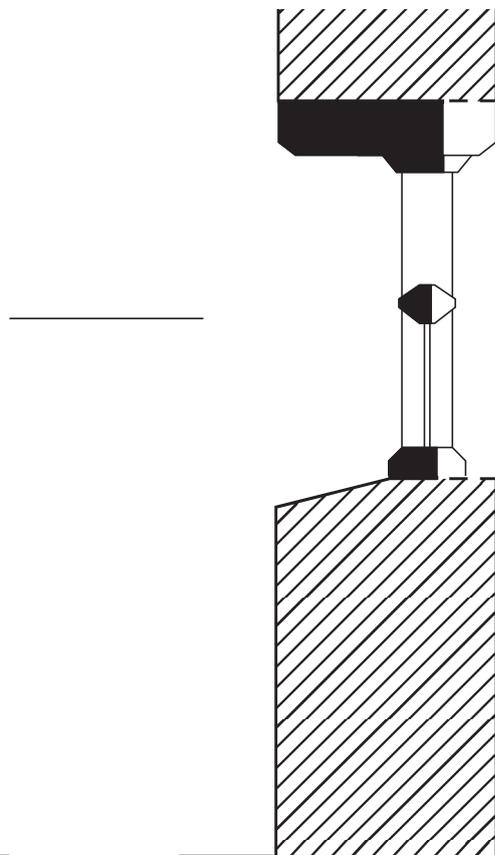
Figure 6: Detailed drawings of timber mullion windows

DETAILED DRAWINGS OF THE TIMBER MULLION WINDOW, ROOM S1

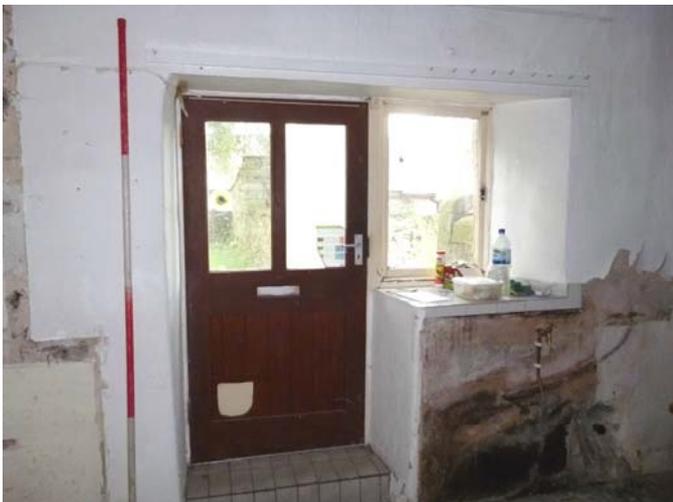
Plate 17 (left): Window and doorway in north elevation of Room G1

4.3.1 **Ground Floor Room 1:** this has a concrete floor and the ceiling is finished with plaster and has a large hand-finished timber beam orientated east/west running against the south elevation. There is a small sloping section of ceiling in the north-east corner (below the stairs in Room G2). The walls are all finished with painted woodchip wallpaper and there are modern kitchen units in the south-east corner and some plain modern skirting board against the west elevation. The north elevation is essentially plain, apart from the large opening forming a doorway and window, which has splayed both sides, more so to the west, and the window has a tiled sill (Plate 17). There is a single step up to the door, which is also finished with tiles. The door is a relatively modern tongue and groove plank and batten type with two lights. The north side of the west elevation is a solid wall, with scars for shelving within a recessed formed by a timber stud wall returning at the south end to the east, within which is a doorway with an early door with six moulded panels although the surround is relatively modern and quite plain (Plate 18). The south elevation is plain, with a batten with iron coat hooks, a radiator, and a towel rail attached. The east elevation is a modern stud wall, forming a boxed area around the stairs with a doorway on the north side allowing access to a small cupboard below the stairs. Within this cupboard there is a wide recess representing the position of the blocked doorway evident externally, which now houses a boiler. Against the north jamb of the blocked doorway was a low block of projecting masonry with a slate capping (perhaps part of a slate bench for cold storage?). The stairs to the south are an entirely modern construction.

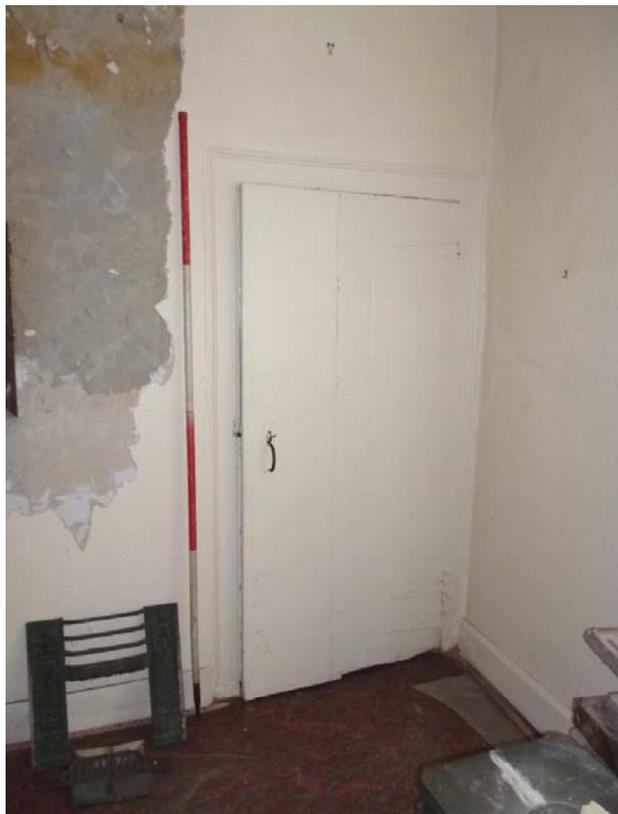
**Plate 20 (left): Cupboard door, west side of the south elevation, Room G2**

4.3.3 The south elevation has a doorway on the west side leading to a cupboard, the door to which is constructed from large beaded planks and held with large strap hinges with long plates (Plate 20). There is also an early latch plate and the door surround is moulded. Within the cupboard are modern timber shelves on modern battens. The centre of the elevation is dominated by a large fireplace. The hearth opening has had a lining added to either side a single brick thick (the bricks being mid-red and machine made), which supports an iron I-beam below the original stone lintel (Plate 21). The resulting space has then been largely filled with more modern red brick leaving a small opening for a wood burning stove, below which are the remains of a modern raised hearth stone with stone cladding, which originally must have extended across the opening. The lintel proper comprises a huge piece of grey gritstone and is decorated in relief with inscription 'ISABEL CANSFIELD' and 'ANO DNI 1623' either side of an armorial design, and with two pairs of shears above the name (Plate 22). It is not clear whether some of the inscription is actually plaster or whether this is in fact layers of plaster on top of the original stone, but it has clearly been painted and probably finished with plaster several times. Where the paint has come away in one area the stonework beneath appears to be sooted or finished with blacking. The remains of a modern timber surround are still present on the west side and a scar runs around the top and bottom. To the east of the fireplace a further blocked doorway is evident as a crack in the modern skim, perhaps extending as far to the west as the lintel over the fireplace. The east elevation is largely covered by an inserted concrete wall of uncertain function. Behind this the wall proper is just visible; it is apparent that the south-east corner is slightly rounded and the line of a blocked window is evident within the wall. At the north end a window has been recently uncovered, apparently from behind a layer of plaster board. It has a four-light mullion casement, the mullions rhomboid in section and quite plain in profile, and a hand-

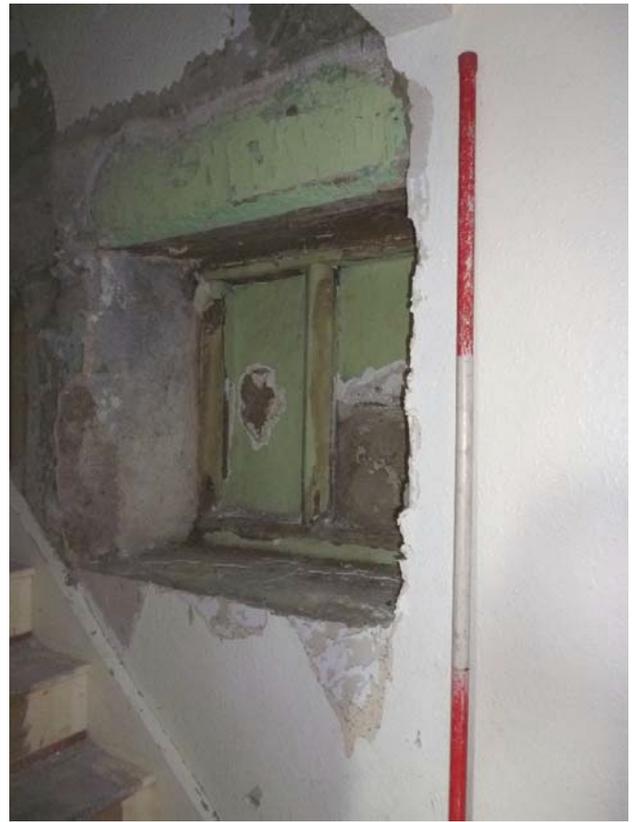
**Plate 23 (right): Timber mullion window at east end of south elevation, Room G2**

finished timber lintel with stop-chamfer decoration (Plate 23). The window is blocked from the outside and had evidently been whitewashed or skimmed with plaster and then painted on the inside. Beyond this, to the north, and effectively within Room G1, the lintel of the blocked doorway is exposed, and it also has a chamfered timber lintel.

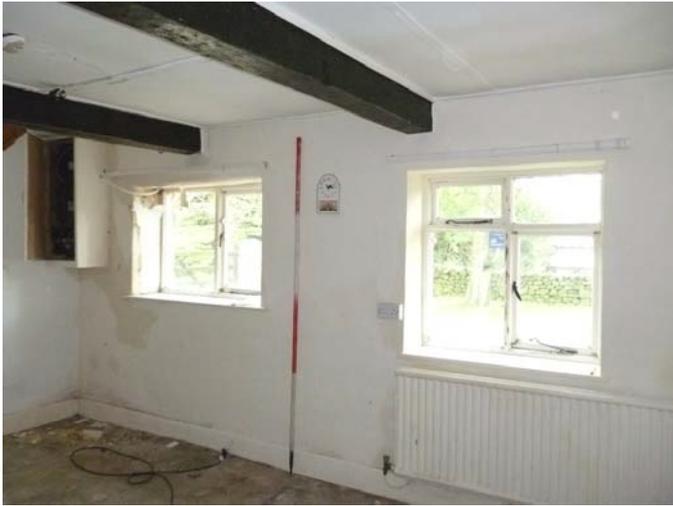
Plate 24 (left): The north elevation of Room G3 showing the windows and beams

4.3.4 **Ground Floor Room 3:** this too has a concrete floor, slightly raised relative to the level of the rooms to the east. The ceiling is finished with plasterboard and there are two beams orientated north/south both of which are sawn square and neatly adze-finished; the western of these had iron meat hooks inserted into its west face. The walls are all finished with painted wood chip wallpaper. The north elevation has two windows, the west with a two-light hinged casement and the east with a four-light hinged casement, and both with a timber sill, probably modern and relatively square jambs (Plate 24). The west elevation is plain and evidently an inserted concrete block construction covering the wall proper (as can be seen within the cupboard covering the fuse box in the north-west corner), perhaps added to support a modern staircase that leads up from the south side or to cover a fireplace at this end (there is no corresponding chimney externally but this could have been removed). The stairs are accessed by a pedestrian doorway with a presumably re-used door with six moulded panels (Plate 25). The south elevation is entirely plain, while the east elevation has a bulge at the base of the wall corresponding to the line of the plinth evident externally to the south, and an opening on the south side with no door or surround, with a single step down into a small lobby between Rooms G1 and G2.

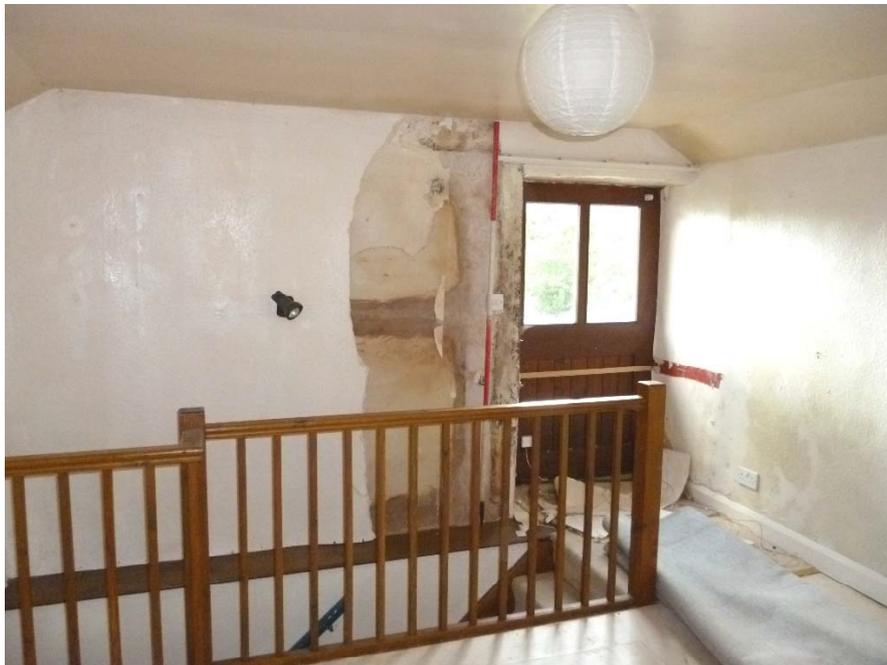
Plate 26: The west elevation of Room F1

4.3.5 **First Floor Room 1:** this has a modern chipboard floor, open on the west side to the stairs with a handrail across the opening, and plasterboard ceiling attached to timber battens. The walls are all finished with painted woodchip wallpaper. Modern stud partition walls have been added in the north-east corner to form an *en suite* toilet and there is a plain skirting board throughout. The north elevation has a single window on the east side with a four-light hinged casement and modern timber sill. The west elevation is stepped out at the base, corresponding to the concrete block wall in the room below and presumably in order to support the staircase. Above this there is a doorway on the north side with a tongue and groove plank and door with two lights in the upper half. The south elevation is plain, but with projecting boxing at floor level presumably covering pipes or cables. The east elevation is plain with a sink and toilet within the *en suite*.

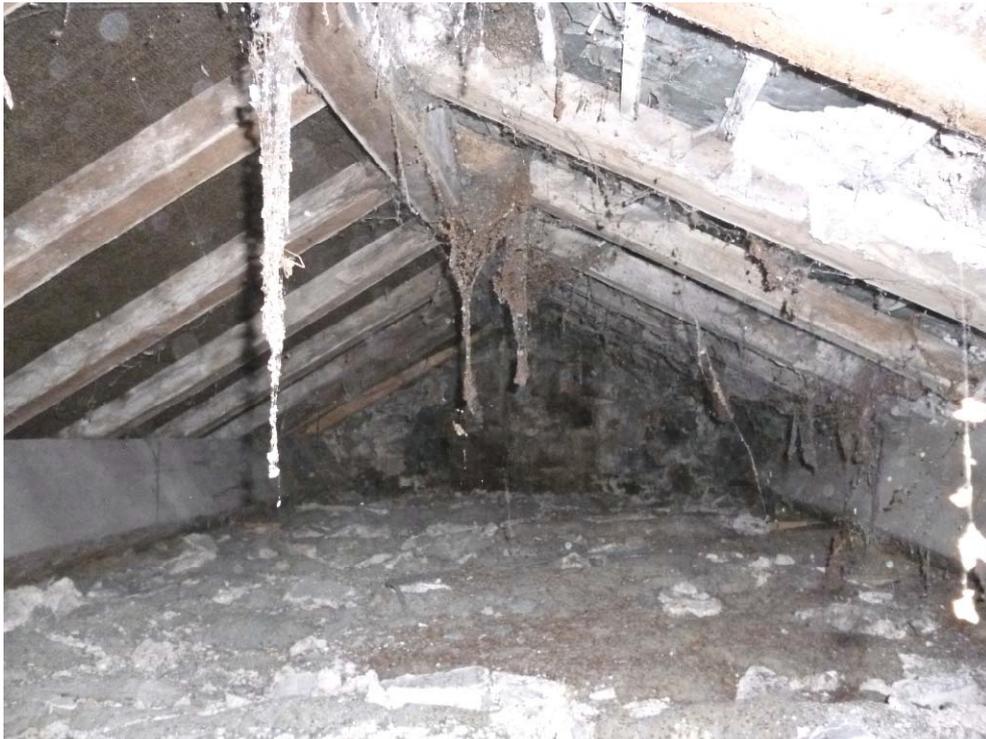
**Plate 27: Roofspace above Room F1**

4.3.6 **Roof space over First Floor Room 1:** this could not be fully accessed but could be viewed through an access hatch in the room below. The roof is supported by a single purlin on each side and a single vertically-set roof purlin, all of which are neatly sawn and likely to be Baltic pine. The rafters appear more recent. The east end is plain and finished with whitewash, while the west end is similar but

appears to have a vertical line running through it, perhaps denoting the position of a flue? Remains of a thick piece of rope are fixed to the upper side of the each purlin at the east end with a U-shaped staple.

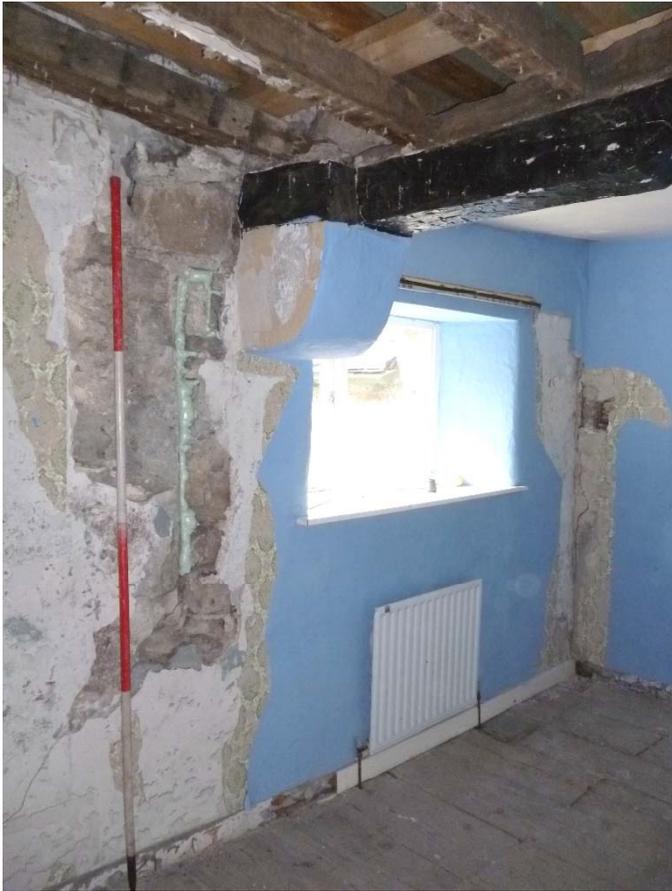
**Plate 28 (left): Beam and corbels and window in west elevation, Room G2**

**4.3.7 First Floor Room 2:** this has wide, presumably original floorboards, which continue into Room F3 to the east. The ceiling is lathe and plaster, although this has been removed on the south side exposing the joists, which are socketed into a single beam orientated east/west, which is hand-finished and chamfered and has an additional timber 'corbel' at the west end supported by a large semi-circular corbel below (presumably stone?) (Plate 28). The walls are mostly finished with painted woodchip wallpaper, and there are scars of former stud walls on the floor on the south side of the room. The north elevation is plain, but an early timber stud partition wall. The west elevation has a window with a modern timber sill and two-light hinged casement. To the south of this the plaster has been removed, exposing the original jamb of the window, which is splayed and finished with plaster, with the gap between it and the extant window blocked with stone (the resulting voids have now been filled with green expanding foam) (Plate 29). The south elevation is mostly plain, although there is a doorway on the west side with an early nailed plank and batten door with long strap hinges with decorative ends in a plain surround, the edges of which are recessed to fit the door. The east elevation is a stud partition wall, the studs of which are exposed but finished with floral wallpaper (Plate 30). On the south side there is an opening, presumably originally a doorway or perhaps an inserted doorway. At the north end there is a definite doorway, with an early plank and batten door in a plain surround, held with pegs and with a slight step at the base.

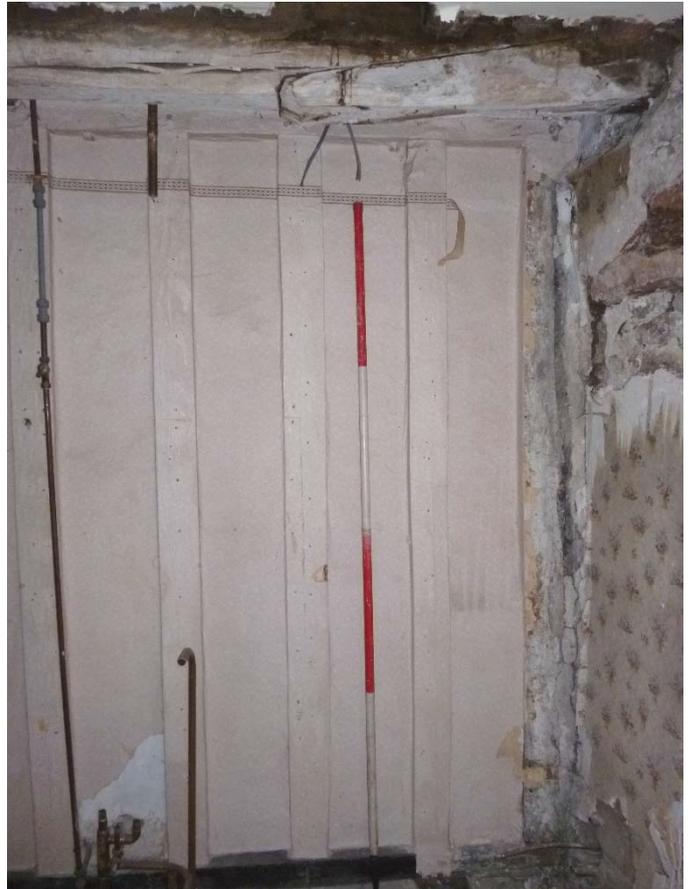
Plate 34 (right): Early stud wall, south elevation, Room F4, showing corbel jointed to beam above

south side. This houses a door of early plank and batten construction on hung hinges, with early timber latch fittings, a plain surround, and a step formed from the base rail of the stud wall.

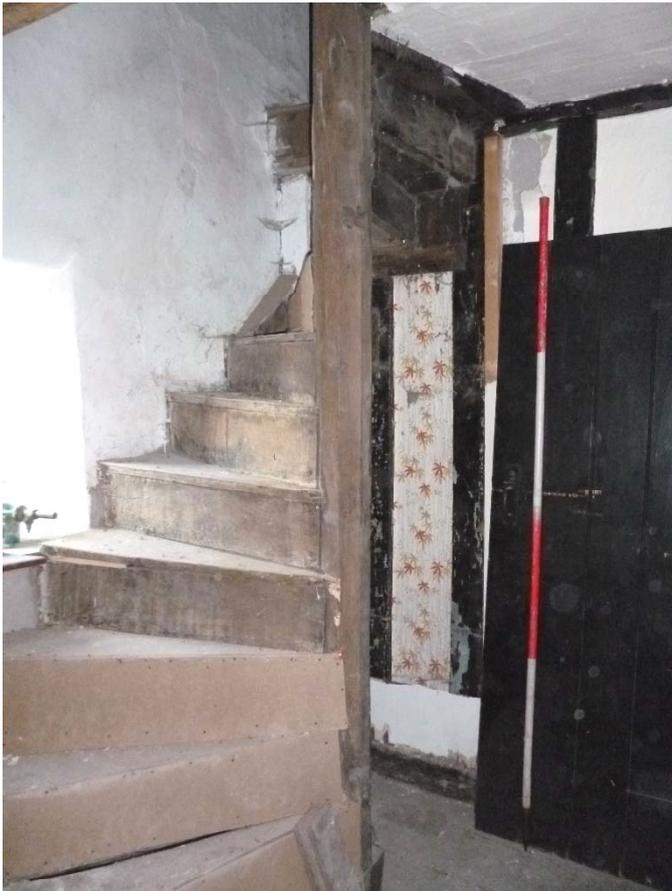
**Plate 35 (left): Spiral staircase in Room F5**

4.3.10 **First Floor Room 5:** this comprises a hall connecting the stairs from Room F2 to the first floor rooms and the spiral staircase to the second floor. The floor is finished with a mixture of early wide boards and more modern tongue and groove type, with a modern flight of timber stairs leading down to the ground floor in the north-east corner and a spiral staircase leading to the second floor against the

east elevation. The modern staircase is essentially plain, with boxed in hand rail around the top, while the spiral staircase has an octagonal newel post with two slots, perhaps relating to a doorway to a cupboard beneath the stairs (Plate 35). The steps are all original sawn planks (although covered with hardboard sheeting) one of which has a levelling mark on its rear (south) face (Plate 36), and the newel post sits on a massive block of timber that extends below the bottom step. All of the walls are finished with plaster and painted wall paper. The north elevation is plain, although a section of plaster has been removed on the west side revealing a narrow blocked aperture, apparently a doorway, in the wall (Plate 37). This has a plain timber surround with pegged joints at the top and a rebate for the door (although this is not present) and the east side of the surround has a group of taper burn marks on it (Plate 38). Internally the jambs are plastered and they appear to be splayed in the reverse direction. This aperture apparently corresponds to the position of a blocked window externally, but it is not clear why a doorframe was added into the opening.

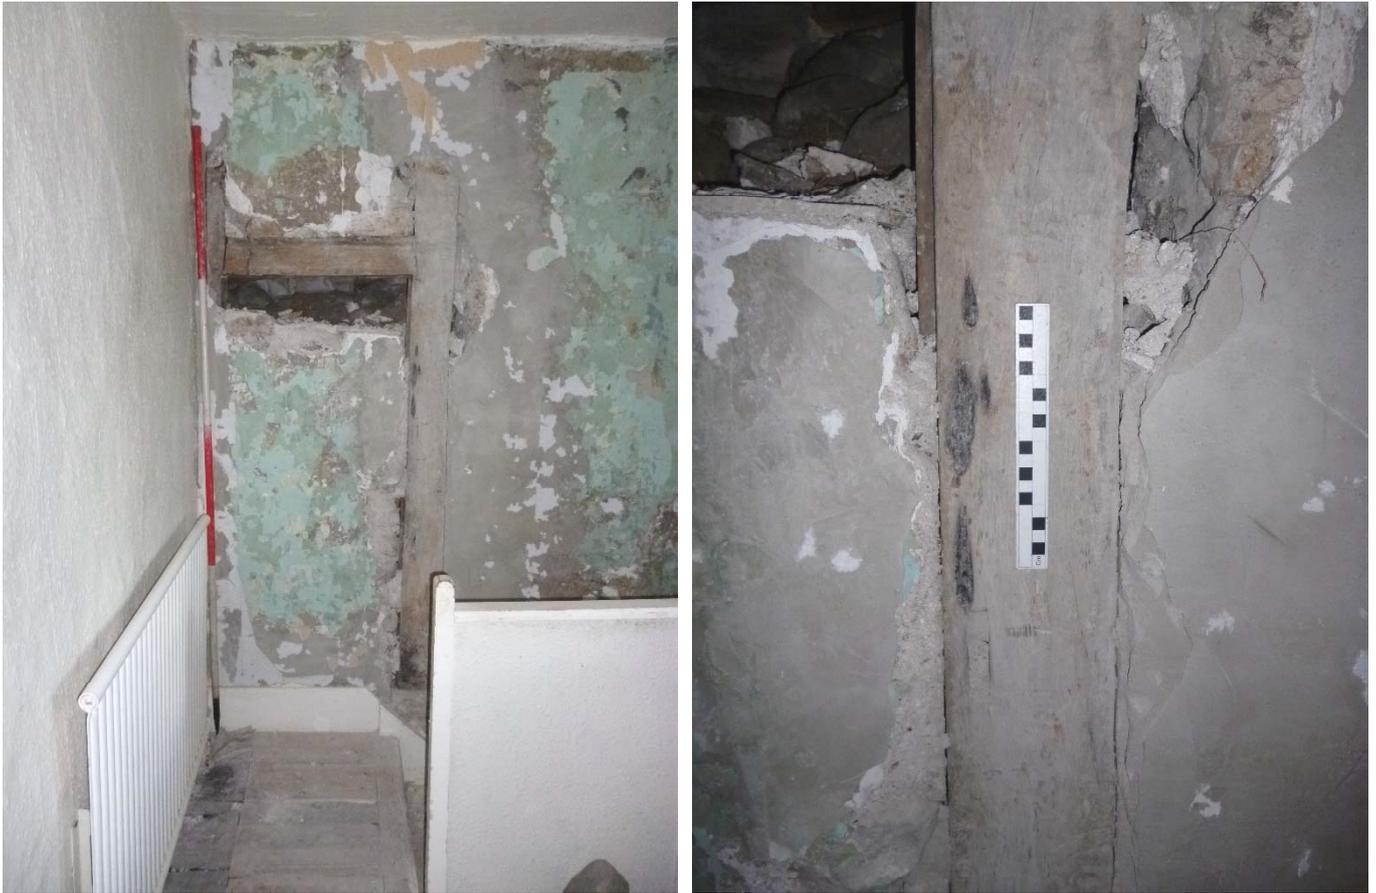
**Plate 37 (left): Blocked doorway in the north elevation of Room F5**

**Plate 38 (right): Detail showing the taper burn marks on the east jamb of the doorway**

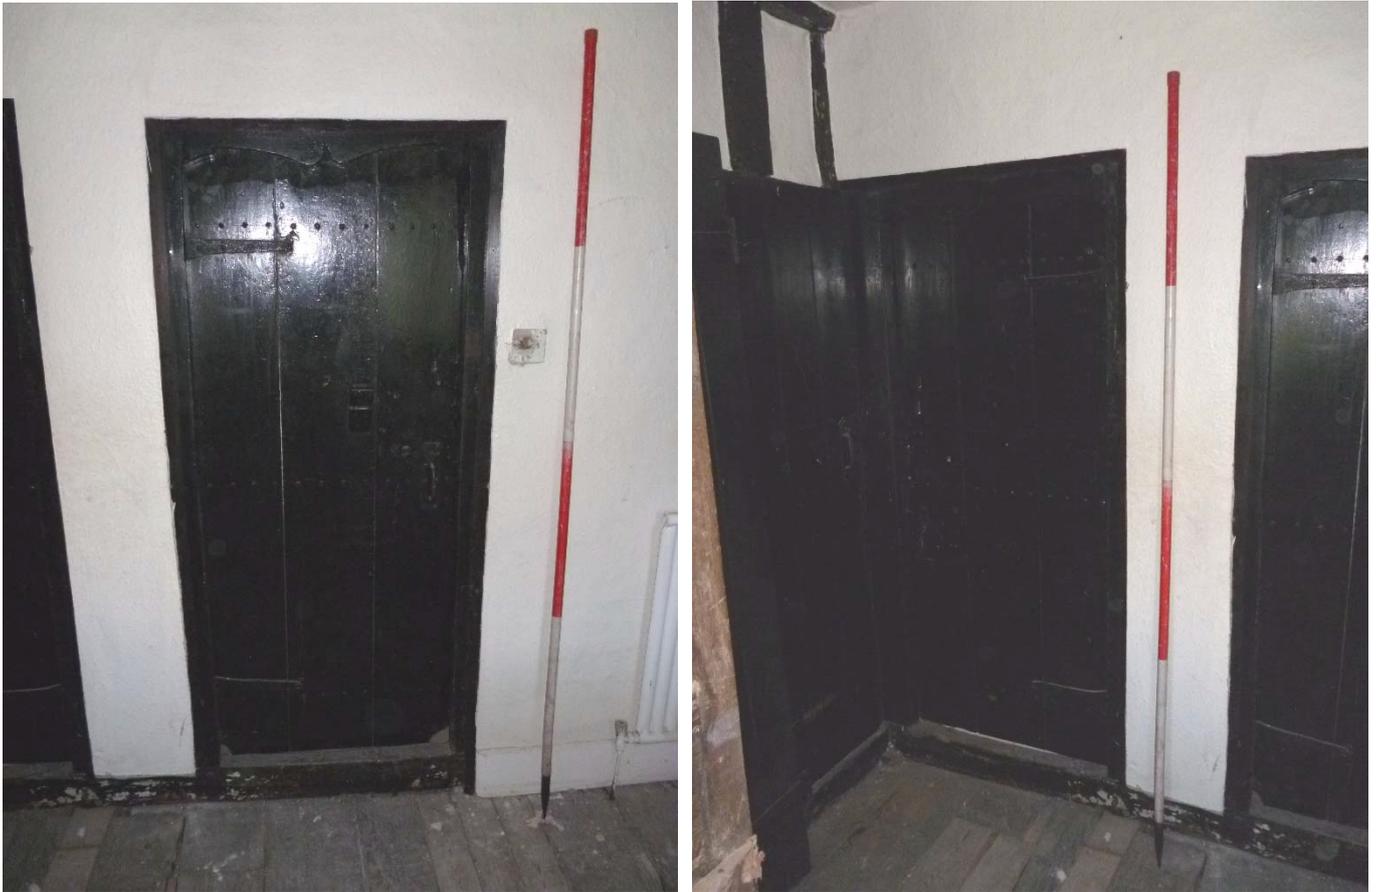
4.3.11 The west elevation has two doorways, both of which have essentially identical early nailed plank and batten doors with long strap hinges with decorative ends set within surrounds that are essentially plain and of pegged construction, but with ogee-moulded heads with denticulate decoration. The northern door also has an attached angled timber bracket or handle. The south elevation is a timber stud wall, with the studs exposed but painted black, and with a narrow doorway on the west side with a plank and batten door. The wall continues behind the spiral staircase on the east side. The south end of the east elevation continues behind the spiral staircase; a loose relatively modern plank and batten door probably originally covered the area below the stairs. Immediately to the north of the stairs is a window with splayed jambs, a hand-finished timber lintel, and a modern casement and sill.

**Plate 39 (left): Northernmost west doorway in Room F5**

**Plate 40 (right): Southernmost west doorway in Room F5**

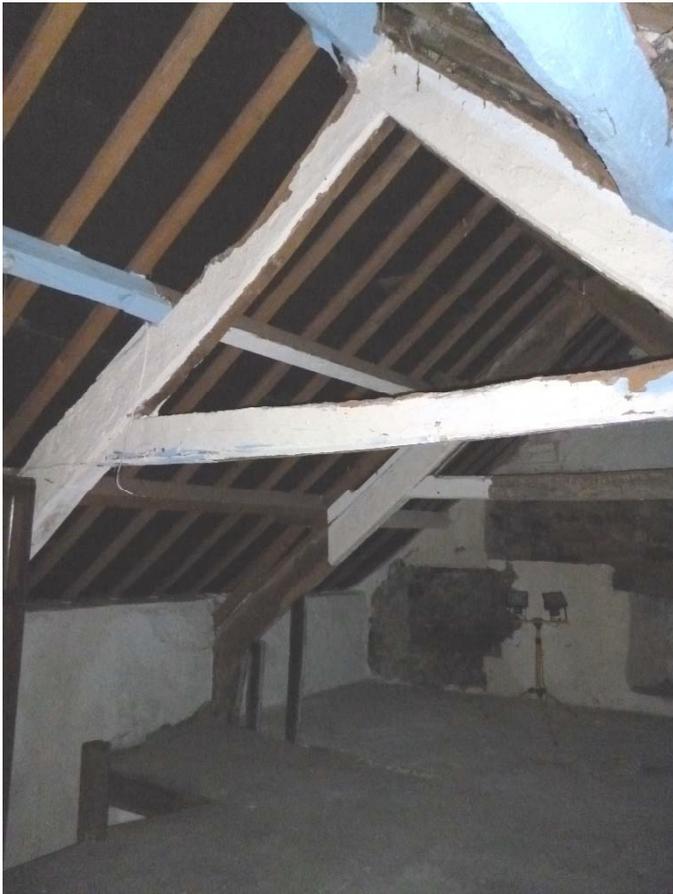
**Plate 41 (left): The trusses in Room S1, east side**

4.3.12 **Second Floor Room 1:** this is essentially an attic room, and so only has proper elevations at the north and south ends. The floor is constructed from sheets of modern chipboard. It is open to the roof, which has two purlins per pitch and a diagonally-set ridge purlin. The purlins on the east side are relatively modern replacements, while those to the west are probably original and neatly hand-finished. The purlins are supported by a pair of raised cruck trusses or curved principal rafters, each with a collar jointed to the cruck blades and pegged together (Plate 41 and Plate 42). There are hammered carpenter's marks on the west end of each truss, on the south face at the junction between the collar and the principal/cruck in the form of Roman numerals: 'I' on the southern example and 'II' on the north (Plate 43). In addition, there is a taper mark on the north face of the principal/cruck of the southern truss at the west end (Plate 44). The base of the both of the western principals/cruks is encased in a block of plaster (Plate 42) and there are upright studs, presumably from former stud walling around the access to the spiral stair case, beneath the east ends. All of the walls are finished with rough plaster and whitewash. The east and west elevations are plain. The north elevation has two windows. The west has recently been exposed and comprises a four-light timber ovolo-moulded mullion and transome window, with vertical timber dividing bars in the lower two lights (Plate 45). The aperture has splayed jambs and a hand-finished timber lintel with stop-chamfer decoration. The east window was partially obscured by an attached sheet of plywood, but was clearly originally similar in style, as the sides of the casement are ovolo-moulded and a scar from where the transome had been sawn off visible. It now has a two-light hinged casement, but the aperture also has splayed jambs and a hand-finished stop-chamfered timber lintel. The south elevation has a window on the east side that has been blocked to leave an alcove (Plate 46). It too has a hand-finished timber lintel with stop-chamfer decoration and splayed jambs although, unlike the windows to the north, the sill is much closer to floor level. Slightly west of the centre there is a former fireplace with a heavy stone lintel, the sides and back of which are finished with rough plaster. At the west side there is a further wide opening forming an alcove, but this is much taller, perhaps indicating that it was originally a doorway. It has no lintel, however, the opening continuing to the roof level, where

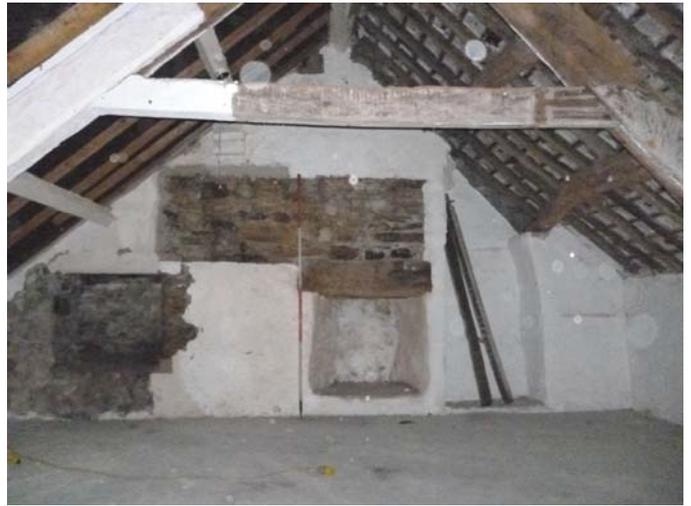
**Plate 46 (right): Window, fireplace and 'doorway' in the south elevation, Room S1**

there is some rebuilt in concrete blocks in the wall behind. The jambs and back are all finished with plaster, and the east jamb turns slightly to the east at the top.
