FORMER ROBINSONS WORKSHOP, GLENFIELD ROAD, DALTON-IN-FURNESS, CUMBRIA

Archaeological Building Recording

Client: M & P Gadsden
Consulting Engineers Ltd

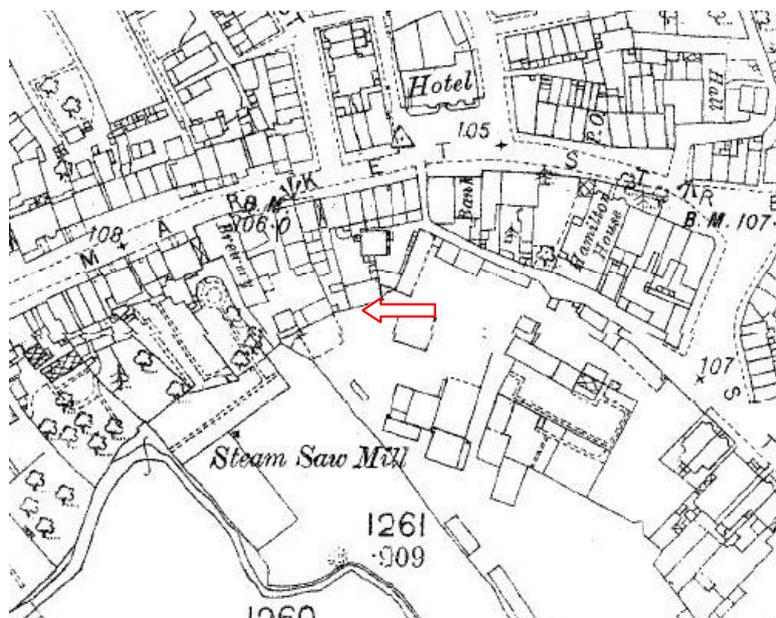
Plate 1: Extract from the Ordnance Survey map of 1891, with site location marked

1.3.2 **Early Maps:** the building is apparently not shown on Merryweather's 1825 plan of Dalton (reproduced in Walton (1984, 66)) or the Ordnance Survey map of 1850. It is also not shown on the Ordnance Survey plan of 1891 (Plate 1), although what is shown is a building immediately to the north of the present building, rather than the building itself, the south wall of which was incorporated into it (see Section 4.1.1). This map is also of interest in showing the wider environs of the site, in particular a large steam saw mill to the south-east, on the site of which Glenfield Road is now situated. The later Ordnance Survey map of 1913 shows that by this date the present building has been constructed, and the building to the north to which it was added, is still present. Again this shows the environs of the site, revealing that by this time several new streets had been constructed nearby, including Garden Terrace.

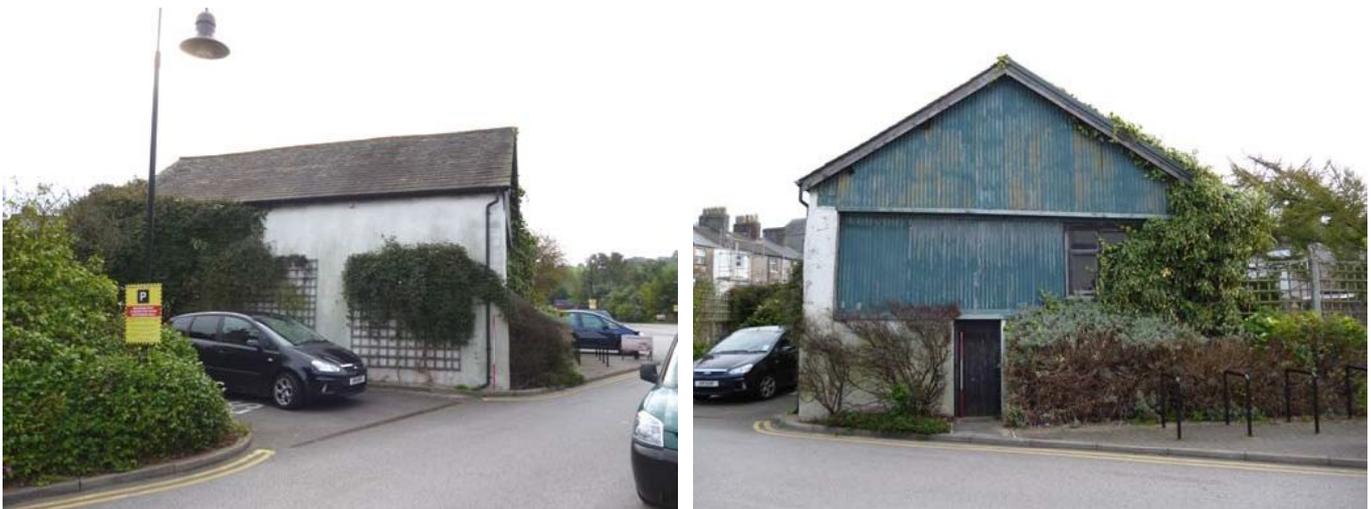
Plate 2 (left): North external elevation

3.2.1 **North elevation:** this elevation is entirely finished with concrete render and has two timber trellises attached to it (Plate 2). It has plastic rainwater goods.

3.2.2 **West elevation:** the lower part of this elevation is rendered, whilst the upper part is clad with corrugated sheet metal on a timber frame (Plate 3). There is a tongue and groove plank and batten door in the lower part with a brass handle re-used from a chest of drawers or similar piece of furniture. There is a window in the upper part on the south side, with a six-light timber casement.

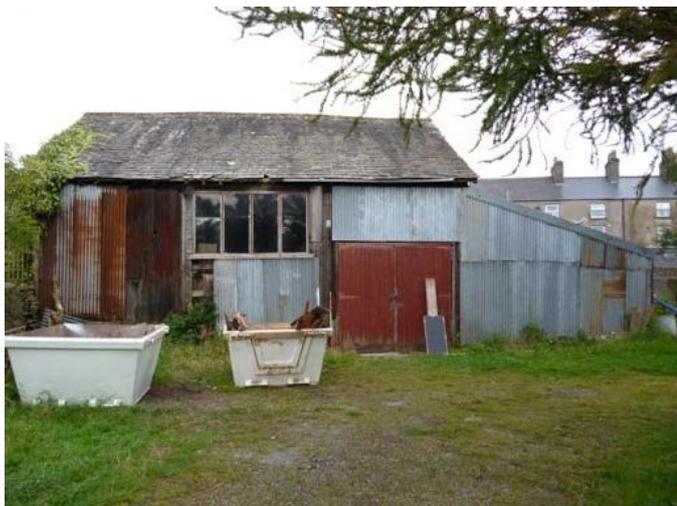
Plate 4 (left): South external elevation

3.2.3 **South elevation:** this elevation is largely clad in corrugated sheet metal, over a timber structure, with a large four-light window in the centre, and a double tongue and groove plank and batten door on the east side of the main block (Plate 4). At the west end is a monopitch extension entirely clad in corrugated sheet metal.

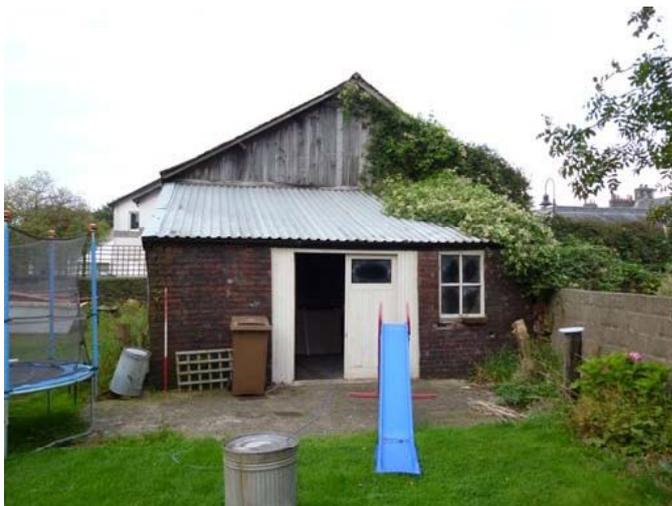
Plate 5 (right): East external elevation

3.2.4 **East elevation:** the lower part of this elevation is the brick the 'extension' (Plate 5). The bricks are machine-made, dark red, and laid in English garden wall bond in a ratio of four rows of stretchers to one row of headers. Typically the bricks measure 23cm x 7.5cm x 11.5cm. There is a central double door, of tongue and groove plank construction, with a single light in each half. There is a small window to the north, which is a four-light fixed casement, with a concrete sill. The upper part of the elevation, comprising the gable end of the main section above the brick 'extension', is clad with planks.

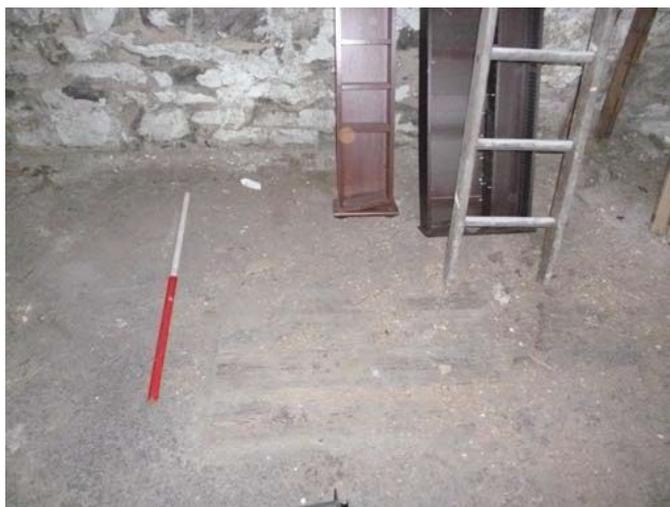
Plate 6: Possible hatch in floor

3.3.1 **Introduction:** the interior of the building is one single space, extending through into the monopitch section to the east. It has a single concrete floor throughout, with a hatch or inspection pit (?) covered with timber boards in the north-west corner (Plate 6).

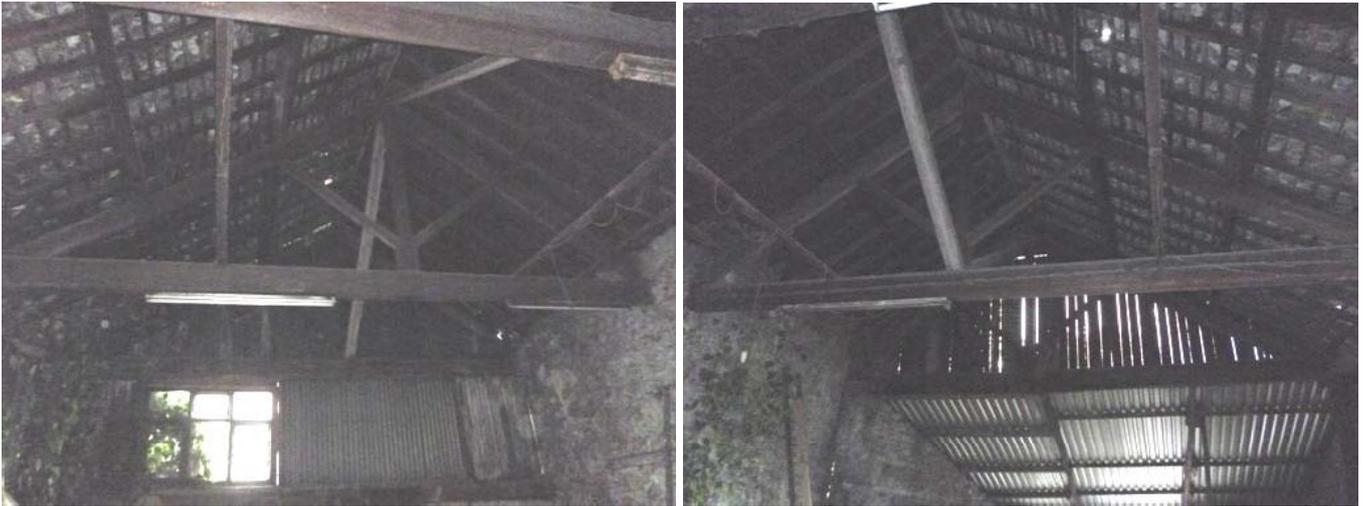
3.3.2 **Roof structure:** the roof is supported by four king post trusses with angled braces, with each also having an angled brace connecting each truss between the base of the king post and the top of the adjacent king post (Plate 7 and Plate 8). The easternmost truss is set against and forms part of the east wall. Its north end is set into the north elevation while its south end is supported on an iron column (see Section 3.3.6 below). The two central trusses are supported in the same way, while the eastern truss is supported on the brickwork of the 'extension' at its north end and the easternmost iron column at its south end (see Section 3.3.3 below). There are two purlins per pitch and a ridge board and the trusses are bolted between the beam and the base of the king post.

Plate 7 (left): Trusses in east end of building

Plate 8 (right): Trusses in west end of building

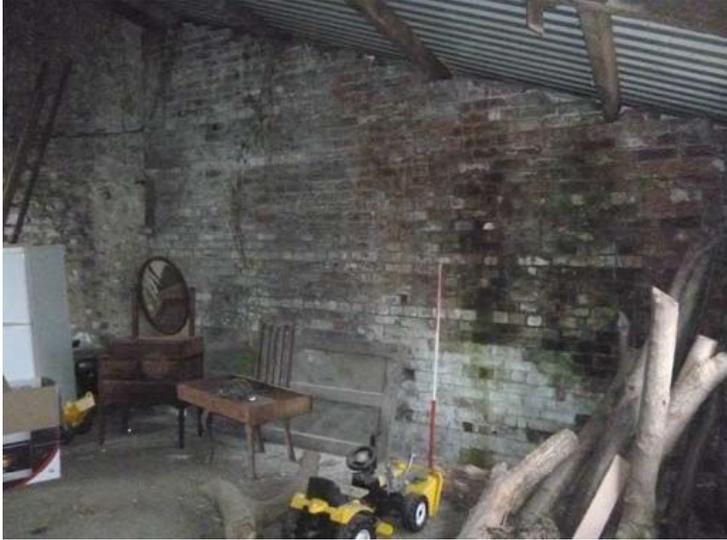
Plate 9 (left): North internal elevation, east side

3.3.3 **North elevation:** the east side of this elevation is brick, which is hand-made, laid in English garden wall bond in a pattern of four rows of stretchers followed by one row of headers, the same as in the east elevation (see *Section 3.3.7* below; Plate 9). There are traces of whitewash, and the sawn-off remnants of a timber shelf or bench, with holes built into the brickwork. There is a concrete course at the base and a brick plinth projecting below this.

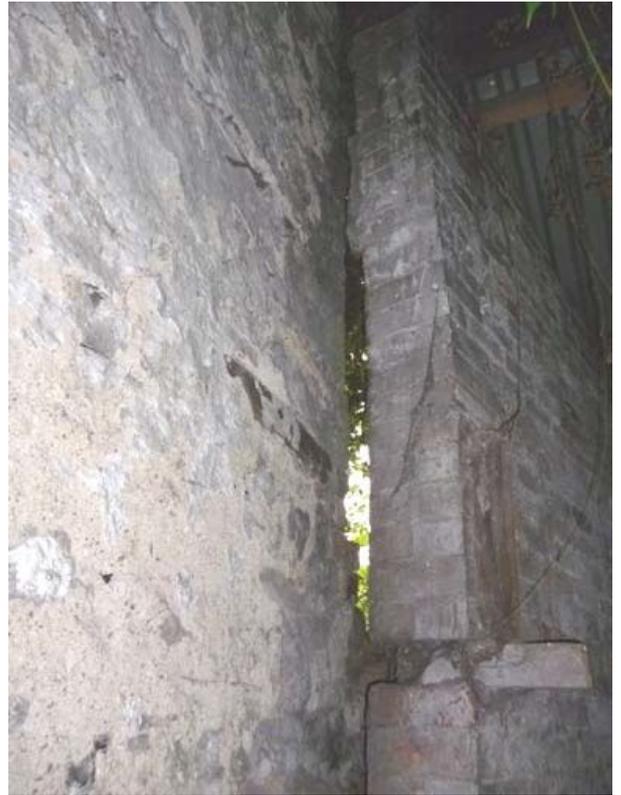
Plate 10 (right): Junction of walls in the north internal elevation

3.3.4 The brick section actually projects beyond the line of the stone wall to the west, and is not bonded to it (Plate 10). The gap is filled with rubbish and insulating foam, and the stone wall appears to be continued by the boundary wall running to the east. The stone wall appears to be built on top of this, with quoins extending above, which are reasonably well dressed. There is no evidence for a return of the stone wall to the south, suggesting this was originally an external wall for a building extending to the north. This wall in general is largely built of local limestone, with the occasional piece of slate and brick (Plate 11). There are lots of battens and modern electrical fittings attached and the remains of lime mortar, render, and whitewash are apparent. There are no obvious openings in the wall, but a possible small one 25cm x 35cm on the east side could be a winnowing slot (Plate 12). Also, there is a row of holes above this, presumably for joists. There are no obvious quoins on the west side but this is rendered externally. The top of the wall is very ragged and the roof on the west side has been replaced with felt underlay added on top of the battens.

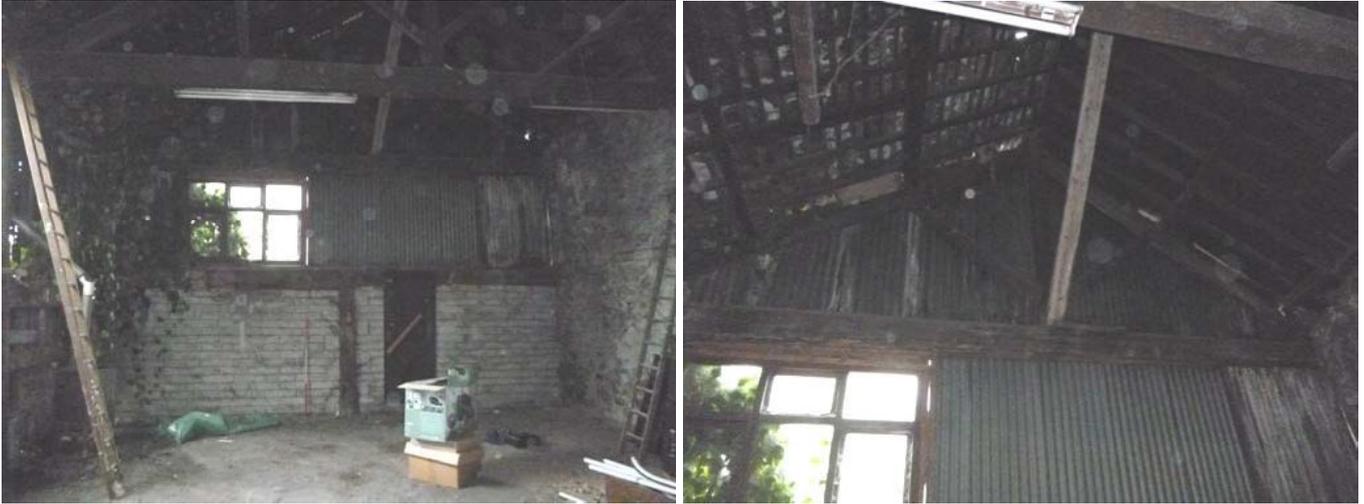
3.3.5 West elevation: the lower part of this elevation is constructed from concrete blocks, incorporating a single upright post in the centre, and topped with heavy timber beams, which support a lightweight timber and corrugated metal structure with a six-light casement window on the south side (Plate 13). There is a doorway to the north of the centre, with a tongue and groove plank and batten door, and a truss forming part of the upper part (see *Section 3.3.2* above). There is some brickwork filling the gap on the lower south side, which is very rough, and a mix of hand-made and machine-made frogged types, clad round the iron column supporting the truss, which effectively runs outside the east elevation and is covered externally on all sides (Plate 14).

Plate 13 (left): West internal elevation

Plate 14 (right): Truss against west internal elevation

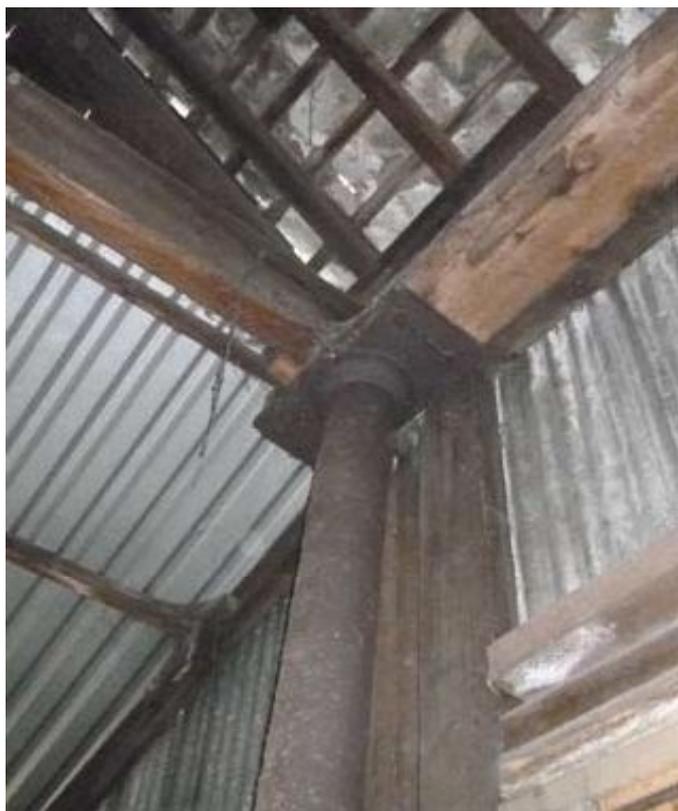
Plate 15 (left): South internal elevation, column top

3.3.6 South elevation: this is entirely constructed from a mix of timber framework and corrugated metal sheeting on a superstructure of four massive cast iron columns, including the one also incorporated into the west elevation, each of which has a flat plate on top with a rounded collar beneath (Plate 15). Each also has a bracket as part of the casting mid-way down with two bolt-holes passing right through (Plate 16), which now apparently serve no purpose and suggest that these columns are re-used from a larger industrial building (as might also be the trusses, timber and bricks; see *Section 4.1* below). The bases are set into the concrete floor. These support a series of massive timber beams, perhaps re-used, sleepers and the ends of the four trusses. The rest of the wall is a mix of timbers, including an old panelled door on the west side, with fairly plain moulding and round head (Plate 17). There is a large central four-light window between two of the columns (Plate 18) with a stub 'wall' below it, two courses high, built of hand-made brick. There is a double door on the east side of the main section, with a modern double door (Plate 19), while the east end is a more basic structure of corrugated sheeting and timber (Plate 19).

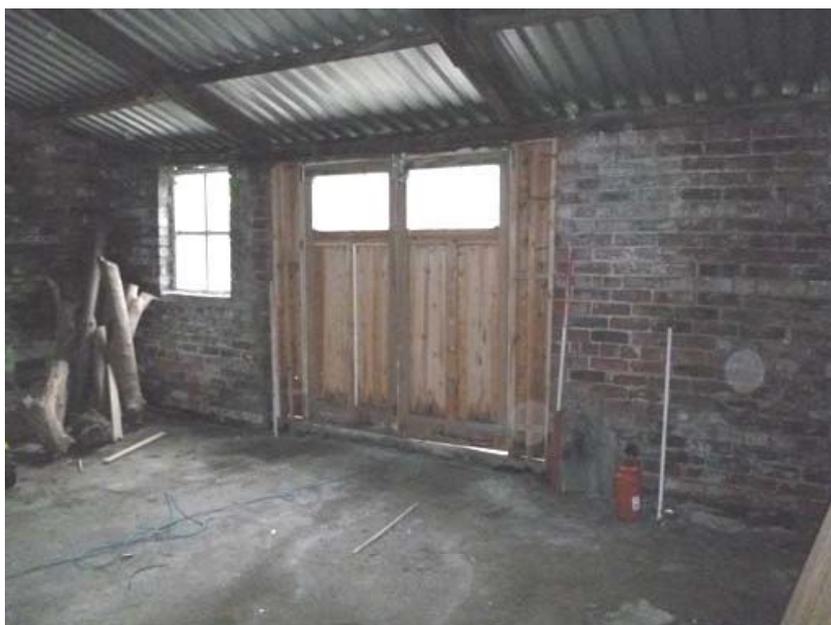
Plate 20: East internal elevation

3.3.7 **East elevation:** this is entirely brick-built, with hand-made brick (the exterior brickwork is presumably a skin), typically a dark orangey-red, hand-made, and measure 23cm x 7 cm x 11cm and laid in English garden wall bond at a ratio of four rows of stretchers to one row of headers (Plate 20). There is a timber wall plate on top. There is a central double plank and batten door, and a four-light window to the north side, and with a concrete sill.
