FORMER HOTEL GARAGE, HIGH STREET, BARROW-IN-FURNESS, CUMBRIA

Archaeological Building Recording

Client: Andrew Hartley

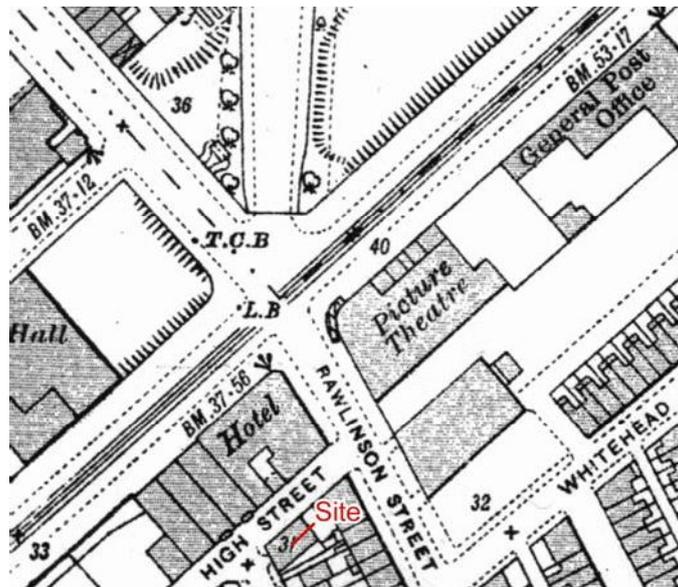
Plate 3: Ordnance Survey map, 1938

3.3.4 **Ordnance Survey, 1938:** the footprint of the building remains the same as shown in the previous maps (Plate 3).

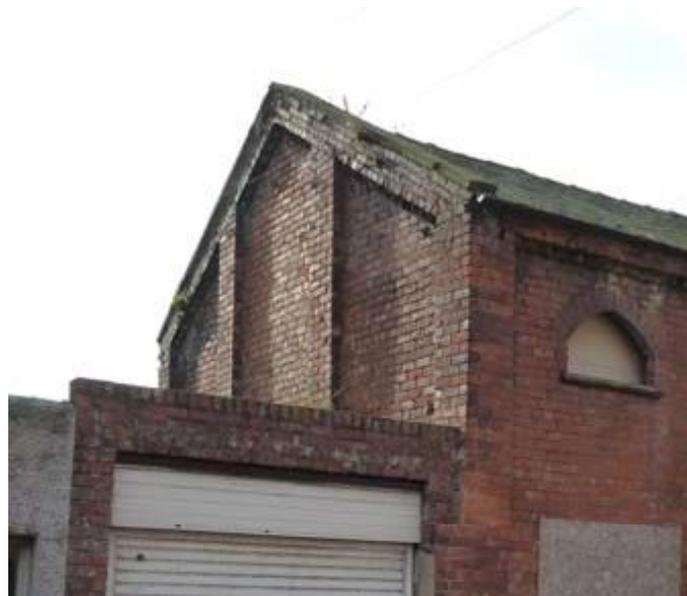
Plate 4: North-east external elevation visible above the attached garage

4.2.1 **North-east elevation:** the north-east gable end is partly obscured by the attached garage at ground floor level (Figure 2; Plate 4). It has two projecting pillars and projects at the ends of the elevation and below the eaves, with coping on top and dogtooth brickwork below.

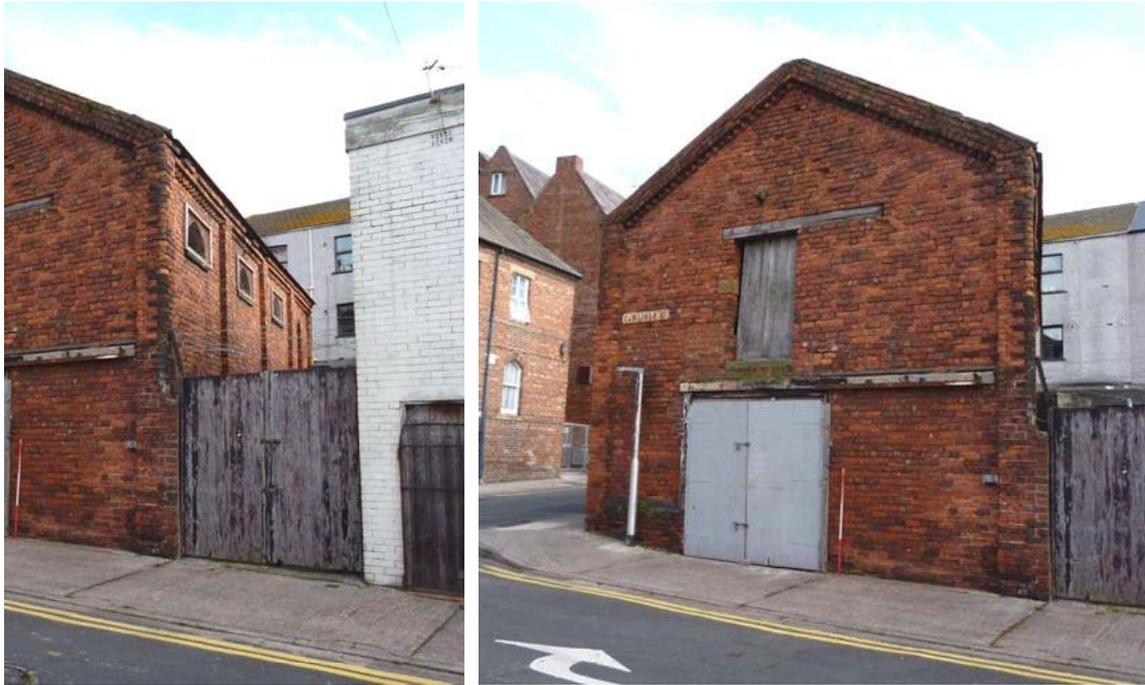
4.2.2 **South-east elevation:** the south-east elevation is similar to the north-west elevation in that it has a row of four windows on both the ground and upper floor (see Section 4.2.4 below). All of the windows on this side of the building are filled with concrete blocks (Figure 2; Plate 5). One window on the first floor at the north-east end has been enlarged and has a lower thin sill, although it is still stone like the others.

4.2.3 **South-west elevation:** this forms the gable and faces onto Carlisle Street, the cast iron sign for which is attached to the north-west side of the elevation (Figure 3; Plate 6). It is plain brick with projecting pillars at the corners, which is enlarged slightly on the ground floor at the south-east side, above which the elevation has bull nosed bricks. There is an angled plinth on the north-west side of the double doorway on the ground floor. The doorway houses a modern double door but the rail for an earlier sliding door is still present above it and to the south-east. The first floor has a loading doorway with an overlarge timber lintel, which extends to the south-east, and there is a projecting timber above this for the hoist. The doorway has a yellow sandstone sill and a similar sandstone block in the north-west jamb. There is dogtooth brickwork below the eaves, which projects to form a wide coping on top of the roof; although this is possibly just a layer of concrete behind an additional course of brick.

Plate 5 (left): South-east external elevation

Plate 6 (right): South-west external elevation

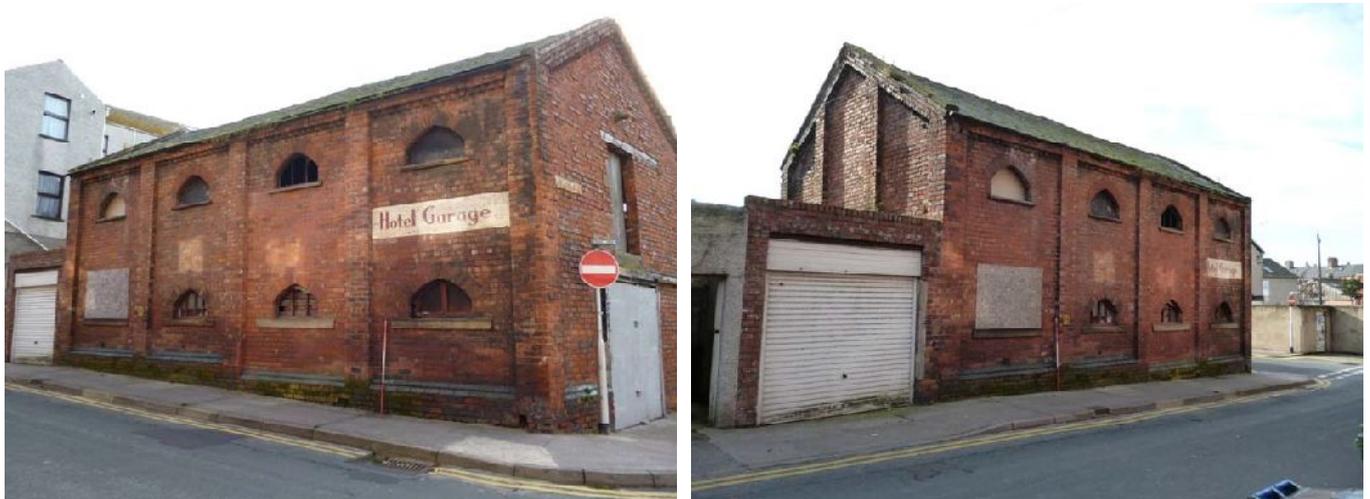
4.2.4 **North-west elevation:** this elevation has an angled burnt brick plinth along its base between projecting pillars (Plate 7). The brick is in better condition on this side compared to the rest of the building. There is a row of four windows on both the ground and upper floor all of which have four-point brick arches and dressed yellow sandstone sills. There are two-, three- and four-light timber casements present. There is an iron gutter and a painted sign which reads 'Hotel Garage' on the south-west side. The wall slightly is extended into a modern garage on the north-east side (Figure 3; Plate 8).

Plate 7 (left): South-west end of the north-west external elevation

Plate 8 (right): North-east end of the north-west external elevation

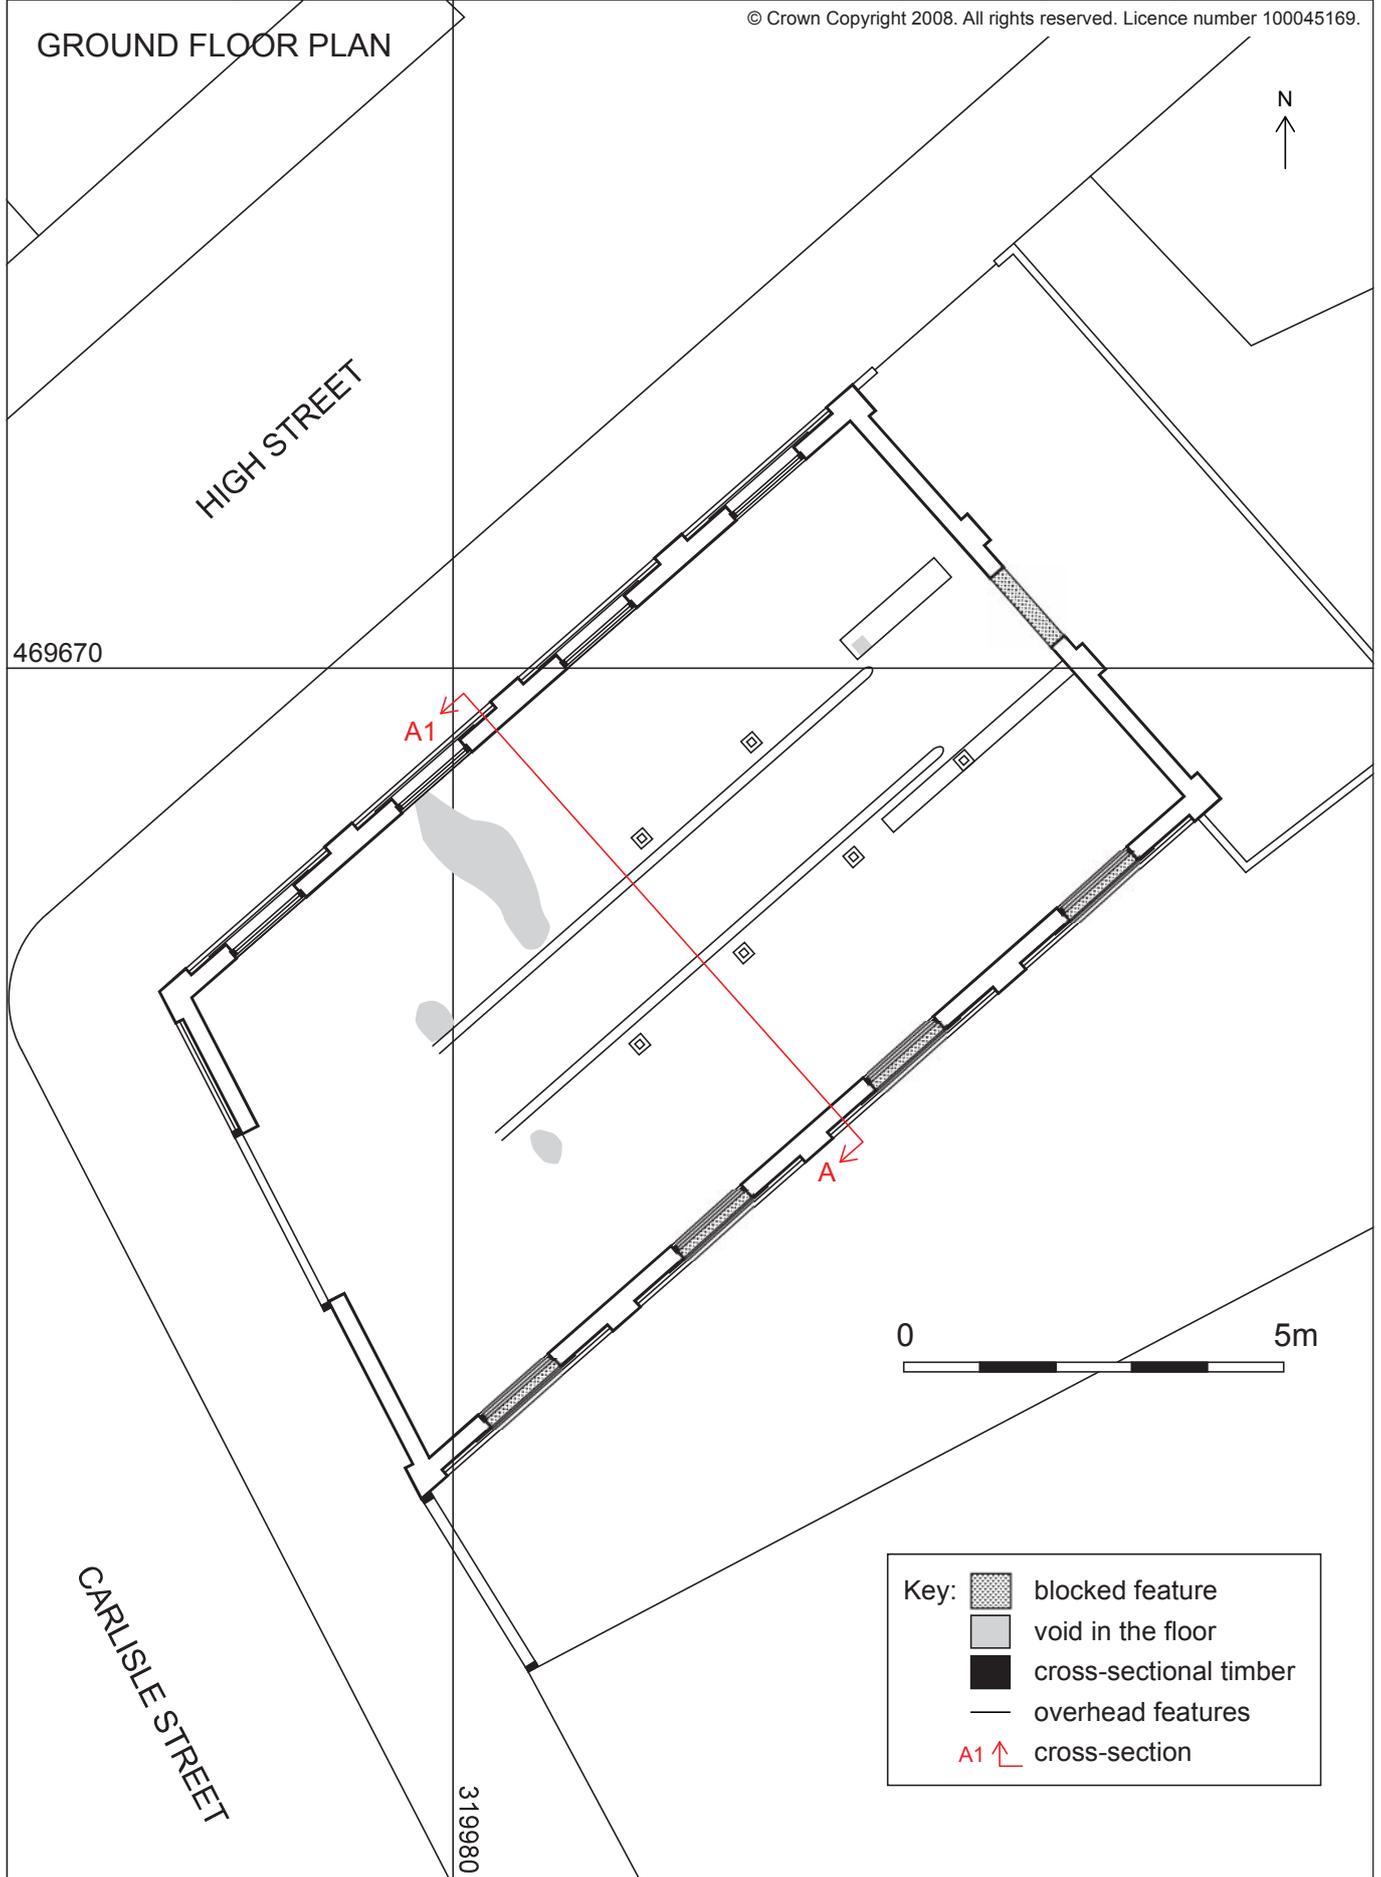
Figure 4: Ground floor plan

4.3.1 **Ground floor:** the room has a concrete floor with two rows of square stone pads with central square sockets running east/west either side of a pair of shallow grooves or drainage channels set in the floor (Plate 9 and Plate 10). The pads were evidently for stall posts, although at the south-western end there are holes in the floor, presumably corresponding to the positions where some of these have been removed.

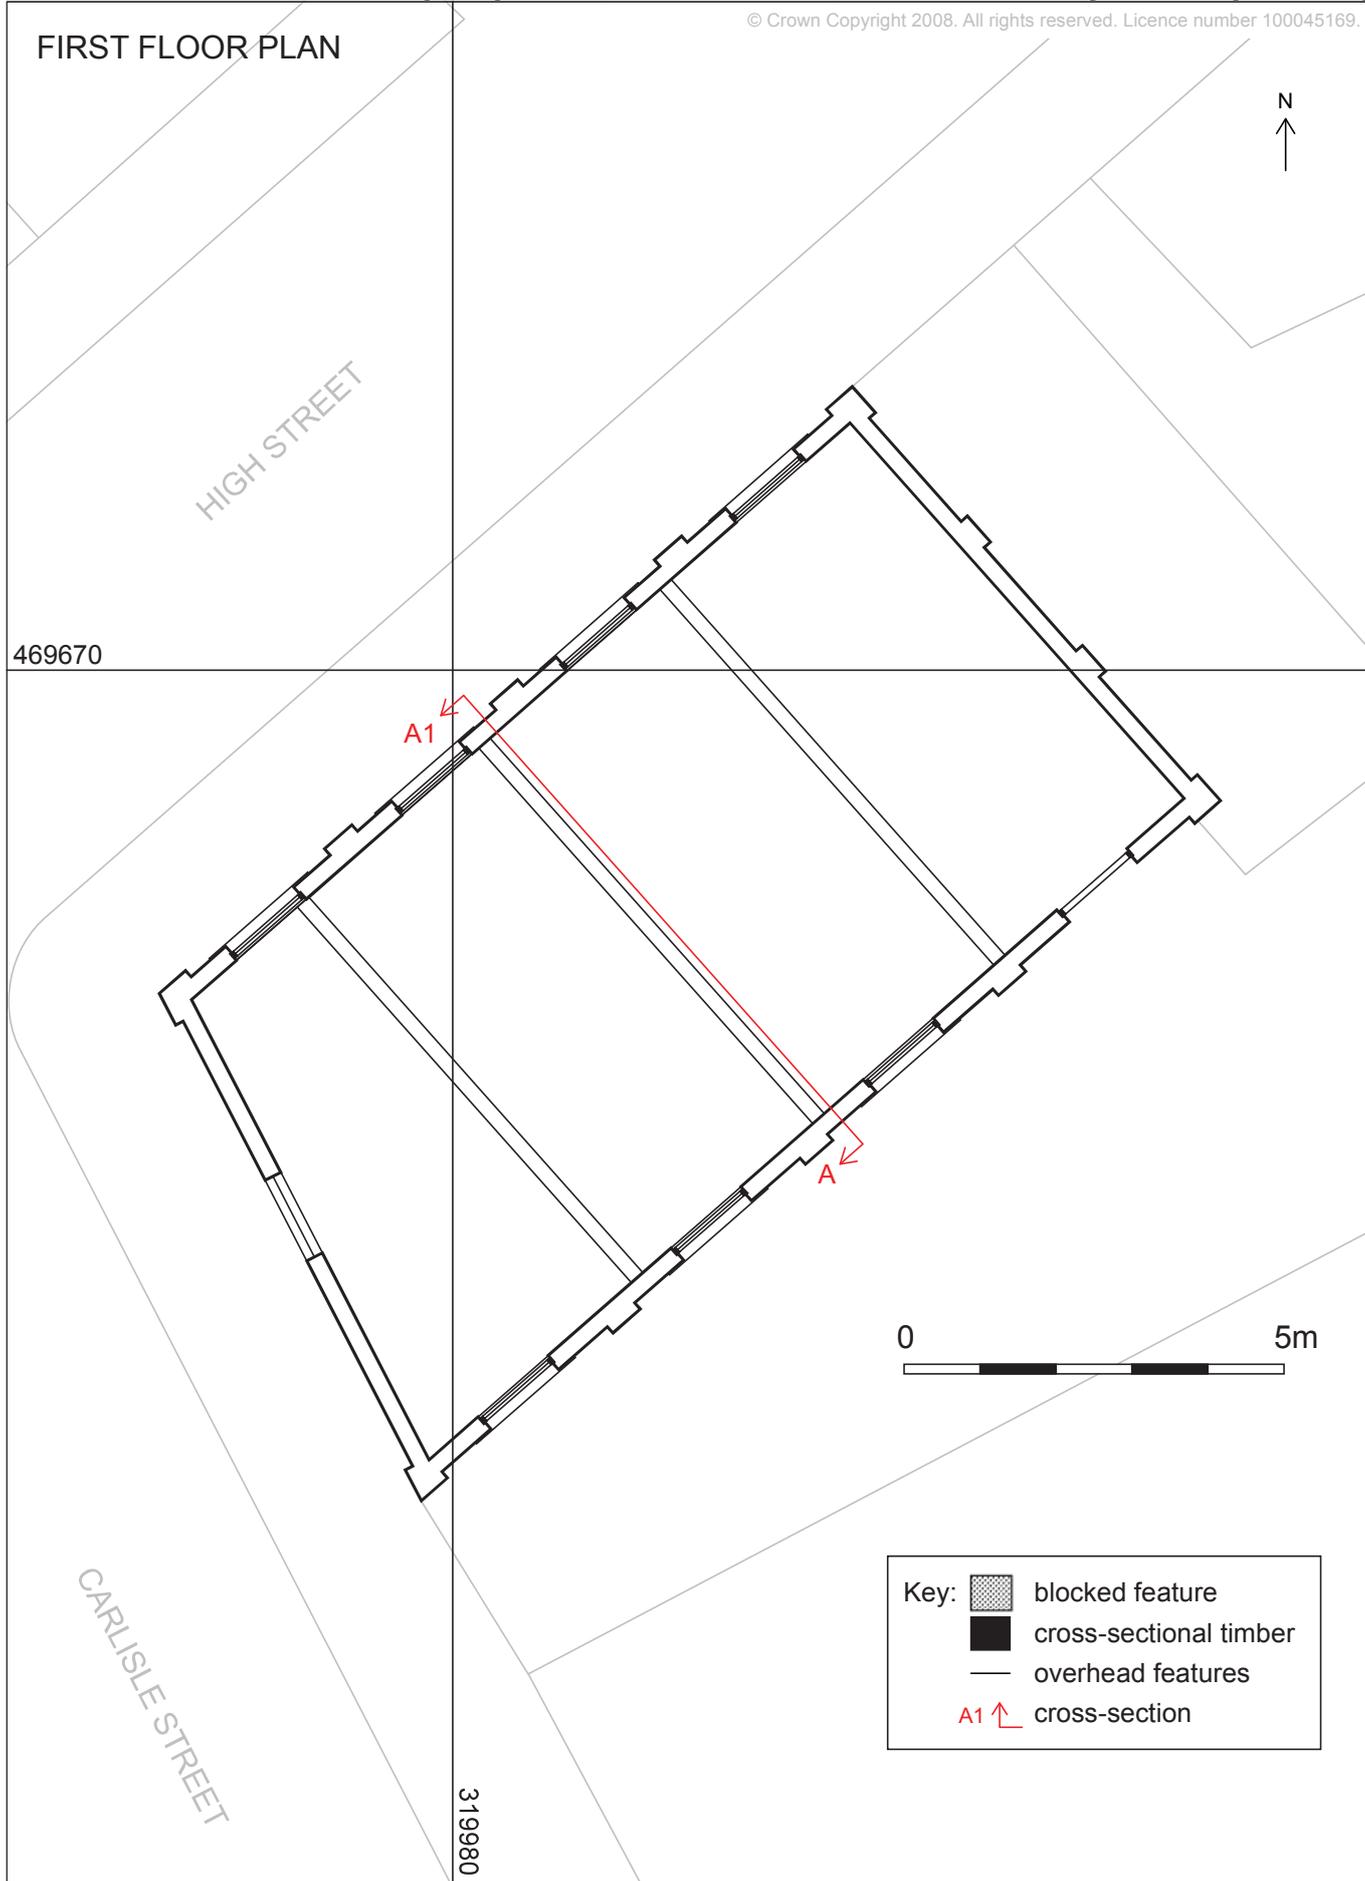
Figure 5: First floor plan

4.3.7 **First floor:** this floor was inaccessible and had to be viewed from the floor below. The floor comprises just the joists and some loose floorboards. The ceiling is supported by three king post trusses with angled braces, which in turn have vertical braces (Figure 6). The king post is joggled to fit the braces and principals and bolted to the tie beam with a single purlin per pitch and a ridge plank. The trusses are bolted between the beam and principals and there is only one vertical batten on the south-east side of each and machine cut timber is used throughout.

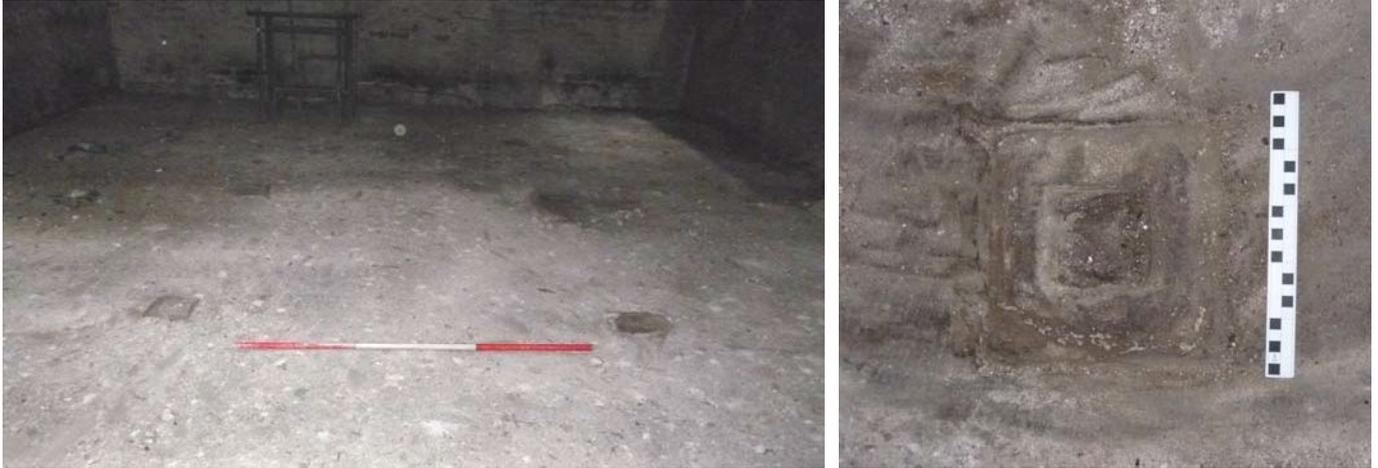
Plate 9 (left): Square sockets in the concrete floor

Plate 10 (right): Detail of one of the square sockets

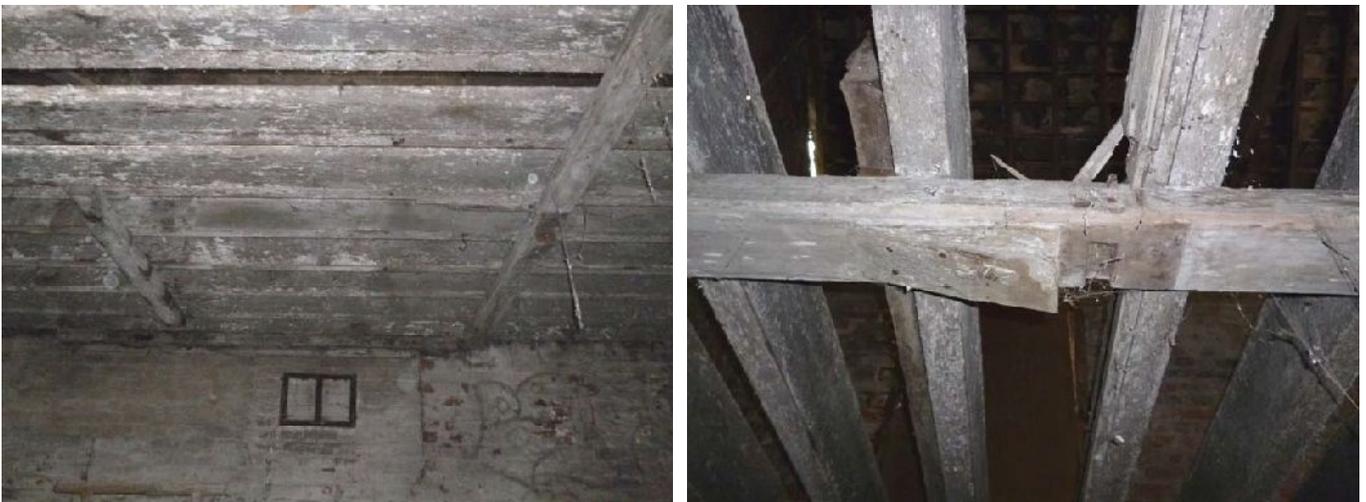
4.3.2 The ceiling comprises just the joists, the boards having been removed, with two east/west timbers attached below the joists at the north-east end (Plate 11). The south-east one has a wedge and a slot (Plate 12), which corresponds to the pad below, and there is a slot in the same position on the north-west one which has a further beaded timber with a slot along it on the north-west side against the wall which was probably a rail for a sliding door. The walls are all whitewashed brick.

Plate 11 (left): Timbers attached below the joists at the north-east end

Plate 12 (right): Wedge and slot on the south-east timber

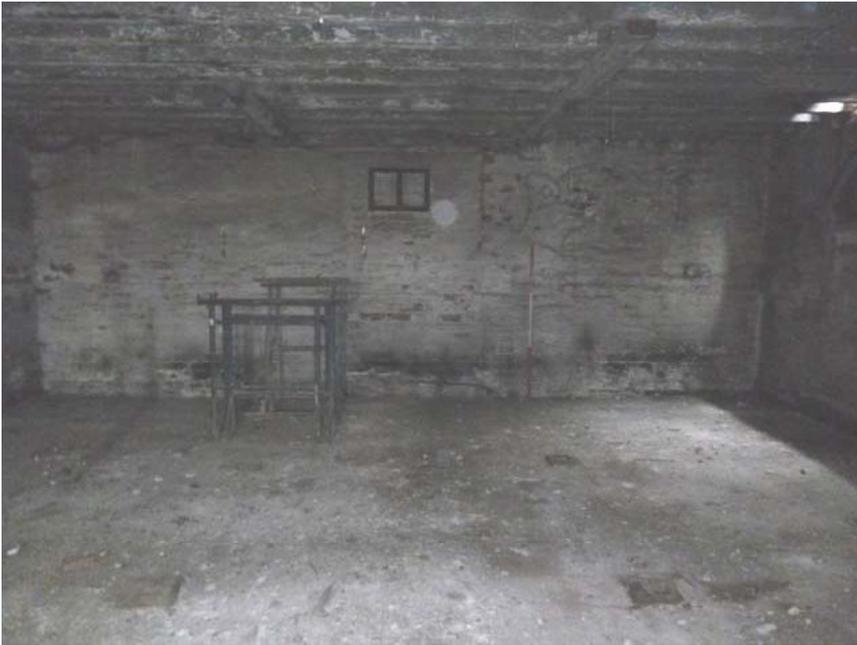
4.3.3 The north-east elevation has a central doorway, which is blocked with brick, attached to which is a timber frame with two panes with chamfered edges and cut off stubs of timbers on the north-west and south-east sides and two chamfered battens on the south-east side (see Plate 13 and Plate 14). This doorway has an overly long timber lintel, which extends to the north-west, and there is a corresponding length of beaded board attached to the joist, creating a slot, which presumably housed a sliding door.

Plate 13 (left): North-east elevation

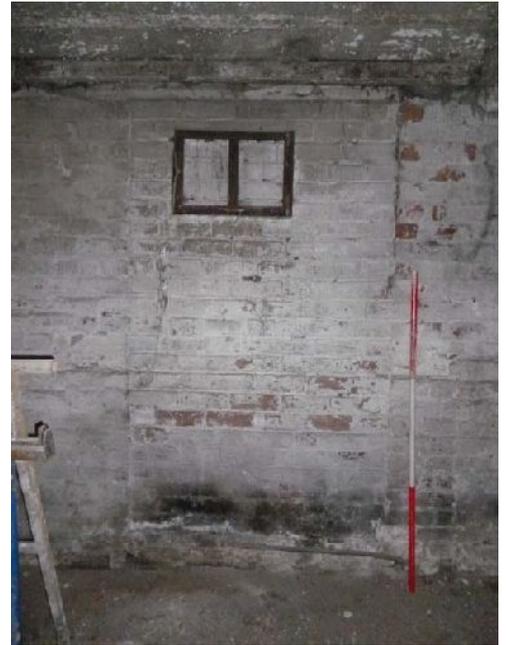
Plate 14 (right): Detail of the blocked doorway on the north-east elevation

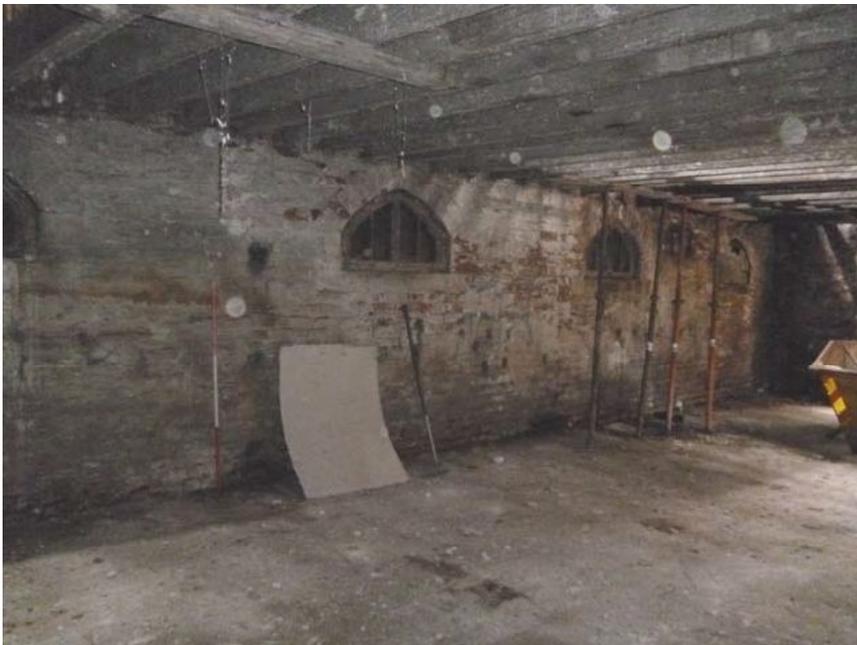
4.3.4 The south-east elevation has four brick-arched windows and stone sills (Plate 15 and Plate 16). Four-light hinged casement windows were visible in three of them, but oddly these seem to hinge inward from the central 'mullion'. These are decorated with chamfer and attached edging strips. There is a further chamfered timber frame, with two panes, attached on the south-west side. This frame and other timbers in this corner are heavily charred and there are rows of small holes along the elevation corresponding to where timbers have been removed from the wall.

Plate 15 (left): Brick-arched windows in the south-east elevation

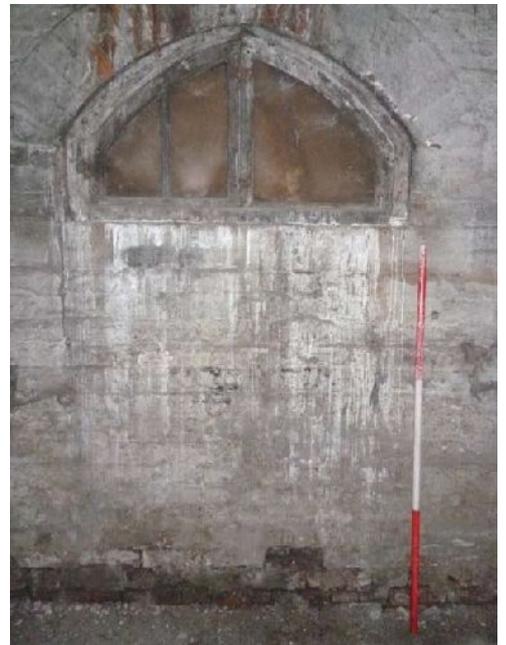
Plate 16 (right): Detail of a window in the south-east elevation

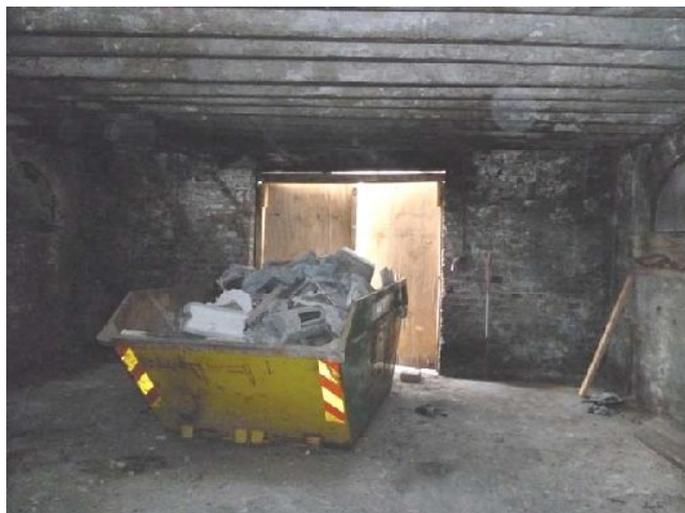
4.3.5 The south-west elevation has a central double doorway, with a machine cut timber lintel, housing a modern door (Plate 17). The elevation is otherwise plain, apart from where there are some pipes attached and two sawn off pieces of timber high on the south-east side, which appear to be joist ends.

Plate 17: The south-west elevation

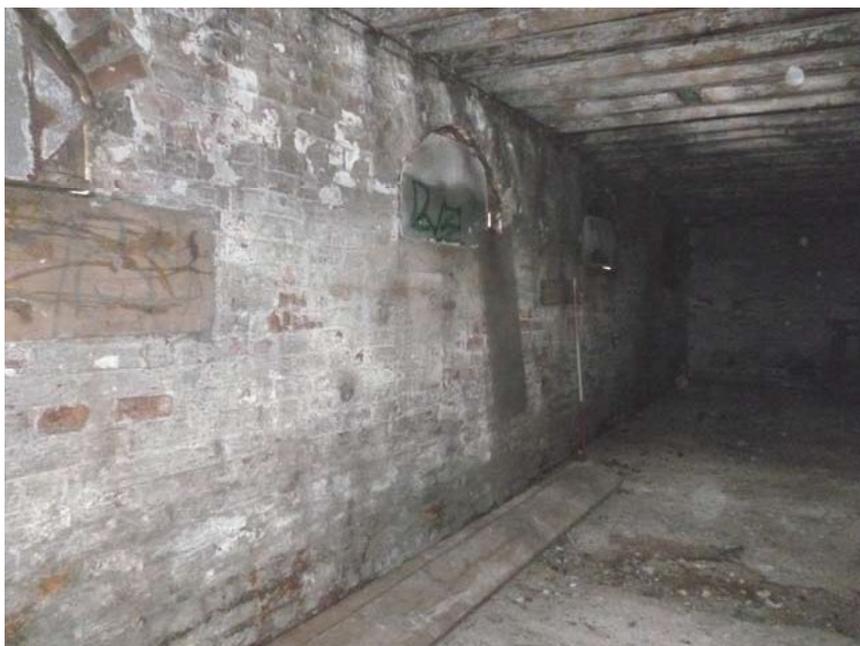
4.3.6 The north-west elevation has four windows (Plate 18), all of which are covered with sheet metal apart from the north-east one, which has no casement and is boarded up (Plate 19). The rest of the elevation is plain, with some modern timber board attached and rows of holes for inserted timber. There is an iron tether ring on a square plate at the north-east end (Plate 20) and a small hole below it at ground floor level.

Plate 18 (left): The north-west elevation

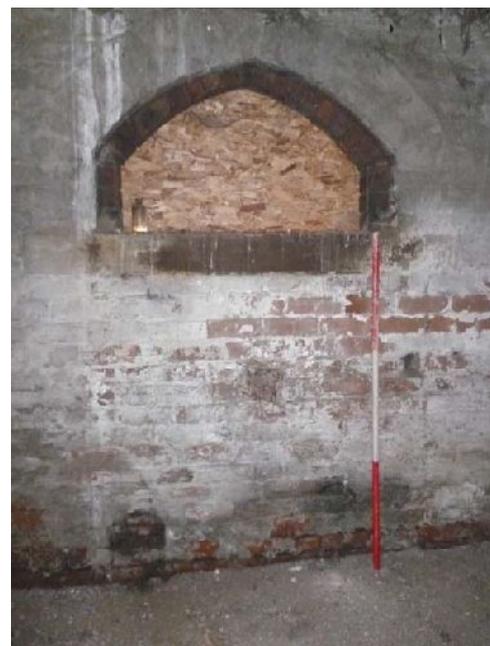
Plate 19 (right): Boarded up window on the north-west elevation

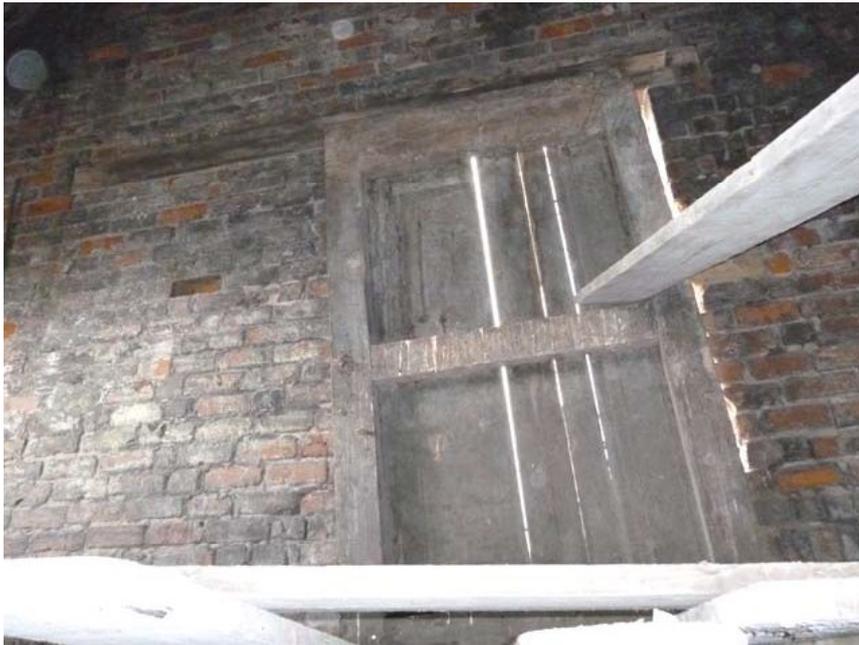
4.3.8 The elevations have the remains of whitewash as per the ground floor. The north-east elevation is plain. The south-east elevation has an enlarged window on the north-east side, which is more like a loading or pitching door, and three windows to the south-west, which are similar to those on the ground floor but have intact frames. The south-west elevation is essentially plain apart from a central loading door (Plate 22). Timber is attached to the lintel and projects out of the wall and a heavy plank and batten door slides below it. A beam is inserted into the wall above (Plate 23) and rests on the tie beam of the truss to the north-east; this presumably forms the hoist which is visible outside (see *Section 4.2.3*). The north-west elevation is plain apart from the four windows, which are similar to those on the ground floor, the central two of which have casements remaining, although these are three-light rather than four-light

Plate 22 (left): Upper floor level loading door on the south-west elevation

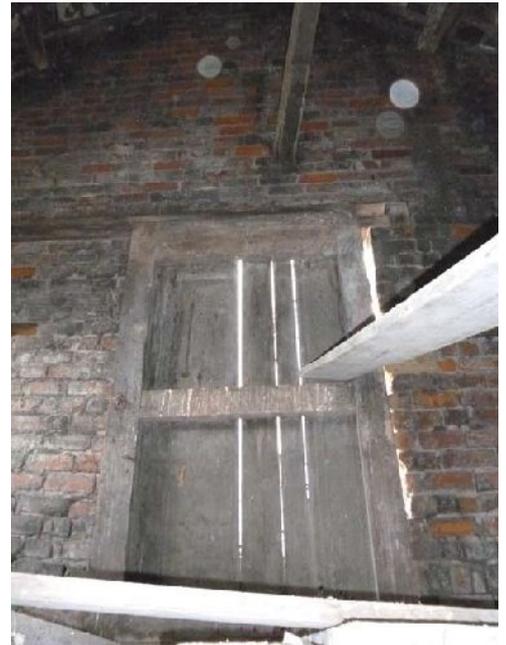
and possibly tilting. The beam forming the hoist has an iron plate strapped to the underside where it rests on the wall.

Plate 23 (right): Beam / hoist above the loading door

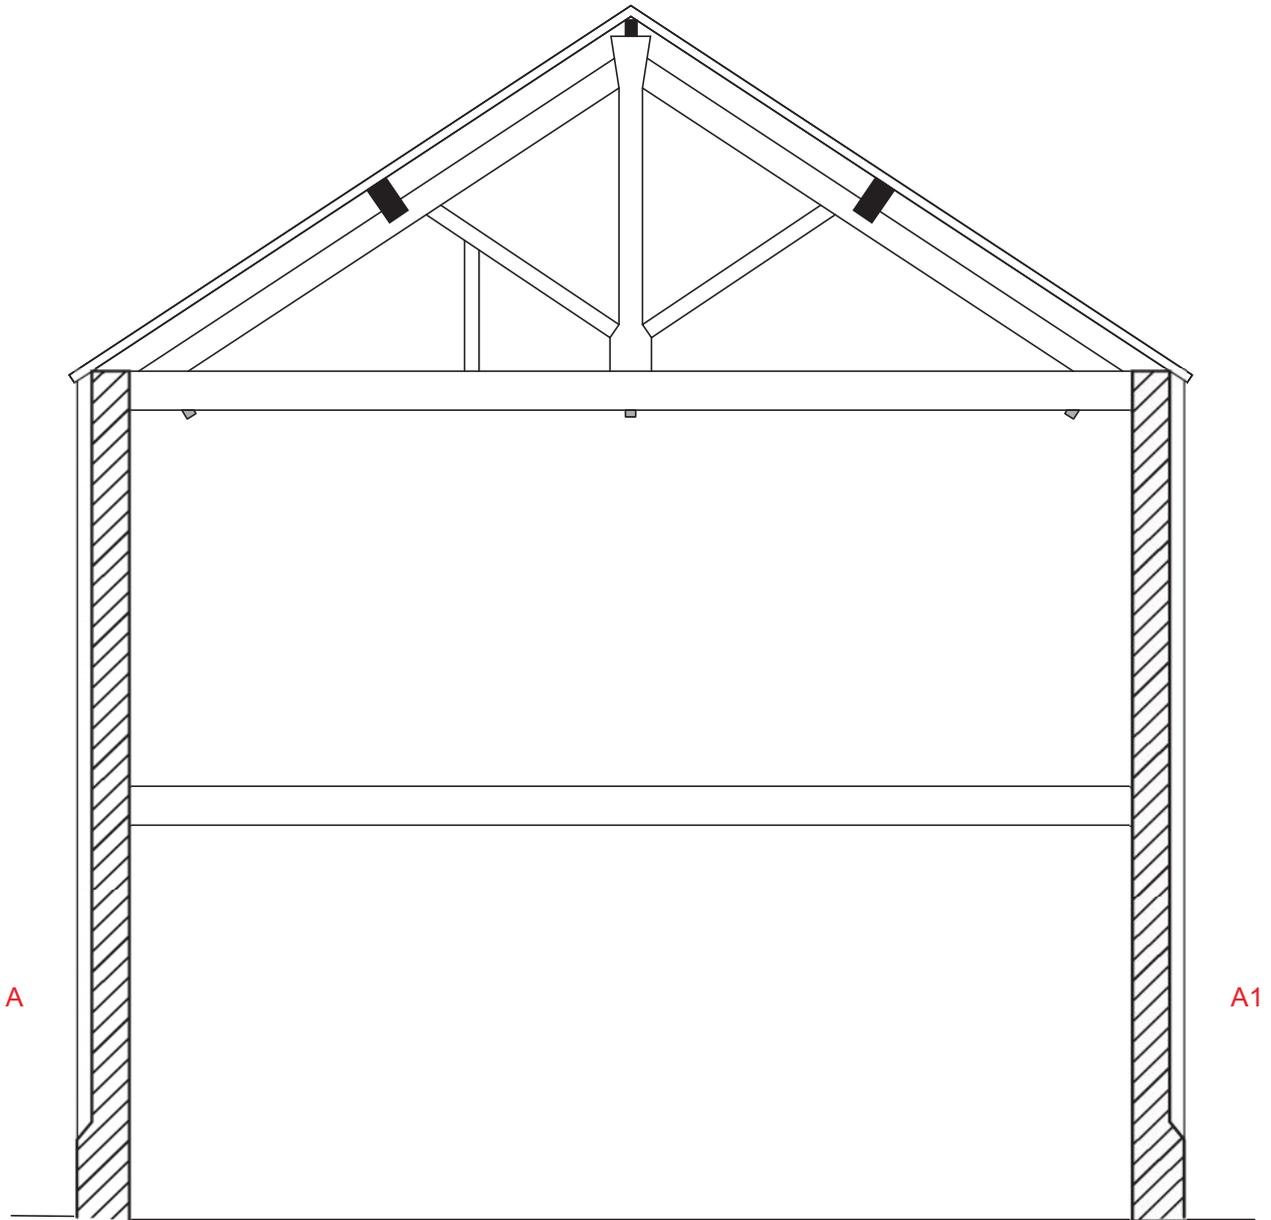
Figure 6: Cross-section A-A1

CROSS-SECTION A-A1, LOOKING SOUTH-WEST
