DALE BECK SMELT MILL, CALDBECK AND ULDALE COMMON, CUMBRIA

Archaeological Survey

Client:
Caldbeck Commoners
Association

February 2012

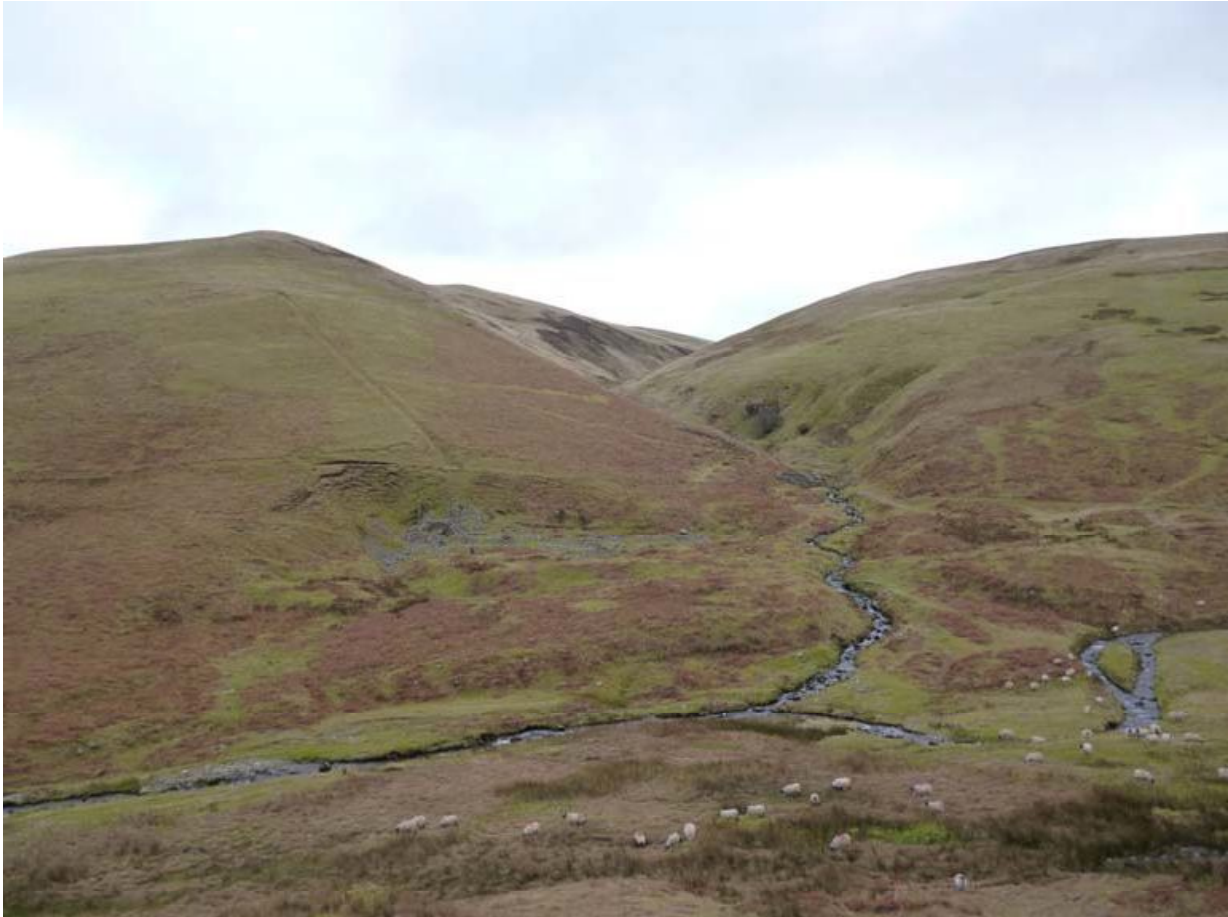
Plate 4: General view of the survey area, from the east

5.1.1 The Level 2 survey, which was carried out between the 13th and 15th February 2012, primarily resulted in the detailed topographic plan and profile of the structures and earthworks comprising the smelt mill and its environs, as shown in Figure 2 and Plate 4. In addition, the written descriptions made during the survey provide a further descriptive account of the various elements.

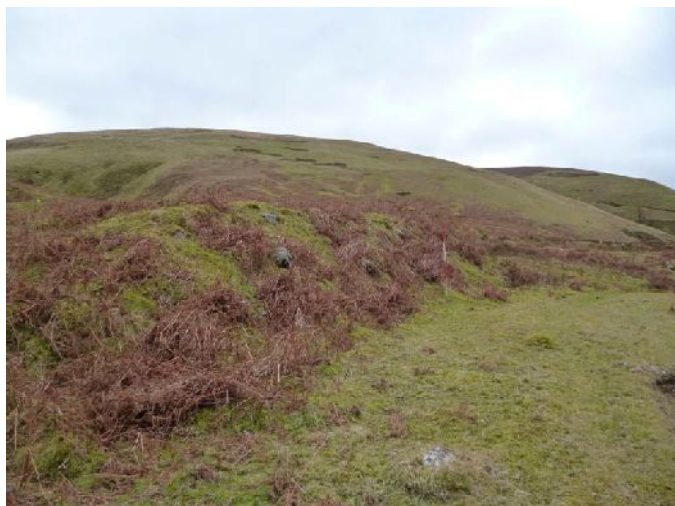
5.1.3 **Site 01:** this comprises a relatively flat terrace at the bottom of the valley adjacent to Dale Beck, which is to the west. Alongside the beck it forms a bank at least 2m tall (Plate 5), which turns back on itself towards the south-east. At this point a narrow trench cuts through it, orientated approximately north-west/south-east, which is evident as a patch of reeds but remaining as a 1m wide and 0.7m deep channel that peters out to the south-east (Plate 5). This is presumably a hollow way, and is augmented by a further shallow channel to the north, orientated east/west at the north-west end running between the beck and **Site 05**.

Plate 5 (left): The bank along the side of Dale Beck forming the west side of Site 01

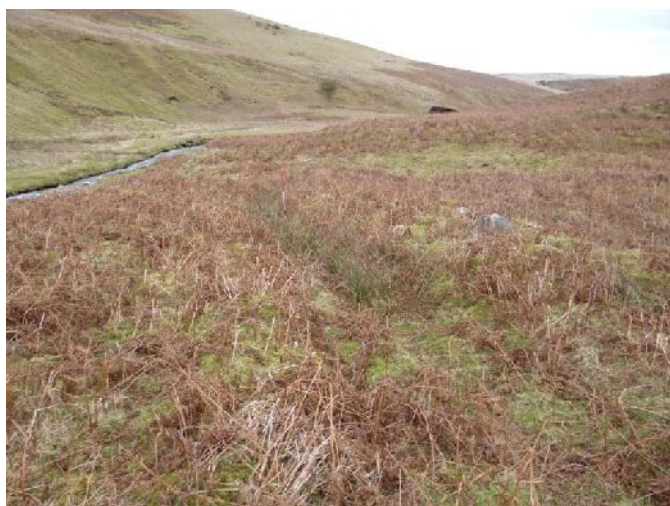
Plate 6 (right): The hollow way, evident as a patch of reeds, within Site 01, viewed from the south-east

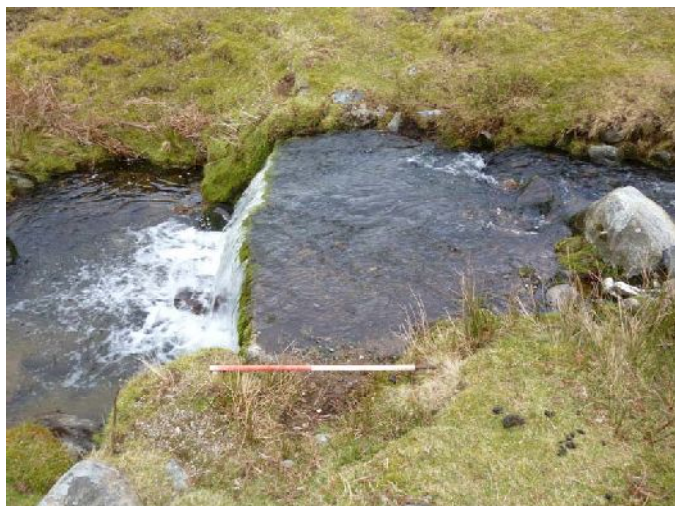
5.1.4 **Site 02:** this comprises a short weir forming a ford across Hay Gill. It is presumably of stone construction – the front (west) face is obscured by moss and flowing water, while the top is finished with gravelly concrete (Plate 7). It is c1m tall and 2m wide and has some upright timbers at the base against it (Plate 8), although these too were obscured by moss.

Plate 7 (left): The weir (Site 02), viewed from the south

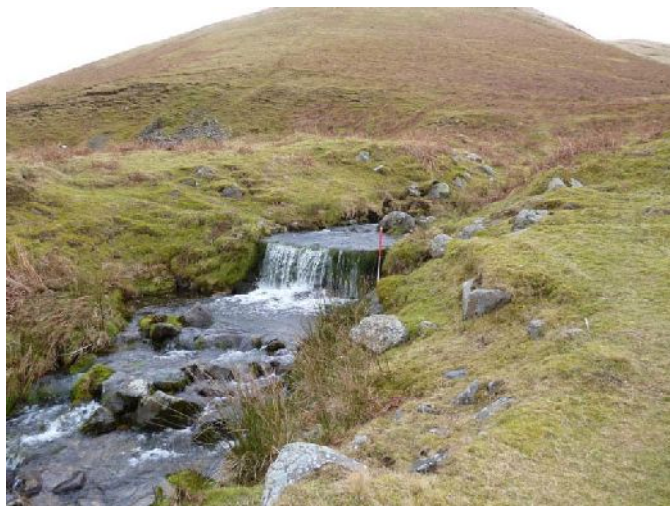
Plate 8 (right): The weir (Site 02), viewed from the west

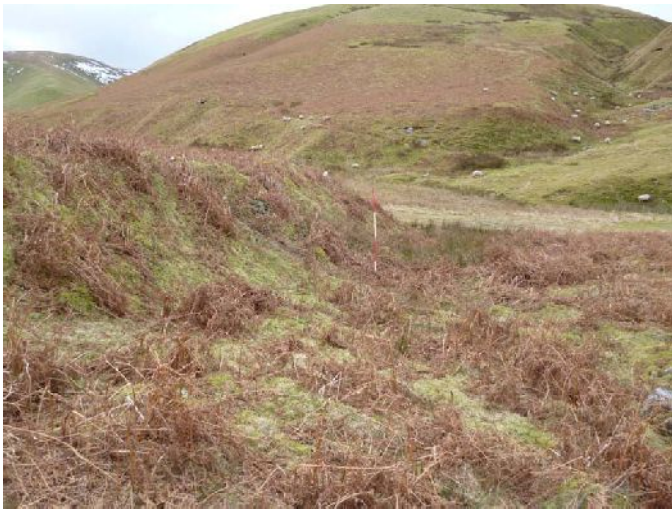
5.1.5 **Site 03:** this forms the remains of what is evidently a former river channel, comprising a tall bank on the south-east side, over 2m tall (Plate 9), and shallower bank to the north-west, closer to 1m tall. The resulting channel is c4-5m wide. There is no evidence of how it originally connected to the extant Hay Gill, and the ground is relatively high where they meet, suggesting that it has been deliberately blocked.

Plate 9 (left): The south-east side of the former channel (Site 03), viewed from the north-east

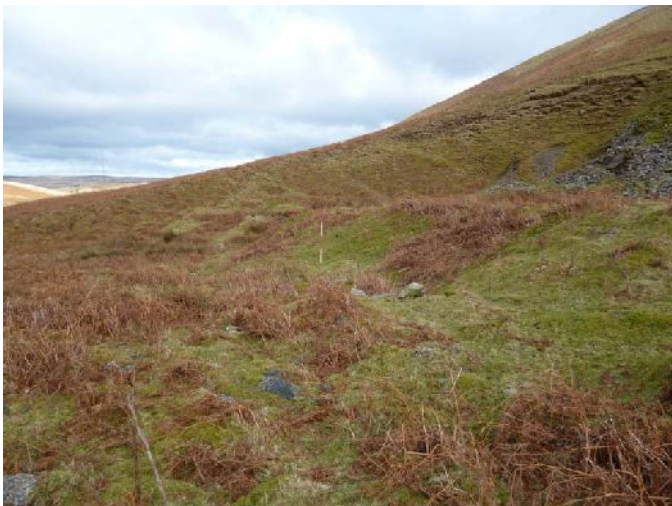
Plate 11 (left): The north/south face of the upper terrace (Site 04)

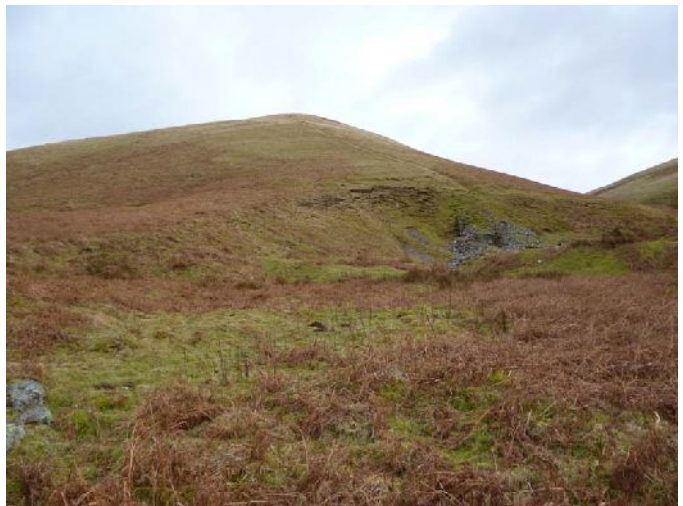
5.1.7 Site 05: this is essentially a natural ravine formed by a tall slope to the north ranging from less than 1m high to the west and up to 5-6m high to the east. The south side is essentially formed by elements of **Sites 01, 04** and **07**. There is a slight turn to the north mid-way along the north slope and at the base of the slope there are amorphous piles of material, perhaps representing slumps or even landslides. Beyond these, to the south and south-west, it is very boggy, perhaps a remnant of the tail race from the wheel pit to the east.

Plate 12 (right): General view of the ravine (Site 05) from the west

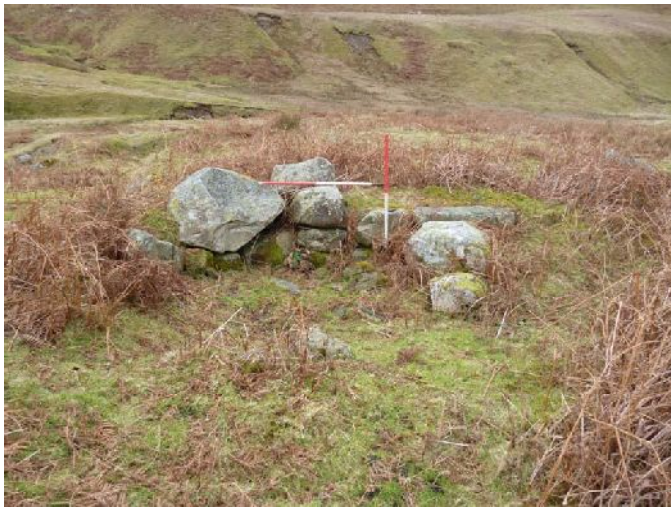
5.1.8 Site 06: this is an amorphous earthwork of uncertain purpose and date. It comprises a central section of apparently orthostatic wall, c3m long and 1m thick, orientated north-south, with a slight return to the east at its south end. Up to three courses (0.8m) of this wall remain standing, which includes some very large boulders (Plate 13 and Plate 14), and it appears to continue as an earthwork to the south and south-east, where there are further large boulders; indeed, there are considerably more boulders in this area than anywhere else on the site (Plate 15). The whole structure covers an area of approximately 6m in diameter and it is no more than 1m tall (Plate 16).

Plate 13 (left): Orthostatic walling forming part of Site 06, viewed from the east

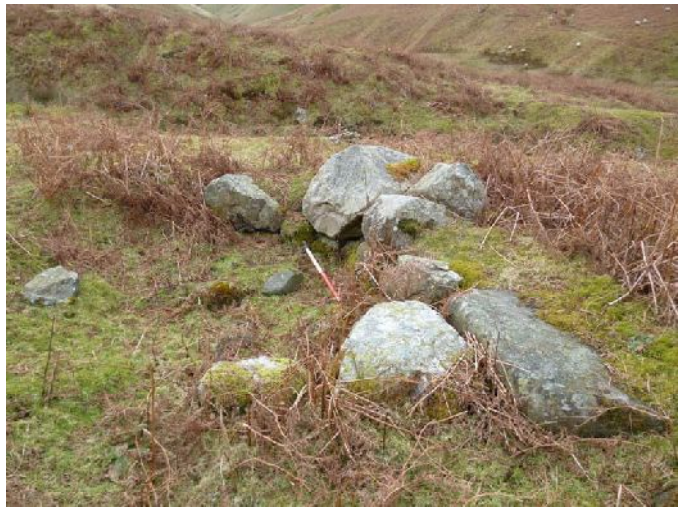
Plate 14 (right): Walling forming part of Site 06, from the north

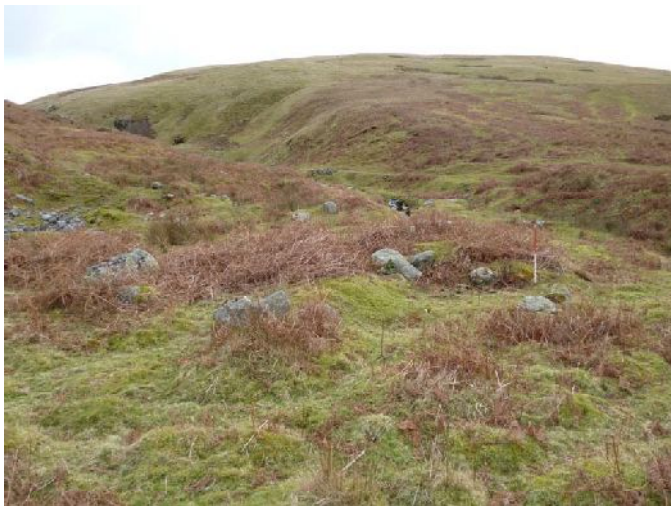
Plate 15 (left): General view of the earthworks and boulders making up Site 06, viewed from the north-west

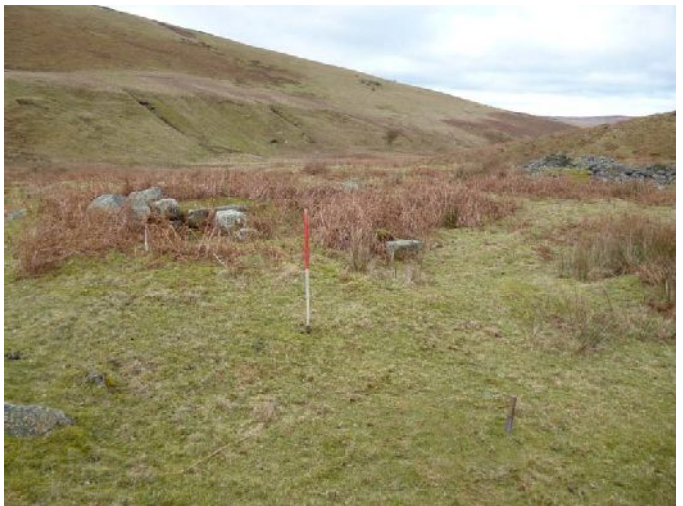
Plate 16 (right): General view of the walling and earthworks making up Site 06, viewed from the east

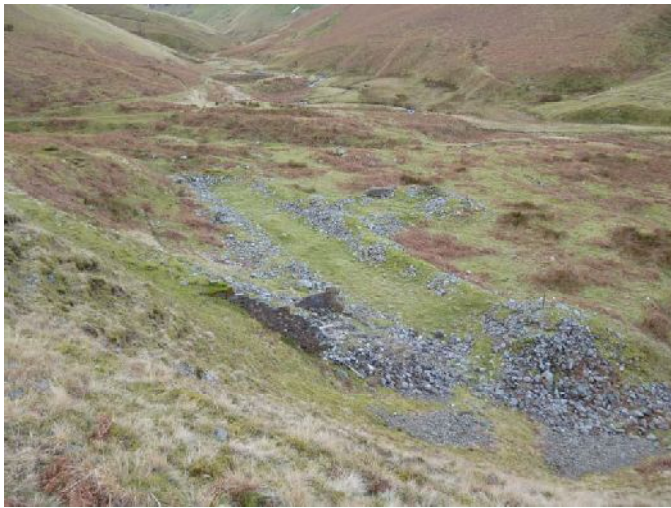
5.1.9 Site 07: this comprises the structure of the actual smelt mill, which survives essentially as earthworks and collapsed rubble (Plate 17) but has some sections of standing wall bonded with a gritty lime mortar. Bricks of various types are evident within the rubble, the most common forms being hand-made perforated bricks of orangey-red colour (at least one waster or badly warped example of these was also present), firebricks in gritty vitrified orange and yellow clay, some evidently hand-made but some with frogs (with an illegible maker's mark) and many with vitrified surfaces and some little more than tiles, and standard hand-made red bricks. One of the yellow firebricks was marked 'TICKLE' (Plate 18); these are thought to have been made by William and George Tickle who were based at Birkby in the 1860s-1870s and Cumwhinton in the 1870s (Davies and Davies 2011, 16). In addition, dressed stone of various sizes was present amongst the rubble, typically in red, pink or yellowish sandstone, often in the form of slabs, but also some large blocks with broaching and cross-broaching. A large slab of red sandstone in the deeper pit (probably the early wheel pit) to the north had the remains of a circular hole cut into it, and was presumably part of the bearing for the water wheel's axle or served some similar function (Plate 19). Some fragments of grey roofing slate are also present amongst the rubble to the north of the building.

Plate 17 (left): General view of the smelt mill (Site 07) from the north-east

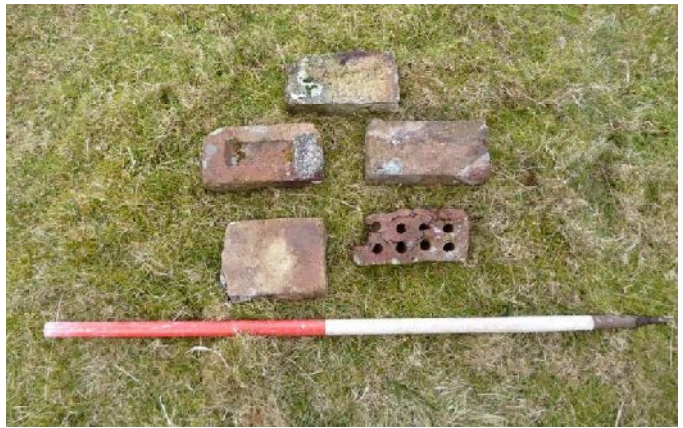
Plate 18 (right): Selection of typical bricks from the rubble of the smelt mill (Site 07): top: firebrick marked 'TICKLE'; top-left: orange firebrick with frog; top-right; red hand-made brick; bottom-left: firebrick tile; bottom-right: perforated red brick

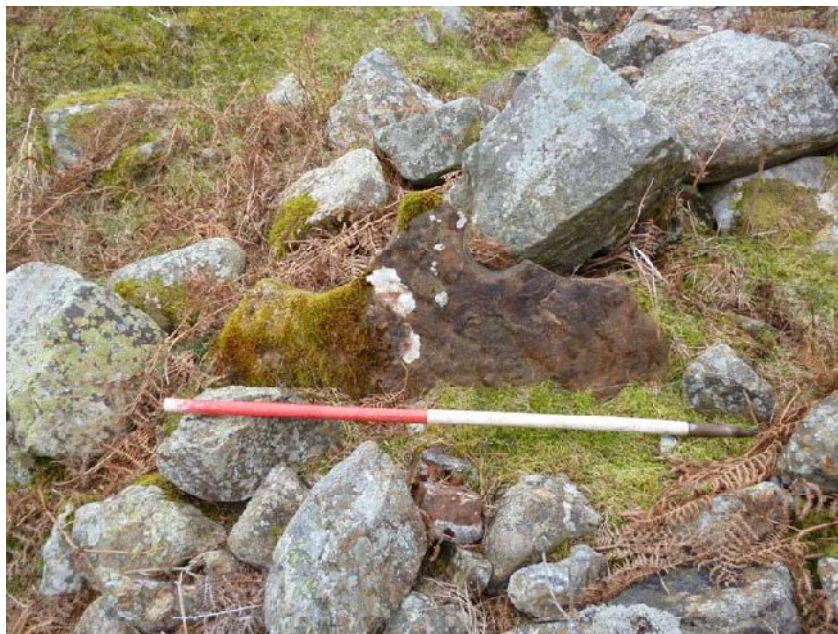
Plate 19: Dressed sandstone slab with a round hole, probably for an axle bearing in the rubble of north of the smelt mill (Site 07)

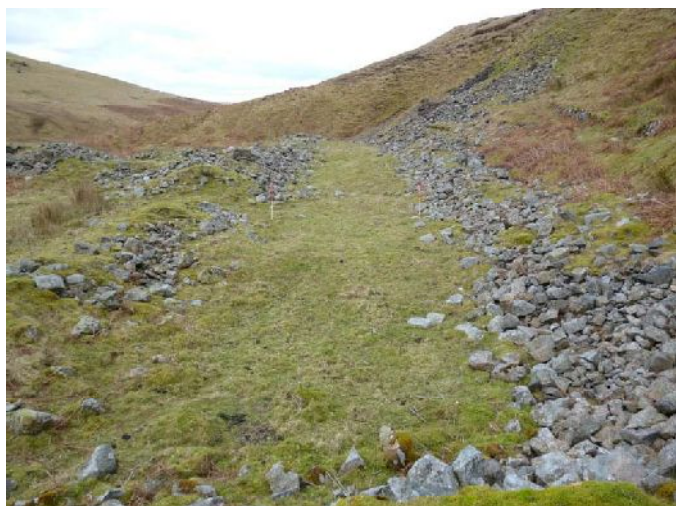
5.1.10 The main section is rectangular and orientated north/south (Plate 20 and Plate 21) between the ravine (**Site 05**) to the north and the slope to the south, with a small projection from the centre of the west side, and another from the north end of the east elevation, which extends up the slope towards the track. The north end drops into a deeper hollow forming part of **Site 05**, which was evidently the location of the wheel pit. The walls of the main rectangular section are typically difficult to identify amongst the rubble, but there are sections in the centre that stand to c1m tall, with two to three courses of masonry visible (although more must be hidden by the collapsed rubble). The standing section to the west has one side of an evident aperture visible as two courses of well-dressed quoins (Plate 22). To the south of these a large slab of uncertain function is built into the wall, and to the north what is probably the jamb opposing the quoined opening is evident with the aperture, which originally must have been approximately 1m wide, thus obviously blocked. The standing wall to the east also has the line of a jamb for an opening evident, although the opposing side is not visible (Plate 23). The centre of the building

Plate 20 (left): General view of the main section of the smelt mill (Site 07), viewed from the south

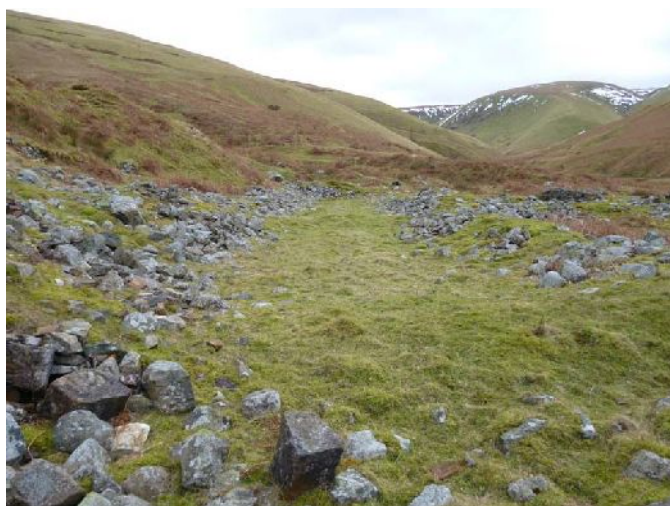
Plate 21 (right): General view of the main section of the smelt mill (Site 08), viewed from the north

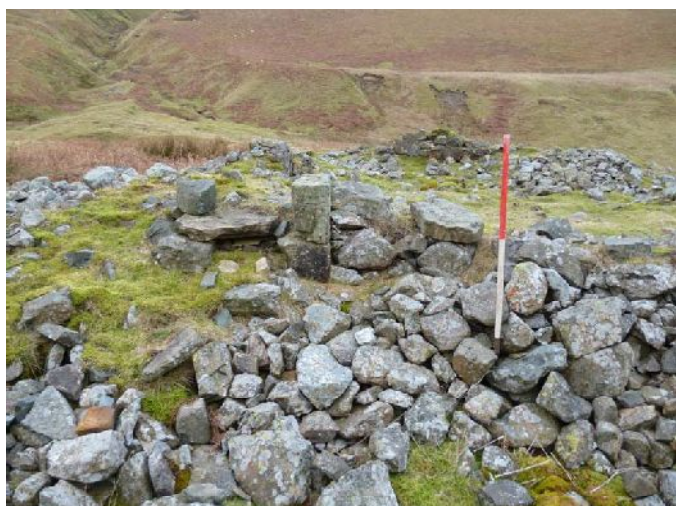
Plate 22 (left): Quoins denoting opening in the standing walling in the west side of the main part smelt mill (Site 07), viewed from the east

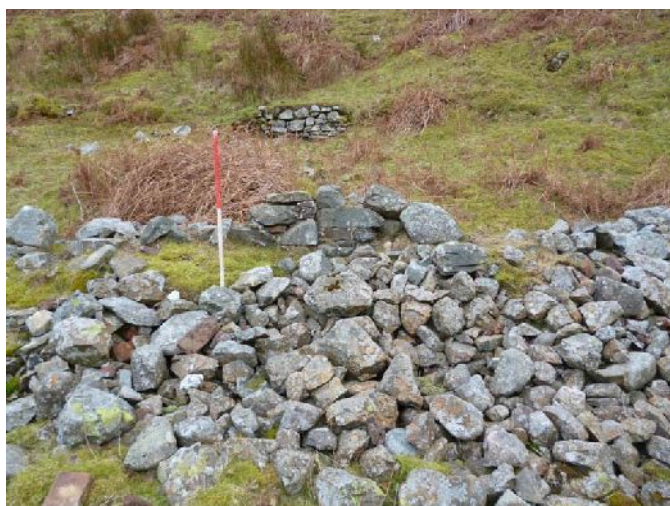
Plate 23 (right): Blocked opening evident in the standing walling in the east side of the main part of the smelt mill (Site 07), viewed from the west

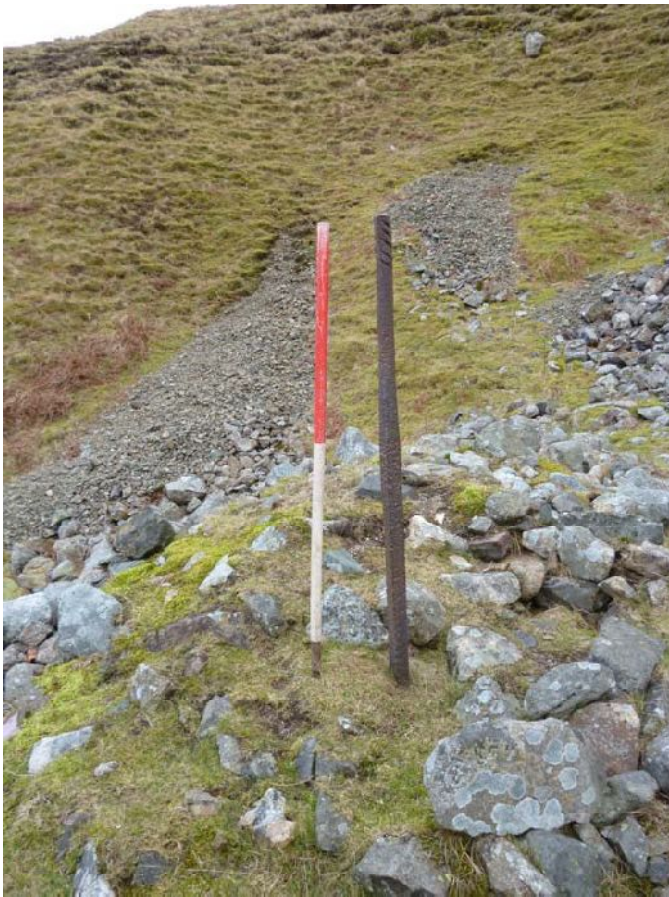
5.1.11 Immediately west of the probable wheel pit to the north a short section of wall remains, perhaps forming part of the tail race. It is c2m long and two courses are visible. The wheel pit is otherwise totally choked with masonry, including some very large fragments, although there is much finer scree up the slope to the east. Within the rubble to the south-west of the wheel pit a large iron bar 1m tall is stood upright (Plate 24); the lower half is square in section while the upper is round and has the remnants of a screw thread at the top. At the top of the slope to the east another iron bar or bolt is just visible projecting through the turf, with a flat square head (Plate 25).

Plate 24 (left): Iron barn in rubble adjacent to wheel pit, viewed from the south

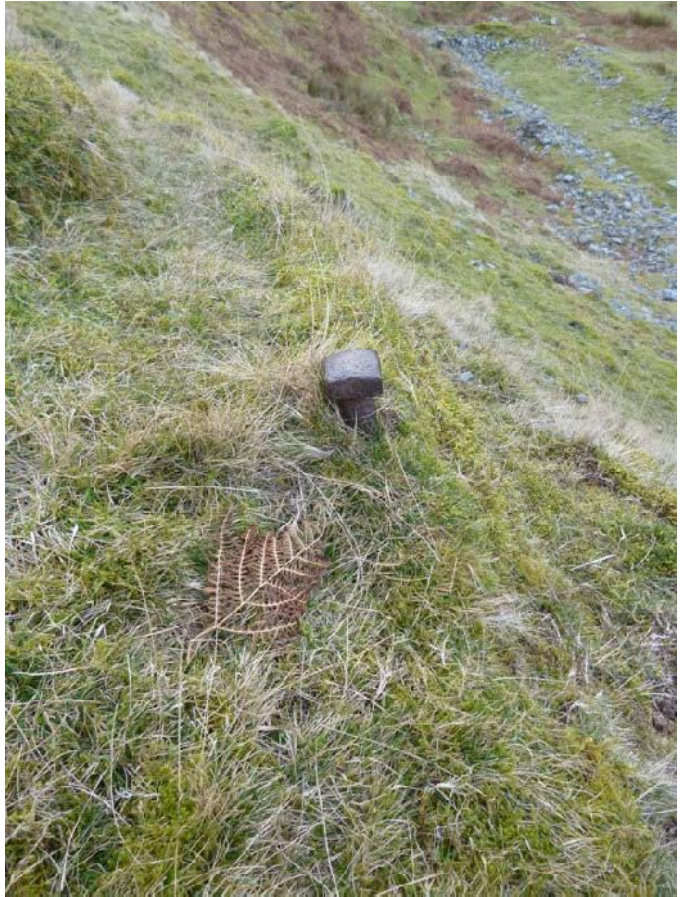
Plate 25 (right): Iron bolt inserted in the ground to the east of the wheel pit, viewed from the north-east

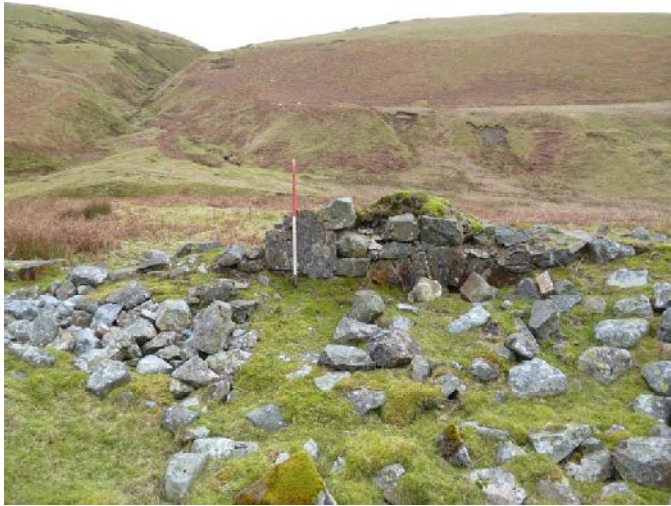
5.1.12 The western extension to the main part of the building has sections of standing wall at the west end and on the south side, and an opening in the rubble delineating the north wall, perhaps a doorway. The west wall has up to five courses remaining (slightly less than a maximum height of 1m), within which the jambs of an opening, c1.2m wide, are visible on the south side while to the north the top of an extant but very low opening with an arched top (perhaps a fireplace) is visible (Plate 26). The full width of this opening is uncertain but it is at least 0.5m wide; both of these openings have been blocked. The southern section of walling has up to six courses standing (again approximately up to 1m tall), and the jambs of an aperture c1.2m wide and blocked with stone are visible within it (Plate 27).

Plate 26 (left): Standing walling at the west end of the west extension of the smelt mill (Site 07) with the arched opening visible, viewed from east

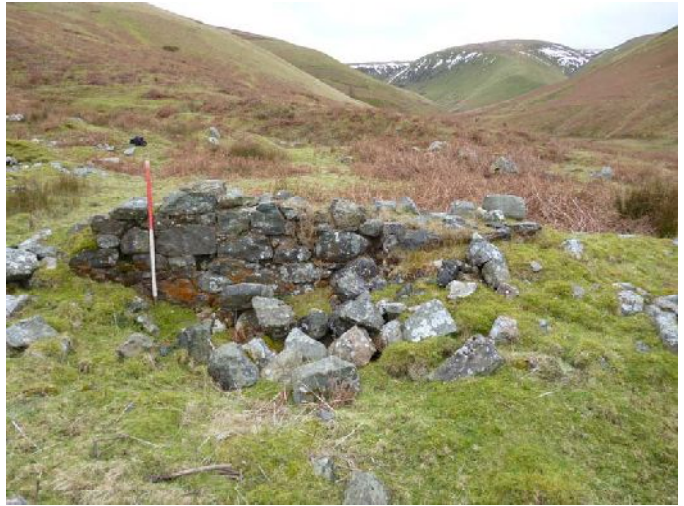
Plate 27 (right): Standing walling in the south side of the west extension of the smelt mill (Site 07), viewed from the north

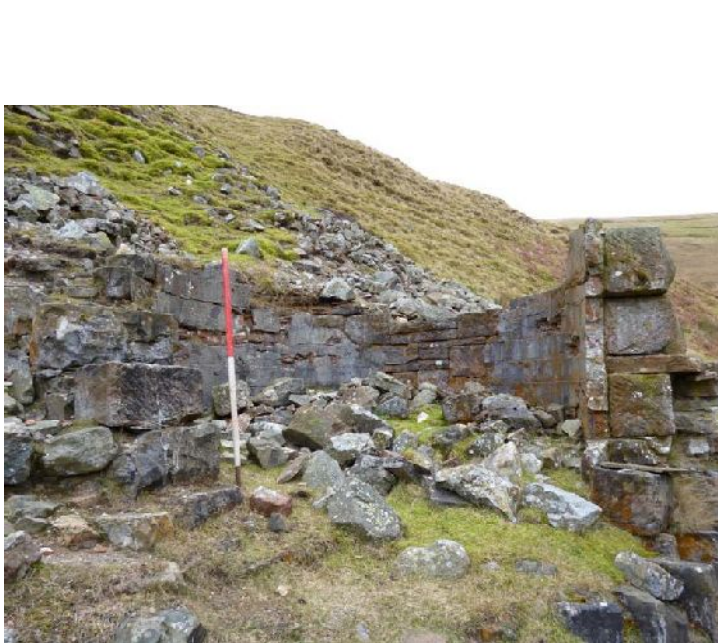
5.1.13 The extension at the north end of the east elevation climbs up the steep slope. Although some sections of walling survive to a considerable height, the overall plan of this part of the building is generally difficult to discern. The lowest section comprises a large round tank, built of dressed stone but mostly lined with brick internally and finished with a skim of concrete (Plate 28). The scar of a pipe, preserved in the mortar, projects from its base on the south-west side (Plate 29) and there are remnants of possible flag flooring to the south, although this is very poorly preserved. To the east are further sections of walling, the most substantial forming the north wall of this extension, orientated east/west and standing up to 2m tall, with a short return to the south at its east end and two low retaining walls to the north. Further low sections of north/south orientated wall are present to the east, with small sections of possible associated flooring.

Plate 28 (left): Interior of the round section in the east extension to the smelt mill (Site 07) showing the brick lining, viewed from the north-west

- **Consolidation** – some consolidation of the site is certainly recommended, even if it is restricted to stabilising the tallest sections of standing wall in the eastern extension (the circular structure and adjacent wall). Consolidation elsewhere is unlikely to be feasible without clearance of some of the rubble, although this could be carried out as part of a programme of further investigation (see below). As a minimum consolidation need only comprise the repointing of standing walls in an appropriate fashion rather than extensive rebuilding;

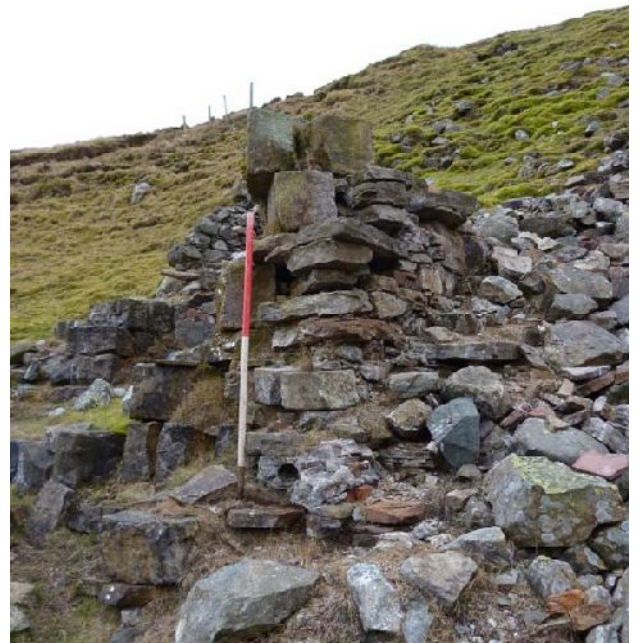
Plate 29 (right): Walling forming the south side of the round section in the east extension to the smelt mill (Site 07) showing the pipe, viewed from the south-west

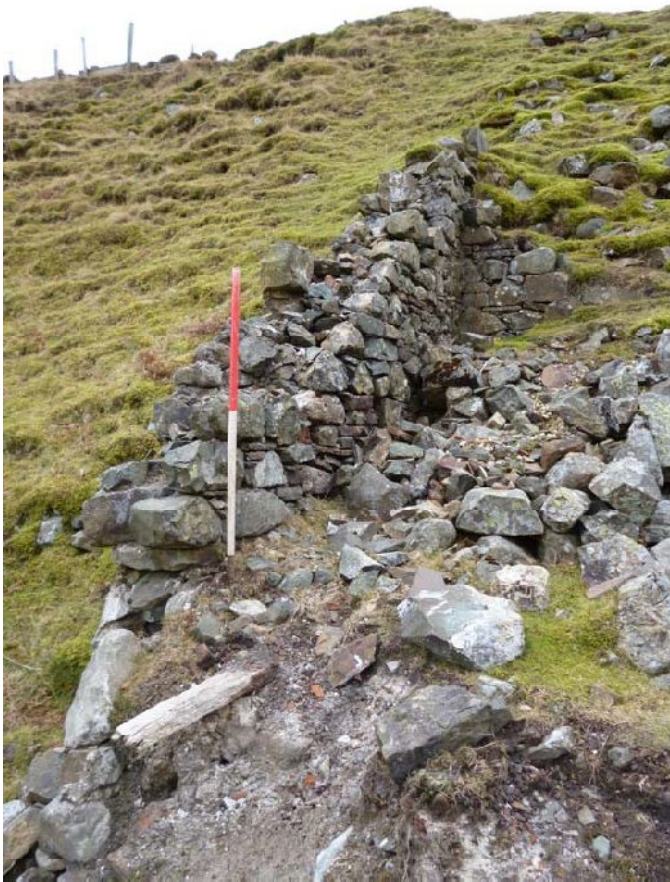
Plate 30 (left): Standing wall along the north side of the east extension to the smelt mill (Site 07), viewed from the south-west

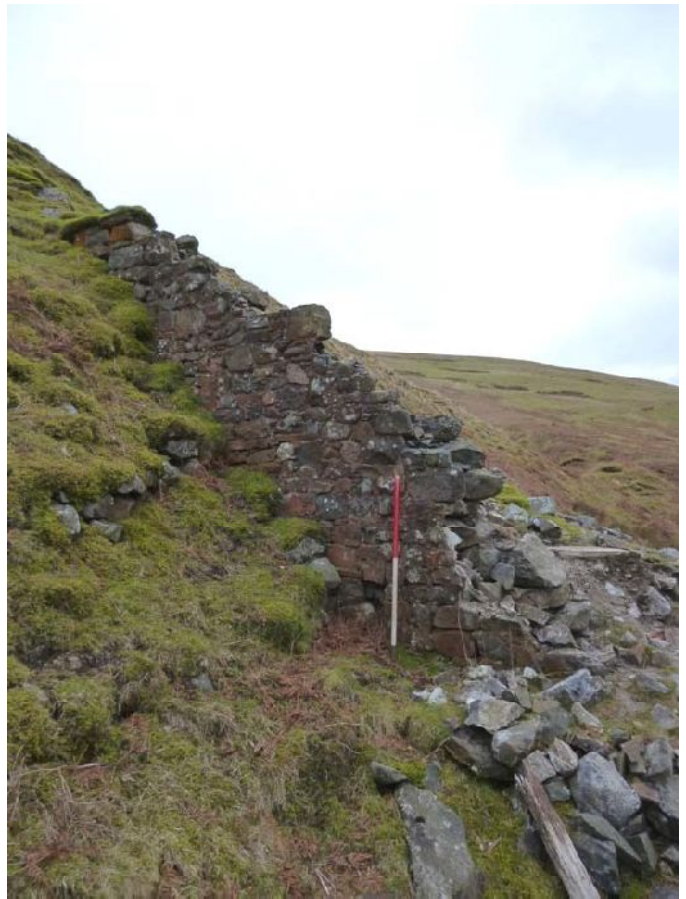
Plate 31 (right): Standing wall along the north side of the east extension to the smelt mill (Site 07), viewed from the north-west

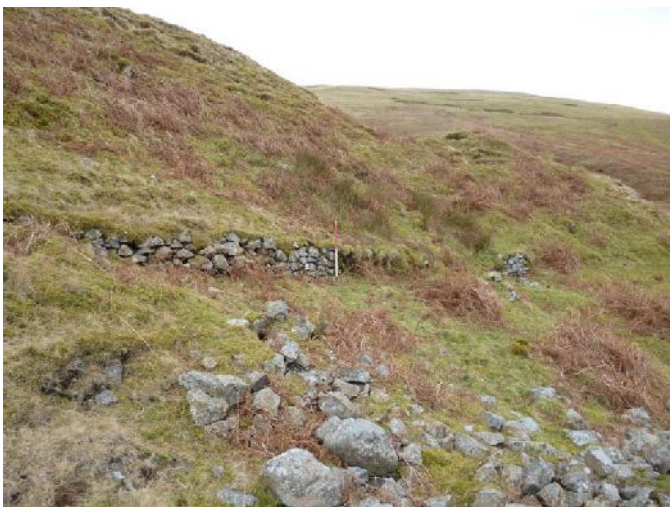
5.1.14 **Site 08:** this forms a low retaining wall built against the slope to the east of the smelt mill (**Site 07**). It is orientated approximately north/south and stands up to six courses (0.7m high). There is a missing section in the centre and the north and south ends disappear into the slope. There is an exposed section of bedrock to the north of the north end of the wall, comprising a thin band of laminated orangey-red sandstone.

Plate 32 (left): Retaining wall (Site 08), viewed from the north-west

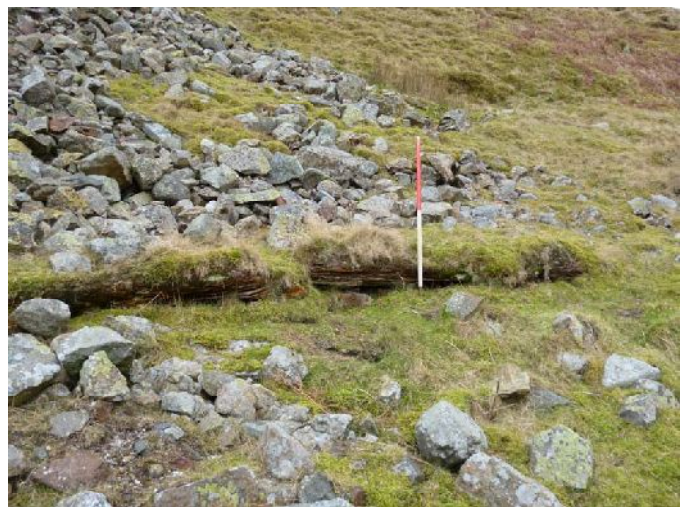
Plate 33 (right): Bedrock exposed to the north of Site 08, viewed from the north-west

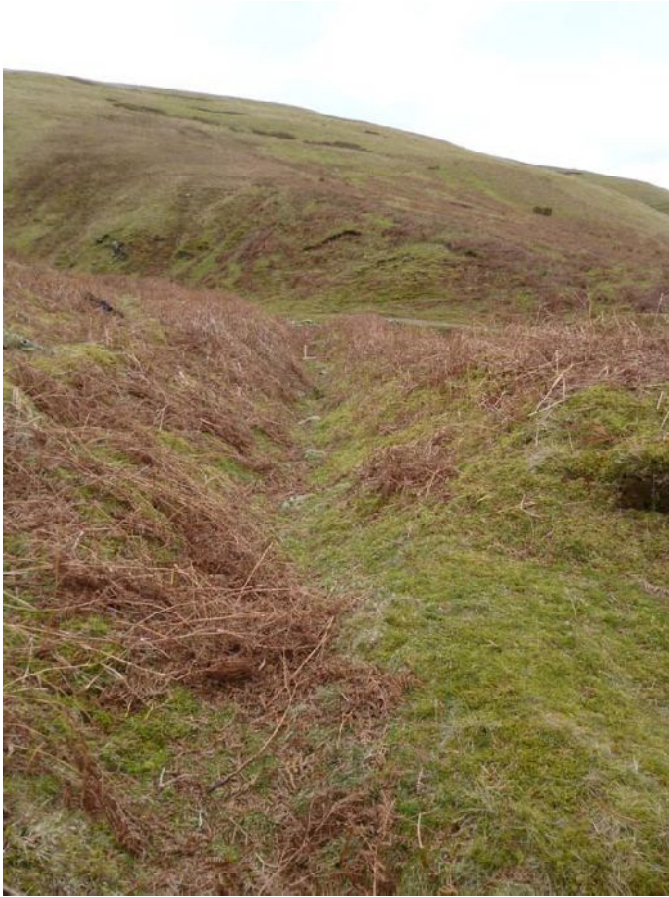
5.1.15 **Site 09:** this comprises a large bank with a ditch to the east, which, along with the slope to the east, forms a water channel linking to the dam to the south (**Site 10**), where there must have originally been a pond. The bank is up to 1m tall and 2m wide at the base, with a broken section near the centre (perhaps erosion caused by sheep?) (Plate 34 and Plate 35). It tapers out at both the north and south ends.

Plate 34 (left): Bank and ditch forming Site 09, viewed from the south

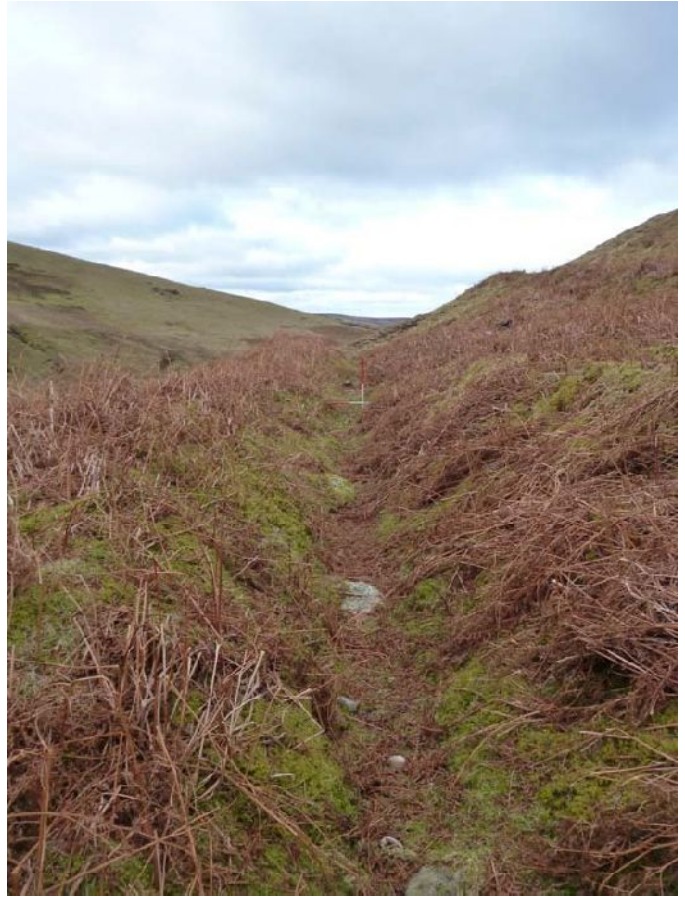
Plate 35 (right): Bank and ditch forming Site 09, viewed from the north

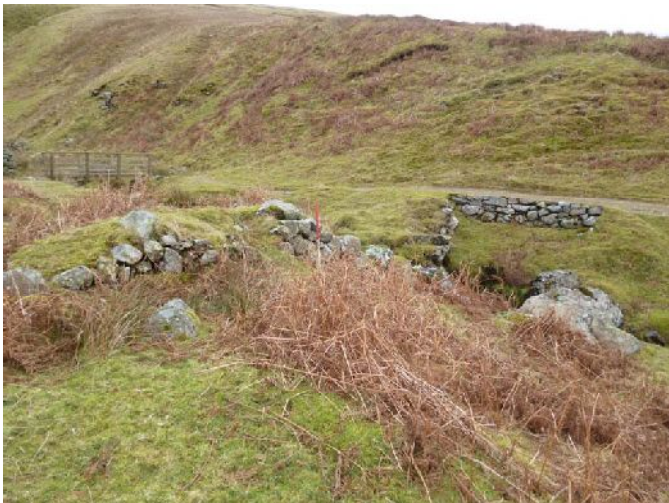
5.1.16 **Site 10:** this is the former dam across Hay Gill, which comprises a thick wall with up to five courses (1m) surviving, including some very large stones (Plate 36), although it is broken through in the centre where the water flows through (Plate 37). The north end is backed by an earth bank 2m thick, while the south end turns to the west where it forms a revetting wall against the track.

Plate 36 (left): Walling forming the dam (Site 10), viewed from the north-west

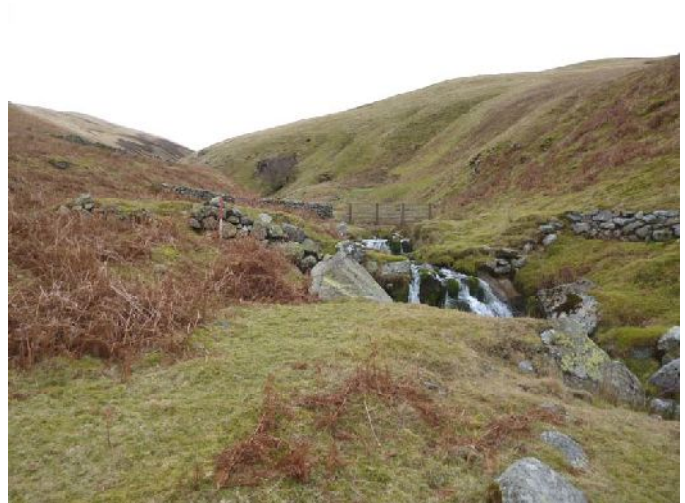
Plate 37 (right): Walling forming the dam (Site 10), viewed from the west

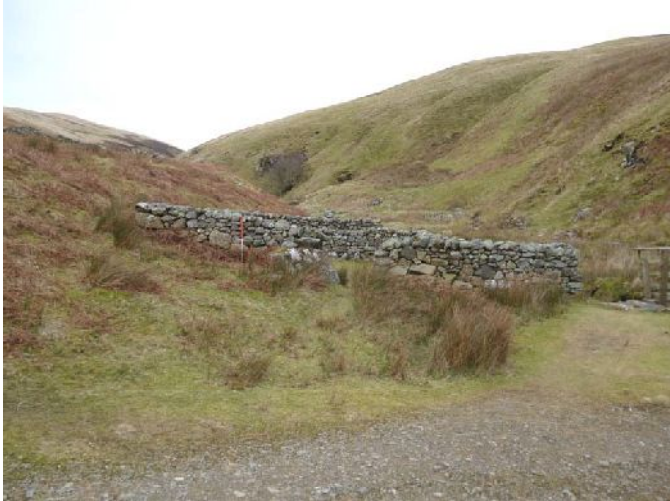
5.1.17 **Site 11:** this is an extant sheepfold, of drystone construction and evidently well-maintained, the long axis of which is orientated approximately east/west. The walls are typically of eight or nine courses (1m) tall (Plate 38), although it is built into the slope on the north side. It is an irregular quadrilateral in plan, with a wall dividing it into two unequal compartments (Plate 39), and there are doorways in the south-east corner, the centre of the west wall, and at the south end of the internal wall.

Plate 38 (left): Sheepfold (Site 11), viewed from the west

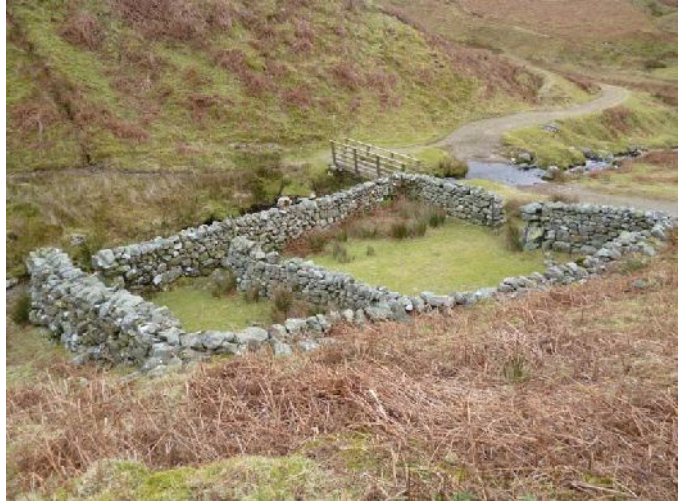
Plate 39 (right): Sheepfold (Site 11), viewed from the north-east

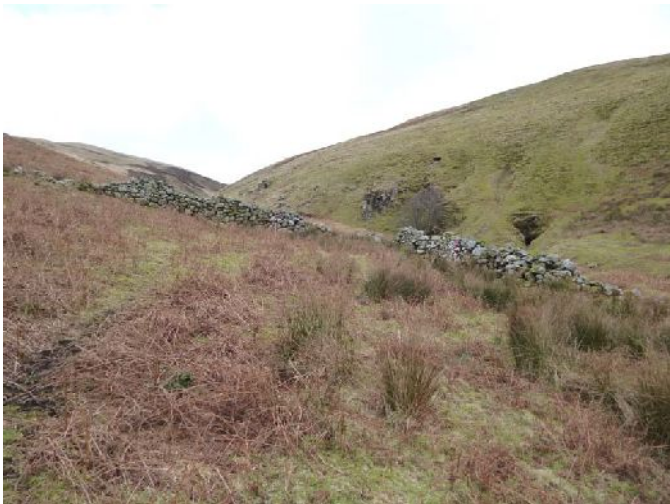
5.1.18 **Site 12:** this is a partially ruined bield to the east of the sheepfold (**Site 11**). The walls are up to 1m tall (seven to eight courses) and it is a slightly irregular L-shape in plan, one arm approximately north/south the other east/west (Plate 40).

Plate 40 (left): Bield (Site 12), viewed from the west

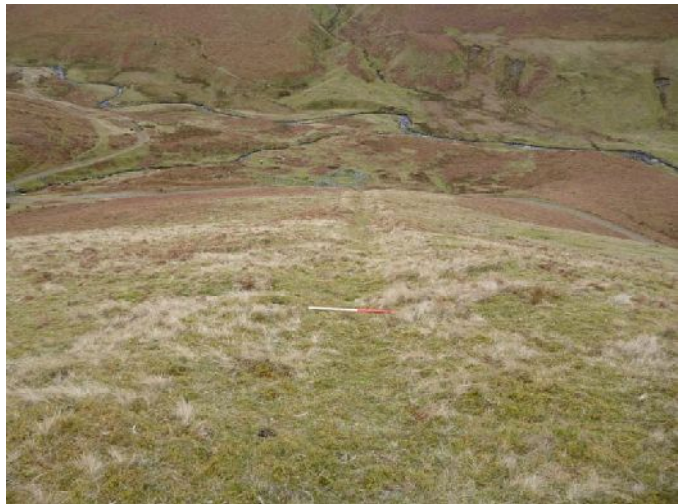
Plate 41 (right): Flue (Site 13), viewed from the top of the slope to the east

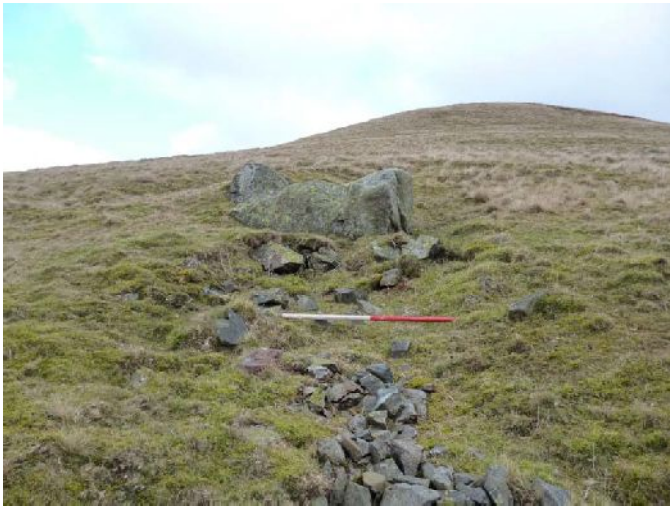
Plate 42 (left): Top (east end) of the flue (Site 13), viewed from the west

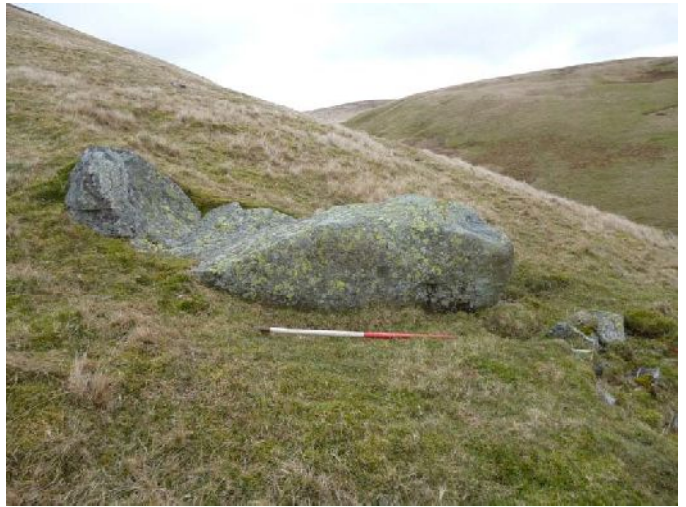
Plate 43 (right): Boulder at the top (east end) of the flue (Site 13), viewed from the north-west

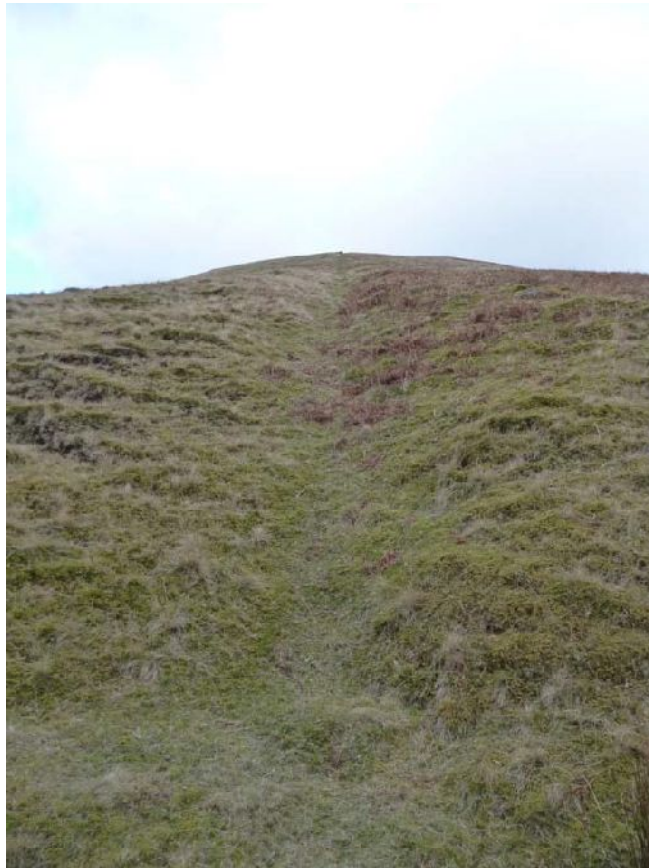
and is evident on the other side of this, but wider still and slightly less regular, where it almost meets the smelt mill (Plate 44).

Plate 44: The west end of the flue (Site 13) where it widens to meet the track, viewed from the west
