# SWARTHMOOR MEETING HOUSE, MEETING HOUSE LANE, SWARTHMOOR, ULVERSTON, CUMBRIA

Archaeological Building Recording

Client:  
Swarthmoor Area Meeting

April 2012

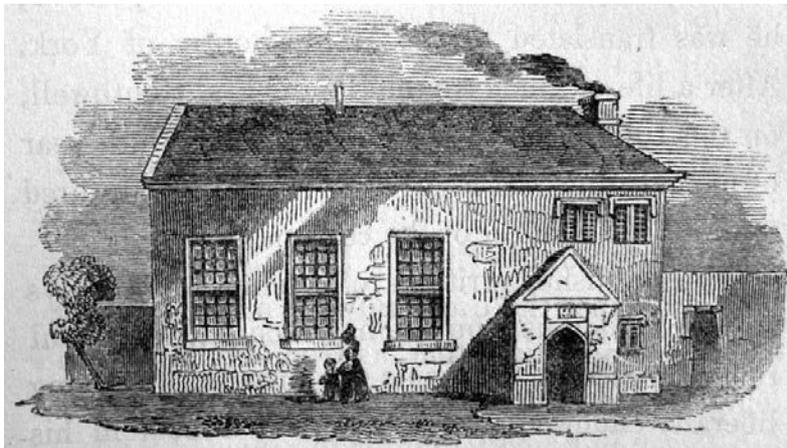
Plate 1: Illustration of Swarthmoor Meeting House (from Jopling 1843, 175)

3.1.2 **Jopling, c1843:** this image of the front (south-west) elevation, reproduced by Jopling (1843, 175), is undated but cannot post-date 1843 (Plate 1). It essentially shows the building as it is now, although there is clearly some artistic licence as the elevation is considerably shorter than it actually is. The three main windows are apparently 32-light sash casements, and all but one of the mullion windows to the south-east are shown; the missing one probably hidden by the side of the porch. There is an off-centre flue projecting through the roof and a doorway in the barn attached to the south-east. The porch shows some differences but these are again probably due to the interpretation of the artist, although the arrangement of the inscription above the door to the porch does appear to be slightly different to what is now present.

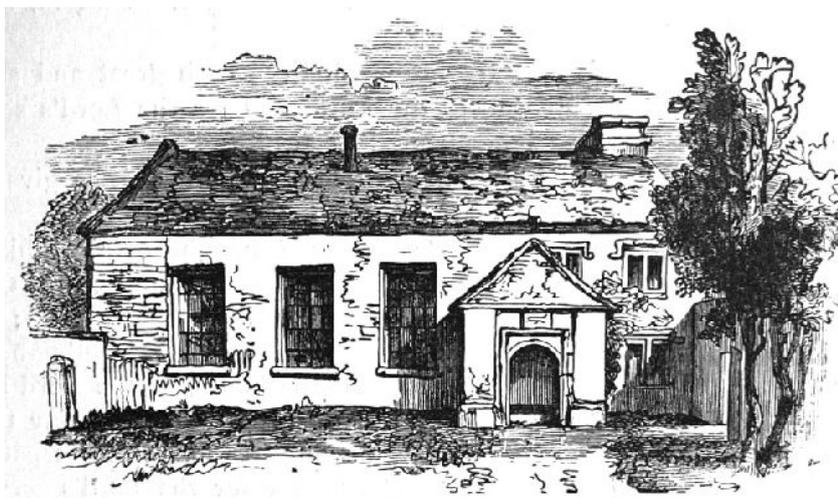
Plate 4 (left): Illustration of c1894 (from Barber 1894, 252)

3.1.5 **Barber, c1894**: like the previous early illustration (Plate 1), this view is also undated but cannot post-date its publication in 1894 (Barber 1894, 252). Again some artistic licence has clearly been used, but this otherwise appears to show much the same detail as the earlier illustration (Plate 4, cf. Plate 1). The three main windows are depicted with 20-light casements, which is perhaps more realistic, the flue through the roof is shown and the porch and mullion windows are depicted as before. In addition, the hung slate is shown at the north-west end and the boundary garden walls butting against the elevation with their gates are also shown.

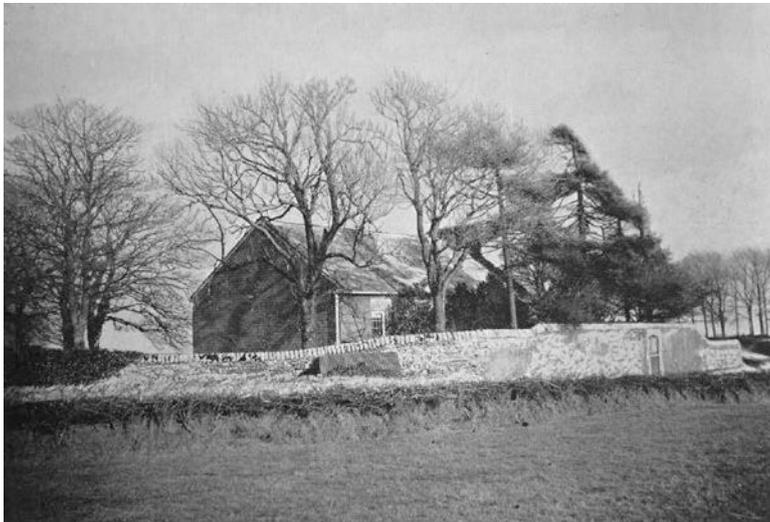
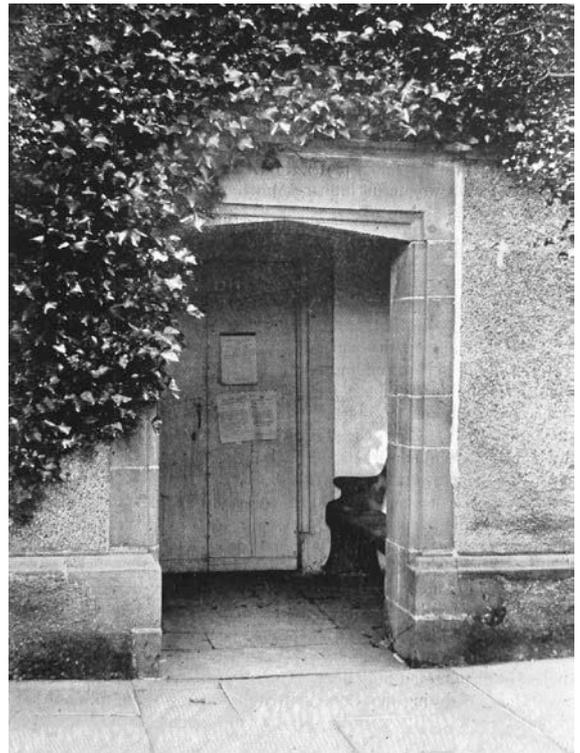
**Plate 5 (left): View of the north-west and south-west elevations (from Ayre 1895, 166 and 169)**

3.1.6 **Ayre, c1895**: these two photographs of the exterior, reproduced by Ayre (1895, 166 and 169) show relatively little, but they demonstrate that the building had essentially reached its present form by this date. The obvious difference is that the main windows are shown and appear to correspond with those in the slightly earlier drawing in having 16 or 20-lights.

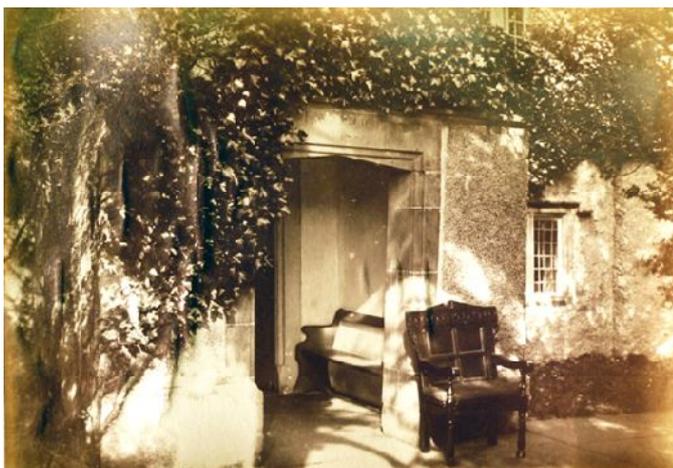
**Plate 7 (left): Late 19<sup>th</sup> century photograph of the porch (from CRO(B) BDFCF/1/128 19<sup>th</sup> century – 1971)**

3.1.7 **Late 19<sup>th</sup> century photographs:** a collection of late 19<sup>th</sup> century photographs of various meeting houses includes two of the Swarthmoor Meeting House (CRO(B) BDFCF/1/128 19<sup>th</sup> century – 1971). One, of the outside of the porch, shows the porch much as it appears today (Plate 7; cf. Plate 15), although it is currently much less overgrown. A late 19<sup>th</sup> century photograph taken inside the main Meeting House shows the shutters and partitions as well as the double door to the south-east side of the main meeting room (Plate 16). The panelling along the north-east elevation does not appear to have vertical struts as it does now and the floor has since been carpeted over. The flue from a heater (which is no longer there) is visible in the centre of the shot.

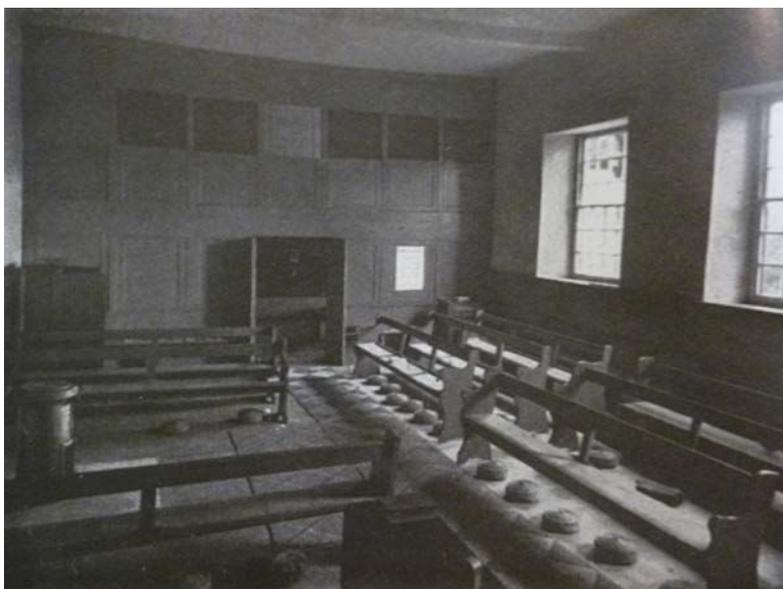
Plate 11: Photograph of the main meeting room from pre-1961 (from Lidbetter 1995, plate v)

3.1.10 **20<sup>th</sup> century illustrations:** the photograph used by Lidbetter (1995, plate v), presumably taken prior to 1961, of the main meeting room (Plate 11) is of particular interest as it shows the position of the benches at this time, and also the presence of a free-standing stove on the north side of the room. In addition, hand-drawn illustrations in Butler (1978, 125), show the south-west side of the Meeting House and the inside of the main Meeting Room much as they appear today (Plate 12 and Plate 13).

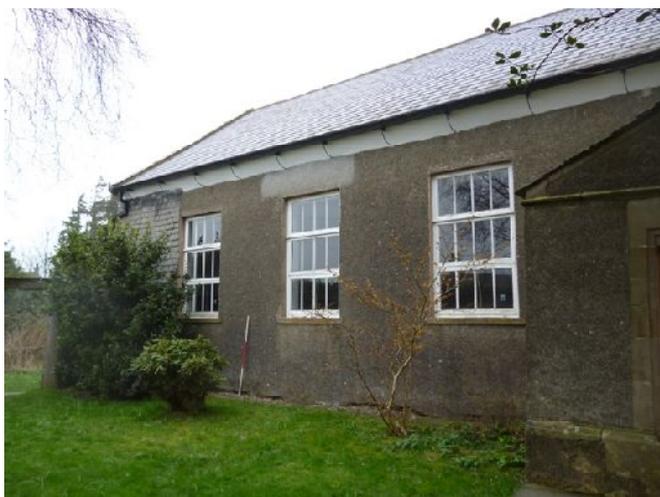
Plate 14 (left): North-west end of the south-west external elevation

4.2.1 **South-west elevation:** slate is hung on the north-west side of the south-west elevation of the main Meeting House and it has the same projecting eaves and iron brackets as on the north-east side as well as neatly dressed stone kneelers at the north-west end. There are three large 12-light hinged casement windows with dressed sandstone sills at the north-west end of the elevation and the lintel of the central window has been re-rendered over (Plate 14). The wall of the main Meeting House has a slight plinth along most of its base, although it does not continue below the central window on this section (despite being present either side). To the south-east of these three windows the main Meeting House has a projecting porch (Plate 15). The porch is gabled above the doorway on the south-west side and has a plinth. The doorway has dressed and moulded surrounds and a cavetto-moulded string/drip course above it. An inscription above the door reads 'EXDONO: G.F. 1688' (Plate 16). Immediately to the south-east of the porch on the ground floor are two two-light leaded mullion windows with cavetto moulding (Figure 7) below a single drip mould in the same style as the porch (Plate 17). The north-west mullion is partially obscured by the porch, which is angled to allow light through the window. There is an oddly shaped red sandstone trough on the floor in front of these mullion windows (Plate 18; Figure 3 and Figure 6). The trough is sat on four 'legs' made from pieces of mullion and hood mould – the mullion is a different style to the ones used in the windows however with a curved profile and possibly ovolo-moulding. There are two further two-light hood moulded mullion windows at first floor level, which are stepped to the north-west relative to those on the ground floor. One is located directly above the porch. They appear to have a more square finish and both are covered by projecting eaves.

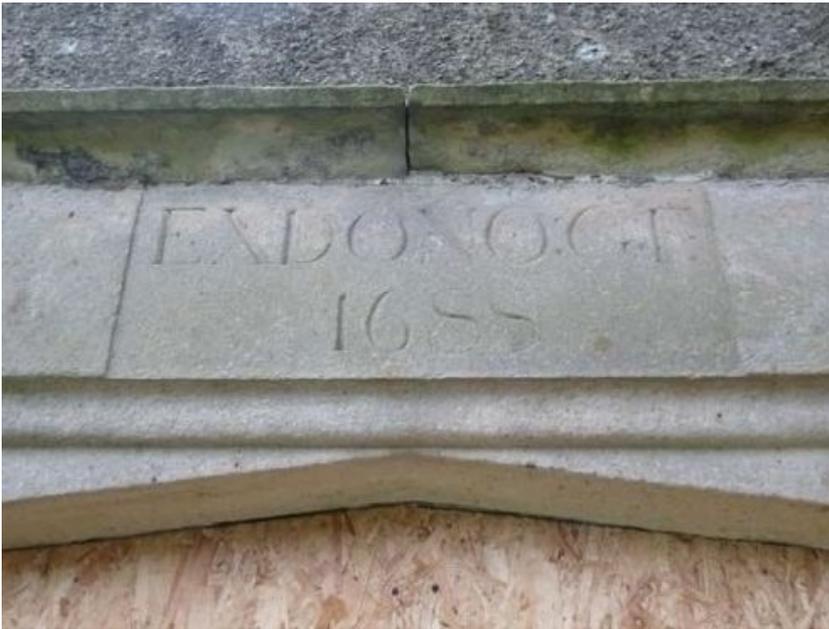
**Plate 16 (left): Inscription above the porch door**

*'I shall tell the Reader, if his has a Mind strengthened by Christianity, to go and see this ancient Building. He must look up over the outward door of a Porch, where he must read in large capital letters; but he must have good Eyes, for it is a deal worn out by that destructive Weapon called Time; it is EX DONO G.F., - the Gift of George Fox.'* (Ayre 1887, 9).

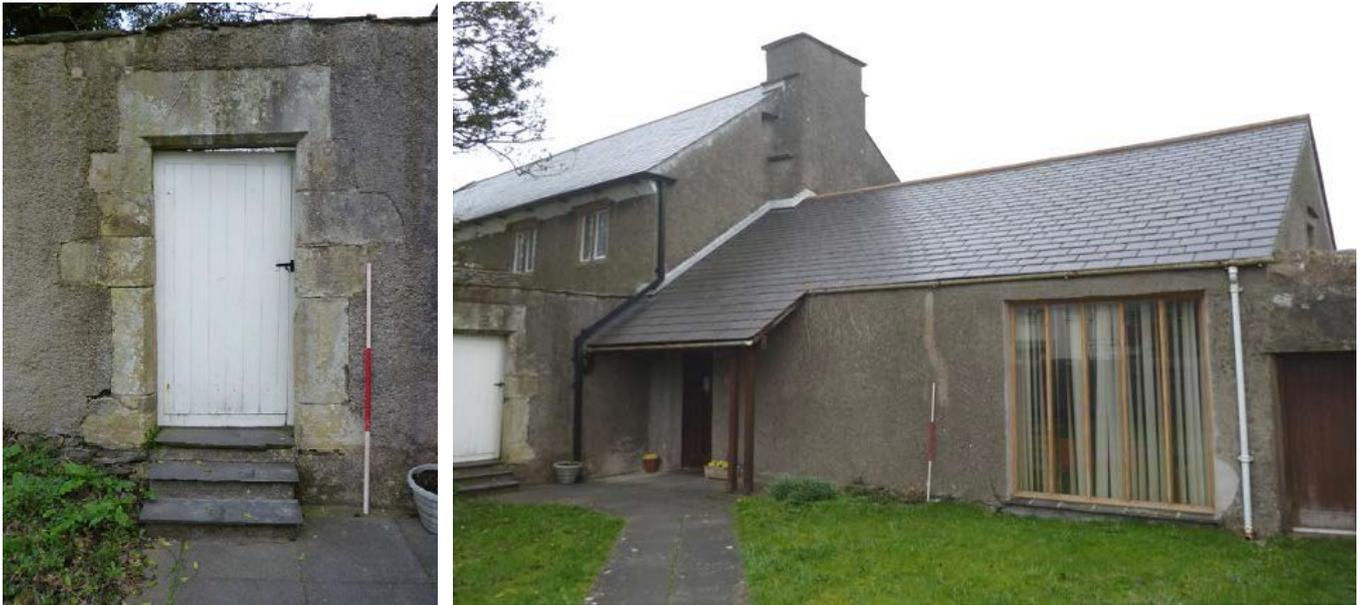
**Plate 19 (left):** Doorway in the boundary wall, viewed from the south-east

4.2.2 The rendered boundary wall attaches to the main Meeting House to the south-east of the mullion windows. The projecting tiered chimney is visible above where the boundary wall butts against the main Meeting House and there is slate capping on the tiers. The doorway through the boundary wall has a plank and batten door, with chamfered, dressed stone quoins and a stone lintel, which are visible from the south-east side (Plate 19; Figure 6). There are two steps down to the south-east. The elevation then continues as part of 'the barn' (Plate 20). The barn has a modern projecting canopy, supported on two posts on the south-east side, above a pedestrian doorway, which has a modern three-light door. There is a larger opening to the south-east, which would originally have been a wagon door but which now houses a full height five-light window. The end of the 'barn' has been extended to the south-east as a rough wall, topped with limestone coping, with a pedestrian doorway with a stone sill and lintel and a modern timber door.

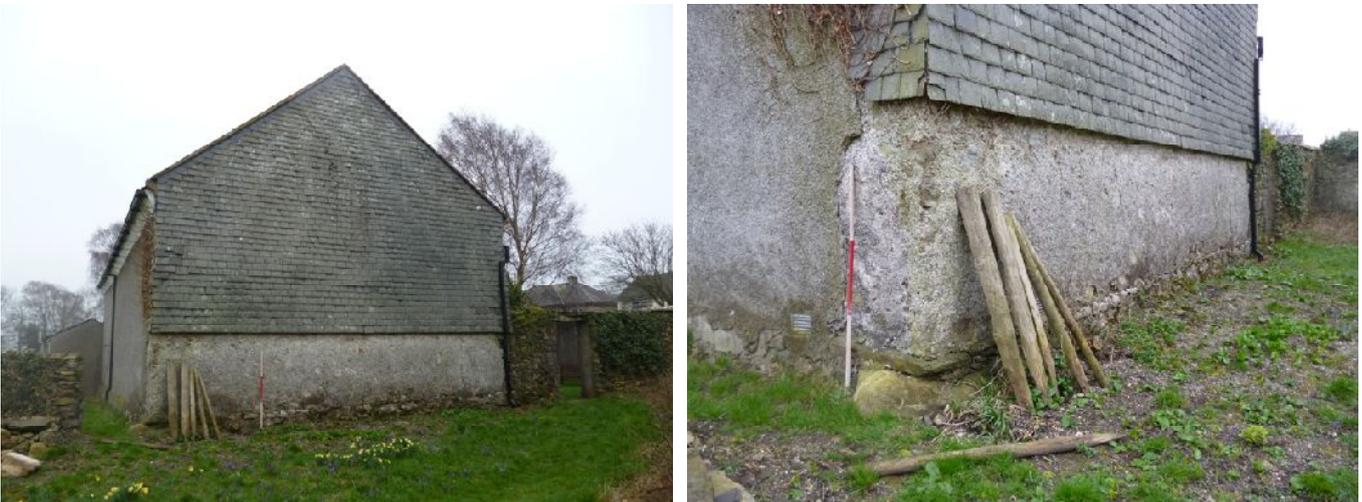
**Plate 21 (left):** The north-west external elevation

4.2.3 **North-west elevation:** most of this side of the building is covered by slate, the lower part, however, has a rough plinth along its base and is finished with a patchy lime render (Plate 21). The boundary wall butts against the south-west end of the main Meeting House but there is a gap to the boundary wall to the north-east side and a large boulder is exposed at the base of the north-east end of the main Meeting House (Plate 22). There is a doorway with a stone lintel in the boundary wall to the south-west side of the main Meeting House, which is probably a later insertion as there is some evident rebuilding.

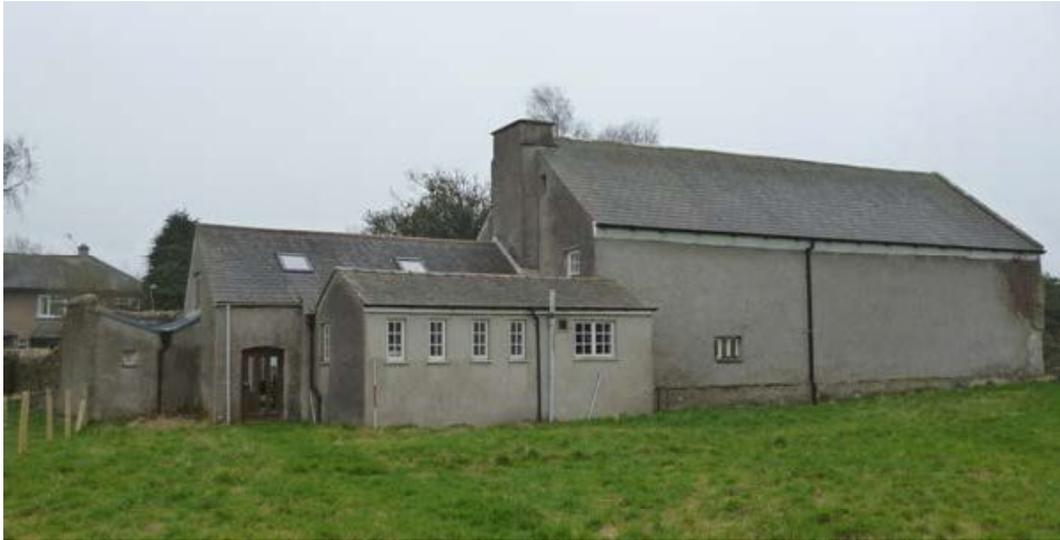
**Plate 23: The north-east external elevation**

4.2.4 **North-east elevation:** the south-east end of the north-east elevation is formed by the side of a small outshut, with a V-shaped valley roof, finished with lead, and a single small one-light hinged casement window (Plate 23). The outshut butts the end of the barn to the north-west. To the north-west of this junction, the barn has a doorway with a rounded head and a three-light modern door. A modern addition causes the elevation to return to the north-east at this point. This addition forms the toilet block and has four six-light hinged / top hung casement windows and one paired six-light hinged casement. At the north-west end of the toilet block the elevation returns to the side of the main Meeting House, which

has a single three-light mullion window with a slate sill (Plate 24). The main Meeting House has a plinth at its base and projecting eaves with iron brackets and supports. The slate hanging from the north-west end extends onto the north-west elevation.

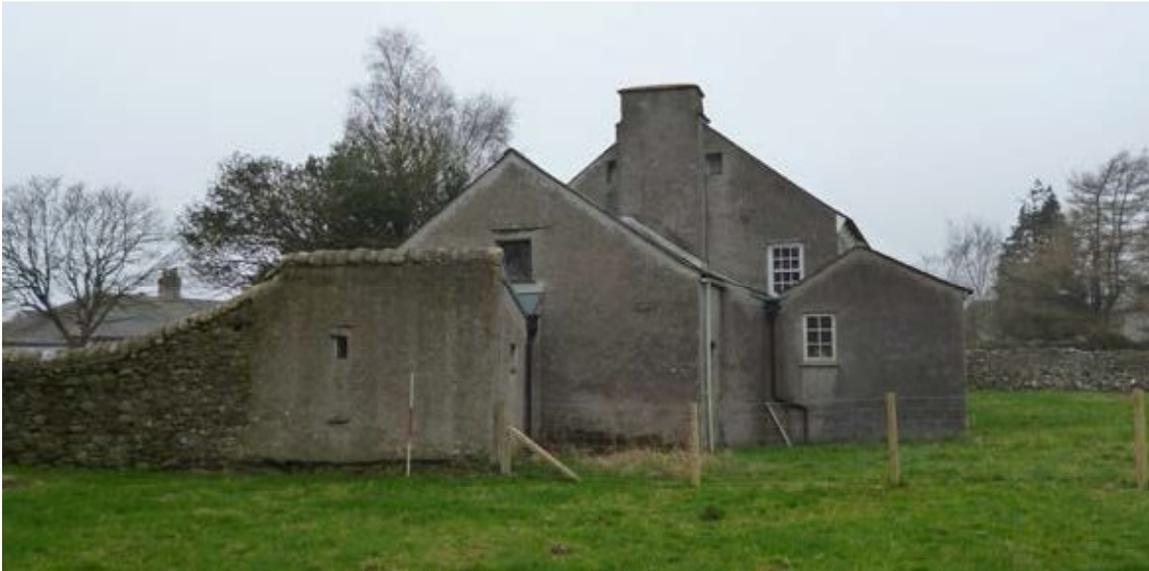
**Plate 25: The south-east external elevation**

4.2.5 **South-east elevation:** the south-west end of the south-east elevation is formed by an irregularly shaped outshut, with a tall wall which is topped with limestone coping and rendered (Plate 25). A single-light casement window, with a stone drip course above it and a slate sill, is visible in the main gable of the 'barn' above the outshut. The gable of the toilet block projects to the north-east and is plain apart from a single six-light window with a thin timber sill. The gable of the main Meeting House, which is dominated by the tiered stack of the chimney, is visible to the rear. There is a small window either side of the chimney stack at attic level; the window to the north-east is slatted but the one to the south-west is blocked from the outside. There is a lower level 12-light sash window to the north-east side of the chimney stack above the stairs.

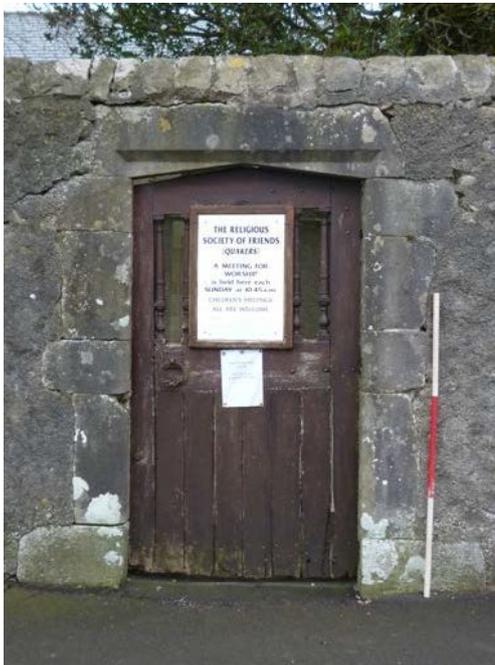
**Plate 26 (left): Rusticated gate viewed from outside the boundary wall**

4.2.6 **Grounds:** the south-west side of the Meeting House is enclosed by a tall boundary wall. The wall is in line with the north-west elevation of the main Meeting House and continues along the south-west elevation up to a dividing wall along the end of the main Meeting House before continuing at a lower level to the south-east in front of the 'barn'. The gated main entrance, opposing the porch, has dressed sandstone quoins, with a stop chamfer and moulded top (similar to the porch; Plate 26). The plank-built gate is rusticated but probably 19<sup>th</sup> or 20<sup>th</sup> century, with an elaborate handle and plate and four reused turned balustrades of maybe 17<sup>th</sup> century date (Plate 26 and Plate 27). To the south-east, opposite the outshut to the south-east side of the 'barn', is a gateway. This has a relatively early dressed limestone gatepost on the south-east side and a later slate one to north-west. The wall is roughcast on both faces and finished with limestone coping. There is a slate topped stone mounting block with two steps up either side roughly 8.5m in front of the 'barn' (Plate 28; Figure 3).

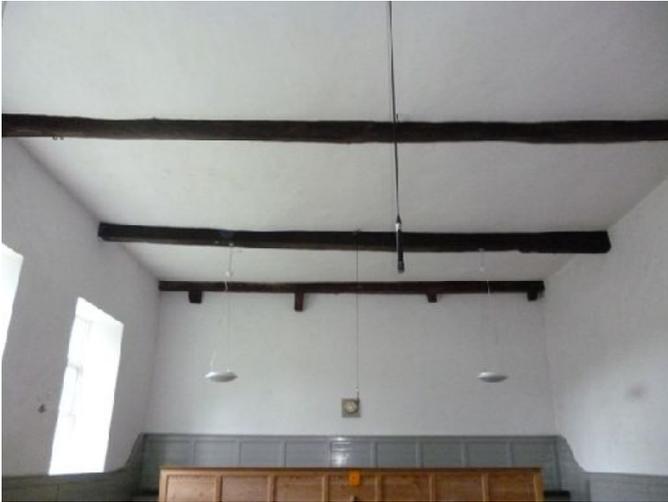
Plate 29 (left): View of the ceiling in Ground Floor Room 1

4.3.1 **Ground Floor Room 1:** this is the main meeting room. The plaster ceiling is supported by four north-east/south-west aligned beams (Plate 29). The one against the north-west wall is supported by four corbels, whereas the others have integrated corbels at the north-east ends (Plate 30). All of the timber beams are hand-finished. The walls are all finished with plaster and paint, with panelling over at least the lower part, and the floorboards are carpeted over.

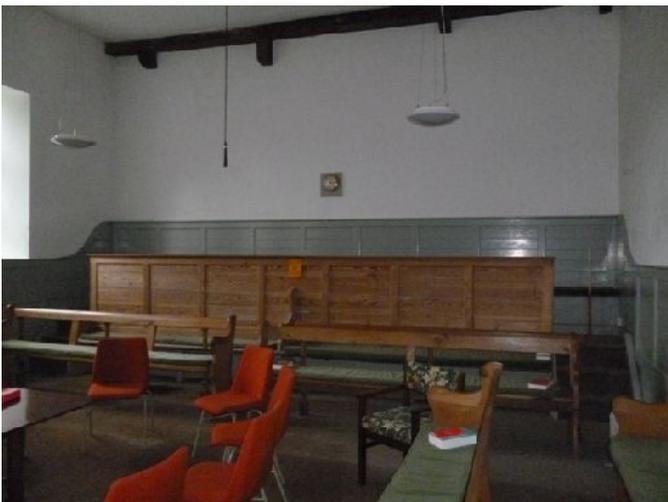
Plate 31 (left): The north-west elevation of Ground Floor Room 1

4.3.2 The north-west elevation has a raised section housing seating built against it (Plate 31), which has a gallery screen along the south-east side constructed from timber panelling, comprises beaded planks laid horizontally, supported by five square-section posts and there is boxed seating on the south-east side. The north-west elevation proper is covered by thinner and very plain planks with battens and rails (decorated with ovolo moulding), and there is a boxed seat or bench in the same style, with beaded skirting against it. Above this the wall is plain apart from the attached clock. The north-east elevation is mostly plain. There is panelling over the lower part, which is the same as that on the north-west elevation, with a curving top rail rising to meet the north-west rail (Plate 32).

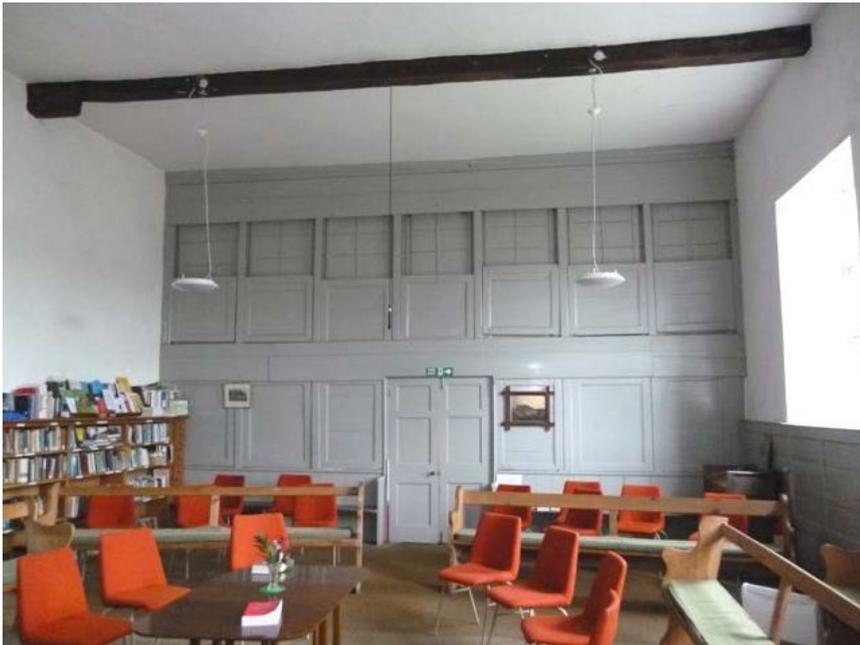
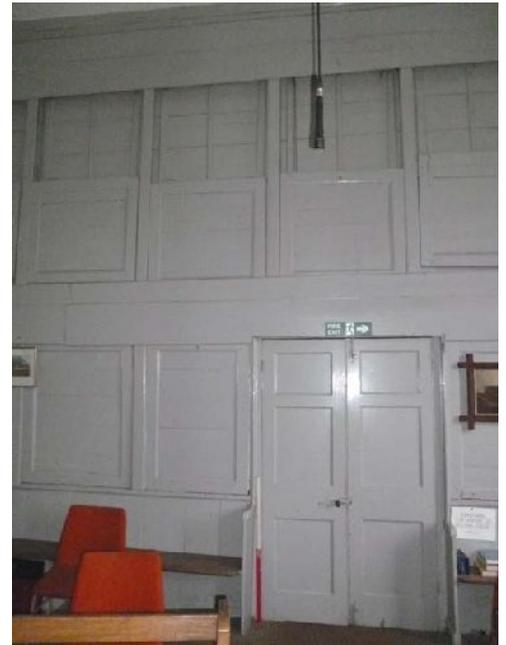
**Plate 33 (left): The south-east elevation of Ground Floor Room 1**

4.3.3 The south-east elevation is entirely panel construction (Plate 33 and Plate 34), made from wider but more irregular boards with beaded decoration. The lower level comprises tilting hatches, six in total, in moulded surrounds, with plank construction and a beaded rail below. There is a double door in the centre, with two sets of three panelled doors with ovolo-moulding, which is later than the surrounding hatches. There is a wide board above the door and hatches which appears to have been tacked on later and rather crudely cut around the door. The upper level has seven hinged hatches constructed from wide planks with moulded side rails and a thin central rail. Again, there is slightly rough planking above this, which partially crosses the surround and an even rougher plank above this. Below these hinged plank hatches there is a row of sliding shutters on pullies (with a similar mechanism to sash windows) below that can be raised to provide a double cover over the top hatches. It is possible that these were originally hinged hatches in a similar style to the ones below that have been reconfigured.

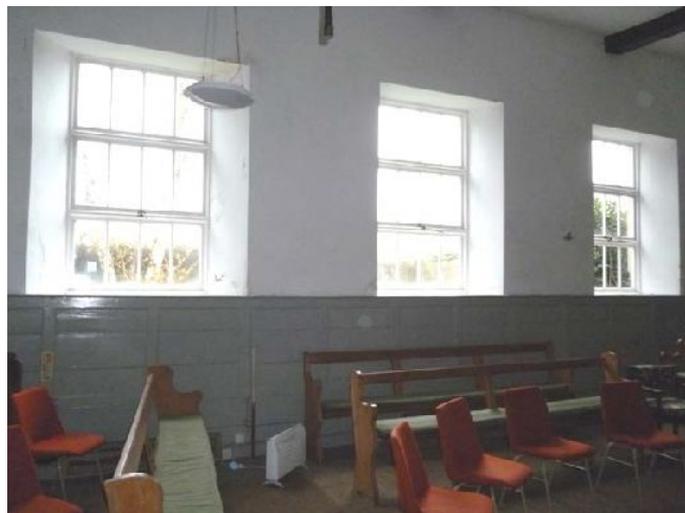
**Plate 35: The south-west elevation of Ground Floor Room 1**

4.3.4 The south-west elevation has panelling covering the lower part and wide planks in ovolo-moulded rails. There is a row of three (possibly 20<sup>th</sup> century) very tall, hinged, 12-light windows, with timber sills which meet the top of the moulding (Plate 35). The windows have splayed jambs.

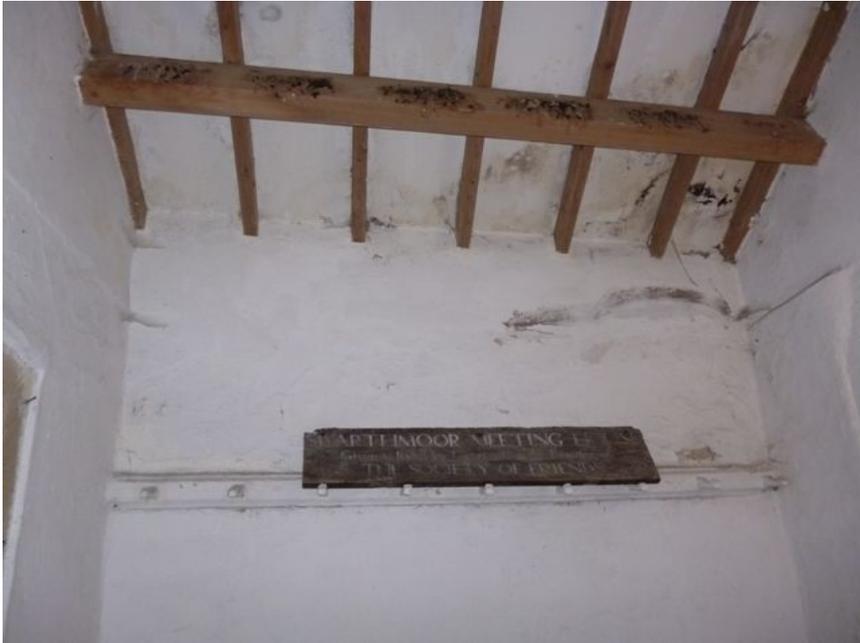
**Plate 36 (left):** The north-west elevation of the porch

4.3.5 **Ground Floor Room 2:** the description for Ground Floor Room 2 covers the corridor (including the porch and the area beneath the stairs) and the stairs. The porch has a flag floor and a gabled roof, with neatly sawn purlins and rafters with one purlin per pitch. The walls are plastered and whitewashed. The north-west elevation is plain apart from a row of old timber coat hooks on a moulded timber batten (Plate 36). The north-east elevation has a doorway with a moulded stone surround with a stop chamfer and a heavy plank door with an early latch plate and iron studs (see Plate 37). The south-east elevation is plain. The south-west elevation has a doorway with dressed stone jambs and an arched top (Plate 38).

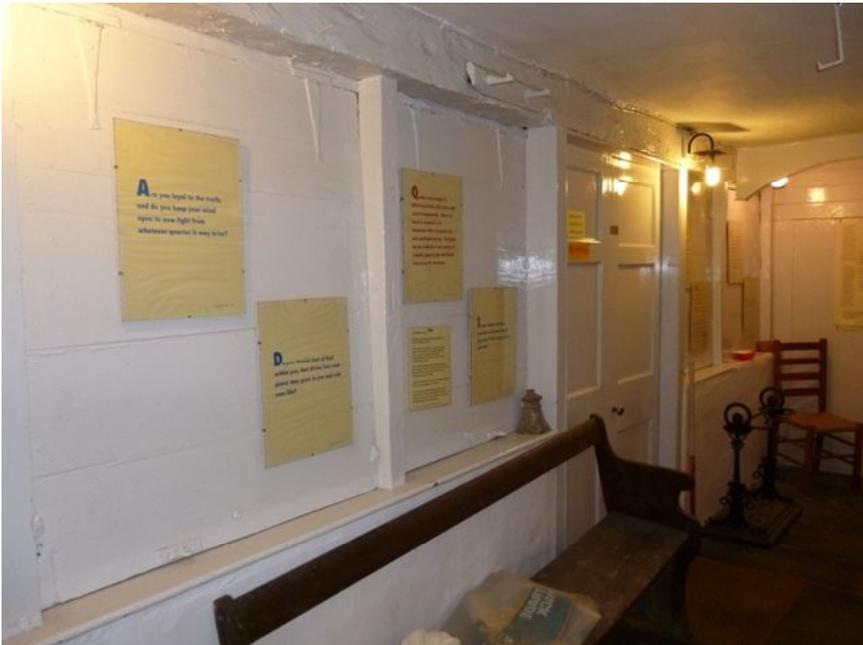
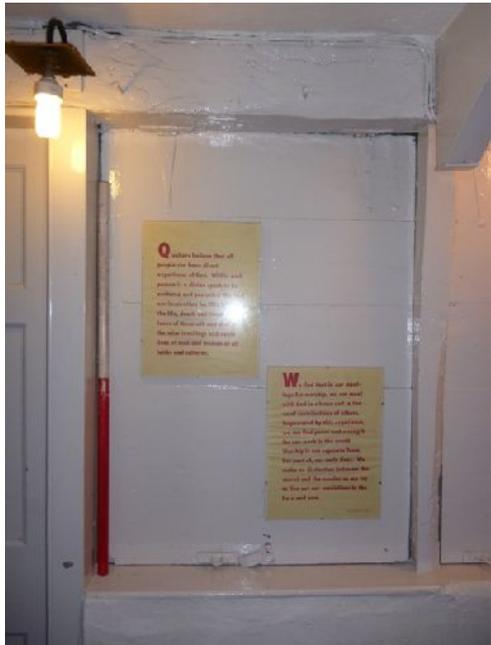
Plate 39 (left): The north-west elevation of the corridor

of Plate 41). The north-west elevation has a row of plank built hatches on early hinges between square posts (Plate 40). The south-west end has been slightly truncated to accommodate an additional post supporting the rotten end of the beam (see Plate 44). The central double door has three panels in each and beading round the square surround. The door is apparently in the position of another hatch, each hatch being approximately 37 inches wide, with the hatches either side having been shortened to accommodate the insertion of the door. The hatch posts sit on a low masonry (possibly brick) wall, which has also been cut through to accommodate the door. The hatches continue beyond the partition wall at the north-east end of the room, which has a beaded plank construction (Plate 41) with a door in a similar style to the ones along the rest of the corridor. The upper part of the partition looks later.

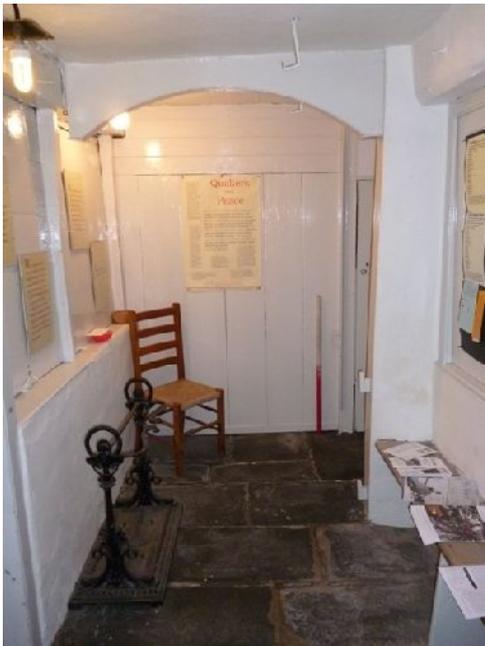
Plate 41: The partition wall along the underside of the stairs

4.3.7 The north-east elevation of the corridor forms the external wall of the building, which is accessible below the stairs. The north-east elevation below the stairs is plain and plastered and has a three-light timber mullion window, with splayed jambs, on the north-east side. The south-east section is leaded and the timber used is octagonal in section and pegged (Figure 7). The south-east side of the room forms the underside of the stairs, which are very modern timber. The south-west side of this space comprises the rear side of the panelled wall, which comprises a mixture of timbers along the top part but in general is earlier than the stairs, although they are fixed together.

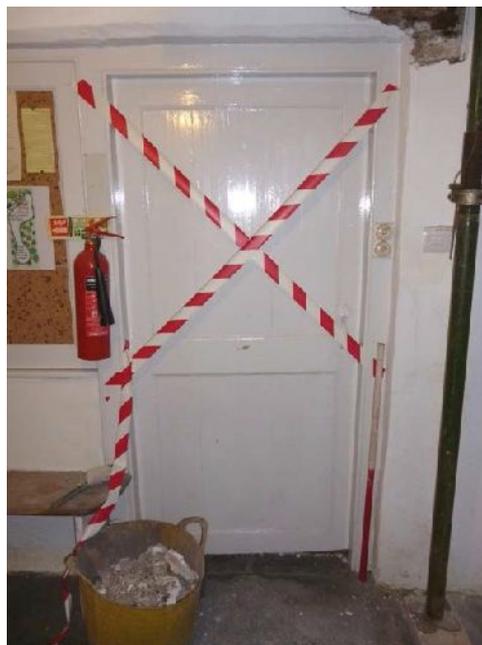
**Plate 43: Door in the south-east elevation of the corridor**

4.3.8 The south-east elevation of the north-east/south-west section is open at the north-east end (along the side of the stairs). The rest comprises a row of four hinged shutters, with moulded panels and beaded surrounds, with a bench below (Figure 6). There is a plank and batten construction door made from wide planks, with beaded edges, and an early latch plate at the south-west end, which is contemporary with the other hatches (Plate 43).

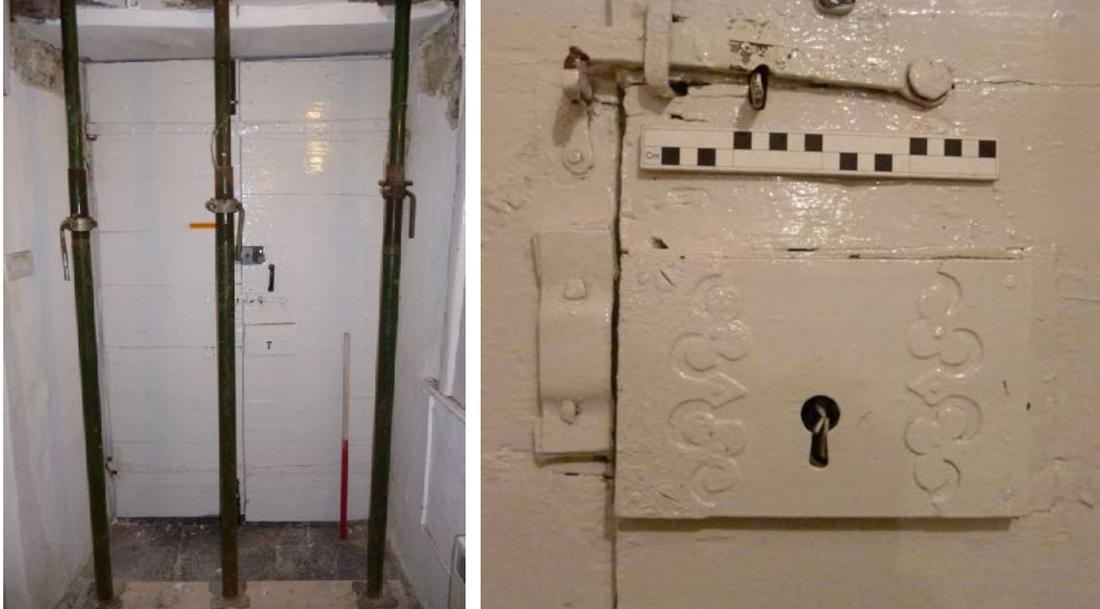
**Plate 44 (left): The doorway to the porch viewed from the corridor**

4.3.9 The south-west end of this section of the corridor houses the double door to the porch (Plate 44). The large double door is made from doubled planks, set vertically on the north-east side and horizontally on the south-west, and hung on large strap hinges. It has an ornate ironwork lock (Plate 45). The beam above is in poor condition and has a large slot in the north-west end, which indicates it has been re-used, perhaps from a piece of timber framing.

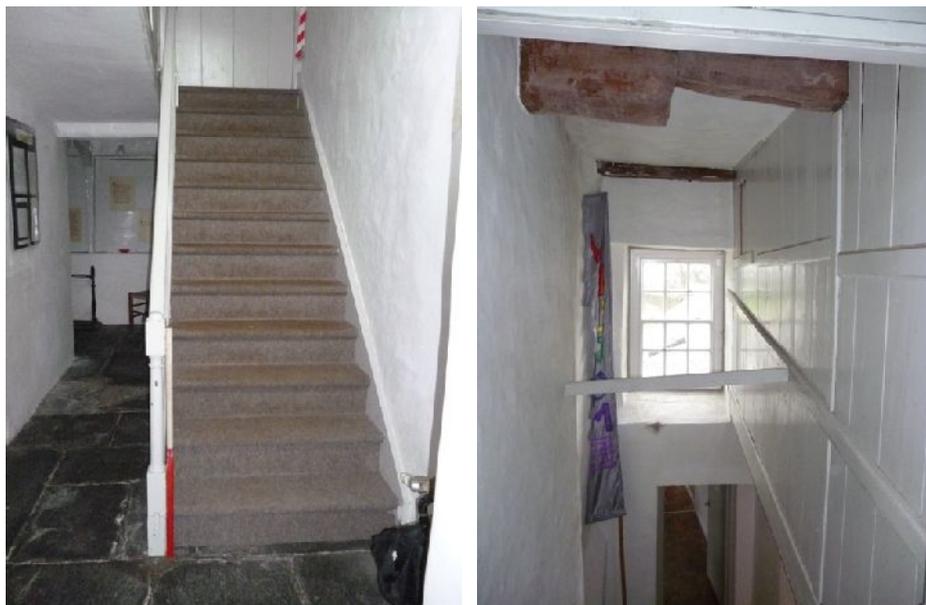
**Plate 46 (left): The stairs, viewed from Ground Floor Room 2**

4.3.10 The north-west/south-east section of the corridor also has a flag floor and a plaster ceiling on the south-west side. The stairs are to the north-east. The stairs are very plain with modern square spindles and a turned newel with a square top and bottom (Plate 46). The north-east elevation (which is the external wall) is plain. There is a modern door in the south-east elevation with a modern 12-light sliding sash window above it at approximately first floor level (Plate 47; see Figure 4). The south-west elevation of this section of the corridor is masonry and plain apart from the door to Ground Floor Room 3. The door has a plain surround but has a beaded plank door and an early latch.

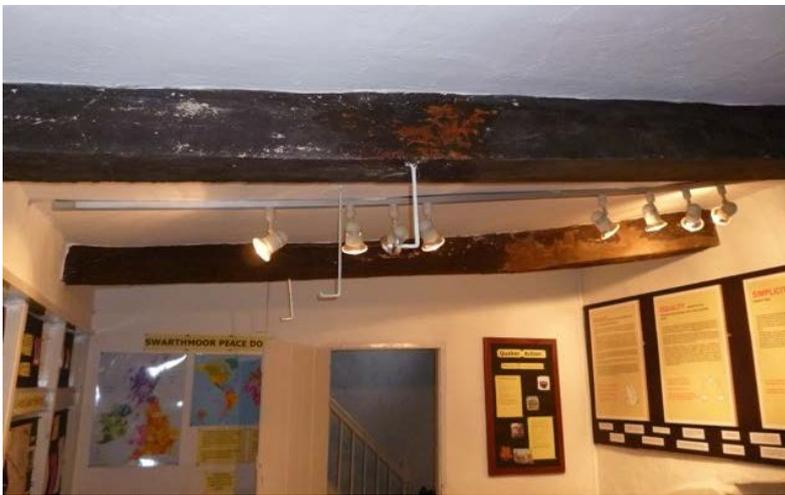
**Plate 48 (left): The beams in Ground Floor Room 3**

4.3.11 **Ground Floor Room 3:** this room has a flag floor and a plaster ceiling, which slopes slightly to the north-west. There are two beams across the ceiling, which have been skimmed with plaster and have hooks for the shutters at the north-west end (Plate 48). The walls are all plastered and painted. The lower part of the north-west elevation is solid masonry which supports the framing for the plank construction hinged shutters on eight early hinges (Plate 49). There is a plank and batten door with long strap hinges hung on pintels at the south-west end (Plate 50). The north-east elevation is plain apart from the plank and batten door to the south-east of centre (Plate 51). The door has a beaded surround and hinges similar to those on the hatches to the north-west. The south-west elevation has central fireplace (Plate 52) and there is an alcove to the south-west which is used for shelving (Plate 53). The fireplace is an odd construction with an arched top and hob grate backed with brick (some of which is modern) and loosely blocked up with more brick internally. It has slightly projecting outer cheeks and there is a piece of moulded stone on the south-west edge. The stone is probably a moulded piece of door jamb and is stylistically the same as those used in the porch. The south-west elevation has two two-light stone mullion windows with slightly arched tops and iron dividing bars in each light and timber sills (Plate 54).

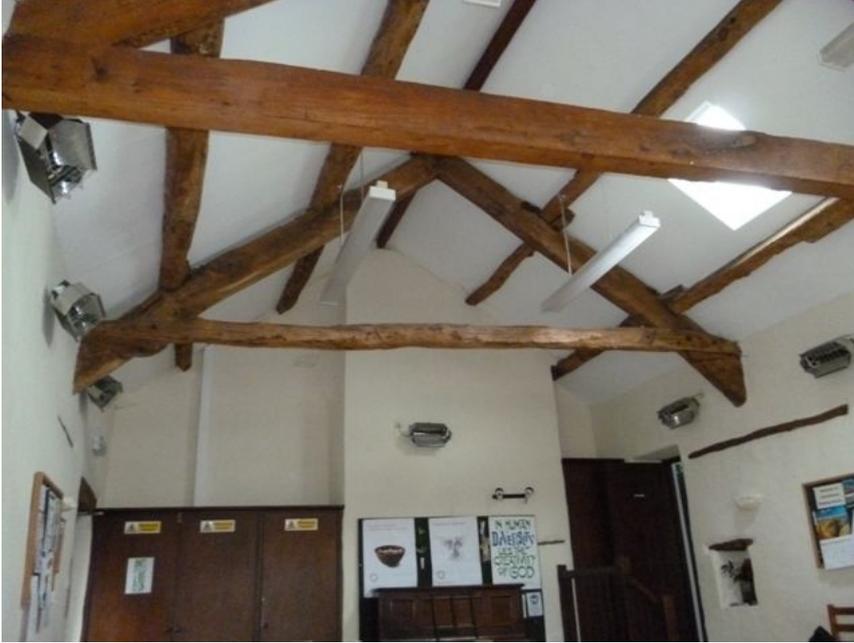
Plate 55 (left): North-west elevation of Ground Floor Room 4

4.3.12 **Ground Floor Room 4:** this room was originally a barn or possibly a stable. There is a vinyl floor in this room and it is open to the roof structure although the rafters are concealed by plaster (Plate 55 and Plate 57). There are two trusses exposed with three purlins per pitch. Most of the timber is hand-finished and there is some evidence for re-use of the timbers, although the south-west rafters and truss are later sawn (perhaps Baltic) timbers. The principals meet at a very basic joint and a group of letters apparently reading “O/C<sup>S</sup>M.I” are painted onto the north-west face at the south-west end of north-west truss. The north-west truss has a very simple lap joint at the principals and the tie beam is slightly raised and sat on additional blocks, which are nailed on. The joints are pegged, but some have additional iron bolts present. The walls are finished with modern plaster and painted. The north-west elevation has a central projecting section (which is the back of the chimneybreast) with modern cupboards in the alcoves to either side (Plate 55). There is a piece of timber built into the chimneybreast on the north-east side, but it is hidden by notice boards to the south-west. There are steps up to the toilet block to the north-east side. There is a doorway at the top of the steps on the north-east elevation, housing a modern plank door. To the south-east of this there are two low-level alcoves with timber lintels, originally vent slots, with some timber built in above, and there is a doorway at the south-east end. The timber lintel above the doorway suggests it was originally much wider, although it now houses a smaller modern door (Plate 56). The south-east elevation has a new opening single-light window on the upper level, with a rough

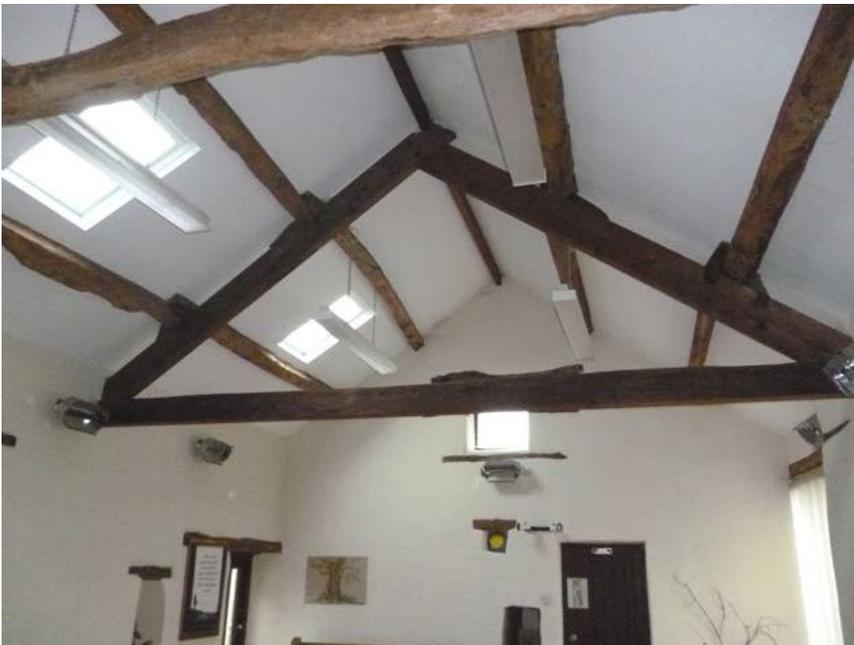
Plate 57 (left): South-east truss in Ground Floor Room 4

(possibly re-used) timber lintel and a timber sill and some pieces in the jambs (Plate 57 and Plate 58). There is an alcove on the ground floor level, which was perhaps originally a vent, which is lined with upright slates, and there is a small alcove with a timber lintel above that. To the south-west of this there is a modern plank and batten door, which is probably a later insertion. The south-west elevation has some exposed timber built into it and there is a wide opening with a rough timber lintel on the south-east side. There is a pedestrian doorway on the north-west side, with a modern door and a rough timber lintel.

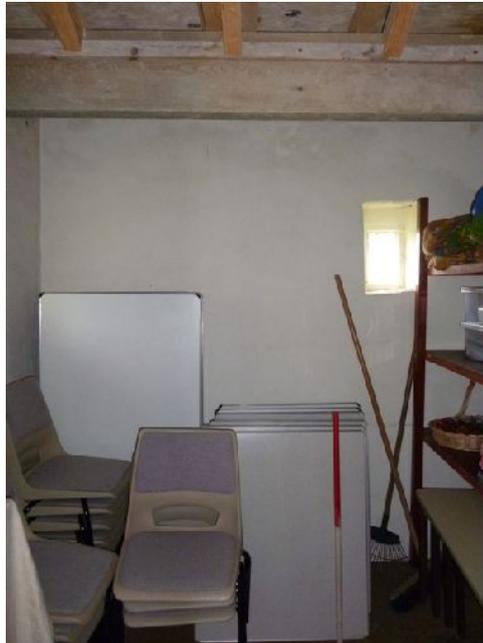
**Plate 59: South-east elevation of Ground Floor Room 5**

shaped ceiling on a central north-east/south-west beam and the beam and rafters are all machine cut. The walls are all plastered and painted. There is a central doorway housing a modern plank and batten door on the north-west elevation. The north-east elevation has a small window on the south-east side, with a tilting single-light casement and there are what look to be two projecting bricks to the north-west of this. There is another small single-light fixed casement window on the south-east elevation (Plate 59) and there is a doorway with a sandstone lintel and a plank and batten door on the north-west side of the south-west elevation.

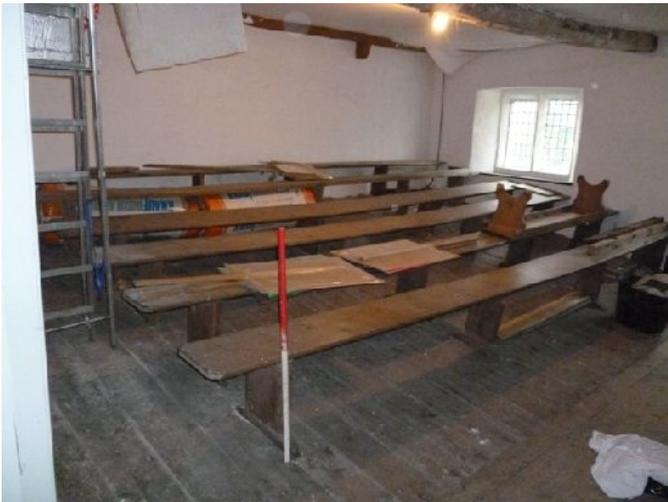
**Plate 60 (left): Tiered seating in First Floor Room 1**

4.3.15 **First Floor Room 1:** the first floor level is only present at the south-east end of the meeting house and is open to the north-west side of the partition above Ground Floor Room 1 (Figure 4). There are narrow tongue and groove boards on a north-east/south-west alignment at the north-west end of the room and the floor slopes upwards to the south-east (Plate 60). The boards on the sloping section are aligned north-west/south-east and are much wider and have benches nailed to them in tiers. The ceiling is plastered and flat and has a single central north-east/south-west beam (Plate 61). The beam is hand-finished and marked with an upside-down 'V' carpenter's mark at the south-west end on the north-west face. There is an iron bolt through the underside (the end of a tie rod running connected to the top of the truss above; see *Section 4.3.16* below) and the north-east end continues through the timber partition wall above the stairs and sits on a corbel. There are further beams in the same style against the north-west and south-east elevations, both of which are plastered. The one to the north-west has a bolt projecting through the underside but the one to the south-east, which sits on a row of three corbels, does not. The walls in this room vary. The upper part of the north-west elevation comprises shuttered panels, with wide

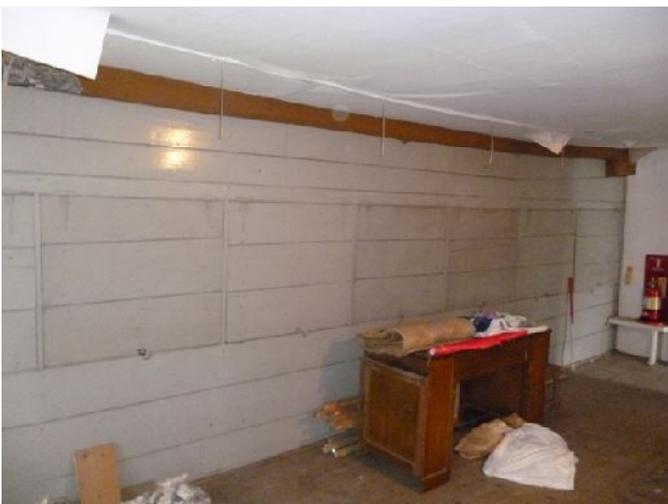
**Plate 62 (left): North-west elevation of First Floor Room 1**

beaded planks laid horizontally, forming seven hinged shutters with corresponding sliding shutters on the north-west side (Plate 62). There are thin beaded studs between the shutters but these are effectively just cut into the plank wall (Plate 63). The north-east elevation is a solid wall on the north-west side, which continues down the stairs. There is a plank and batten door at the top of the stairs (Plate 64), where the wall returns to the south-west, before it continues as a timber stud wall built of beaded planks along the side of the stairway (Plate 65). The battens are beaded and the door has an early latch plate but it has been made wider with the addition of plank to the north-east side and it has modern hinges. There are scars for earlier hinges on the wrong side of the door on the south-east face. The rest of the plank wall is of a similar build, made from wide planks, with a small hatch cut into the plank at the south-east end. The hatch has an early handle and hinges. The south-east elevation is plain. The south-west elevation has two mullion windows, which are octagonal in section and plain, with two leaded lights (Plate 66), similar to those on the ground floor. They are slightly arched to the south-east and have timber sills. The one to the north-west has four iron bars across it. The lintel over the porch door is visible through a hole in the floor and has a slot in the top and a stepped/rebated edge (Plate 67).

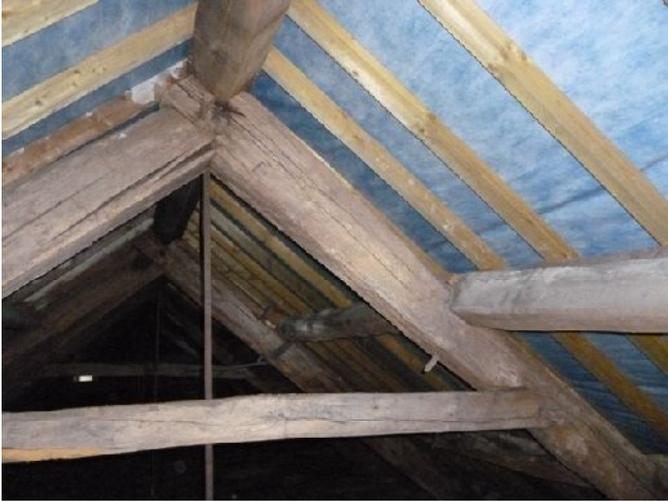
**Plate 68 (left): Truss 'I'**

4.3.16 **Roof Space:** the space above the first floor level of the main Meeting House is open to the roof structure. The joists might be early but they are largely obscured by fibreglass. There are five trusses, dividing the room into six bays (Figure 5), but only one is complete (truss 'IIII'; see Plate 73). They were evidently all tie beam trusses, the beam projecting down to the rooms below, with a collar, and the king post between the tie beam and collar is jointed onto the north-west face of the collar. All but one is now missing the king post and the collar is missing from the second truss from the north-west end (truss 'III'). All of them now have an iron tie rod between the tie beam and principals (see Figure 6). Carpenter's marks are present at the junction between the principals, but there were evidently also marks originally on the junction with the tie beam. From the north-west end the chiselled marks on the trusses read 'I' (Plate 68 and Plate 69) then 'II' (Plate 70 and Plate 71), there is nothing on the central one, then 'IIII' (Plate 73 to Plate 75) and 'V' (Plate 76 and Plate 77; see Figure 5). There are also carpenter's marks at the junction between the collar and king post. The north-west truss has no scar for a king post and so no carpenter's mark, the one to the south-east is missing the collar, the marks then run 'II', 'III', but there is

none on the south-east truss. There are some levelling marks visible on truss 'V' and truss 'II'. The king post truss for truss 'V' has clearly been re-used as there are lots of peg holes and a circular burn mark near the top on the north-east face (Plate 75). There are three purlins per pitch (see Figure 6), which are mostly hand-finished, although some are machine cut replacements, and there is an iron brace between truss 'I' and 'II' on the south-west side (Plate 72). The ridge purlin and rafters are machine cut.
