# SWARTHMOOR MEETING HOUSE, MEETING HOUSE LANE, SWARTHMOOR, ULVERSTON, CUMBRIA

Archaeological Building Recording

Client:  
Swarthmoor Area Meeting

April 2012

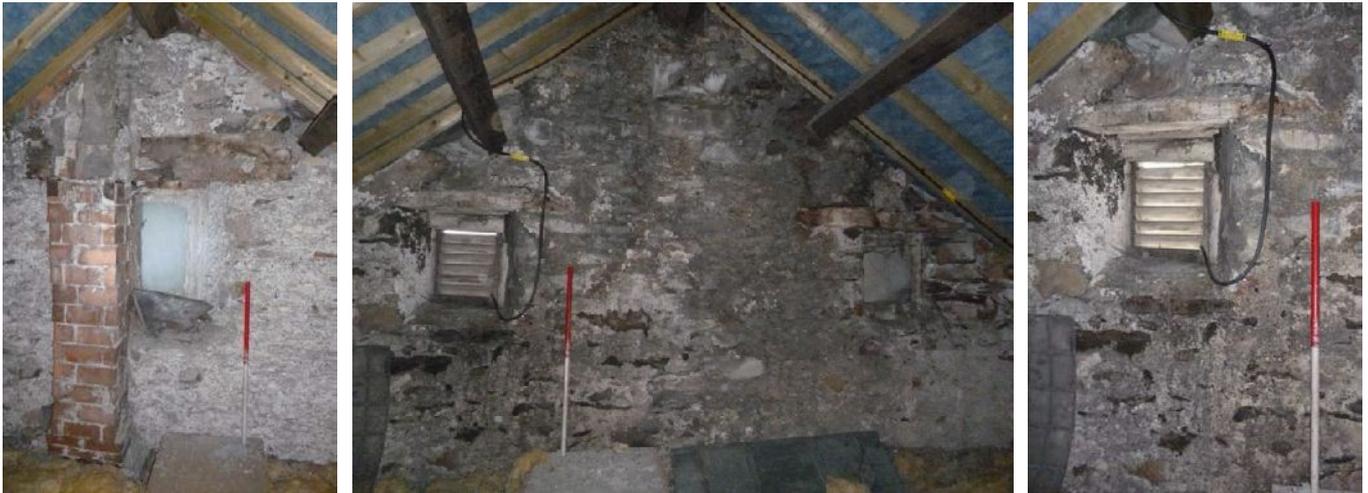
**Plate 78 (left): Window in the north-west elevation of the roof space**

4.3.17 The gable end walls are exposed, but the other elevations are not visible. There is a central window on the north-west elevation with a massive timber lintel, which may have been re-used (Plate 78). The jambs are splayed, dressed stone mullion jambs, but they are covered by mortar and the window is blocked with a large piece of slate and there is a brick-built flue against the south-west side. None of the bricks are frogged, perhaps suggesting a mid-19<sup>th</sup> century date, and similar brick has been added along the top of the ridge. Either side of the centre on the south-east elevation there is a window with timber mullion surrounds and a rough timber lintel (Plate 79). The north-east window has timber slats across it (Plate 80) but the south-west one is blocked with a piece of slate. There is a stone projecting in the centre with "H STABLES 10/92" scored into cement below it (Plate 81) and there is a
