# VICKERSTOWN SCHOOL, LATONA STREET, BARROW-IN-FURNESS, CUMBRIA

## Archaeological Building Recording

Client: Leck Construction Ltd

November 2012

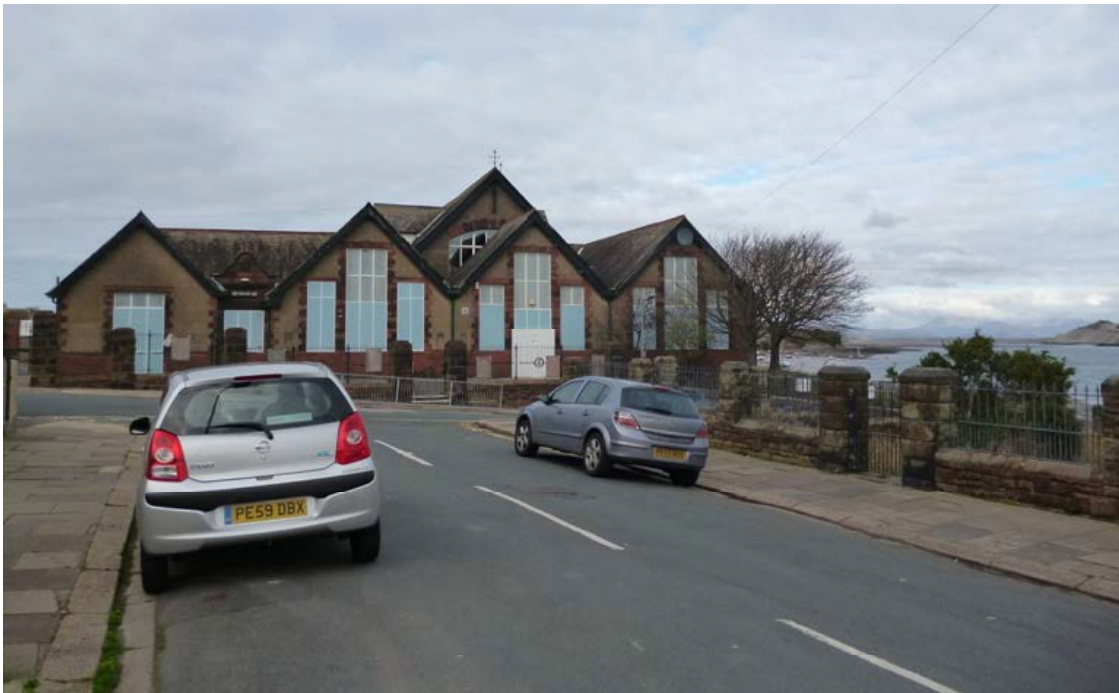
**Plate 1: The school building viewed across Latona Street, from the south-east**

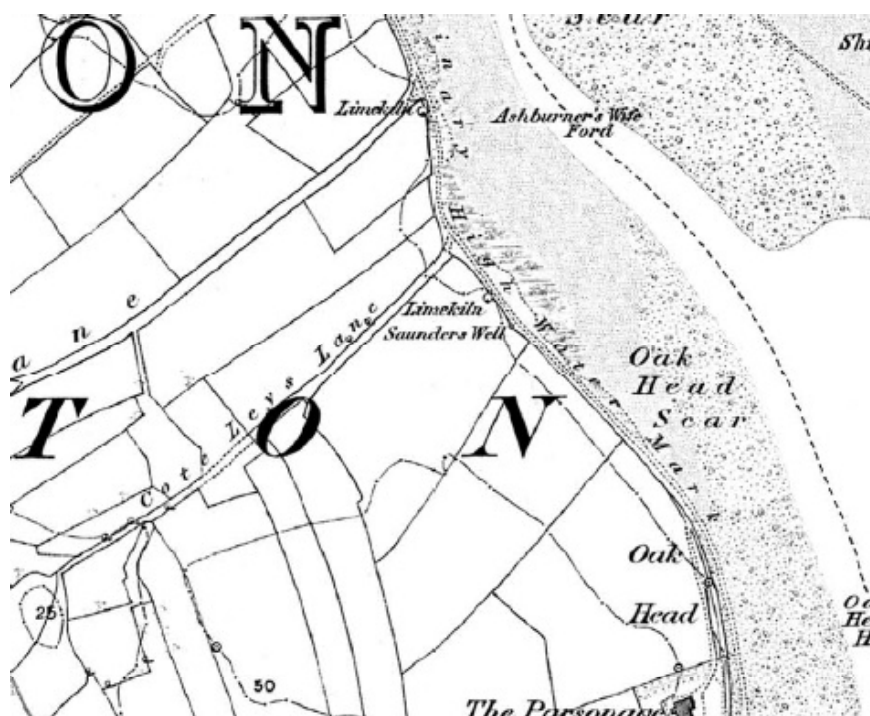
**Plate 2: Extract from the Ordnance Survey map of 1851 showing the site prior to the construction of the school**

3.2.1 **Ordnance Survey 1851:** this is the first detailed Ordnance Survey map of the area and shows the site prior to the construction of the school (Plate 2). At this time the area was entirely rural, with the ancient settlement of North Scale to the north and Walney church and parsonage house to the south. The field in which the school was built can be easily identified as it has Cote Leys Lane, which now survives as a footpath, along the north-west side. On the north-east side of the field a limekiln is shown and 'Saunders Well', but the plot is otherwise unremarkable.

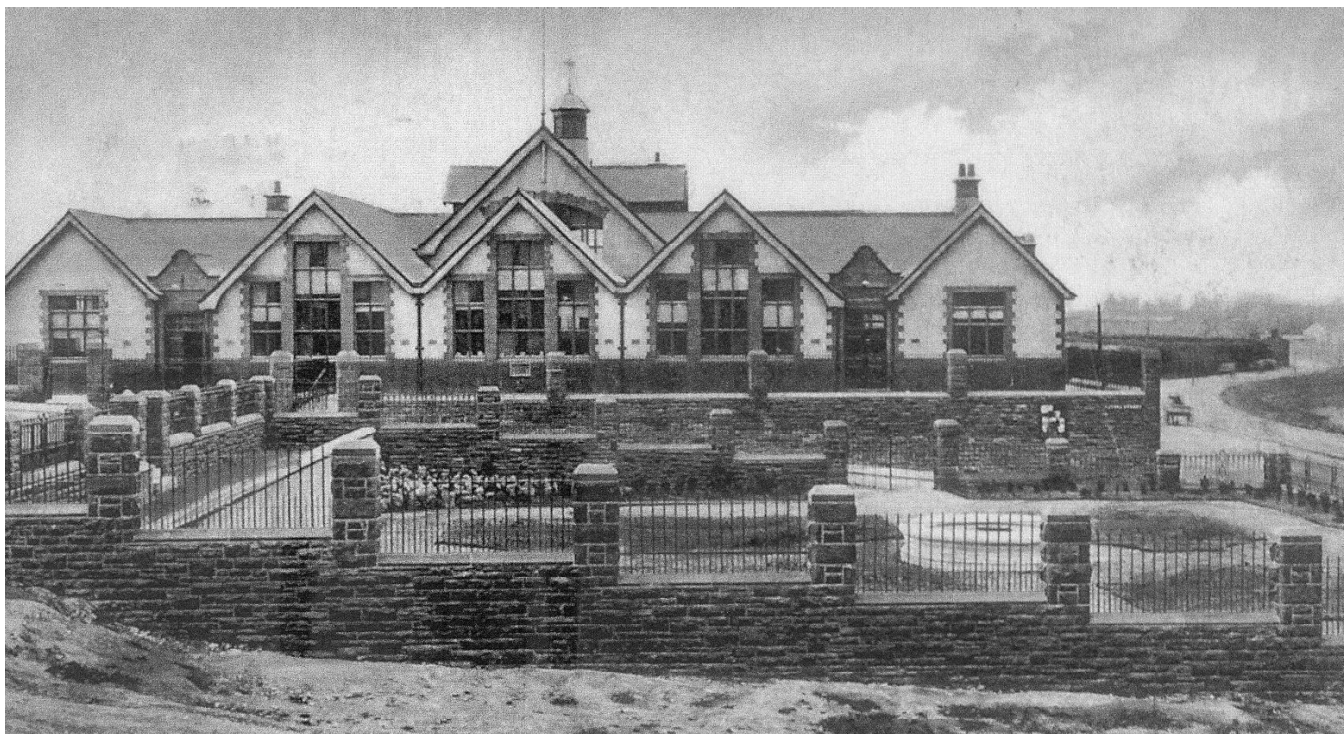
**Plate 11: View of the school from 1906 (after Myers 2000, 117)**

3.2.5 **Photograph, c1902 or 1906:** an early photograph of the school, taken soon after construction, shows the south-east external elevation (Plate 11). The date of this picture is uncertain; two original copies in the archives are dated c1902 (CAC(B) BLC/283/HVIC1 c1902), while one published version of the same view is described as undated (Trescaheric and Baker 1982, 78) and another dated to 1906 (Myers 2000, 117). At this time the building was clearly symmetrical and extended further to the north-east (see Plate 16) and comprised five gables with large windows, with moulded stone 'Dutch gables' at either end between two of the gabled ends. Of interest is the central tower with its dome and chimneys on either side, none of which now remain. One of the two copies in the archive has been coloured, the roof a pale blue suggesting it was slate.

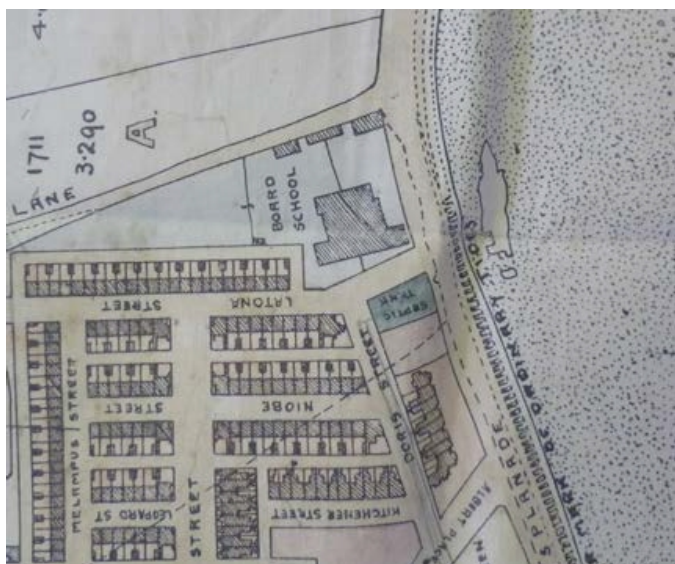
Plate 13 (left): Extract from the plan of Vickerstown, 1905 (CAC(B) Z/318 1905)

**3.2.7 Plans of the Vickerstown Estate, 1905 and 1906:** two contemporary plans of the 'Isle of Walney Estates Co Ltd' Vickerstown development are available dated to 1905 (CAC(B) Z/318 1905) and 1906 (CAC(B) Z/835 1906) (Plate 13 and Plate 14), the latter of which was utilised in a portfolio of drawings produced to illustrate the different properties (CAC(B) BDY/116 c1902). Although not as detailed as the original drawings (see *Section 3.2.3* above) they demonstrate that the school was constructed as proposed and had apparently not been altered in the intervening three years.

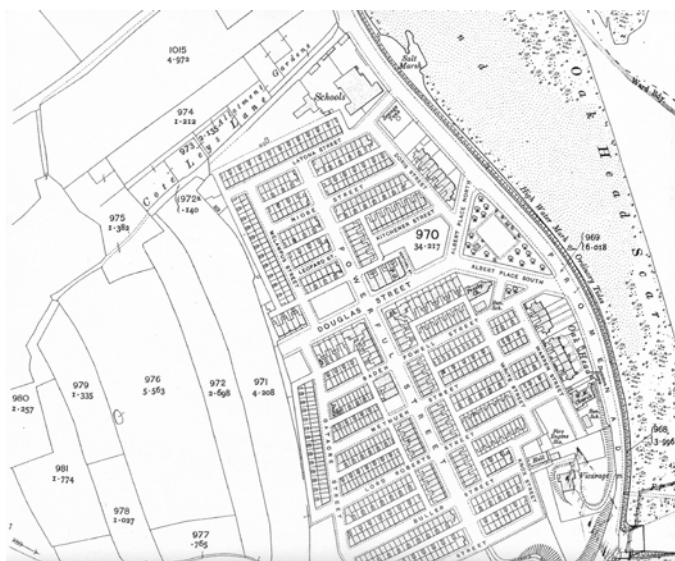
Plate 15 (left): Extract from the Ordnance Survey map of 1913 showing the position of the school relative to the rest of Vickerstown to the south

**3.2.8 Ordnance Survey 1913:** this is the first Ordnance Survey map to be produced after the opening of the school in 1902 and the construction of North Vickerstown (Plate 15). It shows that at this time the school comprised a large rectangular section orientated north-west/south-east, with projecting wings extending from the south-east end of the south-west elevation and north-east elevations. Detail such as the access to the cellar and step up to the main entrance on the north-east elevation can also be seen (Plate 16). Curiously, the detached cruciform building to the south-west, which was shown on the original plans of 1901, is still shown, despite not being depicted on the plans of 1905 and 1906.

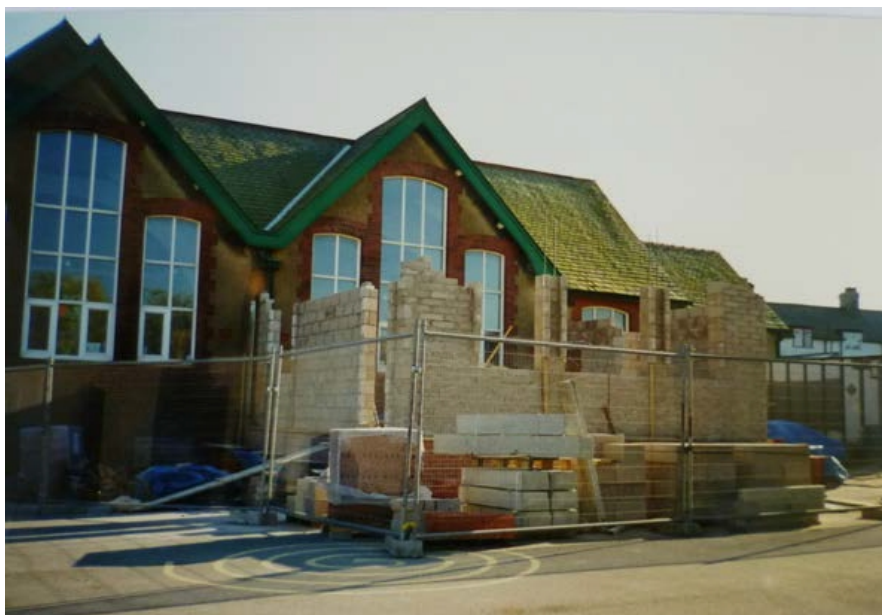
**Plate 23: Building work for the new extension in 2000 (CAC(B) BDS/66/1/19 2000)**

**3.2.11 Photographs, 1999 and 2000:** a poor quality reproduction of a photograph is reproduced in the 'Vickerstown Gazette', a magazine published by pupils at the school on 1<sup>st</sup> November 1999 (CAC(B) BDS/66/1/1 1999). This shows building work taking place at the school for the construction of a new computer room and extra classroom (see *Section 3.1.8*). A slightly later colour photograph (CAC(B) BDS/66/1/19 2000) shows the same construction work ongoing in 2000 (Plate 23).

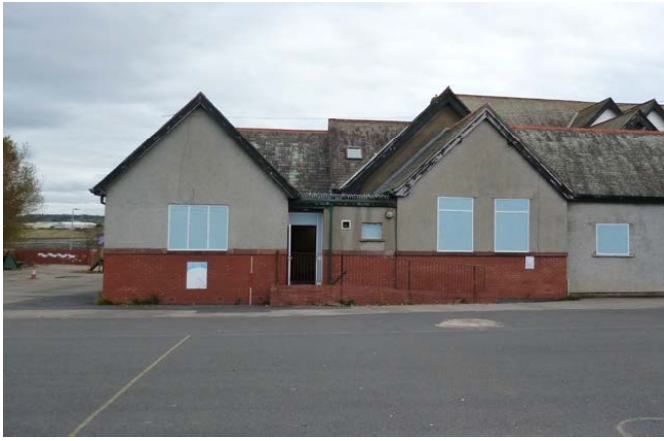
**Plate 24 (left): North-west end of the south-west elevation**

4.2.1 **South-west elevation:** the original structure is mostly obscured by a range of later additions which are built in a broadly similar style. The lower part of the north-west side is constructed from modern machine-made brick, laid in stretcher bond, with ceramic vents. Above this is a string course of concrete, coloured reddish pink to imitate red sandstone, and above this the wall is finished with concrete roughcast render. The north-west side comprises two gables with plain barge boards, between which is a flat-roofed section (Plate 24). There is a single window in the north-western of these two gables and two in the south-east, with a doorway with glazed section above and to the south-east, and a further small window with a concrete sill in the flat-roofed section. A brick-built ramp is situated against this section, which is topped with iron railings. All of the windows are boarded up and the door is modern. There is a slight step in the elevation to the south-east of this, at which point it is entirely finished with roughcast render and has three windows with concrete sills (Plate 25). It makes a larger return to the north-east after this, through a gated entrance, which is also finished with roughcast render, and there is a single window like those to the south-west. The elevation returns completely to the north-west, where it is also entirely finished with roughcast render and meets a timber double door below a flat roof (visible to the left hand side in Plate 26).

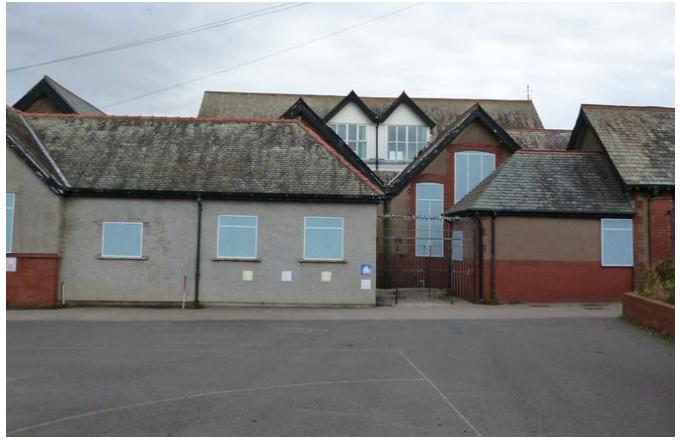
**Plate 25 (right): Central section of the south-west elevation**

4.2.2 The return to the south-east is part of the much taller elevation of the earlier phase of the building and comprises a double gable; the lower part is constructed in brick laid in Flemish bond and topped with ashlar red sandstone above which it is roughcast render. Each gable has three grouped large windows, the central window being taller, all with brick quoins and flat brick header arches surrounded by barge boards with moulded edges, behind which two purlins are hidden in each pitch (Plate 26 and Plate 27). In each case the outermost window (north-west and south-east) has been partially blocked by a later addition and there is a pair of ceramic vents between the windows. The south-east end returns as a porched timber doorway with a double door, and then again to the north-west, where the build is machine-made brick topped with a finely cut dressed sandstone band and roughcast render above, and the corner is finished with sandstone quoins in a similar style to the band. There is a single window in the north-east and north-west elevations, both with sandstone lintels, the sill being incorporated into the sandstone band. The roof of this return is hipped, with the gable of the earlier section raised above the hipped roof and finished with roughcast render, patches of which are more recent, and it has barge boards with moulded edges (Plate 25).

4.2.3 The south-east end proper of the elevation continues as modern brick topped with sandstone and roughcast render. There is a single window with a sandstone lintel in the later section with the hipped roof (Plate 25) and there is a slight step in the wall at the junction with the earlier part of the building, which is built from brick laid in Flemish bond topped with a sandstone band and roughcast render above and there are red sandstone quoins at the corner (Plate 28). Within the roughcast section there are two windows, both with red sandstone quoins and lintel, the sill being incorporated into the band below, and there are two iron grill vents between the windows and a double ceramic vent to the north-west. The roof line projects beyond the top of the wall and is supported by a row of rafters, the scrolled ends of which are visible. A pipe is attached at the south-east end held by *fleur de lis* shaped brackets.

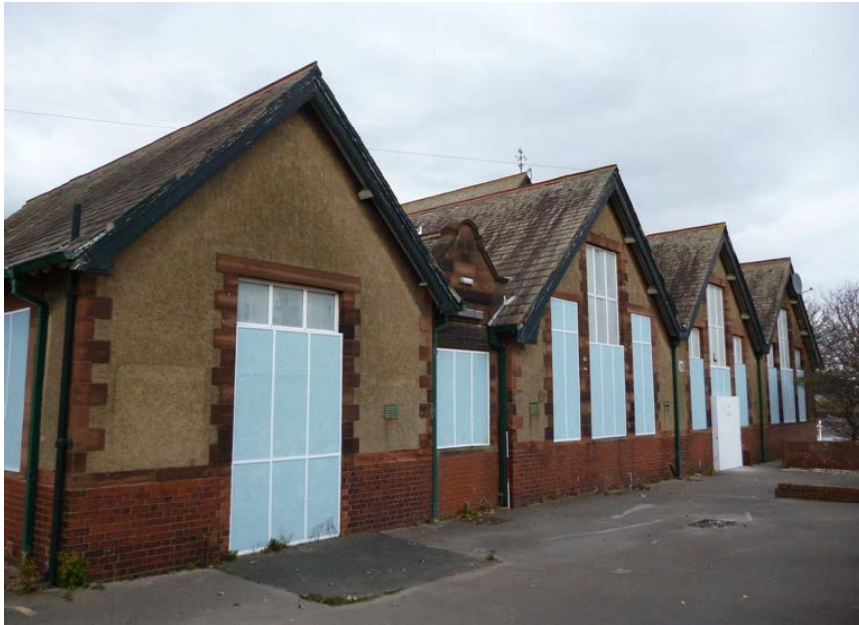
Plate 29 (left): South-east elevation

4.2.4 **South-east elevation:** this comprises a row of four gables, the lower parts of all of which are constructed from machine made-red brick laid in Flemish bond, with a band of ashlar red sandstone on top and roughcast render above within which is a row of large windows with metal grilled vents between (Plate 29). Each gable is finished with barge boards with moulded edges, which hide the ends of two purlins in each pitch. The south-western gable has a central large doorway, forming part of the tall window above, but it is evidently an extension from it as there is some rebuild in the jambs within the brickwork (Plate 30). The window has a sandstone lintel and ashlar sandstone quoins. To the north-east of this gable, between it and the next gable, is a recessed section housing a window with ashlar red sandstone quoins, beneath which is modern brick laid in stretcher bond, and above which is a 'Dutch gable' constructed from dressed ashlar red sandstone with a recessed panel below (now with four metal grills cut through) (Plate 31). The three gables to the north-east are all essentially the same, each with three grouped windows, the central one taller than the rest, with dressed stone quoins and flat voussoir arches with a central keystone (Plate 32). The window in the central gable has been extended through the brick work to form a doorway, within which is a UPVC double door with 'Vickerstown Primary School' and 'Welcome to Vickerstown' printed on the glazed sections. There is a stub of brick wall to the north-east of this forming one side of a gateway in a low wall extending to the boundary wall to the south-east. The bricks within this are marked 'FURNESS BRICK CO LTD BARROW'. There are two square-section down pipes between the three gables, with square hoppers decorated with a heart-shaped motif, and a satellite dish is attached on the north-east side.

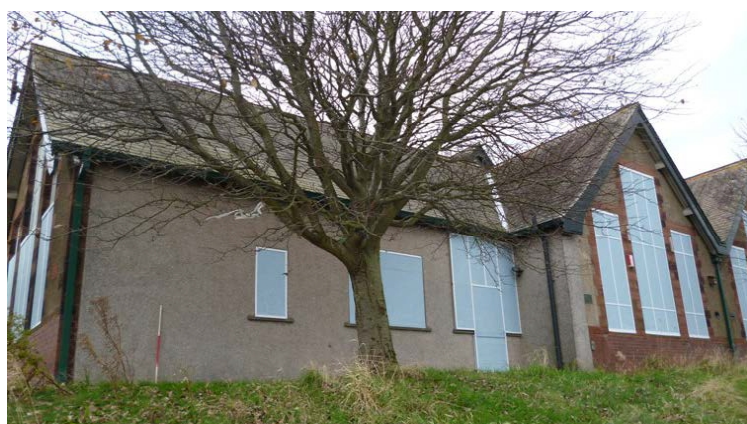
**Plate 33 (left): South-east end of the north-east elevation**

**4.2.5 North-east elevation:** the south-east end comprises the side of the gable and is entirely finished with roughcast render and has two windows, one large and one small, with concrete sills (Plate 33). There is also a doorway to the north-west accessed via a single concrete step, and with flanking windows, which also have concrete sills. The main part of the elevation to the north-west of this comprises two large gables, the lower part of which is constructed from red machine made brick laid in Flemish bond, perforated by a row of ceramic vents in two styles, above which is a band of red sandstone with roughcast above (Plate 34). The gables are finished with moulded barge boards, which hide the ends of two purlins in each pitch and have sarking underneath. There are four metal grill vents in the roughcast section and each gable has three grouped windows, the central one being taller, with sandstone quoins and lintels. There are two square section downpipes with square hoppers. The elevation returns to the south-west at the north-west end where there is a flight of yellow sandstone

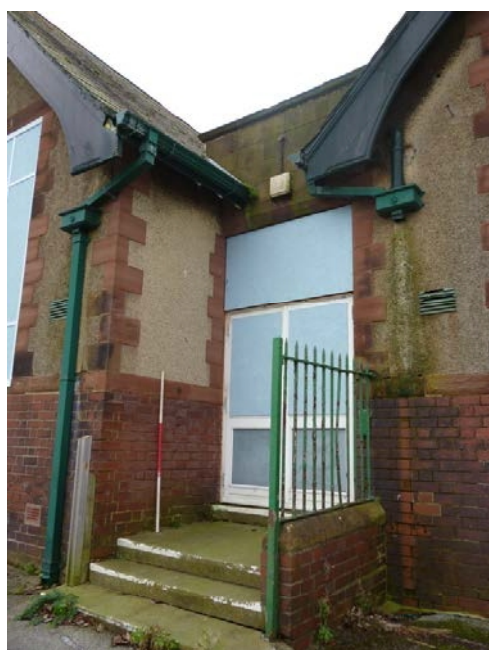
**Plate 35 (left): Doorway in the north-east elevation**

steps with a flanking brick wall on the north-west side topped with stone coping and an iron rail (Plate 35). The steps lead to a doorway with a modern double door with a window over and dressed ashlar red sandstone above, topped with a moulded rail. The wall returns to the north-west at the doorway and forms another gable in a similar style to those to the south-east (Plate 36). Against this is a flight of stone steps accessing the basement via a doorway at the north-west end with a beaded plank and batten door and flat brick arch (Plate 37). To the south-east of this is a wide window with a similar arch and the remains of a four-light casement (Plate 38). Around the stairs is a low brick wall with a stone coping topped with iron railings with an early gate on the south-east side (Plate 38). The north-west side has a more recent gate attached across an opening (Plate 37). An arrangement of I-beam girders is suspended between the wall and the fence over the doorway into the basement with a hook attached (Plate 37). The upper part of the wall has three grouped windows as per those to the south-east and is finished with moulded barge boards. The elevation returns to the south-west and then continues to the north-west as part of a later addition. The later addition comprises a layer of bricks laid in stretcher bond only, topped with a band of pink concrete with roughcast render above and brick quoins at the corners (Plate 39). There is a brick block on the ground at the junction of several down pipes and concrete steps to the north-west, with a brick retaining wall topped with a metal hand rail leading up to a doorway with a UPVC door. There is a single window to the south-east of this.

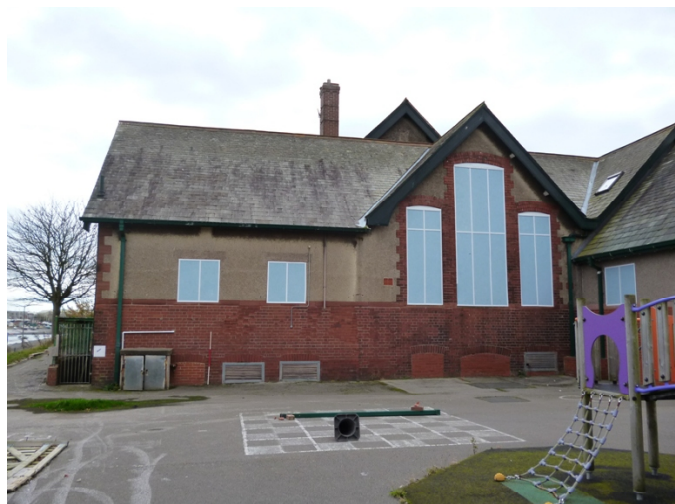
Plate 40 (left): North-east end of the north-west elevation

**4.2.6 North-west elevation:** the north-east side of the elevation is early (Plate 40), the south-west end a later addition (Plate 41). There is a chimney on the north-east side, set back from the elevation, which is square in plan and has a single chimney pot (visible to the back of Plate 40). The lower part of the earlier part of the elevation (as with the remainder of the building) is finished with red machine-made brick laid in Flemish bond, with a row of six windows lighting the basement. Each of these has a flattened brick arch and all of them are now blocked or filled with a slatted metal vent. The brick section is topped with a sandstone band, above which the wall is roughcast rendered. There are two windows in the north-east section, the lintels of which have been re-rendered over (Plate 40). There are two gables near the centre, the north-east one has three grouped windows, the central one being taller, all of which have brick quoins and flattened brick header arched tops. The gables are finished with moulded barge boards,

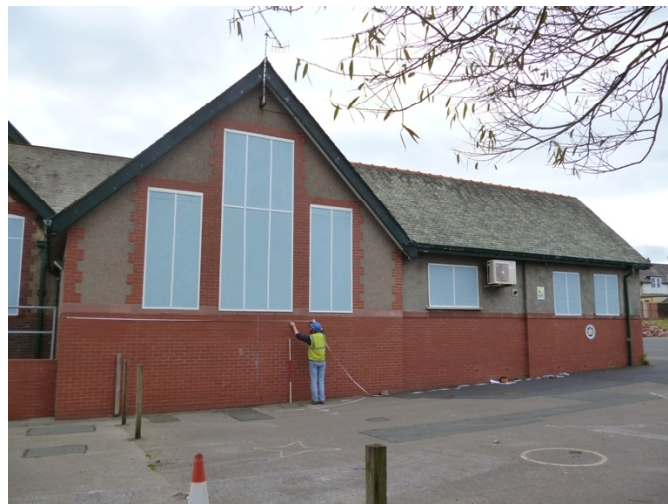
Plate 41 (right): South-west end of the north-west elevation

which hide two purlins per pitch. The south-west gable of the earlier build is largely obscured by a later addition, which returns to the north-west. The return initially comprises a gable, built against the larger earlier one behind, with three grouped windows, the central one being taller, with brick quoins and a header lintel (the earlier gable stands slightly taller than the later addition and is visible to the right hand side in Plate 40; see also Plate 41). The brick is laid in stretcher bond only, topped with a band of pink concrete with roughcast render above and brick quoins at the corners, which continue from the north-east elevation (Plate 41; see also Plate 39). There are chamfered barge boards below the eaves, which hide decorative scrolled purlin ends (similar to those at the south-east end of the south-west elevation; see *Section 4.2.3*). The elevation continues to the south-west of this as a lower section housing three windows with concrete sills and there is a slight step near the centre.

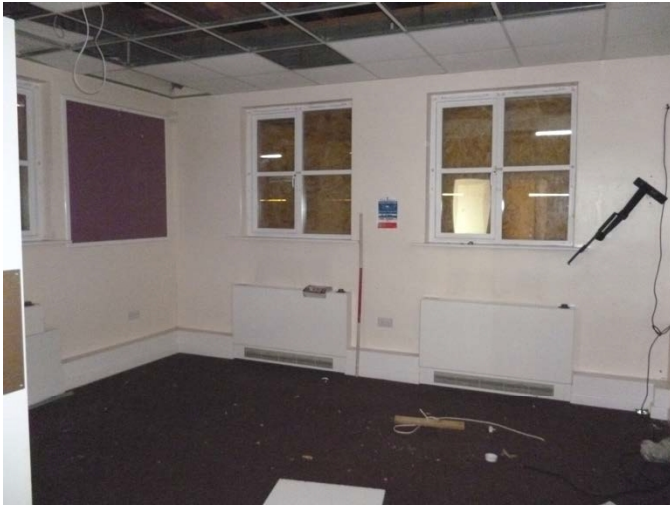
**Plate 49 (left): North-west elevation, Room 1**

**4.3.1 Room 1:** this room has a carpeted floor and a suspended polystyrene tile roof with a further suspended ceiling above supporting insulation. The roof structure and felt is visible above, which is all modern. The walls are plastered and painted and the room has modern heaters and fittings. The concrete block construction is visible above the suspended tiles. There are two four-light windows with modern timber casements and timber sills in the north-west elevation (Plate 49). The north-east elevation is plain apart from a double door leading to a large cupboard inside which there are water pipes against the north-east wall. The south-east elevation has a double door on the north-east side, each door having two glazed sections, and there is a two-light window to the south east (Plate 50). The south-east elevation has a single timber six-light casement window with a timber sill.

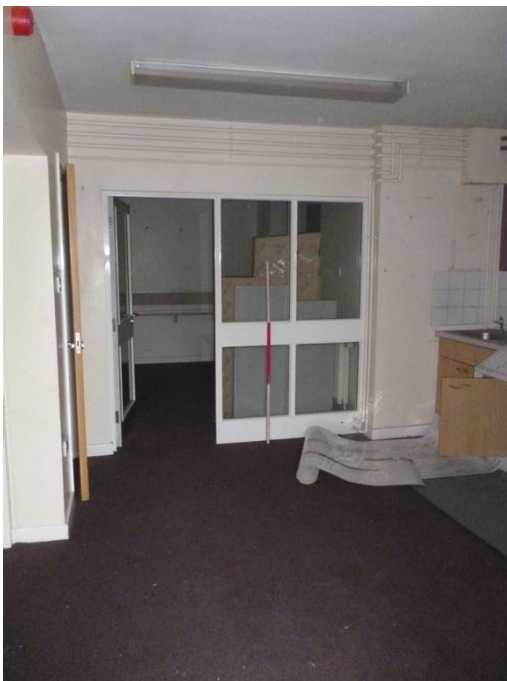
**Plate 51 (left): Doorway at north-east end of Room 2**

**4.3.2 Room 2:** this room forms the main entrance room and lobby. The floor is a mixture of carpet and vinyl and it has a flat plaster ceiling. The room is subdivided in the south corner to form a toilet and store cupboard. The north-west elevation has a double door with a glazed two-light window in the centre. There is a modern door to the north-east of this, leading to another store cupboard with timber shelves. The north-east elevation has a single door, with two glazed panels, and a stud wall to the south-east with four glazed sections (Plate 51). There are a lot of water pipes attached above it and to the south-east. The south-east elevation has kitchen units against it and is part tiled. The door to the south-west goes into the store with timber shelves in the partitioned section at the south side of the room. The south-west elevation has a doorway to the toilet on the south-east side (Plate 52). The toilet is against the south-east wall and the sink is on the south-west wall with boxing for the pipes. There is a small single-light timber casement window in the toilet. The door to the north-west leads outside. It has two glazed panels and timber surround and is glazed around the south-east side and above.

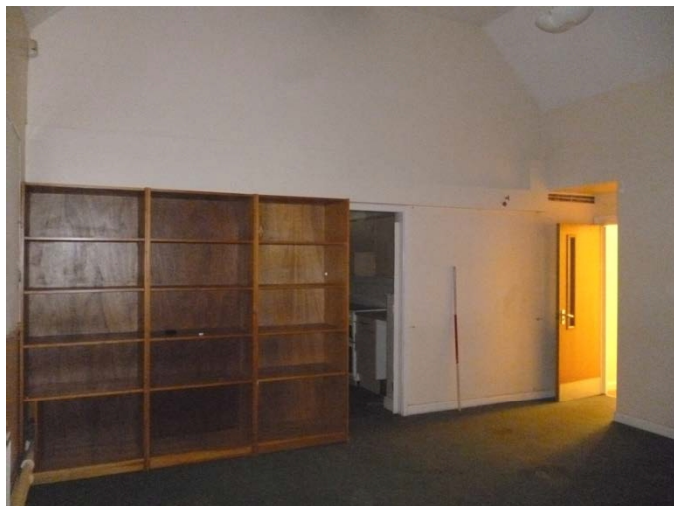
Plate 53 (left): Doorways, east side of Room 3

4.3.3 **Room 3:** the floor is carpeted. It has a sloping plastered roof on the north-west and south-east sides and is flat in the centres. There is an access hatch on the north-east side. The roof above is evidently modern. There is a single large timber purlin per pitch and ridge plank. The walls are finished with plaster and paint with pipes and other fittings attached. The north-west elevation is plain with a pin board attached. The north-east elevation has an off centre doorway with a plain surround and no door and boxed pipes above (Plate 53). The original external roughcast rendered wall and brick header arch of the window are visible in the roof space. The window is blocked with concrete blocks. The south-east elevation has a modern doorway in a deep recess to the north-east. The south-west elevation has two four-light windows with modern timber casements and timber sills (Plate 54).

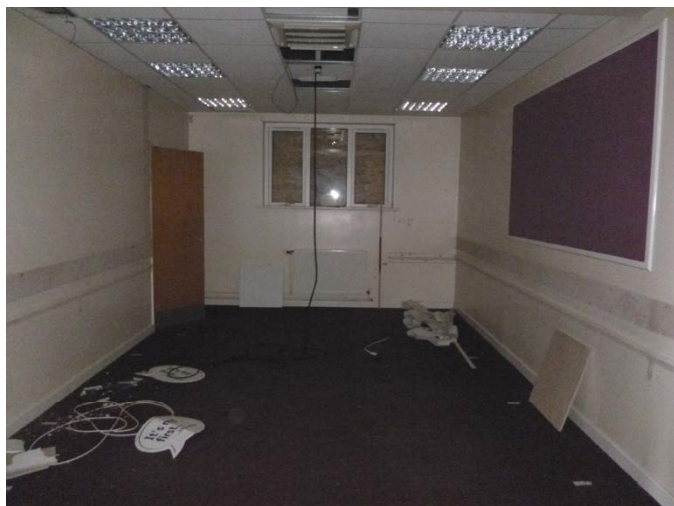
Plate 55 (left): North-west end of Room 4

4.3.4 **Room 4:** this room has a carpeted floor and suspended foam tile ceiling with a further suspended ceiling above supporting insulation. The roof structure above this is modern. The walls are finished with plaster and painted. The north-west elevation has a single three-light window, with a timber casement and sill (Plate 55). The north-east elevation is plain. The south-east elevation has a wide central opening into Room 5 (Plate 56). The south-west elevation has a four-light glazed section to the south-east and two-light door. There is a further door at the north-west end into the gas meter room, which has pipes against the north-west elevation.

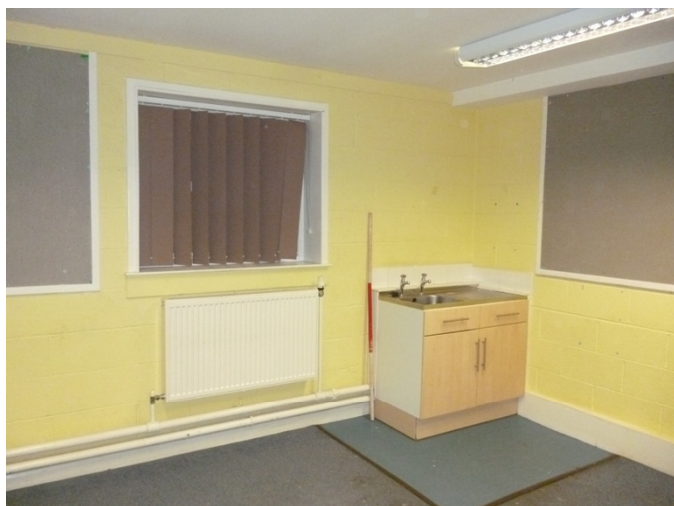
**Plate 59 (left): West corner of Room 6**

**4.3.6 Room 6:** this room is mostly carpeted but has a vinyl floor in the west corner. The ceiling is flat and plastered with a boxed north-east/south-west beam along the north-west side. The walls are painted concrete block. The north-west elevation is plain and partly tiled on the south-west side. The north-east elevation is open below a concrete beam with a stud wall filling the north-west side and a door with a single light to the south-east. There is a further door on the south-east side into a cupboard with timber shelves. The south-east elevation is plain. The south-west elevation has a single four-light window with a timber casement and sill (Plate 59).

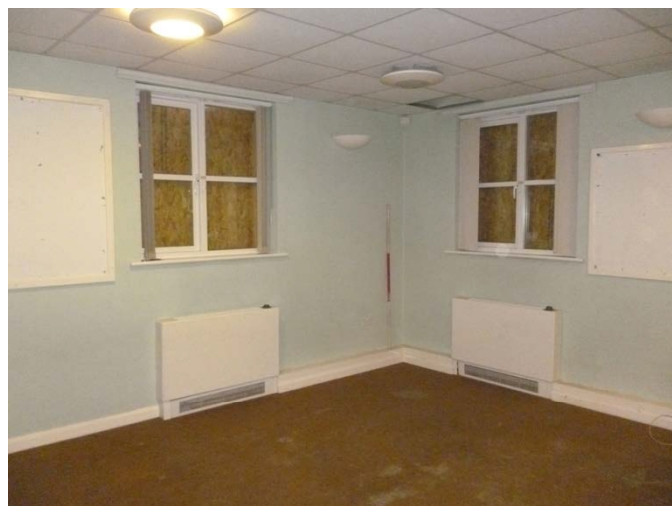
**Plate 60 (right): South corner of Room 7**

**4.3.7 Room 7:** this room has a carpeted floor and suspended foam tile ceiling. Above this there is a suspended ceiling for insulation and then the modern roof structure. The walls are plastered and painted. The north-west elevation is plain and the north-east elevation has a single doorway on the north-west side. The south-east elevation has a single four-light timber casement window with a timber sill and the south-west elevation has two four-light windows in the same style (Plate 60).

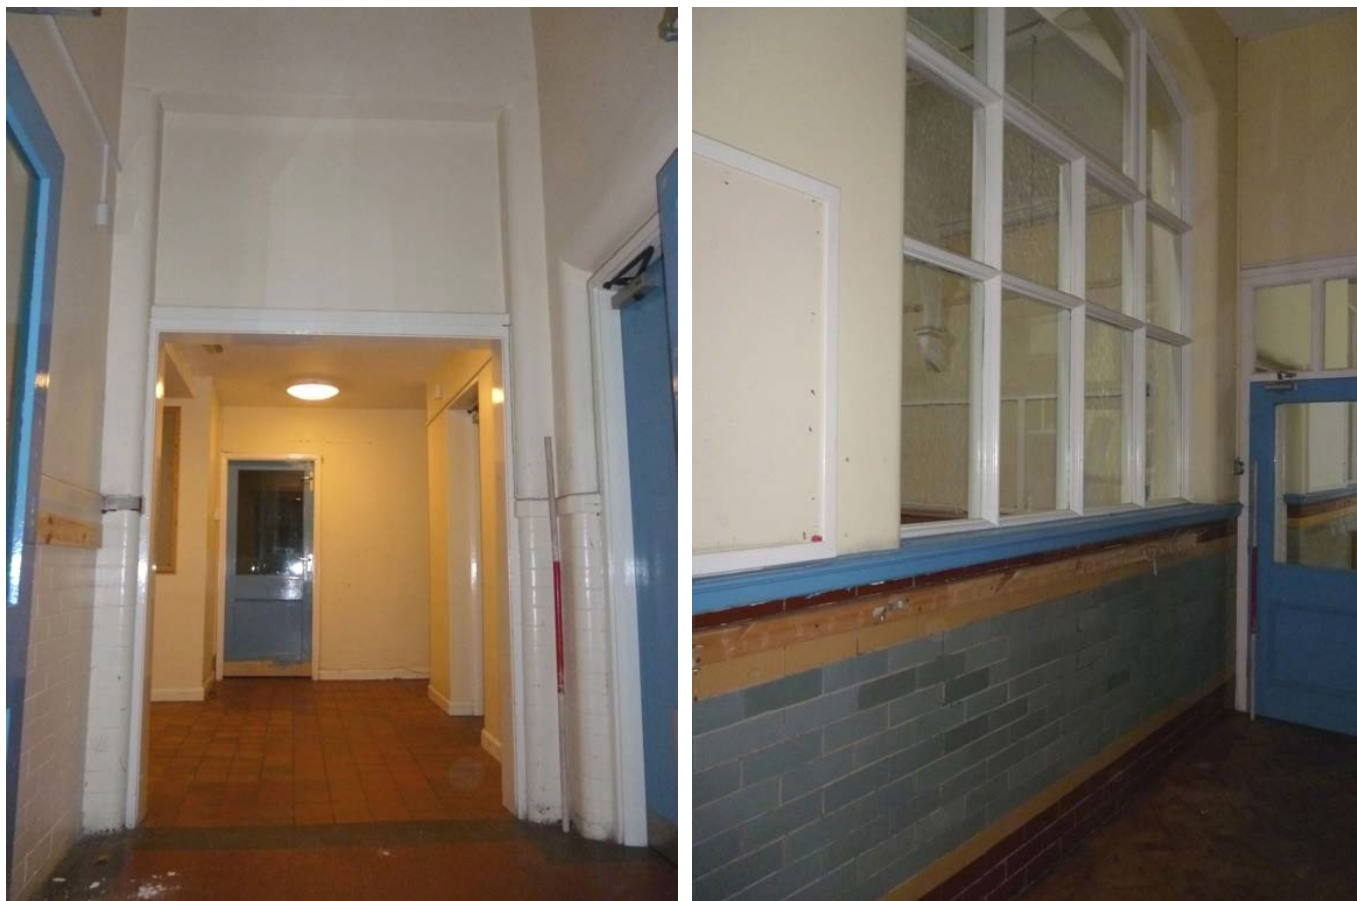
**Plate 61 (left): General view of Room 8, from the north-east**

**4.3.8 Room 8:** this room comprises an L-shaped corridor, the larger section forming a north-east/south-west corridor leading to Room 12. It has mostly red quarry tile finishing the floor with a black band round the edge (Plate 61) although the north-east end is a parquet floor. It has a flat plaster ceiling, which is higher in the corridor. The walls are mainly finished with plaster and paint, although below a moulded rail glazed bricks in bands of mustard yellow, blue, and brown are present (Plate 62), and with a dividing double door part way down the corridor (Plate 61). The north-west elevation of the main section has a doorway to the south-west with a modern single light and plain surrounds in a deep recess. There is a further doorway to the north-east, the door housing a metal grill, which leads to a toilet. The toilet has a vinyl floor and plain walls and ceiling. The toilet is against the north-west side of the room and there is a sink to the north-east. To the north-east there is a wide doorway in the corridor, with a plain surround and taller original opening above (Plate 61). The south-east elevation of the entrance hall has a large double door, with one light in each, and a glazed surround. The wall returns to the south-west and then back to the north-west where there is another door with a single light and plain surround. The north-west elevation has a doorway on the south-west side with a grill and plain surround. This leads to a small toilet as per that to the south-west. There is a large window to the north-east, with a flat arched top, which is divided into 11 lights (Plate 62). It has a timber casement. The wall below has a moulded rail at sill level, running beyond to the north-east and south-west, with the glazed coloured bricks exposed below. These continue to the north-east and south-west, but are painted white to the south-west. The north-east elevation comprises just a double door, with a single light in each, and a moulded rail below, forming a panel. The south-east elevation is plain apart from a moulded rail and coloured tiles as per the north-west elevation. The south-west elevation has a doorway on the south-east side to Room 7, with a single light and plain surround.

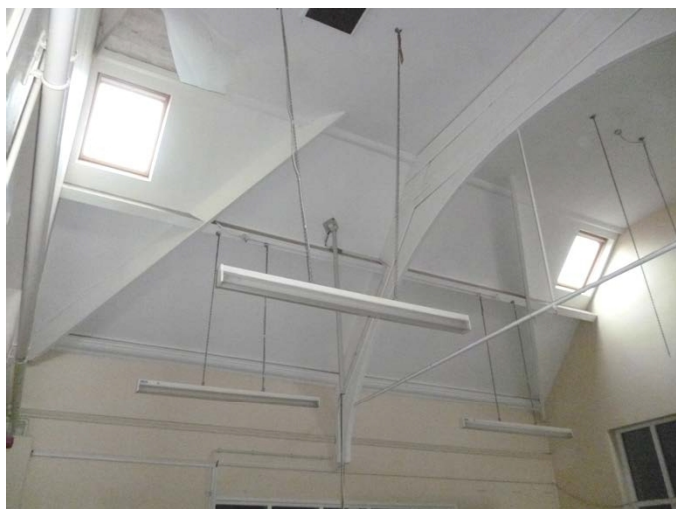
**Plate 63 (left): The south-west end of the truss, Room 9**

**4.3.9 Room 9:** this is one of the large classrooms off the main hall (Room 12). It has a hatch, presumably at one stage for cellar access, on the north-west side. It has a pitched roof on the north-east and south-west sides, with 'principals' from the corners and plain purlins along the north-east and south-west sides and an additional moulded 'purlin' and lower ovolo-moulded cornice below that. It is flat in the centre where there is a rectangular panel or grill. There is a single north-east/south-west truss across the centre with a collar held to the principal rafters with a fork-ended iron strap bolted on (Plate 63 and Plate 64). Below this, timber bracing is fixed to the underside of the principals, forming a rounded arch with a chamfered edge. This in turn is sat on a scrolled bracket on the north-east side, with a moulded plinth/cornice (Plate 65). There is also a tie rod running between the principals and connecting to the king tie rod. The walls are plaster and paint finished and have pin boards attached, although the lower part is painted brick. The north-west elevation has a tall, four-light timber casement window on the south-west side, with a timber sill and moulded rail below, above tiles (Plate 66). These continue below the adjacent larger window, which has a six-light timber casement. There is a further two-light window to the north-east, which has evidently been extended to form a door. The jambs appear to have been rebuilt in brick, but the moulded band continues round. The north-east elevation has a double doorway on the north-west side with a single light and moulded bands added to form a single panel in each. This is probably cutting through the tiles, so it is likely inserted. The south-east elevation has a wide doorway on the north-east side, with two lights and two moulded panels and moulded edges round the lights (Plate 67). The surround is plain but bull-nosed and the moulded band continues around it (but not onto the north-east elevation). There is a large, 11-light window to the south-west, with a rounded arch. There is an added stepped concrete skim over the south-west side of the tiles at floor level and boxing for pipes in the south corner. The south-west elevation is plain apart from an attached bench or desk and a narrow high level five-light window (Plate 68).

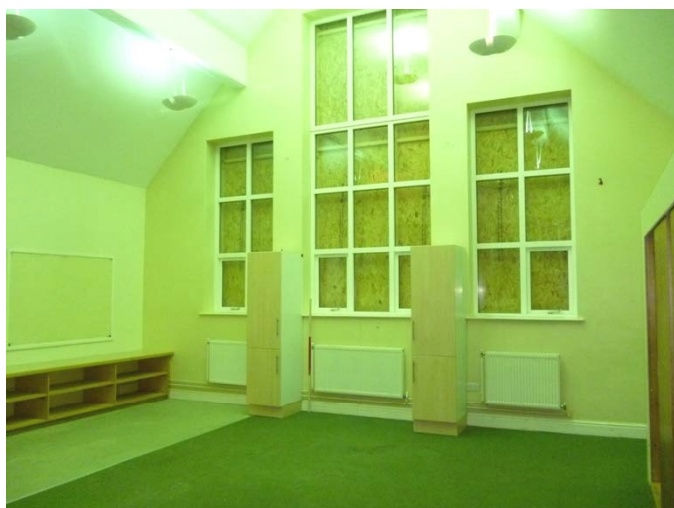
**Plate 69 (left): North-west elevation, Room 10**

**4.3.10 Room 10:** the floor is carpeted on the north-east and there is a thin vinyl strip on the south-west side. It has a pitched roof and a plaster finish and a flat top, with two boxed north-west/south-east purlins. The walls are finished with plaster and paint and there is moulded skirting along the walls. The north-west elevation has a large group of three timber casement windows with timber sills, two six-light ones either side a central taller 12-light window (Plate 69). There is a doorway on the north-west side of the north-east elevation with a plain surround and modern timber door with a single light. There is a shelved cupboard attached to the centre and a small two-light, timber casement window with a timber sill to the south-east end. The south-east elevation has a doorway on one side, with a modern door, with four lights and a plain surround, infilling a larger opening with two lights over. There are two large windows to the south-west, a nine-light and four-light timber casement, and a bench attached below (Plate 70). A boiler is attached in the west corner. The south-west elevation is plain and has pin boards and a bench with a sink attached. There is a hatch in the floor in the east corner.

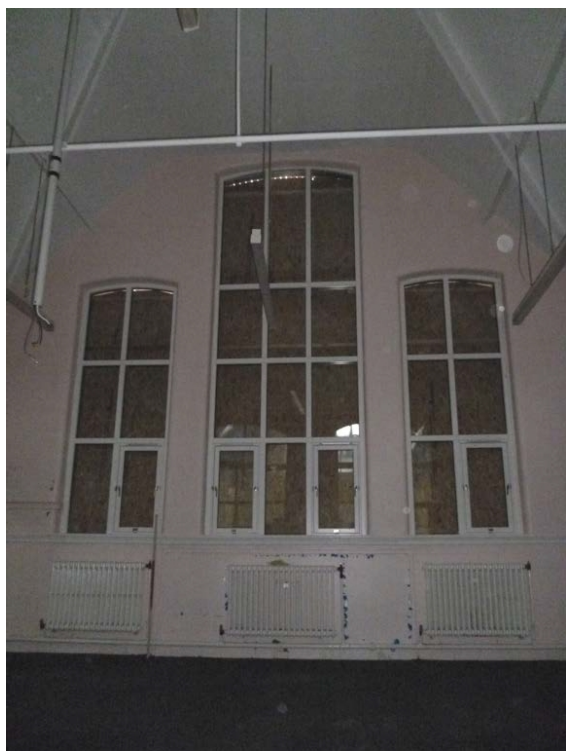
**Plate 71 (left): Windows in the north-west elevation, Room 11**

**4.3.11 Room 11:** this room has a carpeted floor and a pitched roof finished with plaster with principals from all corners and purlins on the north-east, south-east and south-west sides and moulded rail above and ovolo-moulded cornice below a single north-east/south-west truss as per that in Room 9, but with scrolled corbels on both ends. There is a square moulded panel in the flat section of the ceiling, possibly a light position. The walls are mostly plaster and paint finished but the lower part is painted glazed brick rather than tiles. The north-west elevation has a central three part window with flattened arches, and

there is a single vent on either side with a plain hinged metal cover with an emblem on the front. Smaller six-light casements flank the taller 12-light central one (Plate 71). All of the windows have timber casements and timber sills and there is a moulded rail below, extending across the elevation, which appears to have originally continued across the north-east and south-west elevations too. In addition, there is a short extra section of rail on the west side of the north-west and south-east elevations, above the line of the main rail. There is some patched plaster over bricks on the south-west side. The north-east elevation has a large inserted opening to the north-west with a plain surround. There are work benches to the south-east. The south-east elevation has a doorway on the north-east side and the original wide door with two glazed panels and two moulded panels below (Plate 72). There is a projecting section in the east corner, which the bricks and moulded rail run round, respecting the door. The door is set within a large window with an arched top and a nine-light timber casement. There is a further round-headed 11-light window to the south-west. There is a further raised section of moulded rail in the south corner, hidden by boxing for pipes but not obviously continuing to the south-west elevation. The south-west elevation is mostly plain, with bricks visible to a higher level, but the lower part is patched with plaster. A doorway on the north-west side houses a double door with a single light in each and moulded panels. The doorway appears to be inserted. There is a small room leading off the north-east side of Room 11 (Room 11a) via a large opening. It has a vinyl floor and a flat plastered ceiling but the end of the truss is sat on a corbel on the north-east end and north-west side. The room is further divided by a modern stud wall forming a toilet along the north-east side. The walls are mostly plastered and painted. The lower part of the north-west elevation is painted brick, with a moulded dado along the top. There is a work bench with a sink attached and a boiler to the north-east. There is a central two-light very plain timber casement window and a similar window in the toilet. The north-east elevation has a stud wall with a plain modern door on the south-east side. Inside the toilet the wall proper is plain with partitions for cubicles attached and there is a sink in the east corner. The south-east elevation is a plain stud wall, with a door on the south-west side which is plain and modern. The south-west elevation has large opening to Room 11, which has a plain surround and a dado rail above.

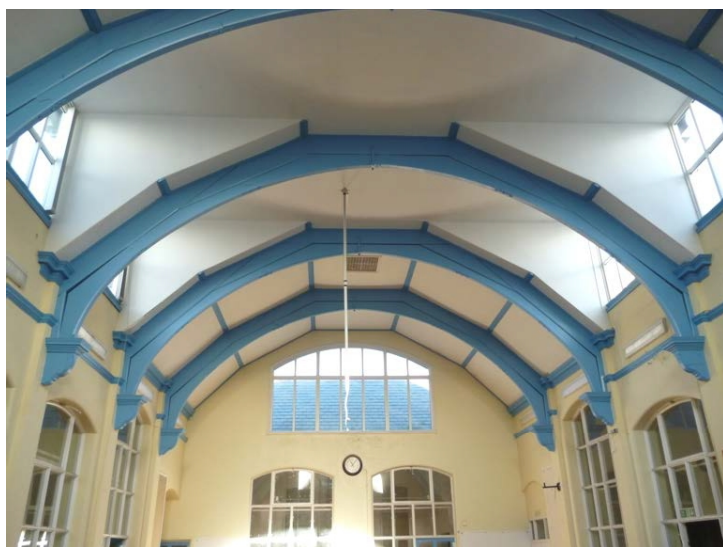
**Plate 73 (left): Trusses in Room 12**

principals and collars with added bracing forming the arches (Plate 73; Figure 3). The braces are held with iron straps and bolts and sit on chamfered scrolled brackets with moulded entablatures (Plate 74). The upper part is obscured by the pitched sections and ceiling. The walls are largely plaster and paint, but the lower part is glazed bricks in bands of pale blue, yellow and brown, topped with a moulded timber rail which forms the window sills. The north-west elevation has a doorway on the south-west side and a moulded surround, with a door with two lights, moulded surrounds and two moulded panels. It is original as the bricks and rail respect it (Plate 75). There is a central large window to the north-east in the same style, with moulded casements, but with nine lights and incorporating a doorway with moulded surround and two glazed sections and two moulded panels. Again, this is original as the brickwork and banding respects it. The north-east elevation has a doorway on the north-west side, with a modern plain double door with three lights set into an earlier timber opening with a rounded head. This leads into a cupboard with shelving to the north-west and south-east sides. The main part comprises a row of combined doors and windows and windows between projecting pillars supporting corbels for the trusses. The north-west window is 15-light casement, then there is a nine-light casement window and a door with two glazed and two raised moulded panels, then an 11-light casement window, then a window with 13 lights and a doorway as per the previous one. All the windows have timber casements and moulded surrounds and there is a further double door at the south-east end, which leads into Room 18. The door is modern and plain and set into a taller opening with a rounded top. The south-east elevation has cupboards built against the north-east side and there is a wide doorway on the north-east side, which is modern. The door has gone but it was glazed above and to the north-east (Plate 76). There is a large window to the south-west. Originally a six-light window, the lower three sections are covered by the cupboard. There is another cupboard to the south-west. There is a large 14-light window at the top of the elevation, with a rounded head (which is the same as on the north-west elevation). Also, there are two high level eight-light windows in the north-east elevation. The south-west elevation has a modern doorway, with surrounding glazed panels on the south-east side, set in a taller opening with a rounded head (Plate 77). The main part is a row of large windows and windows and doors spanning the centre. It is divided by buttresses/pillars supporting brackets for trusses. The south-east window is a 15-light casement, next there is a nine-light window incorporating a door with two lights and two raised moulded panels, then an 11-light window, and then a 13-light window incorporating a similar door (Plate 78). There is an arched opening at the north-west end infilled below with a later double door, with a raised panel and single light in each and three lights over. There are two high level eight-light windows over the central opening below as per the north-east elevation.

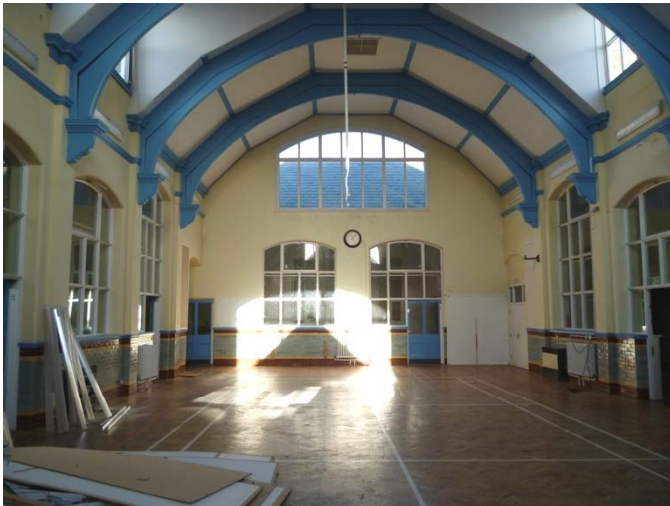
**Plate 75 (left): North-west end of Room 12**

**4.3.12 Room 12:** this is the main hall. It has parquet floor which is marked out as sports pitches and there are some iron fixings set into this. The roof is finished with plaster and pitched to the south-west and north-east, with two grills in the flat top section. It is supported by five trusses, each truss being

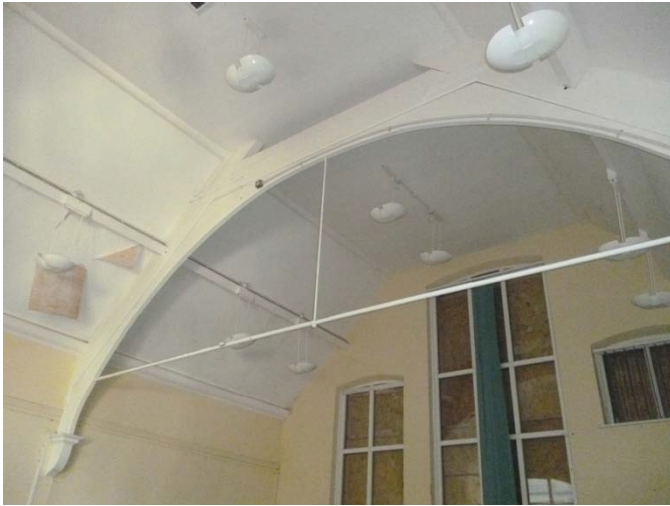
**Plate 79 (left): South-east end of truss, Room 13**

**4.3.13 Room 13:** this room is carpeted apart from a section in the south corner. The walls are mostly plaster and paint and painted glazed bricks are exposed in the lower part. It has a pitched roof to the north-west and south-east and is finished with plaster. There is a single plain purlin in each pitch and a moulded rail above with ovolo-moulded cornice below. The ceiling is flat at the top with a raised panel possibly for a light or for access. There is a single north-west/south-east truss, principals and collar with large straps and braces added below to form an arch sat on scrolled corbels with moulded entablatures and tie rods and tie king rod as well. The walls are plaster and paint, with painted brick along the lower part, topped with a moulded rail in most places and with moulded dado rail to the north-west and south-east. The north-west elevation is plain with a low bench attached. The north-east elevation has a moulded rail throughout, with two large windows as per Room 12, the north-west incorporating a door with moulded panels. The south-east elevation is plain with side units and a sink in the south corner. Some of the brick is plastered over along the floor. The south-west elevation has a group of three windows, two smaller ones and a taller central one. The south-east one has six lights and the central one has twelve, but the north-west one is now partially blocked forming just two lights. They all have timber casements and timber sills.

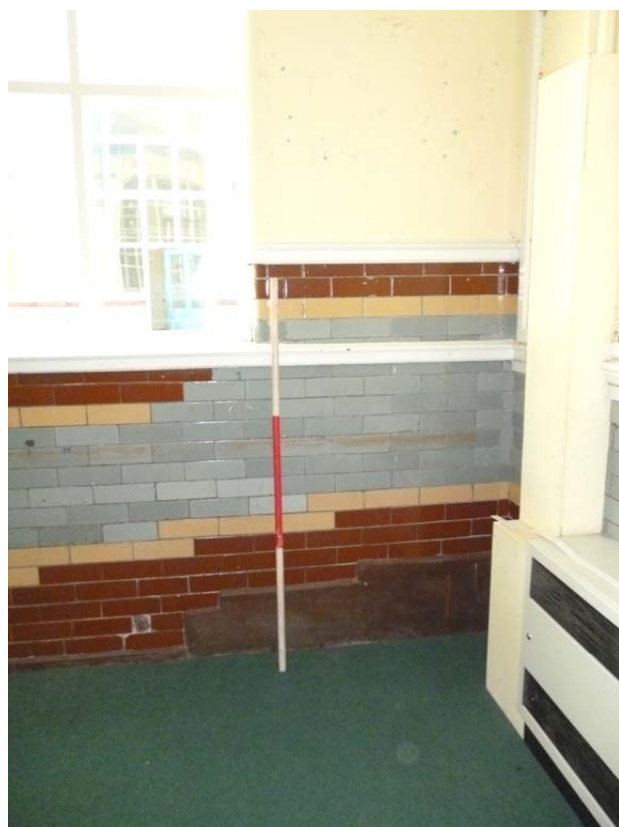
**Plate 83 (left): Stepped bricks and concrete, south-east side, north-east elevation, Room 14**

**4.3.14 Room 14:** the floor is carpeted apart from an area of vinyl in the south corner. The roof and ceiling are the same as per Room 13, with a single elaborate truss on corbels. The walls are mostly plaster and paint finished, but the glazed brick is unpainted in this room. The north-west elevation is plain and covered by fibreboard sheets and there is a moulded dado rail at the top. The north-east elevation has a large window incorporating a door on the north-west side. The door has two moulded panels and moulded surrounds to glazed areas. The door is respected by the moulded rail which runs the length of the elevation. There is a further large window to the south-east. The glazed brick pattern steps up at the south-east end and it has stepped concrete at the base (Plate 83). There is a raised patch of glazed brick at the south-east end with a further moulded band. The south-east elevation is mostly plain with a moulded dado rail and a band above tiles. The lower part is finished with a projecting skim of concrete with rough brick behind. There is a unit with sinks on the south-west side. The south-west elevation has a raised patch of glazed bricks with a rail on the south-east side matching those to the north-east (Plate 84). There were originally three grouped windows, with flattened arches. The lower part of the south-east window is now blocked leaving only the upper two lights. The central window is a very tall 12-light casement and the north-west window is a nine-light casement. All of the windows have timber casements and timber sills with a moulded rail below. There are two hinged vents, one either side of the windows.
