# VICKERSTOWN SCHOOL, LATONA STREET, BARROW-IN-FURNESS, CUMBRIA

## Archaeological Building Recording

Client: Leck Construction Ltd

November 2012

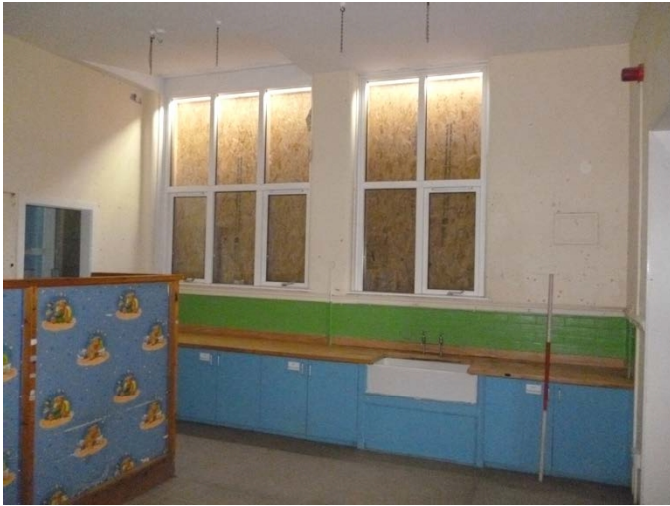
**Plate 85 (left): Windows in the north-east elevation, Room 15**

**4.3.15 Room 15:** this comprises a group of rooms around a former changing room and includes part of the corridor and toilets. It mainly has a vinyl floor and some carpet and there are low timber walls along the north-west side screening the changing area. The room has a flat plaster ceiling but the end of the truss is visible on the south-west side, the corbel matching that in Room 11a. The room is divided by a stud wall on the south-west side. The north-west elevation is a plain stud wall in the centre with doorways to Room 11a at the south-west end and leading to a toilet at the north-east end. The wall proper is painted brick inside the room with the toilet and forming the cubicle walls. The north-east elevation is painted brick and has a grill vent on the north-west side. There is a four-light window in the toilet and a further six-light window and four-light window to the south-east, beyond the stud wall (Plate 85). All of the windows have timber casements and timber sills and a rail below. There is a unit with a sink below along the north-east elevation which returns to the south-west to a large opening, with a plain surround. The rail is cut, which possibly means that the opening is inserted. There is a hinged vent just to the south-east of the window on the north-east elevation. To the south-east of the return wall is a modern glazed area with a door forming a porch to the external door, which is modern timber with three lights over. The doorway is respected by the bricks and rail. The south-east elevation of this area has a glazed panel on the north-east side then a large opening to Room 16 with a plain surround. This returns to north-west at the south-west end and through the opening where there is stud wall filling the gap. There is painted brick with plain rail to the south-west. Continuing into a cupboard, the brick is not painted here (Plate 86) and there is a former doorway now blocked and just forming an alcove. The south-west elevation has a stud wall but the elevation proper inside the cupboard is plain and unpainted brick with a moulded rail above with boxing in the south corner. The north-west side of the cupboard has plain shelving and there is a further cupboard to north-west. Glazed brick is also visible along the south-west elevation but it is otherwise plain. The roof space over the south cupboard reveals the truss and the roof is as per Rooms 13 and 14. The windows to the north-east were much taller originally.

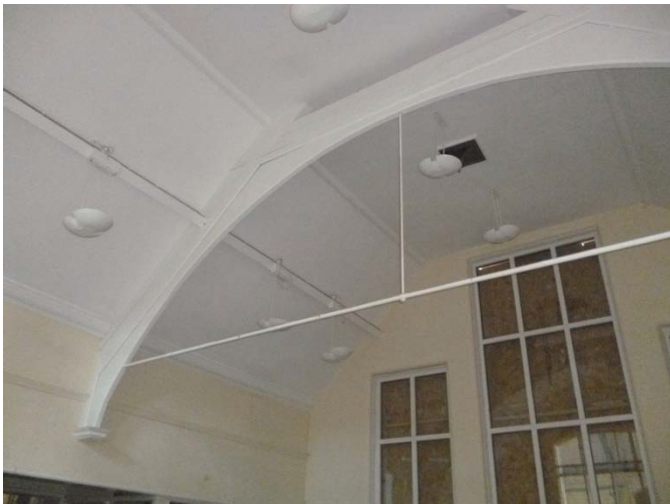
**Plate 87 (left): North-west end of truss, Room 16**

4.3.16 **Room 16:** this room has a carpeted floor and low stud walling in the north corner subdividing the room. The roof is as per Rooms 13 and 14, with a north-west/south-east truss (Plate 87 and Plate 88). The north-west corbel has been removed or was never present with only the entablature remaining (Plate 89). The entablature of the south-east has been sawn off on the south-west side (Plate 90). The flat top section of the ceiling has two grilled openings. The walls are mostly plaster and paint finished, with painted brick over most of the lower parts. The north-west elevation is plain apart from a large opening (Plate 91) in the centre with a glazed section on the north-east side connecting with the porch between Rooms 15 and 16 (Plate 92). The north-east elevation has a raised patch of brickwork with a rail on the north-west side apparently continuing onto the north-west elevation. There is a hinged vent above and three windows across the centre, two six-light and a 12-light timber casement window, with timber sills and a moulded rail below. The south-east elevation is plain and has a low unit attached with fibreboard over. The south-west elevation has a nine-light window on the south-east side and a door with two moulded panels and a round head. There are similar windows to the north-west with 15 lights.

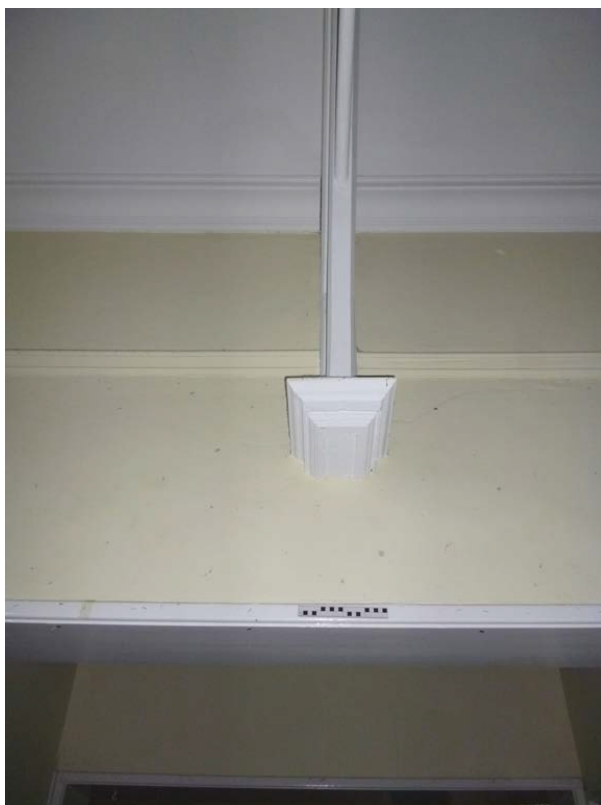
**Plate 89 (left): Damaged corbel, north-west end of truss, Room 16**

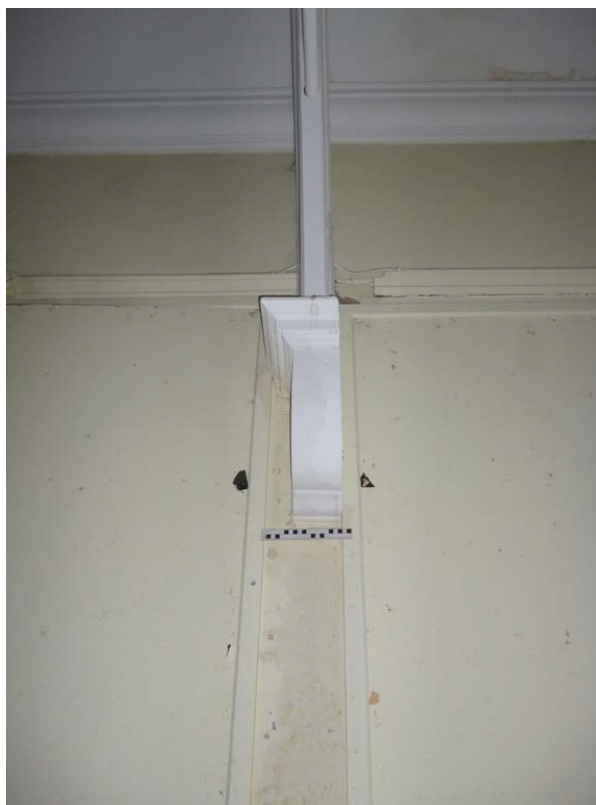
**Plate 90 (right): Damaged corbel, south-east end of truss, Room 16**

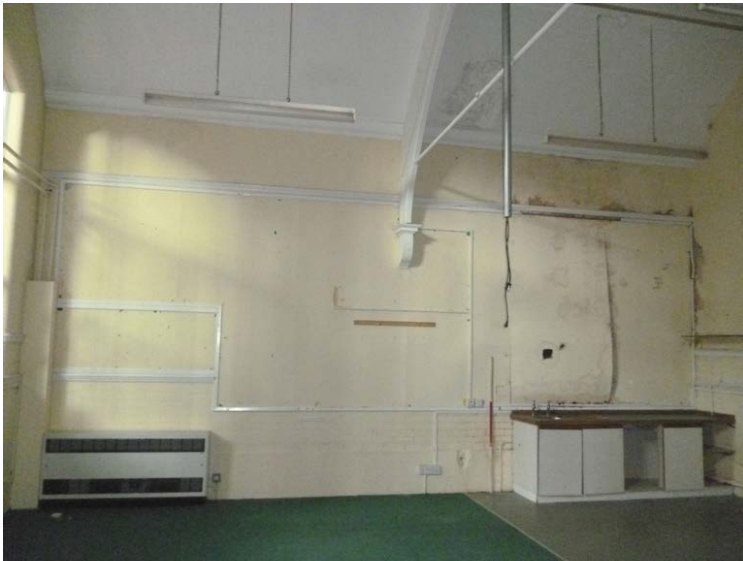
**Plate 93 (left): North-west elevation, Room 17**

remnants of moulded rail along most elevations. The north-west elevation is plain, with concrete or plaster skim over the lower part and a sink unit in the north corner (Plate 93). The north-east elevation has a raised moulded rail on the north-west side with brick below and a concrete skim at the base (Plate 94). There is a hinged vent cover above. There is a group of three windows across the centre; the two either side have six-light casements and the centre one has 12. Each window has timber casements and a timber sill and rail below. There is a hinged vent cover to the south east which is still working (Plate 95 and Plate 96). The south-east elevation is plain and has a work bench attached and is covered by fibreboard with a moulded dado rail above. The south-west elevation has a large 13-light window in a round head with a door on the south-east side with two glazed panels and two moulded. There is a further 11-light window to the north-west. Both use the moulded rail as sill.

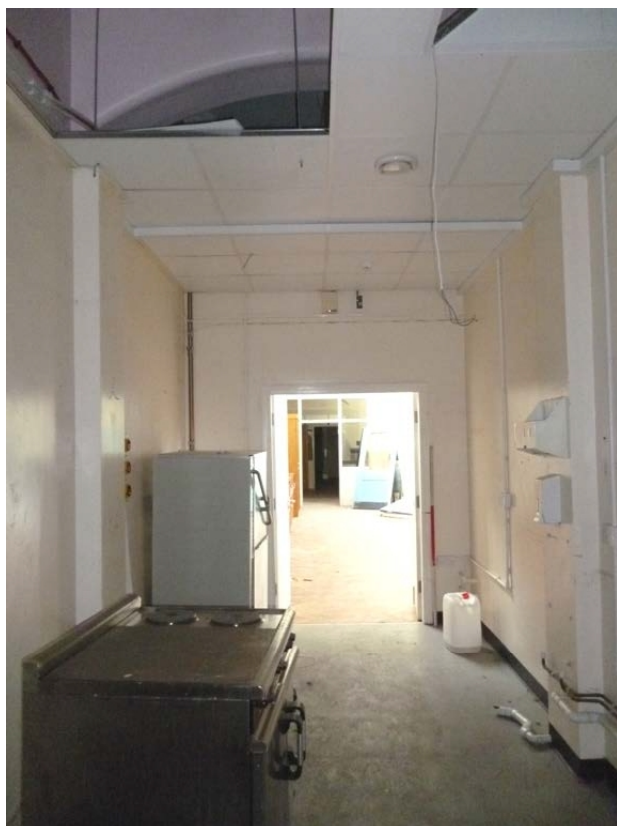
**Plate 97 (left): South-west end of Room 18, showing the arched central opening**

4.3.18 **Room 18:** this is a narrow room, forming little more than a corridor. It has a vinyl floor and suspended ceiling, the original plaster ceiling above with arch corresponding to buttresses on the north-

west and south-east walls (Plate 97). The walls are finished with plaster and painted. There are scars for kitchen fittings and pipes and cables throughout. The north-west and south-east elevations are plain apart from the projecting buttresses. The north-east elevation has a UPVC door and glazed flanks and six-lights over, timber, evidently extended from a window (Plate 98). The south-west elevation comprises only stud wall infilling a wide opening with a modern double door (Plate 97).

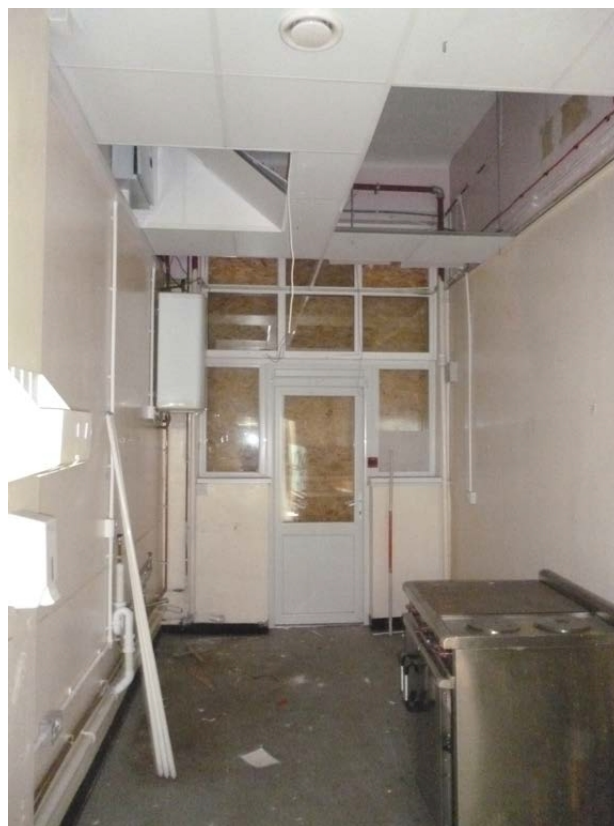
**Plate 98 (right): North-east end of Room 18**

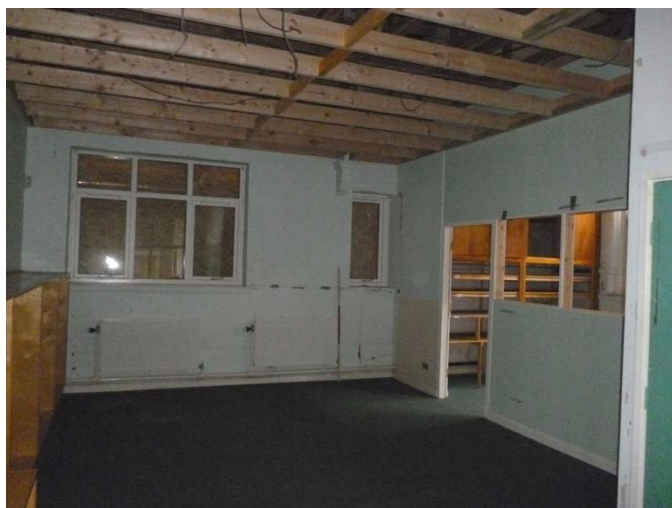
**Plate 99 (left): General view of Room 19, showing the dividing walls and north-east elevation**

**4.3.19 Room 19:** the floor is finished with carpet and the room is sub-divided in two by stud walls, originally housing three glazed panels and a doorway, all of which have now been removed (Plate 100). There was a suspended ceiling, but most of this has been removed, leaving only the timber frame, and the original roof structure is visible above. This comprises a single truss orientated north-west/south-east as per those in the adjoining rooms, with a single plain purlin, moulded purlin and moulded cornice visible against the plaster ceiling. The walls are all finished with plaster and paint although the lower part is painted brick below a moulded rail. The north-west elevation has a blocked opening on the south-west side, which is respected by the rail and bricks and so is likely to be original. It was presumably a doorway but it now has a shelf mid-way up and is covered by later cupboards (Plate 100). The rest of the elevation is plain. The north-east elevation has a window with a six-light timber casement on the north-west side and another with a single-light casement in the centre, both of which have timber sills. The dividing stud wall butts against it to the south-east of the smaller window and beyond this is the original finish of the wall, with moulded rail and brick visible behind later cupboards. The south-east elevation has two windows both of which are partially truncated by the suspended ceiling, and originally comprised part of a large grouped three part window (Plate 101). The outer parts have four lights remaining and two obscured above the suspended ceiling, while the larger has six lights with a further 12 obscured above the ceiling. All of the windows have a timber sill above the moulded rail and the stud wall to the south-west has a large opening. The south-west elevation proper is formed by a stud wall, which returns to the north-east where it forms the back of a cupboard containing electrical fuse boxes and equipment relating to the alarm system. North-west of the internal stud wall the elevation comprises a section of stud wall that formerly had five lights and a door, but these are now missing.

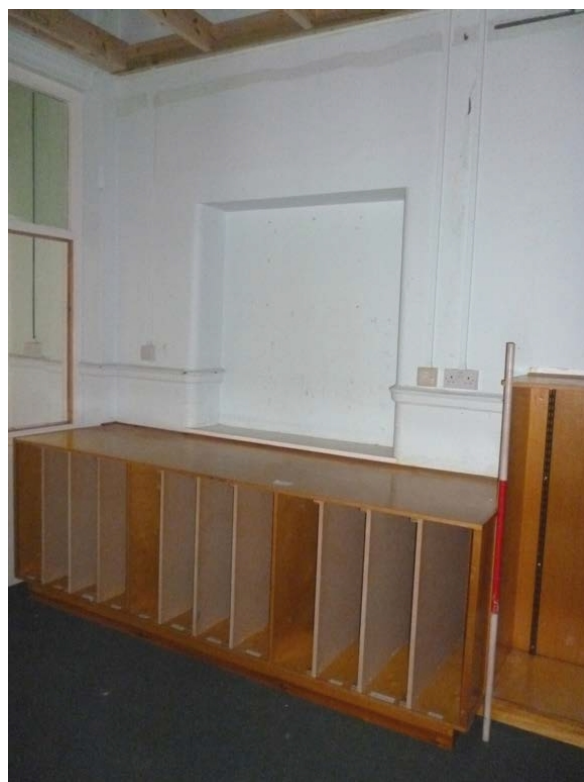
**Plate 100 (right): Blocked doorway, south-west side of north-west elevation, Room 19**

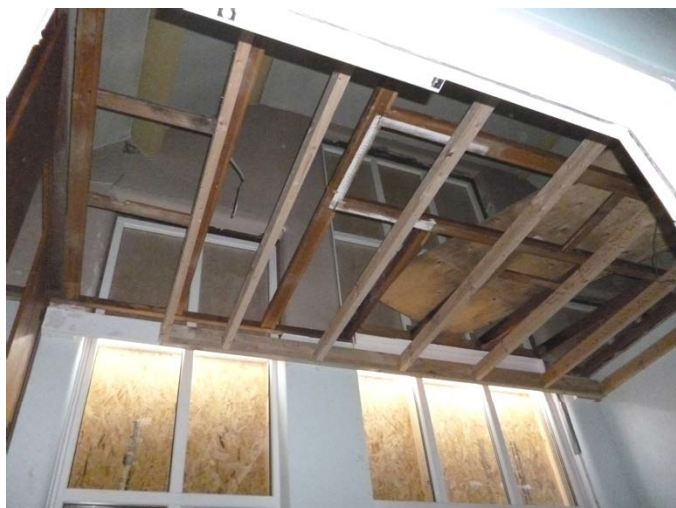
**Plate 101 (left): Tops of windows obscured by a suspended ceiling, south-east elevation, Room 19**

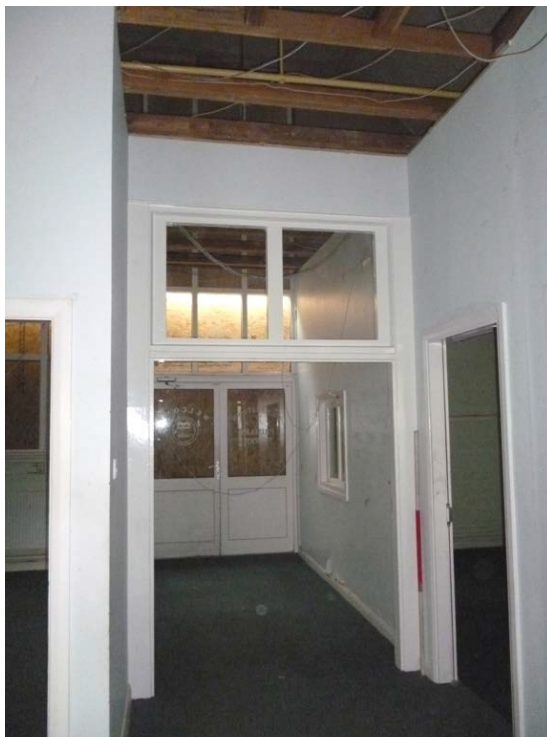
**Plate 102 (right): Internal stud walls forming entrance corridor and flanking rooms, Room 20**

4.3.20 **Room 20:** this comprises a short corridor leading to what was originally the main entrance from the south-east, which is sub-divided to form offices either side of the corridor (Plate 102). The floor is finished with carpet and the ceiling covered by suspended panels, although much of this has been

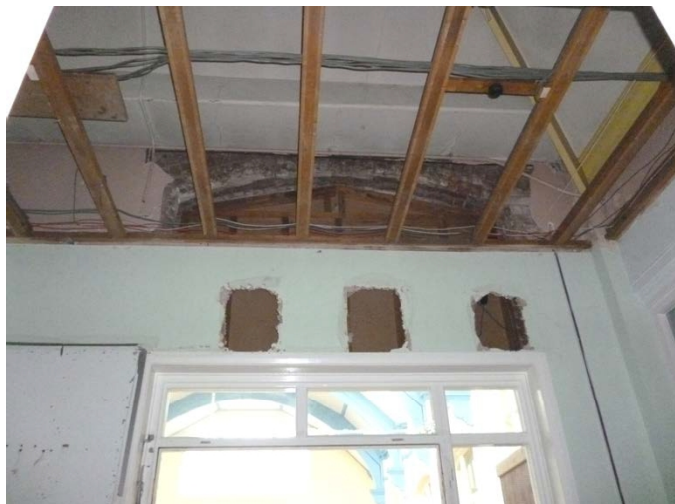
**Plate 103 (left): Top of earlier arch over window, north-west elevation, Room 20**

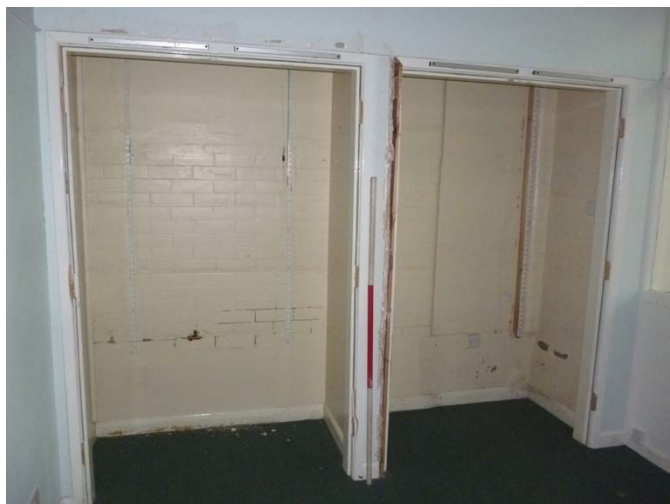
**Plate 104 (right): Cupboards, north-west side of south-west elevation, showing painted brickwork, Room 20**

removed exposing the timber frame and the original roof structure above. This comprises a single truss orientated north-west/south-east as per those in the adjoining rooms, with the same arrangement of purlins, cornice, and plasterwork. The central section of the roof is flat and fitted with a grilled panel. The walls are largely finished with plaster and paint and there are several internal divisions, which form an L-shaped corridor with rooms on either side. All of the internal doorways have modern plain doorways, the doors having been removed, and there are hatches in the rooms to the south-west. There is a dividing wall with two lights over a doorway across the corridor. The north-west elevation has a wide window on the south-west side with a fixed six-light casement, above which the wall has been stripped to reveal that it is set in a larger opening with a rounded brick header arch, rebated to fit the original glazing (Plate 103). To the north-east is a similar glazed opening with a doorway, also set within a taller opening with a brick header arch with rebate. The north-east elevation has a glazed section on the north-west side with a doorway set below a moulded beam, orientated north-west/south-east, which continues beyond the stud walling between two buttresses within the north-west and south-east walls which support the truss. The south-east end of the elevation was apparently originally open to Room G19, beyond the beam, but this space is now filled with a later stud wall. The south-east elevation has three large grouped windows, divided by the stud walls forming the entrance corridor. In each case the lower lights are still open while the upper ones are obscured behind the suspended ceiling and the central part incorporates a double doorway with glazed panels and lights above (three in use, six more obscured). At the south-west end of the elevation there is a short length of moulded rail set high between the window and the south corner. The south-west elevation has the moulded rail and painted brick seen elsewhere, although on the north-west side this is partially obscured by stud walls forming two cupboards (Plate 104).

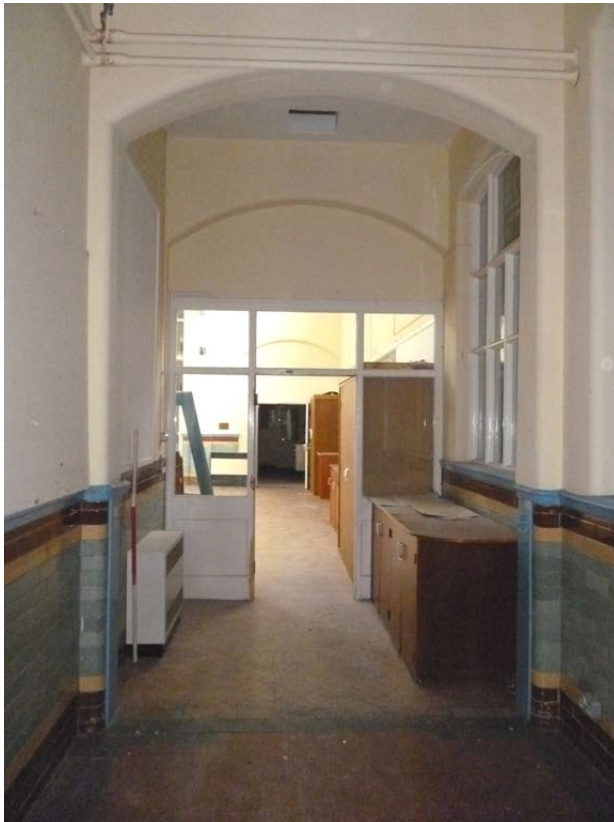
**Plate 105 (left): North-east end of Room 21, showing the divided opening and higher arch over the doorway into Room 12**

**4.3.21 Room 21:** this comprises an L-shaped corridor linking Room 12 with rooms to the south and south-west, and includes a range of small rooms along the south-west side. Initially the floor is parquet but it is mostly finished with red tiles with a black edging band, although this is covered by vinyl tiles over the south section. The ceiling is flat painted plaster with a later suspended ceiling to the south-west and there is a large rounded arch mid way along the north-east/south-west arm of the corridor (Plate 105) and a dividing doorway to the south-west of this with three lights over and glazed side panels. The south-west end of the elevation ends with a modern door into a toilet, which is internally sub-divided to form a lobby and main room. The main room has a window with a three-light casement in the north-west elevation proper, and a single light casement in the return to the south-east. The lobby has a window with a single light casement, before returning to the north-west where there is a doorway with a modern door with a glazed panel and single light over and glazed panel to the south-west. The return of the wall to the north-east of this has lost some plaster due to damp, exposing the original external roughcast render and a vent. The north-east side of the north-west elevation is plain, and comprises unpainted glazed tiles below a moulded rail, with a buttress supporting the rounded arch and modern wall forming the internal wall against it. The north-east elevation comprises only a tall opening with later infilling

housing a modern doorway with three lights over and flanking lights (Plate 105). The south-east elevation has a single large window, with a moulded 11-light timber casement and a timber sill above a moulded rail with the original glazed bricks exposed below. There is a further window with a seven-light casement to the south-west, which incorporates a doorway into Room 24 (Plate 106). This houses a door with two lights and moulded panels. There is a slight return to the north-west then two doorways with plain doors. The first of these leads to a wheelchair accessible toilet with a modern sliding door, which is part-tiled internally, has a toilet and sink, and a modern suspended ceiling. The second doorway leads into a small cupboard, which has shelves along the south-west side, and a sink and boiler to the south-east. The south-west elevation then returns to the south-east, where there is another modern doorway with a plain modern door into an almost entirely tiled room, with a high shelf on the north-east side. The elevation finally returns to the south-west where there is a modern door with two lights. The south-west elevation is a stud wall housing a large high-level three-light window and two doorways, both with modern doors. The south-east of these leads to a small plain room with raised boxing around the base of the wall and a grill vent and a window with a four-light timber casement and sill with a modern sink unit on the south-east side. The room to the north-west forms a toilet and is sub-divided into a small lobby and main room which a urinal and cubicles. There is a window with a two-light casement on the south-east side, which actually forms part of the window in the room to the south-east, and there is a further window with a four-light casement to the north-west of this and a grill vent between the two windows.

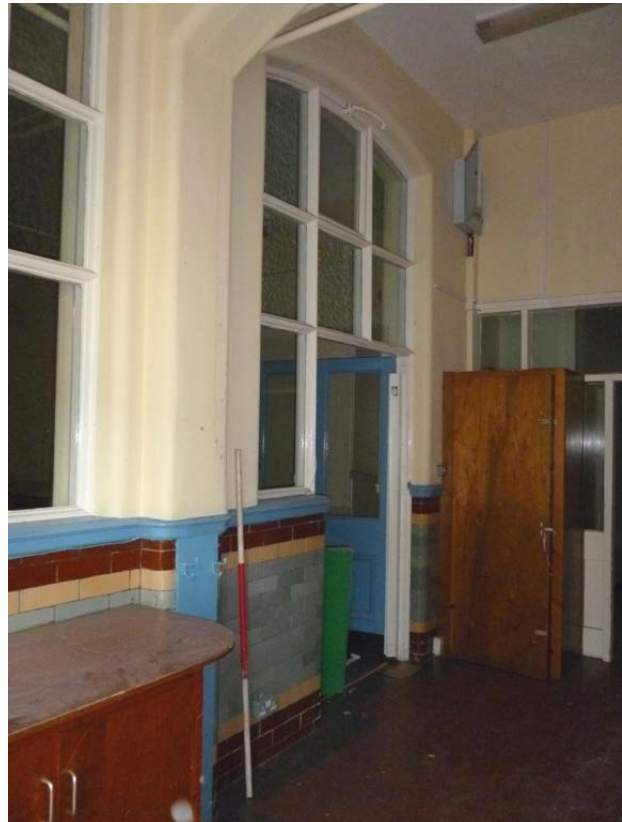
**Plate 106 (right): Glazed bricks and window with door, south-east side of Room 21**

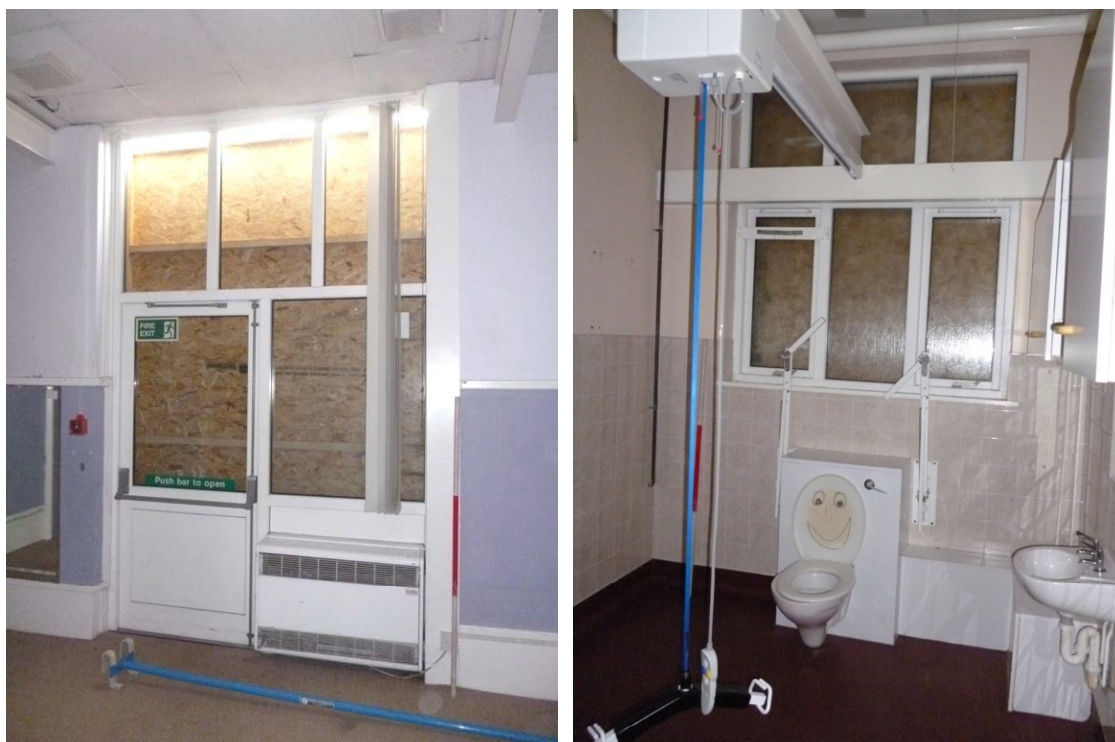
**Plate 107 (left): Doorway and window, south-east elevation, Room 22**

**Plate 108 (right): General view of south-east end of Room 23**

**4.3.22 Room 22:** this forms one of two small rooms at the south-east end of Room 21. The floor is finished with carpet and the ceiling covered by a later suspended tile, above which the roof structure could be partially observed revealing a relatively early purlin. The walls are finished with plaster and paint and there is a tall skirting board throughout. The north-west elevation is plain apart from a doorway on the north-east side with two lights. The north-east elevation has a doorway with a sliding door with a single light on the north-west side. The south-east elevation has a central aperture, the lower part housing a door with a single light and one light to the south-west, above which are three lights (Plate

107), with the original height of the window obscured by the suspended ceiling. The south-west elevation has a window with a six-light casement, again extending above the suspended ceiling.

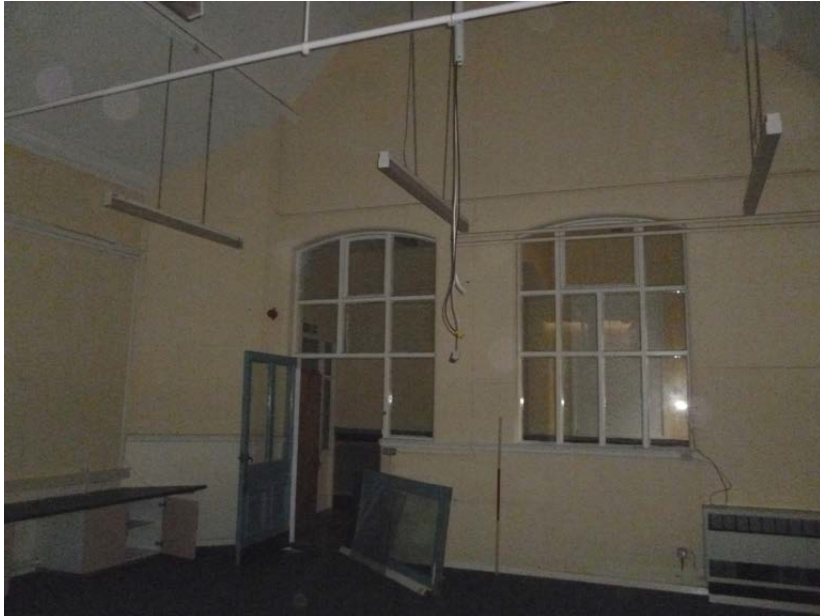
Plate 109 (left): North-west elevation, Room 24

**4.3.24 Room 24:** the floor is covered by carpet and the roof structure is exposed, with a single truss orientated north-east/south-west with the associated arrangement of purlins and cornice as per the similarly sized classrooms. The walls are largely finished with plaster and paint with painted brick over the lower part. The west corner is at a 45 degree angle relative to the rest of the walls. The north-west elevation has a moulded rail along the top of the painted brick, which forms the sill of two large windows, a seven-light casement incorporating a doorway and an 11-light casement, both of which have rounded heads (Plate 109). The north-east elevation is relatively plain with a sink unit on the south-east side and the lower part is covered by beaded tongue and groove boxing with a moulded lip below the top board and there is a moulded dado or picture rail set high on the wall. The south-east elevation has two hinged iron vent covers, one on either side of a three-part central window with a pair of six-light casements flanking a central 12-light casement, the top six of which are obscured. The moulded rail continues to the north-east side of the windows but there is a separate short section above this, as per the similar rooms (Plate 110). The south-west elevation is plain, with a modern workbench against it and a moulded dado rail as per the north-east elevation.

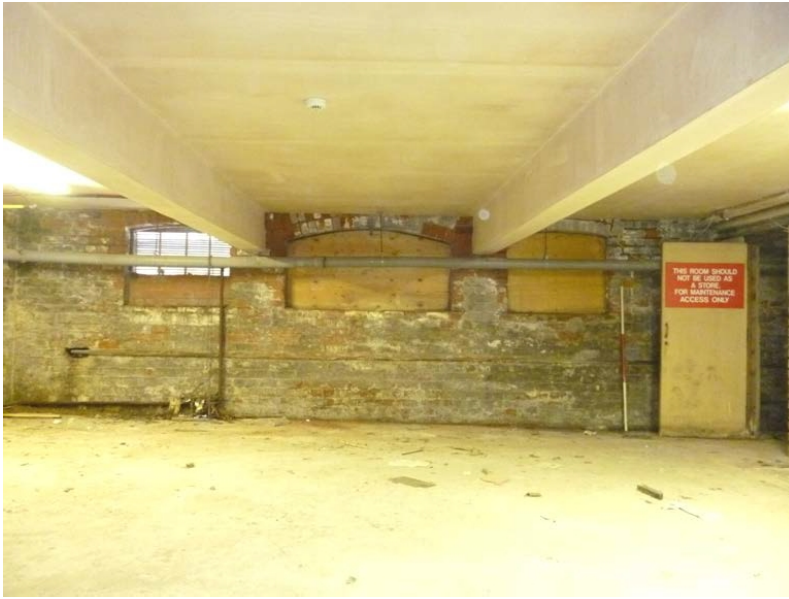
**Plate 111 (left): Windows, north-west elevation of the south-west room of the basement**

4.3.25 **Basement:** this is divided into two similarly-sized rooms, north-east and south-west of a dividing wall. The south-west room forms a single space with a concrete floor and modern plaster ceiling with two beams north-west/south-east across it, which are boxed and similarly plastered. The walls are all exposed brick with traces of whitewash. The brick is relatively rough and contains large gravel inclusions compared to the finish visible externally and is laid in English garden wall bond at a ratio of three rows of stretchers to one row of headers. There are pipes set against the south-west and south-east elevations. The north-west elevation has a row of three windows, the central one slightly wider, and all of them have flat brick arches. The two to the south-west are blocked or filled with board, leaving just an alcove. The other is partially blocked with relatively modern brick with a metal grill on top. The north-east elevation is essentially plain; there is a doorway on the north-west side with an iron I-beam lintel, plain surround, and modern plank door, with timber stud infill to the north-west. There is a projecting buttress in the east corner, which continues to the south-east elevation. The south-east elevation is essentially plain, but the buttress at the north-east end has pipes/ducting entering at the top and an iron hatch with a handle marked 'IVO DRAUGHT STABILIZER' and 'IVO ENGINEERING & CONSTRUCTION CO. LTD. LONDON. W. 12'. The words 'CHIMNEY[?] FLUE CLEAR OUT YEARLY' have been written across it in chalk. The south-west elevation is plain although it has pipes attached across it.

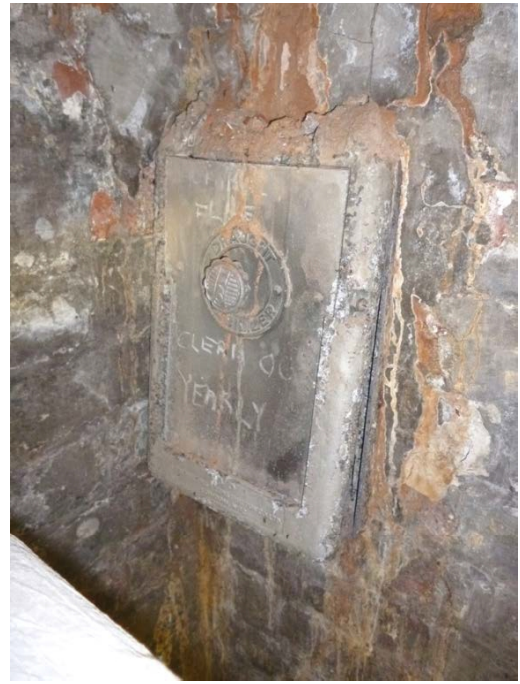
**Plate 112 (right): Vent cover in the east corner of the south-west room of the basement**

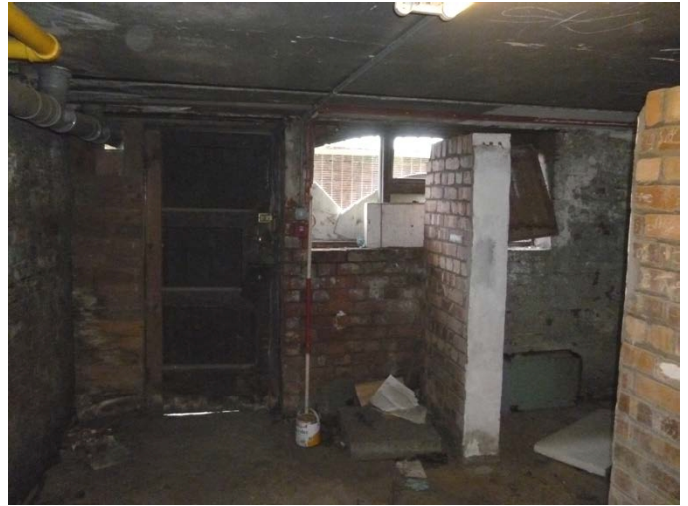
**Plate 114 (right): Doorway and window in the north-east elevation of the north-east room of the basement**

4.3.26 The north-east room of the basement also has a concrete floor and a concrete ceiling supported by iron I-beams and is sub-divided by relatively modern concrete block walls, which do not extend the full height of the room. The room forms three spaces with boilers and associated equipment on the south-east side. The north-west elevation has a row of three windows with flat arched tops, the south-western two are covered with iron mesh, behind which are the remains of two and three-light timber casements, the north-east is filled with a slatted timber grill. A single iron beam forms the lintel to all three. The north-east elevation has a doorway on the north-west side with a plain surround and heavy plank and batten door, the space to the south-east is infilled with rough boards. To the south-east of this is a wide window with a flat arched top and four-light timber casement. An iron beam again forms the lintel to the doorway and window. To the south-east of the window there is a large aperture with an iron I-beam lintel with a row of headers above and a sloping base inside. This was presumably originally a coal chute accessed externally. The south-east elevation is plain, with boilers and associated fittings sat against it. The south-west elevation has pipes and associated fittings attached on the north-west side and a doorway to the north-west of the dividing concrete block wall. Within the cellar there was a loose brick marked '½[?] W.E' on one of the north-west window sills.

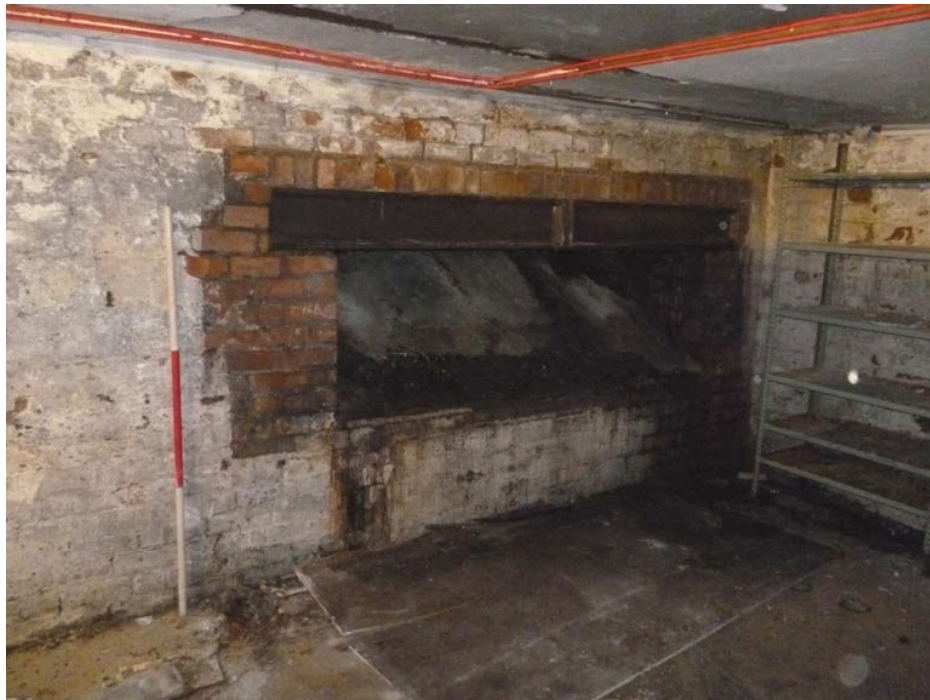
**Plate 115: Coal chute in the north-east elevation of the north-east room of the basement**

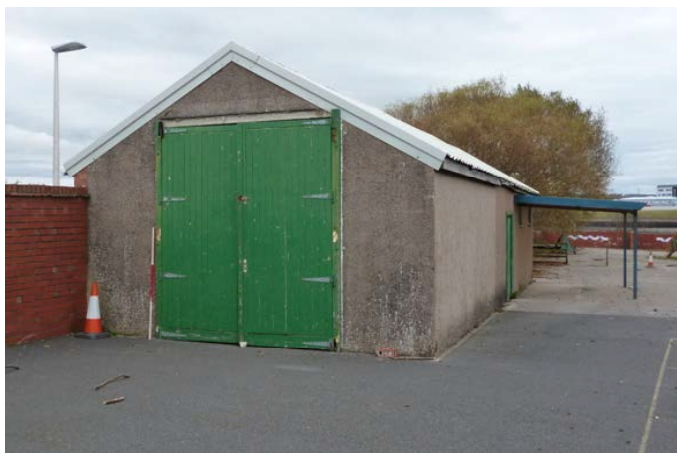
**Plate 116 (left): South-west elevation of the outbuilding**

**4.4.1 External elevations:** the south-west elevation comprises the gable, finished with roughcast render, and has a large doorway with a tongue and groove plank and batten door (Plate 116). The south-east elevation is also finished with roughcast render, although in two different shades, with a plain barge board and a corrugated fibreglass roof (Plate 117). There is a doorway south-west of the centre with a plank and batten double door and plain surround and two small high-level windows at the north-east end with single-light timber casements. Attached at the north-east end is a projecting canopy with a clear plastic corrugated roof supported by an iron frame. Some early brick is exposed at the north-east end, which continues into the north-east elevation (Plate 118). This is constructed from rough, apparently hand-made brick laid in five courses of stretchers to one of alternating headers and stretchers and has a buttress against the north corner, which forms part of the boundary wall. The north-west elevation is constructed from similar brick in three rows of stretchers to one of alternating headers and stretchers, which blend into the more modern bricks at the south-west end (Plate 119). There are five buttresses with sloping tops against the north-west elevation, one of which, at the south-west end, is modern.

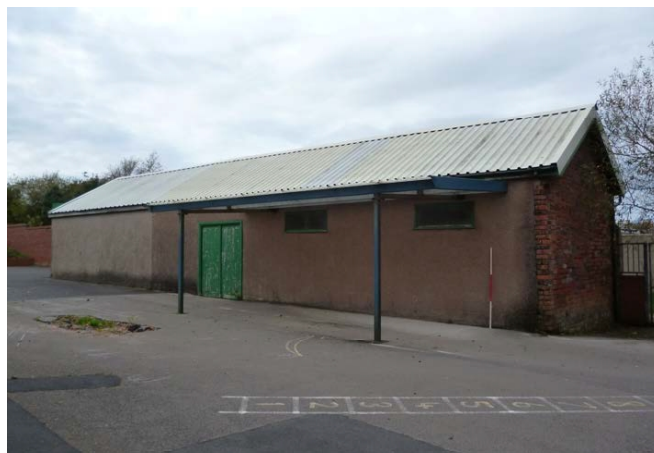
**Plate 117 (right): South-east elevation of the outbuilding**

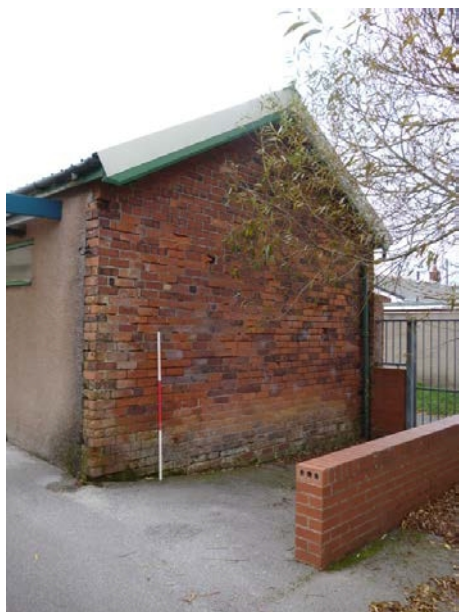
**Plate 118 (left): North-east elevation of the outbuilding**

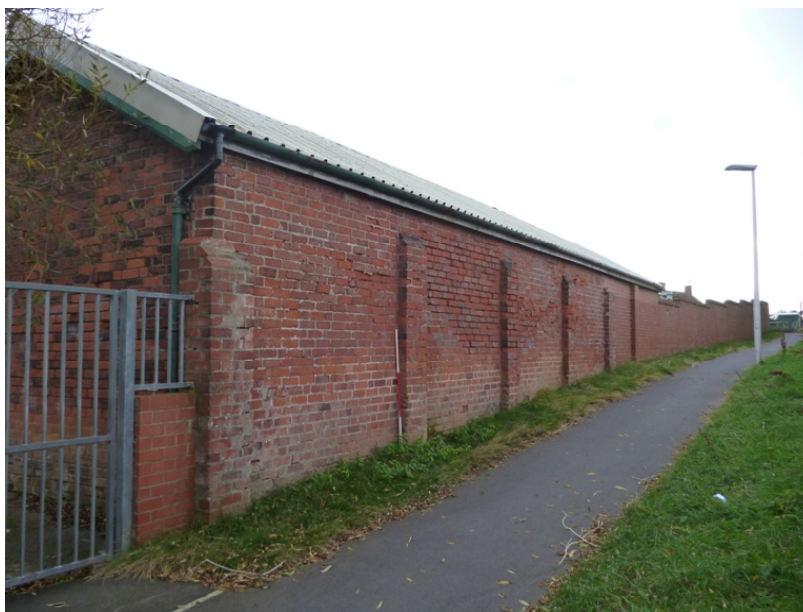
**Plate 119 (right): North-west elevation of the outbuilding**

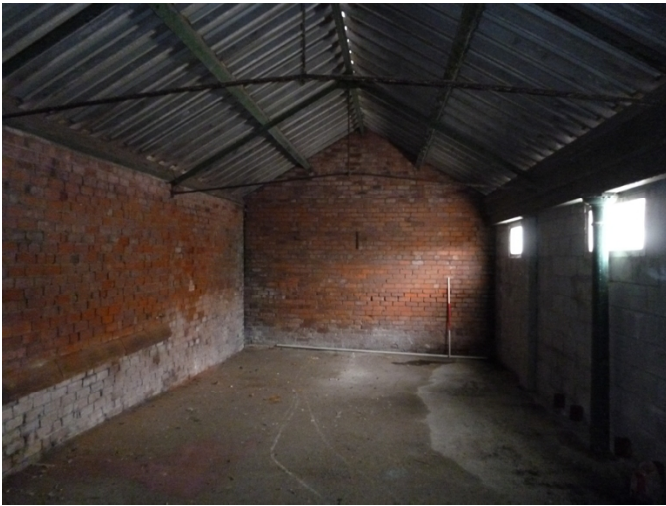
**Plate 120 (left): North-east end of the north-east room of the outbuilding**

**4.4.2 Internal detail:** the building is divided into two spaces internally (Figure 2), the south-west within what is clearly a later addition. The north-east room has a tarmac floor and the roof structure comprises two iron strut trusses with L-shaped beams forming the principal rafters and tie rods forming the king post and tie beam, which divides at each end around the end of the principal rafters (Plate 120; see Figure 3). There is a single machine-cut timber purlin per pitch and a ridge plank. A second purlin is present on each side, effectively forming the wall plate. All of the walls are brick, apart from the south-east wall. The north-west elevation is brick laid in three rows of stretcher bond to one row of alternating headers and stretcher. It is essentially plain apart from a row of three pieces of dressed sandstone with a chamfered edge, each c1m long, set into it close to ground level (Plate 121). The north-east elevation is a plain gable comprising brick laid in five rows of stretchers to one row of alternating headers and stretchers (Plate 120). A vertical iron strap is attached north-west of the centre and the upper part of the north-west side butts the north-west elevation. The south-east elevation was clearly originally open-fronted, with an iron I-beam spanning the whole elevation, with a beaded plank above, now supported by two iron columns, but presumably originally more, and the space filled with concrete blocks (Plate 122 and Plate 123). The columns have round capitals with flanges (Plate 124) and the concrete block walling incorporates two windows on the north-east side and a double door and a single pillar constructed from concrete blocks on the south-west side, presumably in the place of an earlier iron column (Plate 125). The south-west elevation is plain brick, again with five rows of stretchers to one of alternating headers and stretchers, although the brick type appears later than that to the north-east (Plate 125; cf. Plate 120).

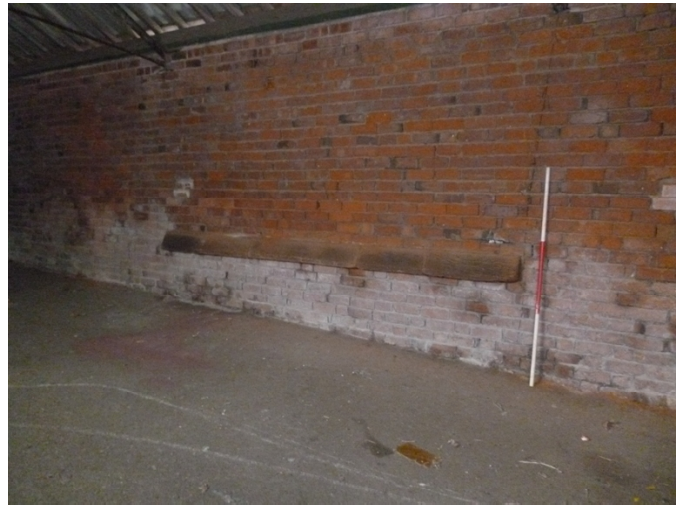
**Plate 121 (right): Detail of the north-west elevation of the north-east room of the outbuilding**

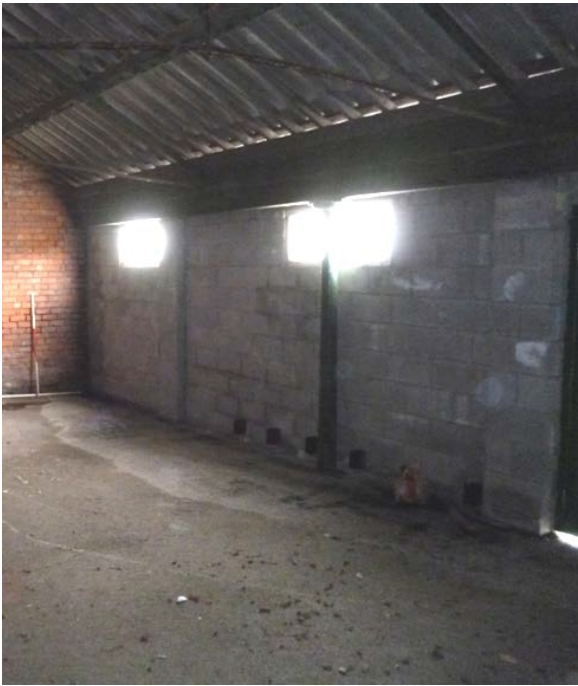
**Plate 122 (left): South-east elevation of the north-east room of the outbuilding**

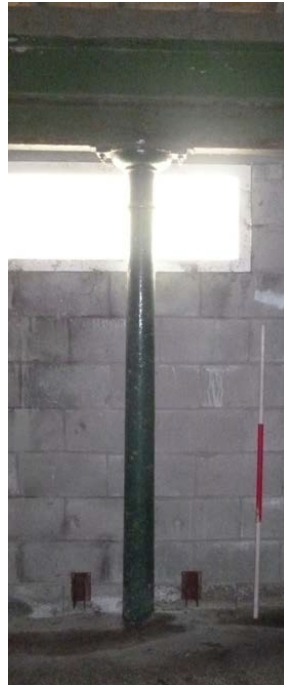
**Plate 123 (centre): Iron column in the south-east elevation of the north-east room of the outbuilding**

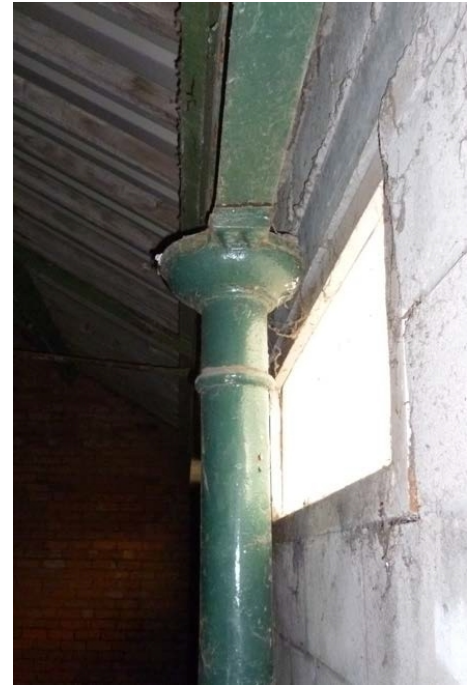
**Plate 124 (right): Detail of an iron column in the south-east elevation of the north-east room of the outbuilding**

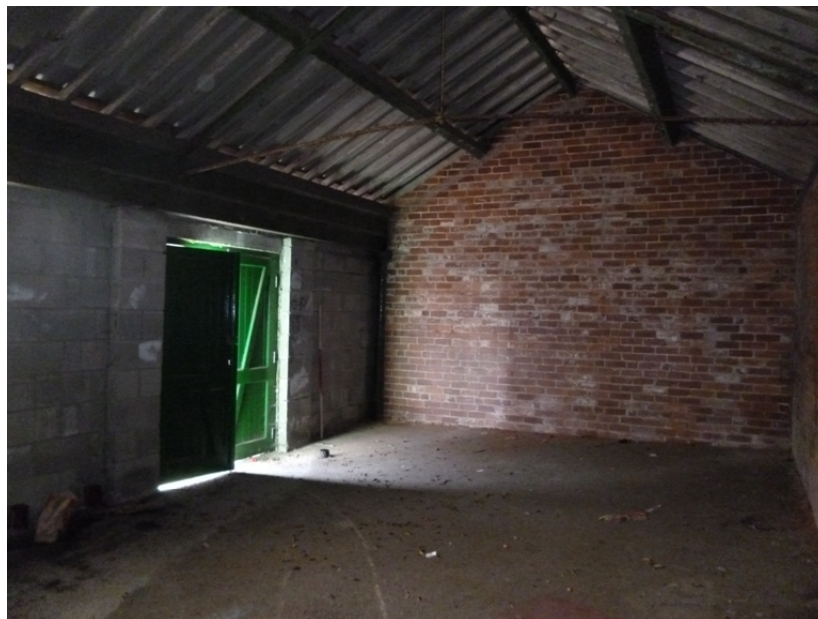
**Plate 125: South-west elevation and doorway in the south-east elevation of the north-east room of the outbuilding**

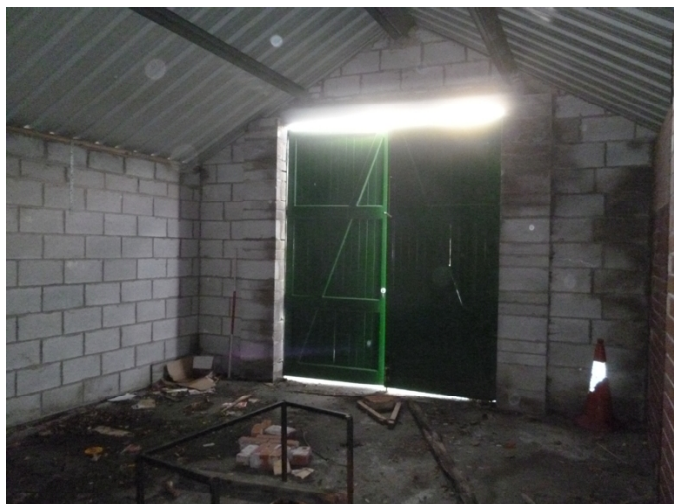
**Plate 126 (left): South-east and south-west elevations of the south-west room**

4.4.3 The south-west room also has a tarmac floor and a modern roof structure comprising only I-beams for the purlins supporting corrugated sheets. The south-east and south-west elevations are constructed from concrete blocks with buttresses in the south-east and a double door in the south-west with flanking buttresses (Plate 126). The north-east and north-west elevations are constructed from brick, although of relatively late type (Plate 127). The north-west wall is laid in three rows of stretchers to a single row of alternating headers and stretchers and as two buttresses, the north-east end of which is partially built of earlier brick. The north-east elevation is laid in a similar bond but at a ratio of five to one and otherwise plain, although the ends of the purlins from the room to the north-east project though it

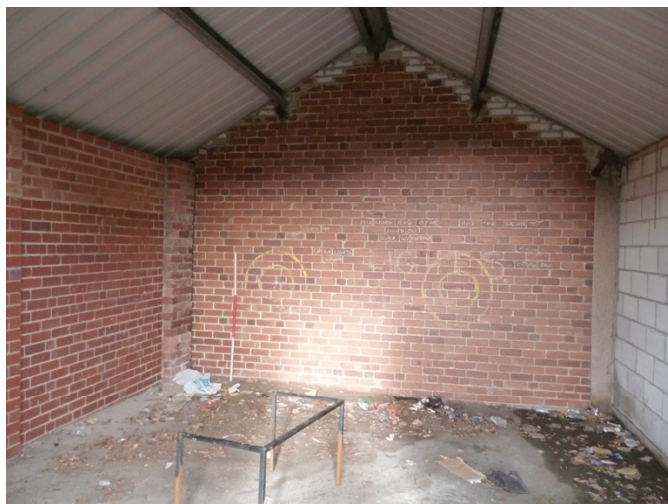
**Plate 127 (right): North-east and north-west elevations of the south-west room**

and the top of the wall is finished with an irregular row of concrete blocks and the south-east side is covered with a skim of concrete.
