# SPOUT HOUSE BARN, LUPTON, CUMBRIA

## Archaeological Building Recording

Planning Application Ref.:  
SL/2009/0781

December 2012

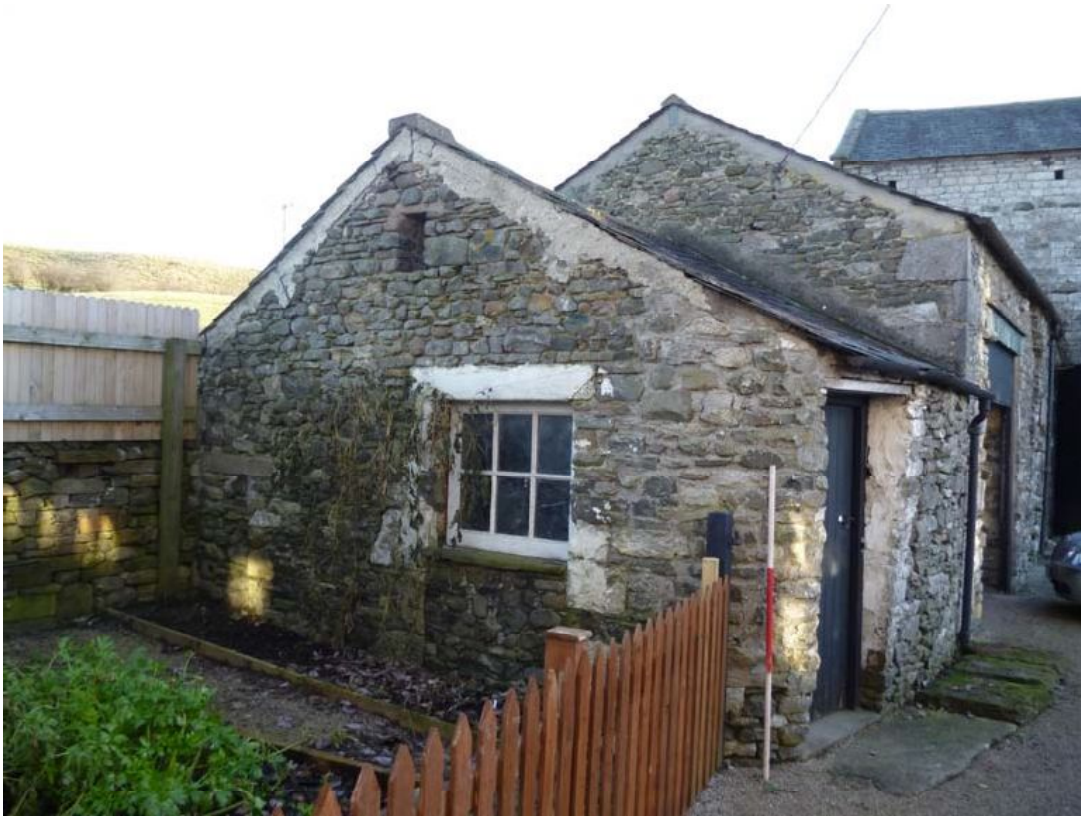
4.2.1 **North-west elevation** (Figure 2): the north-east end is covered by the projecting outshut, which covers the lower part (Plate 8). The north end of this comprises a low gable with the base of a stone finial at the top and a small rectangular owl hole or vent below the eaves. There is a small low aperture on the east side, the east jamb of which butted by the boundary wall, which has a sandstone lintel and rough quoins in the west jamb and is blocked with stone. To the west is a larger aperture, originally a doorway, with quoined jambs and a stone lintel, both finished with limewash, which has been partially blocked leaving a small window. This has a six-light fixed timber casement and sandstone sill. The north-western corner of the building is rounded. Rising above this is the gable end of the main part of the northern outshut, which is essentially plain but with a concrete skim below the roofline. The main elevation of the barn proper is two storeys tall and has four rows of irregular through stones running its entire length, more irregularly spaced square vents and a plinth along the base, which gets higher as the ground level drops to the south-west where there are some large boulders exposed below. On the ground floor there is a tall wagon doorway at the north-east end, with a flat voussoir arch (Plate 9), the stones alternating white limestone and greenish volcanic to produce a decorative effect. The south-west jamb is finished with dressed limestone quoins, including a large one acting as a springer for the arch, and there is a further larger dressed block above on the same line, presumably also a former quoin (see *Section 4.3.4* below). To the south-west there are a further eight smaller doorways (Plate 10), all of which typically have a concrete step and, where they survive, a plank and batten door, painted black. The jambs are finished with dressed quoins and the lintels typically dressed limestone blocks, and all have been limewashed around. The two doorways at the south-west end are slightly different, one having a sandstone lintel dressed with a curious stepping on the top of the north-east side, the other with a shallow voussoir arch. To the south-west of these is a small window with a similar arched top, which has been partially blocked with stone but with a two-light fixed timber casement and sandstone sill. The south-west and north-east ends of the elevation are finished with dressed limestone quoins topped with sandstone kneelers supporting coping. The first floor has two winnowing/loading doorways either side of the centre with shallow voussoir arches, also in alternating white and green stone, sandstone steps, and plain timber surrounds. The north-east is filled with corrugated metal sheets.

**Plate 8: North end of the outshut to the north, comprising the north-east end of the north-west external elevation**

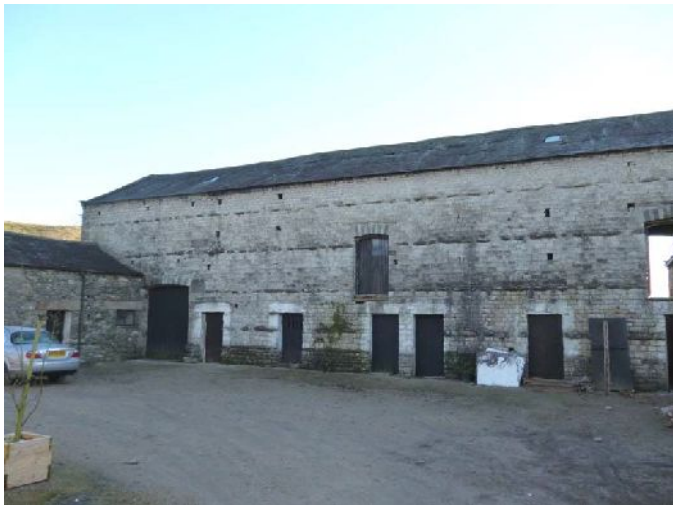
**Plate 9 (left): The north-east end of the main part of the north-west external elevation**

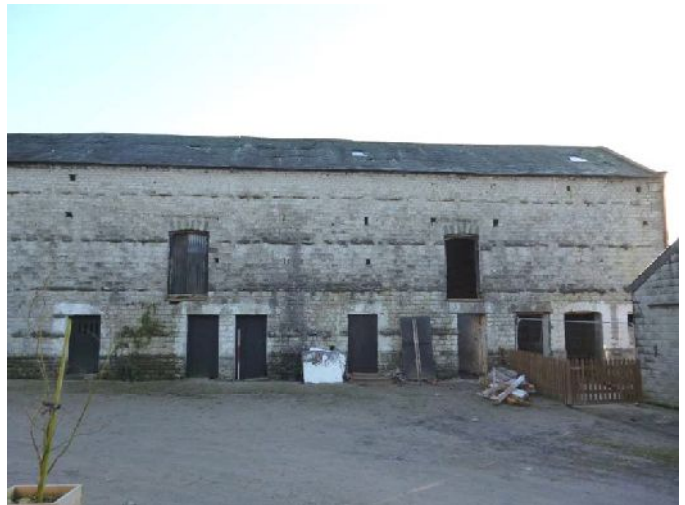
**Plate 10 (right): The south-west end of the main part of the north-west external elevation**

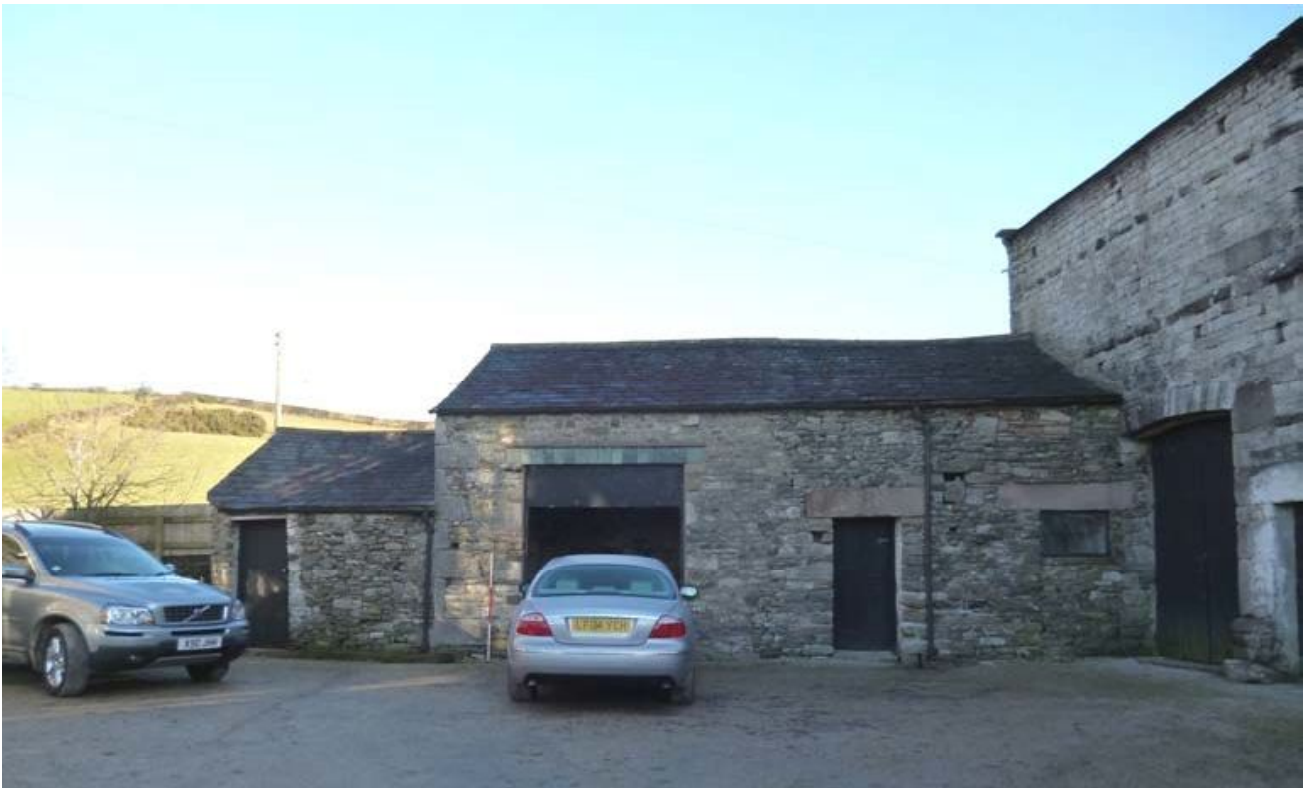
4.2.2 **South-west elevation** (Figure 3): this comprises the gable end of the main barn, the side of the north outhshut, and the side of the larger of the two south-east outhshuts. The north outhshut is lower at the north end and rounded at the north-west corner (Plate 11). To the south of this is a small doorway with a thin timber lintel and tongue and groove plank and batten door. To the south of this the main part of the outshut rises above the north end, which butts against the quoined end. Beyond this there is a wide wagon or garage doorway, the upper part of which is filled in with tongue and groove planks and above which there are hung slates (presumably covering the lintel) and a slate and concrete drip course (Plate 11). The wall has clearly been heavily rebuilt to the south of this, including the south jamb, and there is a distinct and jagged step in the masonry. To the south there are a further two ground floor doorways, both with sandstone lintels, the northern of which has a split plank and batten door, the

**Plate 11: The south-west elevation of the north outshut**

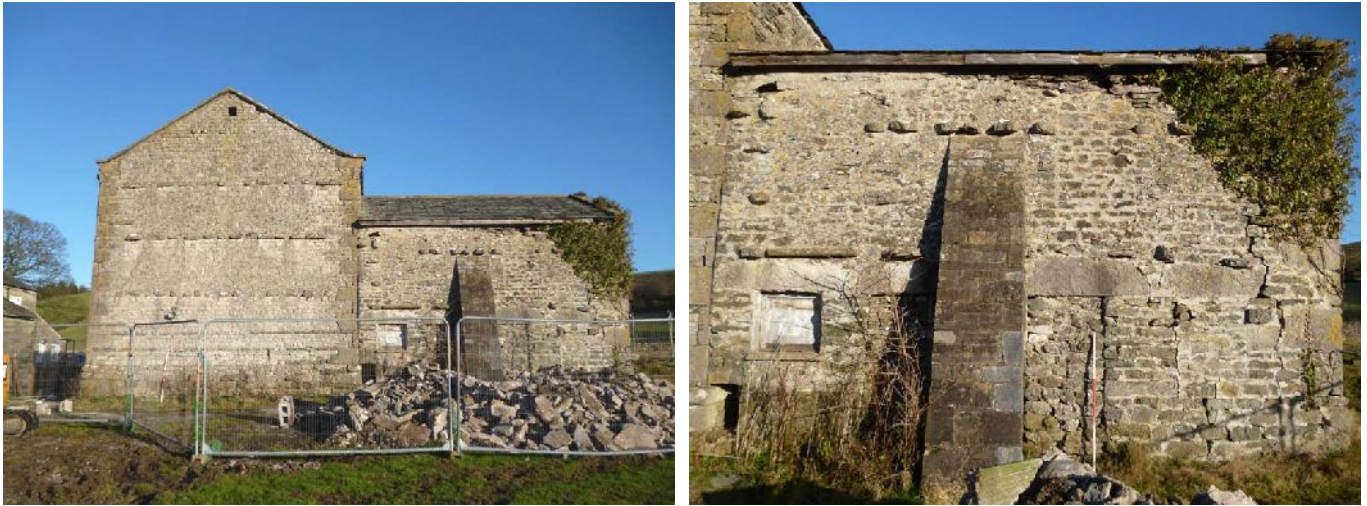
**Plate 12 (left): The central and south-east part of the south-west elevation**

**Plate 13 (right): Detail of the south-east part of the south-west elevation**

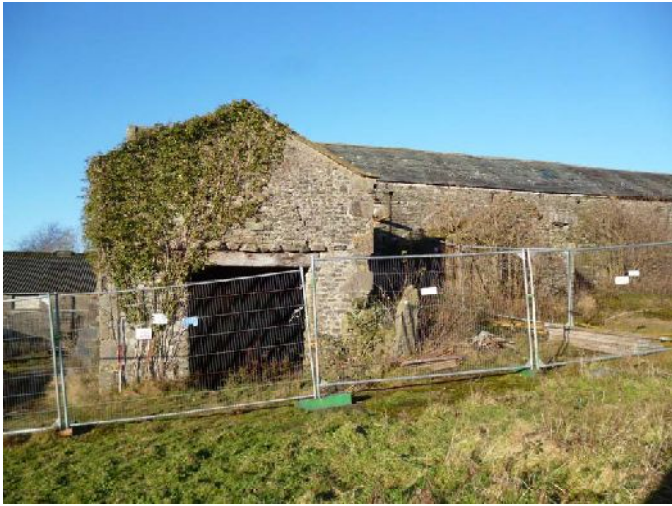
**4.2.3 South-east elevation** (Figure 3): the south-west end is covered by the larger of the two outshuts, the gable end of which has similar sandstone coping and kneelers to the main barn, although the masonry is otherwise much rougher (Plate 14). There are some dressed stones incorporated within it and dressed quoins and a plinth at the base, although this disappears on the north-east side. There is a central wagon doorway, which is evidently inserted as the jambs are rebuilt, and has a very large rough timber lintel. A possible circular aperture, blocked with stone, is visible above this, although the upper part of the elevation is largely obscured by ivy. There is a row of through stones above this, but it is evident that the central section of stonework has also been partially rebuilt. The elevation returns to the north-west on the north-east side, where it is partially collapsed. The tops of two low-level windows are visible on the south-east side of this elevation, one contained within the collapse and with its internal timber lintel exposed, the other with a dressed stone lintel. Above these is an intact window with a thin timber lintel and six-light fixed timber casement and sandstone sill (Plate 15). To the north-west there is a doorway with a rough timber lintel and beaded tongue and groove plank and batten door, fixed to which is an iron sign marked 'M. CROFT KENDAL' (Plate 16). The wall returns to the north-east into the main elevation, where there is a wagon doorway, accessed via a slight ramp from the south-east, with a voussoir arch, again alternating green and white stone, projecting timber either side that evidently originally supported a porch or canopy and a plain square timber frame (Plate 17). Beyond this, to the north-east, the main part of the elevation has rows of square vents and through stones running its full length. Immediately north-east of the south-west wagon doorway, however, it returns to the south-east to form the side of the smaller outshut, although this is plain. The gable end of this outshut has dressed sandstone quoins and a wide central doorway, also with dressed sandstone quoins and a heavy sandstone lintel, and the remains of a timber frame. The return to the north-west, forming the opposing side of this outshut, is also plain. Beyond this, to the north-east, is another wagon doorway accessed by a ramp with a double tongue and groove plank and batten door and flattened voussoir stone arch of alternating green and white (Plate 18). The rest of the elevation, to the north-east of this, is essentially plain, with square vents and through stones, although there is a further small rectangular aperture close to the north-east wagon doorway, with a thin timber lintel and sandstone sill, and there is another similar opening to the north-east, blocked with stone (Plate 18). The end of the elevation is finished with dressed limestone quoins.

**Plate 14 (left): The south-west side of the south-east elevation**

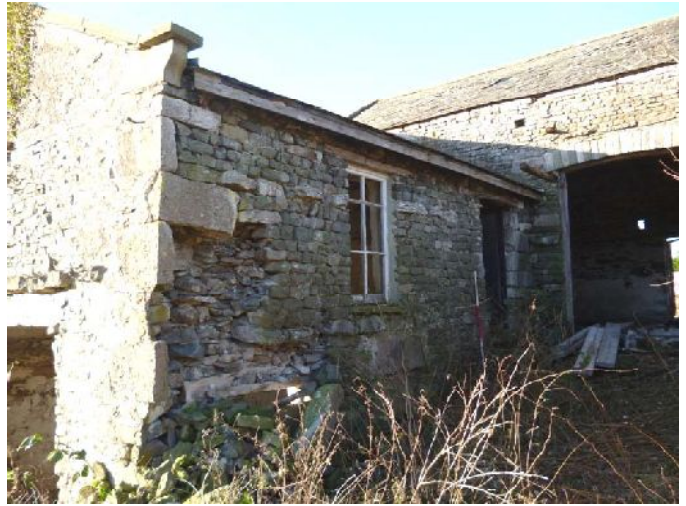
**Plate 15 (right): The north-east side of the larger of the south-east outshuts**

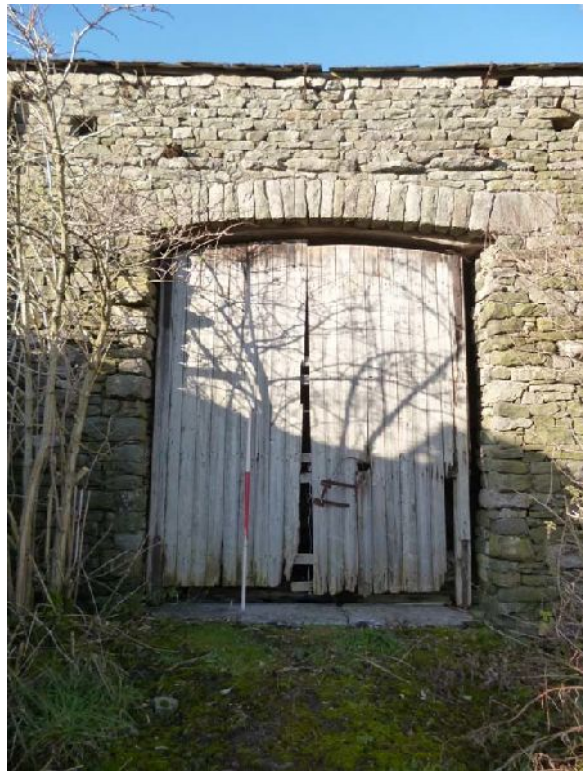
**Plate 17: South-west wagon doorway, south-east elevation**

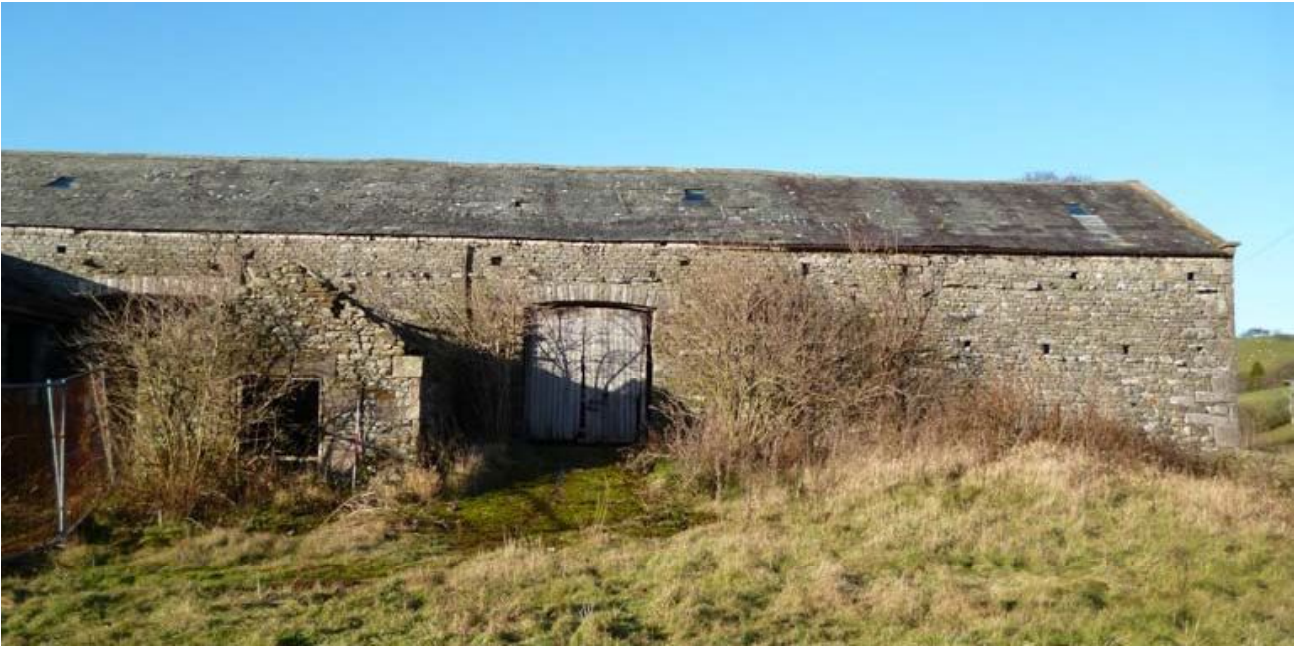
**Plate 18: Centre and north-east side of the south-east elevation**

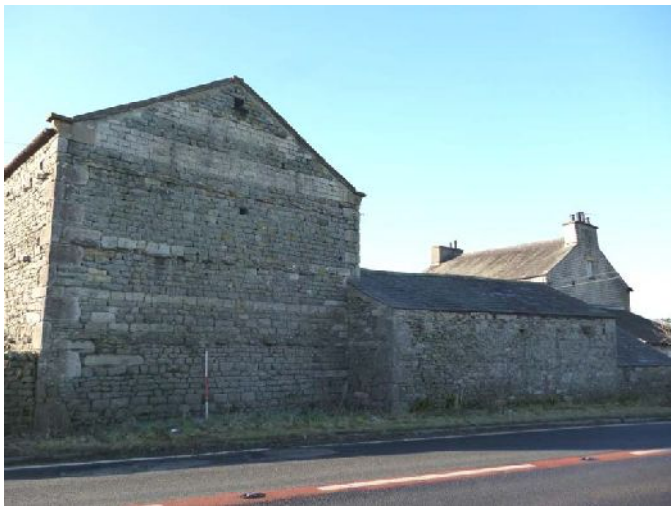
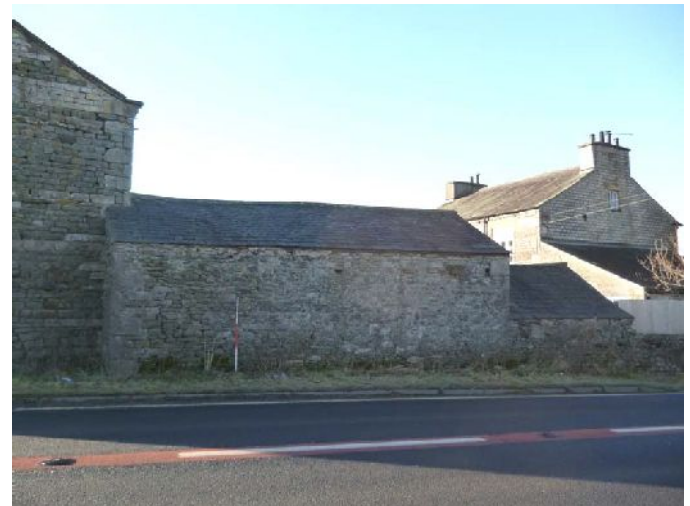
4.2.4 **North-east elevation** (Figure 2): this forms the gable end of the main barn, extended to the north by an outshut, and faces directly onto the adjacent road. The gable has dressed limestone quoins at either end and is topped with dressed sandstone coping ending at scrolled kneelers and top with the base for a finial (Plate 19). The structure of the wall has three rows of through stones and alternating courses of limestone and volcanic stone, forming bands of green and white. There is a rectangular owl hole at the top of the elevation, with a projecting slate (?) sill. The extension to the north is lower but still initially two storeys (Plate 20). It projects from the line of the main barn and has dressed limestone quoins at either end and two rows of small through stones but is otherwise plain. It is extended at the north end by a slightly lower section, which clearly butts the quoins, although appears to be keyed in near the base.

**Plate 19 (left): North-east external elevation**

**Plate 20 (right): North side of north-east external elevation showing outshuts**

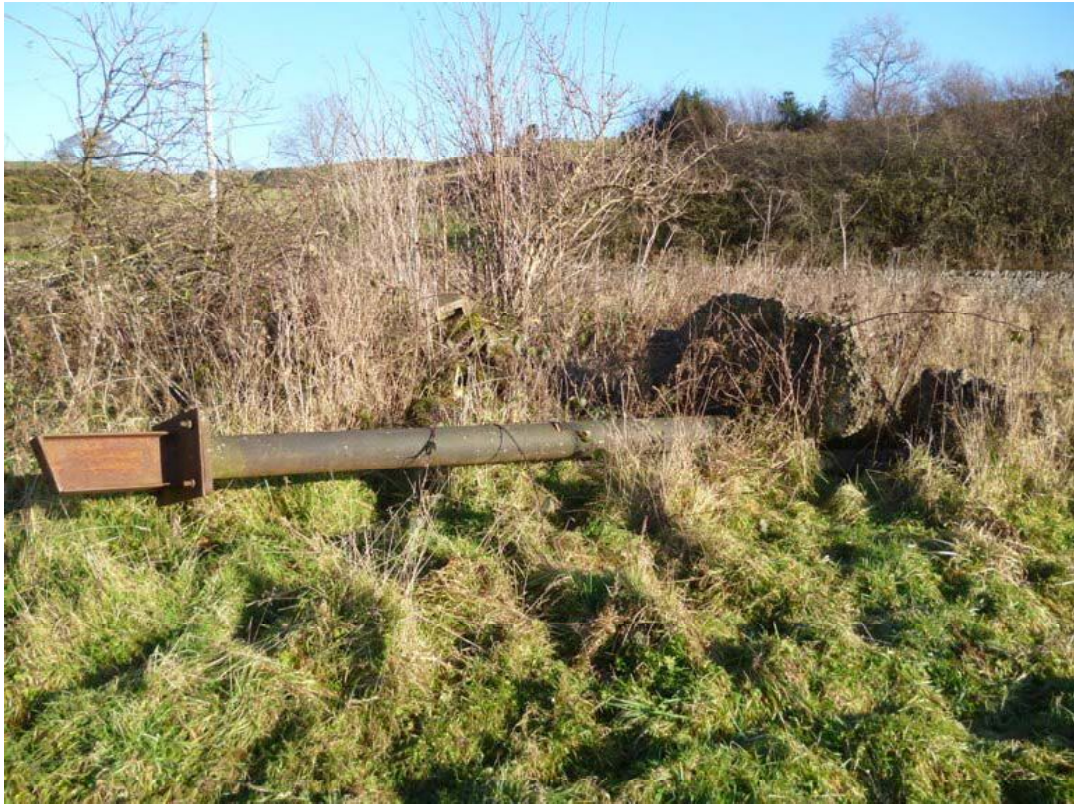
4.2.5 **Other features:** lying on the ground to the south-east of the barn are a pile of three or four cast iron columns with mounded tops with later iron brackets bolted to the top and the concrete supporting the base still attached (Plate 21). One of the columns had the number '1873' cast into, presumably the date of manufacture, it but it was not clear if this was present on them all. To the north-east of these a large area of concrete flooring was also present, although it was not clear if it was in its original position.

**Plate 21: Iron columns lying loose to the south-east of the barn**

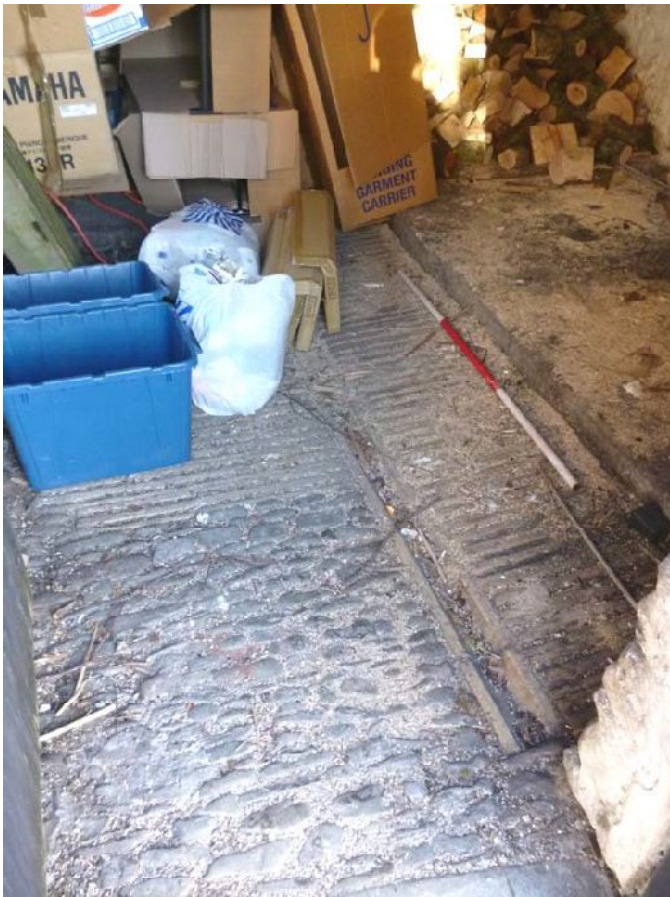
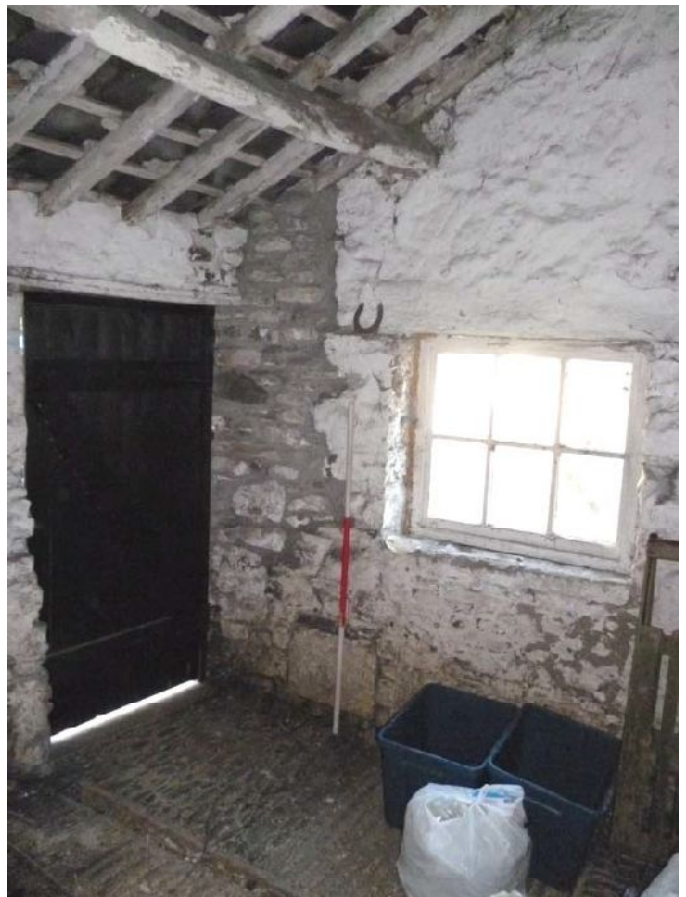
4.3.1 **Ground Floor Room 1:** this comprises a small room at the northern most end of the north outshut, currently used as a wood store. The floor is finished with a mixture of edge-set cobbles in the north-west corner, at the doorway, and ceramic blocks, divided from a concrete floor, stepped up, on the south side by a ceramic trough running east/west (Plate 22). It is open to the roof, which is supported by a single purlin per pitch and double diagonally-set ridge purlins, all of which are sawn. The walls are finished with limewash and plain, apart from the north, which has a small high-level aperture near the centre, perhaps an owl hole, and a lower level window to the west with a fixed 6-light timber casement (Plate 23). The masonry in the far north side is slightly rounded, suggestive of a flue in the wall but has clearly been more recently repointed so this may just represent rebuilding. There is a doorway on the north side of the west elevation, with a tongue and groove plank and batten door, with several thin planks forming the lintel and a plain surround (Plate 23), and there are through stones in the south elevation.

Plate 22 (left): Different types of flooring in Room G1

Plate 23 (right): North-west corner of Room G1

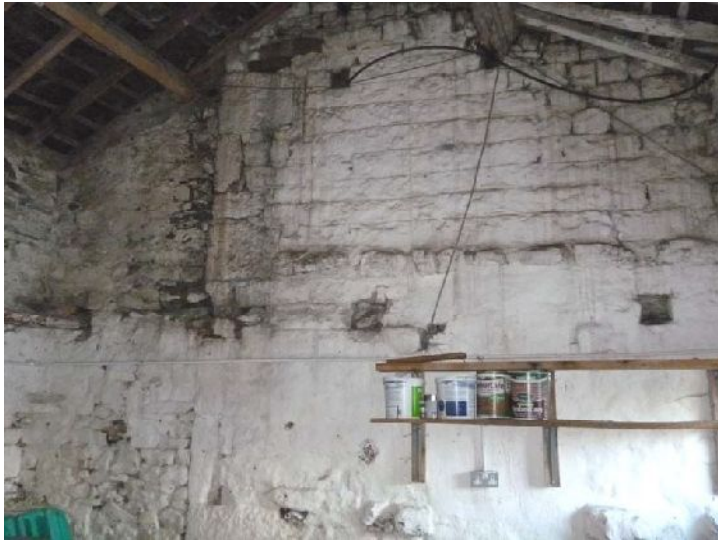
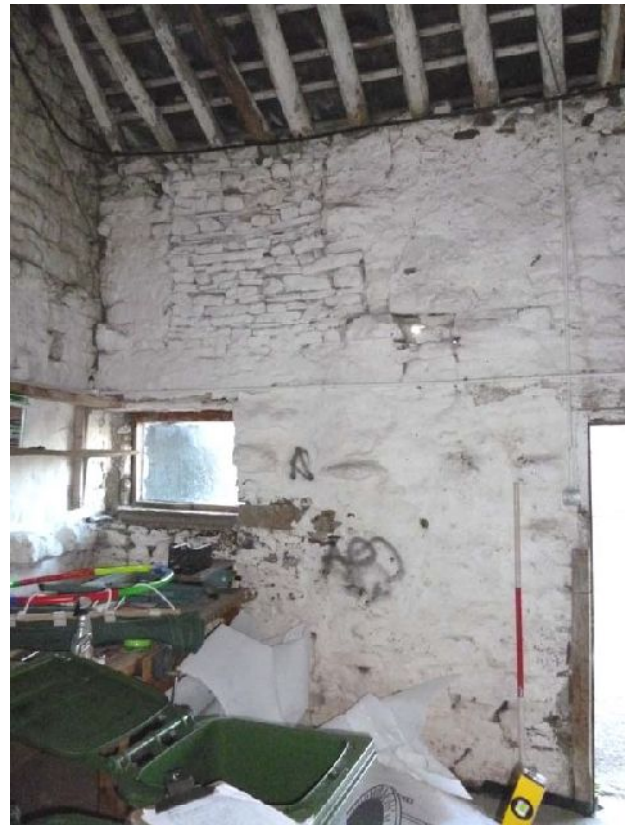
**4.3.3 Ground Floor Room 3:** this comprises another small room to the south of G2, and is currently used as a store. The floor is concrete and it is open to the roof, although it evidently originally had two storeys. The roof is supported by a single purlin in each pitch plus a ridge plank, all of which are sawn. The walls are finished with limewash. The north elevation has a small central aperture at first floor level, covered with board, and two square vents either side plus a row of through stones. There is a timber set into the wall low on the west side with a joist hole above. The east elevation has a beam, which presumably originally formed part of the support of the upper floor, against it running north/south, which is hand-finished and set into the north and south walls. The south elevation has the butt-joint between the outshut wall and the earlier barn showing clearly, with the quoins, coursed stonework and through stones clearly visible on the west side (Plate 26). Three slots for the joists that supported the original first floor are also present. The west elevation has a small window on the south side with a single-light timber casement, a rough timber lintel and sandstone sill. To the north is a doorway with a rough timber lintel and beaded tongue and groove plank and batten door in a plain surround. At first floor level, on the south side of the elevation, is an aperture blocked with stone (Plate 27) and there is some recent repointing in the north-west corner.

**Plate 26 (left): South elevation, Room G3, showing the junction between the outshut and the main barn**

**Plate 27 (right): West elevation, Room G3, showing the blocked high-level aperture**

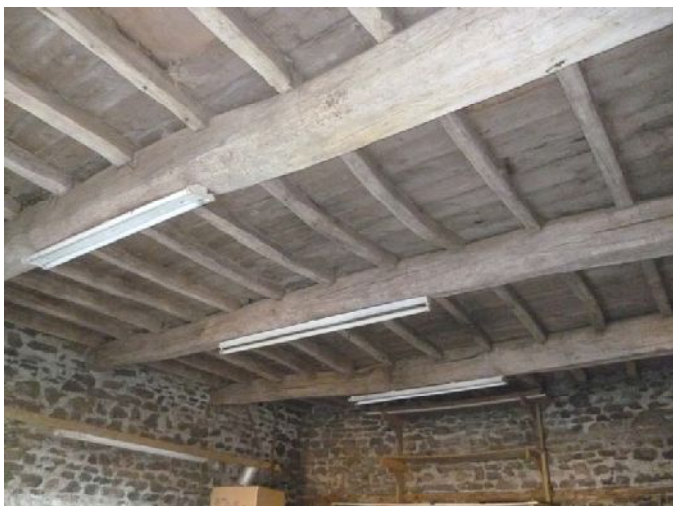
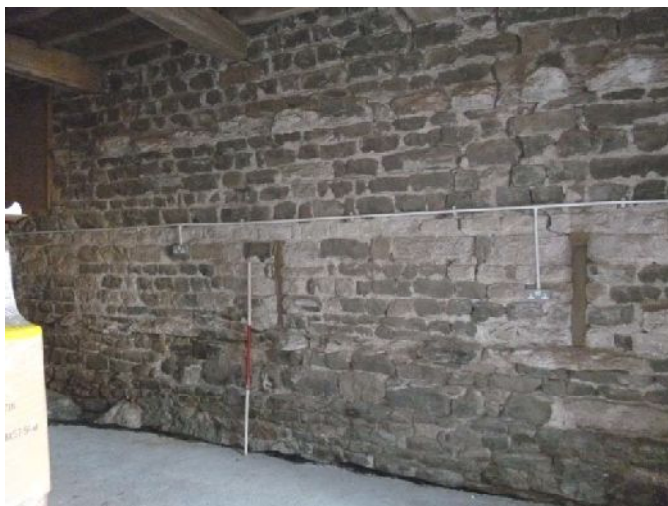
**4.3.4 Ground Floor Room 4:** this forms the north-eastern most room of the main barn, and is currently used for storage. It has a concrete floor, raised in height relative to the external ground level. The ceiling comprises wide sawn boards supported by joists on three large beams orientated north-east/south-west (Plate 28). The joists and beams are hand-finished, and the beams chamfered with a run out stop. The walls are largely exposed stone in rough courses with thick gritty lime mortar. The north-west elevation has a wagon doorway on the south-west side with a double beaded tongue and groove plank and batten door, and an internal frame including a two-light casement at the top. It has a rough timber lintel with a trapezoidal timber block attached in the centre. The rest of the wall to the north-east is essentially plain, although there are some through stones and attached timber battens. The north-east elevation is plain, although the lower part is limewashed and the upper has a row of through stones. The lower part of the south-east elevation is covered by a skim of concrete and limewashed, and there is a rough re-used timber rail built into the wall above this. The south-west elevation was evidently originally external as it has a plinth at the base, continuing from that seen to the north-west through the jamb of the wagon doorway, two rows of through stones, and three tall narrow ventilation slots, the south-east of which is totally blocked (Plate 29). High on the south-east side there is a small aperture covered with modern board and sealed with insulating foam.

**Plate 28 (left): Ceiling, Room G4**

**Plate 29 (right): South-west elevation, Room G4**

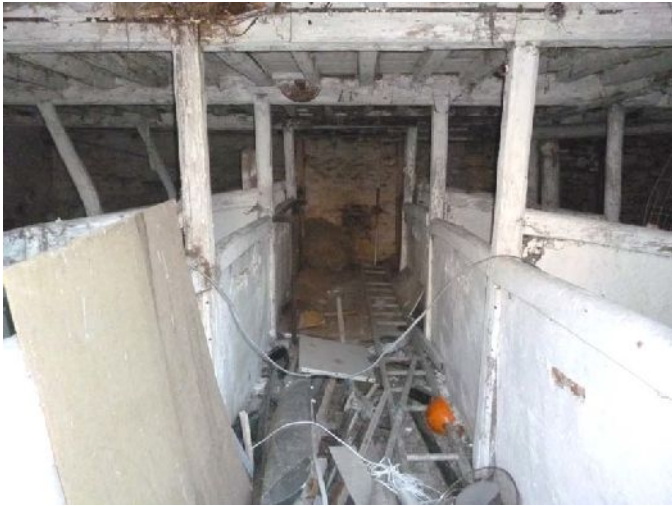
Plate 32 (left): Central feed channel, Room G5

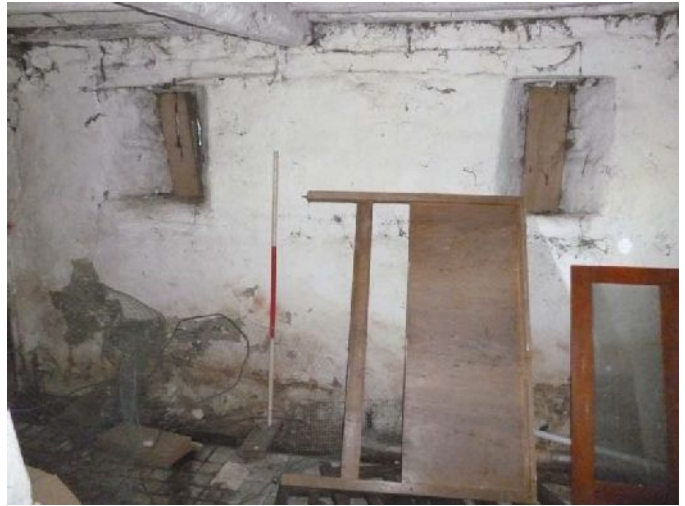
Plate 33 (right): Wincing slots, north-east elevation, Room G5

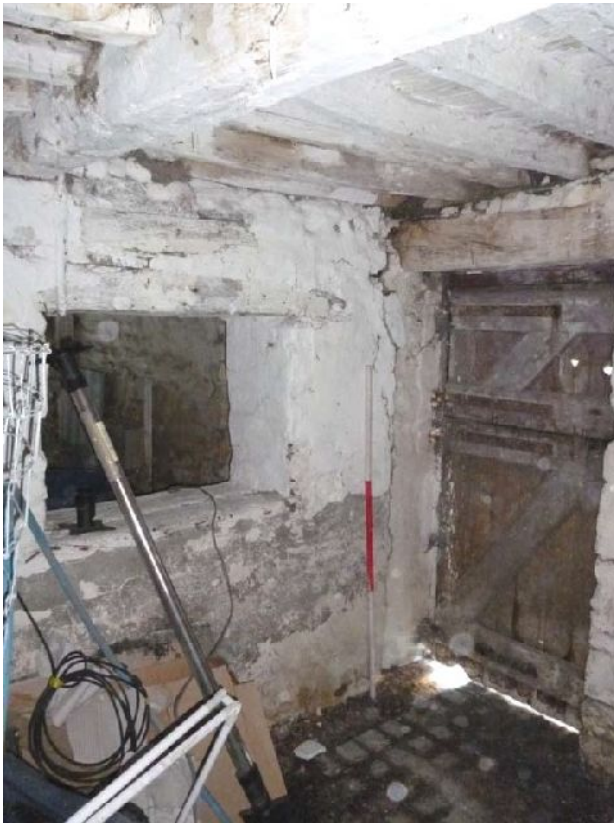
**4.3.5 Ground Floor Room 5:** this is situated to the south-west of Room G4, and is currently used for storage. It comprises a single room, divided into three parts by partitions constructed from timber posts and rails supporting stone slab panels (Plate 30), and forming two rows of animal stalls either side of a central feed channel (Plate 32). The stalls, of which there are four on either side, have a timber tether post on either side and a hole for a further central post (now removed; Plate 31). The floor is concrete, stepping down on the north-east and south-west sides, where it is also gridded, to form a dung channel orientated north-west/south-east and there is a pair of concrete troughs in each stall. The ceiling is supported by three north-east/south-west beams, which are further supported by the posts of the stalls, and the walls, ceiling and stalls are all finished with limewash. The north-west elevation has three doorways, one accessing each of the stalls and one for the feed channel, the south-west and central of which retain plank and batten doors and all of which have hand-finished timber lintels (Plate 34). The north-east elevation has two winnowing slots, in the centre and to the north-west, with splayed jambs (Plate 33). The south-east elevation is plain, while the south-west has a large aperture on the north-west side with a rough timber lintel and sill (Plate 34).

Plate 34 (left): Aperture in the south-west elevation and doorway in the north-west, Room G5

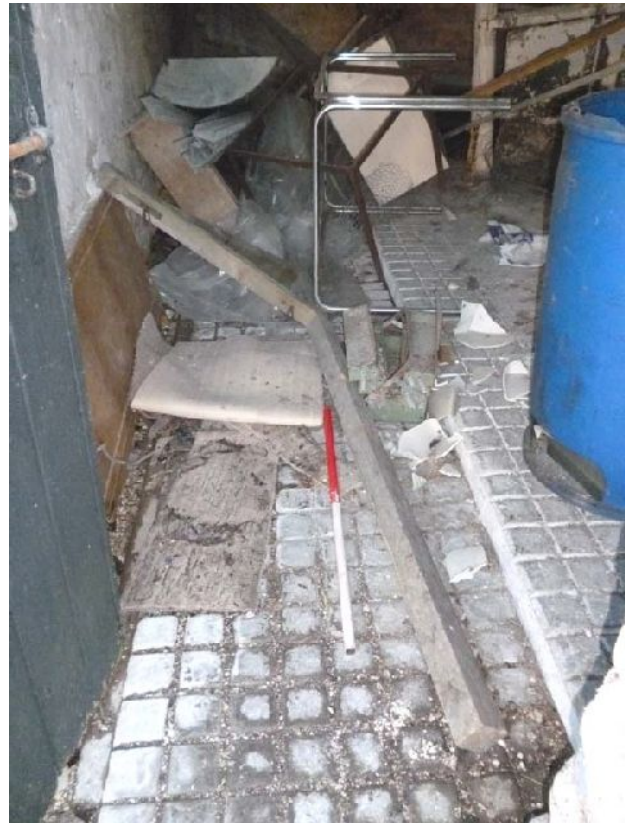
Plate 35 (right): Gridded concrete dung channel, north-east side of Room G6

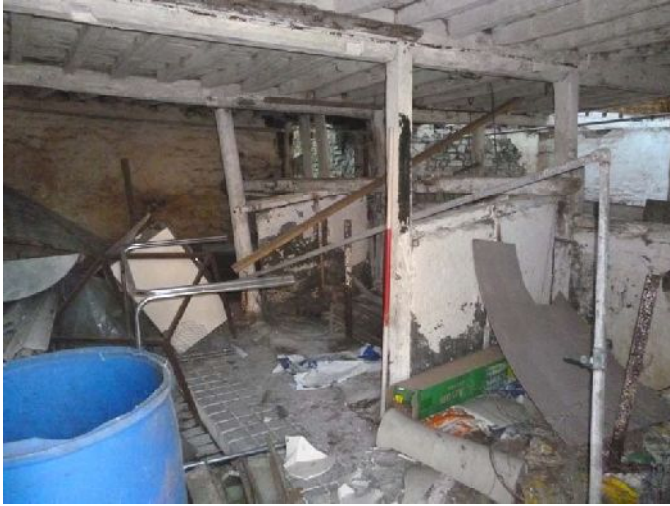
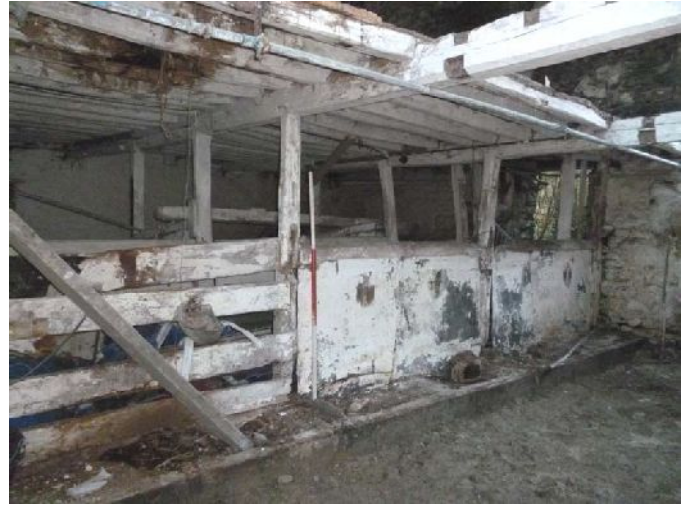
4.3.6 **Ground Floor Room 6:** this is essentially a mirror image of Room G5, although the floor, ceiling and stalls have been removed on the south-west side leaving the earth exposed, whereas the floor is concrete and incorporating a dung channel elsewhere (Plate 35). The concrete troughs remain throughout, however. As per Room G5, an arrangement of timber rails and posts with panels formed by stone slabs create animal stalls either side of a north-west/south-east orientated central feed channel, although there are only three stalls per side, the tether posts on either side are iron with the central iron post surviving (Plate 36), and the stalls on the south-west side of the feed channel have been partially removed (Plate 37). The ceiling comprises wide sawn floorboards and joists, supported by two beams orientated north-east/south-west and all of the timber is hand-finished. The walls are finished with

**Plate 36 (left): Remains of stalls, Room G6**

**Plate 37 (right): Partially removed stalls, south-west side, Room G6**

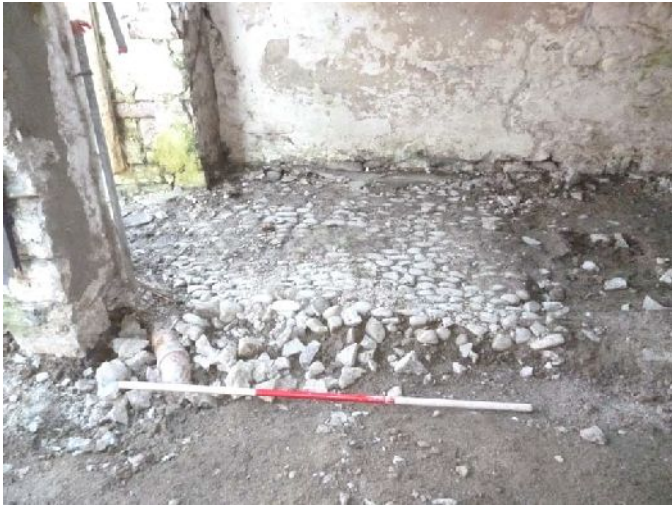
Plate 38 (left): Section of cobbled floor, north corner of Room G7

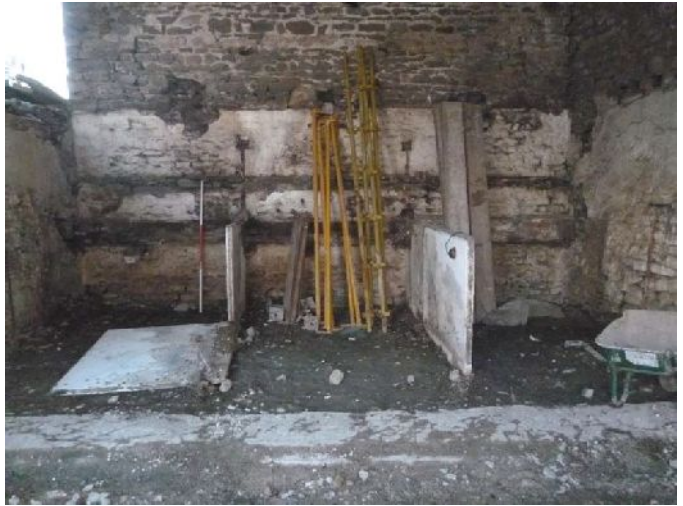
Plate 39 (right): Stalls remaining against the south-east elevation, Room G7

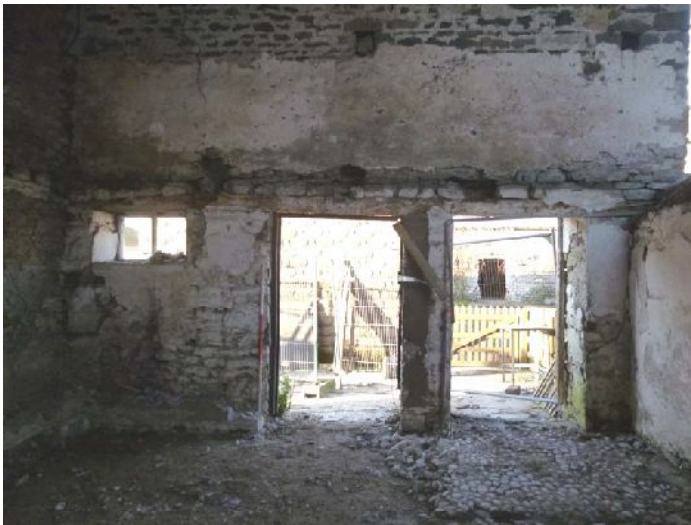
Plate 40 (left): Doorways and window sharing a single piece of re-used timber as a lintel, north-west elevation, Room G7

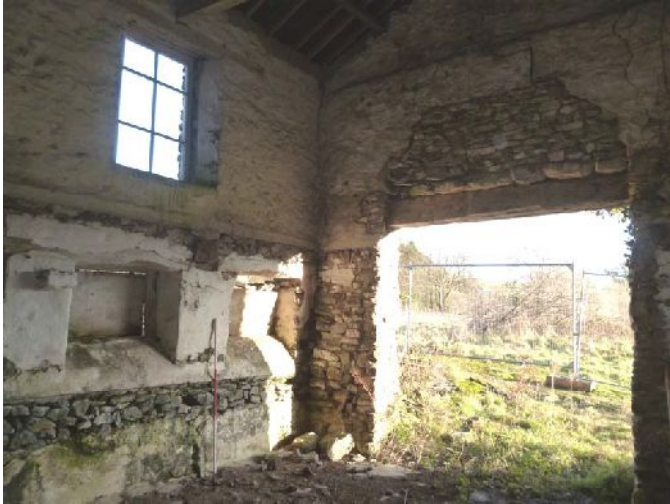
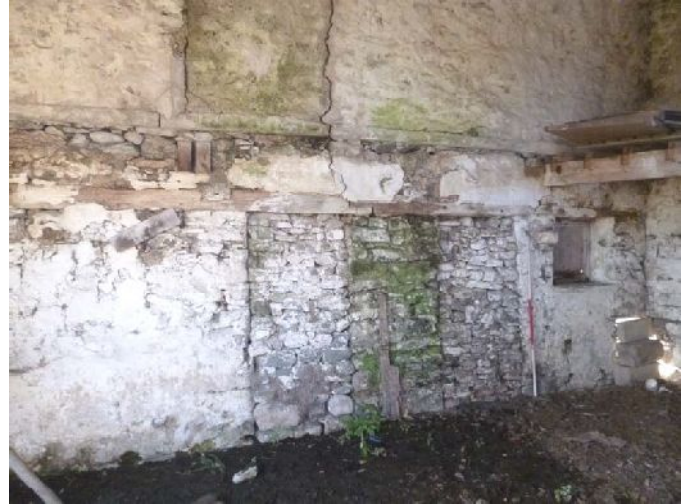
windows, both of which have sloping sills and hand-finished timber lintels (Plate 42). The sawn off ends of a pair of beams are visible between the two windows. The south-east elevation has a wide central doorway, which is evidently inserted as the jambs are rebuilt, and has a very large hand finished and re-used timber lintel (Plate 42). The south-west elevation has a blocked window on the south-east side and two central doorways, also blocked, between which is further scarring and a projecting stone, again suggesting that a dividing wall has been removed. There is further window at the north-west end with a timber single-light casement blocked with board (Plate 43). All of these openings share a single lintel formed by two pieces of hand-finished timber roughly scarf-jointed together, and there is a further small aperture at ground level in the west corner, which is loosely covered by concrete blocks.

**Plate 42 (left): East corner, Room G8**

**Plate 43 (right): South-west elevation, Room G8**

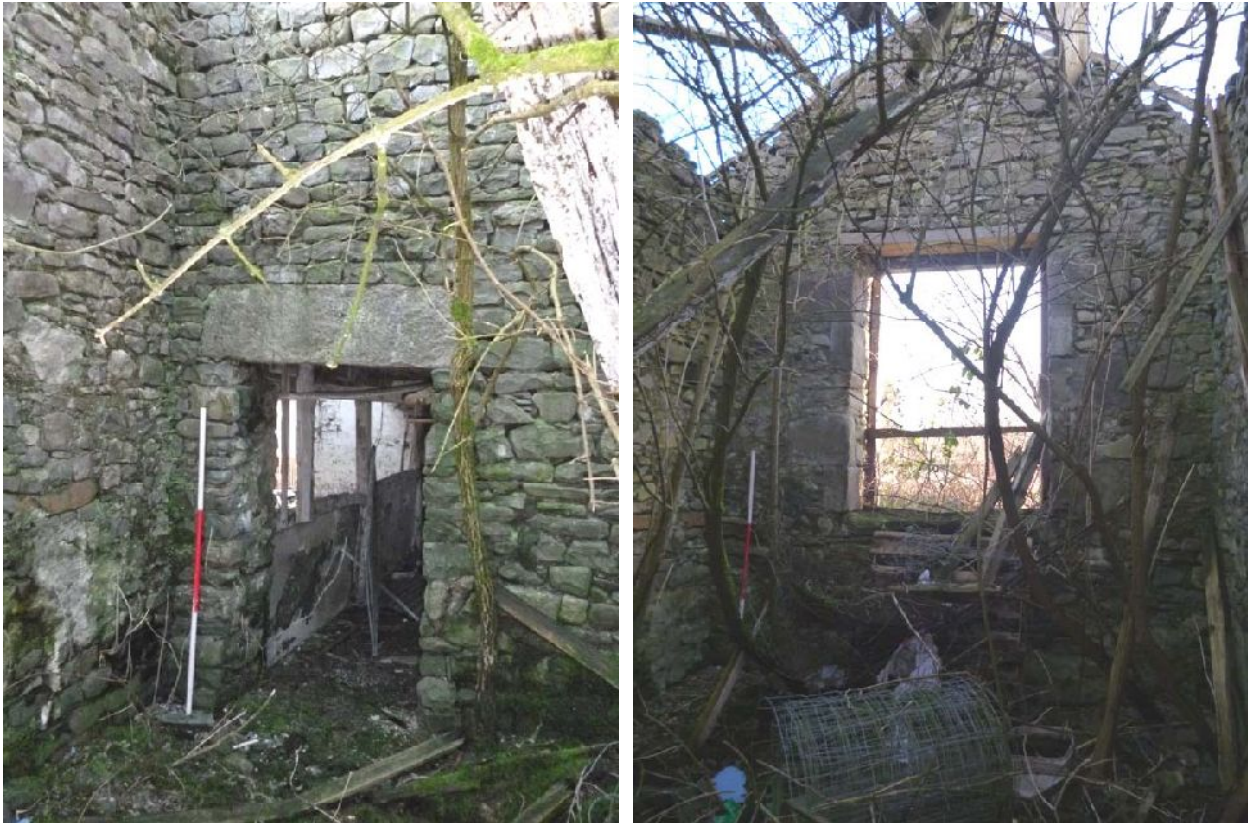
**4.3.9 Ground Floor Room 9:** the floor of this is lower than the ground level to the south-east, the outshut having been cut into the slope, and is covered with debris. It is open to the roof, but most of this is now missing, with only two purlins remaining *in situ*, one per pitch. The walls are all exposed stone, mostly in fairly random courses with thick gritty lime mortar and effectively plain. The north-west elevation has a low doorway with a limestone lintel but no quoins, suggesting it is possibly inserted (Plate 44). There is no plinth in what is the exterior wall of the main barn. The south-east elevation has a doorway at the external ground level with a machine cut timber lintel and dressed sandstone quoins (Plate 45). The north-east and south-west elevations are plain.

**Plate 44 (left): Doorway in the north-west elevation, Room G9**

**Plate 45 (right): Doorway in the south-east elevation, Room G9**

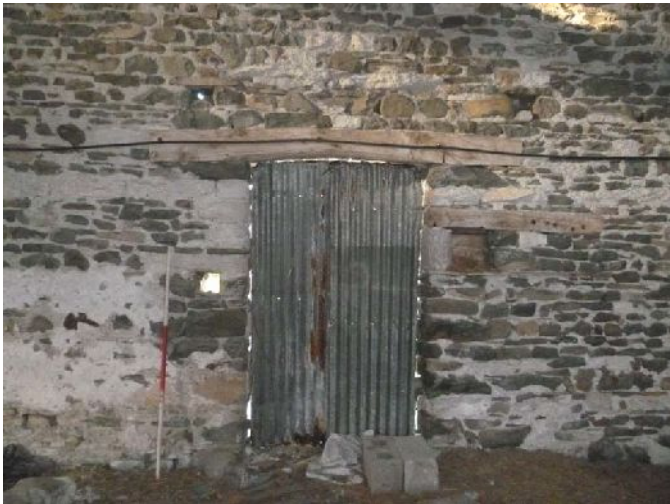
**Plate 48 (left): North-eastern pitching or winnowing doorway, south-east elevation, Room F1**

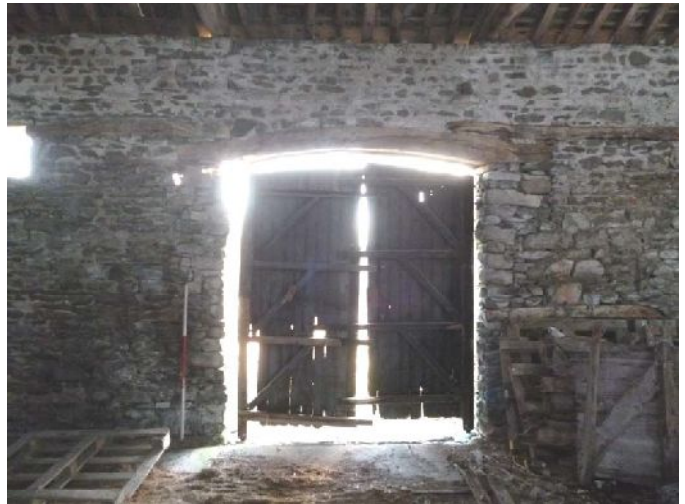
**Plate 49 (right): North-eastern wagon doorway, south-east elevation, Room F1**

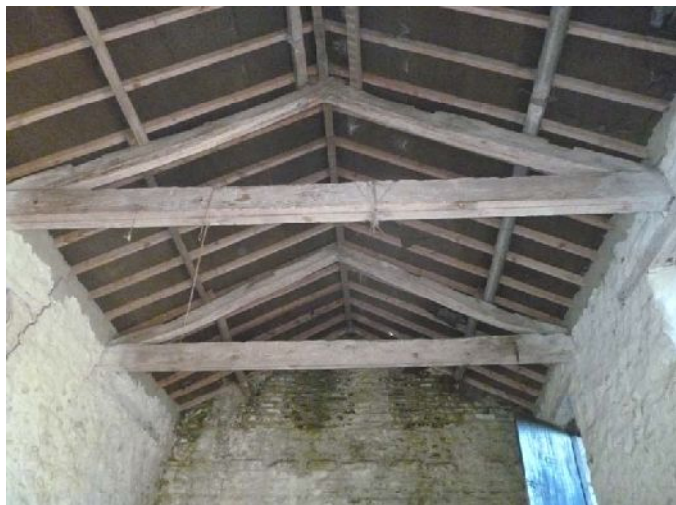
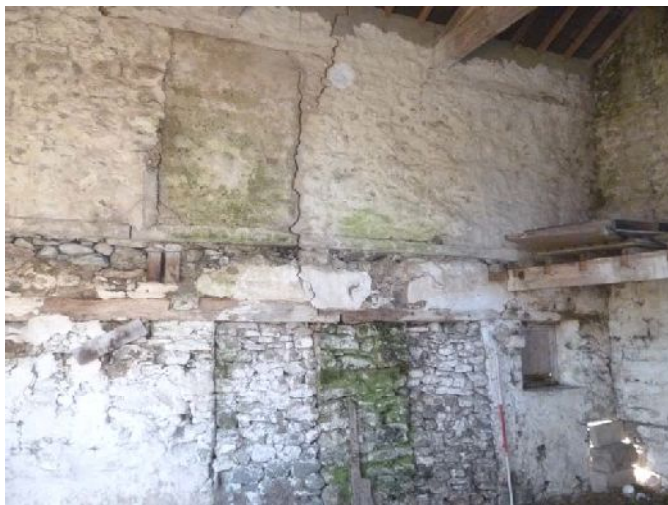
the courses of dressed stone visible behind the limewash. The north-east elevation has a doorway on the north-west side with a timber lintel and plank and batten door. To the south-east is a window, also with a timber lintel, with a six-light timber casement. The south-east elevation is essentially plain, but has been rebuilt above the doorway below. The south-west elevation has two doorways, which have been blocked with stone and limewashed over, both with timber lintels (Plate 51).

**Plate 50 (left): Trusses in Room F2**

**Plate 51 (right): Blocked apertures, south-west elevation, Room F2**
