5 PARK VIEW, CARTMEL, CUMBRIA

Archaeological Building Recording

April 2013

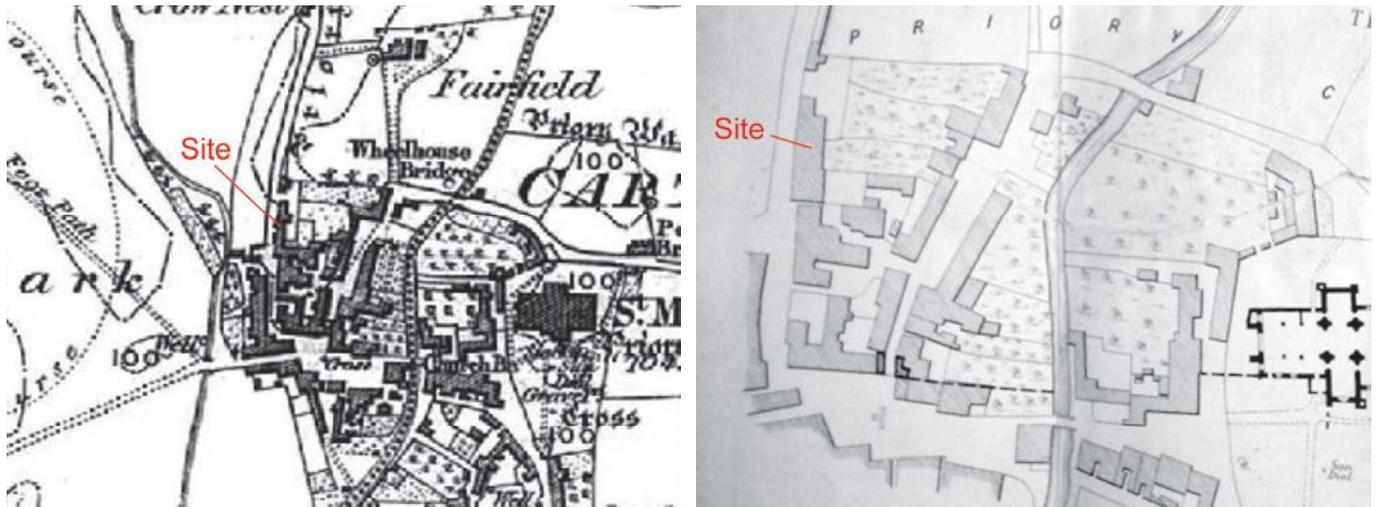
Plate 1 (left): Extract from the Ordnance Survey map of 1851

Plate 2 (right): Extract from Ffoliott's map of Cartmel from 1854

3.1.2 **Ordnance Survey, 1851:** despite the scale this plan is detailed enough to show the general arrangement of buildings forming the block including 5 Park View (Plate 1). It is apparent that by this time much of the present arrangement was in place.

3.1.3 **Ffoliott 1854:** this is essentially the same as the earlier map. It is at a more useful scale but does not provide much additional information (Plate 2). Indeed, it appears to show a more basic level of detail regarding the rear of the property, especially when compared to the more detailed maps that follow.

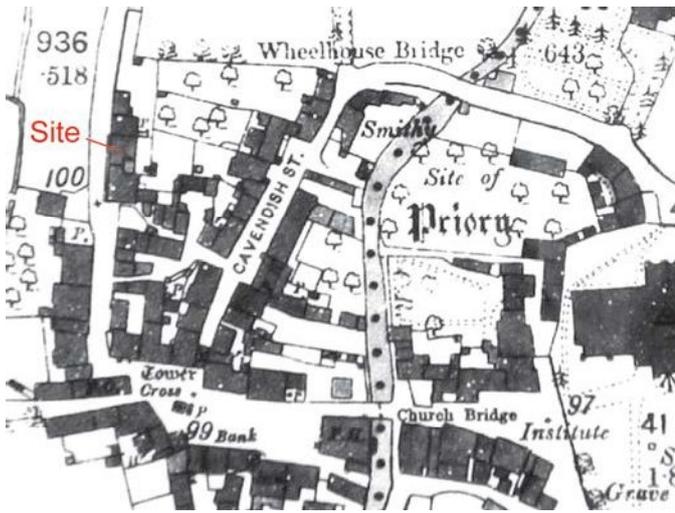
Plate 3 (left): Extract from the Ordnance Survey map of 1890

3.1.4 **Ordnance Survey, 1890:** this is probably the first map to accurately show the divisions between the row of buildings and the manner in which the elements of 5 Park View are arranged (Plate 3). It is apparent that the main part of the house is essentially L-shaped and that there is an infilled section to the rear (east) between it and the adjoining property to the south. A small detached structure is also shown to the east, against the boundary wall.

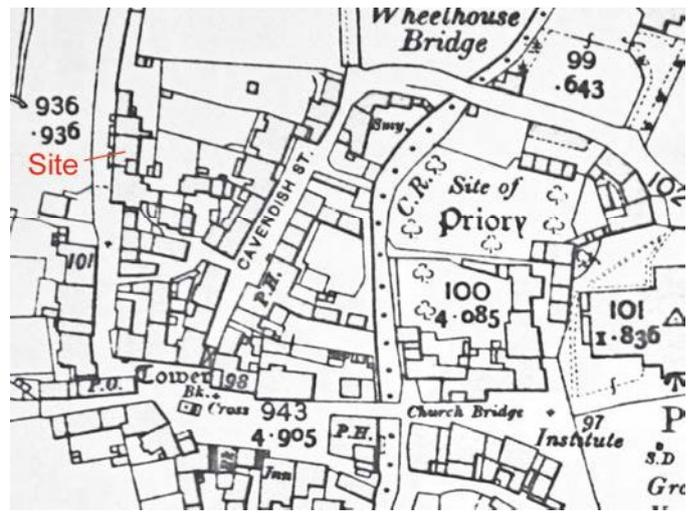
Plate 4 (right): Extract from the Ordnance Survey map of 1913

3.1.5 **Ordnance Survey, 1913:** this provides much the same information as the previous map, although the lack of fill makes distinguishing between structures and open spaces more difficult (Plate 4). It does show, however, that the small structure to the east is in fact made up of two elements.

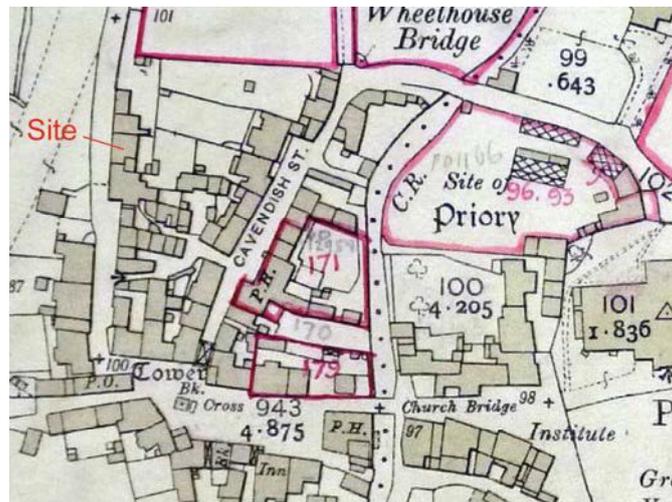
Plate 5 (left): Extract from the Ordnance Survey map of 1933

3.1.6 **Ordnance Survey, 1933:** this shows essentially the same information as the previous maps (Plate 5). The numbering for the rating valuation of 1910 is marked on this map, but is incomplete for Cartmel and does not include the site. This would normally provide the details of the owner and occupier.

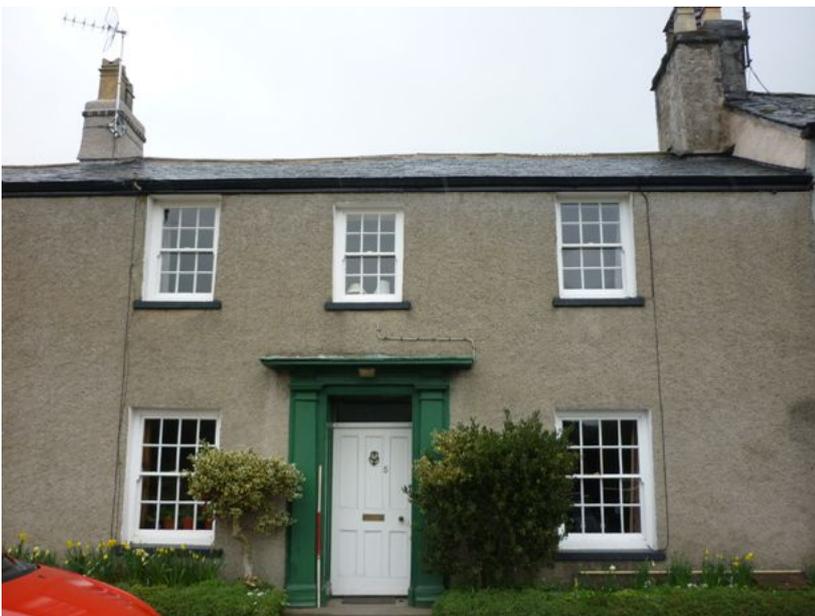
Plate 6 (left): General view of the west external elevation

4.2.1 **West elevation:** this forms the front of the house, looking onto the street. It is two storeys high, with three windows on the first floor each with a 12-light sash casement and stone sill, although the central window is slightly narrower (Plate 6). The casements are evidently relatively modern. The ground floor has a central doorway with flanking engaged pilasters with moulded capitals and plinths supporting a flat canopy (Plate 7). The door has six moulded panels and the doorway is flanked by a window, each with a 16-light sash casement and stone sills. The elevation is topped with a beaded barge board to which is attached a moulded iron gutter.

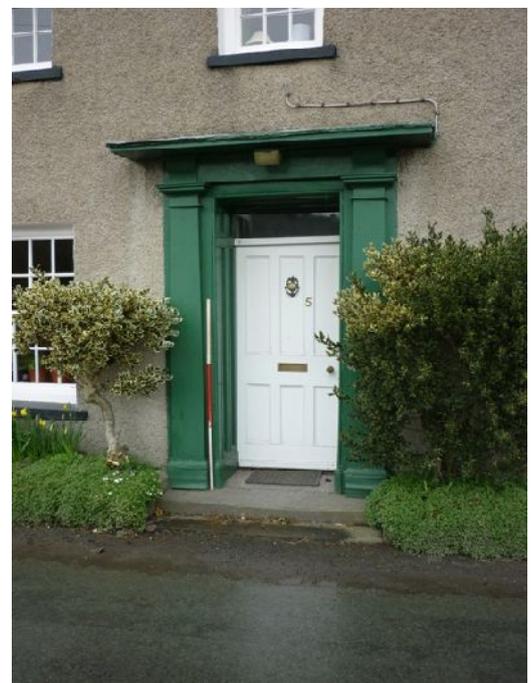
Plate 7 (right): Detail of the door in the west external elevation

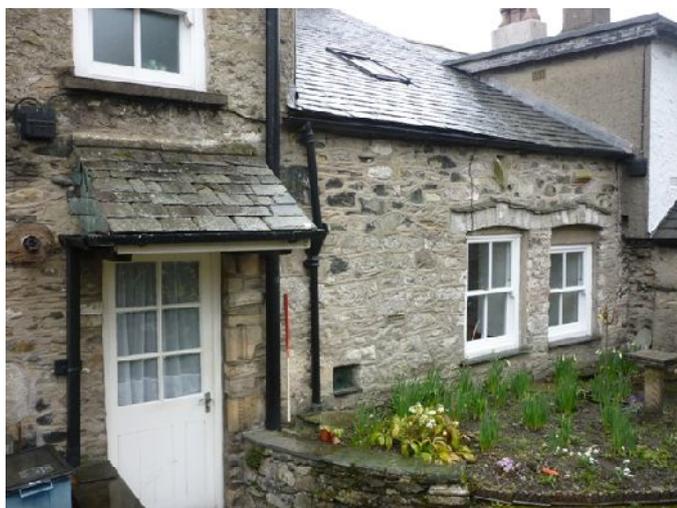
Plate 8 (left): North end of east external elevation

4.2.2 East elevation: this is the rear elevation, facing onto the garden. It is essentially single storey due to the sloping outshut roof, but with a raised dormer in the centre extending to the first floor. There are several pieces of re-used medieval masonry built into the wall, in particular forming the north jamb of the central door. The north end of the elevation has two windows with flattened limestone arches, which are probably relatively modern rebuilds, with slate drip courses above (Plate 8) and a single piece of re-used medieval masonry built into the wall above each (Plate 9 and Plate 10). The casements are modern four-light sash, and the northern most is slightly lower with a concrete infill above and both have thin concrete sills. To the south is a small ceramic vent built into the wall and a small window with a thin slate sill and single light. There are iron downpipes running down from the central dormer and adjacent to the doorway below. This has a gabled porch over it with a slate roof. As already mentioned the north jamb is largely constructed from re-used dressed medieval masonry (Plate 10), suggesting that it is inserted, beyond which is a line of limestone quoins forming the original end of the building, indicating that the wall to the south, including the doorway is a later addition. The door is relatively late in date, and comprises beaded tongue and groove boards with six glazed panels above and there is a flight of curved concrete steps leading down to it.

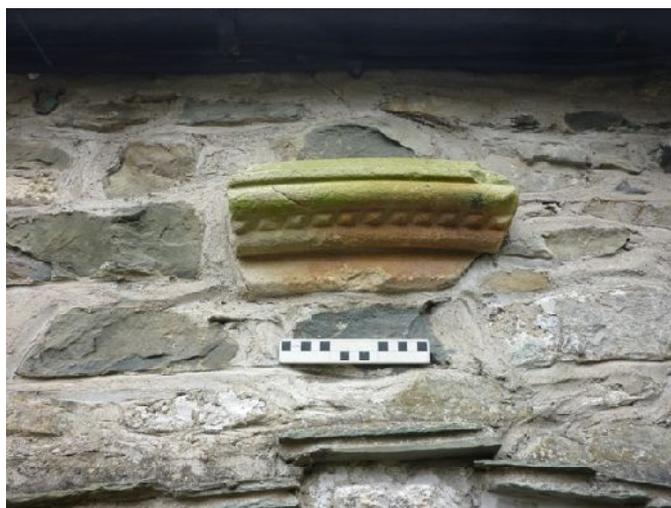
Plate 9 (right): Re-used medieval masonry above the northern window at the north end of the east external elevation, probably part of a moulded window or door arch

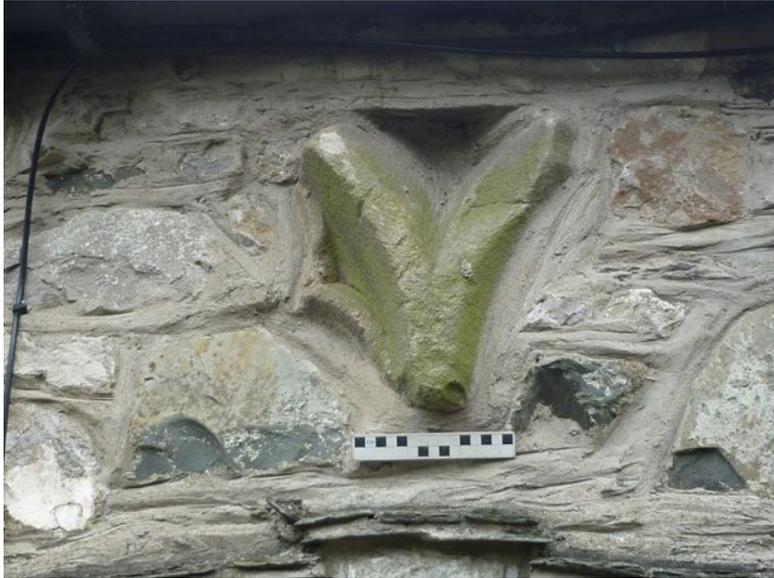
Plate 10 (left): Re-used medieval masonry above the southern window at the north end of the east external elevation, probably a piece of window tracery

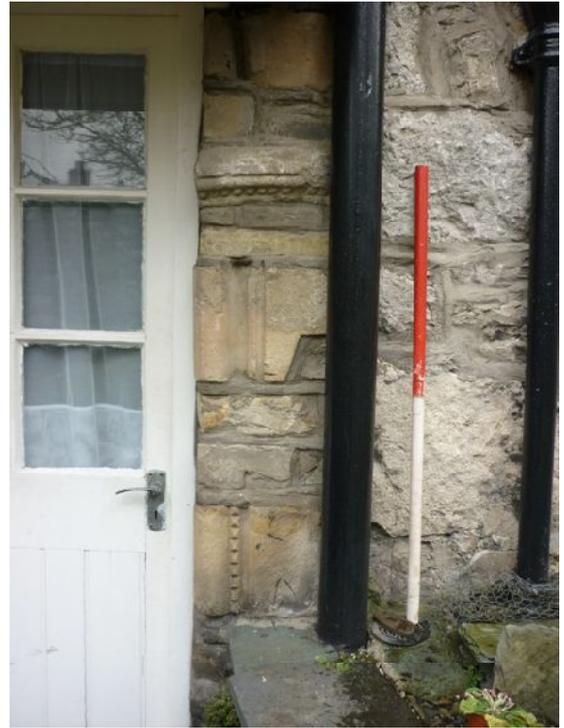
Plate 11 (right): Re-used medieval masonry in the northern jamb of the doorway, probably mostly moulded door and window arches and jambs

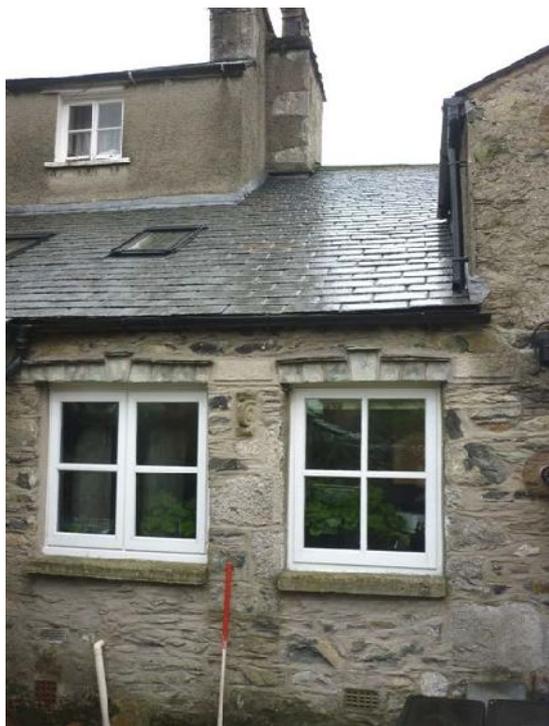
Plate 12 (left): Windows on the south side of the east external elevation

4.2.3 There are two further windows to the south, essentially the same style as those to the north, but with thick sandstone sills and there are ceramic vents below (Plate 12) and a piece of re-used medieval masonry inserted between (Plate 13). There is a row of quoins utilised in the north jamb of the northern window, apparently again marking the line of the original wall end with the wall to the south butting against it. There is a slight return at the south end, finished with dressed limestone quoins, against which is butted by the outshuts extending to the east (see *Section 4.2.3* below). The dormer extending above the central doorway has a gabled roof and a small window with a four light sash casement (Plate 14). To the north of it is a large chimney stack with a tiered square-section base and rounded top (Plate 14). The base is rendered and the tiers topped with slate, while the top is exposed stone, again with a projecting capping and single ceramic pot. A concrete[?] plaque marked '1985' is attached to the round section of the chimney.

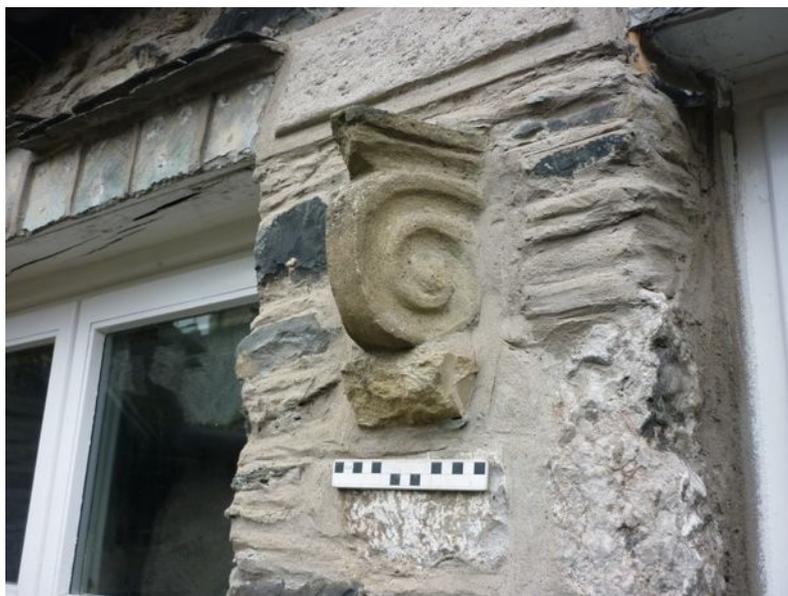
Plate 13 (right): Re-used medieval masonry, probably part of a capital

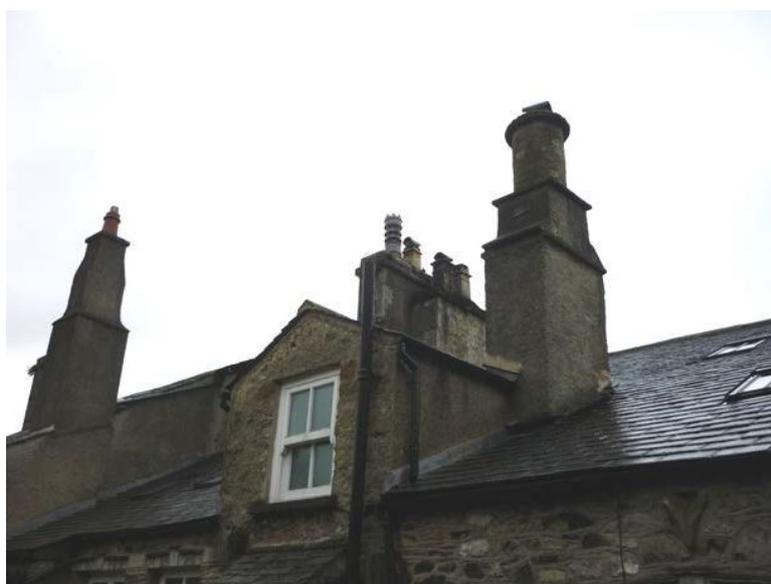
Plate 14 (left): Dormer and chimney in the centre of the east external elevation

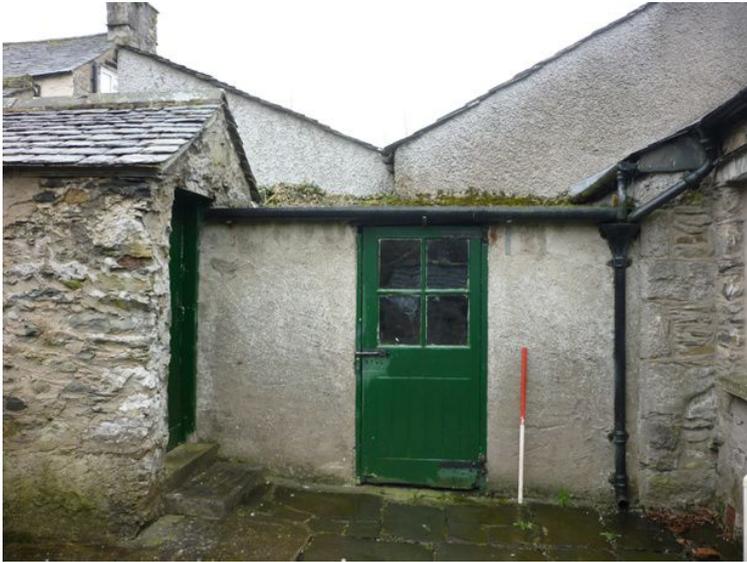
Plate 15 (left): The north-facing elevation of the outshuts

4.2.4 Outbuildings: this comprises a low elevation formed by a row of connected but separate outbuildings. The west end butts against the slight return at the south end of the east elevation. This section comprises concrete blocks, finished with a rough render finished with a corrugated sheet roof (Plate 15). There is a central doorway within this section with a thin timber lintel and four lights above a beaded tongue and groove panel. The elevation returns slightly where the concrete block wall butts against an outside toilet. The return, which faces west, is gabled and contains a single doorway the doorway of which is constructed from tongue and groove planks (Plate 15). The north-facing return to the east contains a small single-light window with a thin slate sill and the wall of the outside toilet appears to butt the boundary wall to the east.

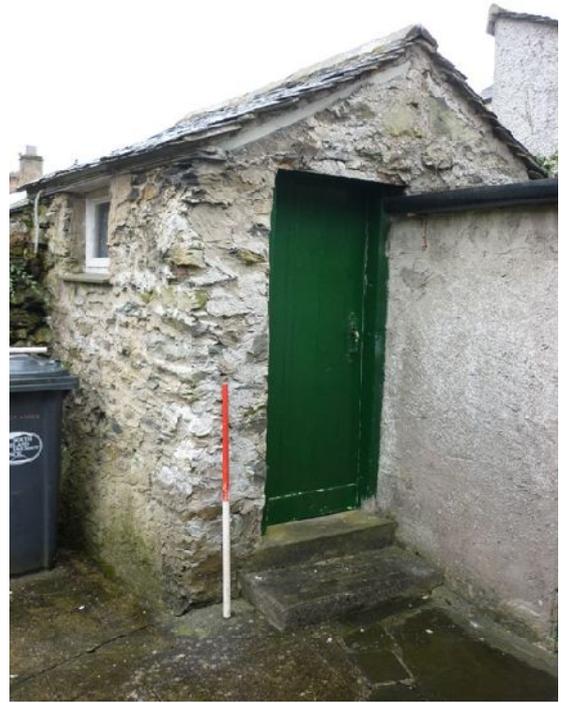
Plate 16 (right): The west-facing elevation of the outside toilet

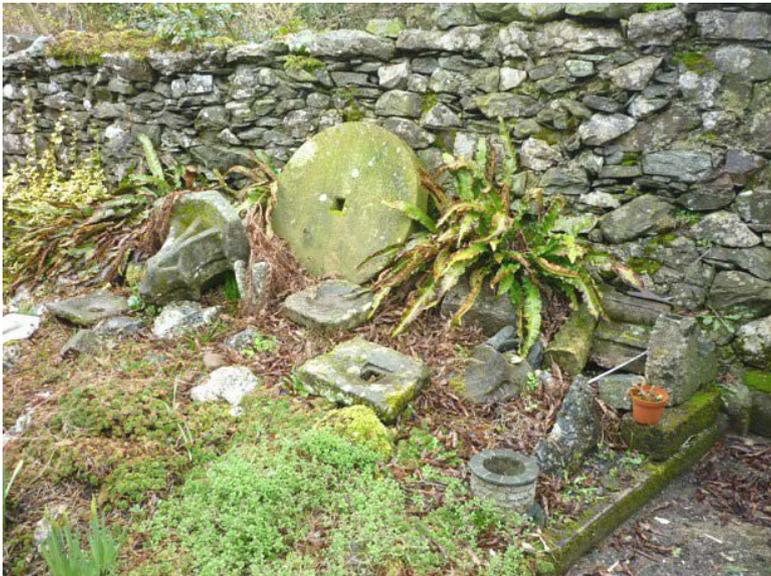
Plate 17 (left): Re-used masonry in the garden to the east

4.2.5 **Garden:** there are several fragments of worked masonry lying loose in the garden to the east of the house (Plate 17). Several of these are clearly medieval, such as fragments of window tracery (Plate 18), door or window surrounds and other less-easily identified fragments, as well as grindstone.

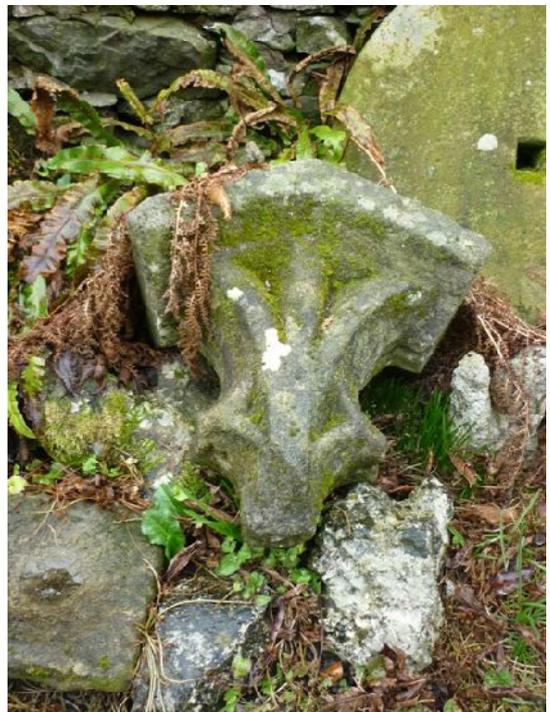
Plate 18 (right): Detail of window tracery in the garden to the east

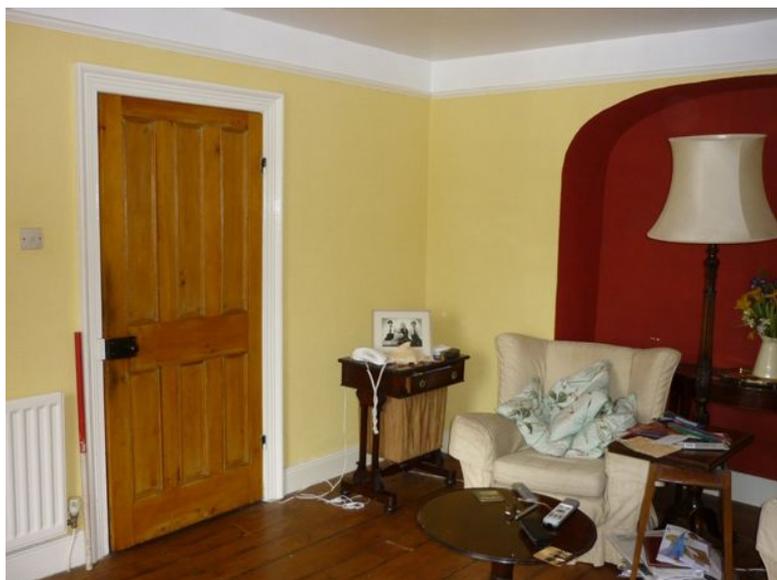
Plate 19 (left): North-east corner of Room 1

4.3.1 **Ground Floor, Room 1:** The floor of this room had varnished floorboards of regular size and spacing that appear relatively late, and the ceiling was covered by plain wallpaper. All the walls had a moulded picture rail and moulded skirting boards, in addition to this, all the walls were covered in modern wallpaper. The north wall was plain with the exception of a six panelled wooden interior door that had a ogee-moulded timber frame (Plate 19). The east wall has a large rounded recessed alcove situated centrally, but is otherwise plain (Plate 19). The south wall has two smaller rounded recessed alcoves on either side of a modern fireplace. The west wall had a 16-light timber sash window within a timber panelled recess with wooden shutters on either side.

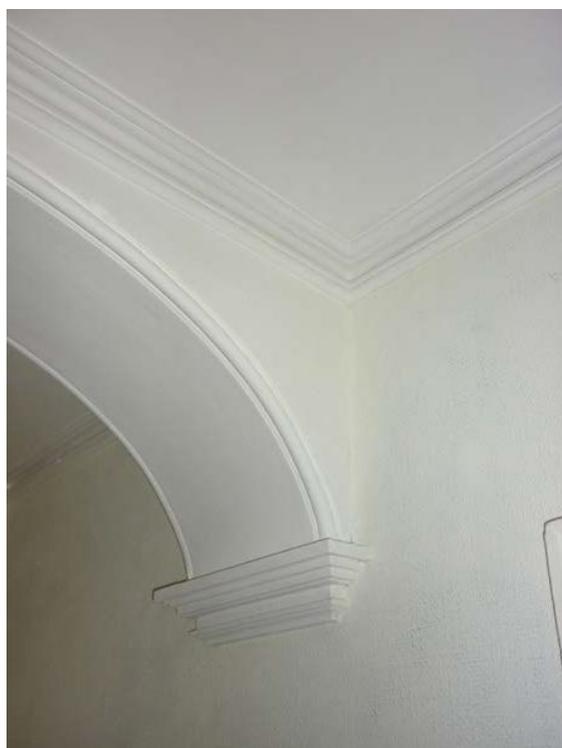
Plate 20 (right): Detail of rounded arch Room 2

4.3.2 **Ground Floor, Room 2:** the main entrance corridor to the house, this room has a modern vinyl laminate floor and a plain plastered ceiling with moulded cornice and moulded skirting board and wallpapered throughout. There is also a moulded decorative arch spanning the width of the corridor (Plate 20). The north, east and south wall are plain and are notable only for interior doorways all with moulded doorframes. The west wall takes the form of a substantial six panelled wooden front door with a glass overlight.

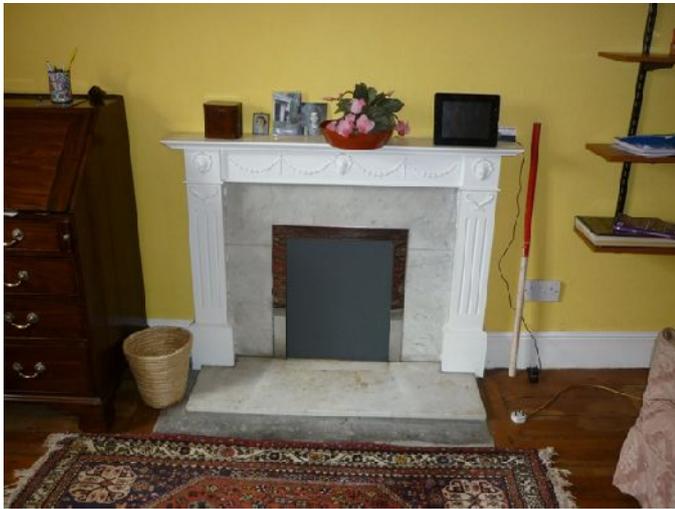
Plate 21 (left): Fireplace in Room 3

4.3.3 **Ground Floor, Room 3:** this room has regular sized varnished floorboards and a plain plastered ceiling, also moulded cornices and moulded skirting boards. The north wall has a modern classical style fireplace but is otherwise plain (Plate 21). The east and south walls are also plain with no distinguishing features. The west wall has a 16-light timber sash window with wooden shutters and a timber panelled cupboard below.

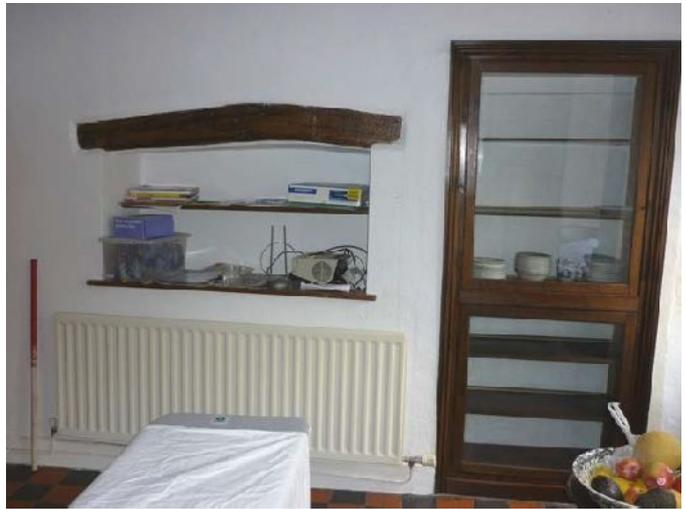
Plate 22 (right): North Wall in Room 4

4.3.4 **Ground Floor, Room 4:** this room has a red and black tiled floor and has a plastered ceiling with exposed joists that have been stained dark; the skirting boards are made of plain unadorned timber and painted white. The north wall has a recessed alcove shelf within the wall that has a curved timber lintel possibly a reused cruck beam (Plate 22). There is also a recessed alcove immediately to the east of this feature that is currently used as a display cupboard with a stained moulded doorframe (Plate 22). The east wall is plainly plastered and has two windows recessed into the wall and separated by a plastered column. The northernmost window has a reused timber lintel above it, again perhaps originally part of a

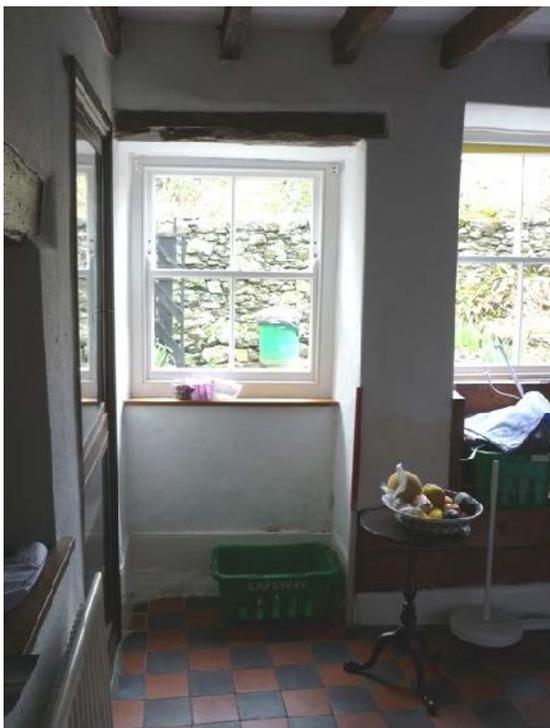
Plate 23 (left): Window, original a doorway, on the north side of the east elevation of Room 4

cruck blade, and may have originally been a doorway as the recess extends to the ground (Plate 23). The southernmost window has a splayed reveal and a timber panelled alcove with a built in window seat (Plate 24). There is also a small recessed shelf high up at the southernmost end of this wall above another alcove with a round-arched top (Plate 24). The south wall has a modern fireplace but is otherwise plain. The west wall is plain apart from an understairs cupboard and a four-panelled varnished interior door.

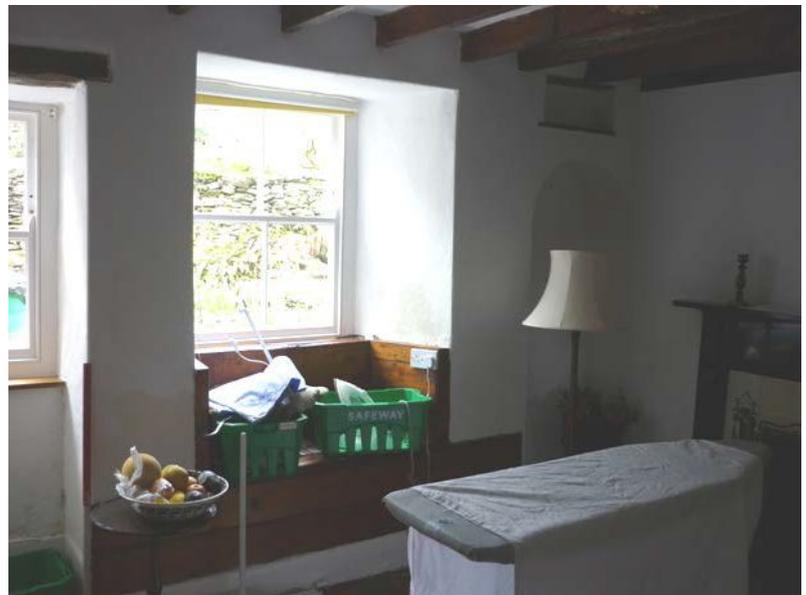
Plate 24 (right): Window and alcove in east elevation of Room 4

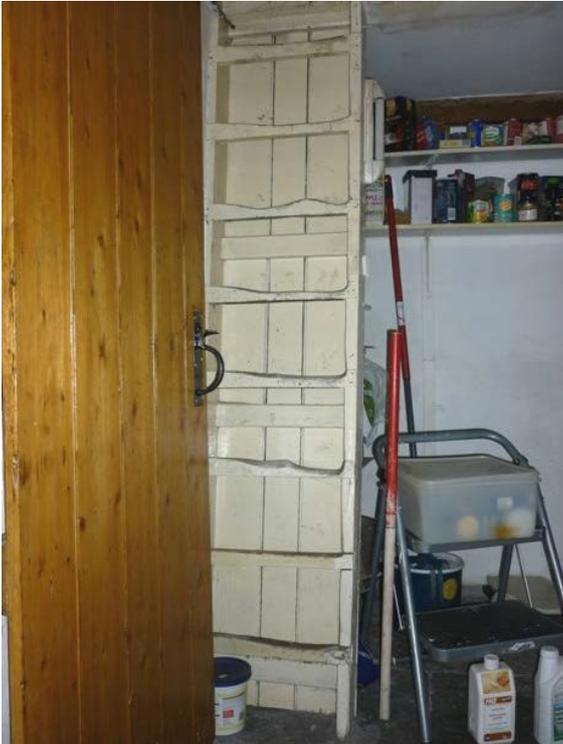
Plate 25 (left): Fixed ladder on east side of Room 7

4.3.7 **Ground Floor, Room 7:** this room has a stone flag floor and a plain plastered ceiling. All the walls are plain and plastered. This room is notable for having an upper level which can be accessed by a timber ladder (Plate 25). The upper area has painted stone walls and shelving on all sides with possible Baltic timber marks, or possibly just graffiti, on the single joist supporting the sloping ceiling (Plate 26).

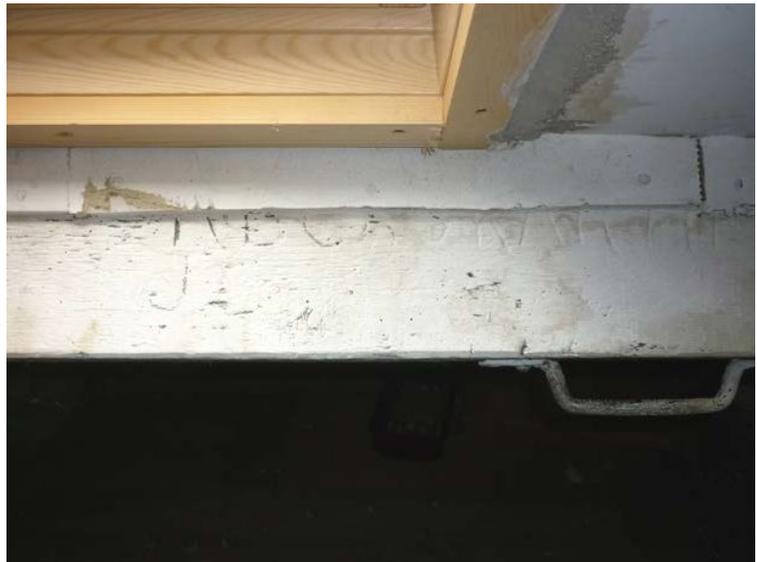
Plate 26 (right): Joist with Baltic timber marks or graffiti, upper level of Room 7

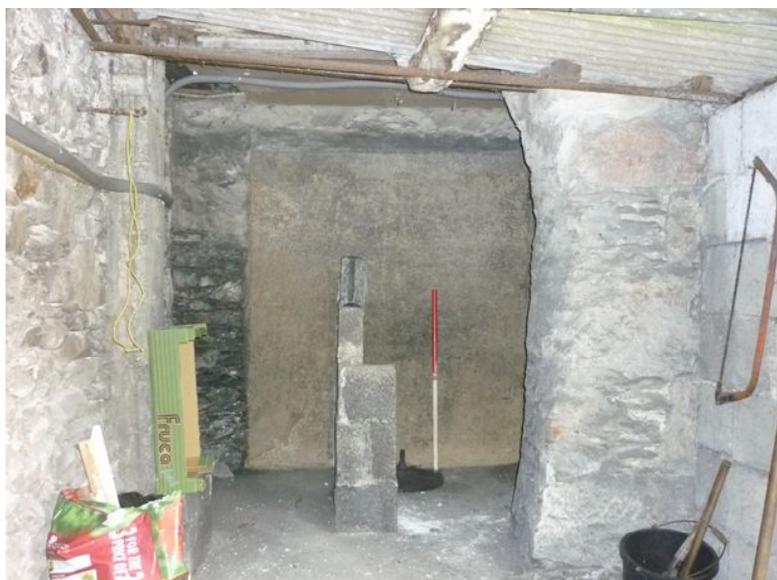
Plate 27 (left): East elevation of Room 8, showing roughcast render

4.3.8 **Ground Floor, Room 8:** this exterior room has a rough cobbled floor with stone flag and concrete patches and a corrugated asbestos roof. The concrete on the west side has '1965' scratched into it. The north wall is comprised of a modern concrete wall adjoining older rough stone wall sections heavily patched up with concrete at either end of the building. The east wall is made of slate and roughly hewn stone that has been heavily patched up with concrete and mortar. The south wall is made of roughly hewn stone that has been patched up with mortar and concrete, there is a clear vertical demarcation running centrally down the wall indicating different phases of construction. The west wall is made of roughly hewn stone with a large patch of roughcast render with a straight edge on the south side, seemingly indicating the position of a former wall line (Plate 27).

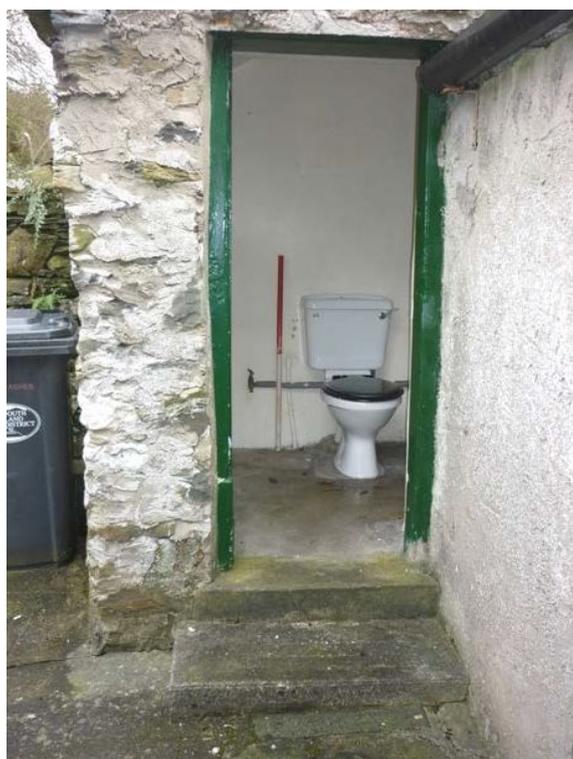
Plate 28 (right): Room 9

4.3.9 **Ground Floor, Room 9:** this room is currently in use as an exterior toilet (Plate 28) and has a concrete floor and a ridge beam wooden roof all the walls are plain apart from the north wall which had a small timber framed window. The interior window sill was made of black polished stone with an intricate design etched into it, possibly re used.

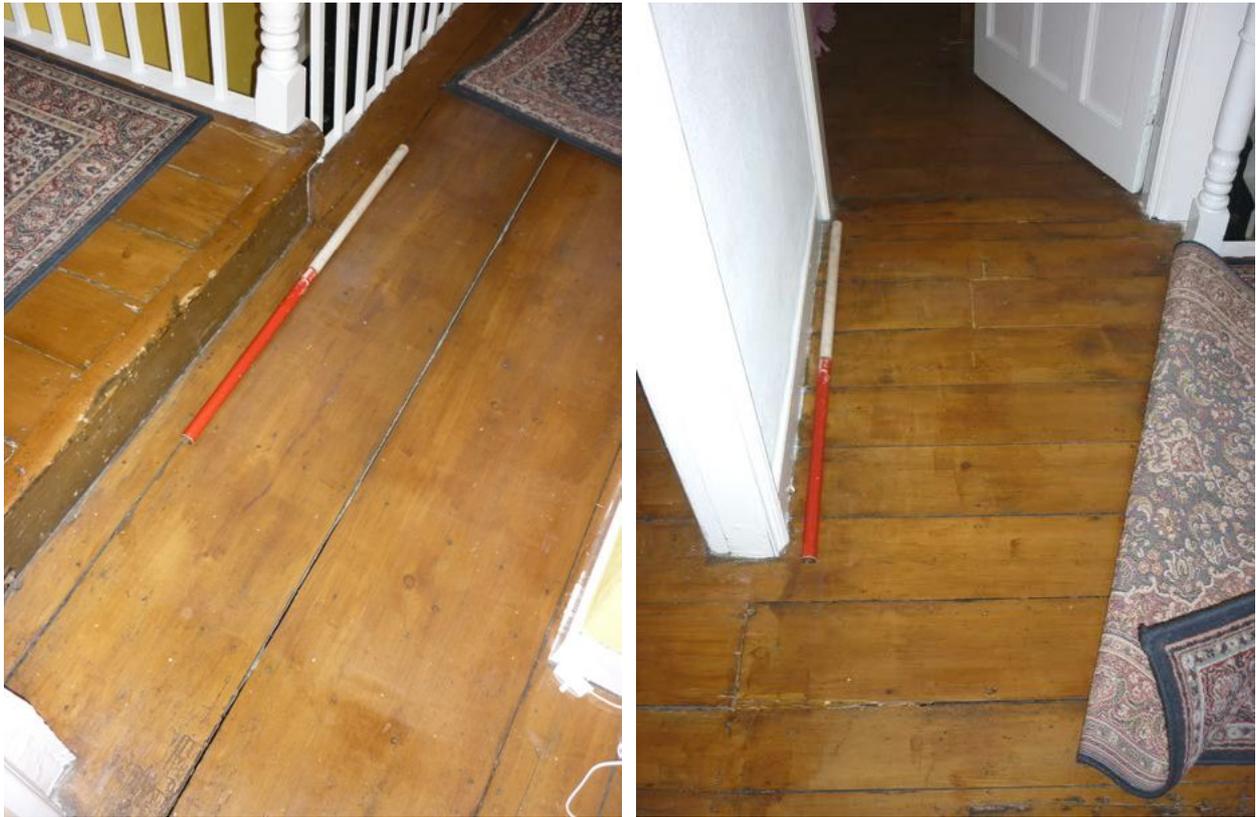
Plate 29 (left): Wide floorboards on the east side Room 10

Plate 30 (right): Regular sized floorboards on the west side of Room 10

4.3.10 **First Floor, Room 10:** this room is a first floor landing and provides access to all the first floor rooms, the room is divided in two by a step that is highest on the west side. The floor has wide varnished floorboards on the east side (Plate 29) and regular sized floor boards on the west side (Plate 30). There are moulded skirting boards throughout, and all the walls and ceiling are plain and wallpapered. The east wall, significantly, is a partition wall that has a door with two fielded panels that could well be original to the house (Plate 31). The central section of the south wall is notable because of its thickness; this could potentially indicate the presence of an earlier construction incorporated into the existing house. The posts on the staircase do not match and the handrails do not fit as smoothly as they perhaps should, this may indicate that work has been carried out on the staircase at some point (Plate 32).

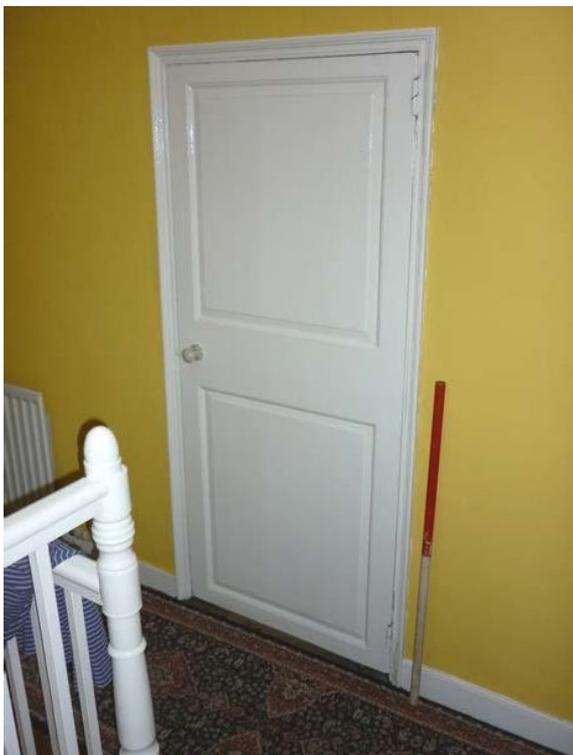
Plate 31 (left): Interior door in Room 10

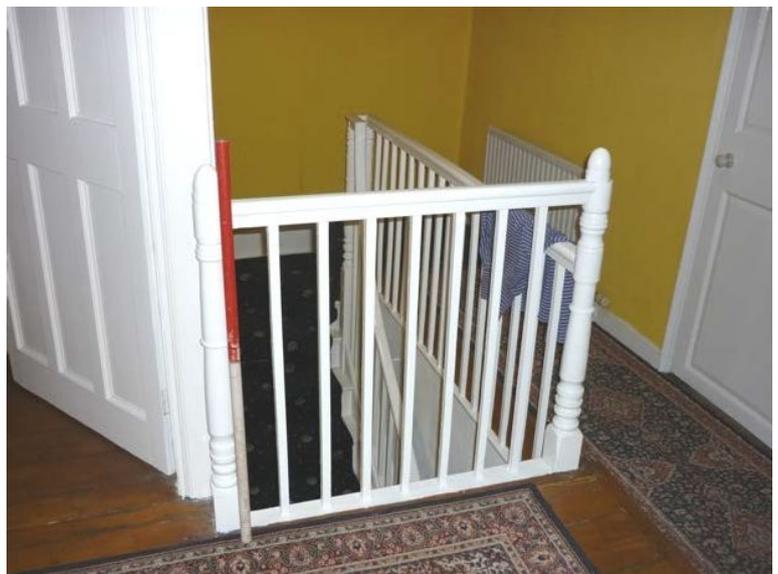
Plate 32 (right): Handrail in Room 10
