ROSECOTE FARM, DUNGEON LANE, BARROW-IN-FURNESS, CUMBRIA

Archaeological Building Recording

Client: Holker Estates Co Ltd

July 2013

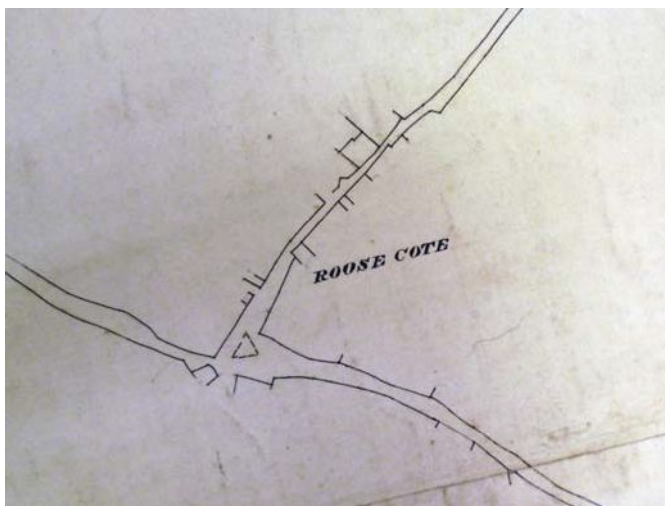
Plate 1: Extract from the Tithe map of 1842 showing 'Roose Cote'

3.1.2 **Tithe map, 1842:** this is typically the earliest detailed map of the area (CAC(B) BPR1/I3/2 1842) but it was clearly not subject to tithes as the map is essentially blank, showing only the arrangement of roads, although 'Roose Cote' is marked (Plate 1).

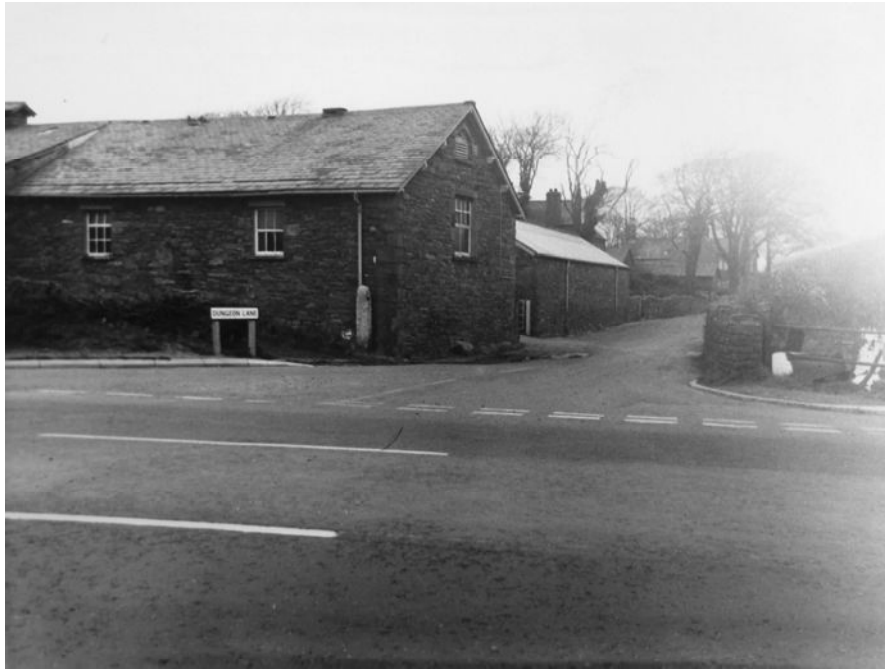
Plate 8: The farm buildings (Buildings 3 and 4) at the junction of Rampside Road and Dungeon Lane in 1973 (CAC(B) BLC/265/VBROO22)

3.1.7 Photographs, 1973: a collection of photographs of buildings at Roosecote taken in 1973 show several of the buildings being recorded (Plate 6, Plate 7 and Plate 8). These show the farm buildings to have essentially their present form, although in much better condition and with some minor alterations. There is an apparently different arrangement of attached outbuildings on the south-west side of Building 3, however.

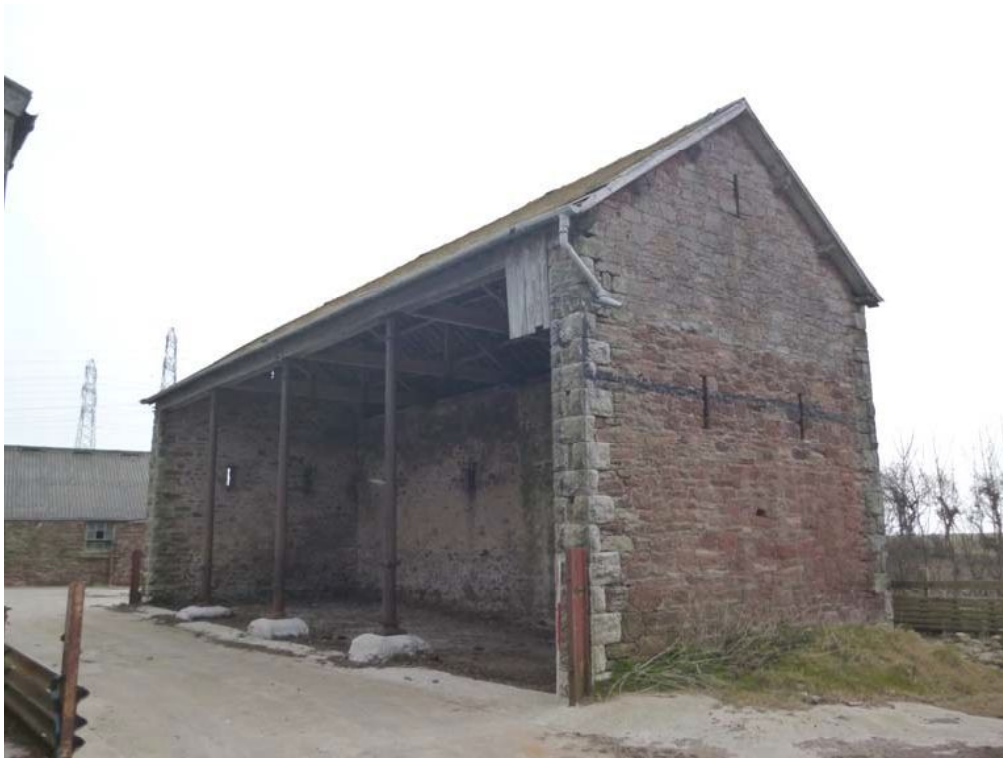
Plate 9: The north-east and north-west external elevations, Building 1

4.2.1 **Building 1 – north-east elevation:** this is the front, facing the farm yard, and is entirely open (Plate 9). The sides comprise the ends of the two gable walls and are finished with rock-faced ashlar quoins with dressed edges. The centre has a thick machine-cut timber beam spanning the entire length of the elevation (probably made up of several parts), which supports the trusses and is supported by three iron columns each with a flanged plate at the top (Plate 10) and a square base sat on a rusticated limestone block with a dressed pyramidal top (Plate 11).

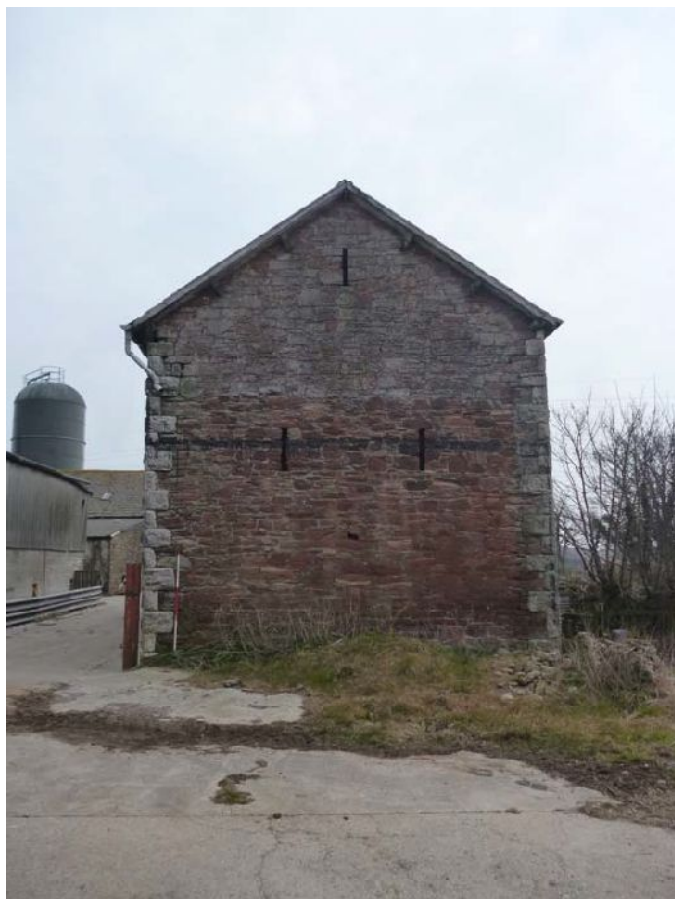
Plate 12 (left): North-west external elevation, Building 1

4.2.2 **Building 1 – north-west elevation:** this forms a gable end and is constructed from essentially plain stonework with dressed limestone quoins as described above. There are two narrow slot vents at mid-height and another above in the centre (Plate 12). Below the higher of the slots, but across the two lower ones, is a horizontal tar line presumably denoting the position of a former outshut roof. At the eaves the ends of the purlins project through the wall and support the roof, which over hangs beyond its line. There are fragments of wall butting the south-west side.

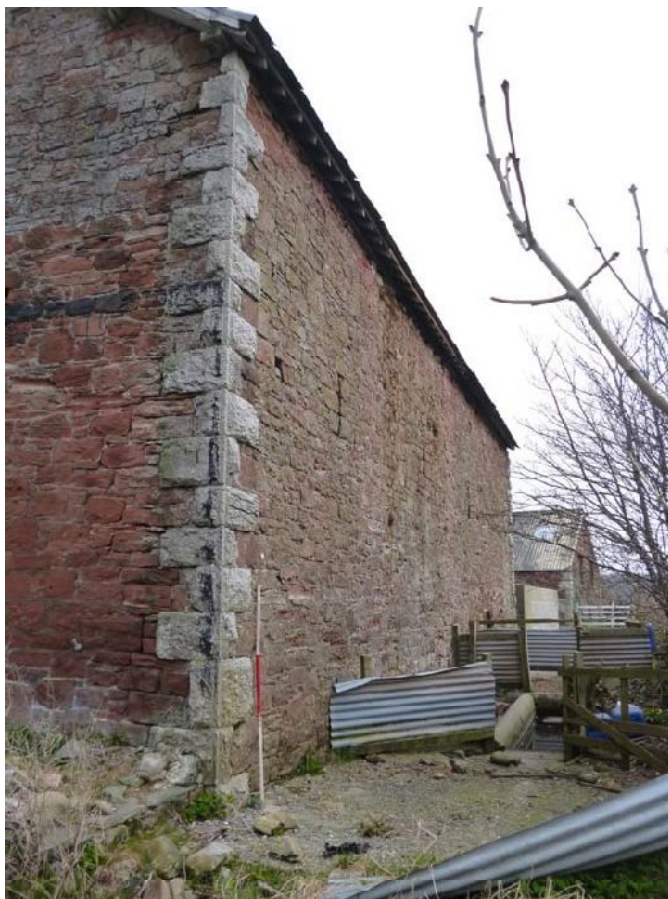
Plate 13 (right): South-west external elevation, Building 1

4.2.3 **Building 1 – south-west elevation:** this is the rear, facing onto the main road. It has rusticated limestone quoins at either end, as elsewhere, and a row of four narrow ventilation slots at mid height with a concrete block wall attached on the south-east end (Plate 13).

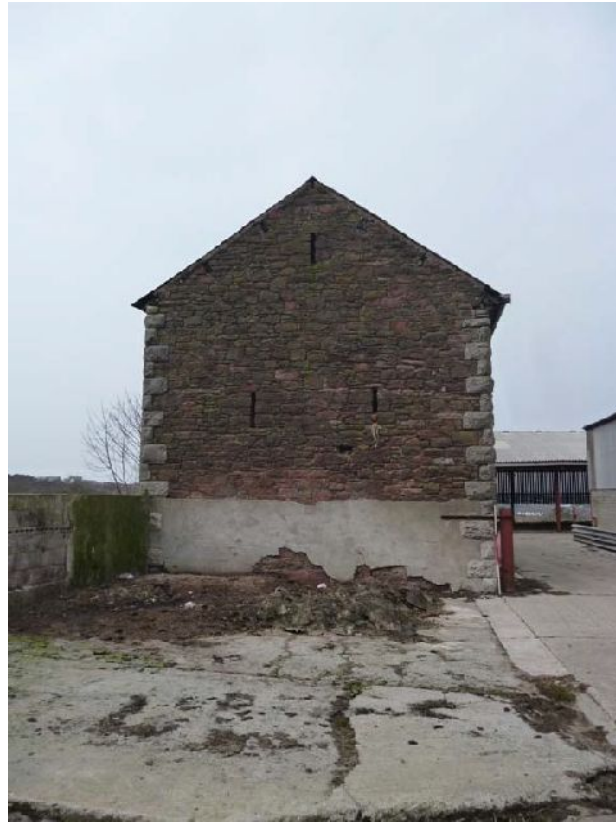
Plate 14: South-east external elevation, Building 1

4.2.4 **Building 1 – south-east elevation:** this is essentially the same as the north-west elevation. It too has rusticated limestone quoins at both ends and three ventilation slots. The lower part is covered by a concrete skim associated with an adjoining manure storage yard and the eaves have been repointed with concrete (Plate 14).

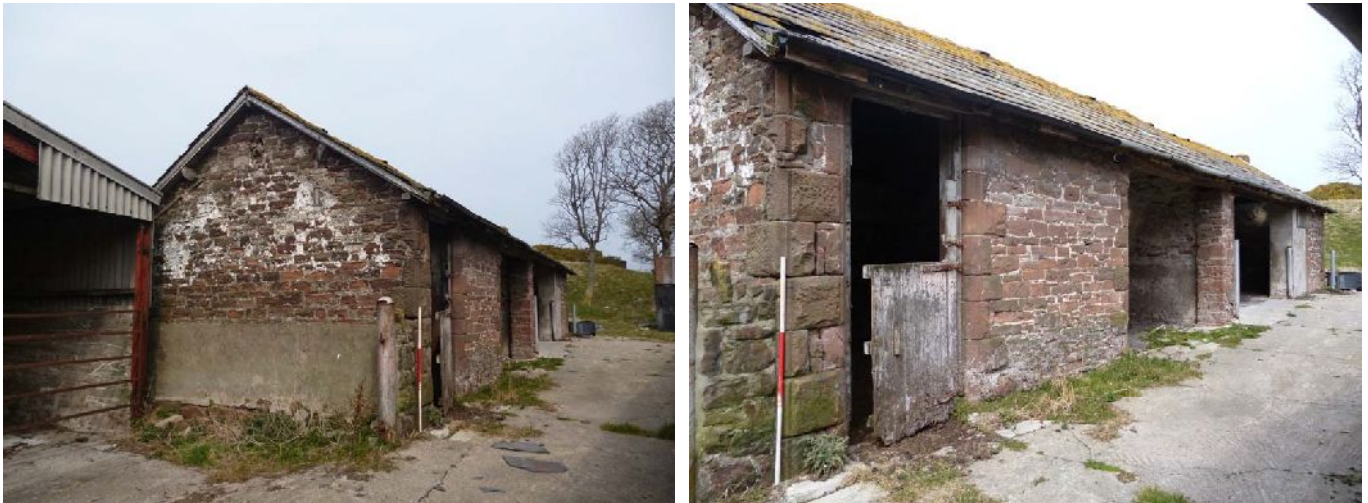
Plate 17 (left): South-west external elevation, Building 2

(Plate 17). There is a short stub wall incorporating a gate post on the south-east side with a concrete scar denoting the position of an attached roof on the north-west side.

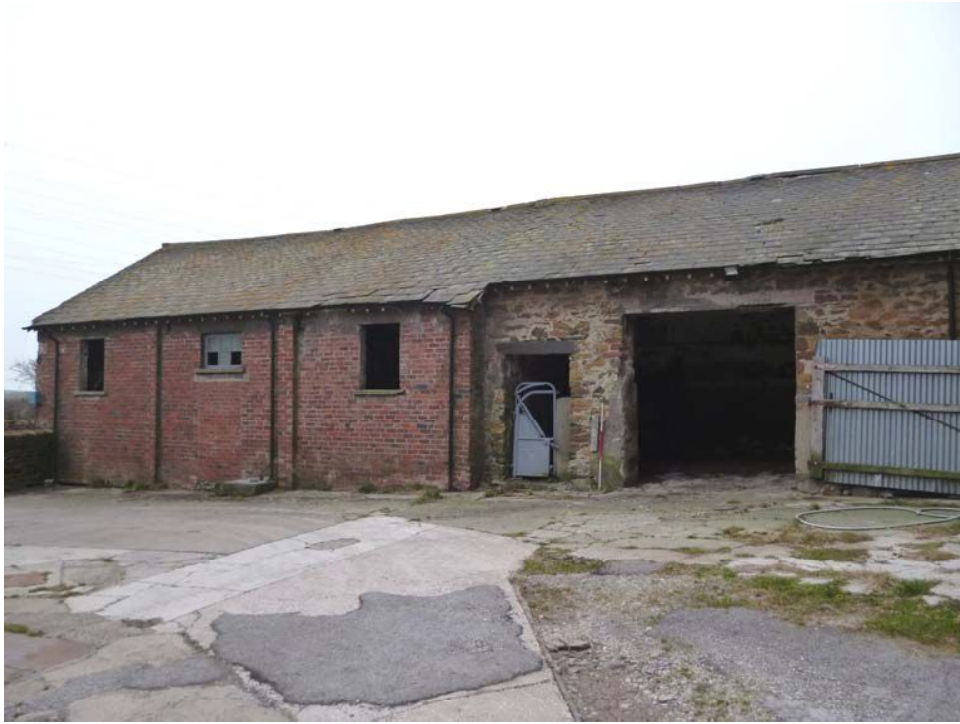
Plate 19: South-east side of the north-east external elevation, Building 3

4.2.9 Building 3 – north east elevation: the south-east side of the elevation is constructed from machine made red brick laid in six rows of stretchers to one row of alternating headers and stretchers (Plate 19). It has a pair of buttresses with a window either side, both with concrete sills and lintels but no surviving casements. In the centre is a blocked doorway with a sill and step. A small window is positioned above this doorway, which uses the lintel of the doorway as its sill and has a six-light casement. This section actually butts the wall to the north-west, where there is a slight step. There is a doorway just beyond this with a slate lintel and concrete step and a metal insert forming an animal gate. Beyond this there is a large wagon doorway with a concrete lintel and a concrete skim over the lower part, which also incorporates some concrete blocks. To the north-west is a large window with a concrete sill and lintel with slatted timber infill. The north-west side of the elevation, beyond the return to the north-east and below the main gable, is covered by monopitch outshut with a corrugated concrete roof and roughcast finish, as is the wall of the main gable above although the ends of the purlins still project through this (Plate 20). This outshut has a window on the north-west side with a 12-light casement, the top four hinged, and a slate sill. There is a doorway to the south-east with an ovolo-moulded surround and wide beaded plank door. To the north-west there is a step in the wall, beyond which the elevation is further extended by a concrete block built monopitch outshut (Plate 21).

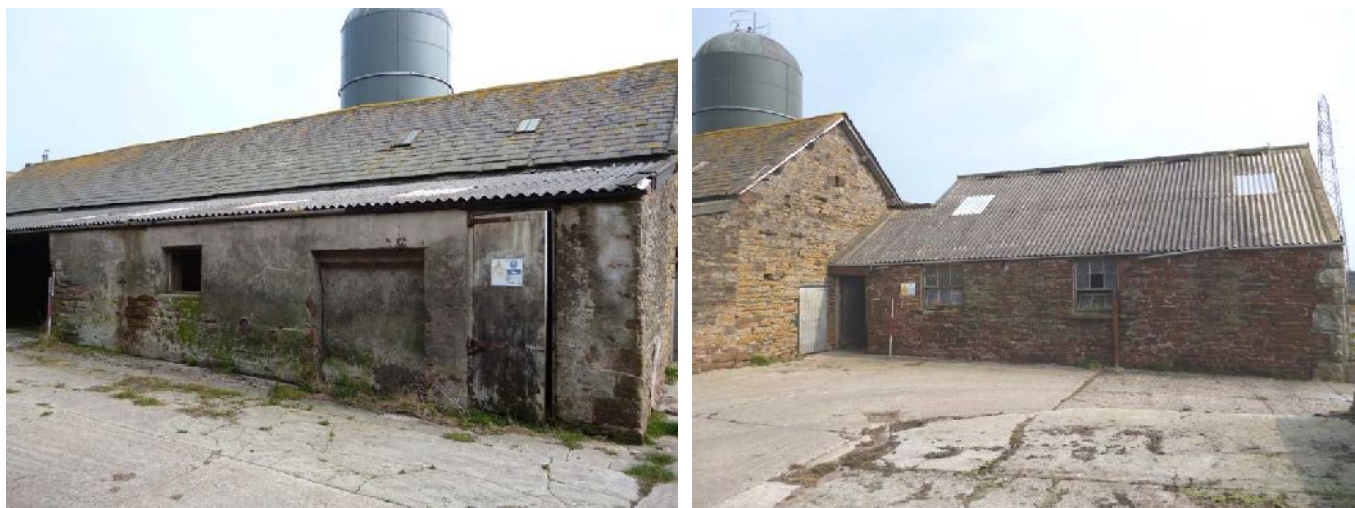
Plate 22 (left): Central section of north-west external elevation, Building 3

end before a wide doorway, all of which have thin timber lintels (Plate 22). This section is of concrete block construction but south-west of this doorway the wall is stone and partially covered with concrete render. There is a window near the centre of this section too with a plain timber frame and blocked opening to the south-west, presumably a doorway, that has left an alcove with a timber lintel that is clearly a re-used railway sleeper. There is a slight return at the south-west end where there is another doorway, which is very tall and has a plain timber door and surround. The wall is finished with dressed quoins where it returns to the south-east. Beyond this the elevation is constructed from exposed stone (Plate 23). There is a doorway on the north-east side with quoined south-west jamb, dressed stone lintel and tongue and groove plank and batten door in a plain surround. To the south-west are two windows, with timber lintels and stone sills with nine-light casements, the bottom three hinged. There is a row of five ceramic vents along the base of the wall and rock-faced limestone quoins at the south-west end.

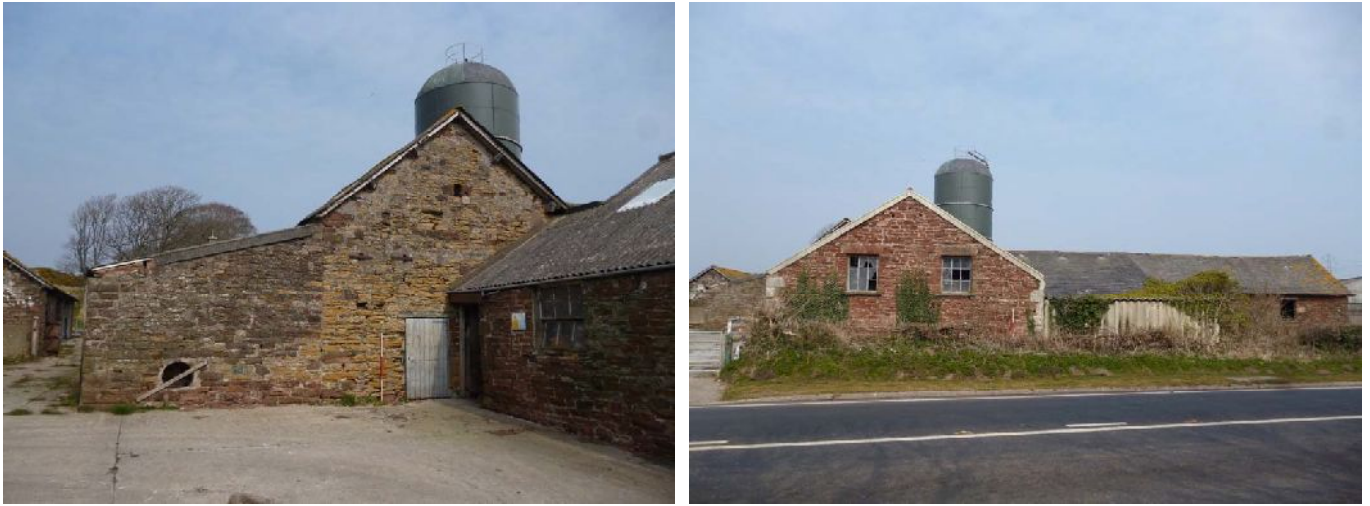
Plate 24 (left): North-west side of the south-west external elevation, Building 3

4.2.11 Building 3 – south-west elevation: the north-west side comprises a monopitch sandstone extension with a large round hole lined with concrete low on the north-west side (Plate 24). This butts against the main part of the building, which forms the gable end at this point. This has an owl hole or large vent near the top, there are some through stones, and the ends of the purlins project through the wall. There is a doorway on the north-west side with a grey stone lintel and tongue and groove plank door. There is a band of concrete pointing across the centre of the elevation and two iron straps bolted to it. It returns to the south-west after which it forms a lower gable. This has dressed limestone quoins at both end and two windows with sandstone sills and lintels and nine-light casements (Plate 25). There are three pipes built into the wall below the eaves forming vents. It is extended to the south-east by a section of corrugated sheeting forming a wall, with a similar roof, forming a room covering the wall proper. To the south-east of this the wall is relatively plain although of exposed stone. There are two windows with concrete lintels and stone sills. The north-west has what appears to be a blocked doorway below it with quoined jambs and there are possible blocked vents on the south-west side, two low level and one high.

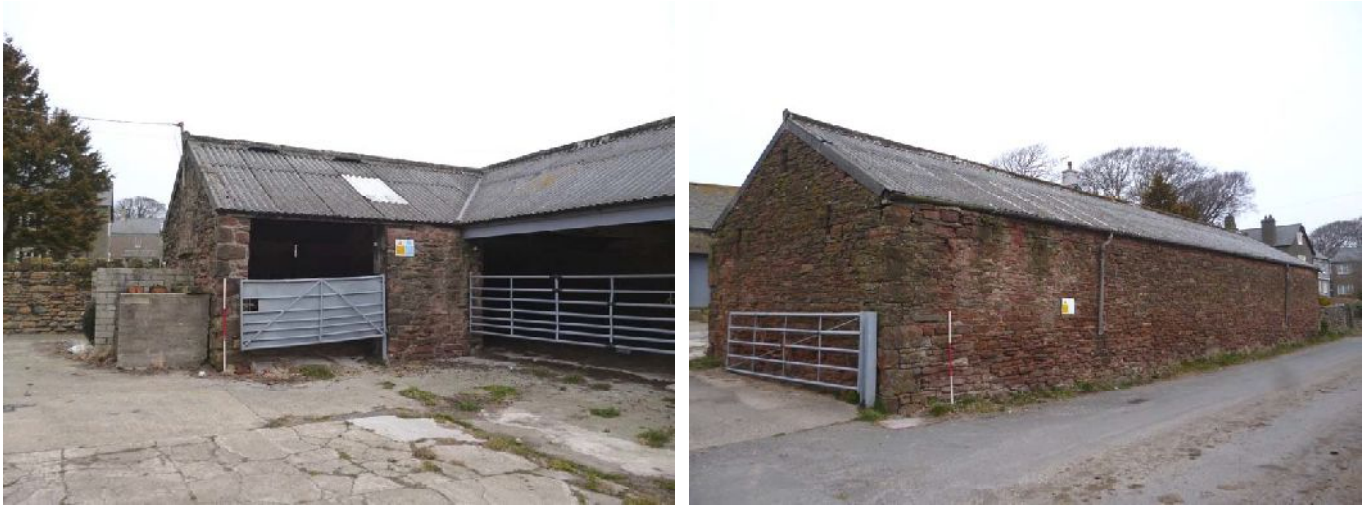
Plate 30 (left): North-west side of the south-west external elevation, Building 4

4.2.16 **Building 4 – south-west elevation:** the north-east end has a wide doorway with quoined jambs and the wall plate for a lintel with a metal gate across (Plate 30). It appears to butt the wall where it returns to the south-west before forming the gable. This is quoined at the corners, although these are larger on the north-west side, and there are two slot vents with slate lintels and sills and a wider vent above, below the eaves, in a similar style (Plate 31).

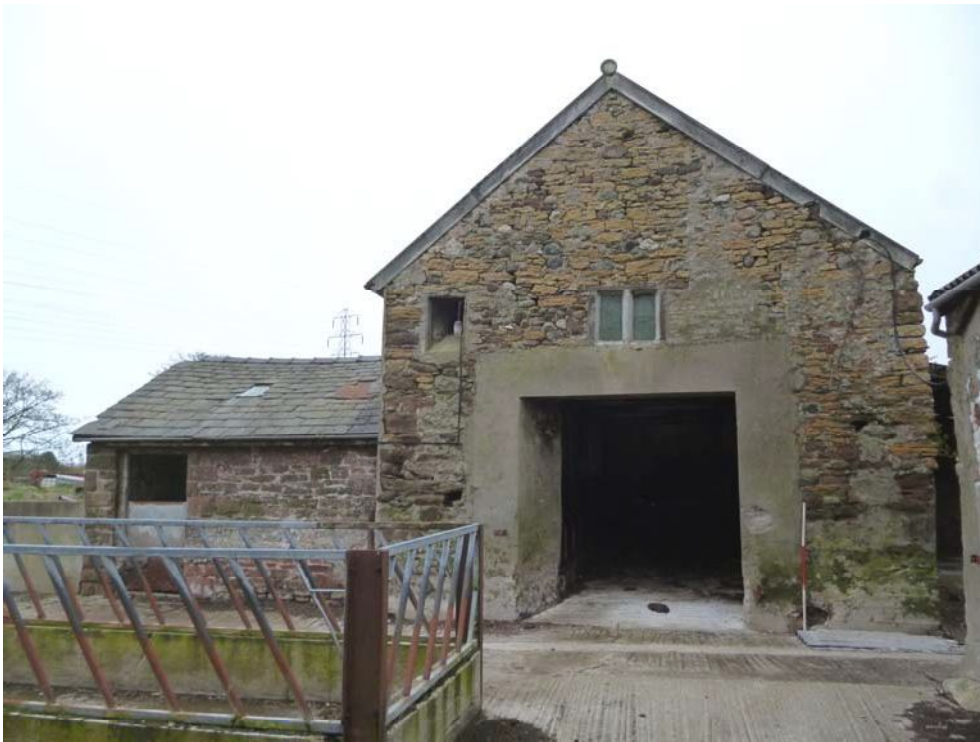
Plate 32: North-east external elevation, Building 5

4.2.18 **Building 5 – north-east elevation:** this comprises the gable end of the building plus a small extension to the south-east. The gable has a large inserted doorway with concrete over the jambs hiding the lintel. Above it is a two-light unglazed mullion window, and to the south-east of this is a smaller single-light window, which is evidently inserted. The south-east extension is the side of a small extension, with a doorway on the south-east side with quoins with dressed edges and stop chamfered surround round a split plank and batten door. There are dressed quoins at the south-east end. The north-west end of the elevation, after a return to the south-west, is covered by a long monopitch outshut. This has a large doorway on the south-east side with a sliding metal door and concrete over the jambs. There are two further doors to the north-west, both with dressed limestone quoins and plank and batten doors, the south-east split. There are also two windows, with concrete sills and plain surrounds but no casement remains.

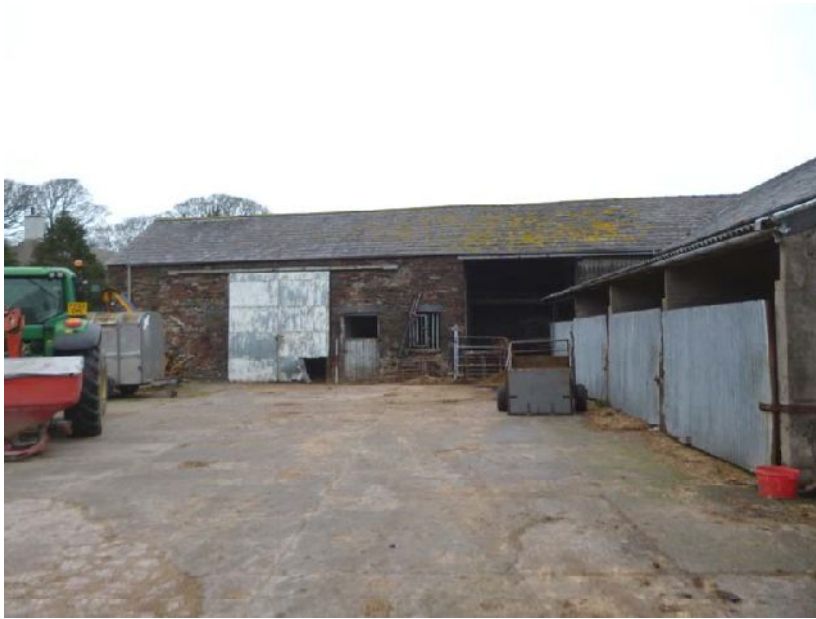
Plate 37: North-west side of the south-west external elevation, Building 5

4.2.20 Building 5 – south-west elevation: the north-west side is mostly constructed from randomly coursed sandstone blocks, although some are more rounded and volcanic, with dressed quoins at the ends and the concrete scar of an attached monopitch outshut with a projecting stone that presumably supported the ridge purlin (Plate 34). There is a blocked aperture to the south-east with a slate lintel then a large wagon doorway with a sliding metal door (Plate 37). There is a further smaller doorway and window to the south-east of this, both with slate lintels and plank and batten split door in the doorway and iron bars over the window. There are quoins to the south-east before a large opening with the roof supported by a long timber lintel. The south-east end is completed with concrete blocks and corrugated sheets and there is a single cast iron column supporting the lintel at this end. After a return to the south-east the remainder of the elevation comprises an end gable with quoined corners and a barge board (Plate 33). There is a ground floor window with a concrete sill and stone quoins and lintel and a two-light hinged casement. Above is another opening with a stone sill, lintel and quoins filled with timber slats. The ends of the purlins project and the gable are extended by a modern steel-frame shed finished with corrugated sheeting to the south-east.

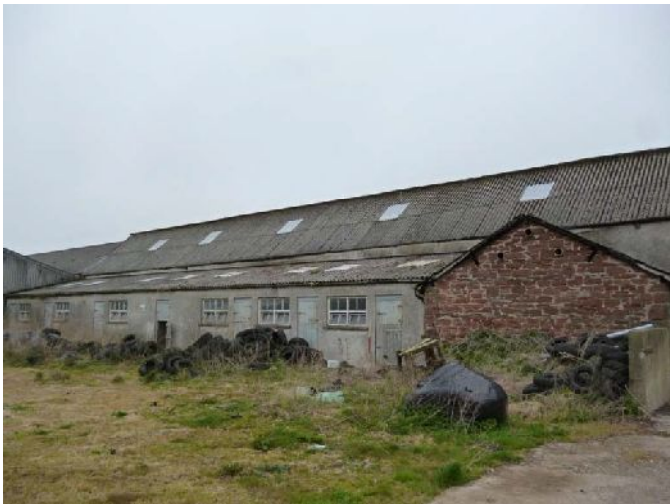
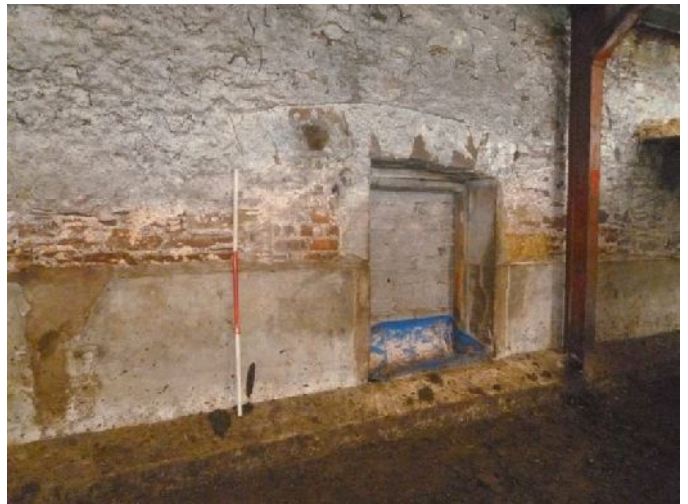
Plate 38 (left): North-east end of the south-east external elevation, Building 5

4.2.21 **Building 5 – south-east elevation:** this is relatively plain, with the gable of the small extension at the north-east end, with dressed quoins. There are three ceramic pipe vents and the burnt ends of purlins projecting through the wall and a barge board (Plate 38). The rest of the elevation is obscured by later outshuts, mostly monopitch finished with rough cast and with seven split doors and six eight-light windows, the bottom four lights hinged (Plate 38). The south-west end of the elevation is obscured by the later steel framed shed, although within this the wall is visible although the only feature of note is the wide blocked doorway corresponding to the doorway in the centre of the north-east elevation of Room 3. This has a dressed stone voussoir arch and the south-west side is totally blocked, with brick on this side, while the north-east side is blocked internally, with concrete blocks, leaving an alcove (Plate 39).

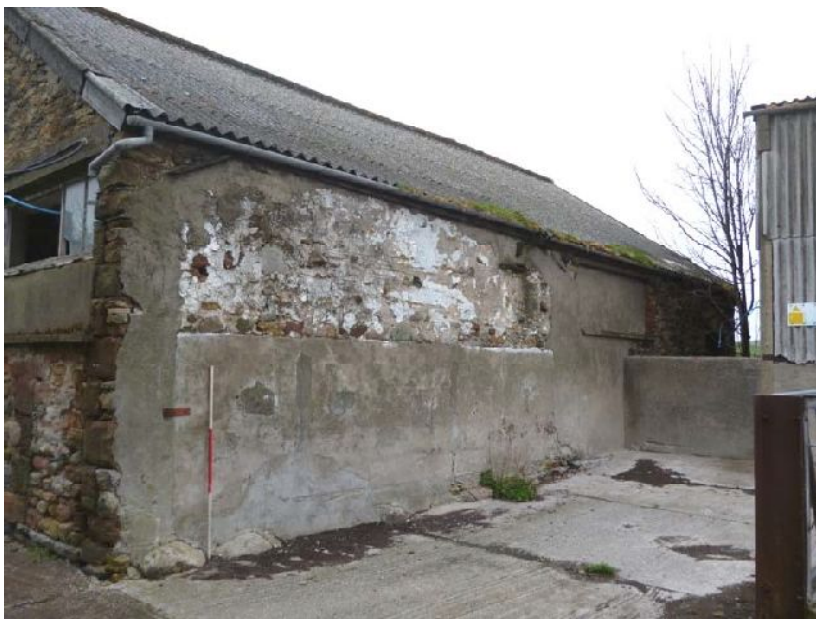
Plate 46: North-east end of the south-east external elevation, Building 6

4.2.25 Building 6 – south-east elevation: the south-west end has stone quoins and is stone but the rest of the elevation is red brick laid in English garden bond at a ratio of six rows of stretchers to one row of headers, with two engaged pillars (Plate 44). There is a row of three windows with concrete sills and lintels, which are partially filled with concrete leaving a slatted opening above. There is a large inserted doorway south-west of the centre, which uses one of the pillars as its south-west jamb and has a timber lintel. After a return to the south-east the north-east end of the elevation is largely covered with a concrete skim and plaster or limewash although some throughstones are visible (Plate 46). There is a window on the north-east side blocked with concrete and with a concrete sill and lintel and red brick in the north-east jamb. To the north-east there is a doorway with a timber lintel and bricks in the jambs. The north-east end has quoins with dressed edges.

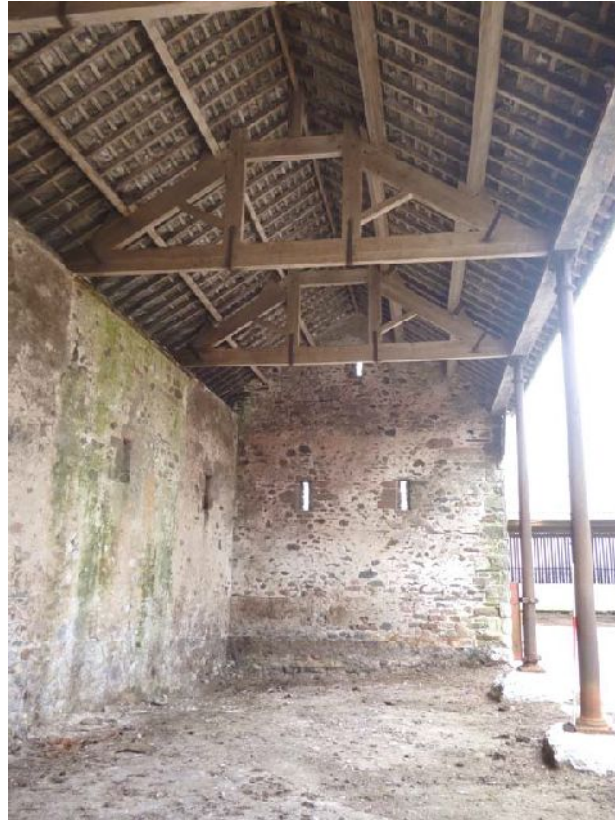
Plate 53: Trusses in Building 1

4.3.1 **Building 1:** the roof of this building is constructed from slate and held up using machine cut timber taking the form of a variation of a queen post truss with iron straps tying the post to the tie beam (Plate 53). The North East wall of this building is completely open apart from three round cast iron pillars each with flanged tops supporting the roof. The North West wall had plain stonework with rusticated quoins made from limestone at both end, and three air vents that were splayed. The South West wall had plain stonework with four splayed vents adjacent to each other horizontally but was otherwise plain. The South East wall was the same as the North East wall.

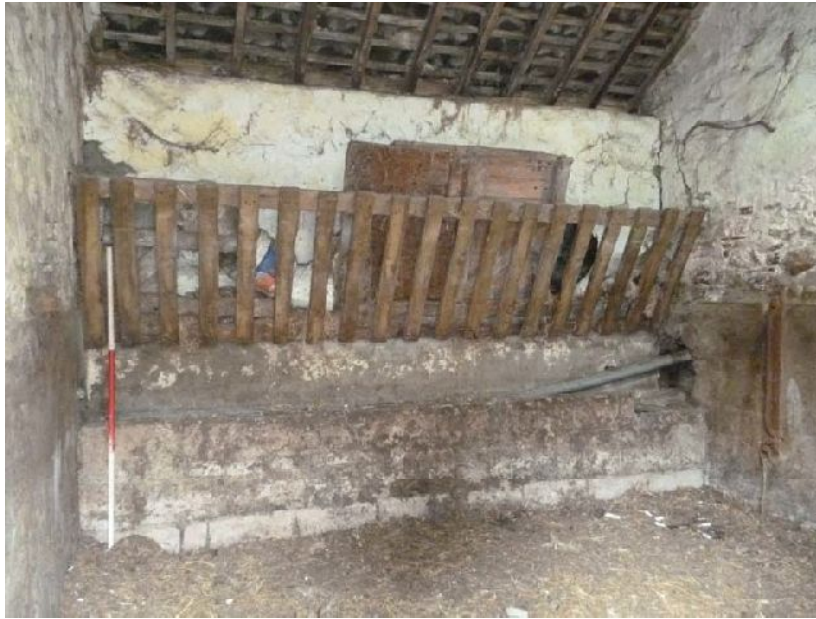
Plate 58: Trough and manger, north-west side of Room 3, Building 2

south-west elevations are plain, although the north-east has a timber manger attached to the wall above an iron tether. The south-east has a pair of ceramic troughs against in on the north-east side on a concrete stand and an iron manger above. There is a doorway to the south-west, the north-east jamb of which is dressed. The north-west elevation has a concrete-block built trough against it with a timber manger above (Plate 58).

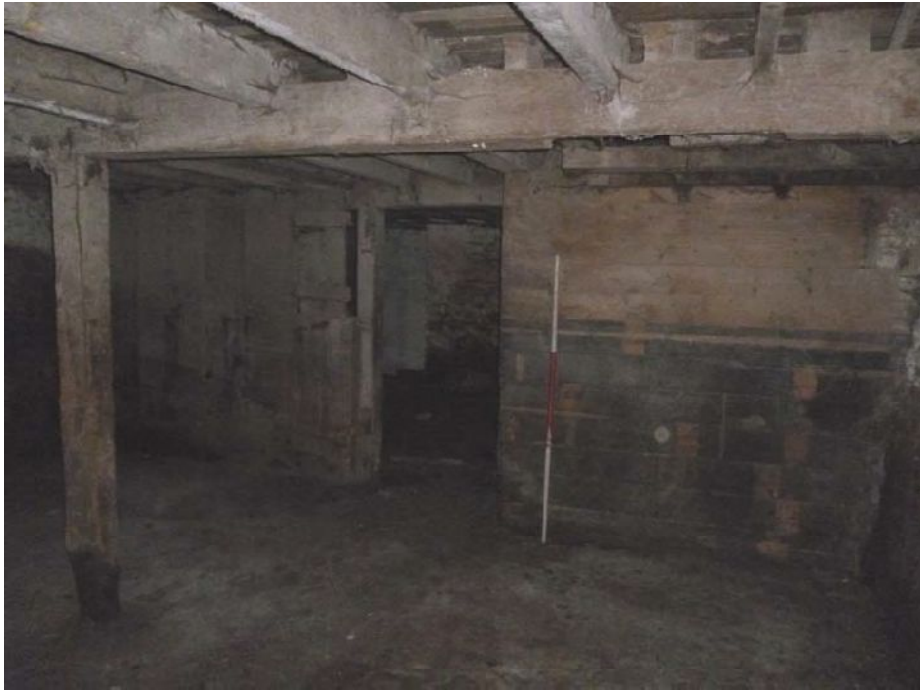
Plate 71: Timber walls below the inserted floor, Room 4, Building 3

steps with an iron hand rail at the north-east end (Plate 70), below which are two short sections of timber wall with a doorway between on the south-west side (Plate 71). The room is essentially open to the roof, apart from below the inserted floor, which is supported by four trusses although another is incorporated into the north-east elevation (see below). All of the trusses are essentially of raised cruck type, with the crucks resting on a tie beam and with a collar and a higher short collar or yoke, with spurs and packing pieces with extending out to the roof and also connecting to wind braces between the latter and the purlins (Plate 72 and Plate 73). In all cases the tie beam has been sawn off at both ends and a further collar or tie beam has been bolted on, with only the truss built into the north-east elevation showing the original arrangement. In several cases the timber used in the trusses is re-used, some clearly fragments of cruck blade and in general hand finished but the bolted pieces are mostly machine cut planks. There are two purlins per pitch plus a ridge plank.

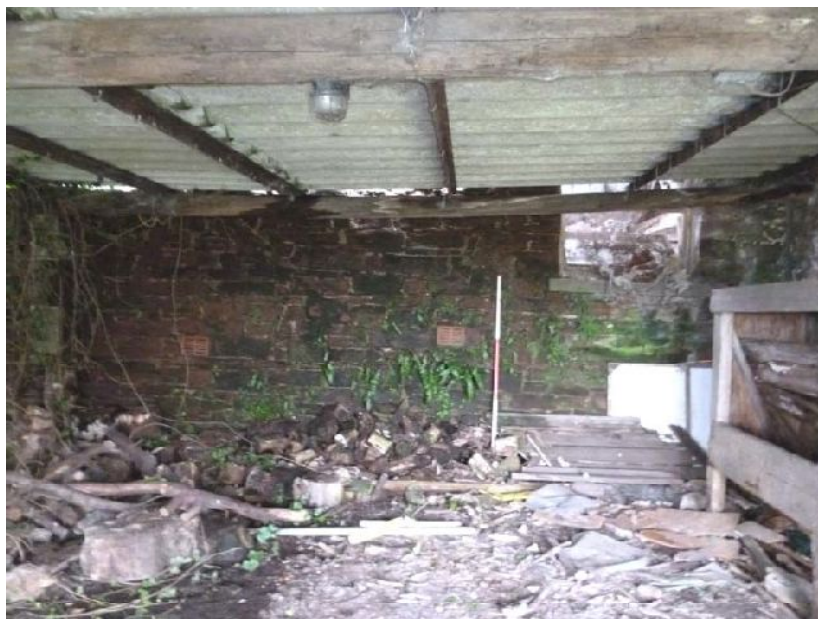
Plate 98: North-west elevation, Room 9, Building 3

4.3.12 To the south-east of Room 8 is a further area (Room 9) enclosed below a corrugated concrete roof and with walls comprising similar sheets held between large upright timber posts and supported by L-shaped iron girders. The north-east elevation is stone, the exterior wall of Room 8, which has two high-level vents. The north-west elevation is the exterior of wall of Room 7 and has two ceramic vents and a window on the north-east side with a stone sill and nine-light casement (Plate 98). The other elevations are just concrete sheets.

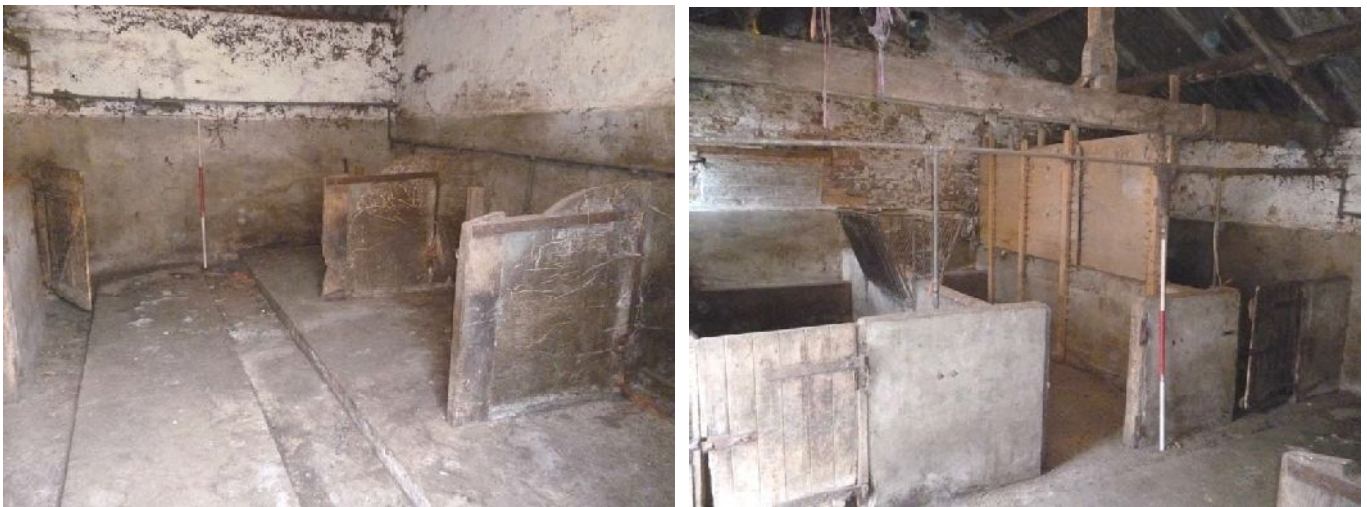
Plate 103 (left): Dung channel and south-west stall, Room 3, Building 4

4.3.14 Room 3 is the central room of the main north-east/south-west part of the building. It has a concrete floor with two north-west/south-east dung channels on the south-west side (Plate 103), leading to a doorway to the north-west. There are concrete stalls on the north-east and south-west sides, those to the north-east are much larger and more elaborate, with attached timber boards raising the south-east stall, timber gates on the south-west end (one now missing), and an iron manger between the two on the north-west side. The south-west stalls are more basic, comprising just low dividing walls in concrete with a central timber tether posts and iron tethers attached (Plate 104). There are troughs attached to the south-west wall. The room is open to the roof, which has a single king post truss the angled braces for which are missing (Plate 105). It has the carpenter's mark 'III' at the junction between the king post and the tie beam but 'V' and 'VI' at the junction between the (missing) braces and the king post. There are also two slots in the underside of the tie beam, presumably relating to earlier stall posts. There are two purlins per pitch plus paired ridge planks and two single-light skylights on the north-west side. The walls

are finished with limeswash and a concrete skim. The north-east elevation has a concrete trough extending along its base and a blocked doorway on its north-west side, filled with concrete blocks (Plate 106). It has a timber lintel, above which there is lots of hand-made brick built into the wall, and there are two possible vents in the wall below a larger vent or owl hole. The south-east elevation is relatively plain, with an attached water pipe and a timber pad for the truss built into it. The south-west elevation has an attached metal water troughs between the stalls, marked 'SALOPIAN', and semi-circular ceramic troughs set in concrete below (Plate 107). Above in the wall there are two square vents and a taller vent or owl hole in the eaves. The north-west elevation has a doorway on the south-west side with a plank and batten door with four lights over (Plate 108). There is a window to the north-east with an eight-light casement, the bottom four of which are blocked externally. Room 4 is at the south-west end of the building. It has a concrete floor and is open to the roof, which has two purlins per pitch and a double ridge plank. The walls are all roughly finished with limewash. The north-east is plain apart from three vents. The south-east has a concrete trough along the base with an iron manger. The south-west has three vents, larger than those to the north-east, the lower two of which have timber lintels and slate sills. A water tank is attached to the elevation and there are pipes leading from it to a water trough on a concrete block in the west corner. The north-west elevation is plain apart from having a large doorway with a gate with quoined jambs, the south-west of which are rougher.
