NATLAND HALL, NATLAND, KENDAL, CUMBRIA

Additional Archaeological Building Recording

July 2013

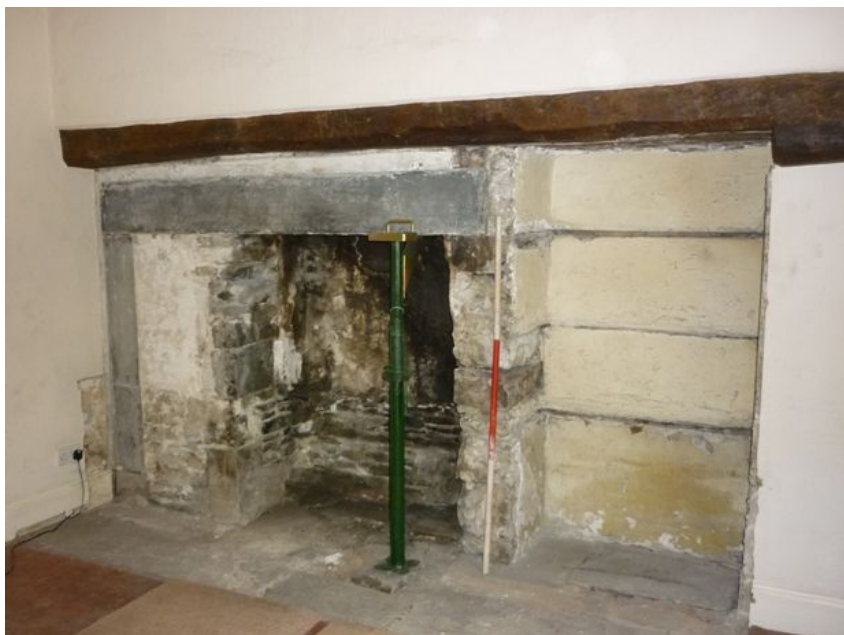
Plate 1 (left): General view of the fireplace as exposed

4.2.1 **Room G6:** the large fireplace on the north side of the room had been entirely exposed, with the modern fire and associated elements removed as well as the cupboard door and surround to the east. This revealed the scar for three shelves within the cupboard, which had multiple pieces of timber comprising the lintel, the southern and largest of which had plaster on the north side suggesting that this area had originally formed an open space also leading into the flue or smoke hood above. The fireplace proper to the west has the remains of a dressed square surround, probably of 18th century date, although the east jamb had been removed (Plate 1) and re-used as a lintel for one of the later fireplaces. The west side, behind this, is partially infilled but with its east side finished with quoins including re-used dressed masonry (Plate 2). This in turn butts a return to the west, which is plastered. The east side of the fireplace has iron rings set into timber built into the wall, which originally no doubt held a fire crane (Plate 3). The floor of the fireplace has the remnants of cobbles and stone flags (Plate 4), the former of which appear to run below the blocking masonry to the west. The floor to the south, extending into the room, is concrete, although evidently originally with flags on top. Although not evident during the additional recording, it is apparent that there were at least two phases of later blocking within the fireplace (Dale Rennard and Dave Tyler pers comm. Plate 5), which no doubt corresponded to later periods of alteration.

5.1.2 **Phase 1 (17th century):** although it was not fully opened out and later blocking remained on the west side, the earliest phase of the fireplace seems to have been an extremely wide opening, extending across much of the width of the room by incorporating the cupboard on the east side. The fire at this time would probably have been supported on a free-standing grate or fire dogs. The arrangement on the west side is less clear, as the apparent blocked doorway in Room G8 would have entered the side. It is possible, given the sloping angle of the flue above this that this doorway actually led to a cellar that was subsequently blocked but without further evidence this remains supposition. Alternatively the 'doorway' in G8 may simply have been an alcove or wall press.

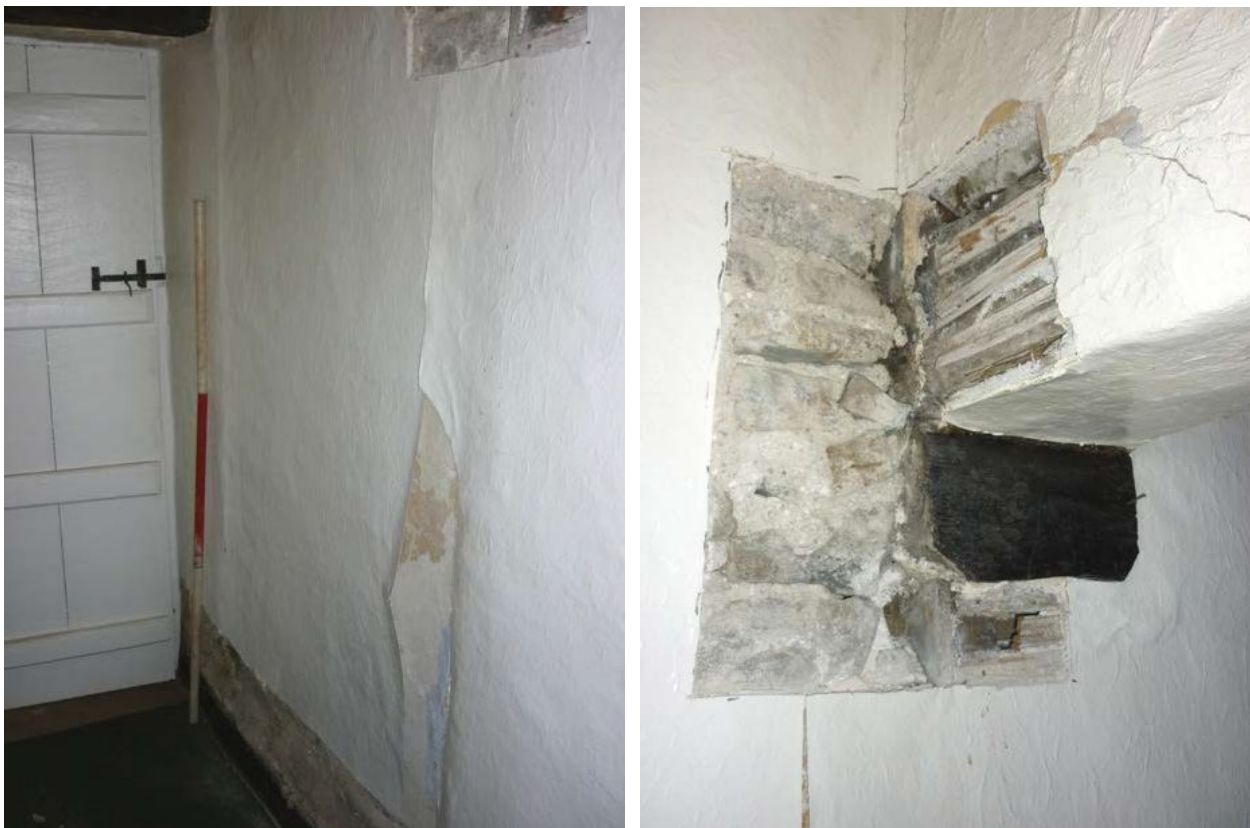
4.2.2 **Room G8:** along the east side of the corridor, adjacent to the chimney breast in Room G6, small areas of plaster had been removed. These revealed an apparent opening, 1m wide, blocked with stone in lime mortar (Plate 6). Its lintel had not been exposed so it is not clear how tall it was. It is not clear if this represents a doorway, although its position would seem to preclude this as it would enter the back of the chimney. It is possible that it is therefore simply a cupboard or wall-press although the possibility of it representing a doorway leading into a blocked cellar is conceivable; the stonework in the flue above is sloping at this point, which would fit such an idea. The removal of plaster along the south edge of this opening, adjacent to the beam, also showed more detail of the beam, and that it was apparently not a single piece running continuously across the room with a section cut out as initially thought, but a separate piece raised on timbers set into the east and west walls (Plate 7).

Plate 6 (left): Blocked area on east side of Room G8

Plate 7 (right): Blocking adjacent to beam on east side of Room G8 showing arrangement of beams

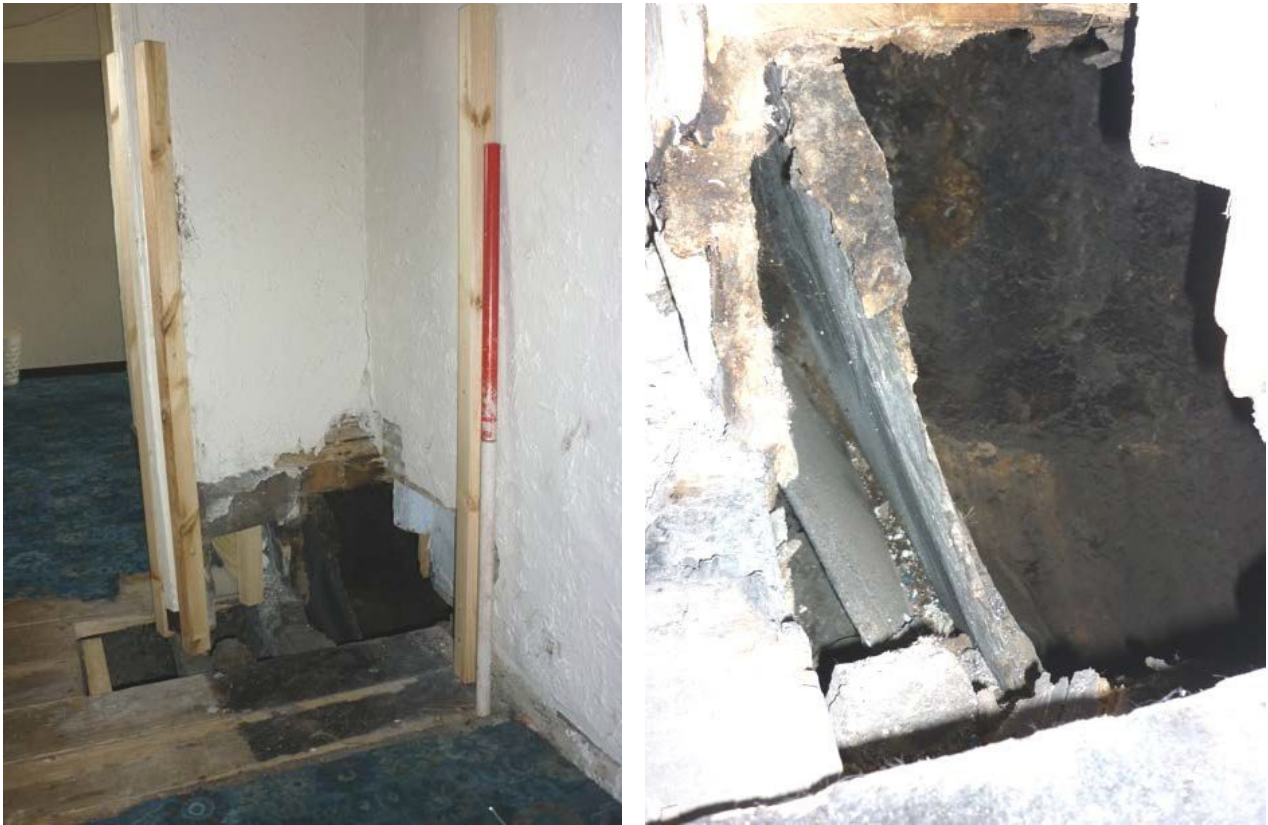
4.2.3 **Room F3:** the interior of the smoke hood was exposed on the east side of the corridor (Plate 8). It was difficult to view in detail although it was apparent that the west side was at least partially lined with slate (Plate 9). Some of the joists and beams were exposed below the floorboards although only small sections were visible and little information could be gained as a result.

Plate 8 (left): Exposed smoke hood in Room F3

Plate 9 (right): Detail of slate lining in smoke hood, visible in Room F3

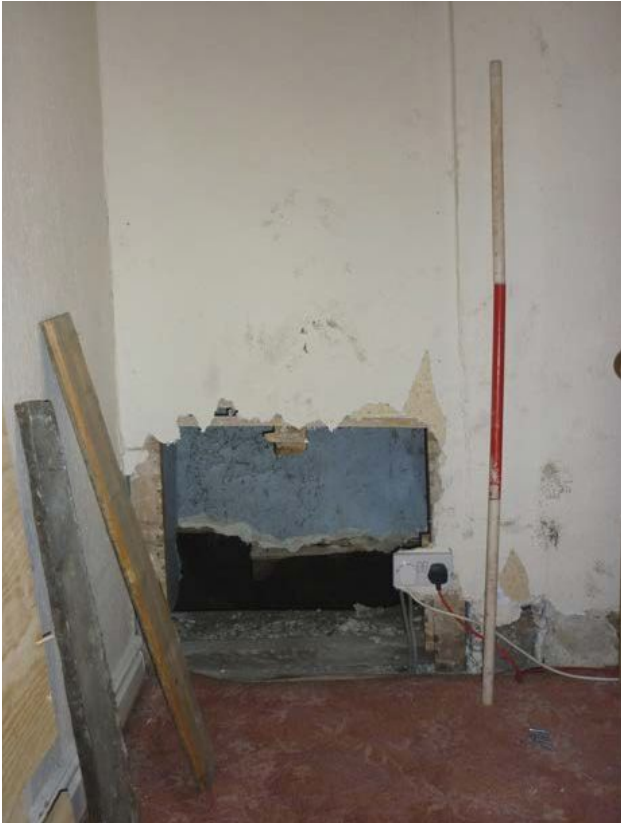
Plate 10 (left): Wall broken through in Room F4

4.2.4 **Room F4:** the stud wall on the west side of the north elevation has been broken out at the base, revealing that this is actually quite a late addition covering what must have originally been an open alcove between the wall to the west, the smoke hood to the north, and the solid masonry chimney to the east. The posts of the smoke hood and the base rail are exposed and the walls within the alcove are finished with plaster and paint with the floorboards continuing into this space (Plate 10). In addition, the planks forming the back of the cupboard in the north-east side of Room F4 have been removed revealing the smoke hood behind (Plate 11).

5.1.5 **Phase 4 (20th century):** the fireplace was ultimately modified again in the later 20th century, with the addition of stone cladding, the partial reduction in size of the cupboard at the east end, and the insertion of the gas fire that was present during the previous building recording. On the first floor it appears that the alcove to the west of the flue in Room F4 was covered at this time with stud walling, although it is not clear why.
