BECKSIDE COTTAGE, BECK SIDE, CARTMEL, GRANGE-OVER-SANDS, CUMBRIA

Archaeological Building Recording

July 2013

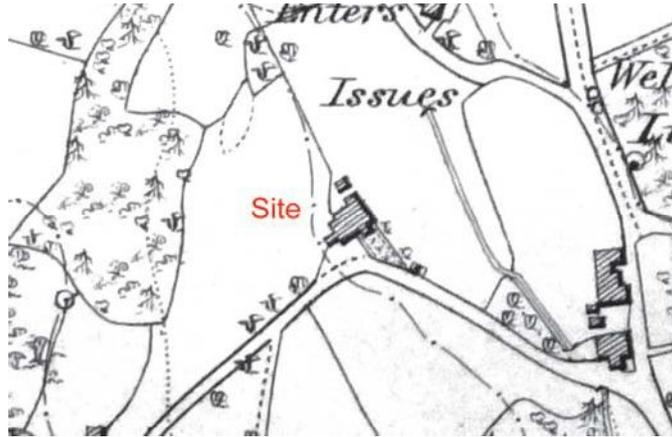
Plate 1: Extract from the Ordnance Survey map of 1851

3.1.2 **Ordnance Survey, 1851:** this is the earliest Ordnance Survey map available of the area and a cottage is clearly marked at the location with another smaller building marked to the north. Unfortunately, the detail is slightly limited and the orientation of the cottage appears to be incorrect, although it may have been altered and has certainly been added to since (Plate 1).

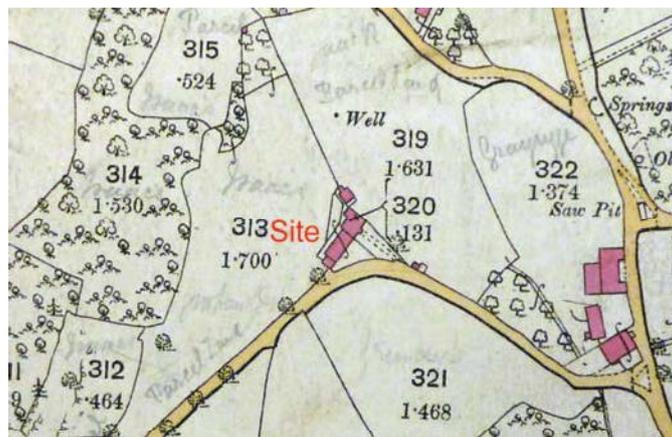
Plate 2: Extract from the Ordnance Survey map of 1890

3.1.3 **Ordnance Survey, 1890:** the footprint of the cottage and principal barns to the south-west is clearly apparent by this time (Plate 2). The layout of these sections of the buildings appears much as it is today although the porch to the north-west side of the cottage is absent. The nearby fields, labelled 313 and 319, notably have 'Isaac' and 'Isaac R' pencilled on, which corresponds with Isaac Rawlinson who is the named owner c1910 (see Section 3.2).

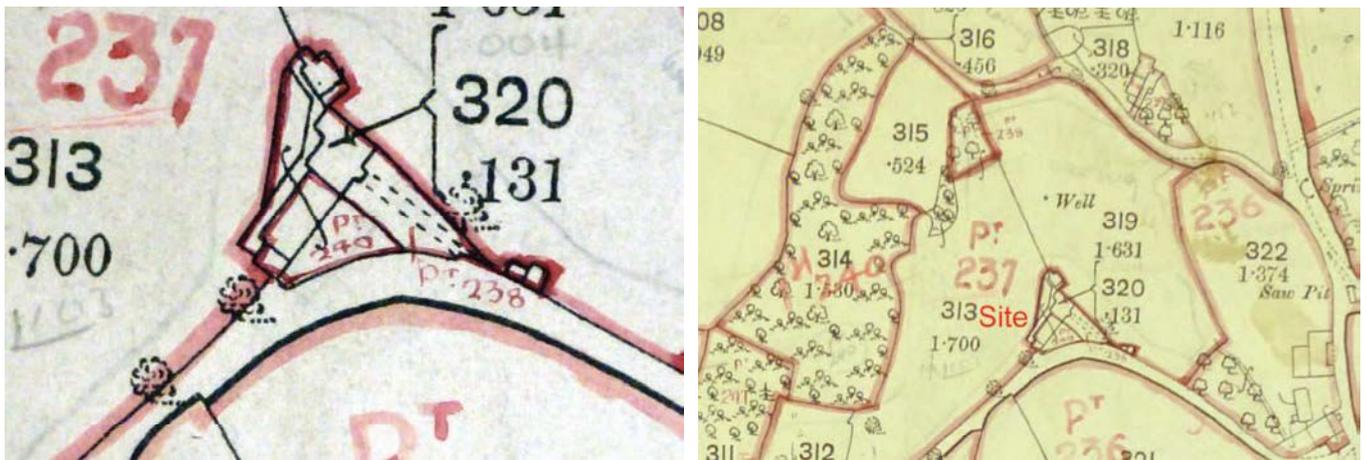
Plate 3 (left): Extract from the Ordnance Survey map, showing detailed rating valuation numbering c1910

3.1.4 **Ordnance Survey, 1890:** the reference numbers for the Inland Revenue *Record of Valuation* of c1910 are marked on a copy of the earlier Ordnance Survey map from 1890. This records the cottage to the north-east and the barn and outbuildings to the south-west as separate entries forming parts of plot 238 and 240 (Plate 3). Plot 240 also includes a sizeable area of woodland to the north and west of the site, as does 238, albeit a smaller area of woodland, both of which are separated by plot 237 (Plate 4). A summary of these entries is presented below in Section 3.2.

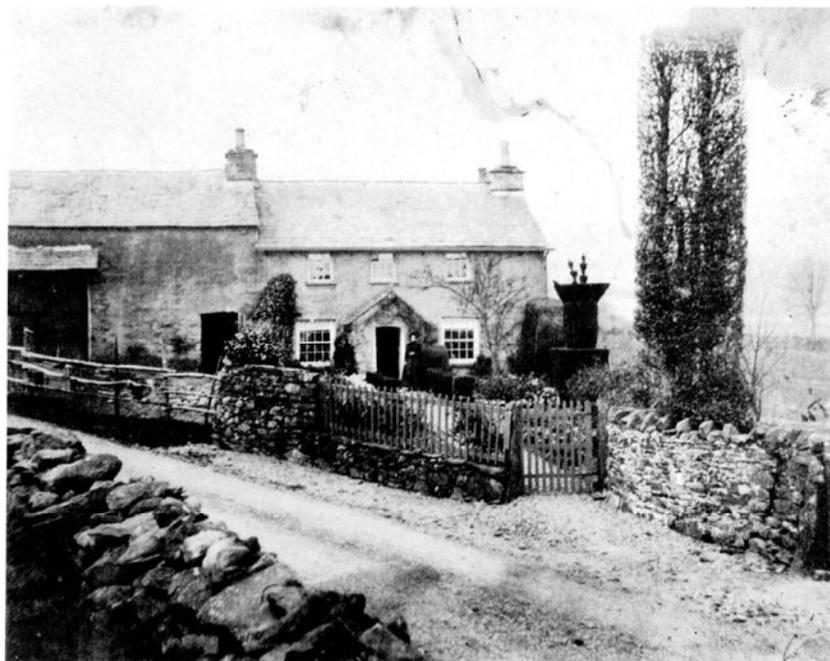
Plate 5: Photograph, c1910

3.1.5 **Photograph, c1910:** this photograph shows the cottage and north-east end of the adjoining barn c1910 (Plate 5). Little has changed to the exterior of the cottage although it appears to have been plastered and painted since this photograph was taken. Two windows have since been inserted in the north-east section of the barn on the first floor and the stonework is no longer exposed apart from in a few small areas.

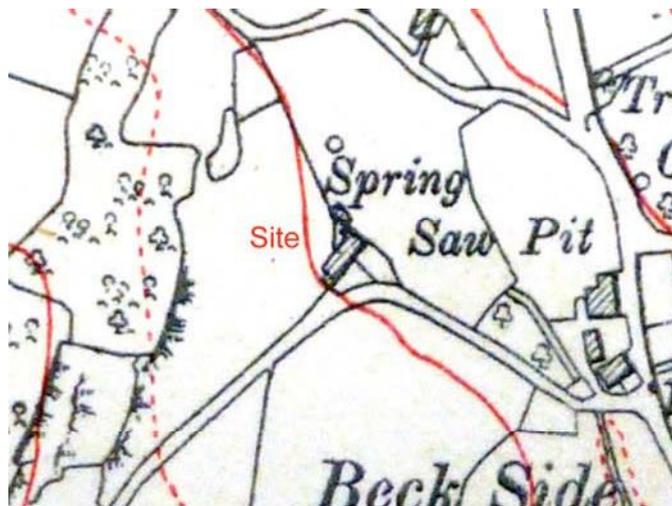
Plate 6: Extract from the Ordnance Survey map, 1919

3.1.6 **Ordnance Survey, 1919:** the footprint of the buildings on site appears unchanged from the 1890 version although the internal division between the cottage and the main barn is not shown (Plate 6).

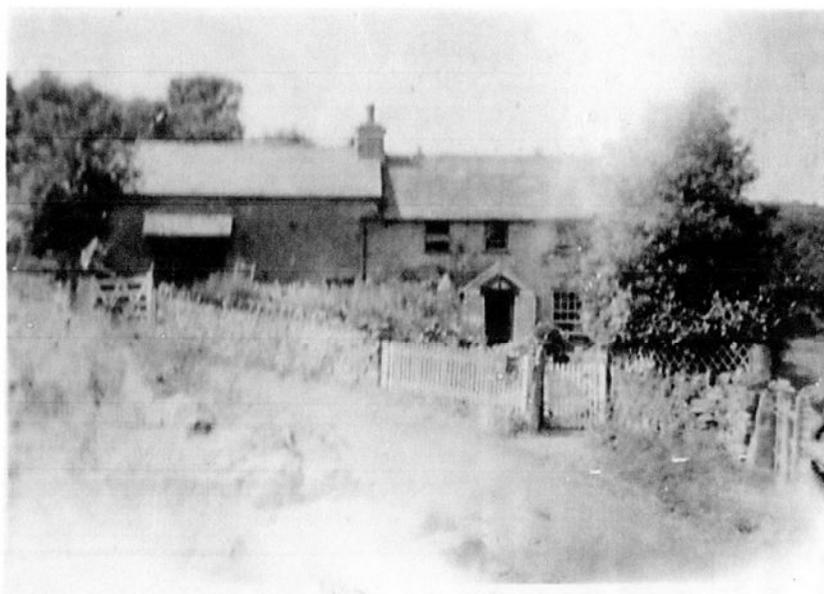
Plate 7: Photograph, c1945

3.1.8 **Photograph, 1945:** a photograph from 1945 of the cottage and main barn to the south-west c1945 shows the upper floor windows in the barn had yet to be inserted and the exterior of the buildings had still not been rendered over and painted by that time (Plate 7).

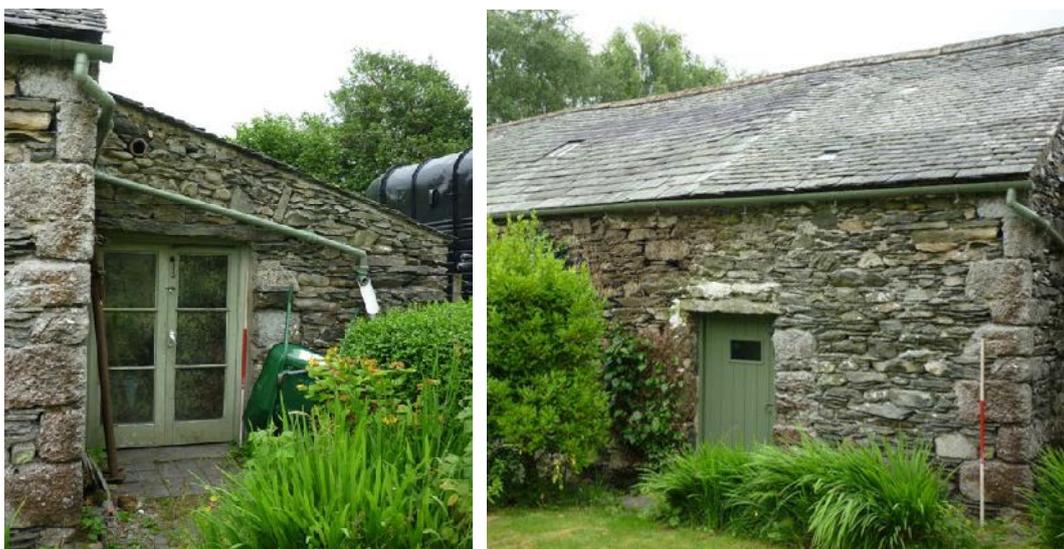
4.2.1 **North-west elevation:** the south-west end is a mono-pitch outshut (Plate 8). There is a ceramic pipe vent above and the end of the purlin projects over the wide doorway on the north-east side. The doorway has a slate lintel and threshold, a double door with three lights in each, and modern dressed limestone quoins on the south-west side. The elevation returns to the north-west at the junction with the main barn, and there are dressed quoins at the corner, one of which has a hole drilled in it (Plate 9). To the north-east of the return there is a doorway which has roughly dressed limestone quoins on the south-west side and a slate lintel above, which has been plastered over. The doorway houses a single-light, tongue and groove, plank and batten door on a pivot hinge in a plain surround and the quoins of the original end of the wall form the north-east jamb. The remaining section of the main barn to the north-east has some throughstones and square holes or vents in the wall, one with the end of a piece of timber visible inside. The wagon doorway to the north-east is at a lower level relative to the south-west end of the building and houses a double tongue and groove plank and batten door (Plate 10). The doorway has a concrete lintel and there is some rebuild above it but the jambs are possibly original. There is a slight plinth on the south-west side, disappearing into the slope, and a high level, five-light, hinged casement window with a concrete sill and slates over the lintel to the north-east.

Plate 8 (left): Outshut at the south-west end of the main barn

Plate 9 (right): South-west end of the main barn

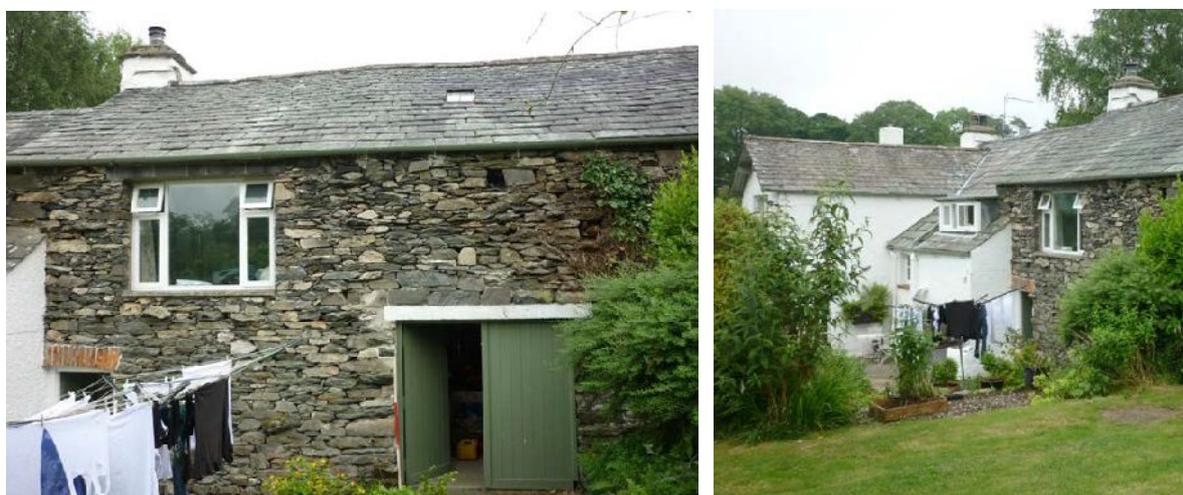
4.2.2 Stepped down again there is a lower doorway with a brick voussoir arch with handmade orange bricks (just visible to the left hand side in Plate 10; see Figure 2). The bricks are very thin, only 0.06m thick by 0.23m long by 0.11m wide. The door below is a modern tongue and groove plank door with a single light in a chamfered surround. The elevation again returns to the north-west where it meets the cottage (Plate 11). The slope of the outshut roof is raised by a three-light dormer window with a flat top and there are two windows in the elevation below, one at ground floor level, with a 12-light fixed casement and slate sill, the other at mid-level with a four-light casement and sandstone sill (Plate 12). The elevation returns again to the north-west along the side of the cottage and then back to the north-east (Plate 11; Figure 1). This side of the cottage is plain apart from a low level, tall, eight-light window with a slate sill and is extended by a porch with a rough render finish and a fixed nine-light window with a slate sill (Plate 13). Continuing the north-west elevation proper, the gabled porch to the south-west side of the cottage has slate hung over the lintel and a beaded tongue and groove plank door with a single light (Plate 14). At first floor level there is a two-light hinged casement window with slate over the sill and there is an 18-light hinged casement window with a sandstone sill and limestone lintel on the ground floor. There are projecting purlins and tongue and groove boards at the top of the gable and there is a further mono-pitch outshut extending the line to the north-east. There is a door into the extension to the north-east end with a timber canopy and a slate roof and a modern plank door with barred window (Plate 14).

Plate 10 (left): Central and north-east end of the main barn

Plate 11 (right): Return in the north-west elevation

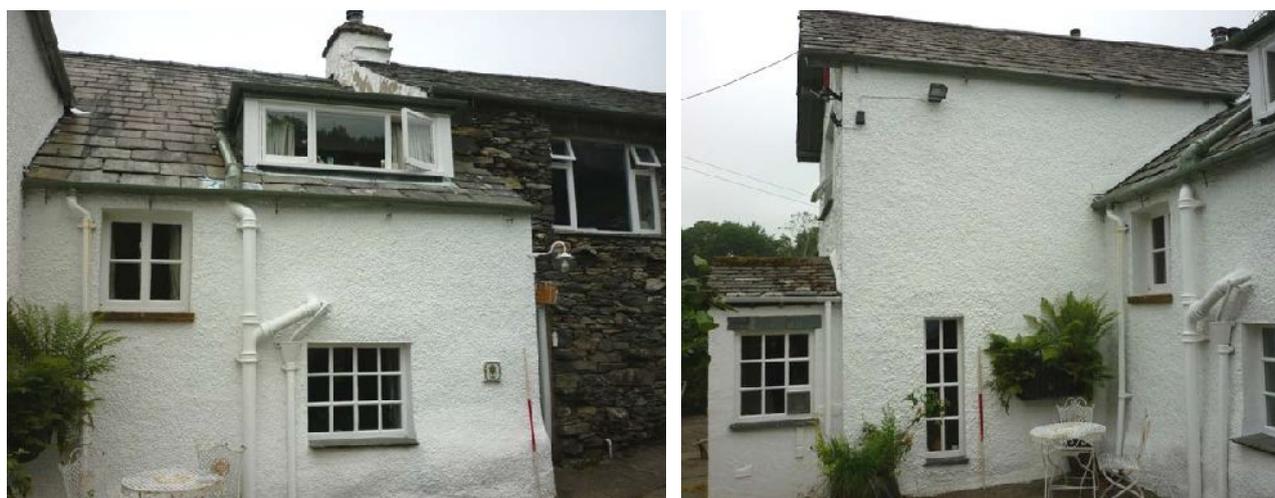
Plate 12 (left): South-west end of the cottage

Plate 13 (right): South-west elevation of the cottage

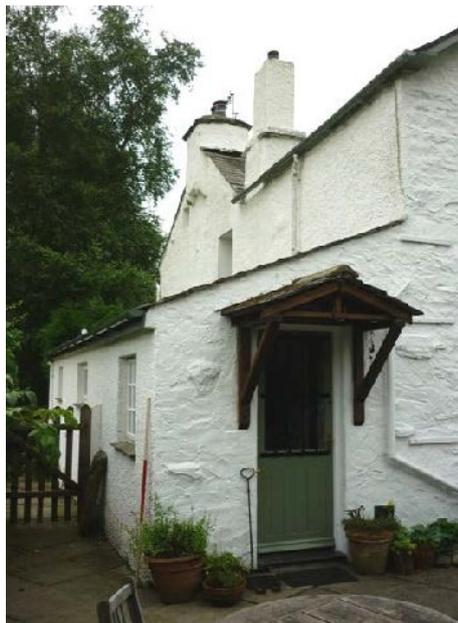
Plate 15: North-east elevation of the cottage

4.2.3 **North-east elevation:** the lower part is covered by a mono-pitch extension to the side of the cottage (Plate 15; Figure 2). The extension has three windows in it with slate sills, the window to the north-west being the largest with nine-lights, the others having a single light. There is a third chimney corresponding to the extension to the north-west, which is smaller than the other two stacks, with a squarer base, topped with a taller, narrower section with slate at the junction and a single pot. The main gable has a window on the north-west side with nine lights and plain, square reveals. The chimney in the centre is projecting on corbels and there is a small single-light window to the south-east at attic level.

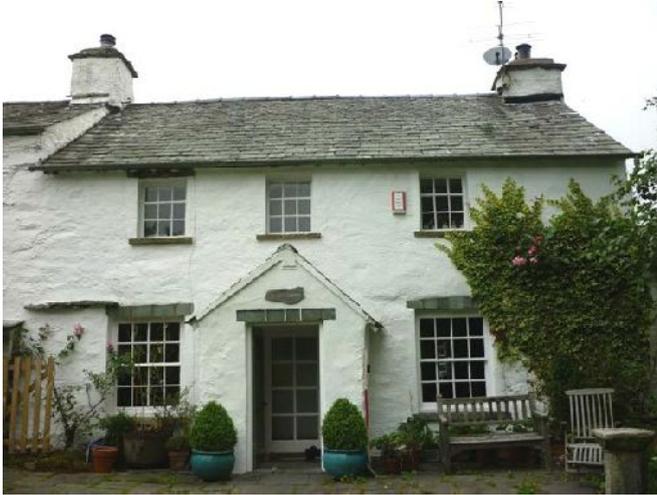
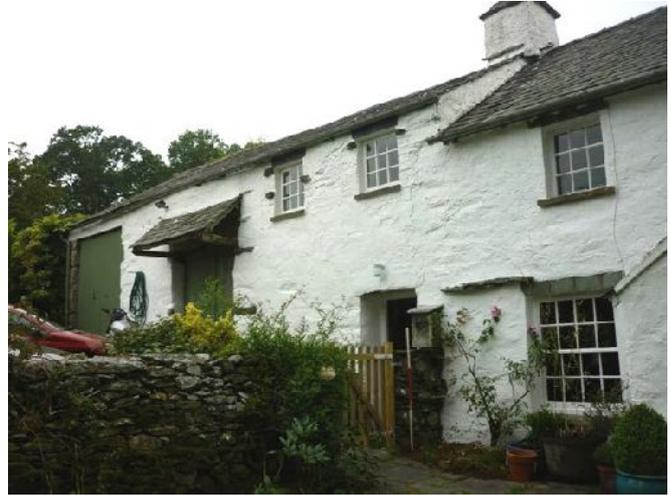
4.2.4 **South-east elevation:** the front elevation of the cottage has a gabled porch with slate hung over the doorway (Plate 16). The door has six panels with three lights over, which are have stop-chamfered decoration. There is a small single-light window in the south-west elevation. There are two windows on the ground floor, one either side of the porch, each with 16-light sashes and no horns. Each of these has slate hung over the lintels and stone sills, slate to the north-east and slightly chamfered limestone to the south-west, and there is a slate drip course to the south-west of the south-west window at lintel height. All three first floor windows have nine-light fixed casements and sandstone sills. The barn to the south-west has a low level doorway on the north-east side with a tongue and groove plank and batten door and a brick voussoir arch (as per the north-west elevation) with a re-used timber lintel behind, but it is covered by render on this side (Plate 17). There are two modern windows at first floor level at this end of

the barn, both with nine-light casements, slate hung over the lintels, and concrete sills. There is a large wagon doorway to the south-west with a slate canopy and timber support housing an early plank and batten door with a stone voussoir arch (Plate 18). Some of the quoins are visible but most are obscured by render. There is a further wagon door housing a tongue and groove plank and batten double door on pivot hinges at the south-west end. The doorway utilises the quoins at the original end of the building on the north east side with dressed limestone quoins on the south-west side connecting with quoins in the end of the building.

Plate 16 (left): North-east end of the cottage

Plate 17 (right): The main barn

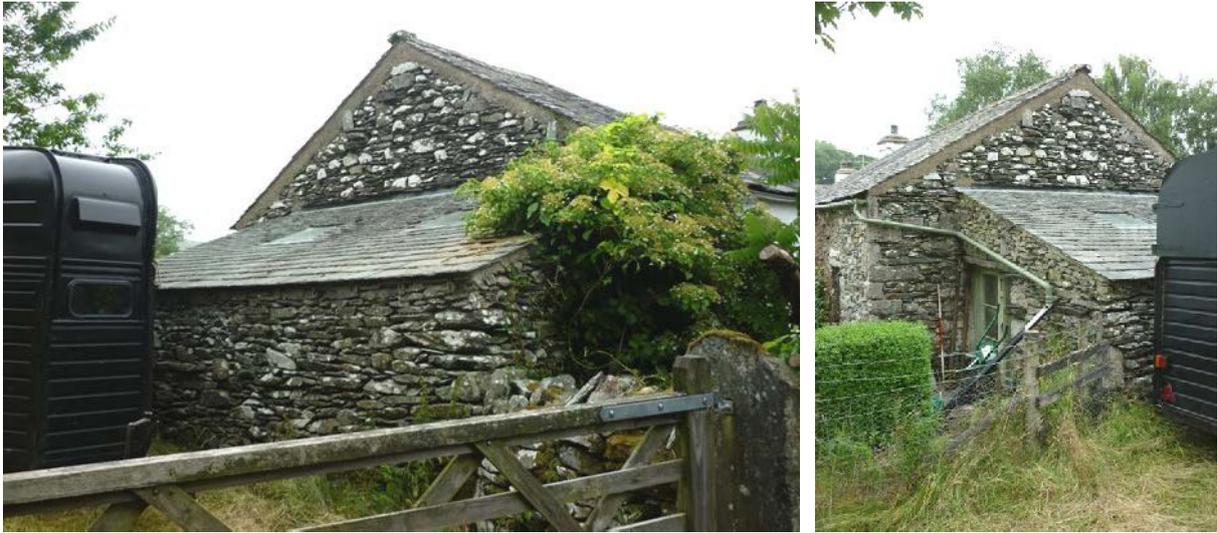
Plate 19 (left): South-east end of the south-west elevation
Plate 20 (right): North-west end of the south-west elevation

4.2.5 South-west elevation: the south-west elevation forms a gable end with a plain outshut attached (Plate 19). The outshut does not extend the full width of the main building and is plain. There is a drip course over the lead flashing of the roof to the outshut and the gable above is topped with a stone finial base and there is a skim of concrete along the eaves. There are one or two purlins per pitch and the ends of the purlins are covered with slate. The north-west side of the main building is finished with dressed limestone quoins.

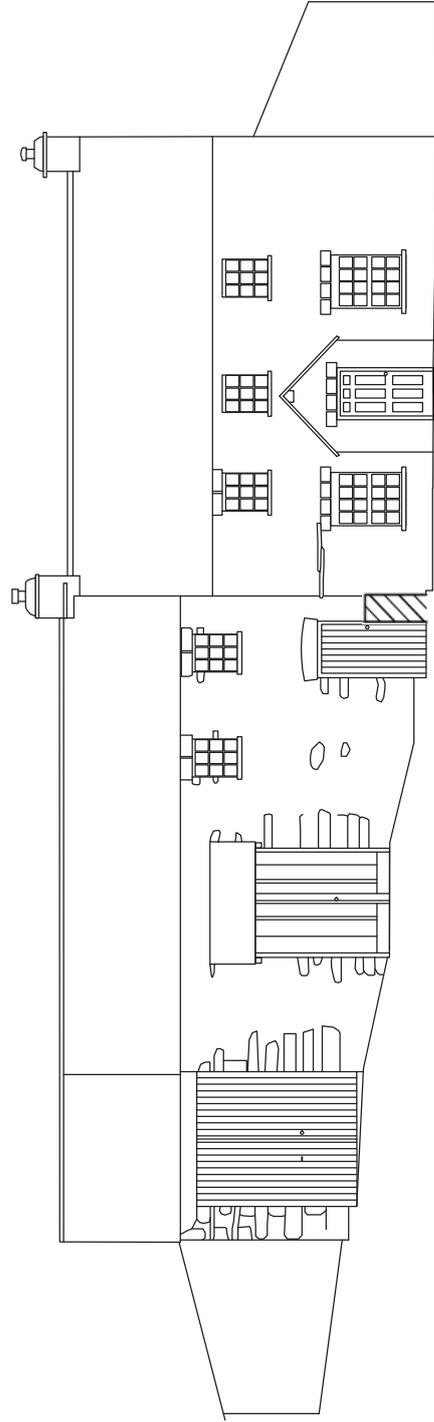
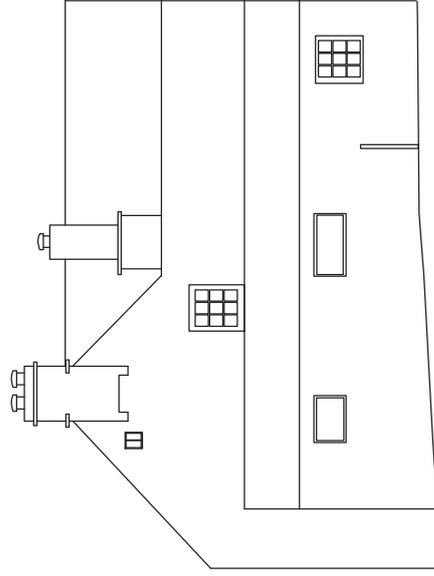
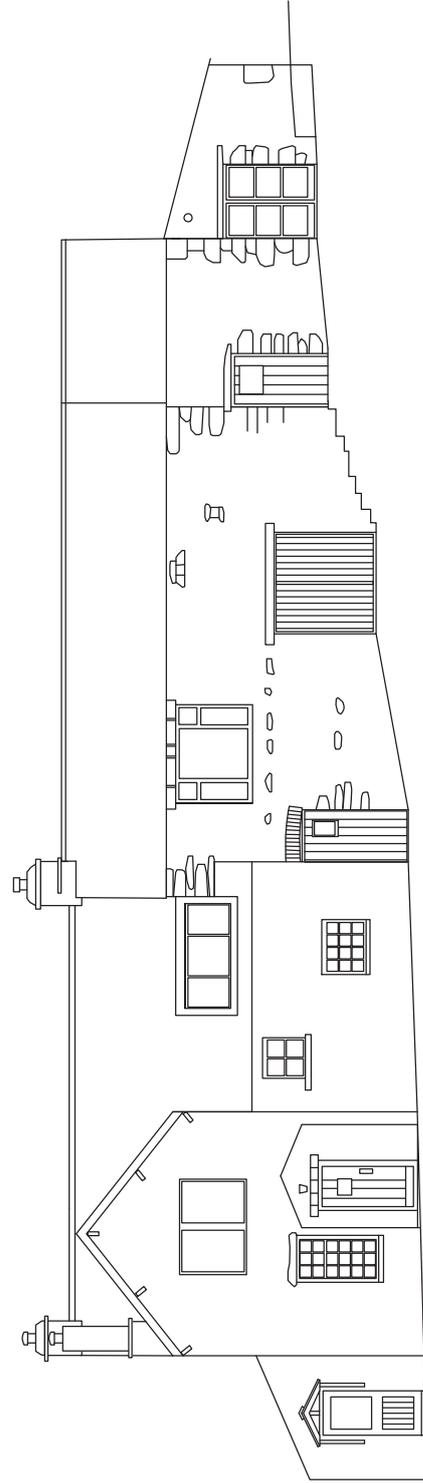
Figure 2: External elevations

4.1.1 The row of buildings on site is aligned approximately north-east/south-west, with Beckside Cottage located at the north-east end (Figure 1). The cottage has a modern extension to the north-east side and there is a large barn adjoining the cottage to the south-west and another smaller barn to the south-west of this. Various parts of the building are split over two floors and it fronts south-east towards the road (see Figure 2 to Figure 5).

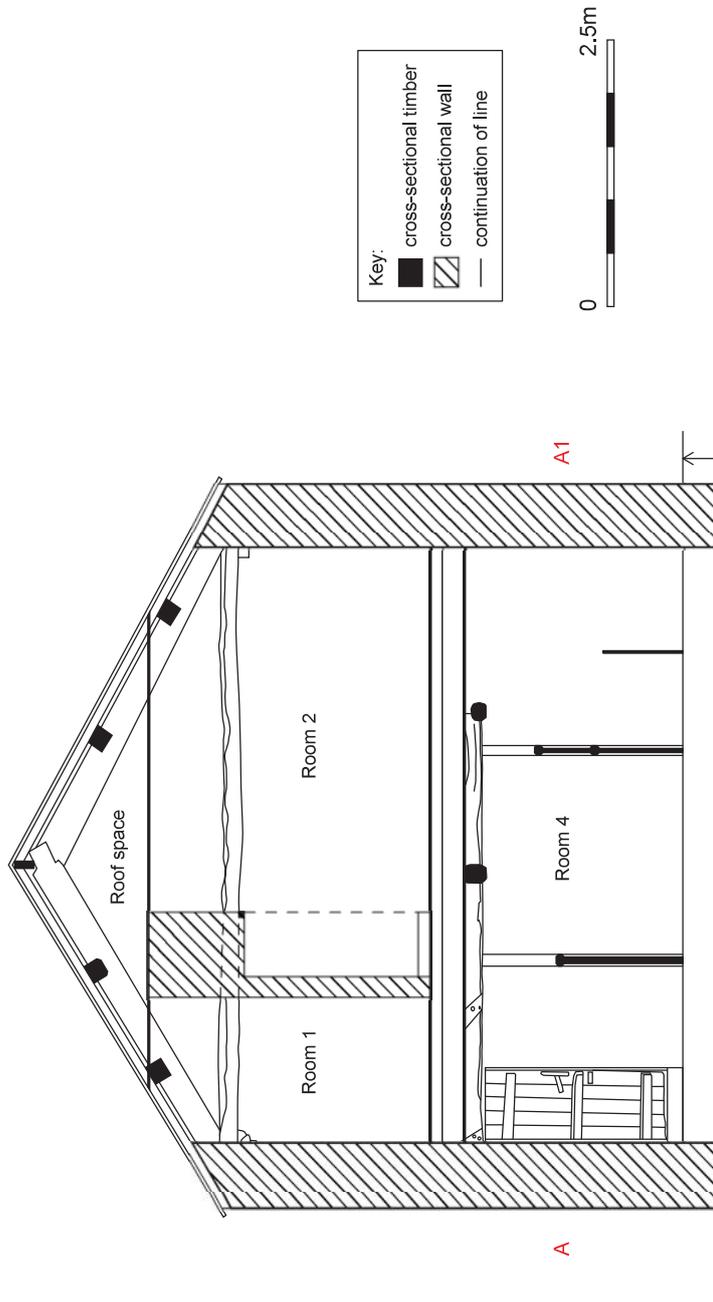
Figure 5: Cross-section A-A1

4.3.16 **Roof space over First floor Rooms 1 and 2:** the top of the truss is visible at the south-west end. It has a simple lap joint and purlins visible (Figure 5; Plate 67). The rafters and north-west purlin are sawn. A concrete block wall extends to the roof. The north-east end is limewashed and the stone bulges out in the centre, presumably on account of the chimney flue.

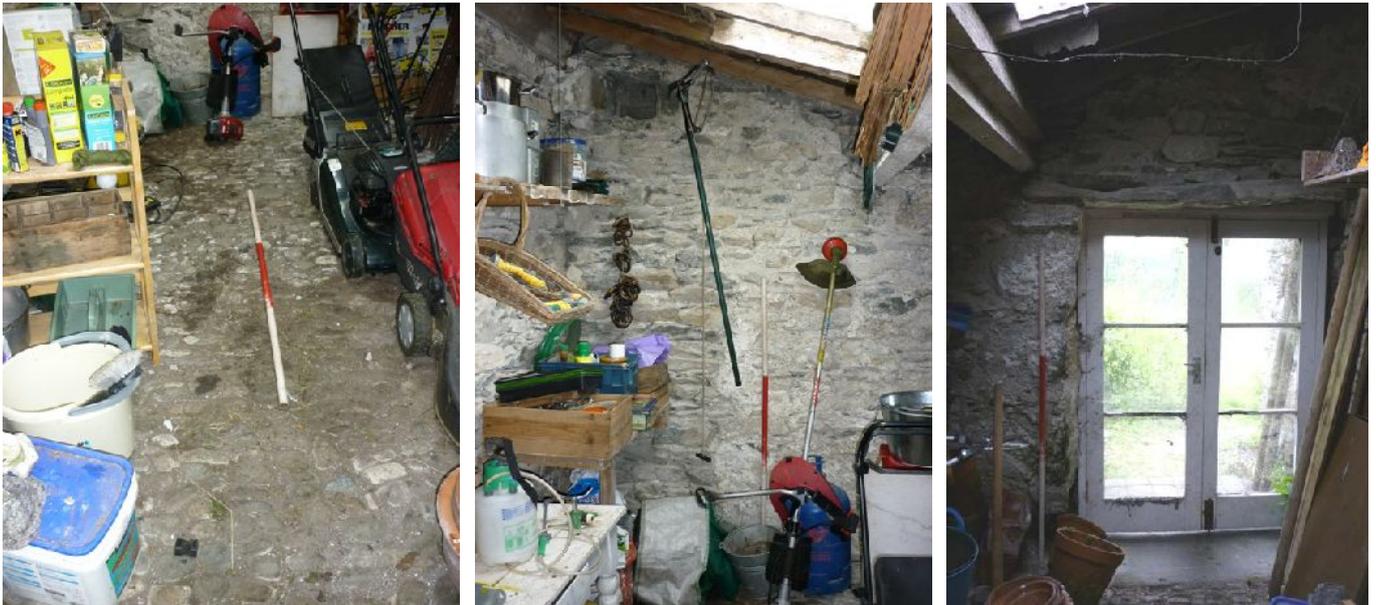
4.3.1 **Ground floor Room 1:** this room forms the outshut at the south-west end of the row. It has a cobble floor and a mono-pitch roof with machine cut rafters on a single north-west/south-east aligned machine cut purlin (Plate 21 and Plate 22). There are two single sheet skylights and a purlin against the north-east elevation held on iron brackets. The walls are all exposed stone with traces of mortar and plaster or limewash on the north-east side. The north-east and south-west elevations are otherwise plain (Plate 22). The north-west elevation has a doorway with a slate lintel and a double door, each with three lights (Plate 23). The south-east elevation has a high level vent on the north-east side. It is square with a slate lintel and a ceramic grill on the outside.

Plate 21 (left): Cobbled floor in Ground floor Room 1

Plate 22 (centre): South-east elevation of Ground floor Room 1

Plate 23 (right): Double door in the north-west elevation of Ground floor Room 1

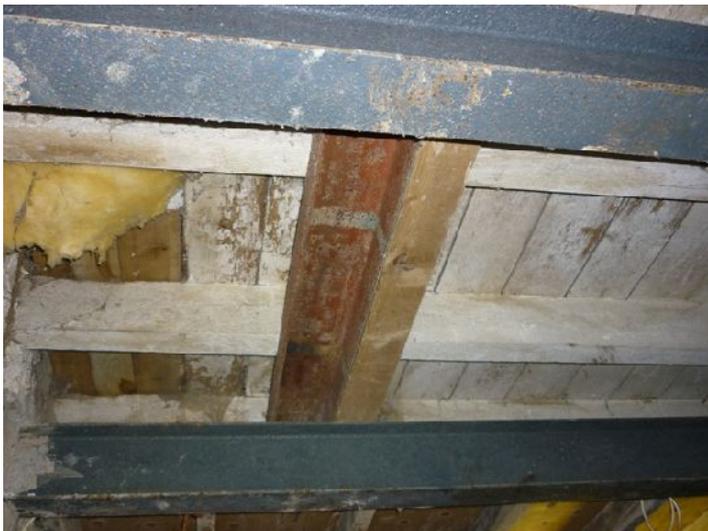
Plate 24 (left): Iron I-beams in the ceiling of Ground floor Room 2

4.3.2 **Ground floor Room 2:** this room has a concrete floor which steps down from ground level outside to the north-west. The ceiling comprises sawn timber joists and floorboards, supported by an arrangement of I-beams aligned north-east/south-west and north-west/south-east, which in turn supports a floor on joists and plywood (Plate 24). This upper level floor only covers the north-west side of the room leaving the rest open to the roof (Plate 25). The roof comprises two purlins per pitch and a ridge plank. One purlin on the north-west side is a piece of round wood. The walls are exposed stone and fairly plain with a piece of timber built in to the south-west, although it is not apparently a lintel. There is a double door to the south-east with a tongue and groove plank and batten door and a re-used cruck forming the lintel (Plate 26 and Plate 27). The door to the north-west has a timber lintel and a stone step and a tongue and groove plank and batten door with a single light.

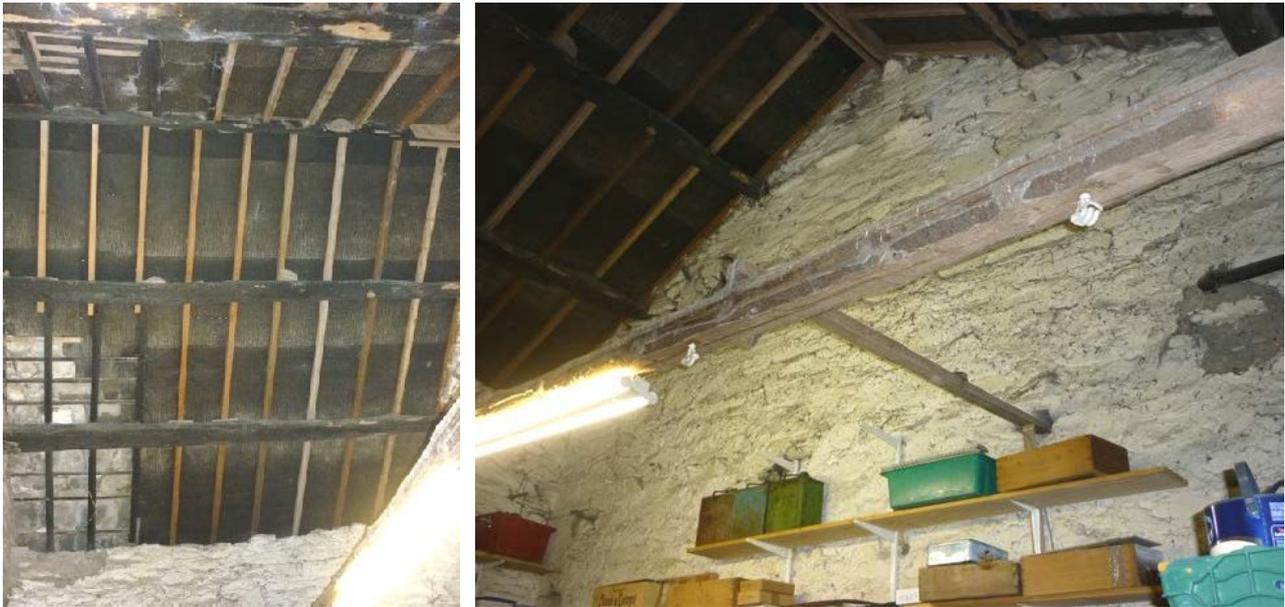
4.3.3 Ground floor Room 3: this room has a concrete floor and is open to the roof. It has two purlins per pitch and a ridge plank which is hand finished but fire damaged and sooted (Plate 28). There is a further north-west/south-east aligned hand-finished timber beam on the south-west side possibly for a hayloft (Plate 29). The walls are whitewashed stone except for the north-east elevation, which is concrete block and has a doorway on the south-east side. The doorway has a concrete lintel and a plank and batten door in a plain surround (Plate 30). The north-west elevation has a double doorway on the north-east side with a rough timber lintel over an inserted iron I-beam and a double plank and batten door (Plate 31). The south-west elevation is plain apart from three possible joist holes. The south-east elevation has a wagon doorway on the north-east side with a rough lintel and re-used cruck blade and double plank and batten door (Plate 32).

Plate 28 (left): Fire damage in the roof above Ground floor Room 3

Plate 29 (right): Timber beam to the south-west side of the Ground floor Room 3, possibly for a hayloft

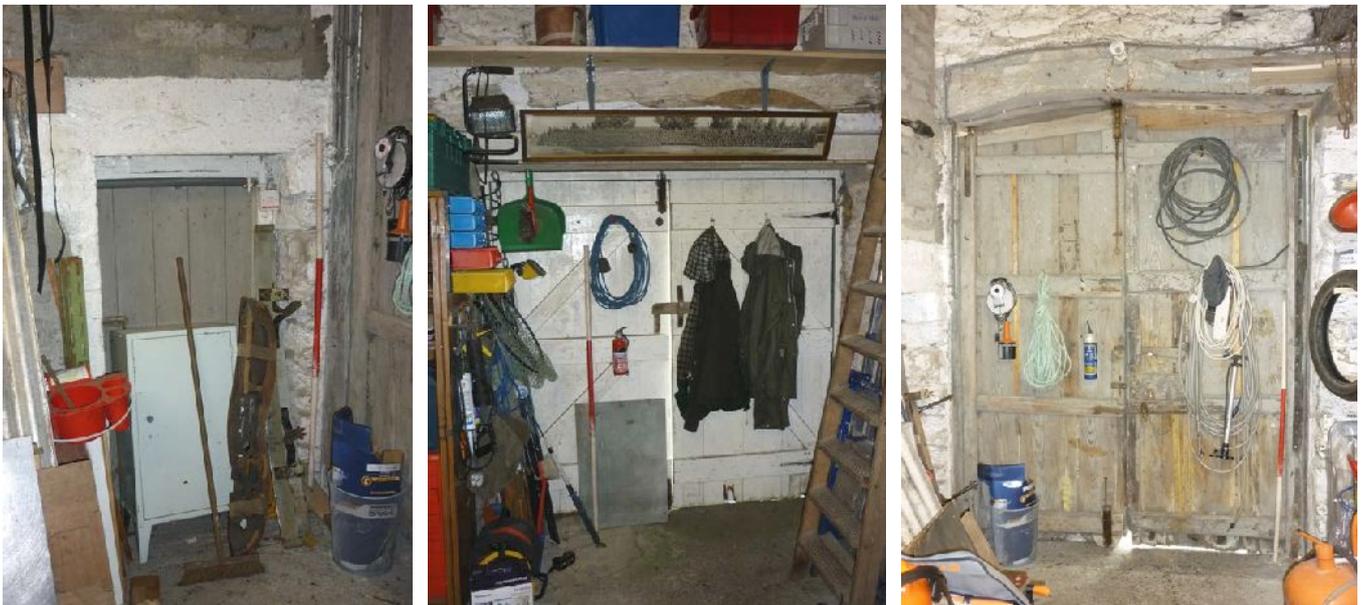
Plate 30 (left): Doorway in the north-east elevation of Ground floor Room 3

Plate 31 (centre): Doorway in the north-west elevation of Ground floor Room 3

Plate 32 (right): Doorway in the south-east elevation of Ground floor Room 3

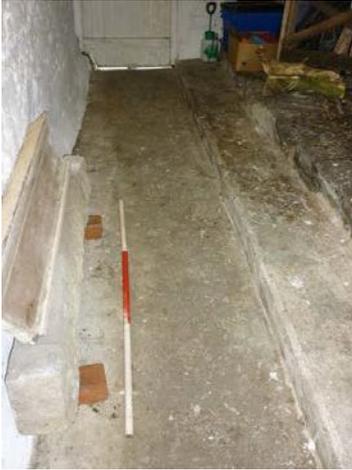
Plate 33 (left): Concrete floor and steps to the north-east side of Ground floor Room 4

4.3.4 Ground floor Room 4: this room has a concrete floor on the north-east side, stepping up twice to the south-west side with stone cobbled edging to the steps (Plate 33). There are two timber stall partitions on the south-east side with upright posts to the ceiling joists (Plate 34 and Plate 35). The ceiling has two beams, aligned north-east/south-west, both of which are re-used crucks, one of which has hammered carpenter's marks at an old joist slot, marked ')))' (Plate 36). There are floorboards on top and a later suspended floor on top of that (see Figure 5). The walls are painted white. The north-east elevation is plain with a slight plinth at the base continuing to the corner at the south-west end where there is a boulder. The north-west elevation has a doorway on the north-east side with a re-used timber lintel and a modern plank and batten door (Plate 37). The south-east elevation is similar with the door on the north-east side (Plate 38). The south-west elevation has a doorway raised up by a concrete step on the south-east side with an early plank and batten door on strap hinges on pivots (Plate 39).

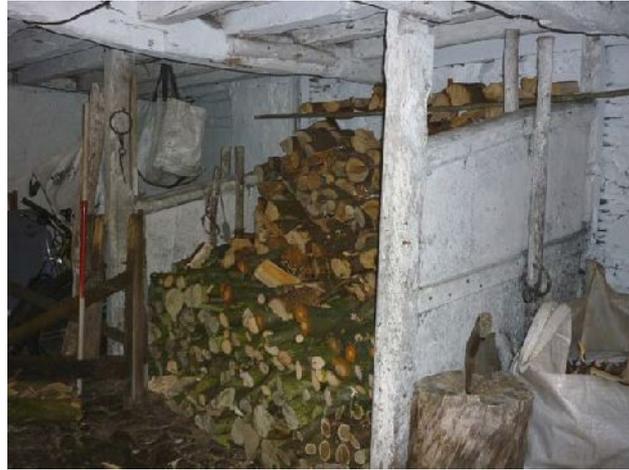
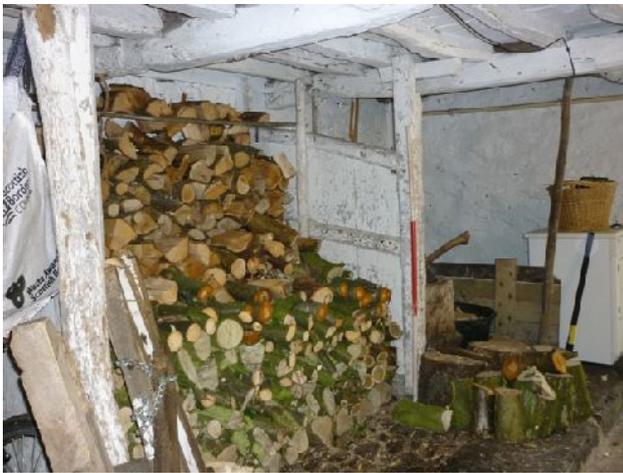
Plate 34 (right): Stalls in Ground floor Room 4 viewed from the north-west

Plate 35 (left): Stalls in Ground floor Room 4 viewed from the east

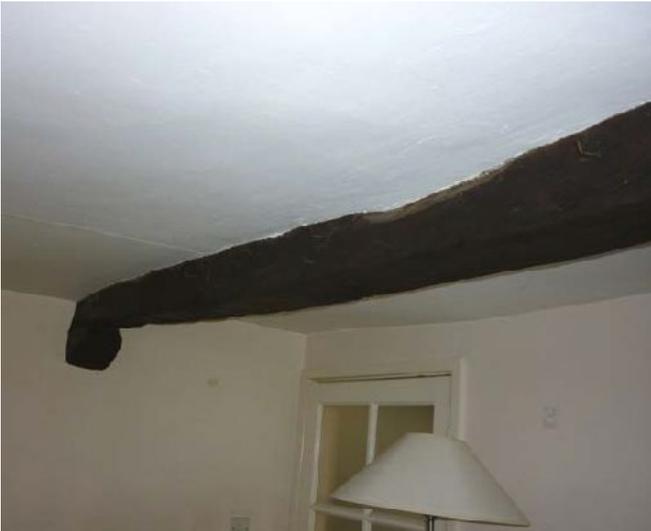
Plate 40 (left): Beam in Ground floor Room 5

4.3.5 Ground floor Room 5: there is carpet covering the floorboards in this room and it has a flat plaster ceiling. There is a north-west/south-east beam on the north-east side sat on a corbel at the north-west end where the wall returns under the stairs. The beam is hand-finished and possibly re-used (Plate 40). The north-west elevation has a 12-light casement window on the south-west side, with splayed jambs and a timber sill (Plate 41). The return to the south-east opens to a cupboard under the stairs. The cupboard has a moulded surround but no door and a rough re-used timber lintel (Plate 42). The return to the north-east is plain. The north-east elevation is a modern stud wall and has a modern eight-light door on the north-west side with a plain surround at the south-east end. The south-east elevation has a window with splayed jambs with moulded panels and shutters (Plate 43). The shutters are either modern or reconditioned as the moulding is very crisp. The south-west elevation is plain apart from the central fireplace, which is completely modernised (Plate 44). The housing is stone and it has a timber lintel on two corbels and two small alcoves, one on each side.

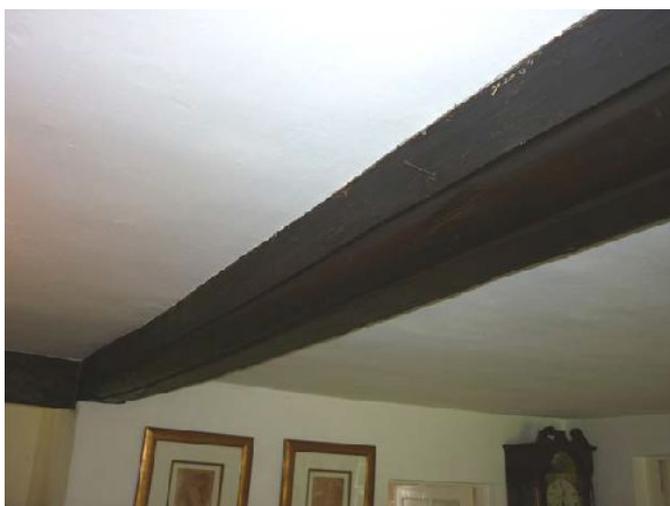
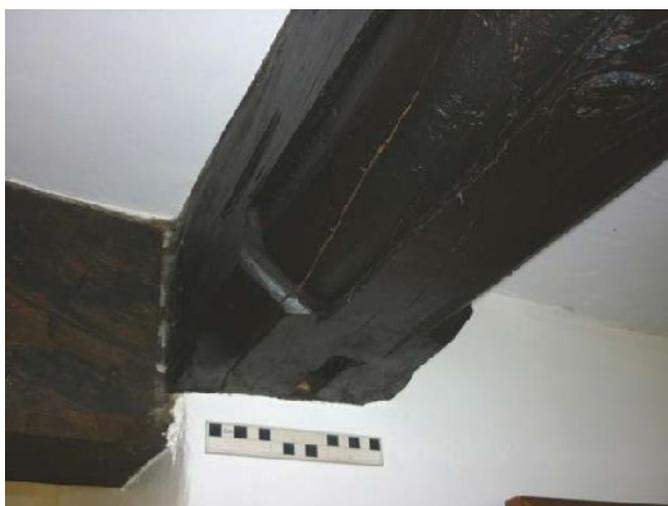
4.3.6 **Ground floor Room 6:** this room has carpet on the floor, possibly over boards. It has a flat ceiling with an ovolo-moulded and stop chamfered beam on the south-west side, with peg holes and a peg and slot on the underside at the north-west end (Plate 45 and Plate 46). The walls are plastered and painted. The north-east elevation has a doorway to the stairs on the south-west side with a rough timber lintel. The door to the north-east has a plain surround and an eight-light door. Similarly, the north-east elevation has a door on the north-west side with a plain surround and an eight-light door. The central fireplace on this side has modern, splayed, firebrick sides with alcoves either side and a modern timber lintel (Plate 47). There is a spice cupboard to the south-east, which has early butterfly hinges and ogee-moulding and outer beading plus a plain interior with one early shelf (Plate 48 and Plate 49). There is a cupboard on the north-east side of the south-east elevation with a rough, chamfered, early surround, but the shelves and timber backing are later (Plate 50). The 16-light sash window to the south-west has splayed jambs and shutters like those in Ground floor Room 5 but there is no evidence that the shutters have been cleaned up (Plate 51). The modern, eight-light door to the south-west goes into the porch, which has a flag floor and a stone bench in an alcove on the north-east side. The south-west elevation is a stud wall with a section of panelling attached (Plate 52). The edging is new and the top has been cut to fit but the rail remains at the base. There are scars and holes for various things and it has clearly been attached to the wall on modern timber battens over the skirting board and the modern wall finish.

Plate 45 (left): Beam in Ground floor Room 6

Plate 46 (right): Detail of the beam in Ground floor Room 6

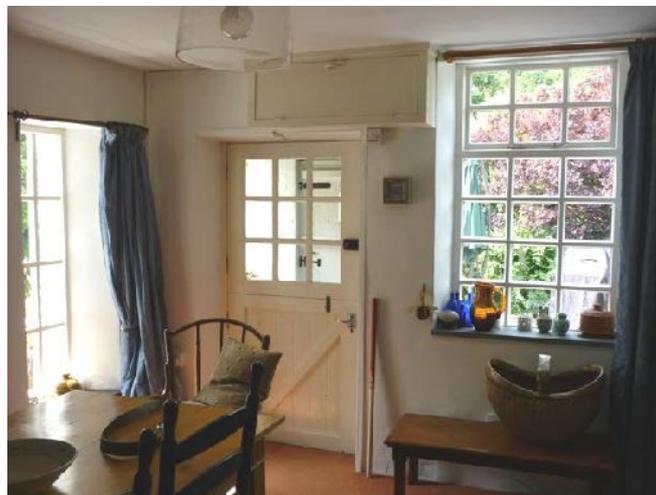
Plate 53: West corner of Ground floor Room 7

4.3.7 **Ground floor Room 7:** this room is carpeted and has a flat plain plaster ceiling. The walls are plastered and painted. The north-west elevation has a door on the south-west side leading to the porch (Plate 53). The door is split with a nine-light in the top section and plank and batten bottom section. The porch has a flag floor and timber board ceiling and rafters and small king post truss on top of the north-west wall. There is a nine-light window to the south-west and plank and batten door to the north-west and a small single-light window to the north-east. The main elevation has an 18-light window to the north-east with a slate sill. The north-east elevation is plain with a doorway on the north-west side with stepped jambs. The south-east? elevation has a modern eight-light door. The south-west elevation steps out on the south-east side and has a tall eight-light window to the north-west but is otherwise plain.

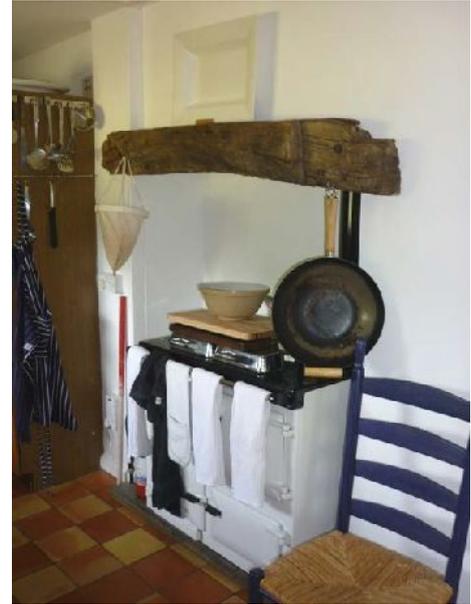
Plate 55 (right): Alcove in the south-west elevation of Ground floor Room 8

elevation there is a central alcove with stove with a hand-finished re-used timber lintel (Plate 55). The door through to Ground floor Room 9 to the south-east has a plain surround but an early plank and batten door with three beaded planks (Plate 56).

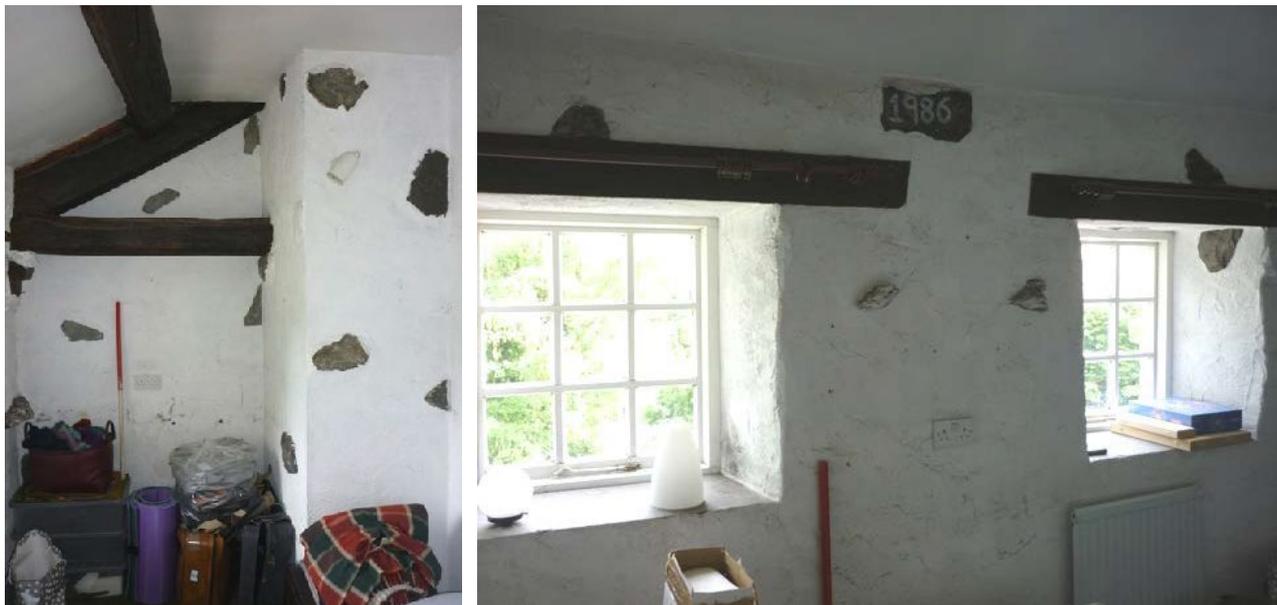
4.3.8 First floor Room 1: the floor is finished with carpet tiles and the ceiling is plaster. The ceiling flattens at the top but part of the tie beam truss is visible at the south-west end of the room sat on stone and timber corbels at the south-east end (Plate 57). There is a single purlin, scarf jointed at the truss which is also hand-finished. The walls have a modern, rough 'country cottage' finish with protruding stones and fragments of pottery and some roof slates pressed into the plaster. '1986' is painted onto one

of the protruding stones in the south-east elevation. The north-east and north-west elevations are plain. The north-west elevation is a stud wall and has a step at the south-west end and a modern plank plank and batten door to the north-east. The south-east elevation has two nine-light hinged casement windows with smooth slate sills and timber lintels (Plate 58).

Plate 57 (left): South-east end of the tie beam truss in First floor Room 1

Plate 58 (right): South-east elevation of First floor Room 1

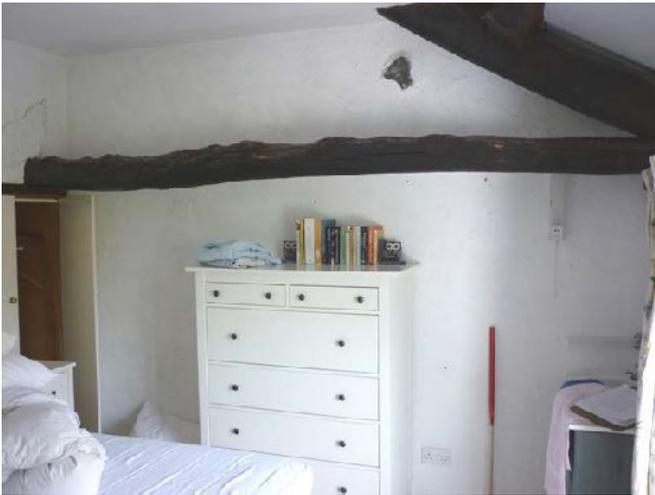
Plate 59 (left): North-west end of the truss visible in First floor Room 2

4.3.9 **First floor Room 2:** this room has a carpet floor and a flat plaster ceiling. The walls are finished like those in First floor Room 1. The lower part of the north-west end of the tie-beam truss is visible along the south-west elevation, which is otherwise plain (Plate 59). The north-west elevation has a five-light hinged casement window with a timber window seat. The north-east elevation has an alcove on the north-west side with a slate sill and a rough timber lintel and a piece of timber with a moulded edge has been re-used to form a shelf above (Plate 60). The south-east elevation is all modern; a stud wall with a return at the door on the north-east side and a cupboard on the south-west side. There is a hatch in the roof in the small lobby between First floor Room 1 and 2. The walls are finished as per Rooms 1 and 2 but with added pottery and coins, four two pence pieces (the two with visible faces dated 1971 and 1979) set in the wall. The walls are all modern stud partitions apart from the north-east elevation where it is stepped down to First floor Room 3 of the cottage. The door to the north-west is earlier and has a stripped, early or possibly replica latch.

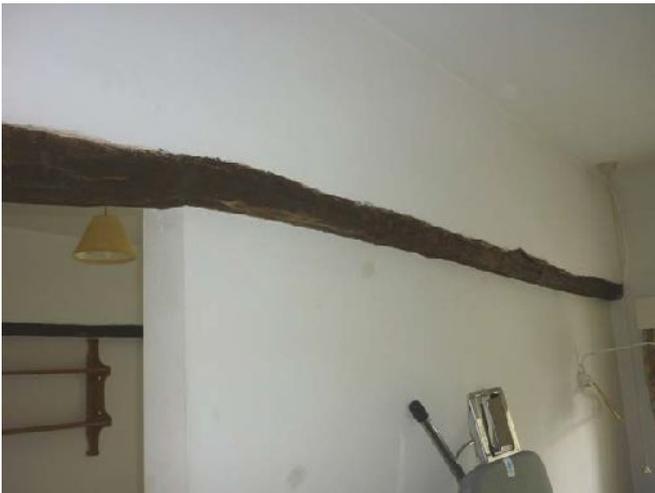
Plate 61 (left): North-east elevation of First floor Room 3

4.3.10 **First floor Room 3:** this room has a carpeted floor and a flat ceiling, sloping down on the south-east side but raised relative to the height of the hand-finished north-east/south-west beam. There is a modern stud wall to the north-east with a gap on the north-west side (Plate 61). The north-west wall is an earlier stud wall, projecting out at the top. The south-west elevation is very plain with a modern cupboard either side of the doorway which steps up in the centre. The south-east elevation has a nine-light casement window on a central pivot and with a hinged bottom part with splayed jambs and a timber sill (Plate 62).

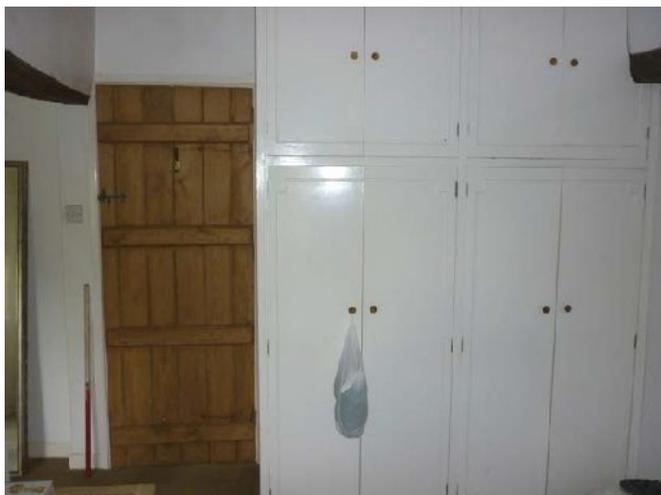
Plate 63 (left): North-west elevation of First floor Room 4

4.3.11 **First floor Room 4:** this room is carpeted and has a flat ceiling sloping down like in Room 3. The north-east and south-west walls are modern stud partitions. The north-west elevation has a large cupboard attached and a beaded plank and batten door with an early-looking latch, which is again either stripped or a replica (Plate 63). The nine-light hinged casement window to the south-east has splayed jambs and a timber sill.

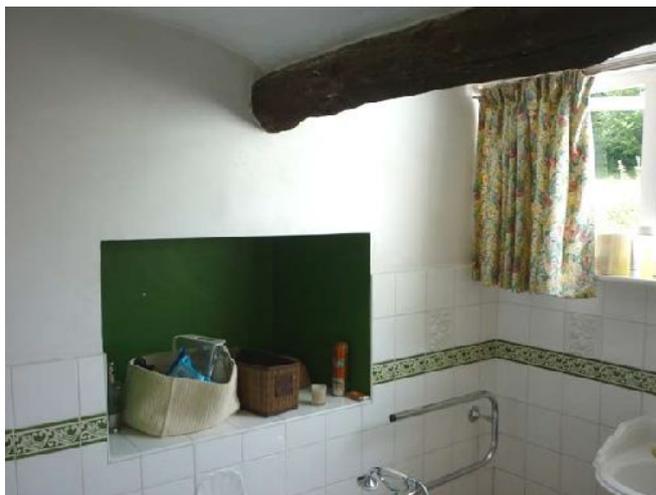
Plate 64 (right): North- and south-west elevations of First floor Room 5

4.3.12 **First floor Room 5:** this is the bathroom. It has a vinyl floor and plaster ceiling, sloping down to the hand-finished north-east/south-west aligned purlin then flat into the dormer to the north-west. The room is plastered and painted throughout. The north-west elevation has a three-light window and a toilet and sink attached. The north-east is plain with a beaded plank and batten door on the south-east side with a Victorian handle. The south-east elevation is also plain. The south-west elevation however has an alcove with splayed jambs on the north-west side (Plate 64).
