BECKSIDE COTTAGE, BECK SIDE, CARTMEL, GRANGE-OVER-SANDS, CUMBRIA

Archaeological Building Recording

July 2013

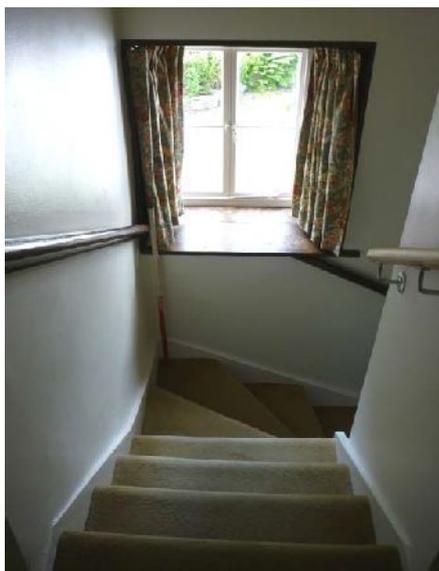
Plate 65 (left): Stairs to Ground floor Room 6 from First floor Room 6

4.3.13 **First floor Room 6:** this carpeted room forms a corridor linking the rooms on this floor. Part way down the steps to the ground floor on the north-west elevation there is a mid-level four-light hinged casement window with splayed jambs and a timber sill (Plate 65). The walls are mostly modern stud, with stripped beaded tongue and groove plank and batten doors with early hatches of various types to the north-west, south-east, and south-west (Plate 66) (one has evidently had a dart board attached to it!). The end of a north-west/south-east beam with a slot and empty peg hole is visible at the north-east end of the corridor.

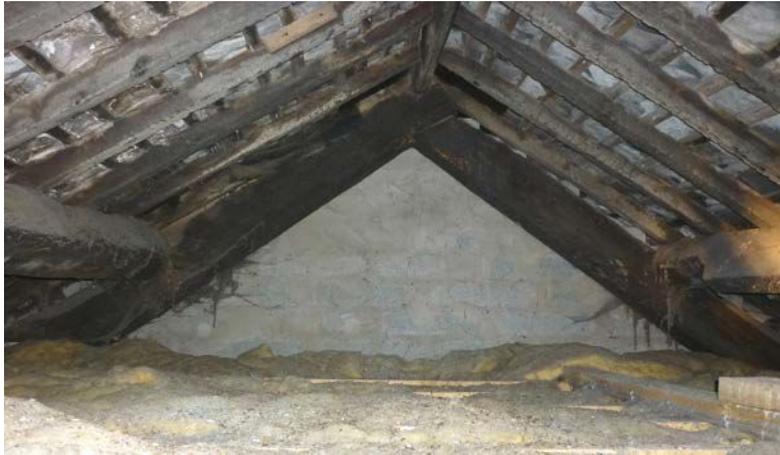
Plate 67: Roof space over First floor Rooms 1 and 2

4.3.16 **Roof space over First floor Rooms 1 and 2:** the top of the truss is visible at the south-west end. It has a simple lap joint and purlins visible (Figure 5; Plate 67). The rafters and north-west purlin are sawn. A concrete block wall extends to the roof. The north-east end is limewashed and the stone bulges out in the centre, presumably on account of the chimney flue.

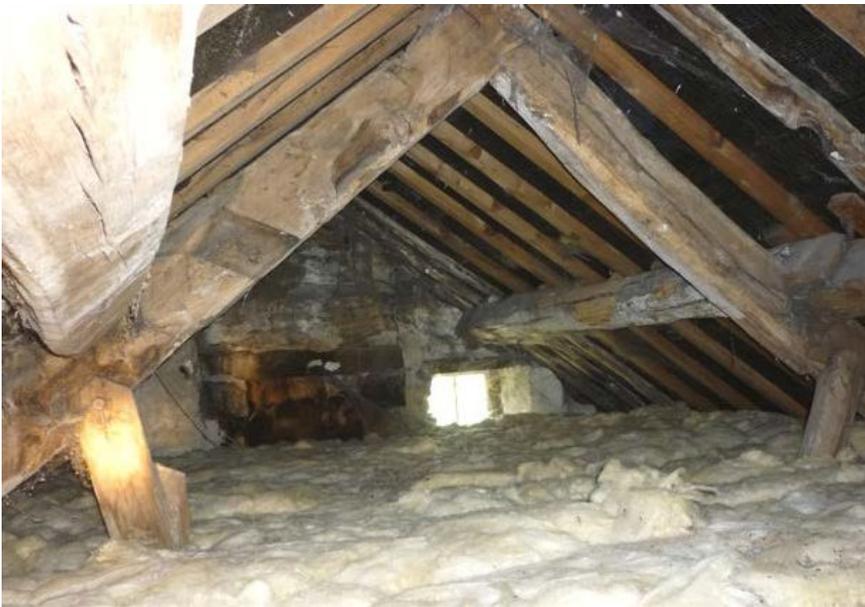
Plate 68 (left): Truss above First floor Rooms 4, 6 and 7

4.3.17 **Roof space over First floor Rooms 3 to 7:** there are the tops of two trusses visible above First floor Rooms 3 to 7. The roof space is boarded out with early boards and there are some original hand-finished rafters on the south-east side but the rest are modern. The north-east truss has angled braces and slots from earlier use and a lap joint at the principal rafters (Plate 68). The south-west truss has curved collars and peg construction and empty slots from its former use (Plate 69). It is hand finished as are the purlins. There is a small window on the south-east side of the north-east elevation and a corbelled stack at the north-east end but no sign of a smoke hood (Plate 68). The wall is plastered at the north-east and south-west ends.

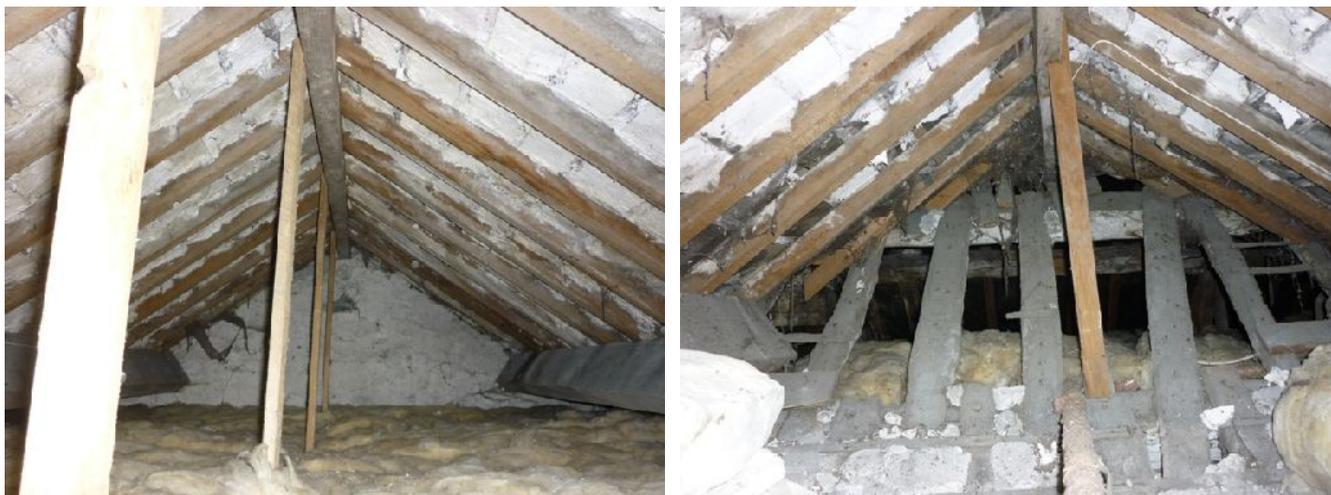
4.3.18 **Roof space over First floor Room 8:** the roof space above First floor Room 8 has basic sawn purlins, one per pitch (Plate 70), and opens into space to the south-east (above First floor Room 7) with rough timbers spanning the junction (Plate 71).

Plate 70 (left): North-west end of the roof space above First floor Room 8

Plate 71 (right): Timbers spanning the junction between the roof spaces above First floor Rooms 7 and 8
