LAND OFF GREEN LANE, PENNINGTON, CUMBRIA

Archaeological Building Recording

Client: HA Sawrey and Son

February 2014

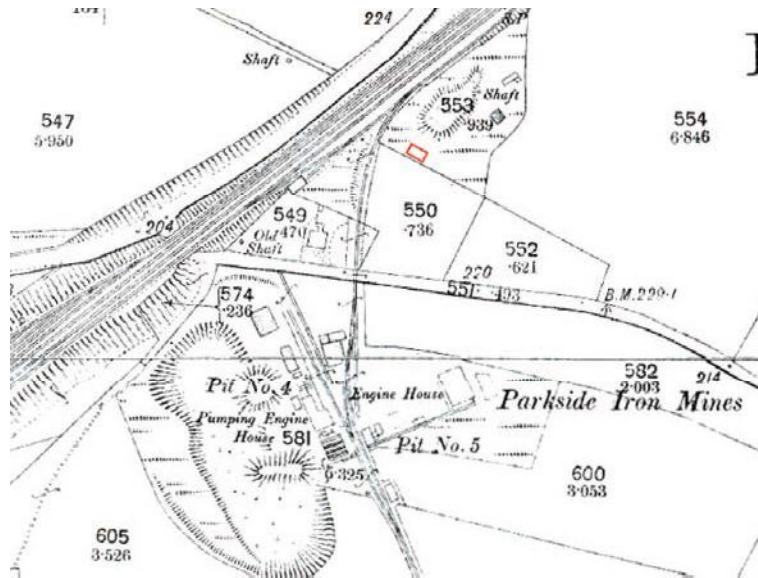
Plate 1: Composite plan of the mines, extracted from the Ordnance Survey maps of 1890 and 1894

3.1.3 **Ordnance Survey, 1890 and 1894:** a rectangular building is located at the site to the north side of Parkside Iron Mines (Plate 1).

3.2.1 Owners and Occupiers: earlier maps of the site show that the building did not exist until the late 19th century, by which time it formed part of the Parkside Iron Mines (Plate 1). These mines were established in 1864 by the Parkside Mining Company of Whitehaven (Kelly 1998, 93). The lease on the area, which formed part of the Muncaster royalty, had been held by Harrison Ainslie and Co, but they neglected to renew it prior to 1864 (*ibid*). The Parkside Mining Company renewed the lease again in 1871 and retained it for some time, despite subsistence causing damage to the nearby railway in 1878, until attempts to alleviate the affects of flooding, which had been a constant difficulty, failed in 1889 (*ibid*). The lease was then taken over by Harrison Ainslie and Co in 1892 (*ibid*; McFadzean 1989, 97). The 1910 Valuation by the Inland Revenue records the plot 327 only as 'Iron ore mines' owned and occupied by 'Harrison Ainslie and Co' (CAC(B) BT/IR 1/25 1910), although the site is labelled as part of the 'Lowfield Mines' on the 1913 Ordnance Survey map (Plate 2).

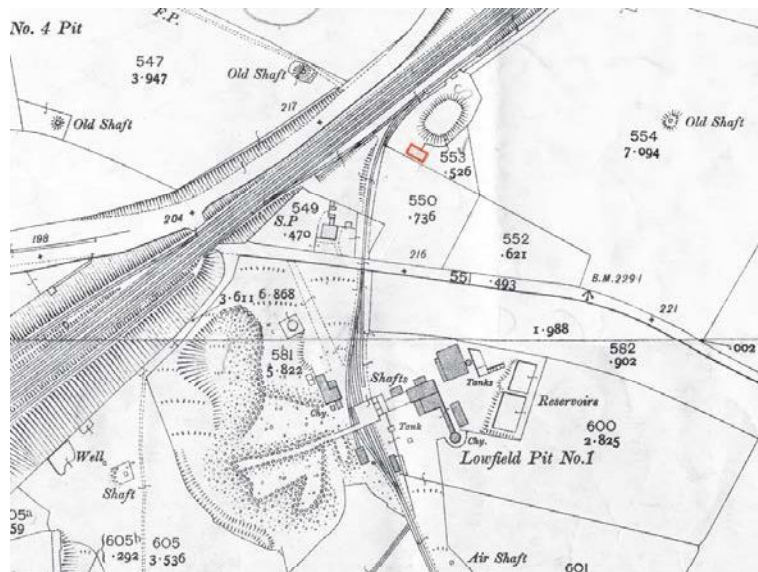
Plate 2: Extract from the Ordnance Survey map of 1913

3.1.4 **Ordnance Survey, 1913:** the shape of the building at the site is unchanged but now forms part of the Lowfield Mines.

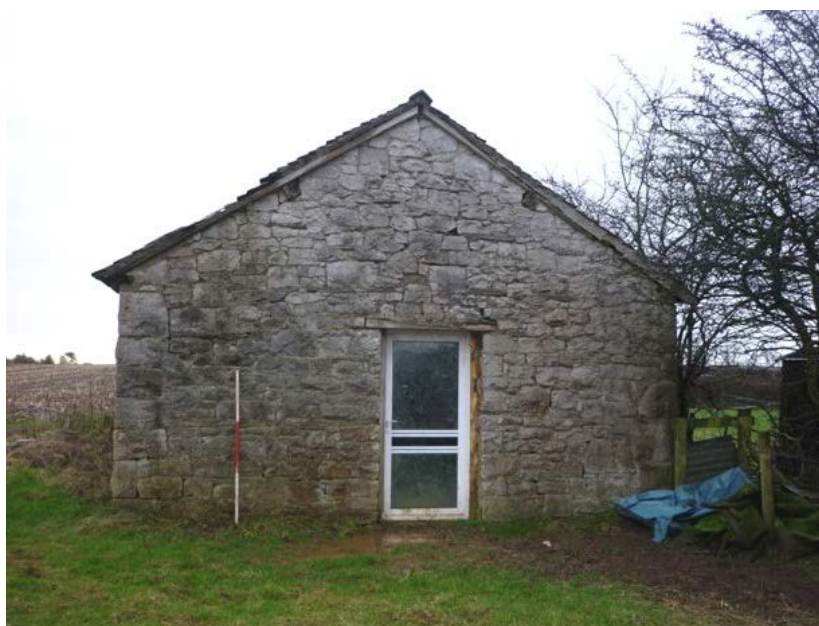
Plate 4: North-west external elevation

4.2.1 **North-west elevation:** this comprises the gable end of the building and is essentially plain apart from the ends of the purlins projecting through and a slightly off-centre (to the south-west) doorway, which has a rough timber lintel and ill-fitting UPVC door with two lights, although the remains of what may be part of the original timber door frame are attached to the north-east jamb.

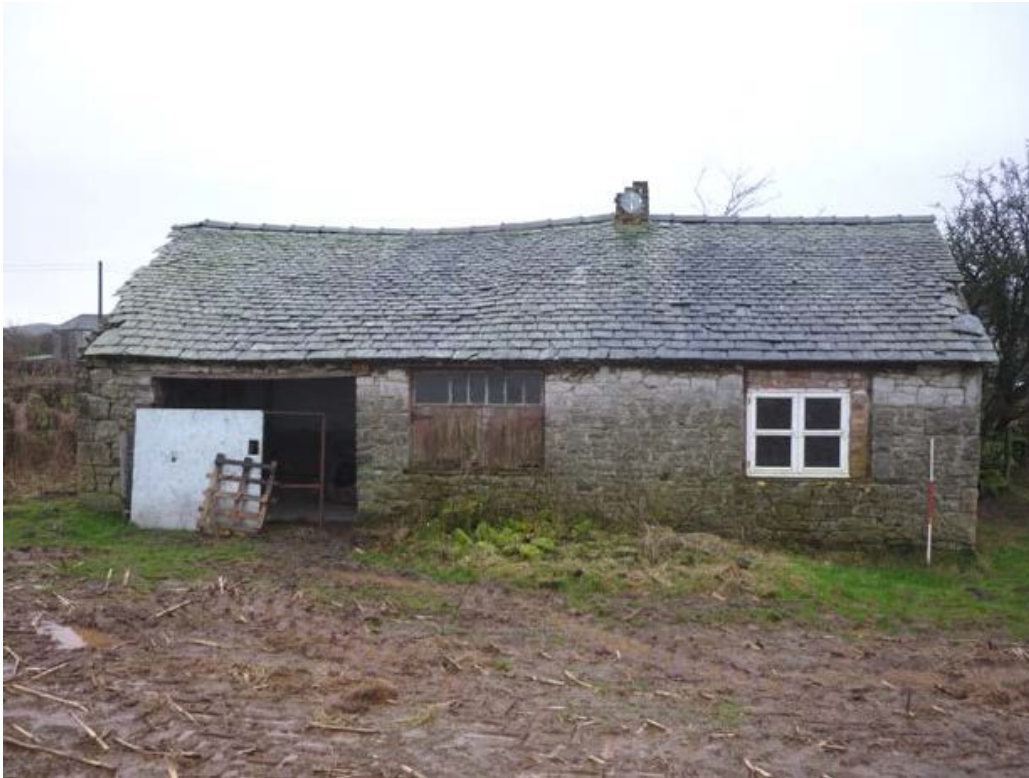
Plate 5: North-east external elevation

4.2.2 **North-east elevation:** there is a window on the north-west side, the original opening of which has been partially blocked with brick to house a modern timber four-light hinged casement. Elements of the original frame remain, with iron pintels, however, as does the badly rotted sill. To the south-east is another window, with the original opening remaining and retaining what is probably the original timber casement with six fixed lights above a pair of hinged shutters, the north-west on early strap hinges held on pintels. To the south-east of this is a wide doorway with a sawn timber lintel, covered by a loose metal fence panel.

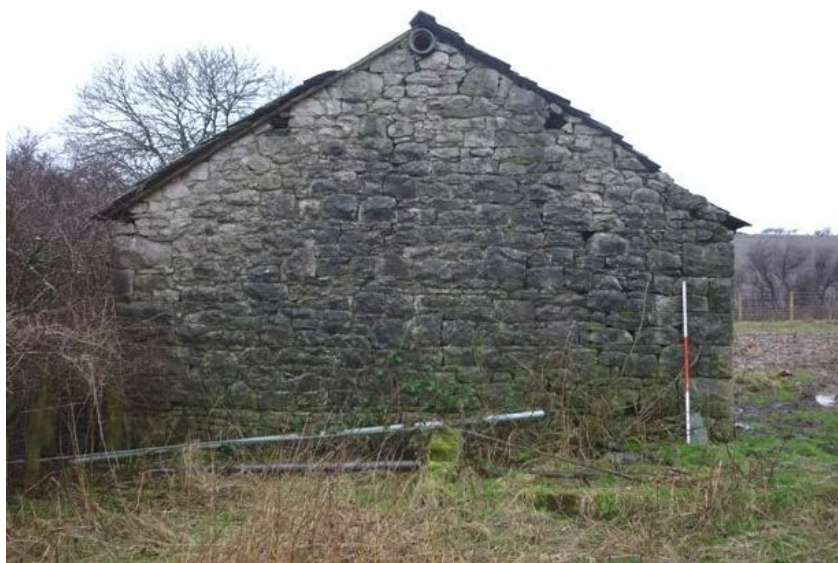
Plate 8: South-east external elevation

4.2.3 **South-east elevation:** this forms the opposing gable and is essentially plain. There is a vent at the apex formed by a section of stoneware pipe and the remains of a brick structure against the north-east side.

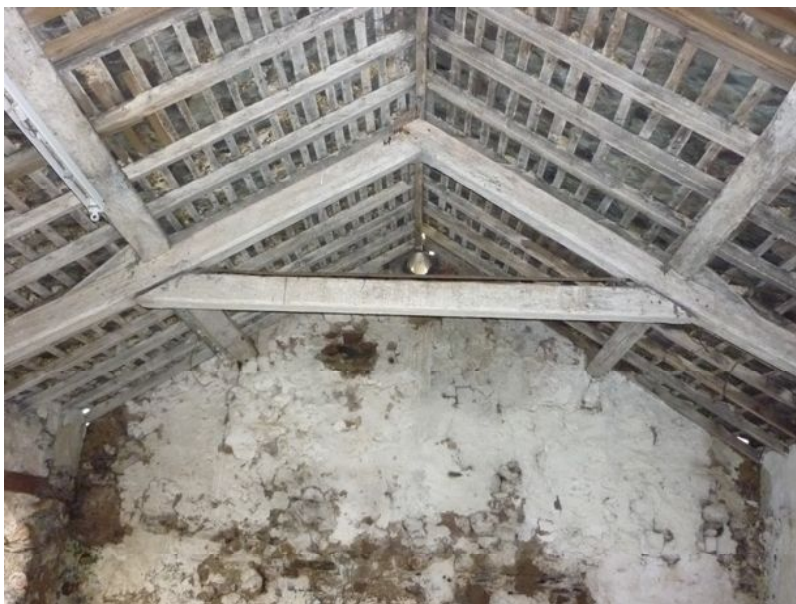
Plate 9: Truss in Room 1, north-west face

4.3.1 **Ground floor Room 1:** this has a concrete floor, with the scar of a small structure on the south-east side and a shallow channel along the middle running north-west/south-east. It is open to the roof, which is supported by two trusses each comprising a just principal rafters and a raised tie beam or collar, the principal overlapping at the apex (Plate 9). There is a single purlin per pitch and a ridge plank and all of the timbers are machine sawn with the collar/tie and principles also finished with a neat stop chamfer decoration. The backs of the slates are visible and are evidently originally finished with lime mortar. The walls are finished with lime wash, although there is a concrete skim over the lower part of all but the north-east. The main outer walls are of stone construction, while the north-west is brick, laid in stretcher bond. There is a plain doorway on the north-east side, with a very thin timber lintel, and it appears to be inserted as there is a rebuild line in the jambs (Plate 10). The north-east elevation has a wide window on the north-west side with a sloping sill, slightly splayed jambs, and a timber lintel. It has a timber casement with six fixed lights over hinged plank shutters (Plate 11). Like the trusses the timber of the casement is finished with stop chamfer decoration. There is a wide doorway to the south-east with a modern timber lintel. The south-east elevation is a plain gable with a vent formed from a stoneware pipe at the top and a drain formed by another at the bottom, meeting the shallow channel in the floor (Plate 12). The south-west elevation has what appears to be an aperture on the south-east side blocked with brick and with a stone lintel. To the north-west is an area of projecting corbelled brick, which presumably originally formed part of a flue. Between these, at lower level, the scar of a possible low wall is evident in the concrete skim (Plate 13).

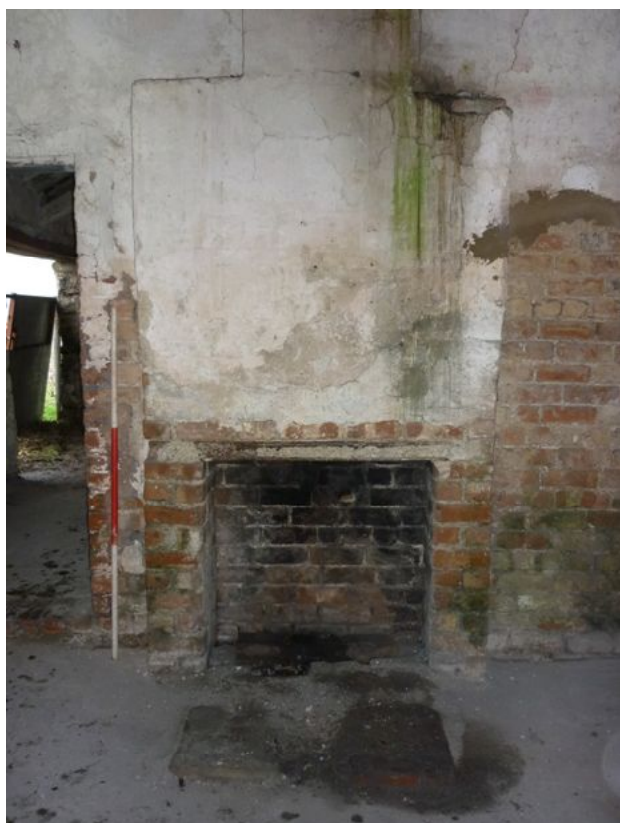
Plate 16 (left): Fireplace, south-east internal elevation, Room 2

elevation there is a projecting chimney breast (Plate 16); the hearth opening has an iron I-beam lintel and the chimney steps in near the top, becoming narrower as it projects through the roof. In front of the fireplace is a low brick platform set into the concrete floor, although more likely where the concrete has been poured in around it. The south-west elevation is essentially plain and covered with rough base coat for modern plaster. There are timber blocks projecting through it in pairs, one denoted by a hole in the wall, which presumably formed fixing points for a fitting in this room such as a workbench (Plate 17).
