THE MINT CAKE WORKS, CROSS LANE, KENDAL, CUMBRIA

Archaeological Building Recording

Planning Application Reference:
SL/2011/0494

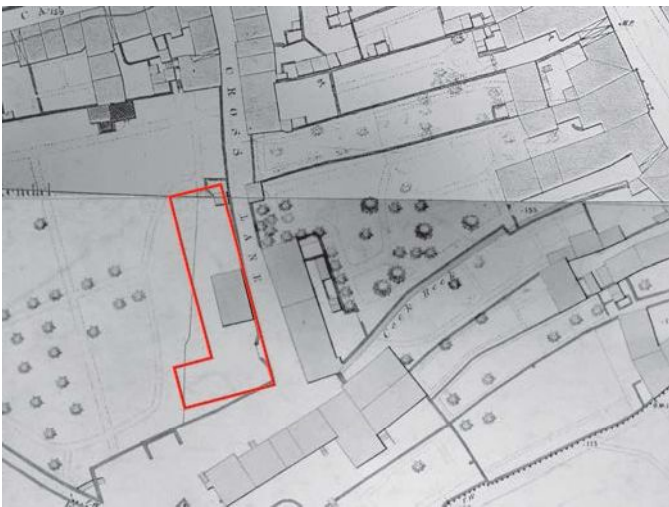
Plate 5 (left): Extract from the Ordnance Survey map of c1858

3.1.6 **Ordnance Survey, c1858:** this map (Plate 5) shows a structure has been built in towards the centre of the site on the east side and there is another small structure at the northernmost corner of the area. An entrance to the yard from Cross Lane is shown to the south of the larger structure. No internal divisions are shown.

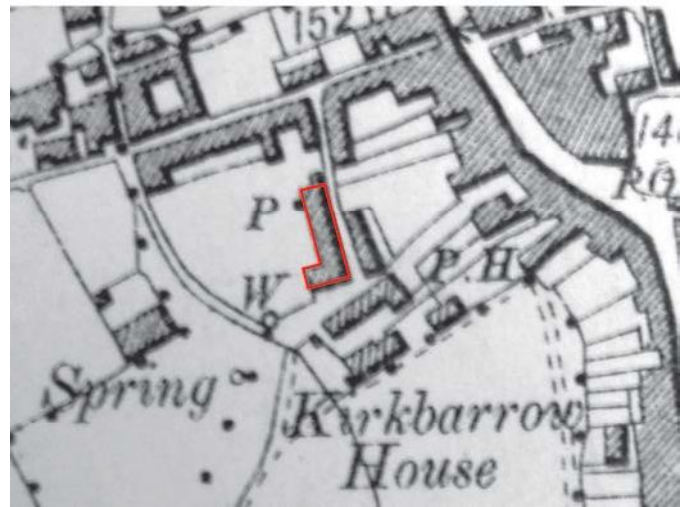
Plate 6 (right): Extract from the Ordnance Survey map of 1899

3.1.7 **Ordnance Survey, 1899:** unfortunately, this was the largest scale map available for this date at the Archive Centre, as they apparently do not hold the second edition 1:2,500 map. Although lacking in detail, it is the first map to show the buildings on the west side of Cross Lane at their fullest extent; the site is occupied by an L-shaped structure(s), with no internal divisions shown (Plate 6), and the area of the yard has been built over, but it is not clear whether the rectangular structure shown on the earlier Ordnance Survey map of c1858 was incorporated into this later structure or was entirely replaced; it may have only been temporary. There appears to be a small square structure at the north corner of the L-shaped structure, which is outside the current area and the letter 'P' to the north-west depicts the location of a pump.

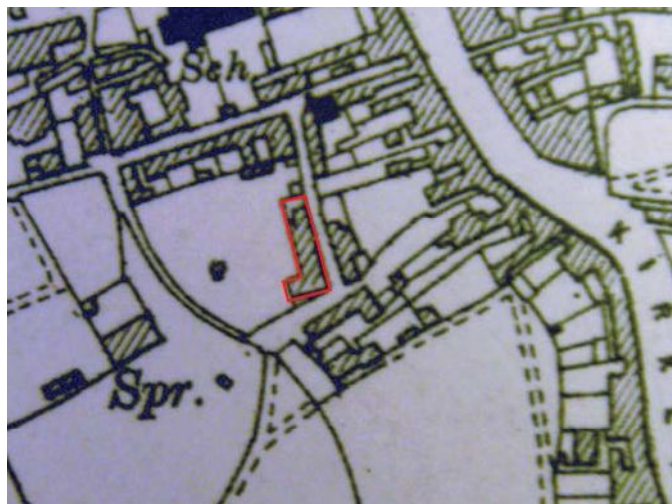
Plate 8 (right): Extract from the Ordnance Survey map of 1920

3.1.9 **Ordnance Survey, 1920:** once again, this was the largest scale map available around this date, as the third edition 1:2,500 scale map for this area was missing from the Archive Centre. Although the map is lacking in detail, for instance, no internal details are shown, the buildings on site appear to have the same or certainly a similar footprint to the one shown on the 1913 edition of the Ordnance Survey map (Plate 8, cf. Plate 7). The square division in the yard to the north-west corner is not shown.

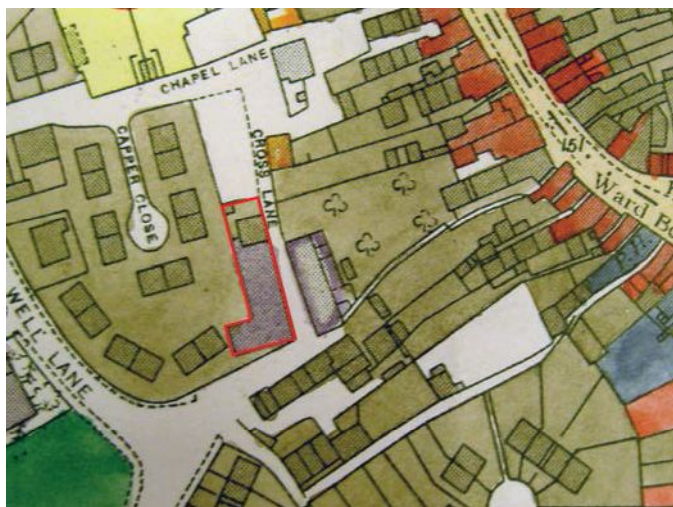
Plate 9 (left): Extract from the Ordnance Survey map of 1938

3.1.10 **Ordnance Survey, 1938:** this map (Plate 9) is more detailed than the previous one. A small building is depicted where there was a division within the yard on the 1913 edition of the map (Plate 7) and a square structure is shown as a separate block at the northern end of the structures fronting onto Cross Lane. Much of the terraced housing along Chapel Lane has been demolished and the area to the rear of the buildings on the west side of Cross Lane has become Capper Close.

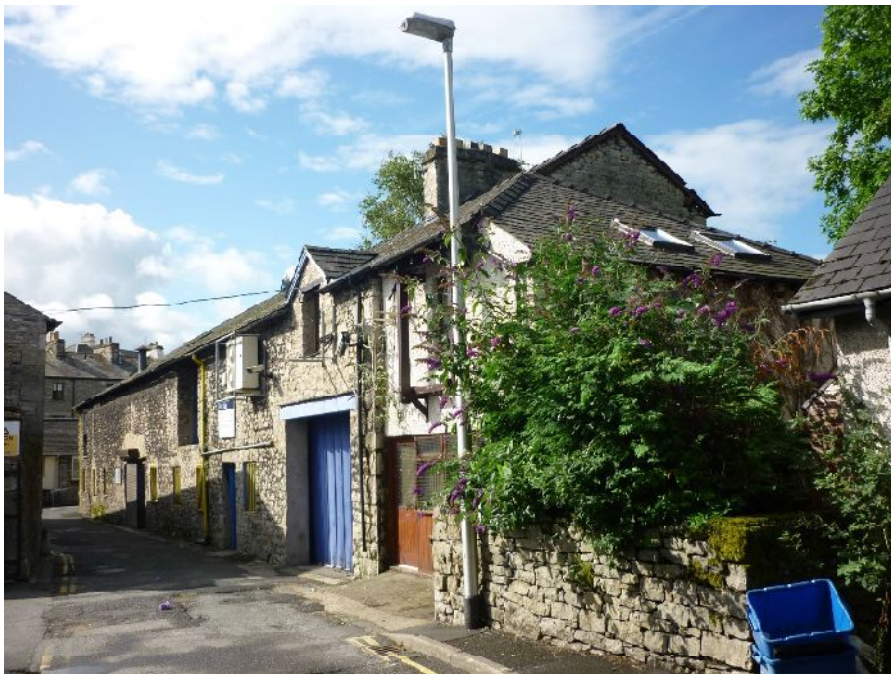
Plate 11: The north external elevation

4.2.1 **North elevation:** this is largely obscured by vegetation and the adjoining building and difficult to access (Plate 11). The lower part is covered by the modern extension, which is finished with painted roughcast render, the lower part slightly stepped out and stone built. The roof over this section is hipped and has two skylights (Plate 11). Above rises the taller elevation of the main part of the building, which comprises a gable end of exposed rough courses of stone in lime mortar, with the ends of the purlins projecting and supporting thick barge planks (Plate 11). The west end of this elevation is effectively continued by the return at the south end, which is essentially plain, apart from a window at ground floor level with a stone lintel and four-light hinged timber casement with bars over.

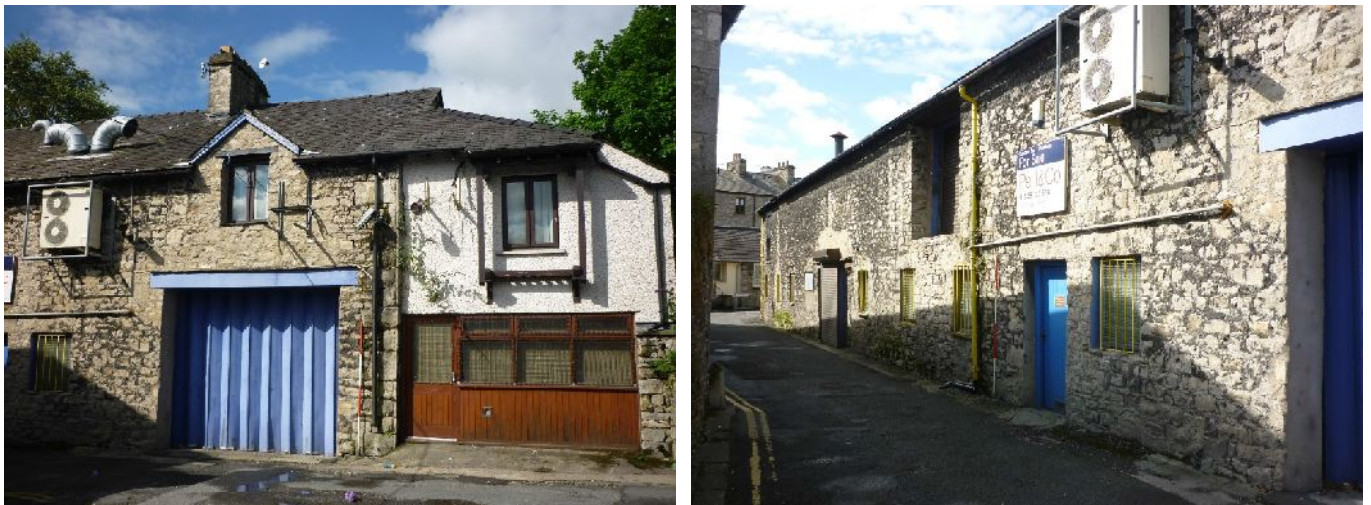
Plate 12 (left): The north end of the east external elevation

4.2.2 **East elevation:** the north end comprises part of the modern extension and is finished with painted roughcast with a hipped roof and it steps in slightly from the main line of the building (Plate 13). The roof

line beyond this projects over a first floor window, and is supported by a substantial timber structure. The window has a timber two-light hinged casement and plain sill, presumably concrete. On the ground floor there is a wide opening largely in filled with tongue and groove planks but incorporating a long window comprised of three two-light windows covered with mesh. To the south of these, within the same opening, is a doorway with a single light and tongue and grove planks below. South of this section the step in the wall is finished with rock-faced quoins with dressed edges denoting the start of the 'cottage' part of the building. This has a window on the first floor with a gabled dormer above, a two-light hinged timber casement, timber lintel, and slate sill. Below is a large doorway with a folding metal door and thick timber lintel. Above the southern jamb of this is an apparent butt joint, presumably denoting where the 'cottage' was added to the original building, although seemingly with only very small quoins. To the south of the 'cottage' the main part of the elevation is a single construction (Plate 13). It has eight ground floor windows, four with the original stone lintels and sills, while three are either later inserts or have been modified and have concrete lintels and slate sills, while the last has had its lower part blocked and then the upper part rebuilt to form two openings with concrete surrounds. The rest all have single-light casements with bars and mesh over, apart from the southernmost, which has been filled with a metal vent. There is an apparently original pedestrian doorway at the north end, with a stone lintel and tongue and grove plank door with a brass plaque attached reading 'J.E. WILSON & SONS (KENDAL) LIMITED REGISTERED OFFICE' and a brass letter box below (Plate 14). To the south is another doorway in a wider opening that has been partially blocked on either side and with a metal roller shutter door in the middle. A thick timber lintel spans all of the wider opening.

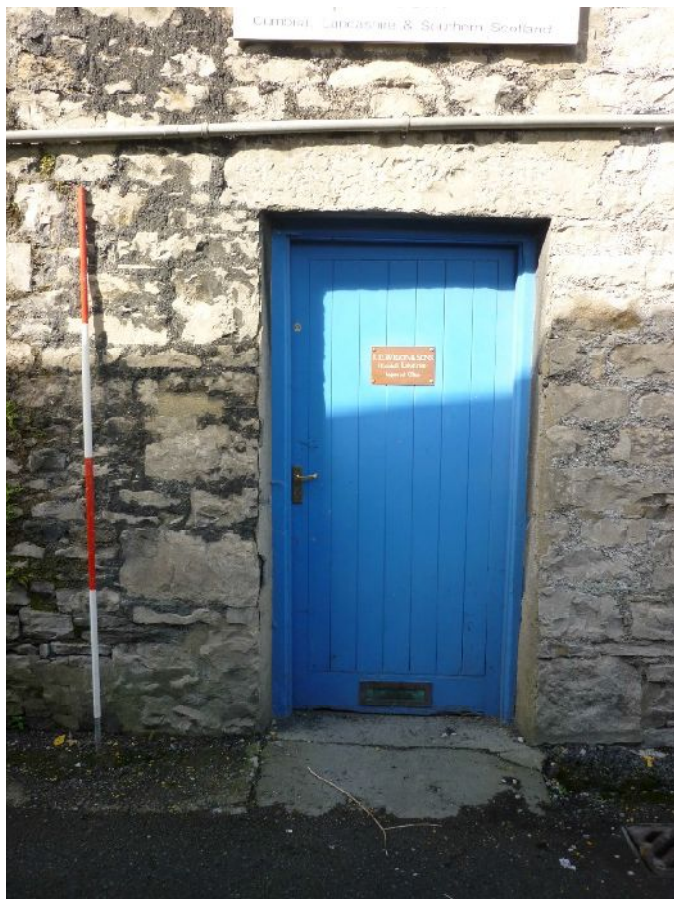
Plate 14 (left): Pedestrian doorway at the north end of the east external elevation

4.2.3 The first floor is largely plain, but with a doorway to the north, which has seemingly been modified, as the south jamb is rebuilt. It now has a metal roller shutter door, below a timber lintel while the sill is covered by concrete. An extractor fan is attached to the north. At the south end there is another doorway on the first floor, which appears to be original. The lower part is blocked with board while the upper has a two light window covered with grill. It has a timber lintel with a block in the centre, perhaps for a hoist, over the centre, and a sandstone sill. The lower part of the south-east corner has been formed into a chamfer with rock-faced dressed quoins with dressed edges and a corbelled top (Plate 15).

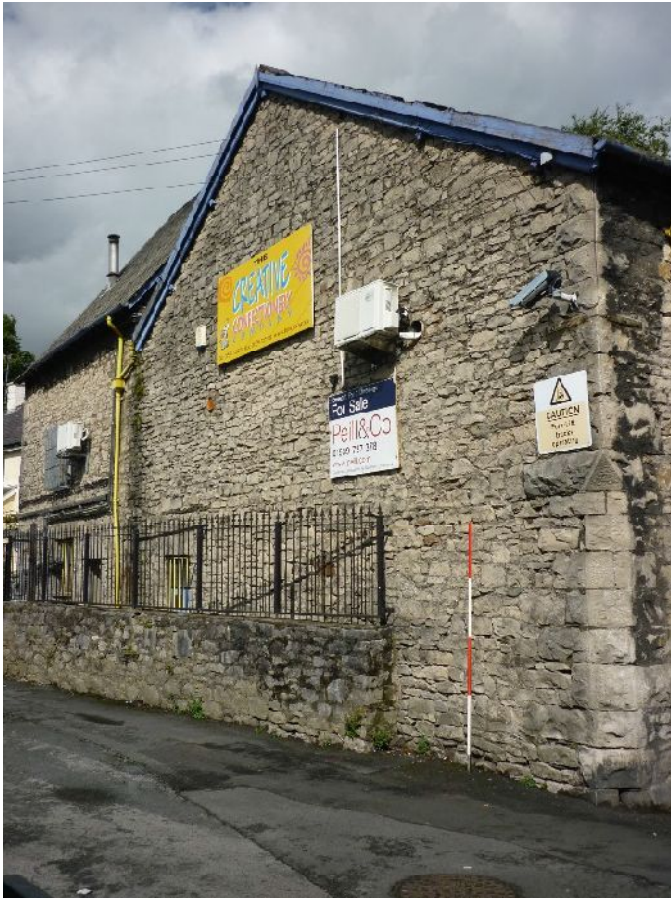
Plate 16 (left): The east side of the south external elevation

4.2.4 **South elevation:** the east side comprises the end gable of the main part of the building, with a quoined corner continuing to the chamfered lower section already described. It is otherwise mostly plain with various modern signs and an extractor fan (Plate 16). There is a window on the lower west with a stone lintel and sill. The upper part houses two vents while the lower is blocked with boards and there are bars over the whole. The west part of the elevation is the side of the west return, and although not continuing the roofline of the rest it appears to be contemporary as there is no evident junction (Plate 17). There is a single window on the first floor with a single light casement, although the window is seemingly inserted or modified as there is clear rebuild around the jambs and it has a concrete lintel. It too is covered by a metal grill. On the ground floor there is a doorway to the east with a stone lintel and modern timber panel door. To the west of this is a window with three lights, the west filled with a timber slatted vent, and pipes coming through the east. Above both the window and the doorway is a tar scar denoting the position of a former outshut and an attached timber joist. The south-west corner is finished with rock-faced quoins with dressed edges.

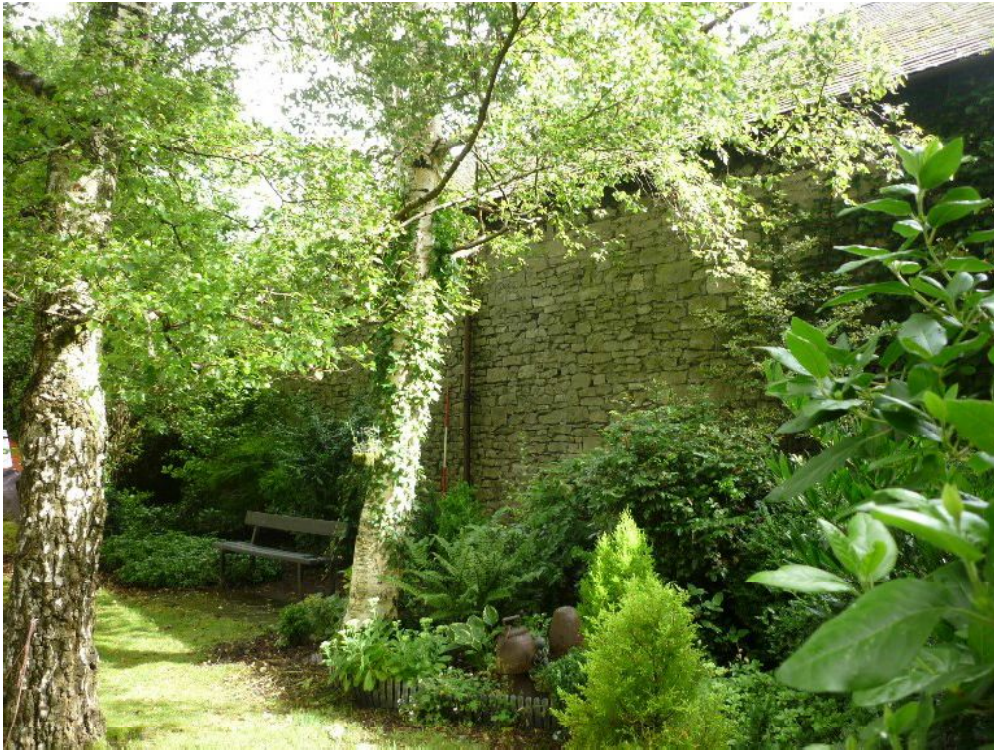
Plate 18: West elevation, obscured by vegetation

4.2.5 **West elevation:** this is partially obscured by vegetation in the adjoining gardens and ivy running up the building (Plate 18). The south end, which comprises the end of the return to the west, is roughcast but the quoins have been left exposed. It has a ground floor window with a stone sill and two lights over a vent, the whole window being covered by bars. Either side of the window is a cross-shaped tie rod plate. At first floor level there is another window with a slate sill and a single light timber casement. There are barge boards over the eaves covering the purlin ends, which project some distance from the wall line. The main part of the elevation is essentially plain, with a row of four ground floor windows, their sills essentially at ground level suggesting that it is built up against this side. The southernmost has a four-light hinged timber casement with bars over, to the north the window has a similar casement, but is blocked internally with concrete blocks, while to the north of that is the window is also blocked internally but has a three-light iron casement, and the northernmost window is entirely blocked with no casement remaining. There is a step at the north end where the modern addition is attached, the lower part of which is a projecting exposed stone wall while the rest is painted roughcast.

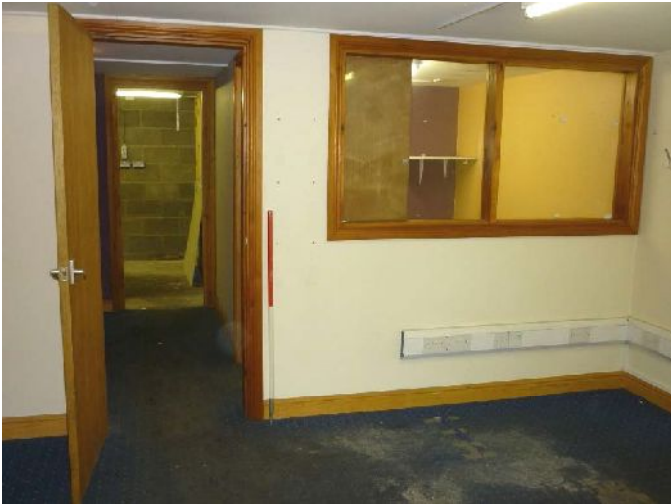
Plate 19 (left): West elevation of the east office in Room G1

4.3.1 **Ground Floor, Room 1:** this represents all of the rooms making up the modern extension on this floor, which comprise three small office spaces and a connecting corridor, as well as a ramped corridor along the west side connecting to Room G4 to the south. All of the rooms have a modern finish, with carpet over concrete floors throughout, with the exception of the ramped corridor, which is exposed concrete. The external walls are clearly concrete block, apart from where timber infill has been used in the east, and they are typically finished with plaster and paint and a plain skirting board, although exposed painted and unpainted concrete blocks are visible in places. Internal walls are stud partitions and doorways have modern timber plywood single panel doors (Plate 19). There is a large window in the eastern office with an associated doorway (Plate 20). The east side of the corridor linking to Room G4 is evidently the original external wall of the 'cottage' and is largely finished with plaster but leaving the quoins exposed, which are rock faced with dressed edges (Plate 21).

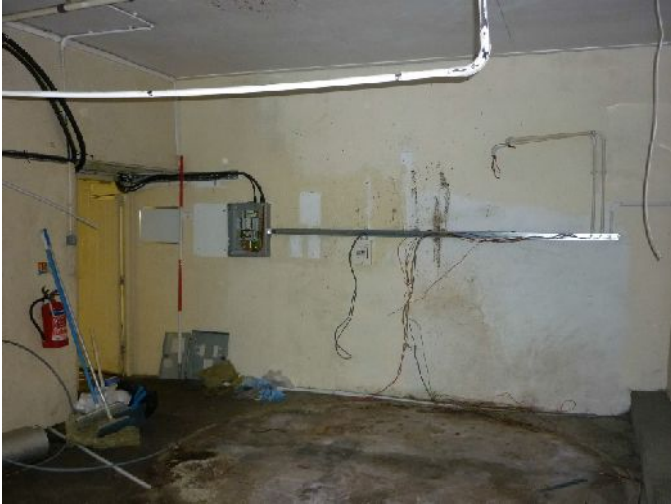
Plate 22 (left): West elevation of Room G2

4.3.2 **Ground Floor, Room 2:** this represents the entirety of the ground floor space in what was the 'cottage', and comprises a single large space presumably formerly utilised as a garage or similar. It has a concrete floor, with a large step along the south side against the wall and a modern plasterboard ceiling (Plate 22). The walls are finished with modern plaster and paint and all are essentially plain, apart from the east, which is largely filled by a massive folding metal door (Plate 23), and the south, which has a tall alcove on the east side (Plate 24), presumably a blocked doorway, and an extant doorway on the west side with a concrete lintel and double plank and batten timber door.

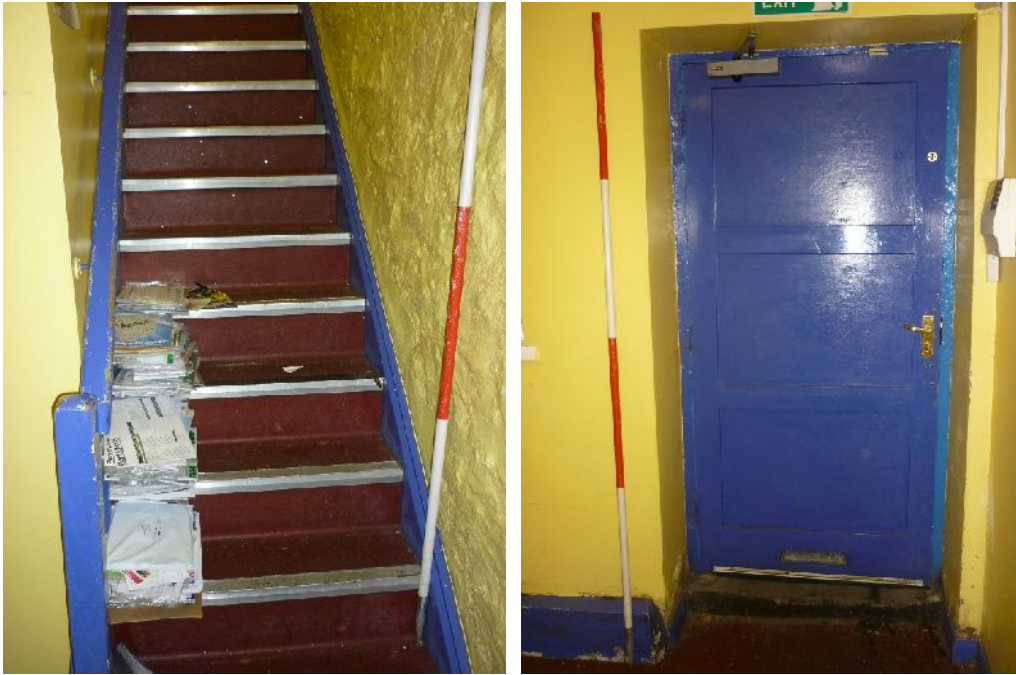
4.3.3 **Ground Floor, Room 3:** this forms a lobby from the main entrance and access to the stairs. The floor is finished with vinyl sheeting while the stairs, which are against the north elevation, are timber with a simple hand rail against the south wall and a square newel post (Plate 25). The walls are finished with modern plaster and paint and the ceiling is plasterboard or similar. The walls are essentially plain, although there are opposing doorways east and west, the east leading outside has three plain panels (Plate 26), while the west is modern plywood with a single panel and single light window.

Plate 25 (left): Stairs to the north side of Room G3

Plate 26 (right): Door to outside from Room G3

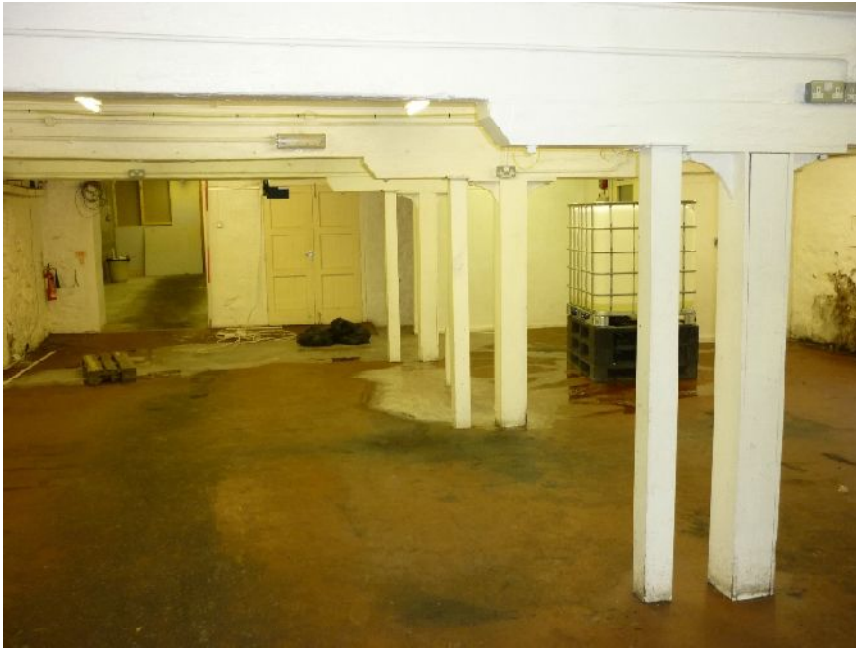
Plate 27 (left): North end of Room G4

4.3.4 **Ground Floor, Room 4:** this forms the northern half of what was originally a single large space, but is now divided in two. It has a concrete floor covered with vinyl sheeting, and plasterboard or similar ceiling supported by timber battens. The ceiling is in turn supported by three beams orientated east/west (with another hidden by the dividing wall at the south end and effectively inside Room G5) (Figure 4; Plate 27, Plate 29). Each beam is supported in the centre by an iron column with flanged brackets at the top bolted to a large timber block (Plate 28). These columns have been boxed square with plywood. To the west side of each column an additional square-section box steel girder has been added to form an additional support and bolted to the timber block above. In addition, a further round-section column with a flanged bracket on top is situated between the two most northerly beams and bolted to a timber block immediately below the ceiling (Plate 30). This has square flanges projecting to the north and west at the base. The walls are all finished with paint over roughly applied plaster or earlier layers of whitewash, apart from the south elevation, which is a stud partition wall. The north elevation has a doorway on the west side (Plate 27) into the ramped corridor in Room G1, which is evidently inserted and has a concrete lintel. To the east is a doorway with a double plank and batten door, and there is a projecting section of stud partition wall running from the north end of the east elevation across the east side of the north elevation hiding the section below the stairs. The east elevation is stud partition at the north end, forming the lobby area (Room G3), which has a modern plywood panel door. The larger part of the elevation proper has three windows running across it (Plate 31). The north and south are probably inserted and have concrete sills and lintels, while the central one has splayed jambs, a sloping sill, and a timber lintel. The south elevation has metal sheeting attached over the lower part of the east side (Plate 28 and Plate 29), and a wide doorway to the west, with a sliding plank and batten door (Plate 32), the metal handle of which is marked 'HENDERSON'. The west elevation has two windows, both of which have been blocked with concrete blocks leaving an alcove (Plate 33).

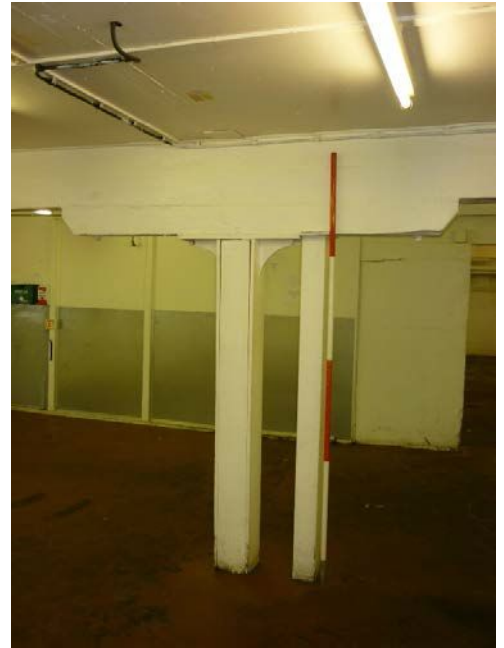
Plate 28 (right): Boxed column and square section girder beneath the beams in Room G4

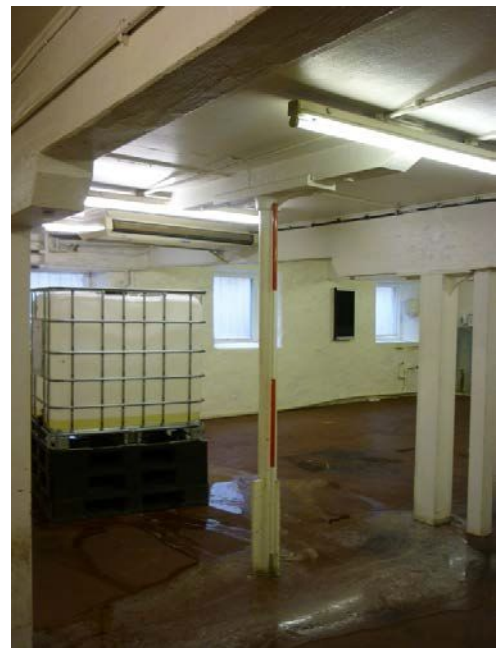
Plate 30 (right): Round-section column with a flanged bracket between the two most northerly beams in Room G4

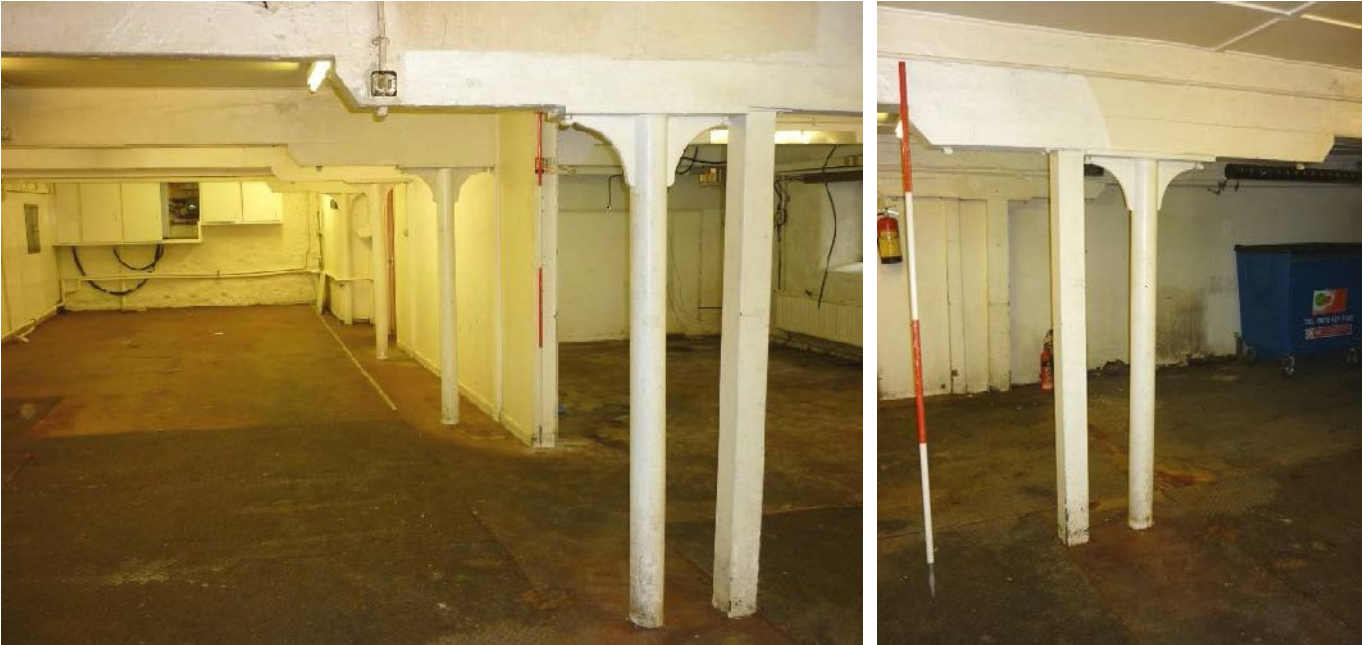
Plate 34 (left): Room G5 and G6 viewed from the north

4.3.6 **Ground Floor, Room 6:** this is a small room formed by stud partition walls within what was the large space represented by Rooms G4 and G5 (see Plate 34; Figure 4). It has a concrete floor finished with vinyl and a plasterboard ceiling supported by timber battens and two of the beams from Room G5 run through it. The south and east walls are stud partitions, as was the north originally although it has been mostly removed. There is an aluminium strip along the floor that denotes its original position, however. The west elevation is painted and plastered stone and has a single window with a four-light hinged timber casement, splayed jambs and a sloping sill (Plate 40).

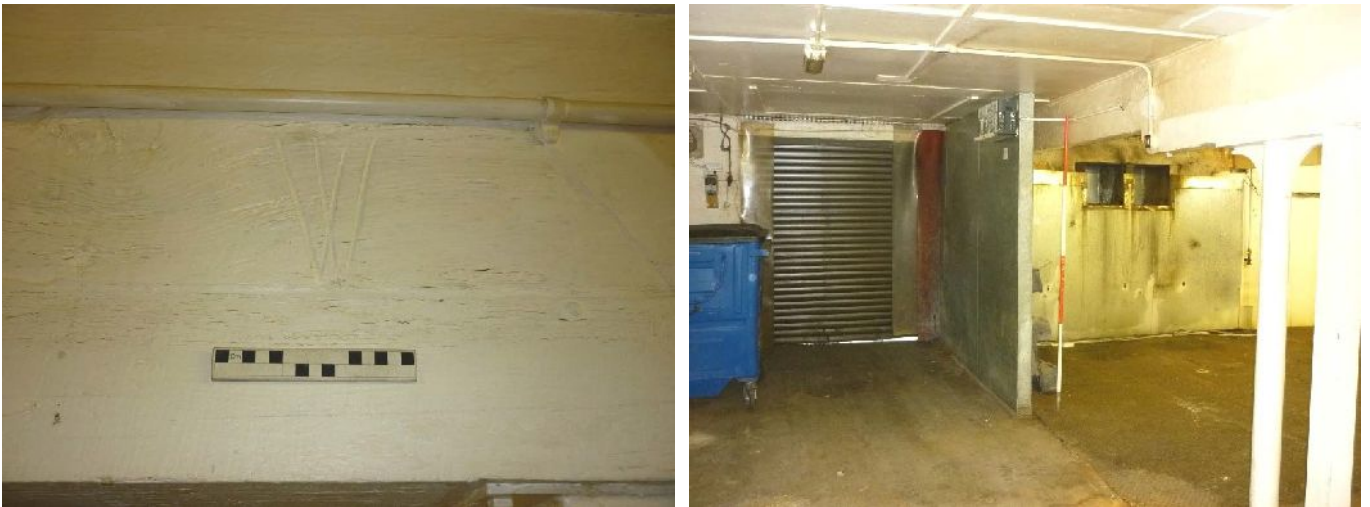
4.3.5 Ground Floor, Room 5: this originally formed the south end of a single large room with Room G4. It too has a concrete floor, finished primarily by vinyl sheeting, but also by gridded iron sheeting in the north-east corner. The walls are finished with paint, although with a mixture of finishes below. The ceiling is relatively modern plasterboard held by timber battens, and is supported by five beams orientated east/west (Plate 34). These are the same as in Room G4, although the central columns are not boxed in with plywood (Plate 35) apart from the northernmost, which is positioned against and incorporated into the north stud wall (Plate 35). The beam south of the north wall has a Baltic timber mark in the form of an overlapping 'W' on the south face above the central column (Plate 36). The north elevation is a stud partition wall, with a doorway with a sliding door on the west side. The east elevation has a doorway on the north side with a metal roller-shutter door, to the south of which is a short metal-clad wall (Plate 37). South of this the wall is finished with metal sheeting, and this area incorporates two apertures in a rebuilt former window. To the south is another window, with splayed jambs, where the wall is clad with plastic sheeting, and there is a further opening at the south end in what was originally a window with metal doors and a metal mesh inside (Plate 38). The south elevation is roughly plastered and painted stone with a cupboard housing electrical fittings attached (Plate 38). The west elevation comprises a timber stud partition wall at the south end with a panel door with a single light window, which

Plate 36 (left): Baltic timber mark in the beam south of the north wall in Room G5

Plate 37 (right): North end of the east elevation of Room G5

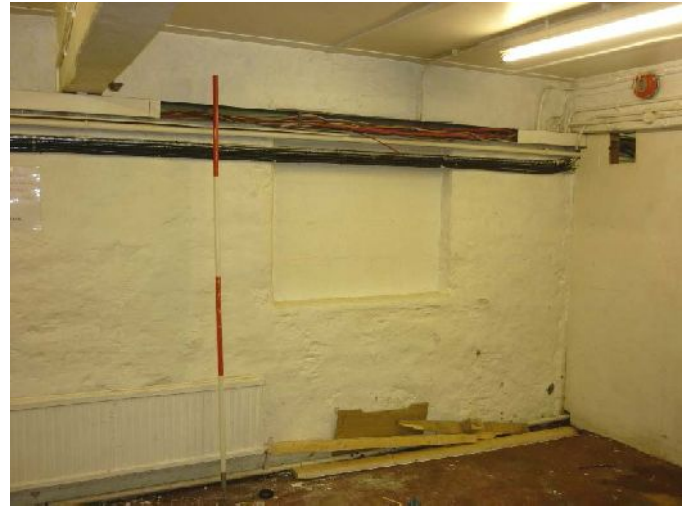
Plate 39 (right): Blocked window at the north end of the west elevation of Room G5

returns to the west (although this section has been mostly removed leaving it open to Room G6). The north end is painted and plastered stone with a single window blocked with concrete blocks leaving an alcove (Plate 39).

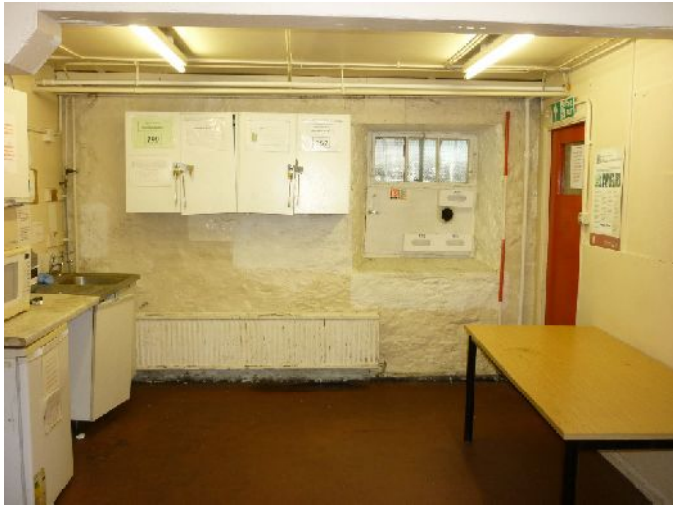
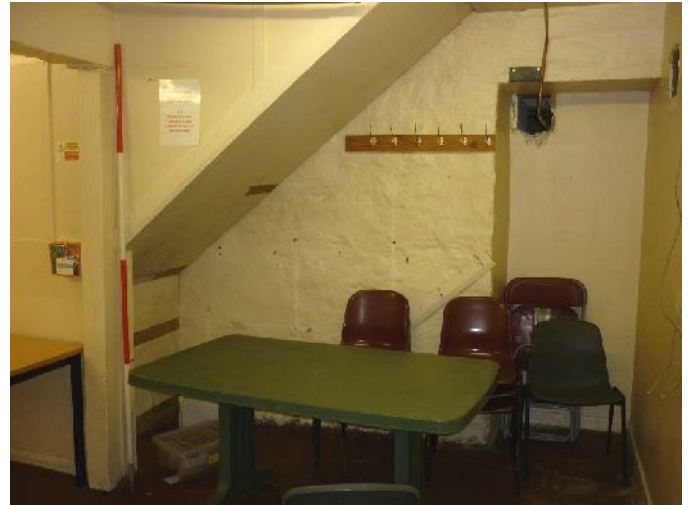
Plate 41 (left): South end of Room G7

4.3.7 **Ground Floor, Room 7:** this forms a space connecting Room G5 to the small range of rooms to the west (G8-12). It has a concrete floor finished with vinyl and a plasterboard ceiling supported by timber battens, with a single beam continuing from Room G5. The walls are all painted over a number of finishes. The north elevation is a plain stud partition. The east is also a stud partition but with a step at the beam and a doorway at the north end with a panel door with a single light window, and kitchen units attached to the south. The south elevation is painted and plastered stone, with cupboards attached and a window on the west side with a three-light hinged timber casement at the top and blocked by boards at

the base (Plate 41). The bulk of the west elevation is a timber stud wall, with a doorway on the west side with a modern panel door with a single light window. It returns where it meets an additional square-section column below the beam, running below the stairs. Beyond this point it is painted stone and plaster and there is doorway at the north end blocked with stud walling leaving an alcove (Plate 42).

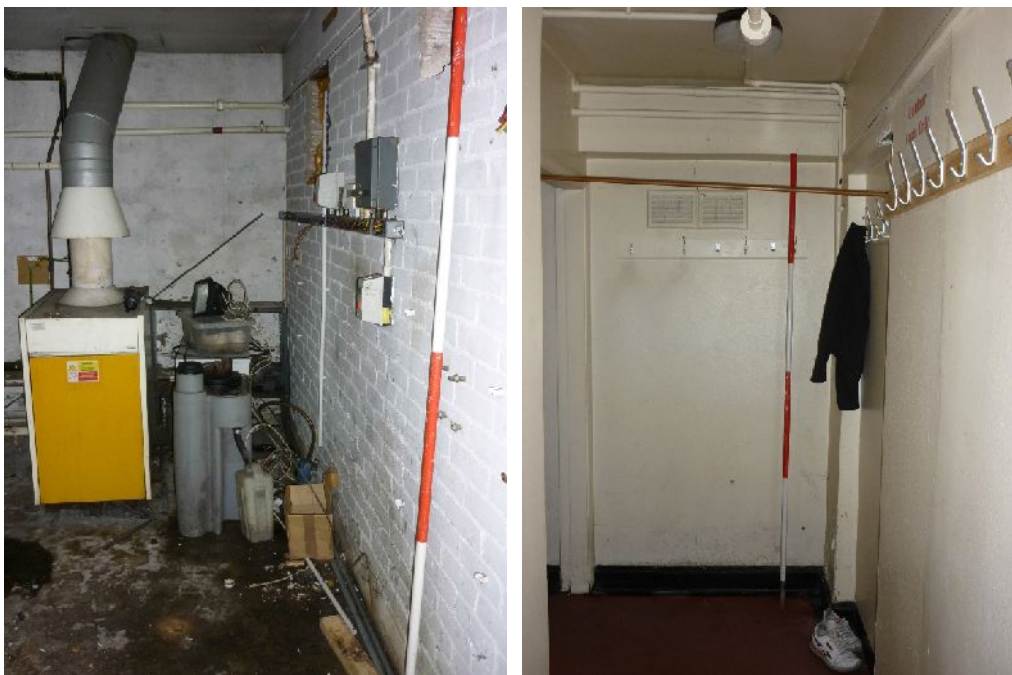
4.3.9 Ground Floor, Room 9: this is a boiler room. It has an exposed concrete floor and plasterboard ceiling, with boxing orientated east/west along the south side, perhaps for pipes. The walls are painted, the south and west are stone, while the north and east are brick laid in stretcher bond and there is a boiler sat on the ground on the west side (Plate 43). The north elevation is plain apart from two square holes cut in the wall, the larger, to the west, housing a vent. The east elevation has a doorway on the north side with a timber surround but no door. The south elevation has a window, which is mostly blocked to allow pipes to pass through it, and is divided down the centre. The west elevation is plain.

4.3.10 Ground Floor, Room 10: this forms a short connecting corridor leading into the female toilets. It has a concrete floor finished with vinyl, and the ceiling is painted plasterboard or similar. There is a thin beam running across the corridor, corresponding to the turn into the toilets proper. The walls are finished with plaster and paint and are mostly plain although there are two ceramic vents in the north elevation (Plate 44). There is a doorway in the north end of the east elevation with a timber lintel, which has been partially blocked leaving an alcove. There is also a doorway at the north end of the west elevation with modern plain surrounds and a panel door with a single long light. The door in the south elevation is in the same style.

Plate 43 (left): North-west corner of Room G9

Plate 44 (right): North end of Room G10

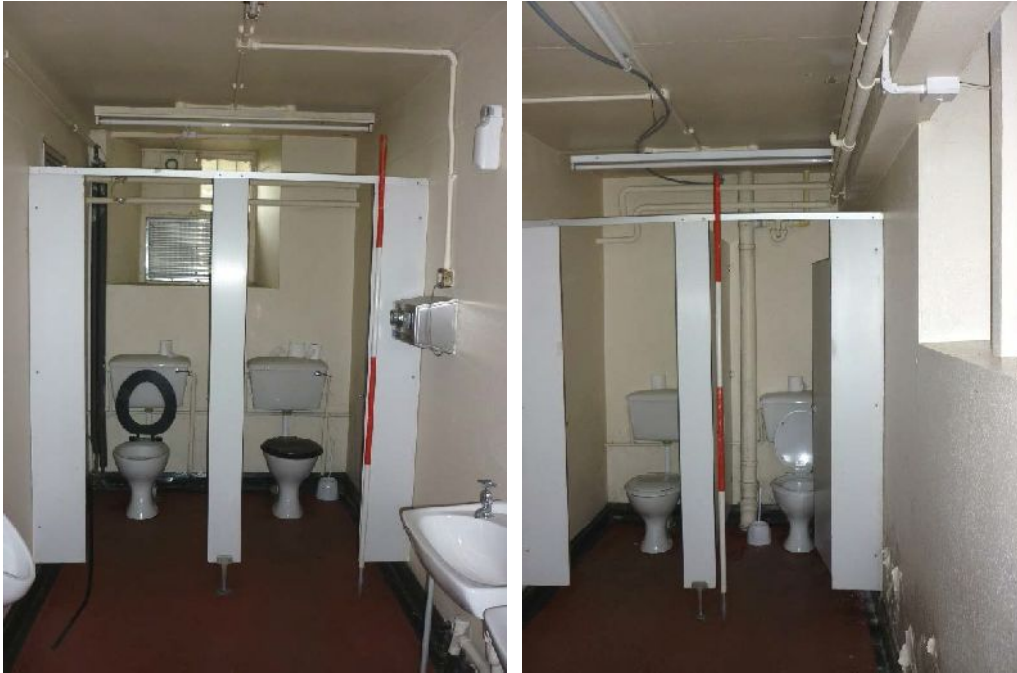
4.3.11 **Ground Floor, Room 11:** this forms the male toilet. It has a concrete floor finished with vinyl and painted plasterboard ceiling. The walls are finished with plaster and paint and mostly plain. There are sinks attached to the north elevation, with tiled splashbacks and a hole cut in the wall, presumably for a vent. The west elevation has inserted panel walls against it forming two cubicles and there are two toilets attached (Plate 45). Beyond these is a window with a four-light casement, although most are now vents. The south elevation has two urinals attached and a doorway on the east side with a modern panel door with a single long light. There is also a hole cut in the wall and a large vent to the west.

4.3.12 **Ground Floor, Room 12:** this has a concrete floor finished with vinyl and the ceiling is painted plasterboard. The walls are finished with plaster and paint and mostly plain and there are inserted panel walls against the west elevation forming two cubicles with two toilets attached to the wall (Plate 46). The north elevation has a window with four-lights, although one is a vent, and the whole window has been divided down the centre by tongue and groove boards and there is timber boxing running along the top of the elevation. Two sinks are attached to the south elevation and there is a doorway to the east with a modern panel door with a single long light. Both the south and east elevations have square holes cut in them, perhaps for vents or to allow piping through.

Plate 45 (left): West end of Room G11

Plate 46 (right): West end of Room G12

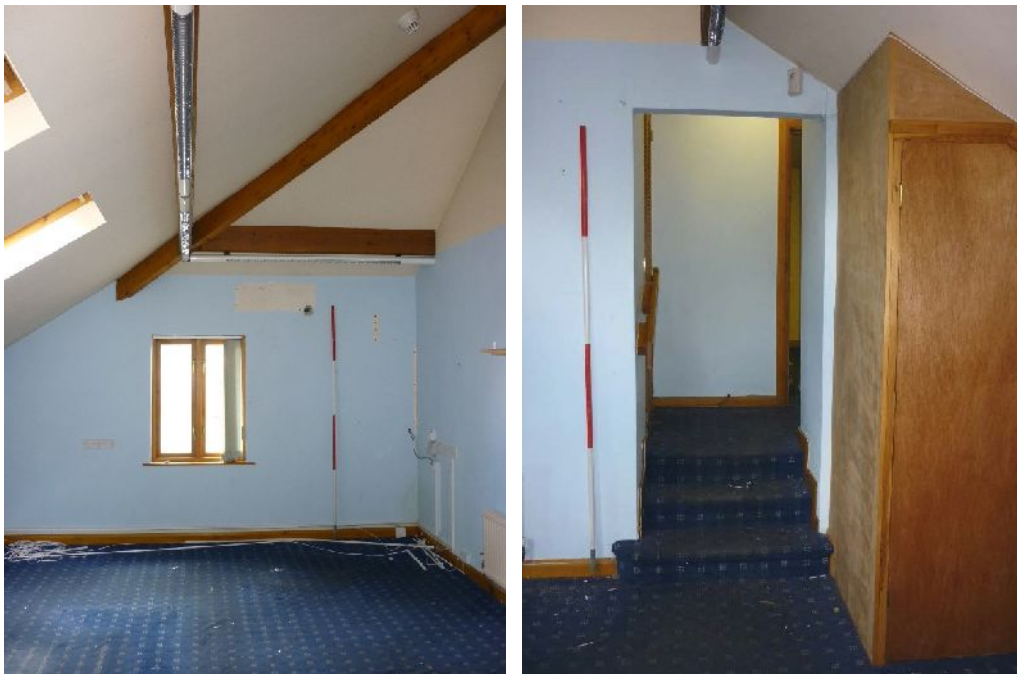
Plate 47 (left): East elevation of Room F1

4.3.13 **First Floor, Room 1:** this room has a hipped roof supported by machine cut beams and two skylights on the north pitch (Plate 47). The walls are finished with plaster and paint and finished with plain skirting. The north elevation is plain. The east elevation has a two-light timber casement window with a timber sill (Plate 47). The south elevation has three steps on the west side, with a handrail on the east side, leading up to the doorway to Room F2, which has no door (Plate 48). There are cupboards attached to the west of this. The lower part of the west elevation is covered by stud walling forming a small attic space (Plate 49).

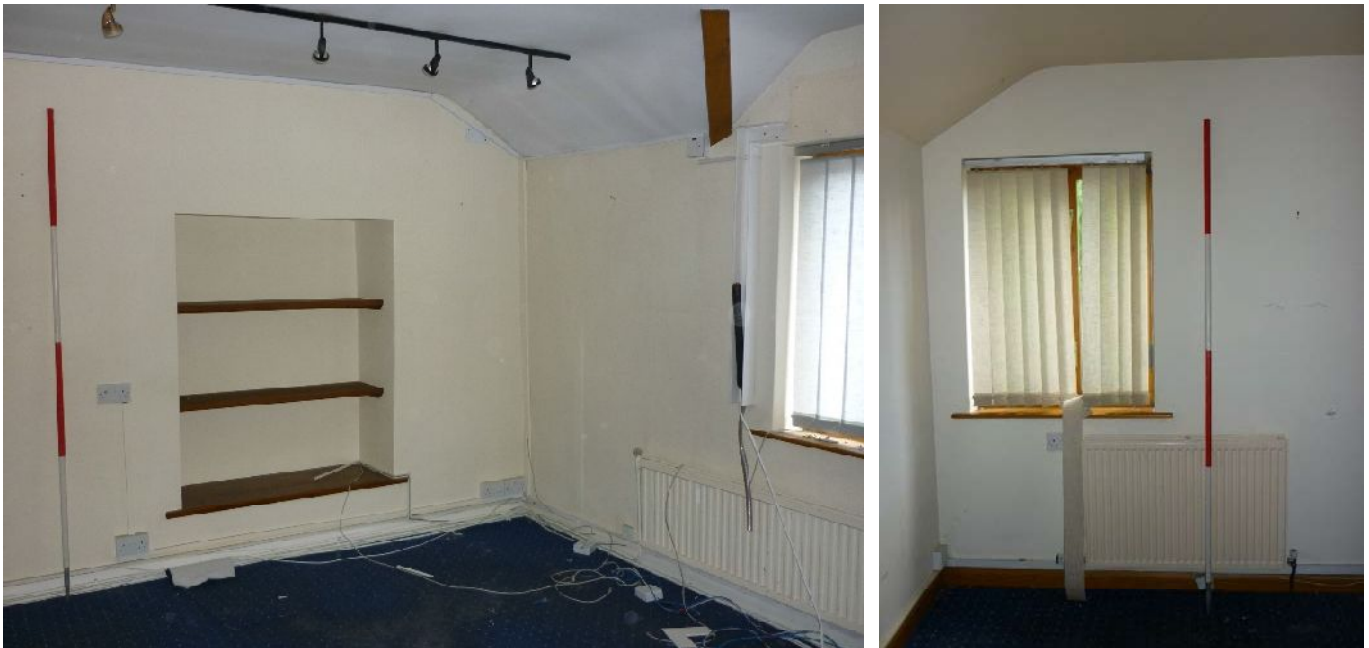
4.3.15 First Floor, Room 3: this previously formed a small office to the east of Room F2. The floor is finished with carpet, over floorboards or modern timber sheeting, and the ceiling is finished with plaster and paint with a narrow beam orientated north-south on the west side and angled beams supporting the dormer projecting from the top of the east elevation. The ceiling also slopes to the south of the east dormer. The walls are finished with plaster and paint and there is a plain skirting board. The north elevation has an alcove on the east side with a modern timber sill and two timber shelves (Plate 50). This was presumably originally a window. The east elevation has a central window with a two light hinged timber casement and modern timber sill. The south elevation is plain, while the west has a doorway on the south side with a modern plain surround and a panel door.

4.3.16 First Floor, Room 4: this is another former office, to the west of Room F2. The floor is finished with carpet and the ceiling is plaster and paint, sloping on the west side. The north elevation has a window with a two light hinged timber casement and timber sill (Plate 51), while the east elevation has a doorway with a plain timber surround and panel door. The south elevation is covered by large fixed cupboards but plain behind these and the west elevation is also plain.

Plate 50 (left): North-east corner of Room F3

Plate 51 (right): North elevation of Room F4

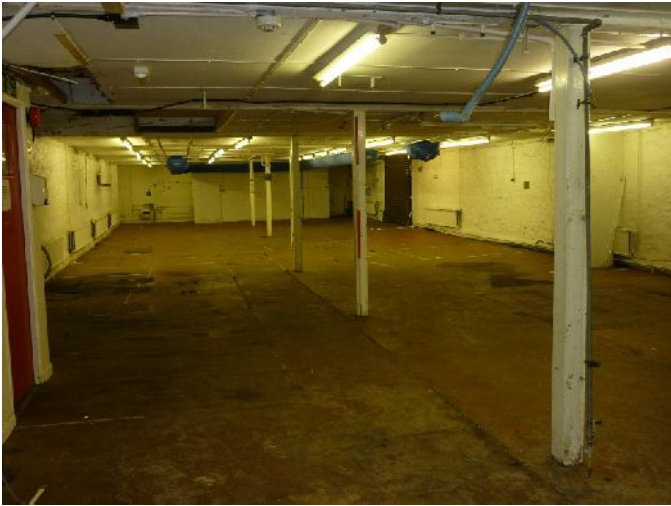
Plate 52 (left): View of Room F5 from the south

4.3.17 First Floor, Room 5: this comprises a large room, filling most of the main part of the building. The floor is presumably timber boards, finished with vinyl sheeting, with at least one remaining metal-lined chute through to the ground floor on the west side and scars for other possible openings elsewhere. The ceiling is plaster board or similar supported by timber battens and six beams (actually the tie beams of the trusses above), each of which is supported by a square-section iron column bolted to its underside (although most of these do not line up with the beams and columns below) (Plate 52 and Plate 54). The three at the north end are slightly east of centre; those to the south are slightly west of centre. The walls are all exposed stone finished with plaster and paint but showing the original surface. The west side of the north elevation is clad with hardboard or similar, before it returns as a stud wall covering the stairs to the ground floor and forming part of Room F2 (Plate 53). There is a doorway on the west side, within the return, with a modern plain surround and panel door with a single light. The east return has access to the stairs to the attic floor, which are constructed from modern timber. The east elevation is mostly plain (Plate 54) but has a wide loading door on the north side housing a metal roller shutter and the south jamb appears stepped or to have originally been slightly wider (Plate 55). There is an area of plywood boxing in the centre, forming a tube or chute against the wall and a window at the south end. This too was originally a loading doorway and has a two-light metal casement in the top while the lower part is filled with boards (Plate 56). The south elevation is plain although there are numerous modern fittings and attachments (Plate 57). The south end of the west elevation is open to Room F6 through a large doorway with a concrete lintel and there is stud walling attached over the wall to the north of this, incorporating a large metal lined horizontal chute and a doorway with a modern panel door with a single light leading into a staircase to the ground floor (Plate 58). Within this is another doorway to the west with a concrete lintel and brick rebuild in the base of the jambs, suggesting it was originally a window or perhaps loading doorway. The door has a plain surround and plain panel door with a single long light. The remainder of the west elevation proper is fairly plain, with modern fixings and timber sheeting over the north end.

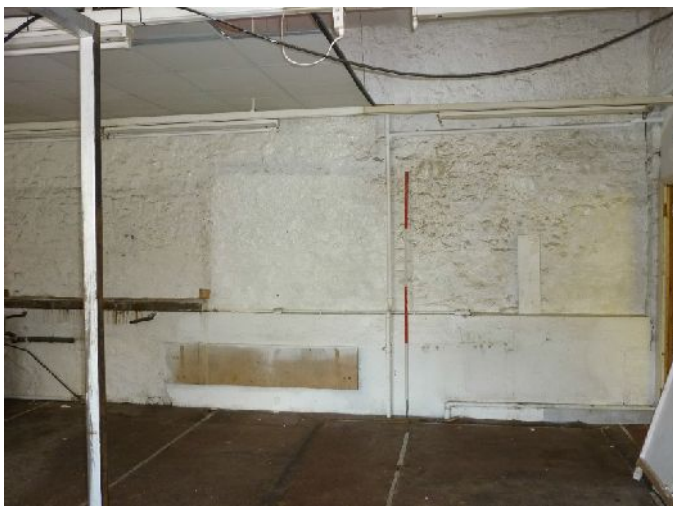
Plate 59 (left): North elevation of Room F6

4.3.18 **First Floor, Room 6:** the floor is covered with vinyl, probably with a timber floor below. There is a suspended tile ceiling over most of the room, although the north-east corner is open and the ceiling above this is finished with plasterboard. The walls are painted stone and concrete skim. All the walls have a step about 0.8m above the level of the floor. The top is finished with concrete, perhaps where the building has been raised in height. The north elevation is concrete built on top of the west end of the step (Plate 59) and appears to butt the east elevation. The east elevation has a door on the north side and rebuild in the lower part of the jambs continues into the step where it is topped with concrete. The south end of the east elevation has a large opening which forms one end of a metal-lined chute, which cuts through the step in the wall, with a concrete lintel above. The north side of the opening has been rebuilt above the step, suggesting the opening was inserted (Plate 60). The doorway in the east elevation to the north side extends above the lower concrete lintel to a timber lintel and the gap is filled with board. There is a window in the south elevation, near the centre, with rebuild around and a concrete lintel (Plate 61). The west elevation is covered by panel boxing, hiding electric meters and the like, with a cupboard built in on the south side (Plate 62). The wall behind is apparently plain, although a high-level window was visible in this elevation from outside.

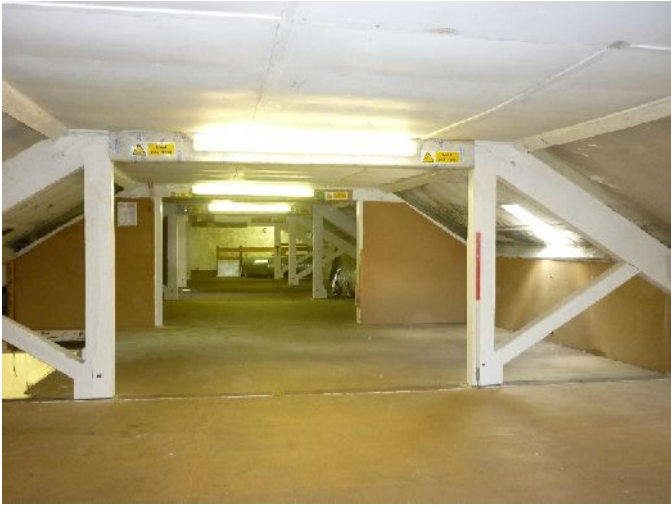
Plate 63 (left): Lower part of the trusses in Attic Room 2

4.3.20 **Attic, Room 2:** this room is above F5. The floor is modern chipboard, fixed either side of tie beams or trusses. It is not clear if the floor is on original joists or not. Six trusses are visible, each a tie beam with principles and additional queen posts with angled braces, jointed and strapped to the principles and supporting a collar from which a king post supports the ridge purlin (Plate 63; Plate 64). Some have chiselled carpenter's marks. The northern two are marked 'VIII' and 'X' from west to east, then 'XI' and 'XII' at the junction of queen posts and tie beam. Then there are no carpenter's marks until two from the south end, where there is a 'III' on the junction with the brace and principle rafter on the west side, one up from south end, and then 'I' and 'II' from west to east on the southernmost at the junction with queen posts and tie beam. The arrangement of carpenter's marks is odd: there are enough trusses for the numbers given but not enough marks and they are not quite in the right order, all of which suggests that they have perhaps been reused. There is one purlin per pitch visible in the top of the roof, making two in total, and a ridge plank; the sections of purlin are attached with hooked scarf joints (Plate 66). The tops of the queen posts carry on to rafters. The south king post is marked 'VIII' at the top, but it was too difficult to access the rest. The joists appear quite modern and there are several large sets of Baltic marks on the south truss on the west face of the tie beam and principle rafter and truss marked XI and XII also have Baltic marks on the east face of the west queen post. There are multiple skylights, almost one per bay, in both sides. Most have a single light, some are covered with board, while the east and west ones at the south end have nine-light iron casements (Plate 68).
