THE MINT CAKE WORKS, CROSS LANE, KENDAL, CUMBRIA

Archaeological Building Recording

Planning Application Reference:
SL/2011/0494

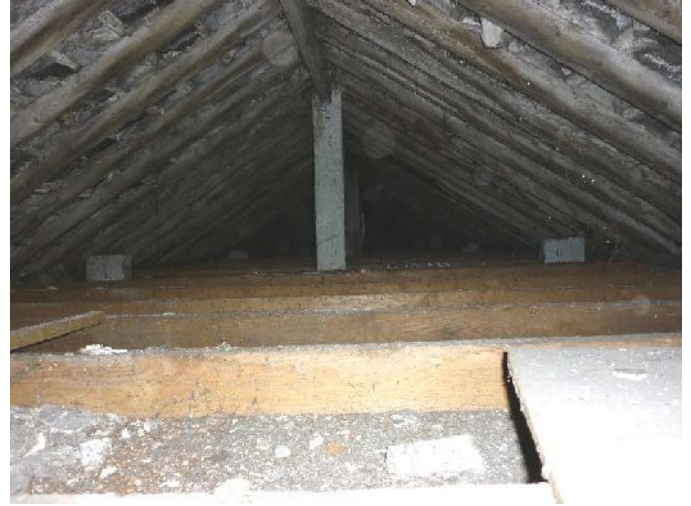
Plate 64 (right): Upper part of the truss above Attic Room 2

4.3.20 **Attic, Room 2:** this room is above F5. The floor is modern chipboard, fixed either side of tie beams or trusses. It is not clear if the floor is on original joists or not. Six trusses are visible, each a tie beam with principles and additional queen posts with angled braces, jointed and strapped to the principles and supporting a collar from which a king post supports the ridge purlin (Plate 63; Plate 64). Some have chiselled carpenter's marks. The northern two are marked 'VIII' and 'X' from west to east, then 'XI' and 'XII' at the junction of queen posts and tie beam. Then there are no carpenter's marks until two from the south end, where there is a 'III' on the junction with the brace and principle rafter on the west side, one up from south end, and then 'I' and 'II' from west to east on the southernmost at the junction with queen posts and tie beam. The arrangement of carpenter's marks is odd: there are enough trusses for the numbers given but not enough marks and they are not quite in the right order, all of which suggests that they have perhaps been reused. There is one purlin per pitch visible in the top of the roof, making two in total, and a ridge plank; the sections of purlin are attached with hooked scarf joints (Plate 66). The tops of the queen posts carry on to rafters. The south king post is marked 'VIII' at the top, but it was too difficult to access the rest. The joists appear quite modern and there are several large sets of Baltic marks on the south truss on the west face of the tie beam and principle rafter and truss marked XI and XII also have Baltic marks on the east face of the west queen post. There are multiple skylights, almost one per bay, in both sides. Most have a single light, some are covered with board, while the east and west ones at the south end have nine-light iron casements (Plate 68).
